## STONY PLAIN REGION GEOHAZARD RISK ASSESSMENT SITE INSPECTION FORM

| <b>SITE NUMBER AND NAME:</b><br>NC 23 – Landslide near Greenwood Lake Road | <b>HIGHWAY AND KM:</b><br>Hwy 39:06, km 13.08 | <b>PREVIOUS INSPECTION DATE:</b><br>June 10, 2014 | <b>INSPECTION DATE:</b><br>June 16, 2015 |

| <b>PRIMARY SITE ISSUE:</b> Highway situated on a large historic landslide which is failing primarily north toward Modeste Creek; the lower west flank portion continues to move which has previously caused pavement distress. | |

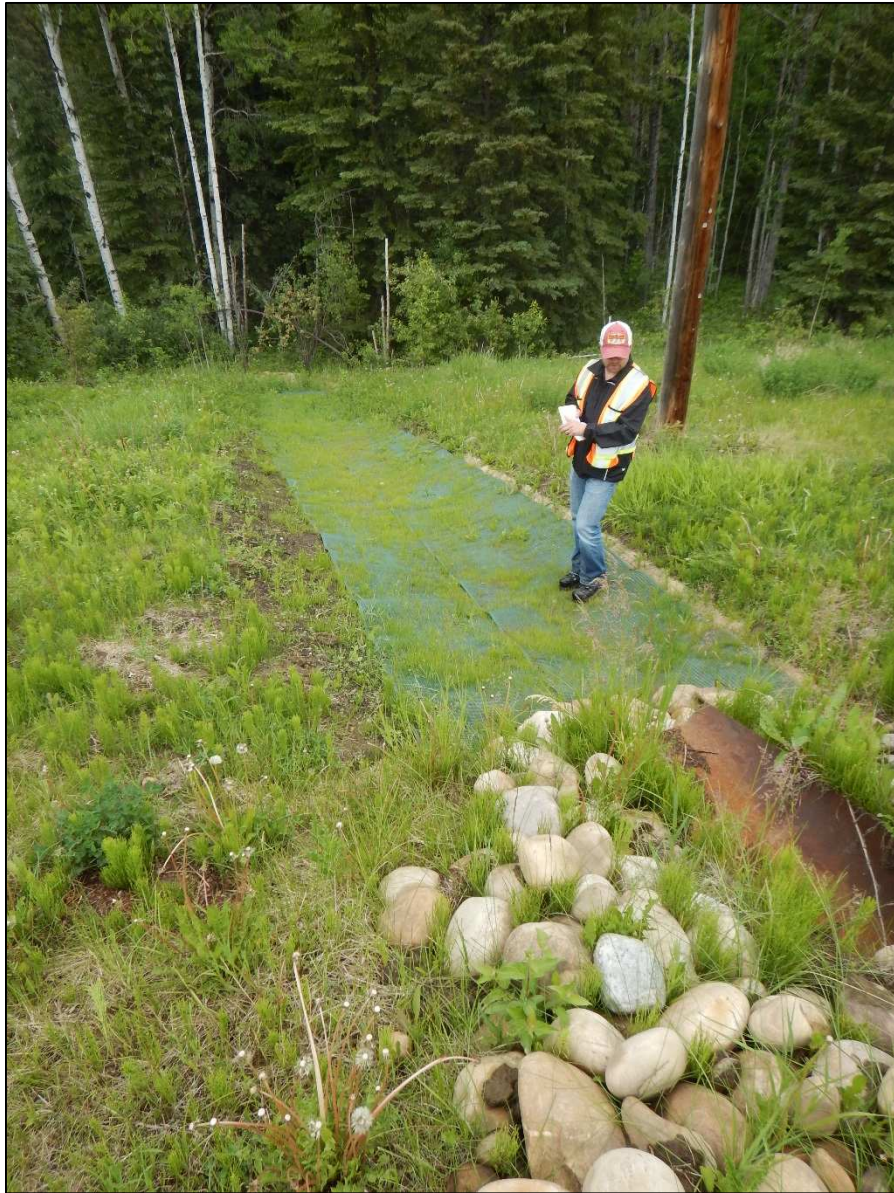
- A culvert located at approximate km 13.1 historically discharged onto a small armoured splash pad located at the midpoint of the north facing slope. The splash pad consisted of sparsely placed rounded to sub-rounded rip-rap extending approximately 1 to 2 m past the culvert outfall. During sustained or intense precipitation events, water drains over the splash pad onto the lightly vegetated fill which has formed a channel extending from the splash pad to the toe of the embankment. This issue was addressed in 2015 through installation of a soft revetment, scour protection mat extending from the culvert outlet to the toe of the slope. The rip-rap from the old splash pad was collected and anchored at the culvert outlet for additional energy dissipation and protection. The system appeared to be performing relatively well during the site visit.

**Photo 1:** Recently installed erosion and sediment control at outlet of east culvert

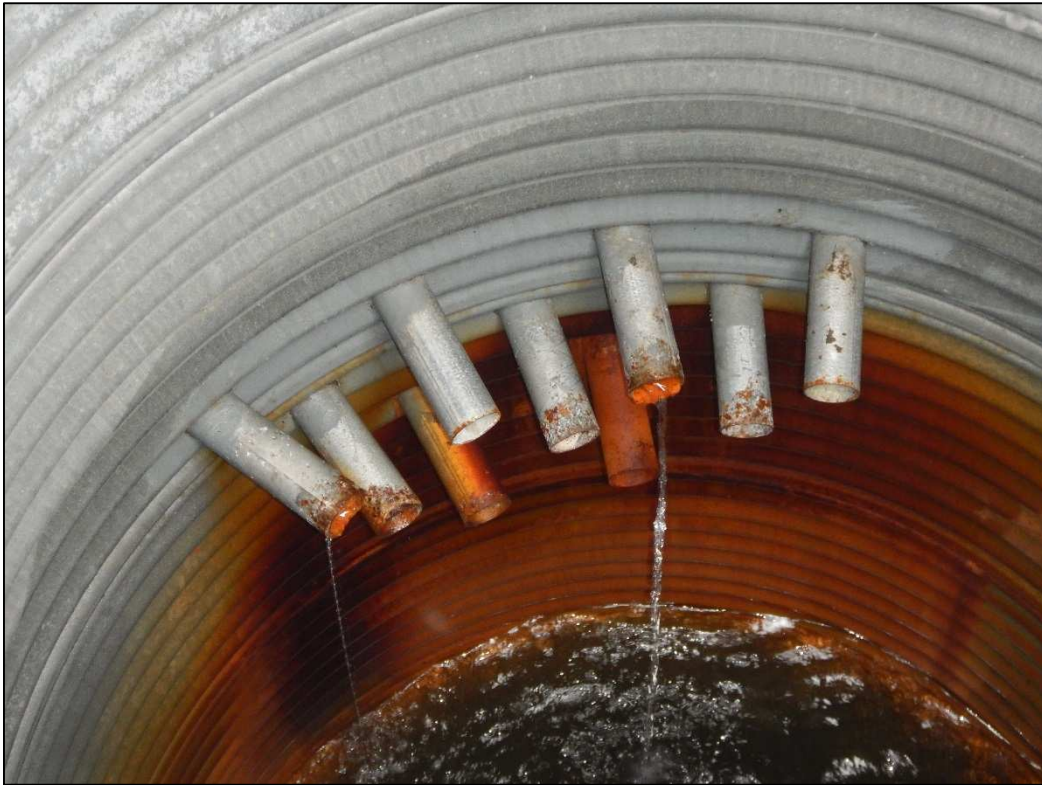
- The horizontal drainage galleries located at the toe of the embankment near Modeste Creek were inspected. The east gallery was opened and zero of the nine drainage pipes were observed to be flowing. The west gallery was opened and two of the nine drainage pipes was observed to be flowing.

**Photo 2:** West drainage gallery – two of nine running

- All drains beneath the passing lane fill should be exposed to ensure they are operating adequately. They should be extended and backfilled with free drainage gravel. A proposal has been submitted to AT for this work (File No. PE12101119, dated May 13, 2009). This proposal also includes steam cleaning of the horizontal drains to improve drainage of ponding water and groundwater from upslope to the drainage galleries located at the toe of the embankment near Modeste Creek. Tetra Tech EBA can provide an updated proposal if required.

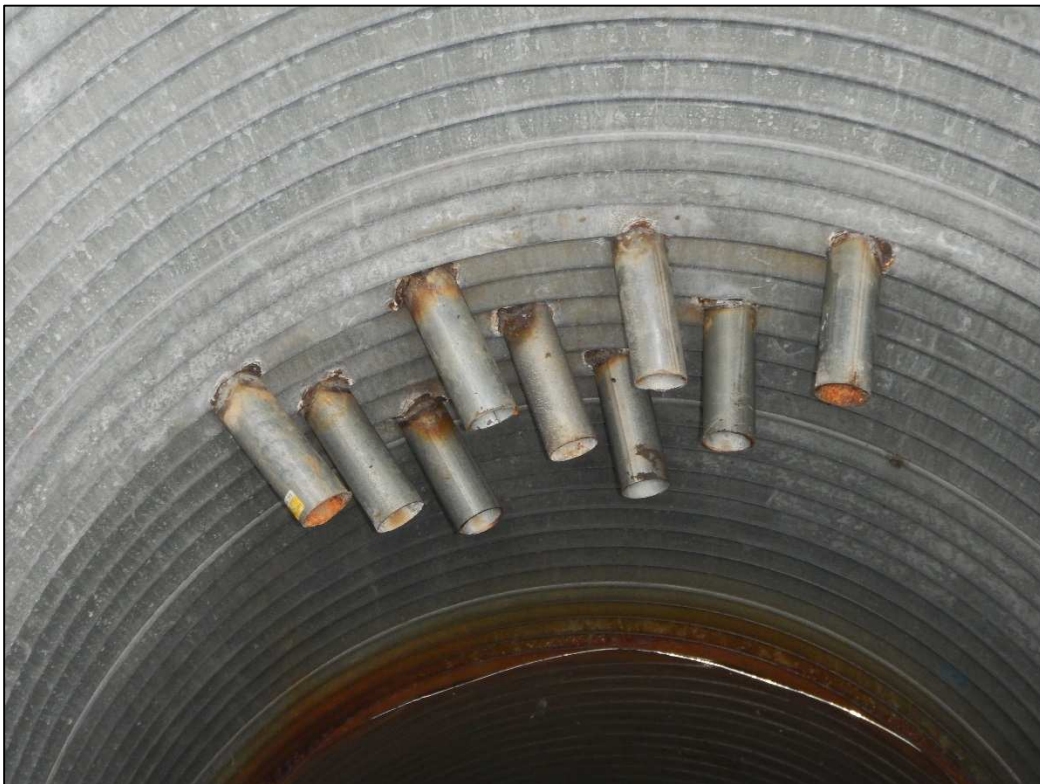
**Photo 3:** East drainage gallery – zero of nine running

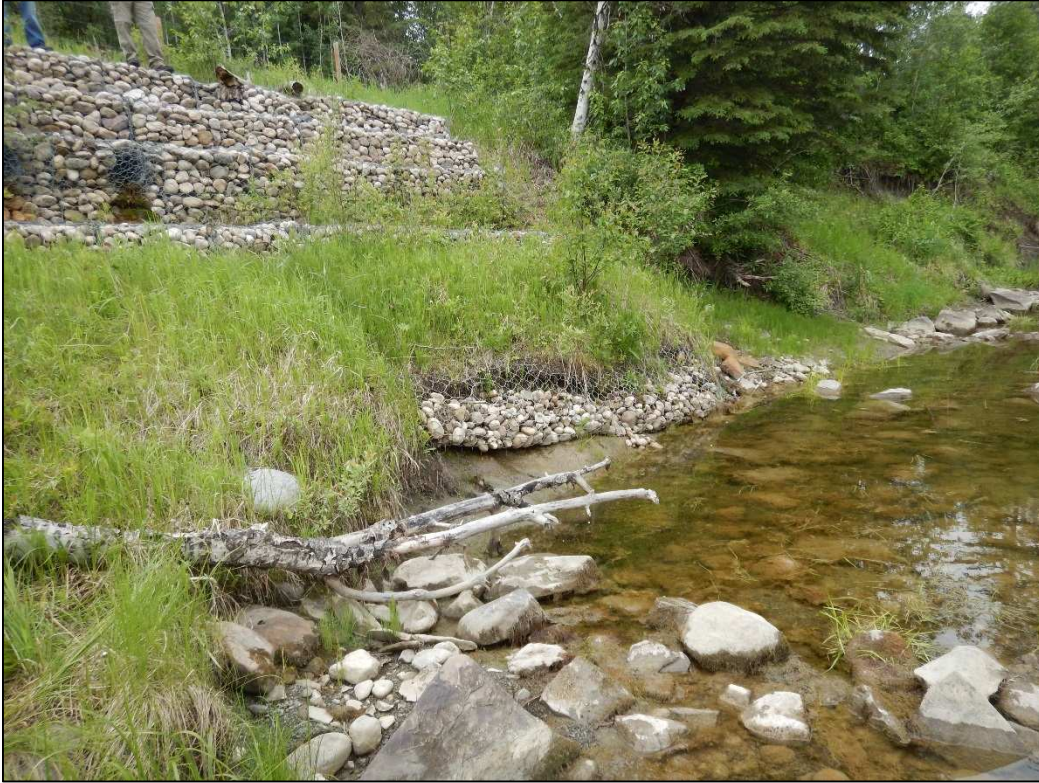
- The gabion basket structure that supports and armors the drainage gallery discharge was in relatively good condition aside from minor basket bulging. As noted in previous inspections, some minor erosion from surface water flow was noted on the west flank of the structure. The culvert installed through the gabion basket was conveying water from the drainage galleries to Modeste Creek.

**Photo 4:** Erosion and deformation of gabion baskets along riverbank at toe of slope

- The silt fence at the toe of the north facing slope can be removed as vegetation has been established.
- Erosion occurring at the west flank of the gabion structure adjacent to the drainage galleries should be repaired. It is understood that AT is currently initiating a program to address this item.

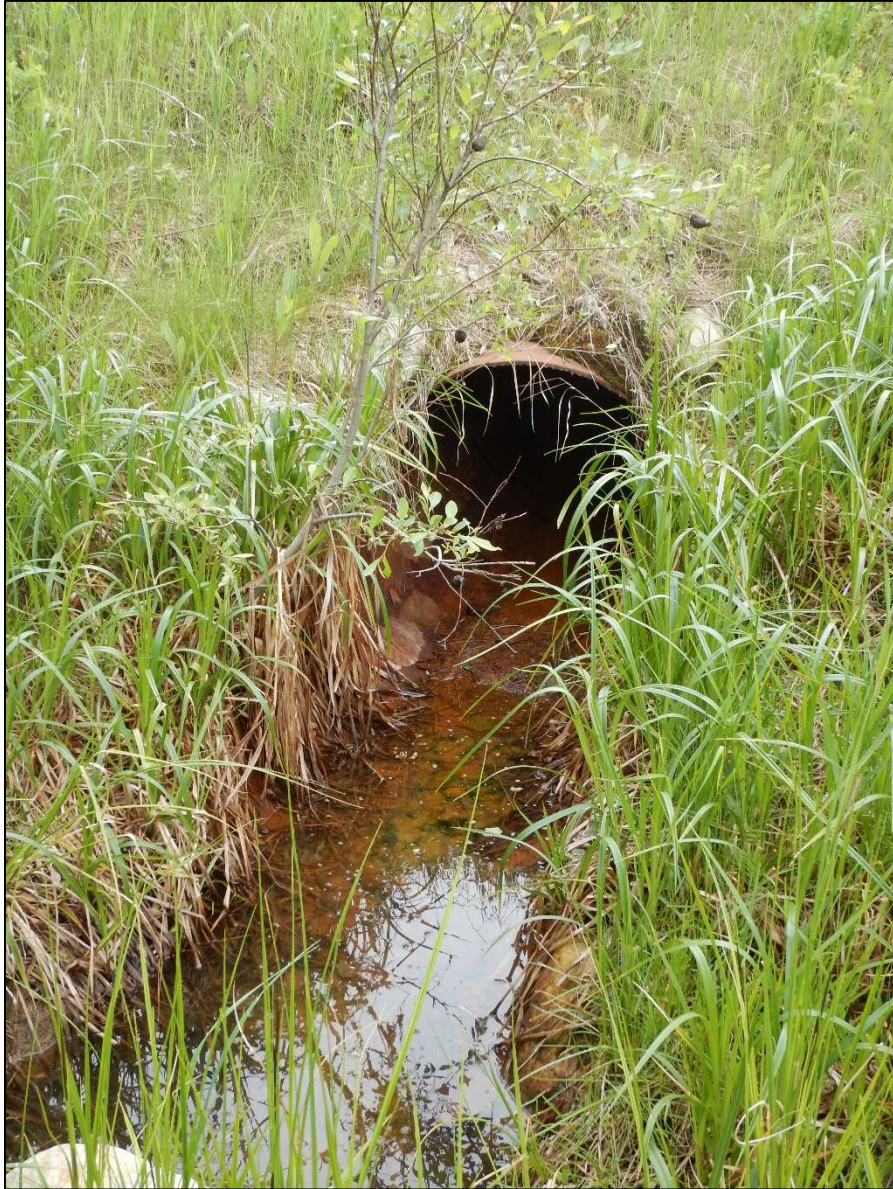
**Photo 5:** Ponding water at west culvert outlet

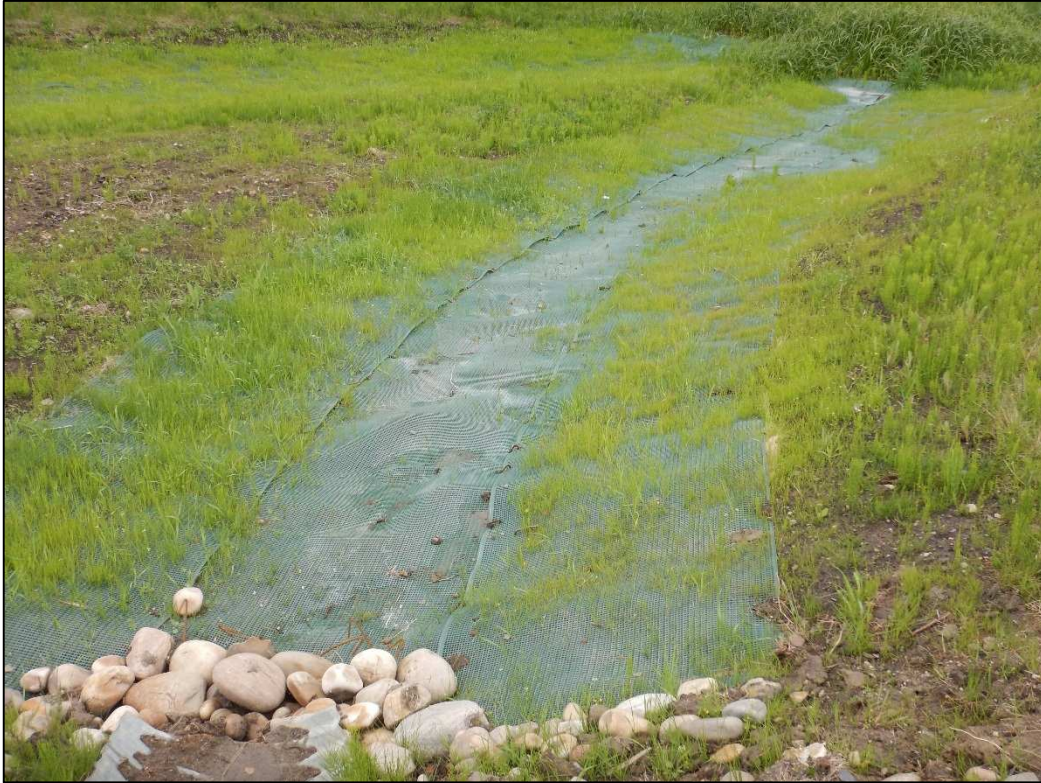
**Photo 6:** Erosion and sediment control installed along drainage path immediately west of the site

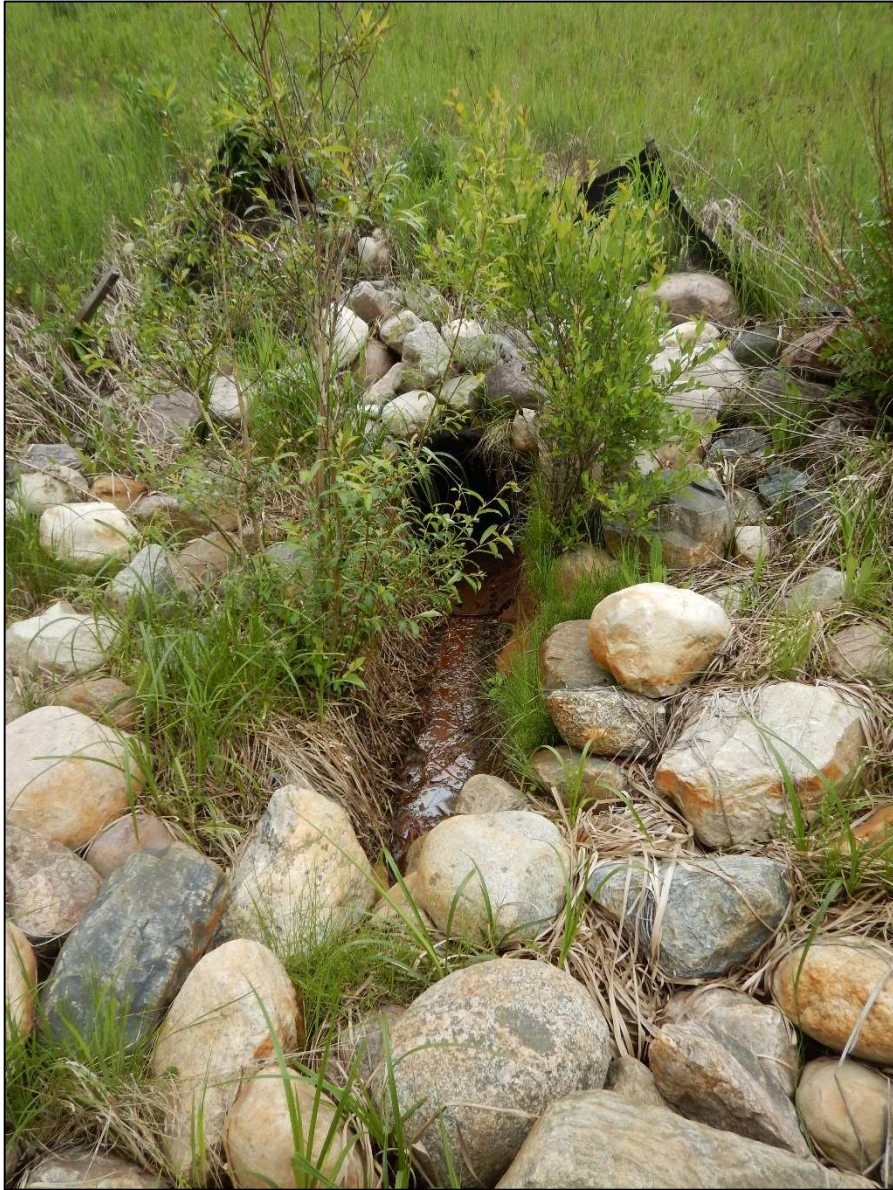
**Photo 7:** West culvert inlet protection well vegetated
