## GEOHAZARD RISK MANAGEMENT PROGRAM

### North Central Region – Edson / Stony Plain Area

#### 2016 Inspection Report

Site Number	Site Name		Hwy	km
NC23	Landslide near Greenwood Lake Road		39:06	13.08
Legal Land Description	NE 4-49-5-W5M			
NAD 83 Coordinates	3TM 114	N5896868	E -44710	
Operational Site Instrumentation	Slope Inclinometers		5	
	Pneumatic Piezometers		11	
	Vibrating Wire Piezometers		0	
	Standpipe Piezometers		3	
Date of Last Instrumentation Readings	May 29, 2016

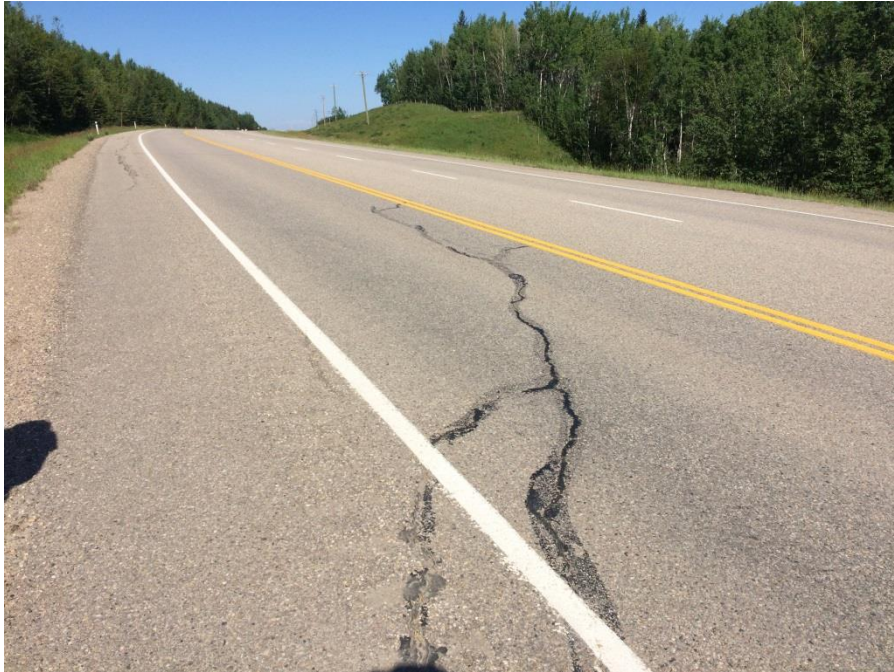
<b>Discussion</b>	<p>Pavement cracking consisting of transverse and longitudinal cracks was observed at various locations at the site as shown in Photos 1 to 3. Cracks at the site had widths up to 25 mm with no vertical differential. A slight dip in the pavement was also observed at approximately km 12+900 as shown in Photo 4.</p> <p>The three culverts at the site appeared to be in good condition. The west culvert was observed to be draining. The east culvert at approximately km 13+100 was observed to be dry with standing water in the ditch. The disturbance on the sideslope near km 12+900 noted in the 2015 inspection was not observed during this current inspection.</p> <p>A toe bulge, was observed near SI01-1 as shown in photo 5. The toe bulge was well vegetated and appears to be older.</p> <p>No flow was observed in the east drainage gallery as shown in Photo 6. Two of the nine drainage pipes in the west gallery were flowing as shown in Photo 7. These observations were similar to the 2015 inspection.</p> <p>The gabion outfall along Modeste Creek appeared to be in good condition as shown in Photo 8. Some flow was observed at the gabion outfall. This outfall was observed to be eroding in 2015. Since then, rip rap was placed in front and around the gabion outfall.</p> <p>Vegetation has begun to grow through the recently installed turf mats as shown in Photo 9.</p> <p>Similar to the 2015 inspection, the drainage channel was observed to be wet with ponded water in front of the culvert outlet as shown in Photo 10.</p> <p>No signs of visual distress were observed within the north facing slope as shown in Photos 11 and 12.</p>

**Photo 1:** Sealed pavement crack north of SI01-1 on eastbound lane. Looking northwest.

<b>Recommendations</b>	<p>Pavement cracks should be sealed to reduce surface water infiltration into the slope and pavement structure.</p> <p>Regular inspections of the culverts should also be completed to ensure water is draining out of them instead of ponding in them to reduce the risk of water infiltration into the slope.</p> <p>The culvert inlet at km 13+100 should be infilled to allow for better drainage into the culvert and reduce ponding within the ditch.</p> <p>Re-grading of the culvert outlet at km 12+900 may also be considered to promote positive drainage away from the slope. Moreover, monitoring of the disturbance area noted in 2015 along the sideslope above this culvert should be continued.</p> <p>Instrumentation monitoring should continue to be completed semi-annually with site inspections completed annually.</p>
------------------------	--

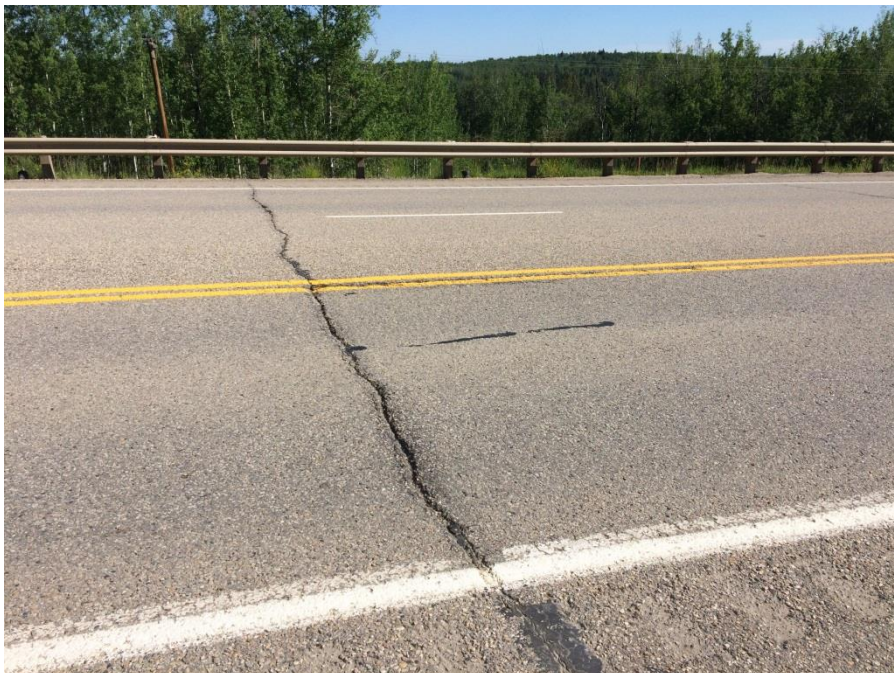
**Photo 2:** Transverse crack up to 70 mm wide. Looking north.

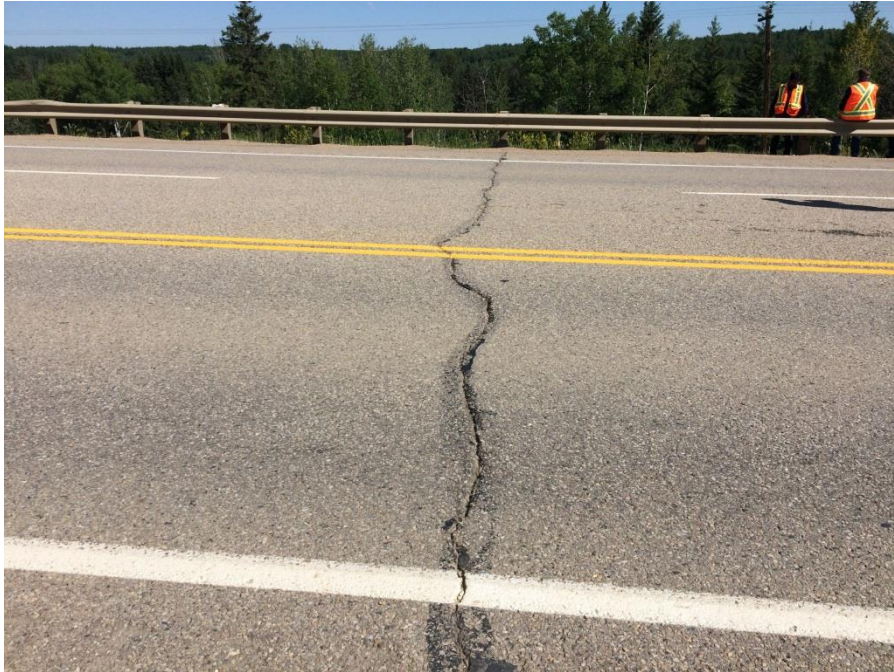
**Photo 3:** Transverse crack up to 100 mm approximately 10 m from the east culvert. Looking north.

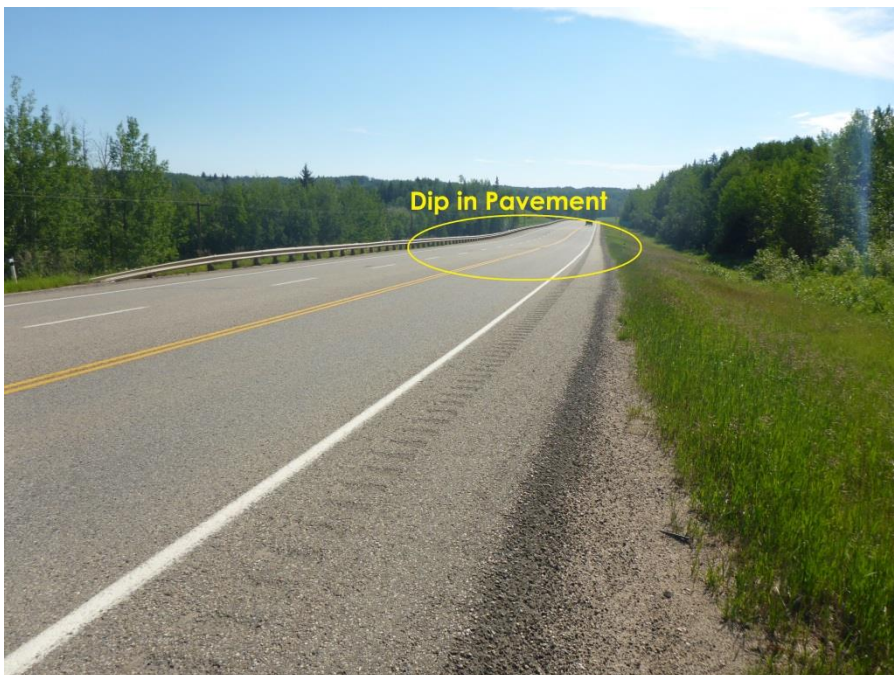
**Photo 4:** Slight dip in pavement at approximately 12+900 km. Looking east.

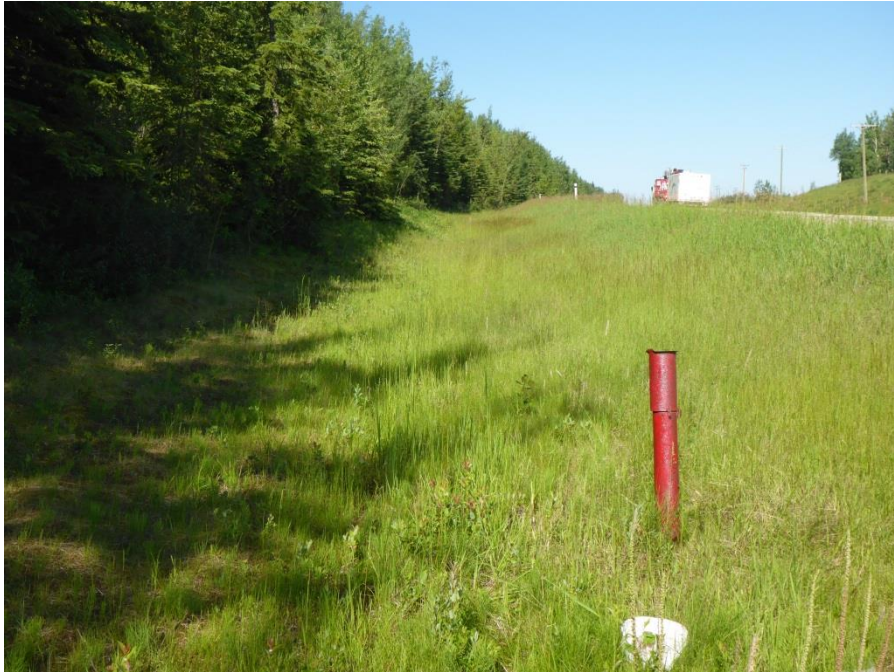
**Photo 5:** Well vegetated toe bulge south of SI01-1. Looking west.

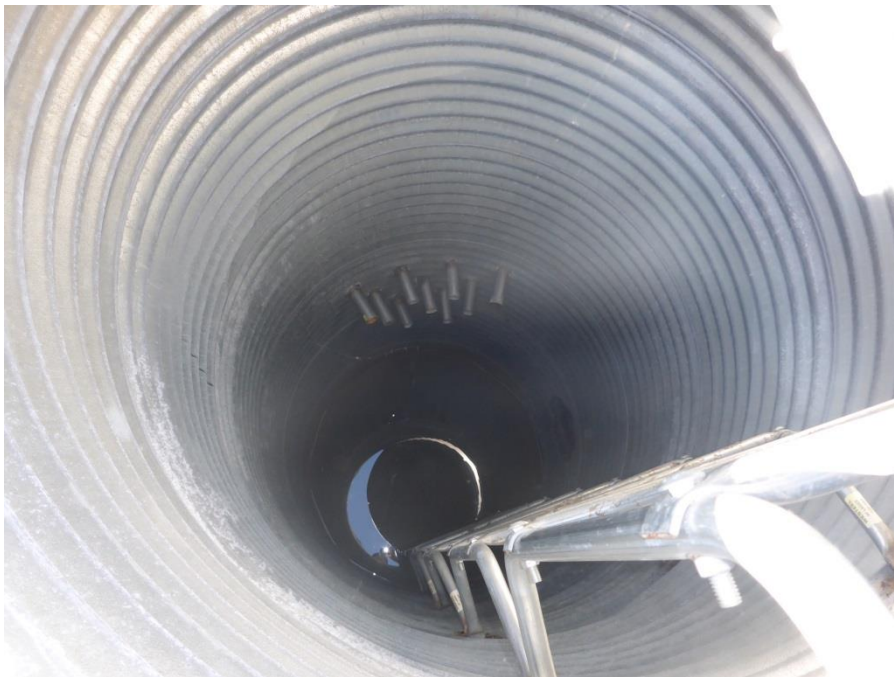
**Photo 6:** No flow in east drainage gallery.

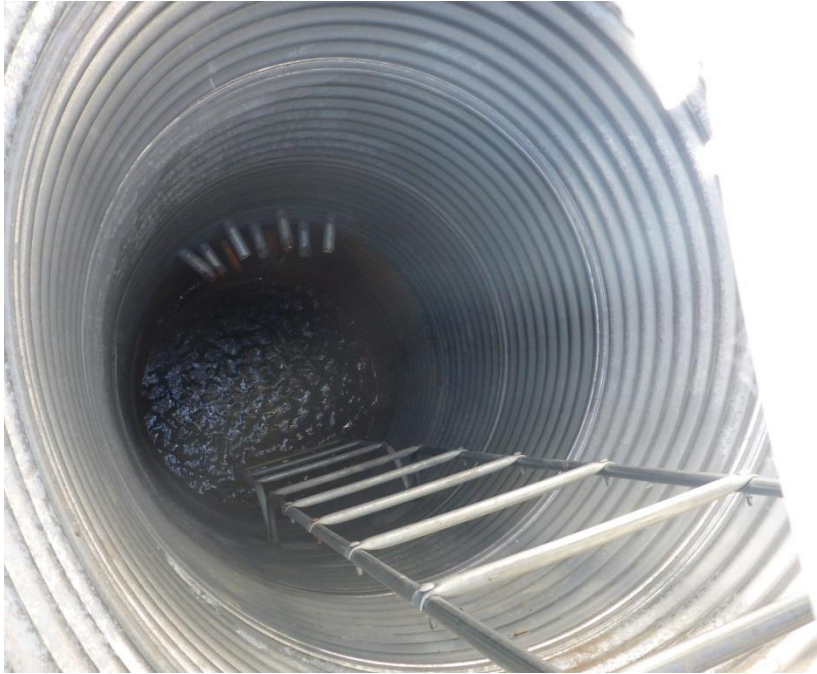
**Photo 7:** Estimated flow of approximately 1L/min in the west drainage gallery.

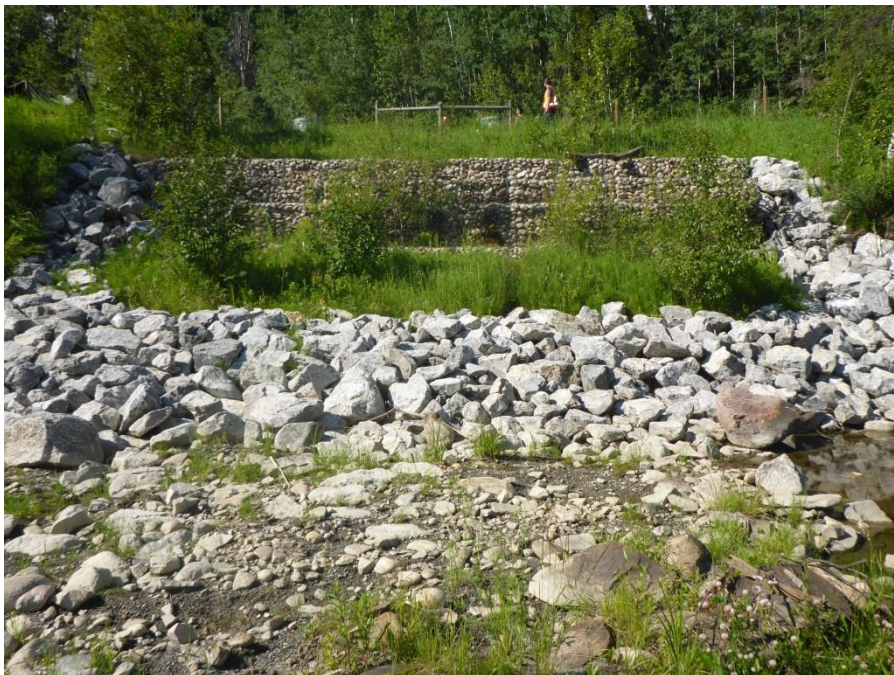
**Photo 8:** Some flow was observed out of the gabion outfall. Looking southwest.

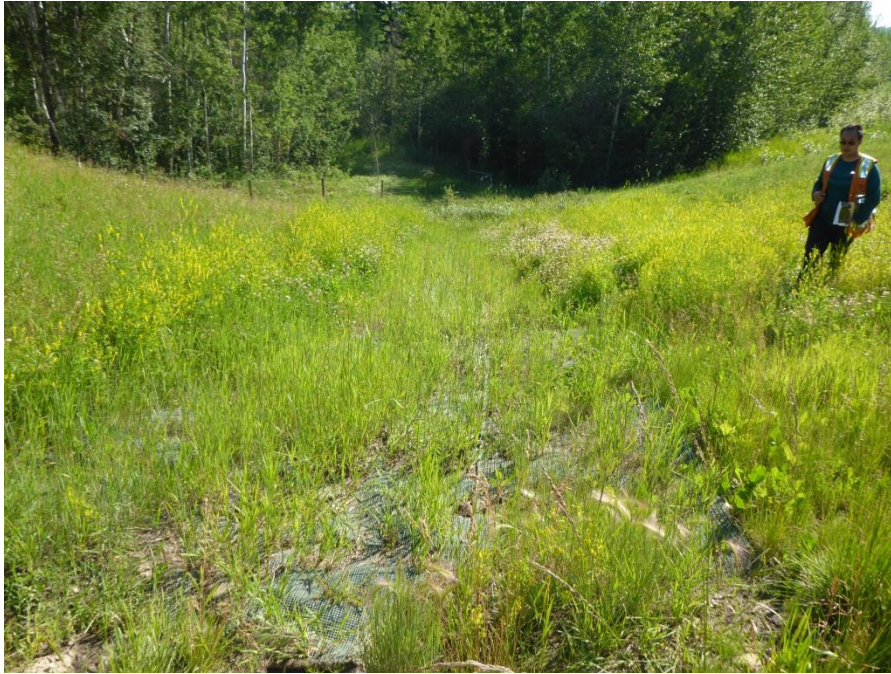
**Photo 9:** Vegetation growing through the turf mats. Looking north.

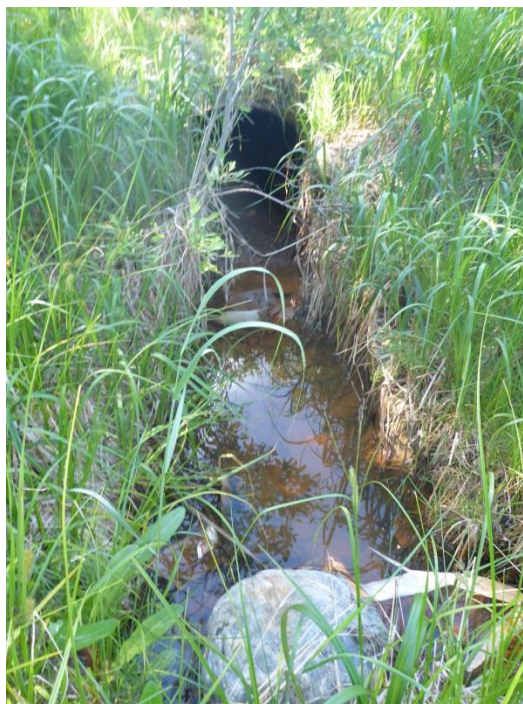
<b>Assessment</b>	<p>The piezometer measurements continued to remain stable with little change. However, piezometric levels at PN01-1, PN01-1A, and PN01-2 also remain high ranging from 1 m to 6 m below ground surface. The piezometric levels at PN01-5 to PN01-7 have been lowered since the drain construction in 2005 and remain stable indicating a functioning drain.</p> <p>Increased movements were observed at SI01-1 and may be due to the near artesian pore pressures observed at PN01-1A. The low rate of movements observed in the majority of the slope indicators are further indications that the drains are performing well.</p> <p>The east drain gallery has been noted to be not flowing for two consecutive annual inspections and may be an indication of damage.</p> <p>The south inlet at km 13+100 is too high causing water to pond in the ditch.</p> <p>The grades appear relatively flat near the culvert outlet at km 12+900 and may be hindering positive drainage away from the slope.</p>

**Photo 10:** Ponded water at the culvert outlet near km 12+900.

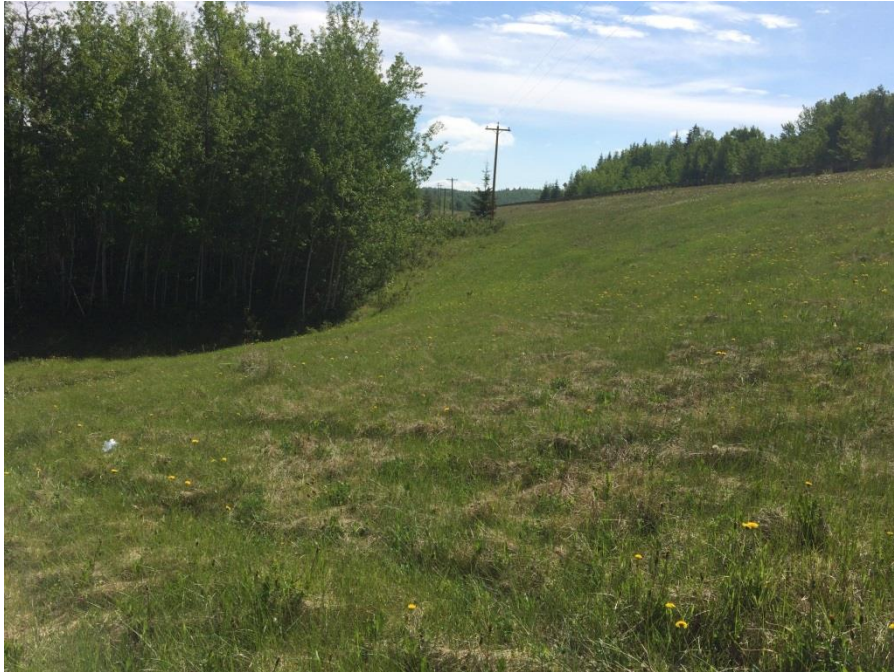
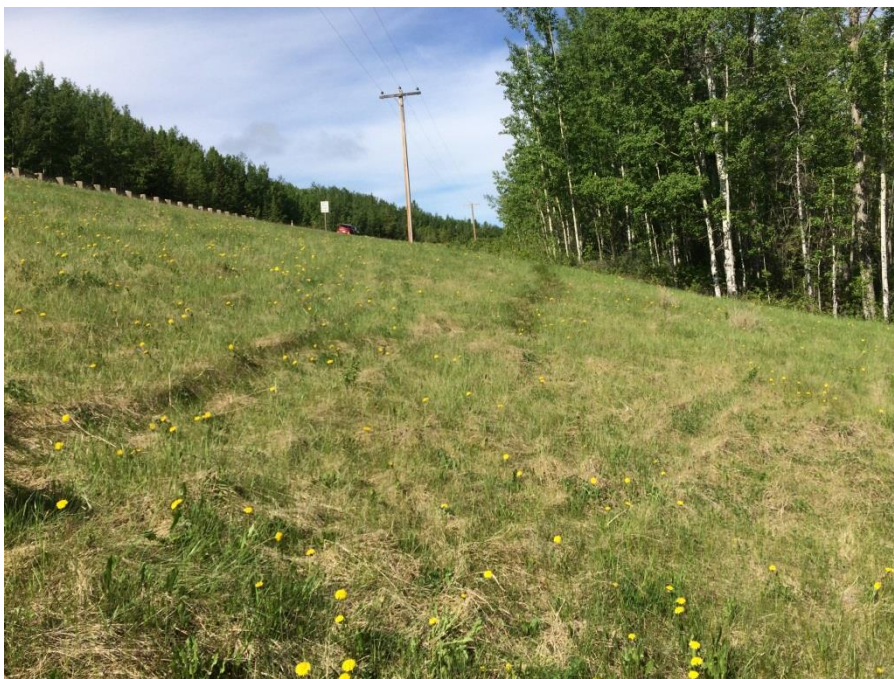
**Photo 11:** Slope north of SI09-1. Looking east.

**Photo 12:** Slope north of SI09-1. Looking west.
