Slide Name: (GP 15a) SH 727:02 Rat/Howard Creek
Inspection Date: May 4, 2005
Inspection by: Alberta Infrastructure & Transportation and EBA staff listed on Page 1

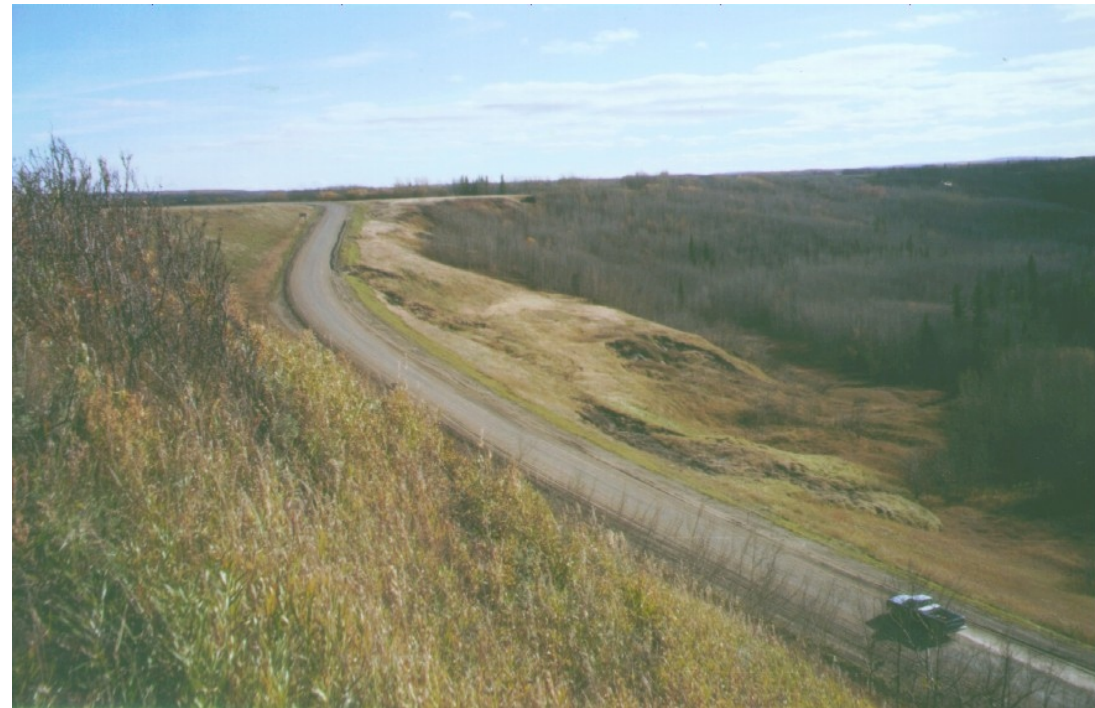
Photo 1a

Looking south from top of upland. Multiple slides along alignment down the upper portion of sidehill alignment with headscarp along shoulder edge or towards centreline. The roadway was shifted repeatedly towards the backslope upland, thus steepening the backslope to render it less stable.

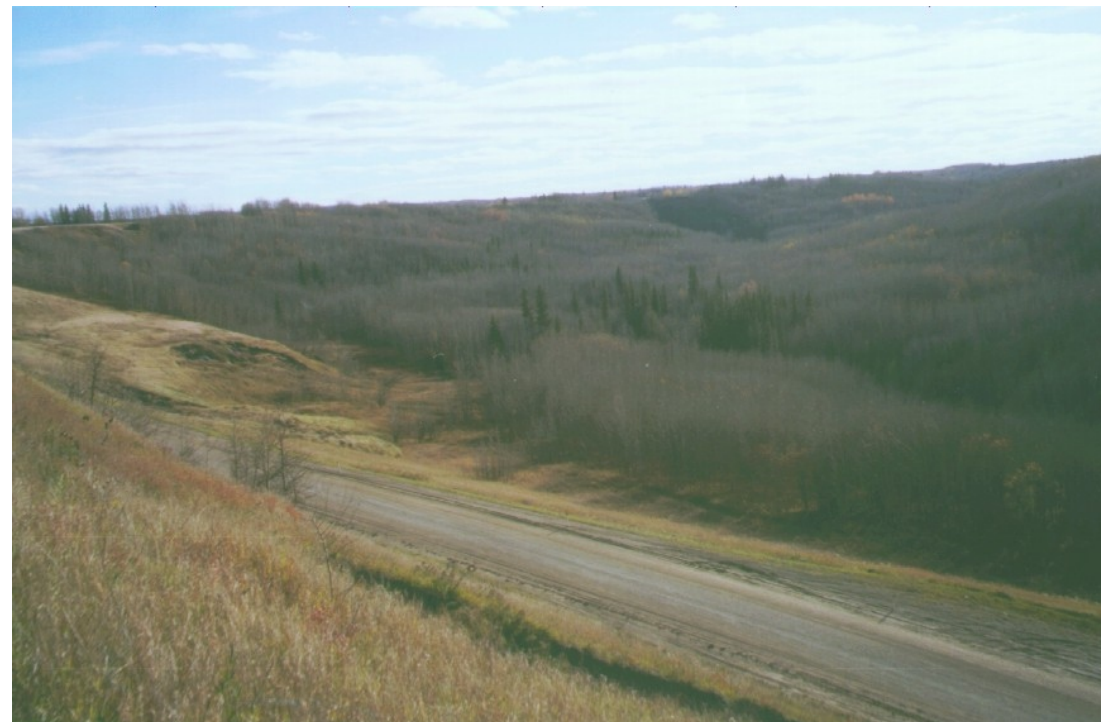
Photo 1b

Looking south from the upland. Another view of upper portion of this sidehill alignment down Rat Creek valley.

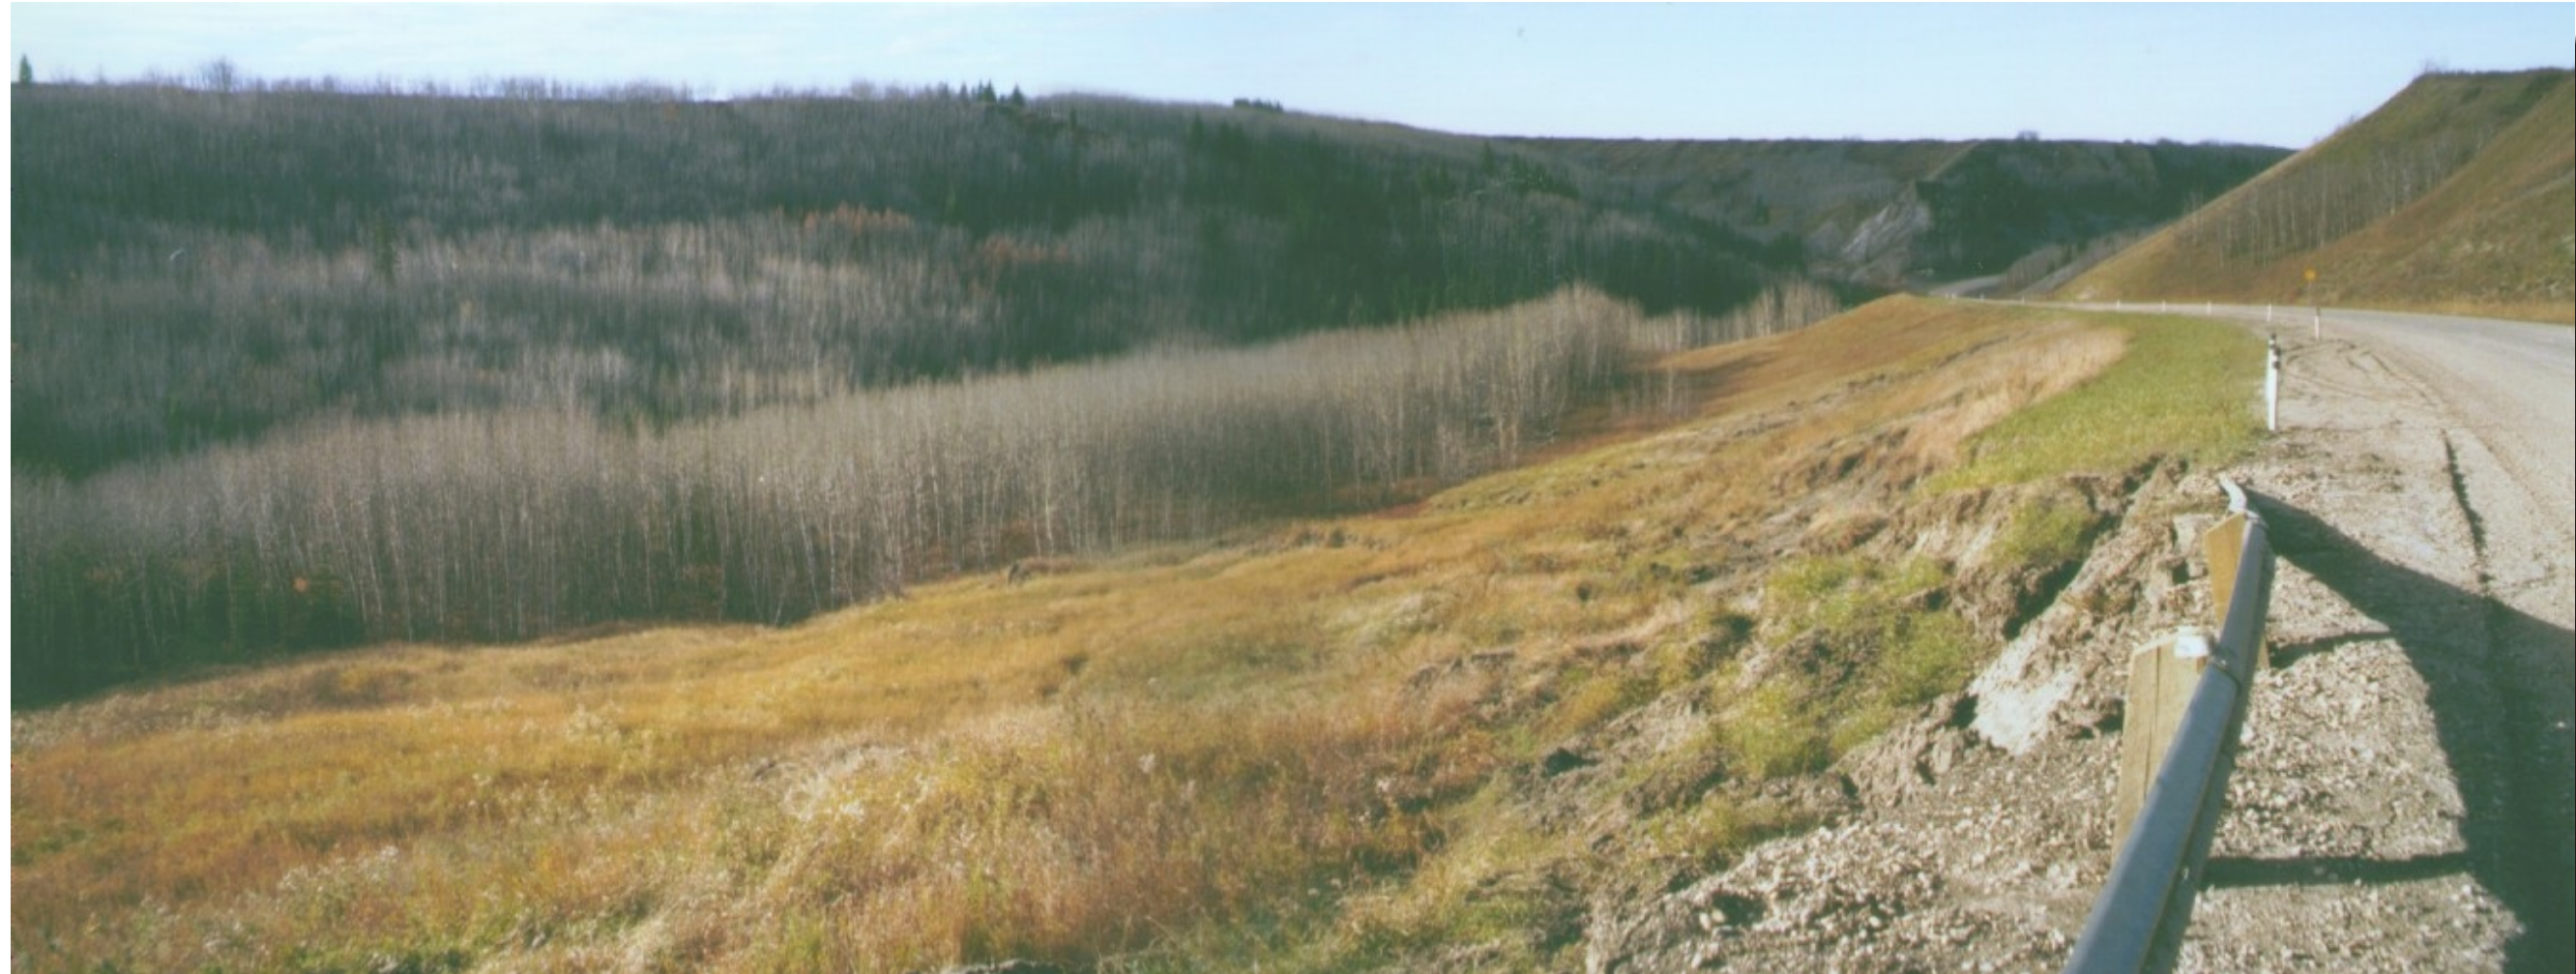
Photo 2

Looking north along highway sideslope. Slides encroachment to cross highway shoulder. Steep backslope as a result of previous shifts of alignment (away from sideslope slides towards upland).

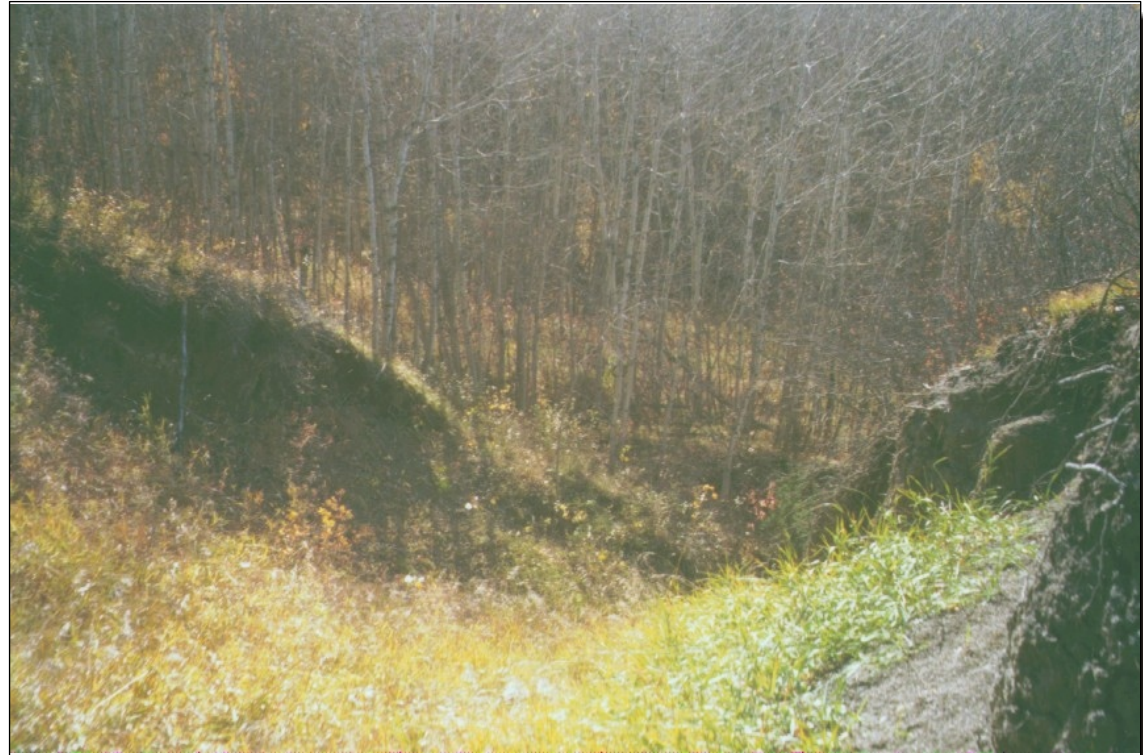
Photo 3a
Looking west down valley slope. Erosion gully at top portion of Rat Creek valley.

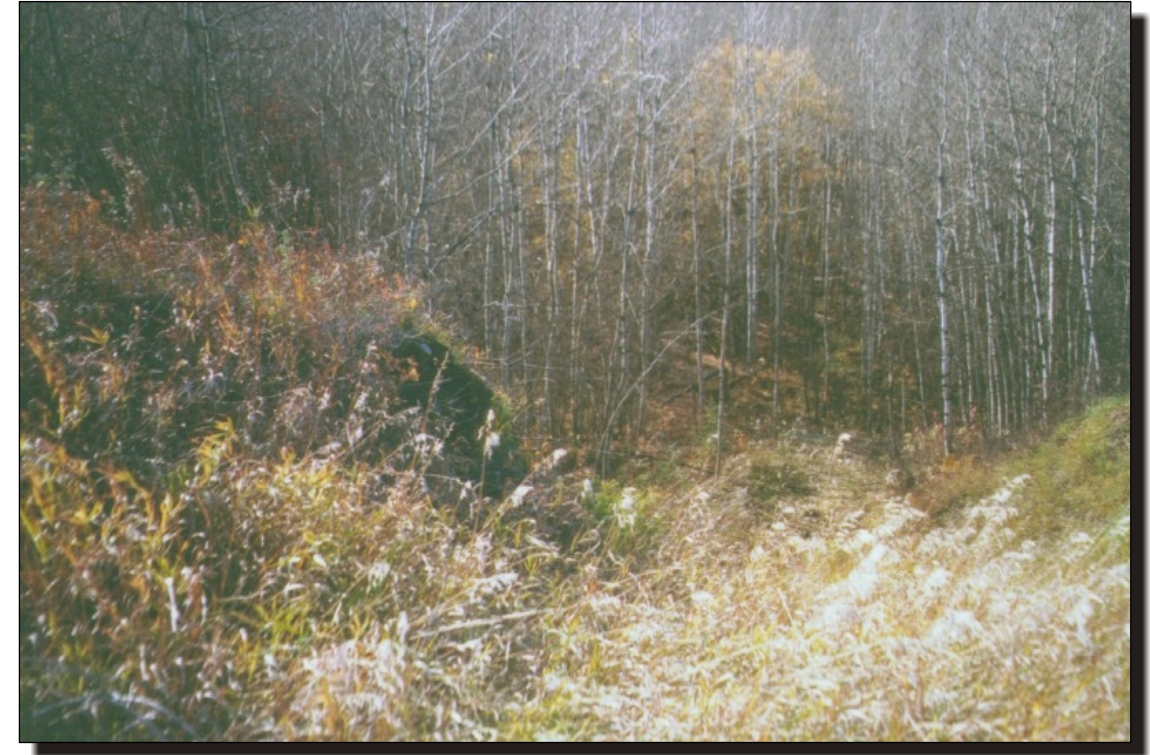
Photo 3b
Another view of erosion gully.

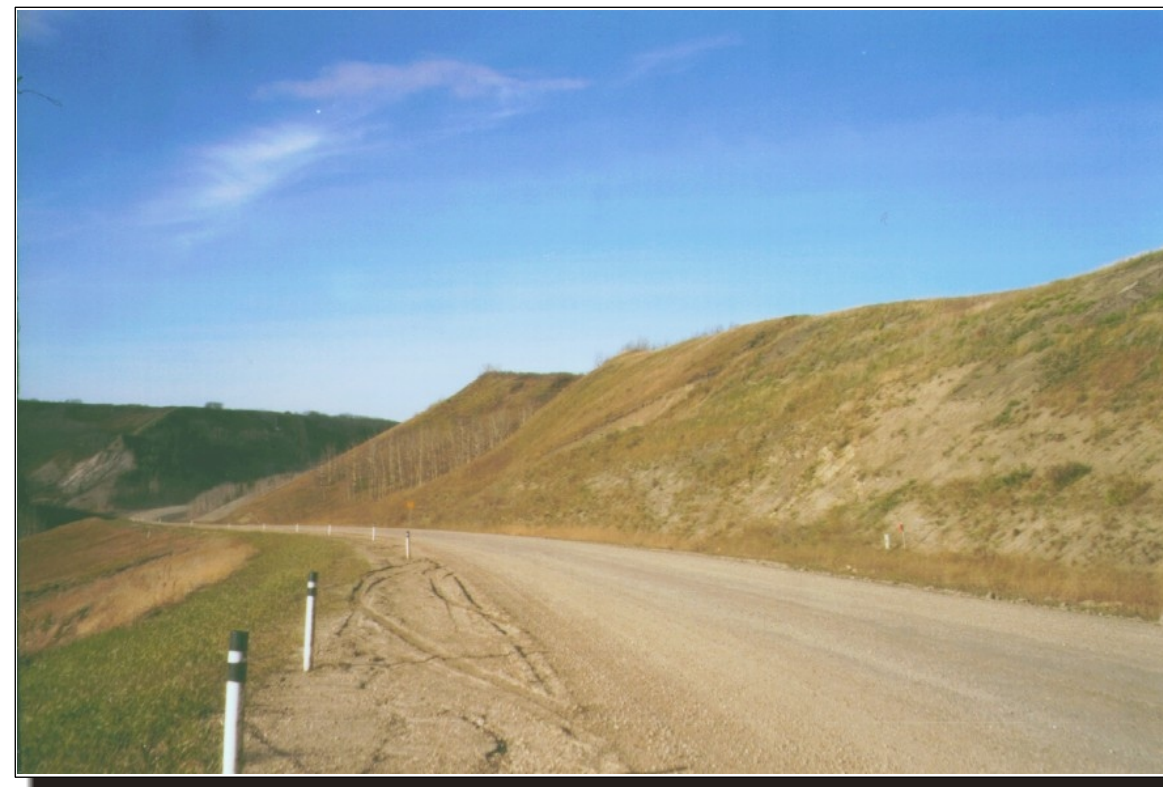
Photo 3c
Looking downgrade. Steep backslope as result of previous alignment shifts towards upland.

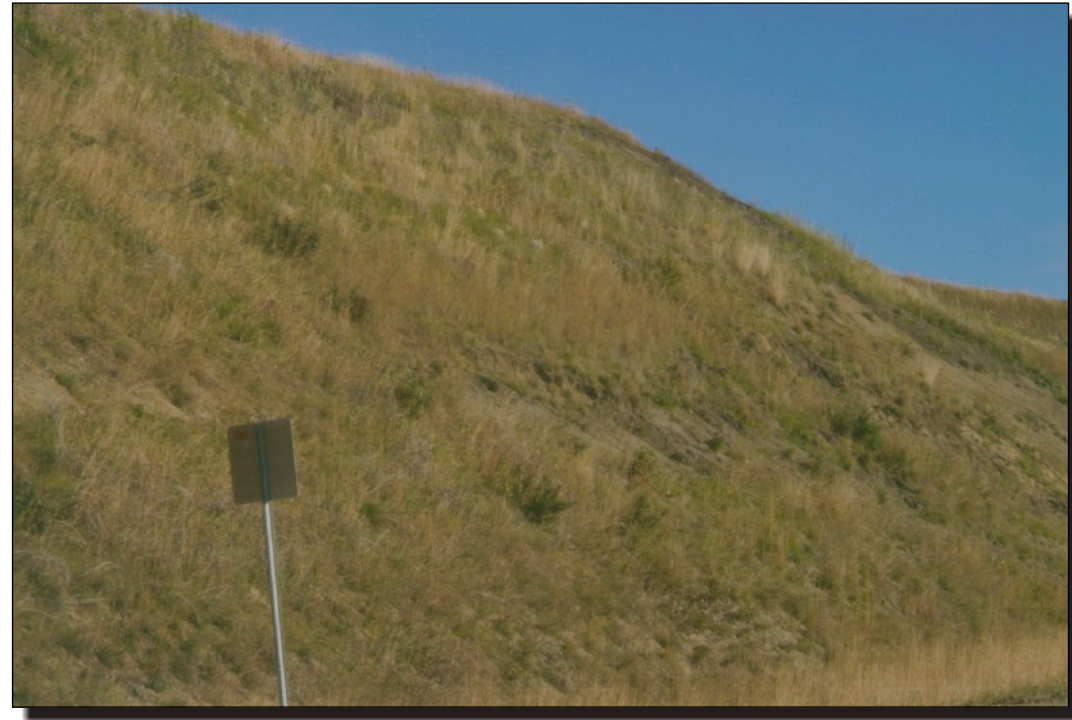
Photo 3d

Another view of steep backslope and slides under development along backslope areas in general.

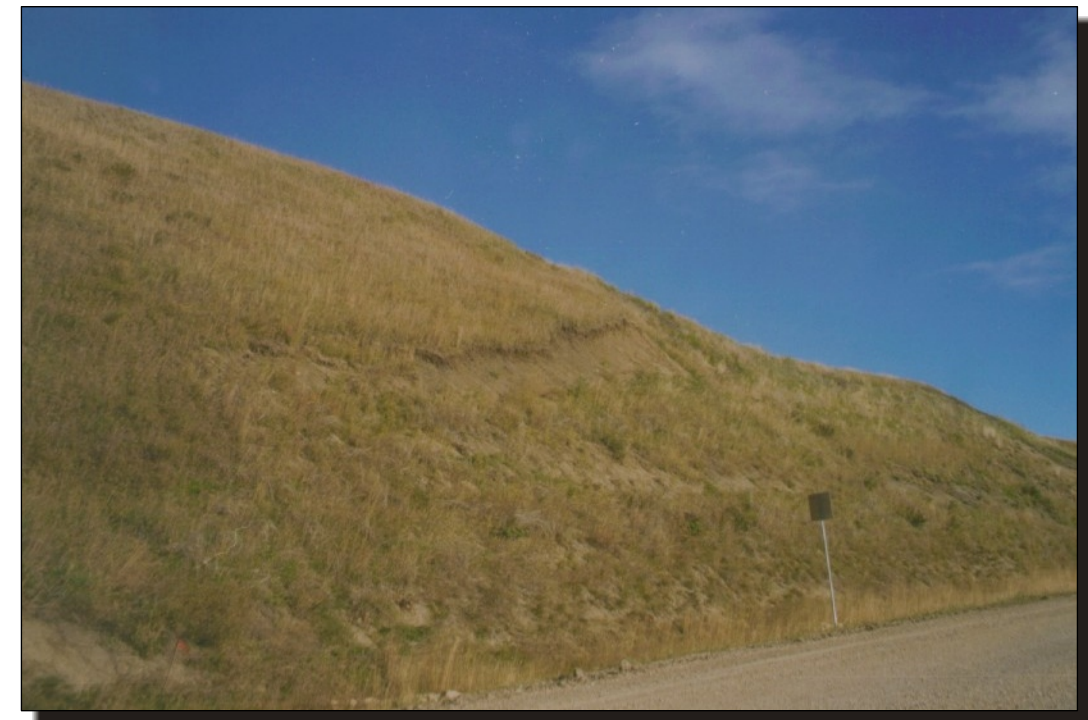
Photo 3e

Another view of steep backslope and slides under development along backslopes of the alignment.

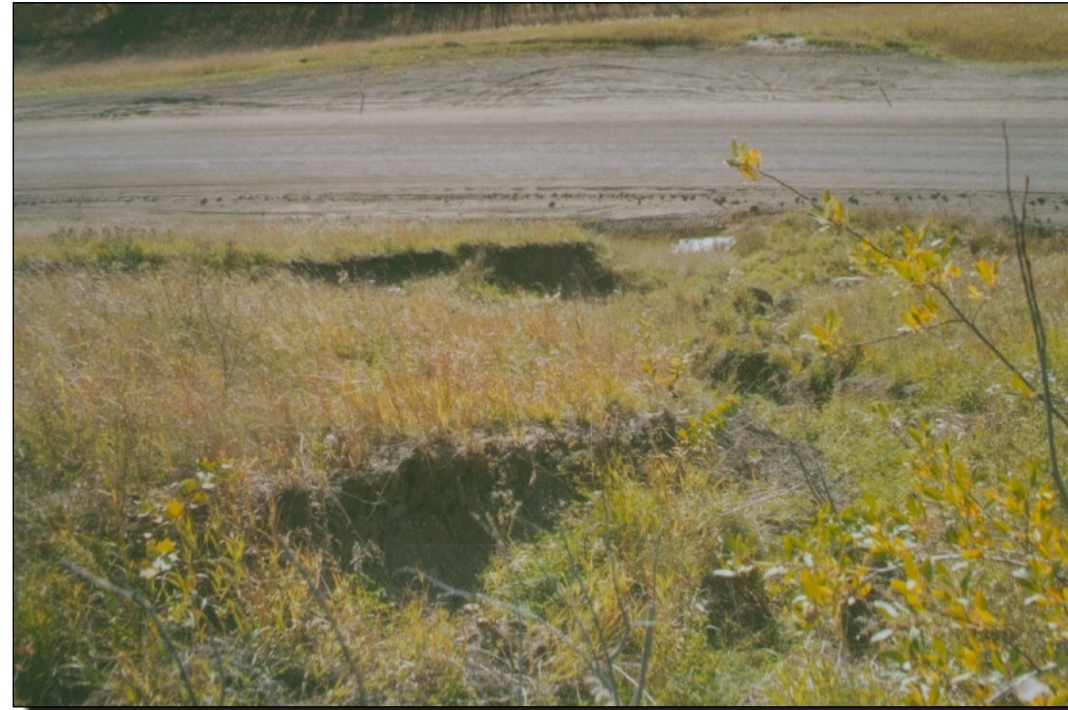
Photo 4a
Looking downslope from upland. Centre portion of alignment.
Backslope slide - erosion gulley formed from a breach of a low dyke along the upland edge causing snow melt runoff concentrated flow to erode down the backslope.

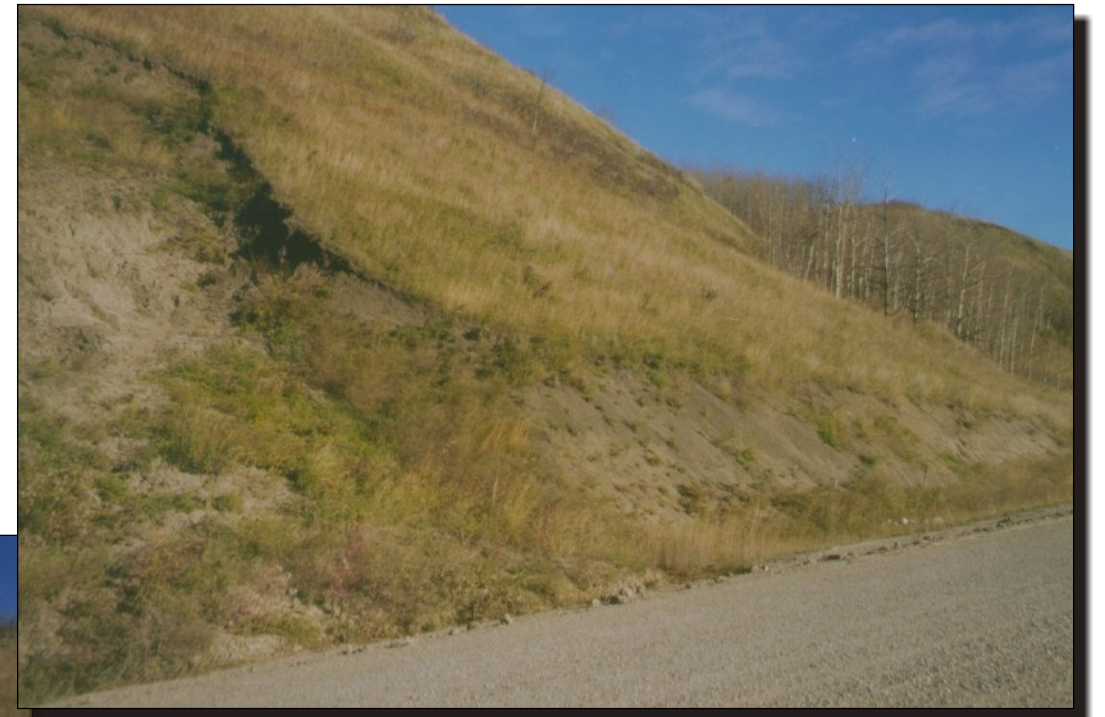
Photo 4c
Another view. Steepening of slope toe from previous shifting of alignment.

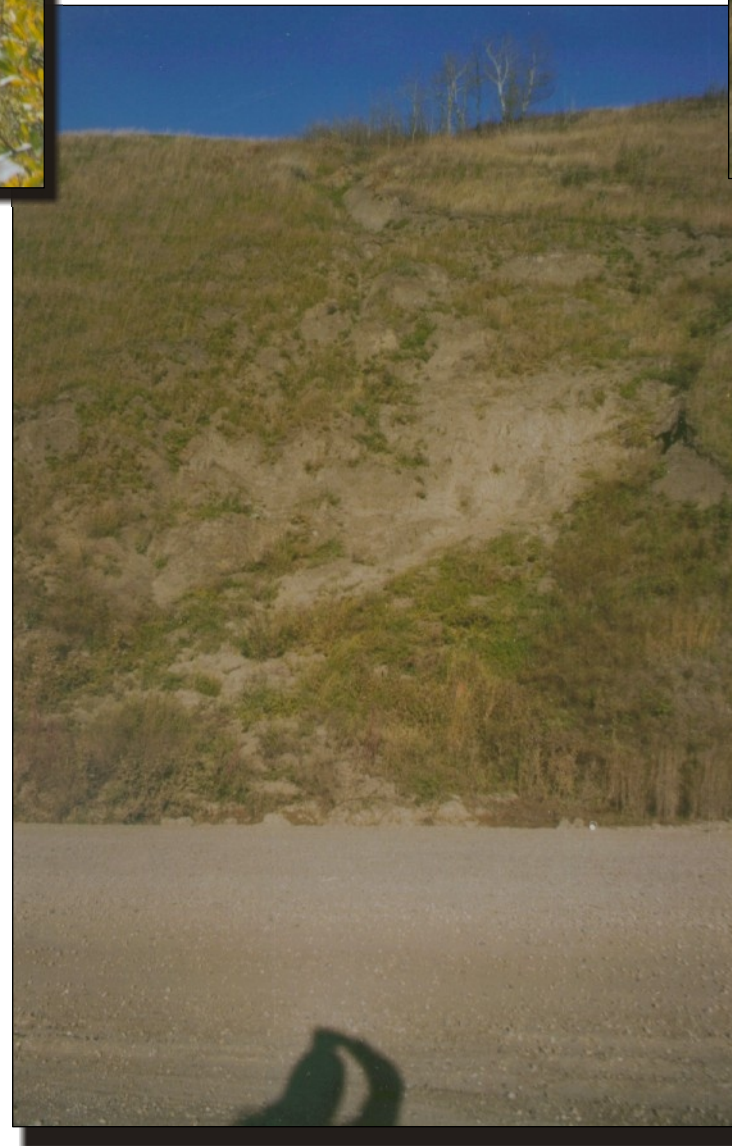
Photo 4b
Looking upslope. Erosion slide of backslope.

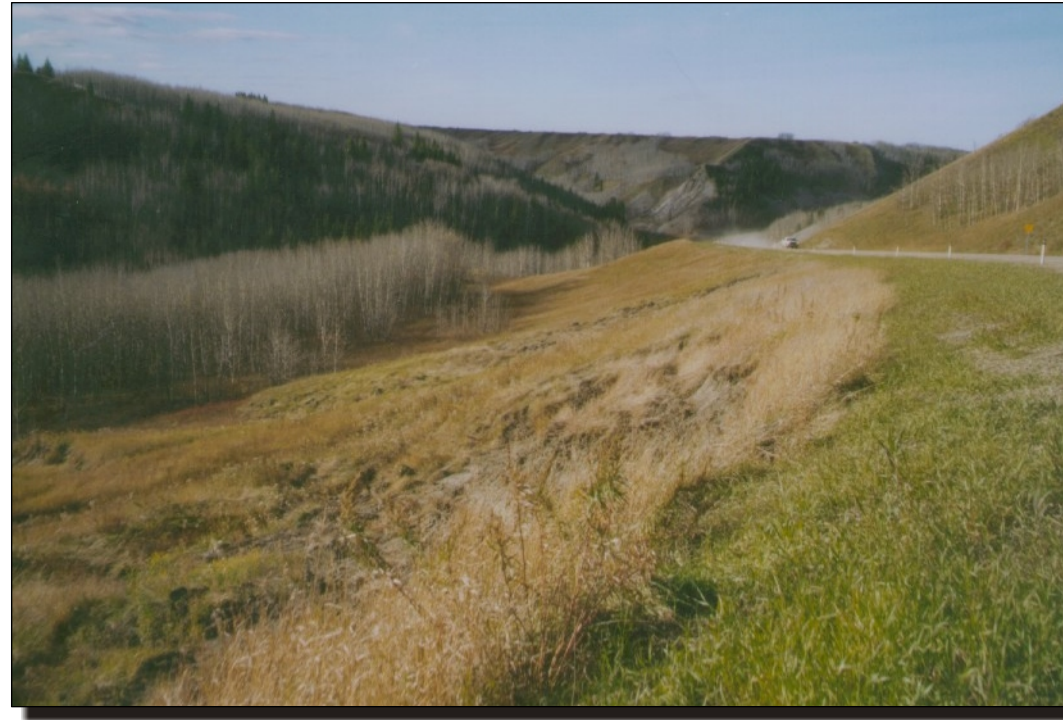
Photo 5a
Slides along sideslope.

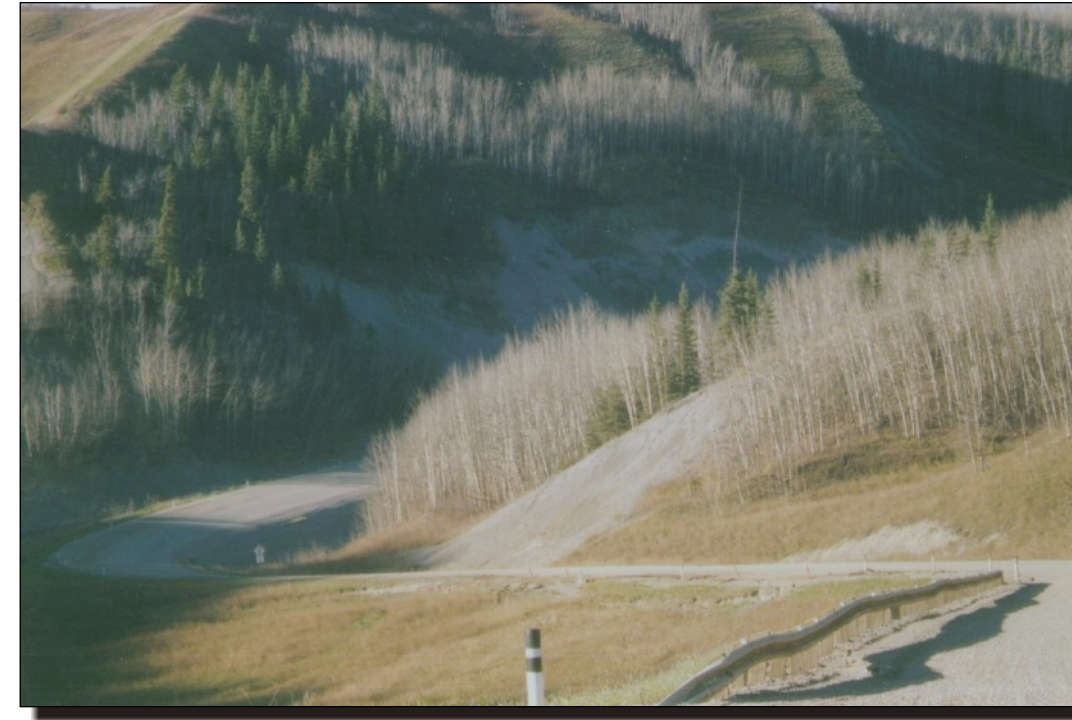
Photo 5c
Sideslope slide transgressing highway centreline. Gravel road regraded to allow passage of traffic.

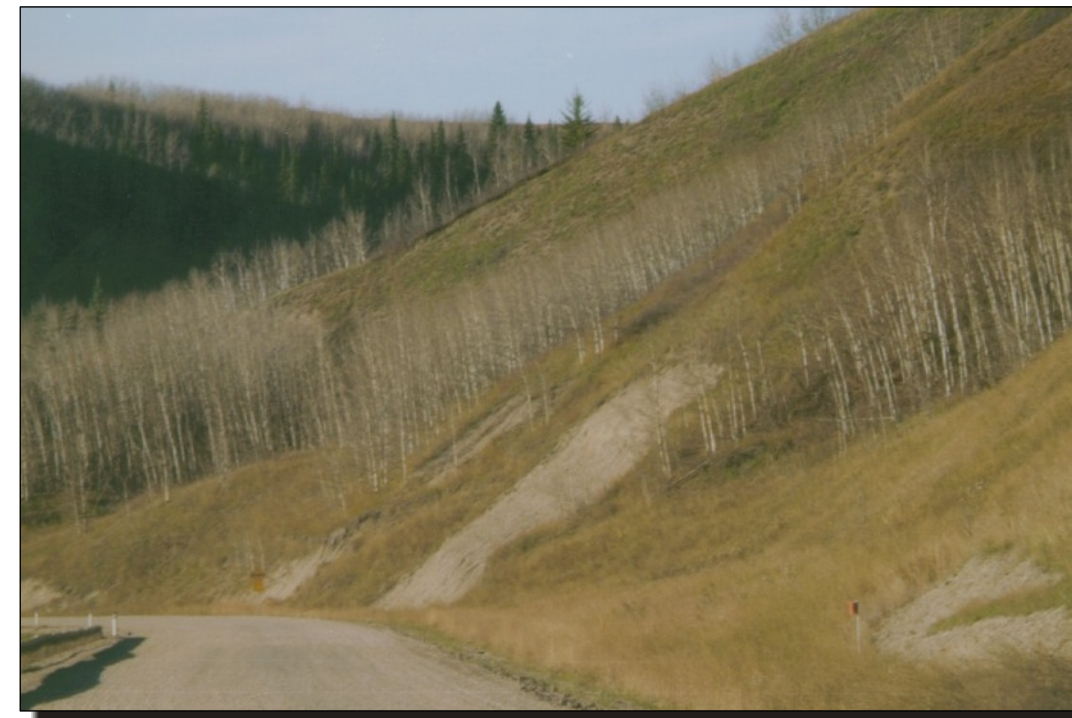
Photo 5d
Steepening of backslope.

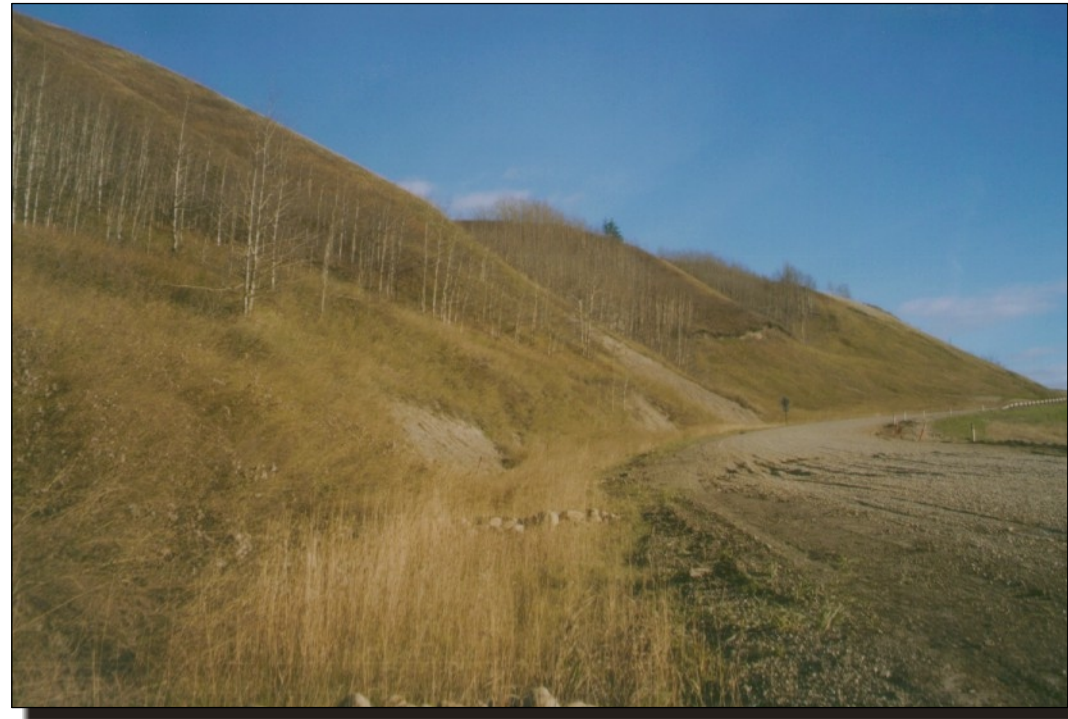
Photo 5e
Another view of slide headscarp crossing highway and backslope.
