Slide Name: (GP 15a) SH 727:02 Rat/Howard Creek

Inspection Date: June 20, 2006

Inspection by: Alberta Infrastructure & Transportation and KarlEng Staff listed on Page 1

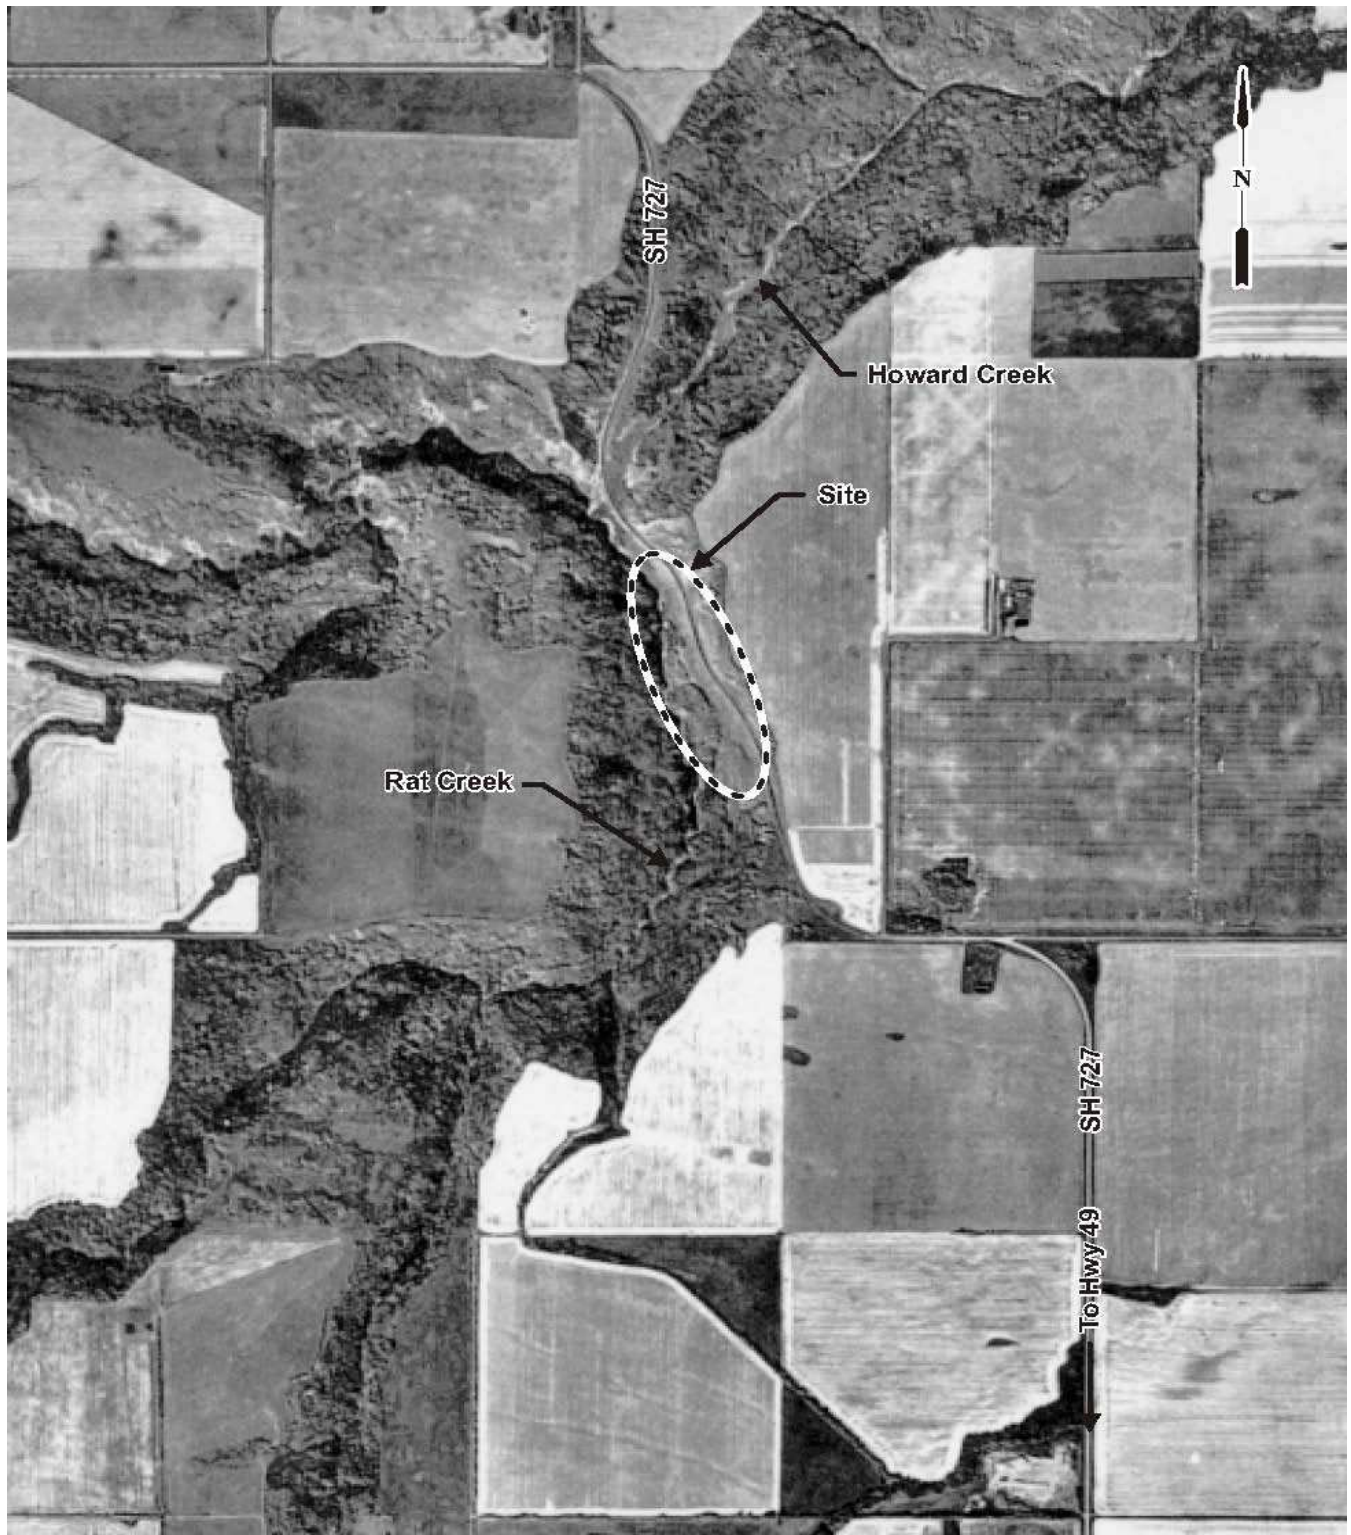
Figure 1
Site Plan

Based on 1995 Aerial Photograph

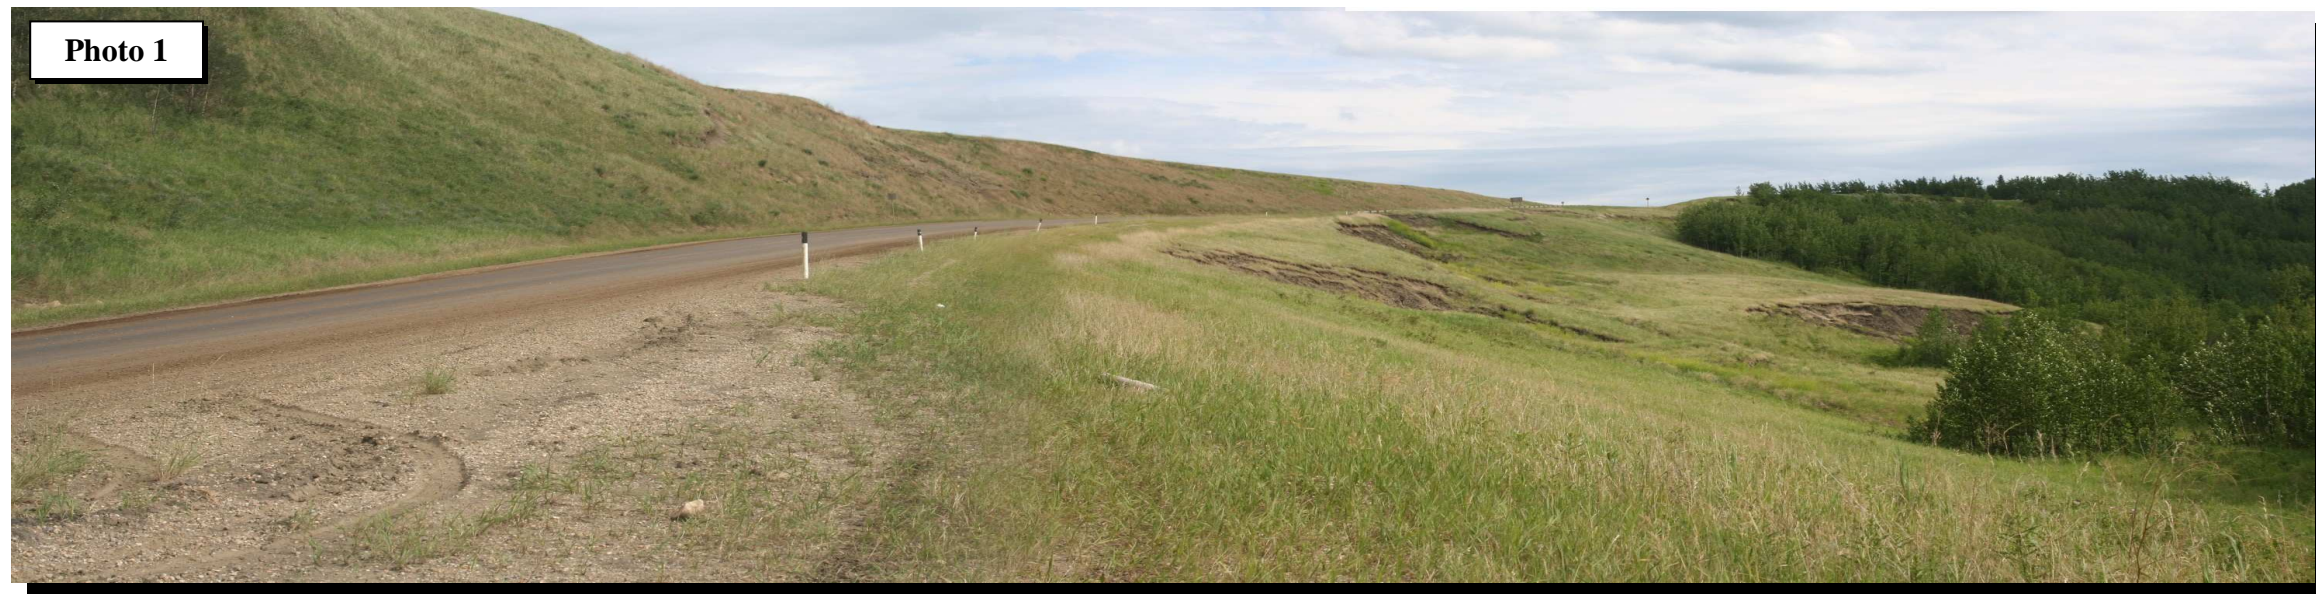
Photo 1

Looking upgrade (south) towards Hwy. 49 Jct.

- Sideslope slides along upper portion of valley slope
- Steep backslope showing signs of slippage; backslope steepened as a result of shifting of alignment inland
- One lane traffic can be maintained in the event of slide deterioration

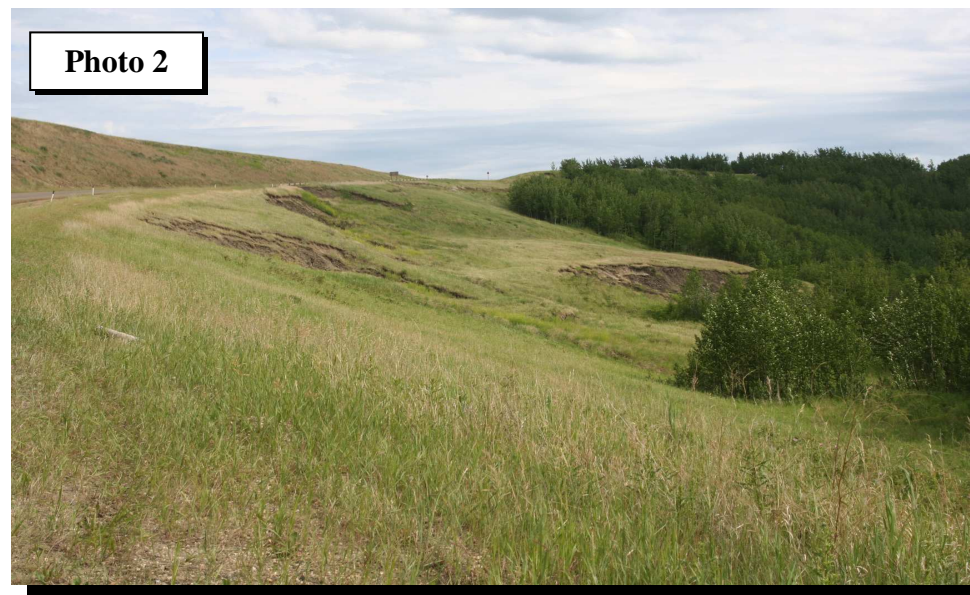
Photo 2

Looking upgrade (south)

- Closed up
- Sideslope slides along upper portion of valley slope

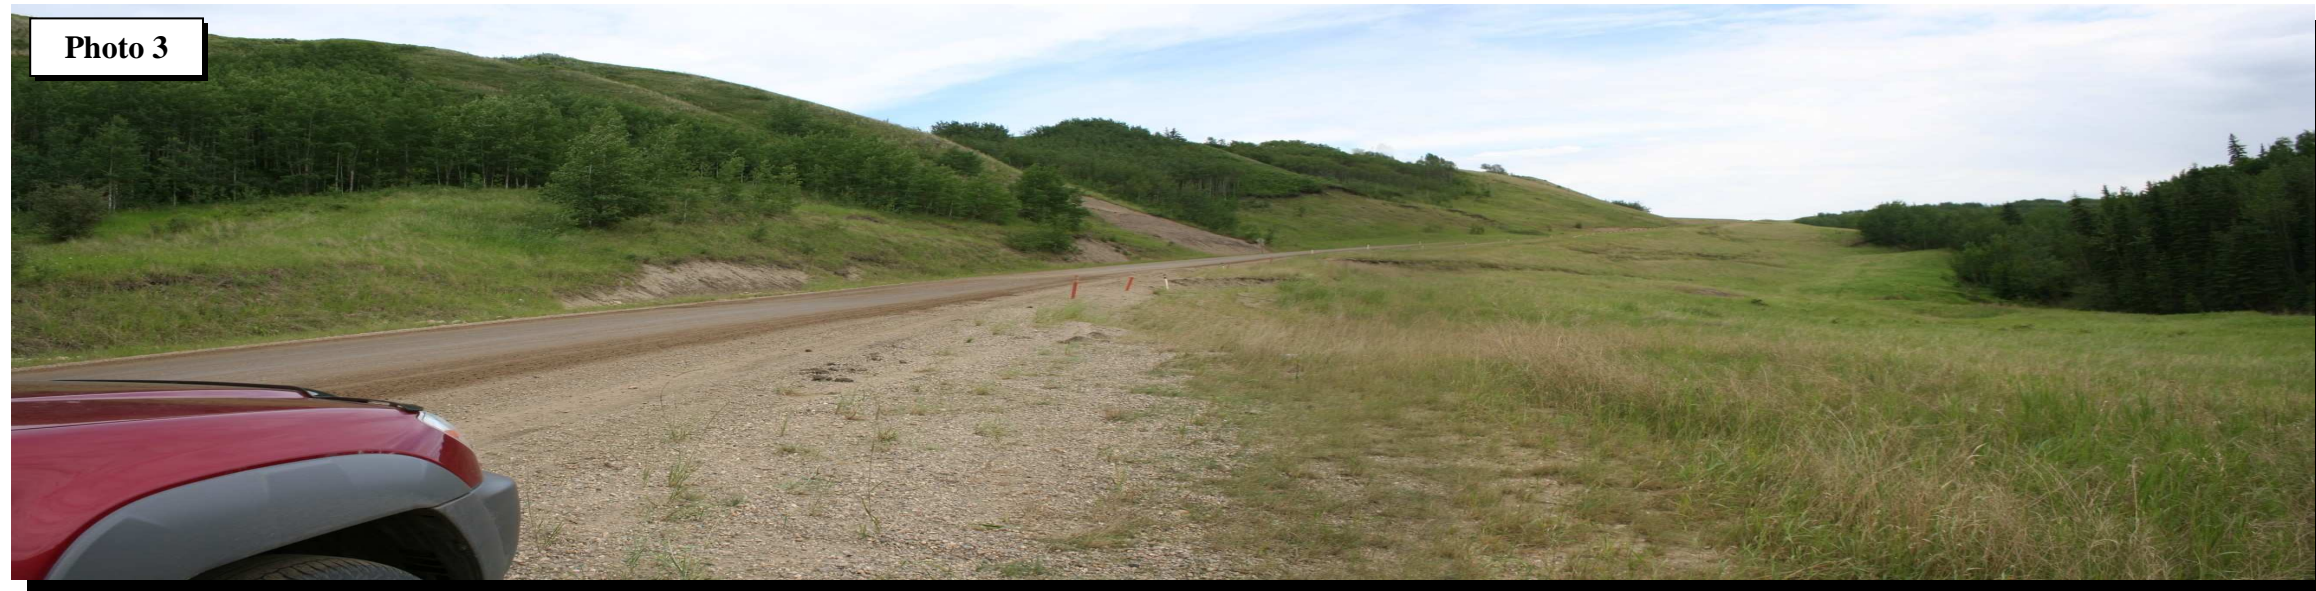
Photo 3

Looking south upgrade (towards Hwy. 49 Jct.)

- Slides at mid-portion of Rat Creek valley slope
- Rat Creek to right of photo

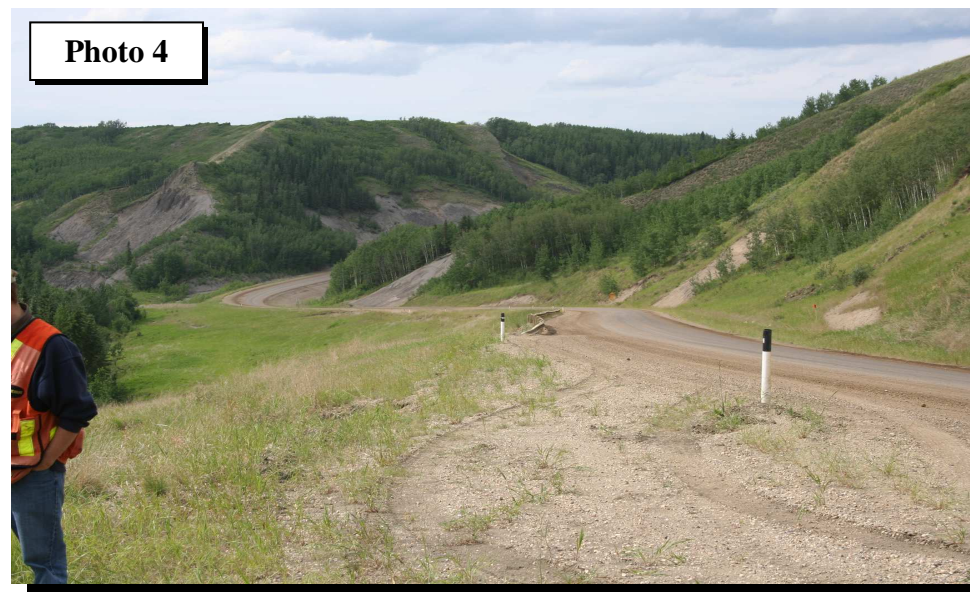
Photo 4

Looking north downgrade (towards Howard Creek)

- Lower portion of slides along mid-stretch of Rat Creek valley slope
- Rat Creek to left of photo
- This slide deteriorated during 2004/05 to cross centerline to backslope ditch. However, no obvious drastic accelerated movement was reported in 2005/06
- The section of road should be maintainable to provide one-lane traffic in event of drastic sliding movements

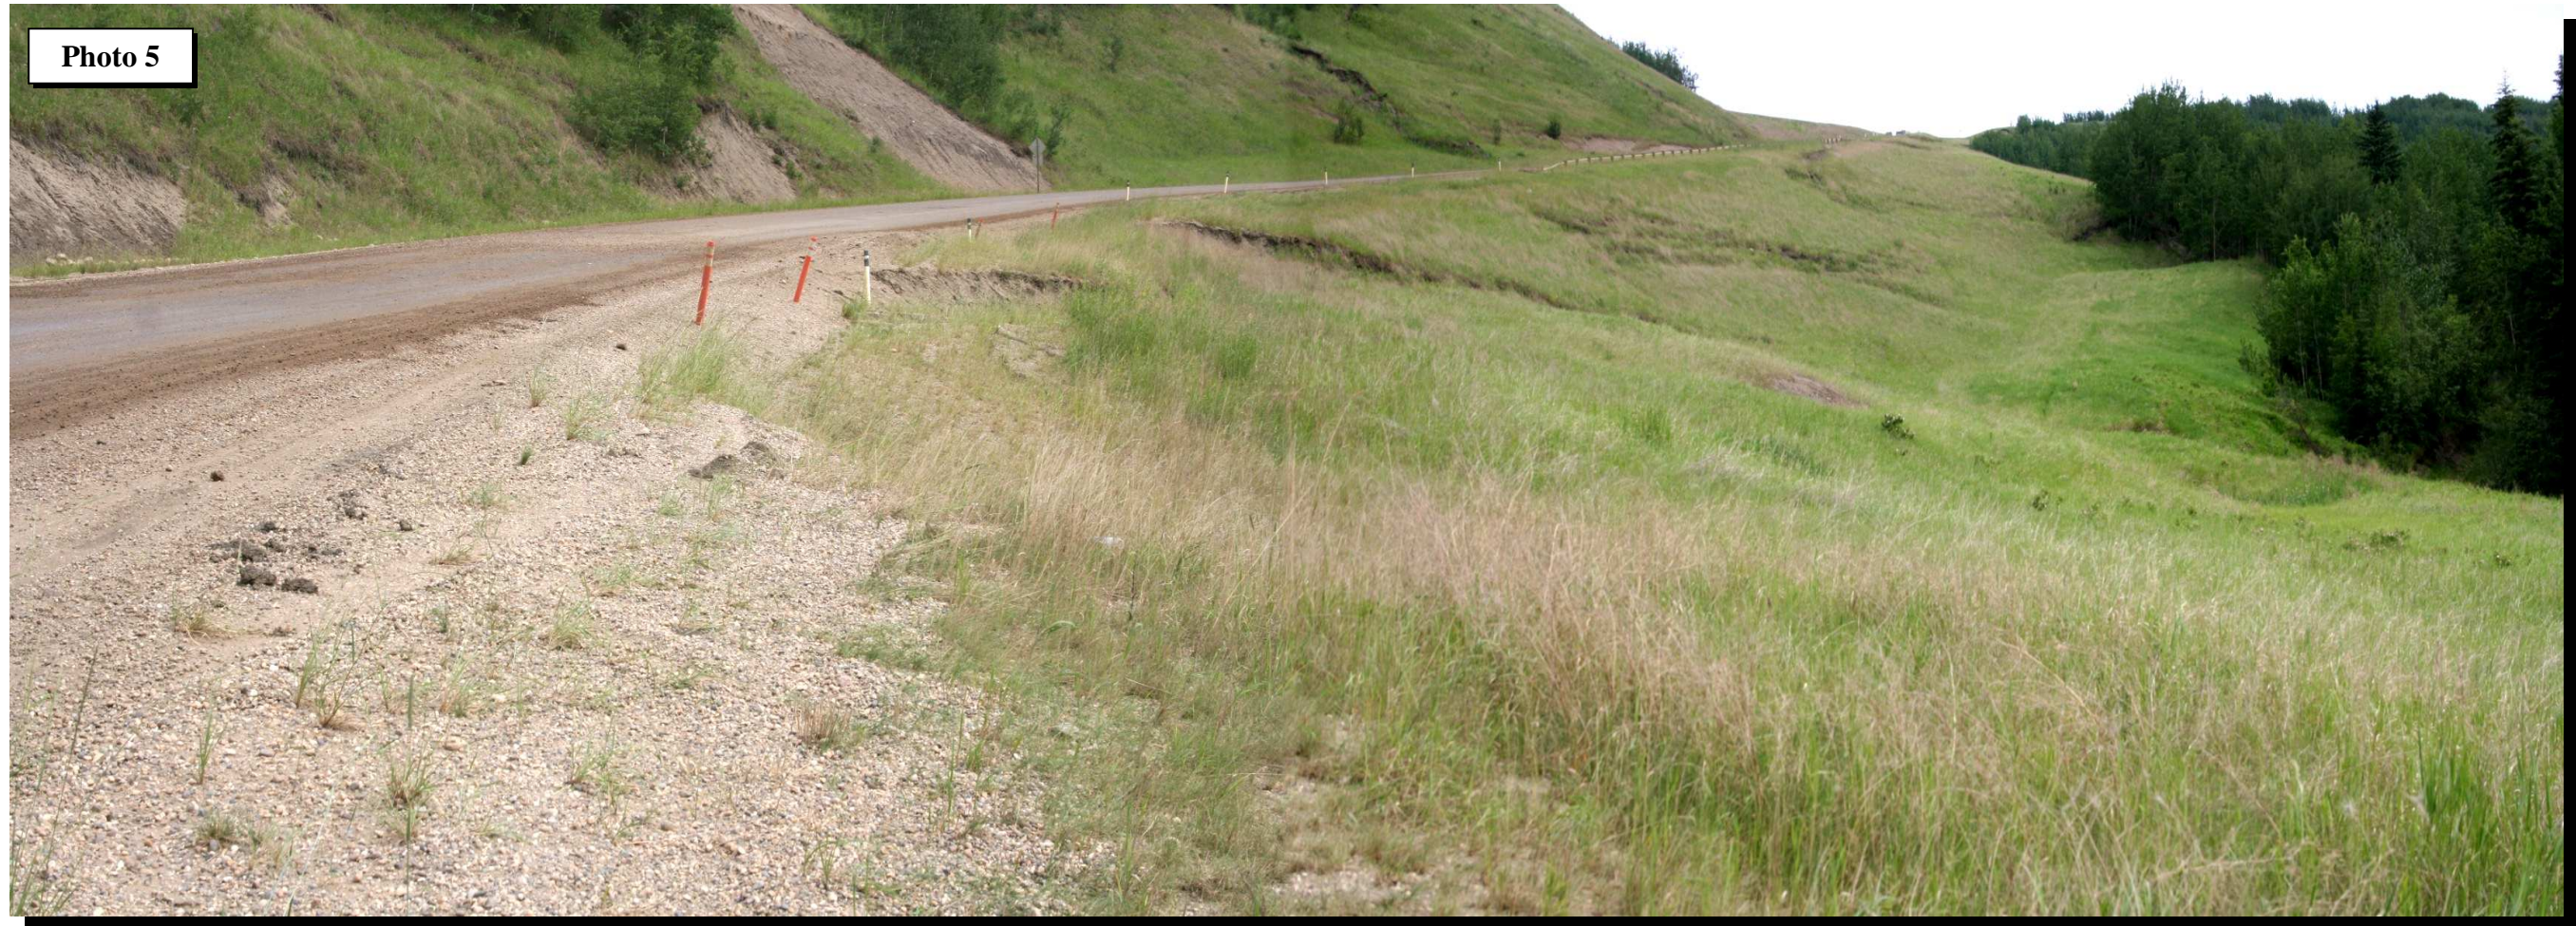
- Looking upgrade (towards Hwy. 49 Junction)
- Close up view of lower slides along mid-stretch of valley
 - Existing roadway 2 lane width
 - Roadway can be maintained to provide 1 lane traffic in emergency event of slide deterioration
