**Slide Name:** (GP 15b) SH 727:02 Ksituan River  
**Inspection Date:** May 4, 2005  
**Inspection by:** Alberta Infrastructure & Transportation and EBA staff listed on Page 1

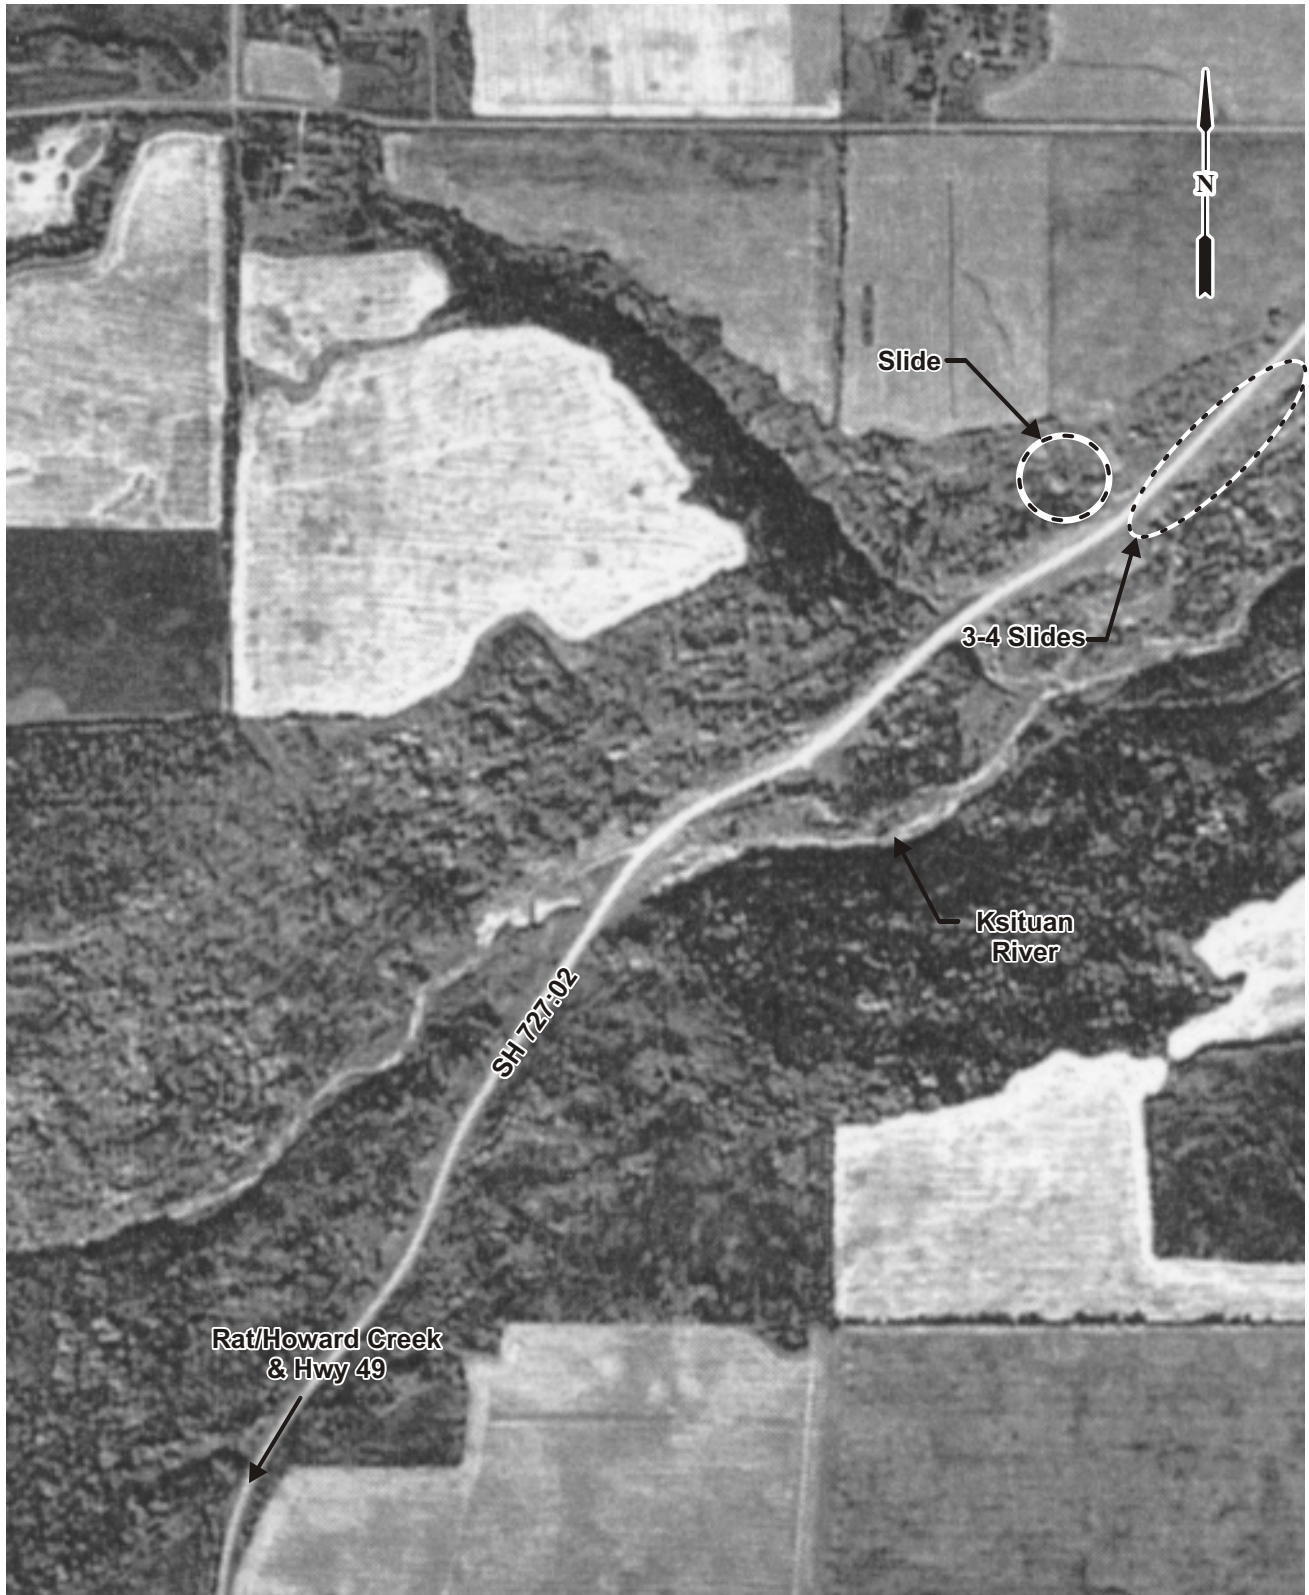
Figure 1  
Site Plan

Based on 1995 Aerial Photograph

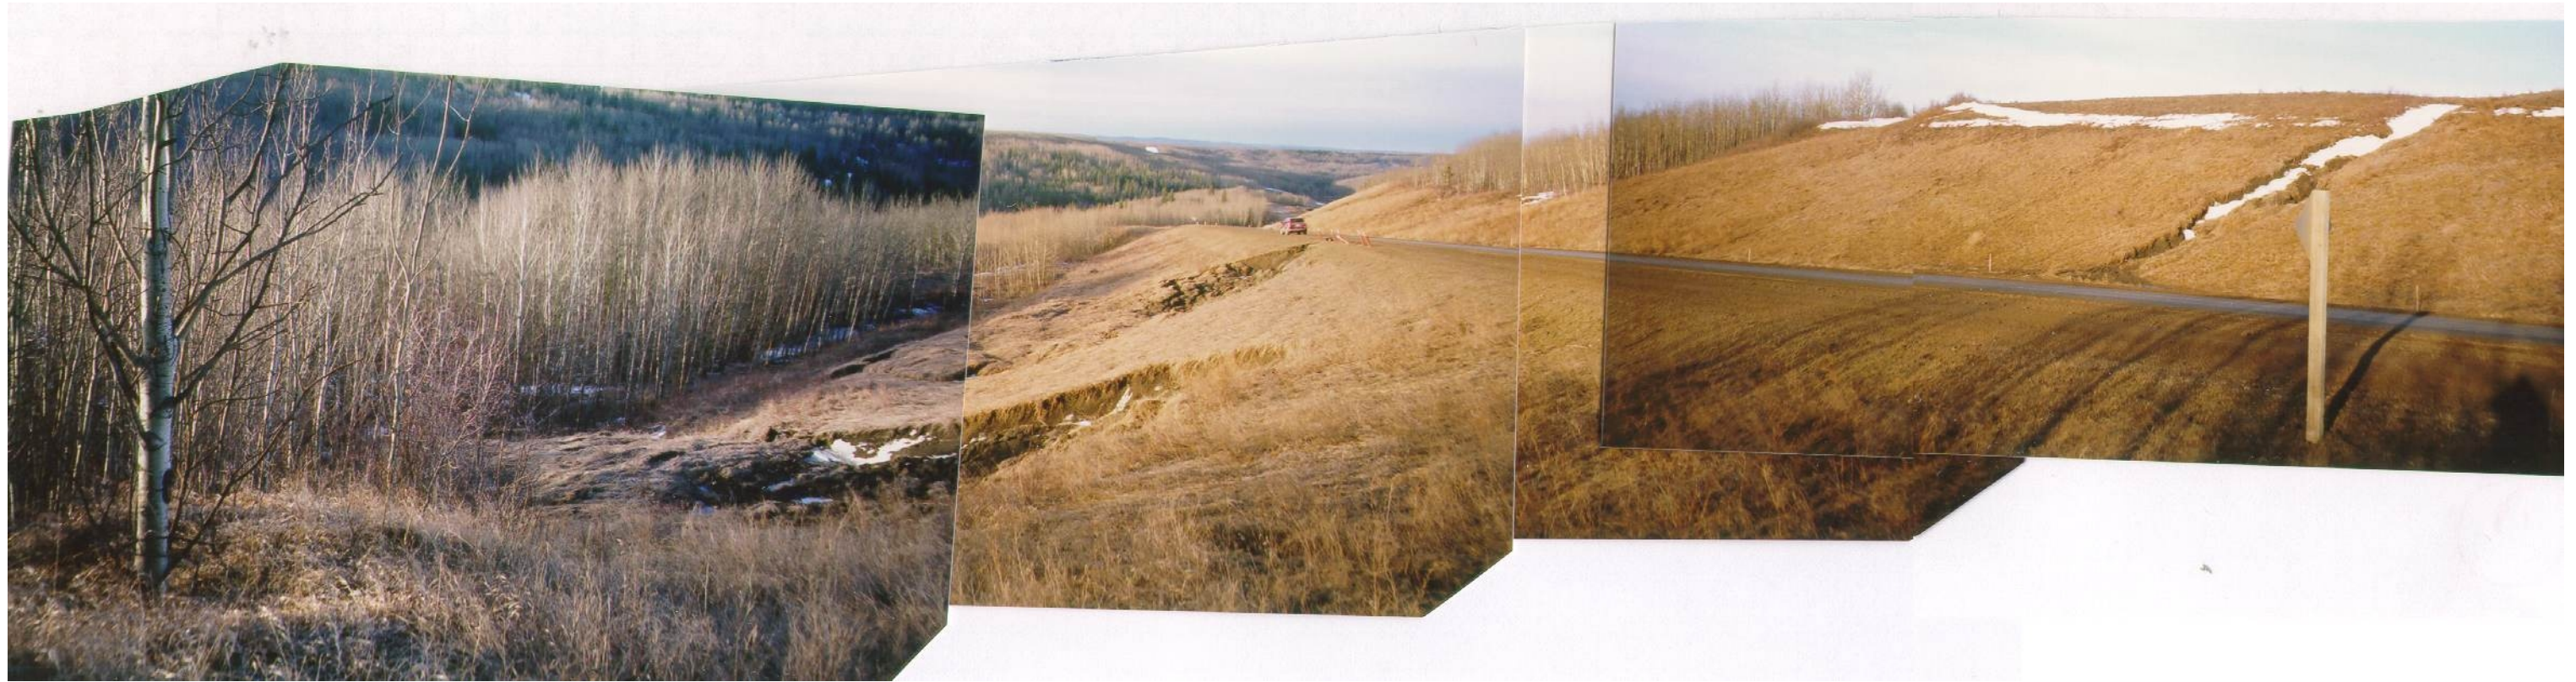
**Photo 7**

Looking south down Ksituan River valley slope (north side)

- 1) Upper side of sideslope (foreground of photo) at elbow of fill and natural valley slope
- 2) Adjacent lower side at sideslope (middle centre of photo before parked vehicle)
- 3) Erosion gully a backslope with upland farm (at top right of photo)
- 4) A backslope new slide at centre of photo (to right and above parked vehicle - SEE PHOTO 12).

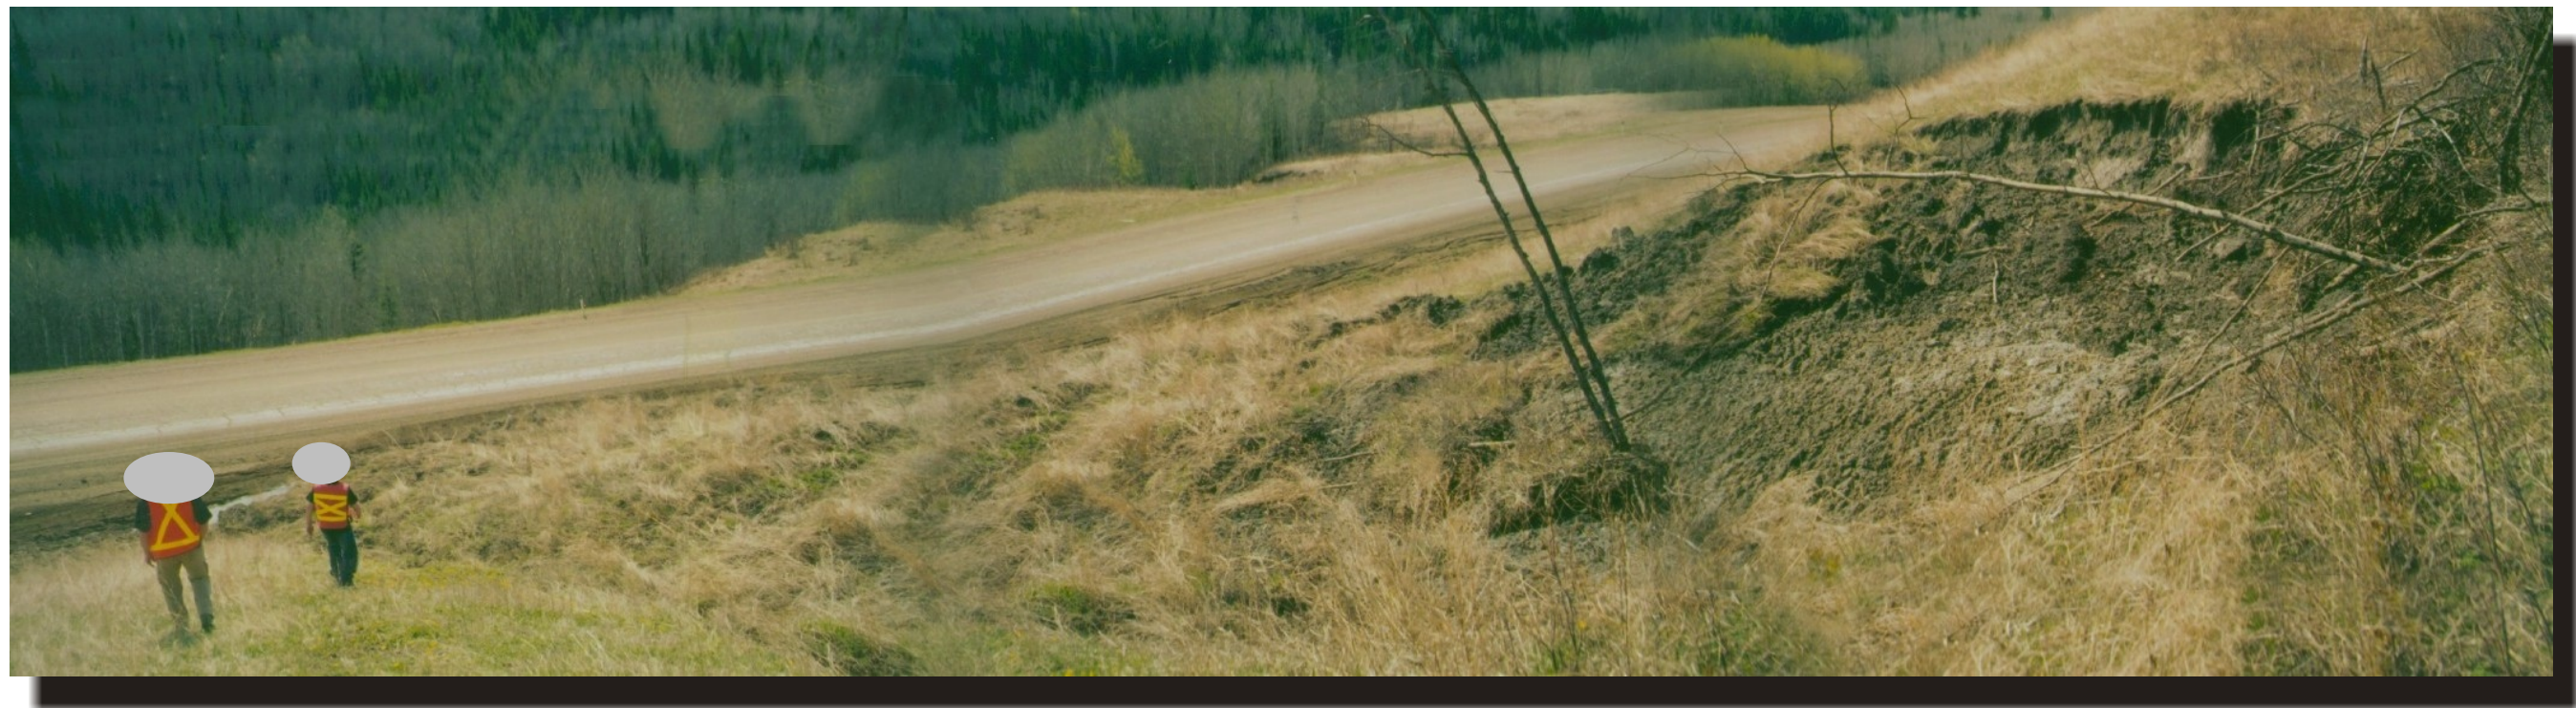
**Photo 12**

Looking south (downgrade) from backslope - new backslope slide (30m x 60m area) at approx 500m from top.

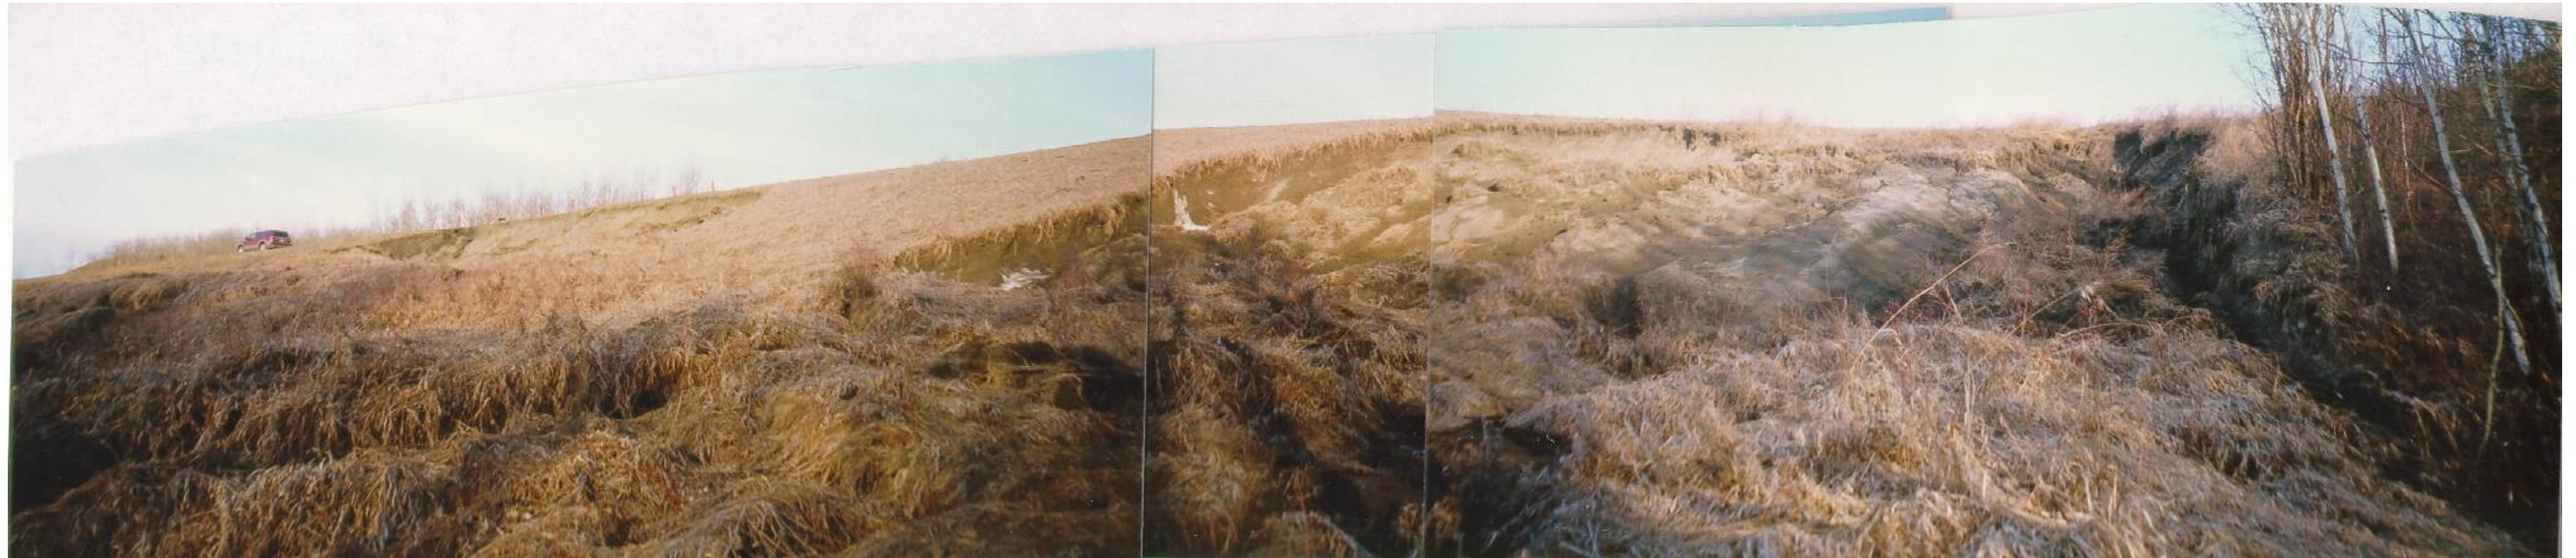
**Photo 8**

Looking from toe and side of slide (up sideslope)

- 1) Slide possibly triggered by seepage and long term erosion outfall from highway ditch down elbow of fill and natural valley slide (treed area to right of photo)
- 2) Slumping soil block movements of shallow to medium seated nature
- 3) Seepage exit of groundwater probable, willow growth at bottom toe area

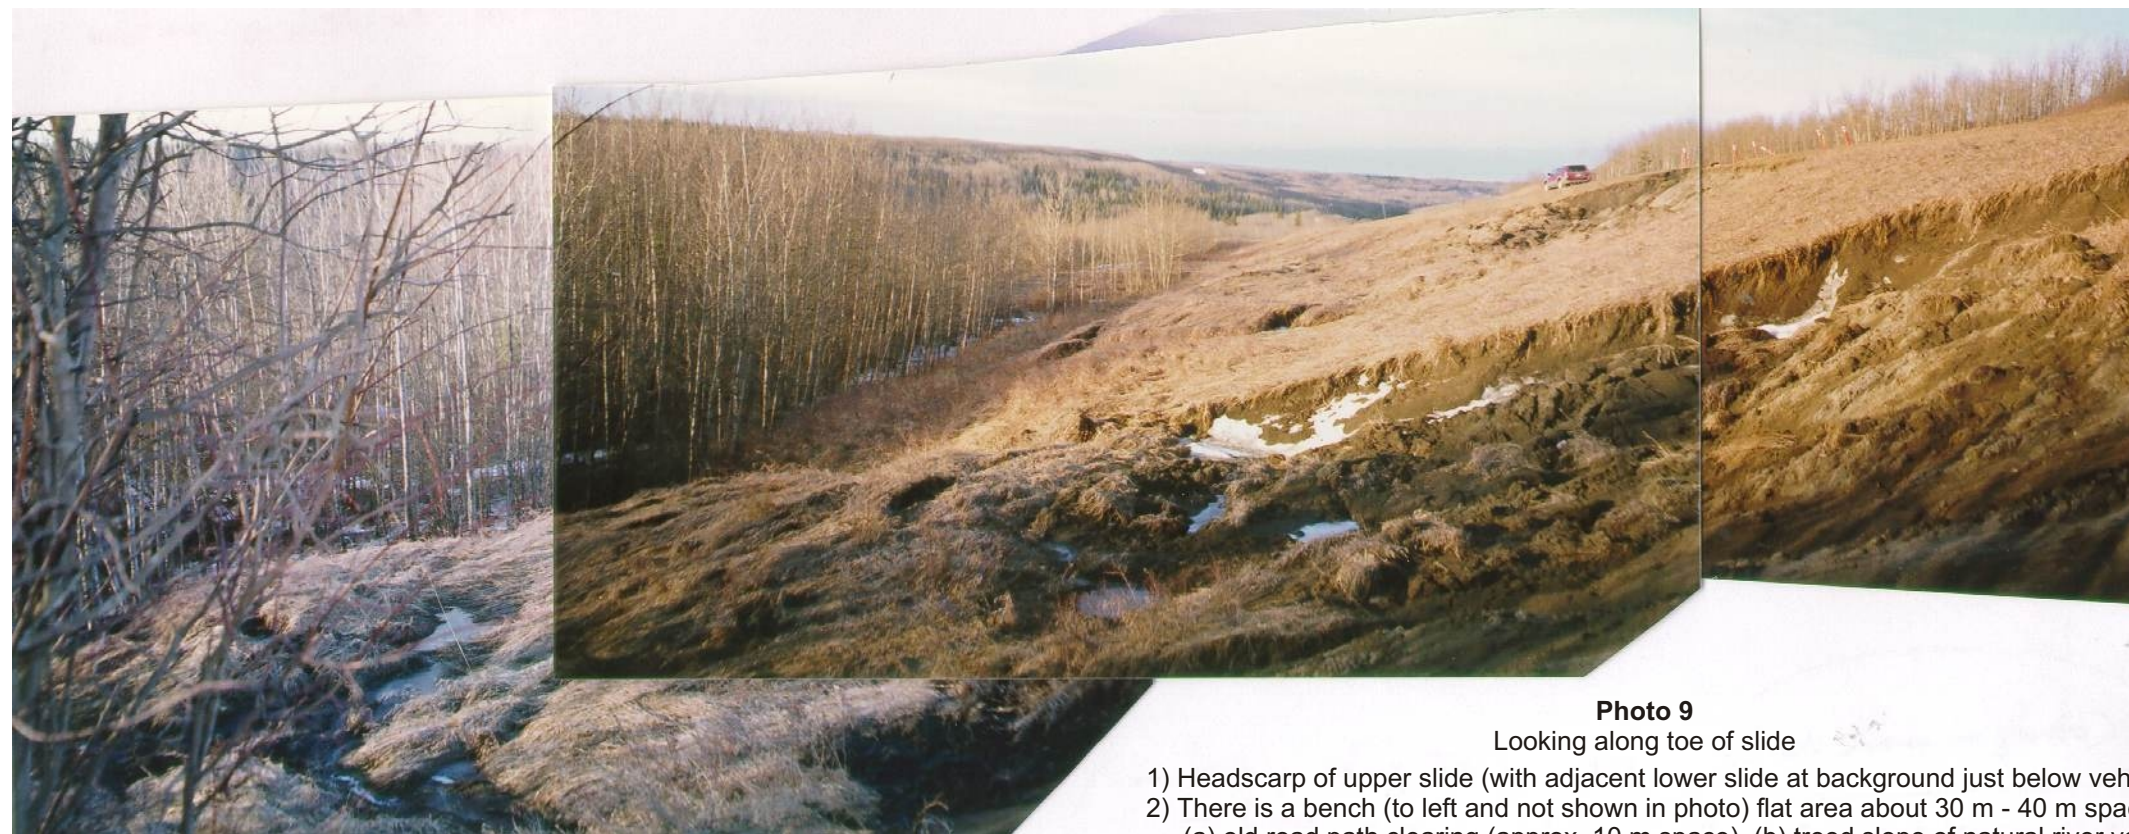
**Photo 9**

Looking along toe of slide

- 1) Headscarp of upper slide (with adjacent lower slide at background just below vehicle)
- 2) There is a bench (to left and not shown in photo) flat area about 30 m - 40 m space followed by (a) old road path clearing (approx. 10 m space), (b) treed slope of natural river valley
- 3) Space (to left of photo) can be available for earthwork berm

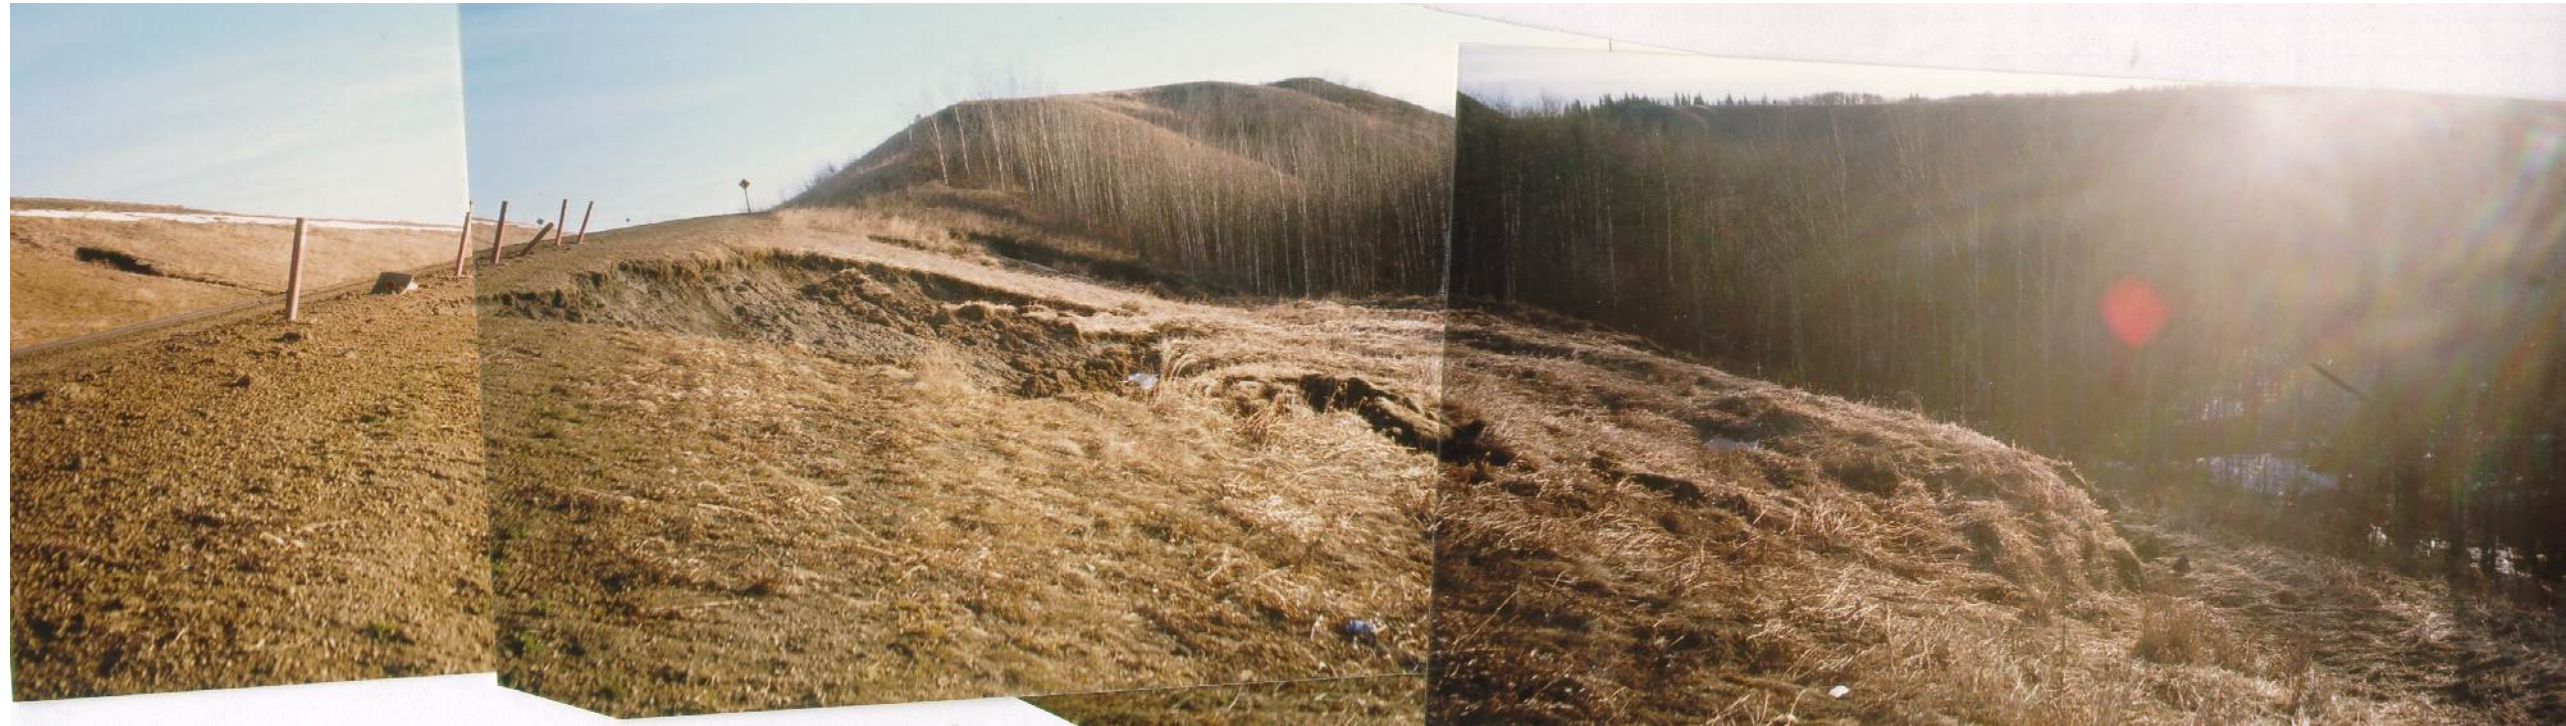
**Photo 10**

Looking upgrade at a lower slide from upper slide

- 1) Headscarp at about 2 m setback separation from shoulder edge
- 2) Slide about 50 m (wide along shoulder) X 60 m (long, down slope) (slope at approx. 2.5H:1V)
- 3) Note (background) ditch outflow into upper slide at far top of photo
- 4) Note: possible seepage influence from upland and backslope erosion gully (left) across roadway to affect stability of slope (right)

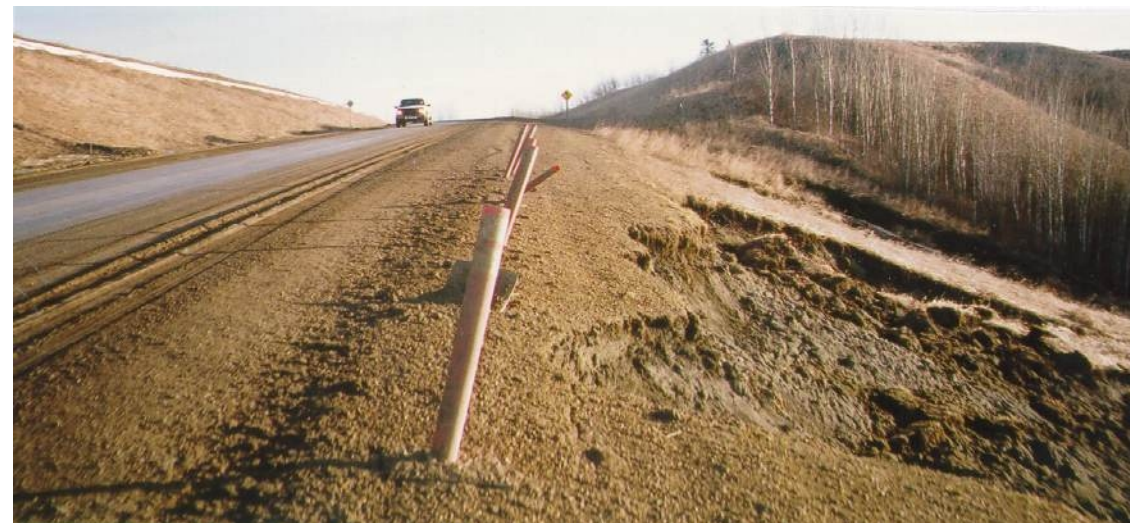
**Photo 11**

Looking upgrade

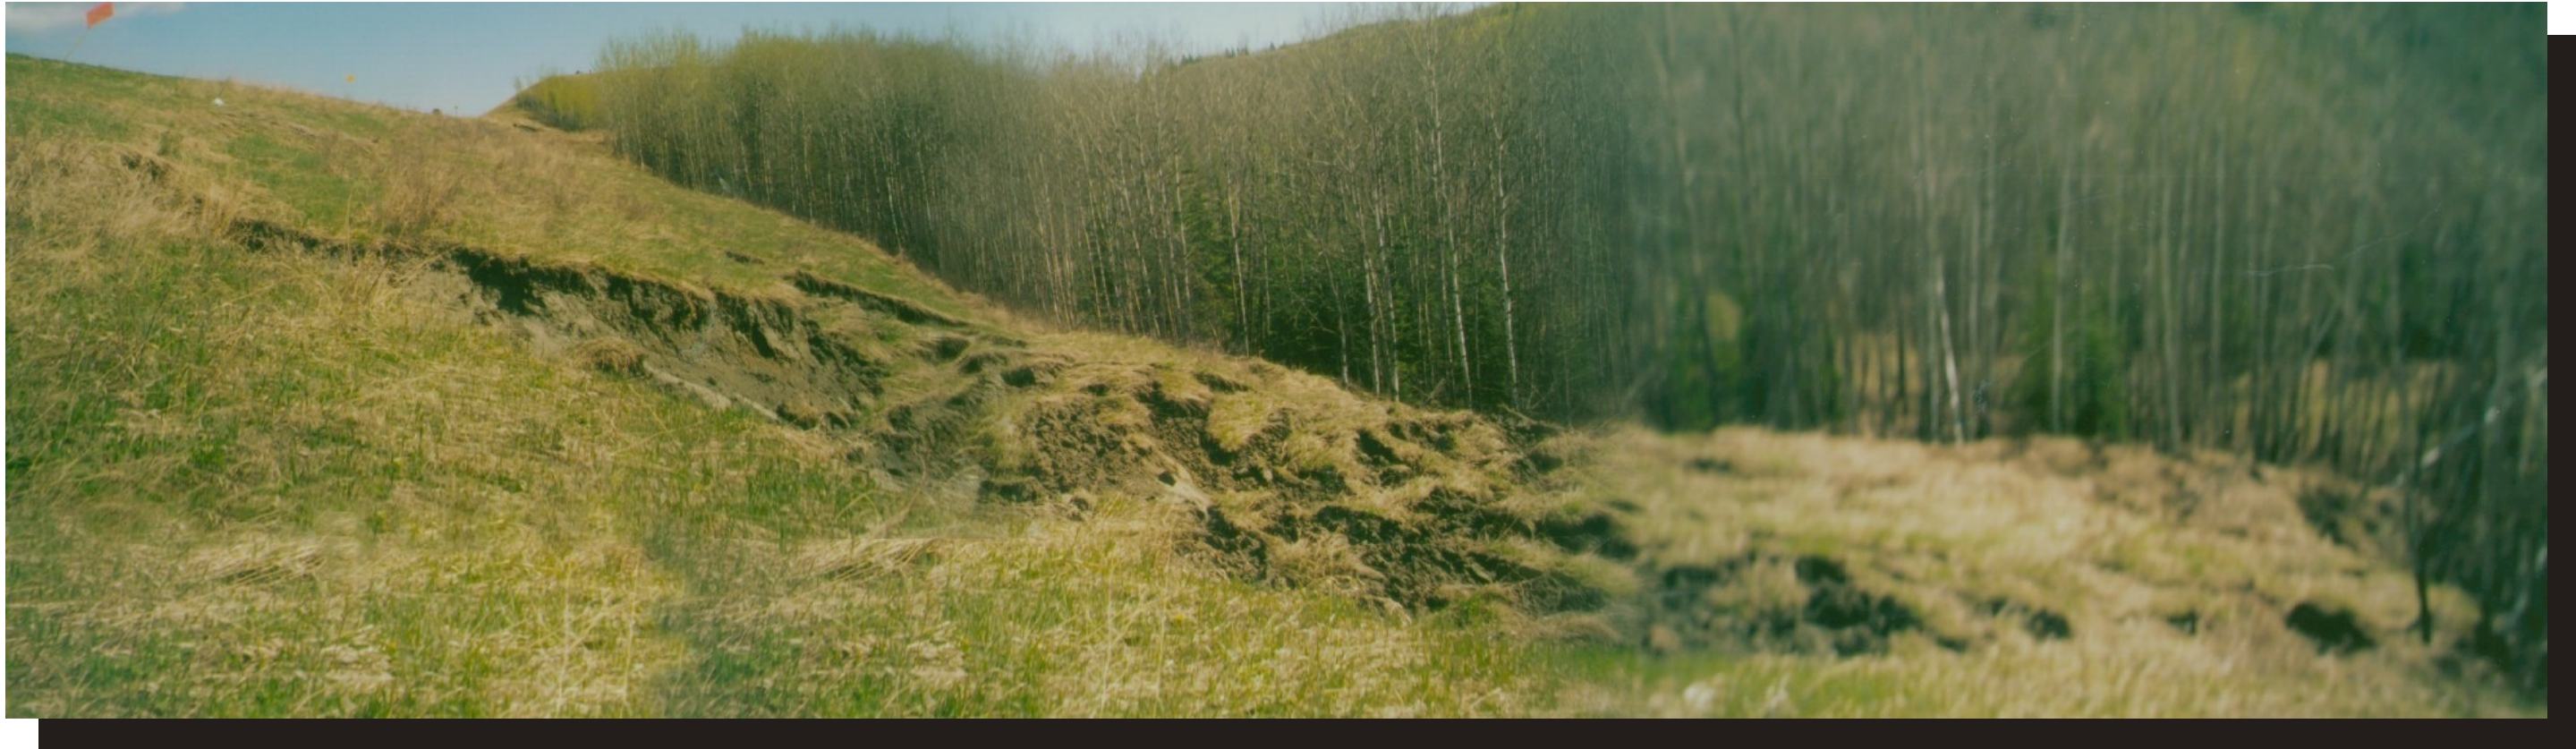
**Photo 11a**

Looking upgrade. Lower slide at sideslope. Slide at approx 50m south of centre slide. Headscarp at approx 15m setback separation from road shoulder edge.

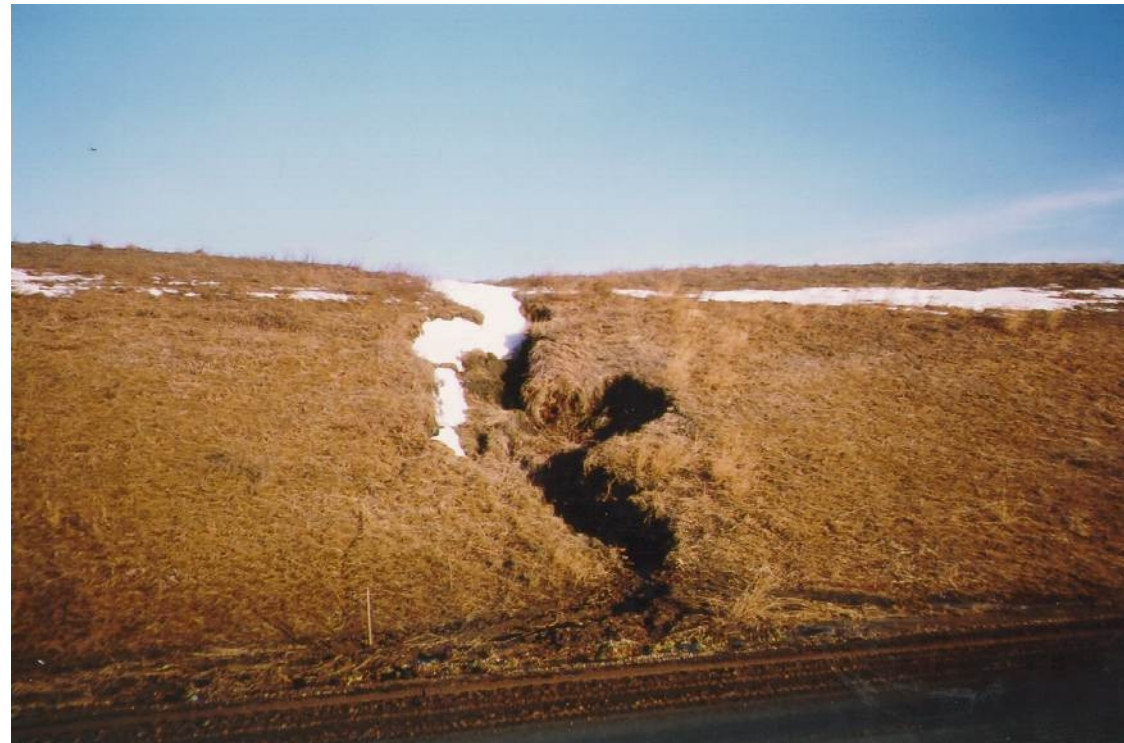
**Photo 13**  
3 m depth erosion gully at backslope  
Effect of erosion from upland (farm) runoff

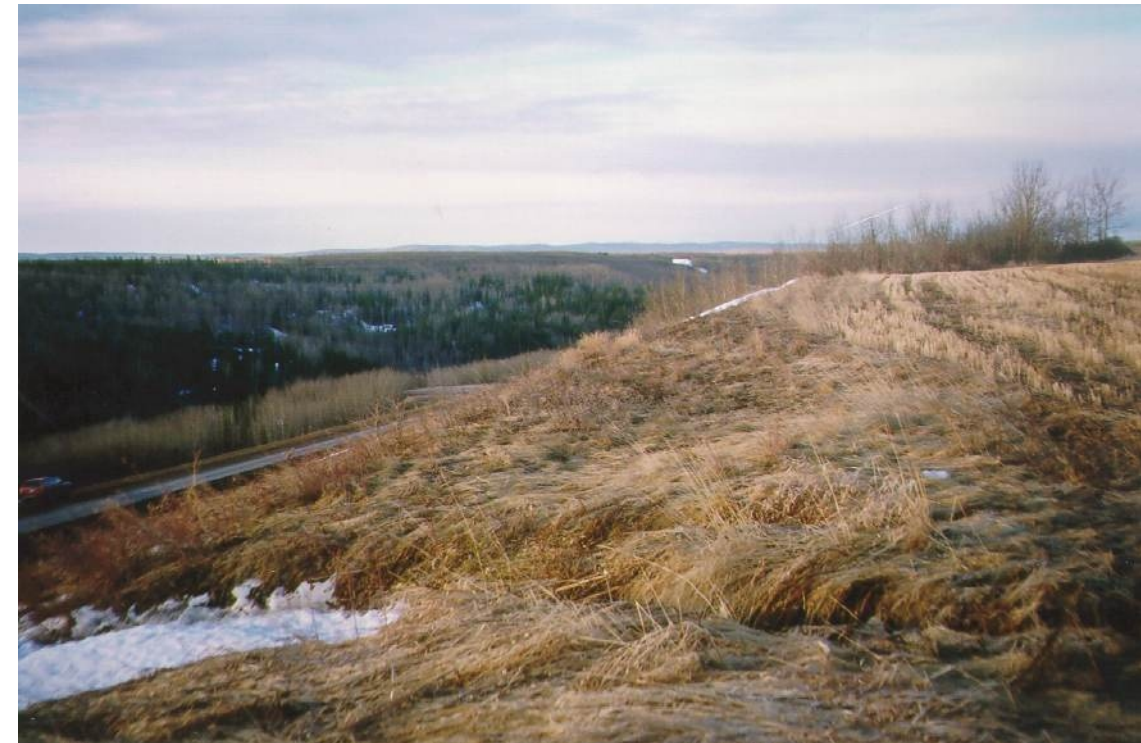
**Photo 14**  
Looking south downgrade (along top of valley slope edge of upland farm area)  
1) Surface water outfall down backslope to cause concentrated flow erosion  
2) No swale or catchwater ditch (dyke) along perimeter of upland farm

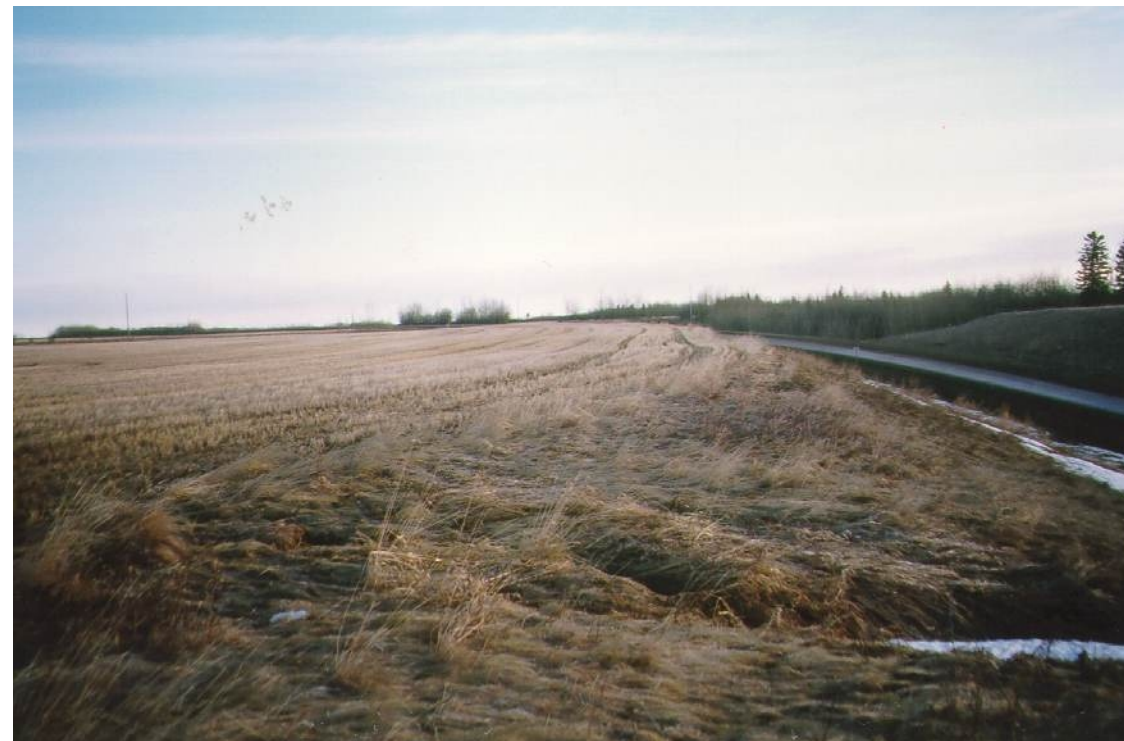
**Photo 15**  
Looking north upgrade (along top of valley slope)  
1) Surface water outfall down backslope to cause concentrated flow erosion  
2) No swale or catchwater ditch (dyke) along perimeter of upland farm

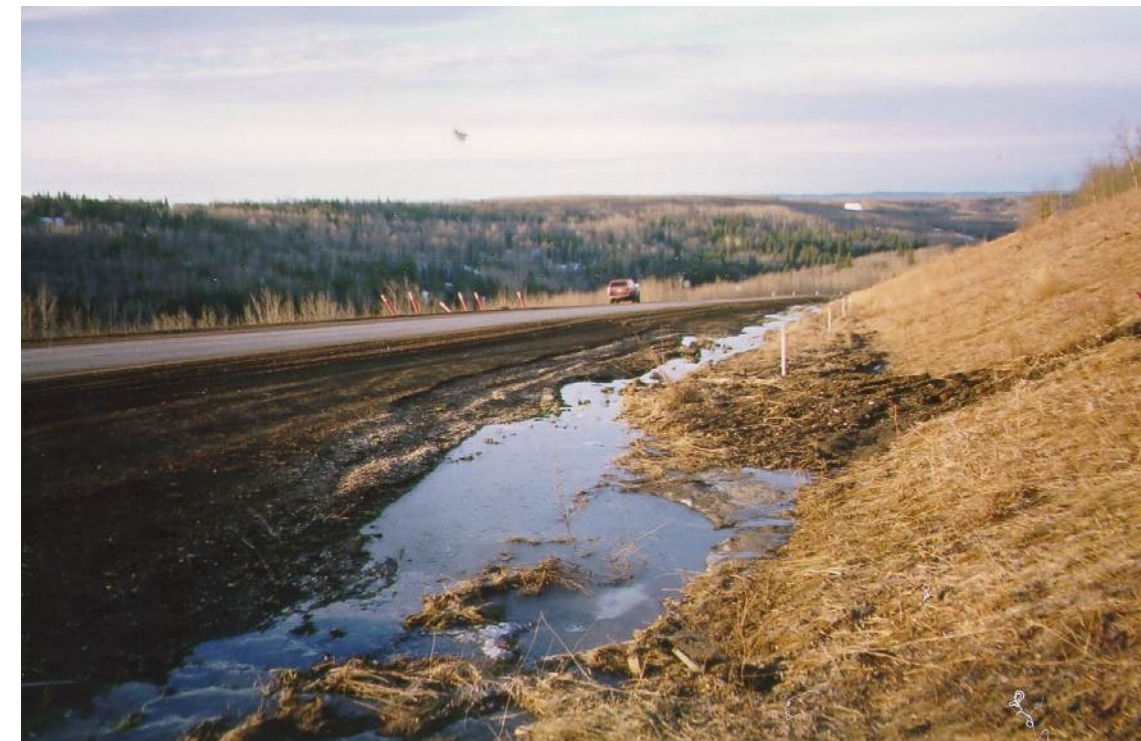
**Photo 16**  
Toe of slope  
1) Water ponding and erosion debris  
along backslope ditch
