Slide Name: (GP 15b) SH 727:02 Ksituan River

Inspection Date: June 20, 2006

Inspection by: Alberta Infrastructure & Transportation and KarlEng Staff listed on Page 1

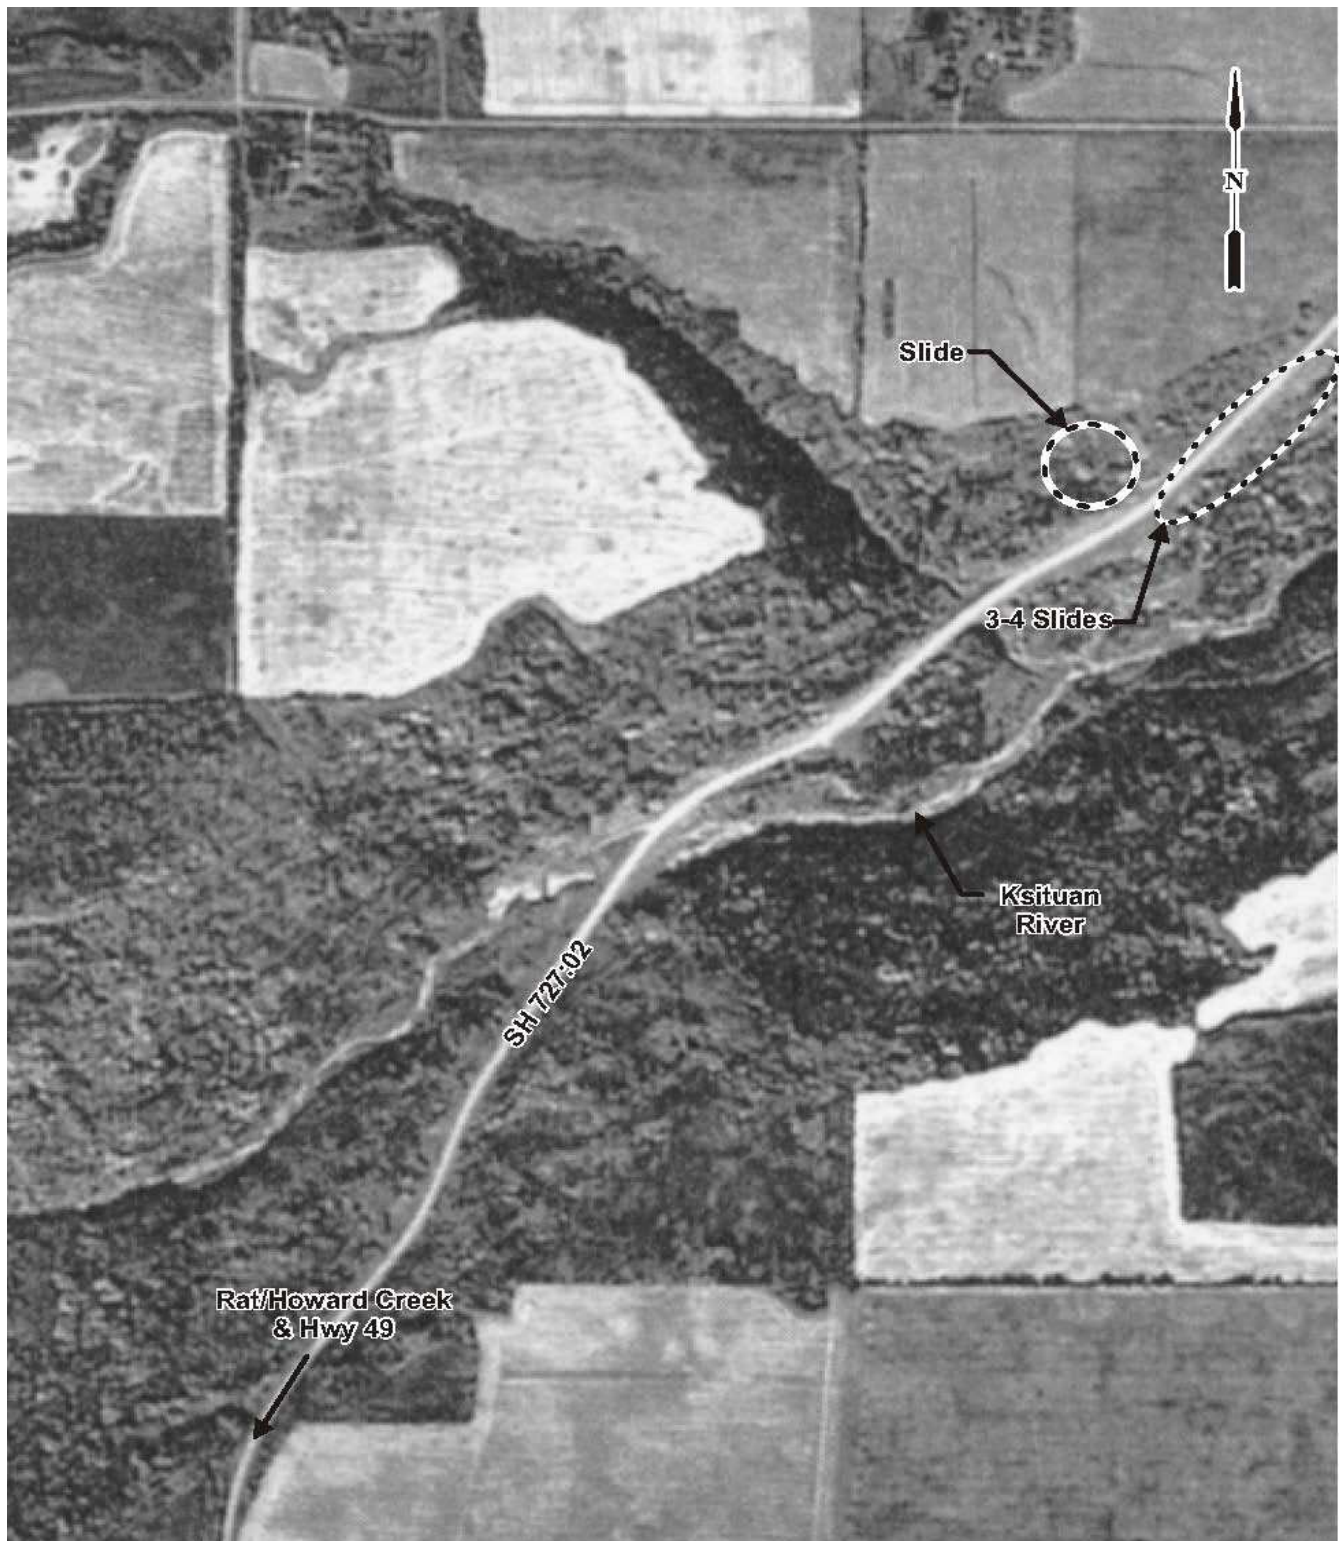
**Figure 1**  
Site Plan

Based on 1995 Aerial Photograph

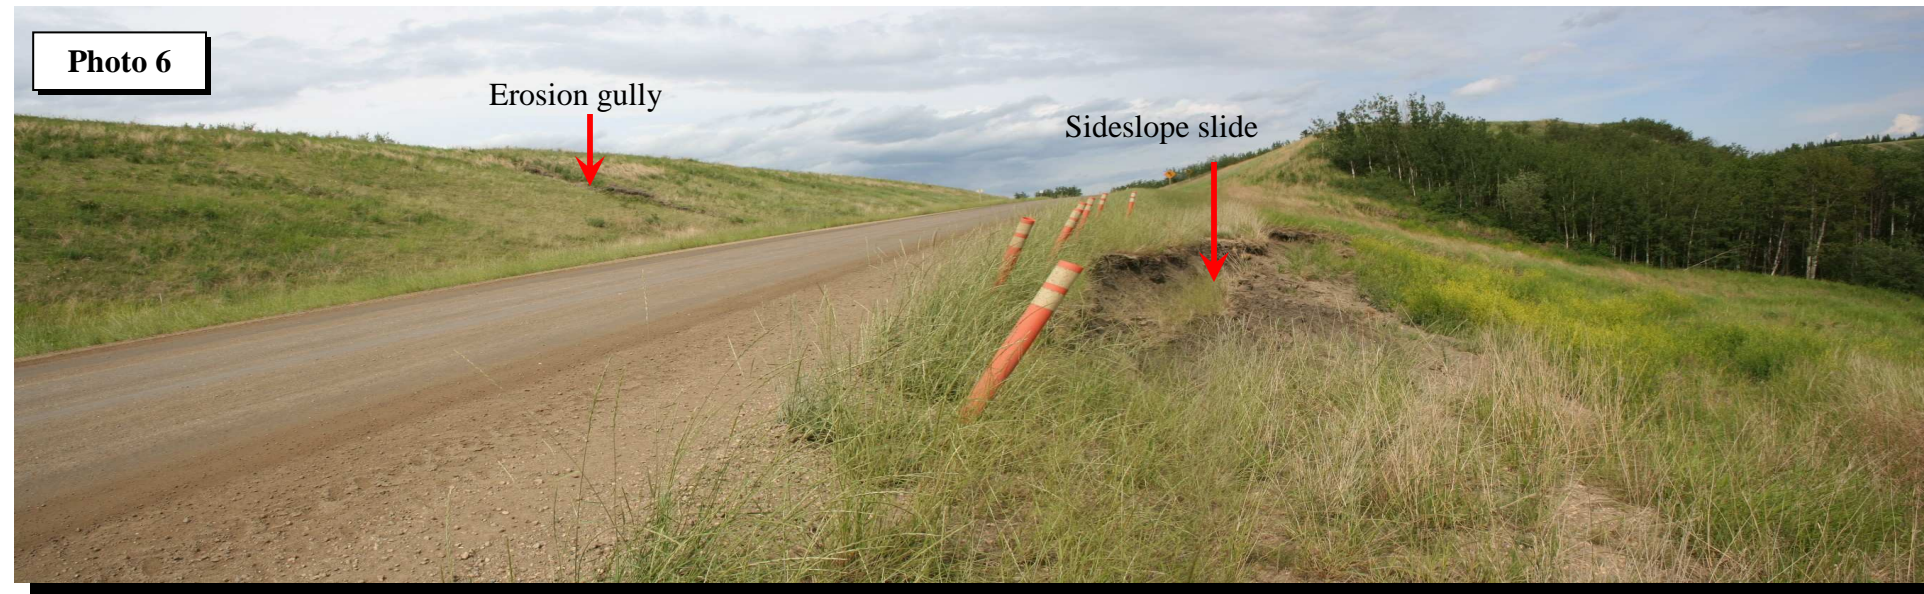
Looking upgrade north (away from Hwy. 49 Jct.)

- Sideslope slides (right) has encroached to shoulder of northbound lane
- Erosion gully formed at backslope (left) as a result of runoff from upland farm area

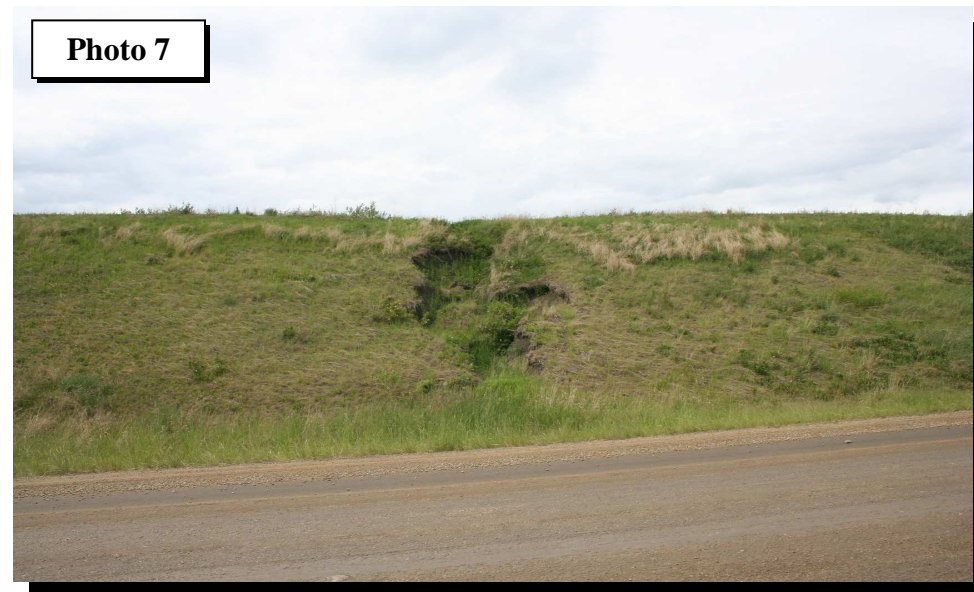
Looking west (another view)

- Erosion gully at backslope at upper portion of river valley

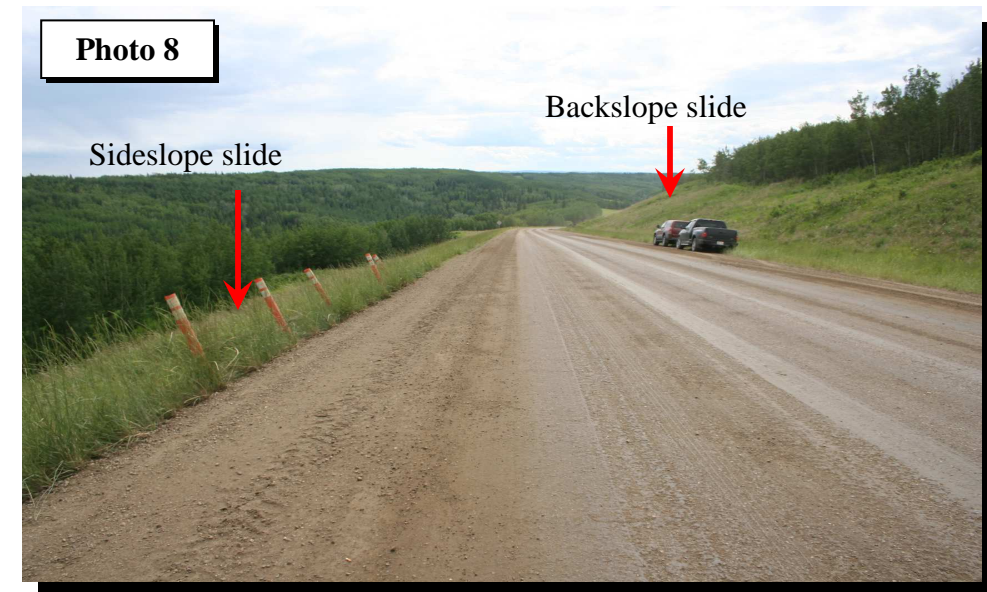
Looking downgrade south (toward Ksituan River)

- Sideslope slides to left of photo (no clearly visible from road elevation)
- Backslope slides on right started to develop

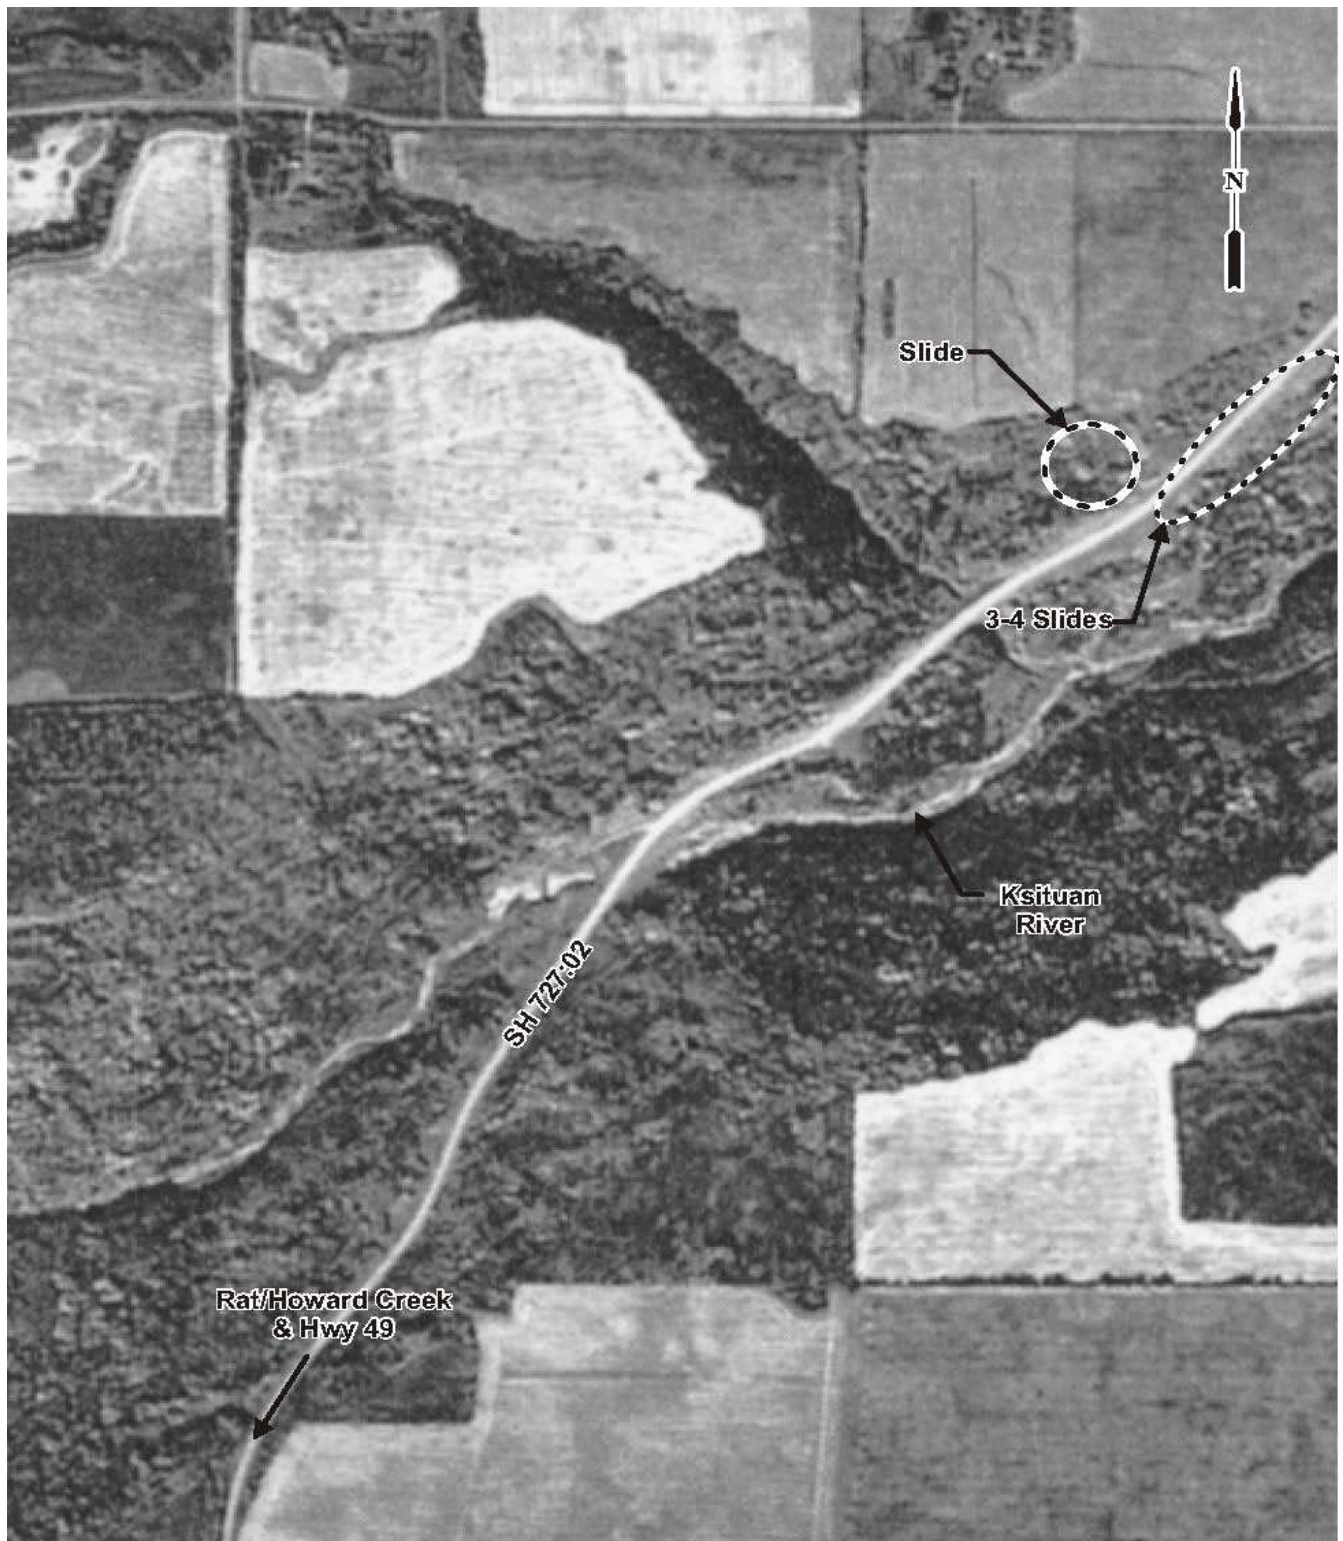
**Figure 1**  
Site Plan

Based on 1995 Aerial Photograph

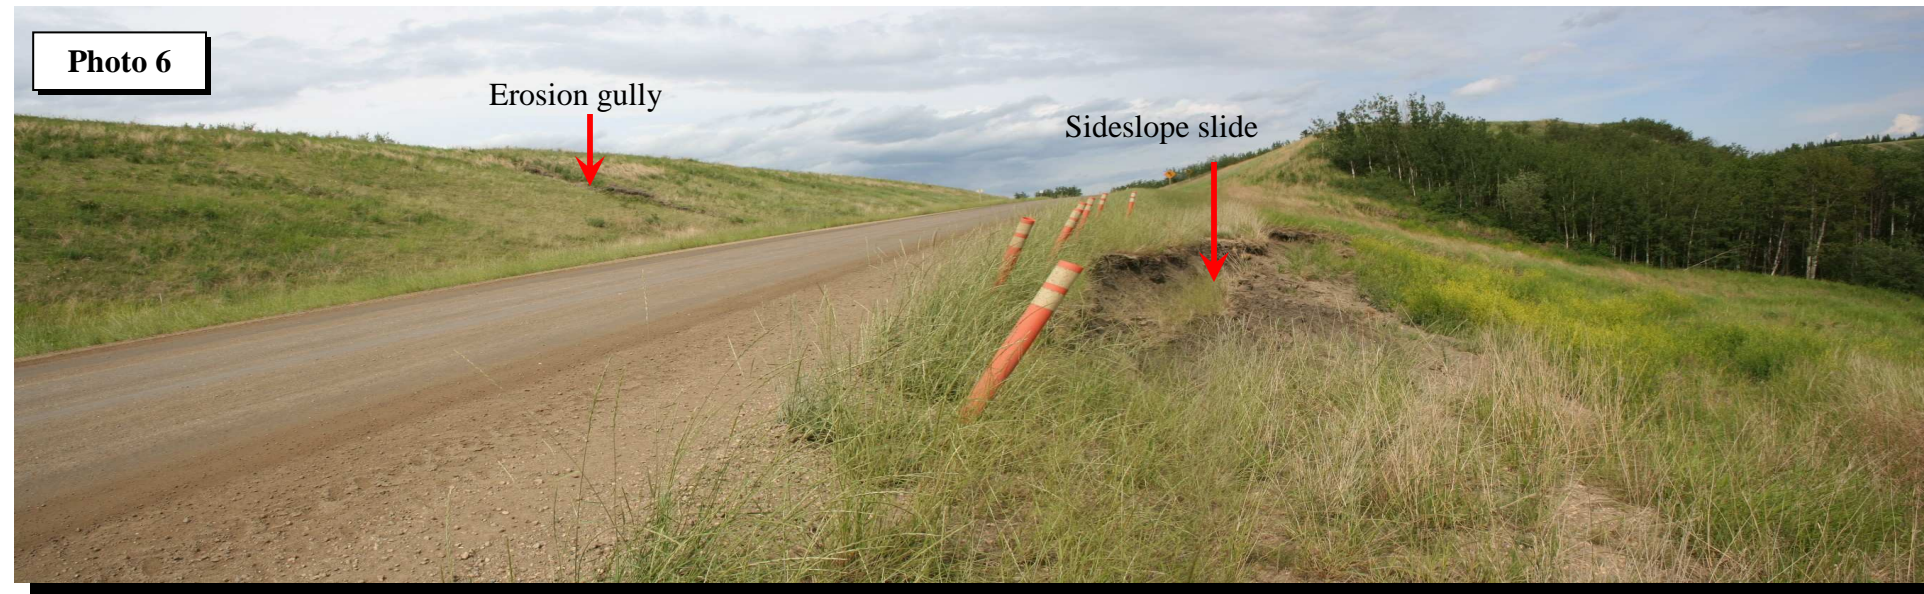
Looking upgrade north (away from Hwy. 49 Jct.)

- Sideslope slides (right) has encroached to shoulder of northbound lane
- Erosion gully formed at backslope (left) as a result of runoff from upland farm area

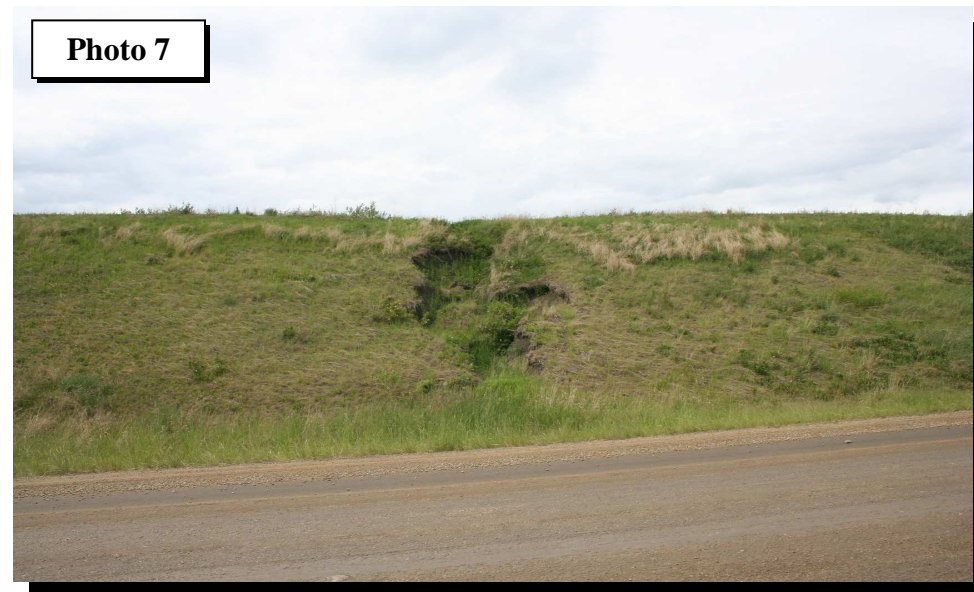
Looking west (another view)

- Erosion gully at backslope at upper portion of river valley

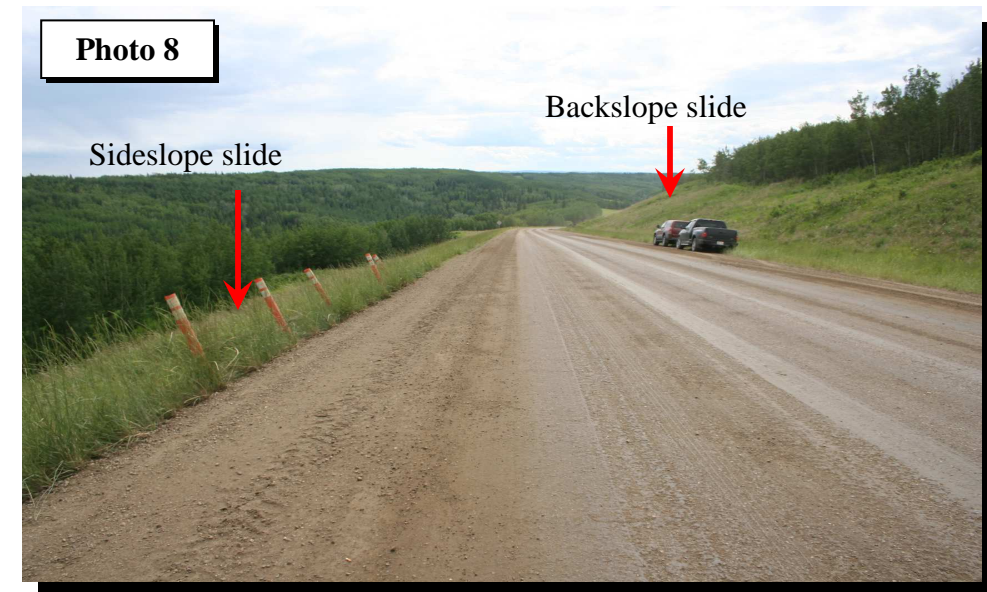
Looking downgrade south (toward Ksituan River)

- Sideslope slides to left of photo (no clearly visible from road elevation)
- Backslope slides on right started to develop
