**ALBERTA TRANSPORTATION  
GEOHAZARD ASSESSMENT PROGRAM  
PEACE REGION – GRANDE PRAIRIE  
2023 INSPECTION**

Site Number	Location	Name	Hwy	km
GP040	4.7 km's N. of Rycroft	Spirit River Bridge (BF75106)	2:68	4.7
Legal Description		UTM Co-ordinates		
SE¼ 34-078-5 W6M		11U E 394291	N 6184727

**GP040-1: HWY 2:68 - SPIRIT RIVER BRIDGE (BF75106)  
2023 INSPECTION PLAN**

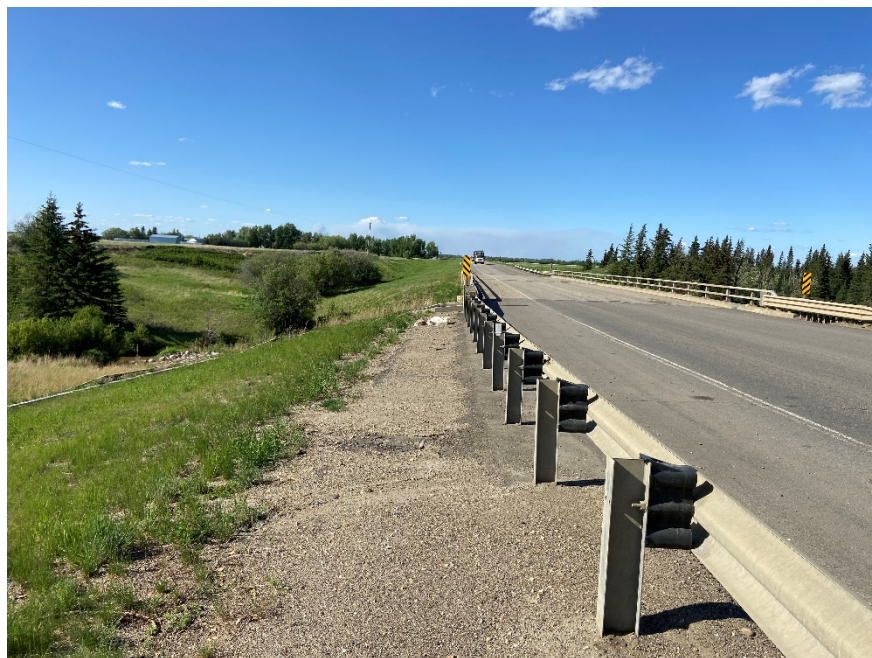
**Photo 1. Looking north along the west shoulder of the highway. Photo credit: Don Proudfoot.**

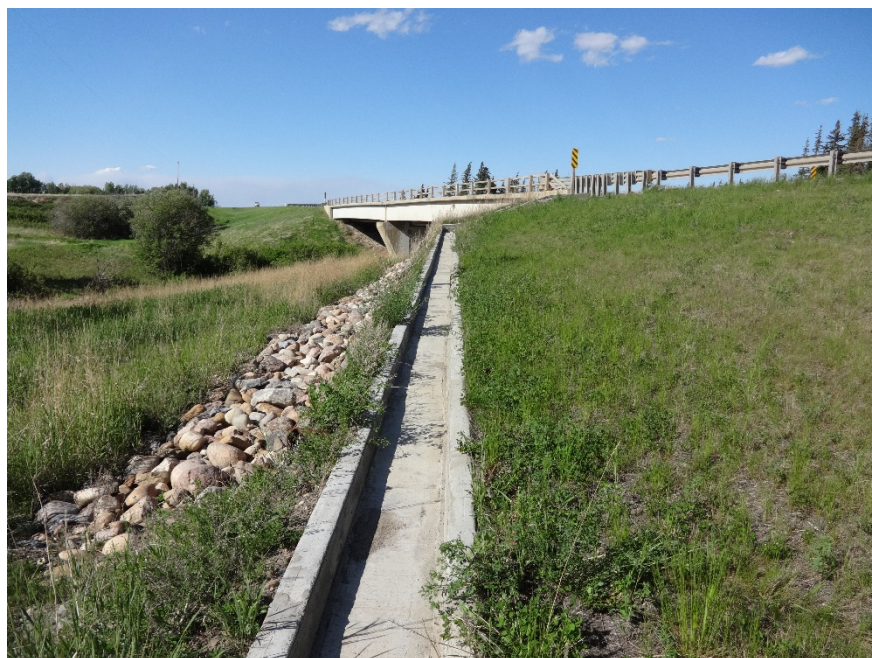
**Photo 2. Looking northeast at the concrete drain trough above the west pile wall.  
Photo credit: Nicole Wilder.**

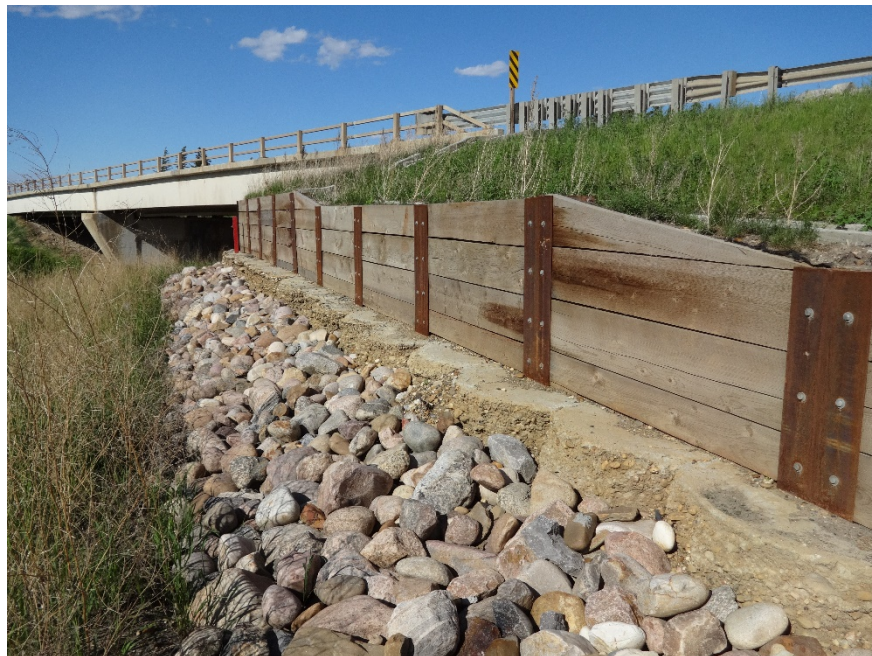
The site was repaired between 2020 and 2021 by constructing two concrete tangent pile walls and soil nails below the south headslope. However, during the 2023 inspection the slope below the pile walls had settled and dropped between 0.51 m and 2.1 m below the top of the pile walls. The magnitude of the drop was reviewed with the design team and it is understood that the wall can accommodate this amount of loss of passive support. However, this may become a concern if the slide mass settles even further in front of the wall. This should be monitored going forward. There was an erosion gully that formed on the east side of the bridge which should be filled in by the maintenance contractor before it enlarges and poses a risk to the bridge.

**Photo 3. Looking northeast at riprap that appeared to have settled on the downslope side of the pile wall.  
Photo credit: Nicole Wilder.**

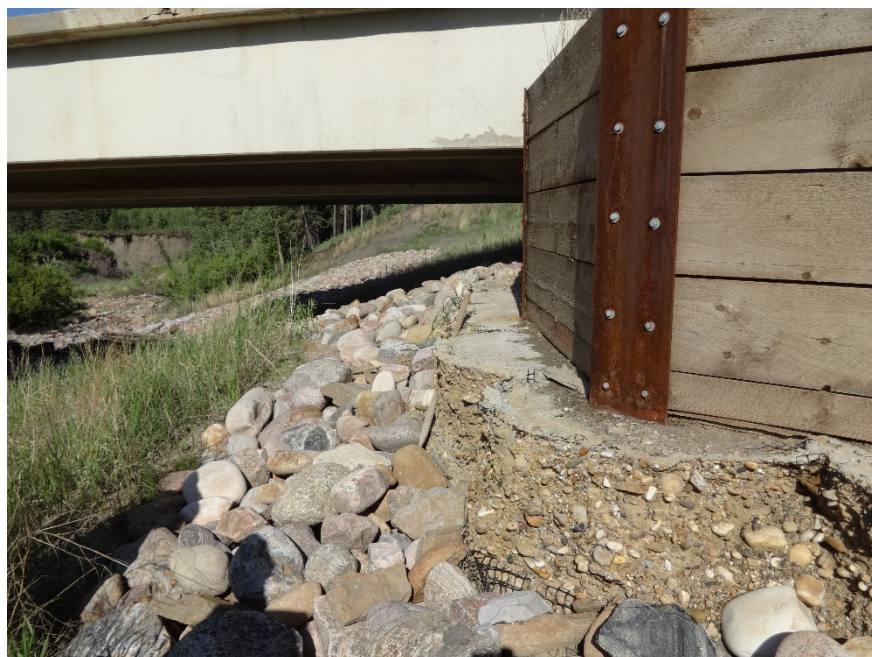
**Photo 4. Looking east at the corner of the pile wall and settled riprap. Photo credit: Nicole Wilder.**

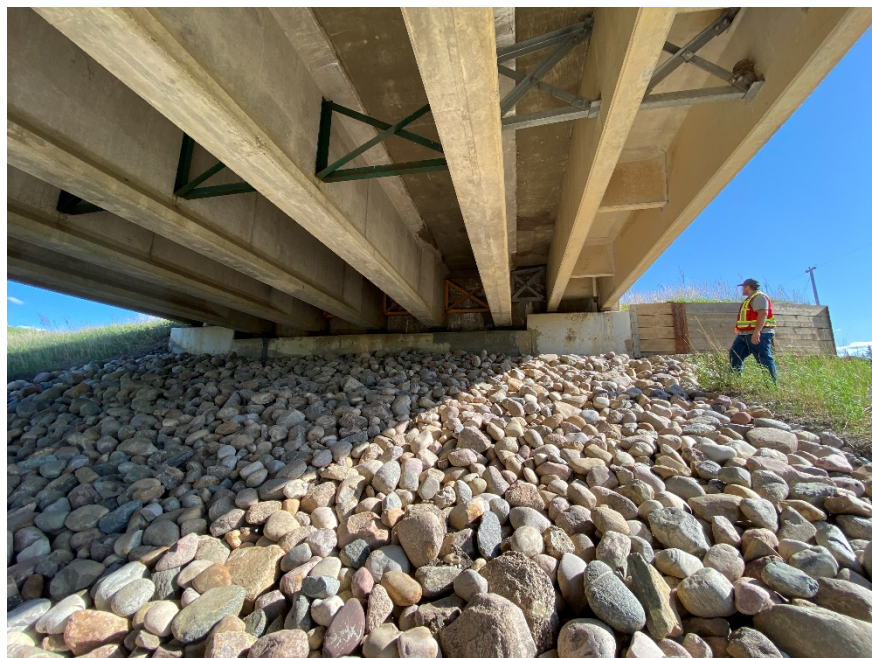
**Photo 5. Looking south at the south abutment and head slope. Photo Credit: Don Proudfoot.**

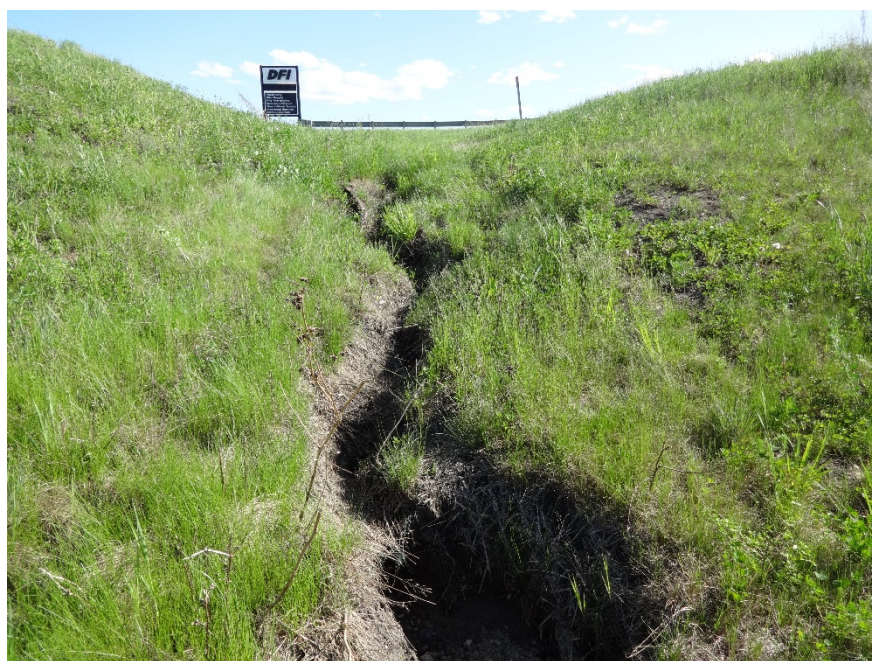
**Photo 6. Looking south at erosion gully that has formed east of the south side of the bridge. Photo Credit: Nicole Wilder.**

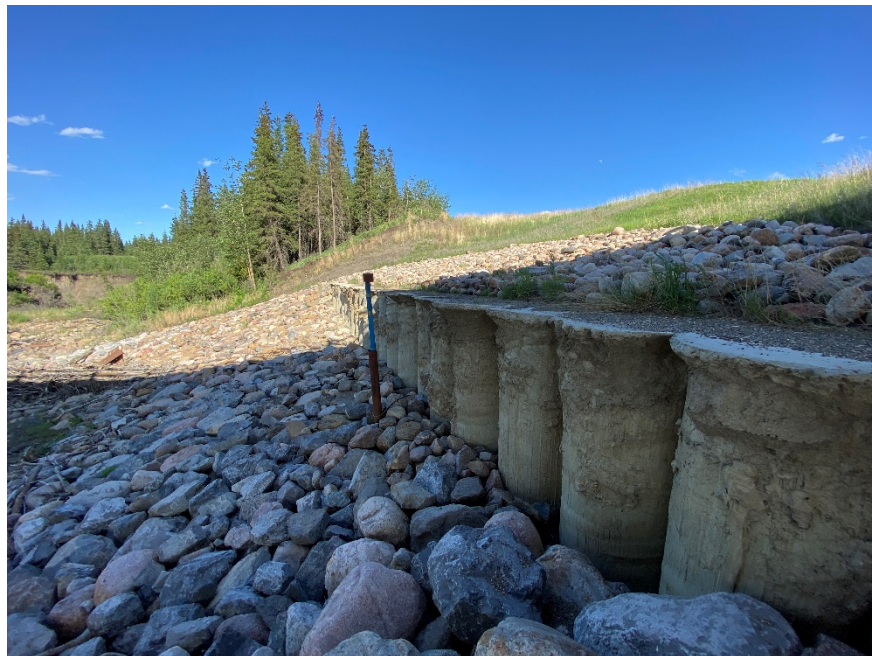
**Photo 7. Looking east at riprap that settled below the east pile wall. Photo Credit: Don Proudfoot.**

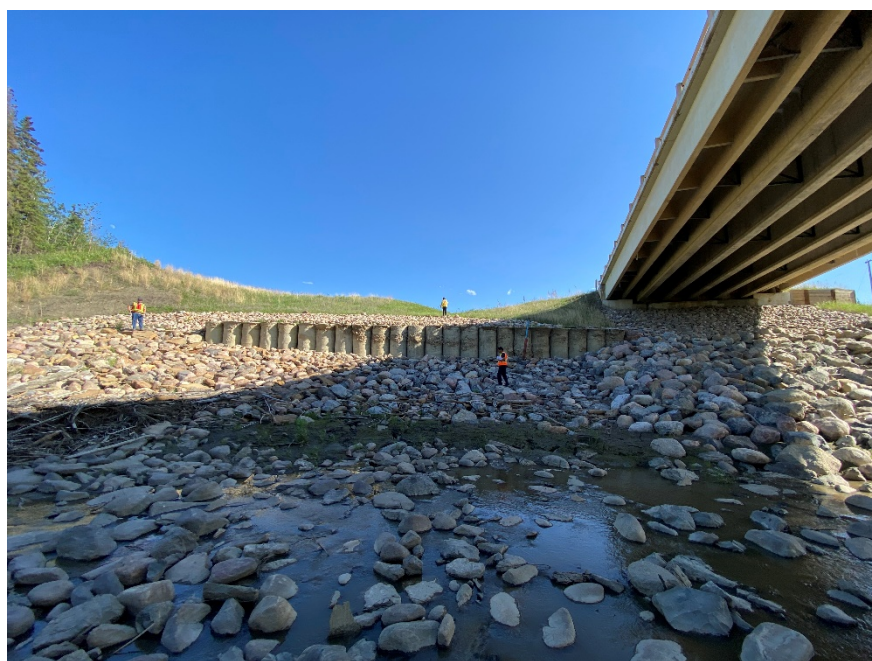
**Photo 8. Looking south towards the east pile wall and riprap. Photo Credit: Don Proudfoot.**

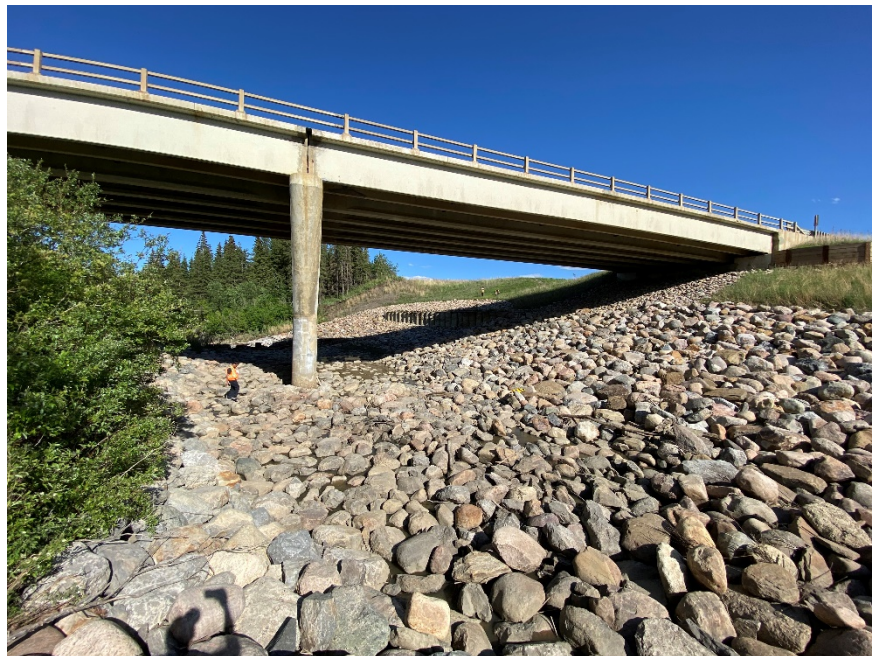
Photo 9. Looking southeast at the pier and riprap. Photo Credit: Nicole Wilder.

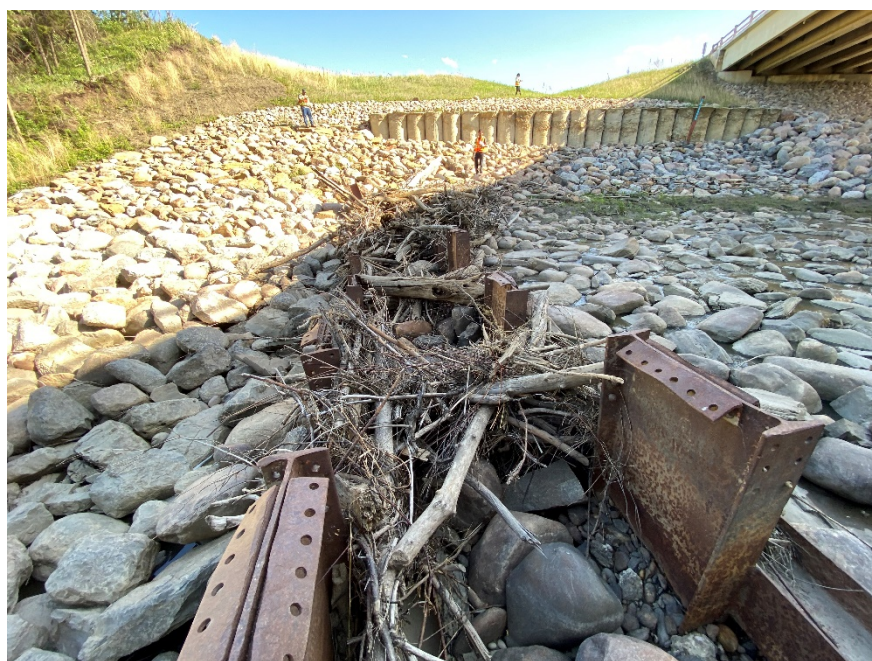
Photo 10. Looking south at debris that has accumulated in the pile weirs. Photo Credit: Don Proudfoot.

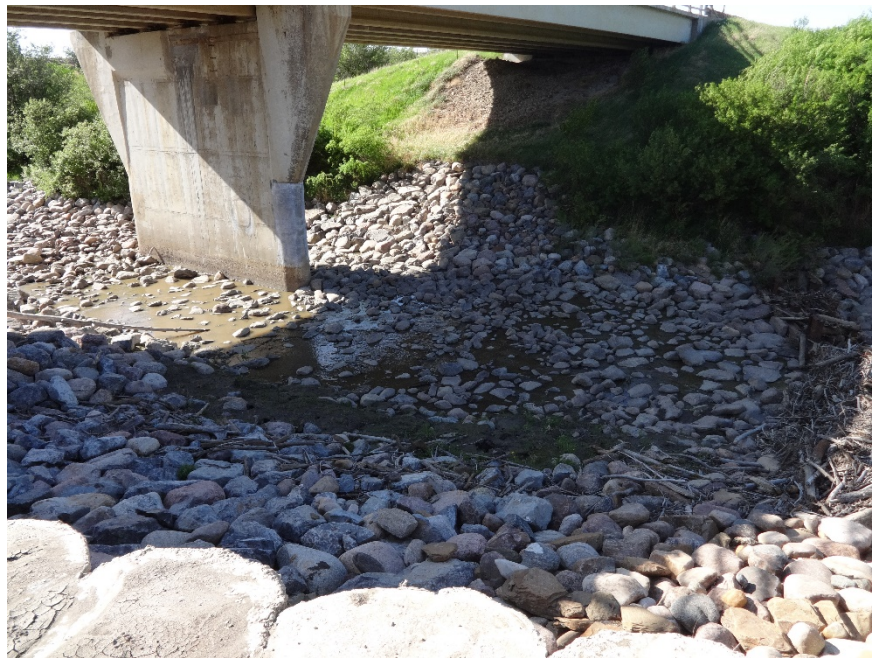
**Photo 11. Looking northwest at the north head slope. Photo Credit: Nicole Wilder.**

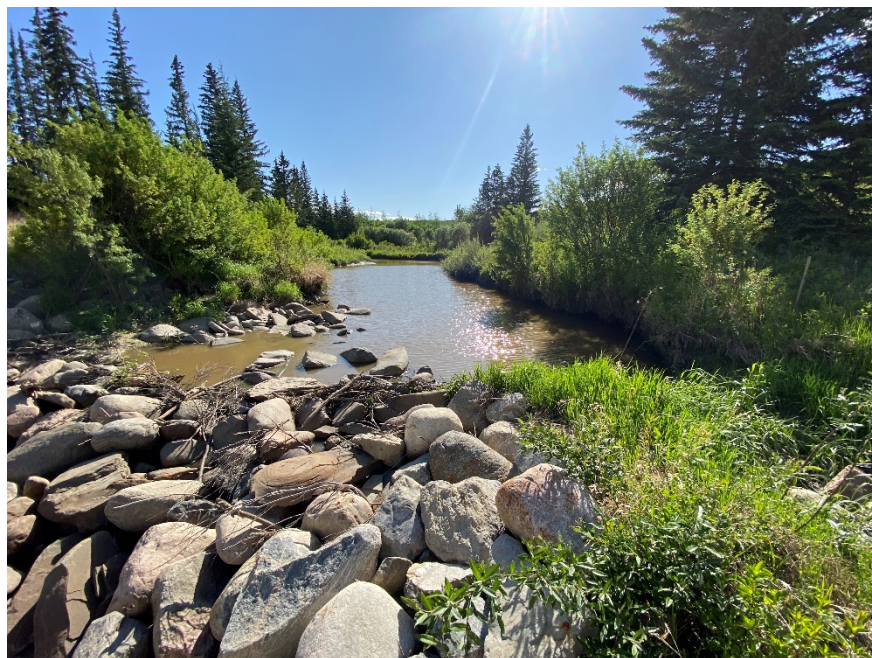
**Photo 12. Looking west at the river upstream of the placed riprap. Photo Credit: Don Proudfoot.**
