ALBERTA TRANSPORTATION AND
ECONOMIC CORRIDORS GRMP
PEACE REGION
(GRANDE PRAIRIE DISTRICT - NORTH)
INSTRUMENTATION MONITORING - FALL 2024

Site Number	Location	Name	Hwy	km
GP040	Hwy 2, 5 km North of Rycroft	Spirit River Bridge	2	5 km North of Rycroft
Legal Description:		UTM Co-ordinates		
16-4-77-5 W6		11U E 394305	N	6184771

Current Monitoring:	25-Sept-2024	Previous Monitoring	26-May-2024
Instruments Read By:	Mr. Neil McDonald and Mr. Nixson Mationg, of Thurber

SITE GP040: HWY 2, 5 km NORTH OF RYCROFT – SPIRIT RIVER HEAD SLOPE SLIDE

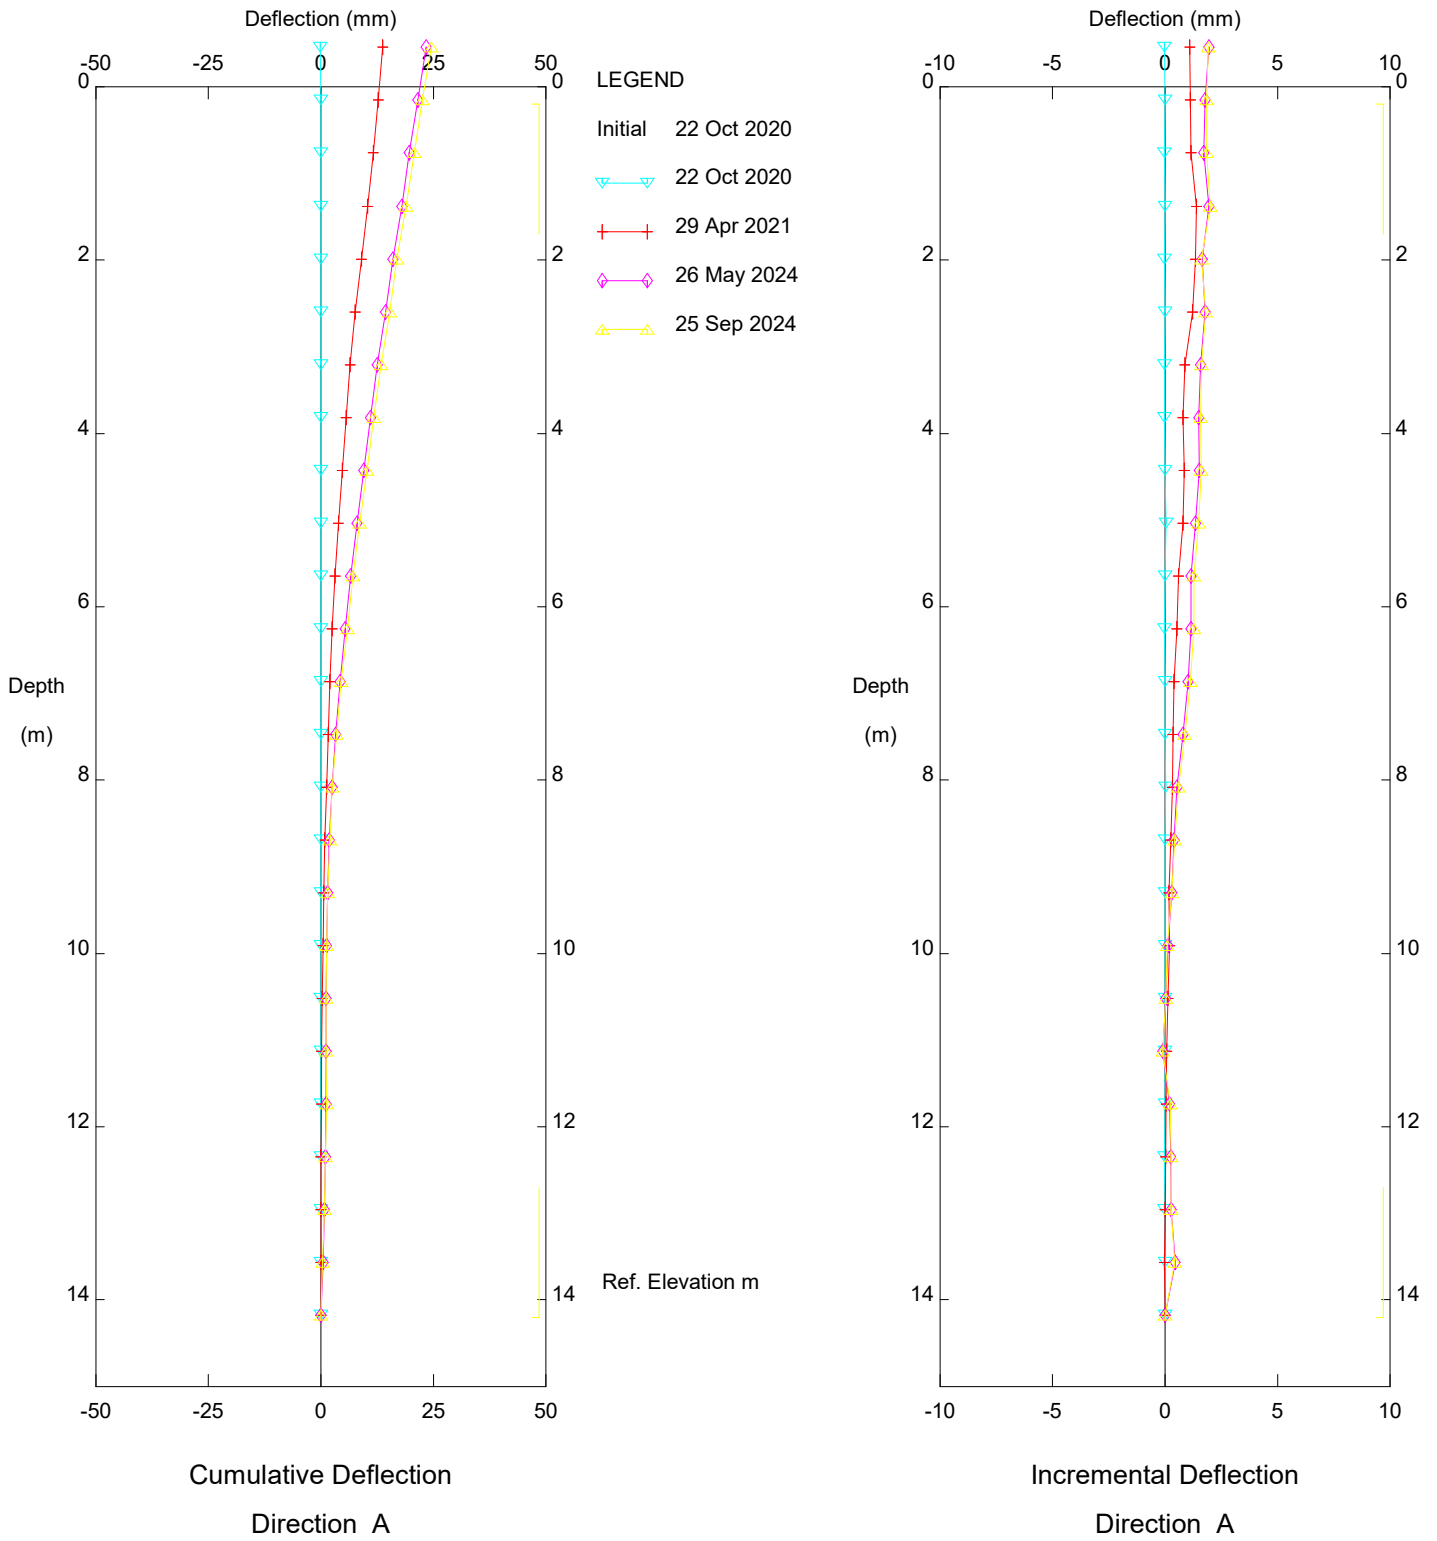
Spirit River Bridge, Inclinometer SI20-1

Zones of New Movement:	None
Interpretation of Monitoring Results:	<p>Slope inclinometer SI17-3 was found to have been blocked or sheared at 3.27 m below the top of casing since June 22, 2020.</p> <p>SI20-1 is located within the pile wall on the east side of the south abutment. It showed a gentle tilt pattern of movement and a rate of movement of 1.4 mm/yr over 0.2 m to 14.2 m depth since the previous reading on May 26, 2024. This corresponds to an increase in rate of movement of 0.88 mm/yr since the previous reading. The readings are consistent with the cantilevered concrete pile wall performance expectations.</p> <p>All of the pneumatic piezometers on this site were previously damaged.</p>
Future Work:	Due to there being only one active instrument left on the site, we recommend reading this site once annually. The instruments should be read again in the fall of 2025.
Instrumentation Repairs:	No instrument repairs are required at this time.

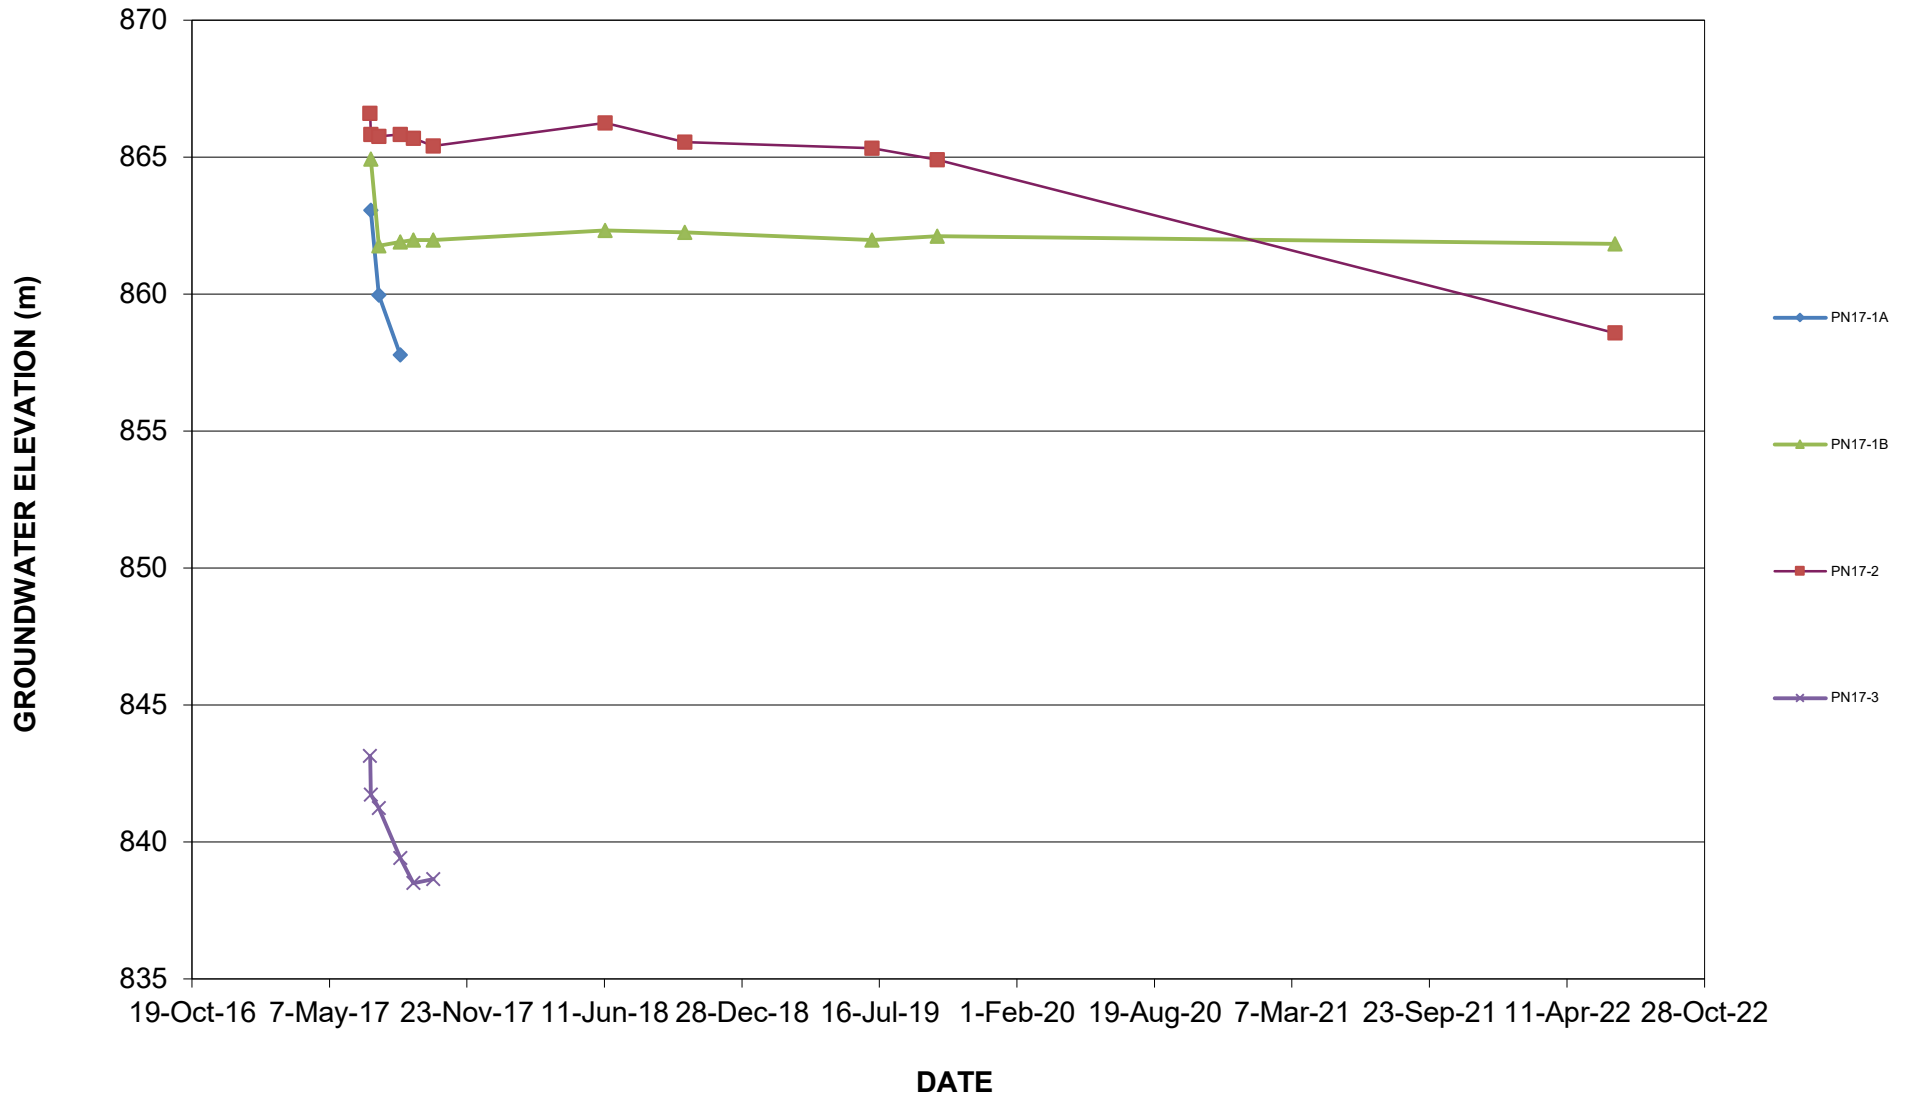
FIGURE GP040-1
PIEZOMETRIC ELEVATIONS FOR HWY 2:68 4.7 km NORTH OF RYCROFT

*water return. Purged water and took readings.
PN Piezometers on site are damaged
