**ALBERTA TRANSPORTATION AND  
ECONOMIC CORRIDORS GRMP  
GRANDE PRAIRIE REGION –  
(GRANDE PRAIRIE NORTH)  
INSTRUMENTATION MONITORING - SPRING 2024**

Site Number	Location	Name	Hwy	km
GP040	Hwy 2:68 km 29.41, 5 km North of Rycroft	Spirit River Bridge	2:68	29.41
<b>Legal Description:</b> 16-4-77-5 W6		<b>UTM Co-ordinates</b>		
		11U E 394305	N	6184771

<b>Current Monitoring:</b>	26-May-2024	<b>Previous Monitoring</b>	29-Apr-2021
<b>Instruments Read By:</b>	Mr. Niraj Regmi, G.I.T and Mr. Nixson Mationg, of Thurber

**SITE GP040: HWY 2, 5 km NORTH OF RYCROFT – SPIRIT RIVER HEAD SLOPE SLIDE**

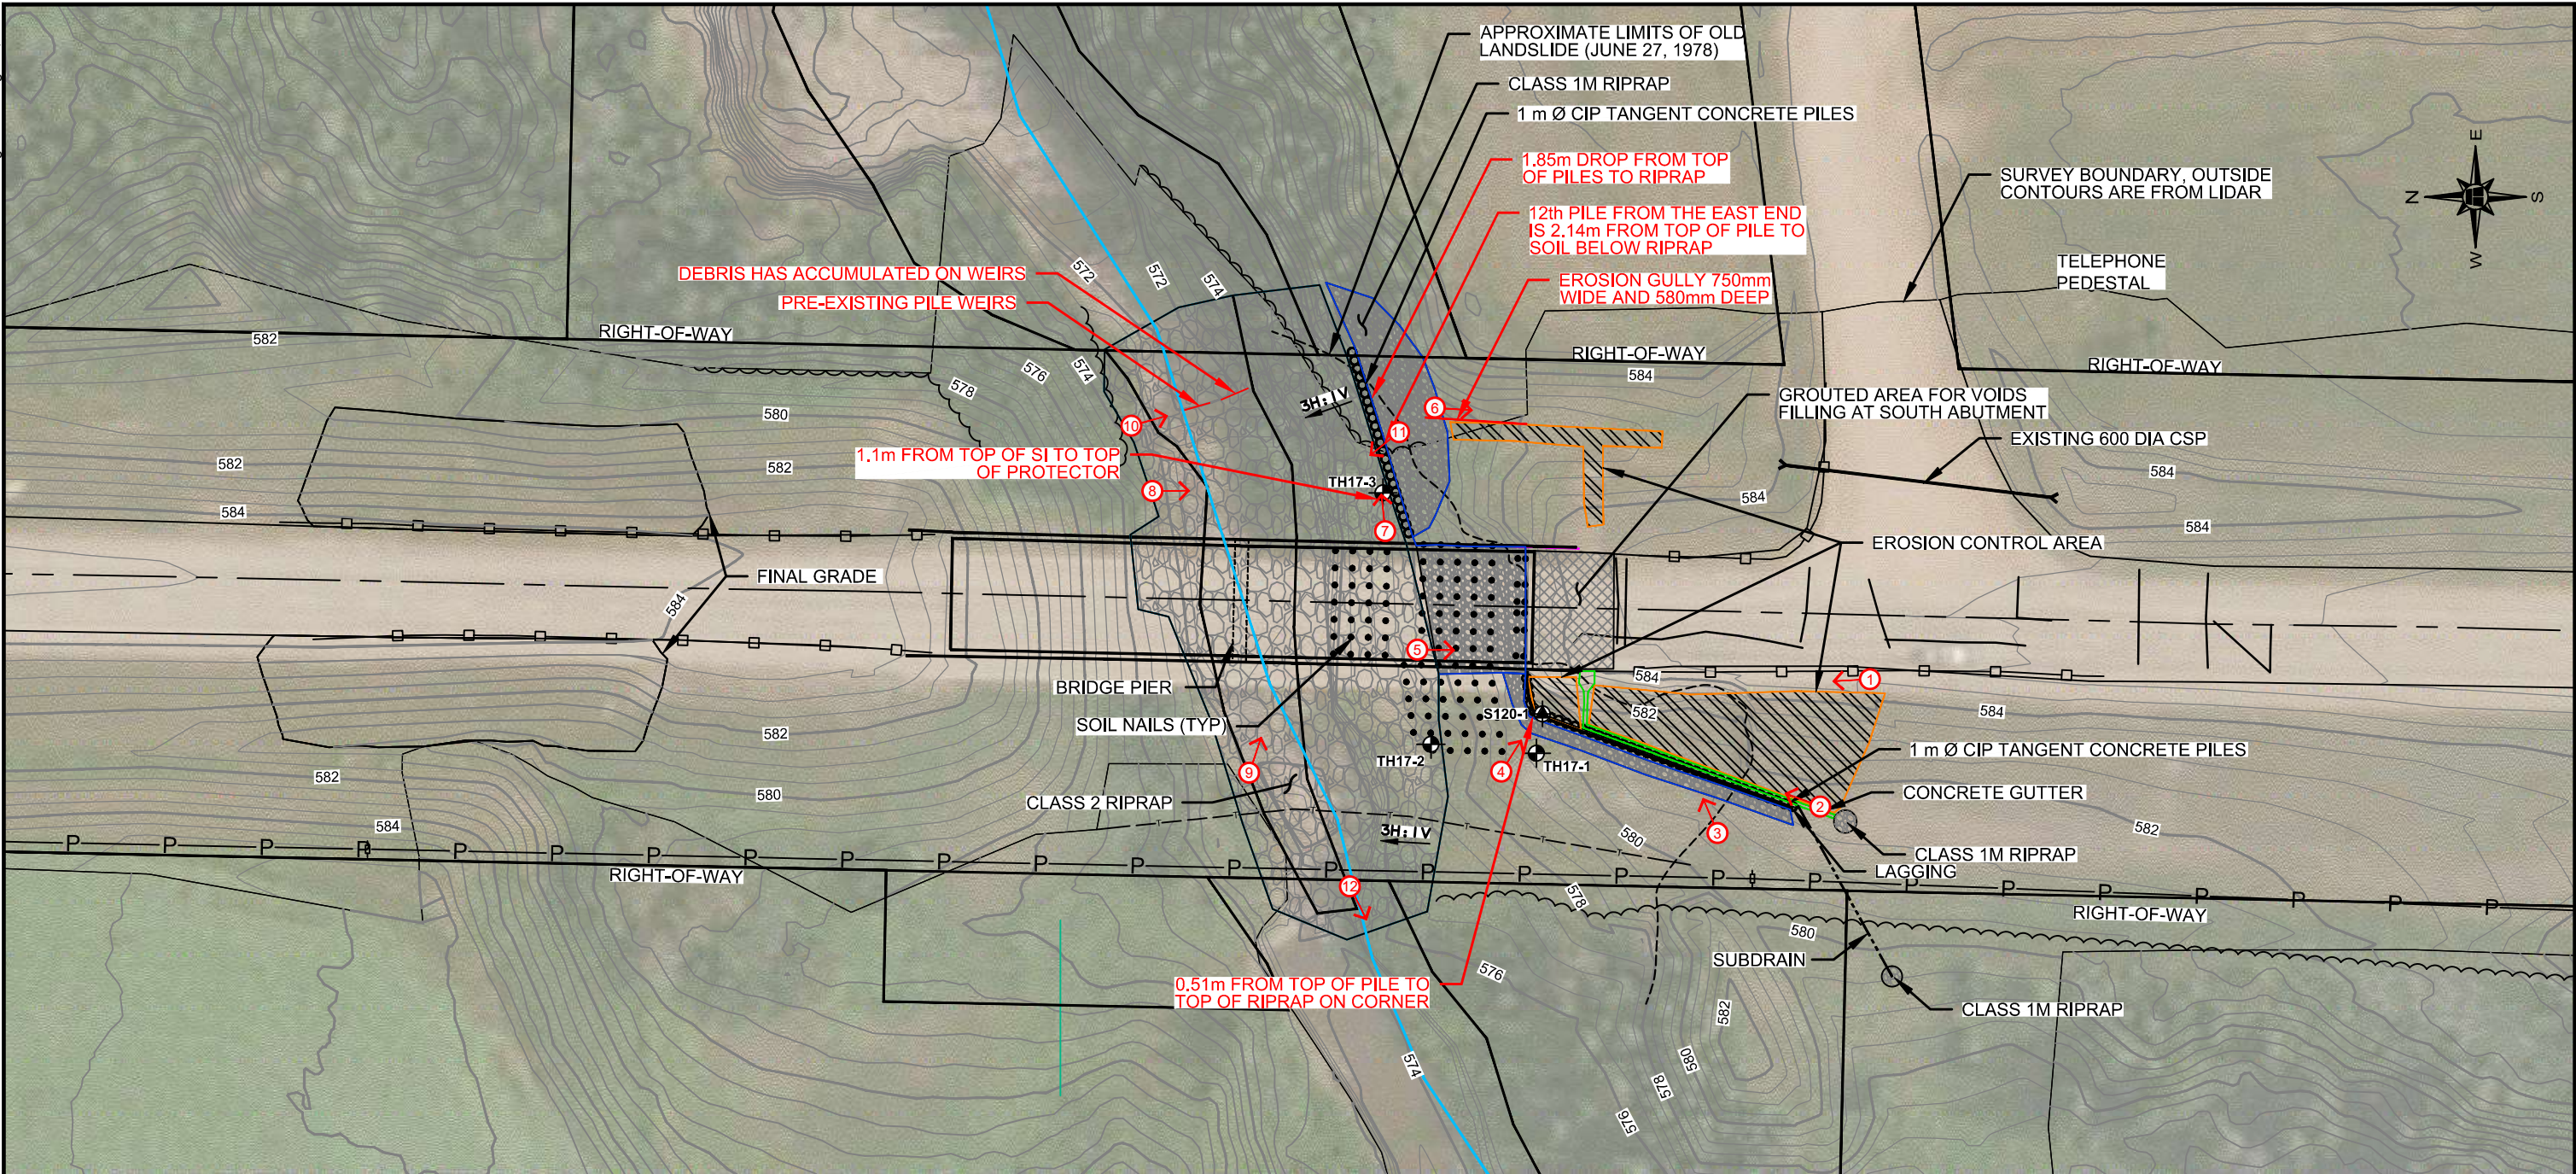
**DWG No. 32123-GP040-1**

Drawing GP040-1 in Appendix A provides a sketch of the approximate location of the monitoring instrumentation for this site.

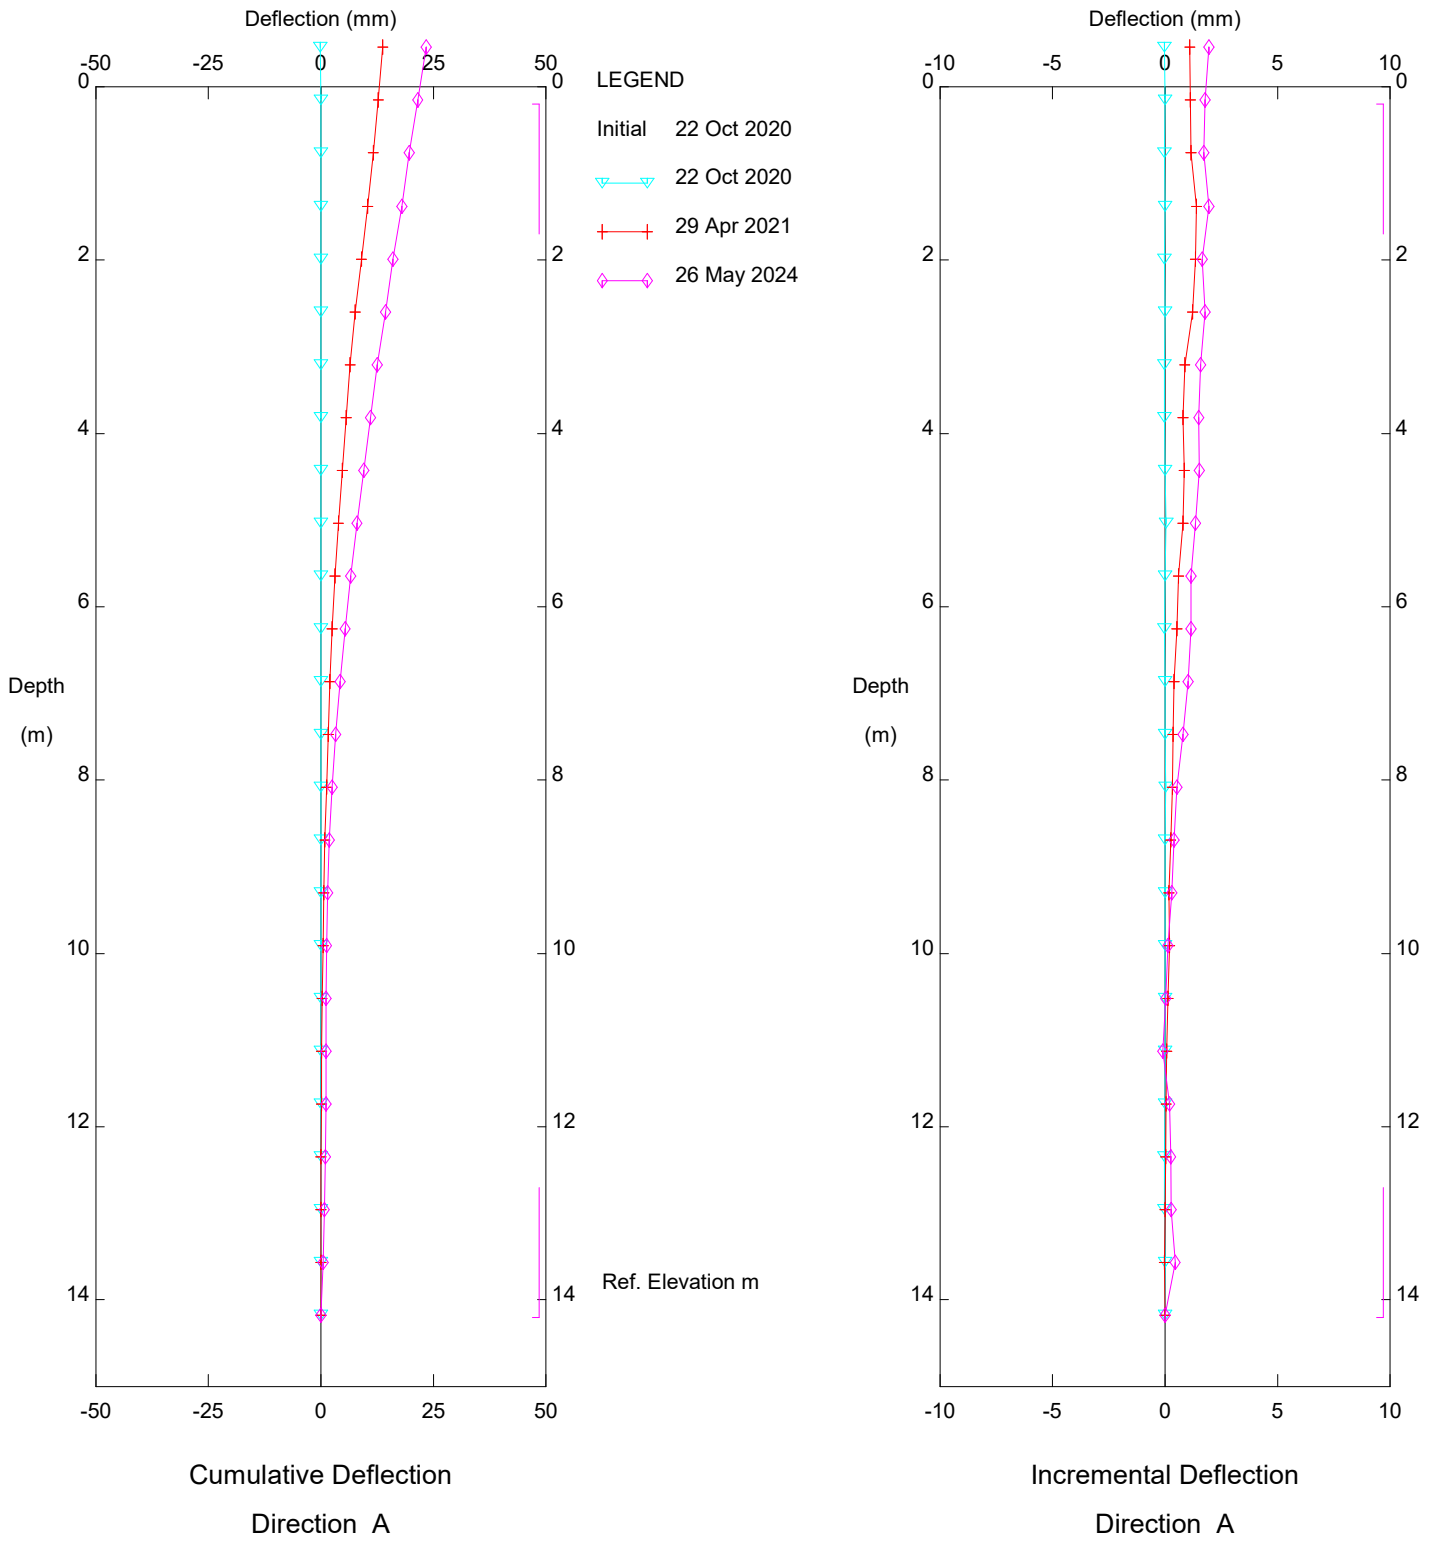
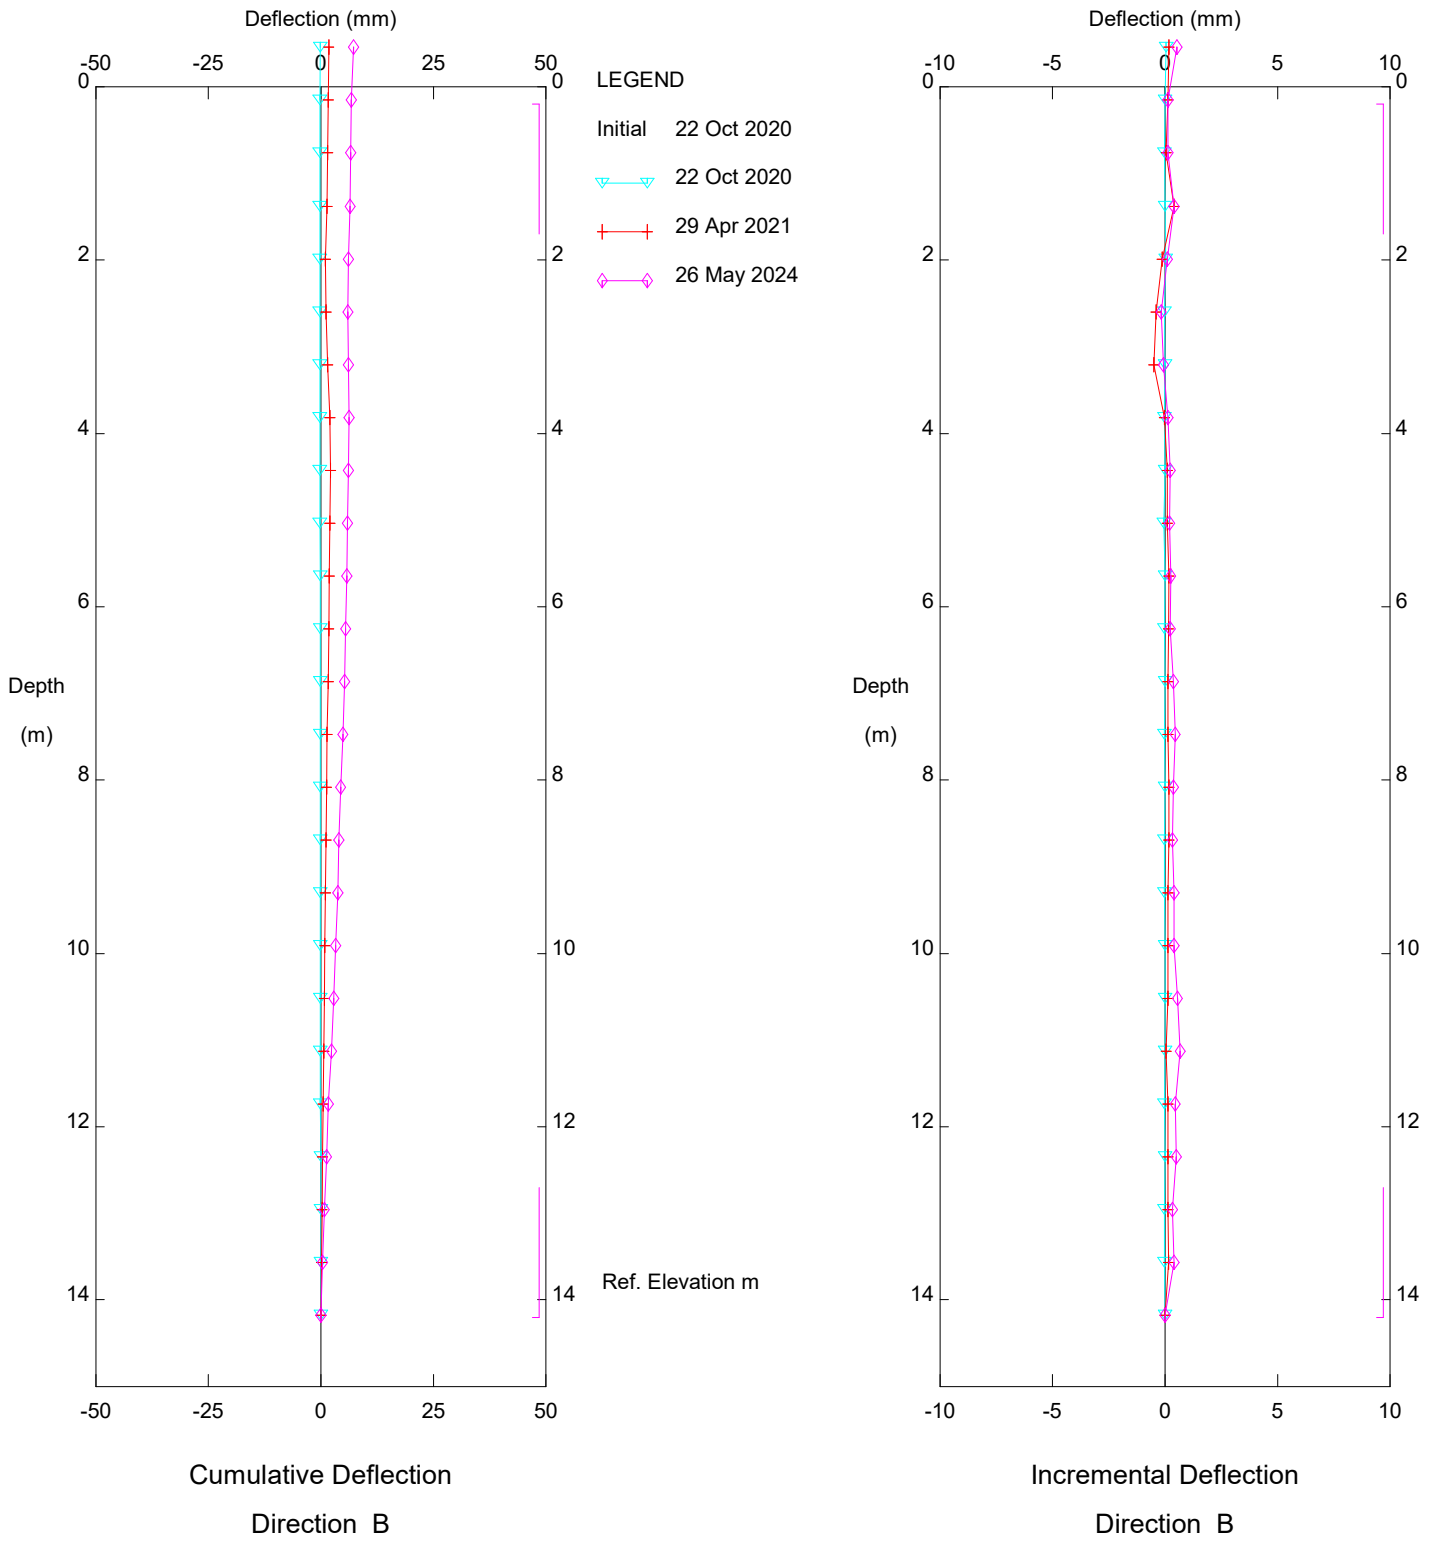
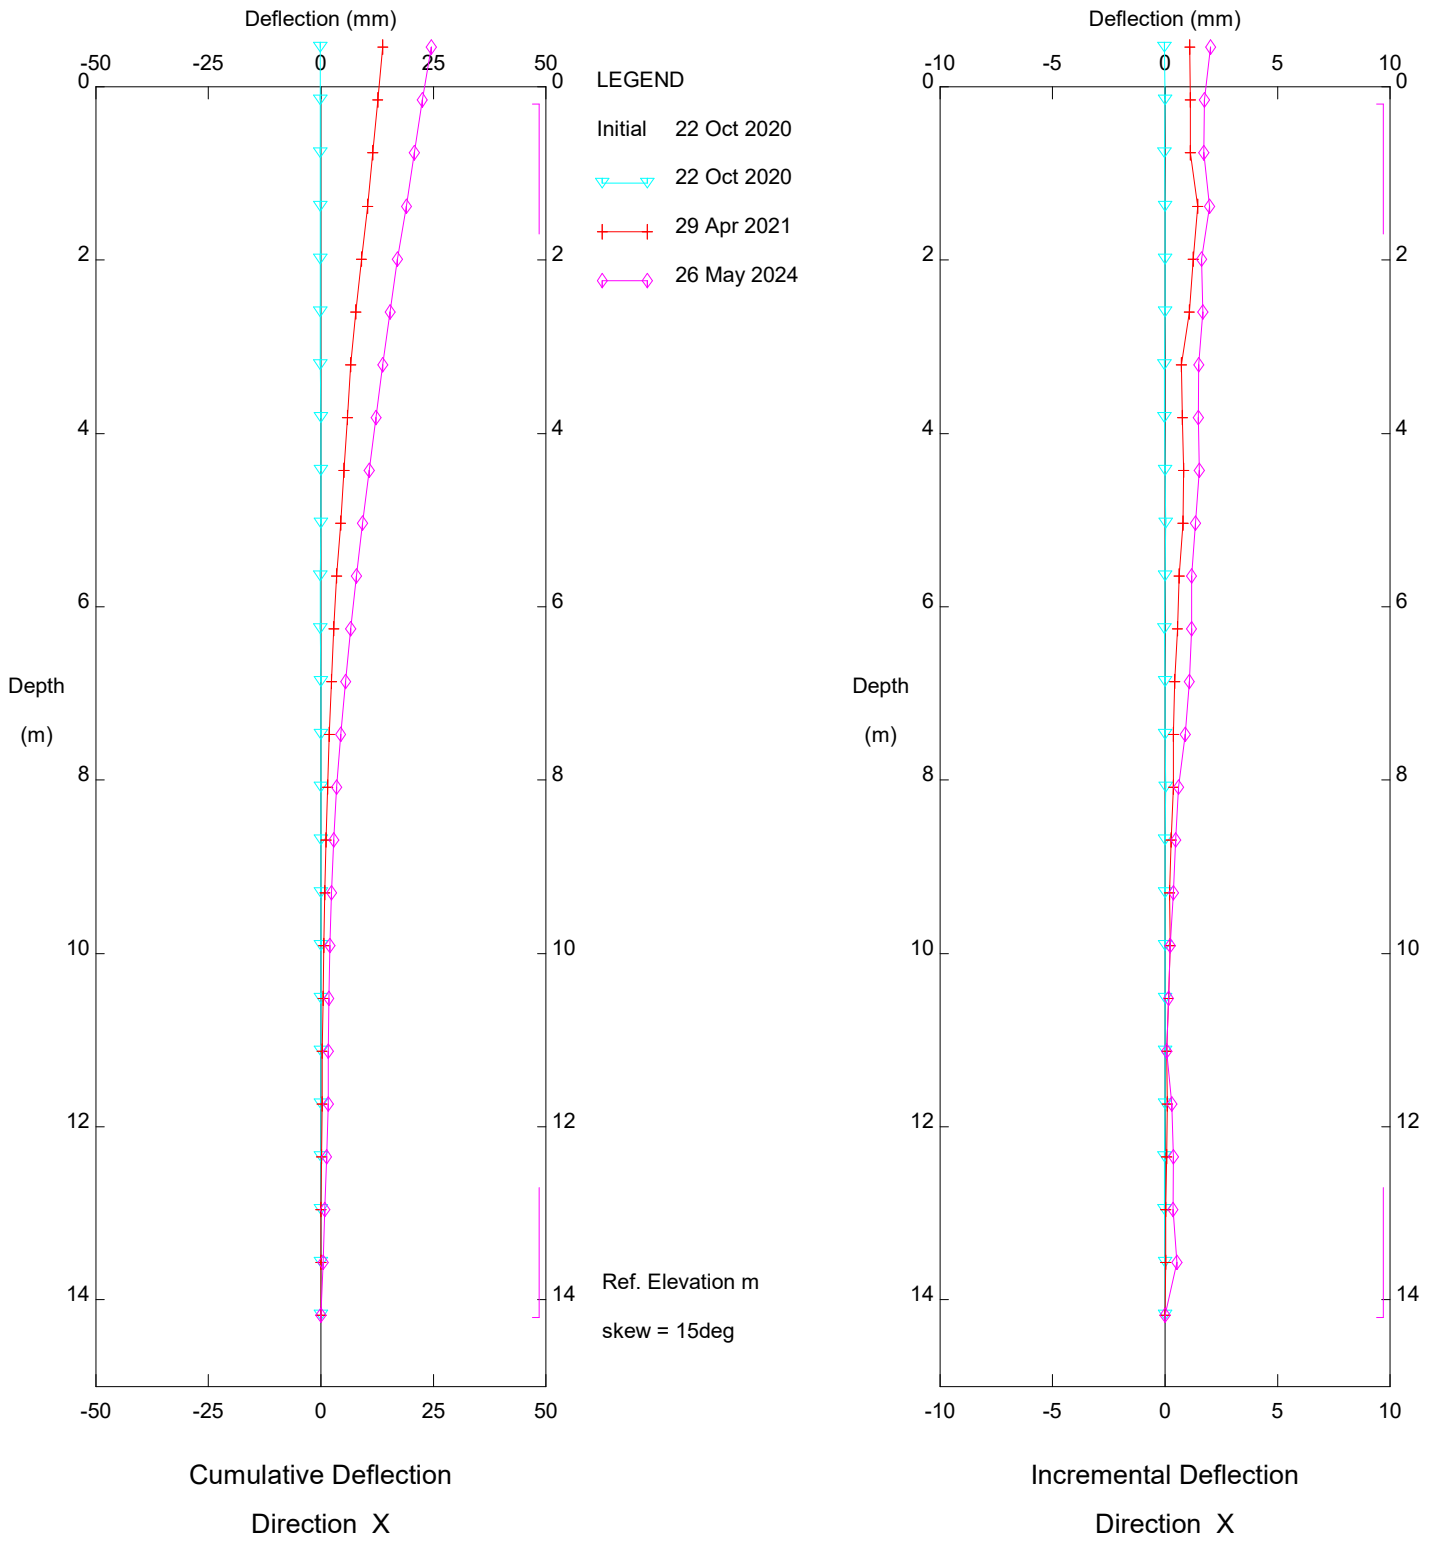
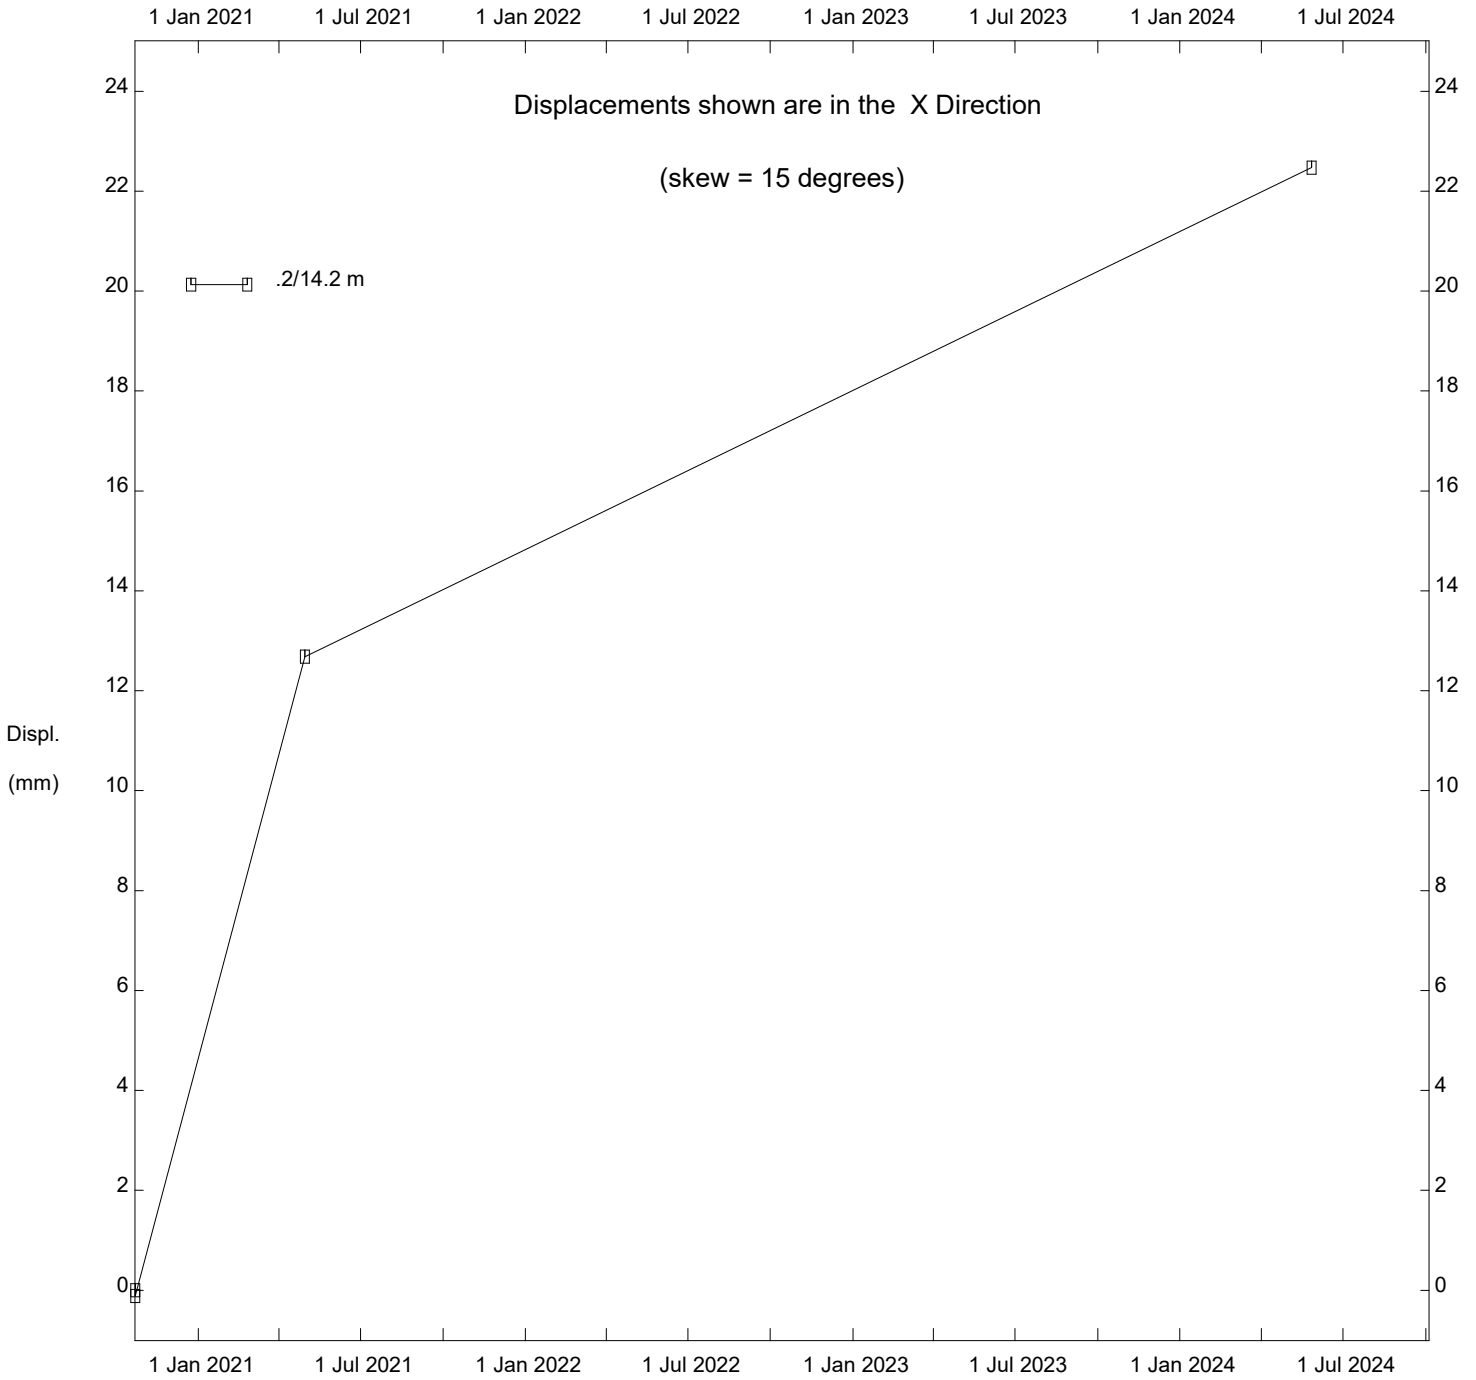
Spirit River Bridge, Inclinometer SI20-1

Discussion	
<b>Zones of New Movement:</b>	None
<b>Interpretation of Monitoring Results:</b>	<p>Slope inclinometer SI17-3 was blocked or sheared at 3.27 m below the top of casing. SI17-3 is located east of the repaired headslope and just north of the pile wall installed in 2020/21. Continued slope movement at this location may expose more of the pile wall. This situation should be monitored.</p> <p>SI20-1 showed a rate of movement of 3.2 mm/yr over 0.2 m to 14.2 m depth since the previous reading on April 29, 2021. This corresponds to a decrease in rate of movement of 21.5 mm/yr since the previous reading. The movement pattern indicates a gradual tilting of the pile the SI is installed in; this should continue to be monitored. The reduced rate of movement suggests the mitigation work (soil nails and pile walls) is performing satisfactorily.</p> <p>All of the pneumatic piezometers on this site were previously damaged. Historical piezometer plots are provided in the Appendix.</p>

<b>Future Work:</b>	<p>Due to there being only one active instrument left on the site, we recommend reading this site once annually. The instrument should be read again in the spring of 2025.</p> <p>The pile head deflections in SI20-1 should be monitored to ensure that they are within the design limits. If these limits are exceeded it may be necessary to reinforce the pile wall with tie-back anchors or other remedial measures.</p>
<b>Instrumentation Repairs:</b>	No instrument repairs are required at this time.
<b>Additional Comments:</b>
