THURBER ENGINEERING LTD.

December 21, 2018

File: 13351

**GEOHAZARD ASSESSMENT PROGRAM
CALL-OUT INSPECTION REPORT
HWY 2:68 KM 12.30 TO KM 12.42
NE08-080-04-W6M
(PH001-2) DUNVEGAN NORTH SITE**

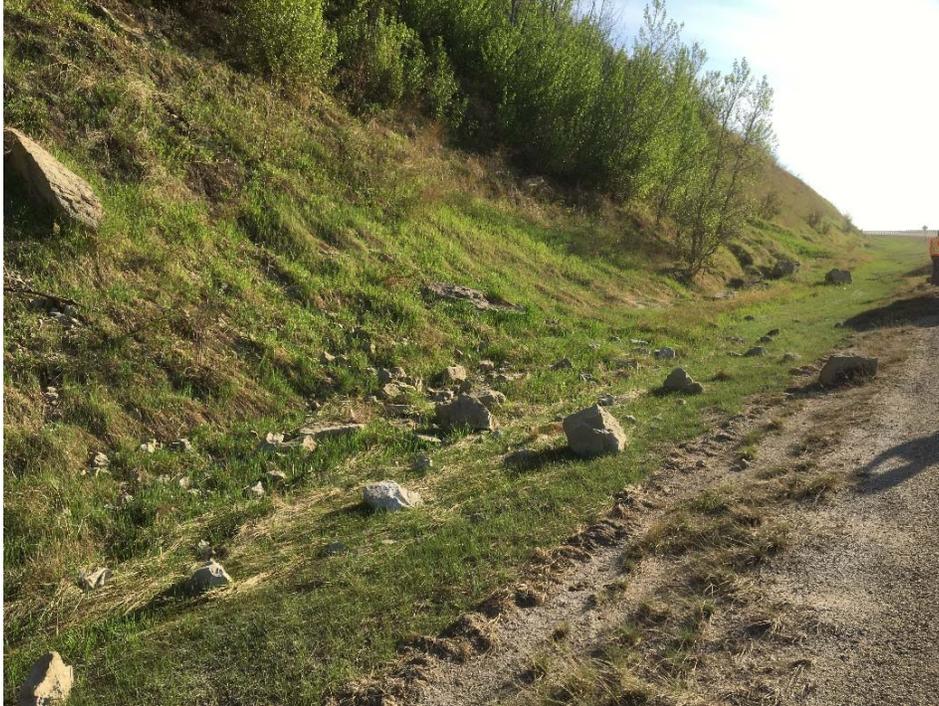
The exposed stratigraphy in the backslope near the debris flow consists primarily of an upper 2 m thick ledge of sandstone bedrock underlain by weathered claystone and layered sandstone bedrock layers. Some light seepage was observed at the base of the upper sandstone ledge. The backslope and ditch bottom were littered with blocks of sandstone pieces (Photos 1 and 2) with several loose blocks of sandstone throughout.

Photo 1: Looking northeast from the SBL shoulder at km 12.32 of Hwy 2:68 at sandstone blocks in the ditch and along the sideslope above the highway.

The loose hanging slide blocks and debris flow material should be carefully removed from the lower backslope area and ditch and hauled out of the valley for disposal. Due to the possibility of crumbling of the edge of the overlying sandstone bedrock layer, people should not be present in the ditch area unless they are protected within heavy equipment equipped with roofed cabs.

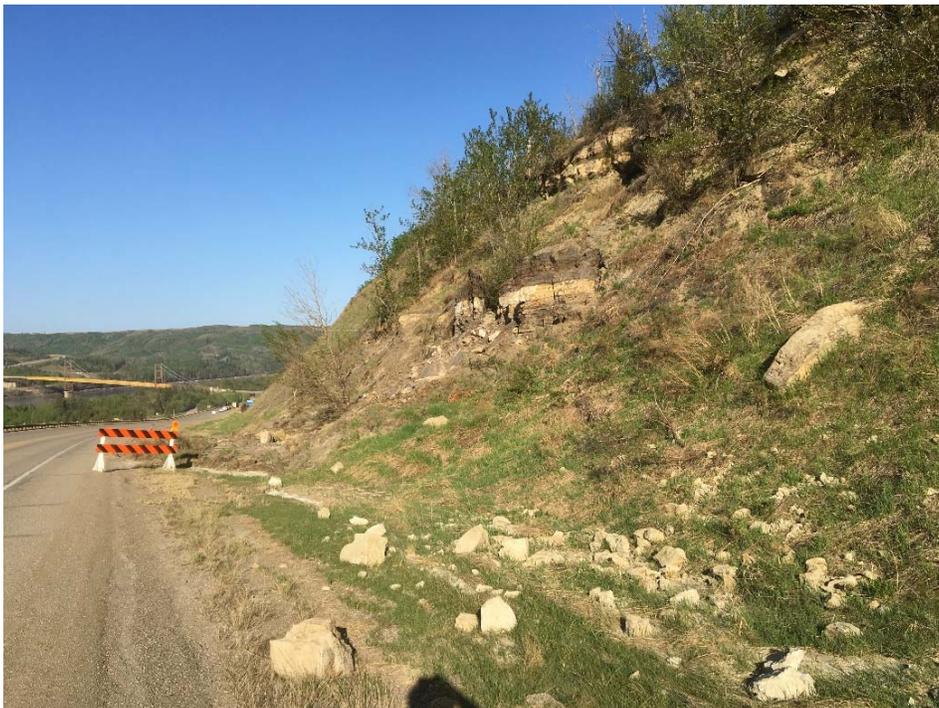
Accumulated soil debris and sandstone blocks were partially obstructing the ditch water flow (Photo 2). The debris accumulated in the SBL ditch consisted primarily of small chunks and small to large sized slabs of silty weathered sandstone bedrock and colluvium soil mixed with peat, grass, shrubs and small trees. The largest observed sandstone block in the ditch was 0.5 m X 0.5 m X 2.1 m in size.

Photo 2: Looking southwest from the shoulder of the SBL from km 12.29 of Hwy 2:68 at the accumulated debris and sandstone pieces along the base of the debris flow.

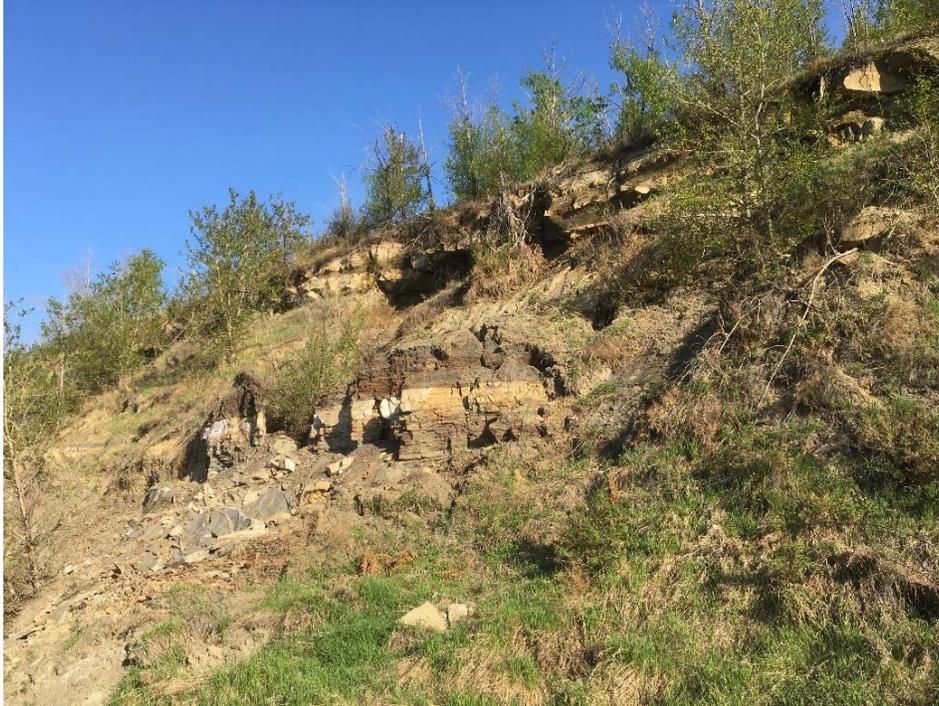
Photo 3: Looking northwest from km 12.34 at dislodged landslide block from the upper sandstone outcrop hanging at midslope.

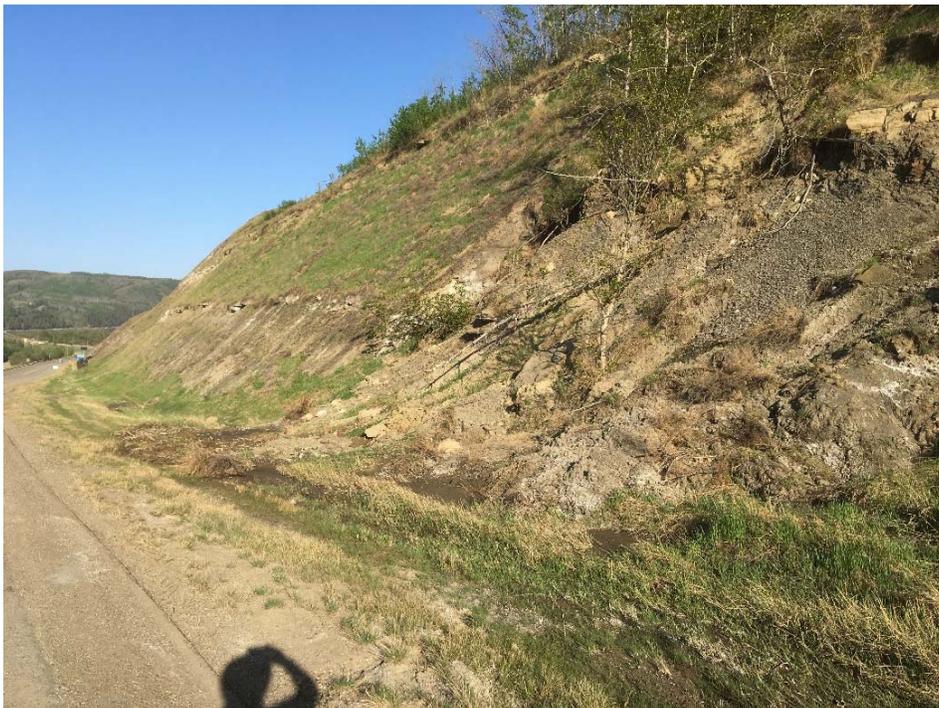
A debris flow/rock slide geohazard was observed in the backslope of Hwy 2:68 between km 12.3 and km 12.42 of Hwy 2:68. At this location the grade of the highway is at about 7 percent and the overall backslope cut above the highway cut is about 24 m high with about 18 m of exposed bedrock in the lower part of the cut. The backslope cut is inclined at 1.5H: 1V in the bedrock and is at 2H: 1V in the colluvium overlying the bedrock in the upper part of the cut (Photos 2 and 4).

Photo 4: Looking northwest from shoulder of SBL at km 12.385 at the south end of debris flow.

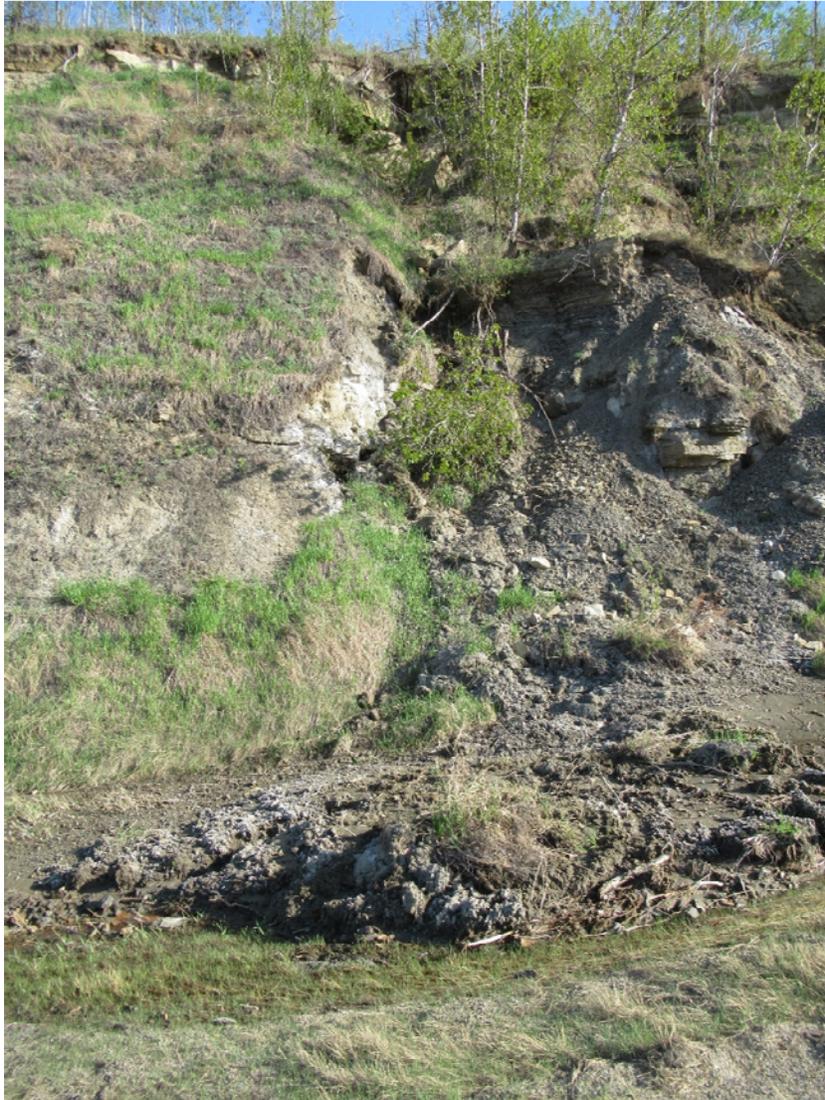
Photo 5: Looking north at gully at west end of debris flow with small fan of wet material at the base in the SBL ditch at km 12.415.

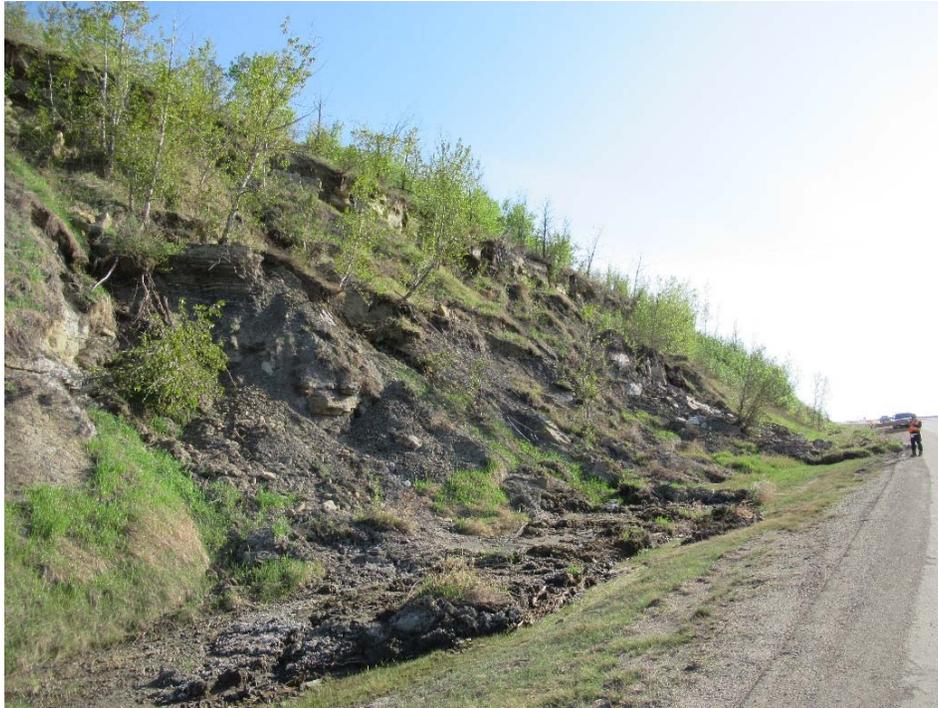
Photo 6: Looking northeast along the base of the debris flow from the shoulder of the SBL at km 12.425.

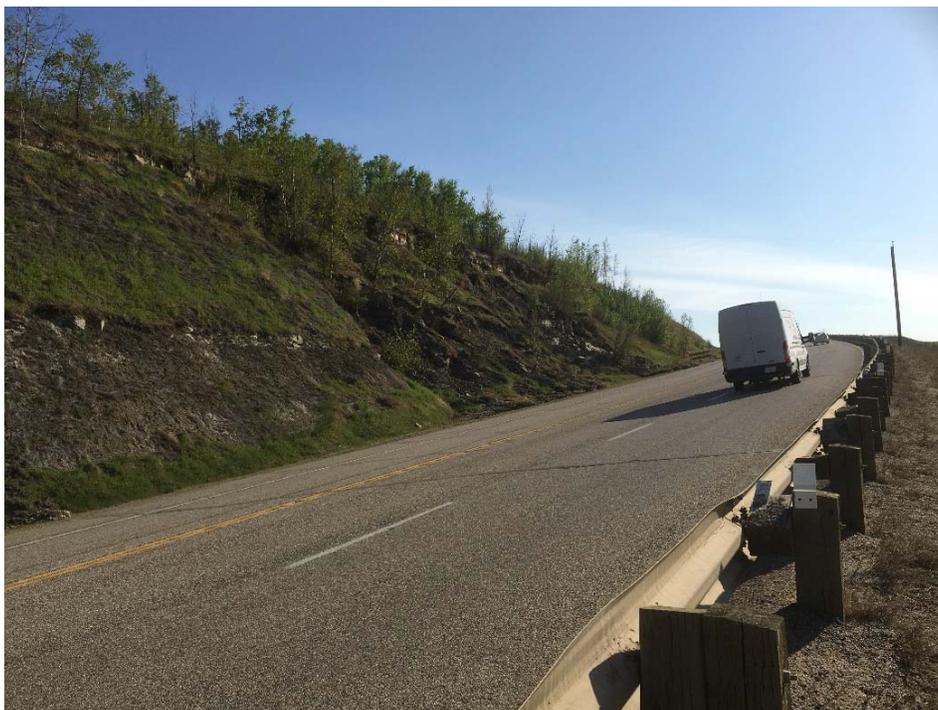
Photo 7: Looking northeast from the shoulder of the NBL at km 12.45 towards the debris flow.

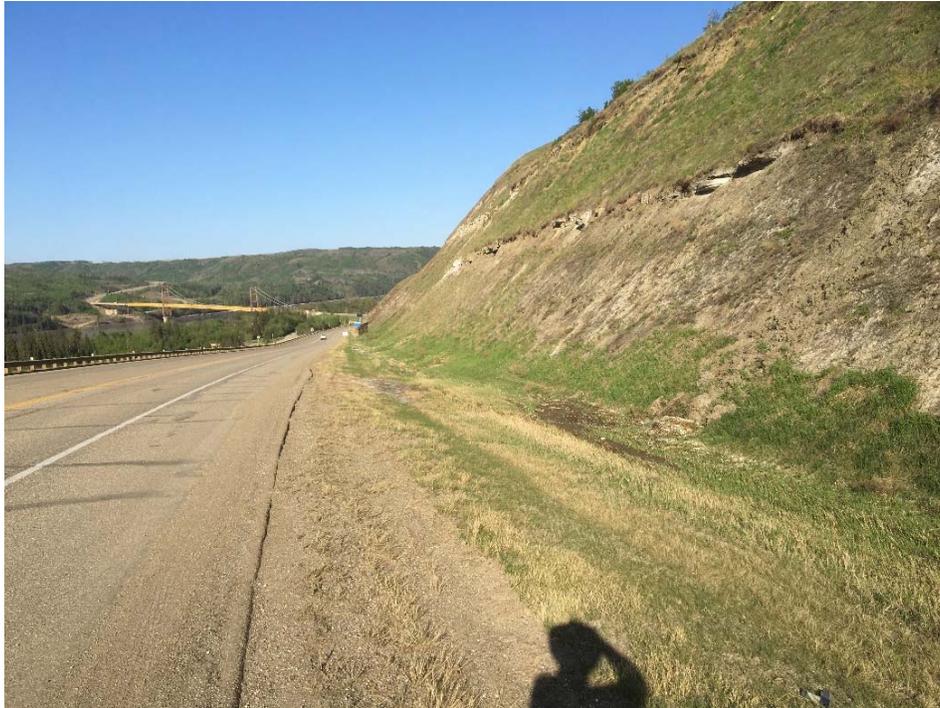
Photo 8: Looking southwest from the shoulder of the SBL at km 12.435 along the SBL at the staining in the backslope and the soil loss below the lower sandstone ledge.

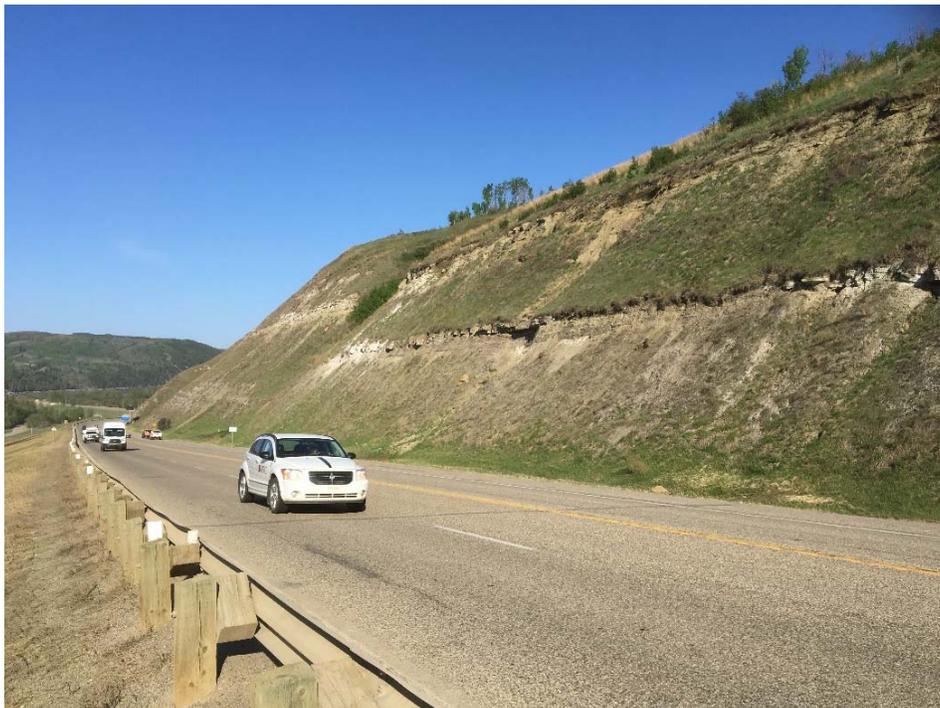
Photo 9: Looking NW from the guardrail at km 12.46 west of the debris flow at salt staining/soil loss below the lower sandstone ledge and an erosion gully in the backslope (May 15, 2018)

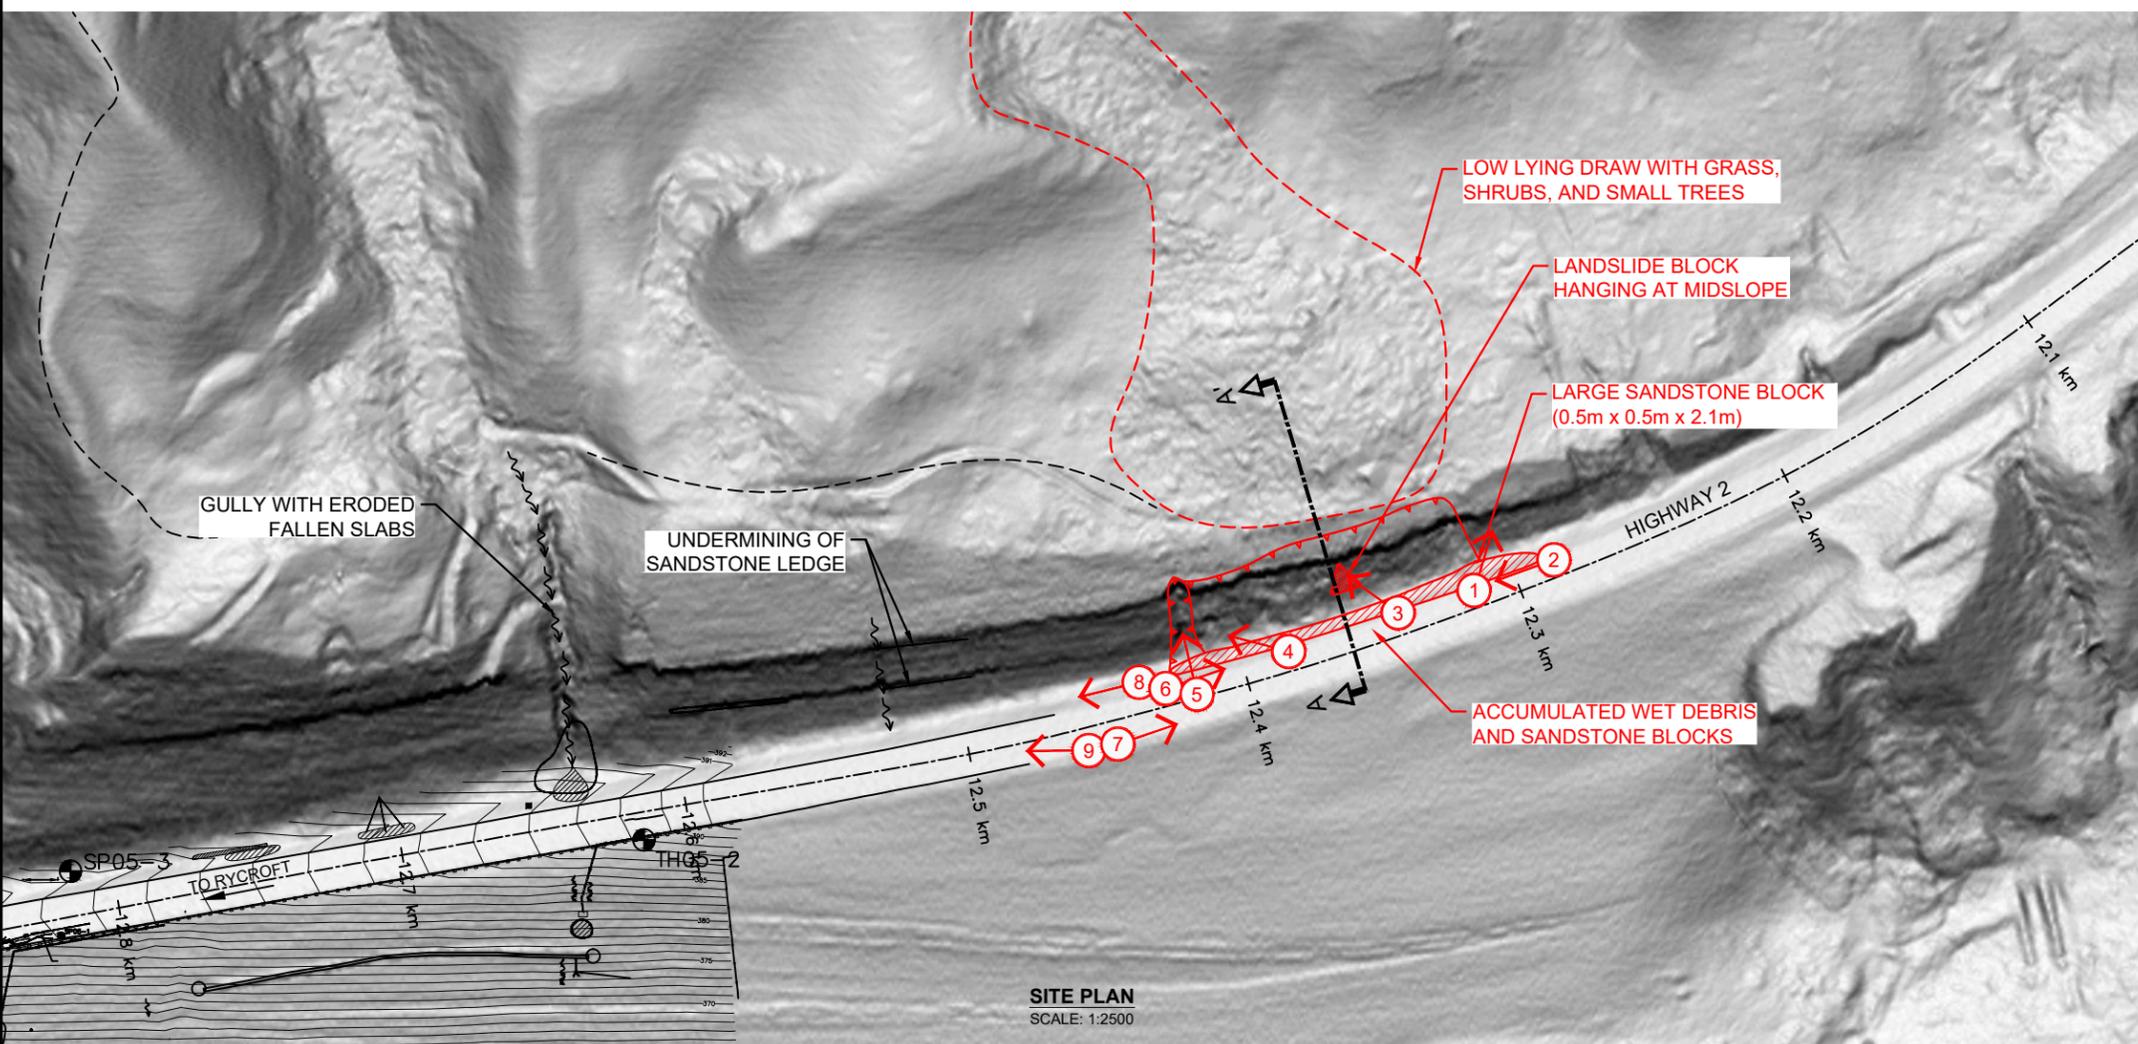
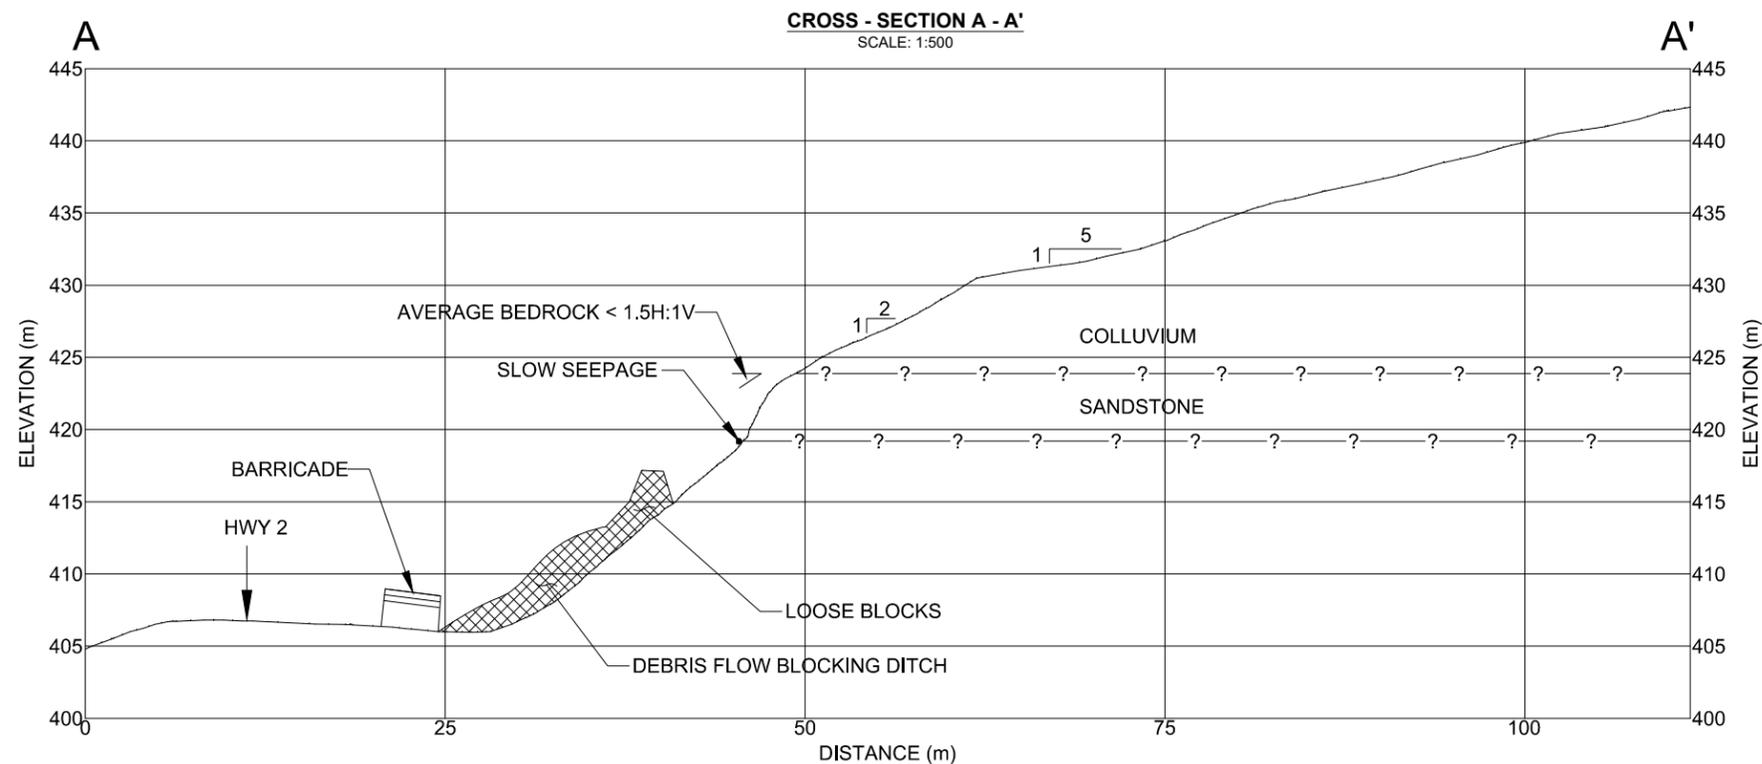
DWG No. 13351-PH001-CALLOUT 1

Selected photographs taken during the Call Out inspection are attached to the report. A plan showing site features, and an approximate cross-section through the highway backslope, are shown on DWG. No. 13351-PH001-CALLOUT 1.

The debris flow/rockfall hazard measured 120 m in overall length and spanned between a natural drainage gully to the west (km 12.42) and the east limits of a natural drainage draw in the upper valley slope above the highway to the east (km 12.3). The outline of the debris flow/rock fall hazard recorded with a handheld GPS is shown on Drawing No. 13351-PH001-CALLOUT1.
