July 11, 2018

File: 13351

**GEOHAZARD ASSESSMENT PROGRAM  
CALL-OUT INSPECTION REPORT  
HWY 2:68 KM 12.6  
NE08-080-04-W6M  
(PH001-2) DUNVEGAN NORTH SITE**

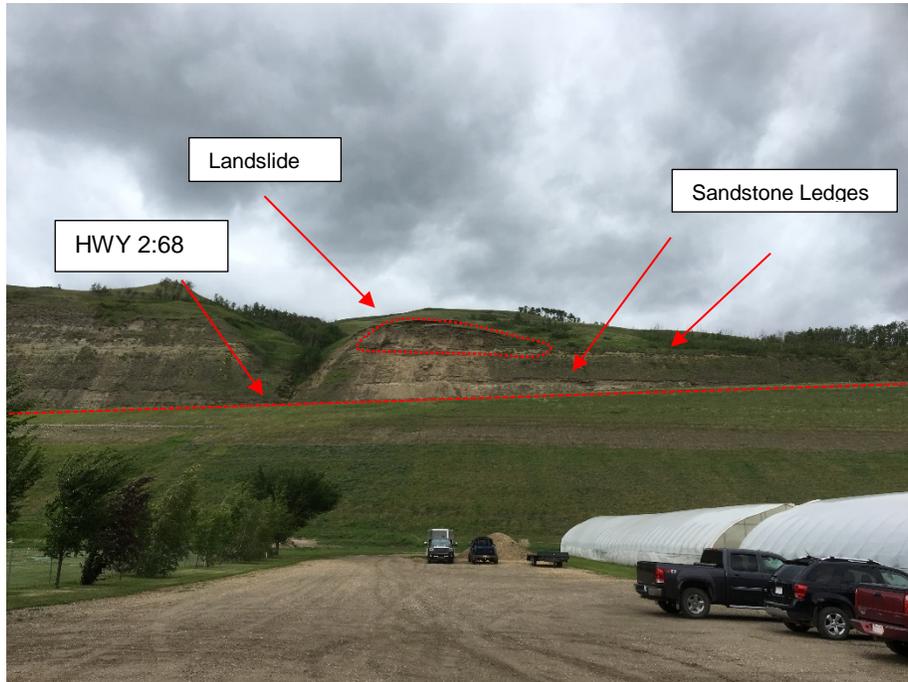
A landslide was observed in the upper part of the highway backslope at approximately km 12.6. At this location the backslope is about 55 m high. The lower 30 m of the backslope, where the bedrock is exposed is inclined at 1H:1V. The upper 25 m, in which the landslide is located in soil material, is inclined at about 2H:1V (Photos 1 to 3). The landslide was overlying an upper 300 mm to 800 mm thick sandstone bedrock ledge situated about 25 m to 30 m above the SBL ditch (Photo 3).

Photo 3: Looking north at the landslide site from the north side lower flood plain terrace (June 26, 2018)

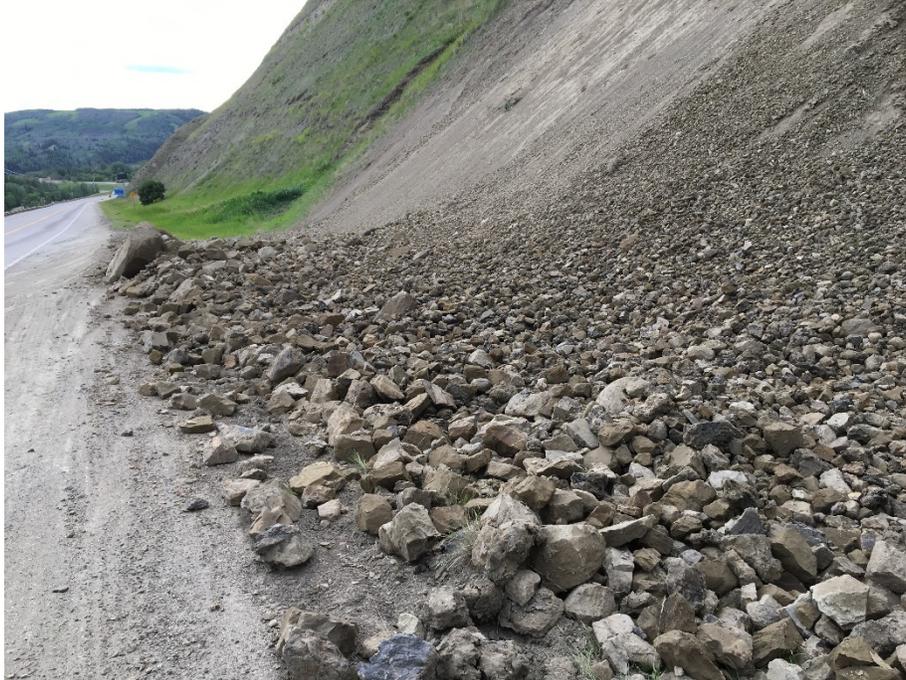
The landslide debris accumulated in the SBL ditch consisted primarily of small chunks and small to large sized slabs of silty weathered sandstone bedrock and colluvium mixed with organics.

Photo 5: Looking west from SBL ditch of Hwy 2:68 at sandstone slabs and soil chunks that have accumulated in the ditch below the landslide (June 26, 2018)

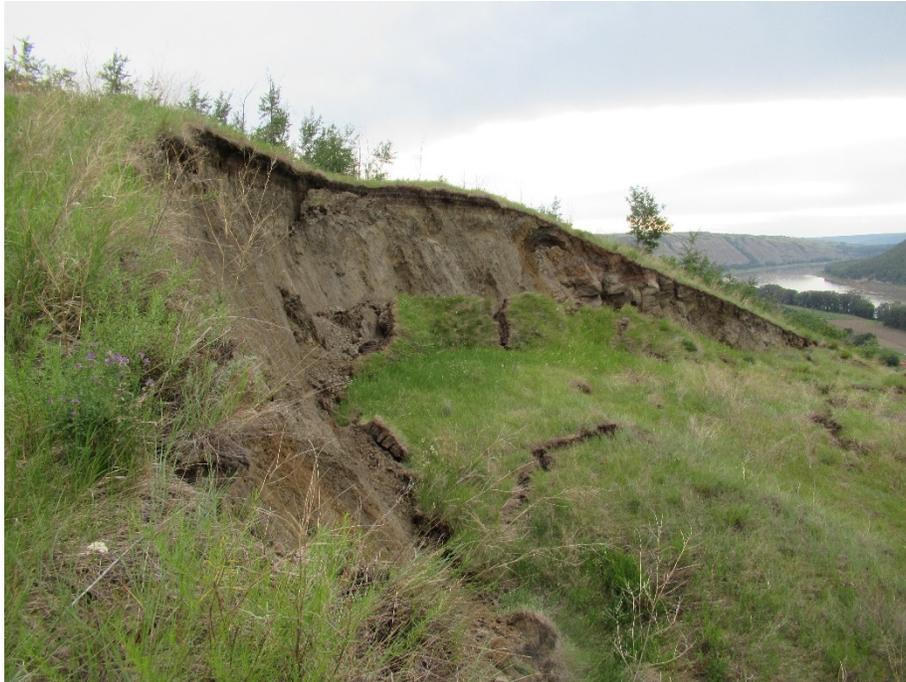
The exposed backscarp height at the center of the landslide was about 6 m (Photos 9 and 13). A graben had formed along the base of the scarp. The soil exposed in the backscarp and slide mass

Photo 9: Looking NE along backscarp of the landslide (July 6, 2018)

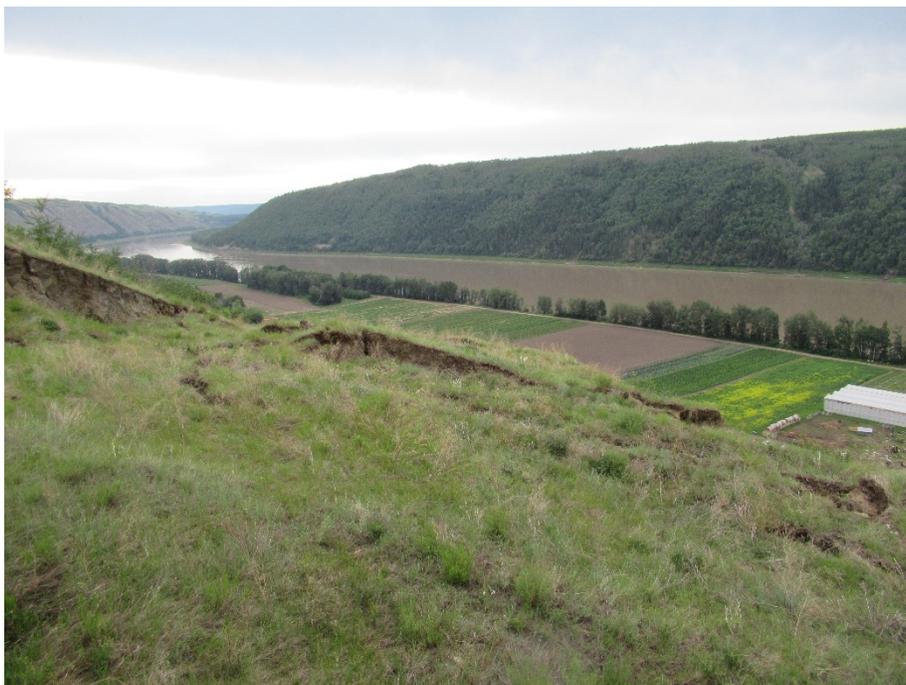
appear to consist mainly of silty sand, with some clay and hard/strong sandstone pieces embedded within it (Photos 10 to 14).

Photo 10: Looking SE from west side of the landslide backscarp July 6, 2018)

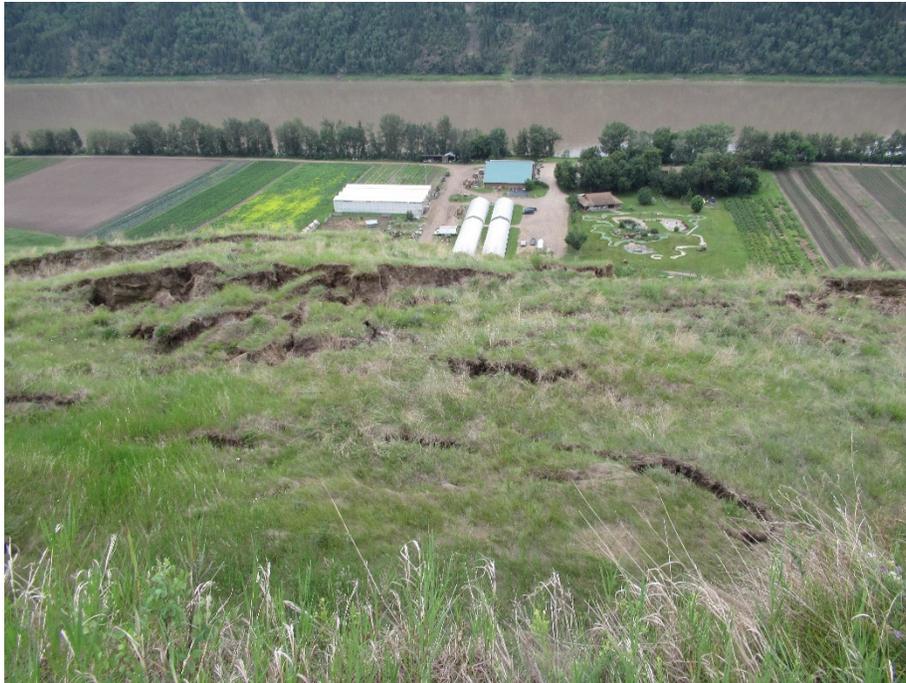
Photo 11: Looking south from the middle of the backscarp of the slide (July 6, 2018)

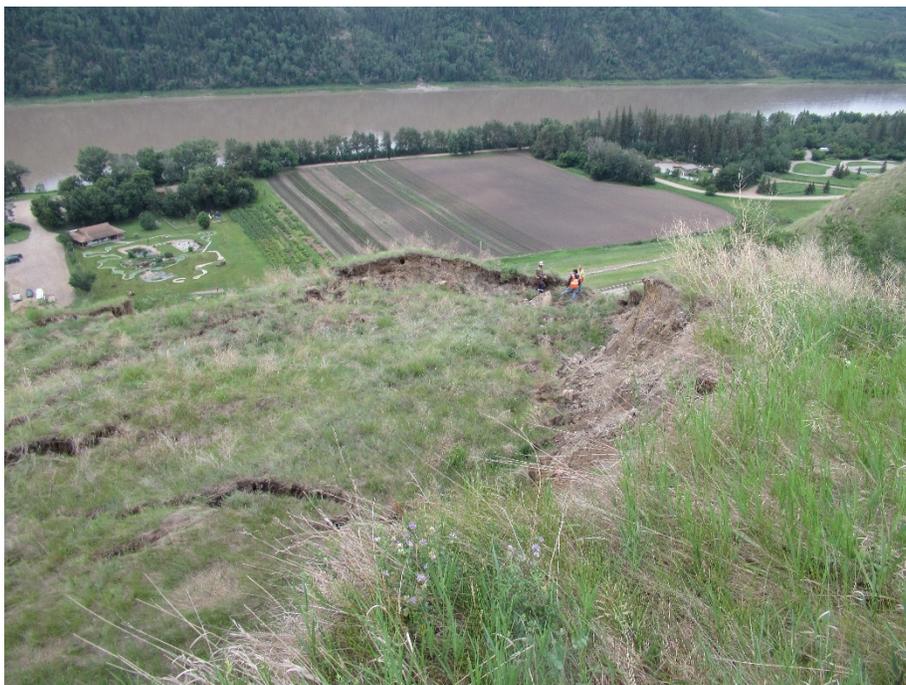
Photo 12: Looking SW from the middle of the slide from the backscarp (July 6, 2018)

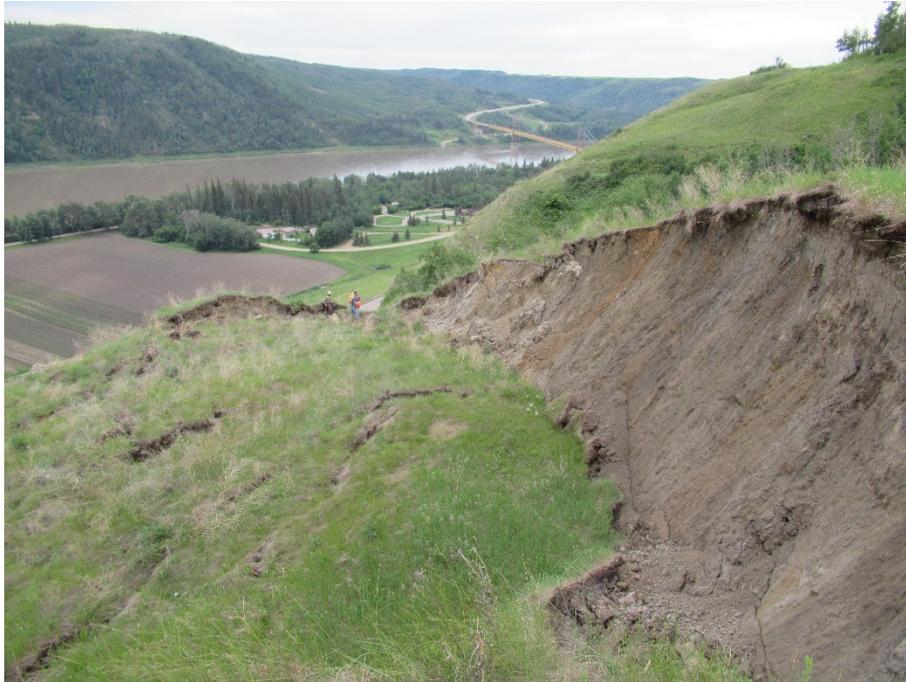
Photo 13: Looking SW from middle of the landslide along the backscarp (July 6, 2018)

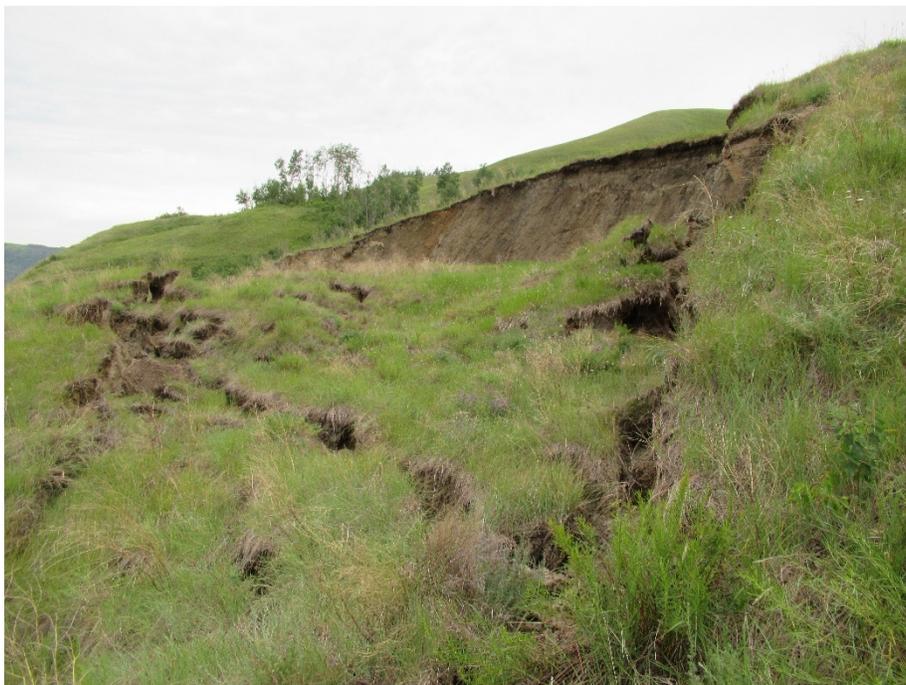
Photo 14: Looking NW from the east end of the backscarp (July 6, 2018)

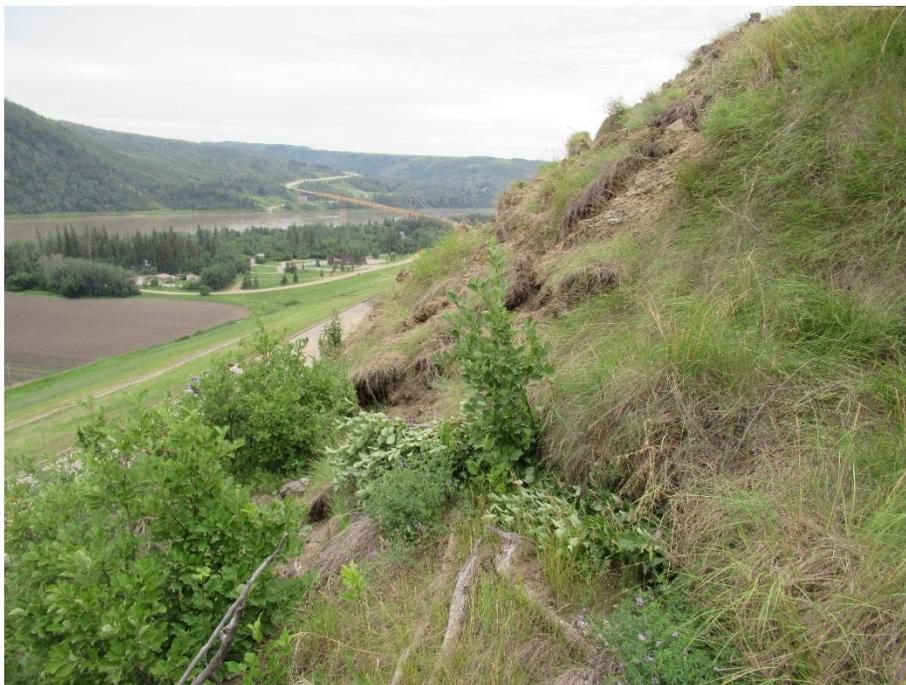
Photo 16: Looking west along the slide at the possible toe roll of the landslide (July 6, 2018)
