**ALBERTA TRANSPORTATION
GEOHAZARD ASSESSMENT PROGRAM
PEACE REGION –
GRANDE PRAIRIE DISTRICT - NORTH
2023 INSPECTION**

Site Number	Location	Name	Hwy	km
PH001	Dunvegan	Dunvegan Hill, North	2:68	12.60
Legal Description		UTM Co-ordinates		
NE¼ 08-080-04 W6M		11U E 400694	N 6198867

PEACE REGION (GRANDE PRAIRIE DISTRICT - NORTH)
PH001 DUNVEGAN HILL - NORTH

2023 PH001 INSPECTION PLAN

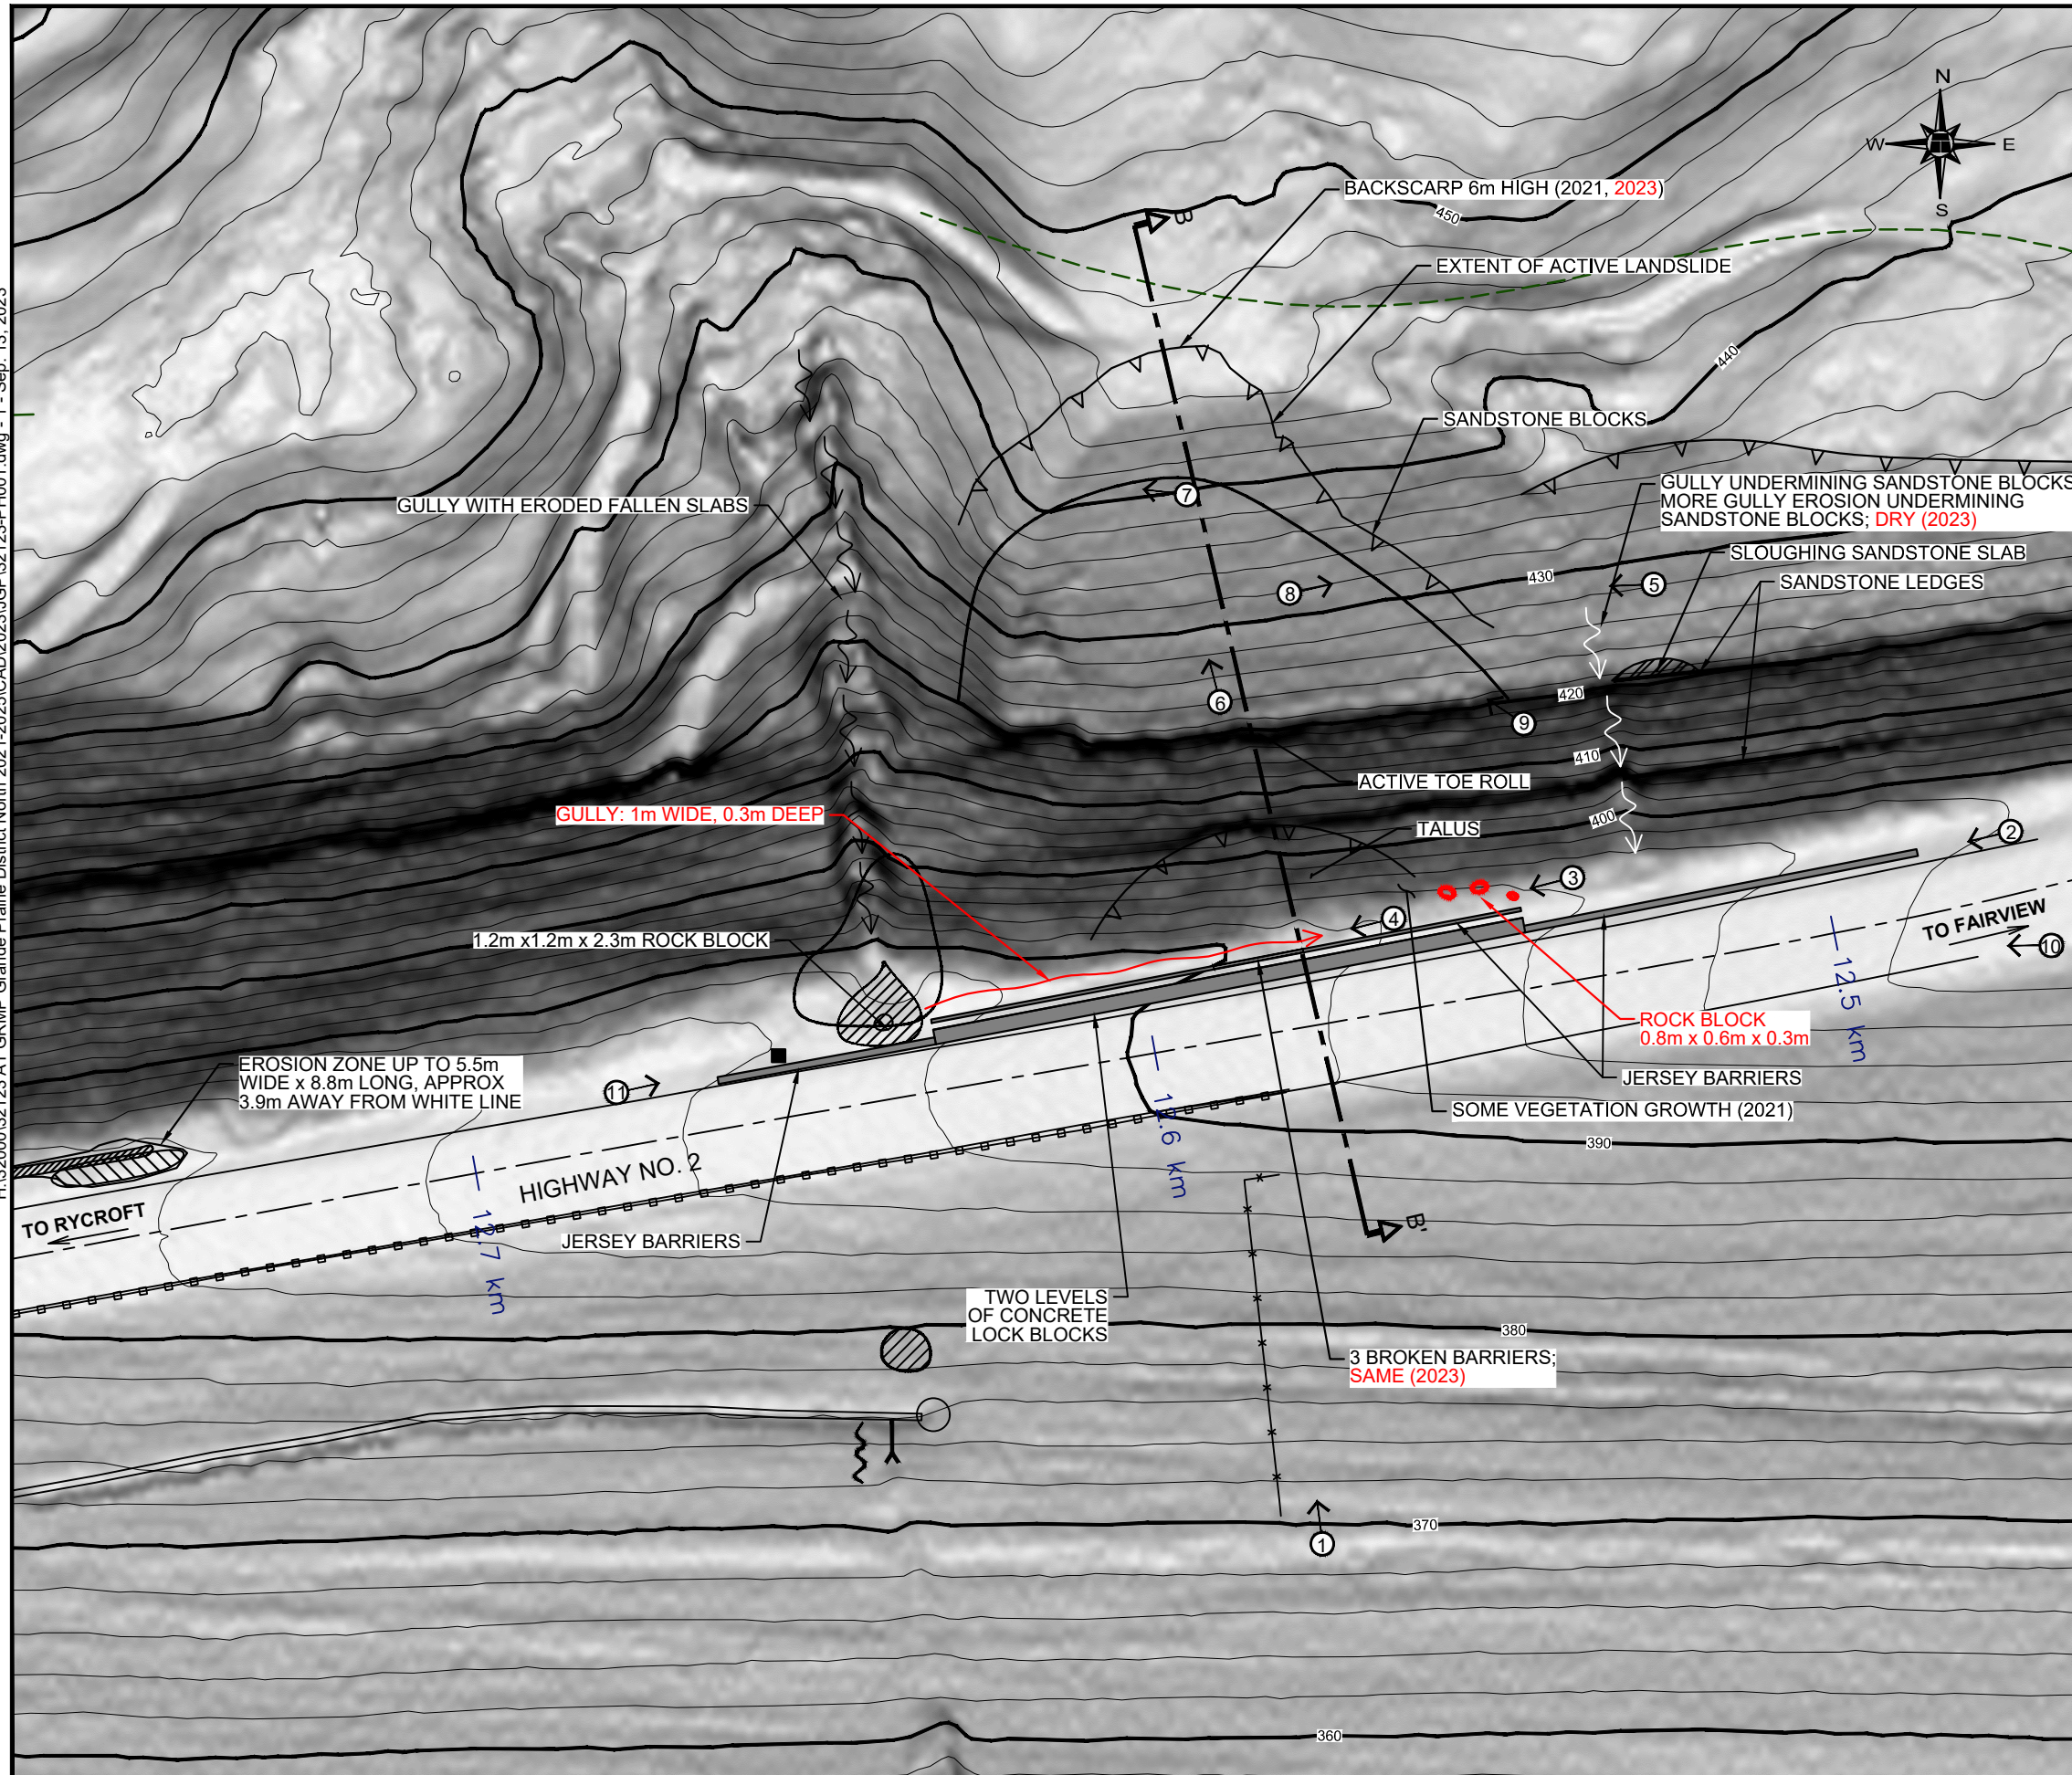
FIGURE 1

1. JUNE 1, 2023 OBSERVATIONS SHOWN IN RED

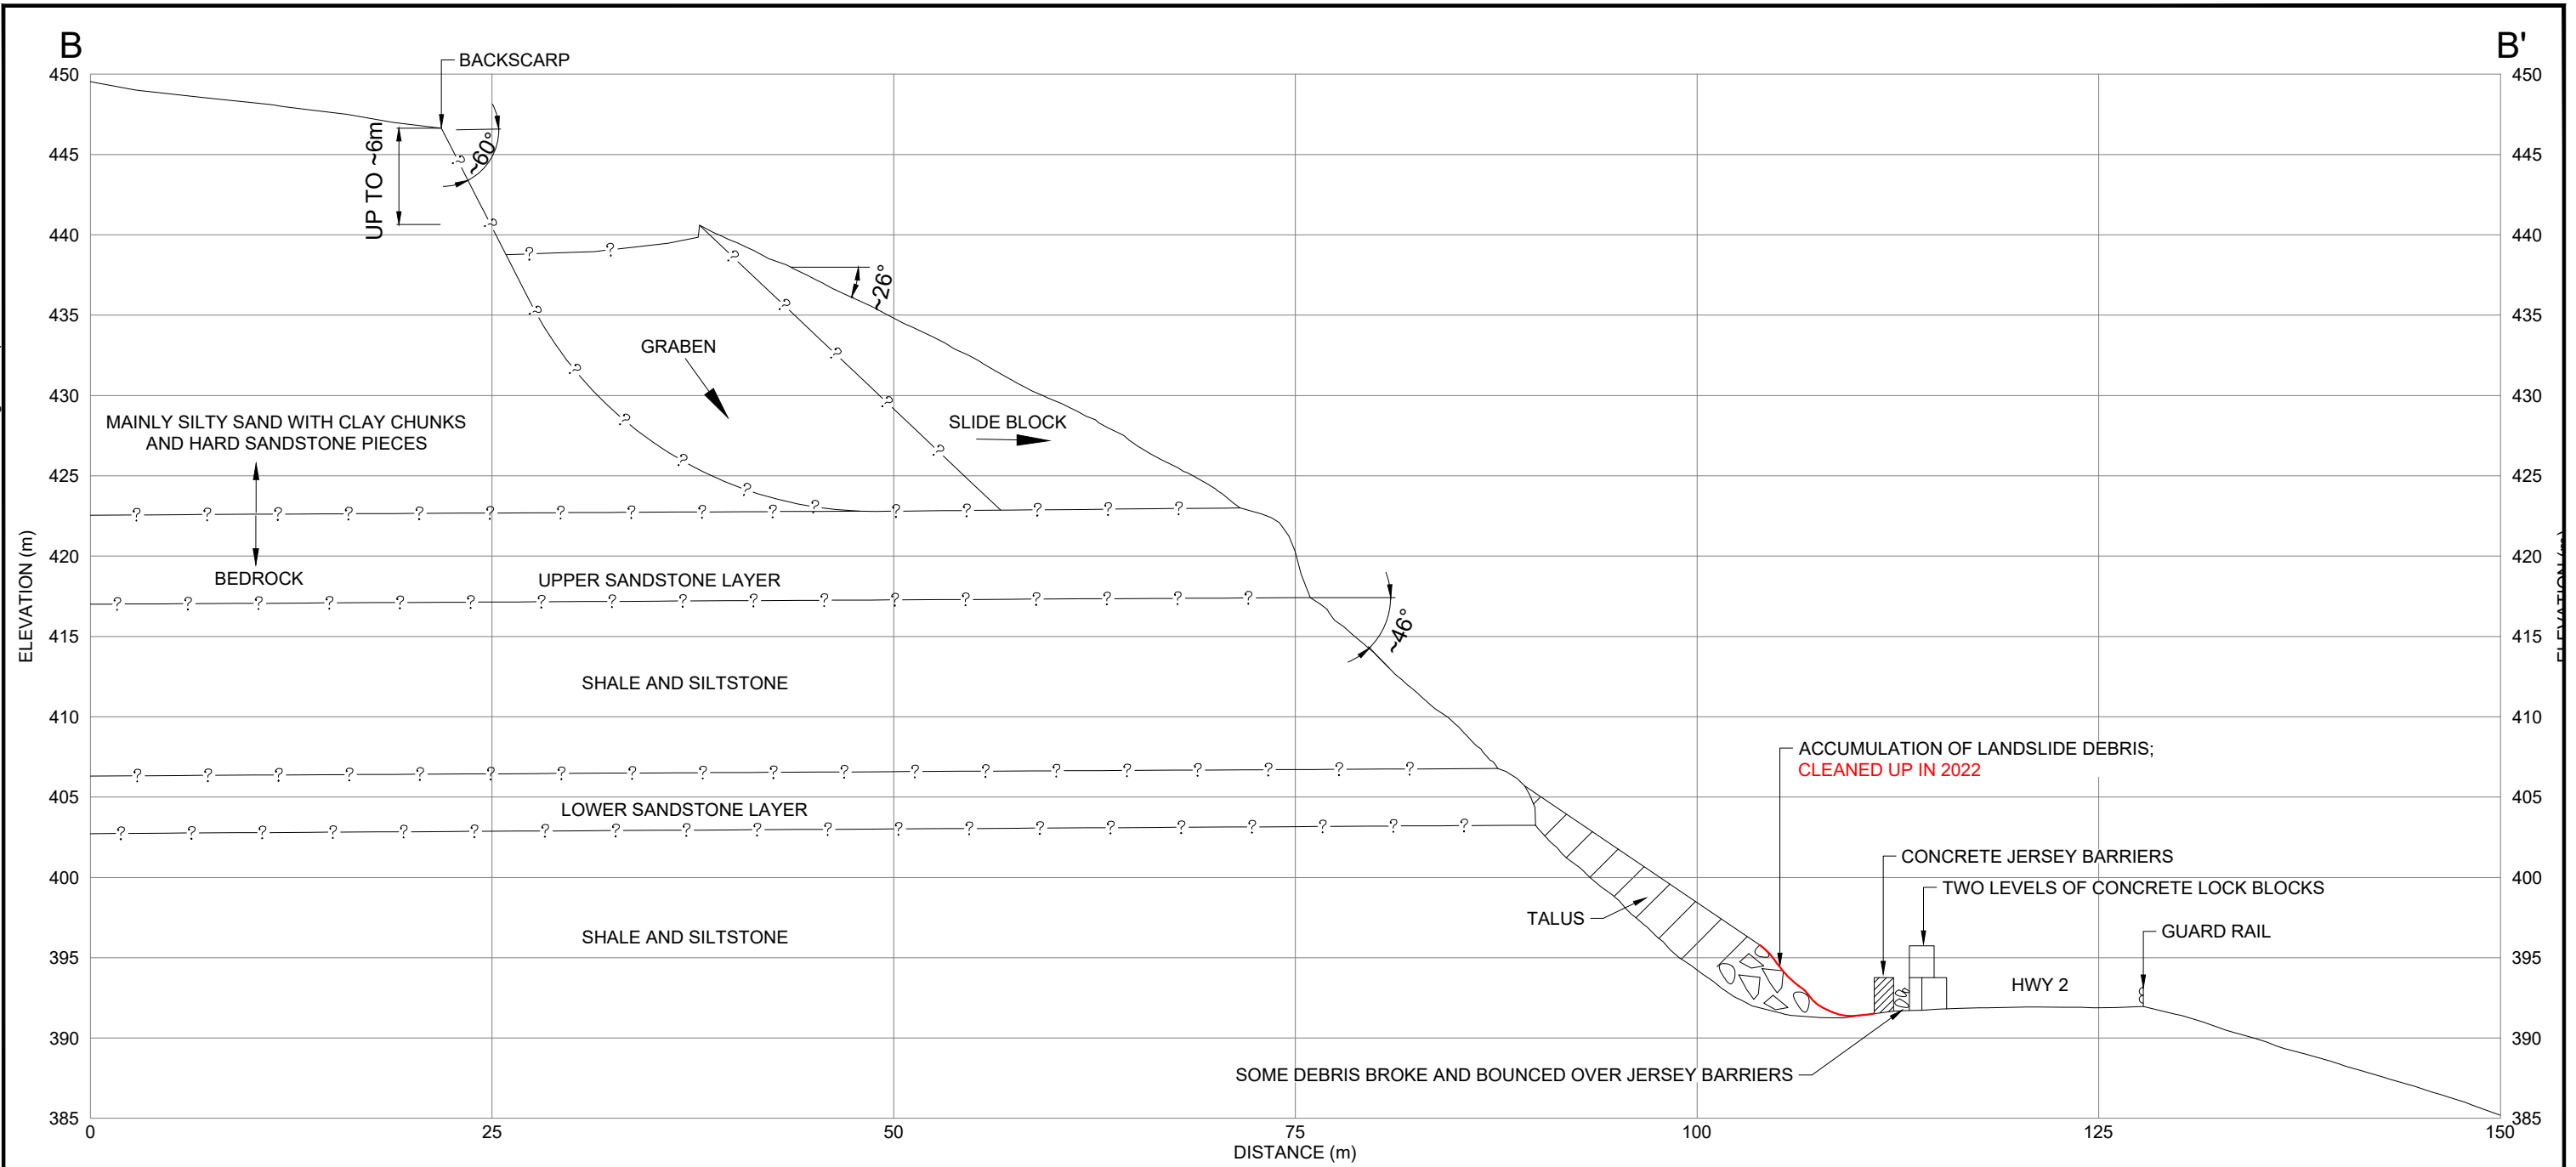
FIGURE 2

CROSS - SECTION B - B'

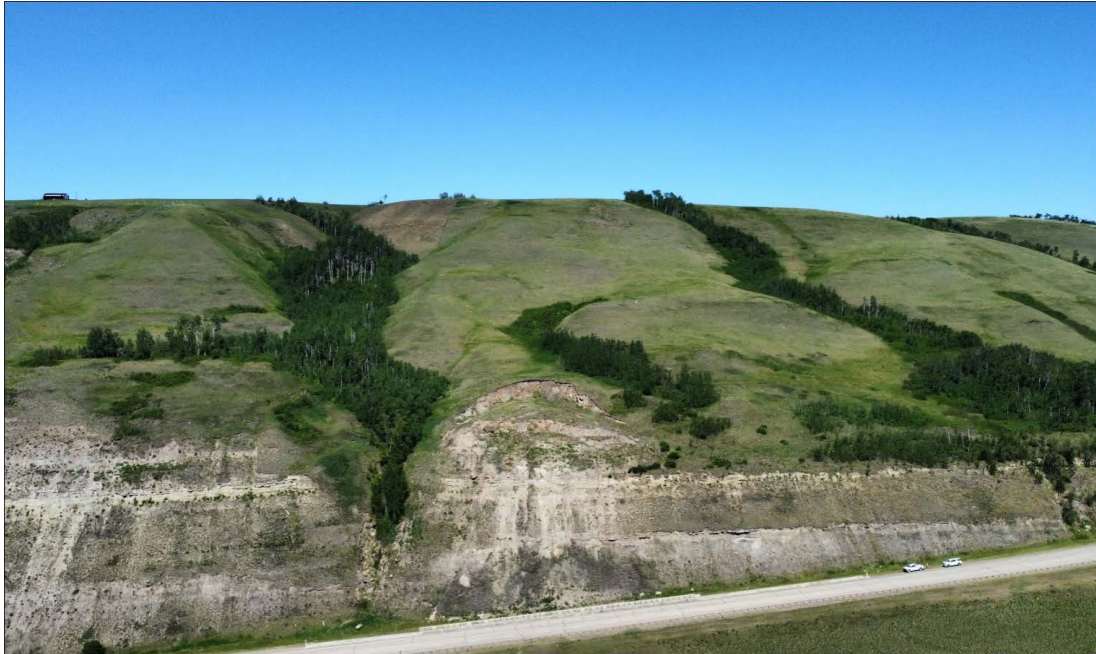
Aerial Photo 1: Looking north at the landslide site and surrounding area

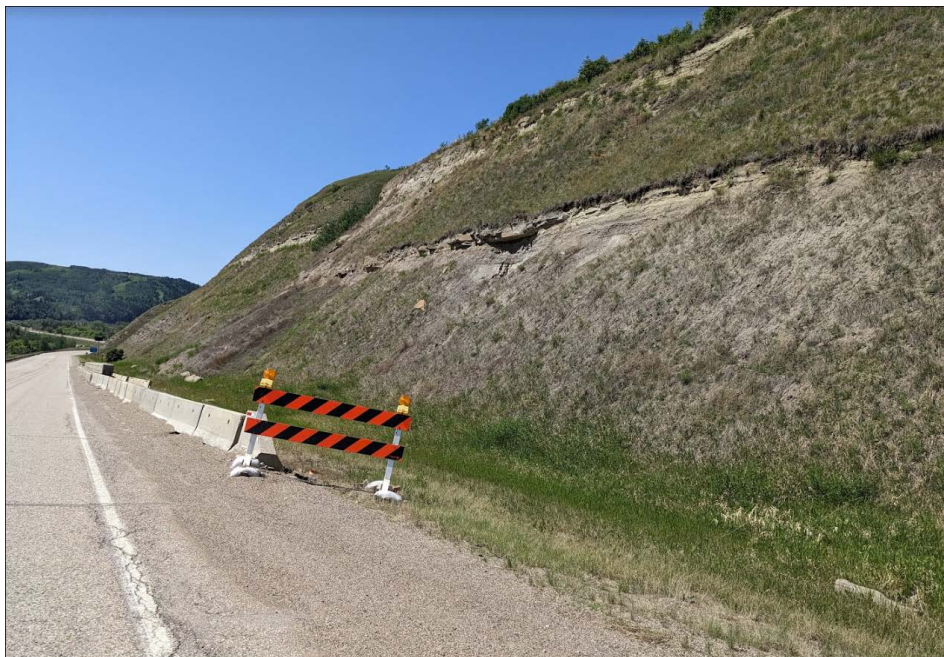
Photo 2: Looking west at the highway backslope and concrete barriers below the landslide

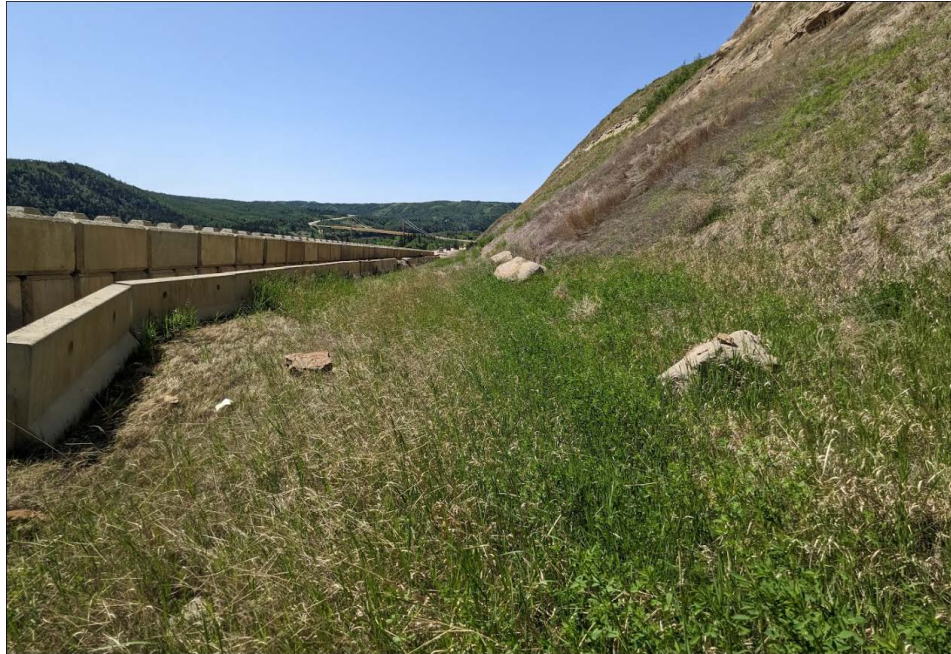
Photo 3: Looking west at accumulated debris in the ditch below the landslide.

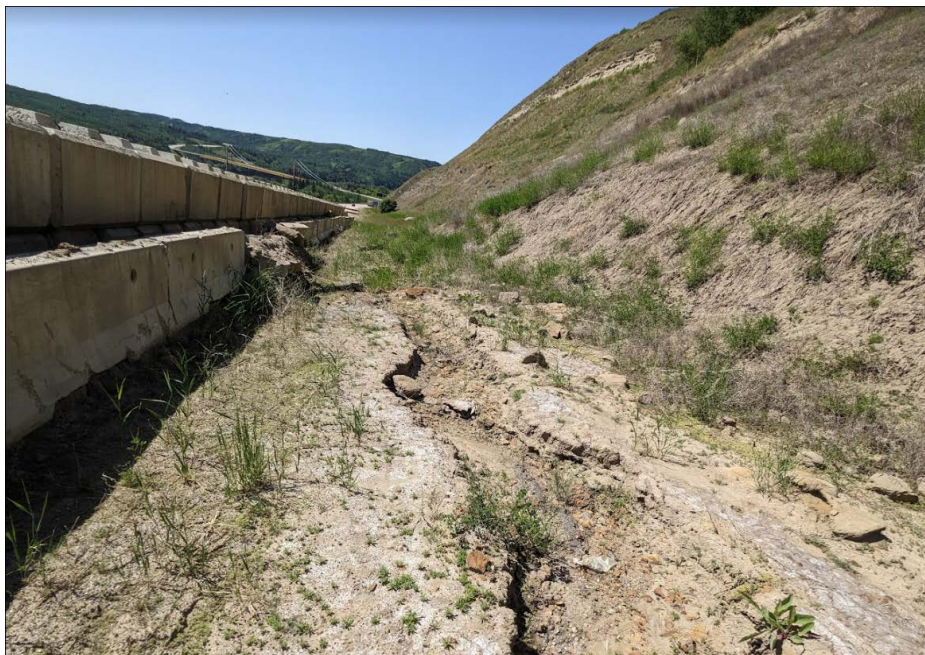
Photo 4: Area where sandstone slabs, talus, boulders accumulated the most prior to the 2022 clean up.

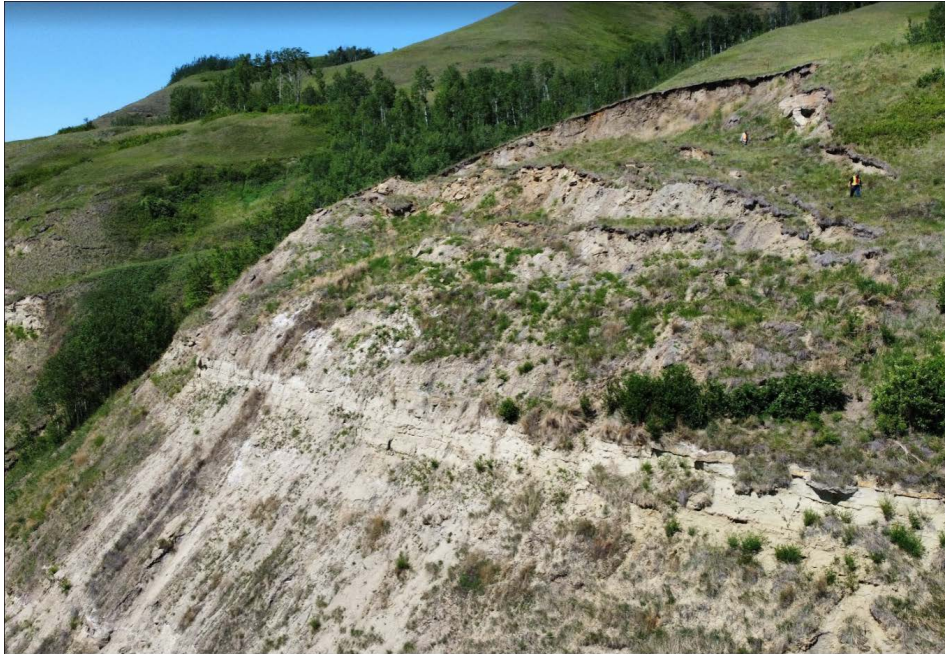
<input checked="" type="checkbox"/> Other	Currently, the slide material is toppling over the edge of the steep bedrock slope at a relatively slow rate. The landslide debris has historically accumulated in the SBL ditch was cleaned in 2022. The landslide debris consisted primarily of small chunks and small to large sized slabs of silty weathered sandstone bedrock and colluvium mixed with organics. Some vegetation is starting to grow at the toe of the slide	<input type="checkbox"/>	
Instrumentation:	There are no available records of previous geotechnical investigations and there are currently no instruments installed at the site.

Aerial Photo 5: Looking northwest where landslide debris has been toppling over the edge of the steep bedrock slope

Recommendations:	Cost
<p>A warning sign should be posted at the top and bottom of the hill to warn of higher risk of rockfall and mudslide activity particularly during wet weather conditions.</p> <p>If possible, the remaining slide mass should be carefully removed from the top of the slope to reduce the potential for further debris to fall onto the highway below. Due to the possibility of crumbling of the edge of the sandstone bedrock layer, equipment should be kept back at a minimum distance of 3 m from the crest of the steep backslope. This could be accomplished using a long reach excavator that would access the site from privately owned land to the north of the landslide. The excavator would push the failed material over the crest of the slope. This would need to be monitored with spotters equipped with two-way radios positioned at the top of the steep backslope section and along the highway. Once the outer 15 m of the landslide debris has been removed, the backscarp should be flattened to an inclination of 2.5H:1V and the remaining slide debris should be cut-down and flattened as a buttress with a slope angle of 5H:1V. Depending on the extent of the backscarp, this may require the acquisition of privately-owned land above the current landslide.</p> <p>An alternate plan would be to leave the landslide mass to tumble down the backslope at its own rate and complete regular maintenance to remove the fallen debris during dry weather conditions to maintain a storage capacity behind the barriers and allow the ditch to pass runoff drainage. This option is what is currently being done at site but carries a higher risk of injury to the public if an extended period of heavy rain fall occurs.</p>	\$250,000

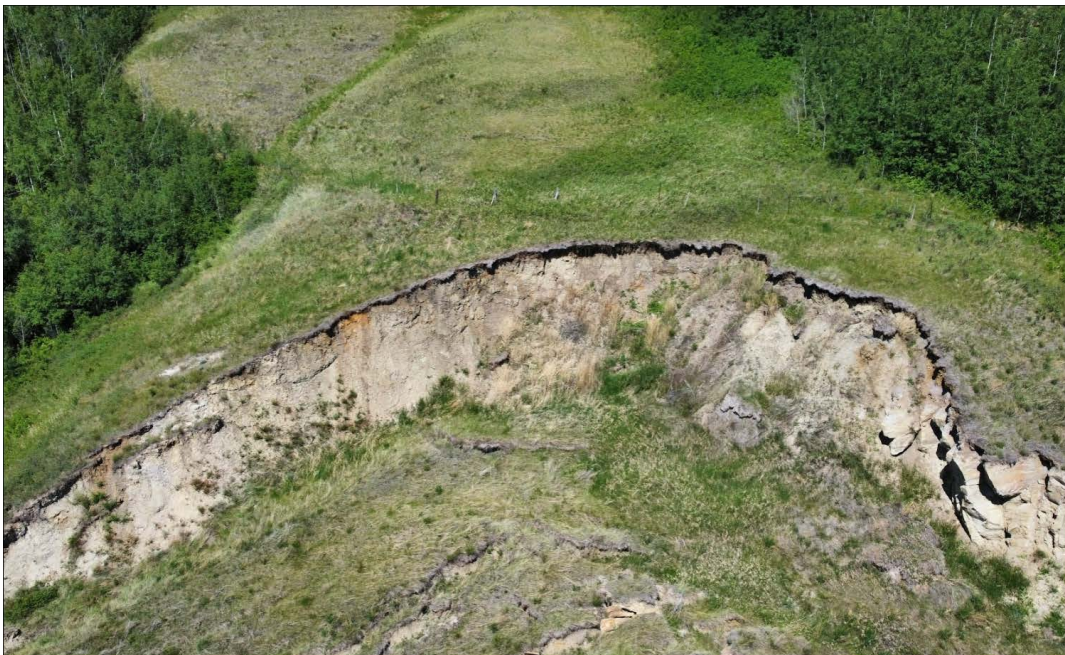
Aerial Photo 6: Looking northeast along backscarp of the landslide

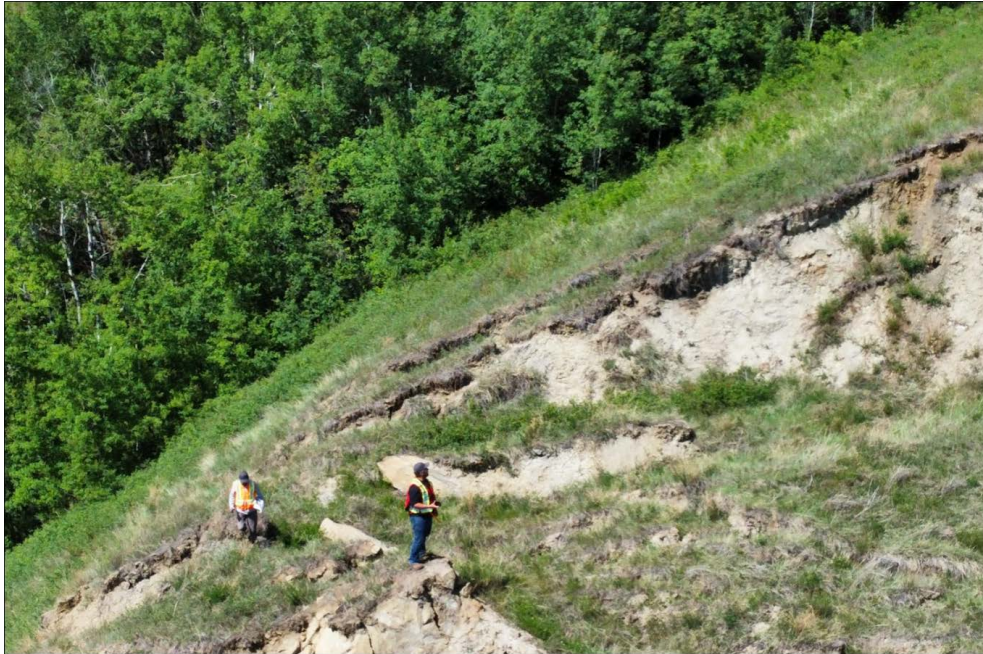
Aerial Photo 7: Looking west landslide backscarp western flank

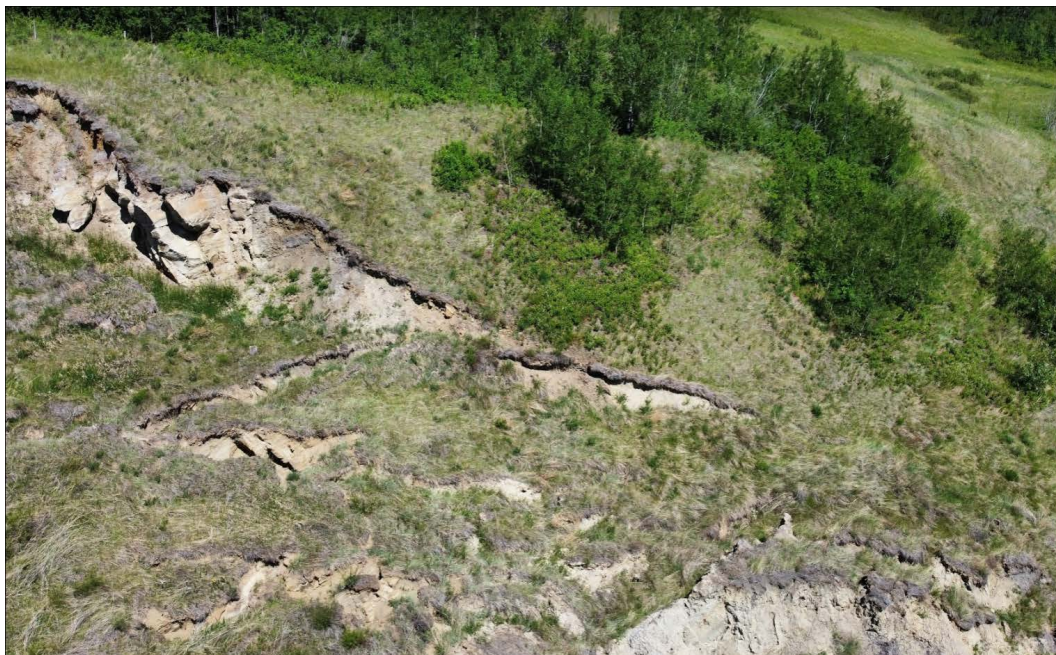
Aerial Photo 8: Looking east landslide backscarp eastern flank

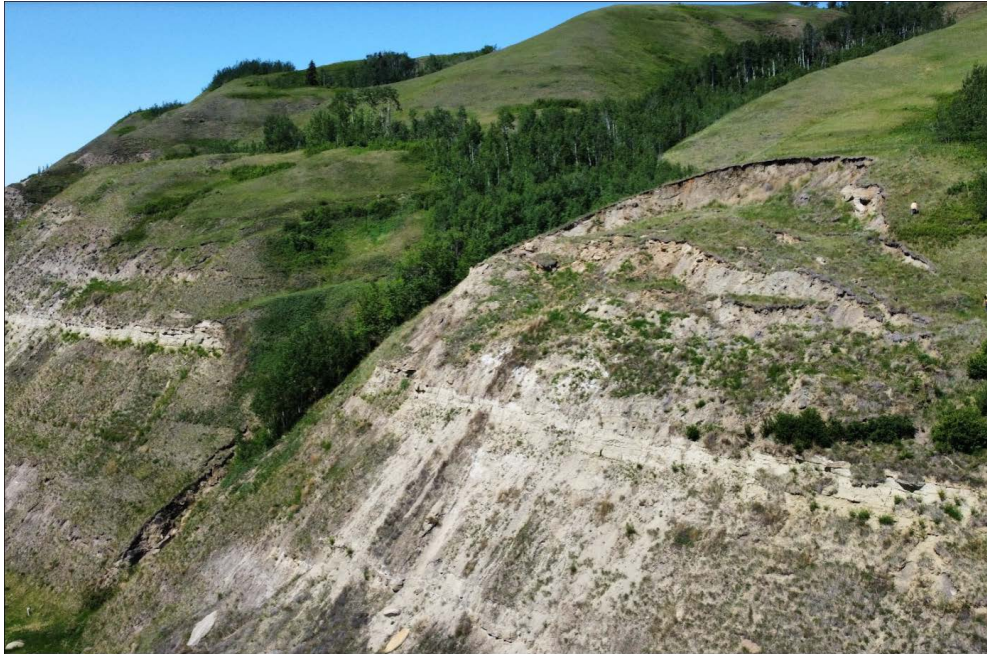
Aerial Photo 9: Note graben formed along the backscarp, sandstone rock slabs resting on the slope near the bottom, and seepage in the central area developing near the toe of the slide.

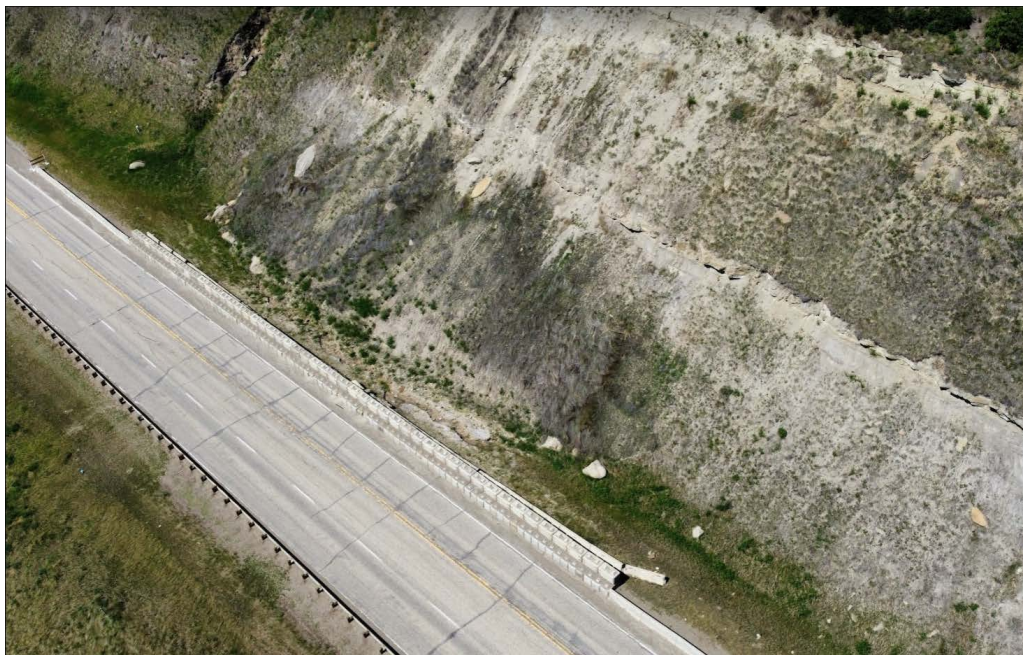
Aerial Photo 10: Few recent sandstone rock slabs accumulating behind the Concrete Jersey Barrier

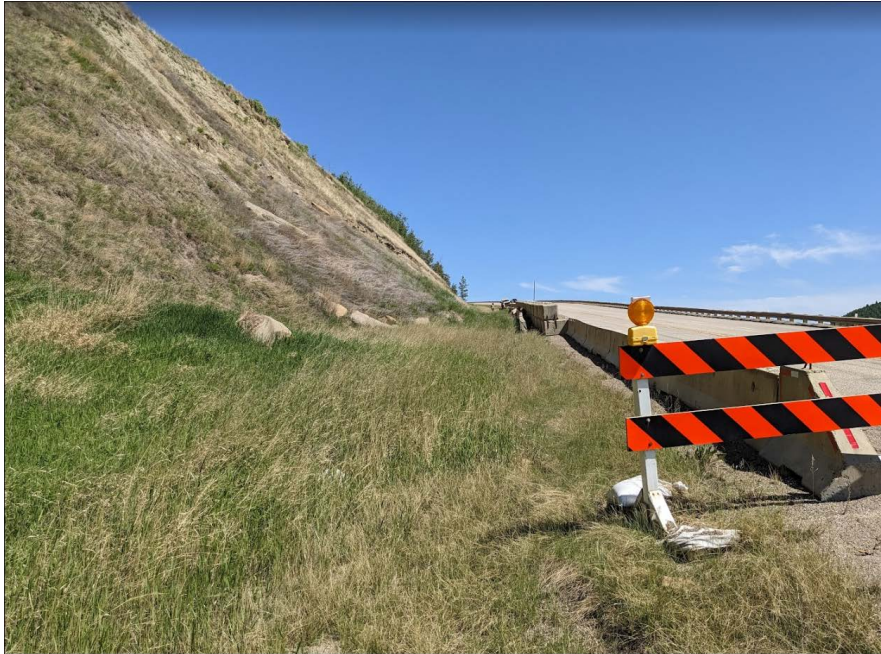
Photo 11: Looking east at steep rock backslope and a few sandstone blocks accumulating behind the Concrete Jersey Barrier |
