**ALBERTA TRANSPORTATION AND ECONOMIC ORRIDORS  
GEOHAZARD ASSESSMENT PROGRAM  
PEACE REGION –  
GRANDE PRAIRIE DISTRICT - NORTH  
2024 INSPECTION**

<b>Site Number</b>	<b>Location</b>	<b>Name</b>	<b>Hwy</b>	<b>km</b>
PH001	Dunvegan	Dunvegan Hill, North	2:68	12.60
<b>Legal Description</b>		<b>UTM Co-ordinates</b>		
NE¼ 08-080-04 W6M		11U E 400694	N 6198867

<b>Date</b>	<b>PF</b>	<b>CF</b>	<b>Total</b>
<b>Previous Inspection:</b>	June 1, 2023	11	4	44
<b>Current Inspection:</b>	May 24, 2024	11	4	44
<b>Road WAADT:</b>	2,520		<b>Year:</b>	2023
<b>Inspected By:</b>	Robert Senior, TEC Rocky Wang, TEC		José Pineda, Thurber Don Proudfoot, Thurber	
<b>Report Attachments:</b>	<input checked="" type="checkbox"/> Photographs	<input checked="" type="checkbox"/> Plans	<input checked="" type="checkbox"/> Maintenance Items

<b>Primary Site Issue:</b>	A landslide in the highway backslope. Upslope debris flow/rock fall hazard.	
<b>Dimensions:</b>	Extends 90 m wide and 90 m north from the highway into the backslope. The lower 30 m of the backslope, where bedrock is exposed is inclined at 1H:1V. The upper 25 m of the backslope where the landslide is located in the colluvium, is inclined at 2H:1V.	
<b>

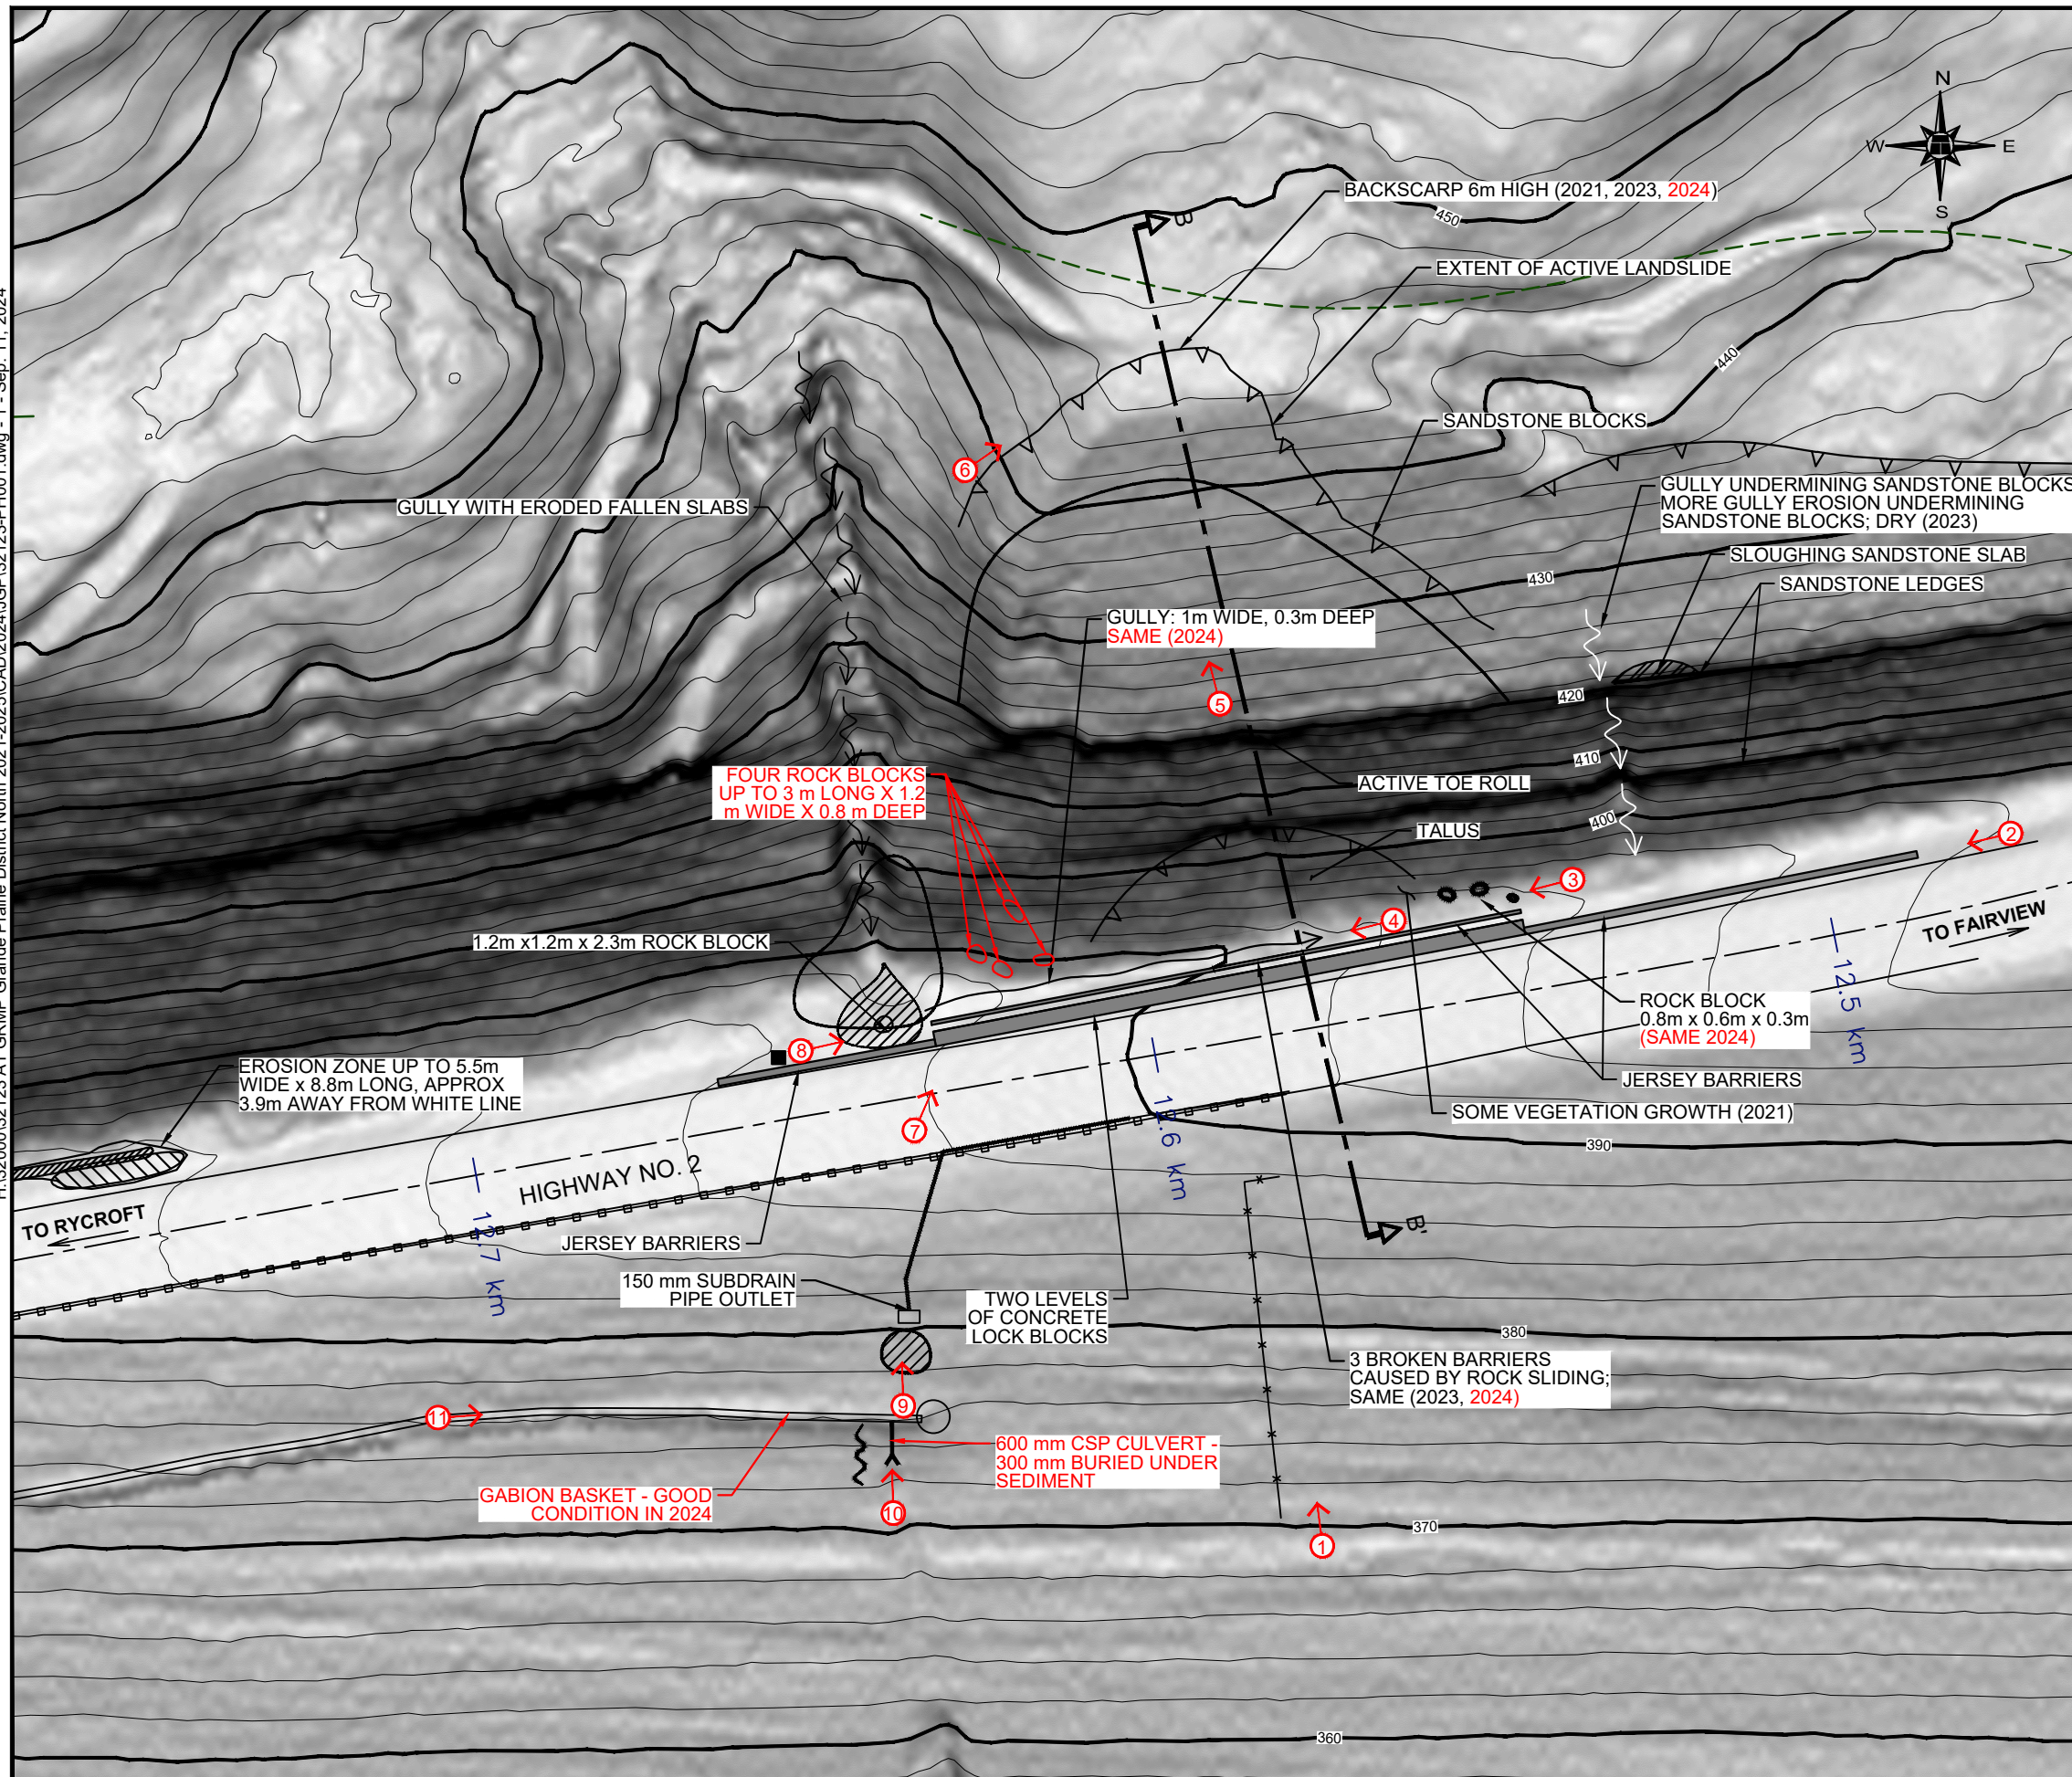
**FIGURE 1**

**2024 PH001 INSPECTION PLAN**

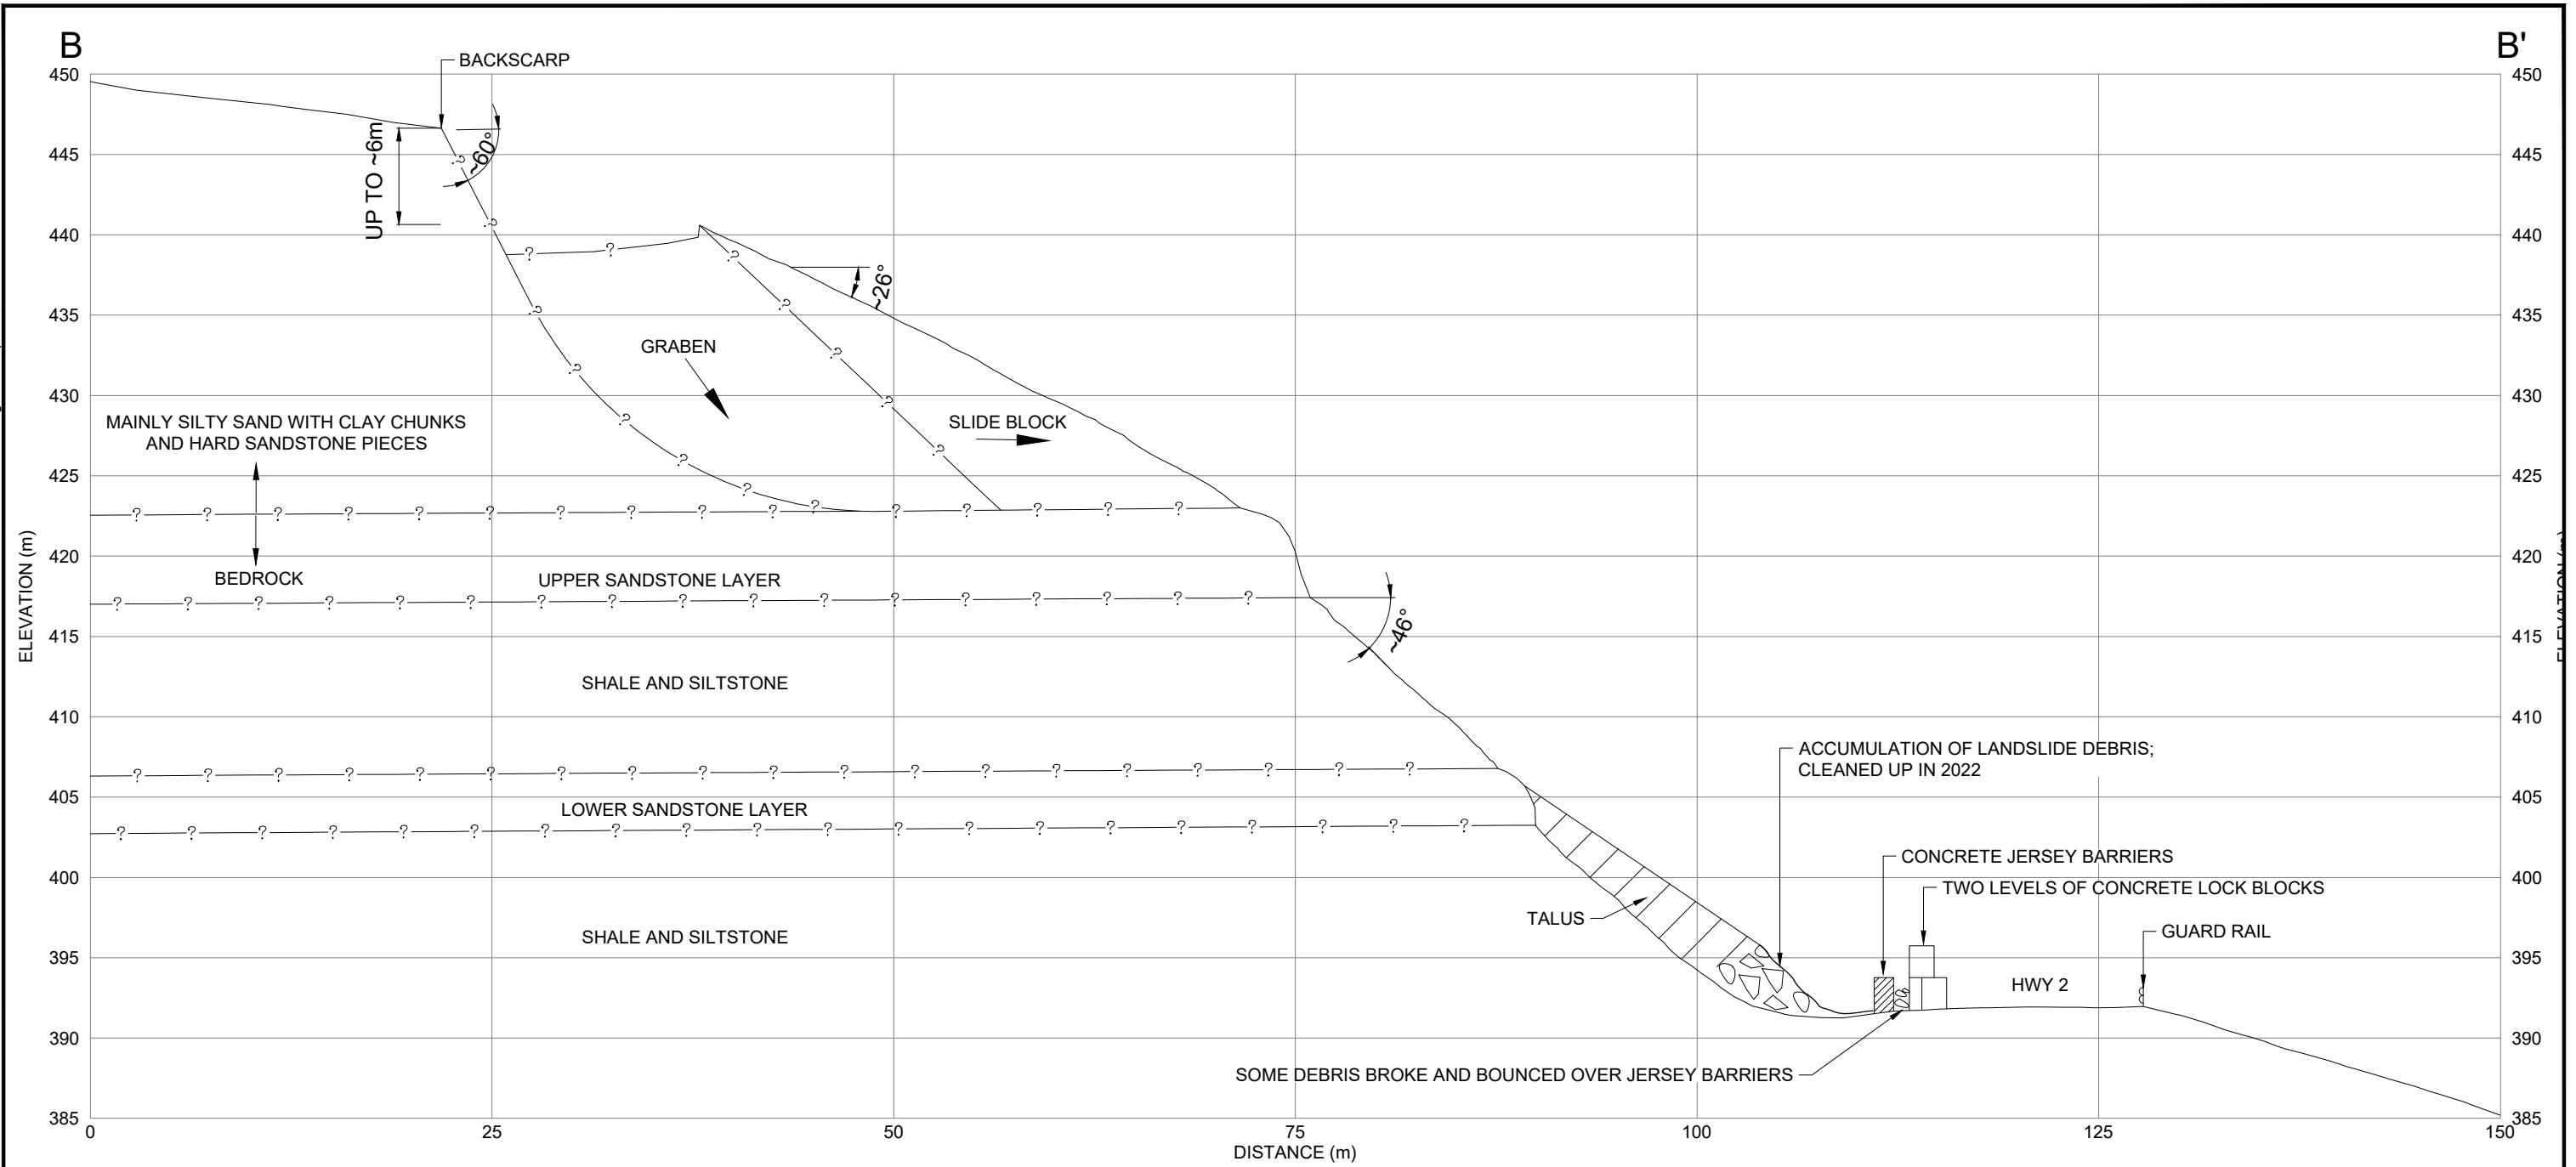
**FIGURE 2**

<b>Assessment:</b>
In the past, similar landslides and debris flows in this area have typically occurred in the gullies due to the concentration of surface runoff water from heavy rain fall events. The inferred slip surface for this landslide is along the top of the upper sandstone bedrock layer at an approximate elevation 423 m (Refer to Figure 2).

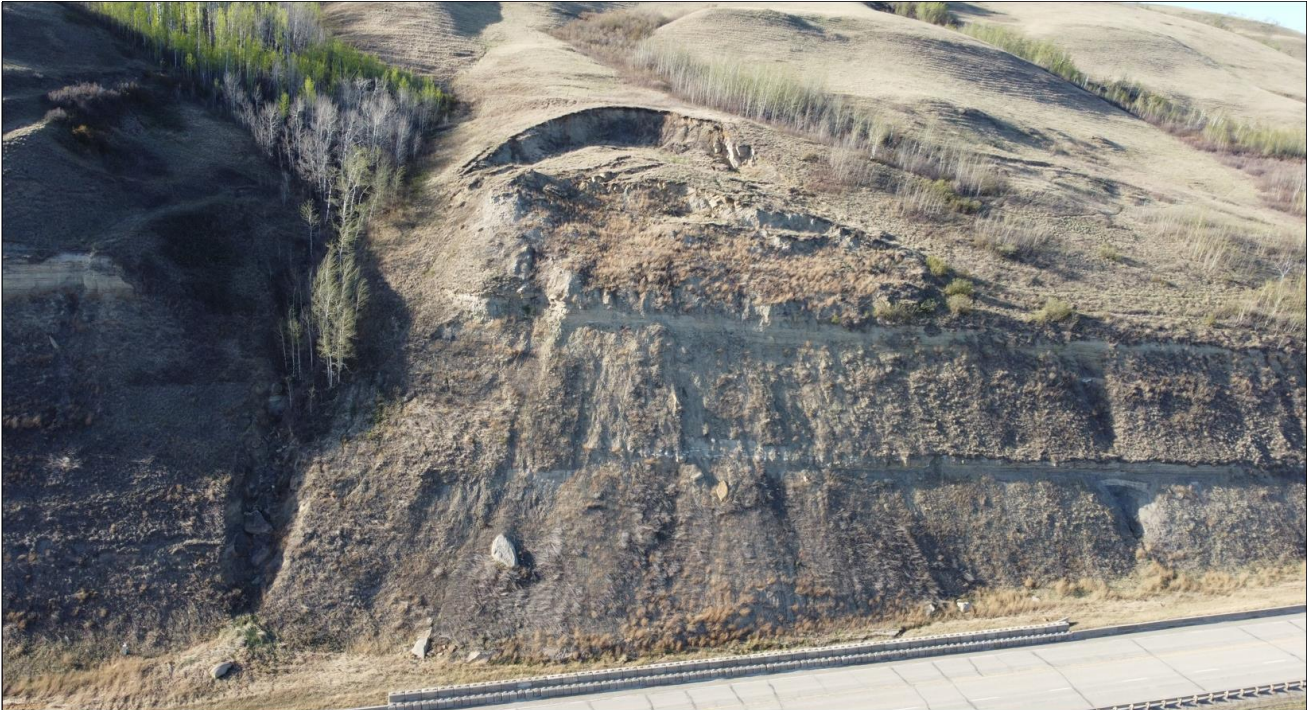
**Aerial Photo 1: Looking north at the landslide site and surrounding area**

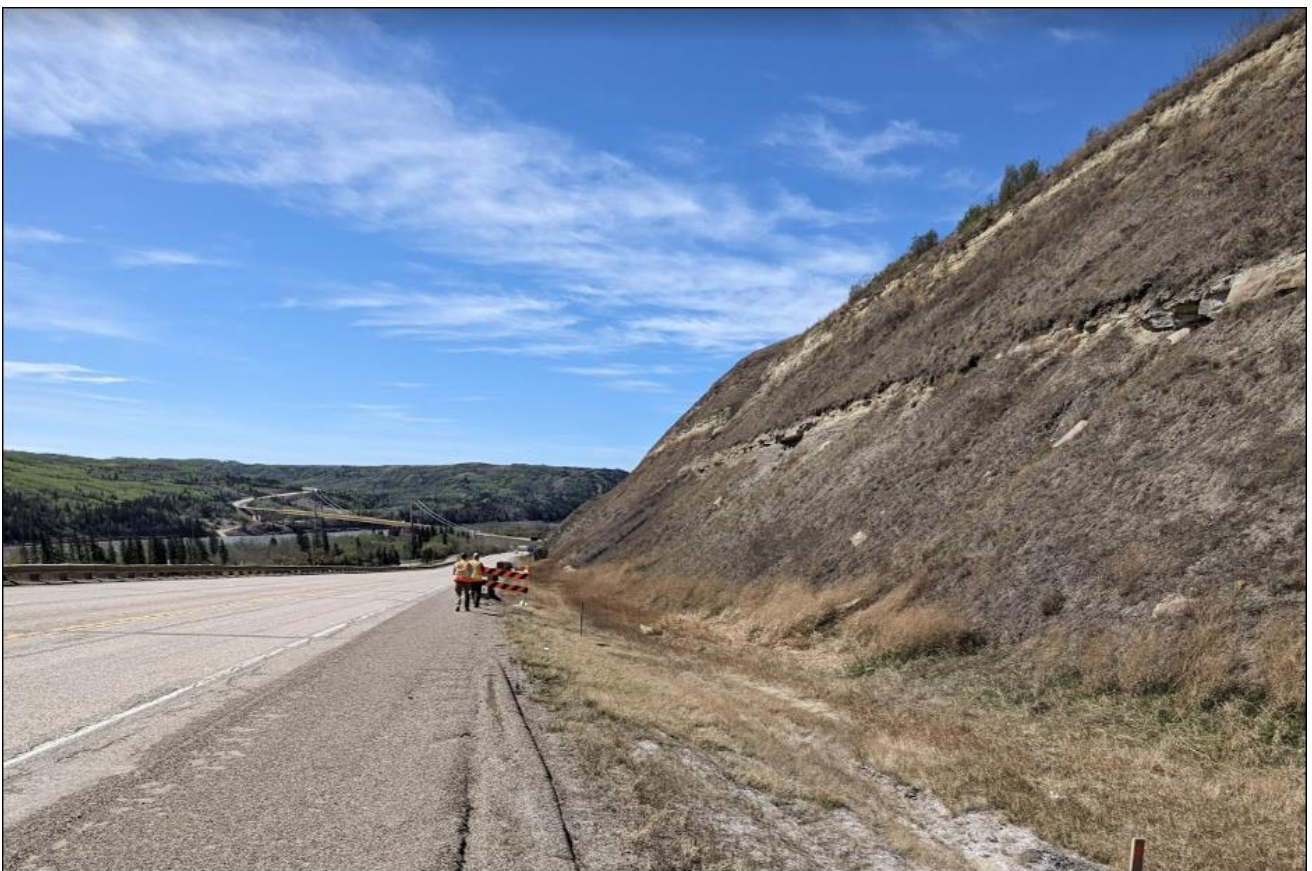
The concrete lock blocks and jersey barriers erected by the maintenance contractor has helped containing the debris to keep it off the highway. However, there is still a risk that the remainder of the slide debris volume (about 20,000 m<sup>3</sup>) could fall catastrophically onto the highway in a fast-moving mudslide if it gets saturated during a heavy precipitation event. If the slide material came down in a big single event it could dislodge the concrete barriers and flow out onto and close the highway.

Overall, the provision of the concrete barriers has reduced but not eliminated the risk of further rock falls to the travelling public.

**Photo 2: Looking west at the highway backslope and concrete barriers below the landslide**

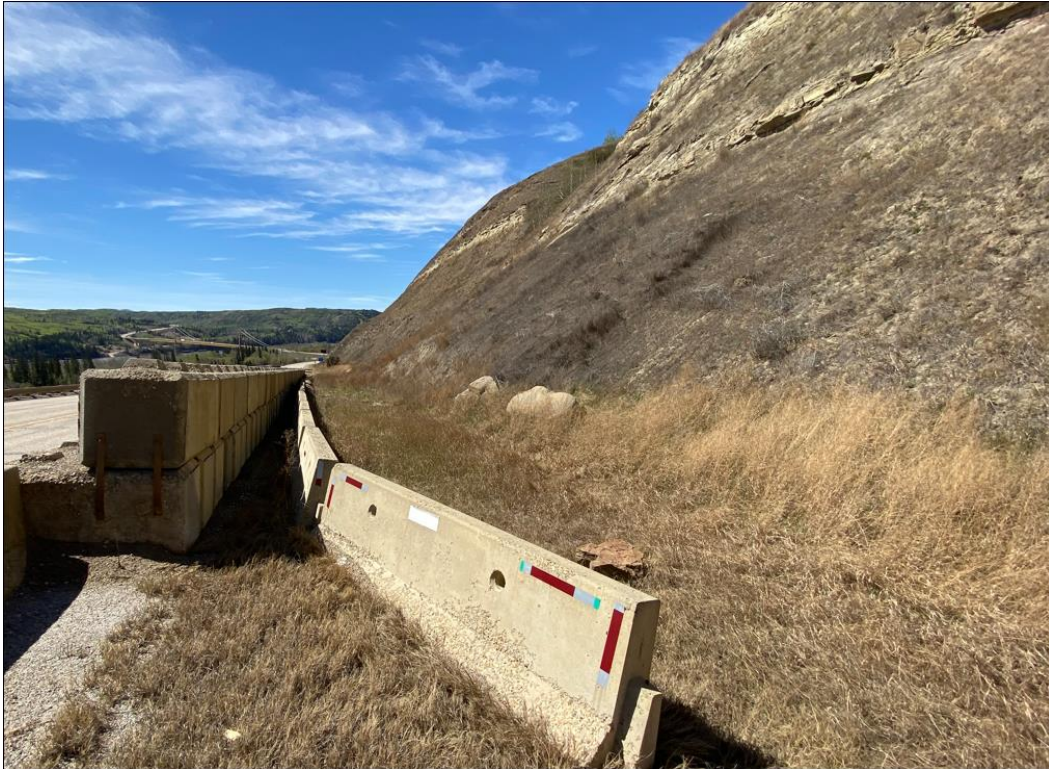
**Photo 3: Looking west at accumulated debris in the ditch below the landslide.**

An alternate plan would be to leave the landslide mass to tumble down the backslope at its own rate and complete regular maintenance to remove the fallen debris during dry weather conditions to maintain a storage capacity behind the barriers and allow the ditch to pass runoff drainage. This option is what is currently being done at site but carries a higher risk of injury to the public if an extended period of heavy rain fall occurs.

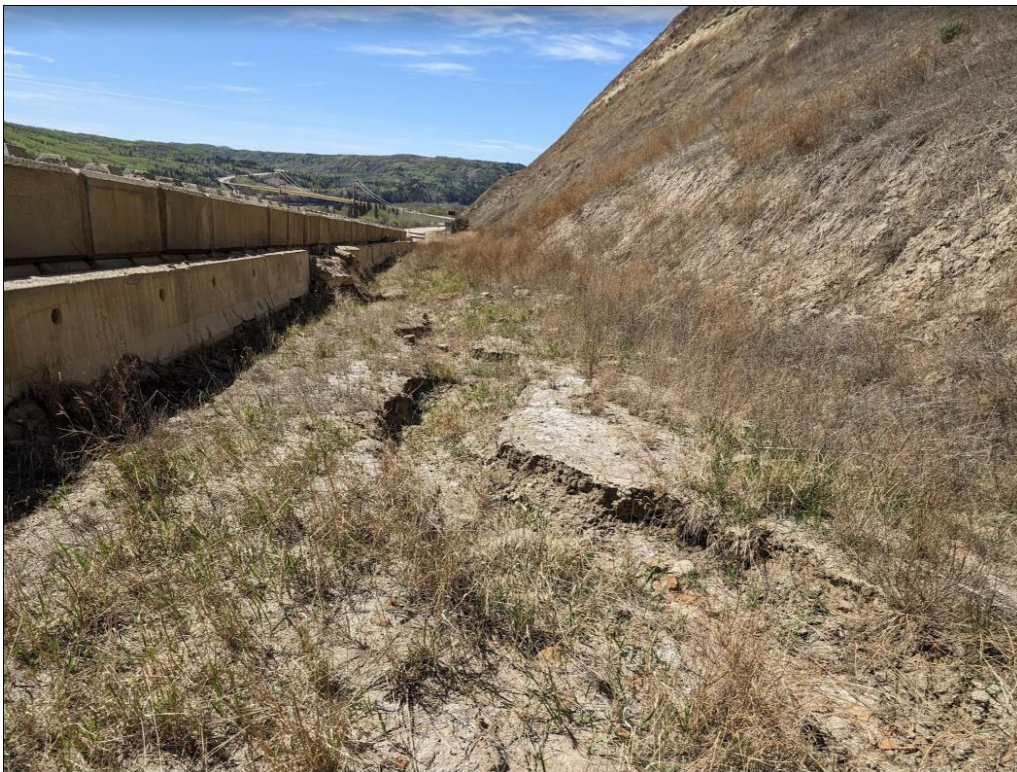
**Photo 4: Area where sandstone slabs, talus, boulders accumulated the most prior to the 2022 clean up.**

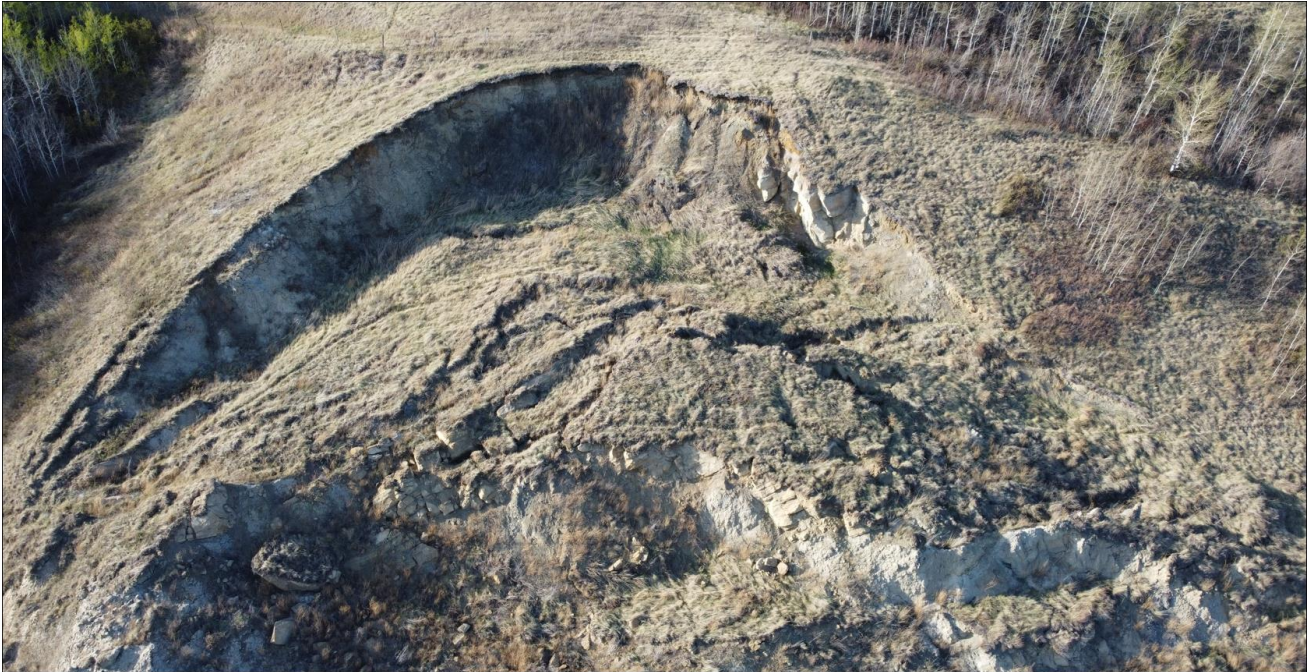
<input checked="" type="checkbox"/> Other	Currently, the slide material is toppling over the edge of the steep bedrock slope at a relatively slow rate. The landslide debris consisted primarily of small chunks and small to large sized slabs of silty weathered sandstone bedrock and colluvium mixed with organics. Some vegetation has been growing at the toe of the slide.	<input type="checkbox"/>
<b>Instrumentation:</b>	There are no available records of previous geotechnical investigations and there are currently no instruments installed at the site.

**Aerial Photo 5: Looking northwest where landslide debris has been toppling over the edge of the steep bedrock slope**

If possible, the remaining slide mass should be carefully removed from the top of the slope to reduce the potential for further debris to fall onto the highway below. Due to the possibility of crumbling of the edge of the sandstone bedrock layer, equipment should be kept back at a minimum distance of 3 m from the crest of the steep backslope. This could be accomplished using a long reach excavator that would access the site from privately owned land to the north of the landslide. The excavator would push the failed material over the crest of the slope. This would need to be monitored with spotters equipped with two-way radios positioned at the top of the steep backslope section and along the highway. Once the outer 15 m of the landslide debris has been removed, the backscarp should be flattened to an inclination of 2.5H:1V and the remaining slide debris should be cut down and flattened as a buttress with a slope angle of 5H:1V. Depending on the extent of the backscarp, this may require the acquisition of privately-owned land above the current landslide.

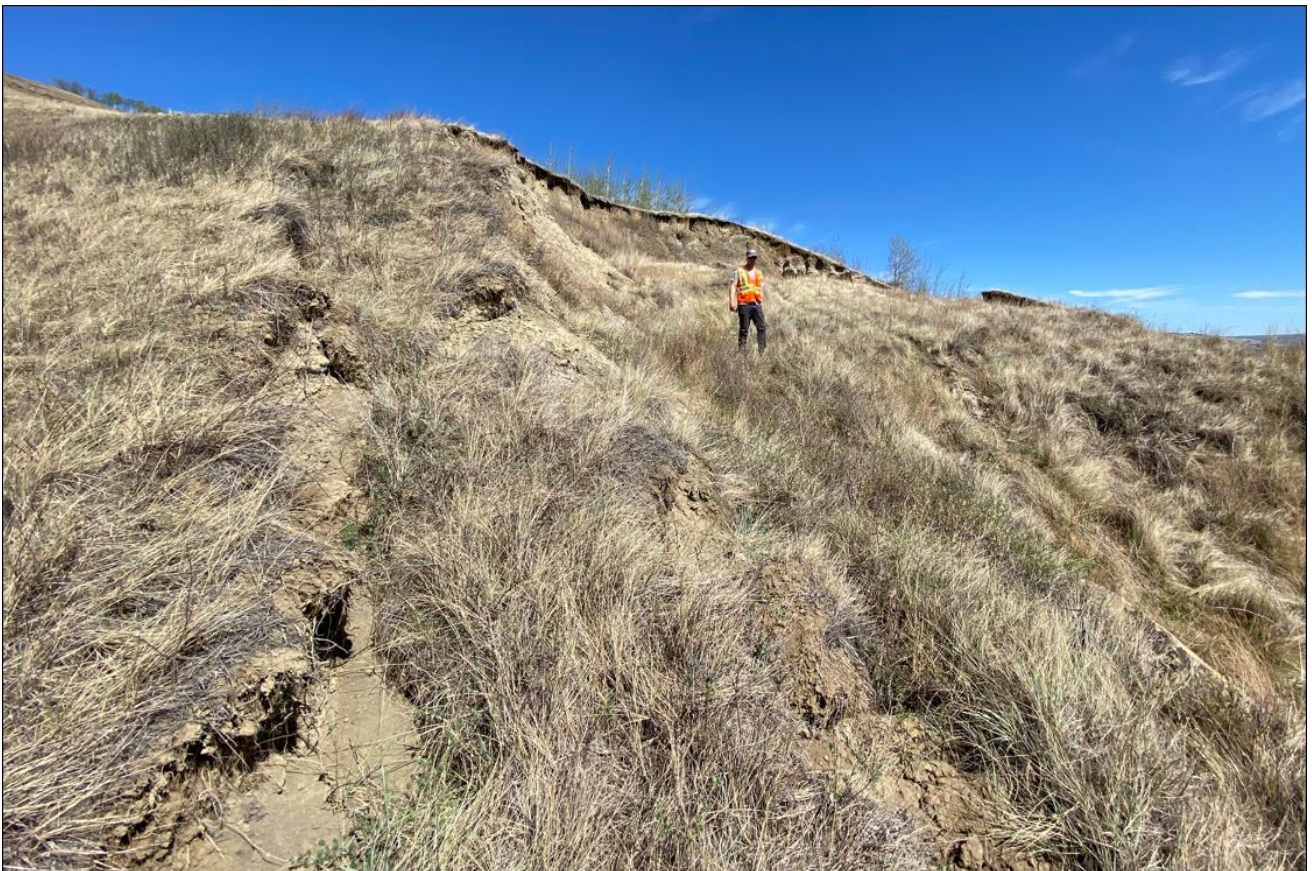
**Photo 6: Landslide backscarp showing movements since 2023.**

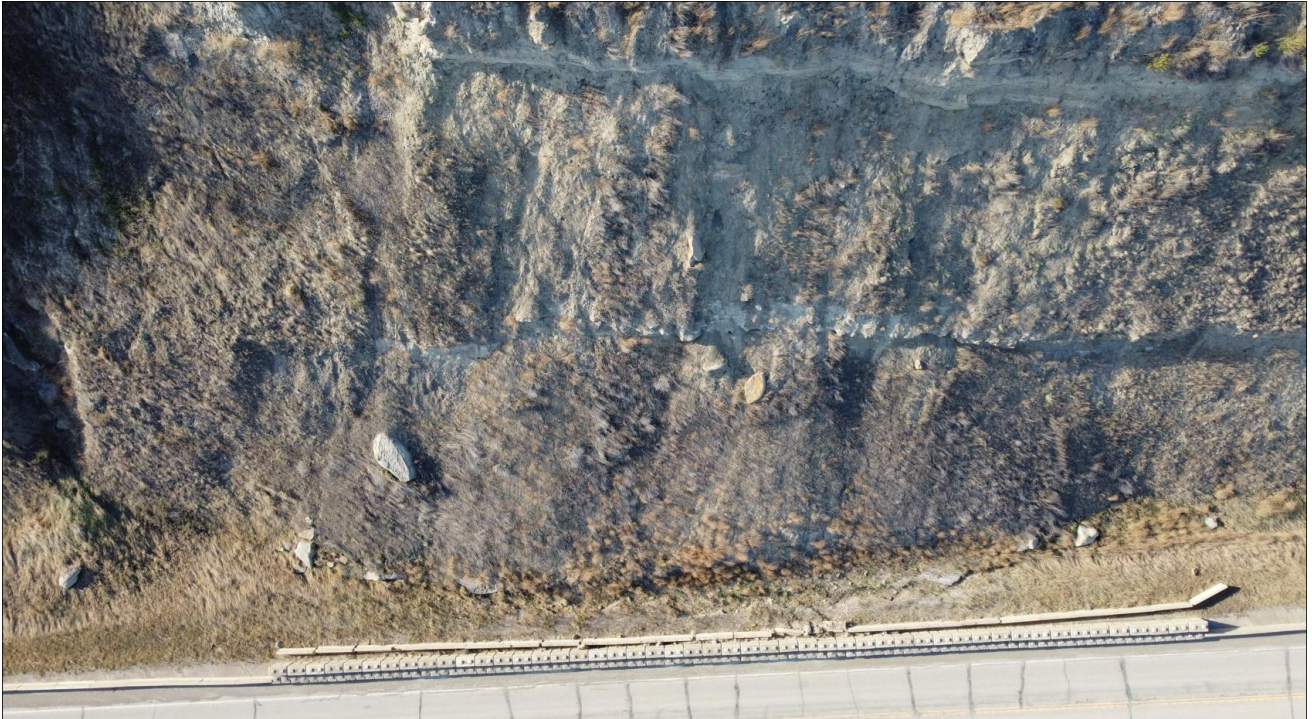
**Aerial Photo 7: Few sandstone rock slabs accumulating behind the Concrete Jersey Barrier**

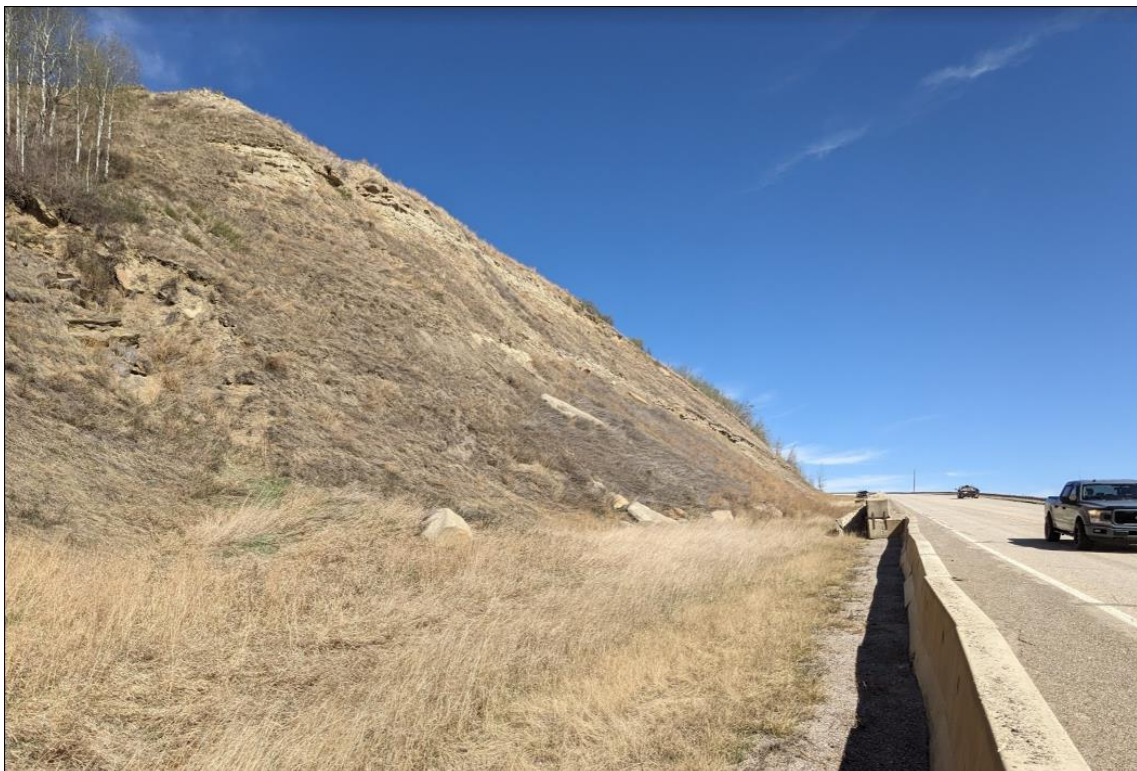
**Photo 8: Looking east at steep rock backslope and a few sandstone blocks accumulating behind the Concrete Jersey Barrier**

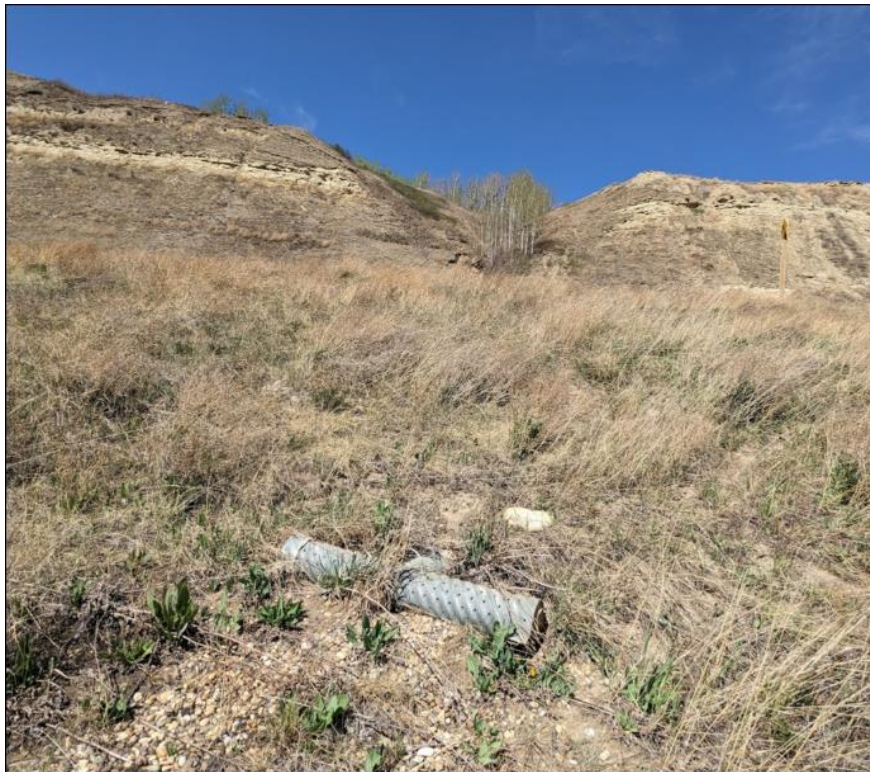
**Photo 9: Subdrain outlet located upslope from gabion basket. Dry in 2024**

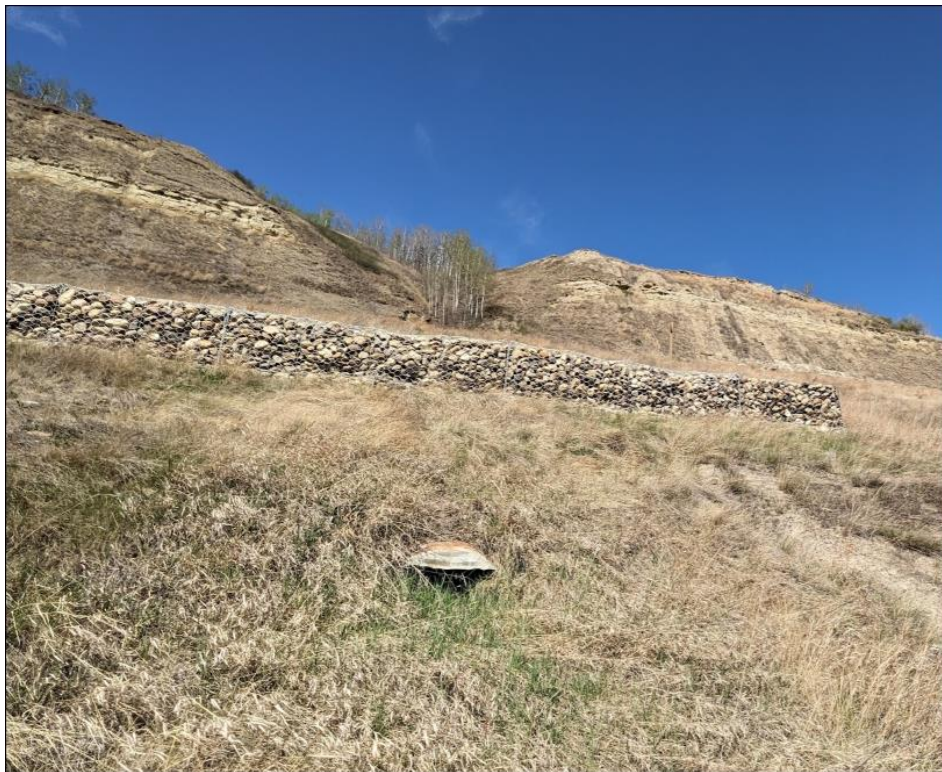
**Photo 10: 600 mm CSP Culvert. Approximately 300 mm buried under sediment. Dry in 2024**

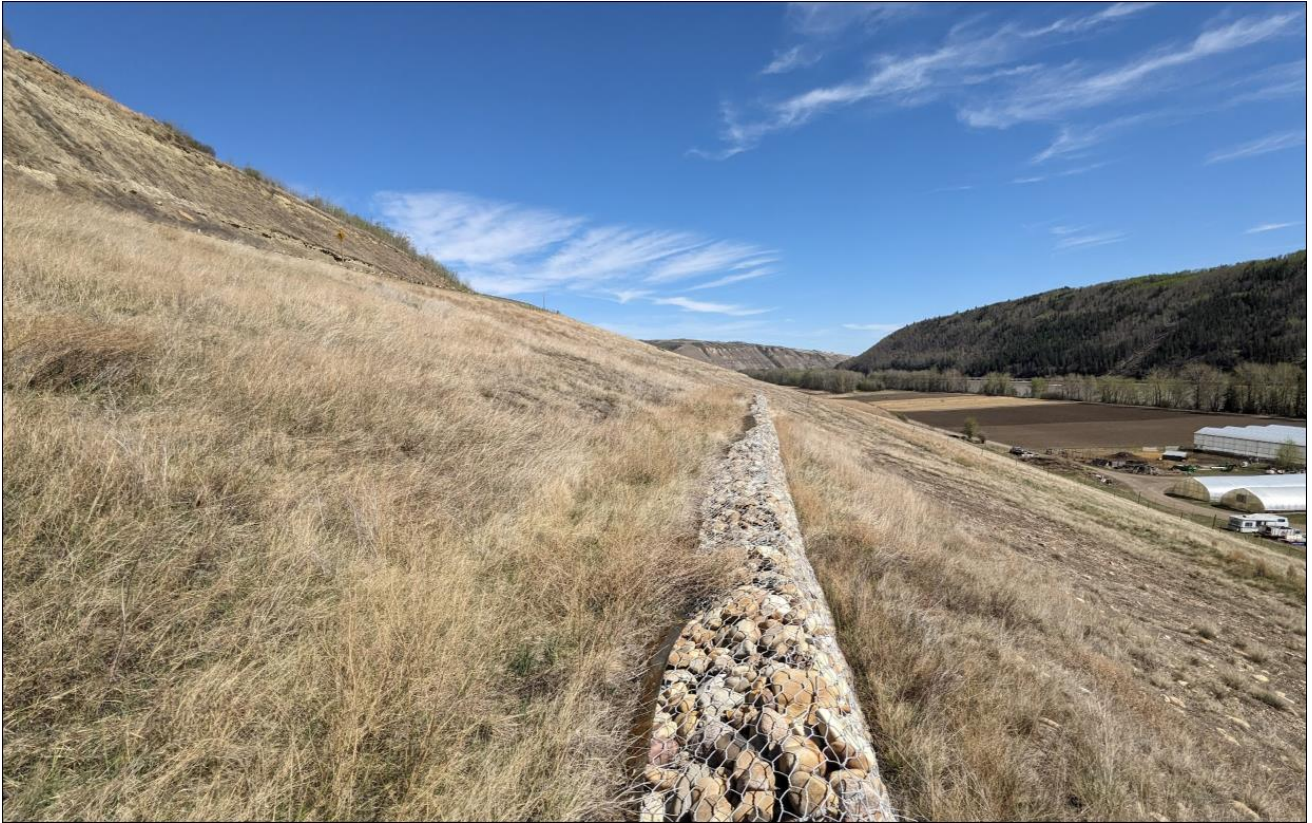
**Photo 11: Gabion Basket. Acceptable condition in 2024**
