**ALBERTA TRANSPORTATION AND  
ECONOMIC CORRIDORS  
GEOHAZARD ASSESSMENT PROGRAM  
PEACE REGION (GRANDE PRAIRIE DISTRICT - NORTH)  
2024 INSPECTION**

<b>Site Number</b>	<b>Location</b>	<b>Name</b>	<b>Hwy</b>	<b>km</b>
PH036	Dunvegan	Dunvegan South Elephant Trunk	2:68	16.216
<b>Legal Description</b>		<b>UTM Co-ordinates (NAD 83)</b>		
NW¼ 06-080-04 W6M		11U E 398549	N 6196741

**PEACE REGION (GRANDE PRAIRIE DISTRICT - NORTH)  
 PH036 DUNVEGAN SOUTH - ELEPHANT TRUNK**  
**2024 PH036 INSPECTION PLAN**  
**FIGURE 1**

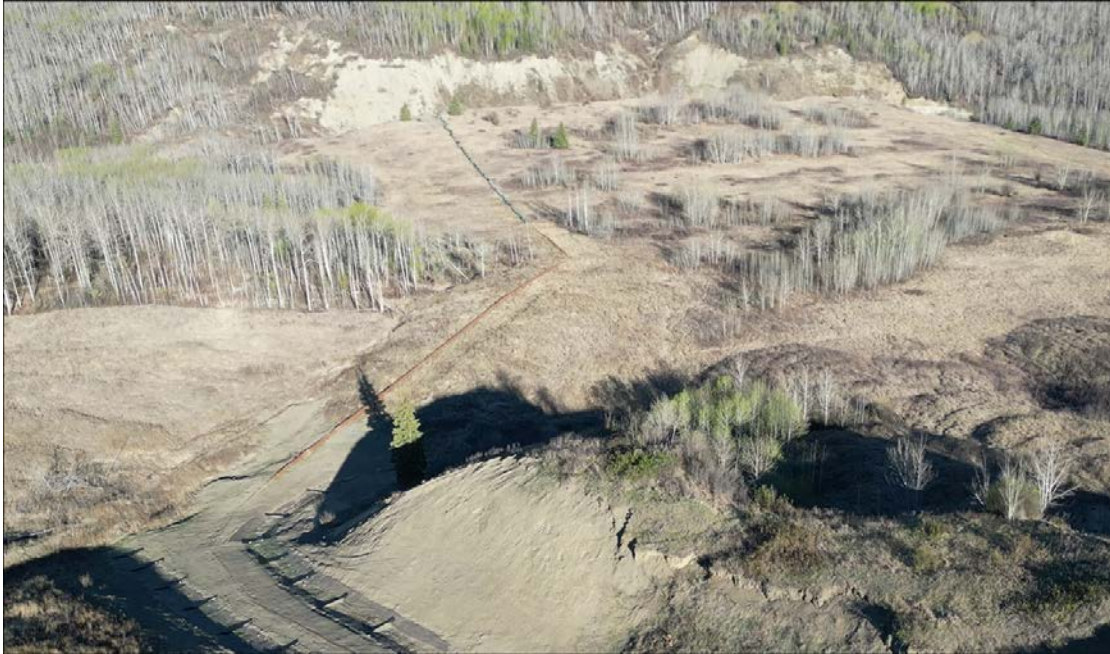
**Photo D1.**  
**Oblique drone view of elephant trunk on lower slope**

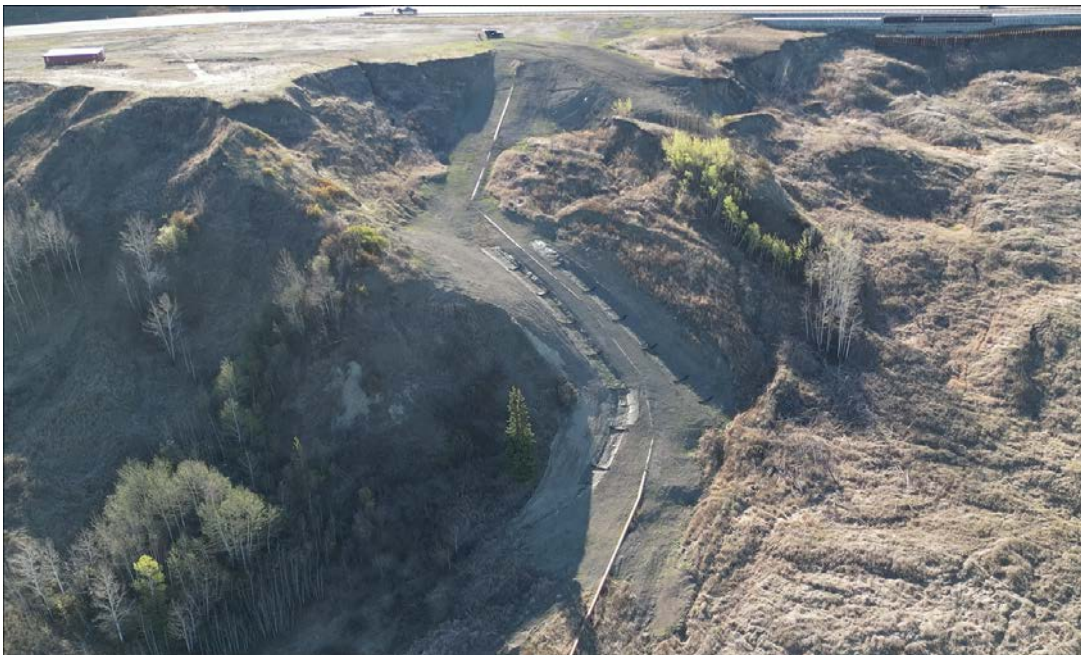
**Photo D2.**  
**Oblique drone view of elephant trunk on upper slope**

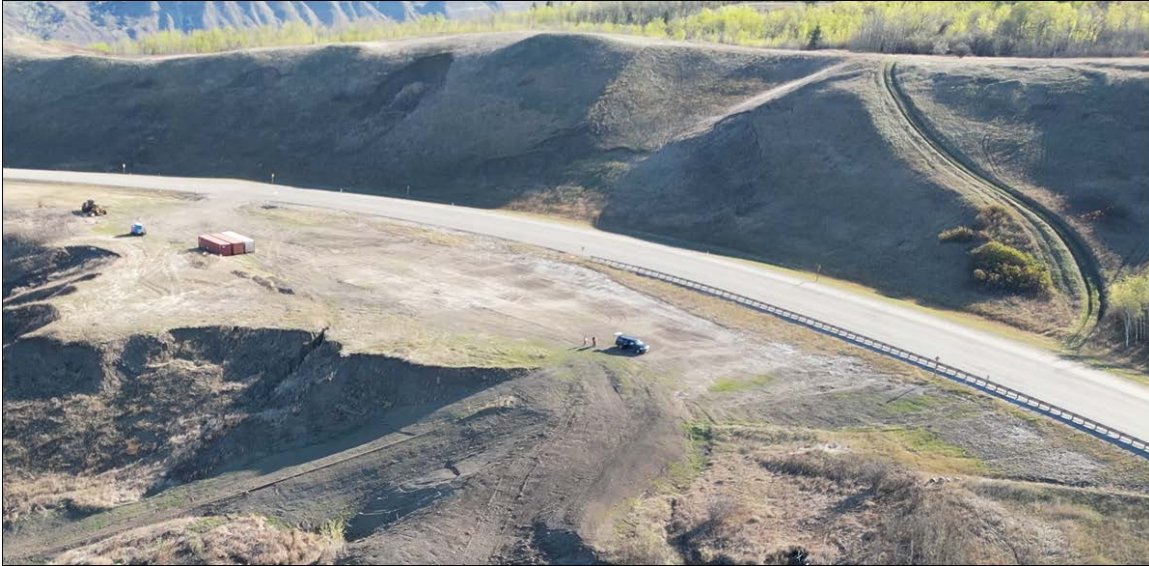
The four backslope slumps from Station 2+050 to about 2+280 continue showing creep movement and partial blocking the upslope ditch.		
<input checked="" type="checkbox"/> Erosion	Minor rills developed on the side slope below the SWSP second horizontal bend	<input type="checkbox"/>	<input checked="" type="checkbox"/>
<input checked="" type="checkbox"/> Seepage	Some seepage noted on the side slope near the top of the backscarp.	<input type="checkbox"/>	<input checked="" type="checkbox"/>
<input checked="" type="checkbox"/> Bridge/Culvert Distress	No signs of structural damage were noted in the new SWSP.	<input type="checkbox"/>	<input checked="" type="checkbox"/>
<input type="checkbox"/> Other		<input type="checkbox"/>	<input type="checkbox"/>

**Photo D3.**  
**Oblique drone view of backslope slumps**

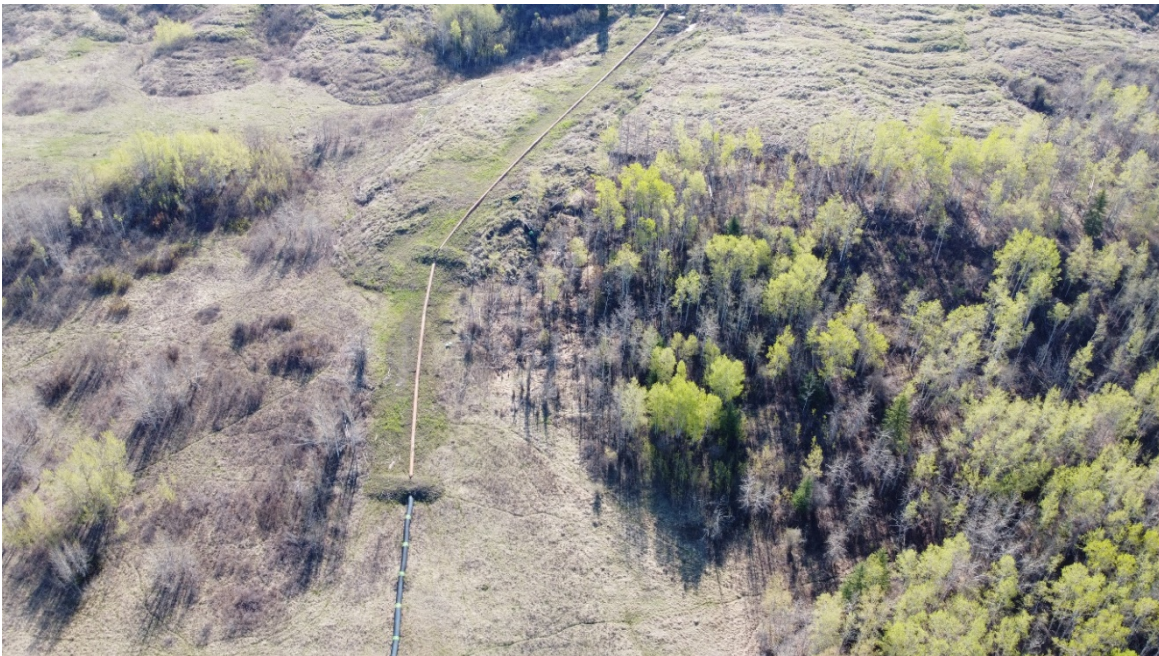
**Photo D4.**  
**Oblique drone view of elephant trunk on lower slope**

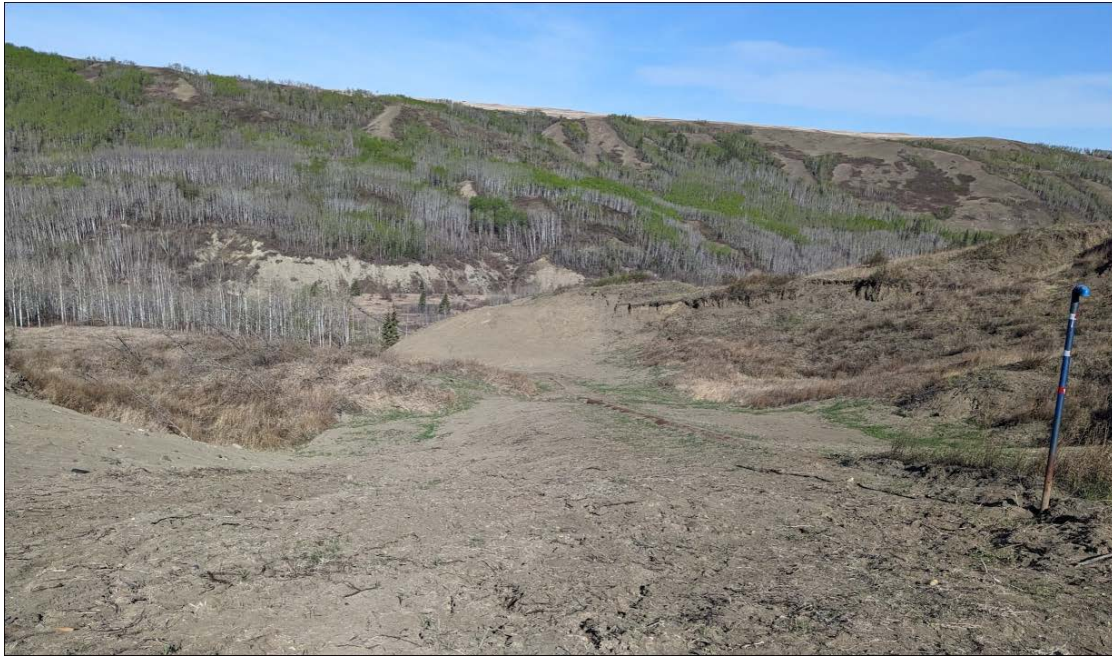
**Photo 1. Looking northeast from Sta. 2+320 towards the Dunvegan Elephant Trunk consisting of a 760 mm diameter smooth wall steel pipe**

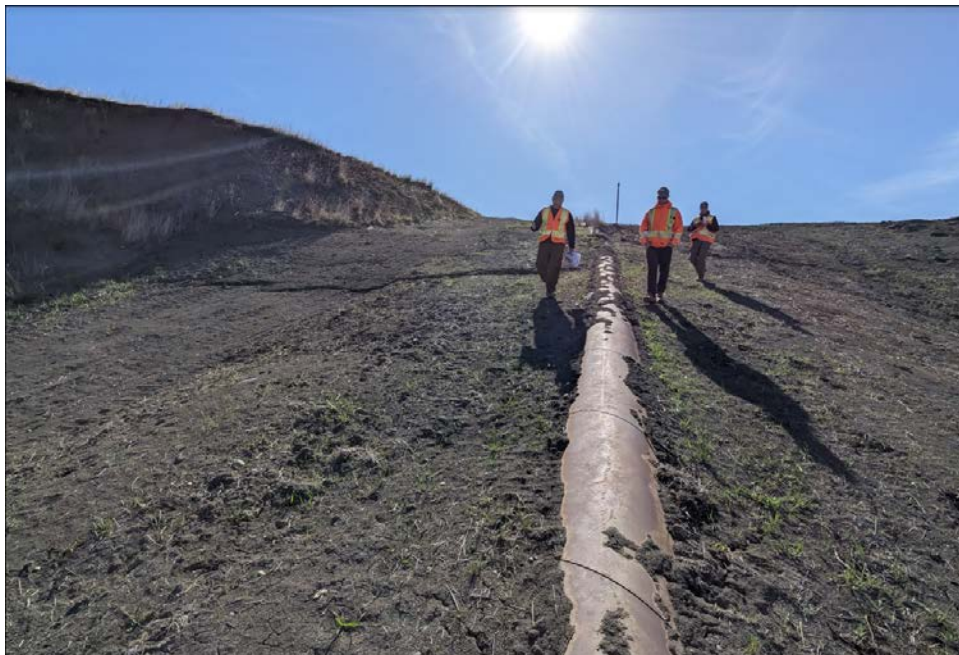
**Photo 2. Looking upslope at Elephant Trunk Pipe where fill was placed in 2023 to support the underside of pipe and erosion gullies.**

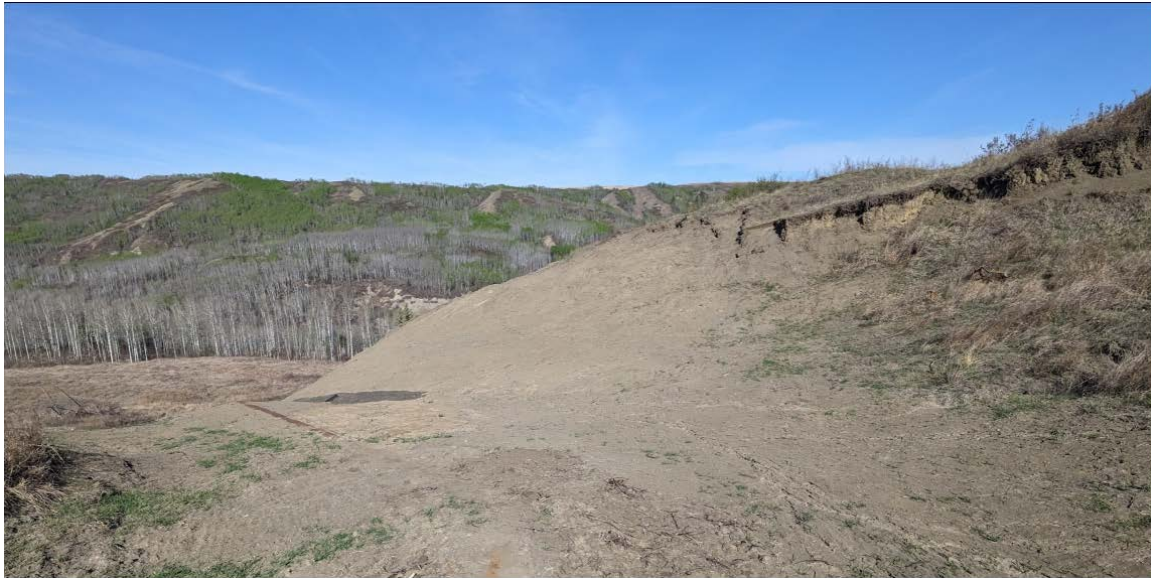
**Photo 3. Looking at graded Borrow Area B used during the 2023 repairs.**

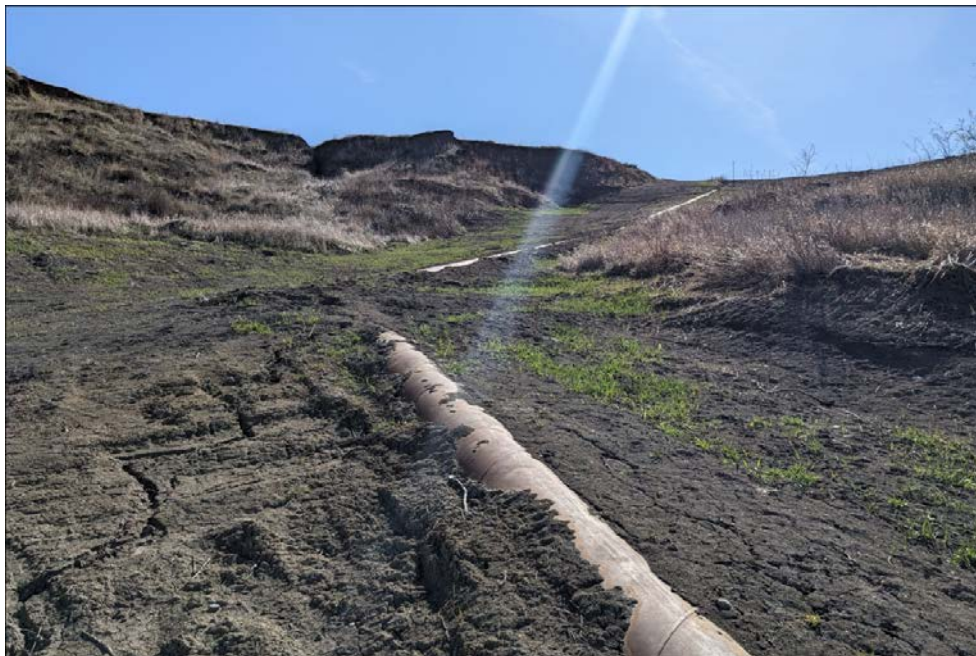
**Photo 4. Minor Rills and some seepage noted in 2024**

The TRM lined swale north of the SWSP will be extended (as part of some ongoing hillside repairs at PH055 and PH037) about 30 m east to address local erosion occurring in this area.

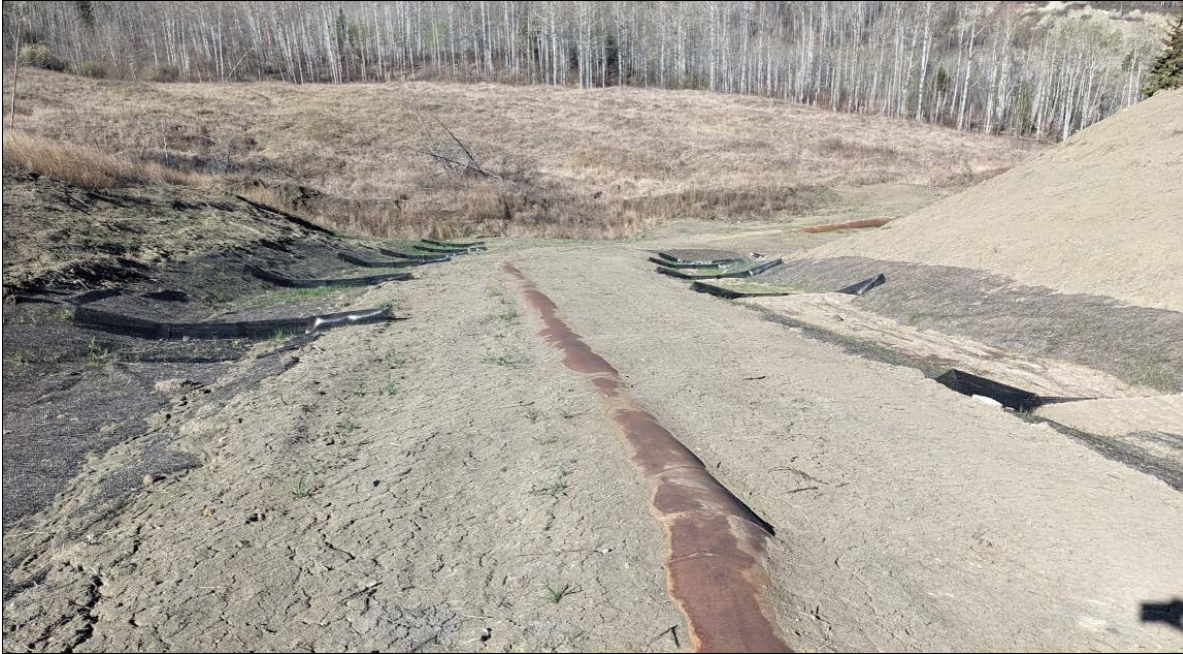
**Photo 5. Looking downslope at SWSP middle bend where the ground surface shaped, seeded, and swales were lined with TRM and protected with geosynthetic ditch barriers.**

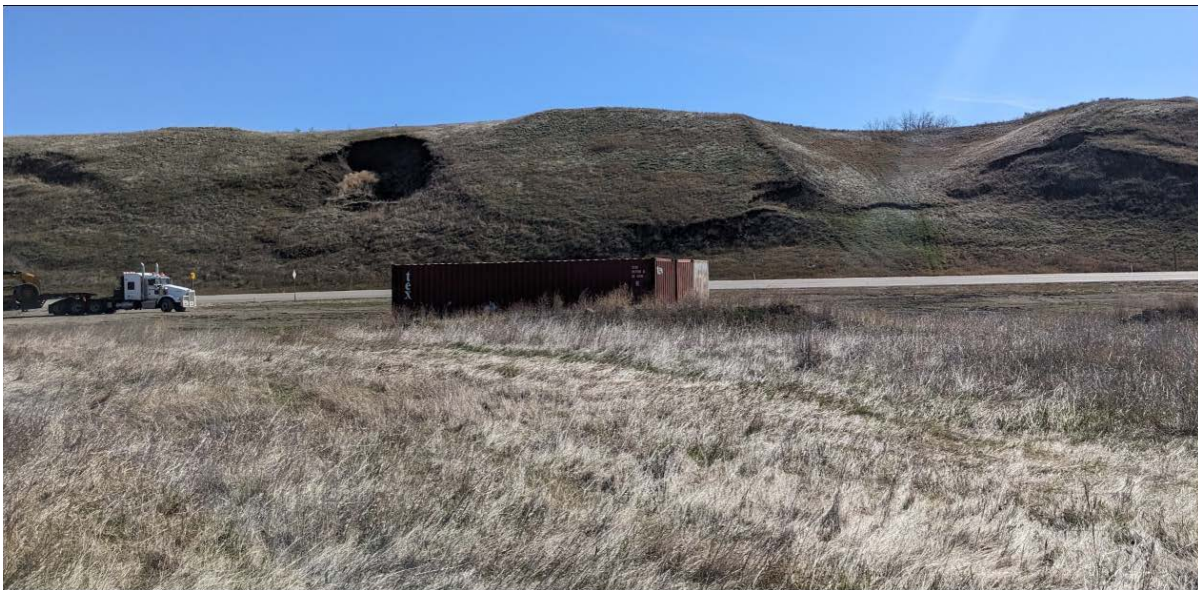
**Photo 6. Looking east at backslope slumps showing ongoing creep movement**
