**ALBERTA TRANSPORTATION
GEOHAZARD ASSESSMENT PROGRAM
PEACE REGION –
GRANDE PRAIRIE DISTRICT – NORTH
2023 INSPECTION**

Site Number	Location	Name	Hwy	km
PH037	Dunvegan	Dunvegan South 1+250 to 2+000	2:68	15.674
Legal Description		UTM Co-ordinates		
NW¼ 06-080-04 W6M		11U E 398514	N 6197340

Date	PF	CF	Total
Previous Inspection:	May 20, 2022	10	7	70
Current Inspection:	June 2, 2023	10	7	70
Road WAADT:	2,491		Year:	2022
Inspected By:	Rishi Adhikari, TEC Max Shannon, TEC		José Pineda, Thurber	
Report Attachments:	<input checked="" type="checkbox"/> Photographs	<input checked="" type="checkbox"/> Plans	<input checked="" type="checkbox"/> Maintenance Items

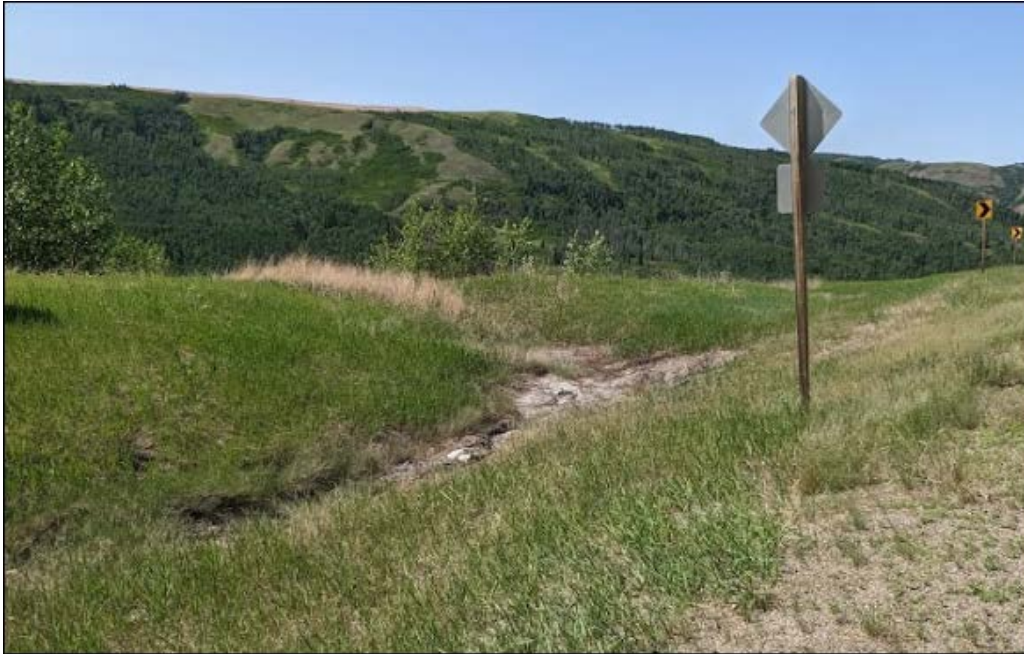
Photo 1: Looking northwest from Sta. 2+000 at erosion gully in SBL ditch south of ditch block

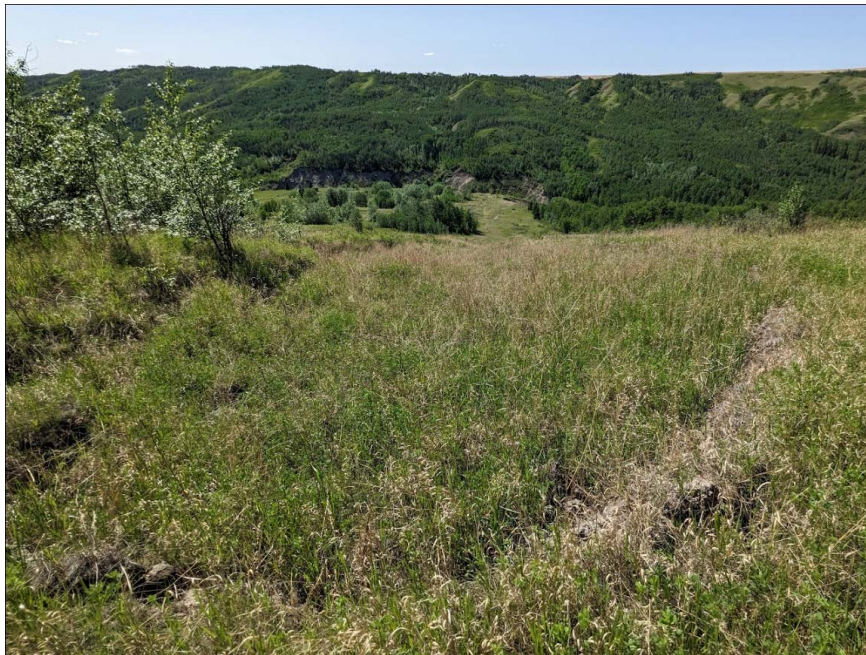
Photo 2: Looking west from Sta. 1+980 below the SBL highway. More movement noted in 2023

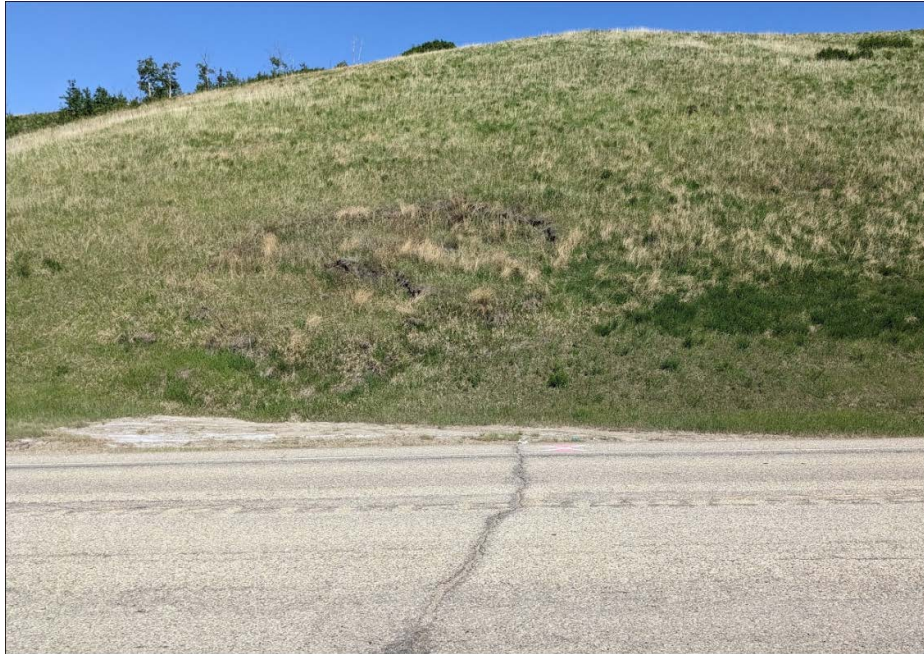
Photo 3: Looking east at backslope skin failure at Sta. 1+900 (Less movement since 2022).

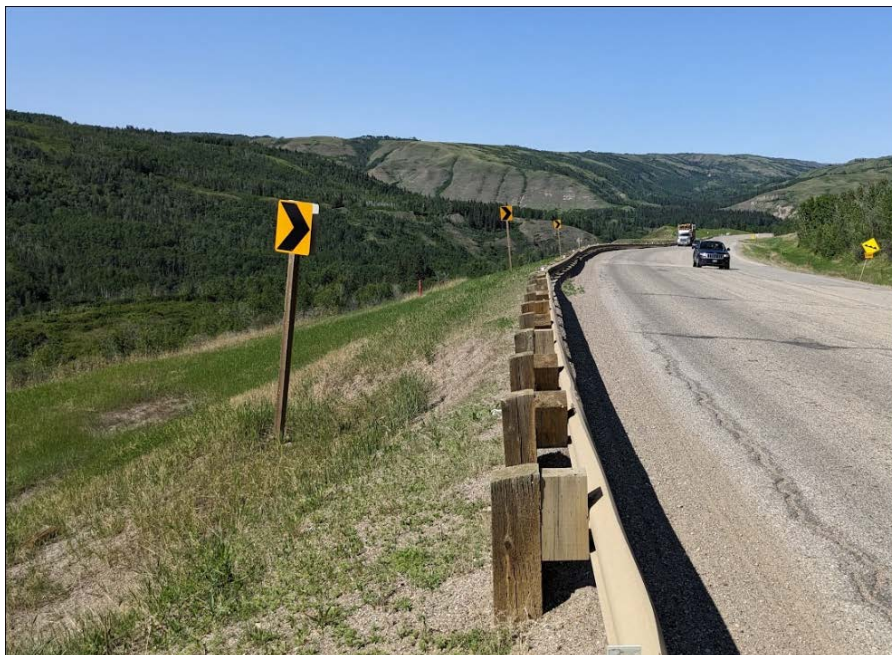
Photo 4: Looking north from Sta. 1+890 at the slump in the sideslope of the SBL. More movement since 2022. The scarp is 1.5 m high and 0.4 m from the guardrail.

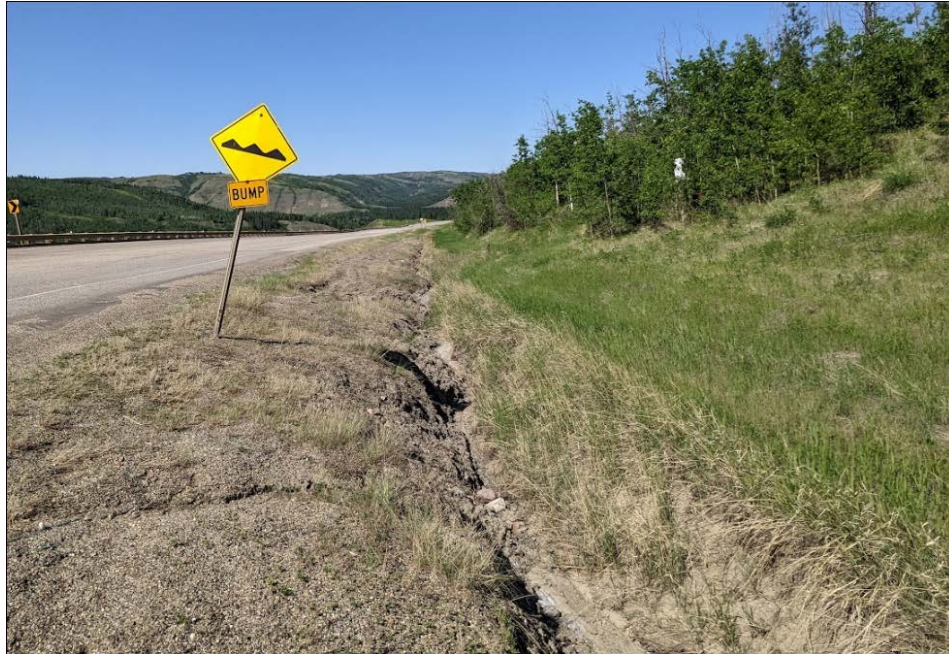
Erosion and slope movement downslope of the highway near Sta. 2+000 are a function of water flows in the ditch and are expected to worsen.

Photo 5: Looking north from Sta. 1+800 at the erosion gully developed on the ditch up to 5 m wide and 0.8 m deep. Erosion gully wider and deeper than noted at the 2022 inspection.

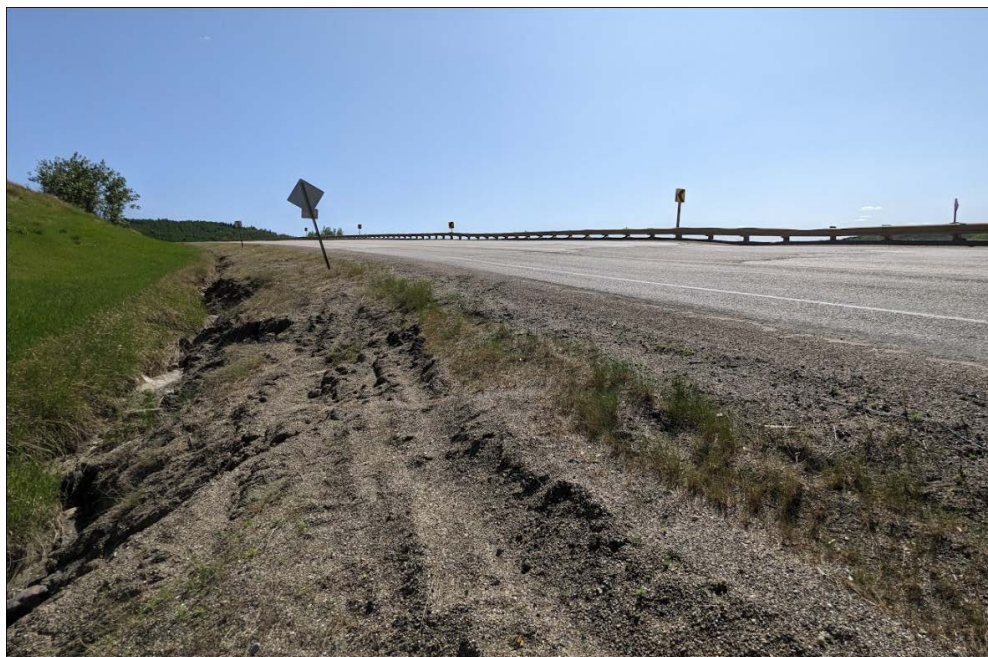
The 1+800 slide is a deep-seated slide that is currently affecting all three lanes of the highway over a 200 m length with the backscarp likely within the NBL ditch bottom. Based on the ongoing slope inclinometer monitoring, the 1+800 slide plane depth varies within the embankment of the highway from about 18 m near the SBL shoulder to a depth of 28 m below the NBL shoulder with the toe of the landslide is likely situated some 300 m further downslope towards Dunvegan Creek. Rates of movement in the 1+800 slide SI's typically vary from small creep movements to 11 mm/yr. and have accelerated to about 20 mm/yr. in recent years. The 1+800 slide continues to exhibit moderate rates of movement up to 13 mm/yr; however, its footprint currently affects the entire highway embankment whereby a complete closure of the highway could result from a sudden increase in slide activity.

Photo 6: Looking south across the dip in the highway at the south end of the 1+800 slide.

Continue to monitor visually for signs of activity at both slides and close the outer SBL at the 1+400 slide should tension cracks or dips appear in the roadway surface. Apply small asphalt patches at each end of the 1+800 slide to smooth out the dip when required for traffic safety.

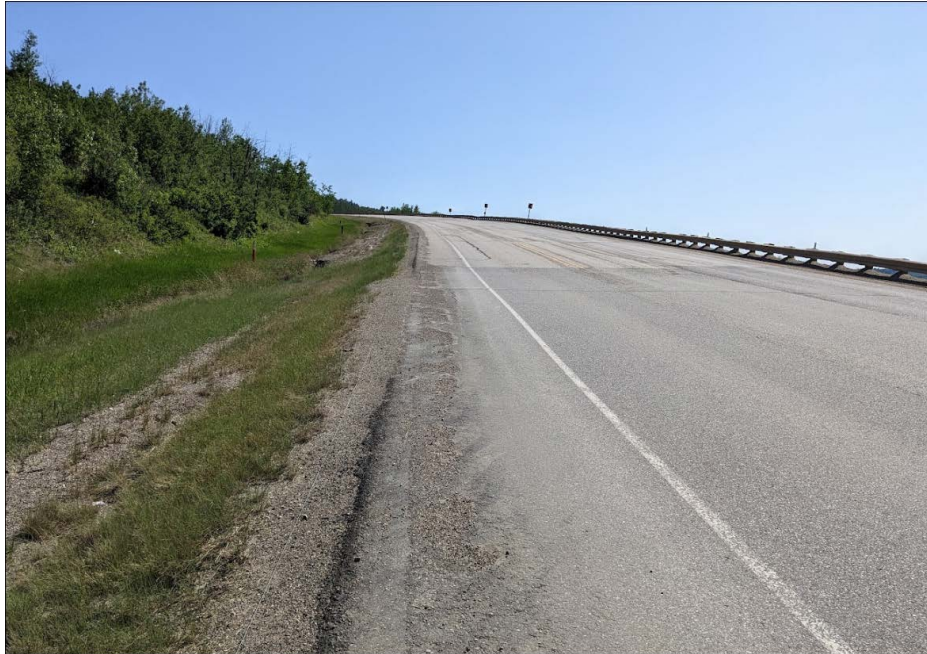
Photo 7: Looking from the shoulder of the SBL at Sta. 1+670 across the dip in the highway at the north end of the 1+800 slide.

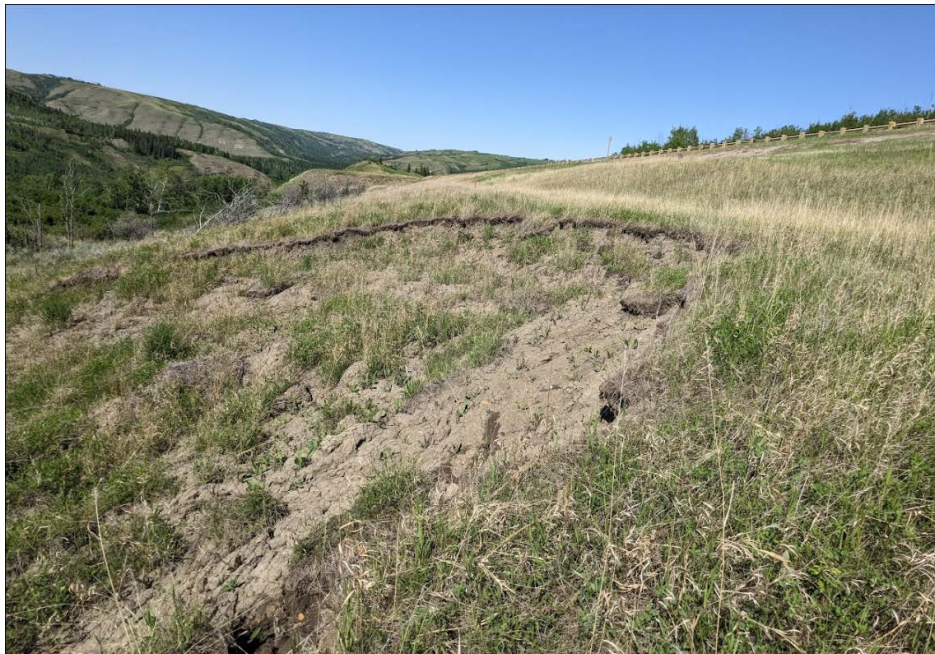
Photo 8: Looking north near Sta. 1+670 at slumping occurring on the highway side slope approximately 20 m from the edge of pavement. More movement noted since 2022

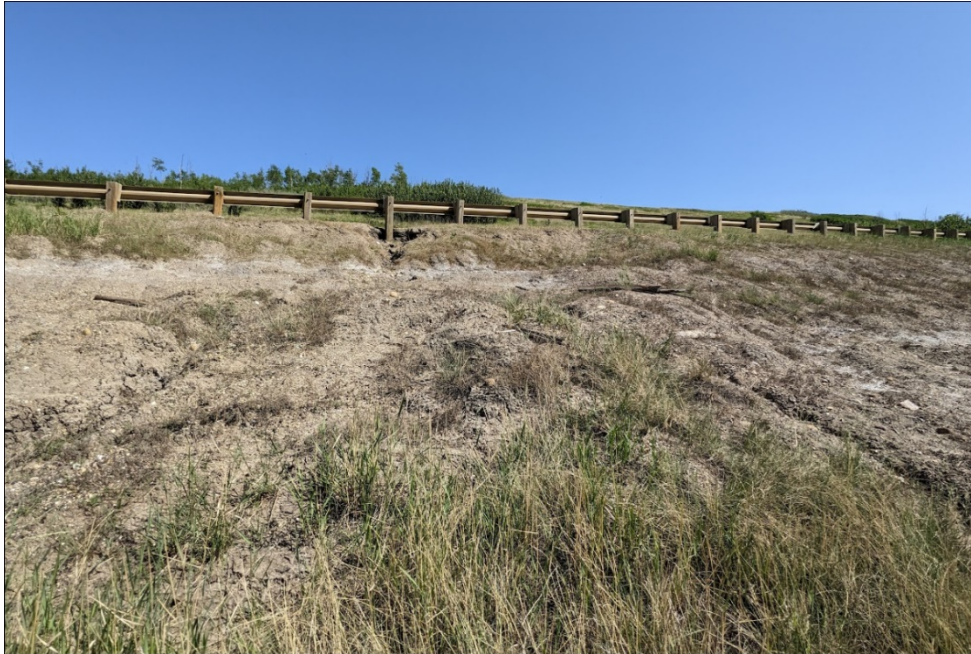
Photo 9: Looking east near Sta. 1+550 at fresh erosion rills and gullies developed on the highway side slope. Erosion became worse in 2023

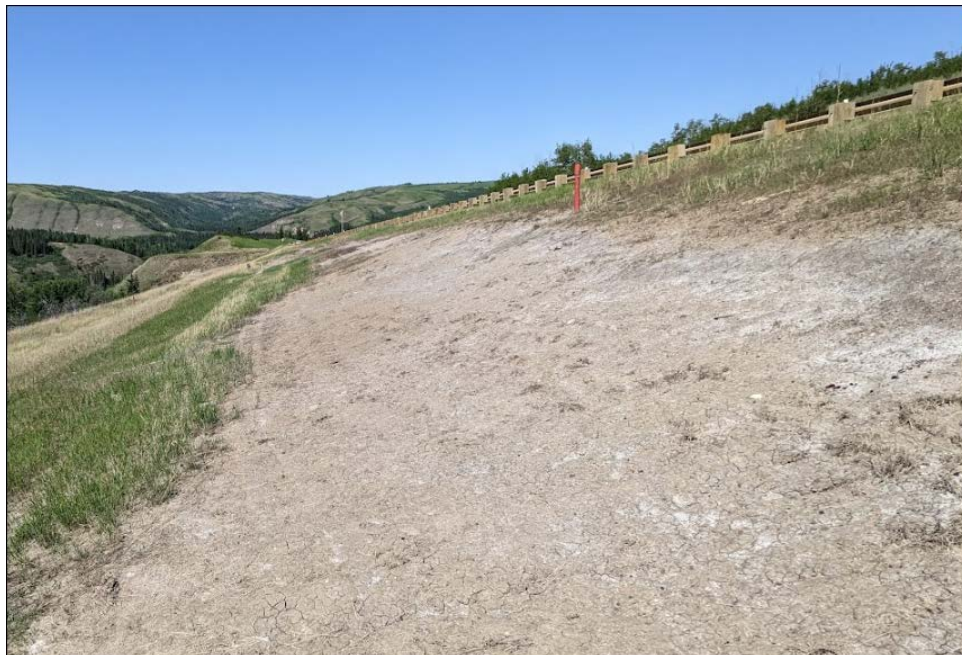
Photo 10: Looking north near Sta. 1+560 at rough area (drill access bench) with some seepage and tension cracks

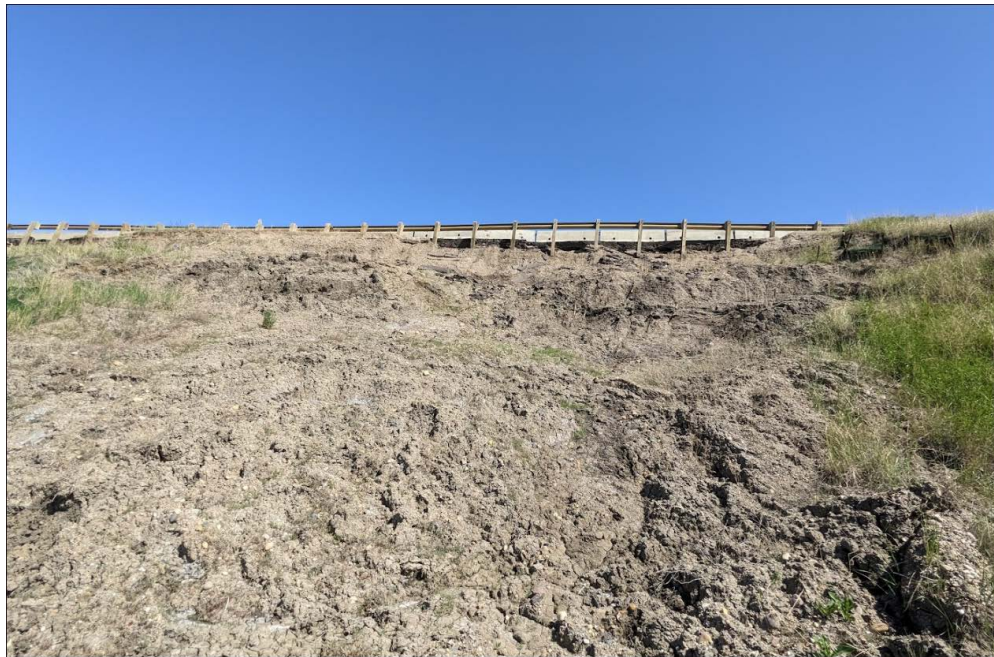
Ongoing slide activity was observed at the Sta. 1+400 slide in 2016 right through 2023. Soil below the matting and around the soil nails, installed in 2010, has failed superficially, with more substantial failure extents below the surface treated area. It is anticipated that the rate of retrogression will likely accelerate above the areas where the soil nails have been bent downward due to a combination of confining soil loss and slope movement. The backscarp located at the shoulder of the SBL ranges between 5 to 7 m high. The SI's installed within the footprint of the 1+400 slide had rapid rates of movement in the spring and summer of 2018 (50 to 700 mm/yr.) and sheared off at a depth of 2 m as a result of a mud flow after the fall of 2018.

Photo 11: Looking east at failed soil matting and nails which were installed in August 2010 at Sta. 1+450 slide.

Backscarp (5 m to 7.5 m high) continues retrogressing and impacting the highway. Four guardrail posts are hanging and other four posts are partially exposed.

Install driven steel pile walls at the Sta. 1+400 landslide location to temporarily maintain the climbing lane until a more permanent repair is implemented.

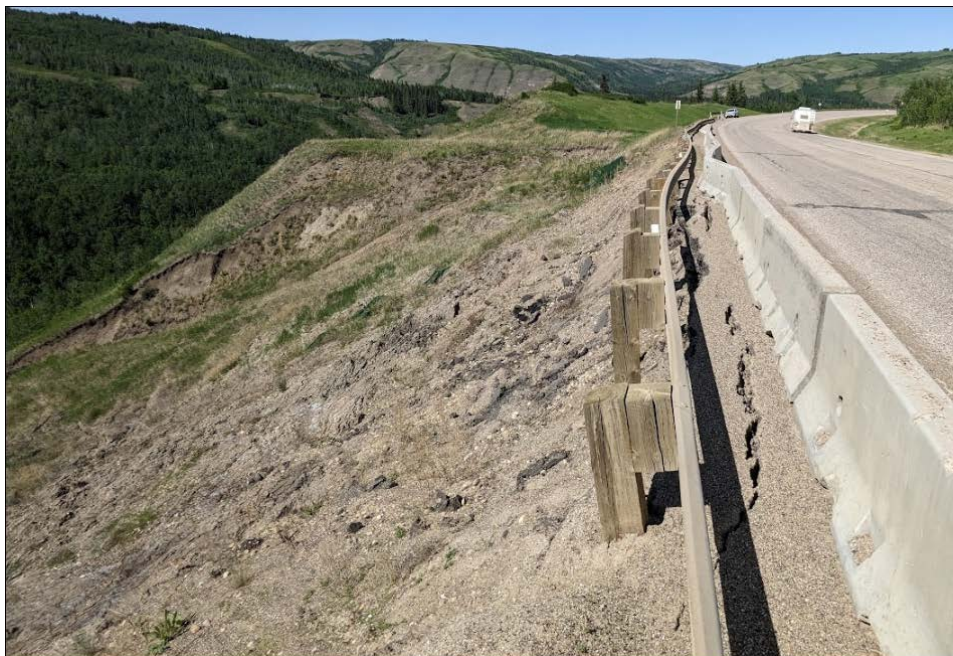
Photo 12: Looking north from Sta. 1+450 backscarp. New Jersey Barrier installed in 2023

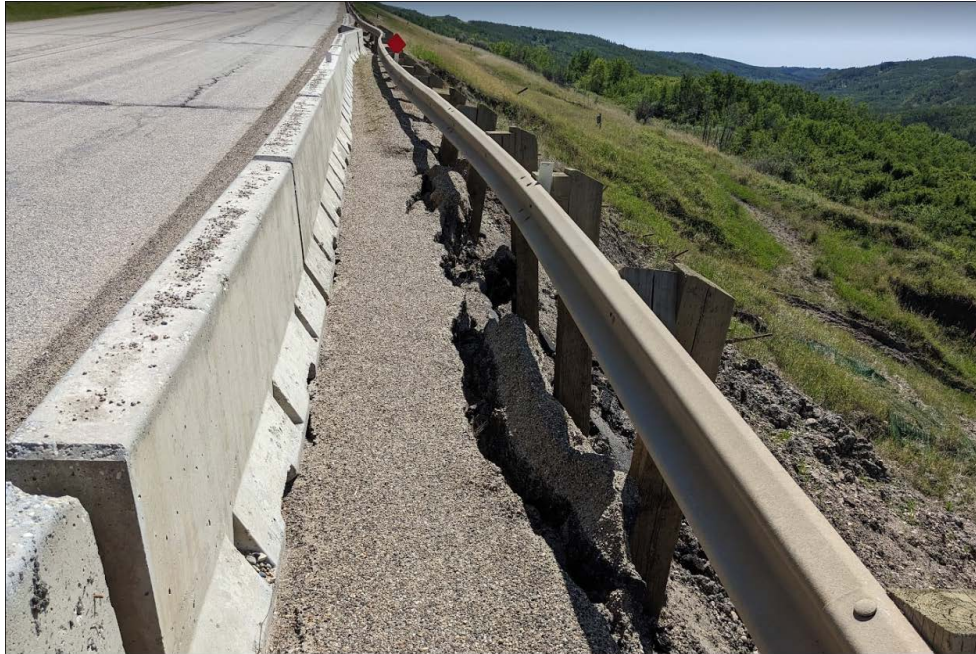
The 1+400 slide is retrogressing rapidly and is impacting the SBL shoulder. When considering the existing smaller slide features to the south, this suggests that the expansion of this slide further to the south should be anticipated.

Photo 13: Looking south from Sta. 1+390 at the backscarp of the 1+400 slide which is impacting the highway shoulder. Slide cracks are wider and closer to the driving lane

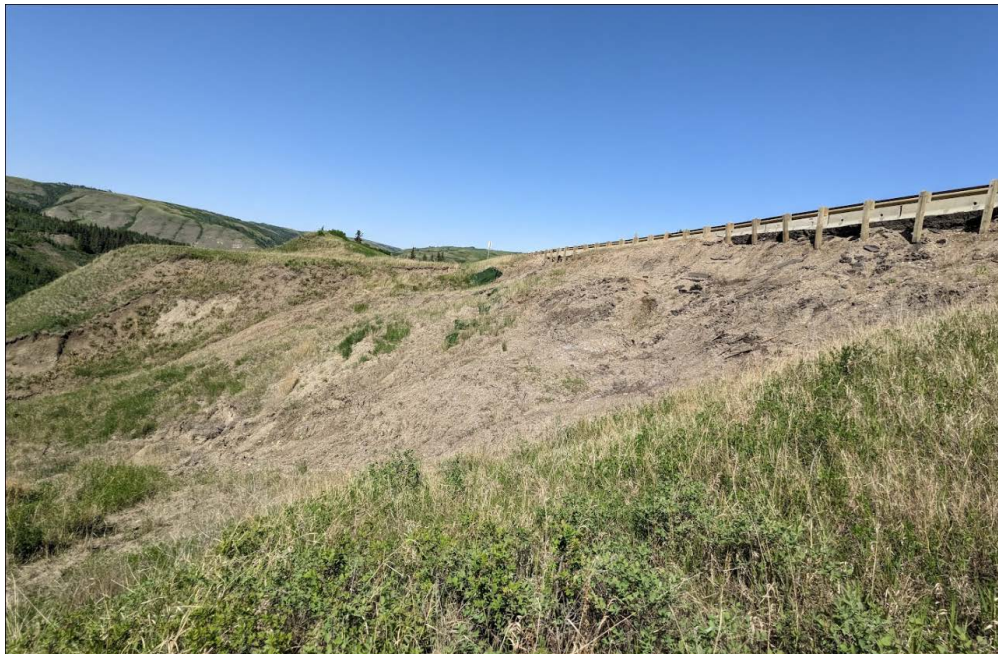
Photo 14: Looking north towards the 1+400 slide. The slide has further retrogressed towards the highway, is wider than in 2022 and there is a 5 m to 7.5 m drop below the guardrail.

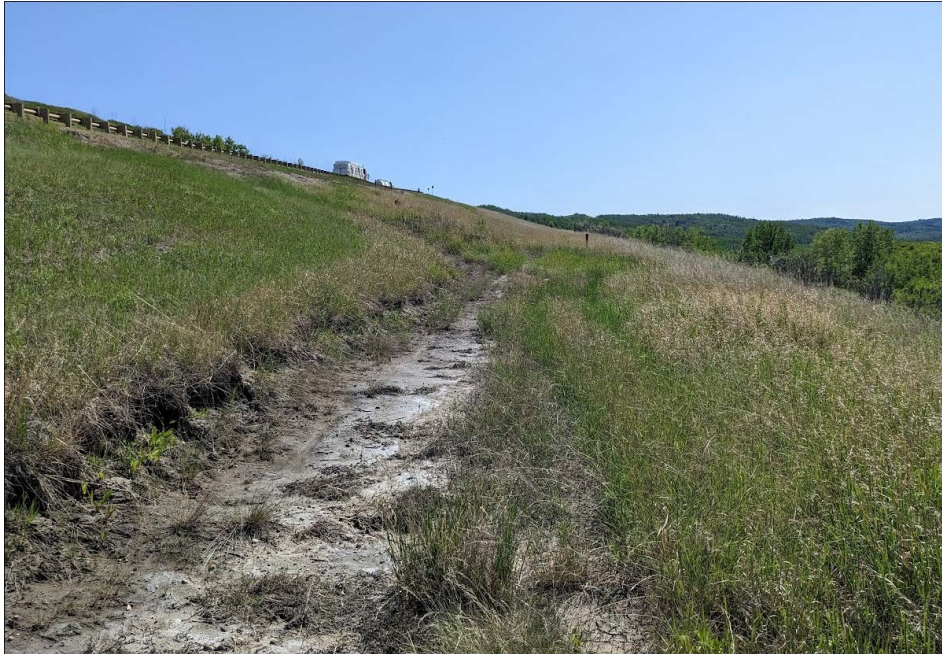
Photo 15: Looking south at the north end of slumping occurring from Sta. 1+450 to 1+550. Photo showing a drop of about 0.3 m

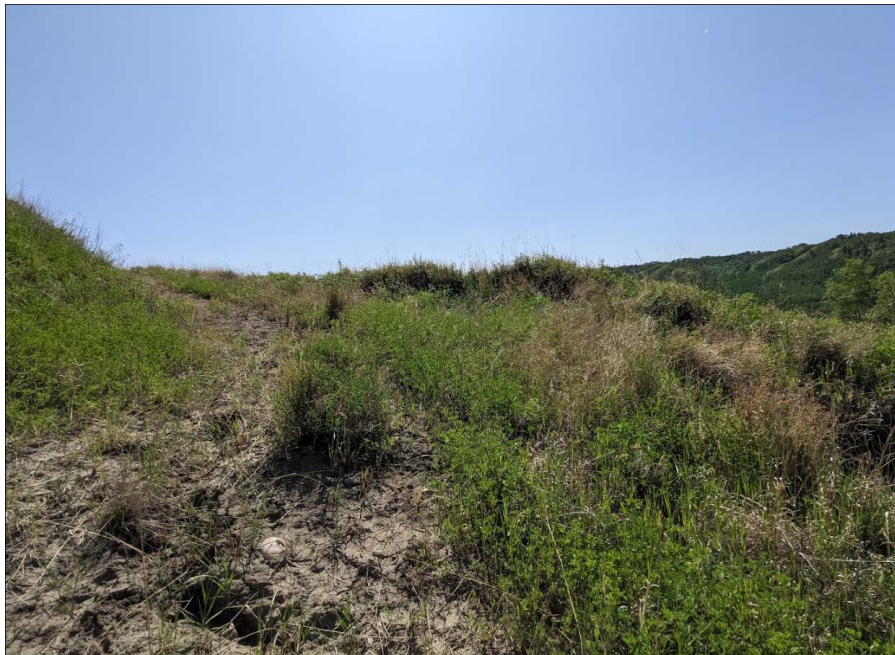
Photo 16: Looking south at the middle portion of slumping occurring from Sta. 1+450 to 1+550. Photo showing a drop of about 1 m.
