**ALBERTA TRANSPORTATION AND
ECONOMIC CORRIDORS GRMP
PEACE REGION
(GRANDE PRAIRIE DISTRICT - NORTH)
INSTRUMENTATION MONITORING - FALL 2024**

Site Number	Location	Name	Hwy	km
PH037	Station 1+250 to 2+000	Dunvegan South	2:68	Km 15.7
Legal Description: 4-7-80-4 W6		UTM Co-ordinates		
		11U E 398593.62	N	6197597.09

Current Monitoring:	28-May-2024	Previous Monitoring	28-May-2024
Instruments Read By:	Mr. Neil McDonald and Mr. Nixson Mationg of Thurber

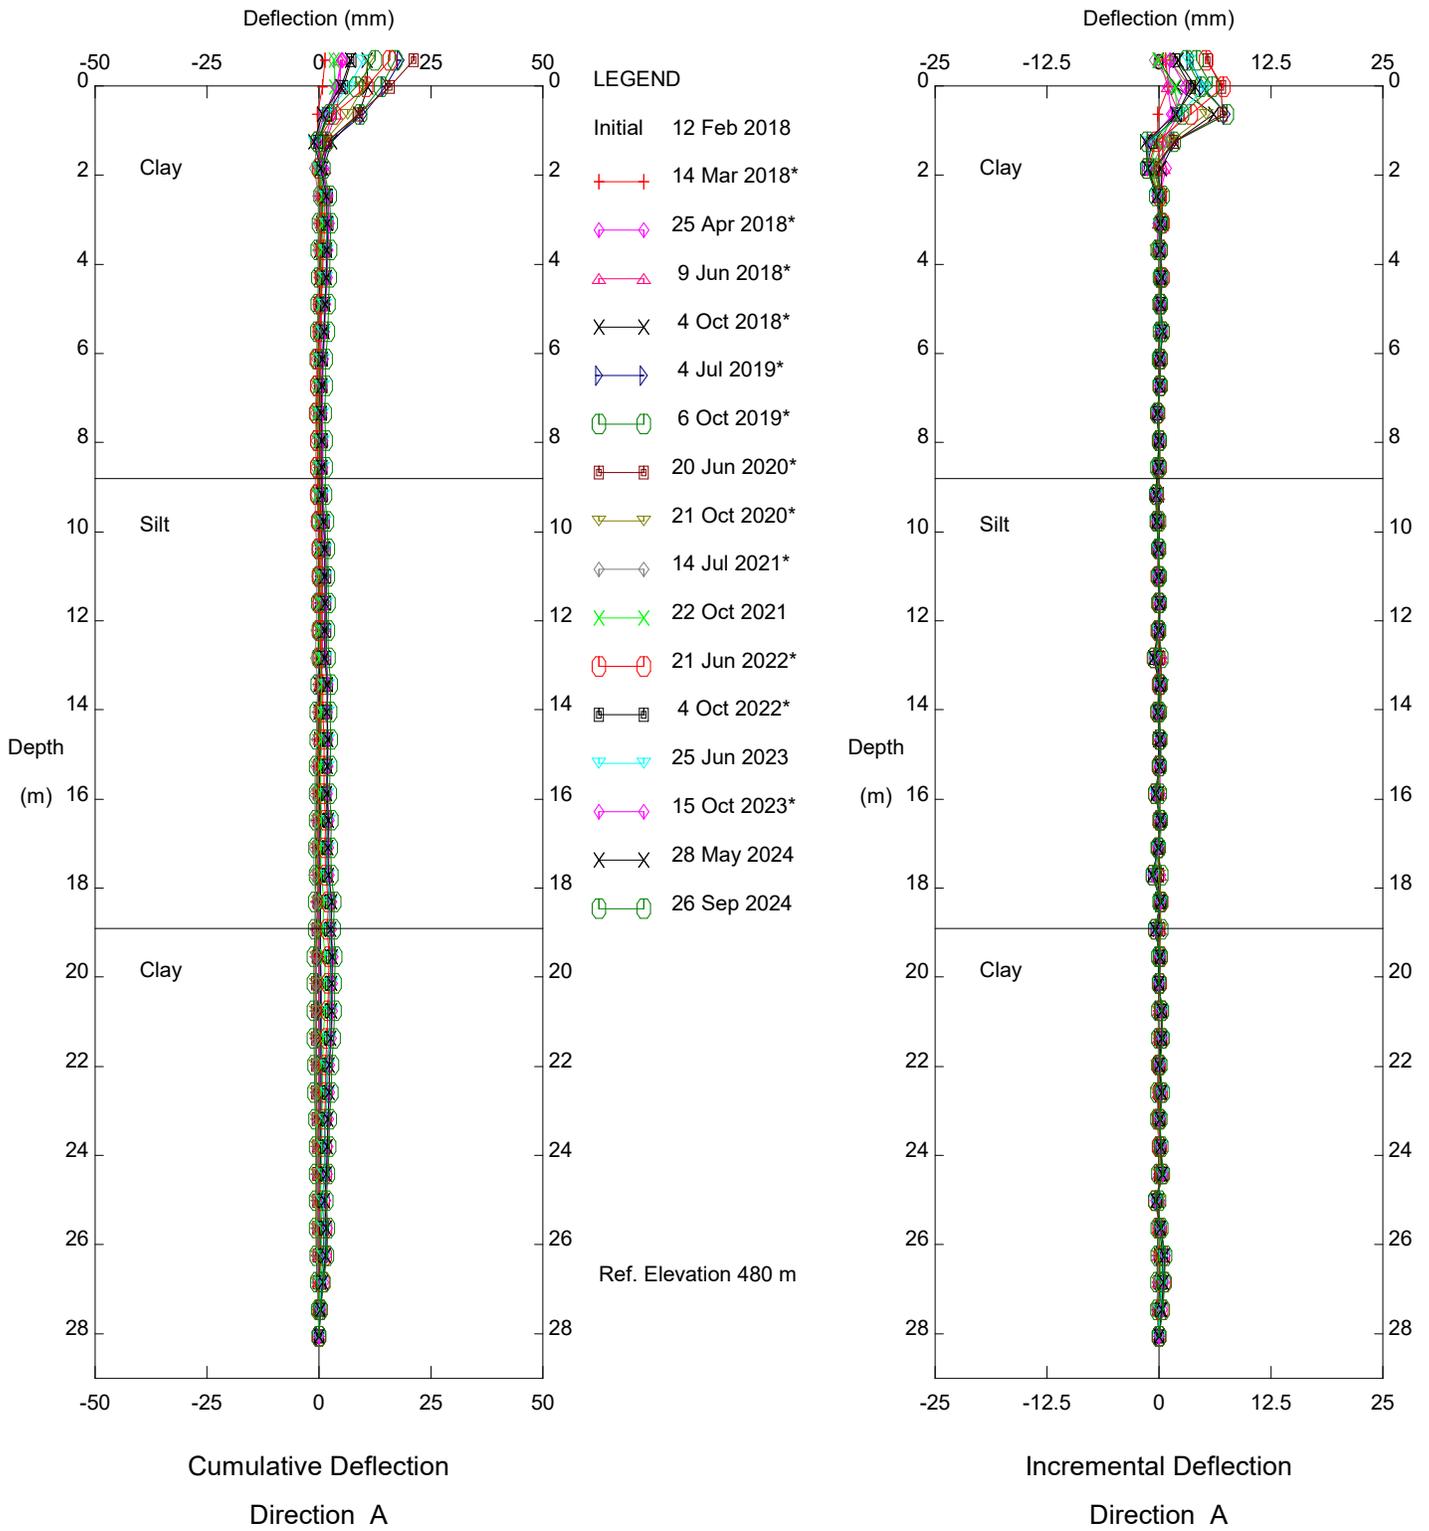
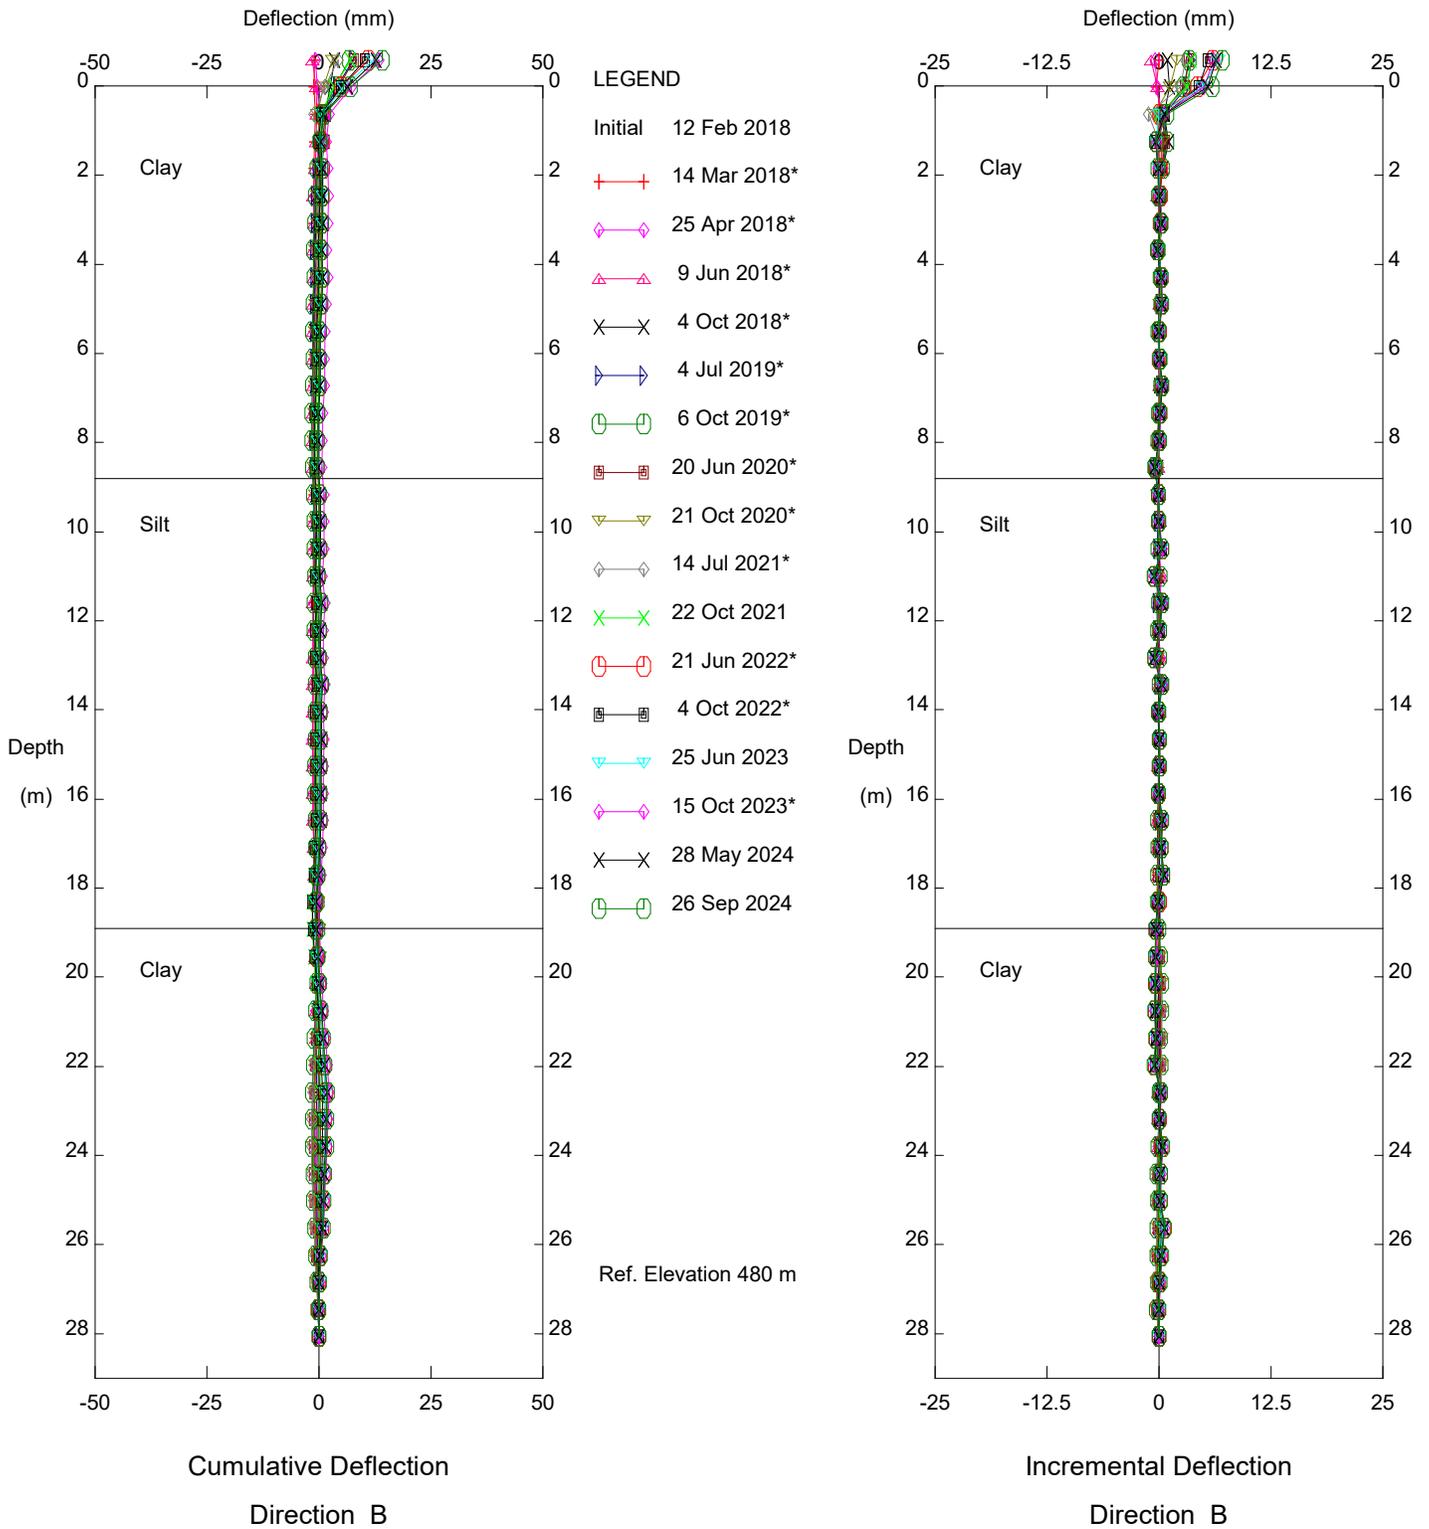
HWY 2:68 (PH037), Inclinometer SI18-4

SI18-4 is in the cut slope above the highway and shows no discernible movement throughout the 28 m length of the slope indicator pipe.

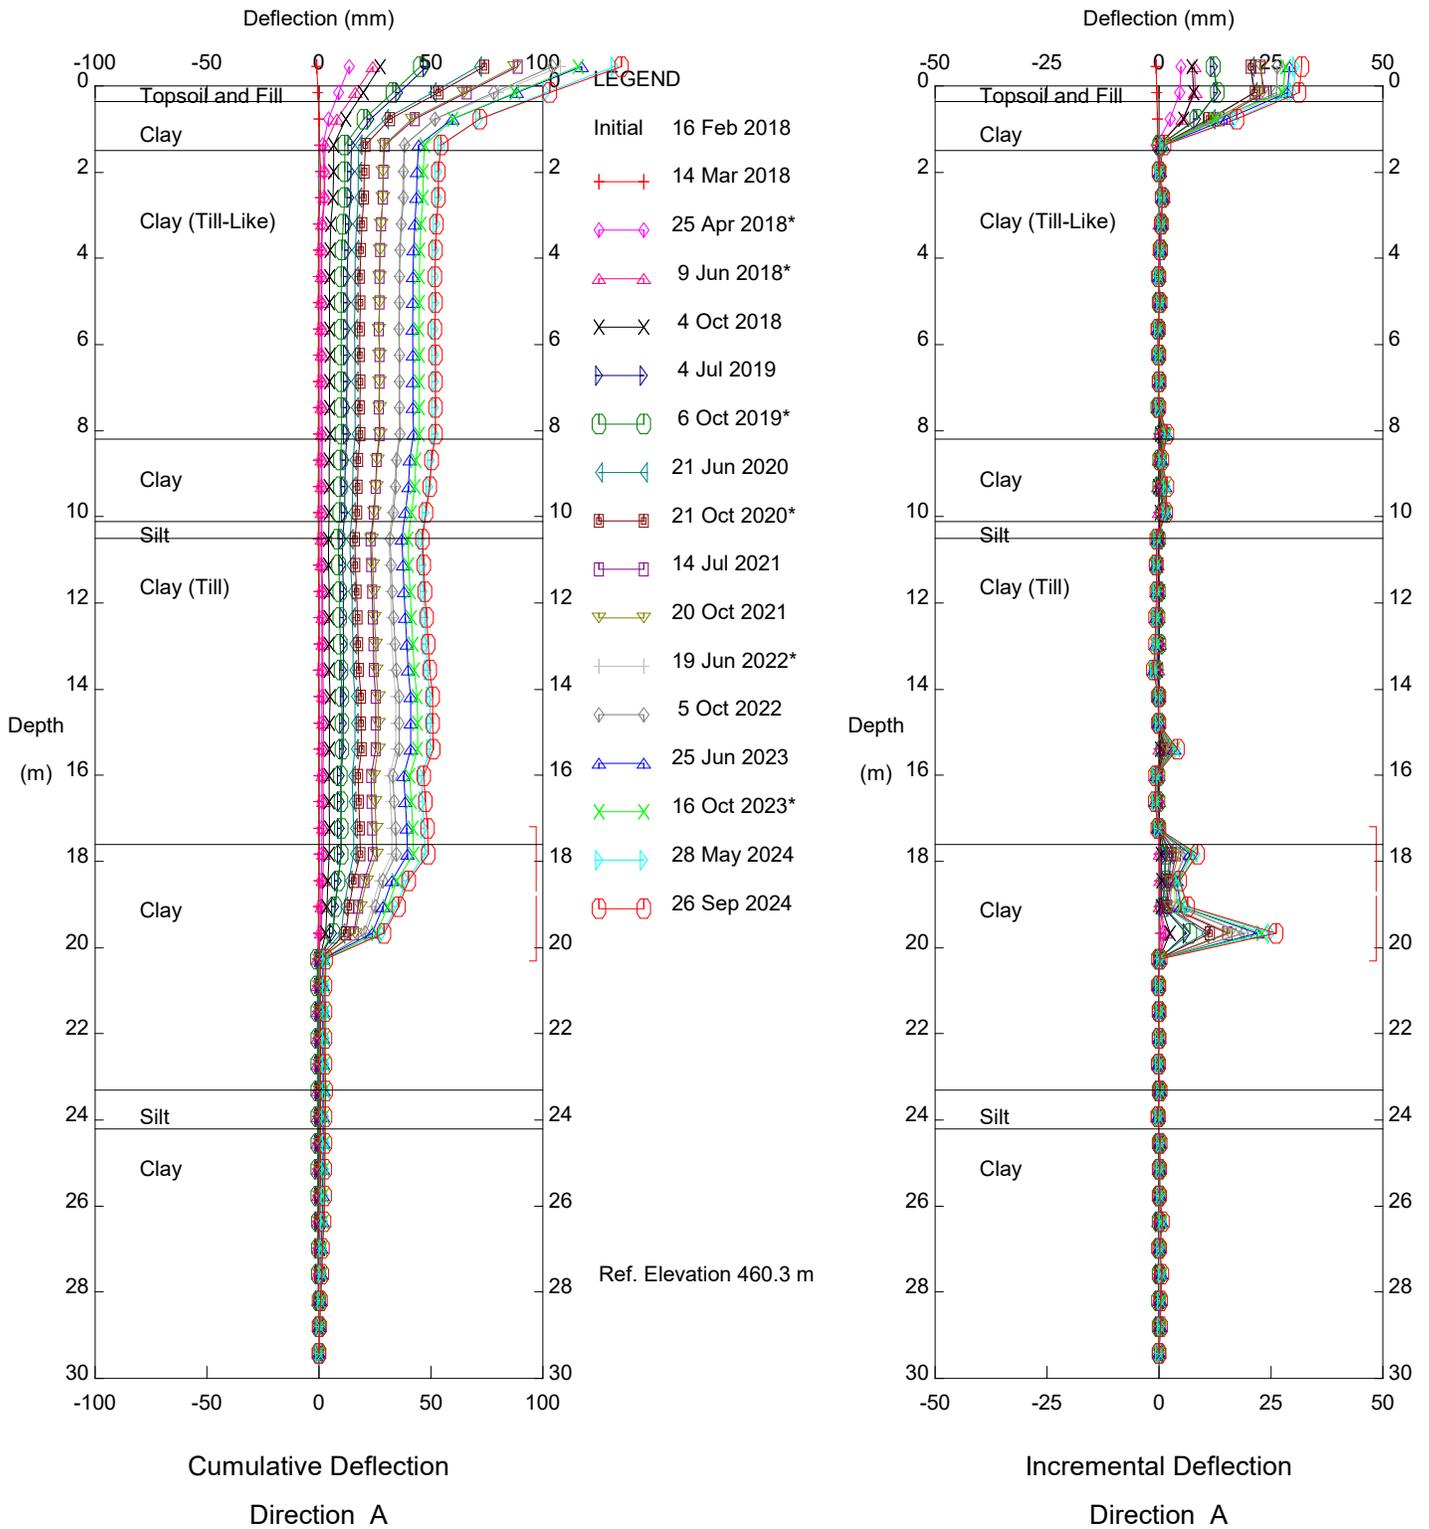
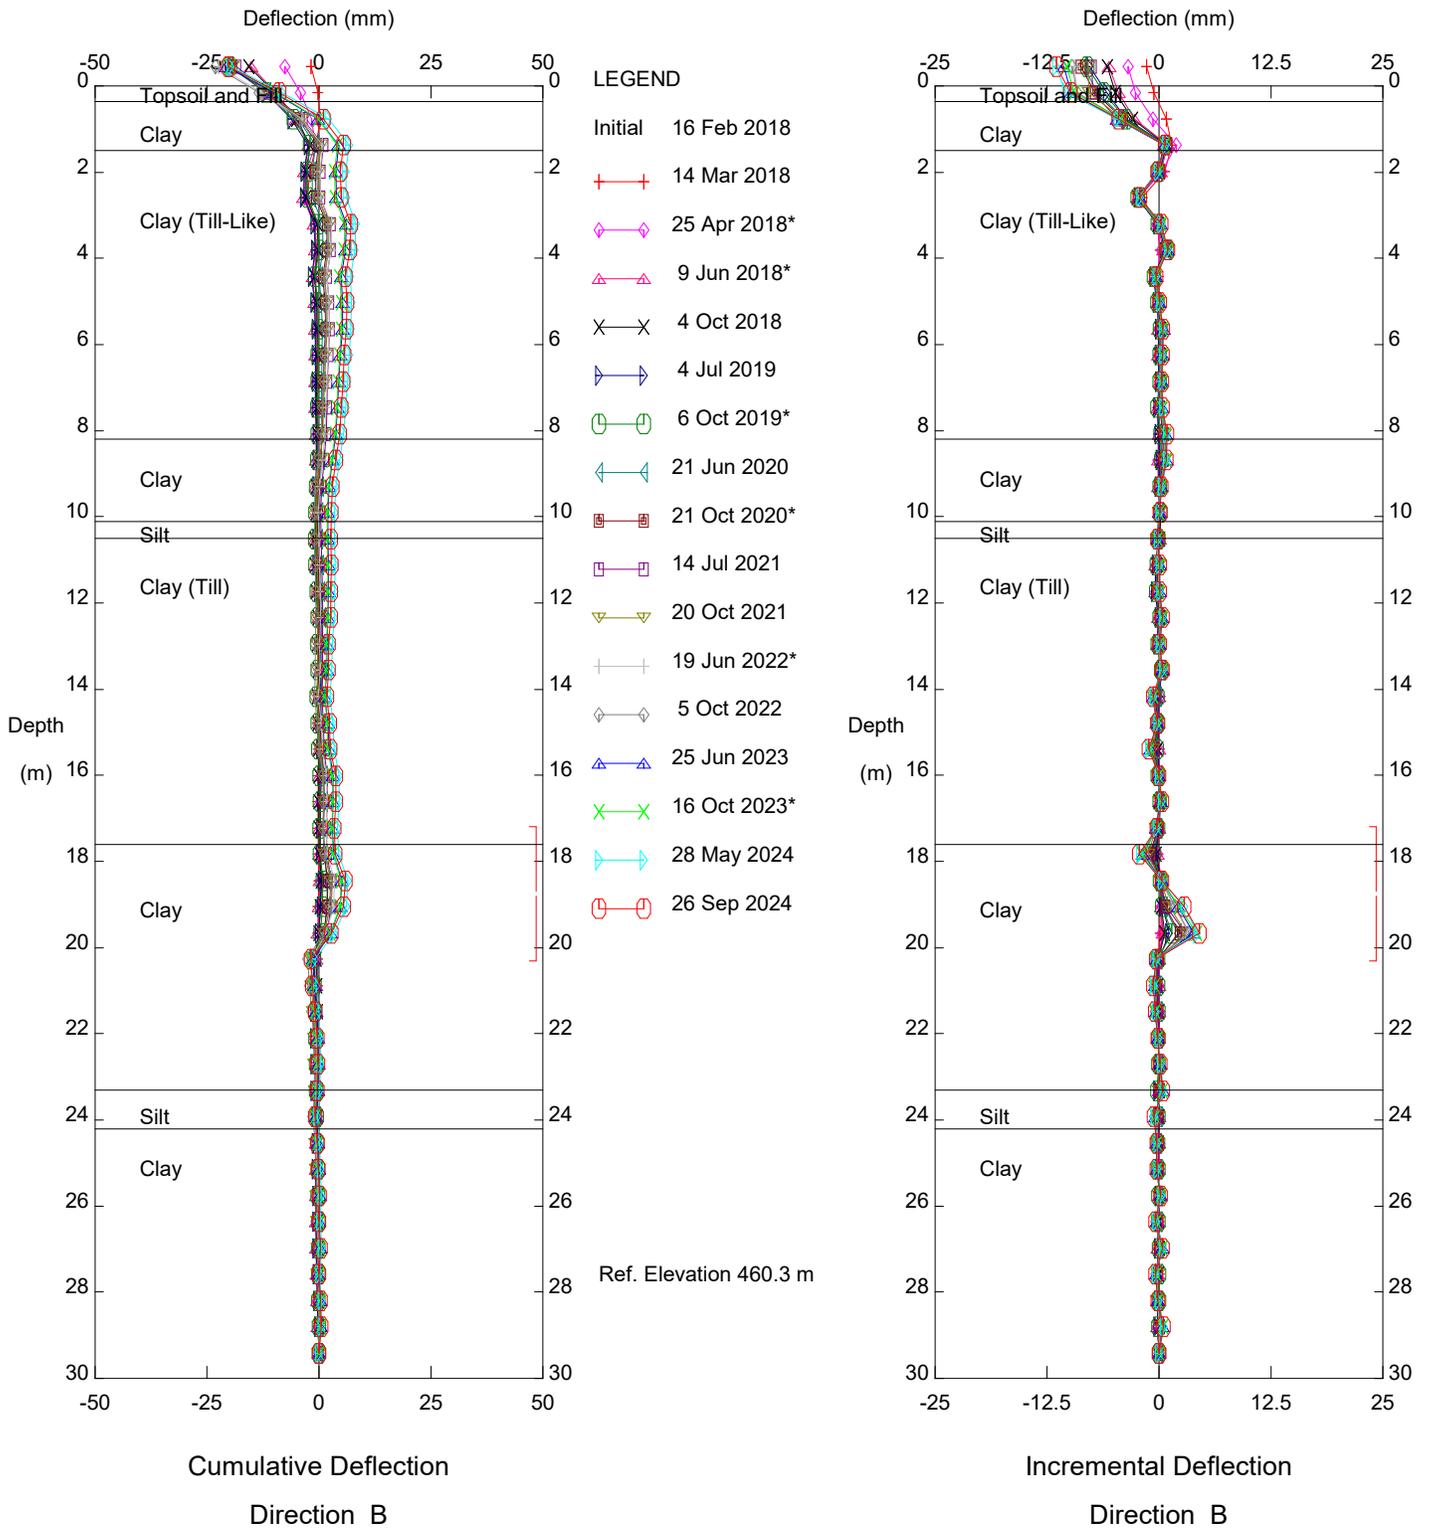
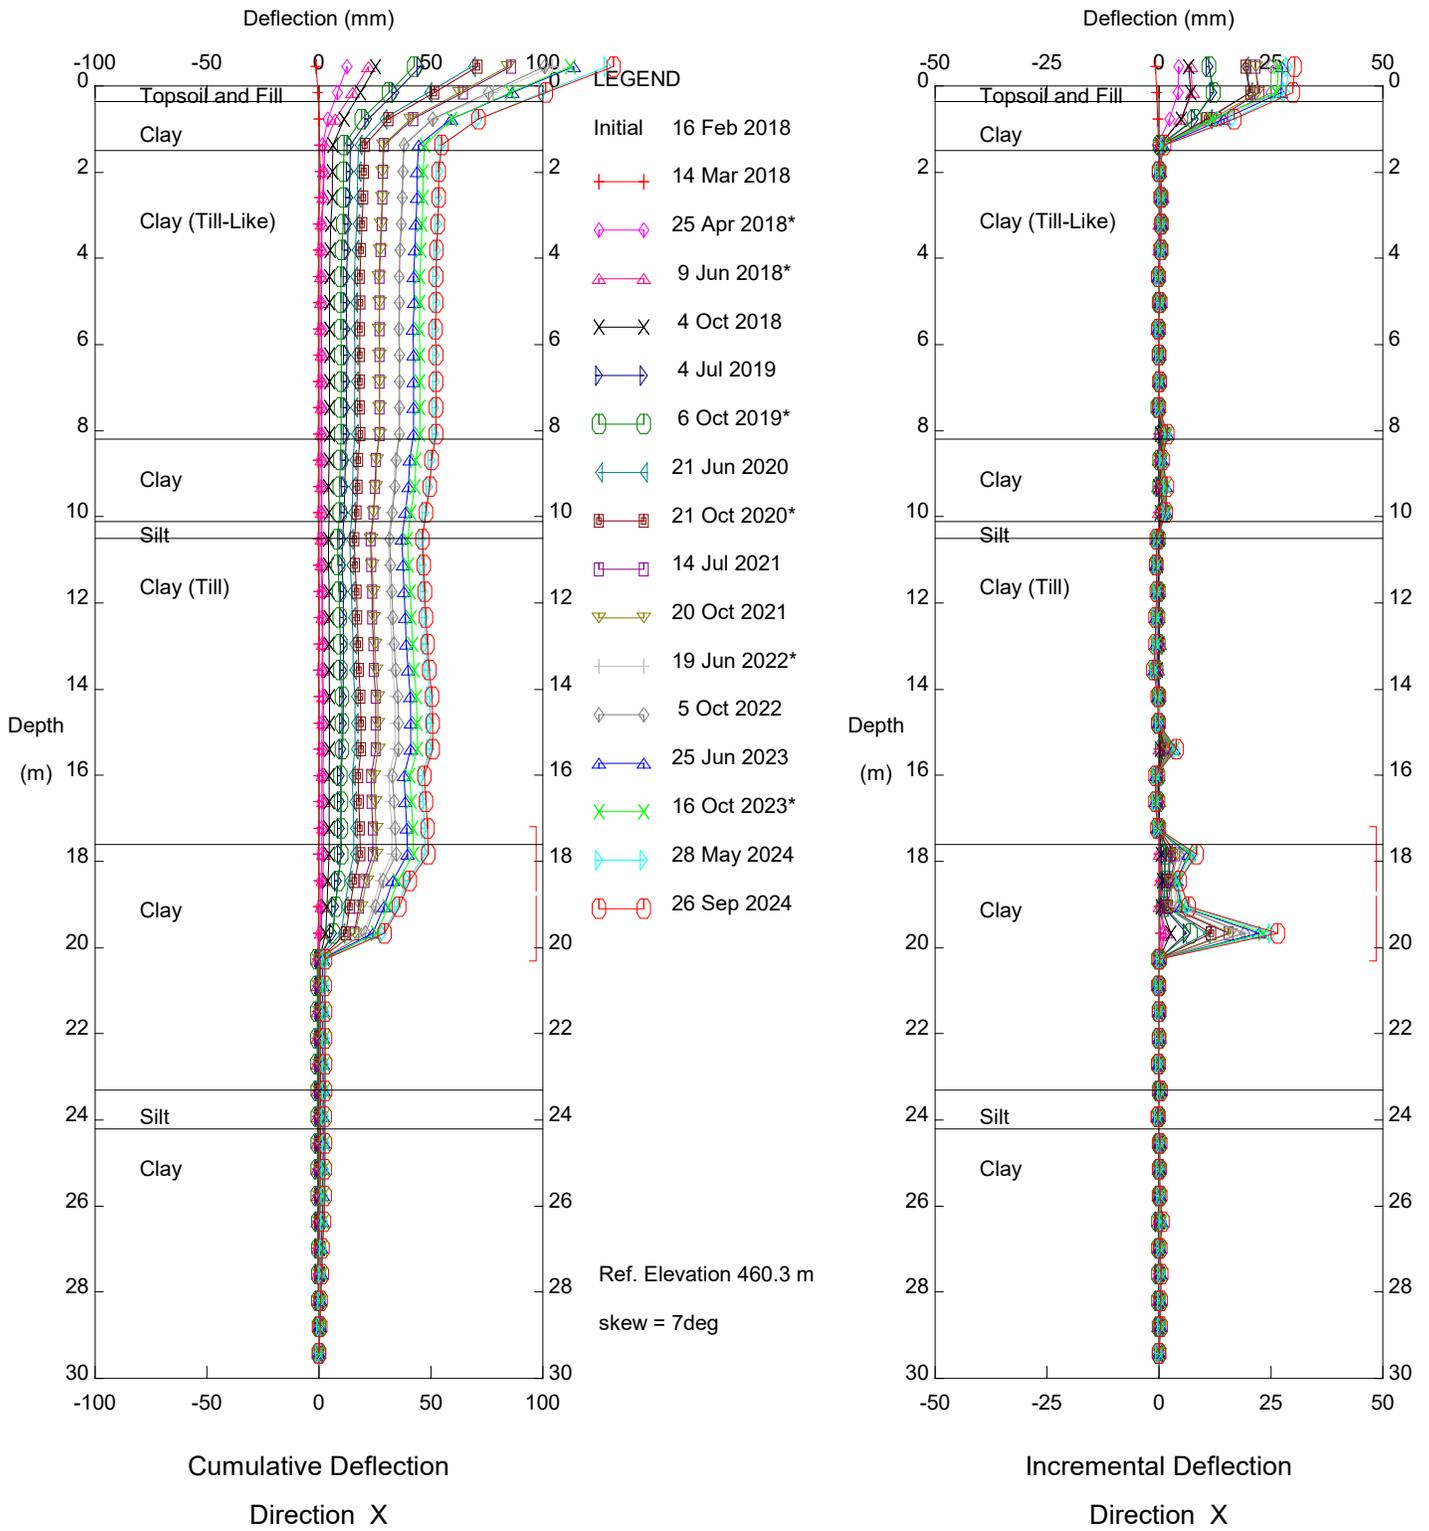
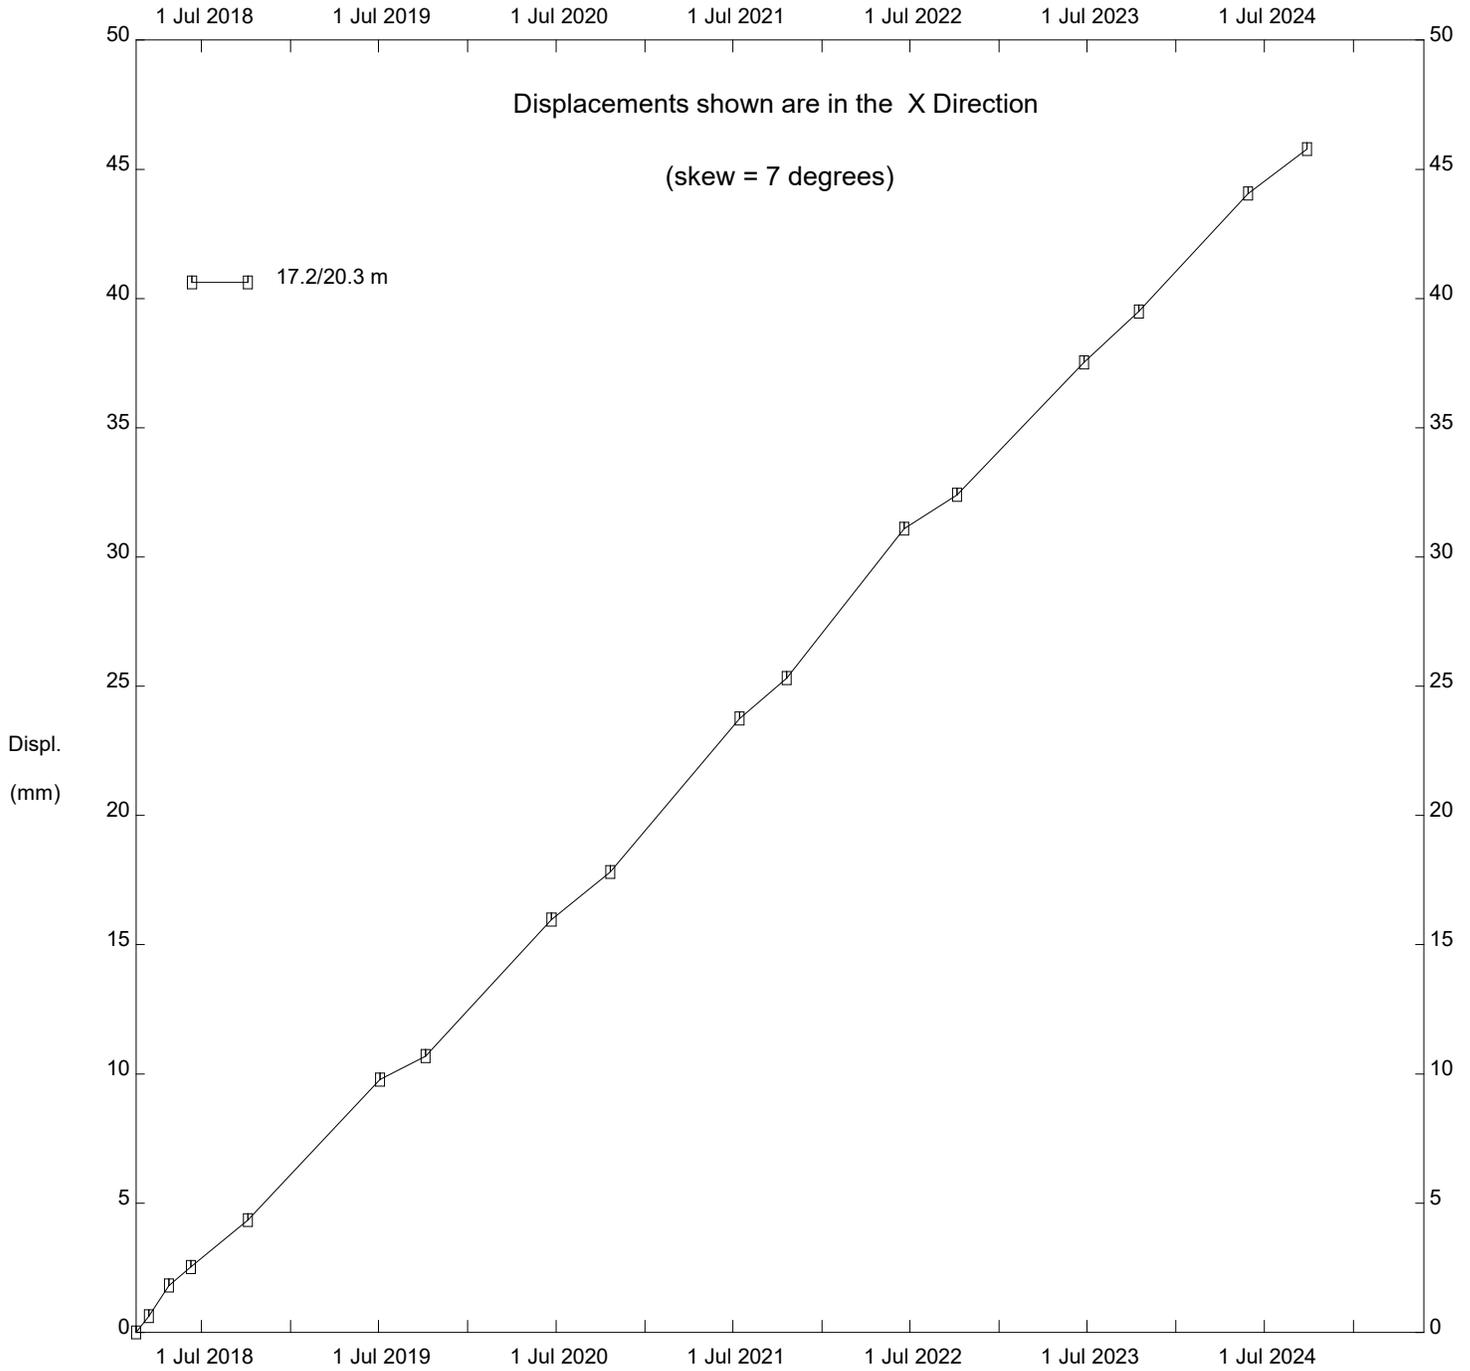
HWY 2:68 (PH037), Inclinometer SI18-5

SI18-5 is just east of the highway and shows a rate of movement of 5.2 mm/yr over a distinct shear zone between 17.2 m to 20.3 m depth within a clay layer. This movement rate has been steady since the SI was installed in 2018.
