**ALBERTA TRANSPORTATION AND
ECONOMIC CORRIDORS GRMP
PEACE REGION
(GRANDE PRAIRIE DISTRICT - NORTH)
INSTRUMENTATION MONITORING - FALL 2024**

Site Number	Location	Name	Hwy	km
PH037	Station 1+250 to 2+000	Dunvegan South	2:68	Km 15.7
Legal Description: 4-7-80-4 W6		UTM Co-ordinates		
		11U E 398593.62	N	6197597.09

Current Monitoring:	28-May-2024	Previous Monitoring	28-May-2024
Instruments Read By:	Mr. Neil McDonald and Mr. Nixson Mationg of Thurber

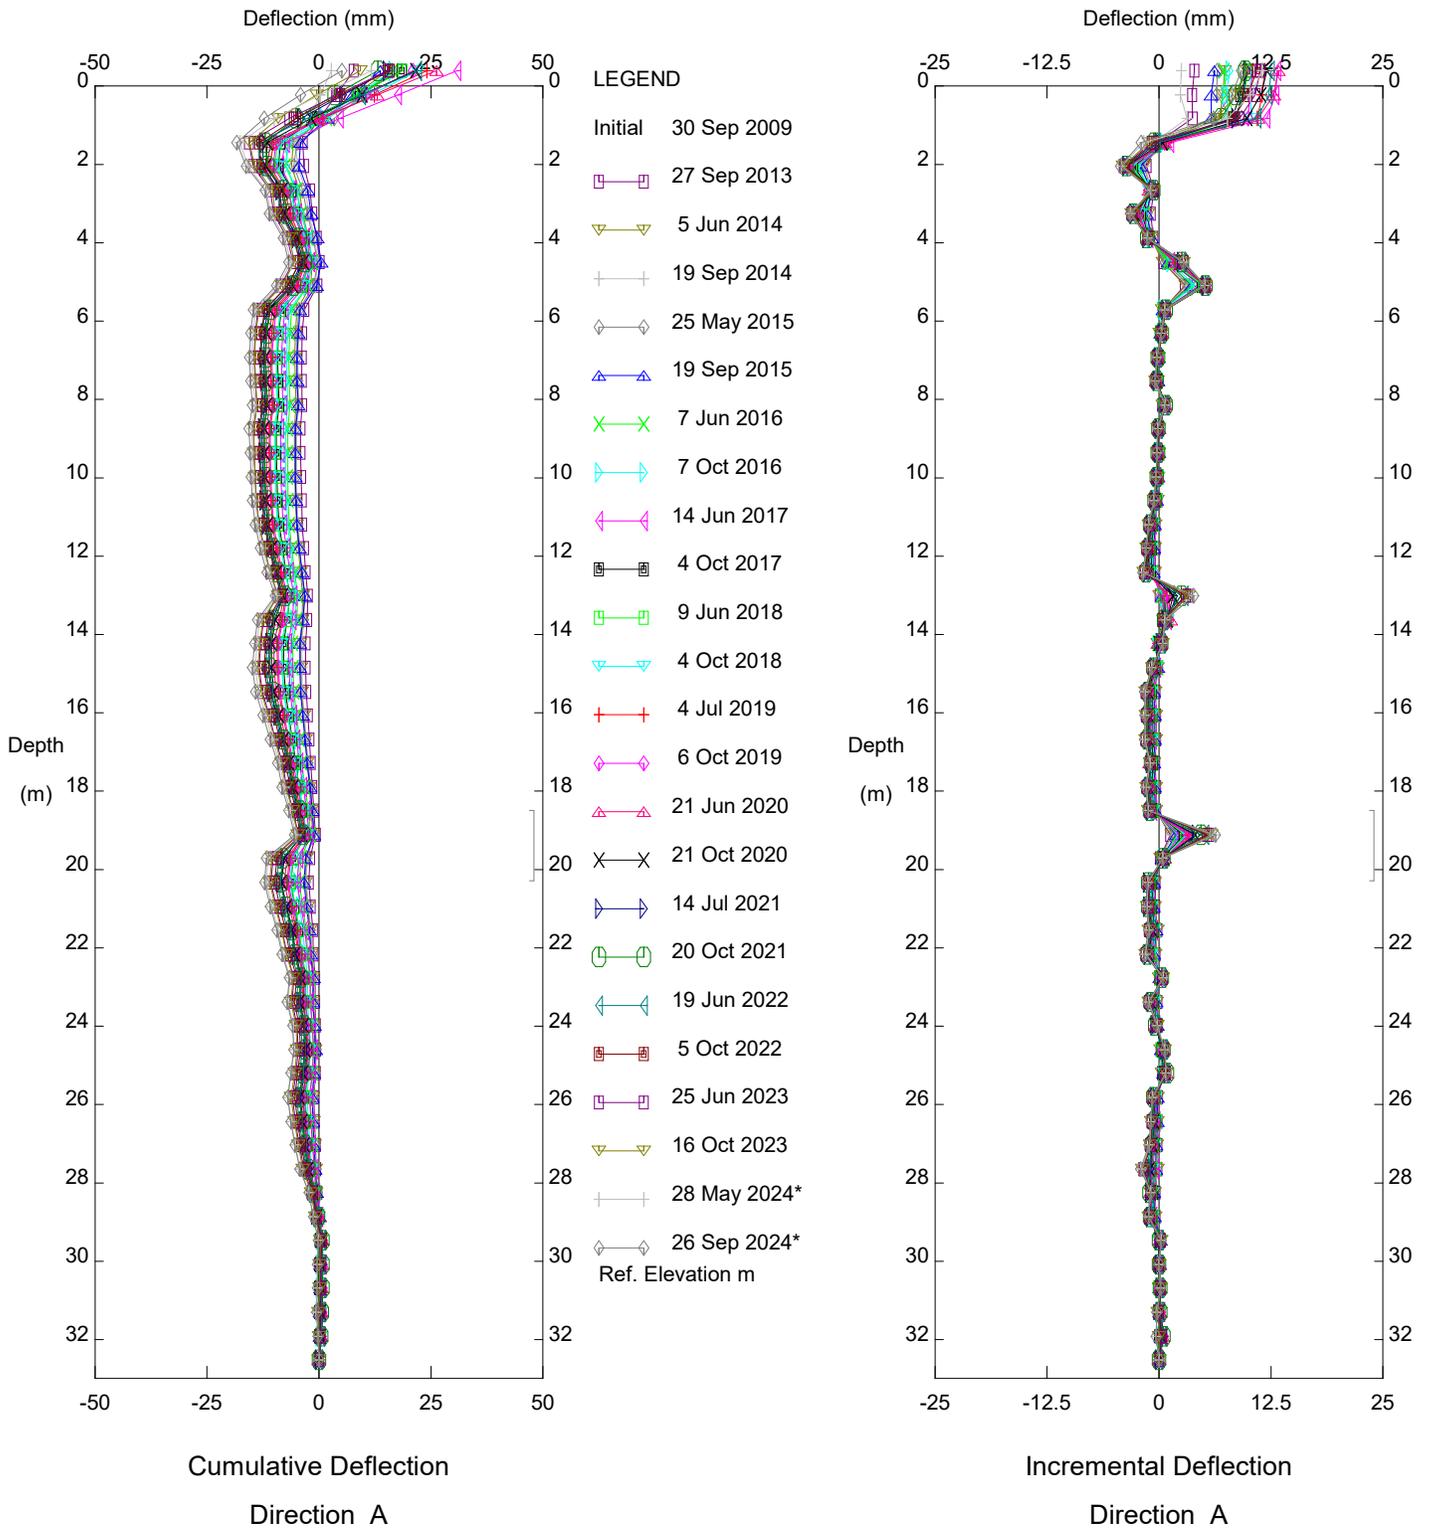
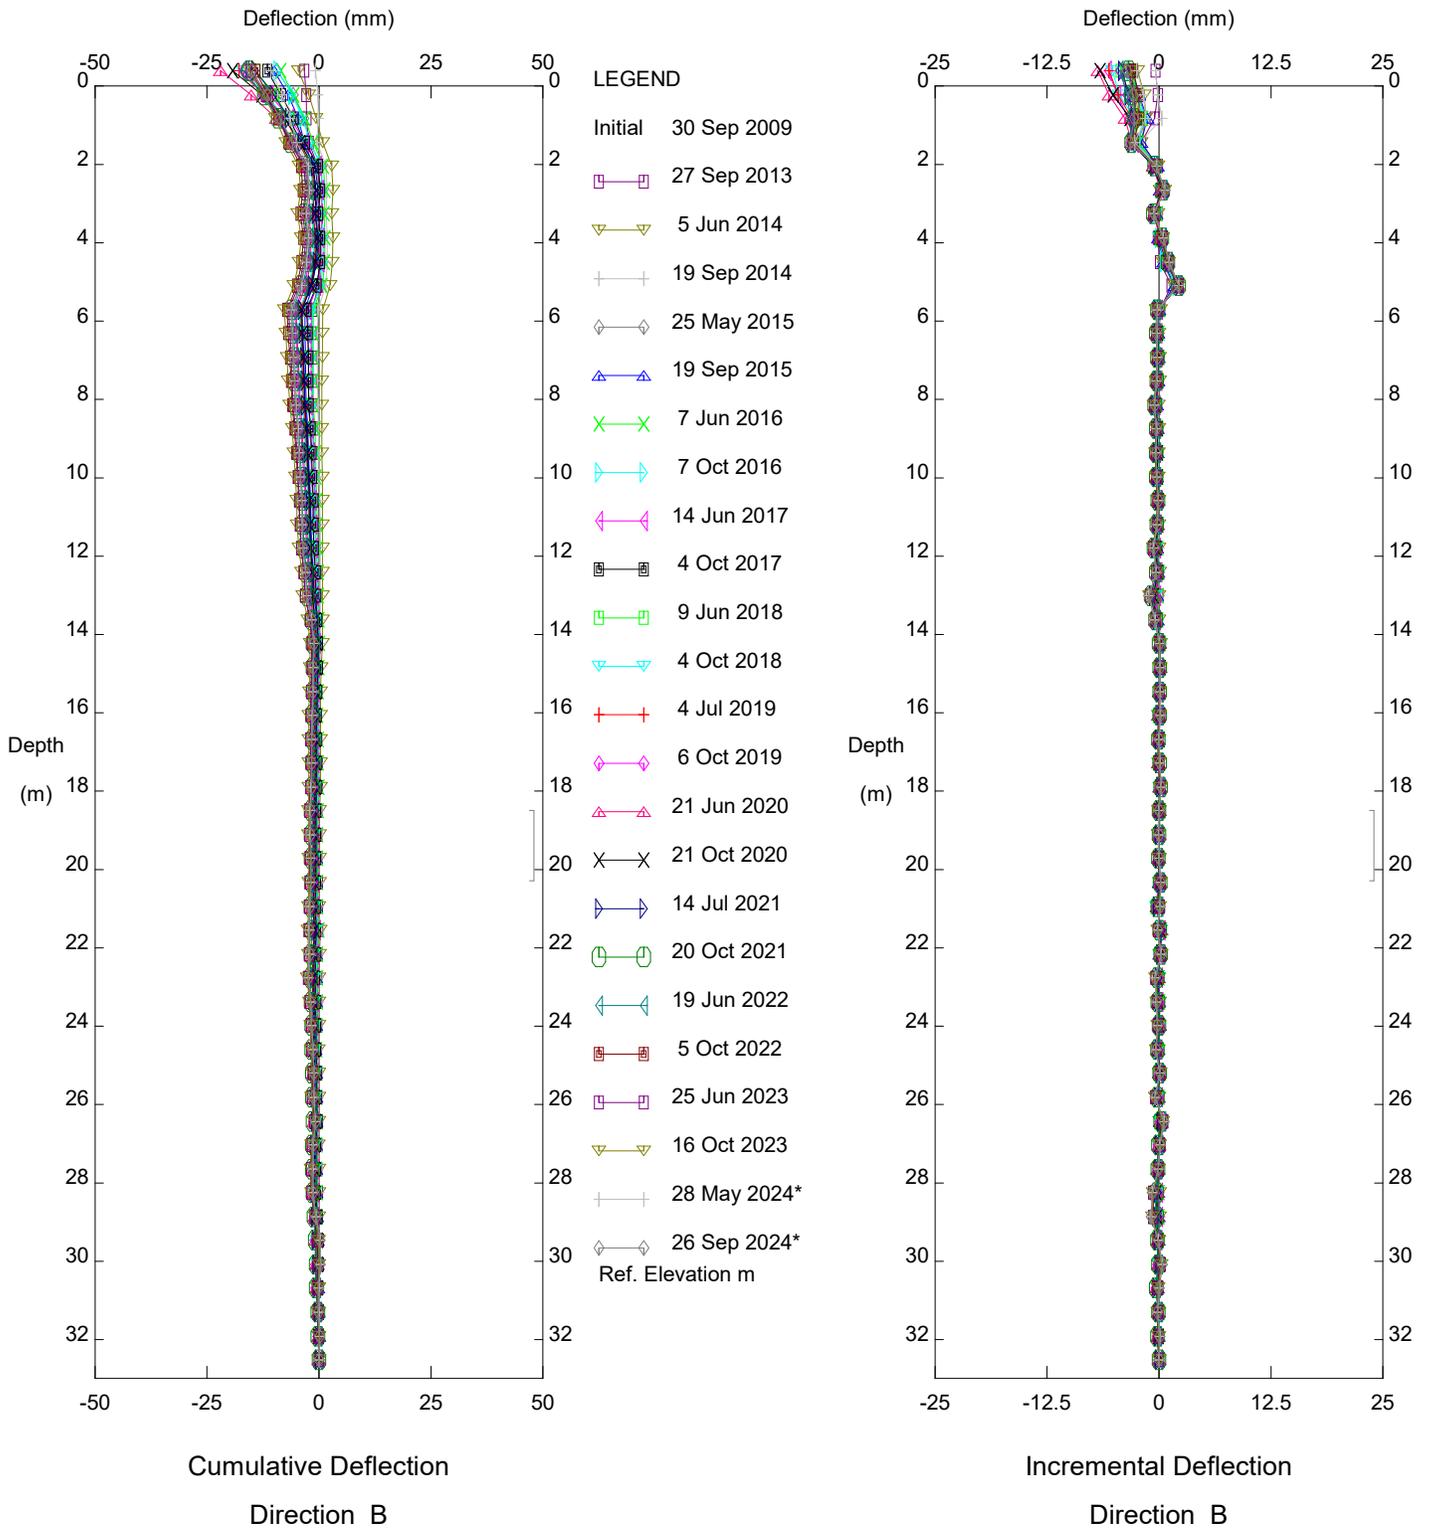
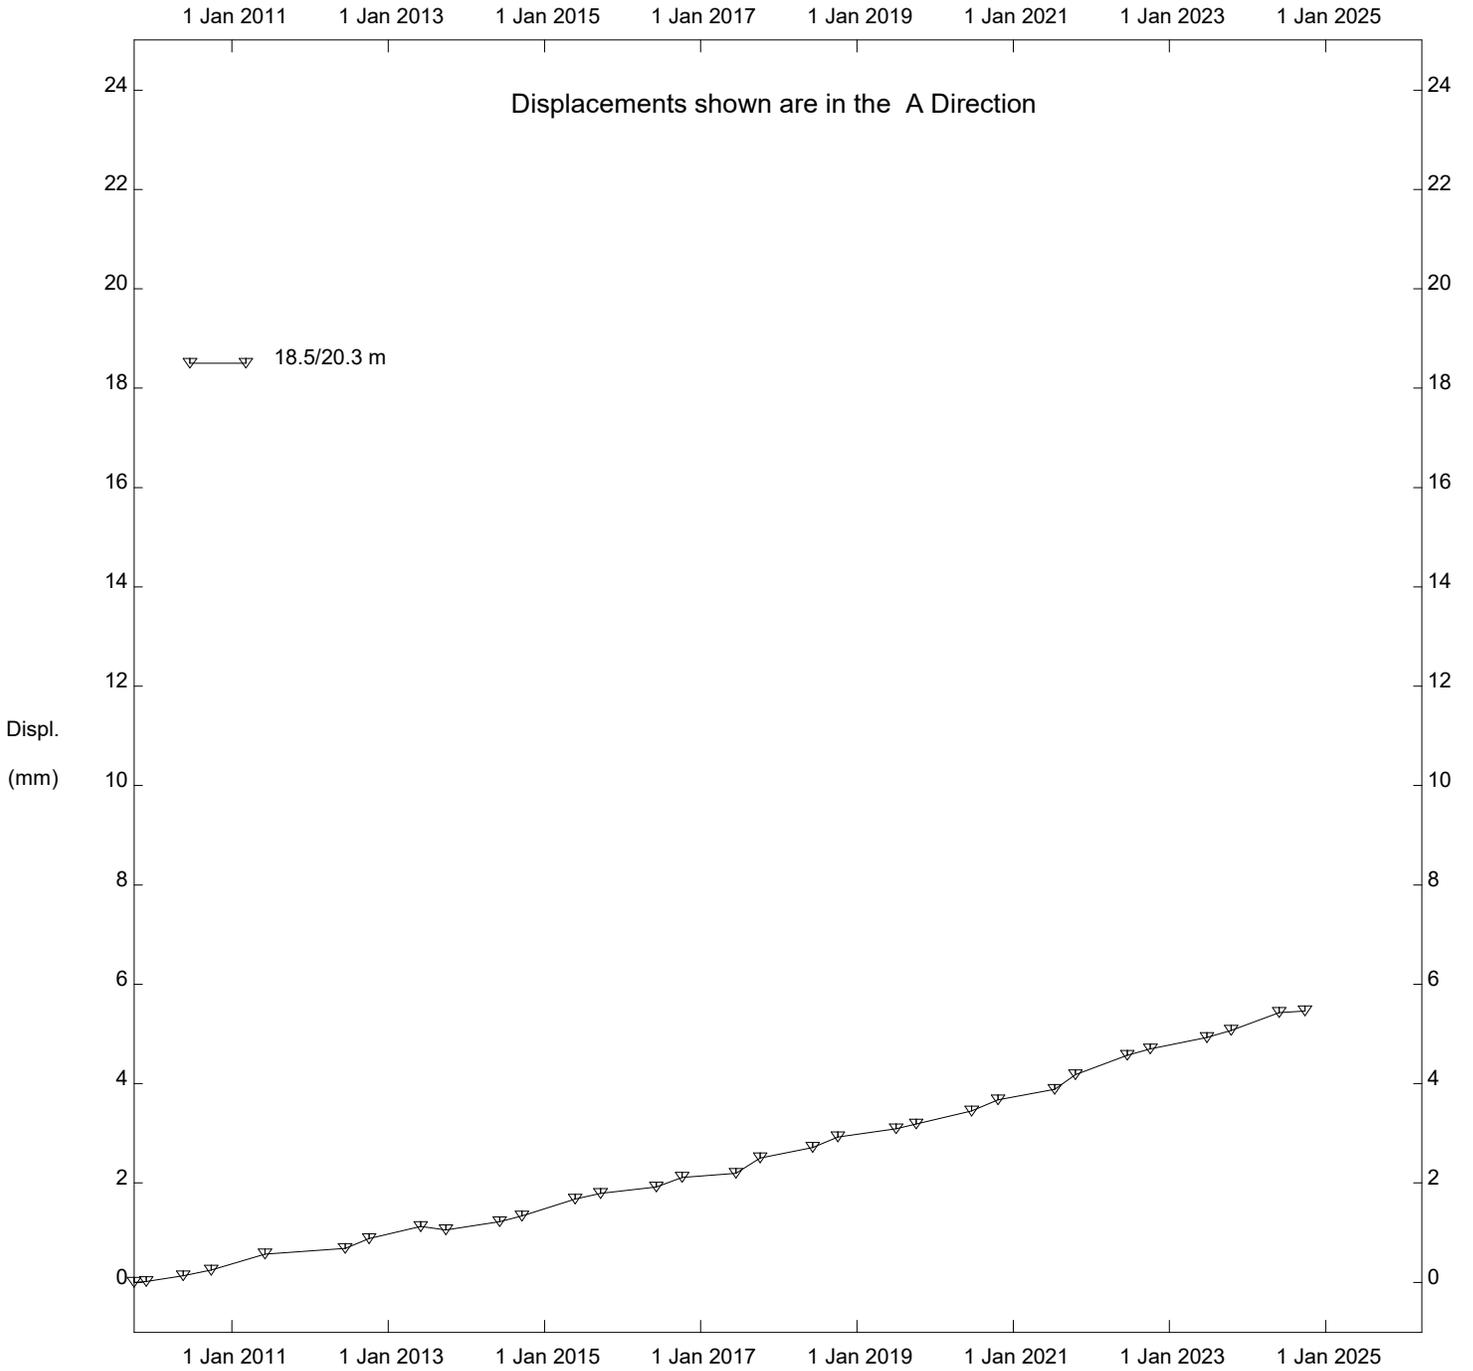
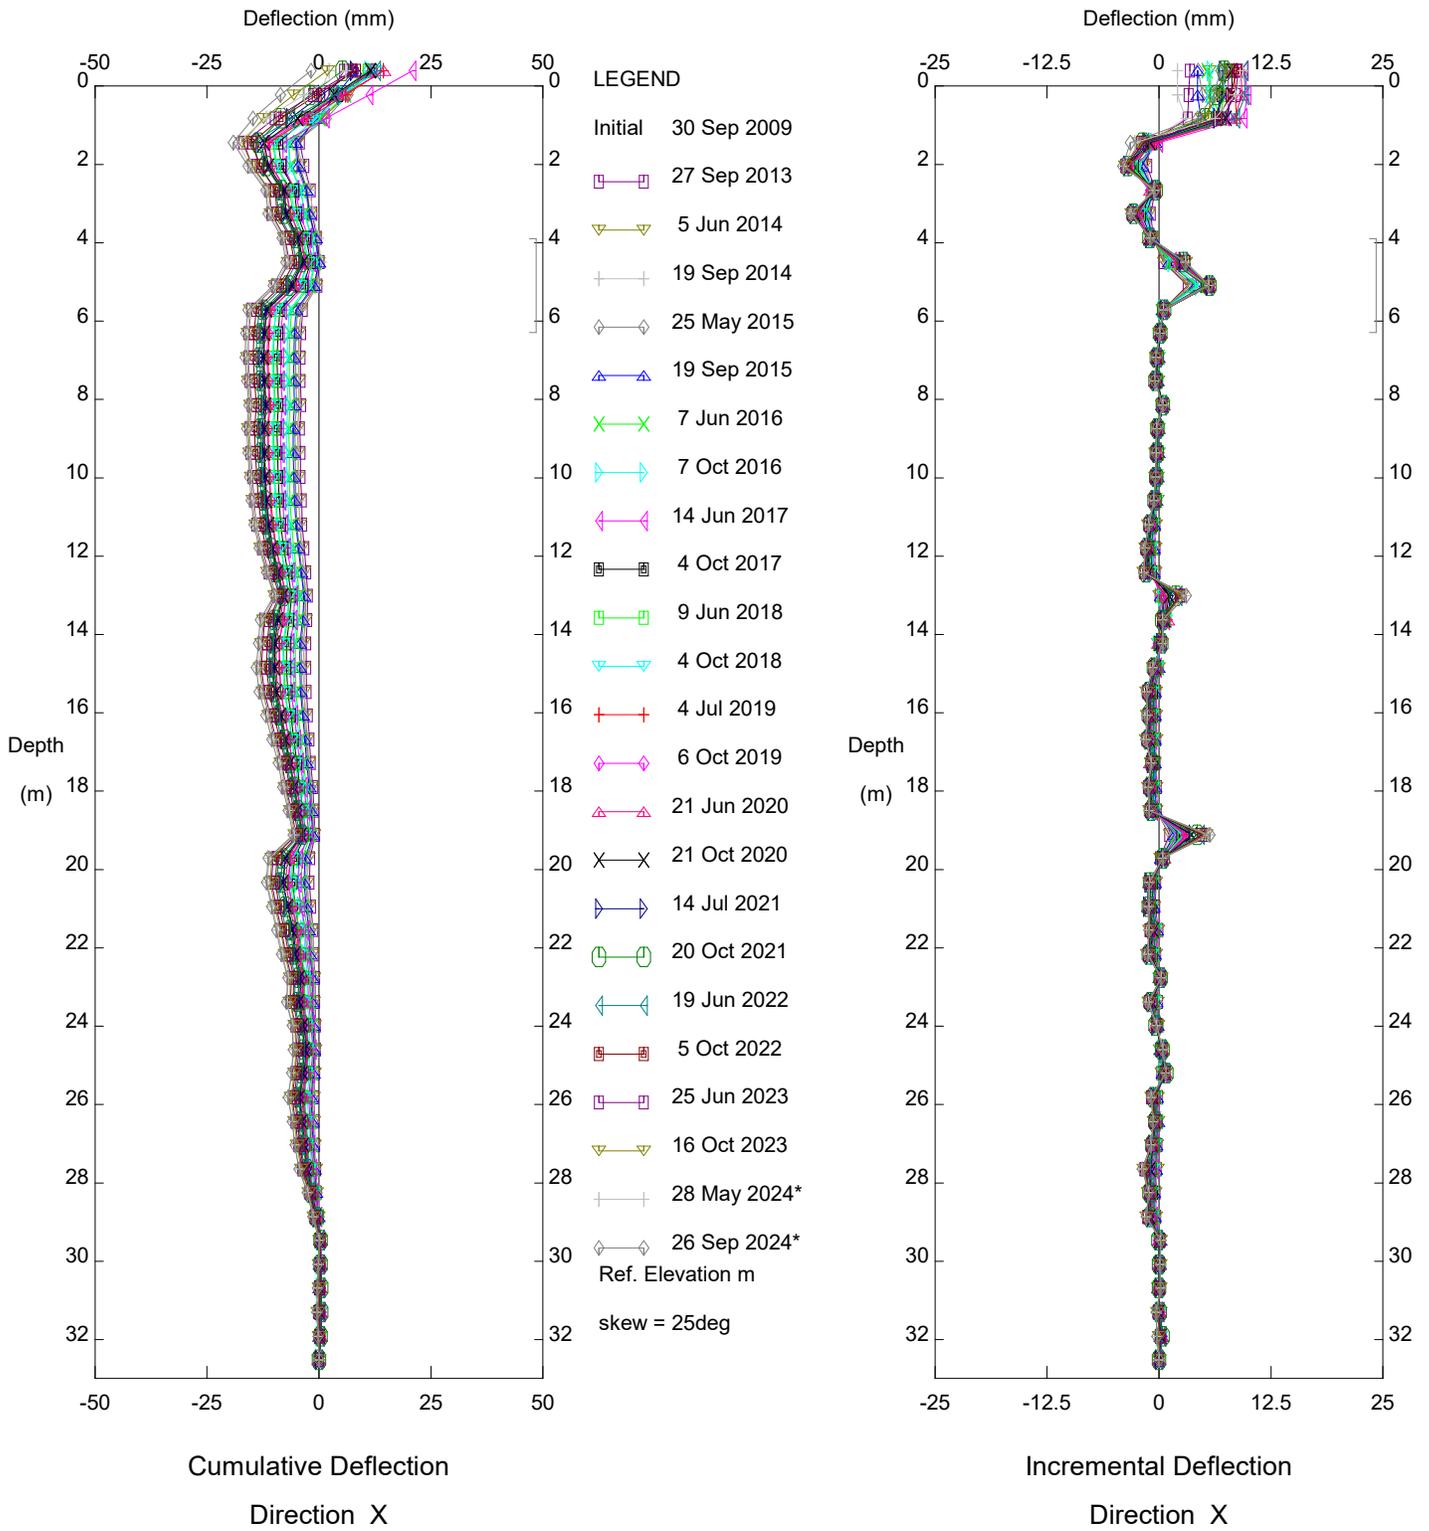
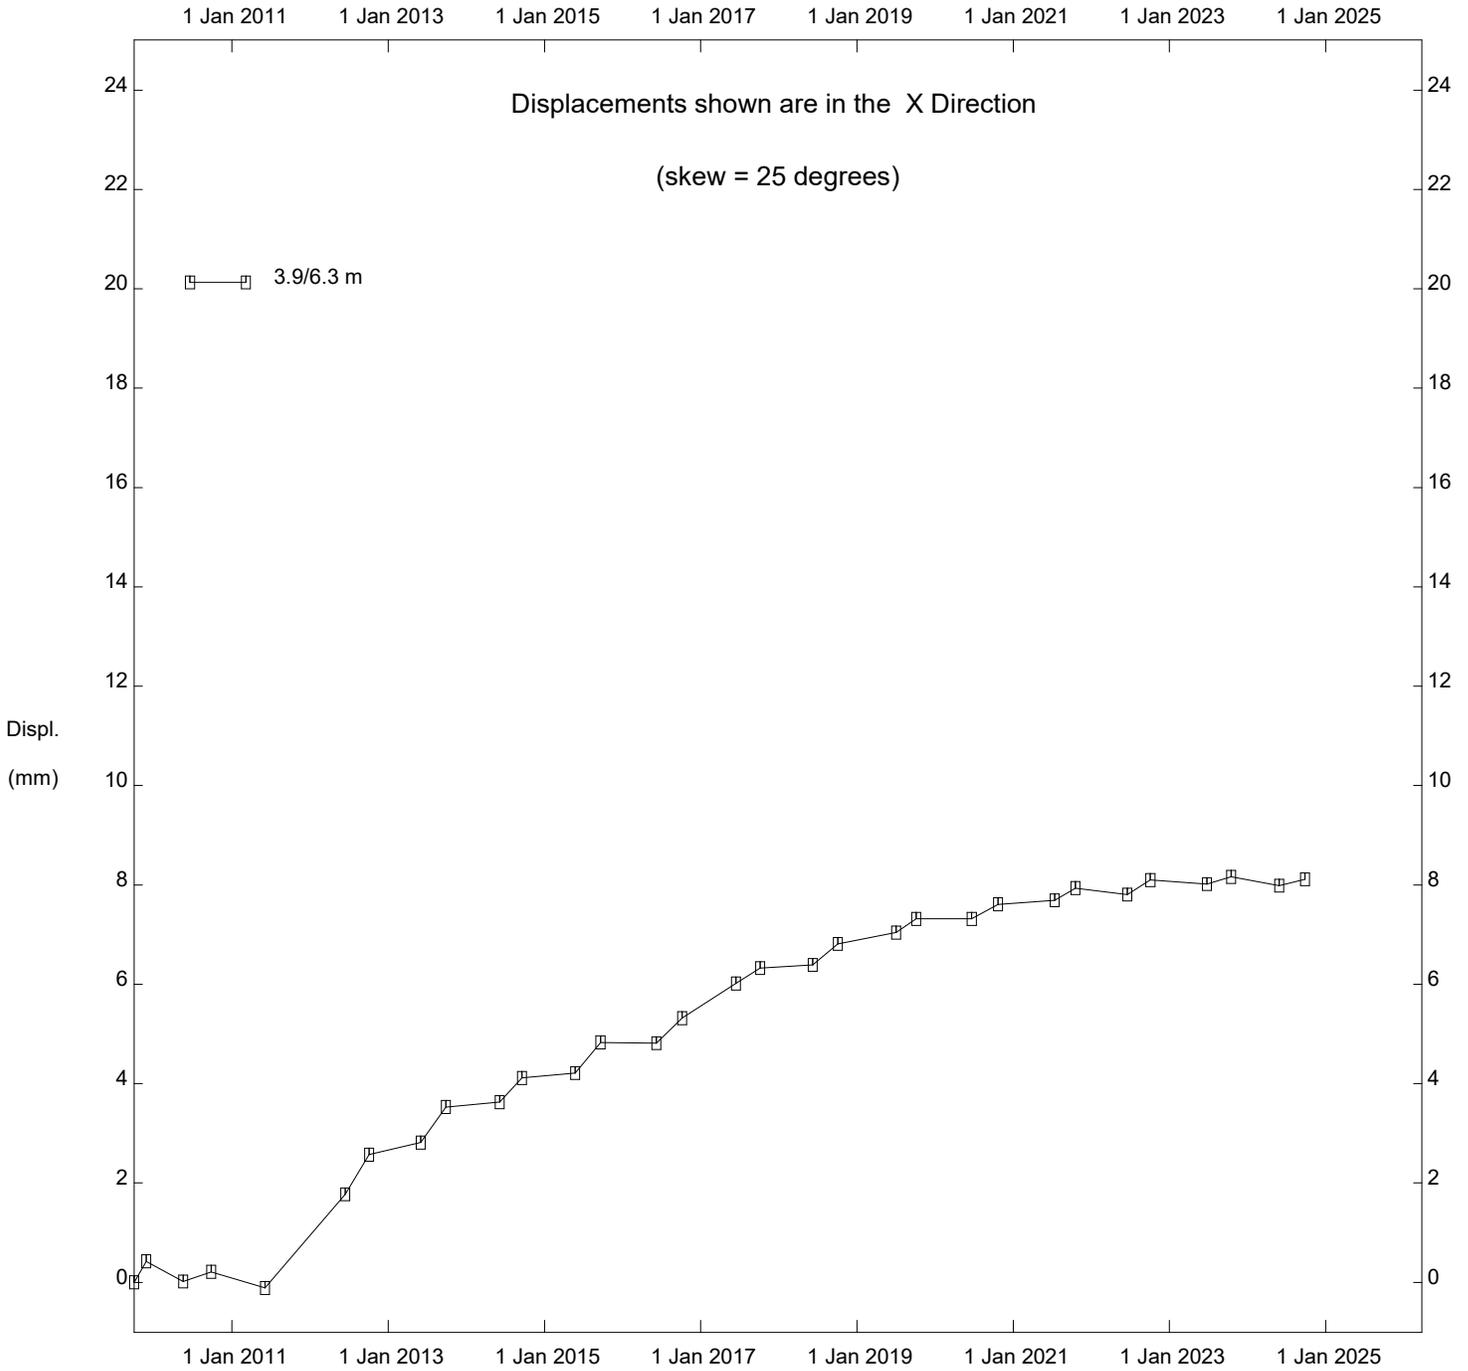
HWY 2:68 (PH037), Inclinometer SI09-7

SI09-7 is about 90 m west of the highway and has several zones of movement. A rate of movement of 0.4 mm/yr was measured over the past two years over the shear zone between 3.9 m to 6.3 m depth and the total movement since 2009 is about 8.1 mm. A rate of movement of 0.7 mm/yr was measured over 18.5 m to 20.3 m depth. This rate of movement has been steady since 2009 and total recorded movements are about 5.5 mm.

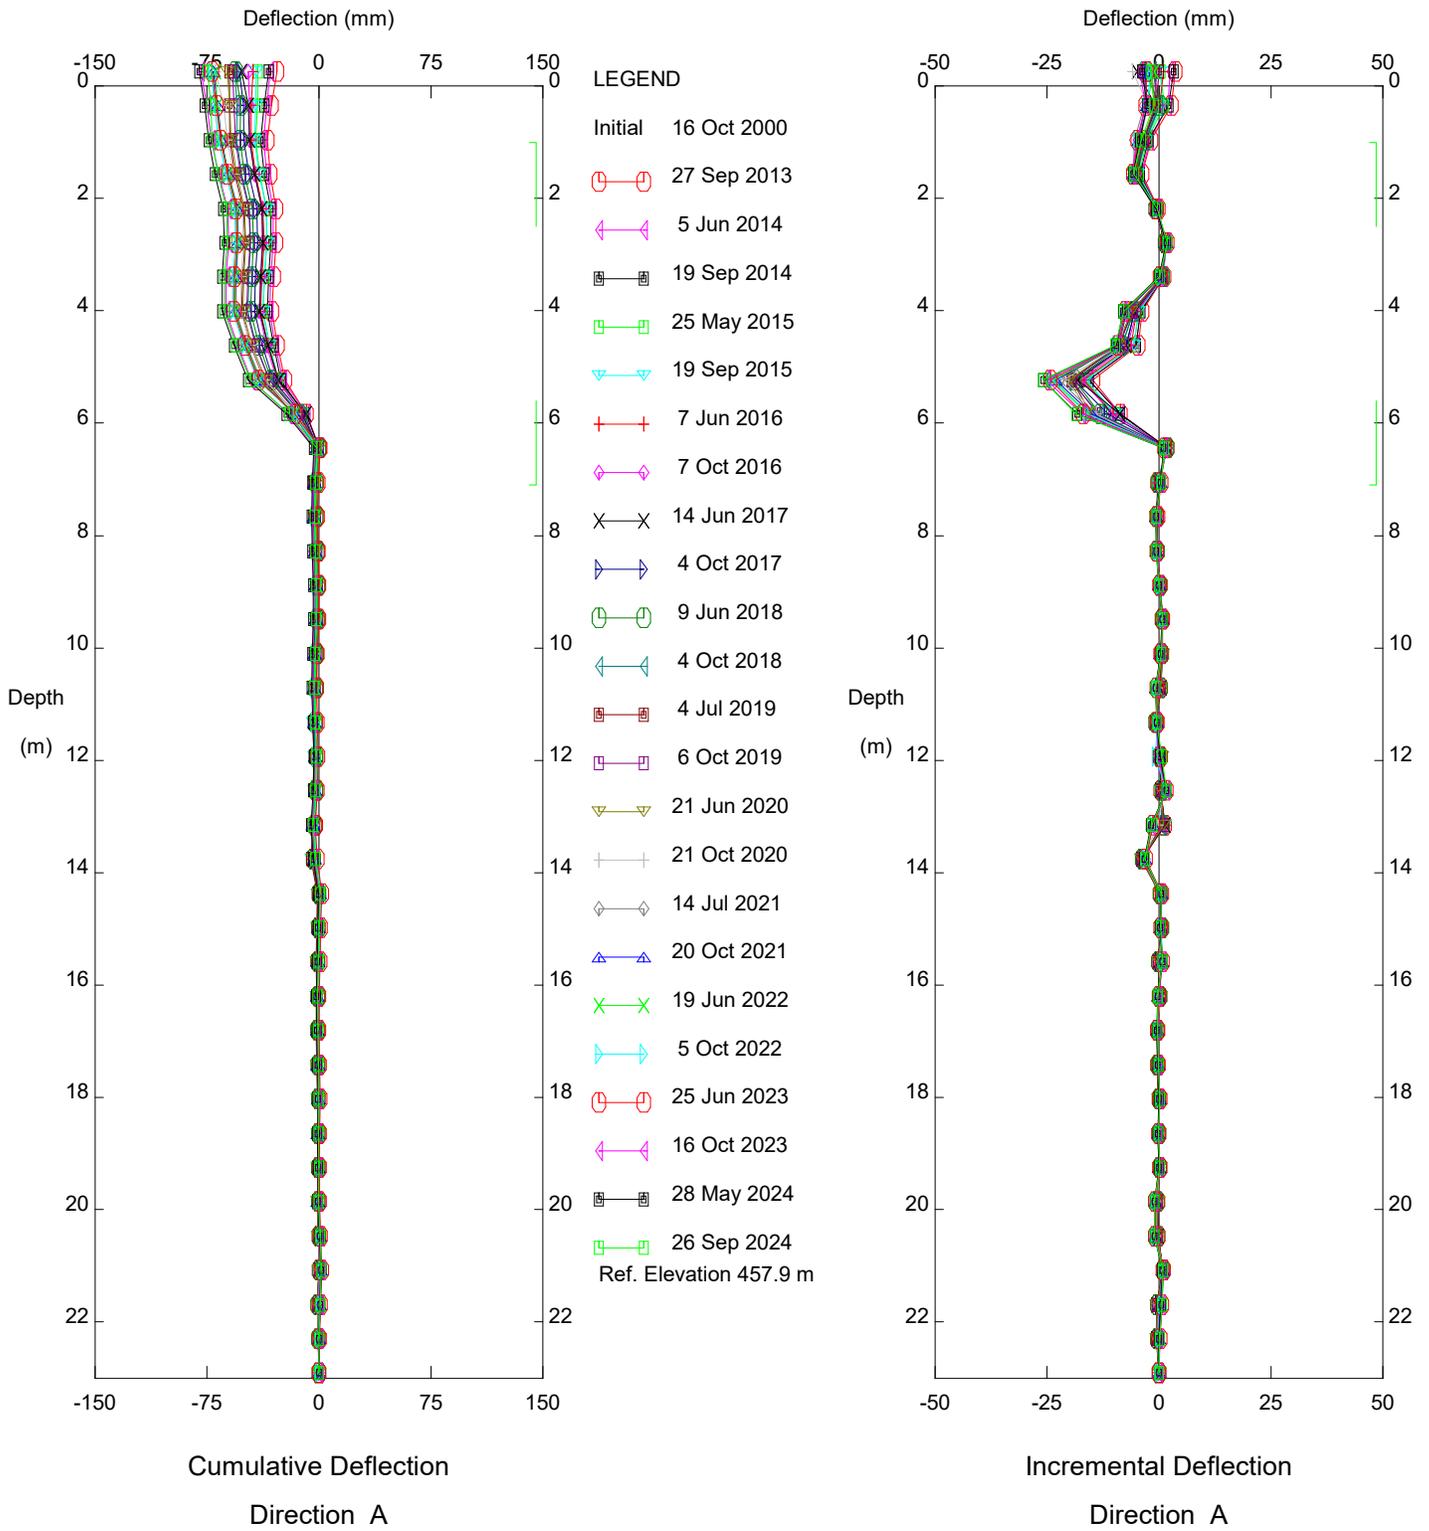
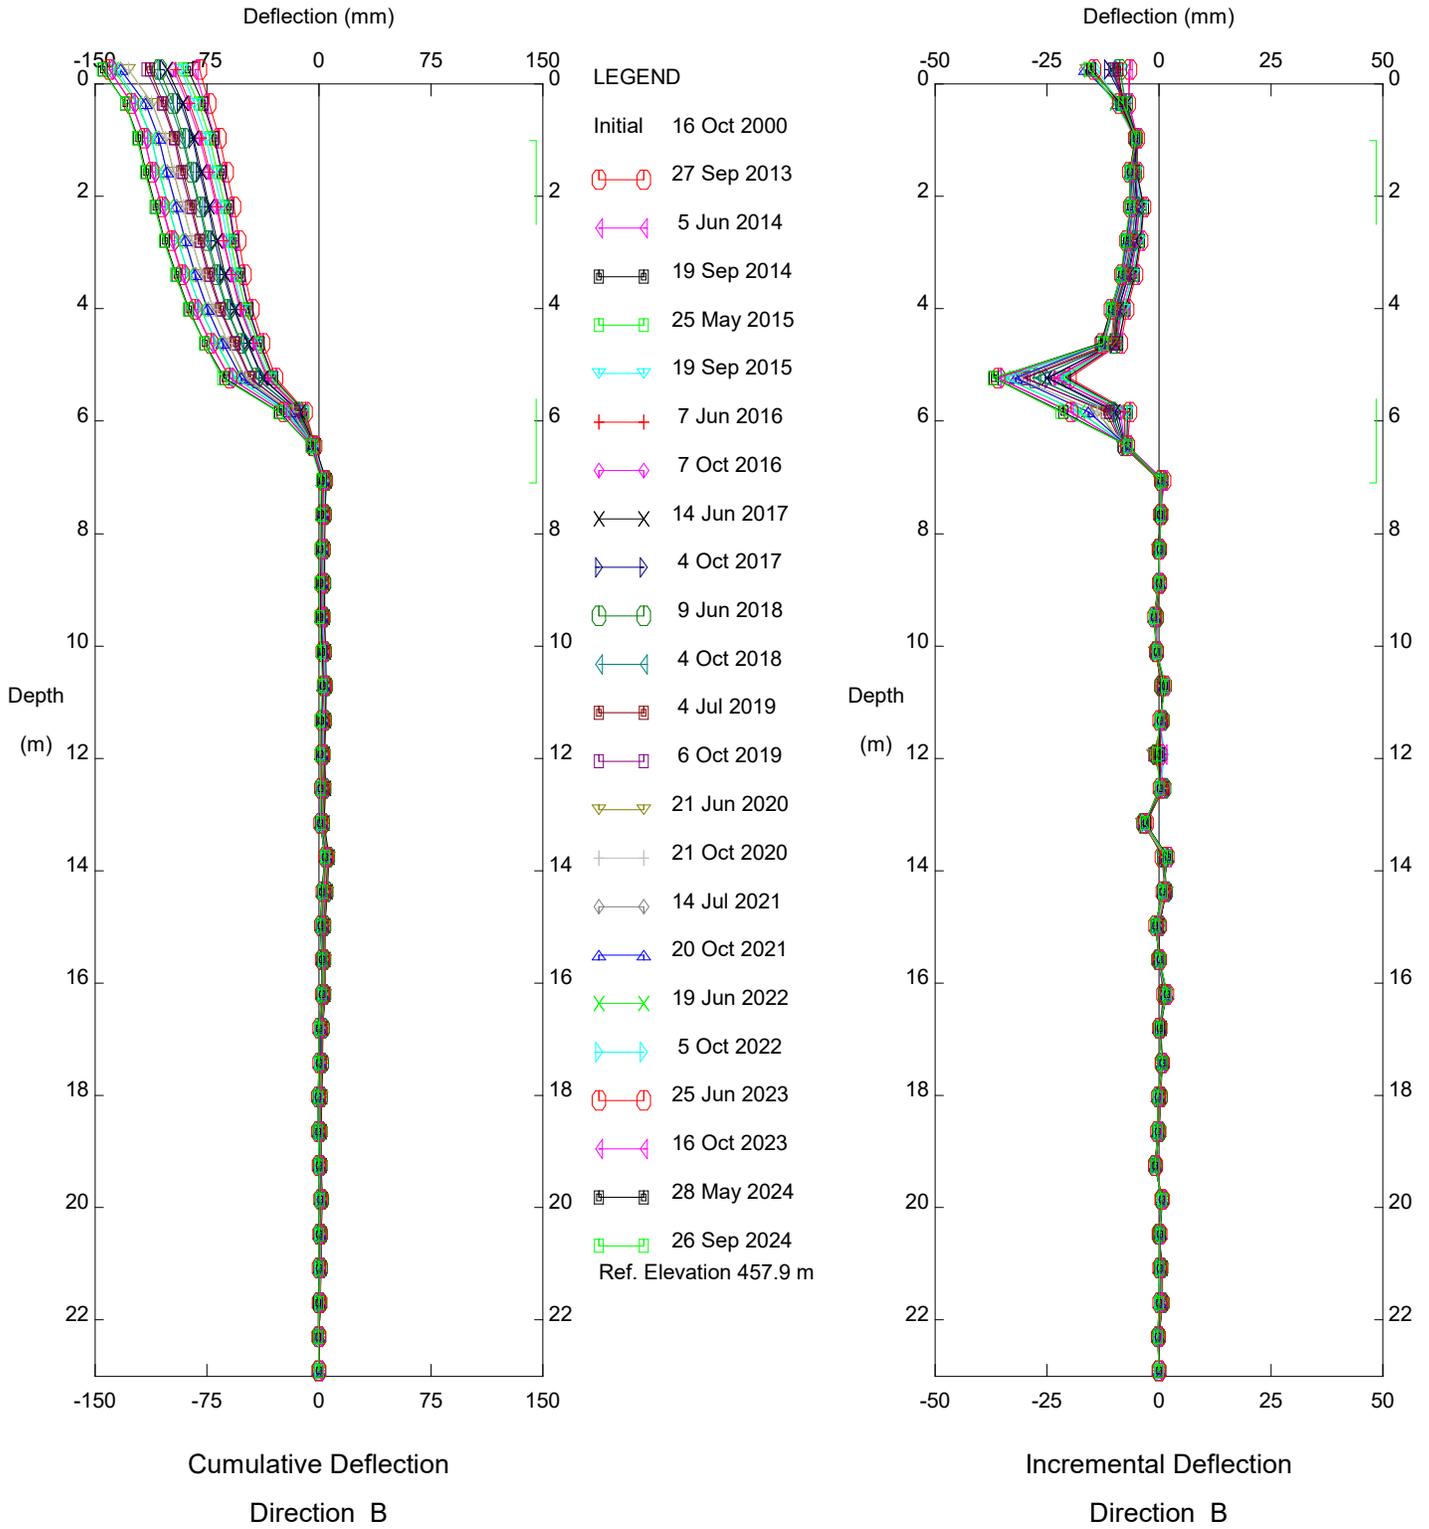
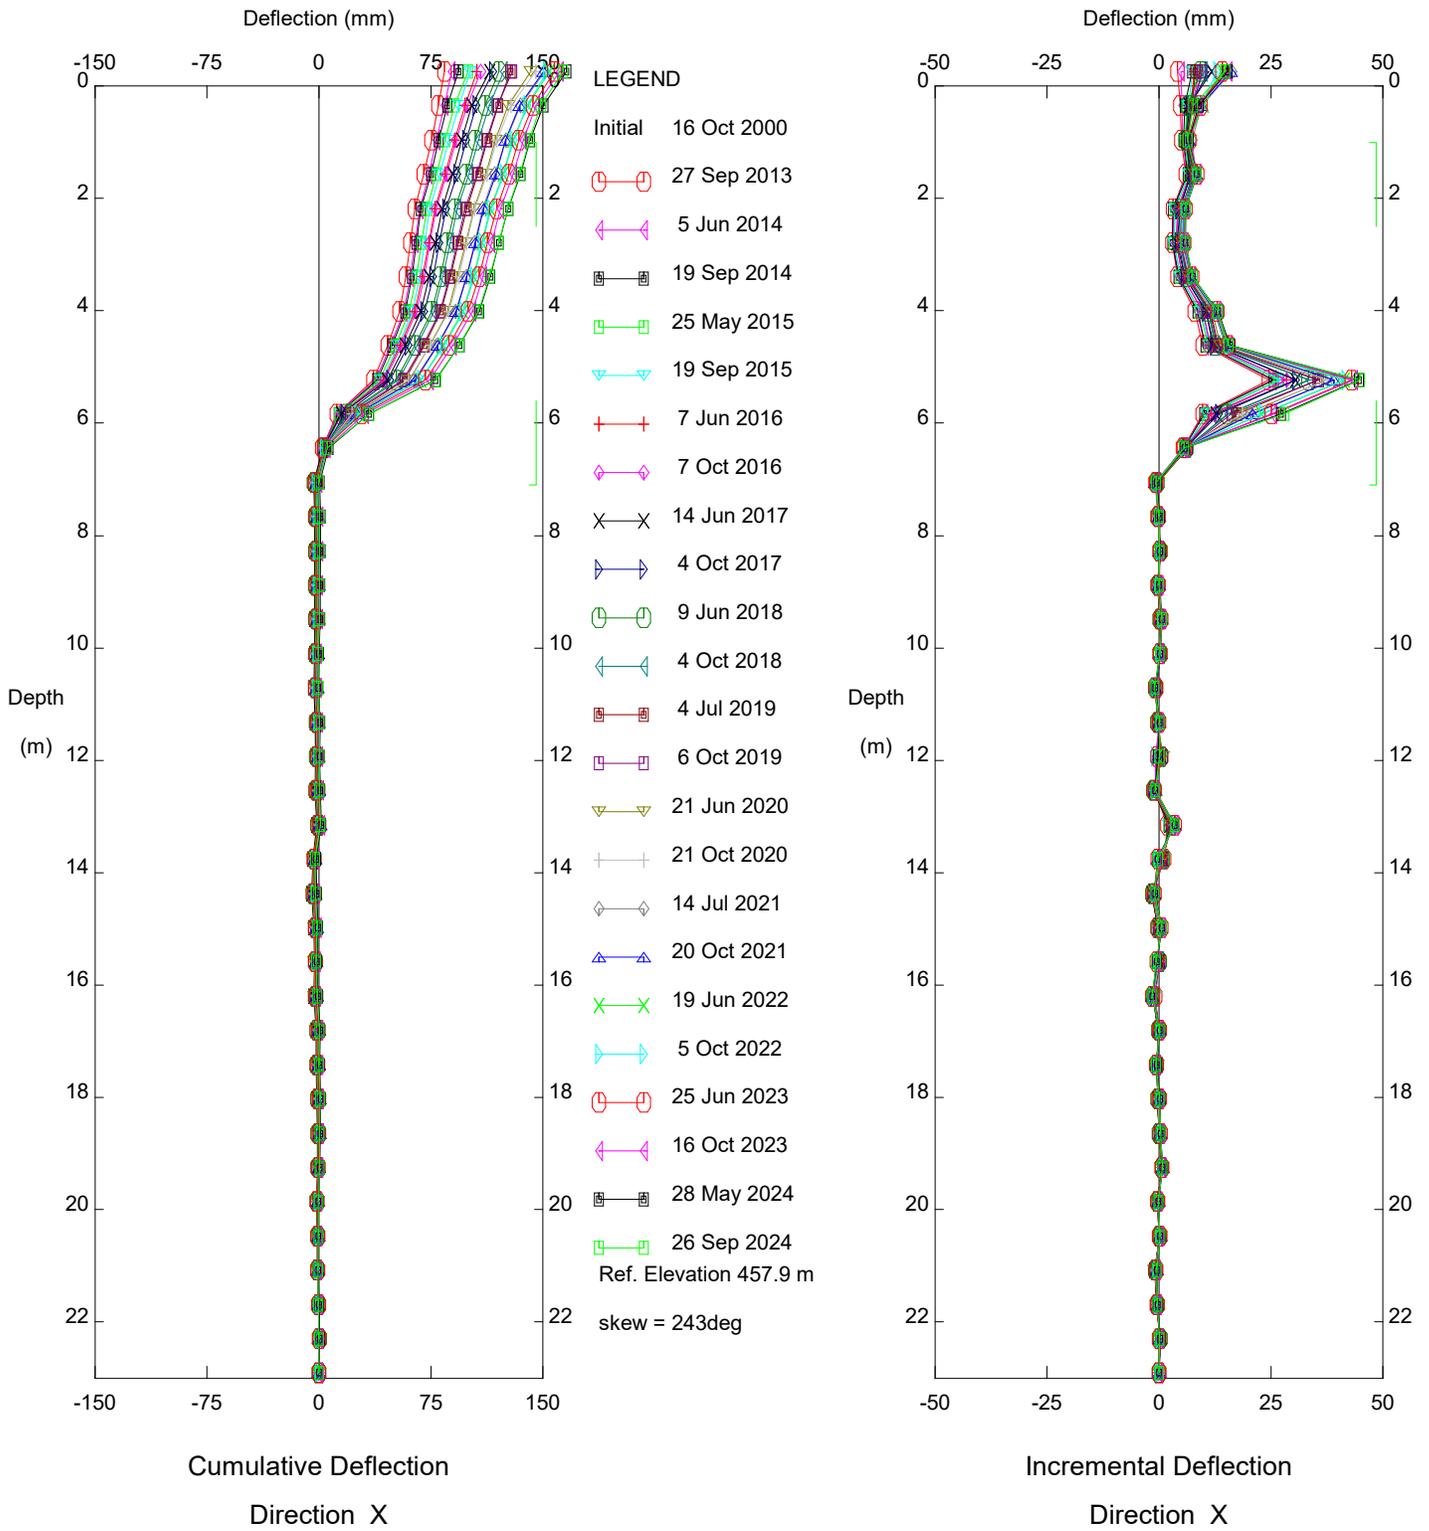
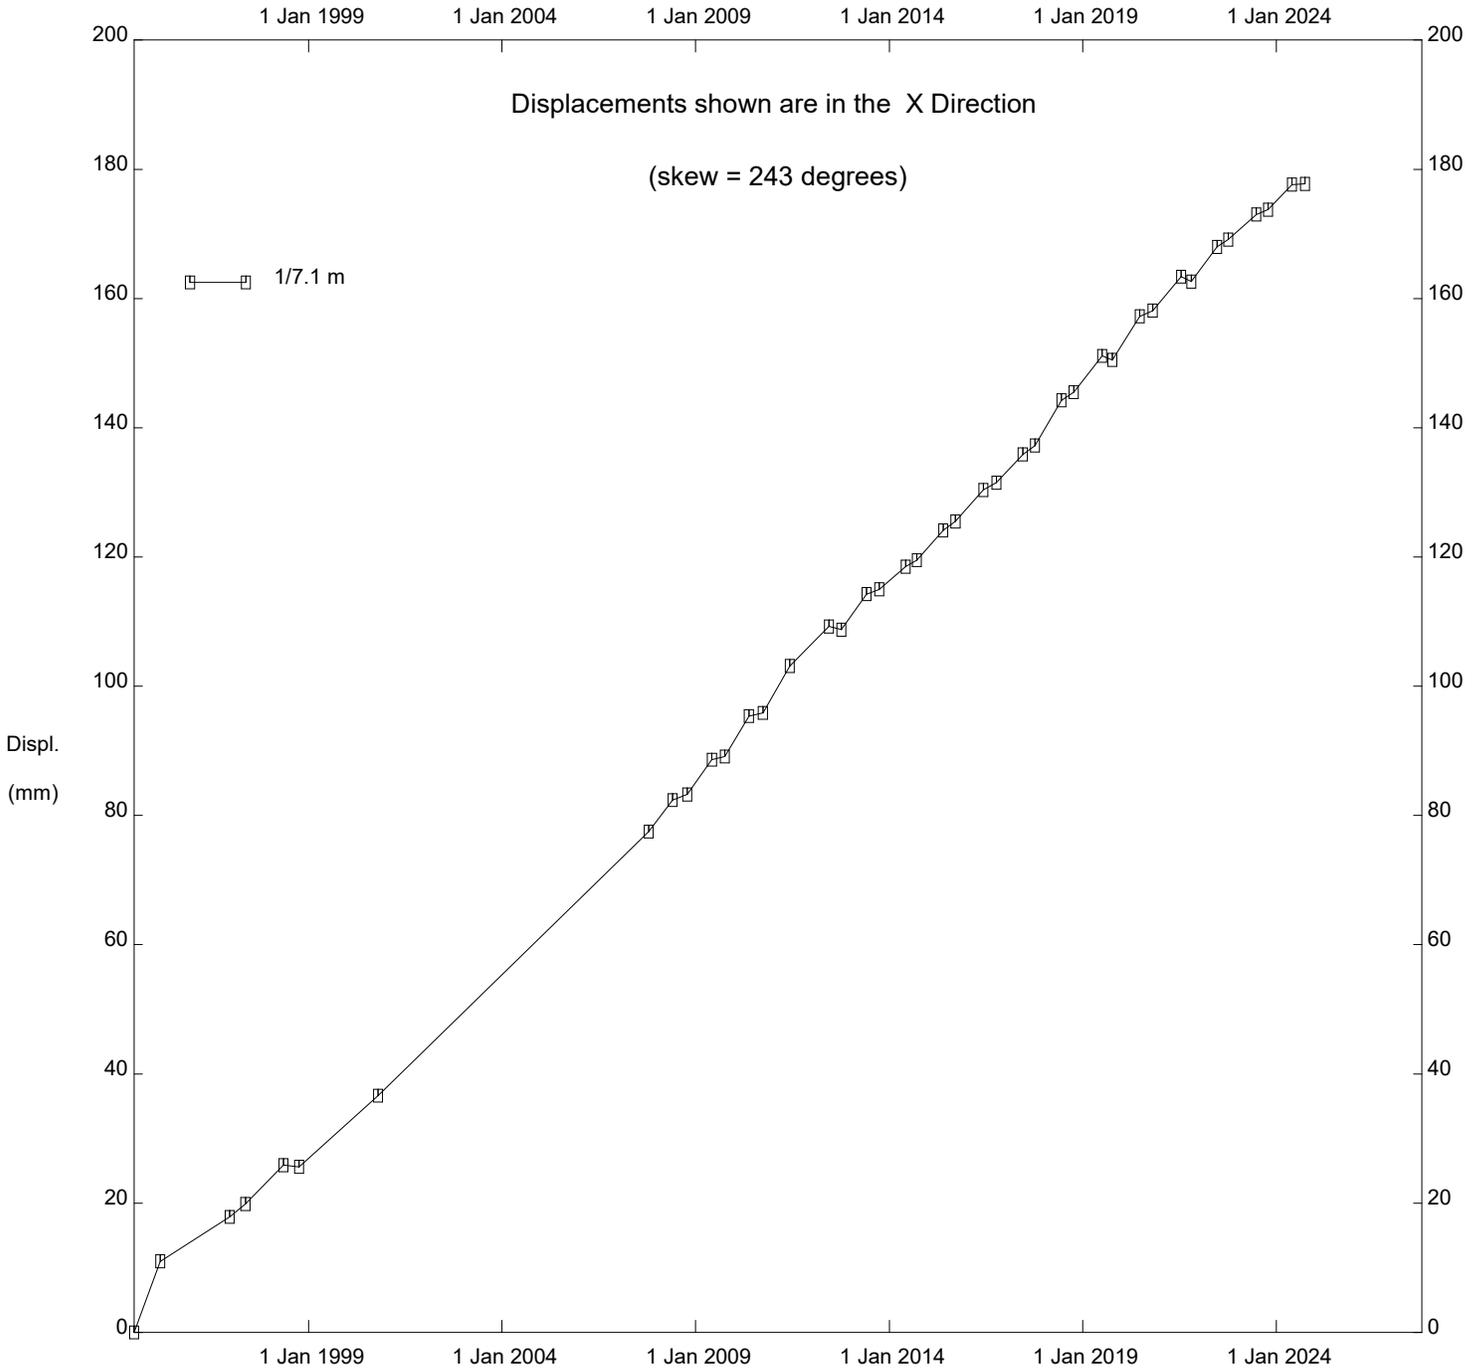
HWY 2:68 (PH037), Inclinometer SI-59

SI-59 is in the highway east ditch near the assumed backscarp north flank of the landslide that is affecting the highway. It showed a rate of movement of 0.4 mm/yr over 1.0 m to 7.1 m depth. This SI has moved 177.7 mm over this depth zone, since it was first installed in 1994. A slower moving, subtle shear zone at 13 m depth may be present.
