**ALBERTA TRANSPORTATION AND
ECONOMIC CORRIDORS GRMP
PEACE REGION
(GRANDE PRAIRIE DISTRICT - NORTH)
INSTRUMENTATION MONITORING - FALL 2024**

Site Number	Location	Name	Hwy	km
PH037	Station 1+250 to 2+000	Dunvegan South	2:68	Km 15.7
Legal Description: 4-7-80-4 W6		UTM Co-ordinates		
		11U E 398593.62	N	6197597.09

Current Monitoring:	28-May-2024	Previous Monitoring	28-May-2024
Instruments Read By:	Mr. Neil McDonald and Mr. Nixson Mationg of Thurber

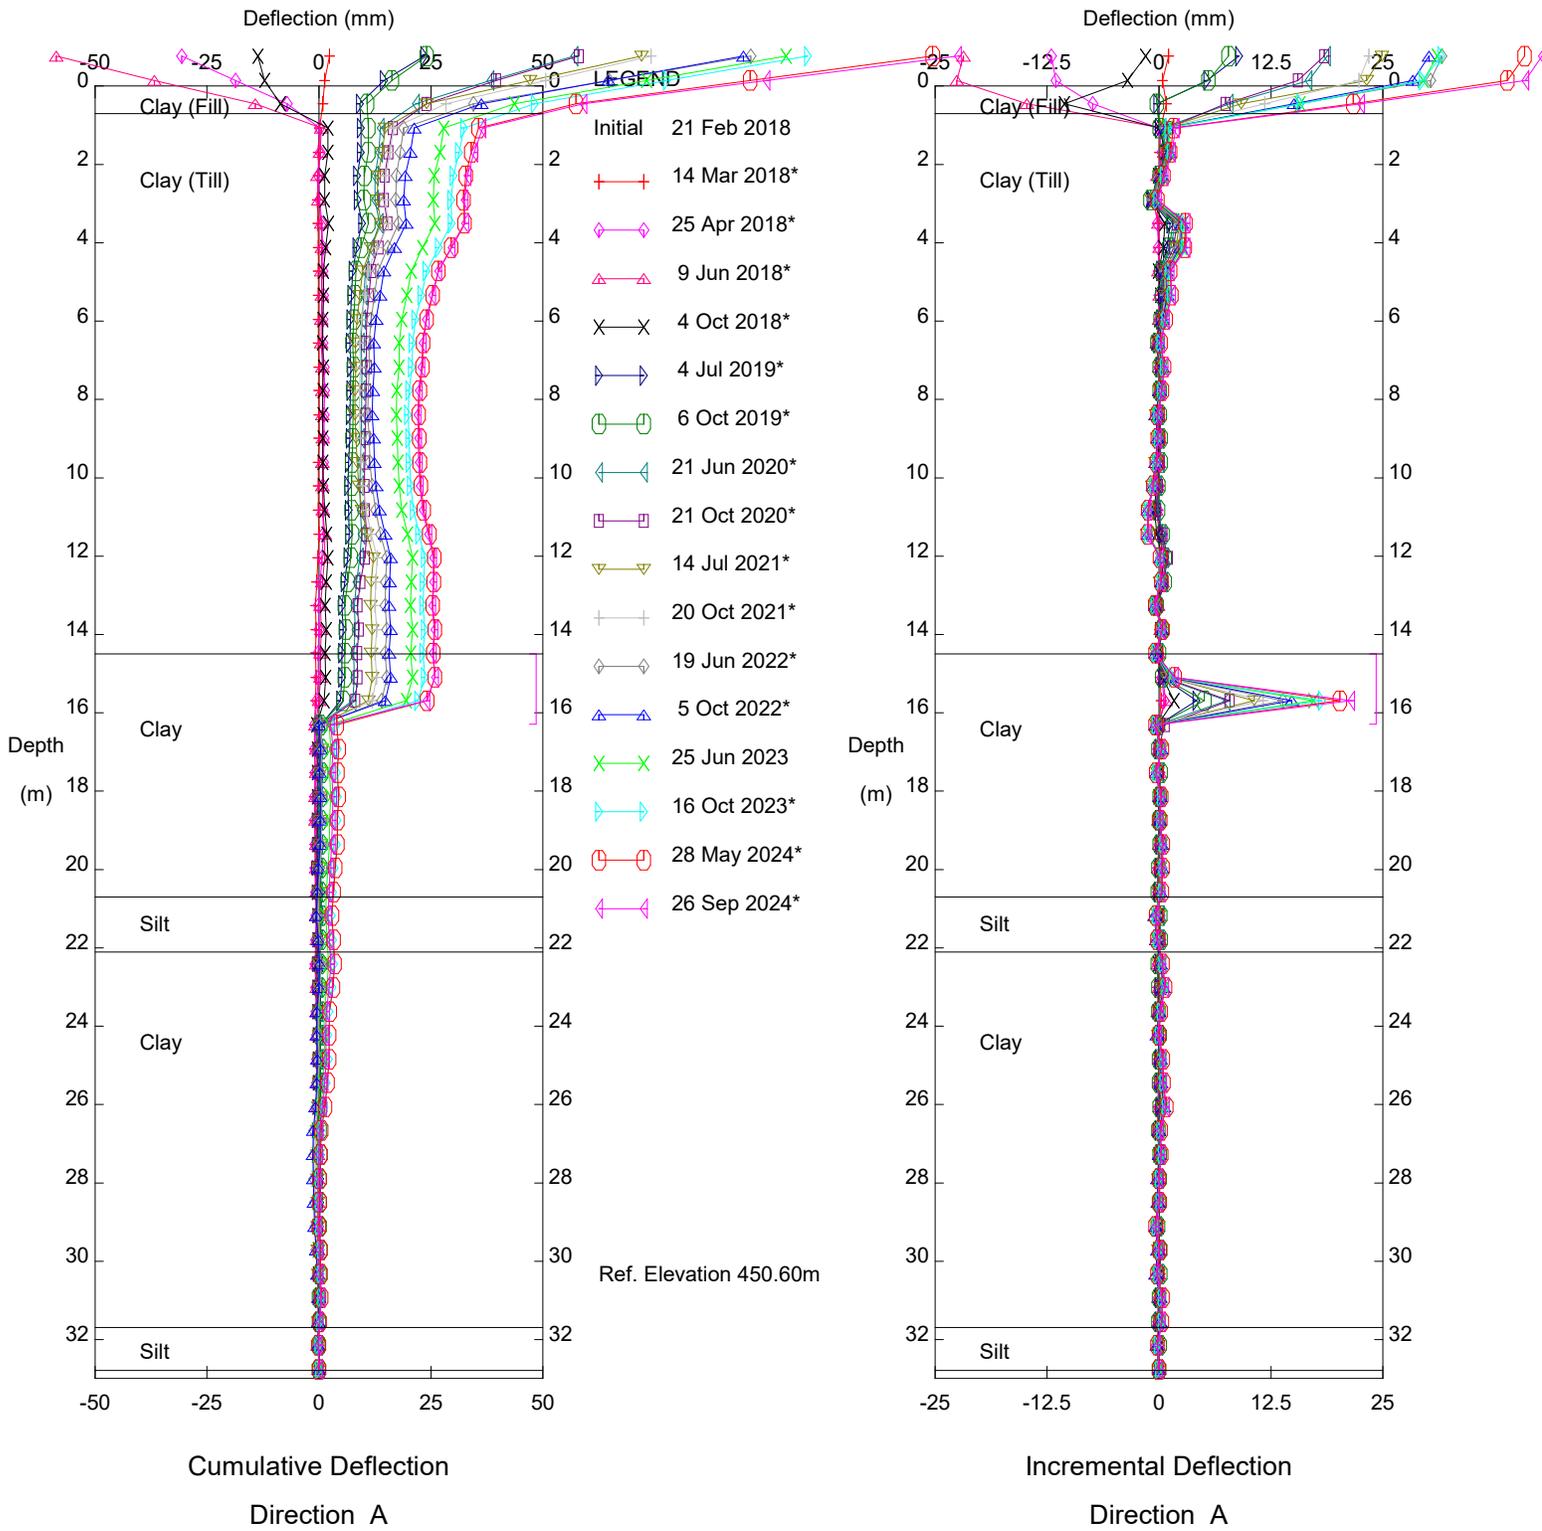
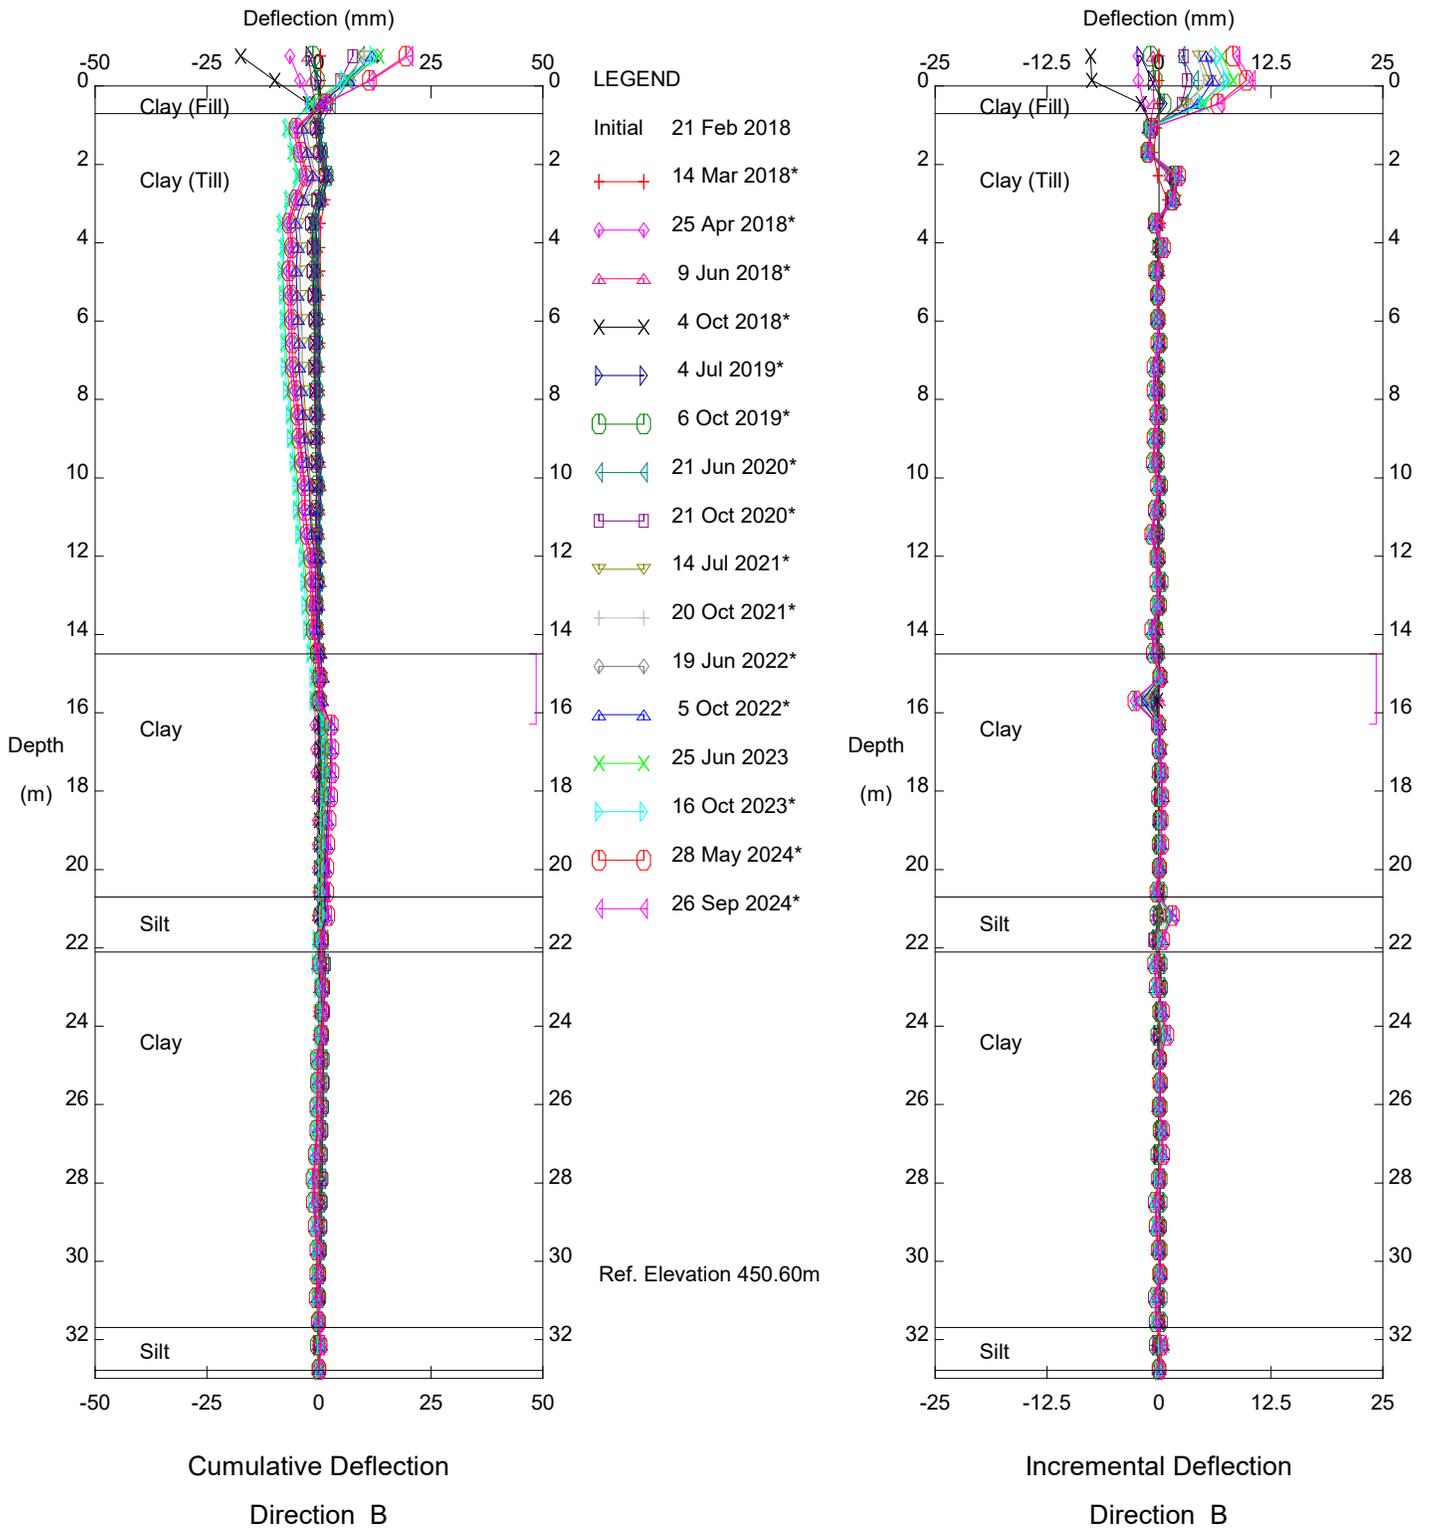
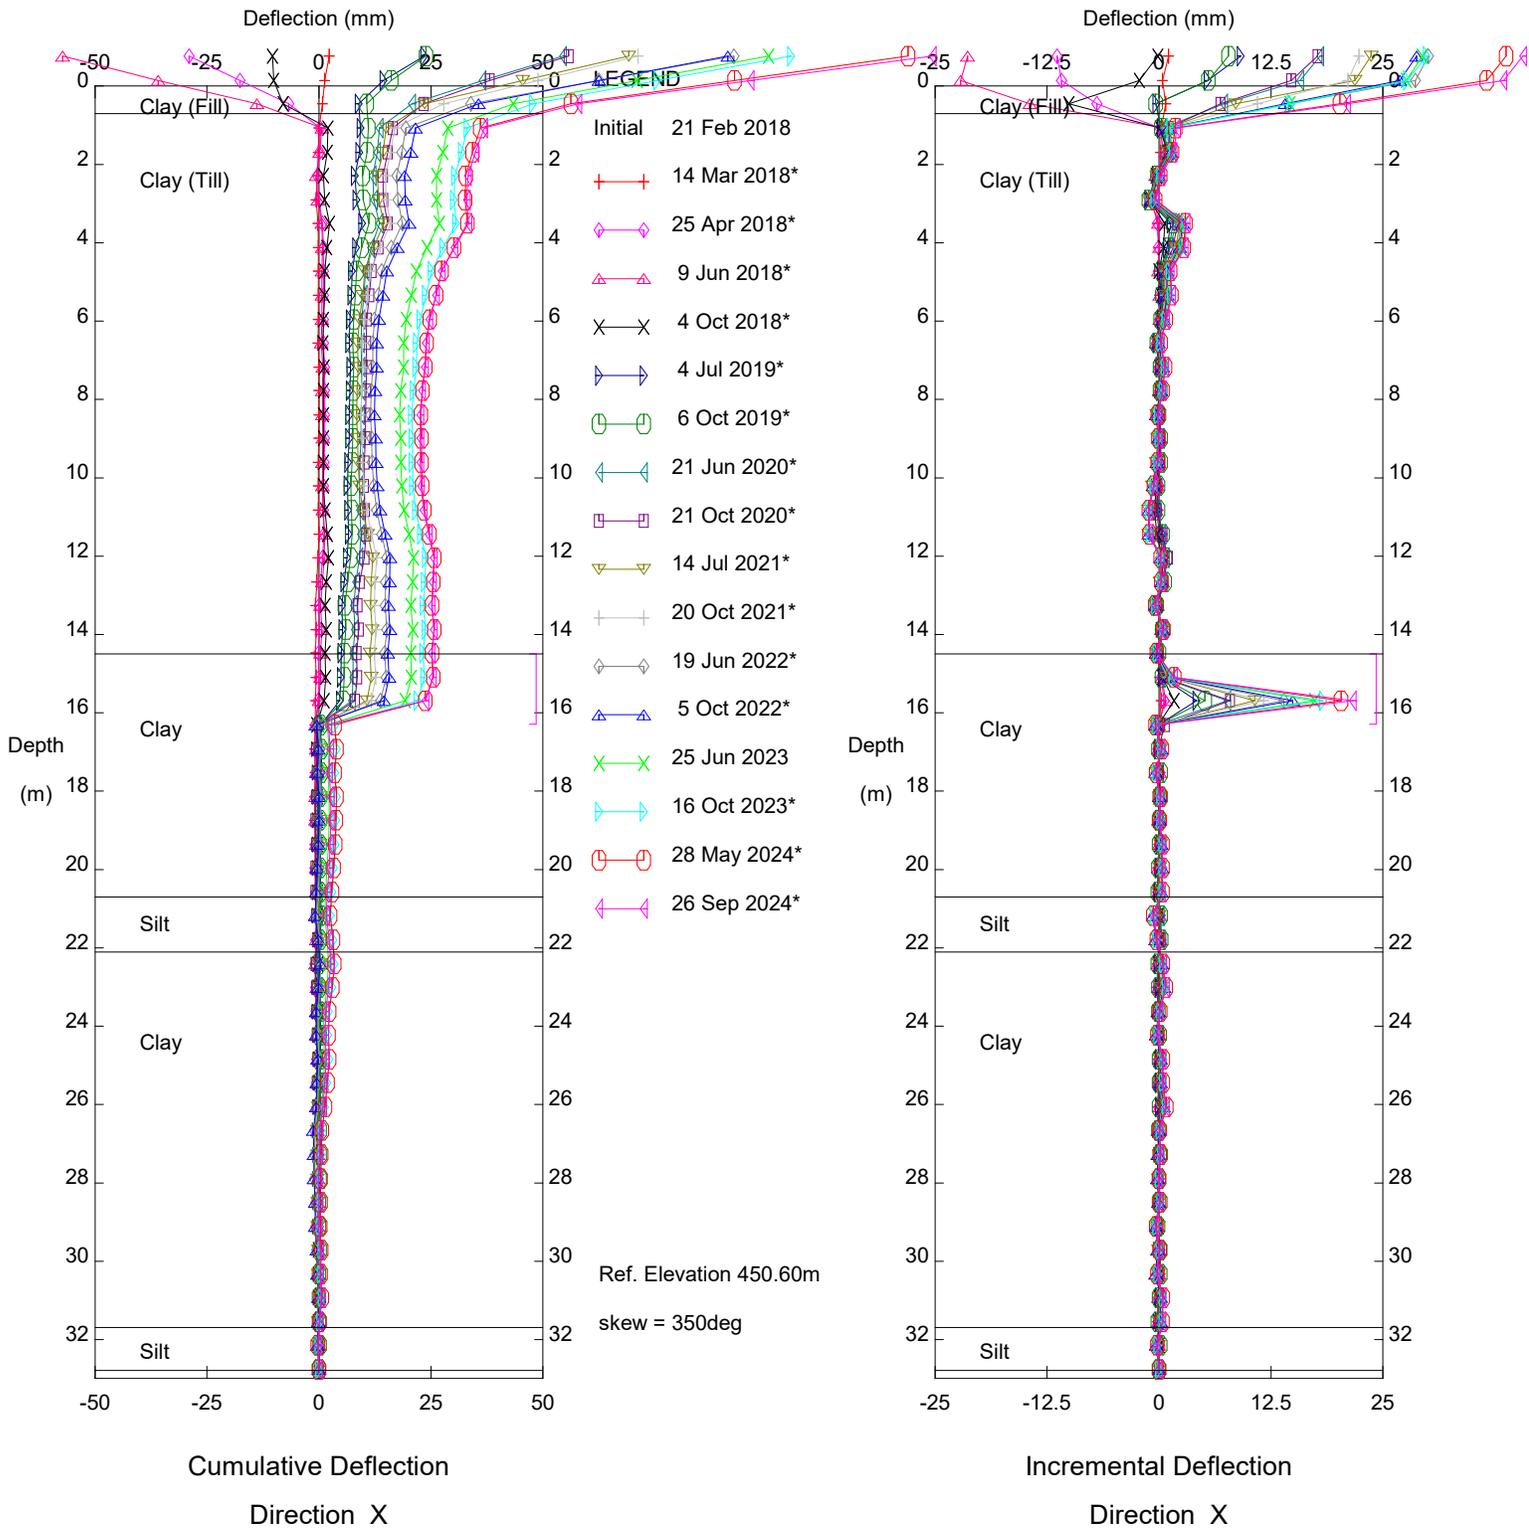
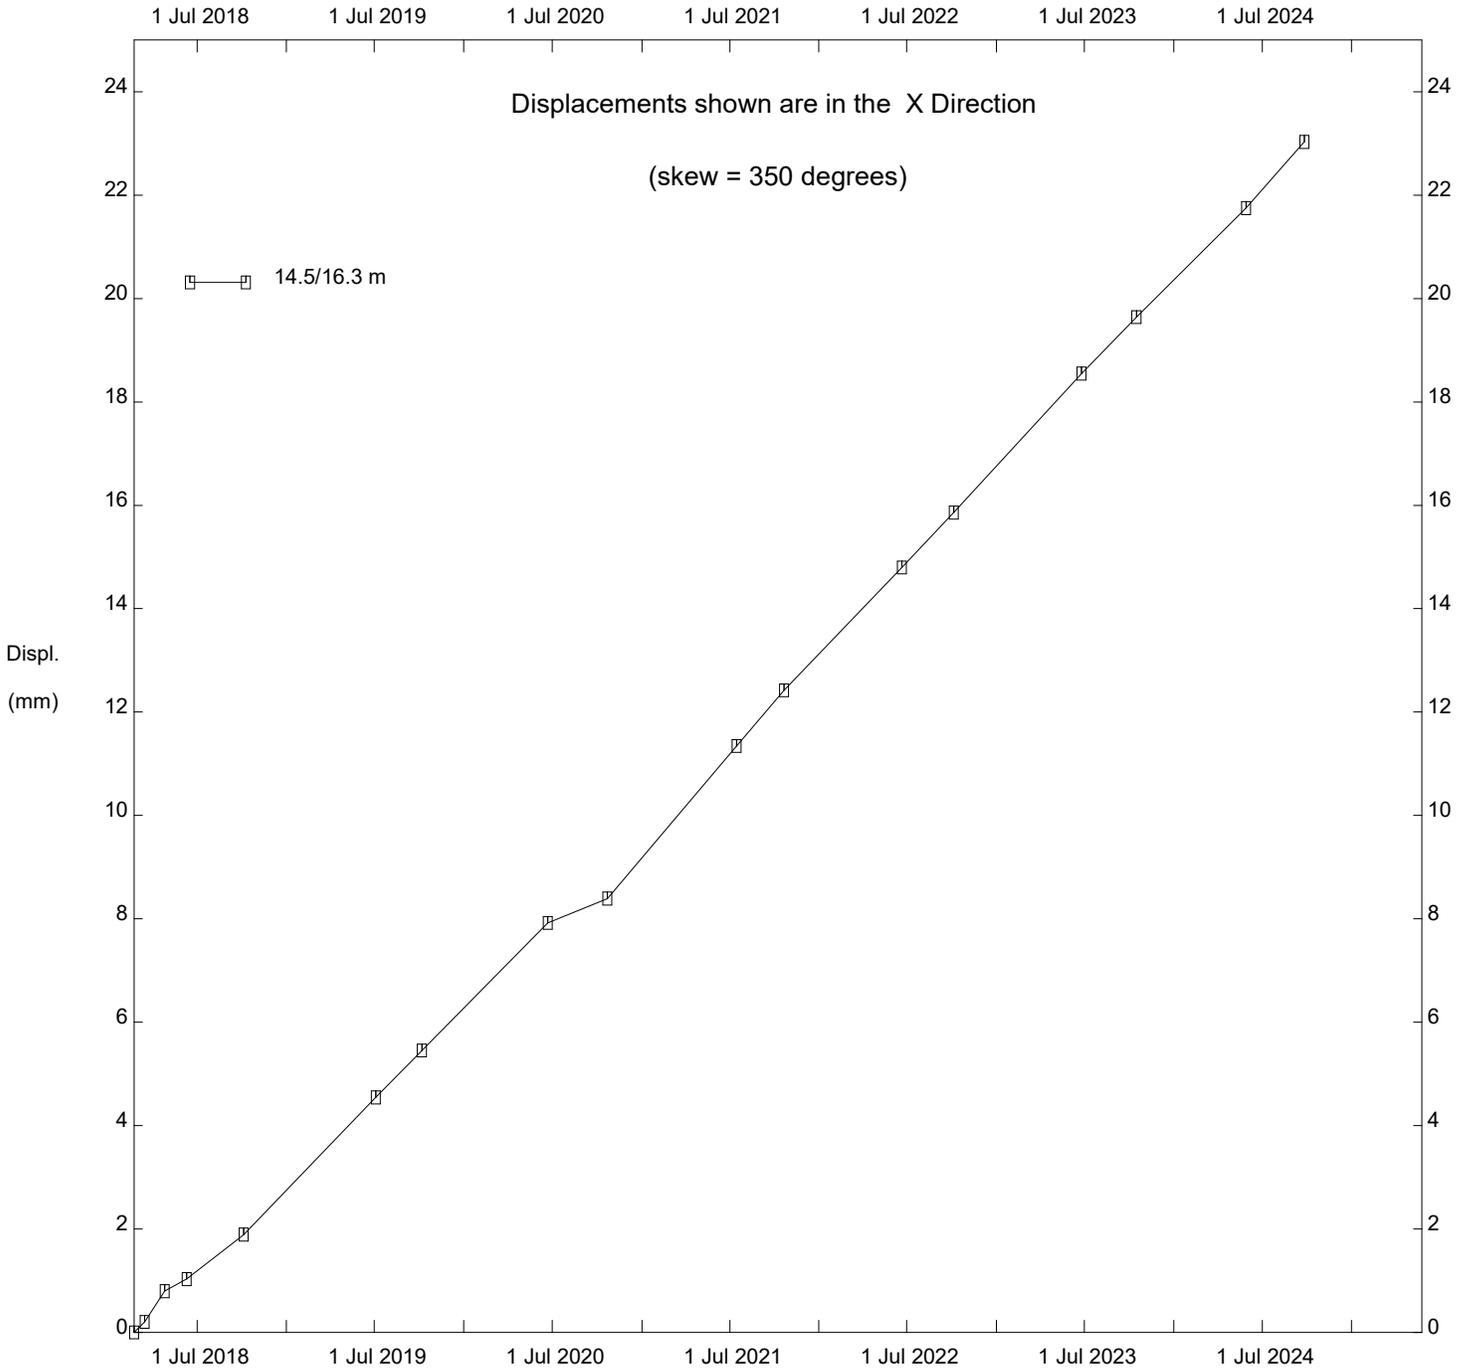
HWY 2:68 (PH037), Inclinometer SI18-8

SI18-8 is just west of the highway and showed a rate of movement of 3.9 mm/yr along a distinct shear plane over 14.5 m to 16.3 m depth in a clay layer. This movement rate has held steady since 2018 and total movement to date is about 23 mm.

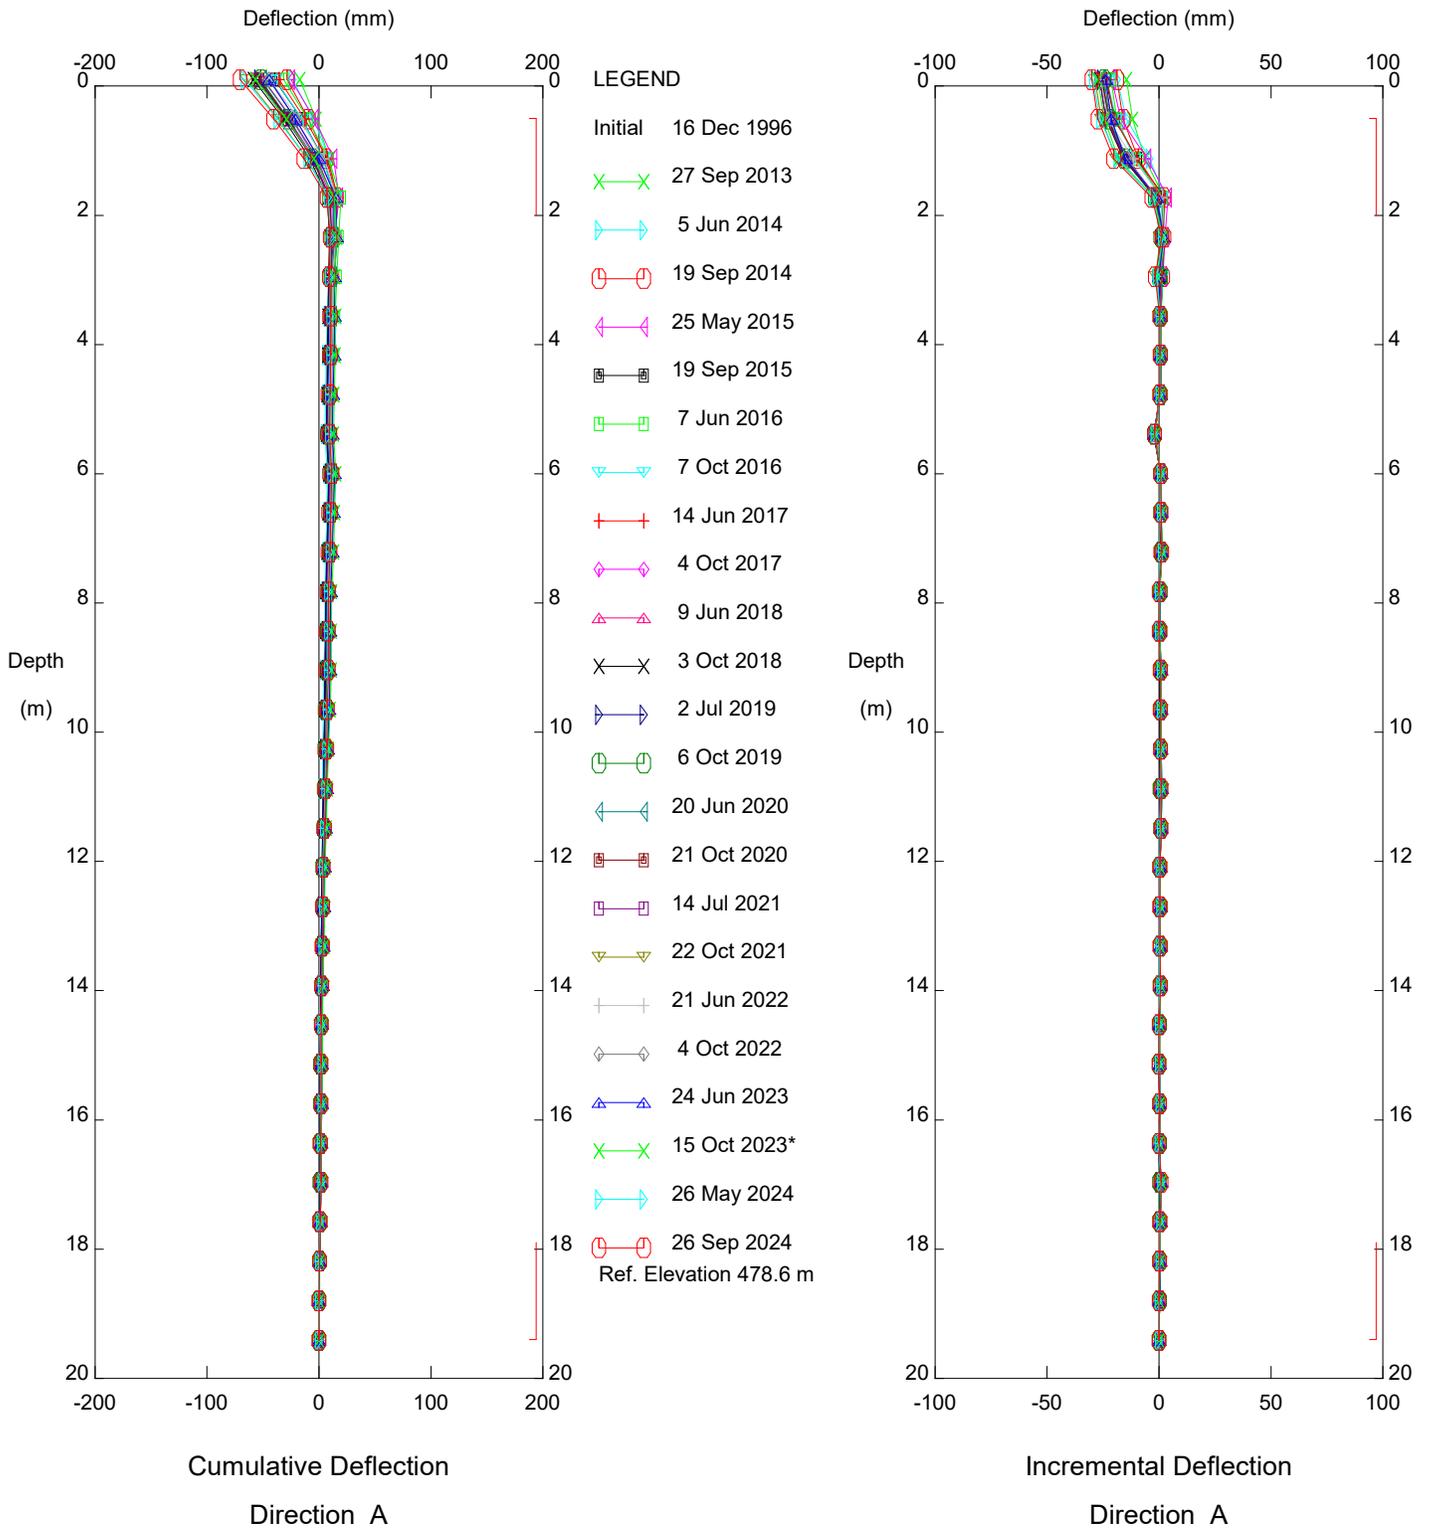
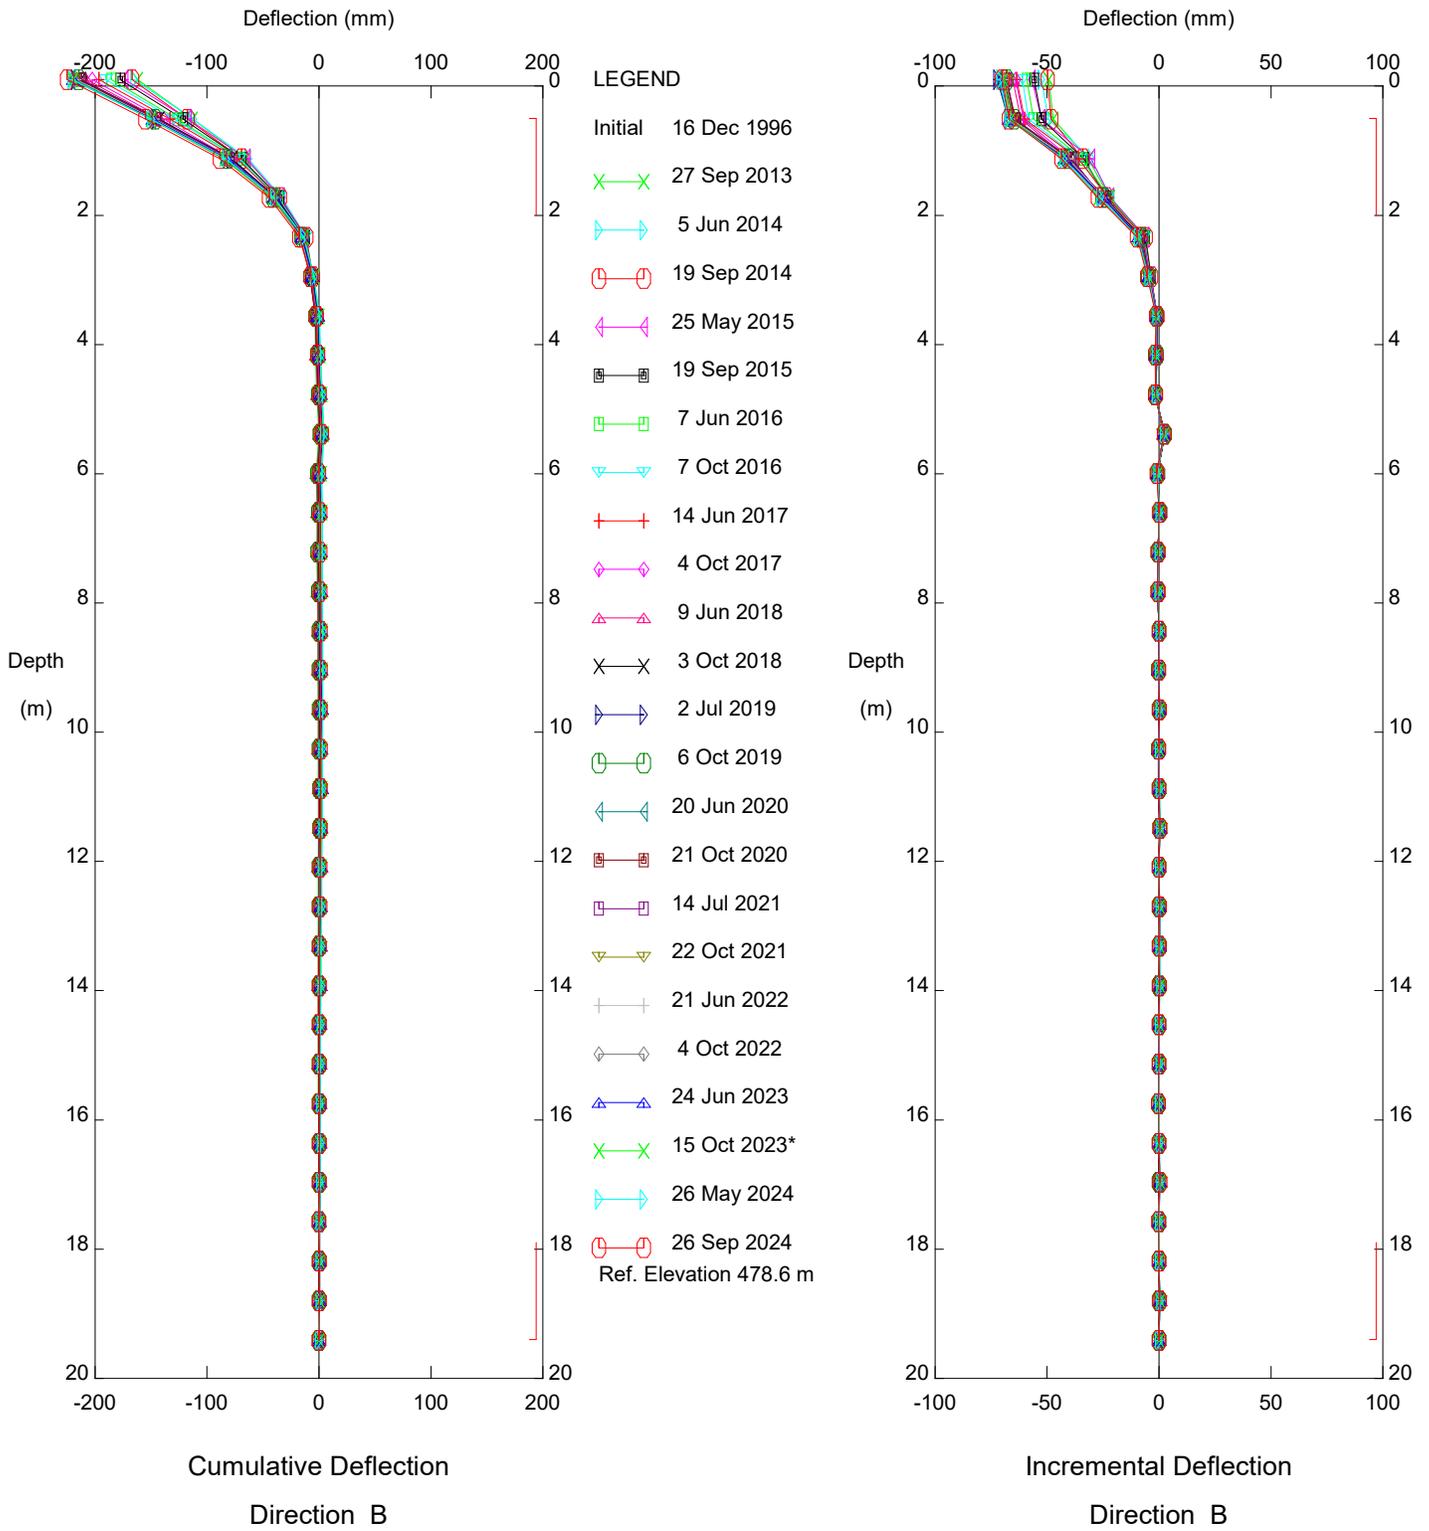
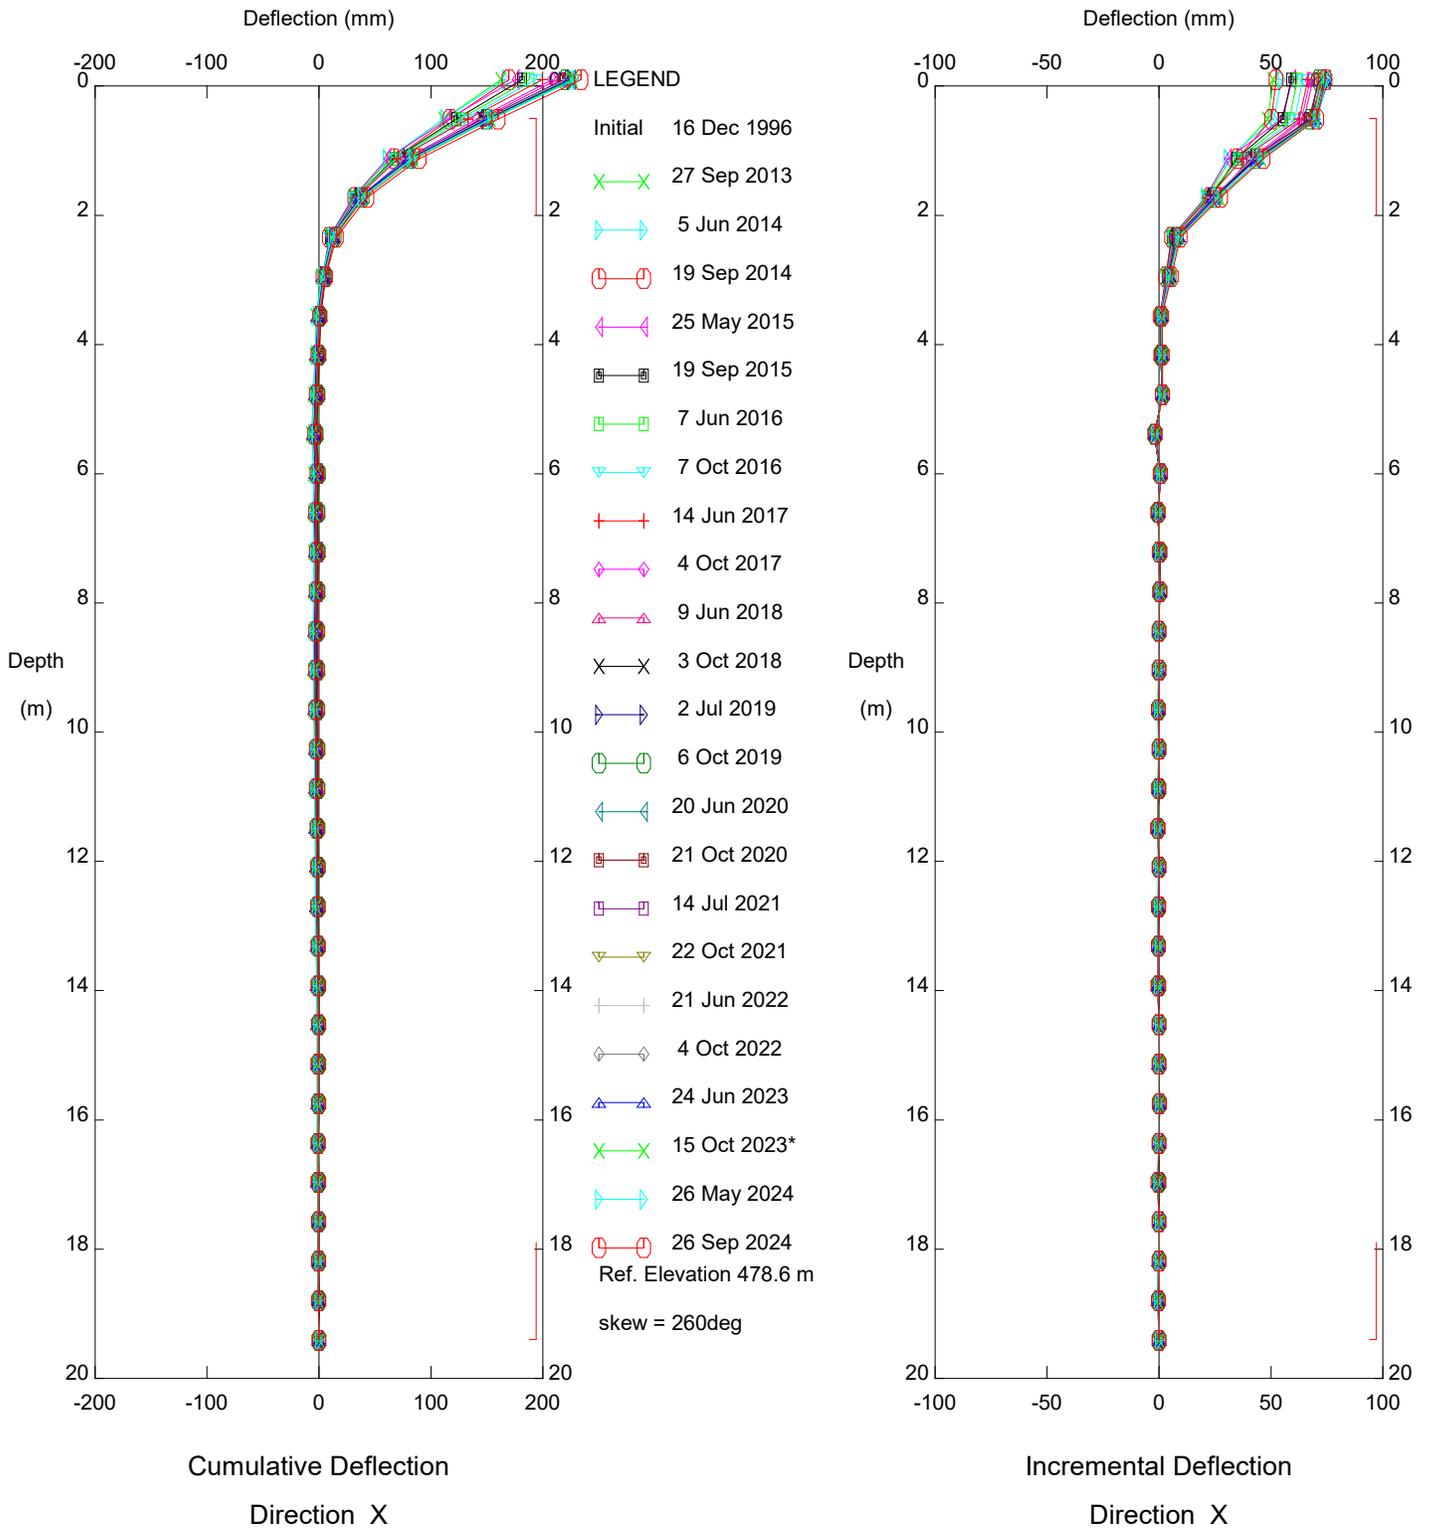
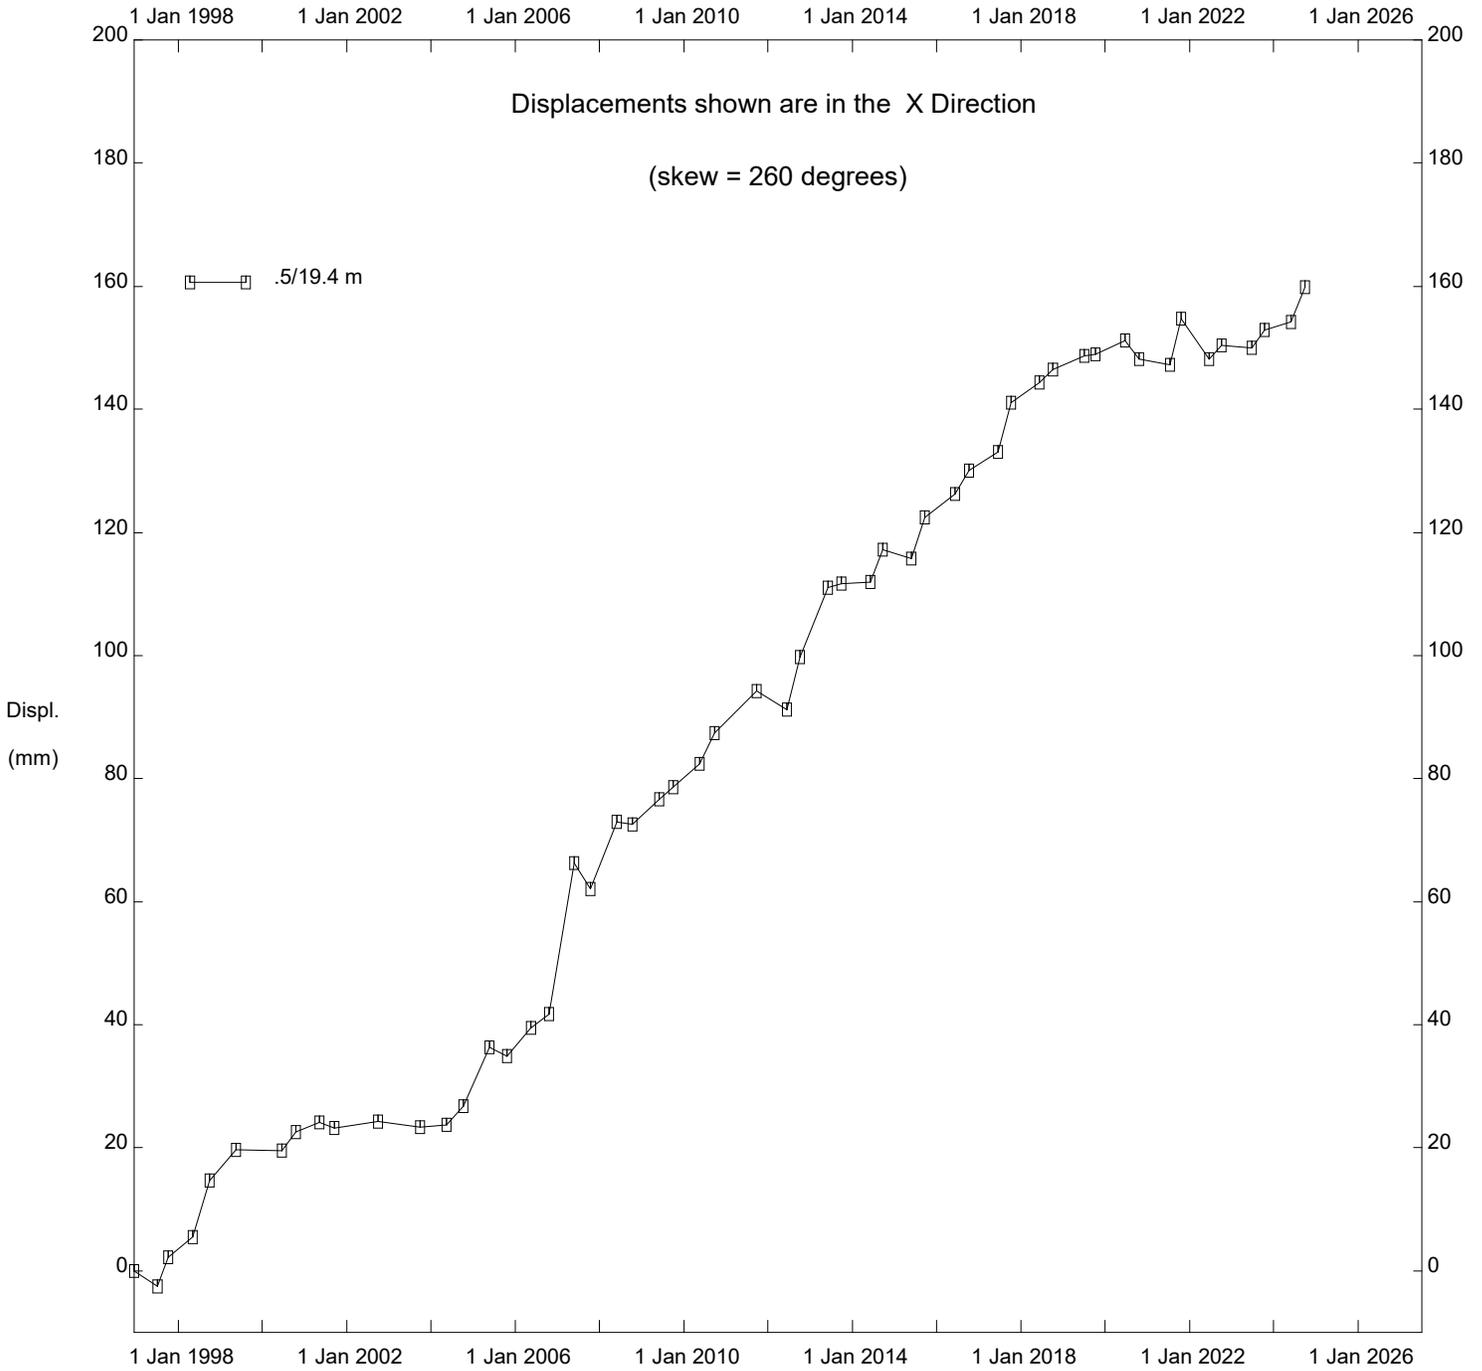
HWY 2:68 (PH037), Inclinometer SI-58

SI-58 is about 100 m east of the highway and showed a rate of movement of 17 mm/yr over 0.5 m to 3.6 m depth. The movement pattern at SI-58 is bending with no well-defined shear zone.
