**ALBERTA TRANSPORTATION AND
ECONOMIC CORRIDORS GRMP
PEACE REGION
(GRANDE PRAIRIE DISTRICT - NORTH)
INSTRUMENTATION MONITORING - FALL 2024**

Site Number	Location	Name	Hwy	km
PH037	Station 1+250 to 2+000	Dunvegan South	2:68	Km 15.7
Legal Description: 4-7-80-4 W6		UTM Co-ordinates		
		11U E 398593.62	N	6197597.09

Current Monitoring:	28-May-2024	Previous Monitoring	28-May-2024
Instruments Read By:	Mr. Neil McDonald and Mr. Nixson Mationg of Thurber

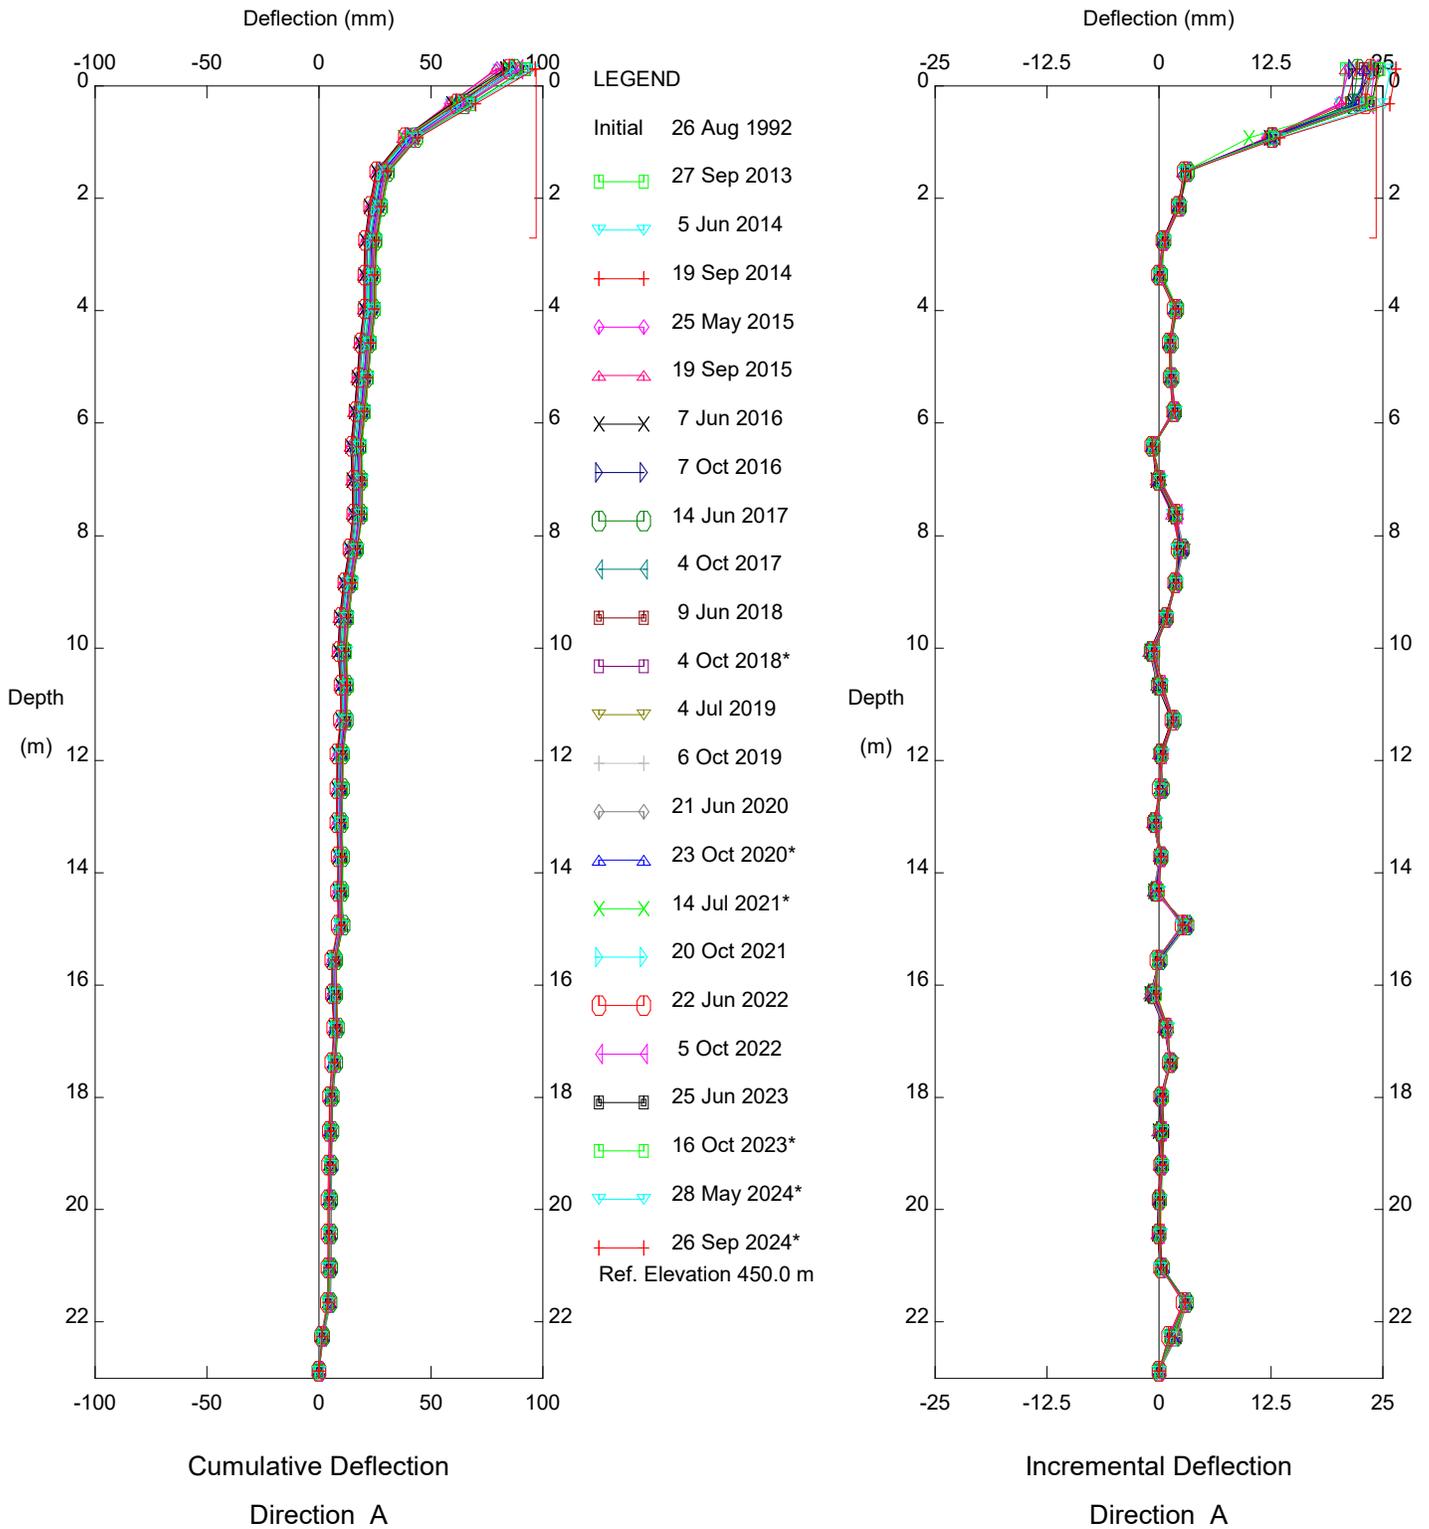
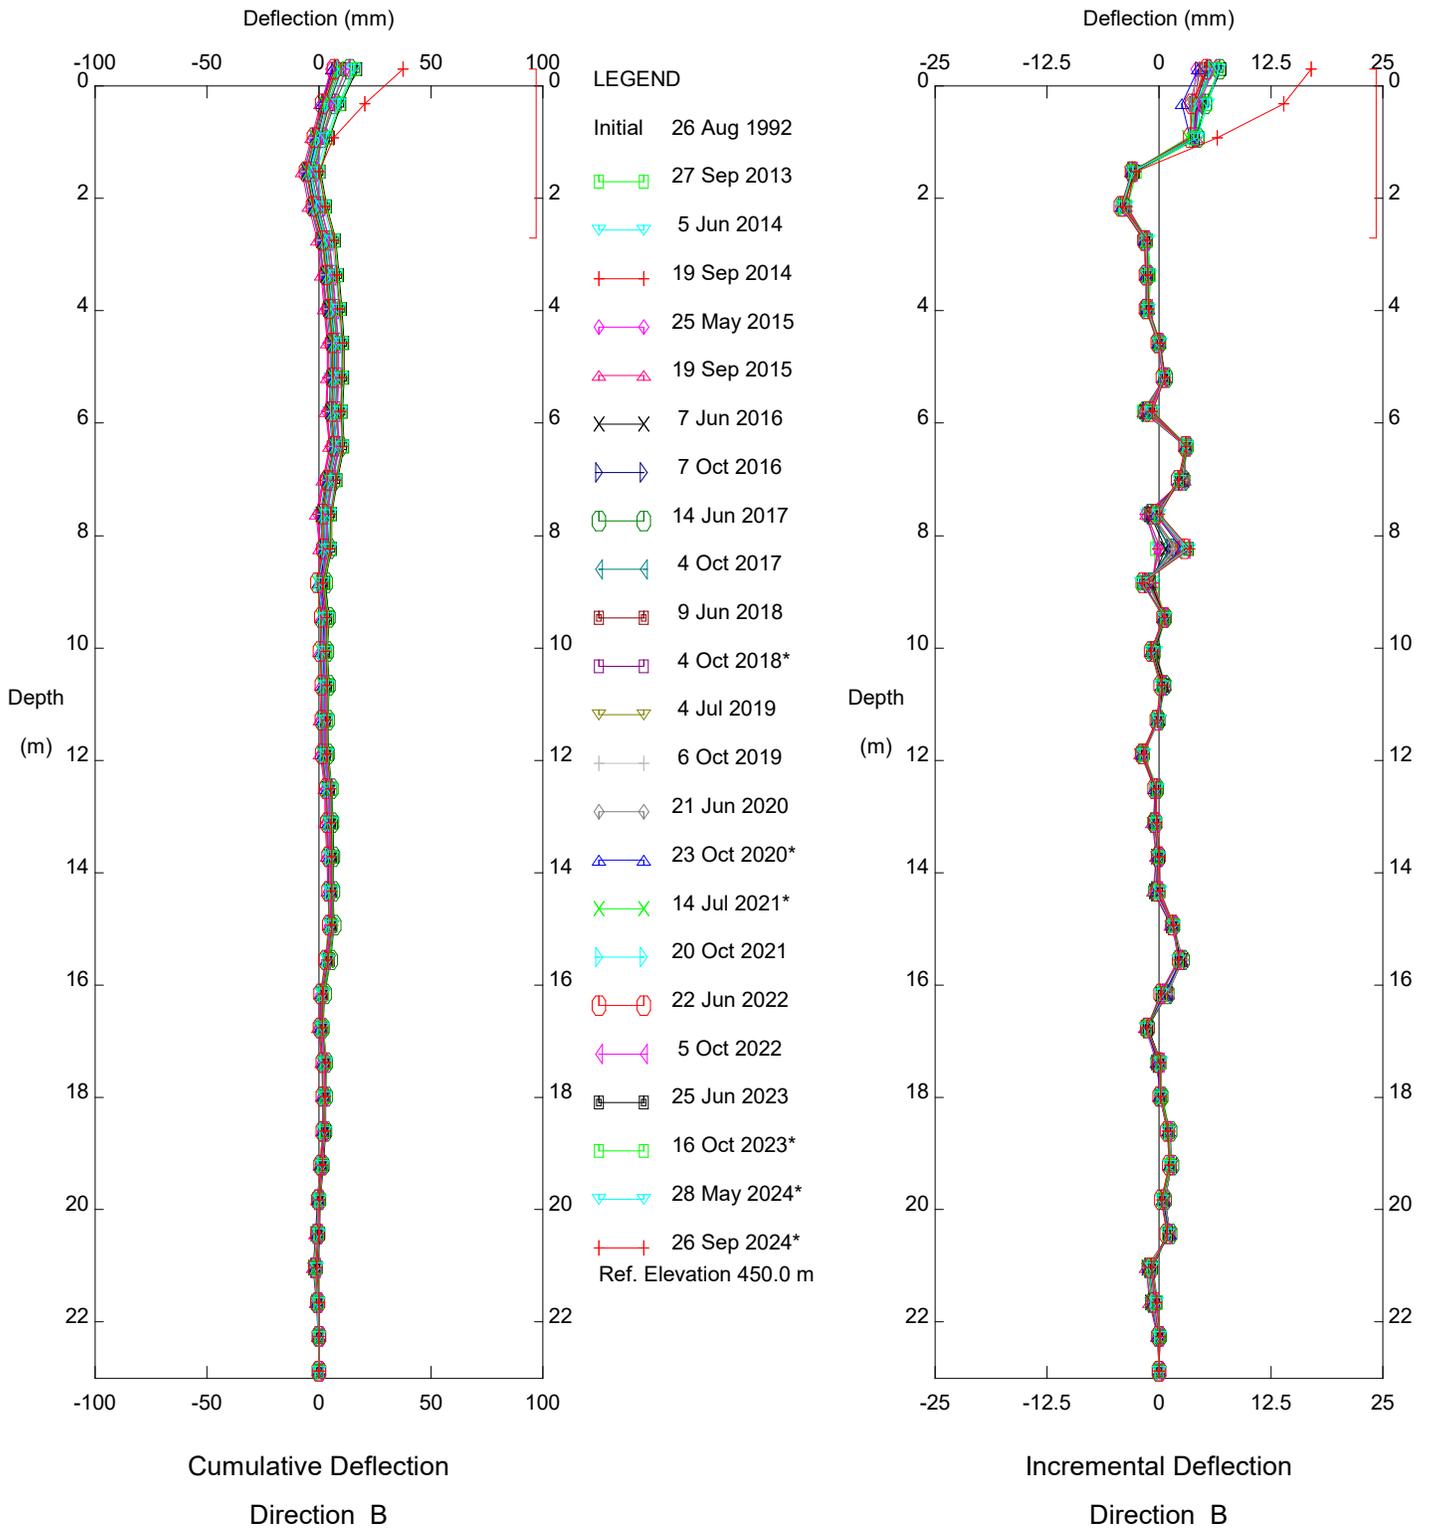
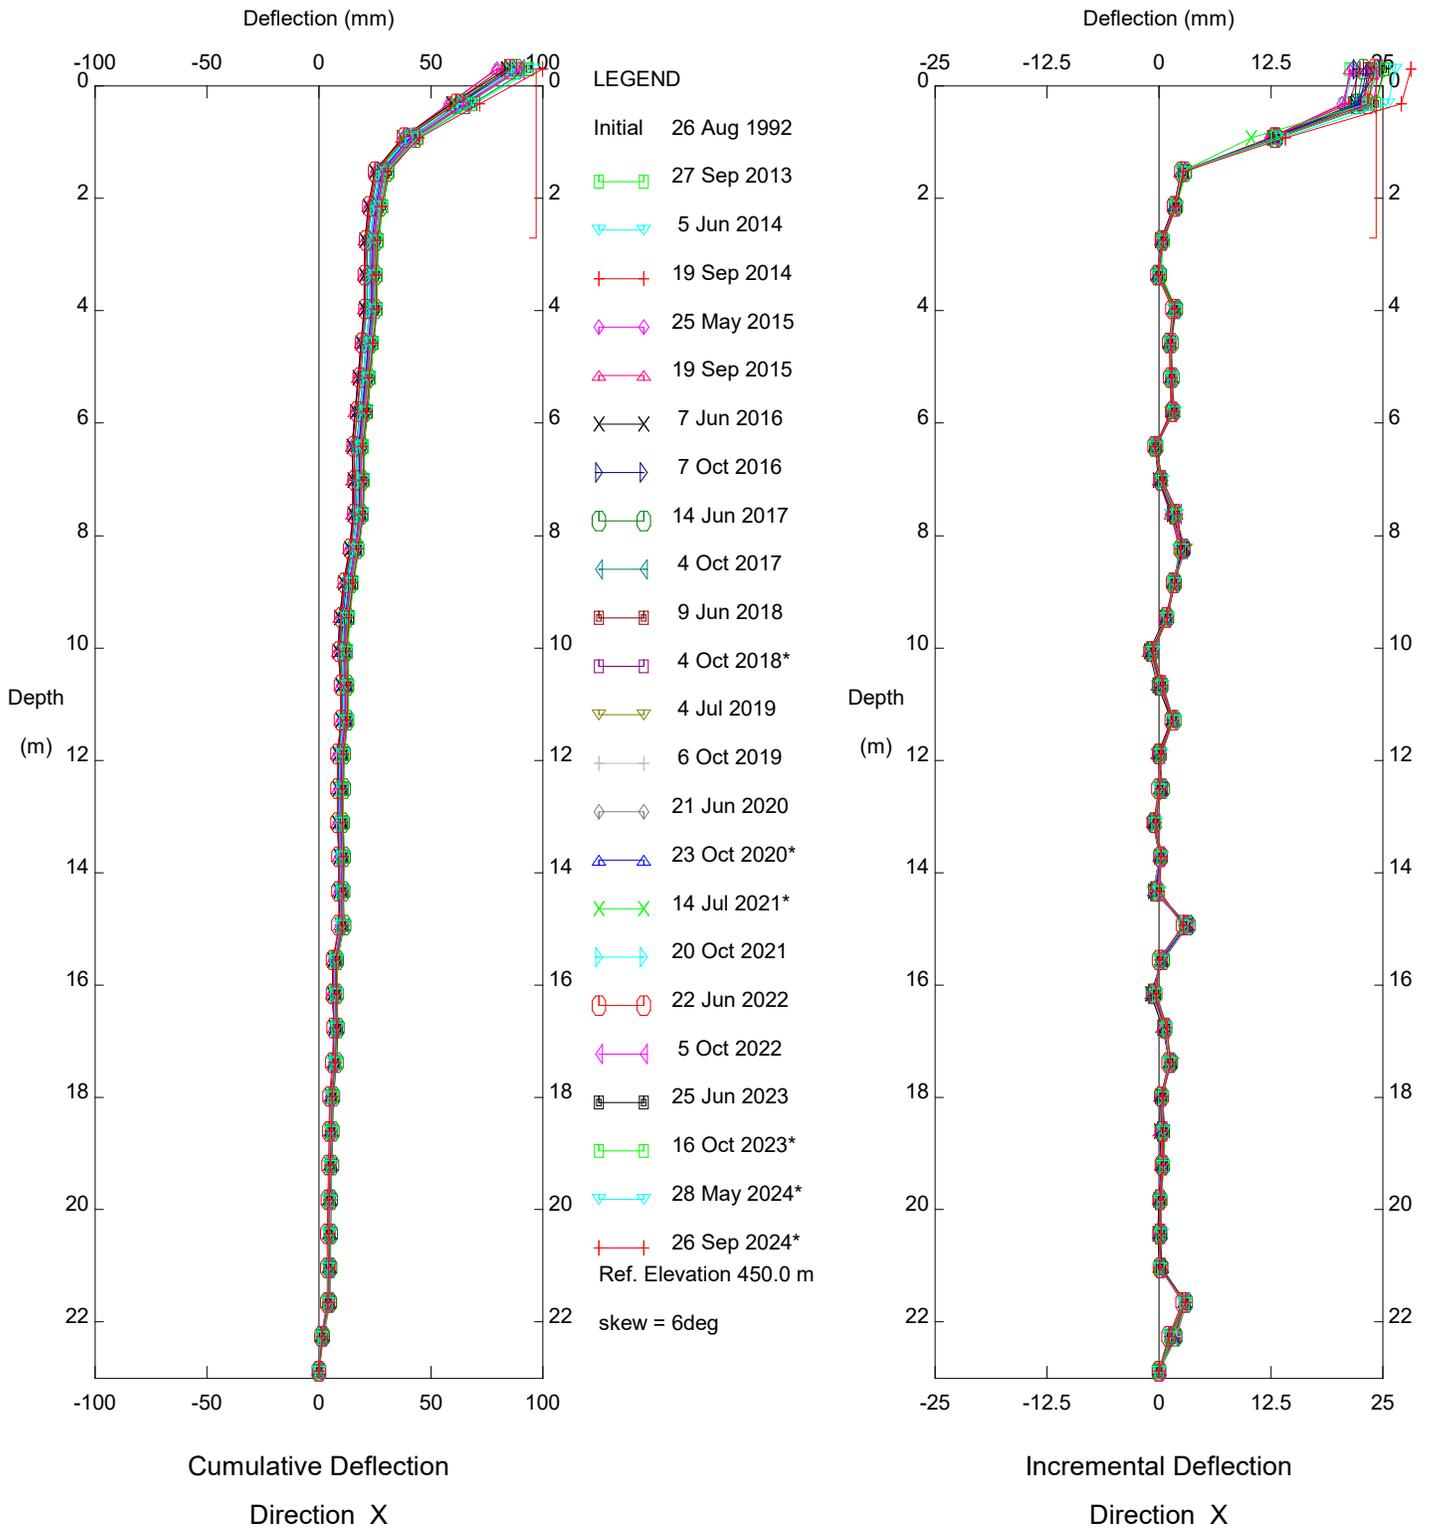
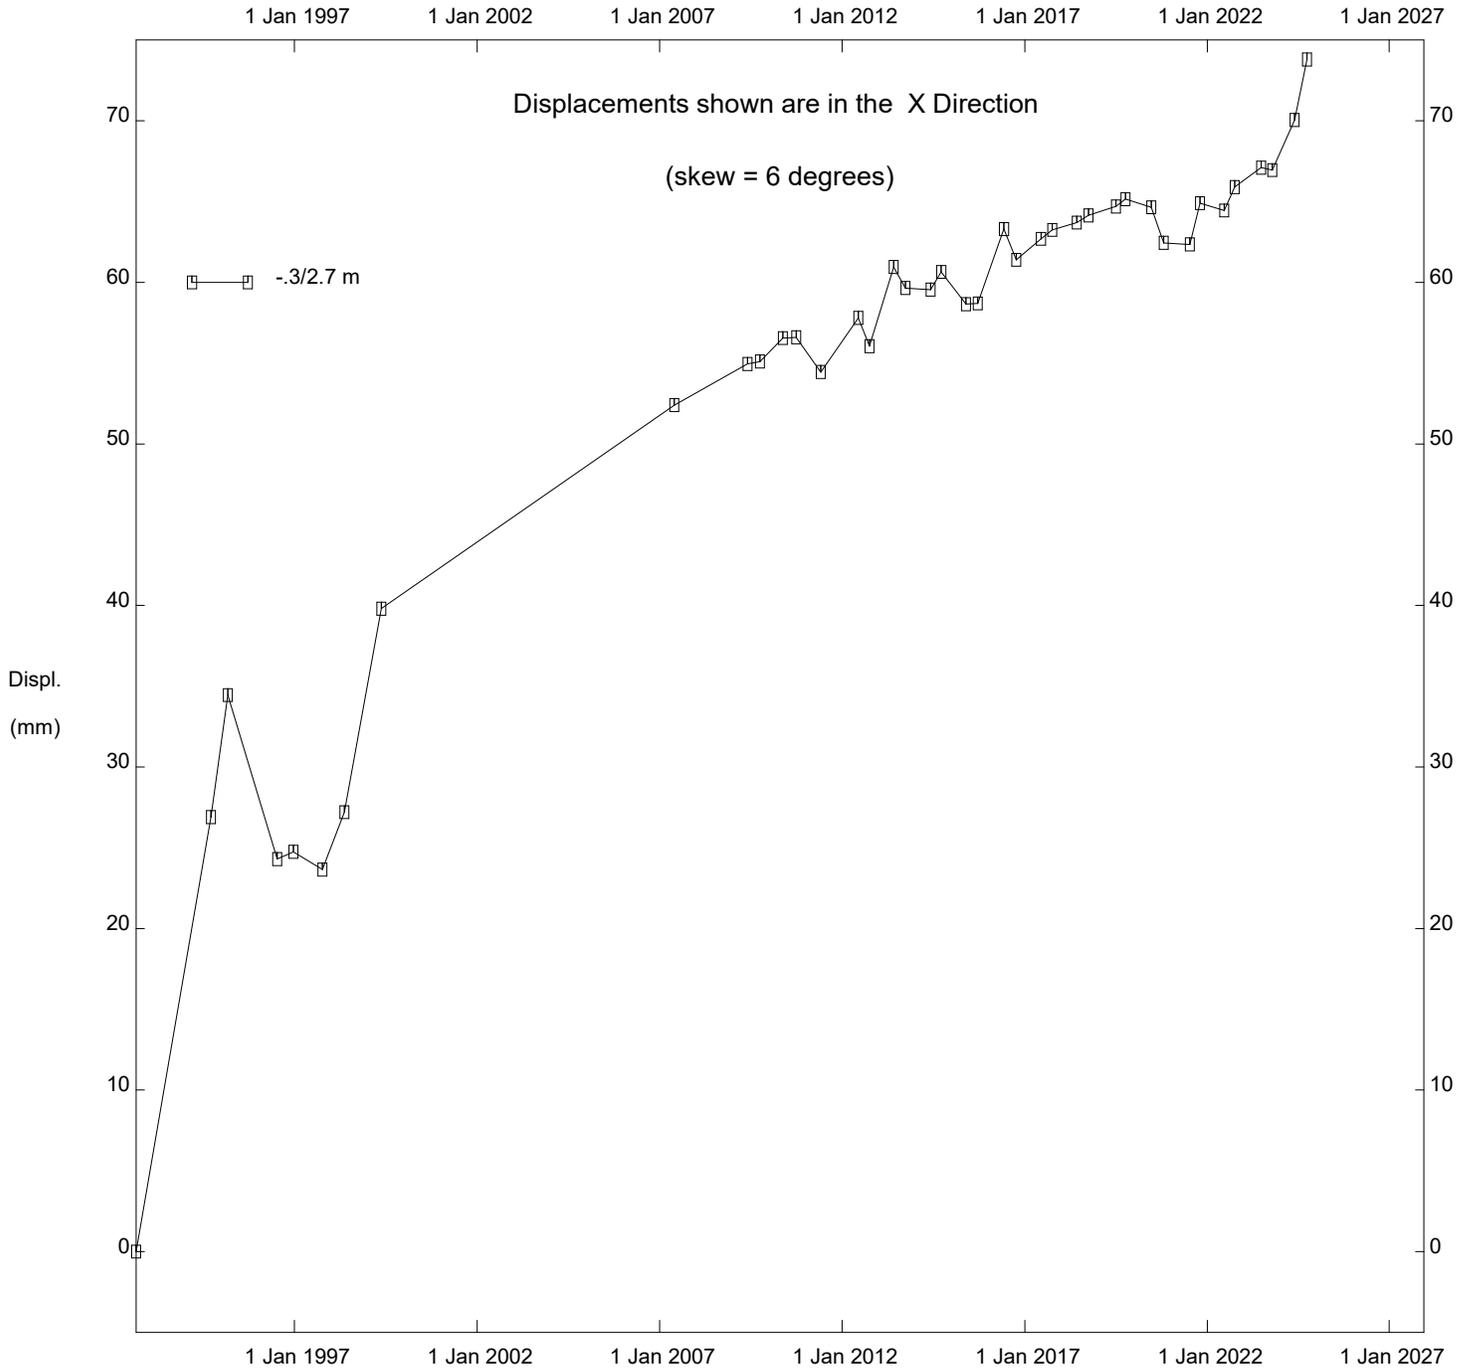
HWY 2:68 (PH037), Inclinometer SI-56

SI-56 is just east of the highway and showed a rate of movement of 11.4 mm/yr over 0 m to 2.7 m depth. There are several subtle zones of movement deeper in SI-56 with movement rates less than 0.5 mm/yr. The overall movement pattern is bending in the upper 2 m and tilting below that depth.

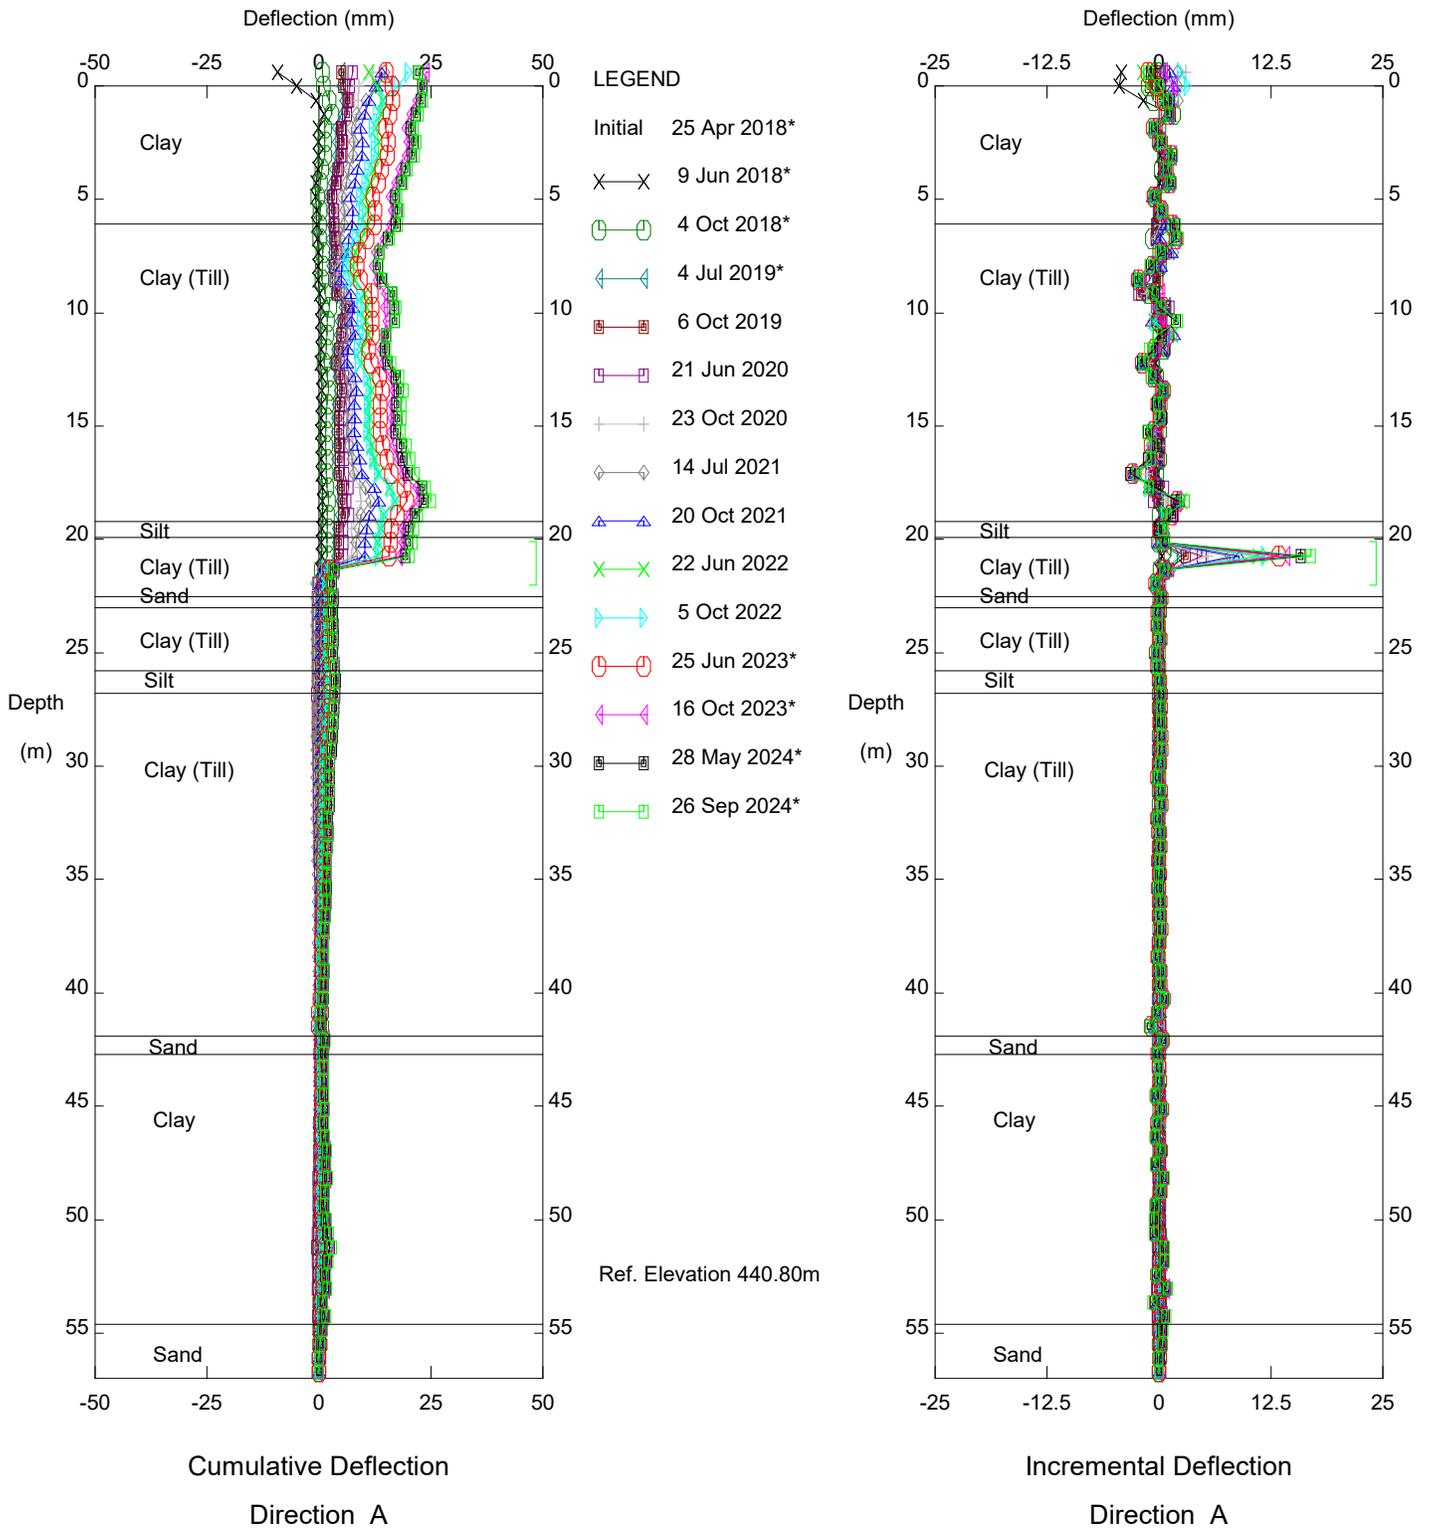
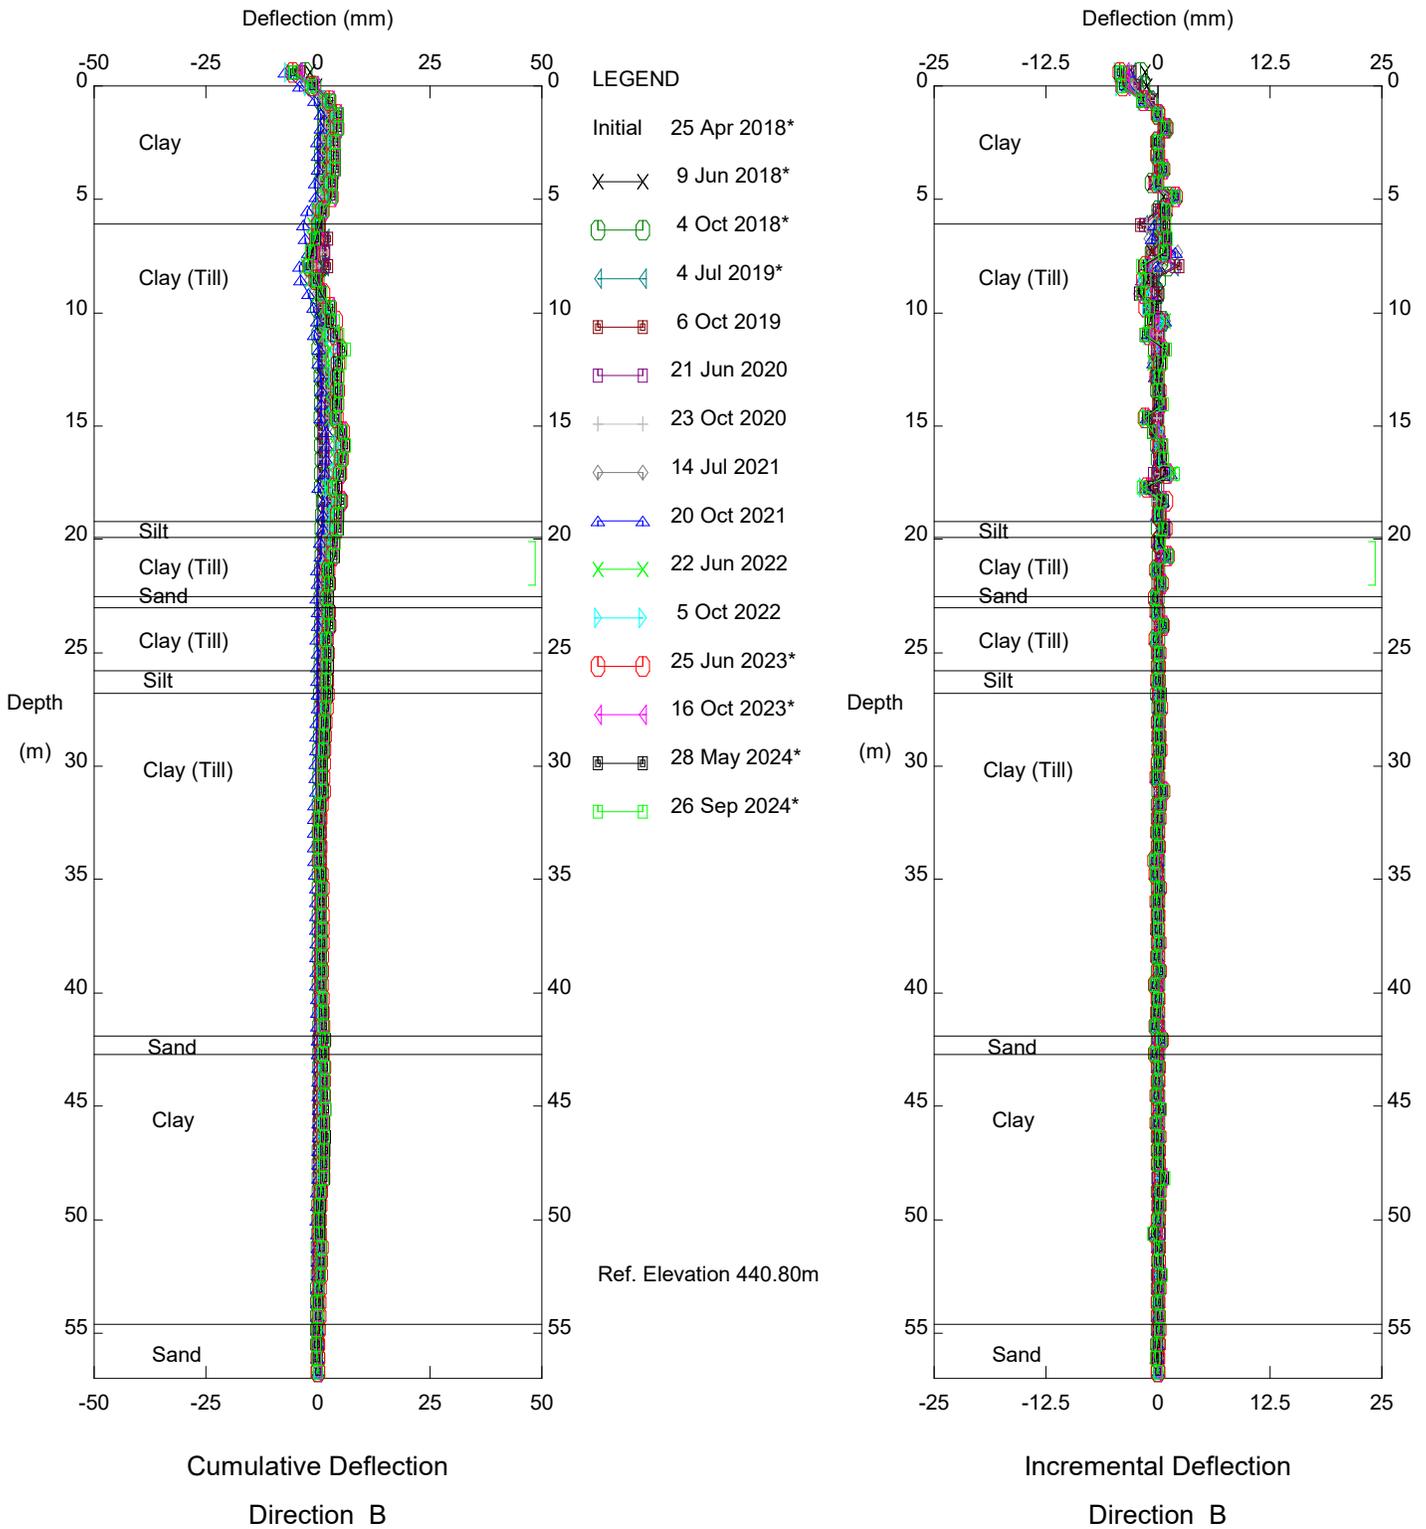
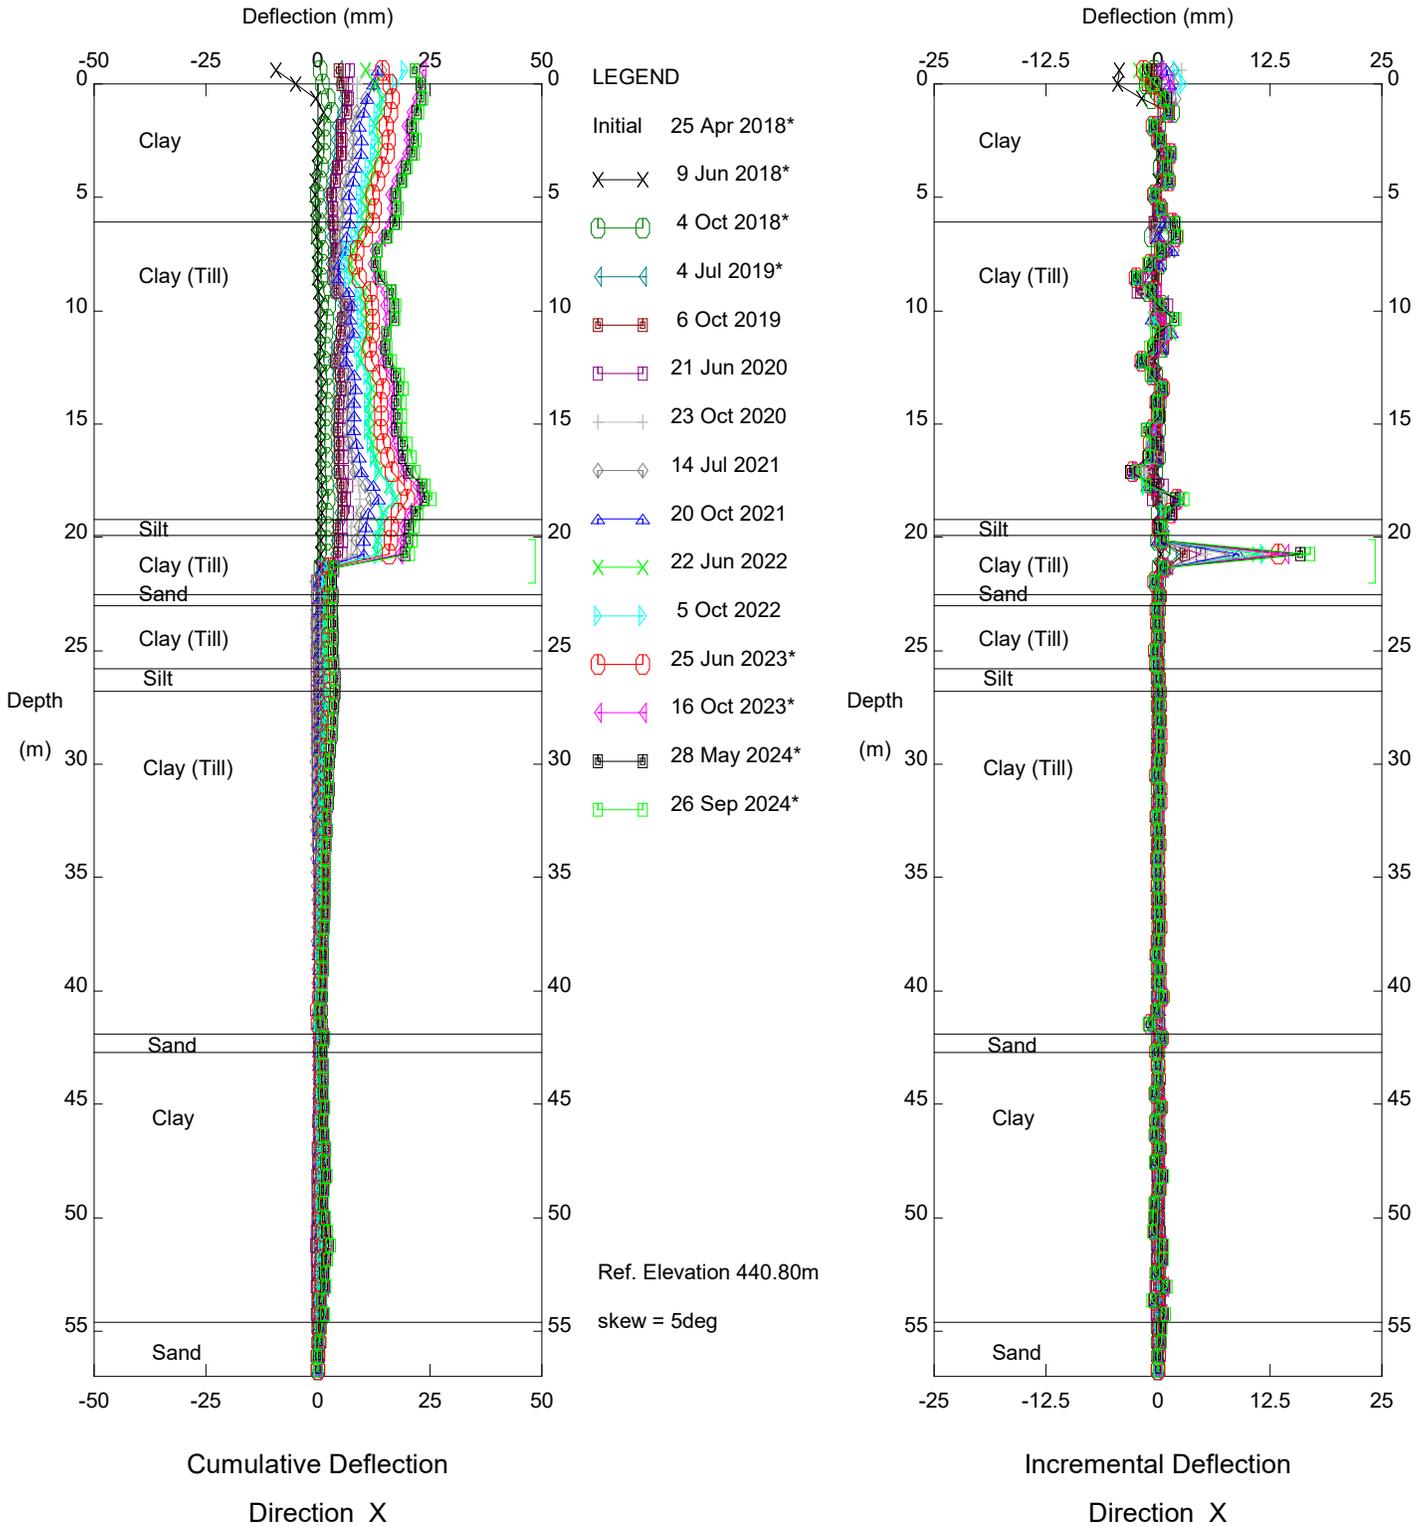
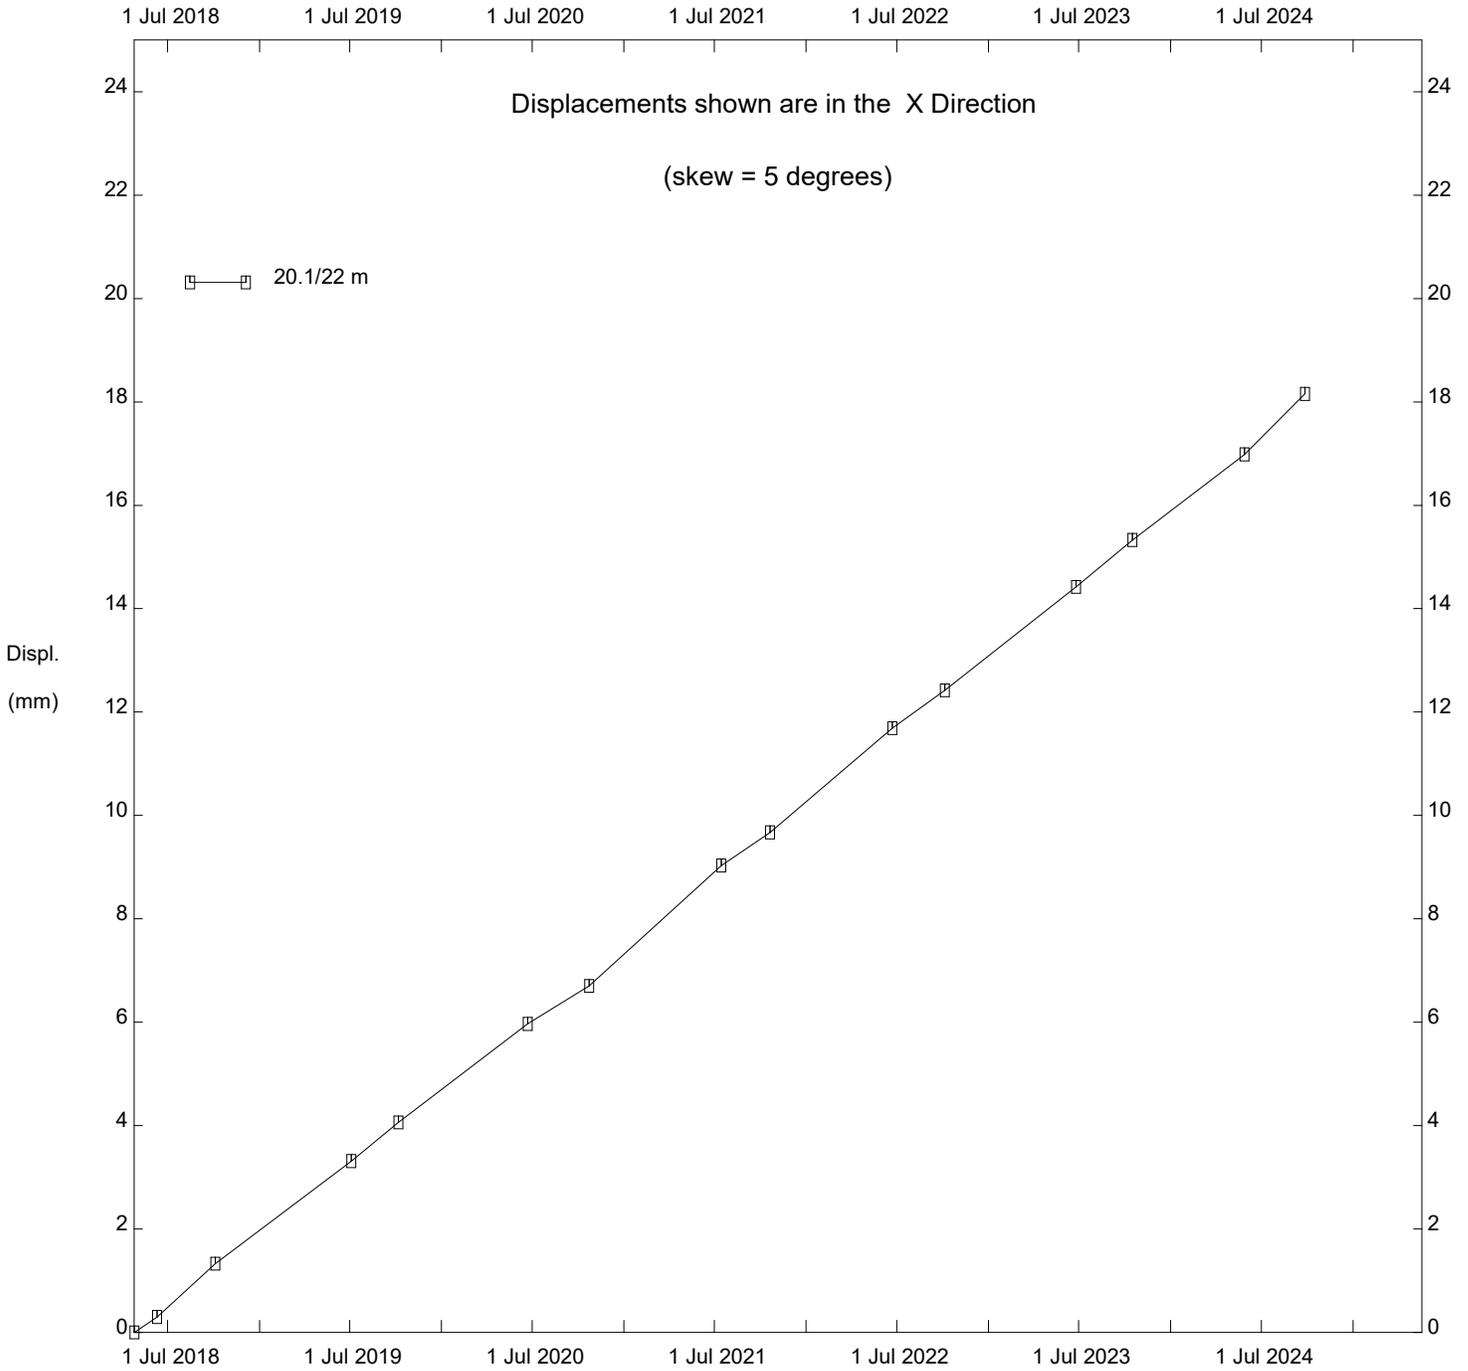
HWY 2:68 (PH037), Inclinometer SI18-9

SI18-9 is about 35 m west of the highway and showed a rate of movement of 3.5 mm/yr along a well-defined shear plane over 20.1 m to 22.0 m depth in a clay till layer.
