**ALBERTA TRANSPORTATION AND
ECONOMIC CORRIDORS GRMP
PEACE REGION
(GRANDE PRAIRIE DISTRICT - NORTH)
INSTRUMENTATION MONITORING - FALL 2024**

Site Number	Location	Name	Hwy	km
PH037	Station 1+250 to 2+000	Dunvegan South	2:68	Km 15.7
Legal Description: 4-7-80-4 W6		UTM Co-ordinates		
		11U E 398593.62	N	6197597.09

Current Monitoring:	28-May-2024	Previous Monitoring	28-May-2024
Instruments Read By:	Mr. Neil McDonald and Mr. Nixson Mationg of Thurber

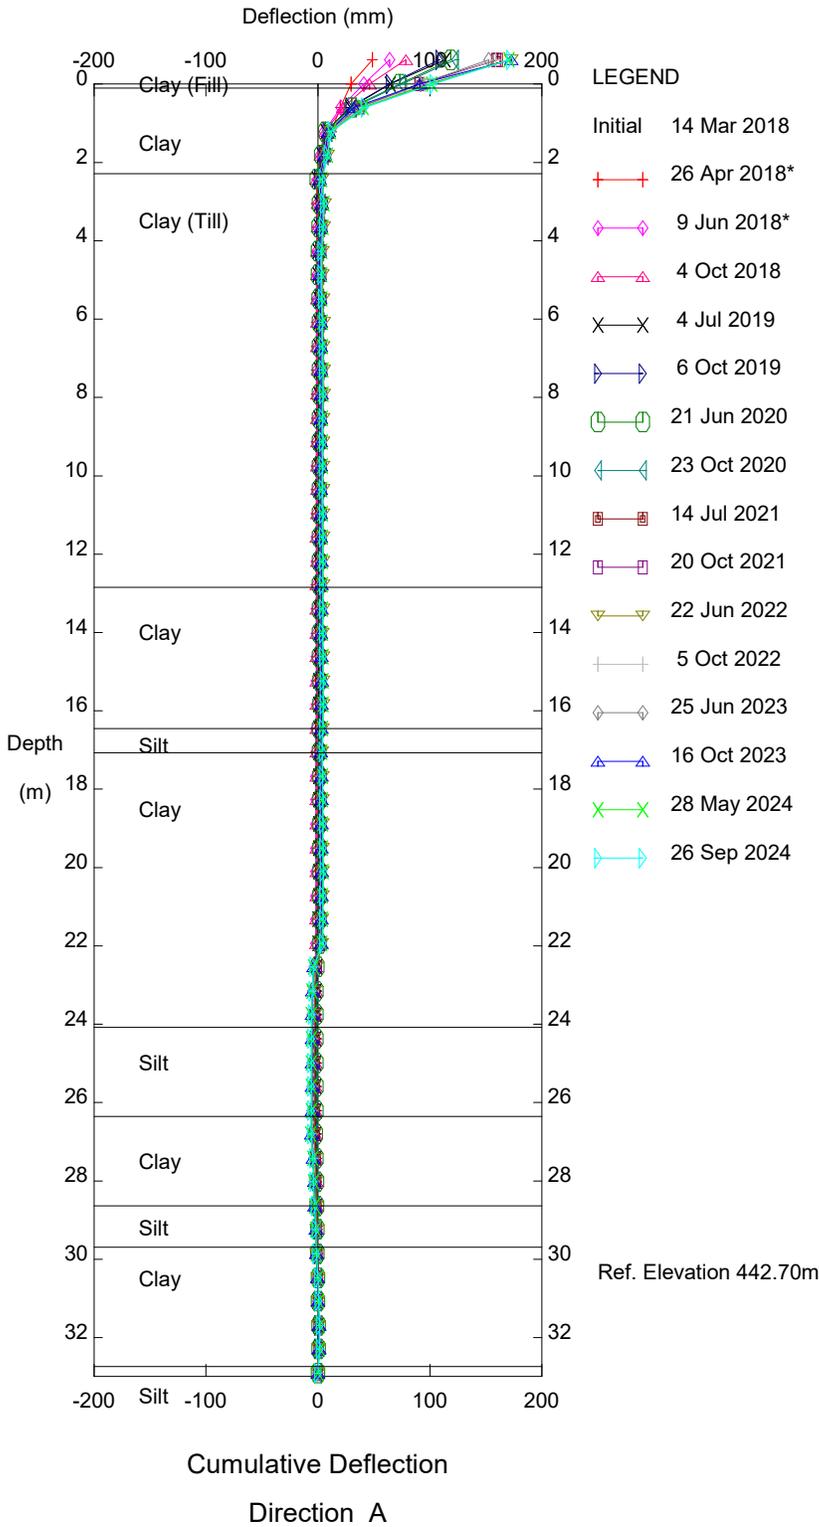
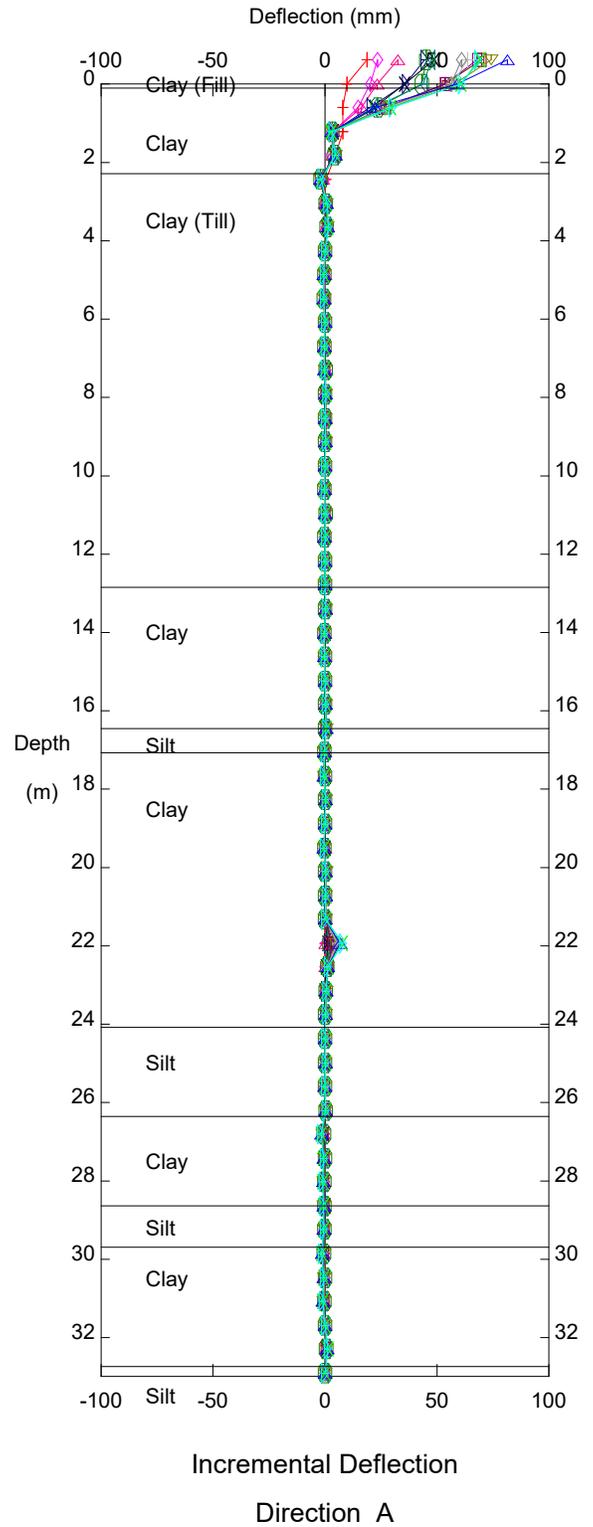
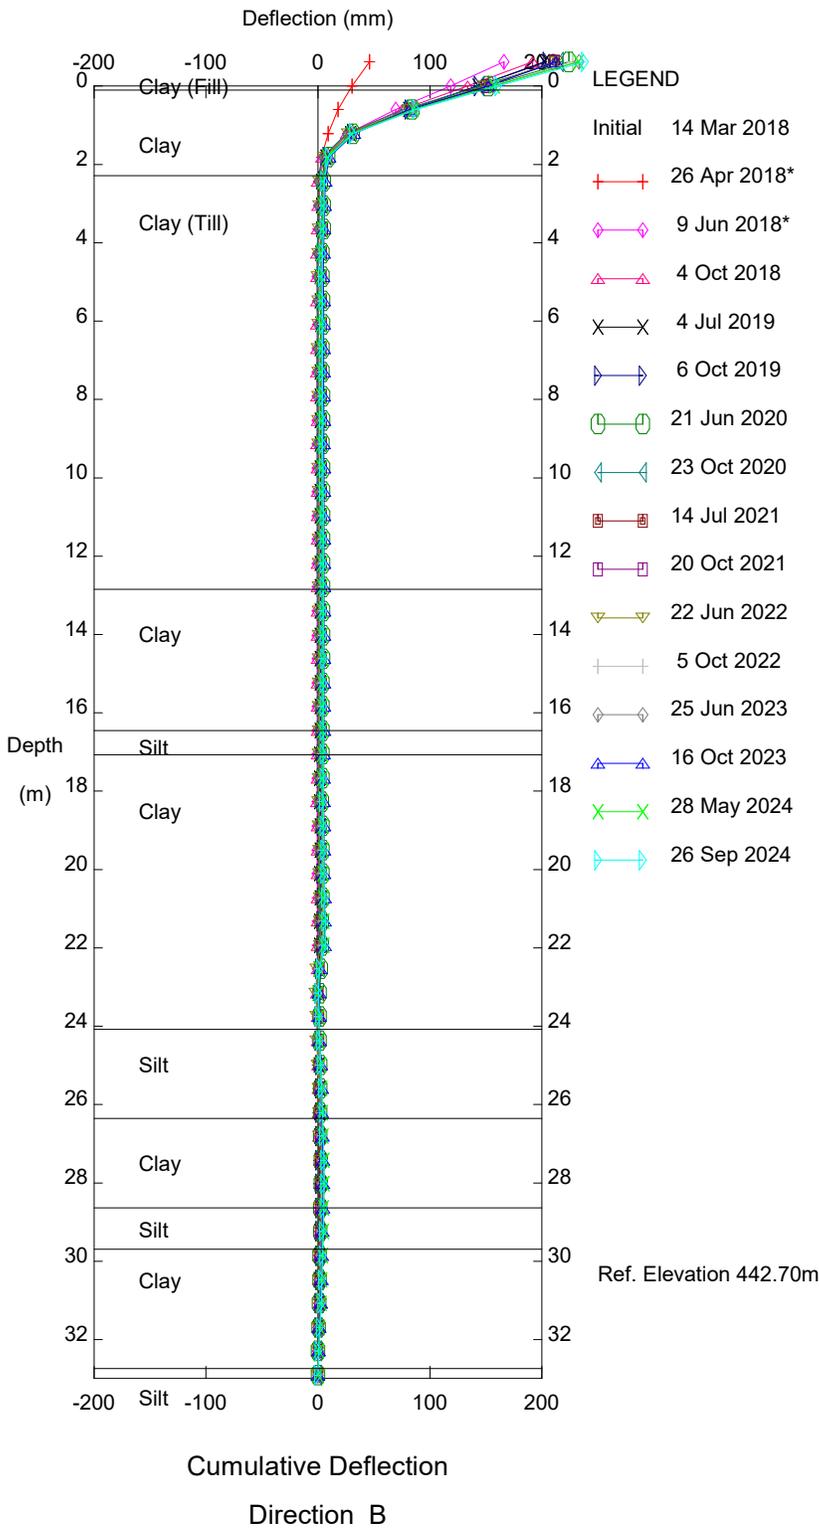
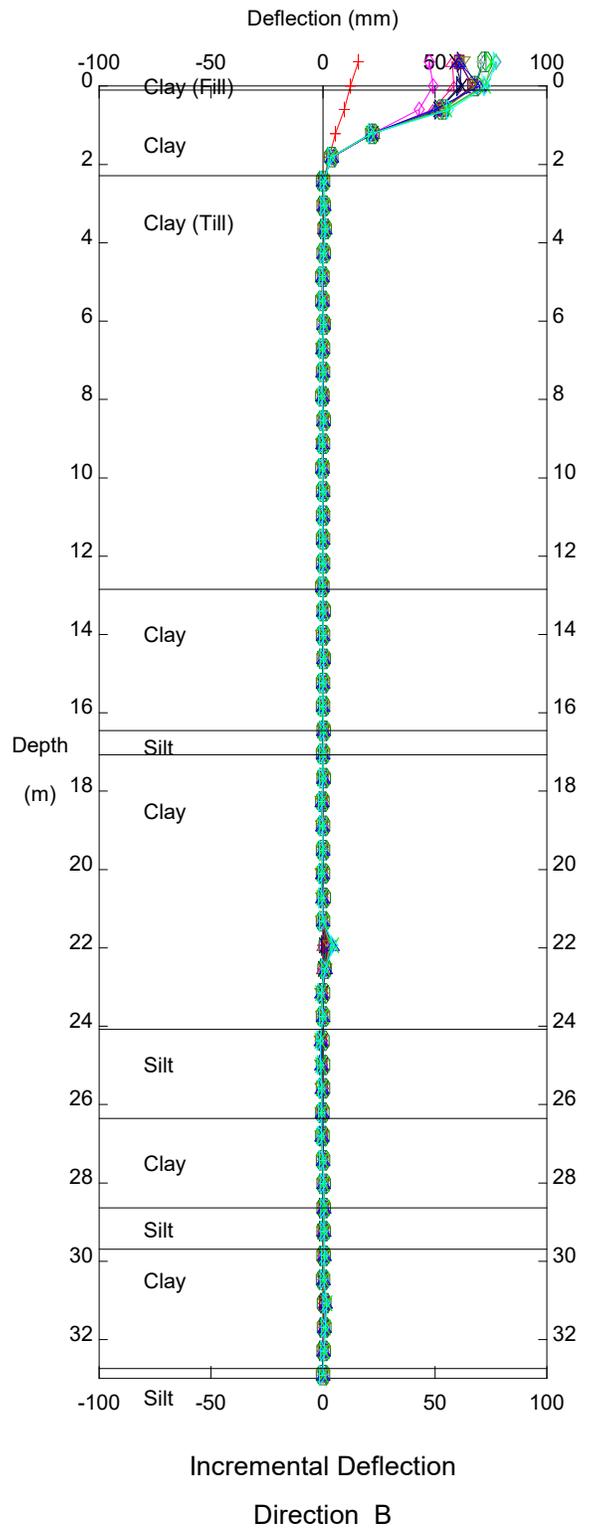
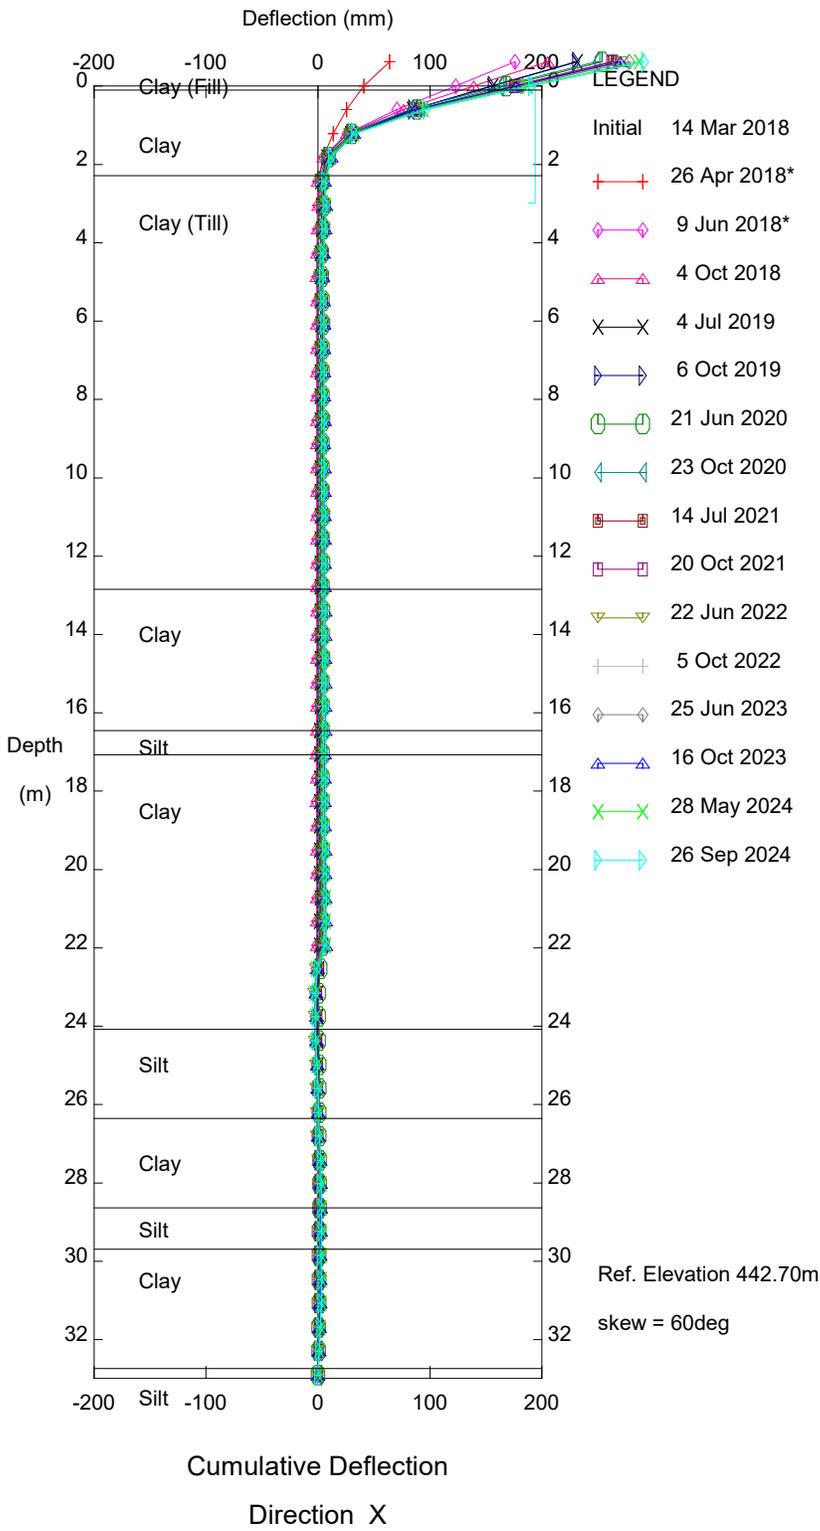
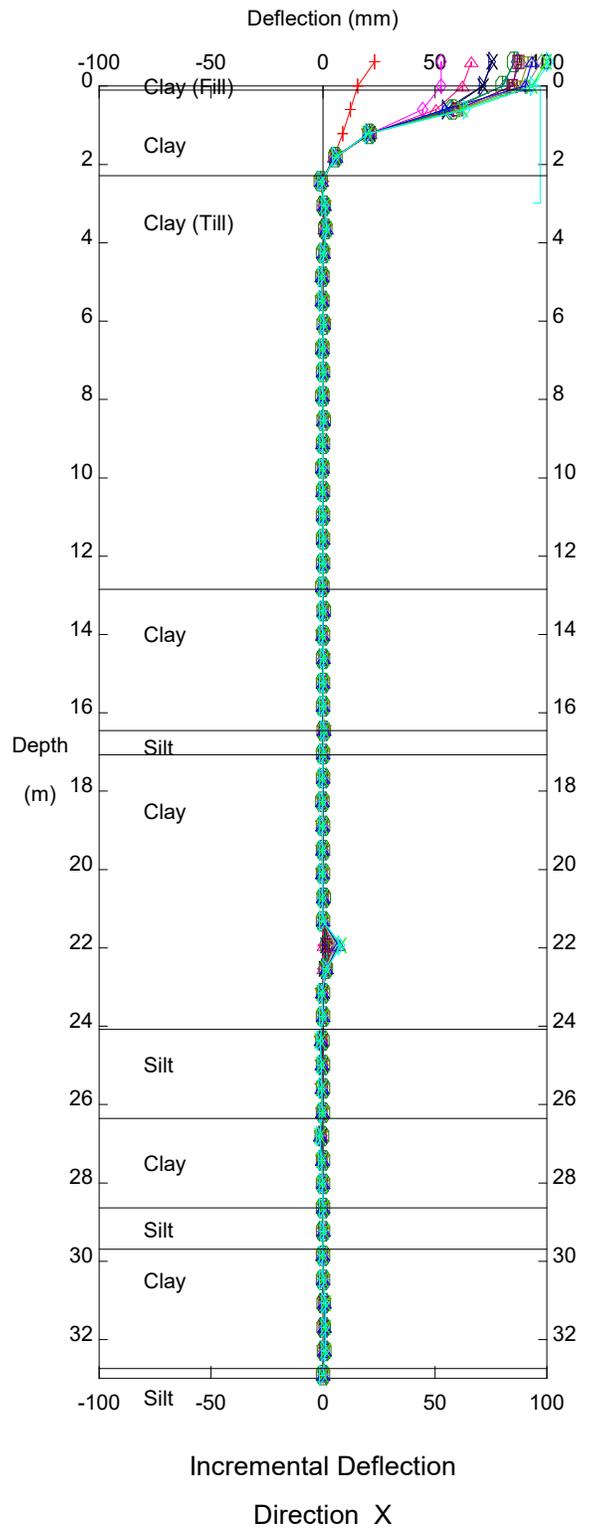
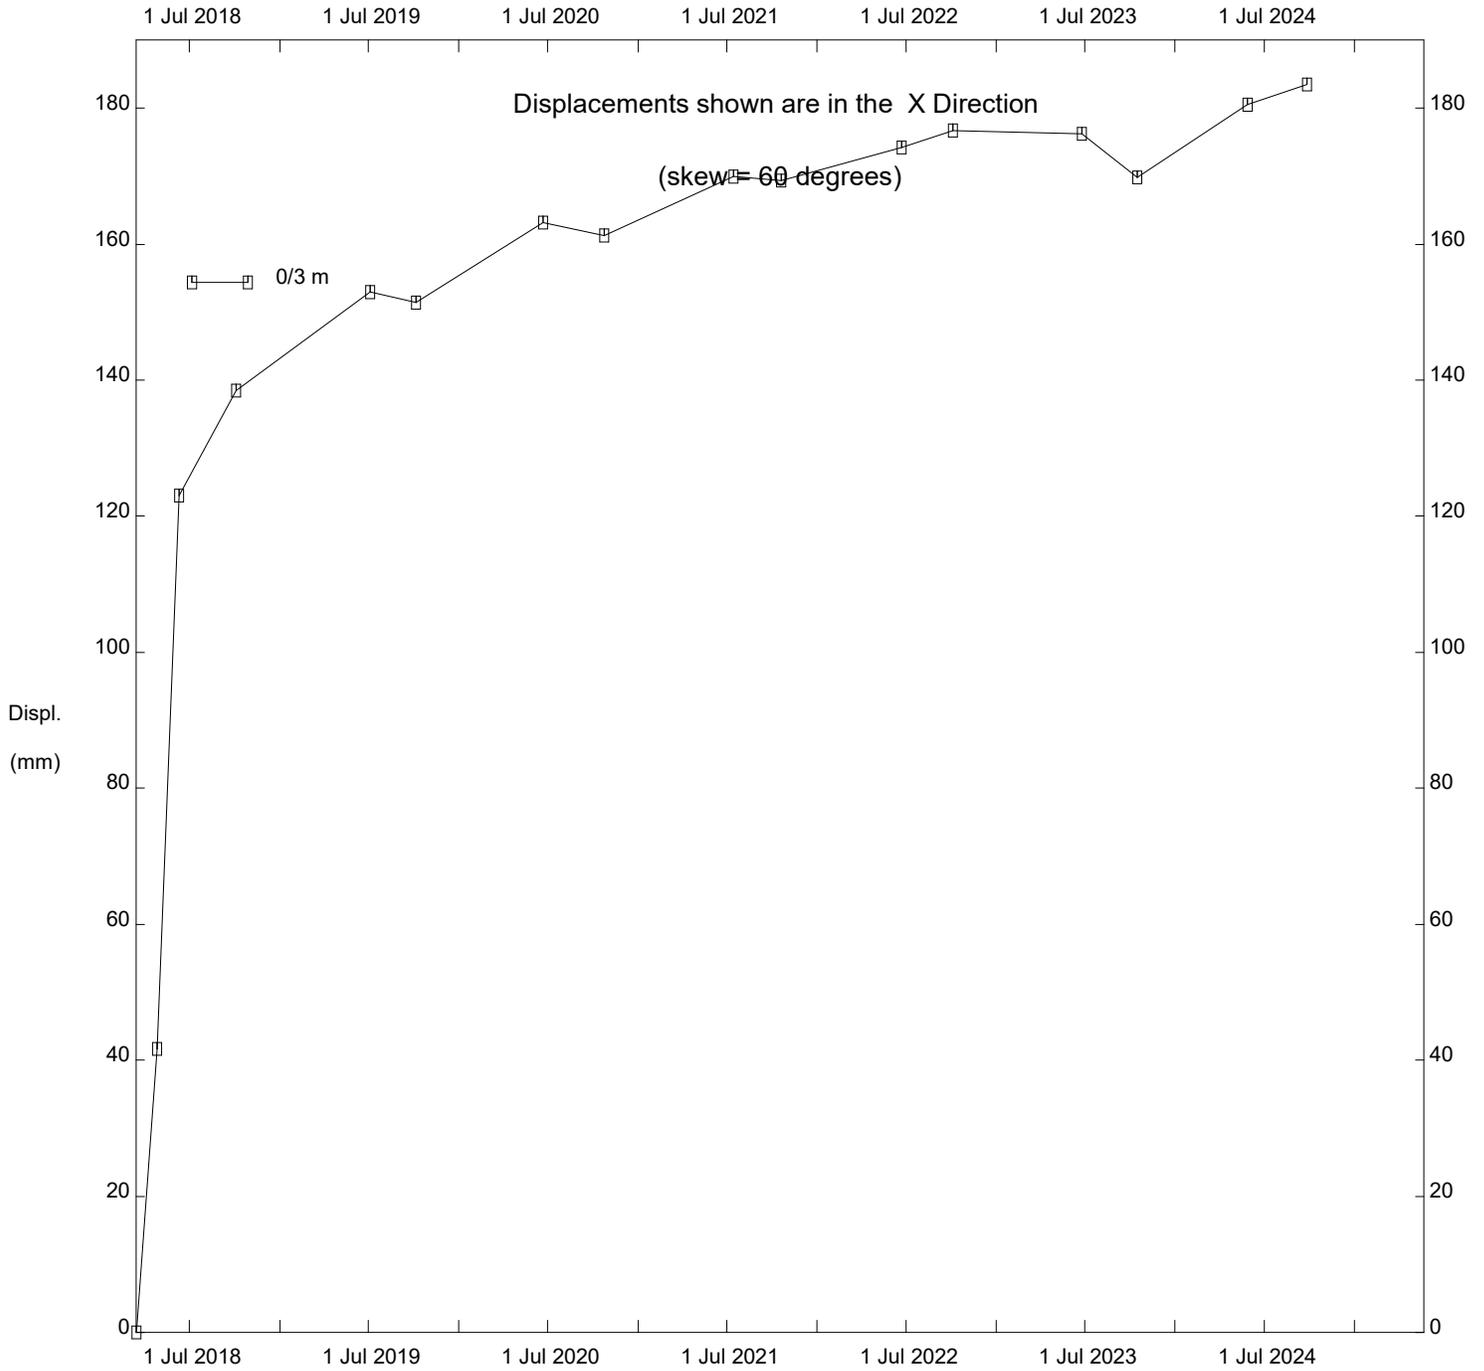
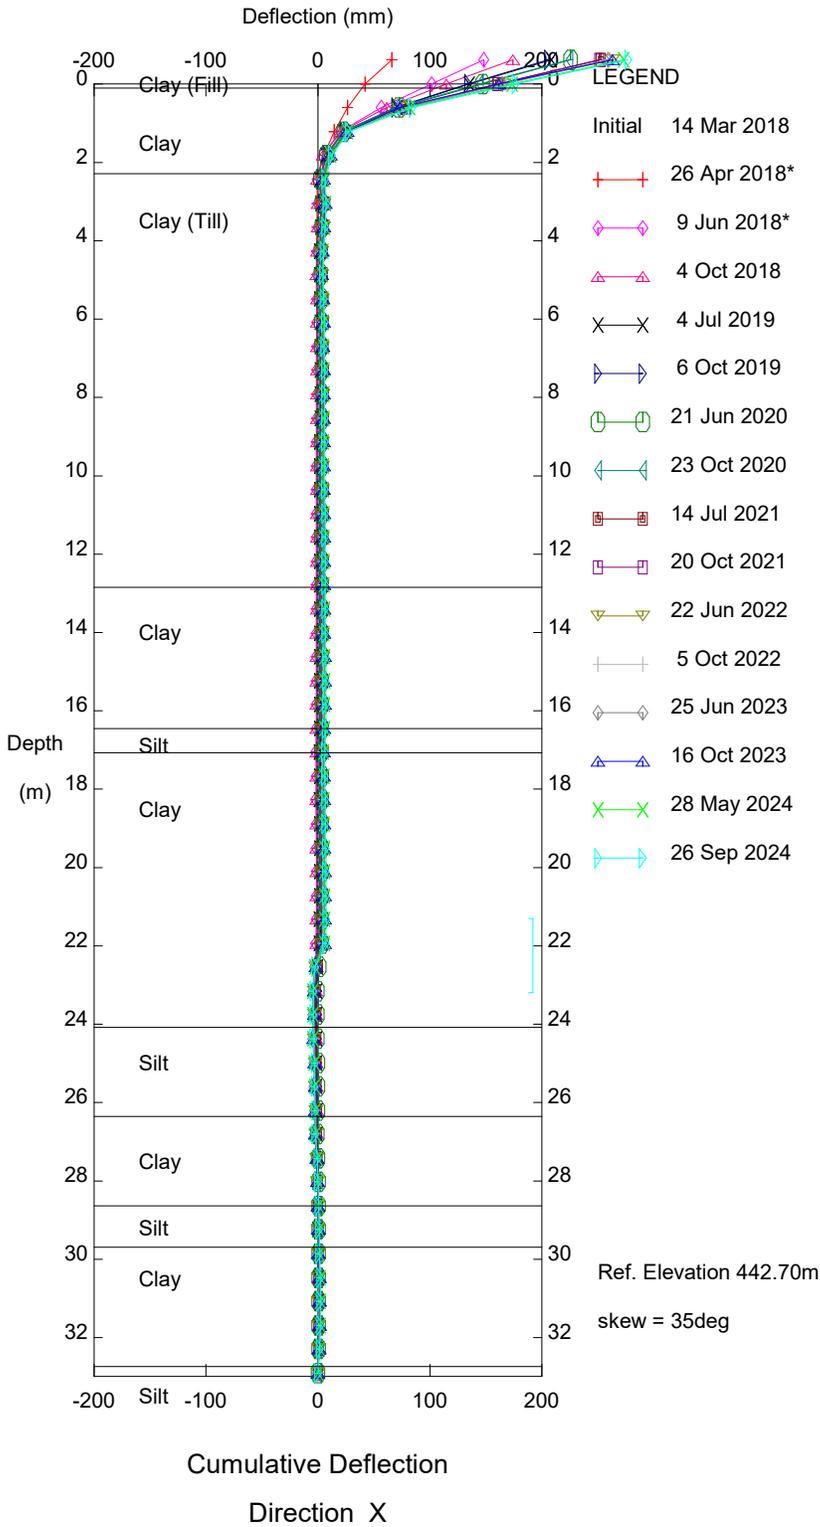
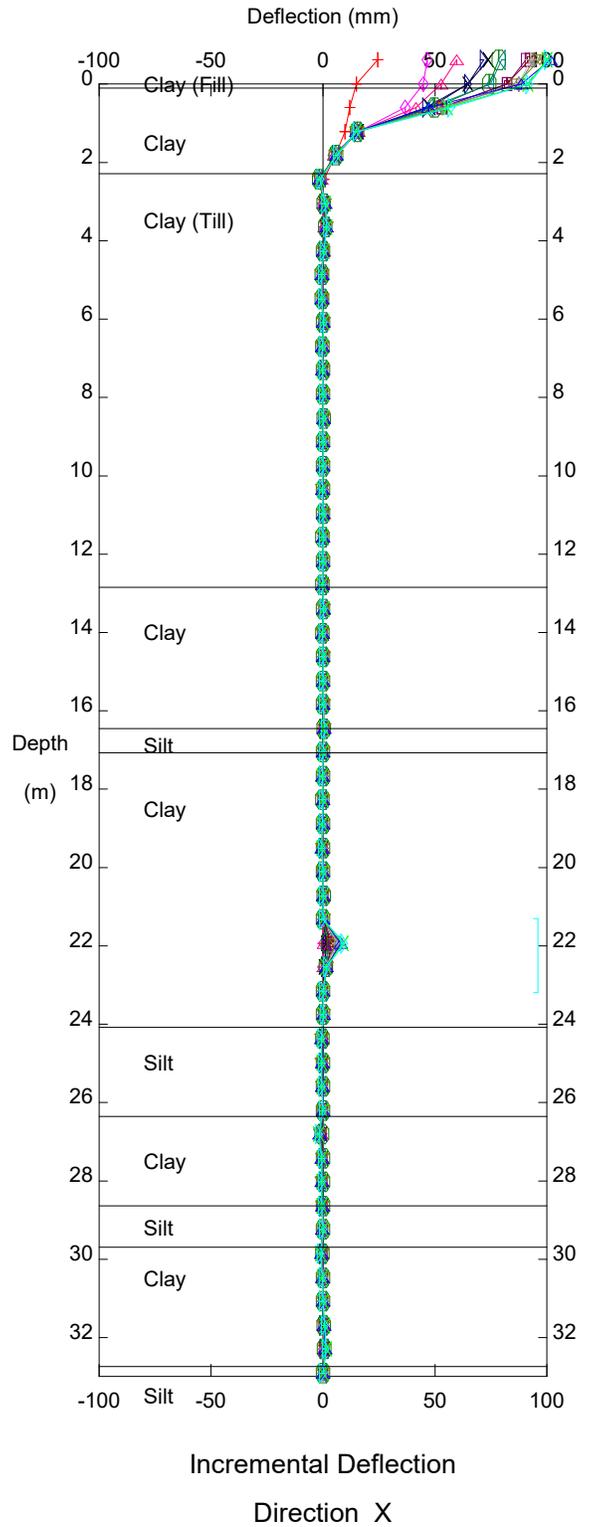
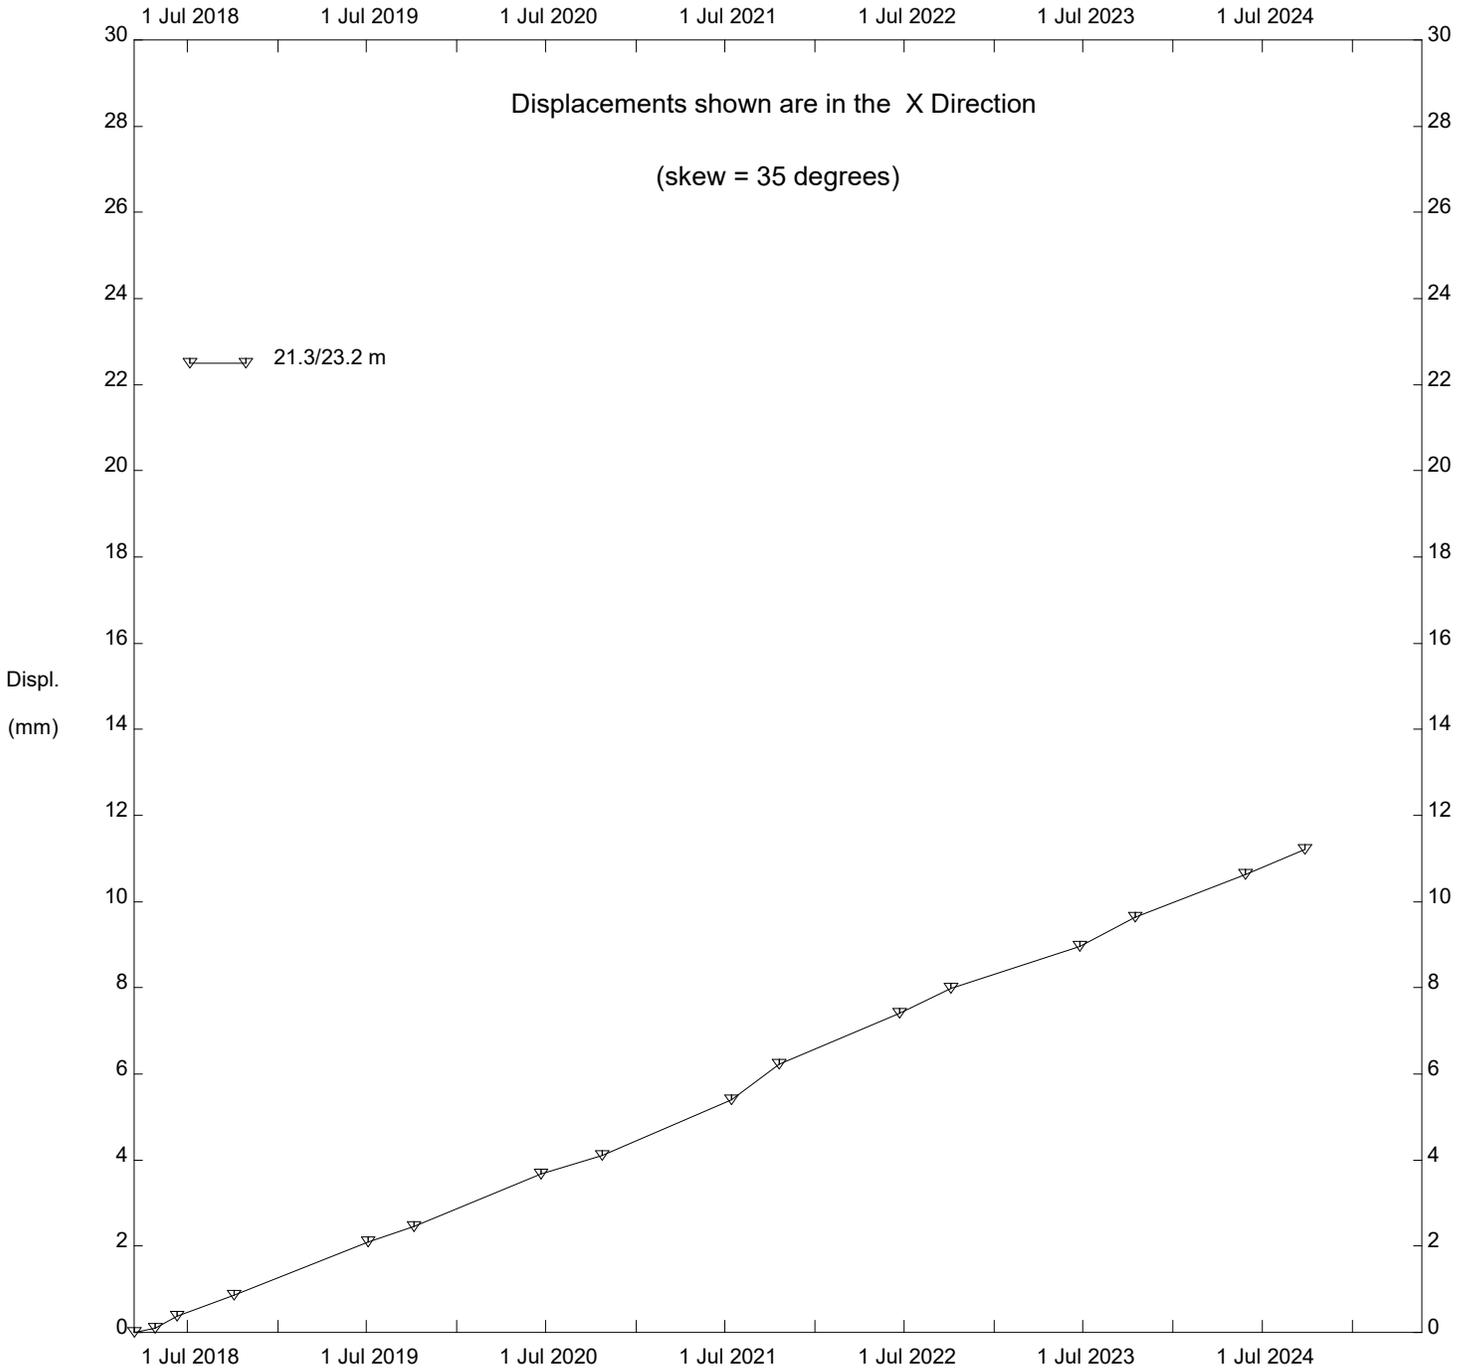
HWY 2:68 (PH037), Inclinator SI18-10

SI18-10 is just west of the highway and showed a rate of movement of 9.0 mm/yr over 0 m to 3.0 m depth and a rate of movement of 1.8 mm/yr over 21.3 m to 23.2 m depth. The upper shear zone is tilting within a clay layer while the lower zone is a slowly developing distinct shear within a different clay layer.

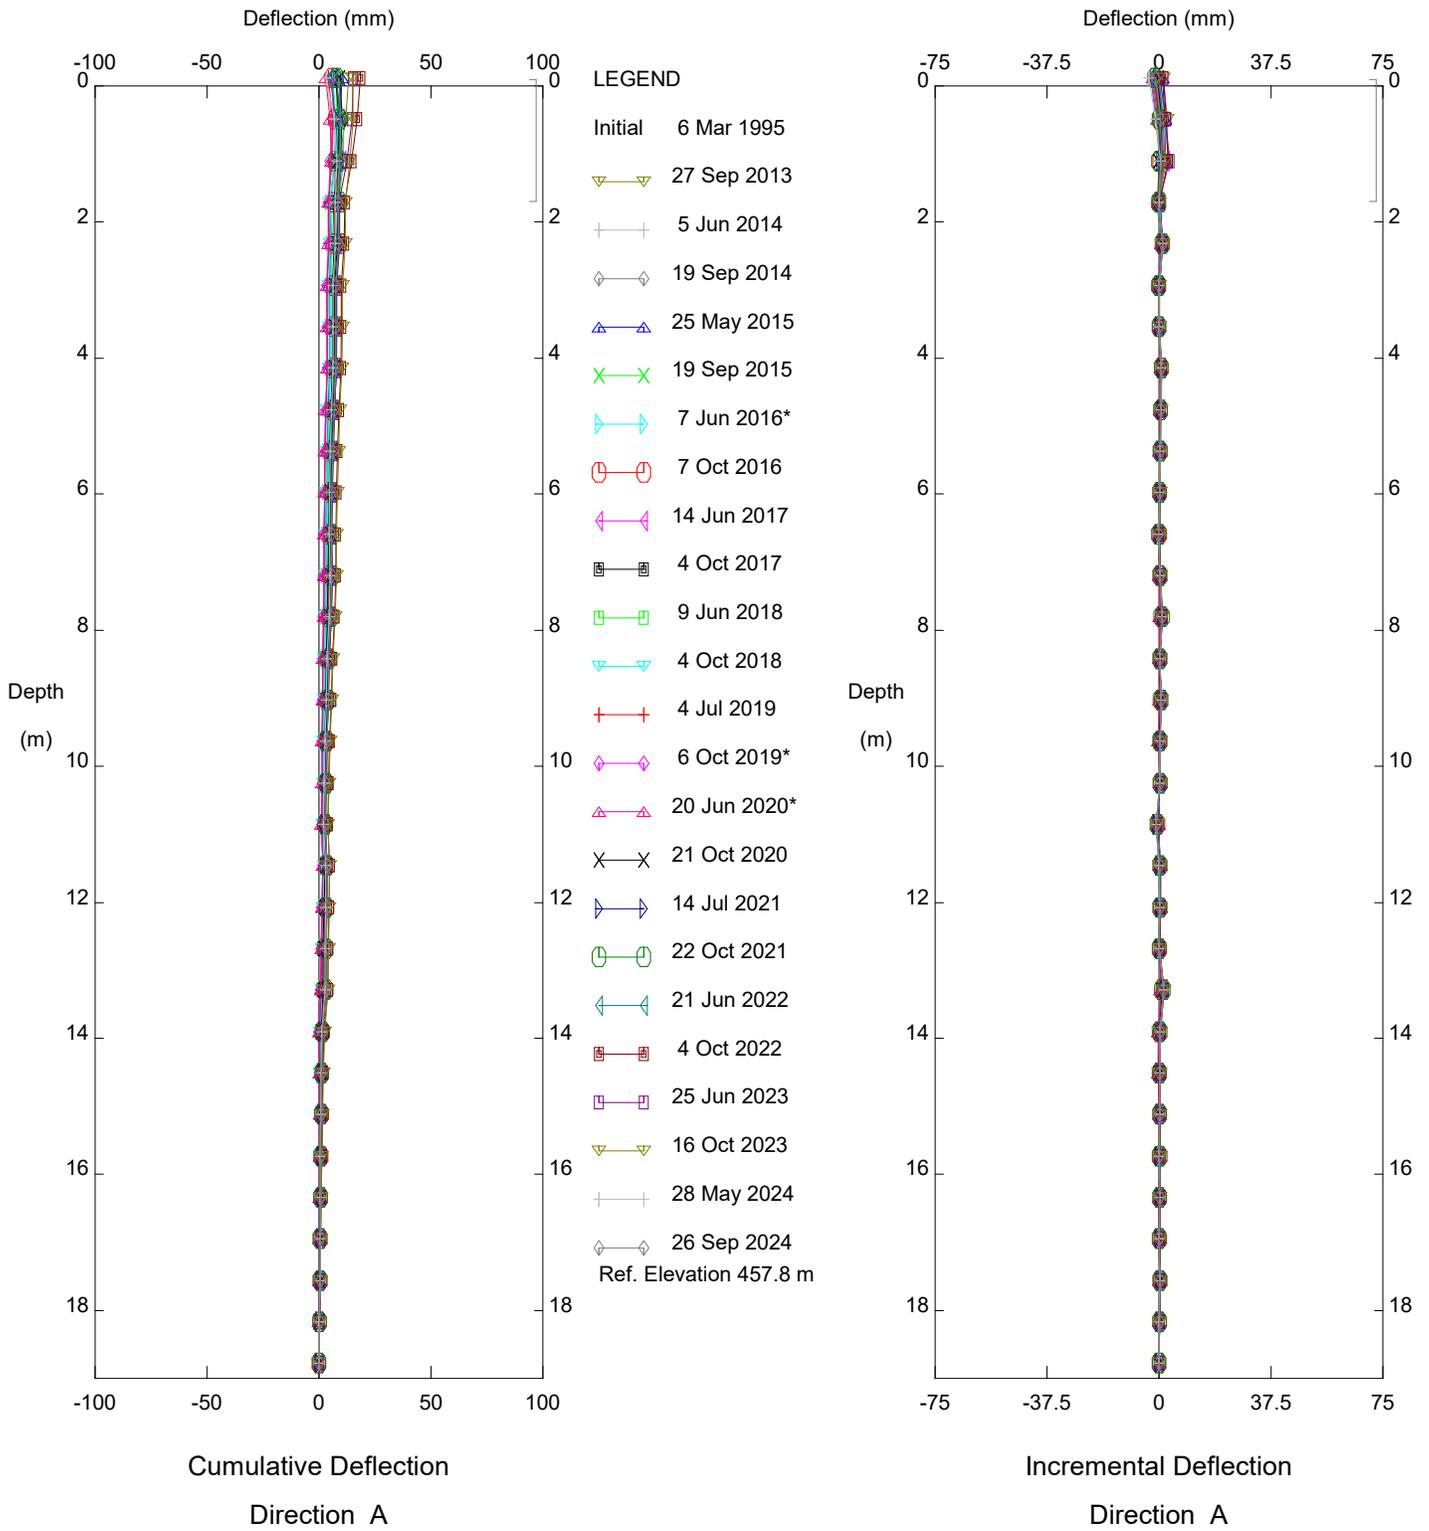
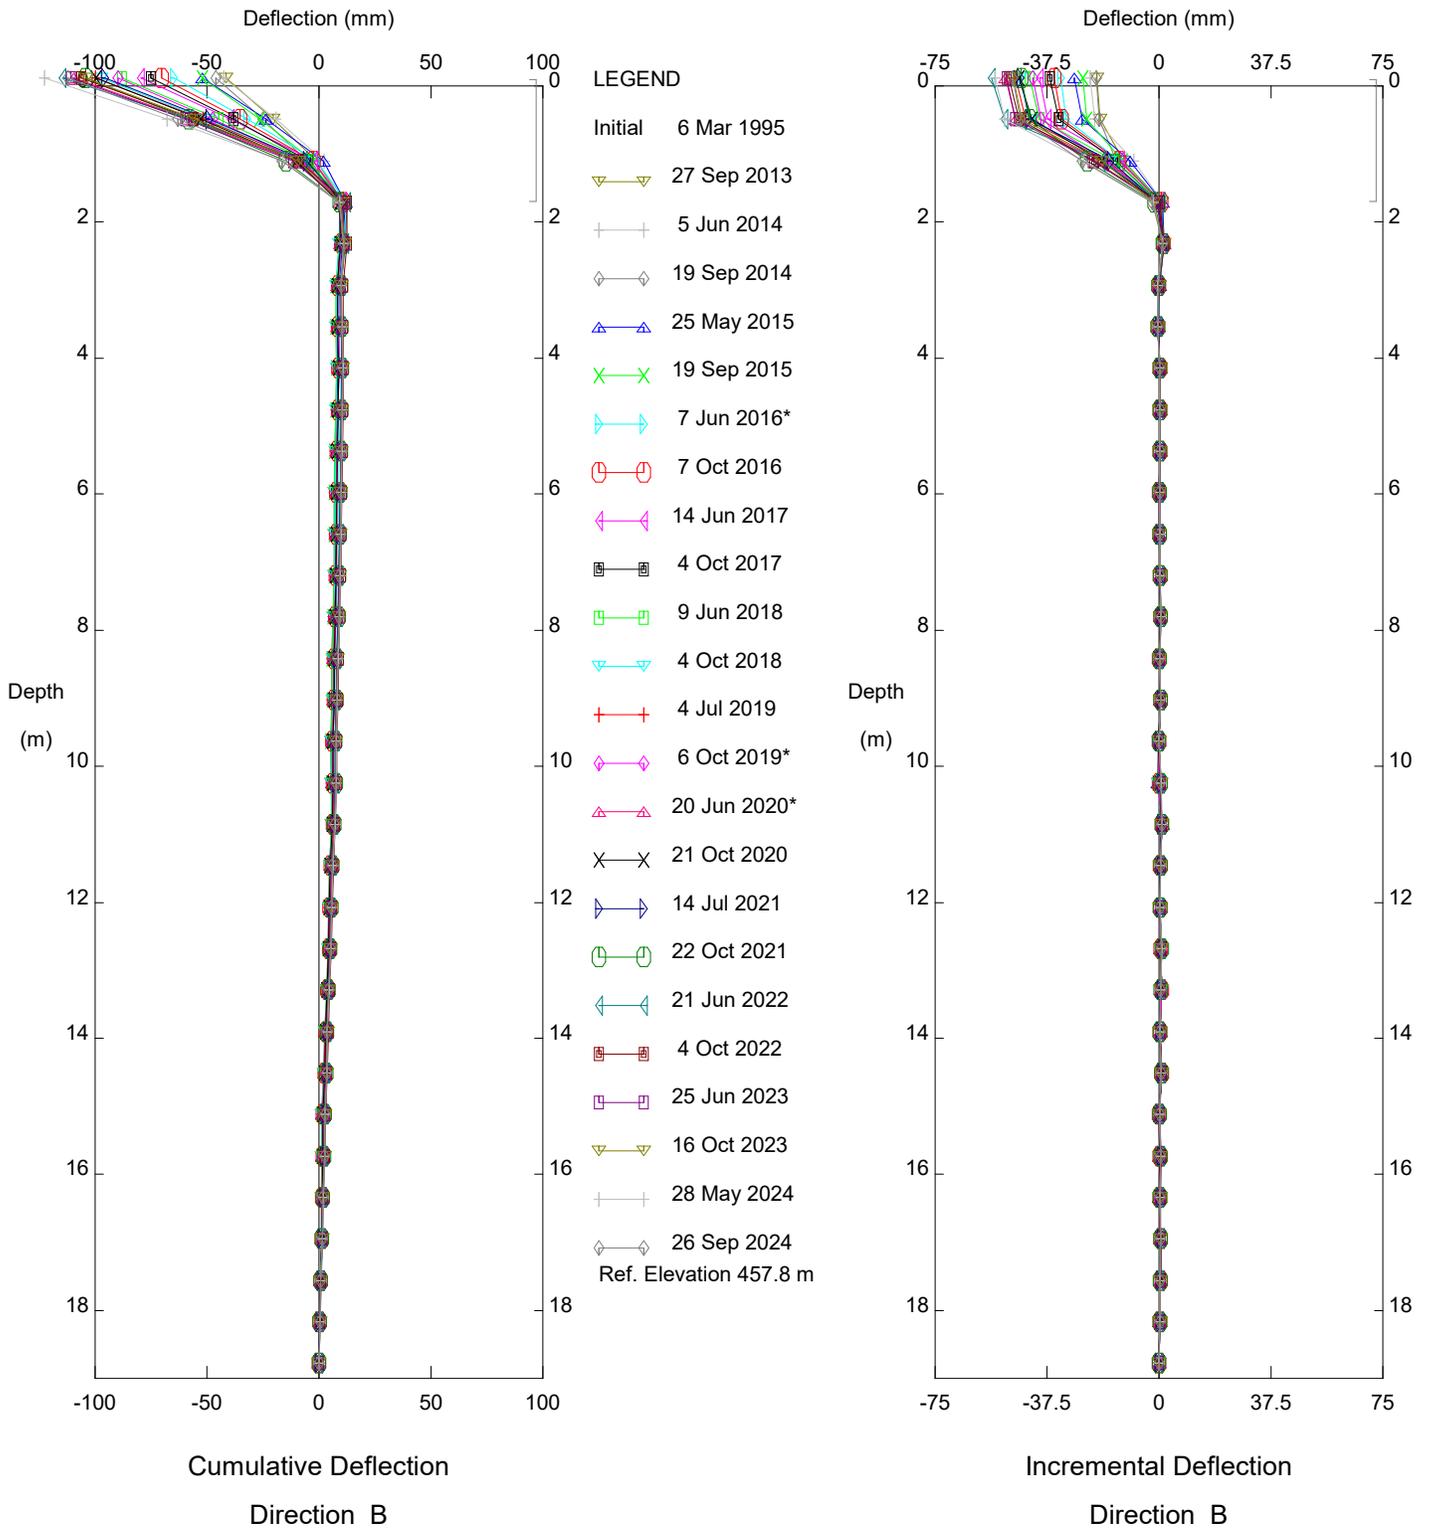
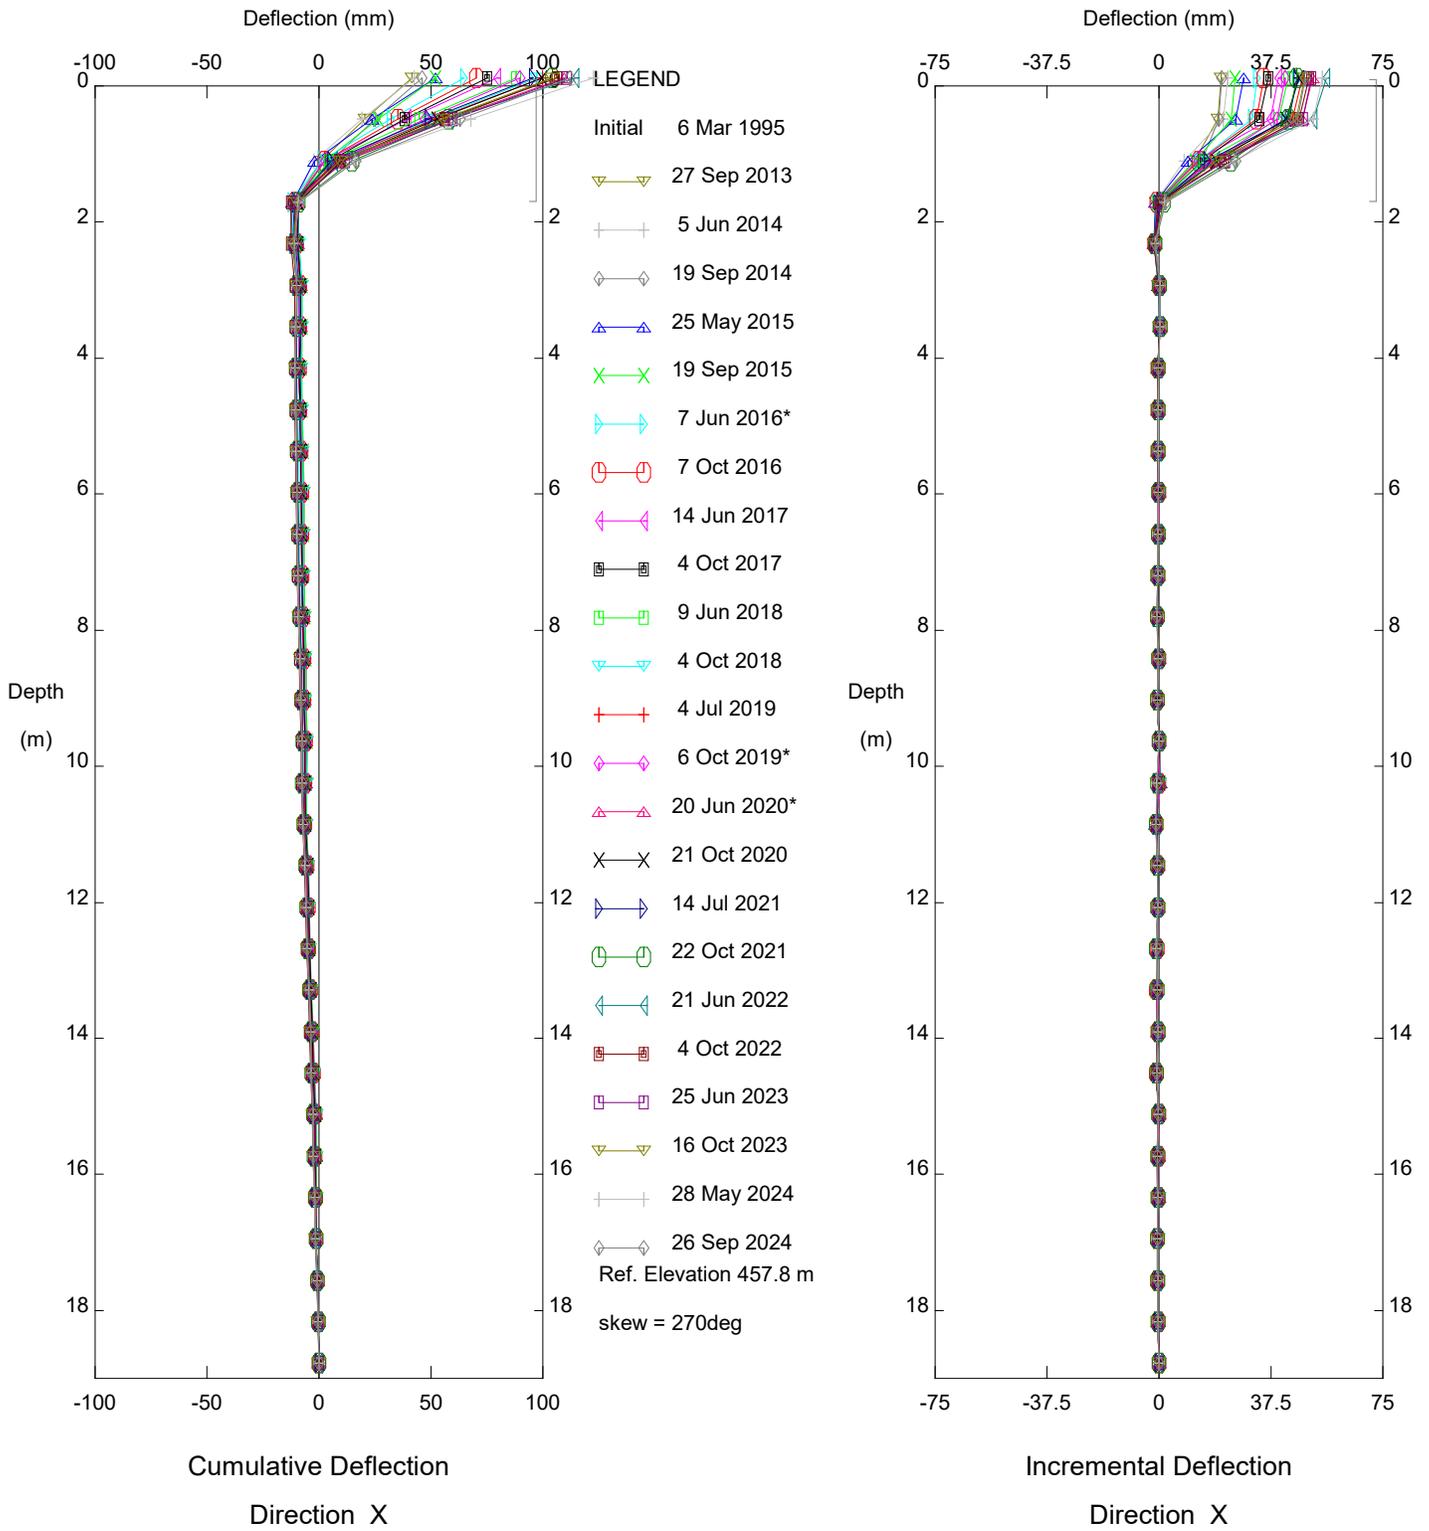
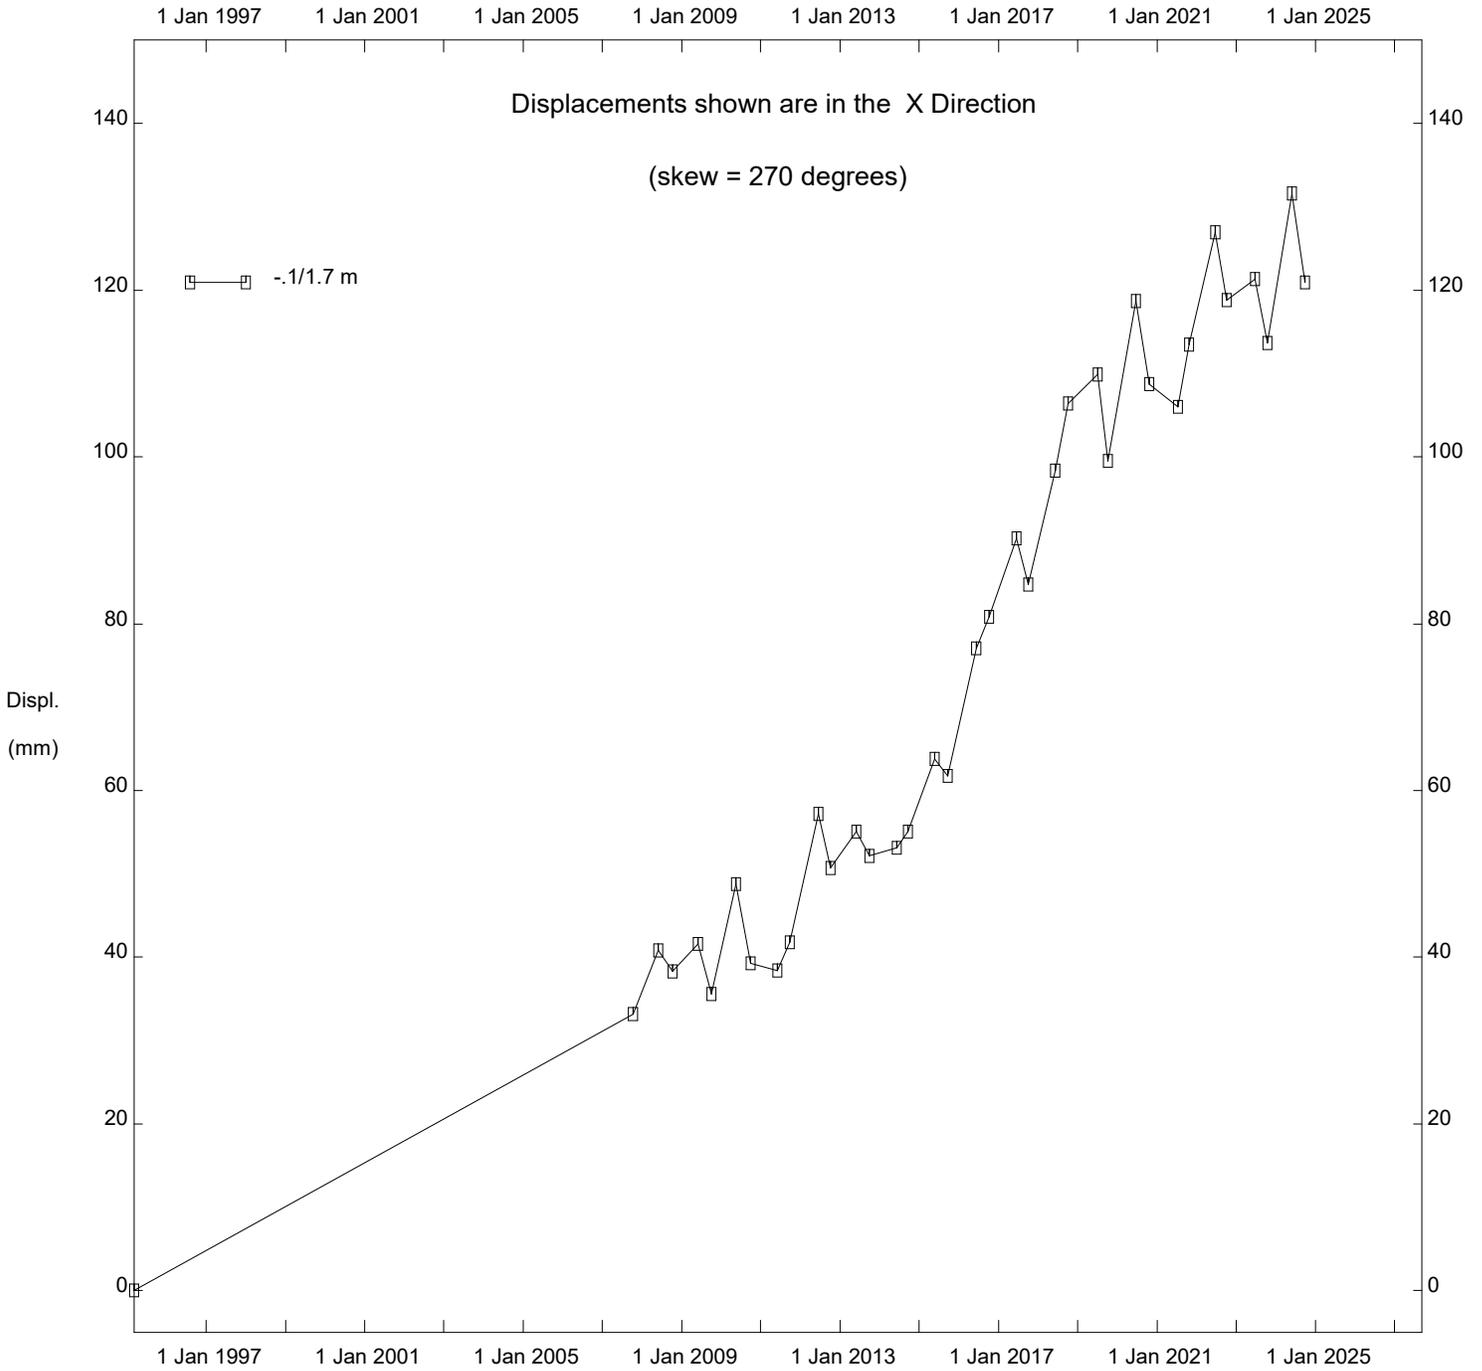
HWY 2:68 (PH037), Inclinometer SI-54

Slope inclinometer SI-54 is about 70 m east of the highway and showed no discernible new movement over 0 m to 1.7 m depth since the spring of 2024 readings, which corresponds to a decrease in rate of movement of 61.1 mm/yr. Of more significance with this slope indicator is the lack of observed shear zones below the near ground surface movement zone.
