**ALBERTA TRANSPORTATION AND
ECONOMIC CORRIDORS GRMP
PEACE REGION
(GRANDE PRAIRIE DISTRICT - NORTH)
INSTRUMENTATION MONITORING - FALL 2024**

Site Number	Location	Name	Hwy	km
PH037	Station 1+250 to 2+000	Dunvegan South	2:68	Km 15.7
Legal Description: 4-7-80-4 W6		UTM Co-ordinates		
		11U E 398593.62	N	6197597.09

Current Monitoring:	28-May-2024	Previous Monitoring	28-May-2024
Instruments Read By:	Mr. Neil McDonald and Mr. Nixson Mationg of Thurber

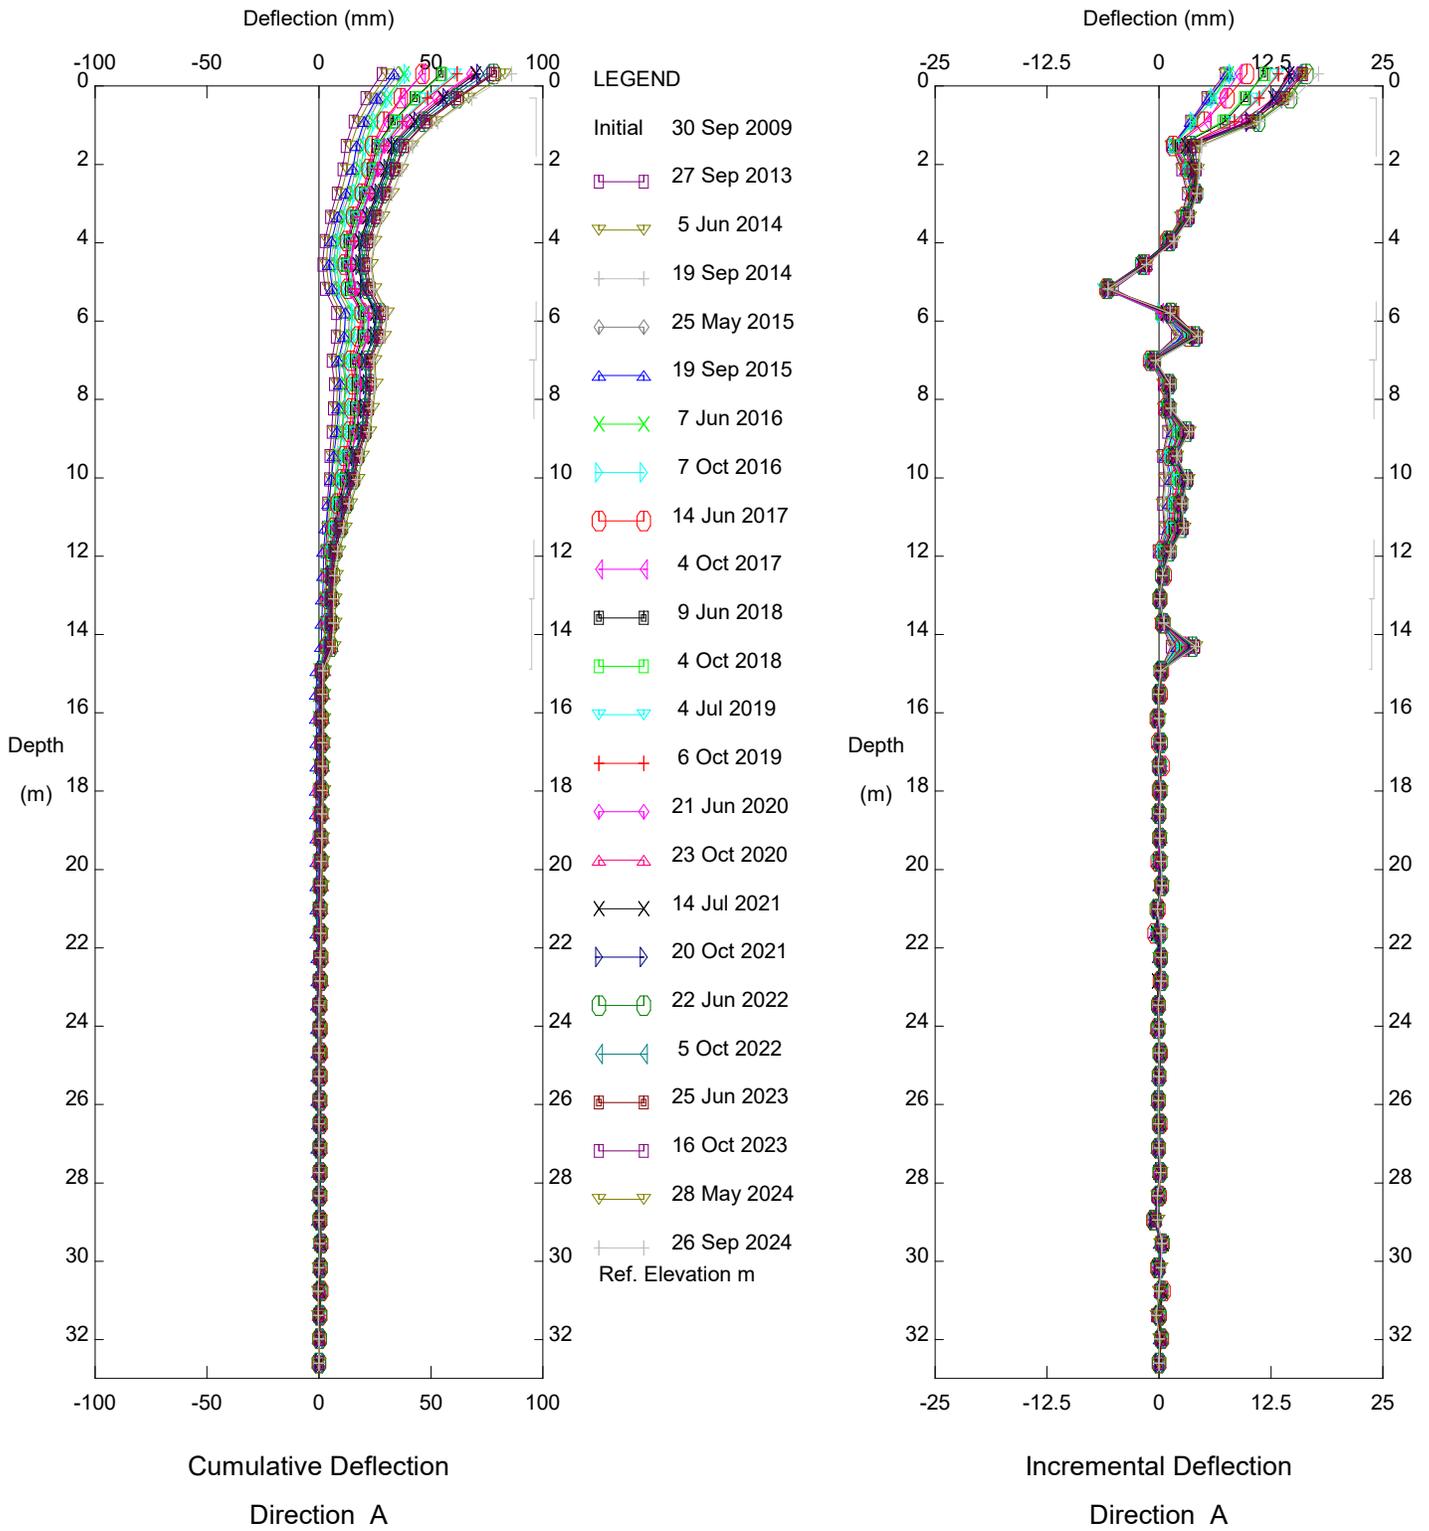
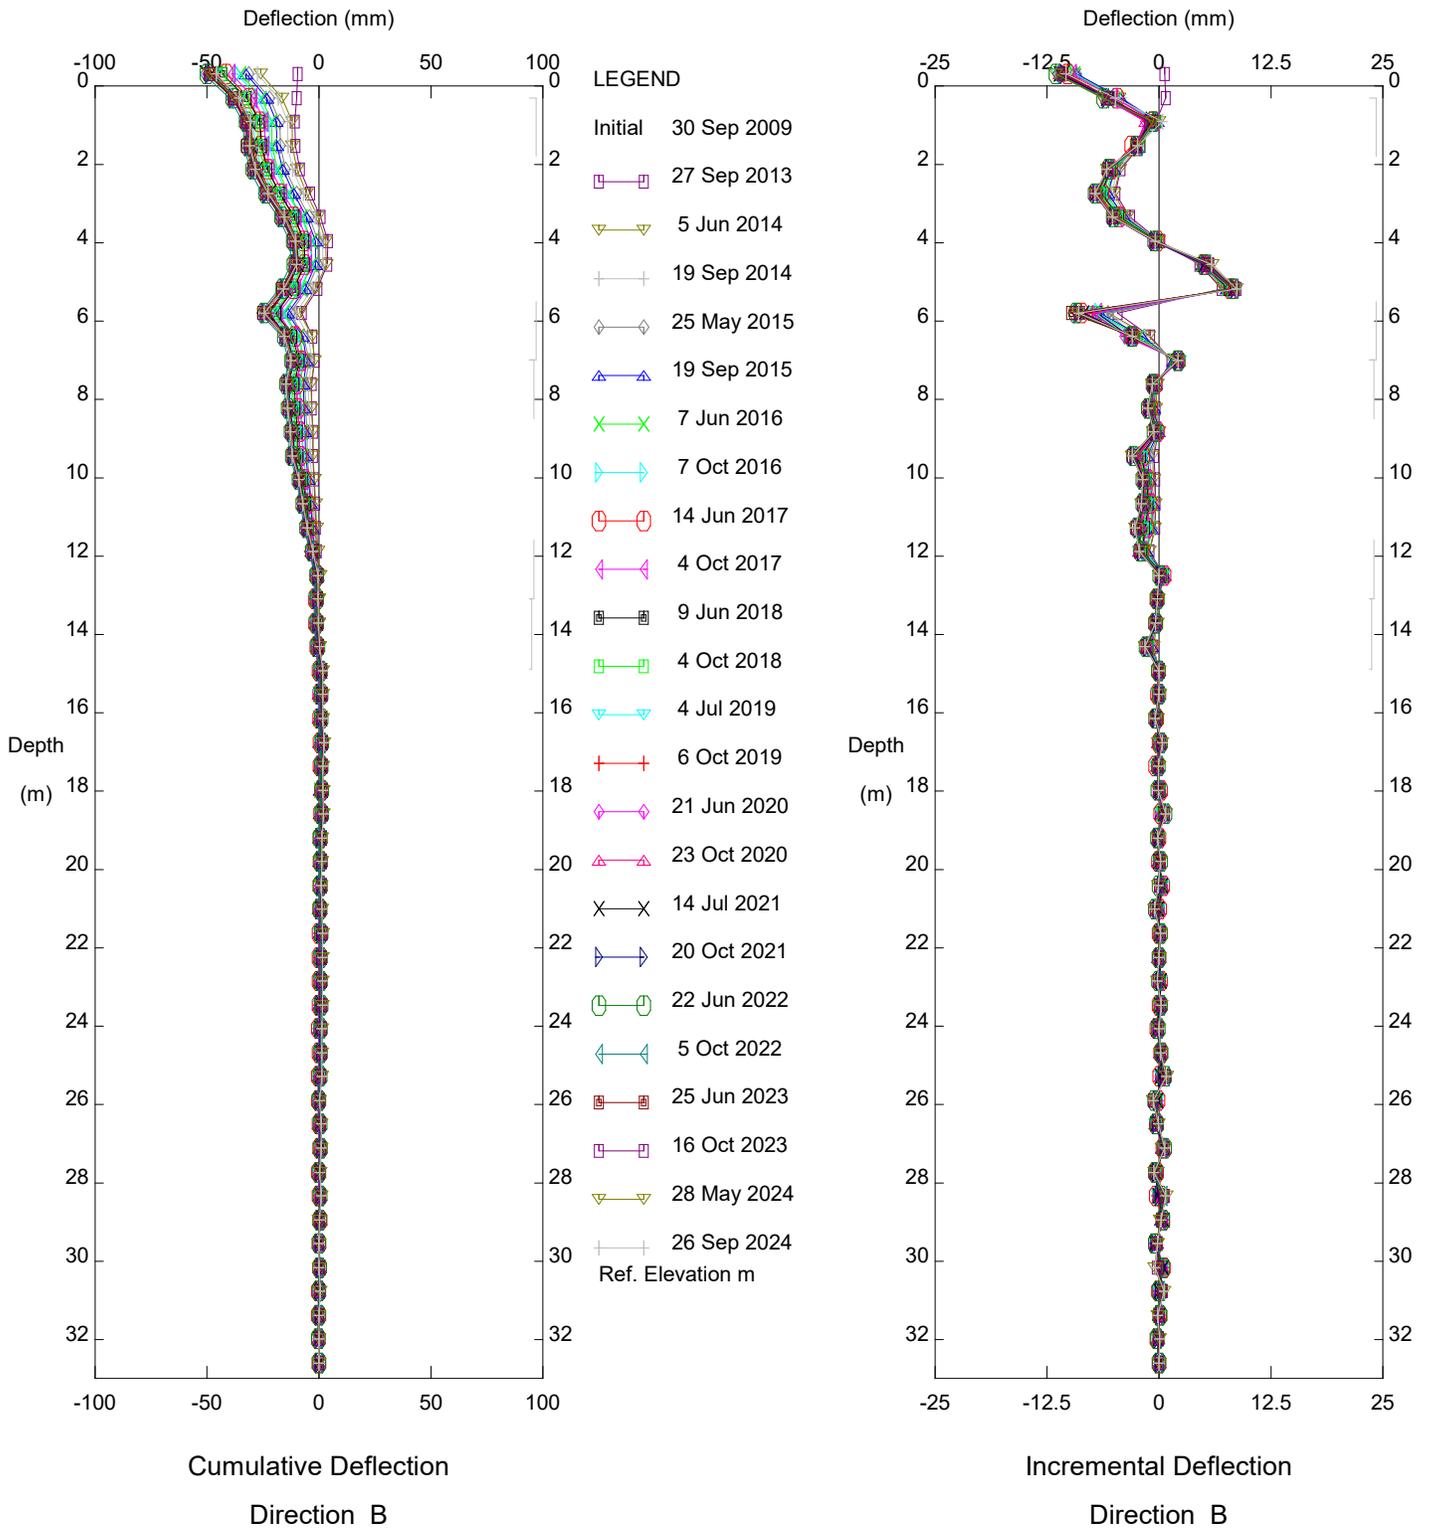
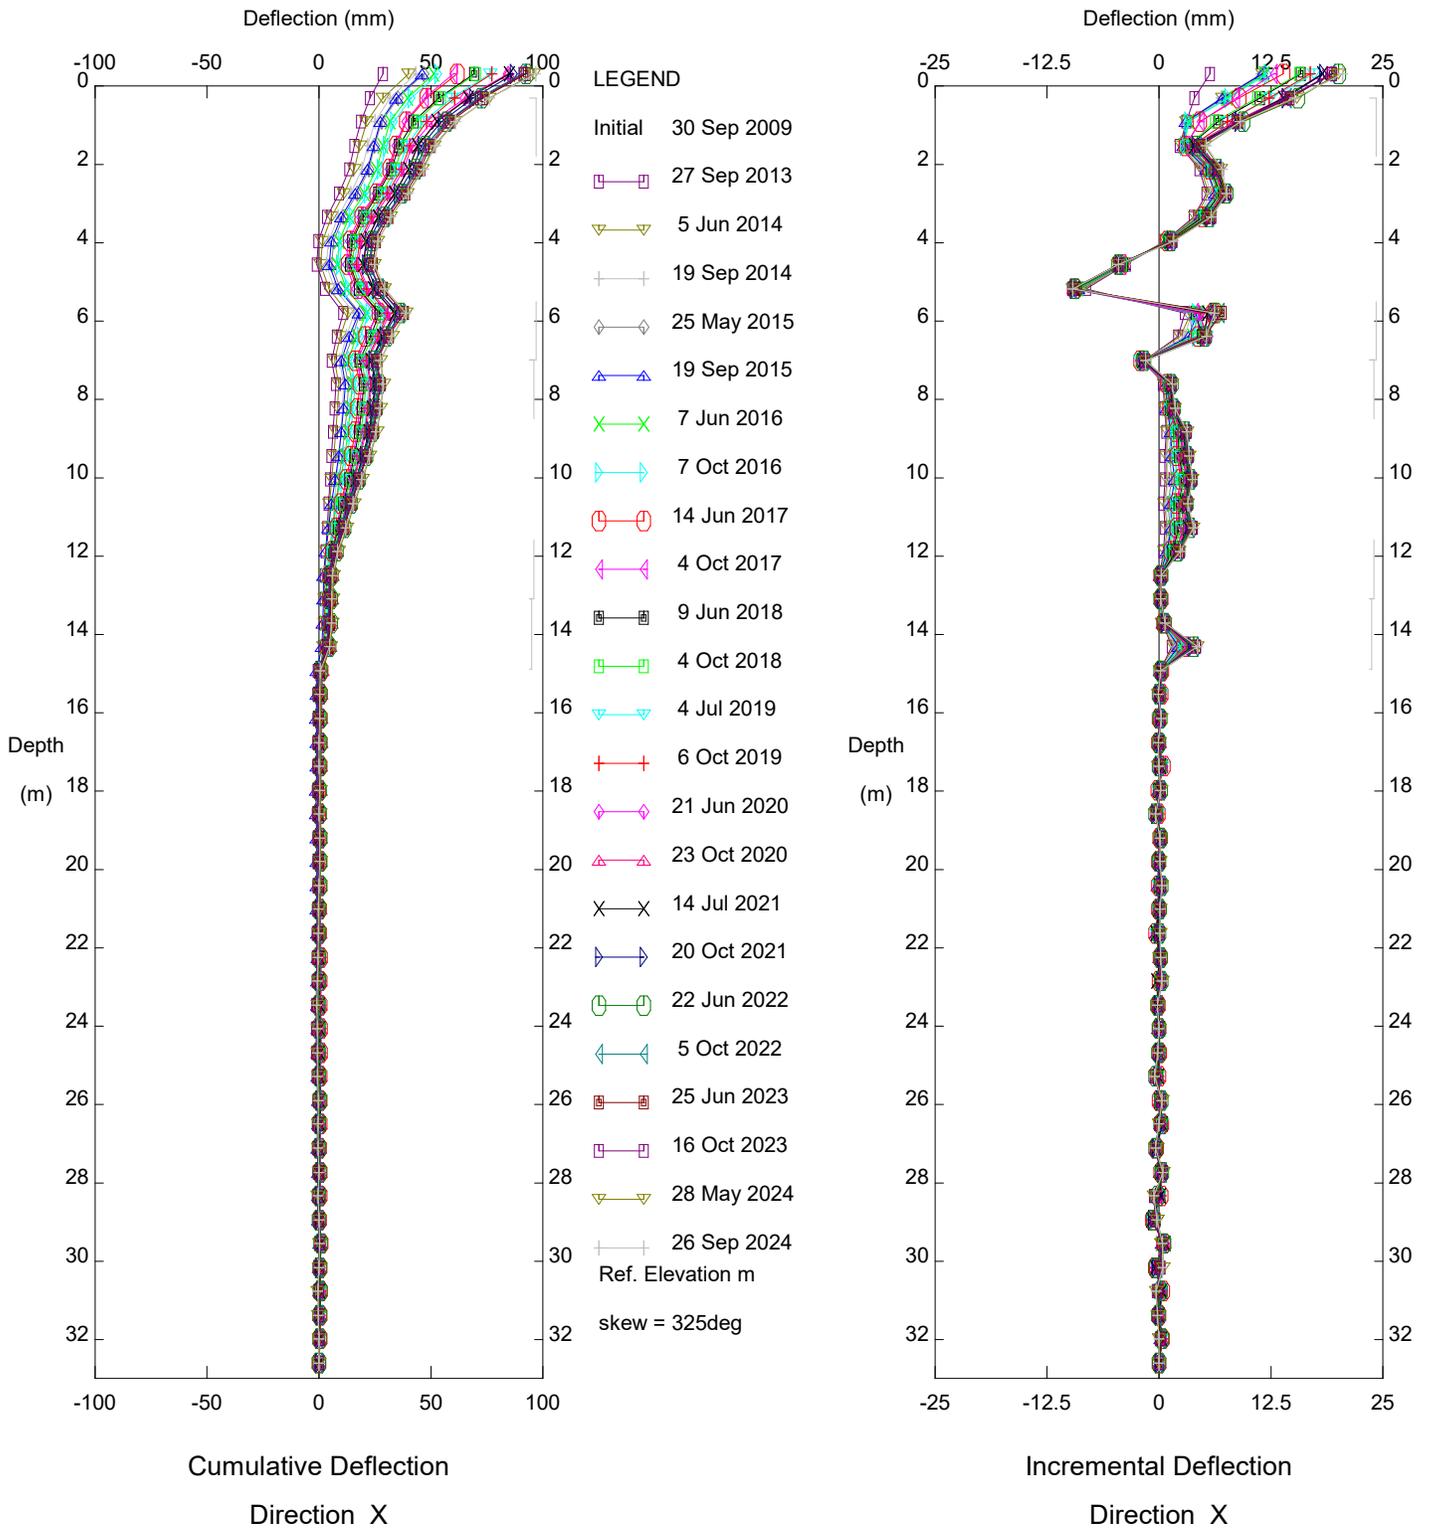
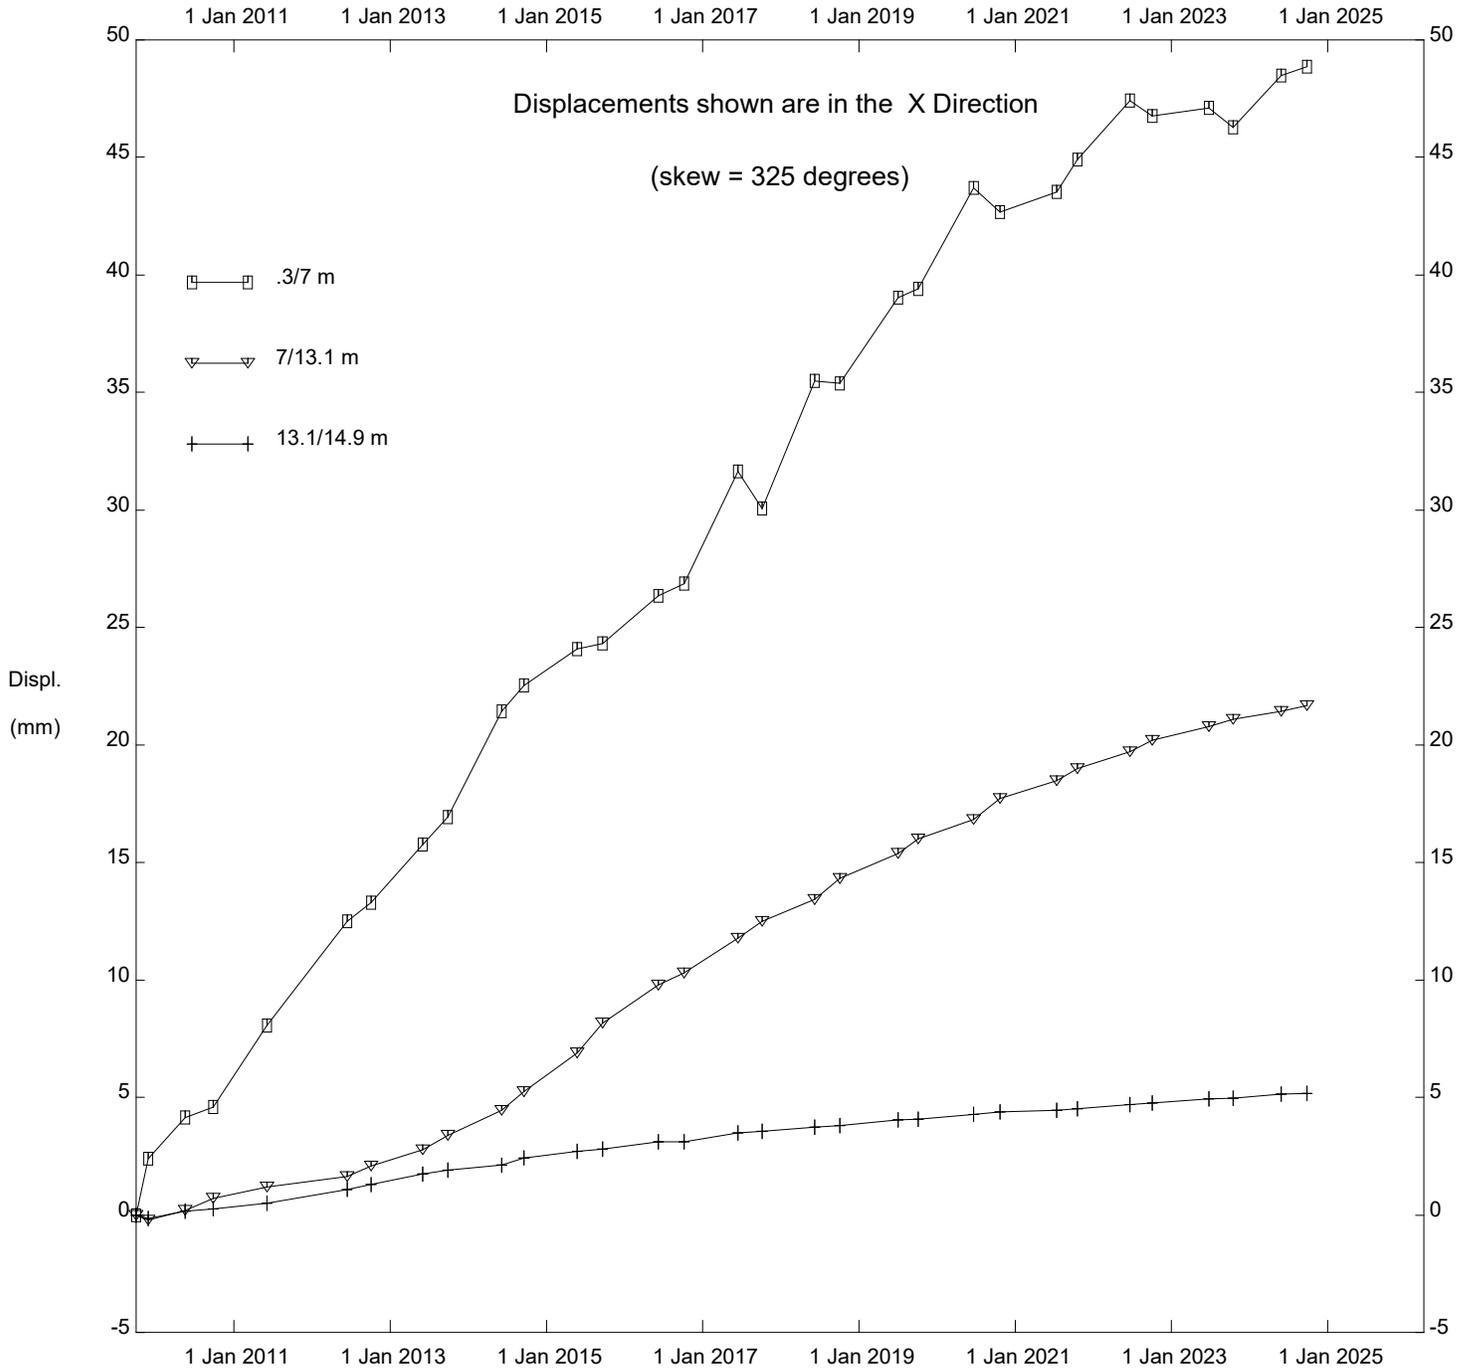
HWY 2:68 (PH037), Inclinometer SI09-1

SI09-1 is just west of the highway and showed a rate of movement of 1.1 mm/yr over 0.3 m to 7.0 m, and rates of movement of 0.7 mm/yr, and less than 0.1 mm/yr at depths between 7.0 m to 13.1 m, and 13.1 m to 14.9 m, respectively, since the spring of 2024 readings.

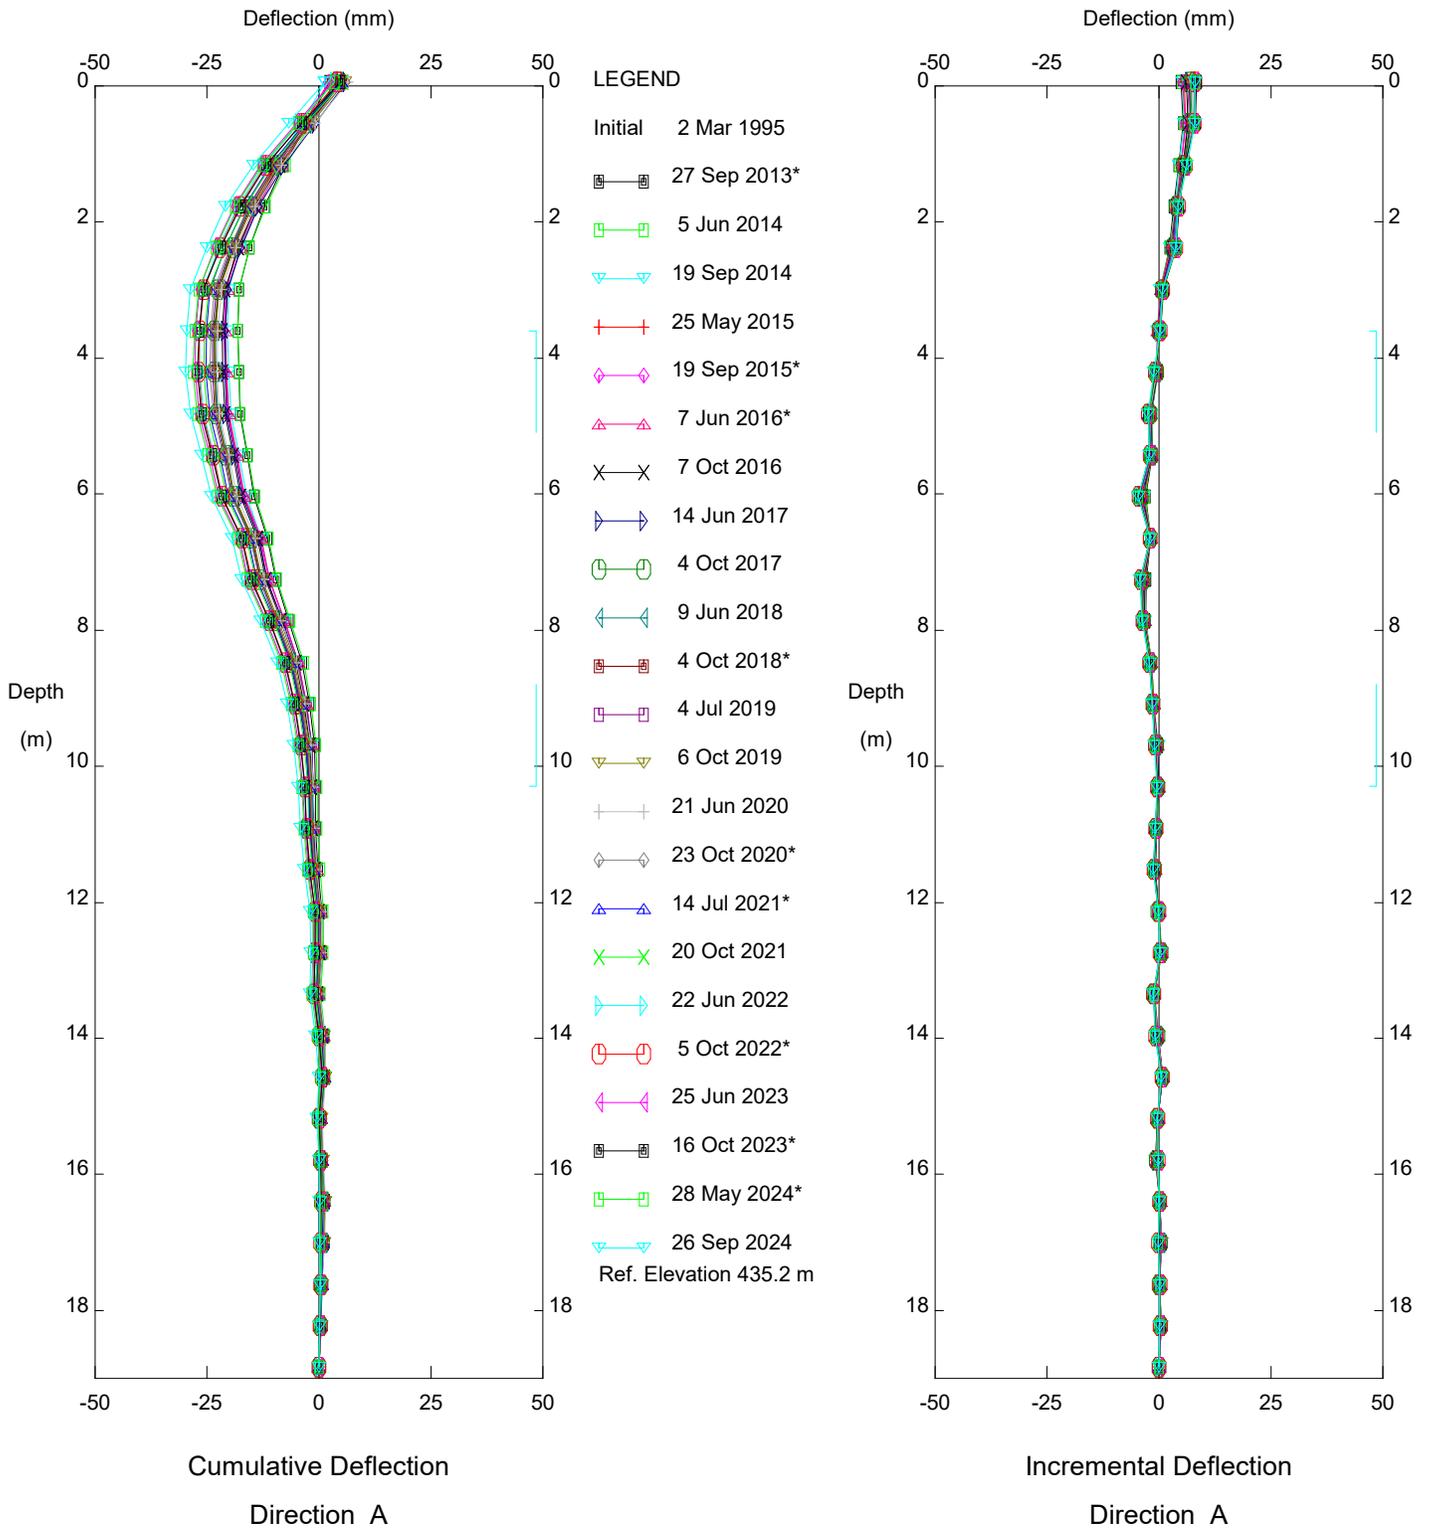
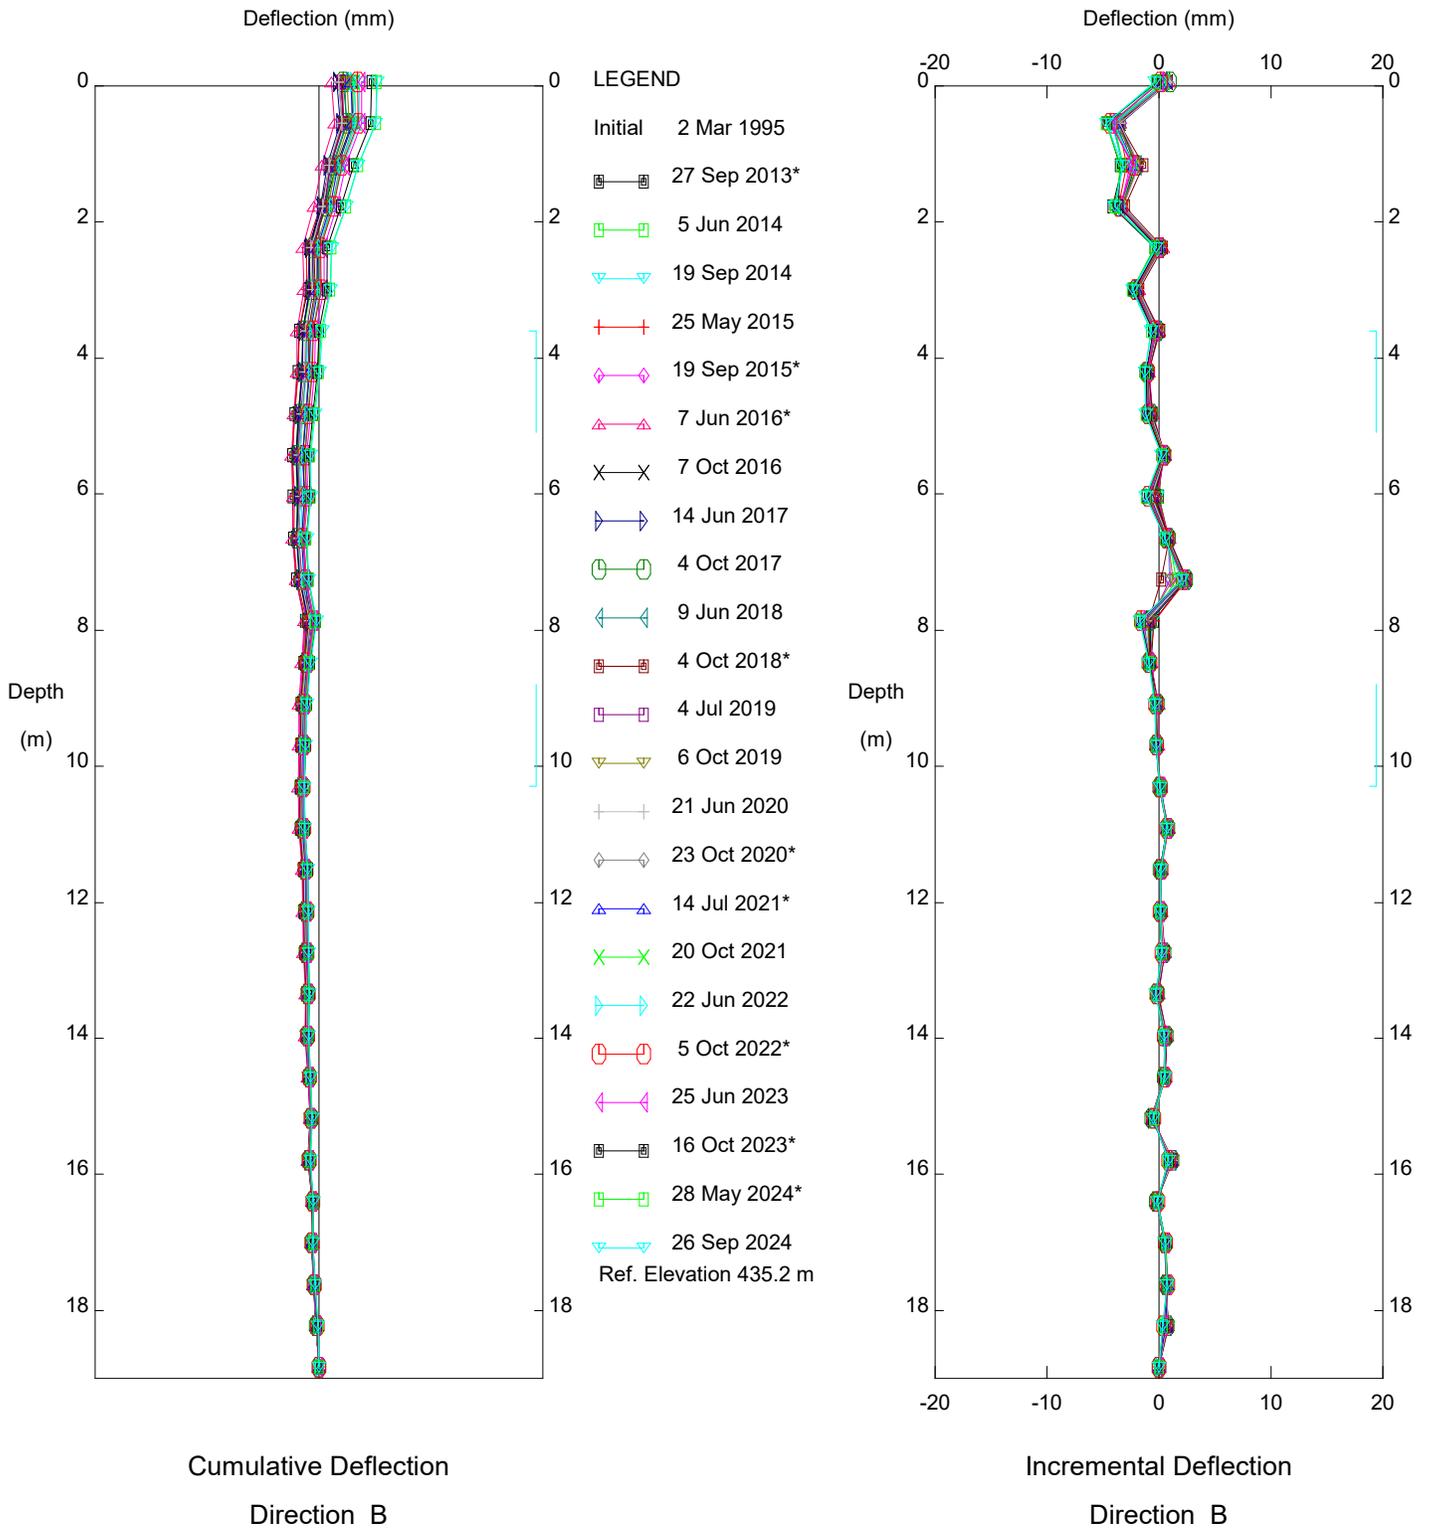
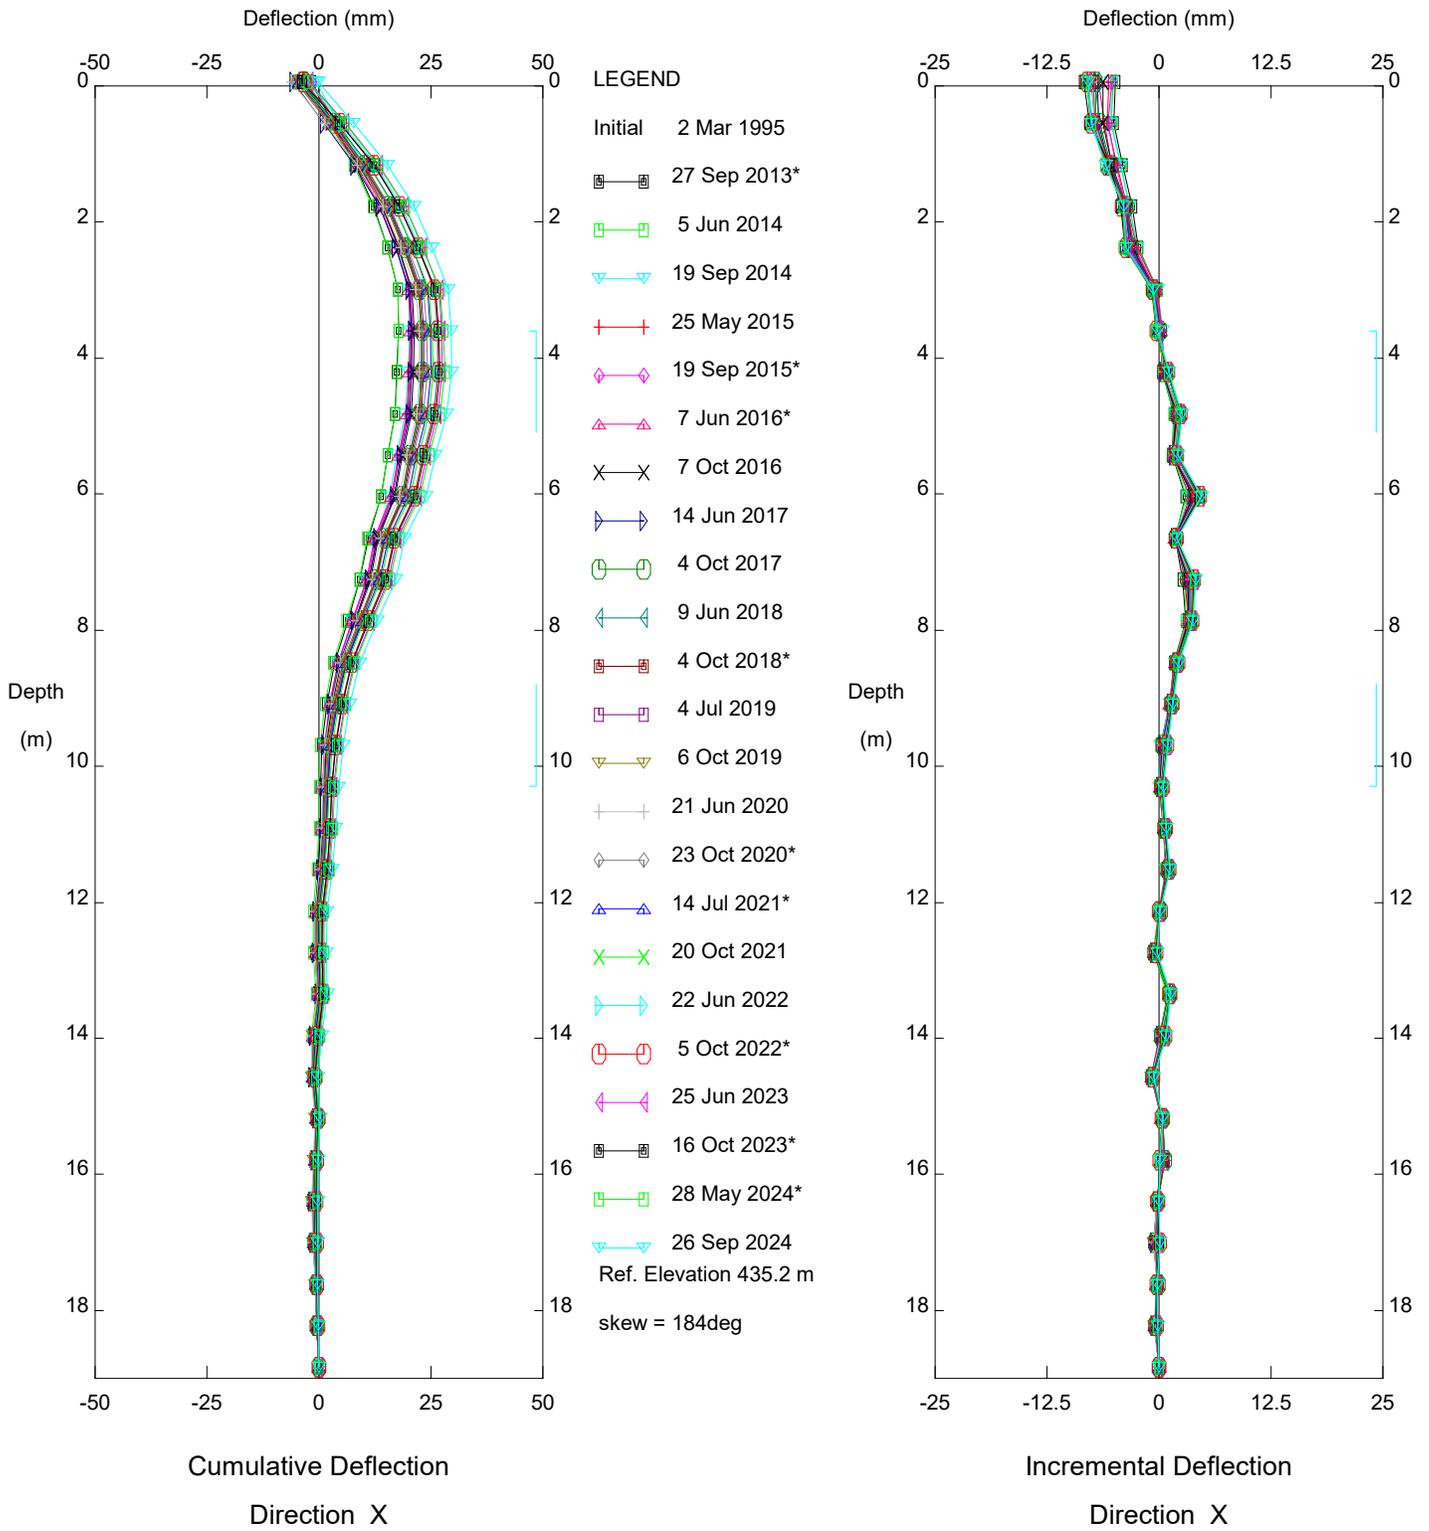
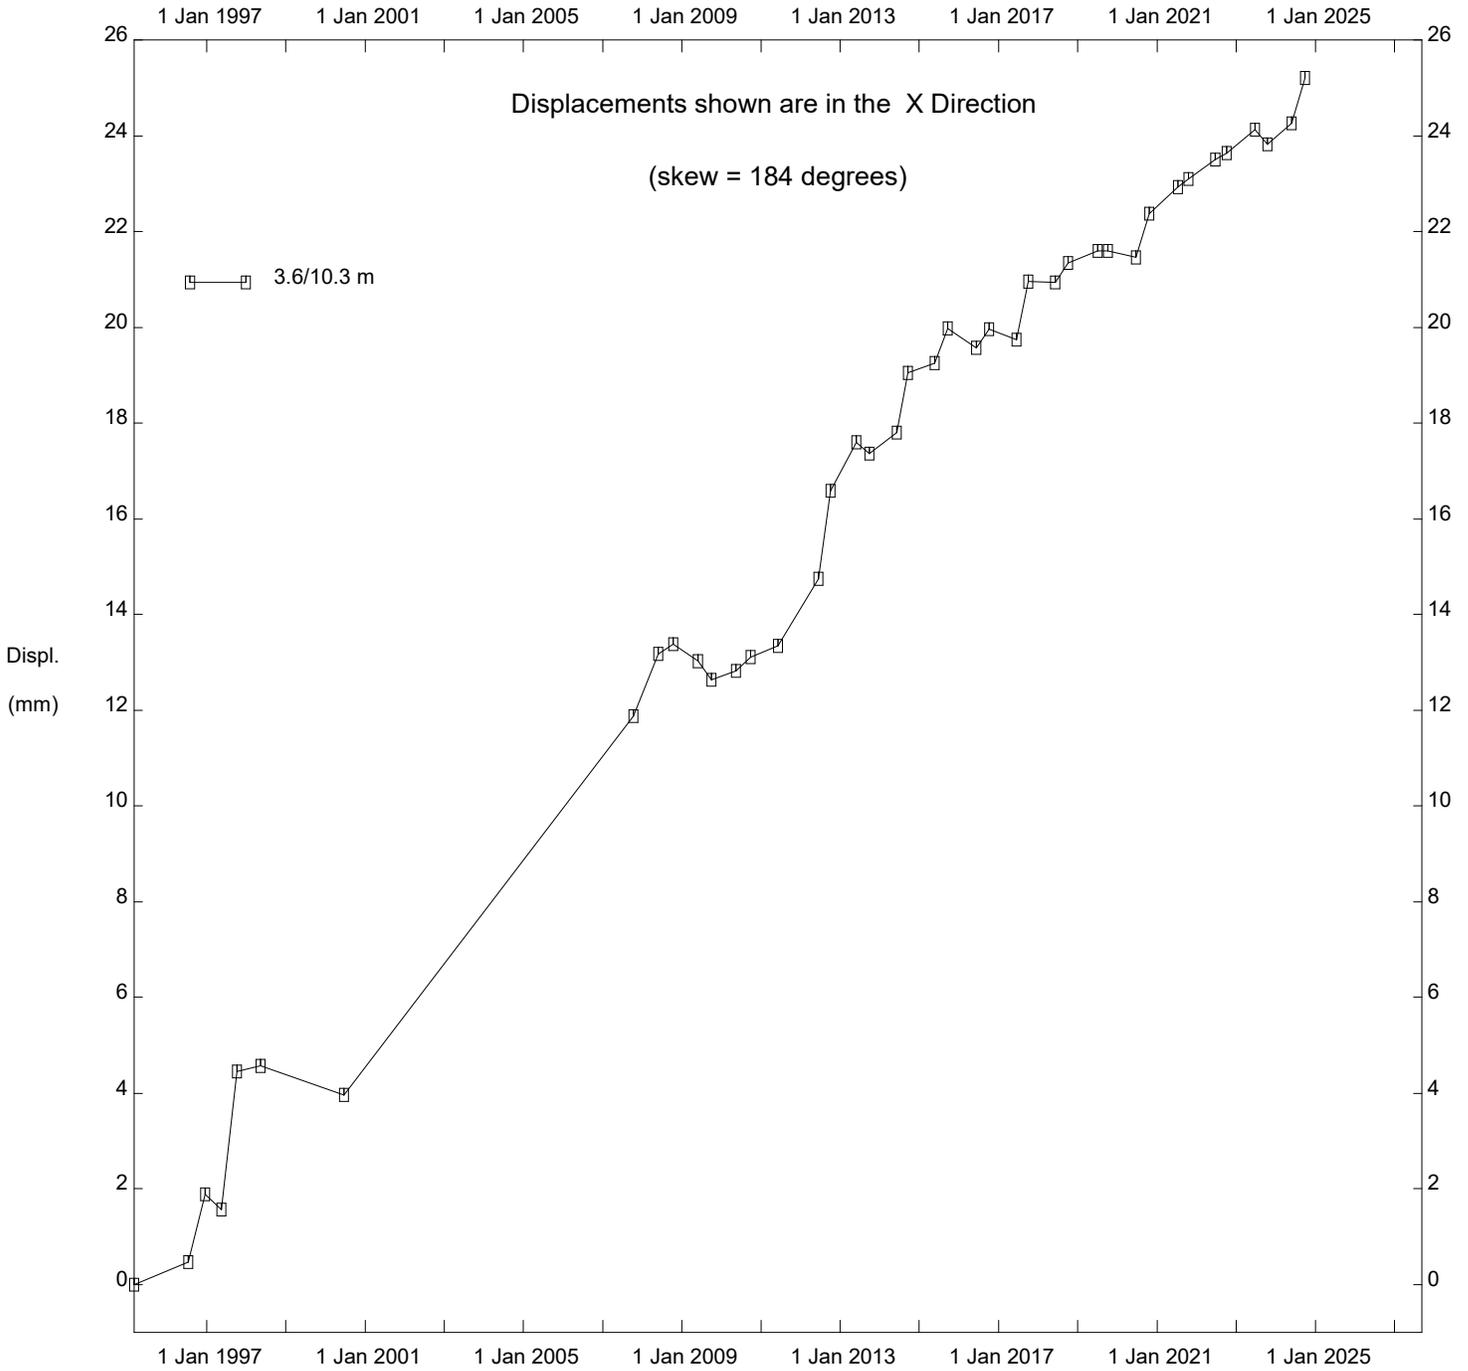
HWY 2:68 (PH037), Inclinometer SI-61

SI-61 is just west of the highway and just north of SI09-1; it showed a rate of movement of 2.9 mm/yr over 3.6 m to 10.3 m depth. The pattern of movement at SI-61 is best described as a bulge which is unusual for this site.
