**ALBERTA TRANSPORTATION AND
ECONOMIC CORRIDORS GRMP
PEACE REGION
(GRANDE PRAIRIE DISTRICT - NORTH)
INSTRUMENTATION MONITORING - FALL 2024**

Site Number	Location	Name	Hwy	km
PH037	Station 1+250 to 2+000	Dunvegan South	2:68	Km 15.7
Legal Description: 4-7-80-4 W6		UTM Co-ordinates		
		11U E 398593.62	N	6197597.09

Current Monitoring:	28-May-2024	Previous Monitoring	28-May-2024
Instruments Read By:	Mr. Neil McDonald and Mr. Nixson Mationg of Thurber

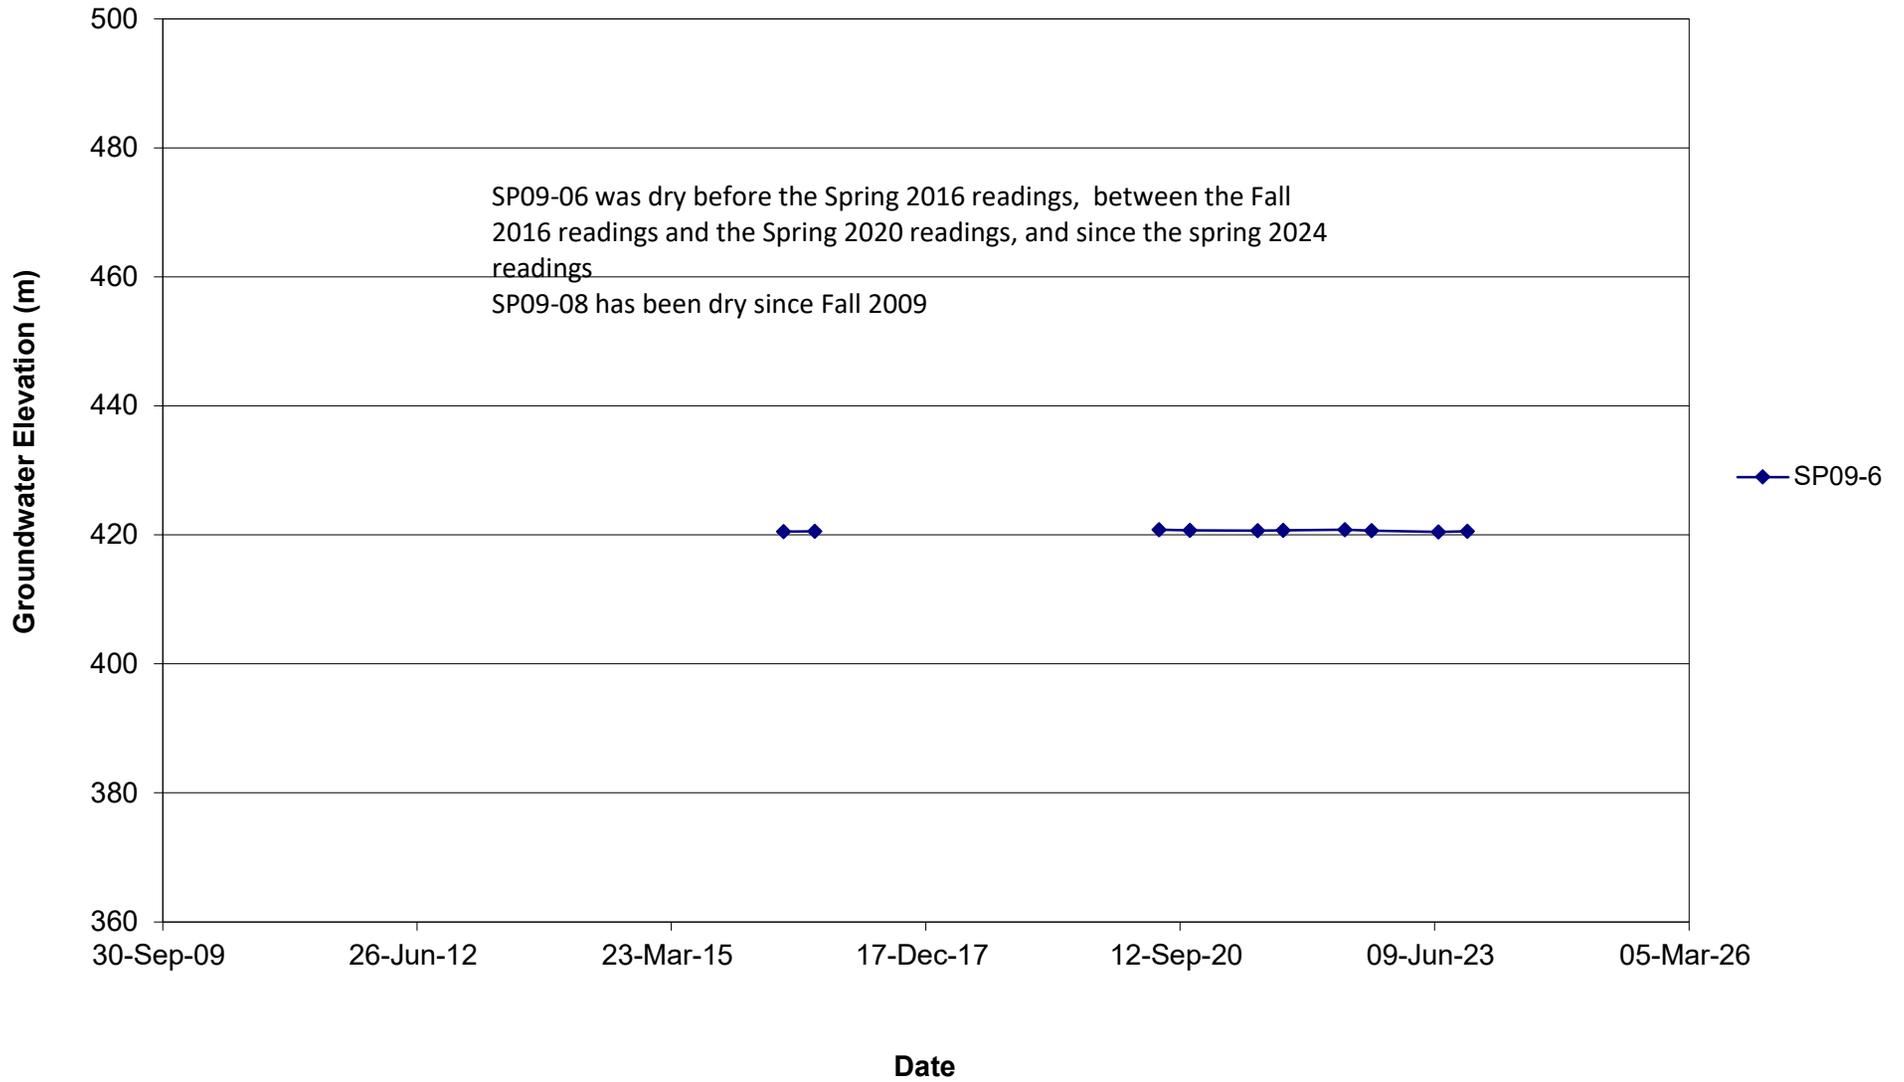
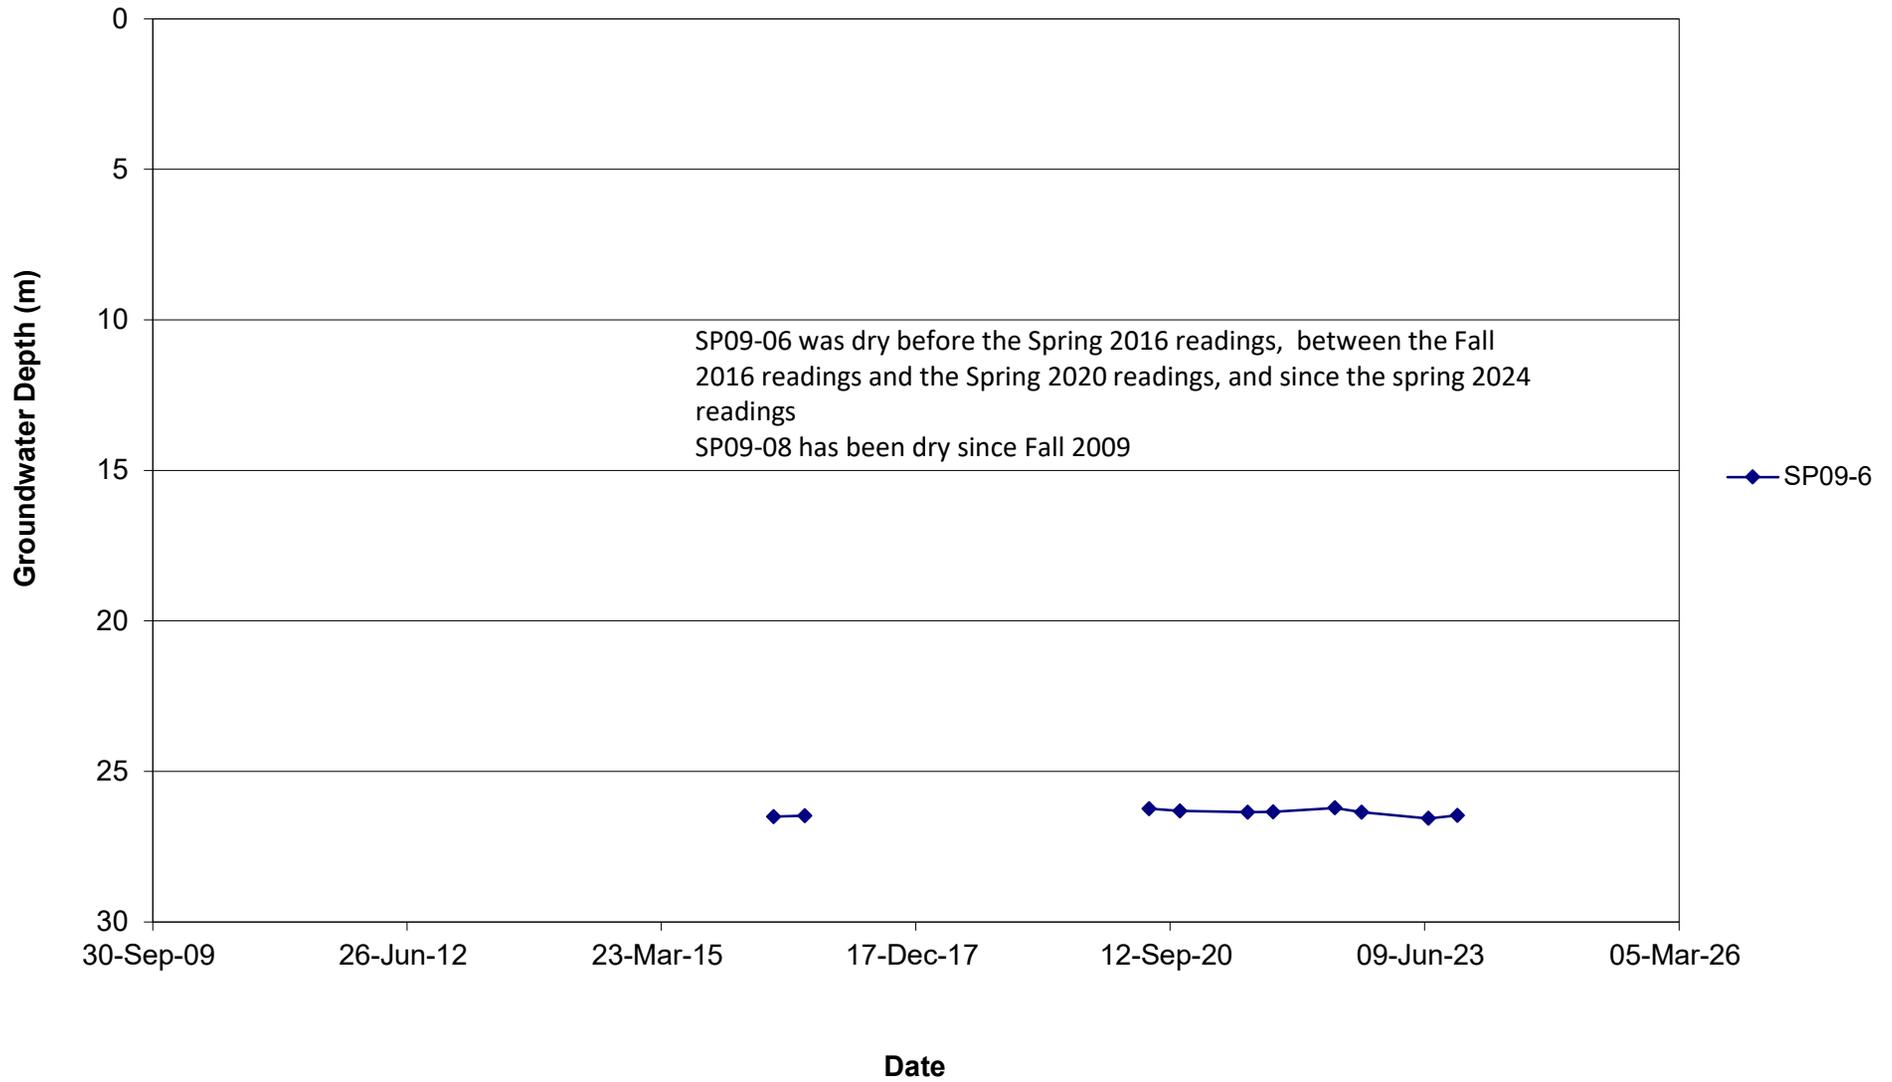
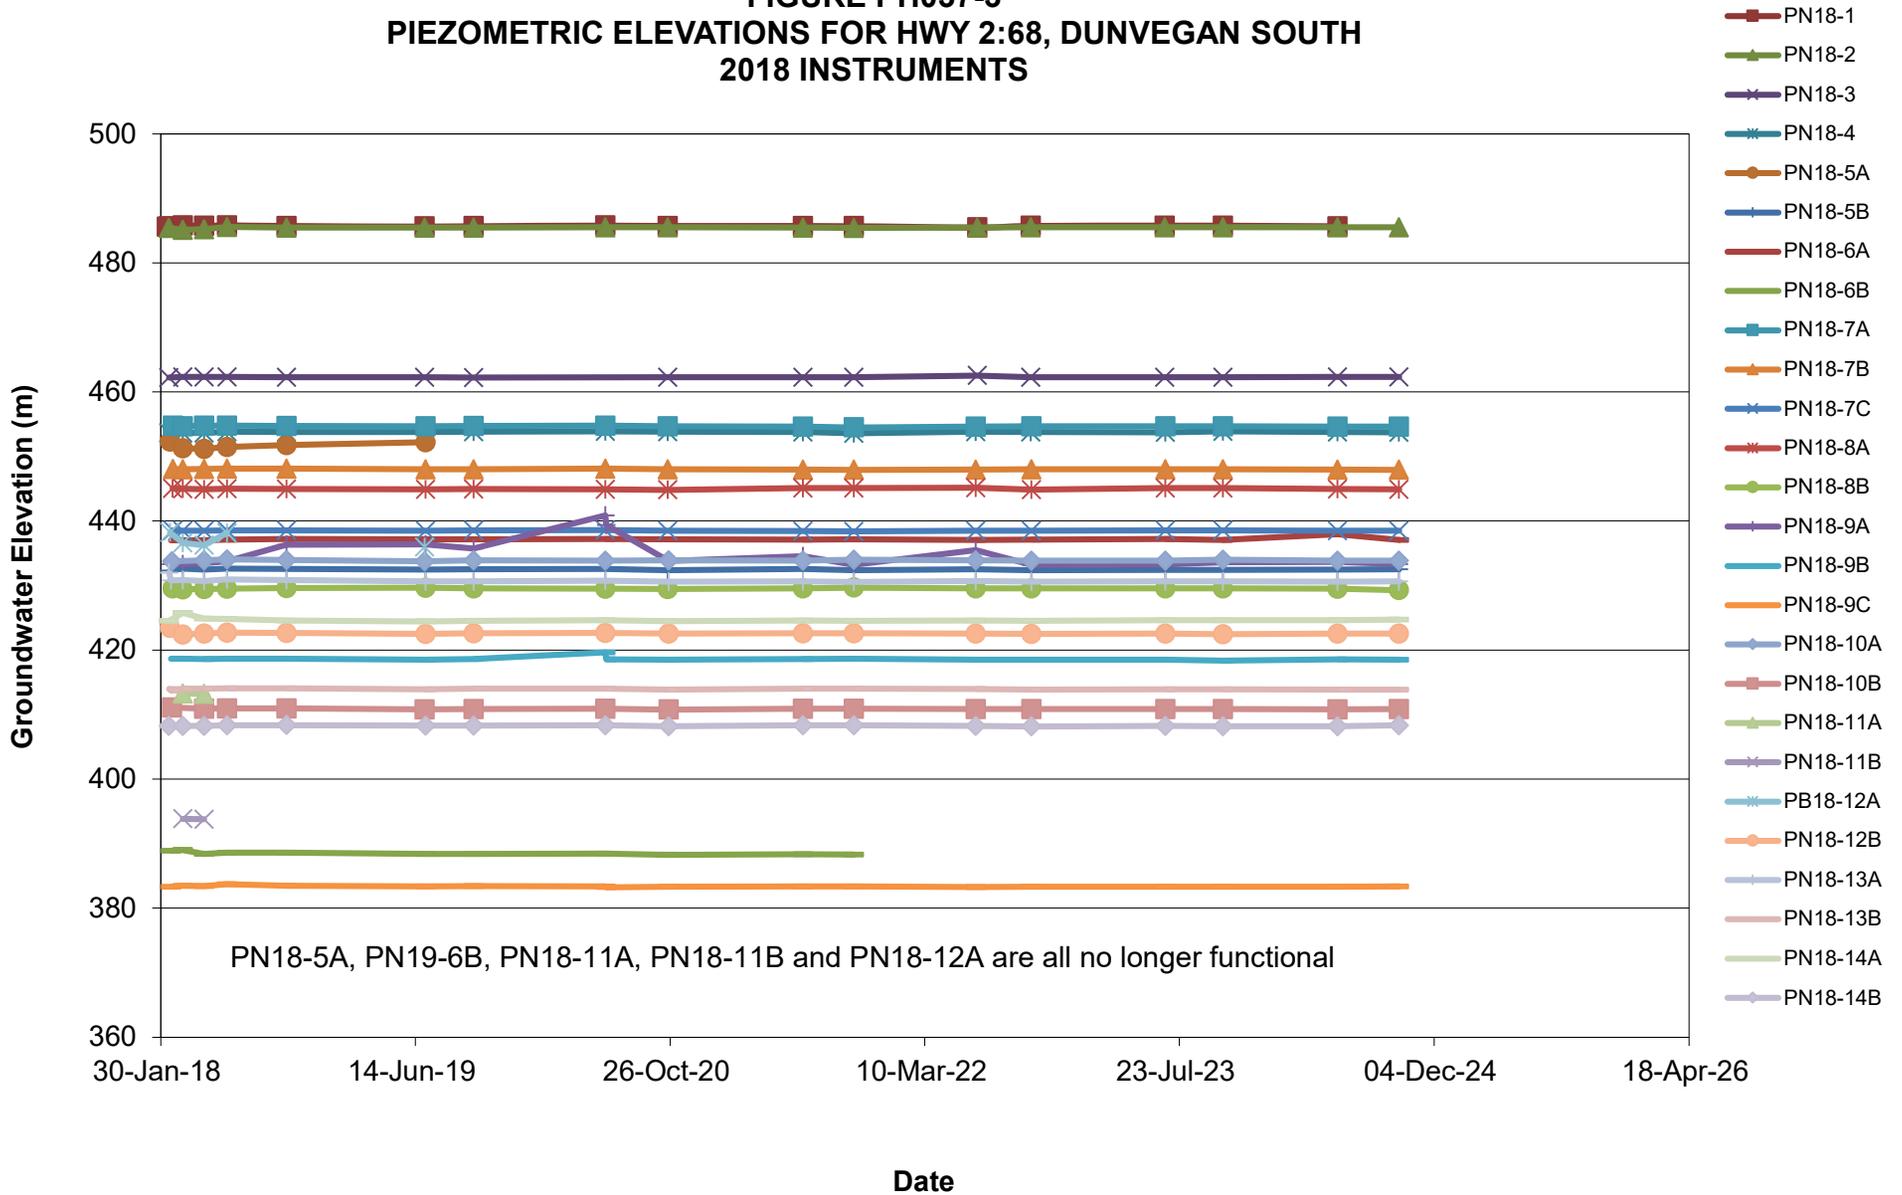
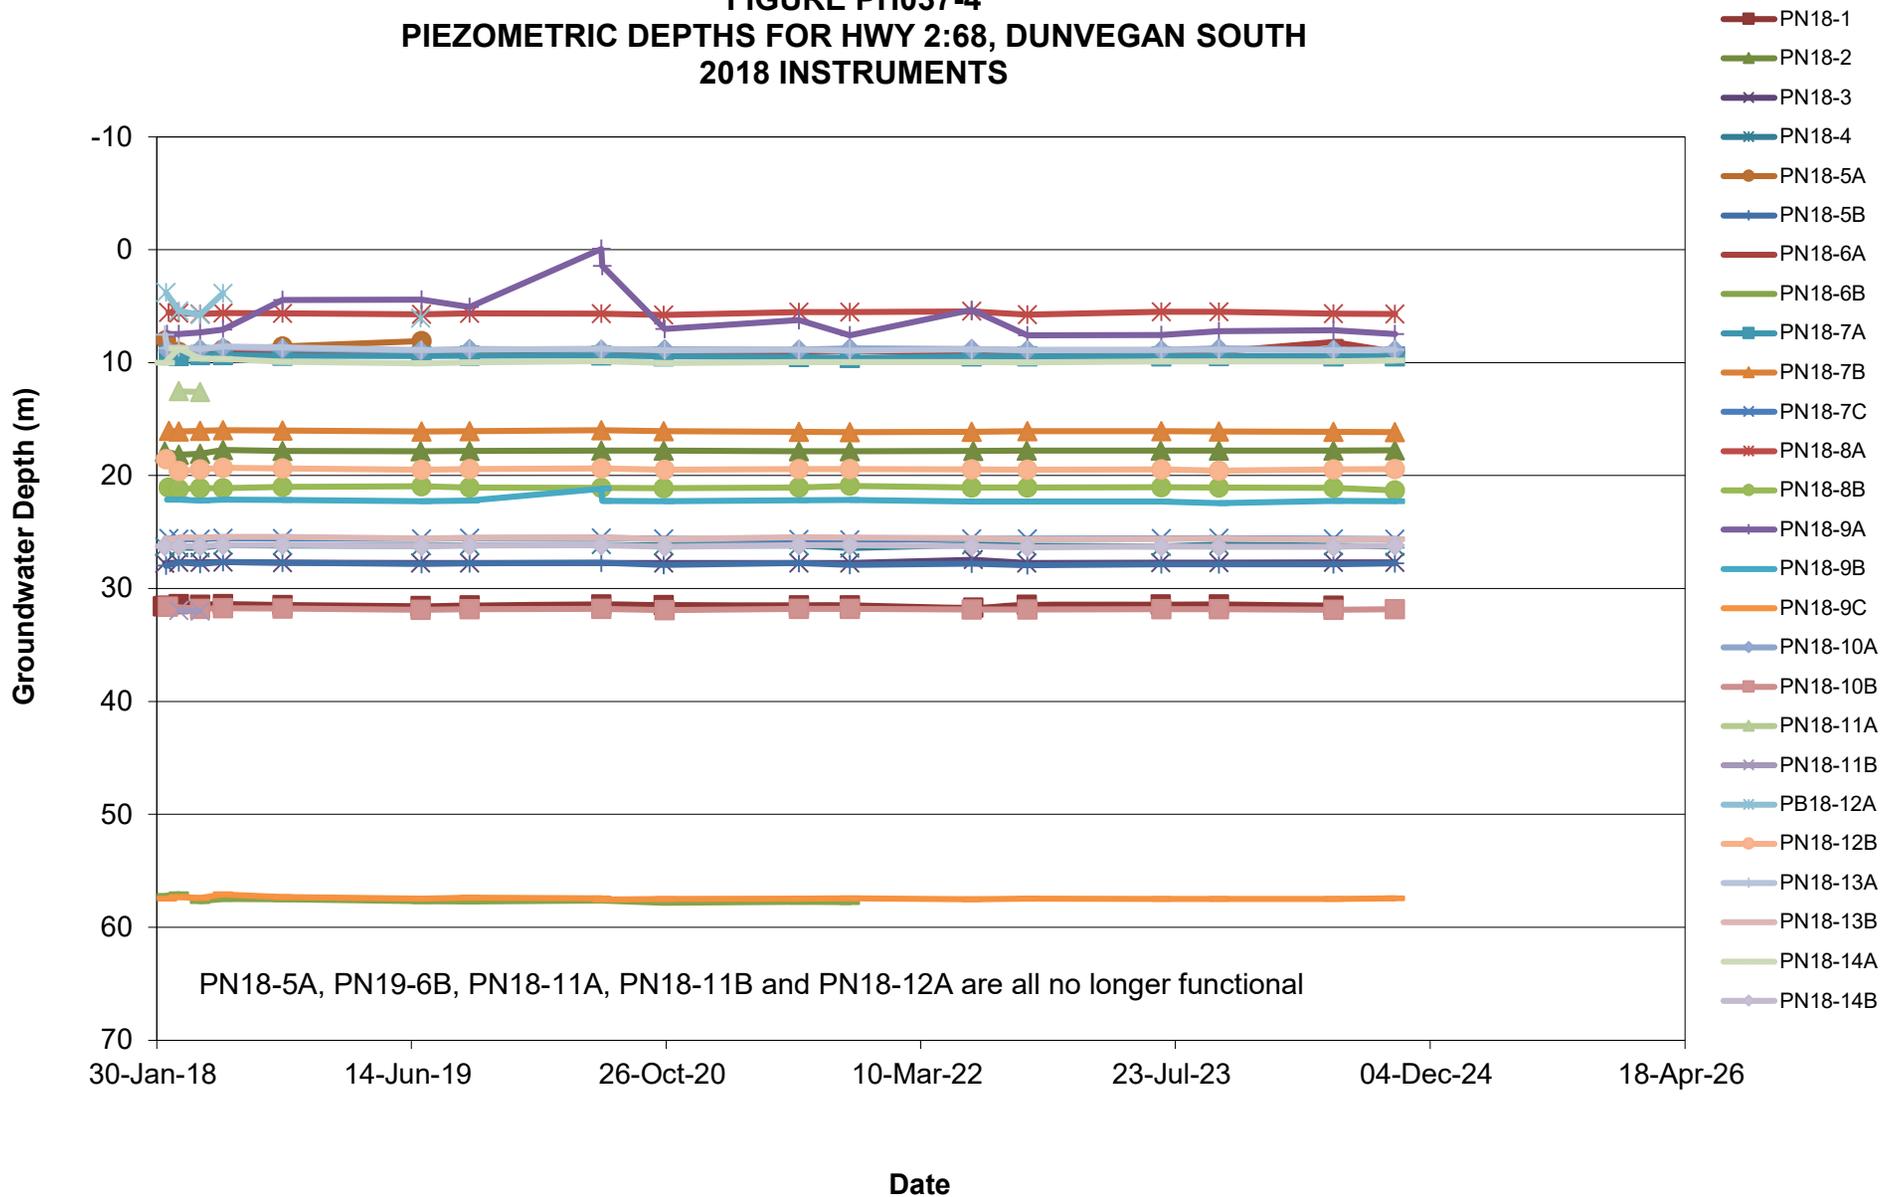
Standpipe piezometers SP09-6 and SP09-8 continued to be dry. Most of the pneumatic piezometers except for PN18-6A generally showed relatively small changes in groundwater level compared to the spring of 2024, ranging from a decrease of 0.89 m in PN18-6A to an increase of 0.28 m in PN18-1. PN18-1 showed a groundwater elevation of 485.96 m, the highest measured in the instrument since it was initialized.
Future Work:	The instruments should be read again in the spring of 2025.
Instrumentation Repairs:	SI-55 should be checked to see if repairs are feasible and can be done by hand, or if mechanical excavation would be required.
Additional Comments:
