**ALBERTA TRANSPORTATION AND
ECONOMIC CORRIDORS
GEOHAZARD ASSESSMENT PROGRAM
PEACE REGION (GRANDE PRAIRIE DISTRICT - NORTH)
2024 INSPECTION**

THURBER ENGINEERING LTD.

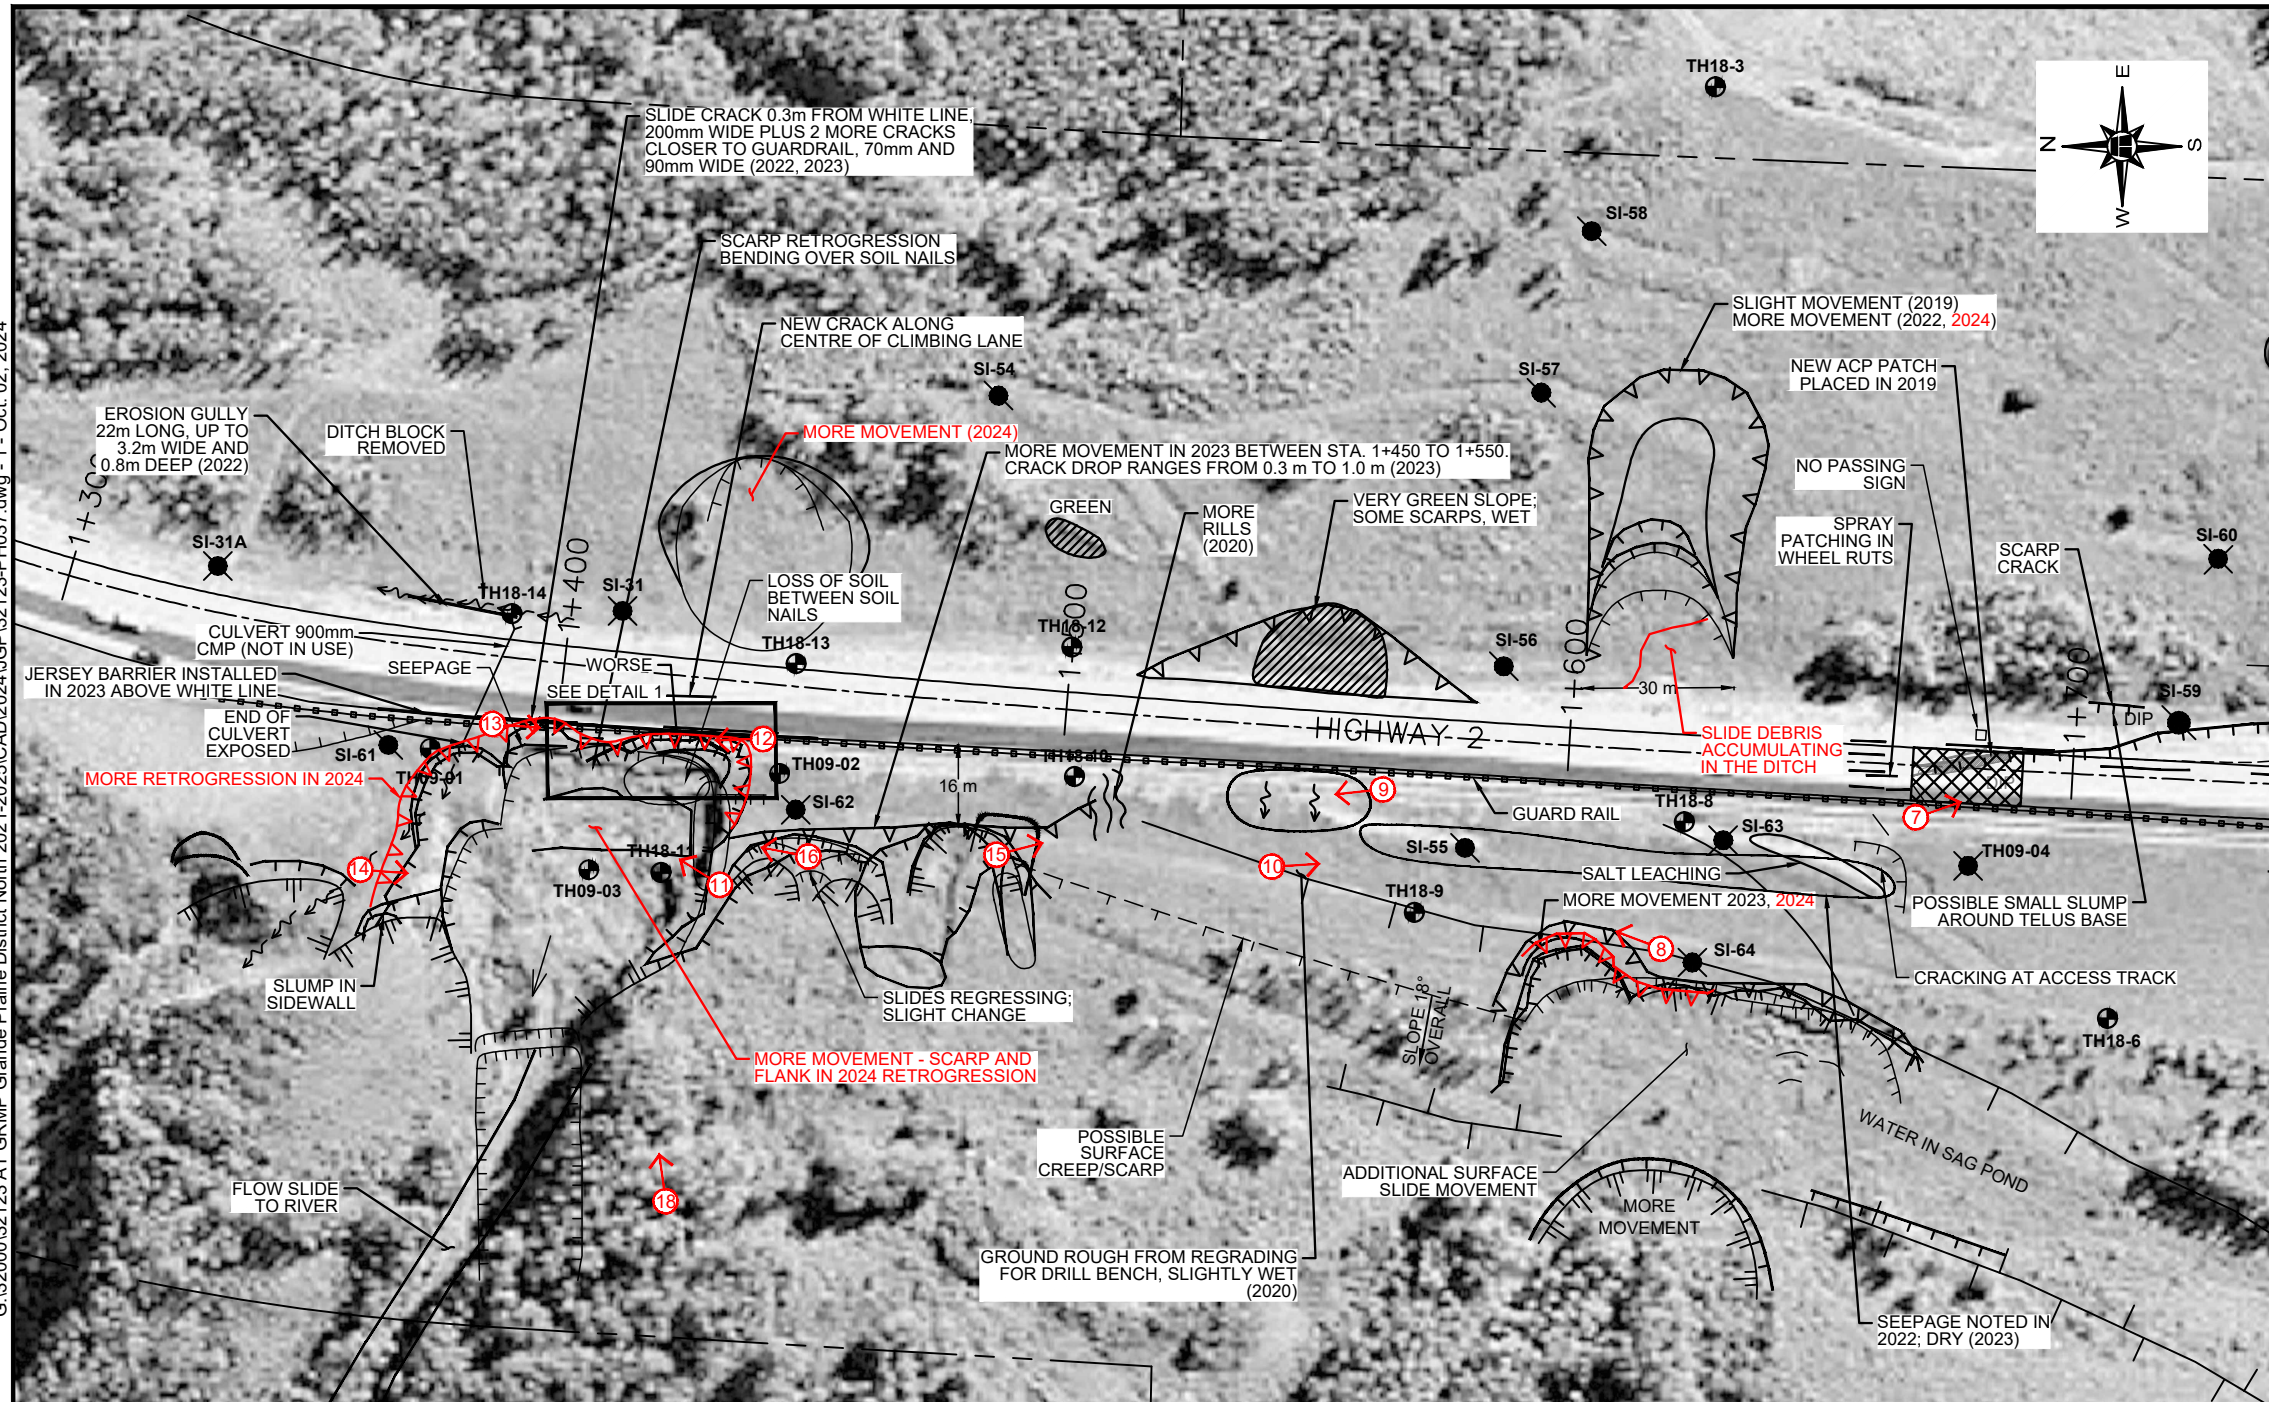
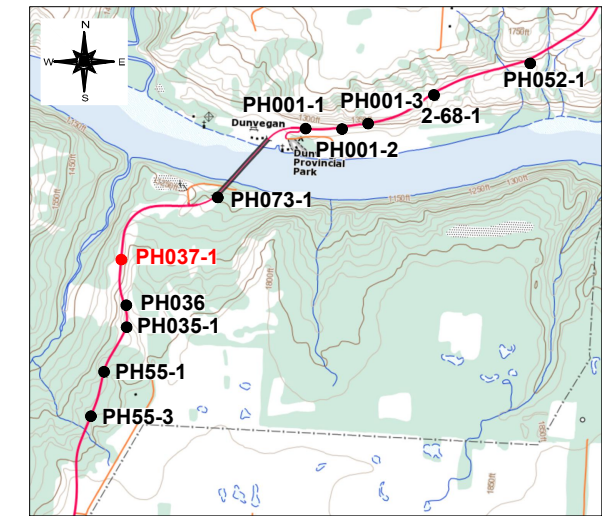
KEY PLAN
SCALE: 1:75 000

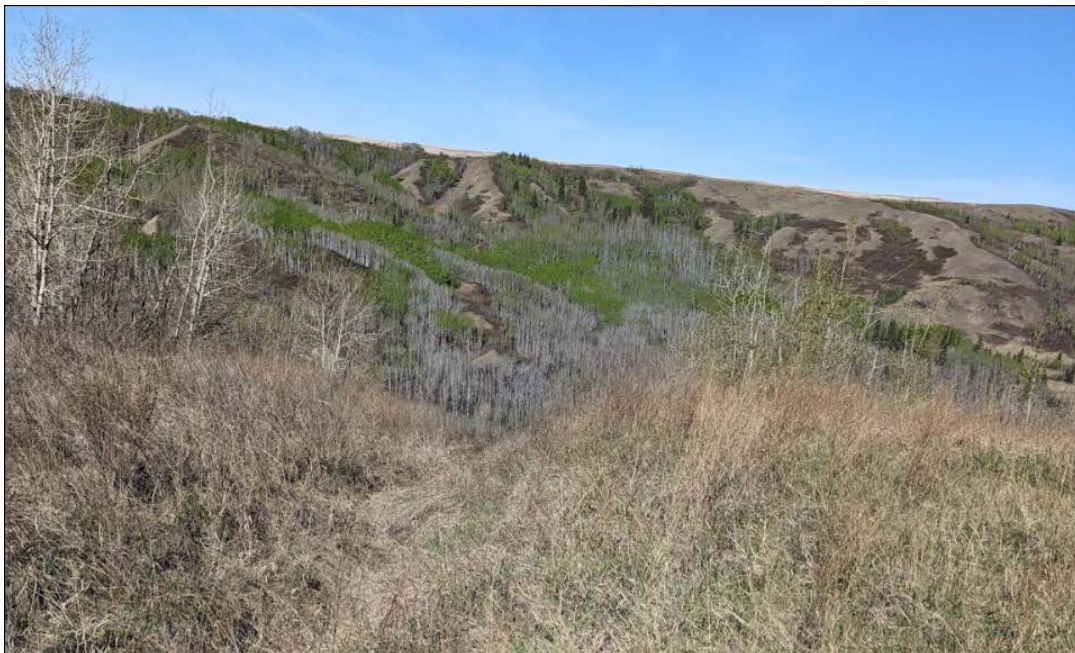
Photo 2: Looking west from Sta. 1+980 below the SBL highway. More movement noted in 2024

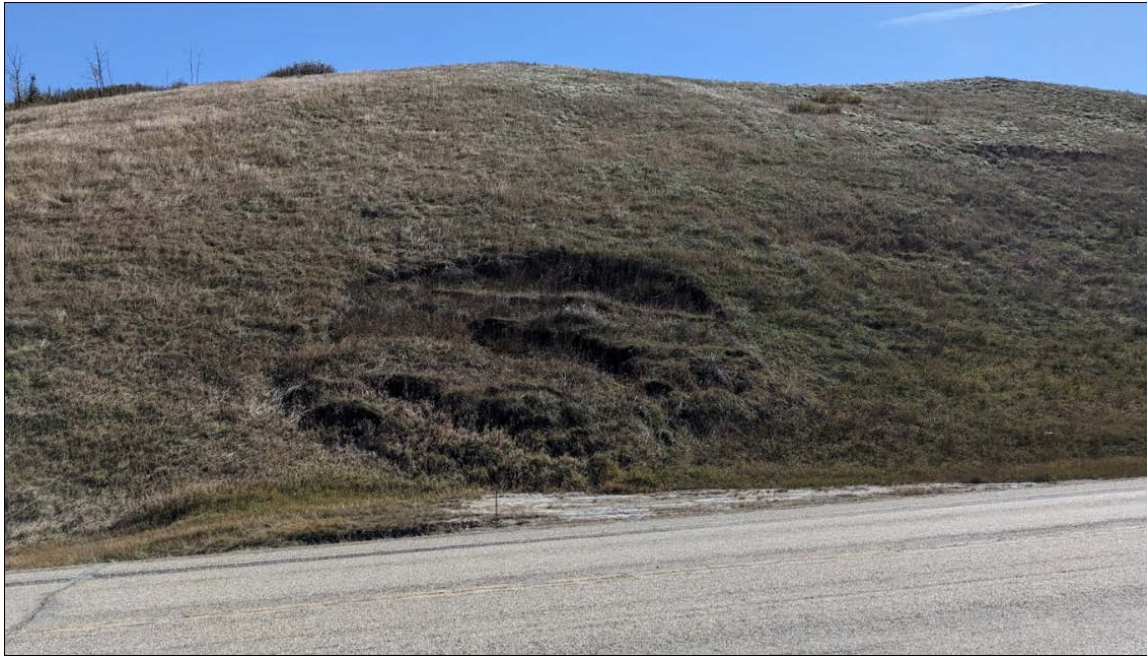
Photo 3: Looking east at backslope skin failure at Sta. 1+950

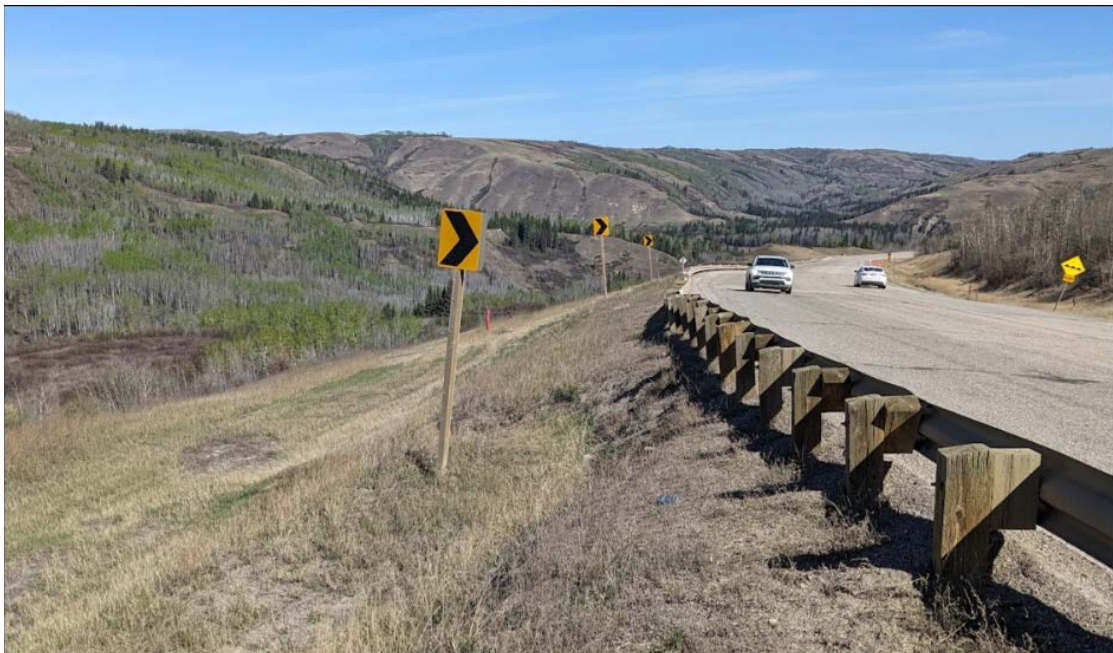
Photo 4: Looking north from Sta. 1+890 at the slump in the sideslope of the SBL. More movement since 2023. The scarp is 1.5 m high and 0.8 m from the guardrail.

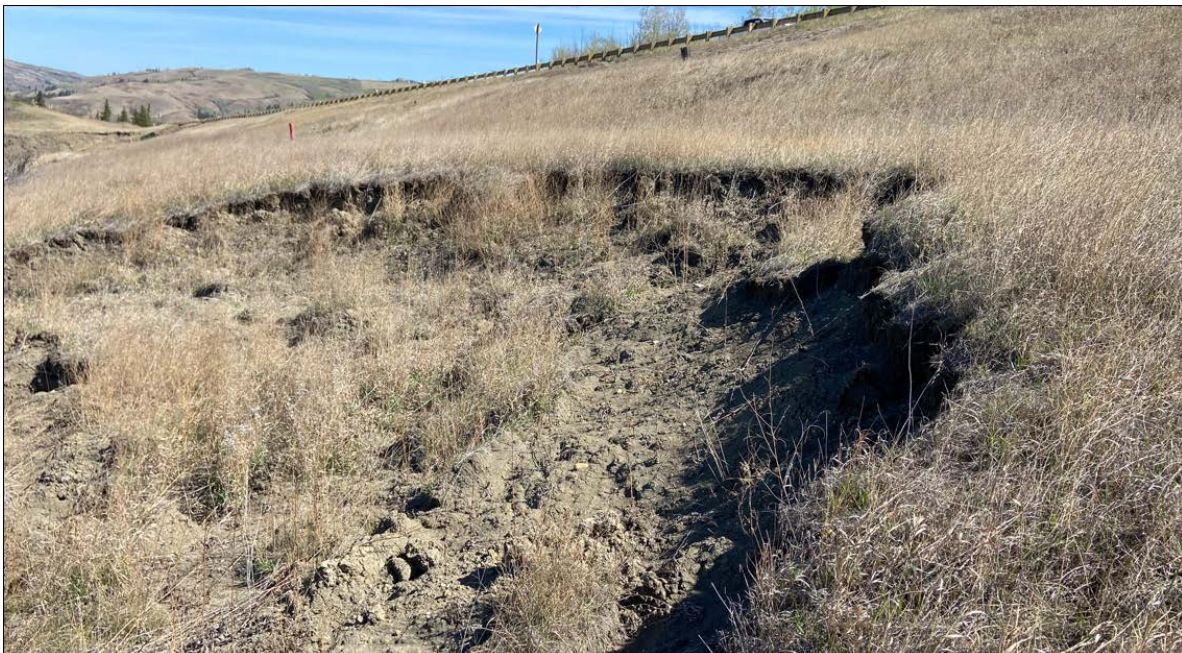
Photo 8: Looking north near Sta. 1+670 at slumping occurring on the highway side slope approximately 20 m from the edge of pavement. More movement noted since 2022

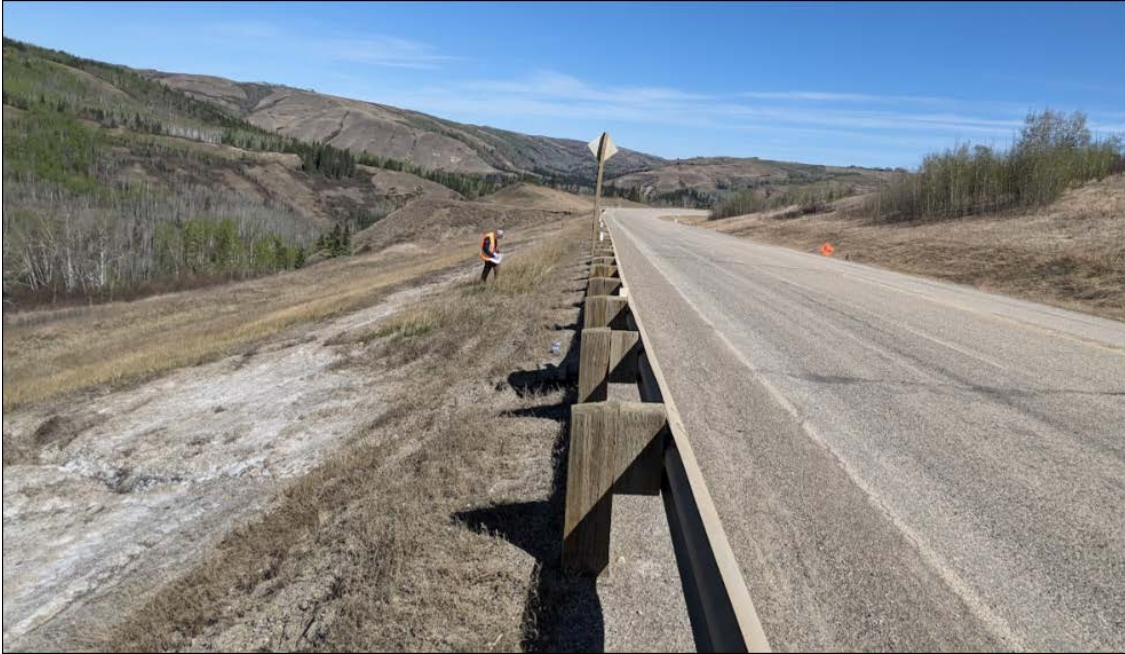
Photo 9: Looking north near Sta. 1+550 at fresh erosion rills and gullies developed on the highway side slope. Erosion became worse in 2023

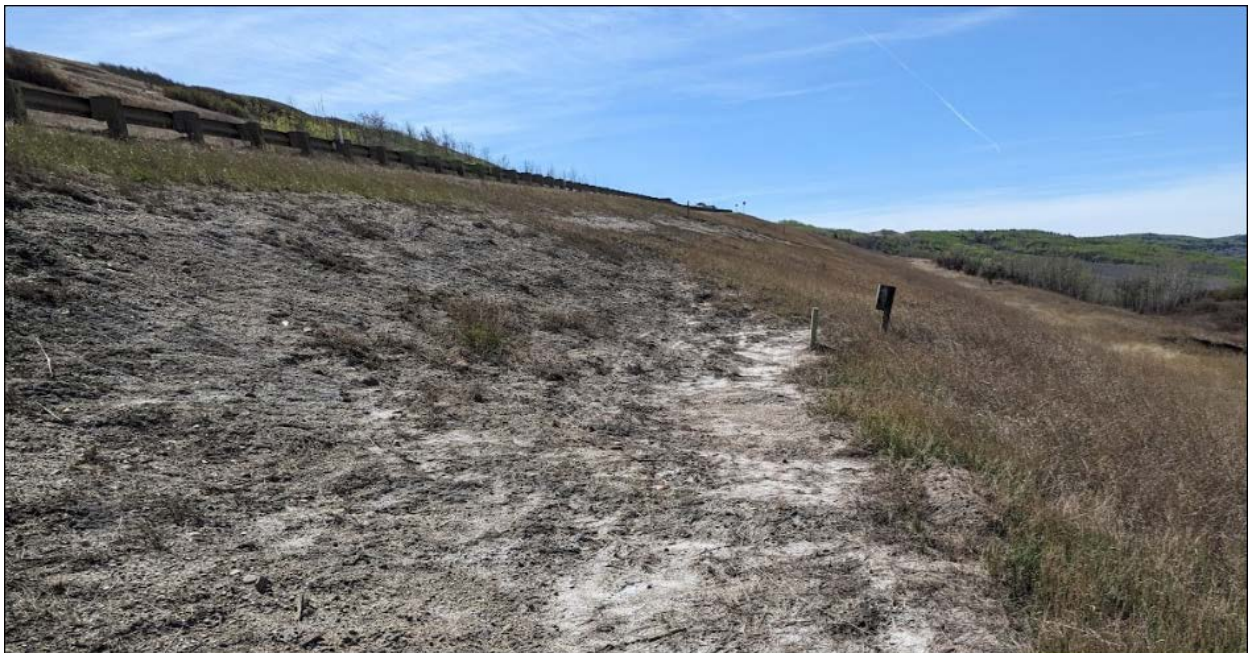
Photo 10: Looking south near Sta. 1+560 at rough area (drill access bench) with some seepage and tension cracks

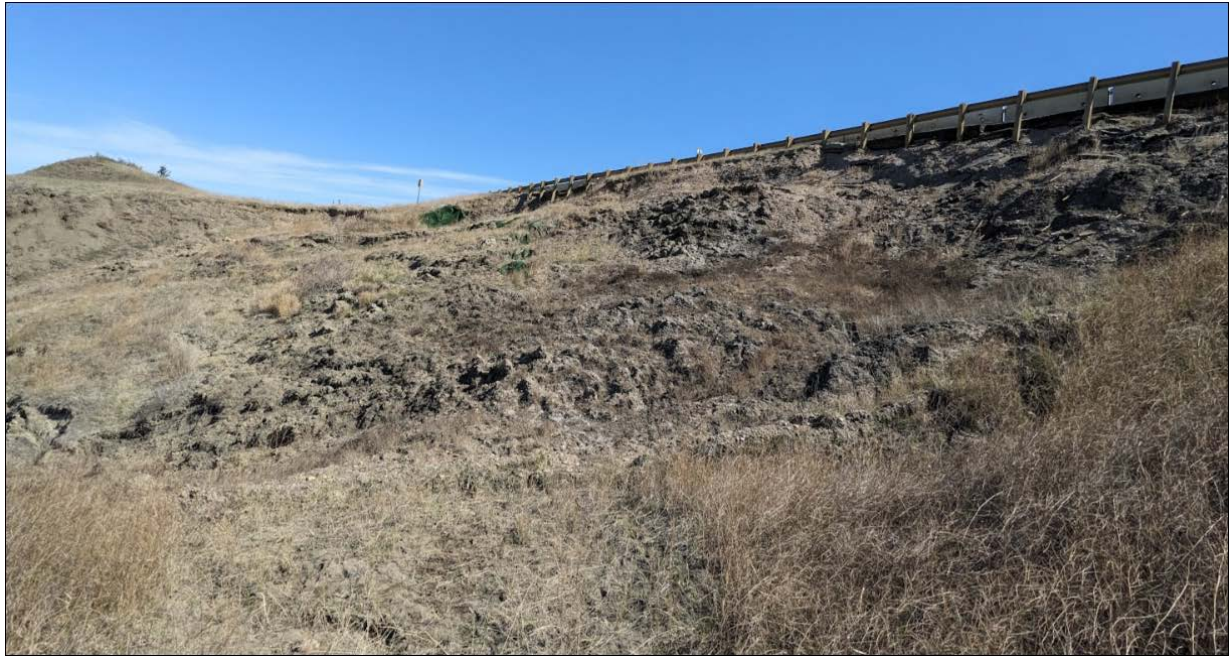
Photo 11: Looking east at failed soil matting and nails which were installed in August 2010 at Sta. 1+450 slide. Backscarp (5 m to 7.5 m high) continues retrogressing and impacting the highway.

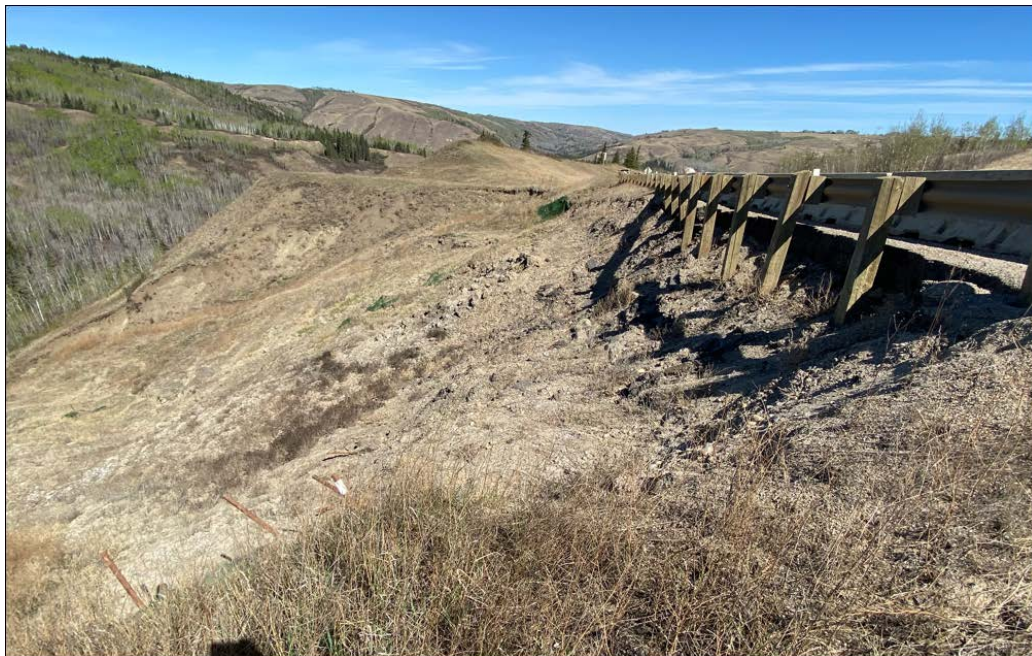
Photo 12: Looking north from Sta. 1+450 backscarp.

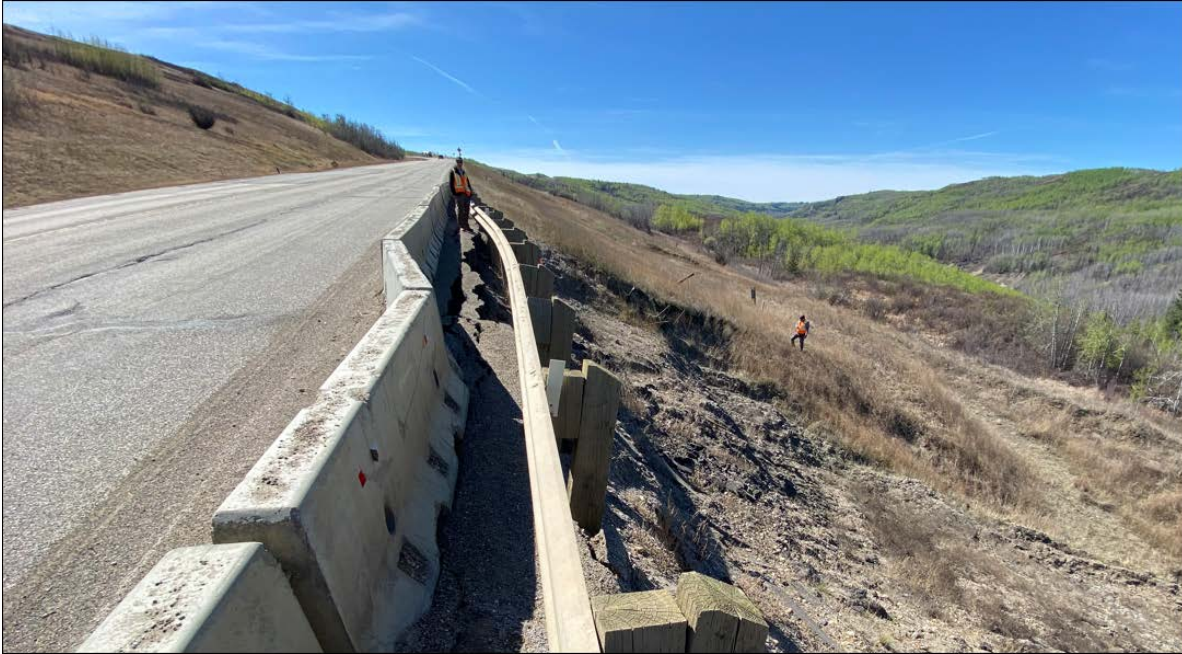
Photo 13: Looking south from Sta. 1+390 at the backscarp of the 1+400 slide which is impacting the highway shoulder. Slide cracks are wider and closer to the driving lane

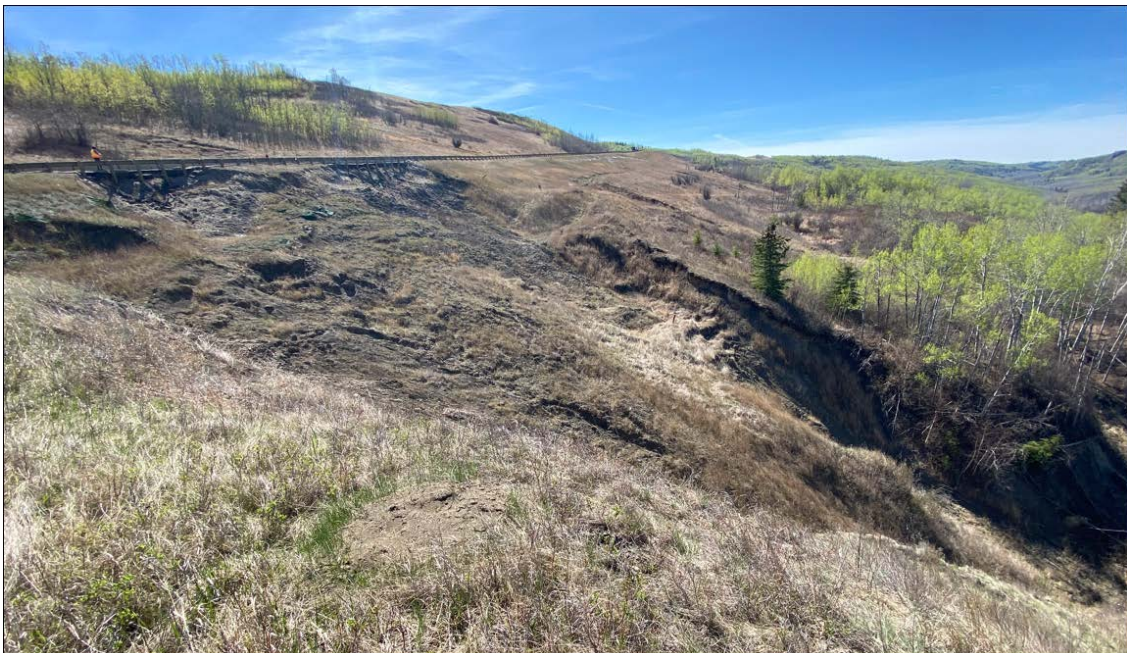
Photo 14: Looking south towards the 1+400 slide. The slide has further retrogressed towards the highway, is wider than in 2023 and there is a 5 m to 7.5 m drop below the guardrail.
