ALBERTA TRANSPORTATION AND
ECONOMIC CORRIDORS GRMP
GRANDE PRAIRIE REGION –
(GRANDE PRAIRIE NORTH)
INSTRUMENTATION MONITORING - SPRING 2024

Site Number	Location	Name	Hwy	km
PH037	Station 1+250 to 2+000	Dunvegan South	2:68	Km 15.7
Legal Description: 4-7-80-4 W6		UTM Co-ordinates		
		11U E 398593.62	N	6197597.09

Current Monitoring:	28-May-2024	Previous Monitoring	16-Oct-2023
Instruments Read By:	Mr. Niraj Regmi, G.I.T and Mr. Nixon Mationg, of Thurber

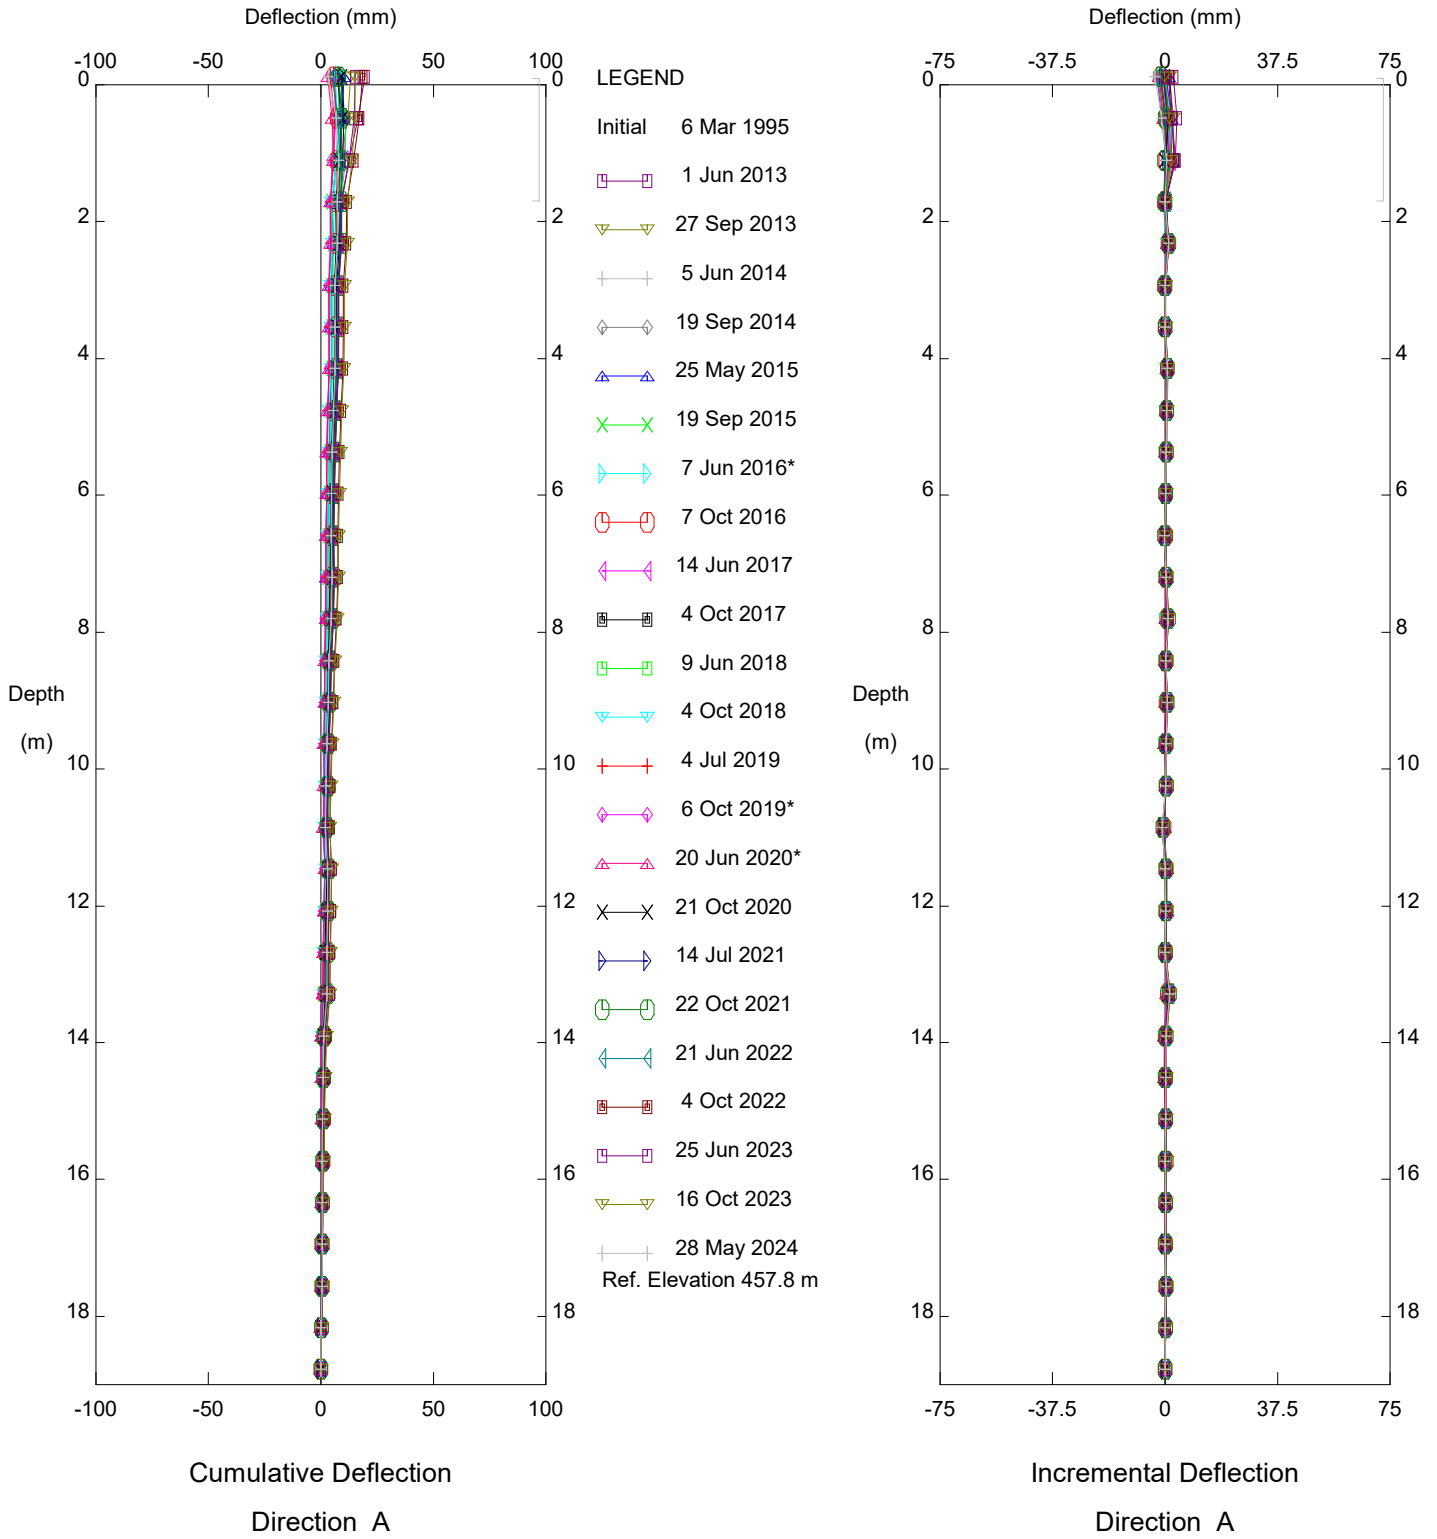
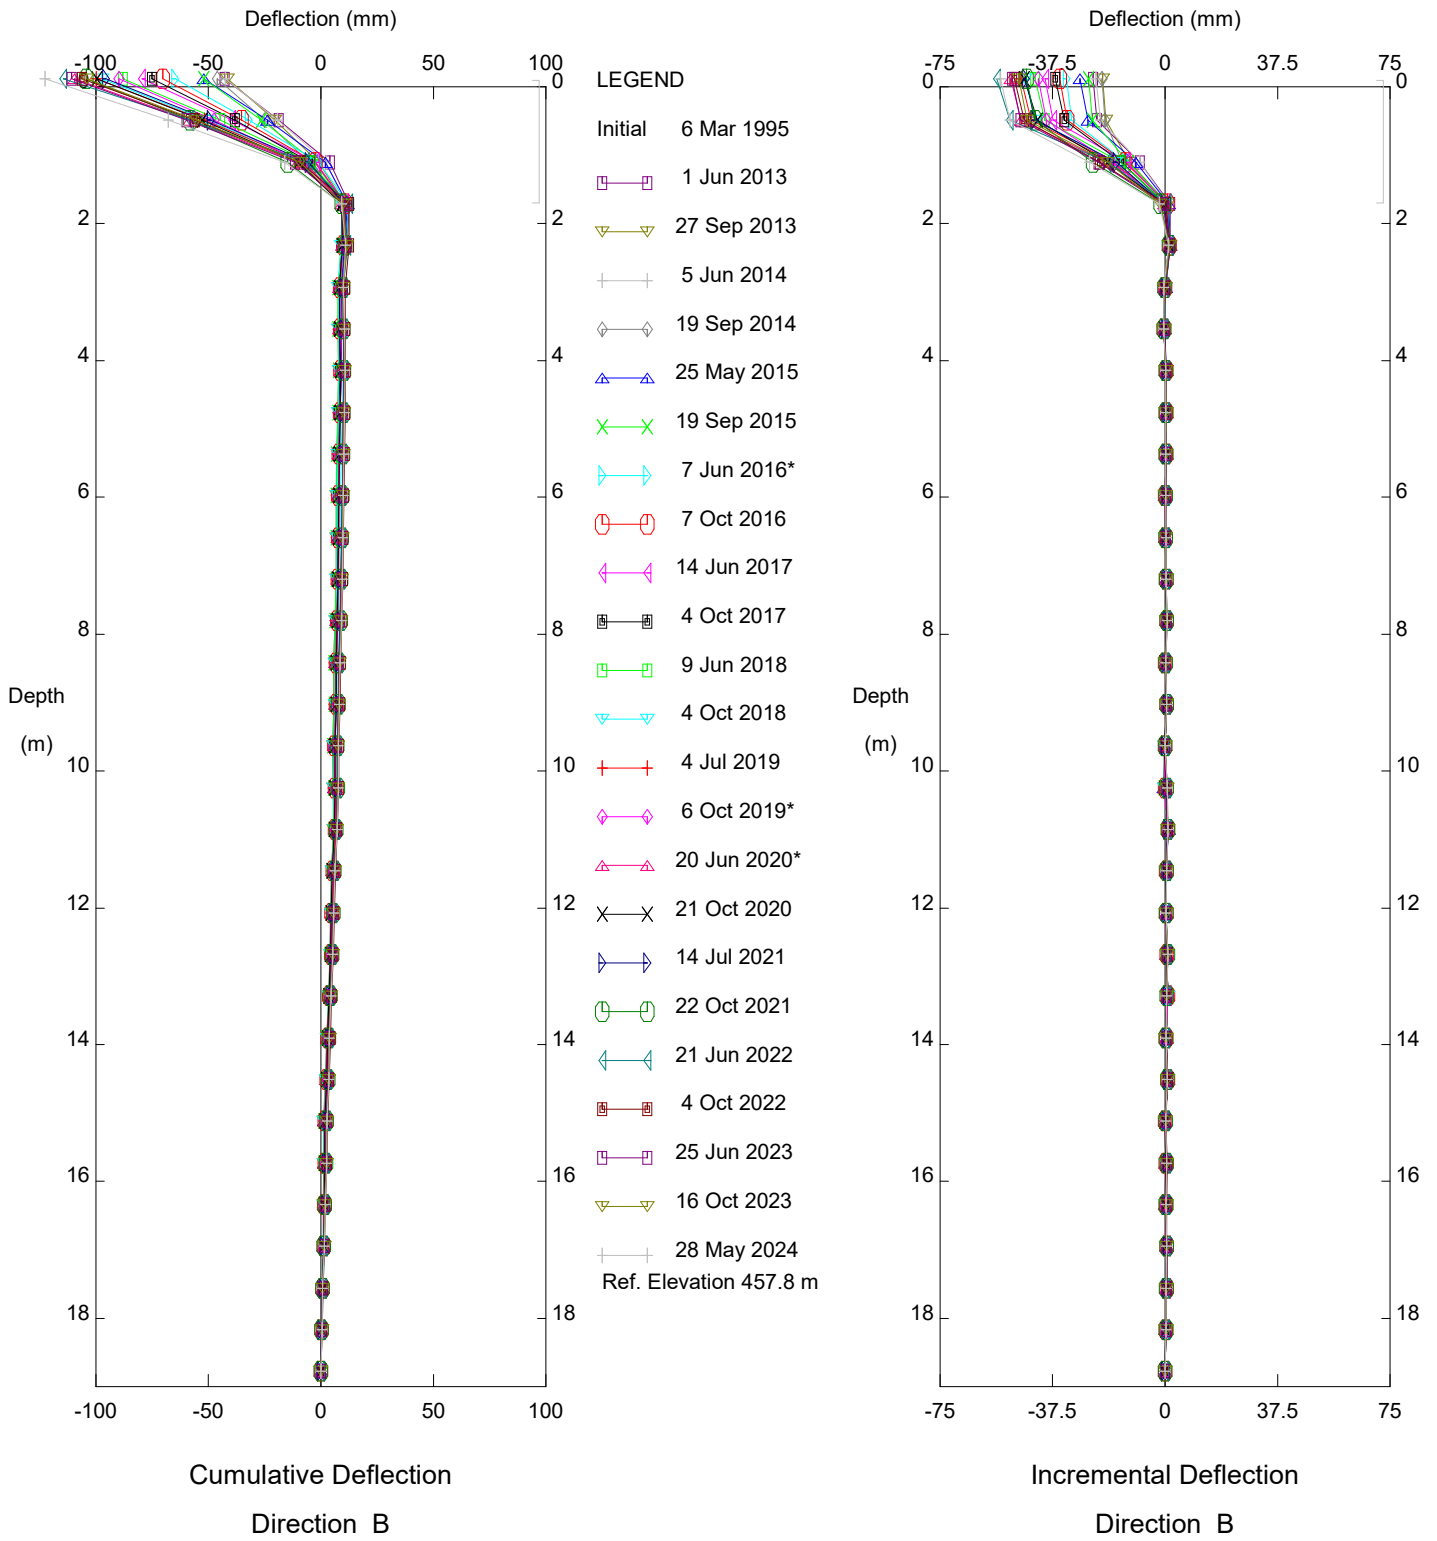
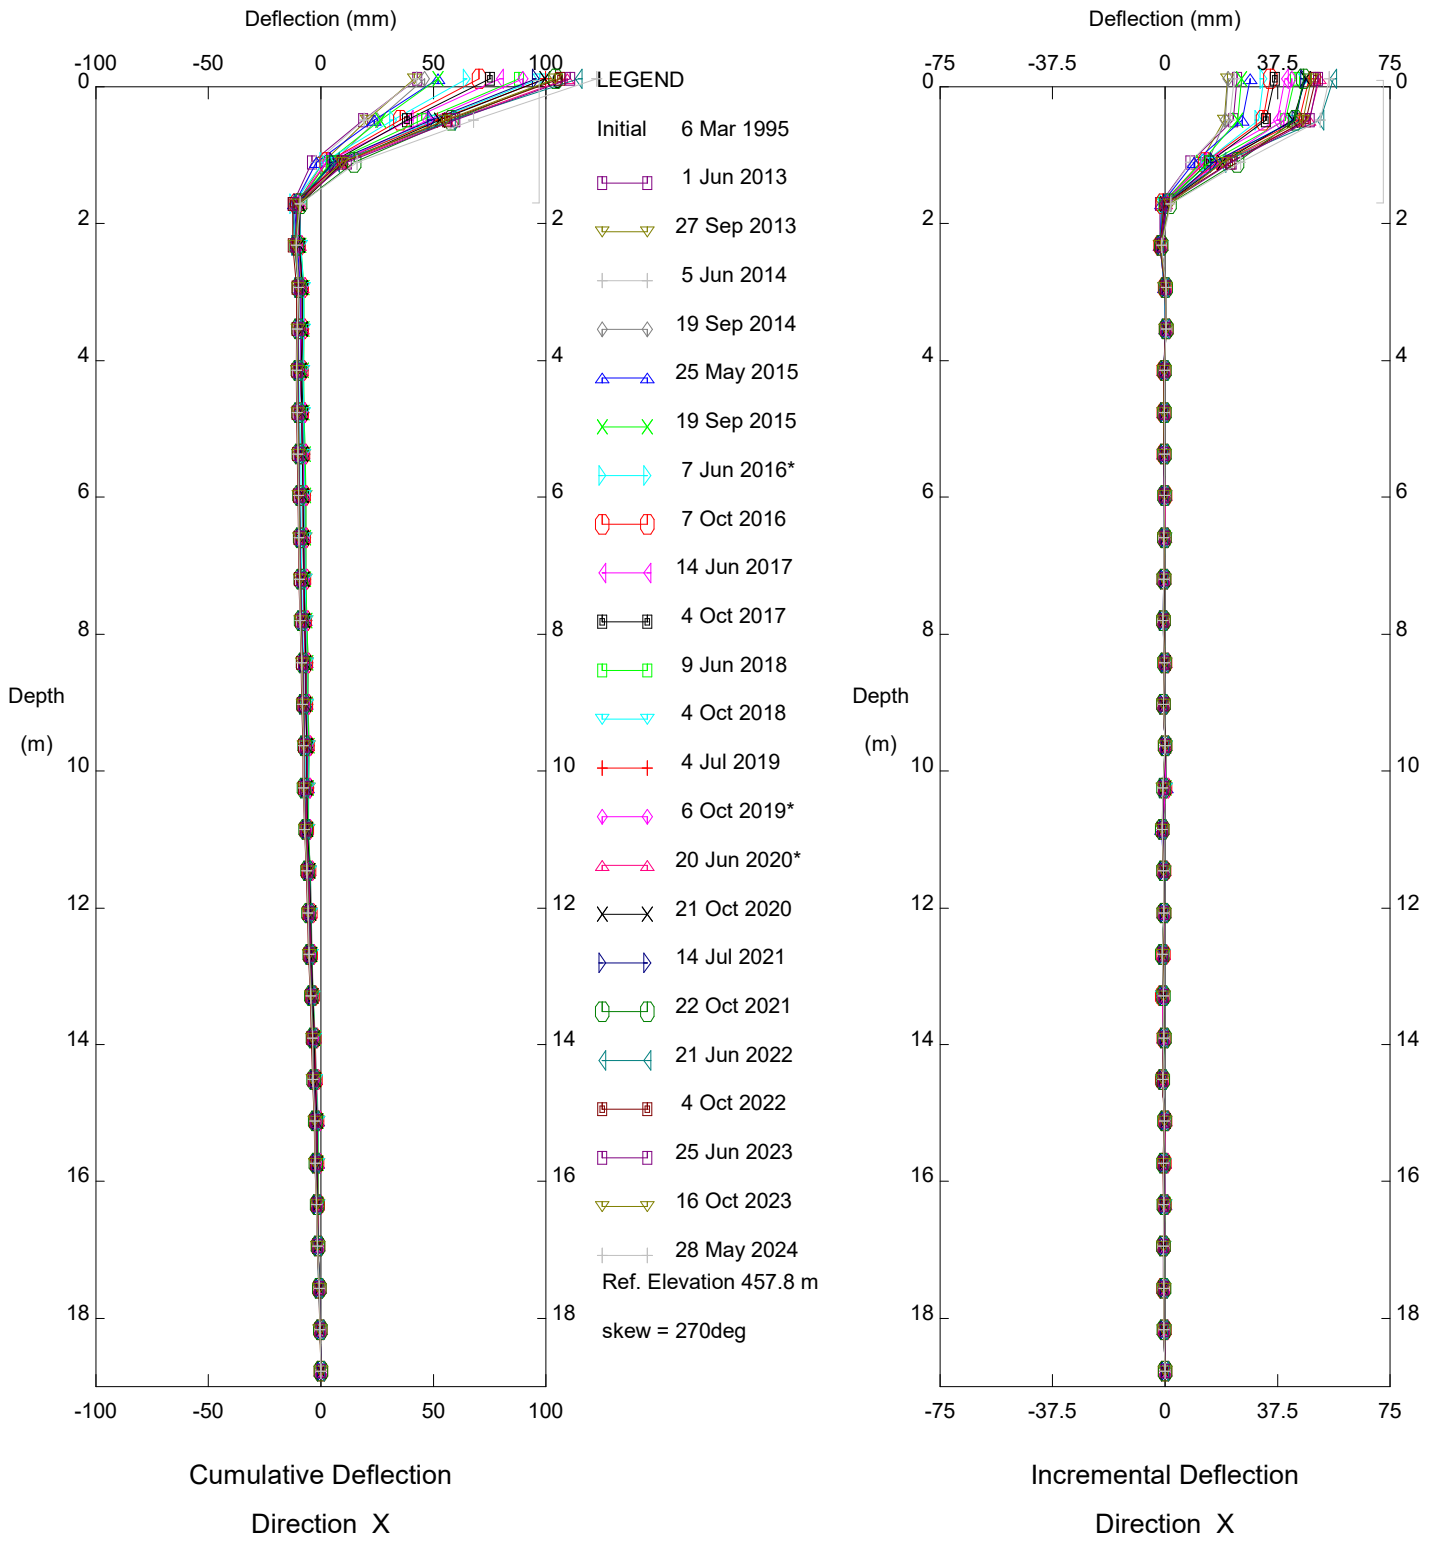
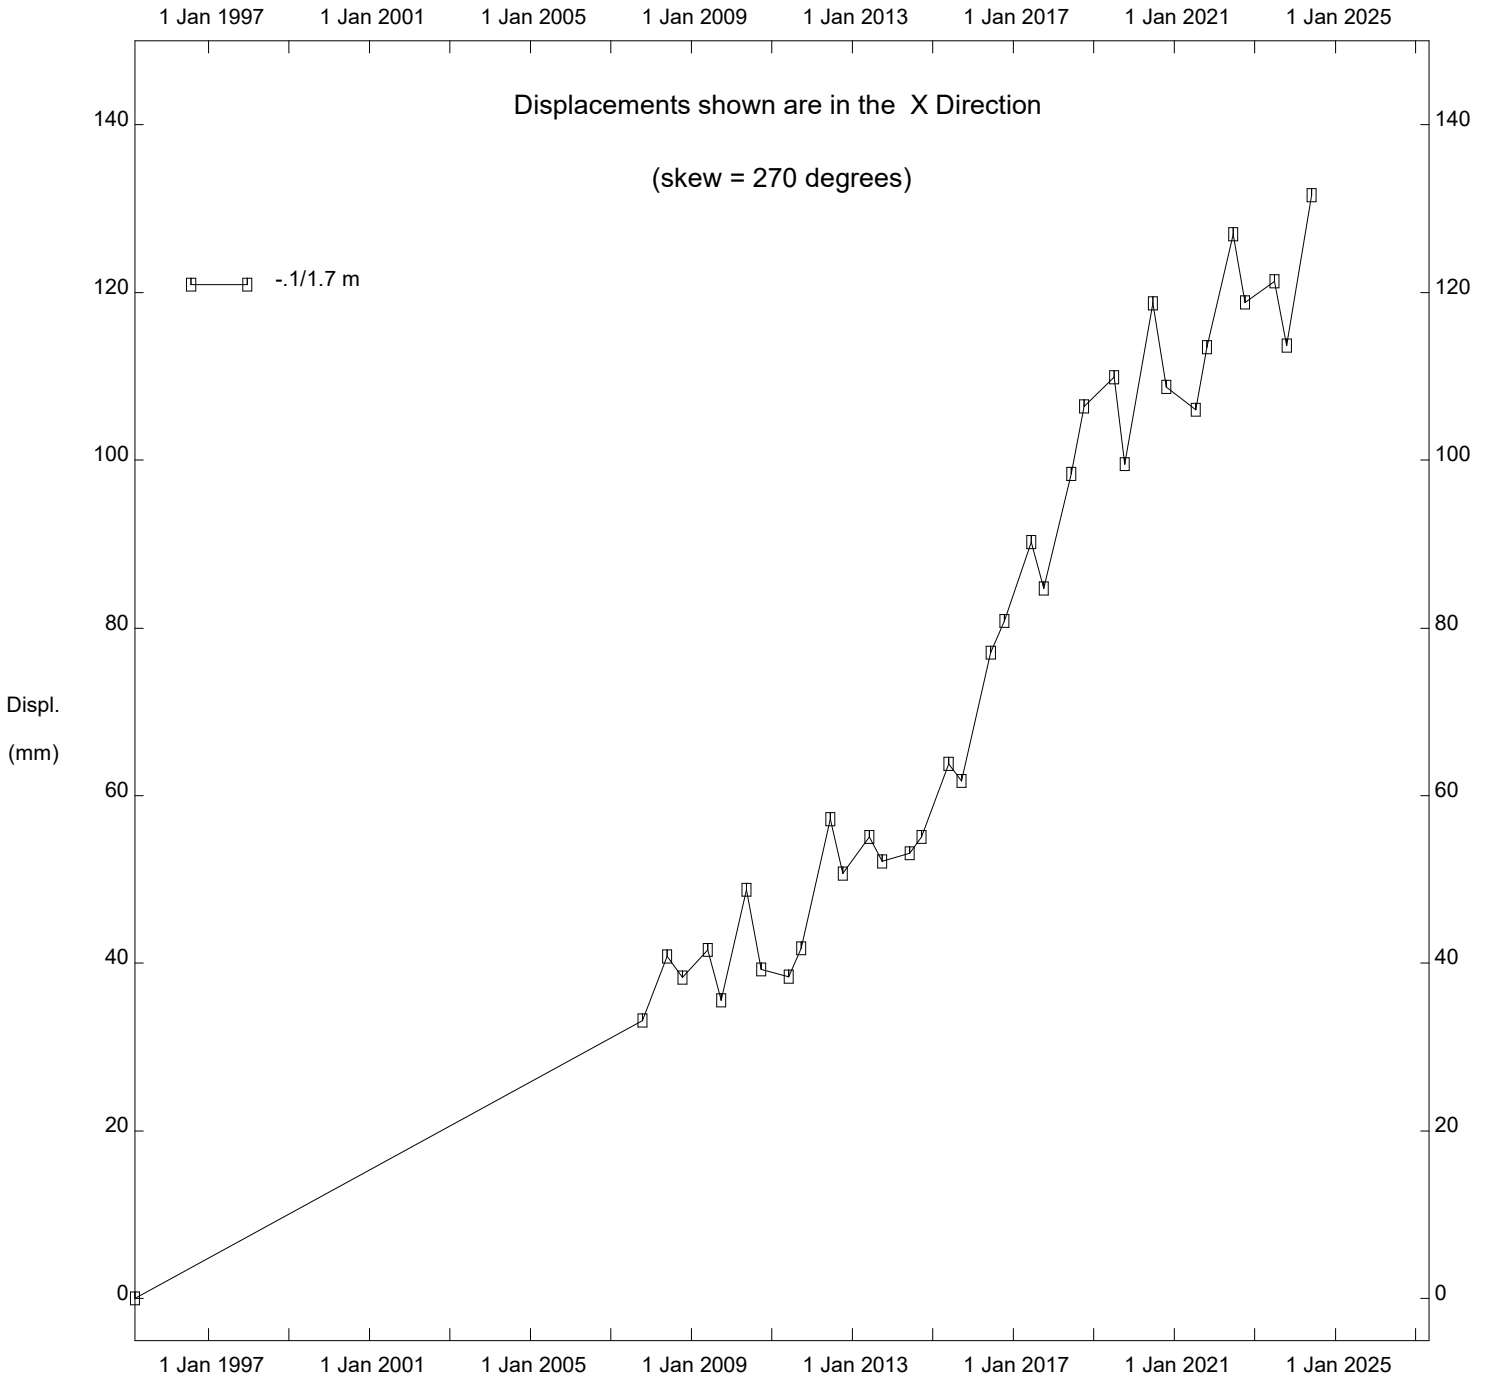
HWY 2:68 (PH037), Inclinometer SI-54

Slope inclinometer SI-54 is located about 70 m east of the highway and showed a rate of movement of 29.0 mm/yr over 0 m to 1.7 m depth, which corresponds to an increase in rate of movement of 53.9 mm/yr since the fall of 2023 readings. Of more significance with this slope indicator is the lack of observed shear zones below the near ground surface movement zone.

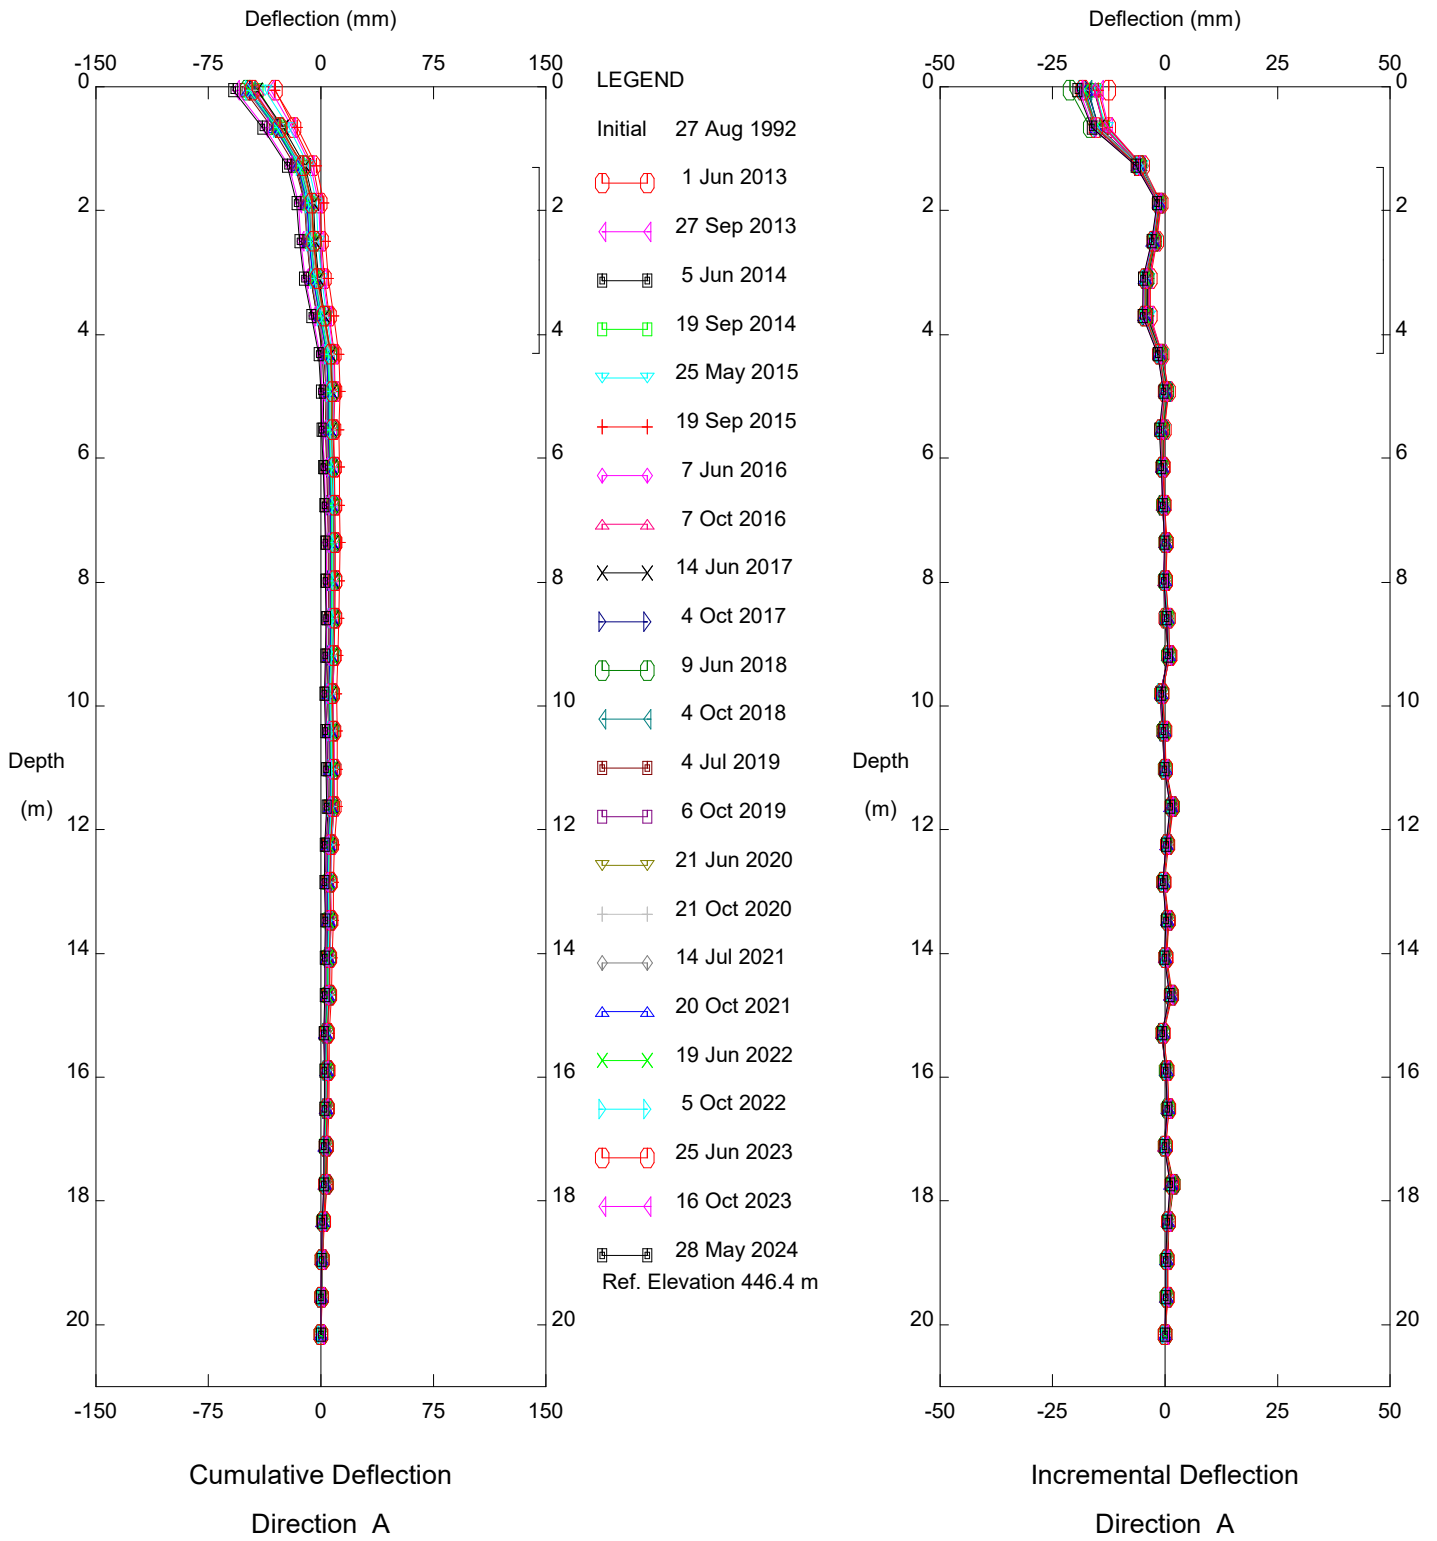
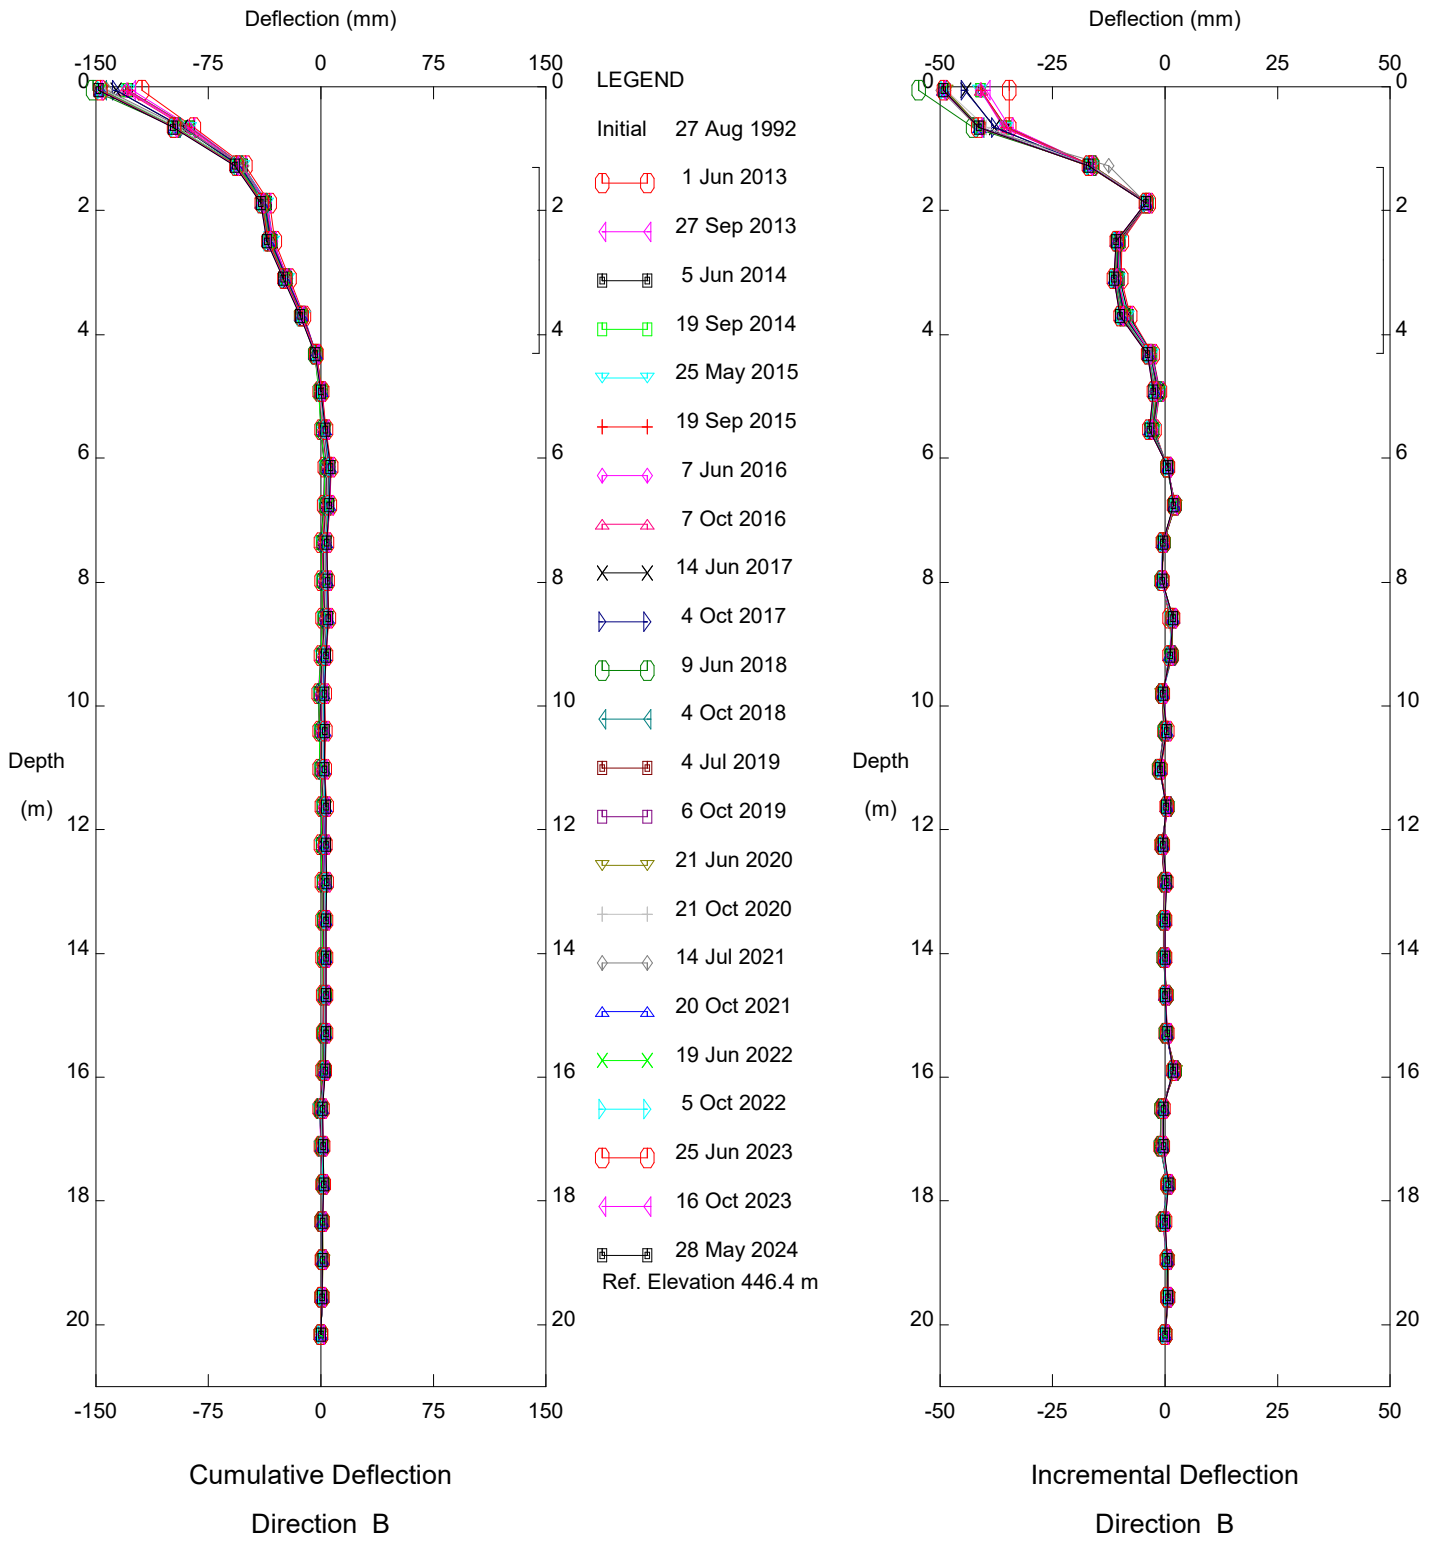
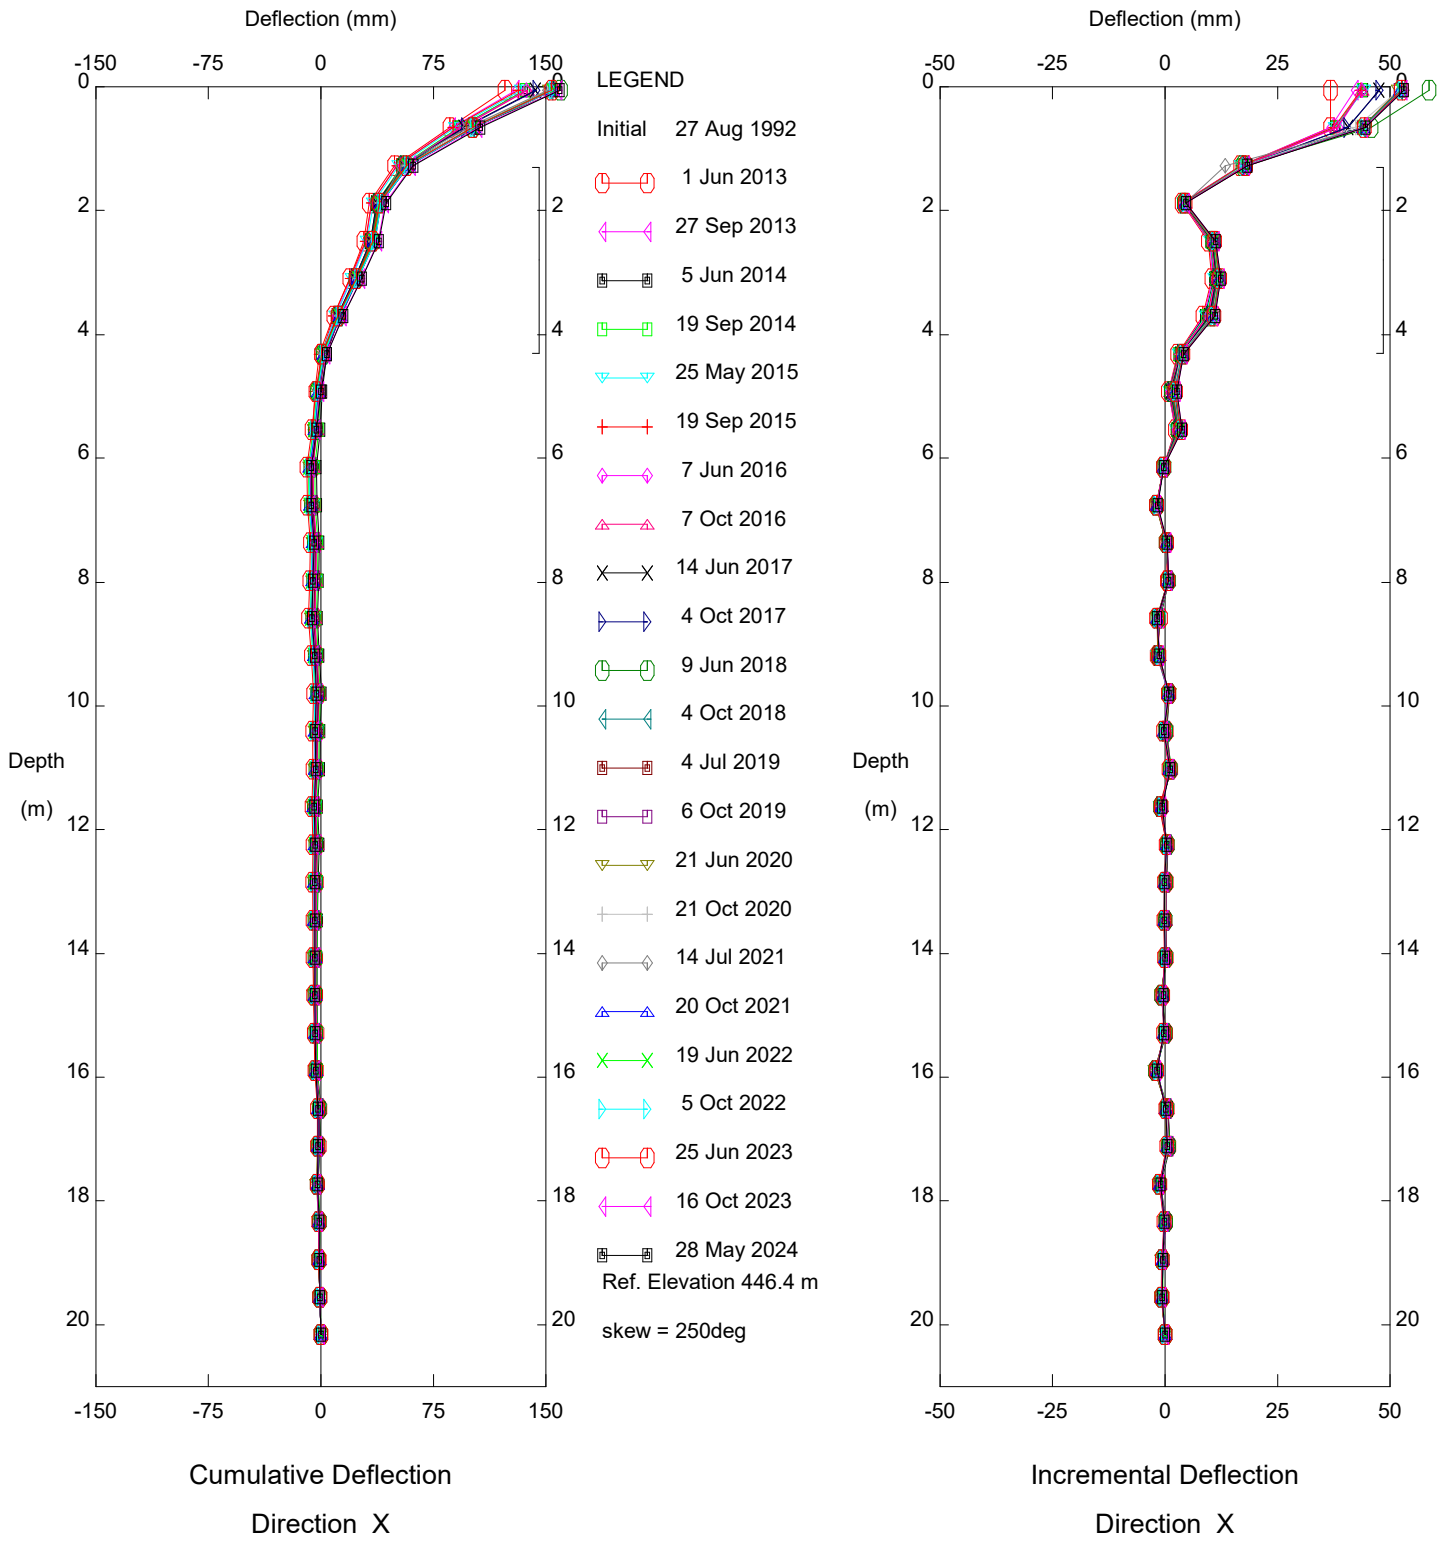
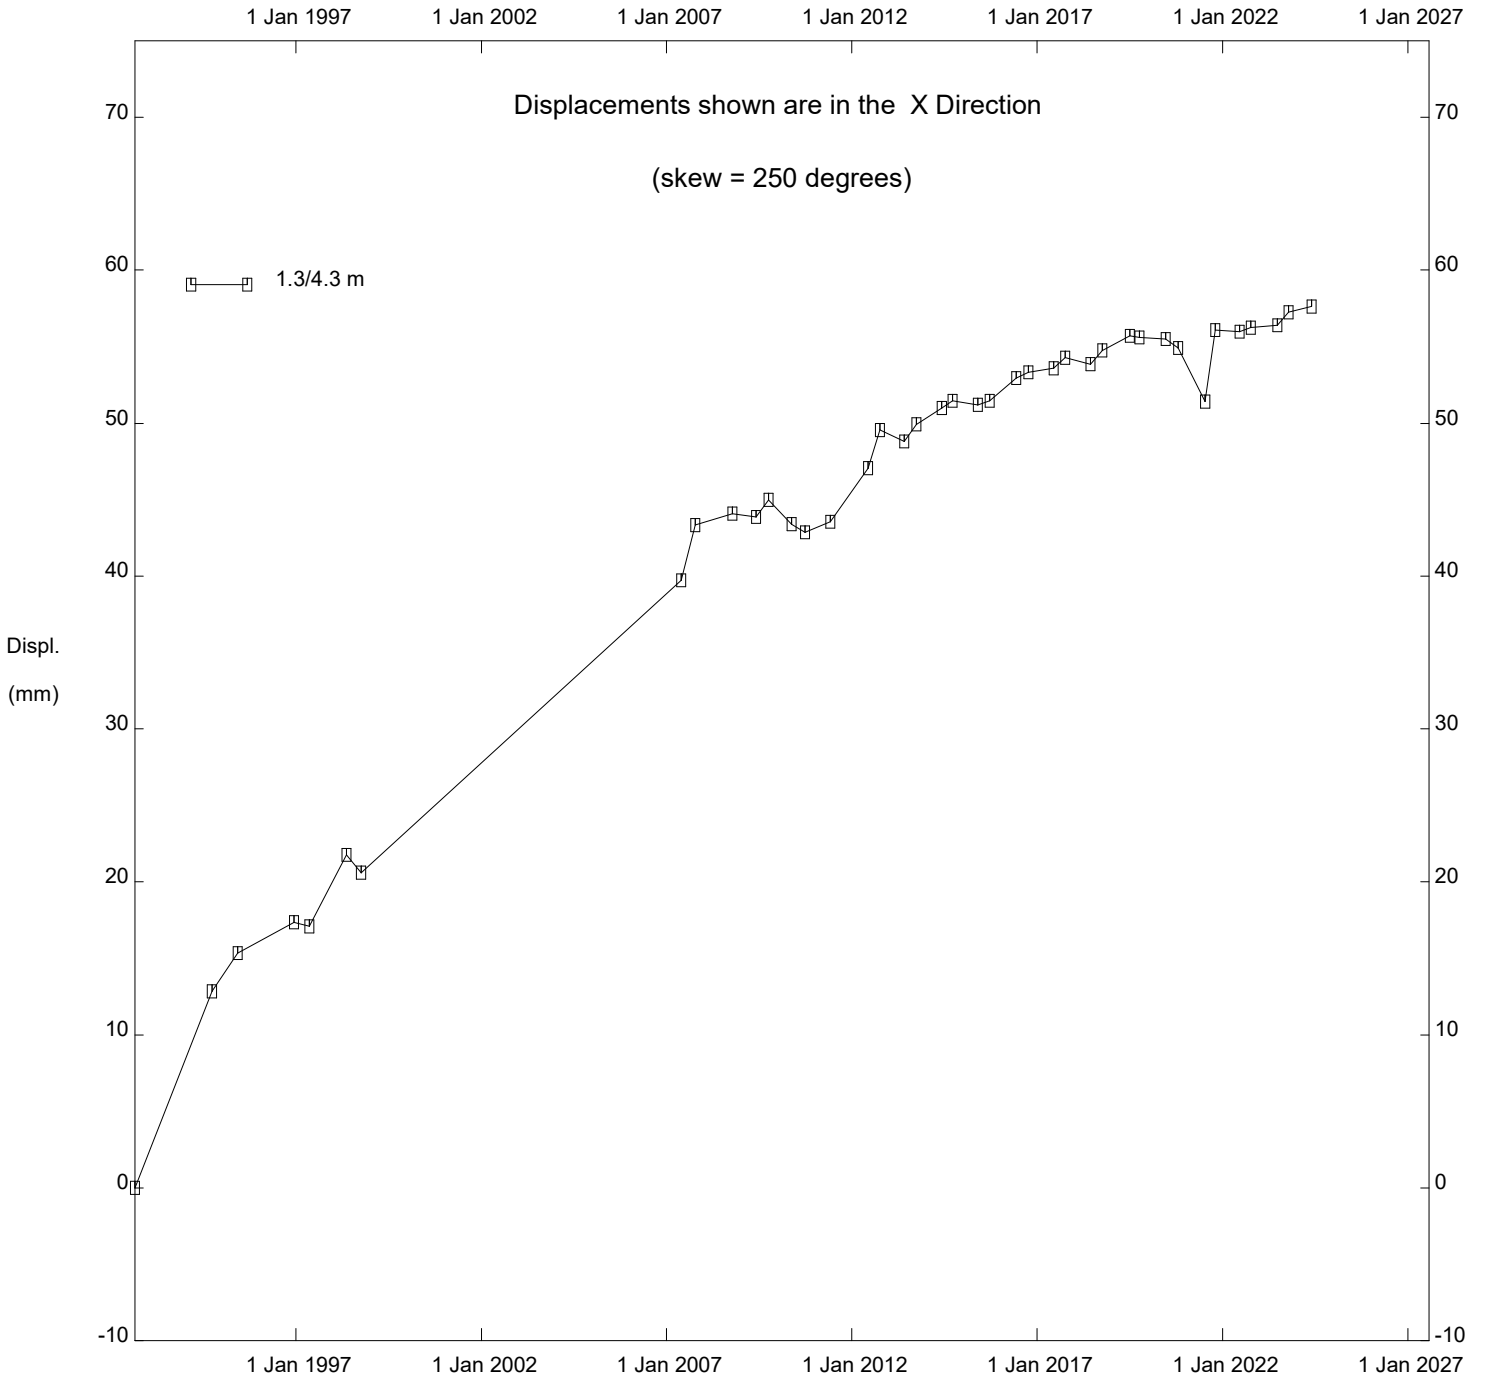
HWY 2:68 (PH037), Inclinometer SI-55

SI-55 is located about 20 m west the highway and showed a rate of movement of 0.6 mm/yr over 1.3 m to 4.3 m depth over a non specific shear zone. This rate of movement has been relatively consistent since 2016.
