ALBERTA TRANSPORTATION AND
ECONOMIC CORRIDORS GRMP
GRANDE PRAIRIE REGION –
(GRANDE PRAIRIE NORTH)
INSTRUMENTATION MONITORING - SPRING 2024

Site Number	Location	Name	Hwy	km
PH037	Station 1+250 to 2+000	Dunvegan South	2:68	Km 15.7
Legal Description: 4-7-80-4 W6		UTM Co-ordinates		
		11U E 398593.62	N	6197597.09

Current Monitoring:	28-May-2024	Previous Monitoring	16-Oct-2023
Instruments Read By:	Mr. Niraj Regmi, G.I.T and Mr. Nixon Mationg, of Thurber

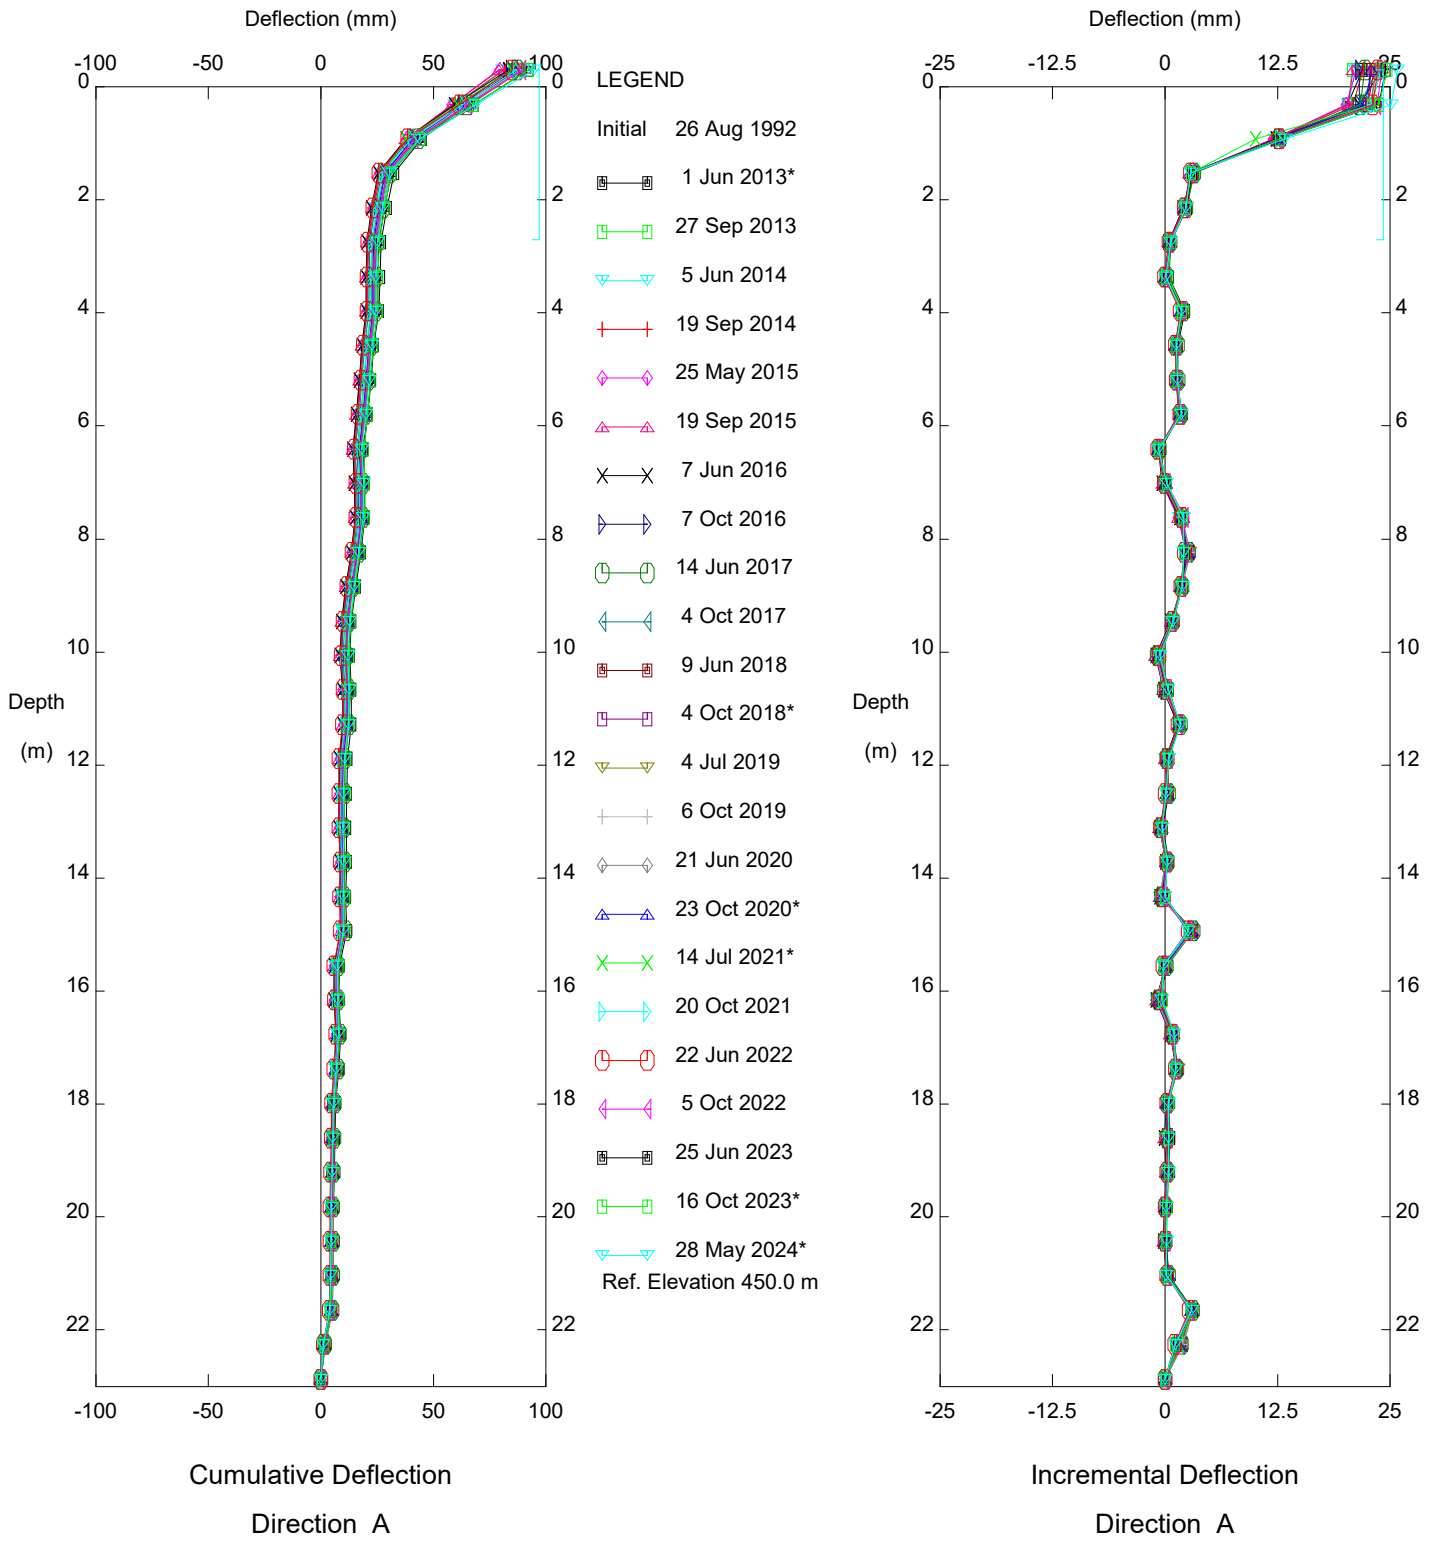
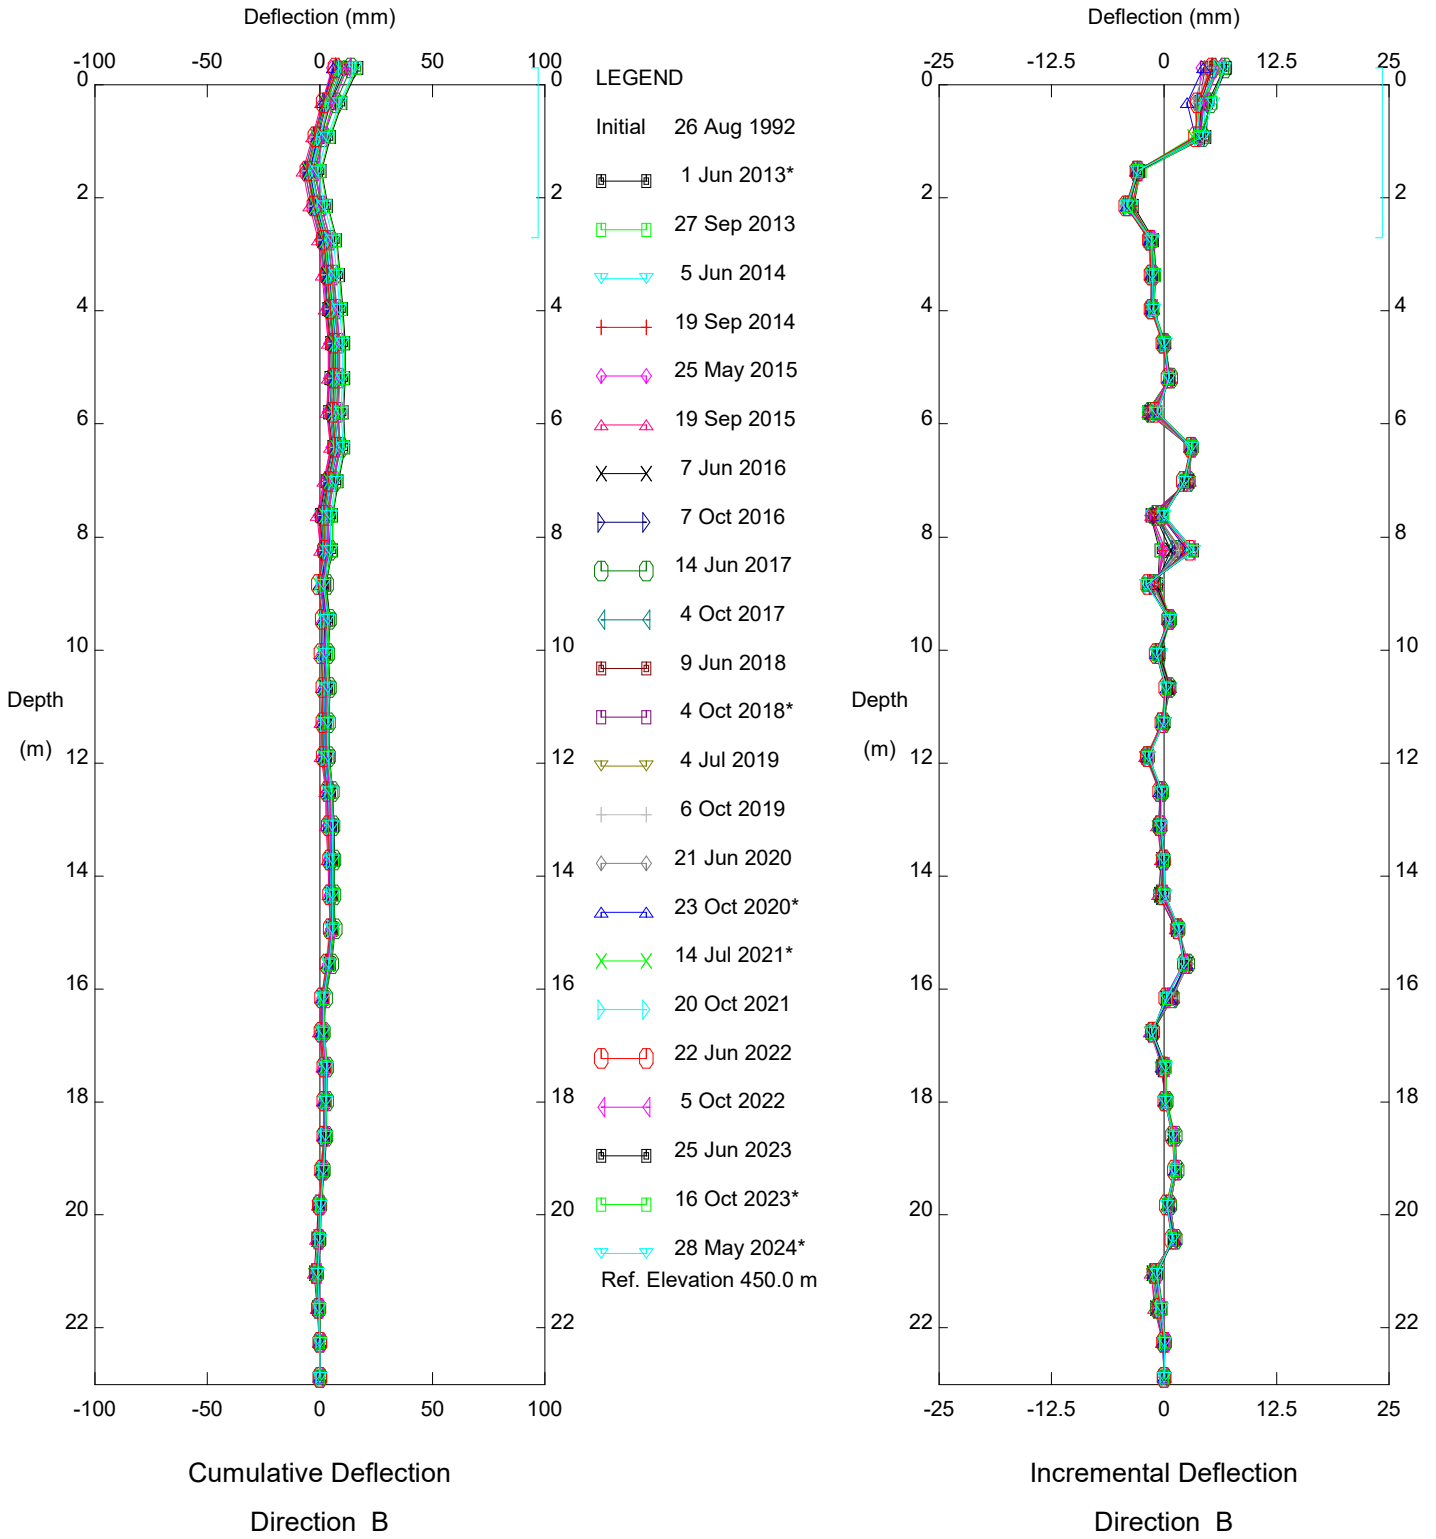
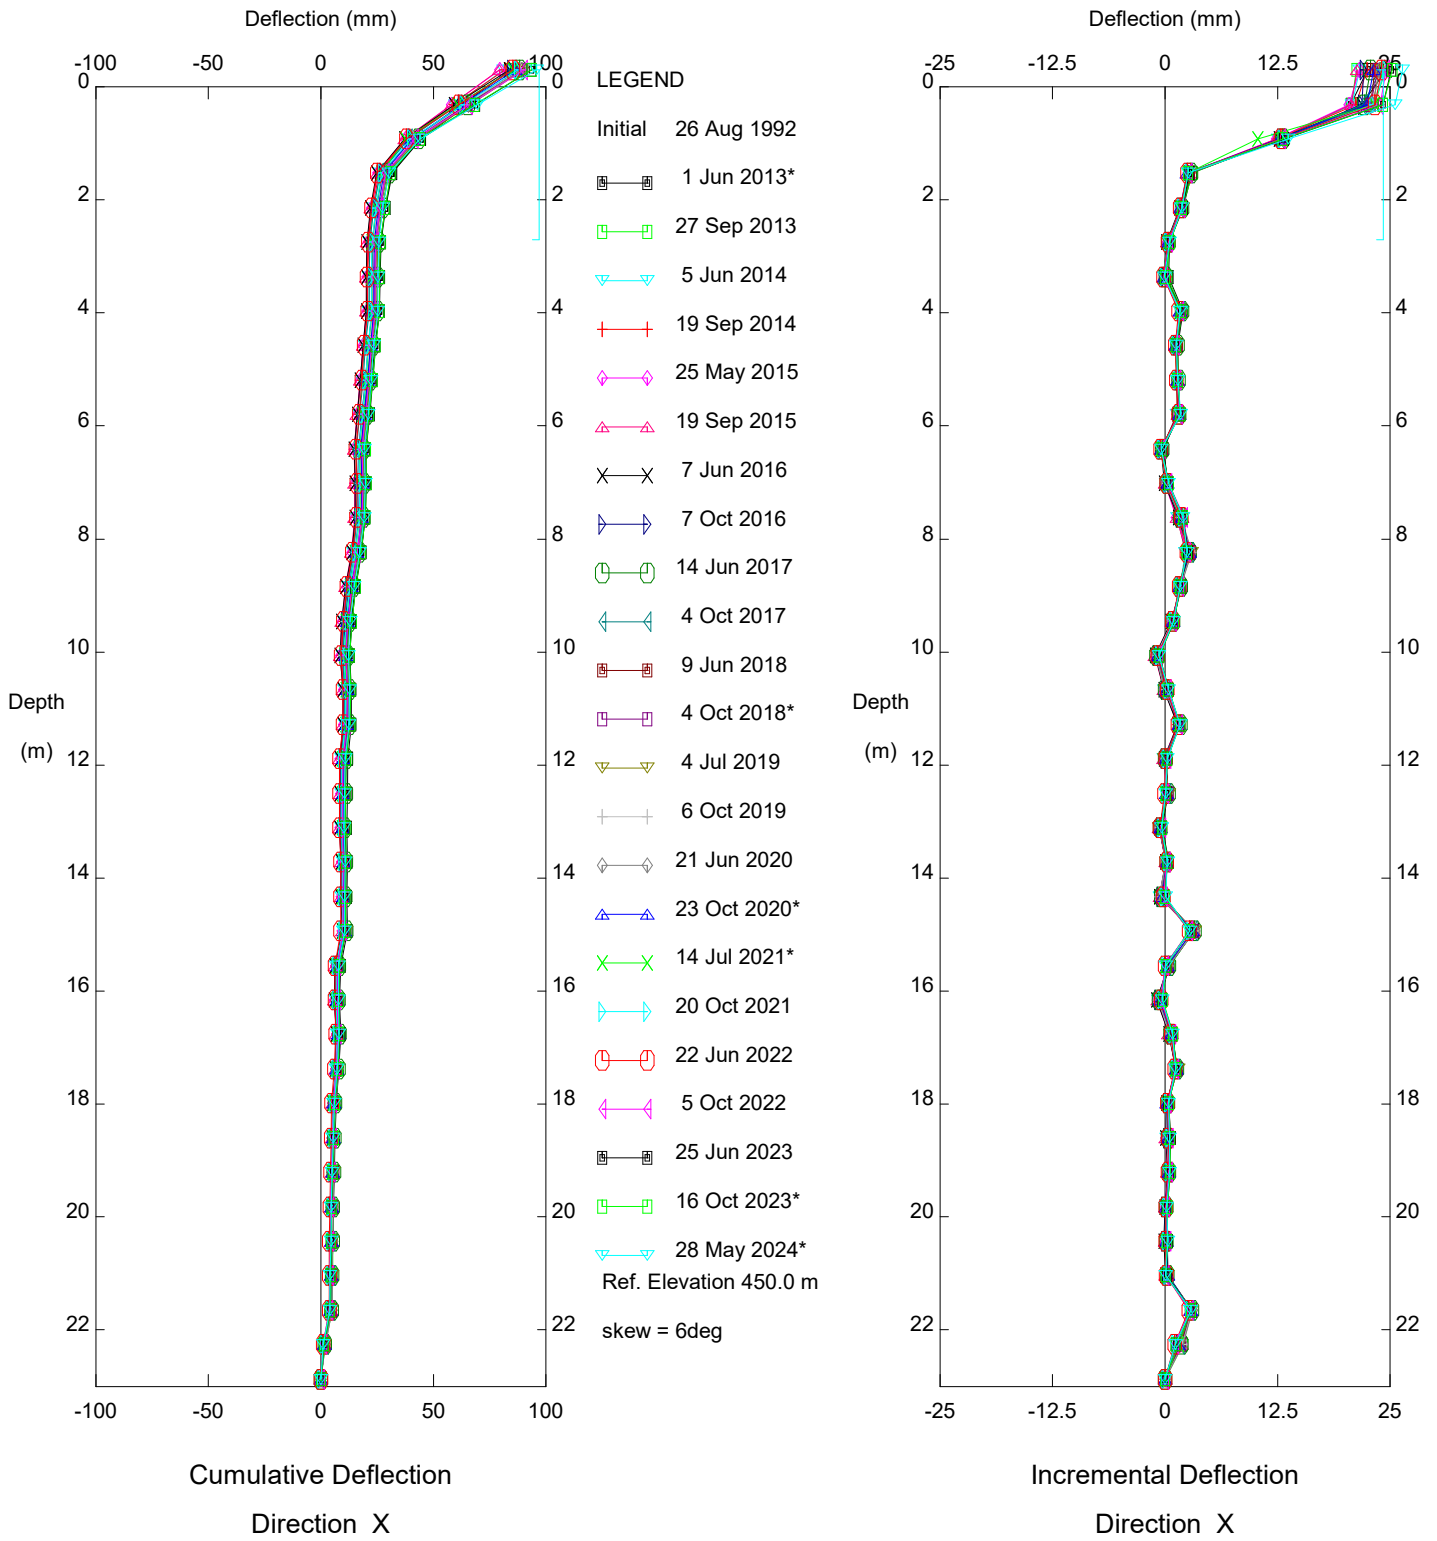
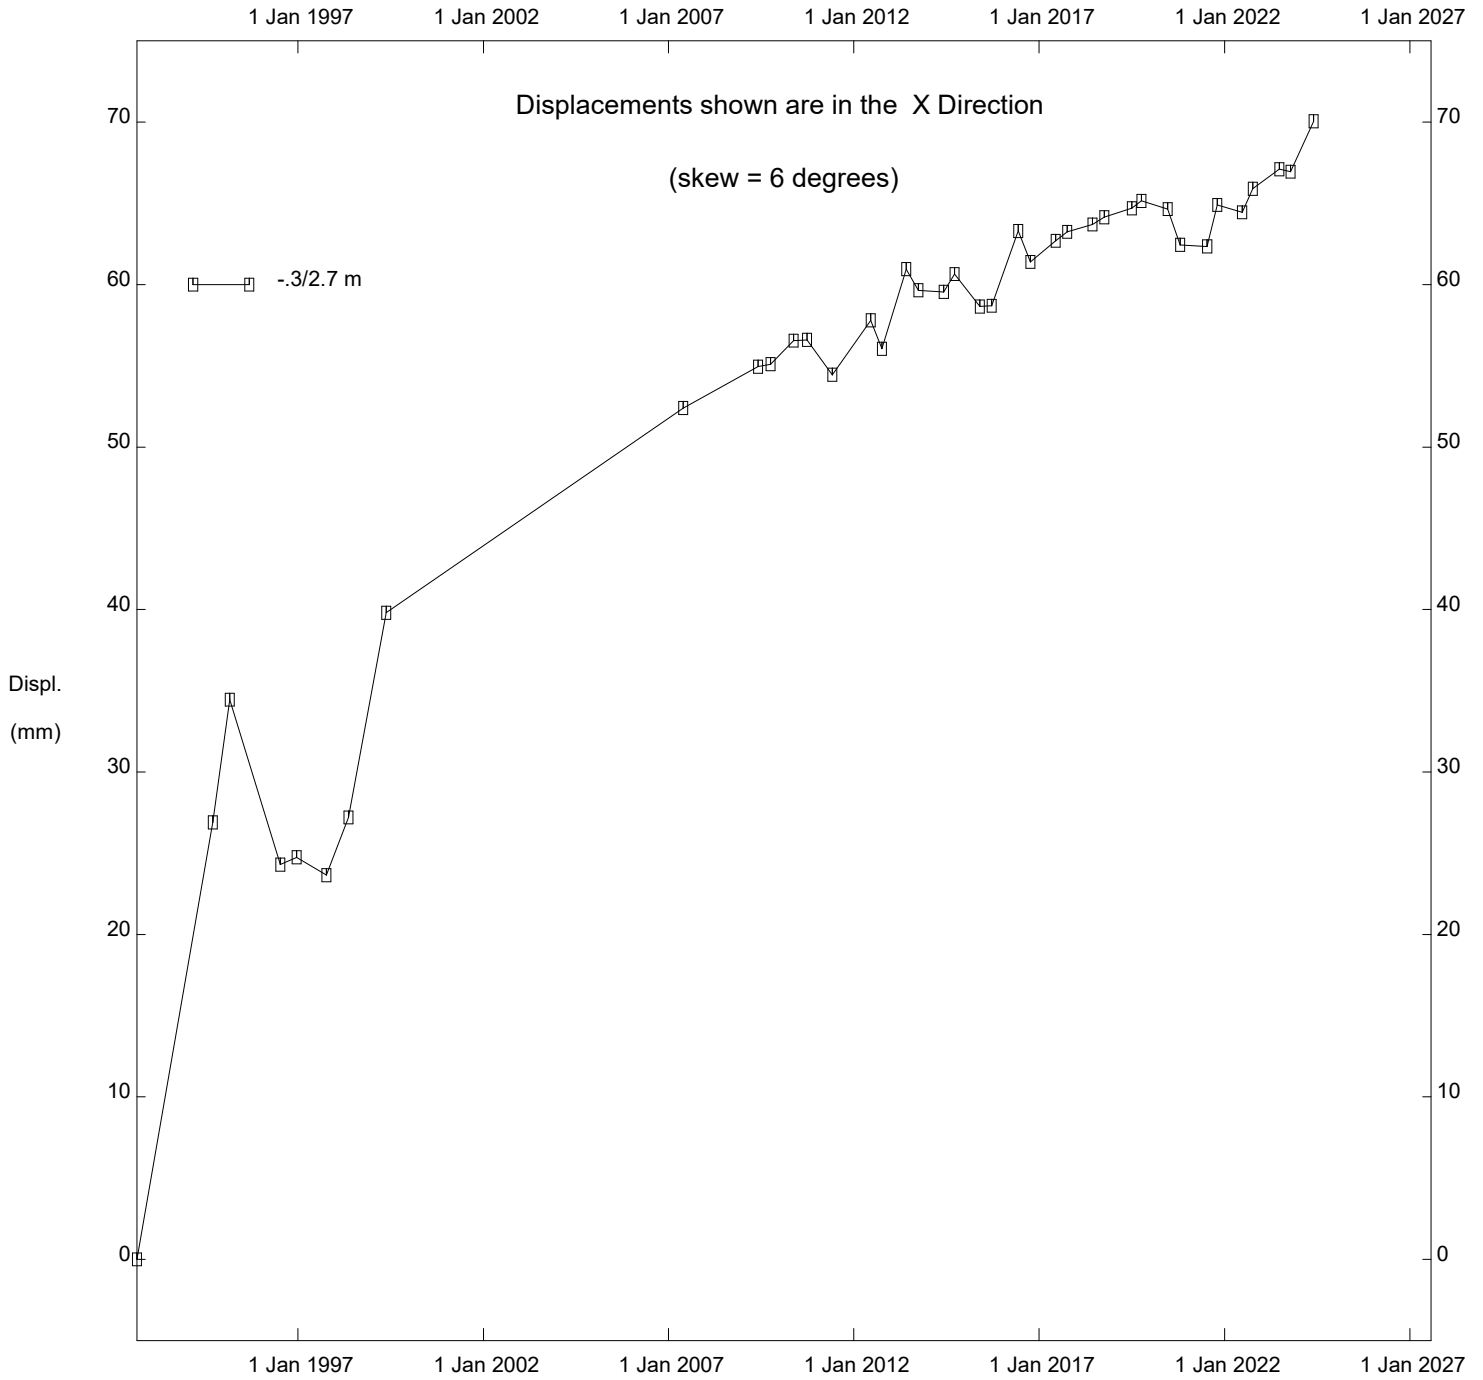
HWY 2:68 (PH037), Inclinometer SI-56

SI-56 is located just east of the highway and showed a rate of movement of 5.0 mm/yr over 0 m to 2.7 m depth. There are several subtle zones of movement deeper in SI-56 with movement rates less than 0.5 mm/yr.

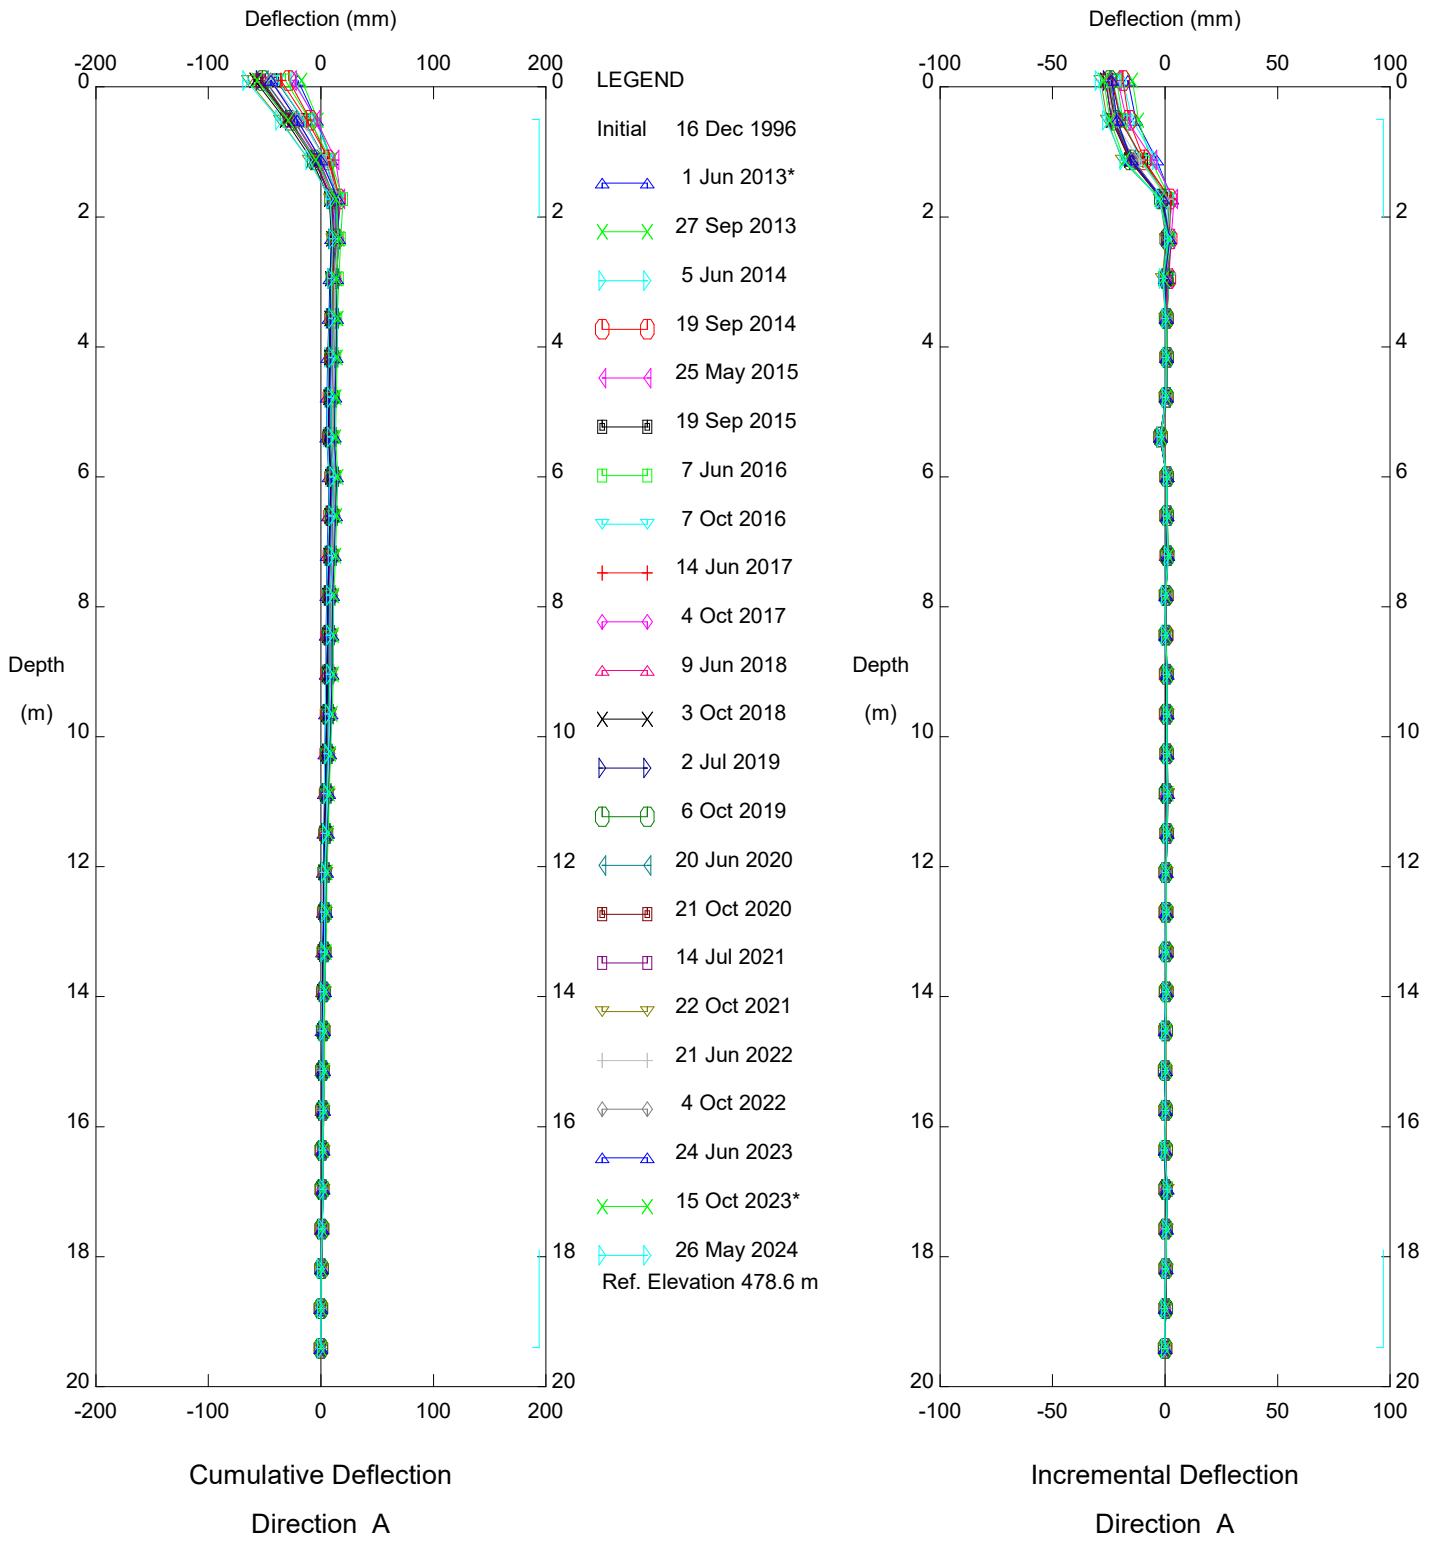
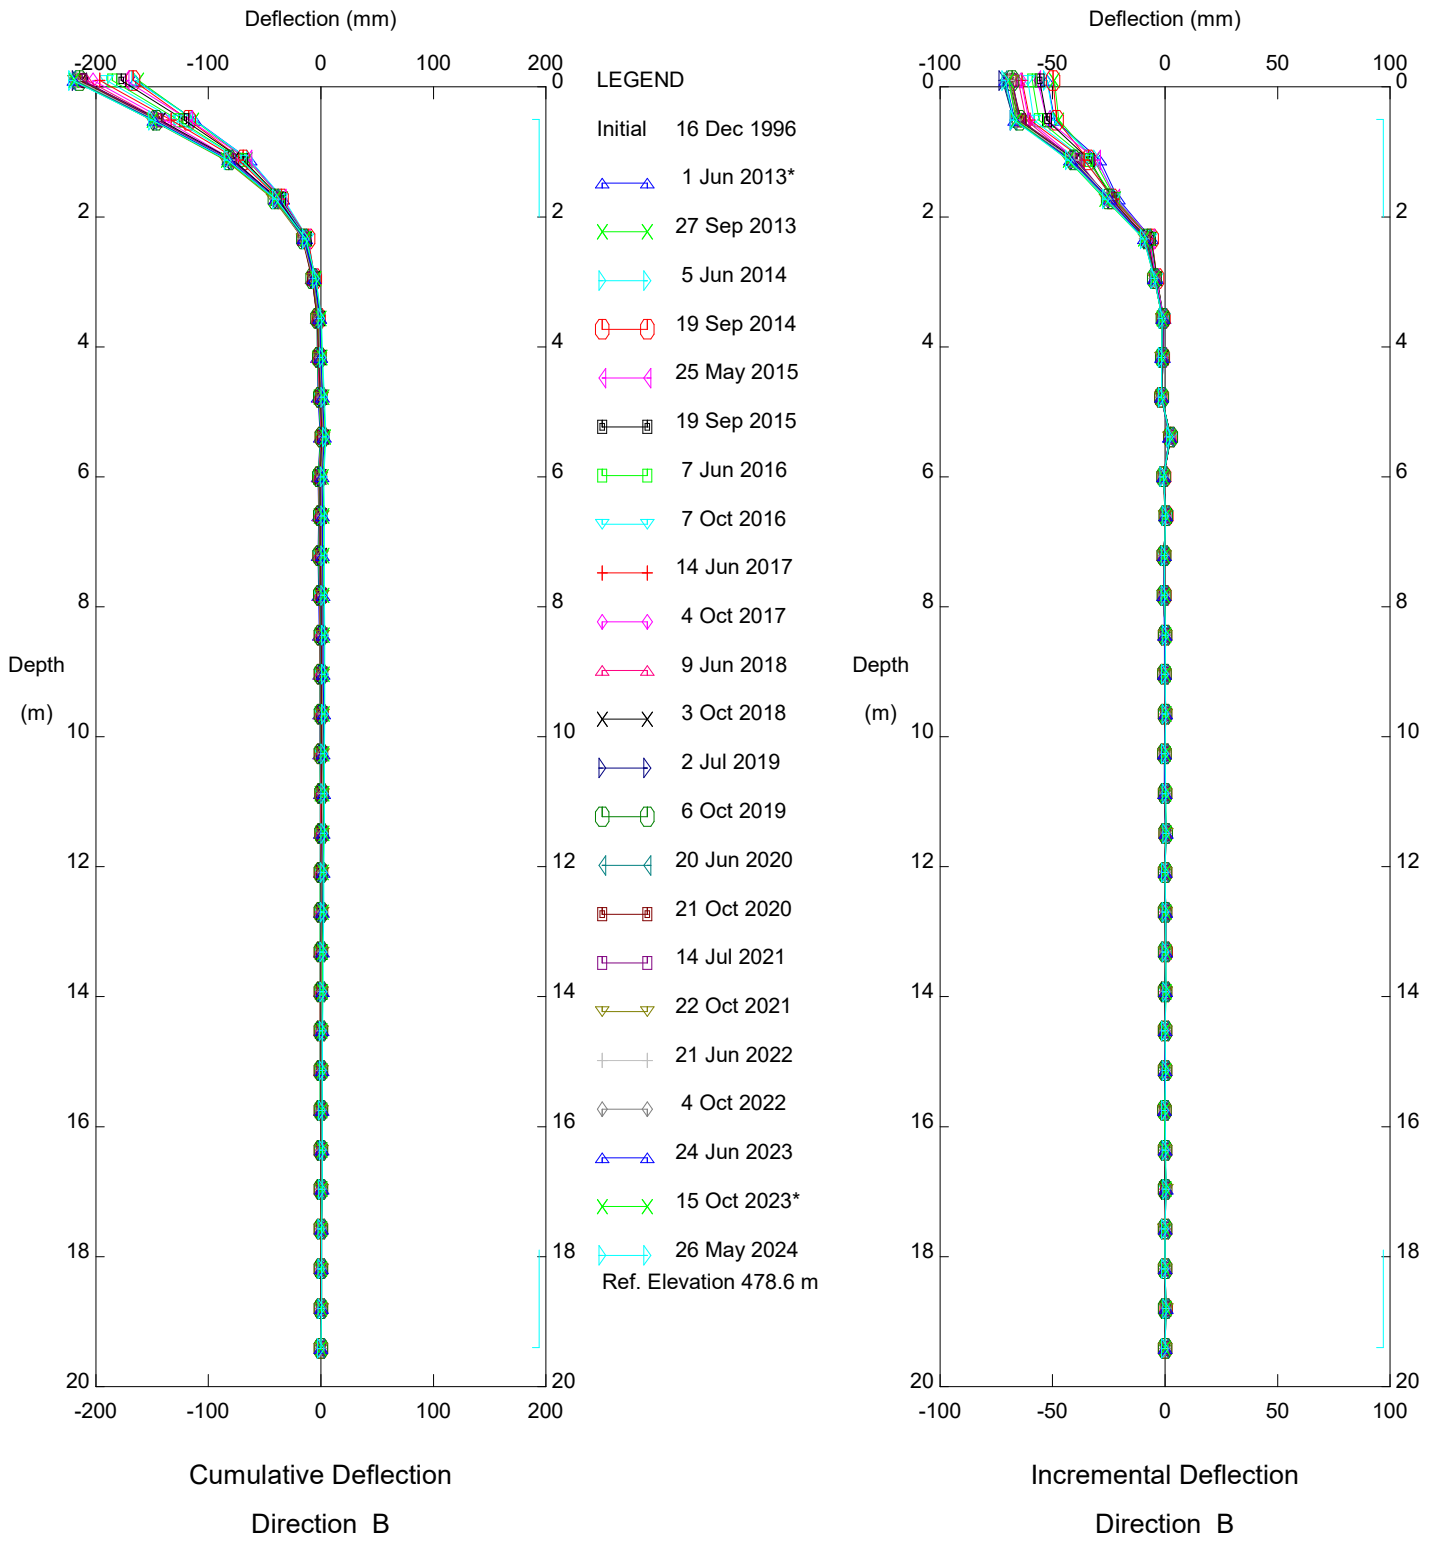
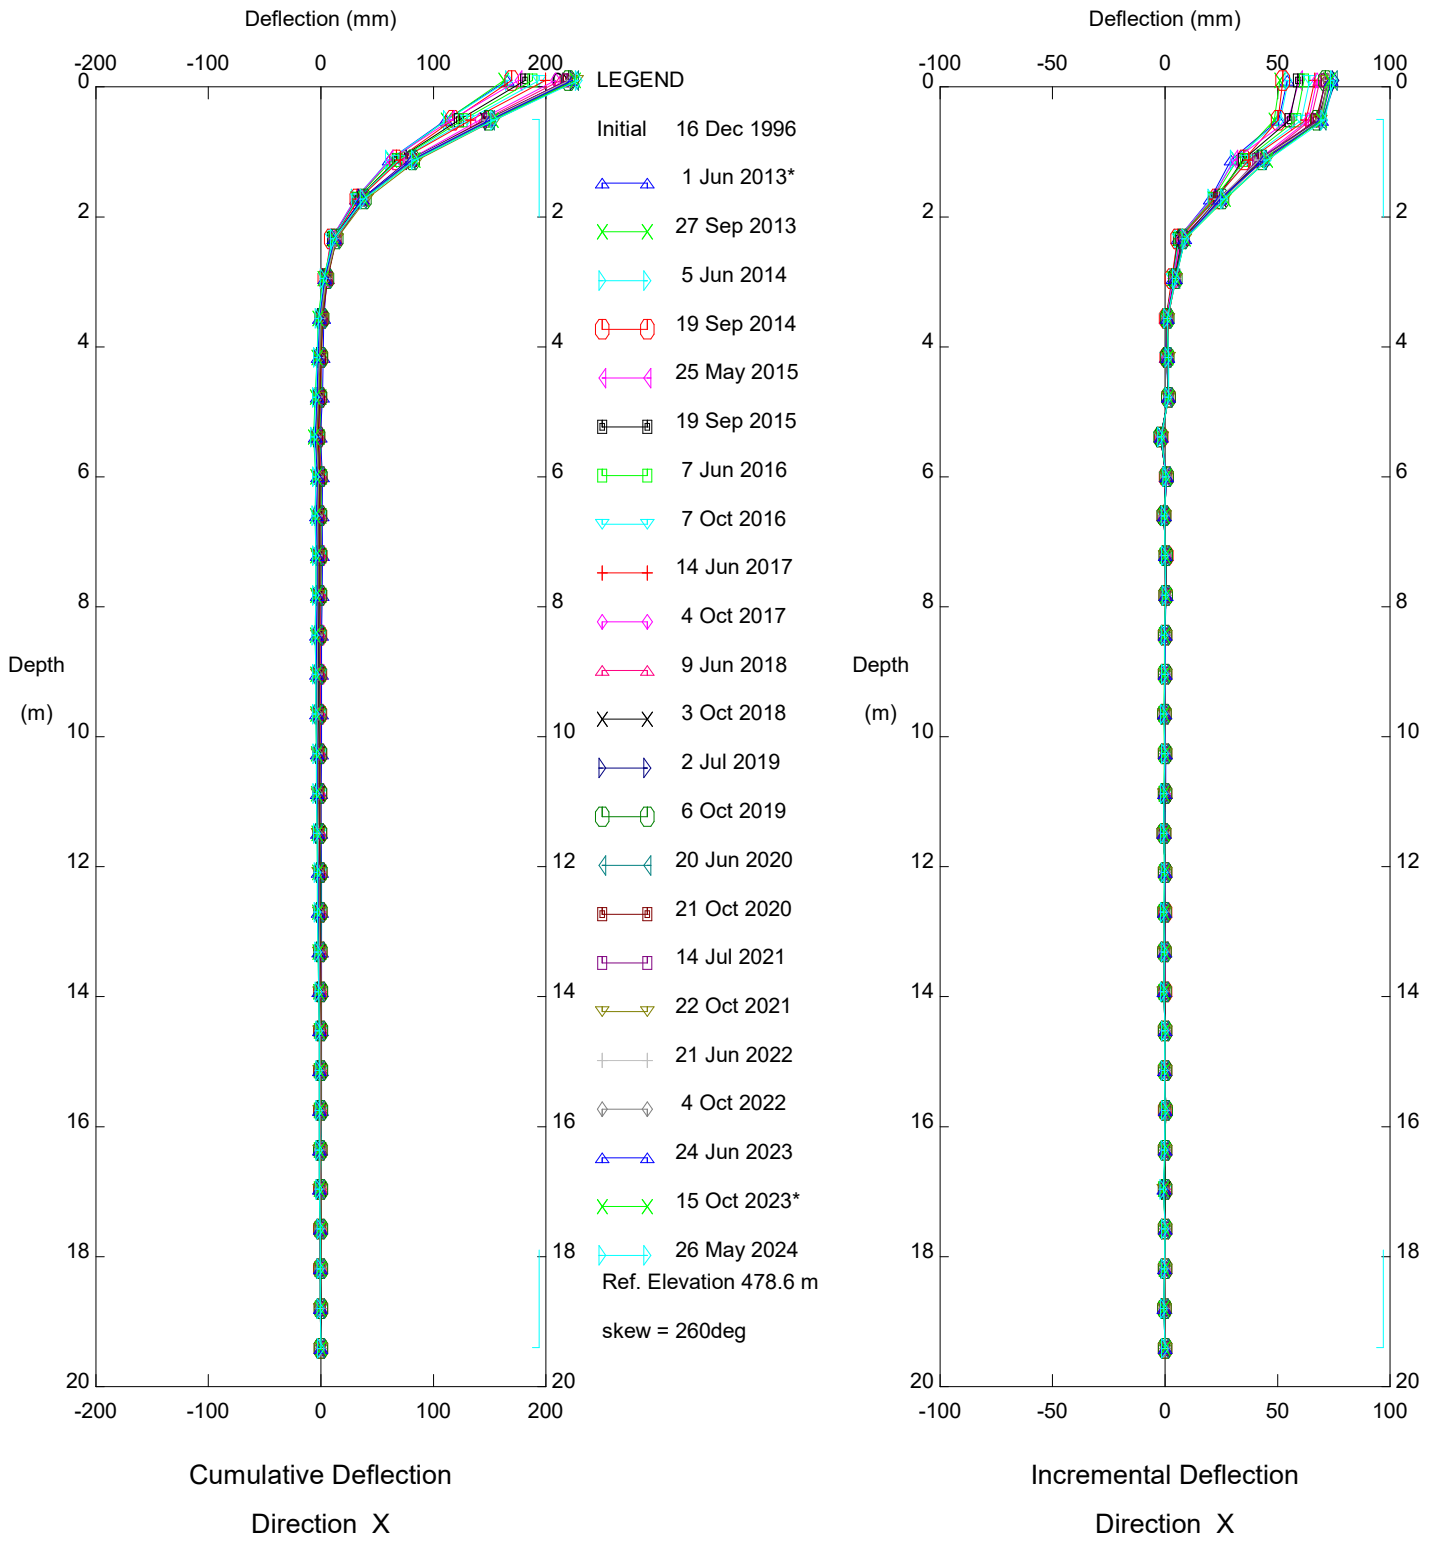
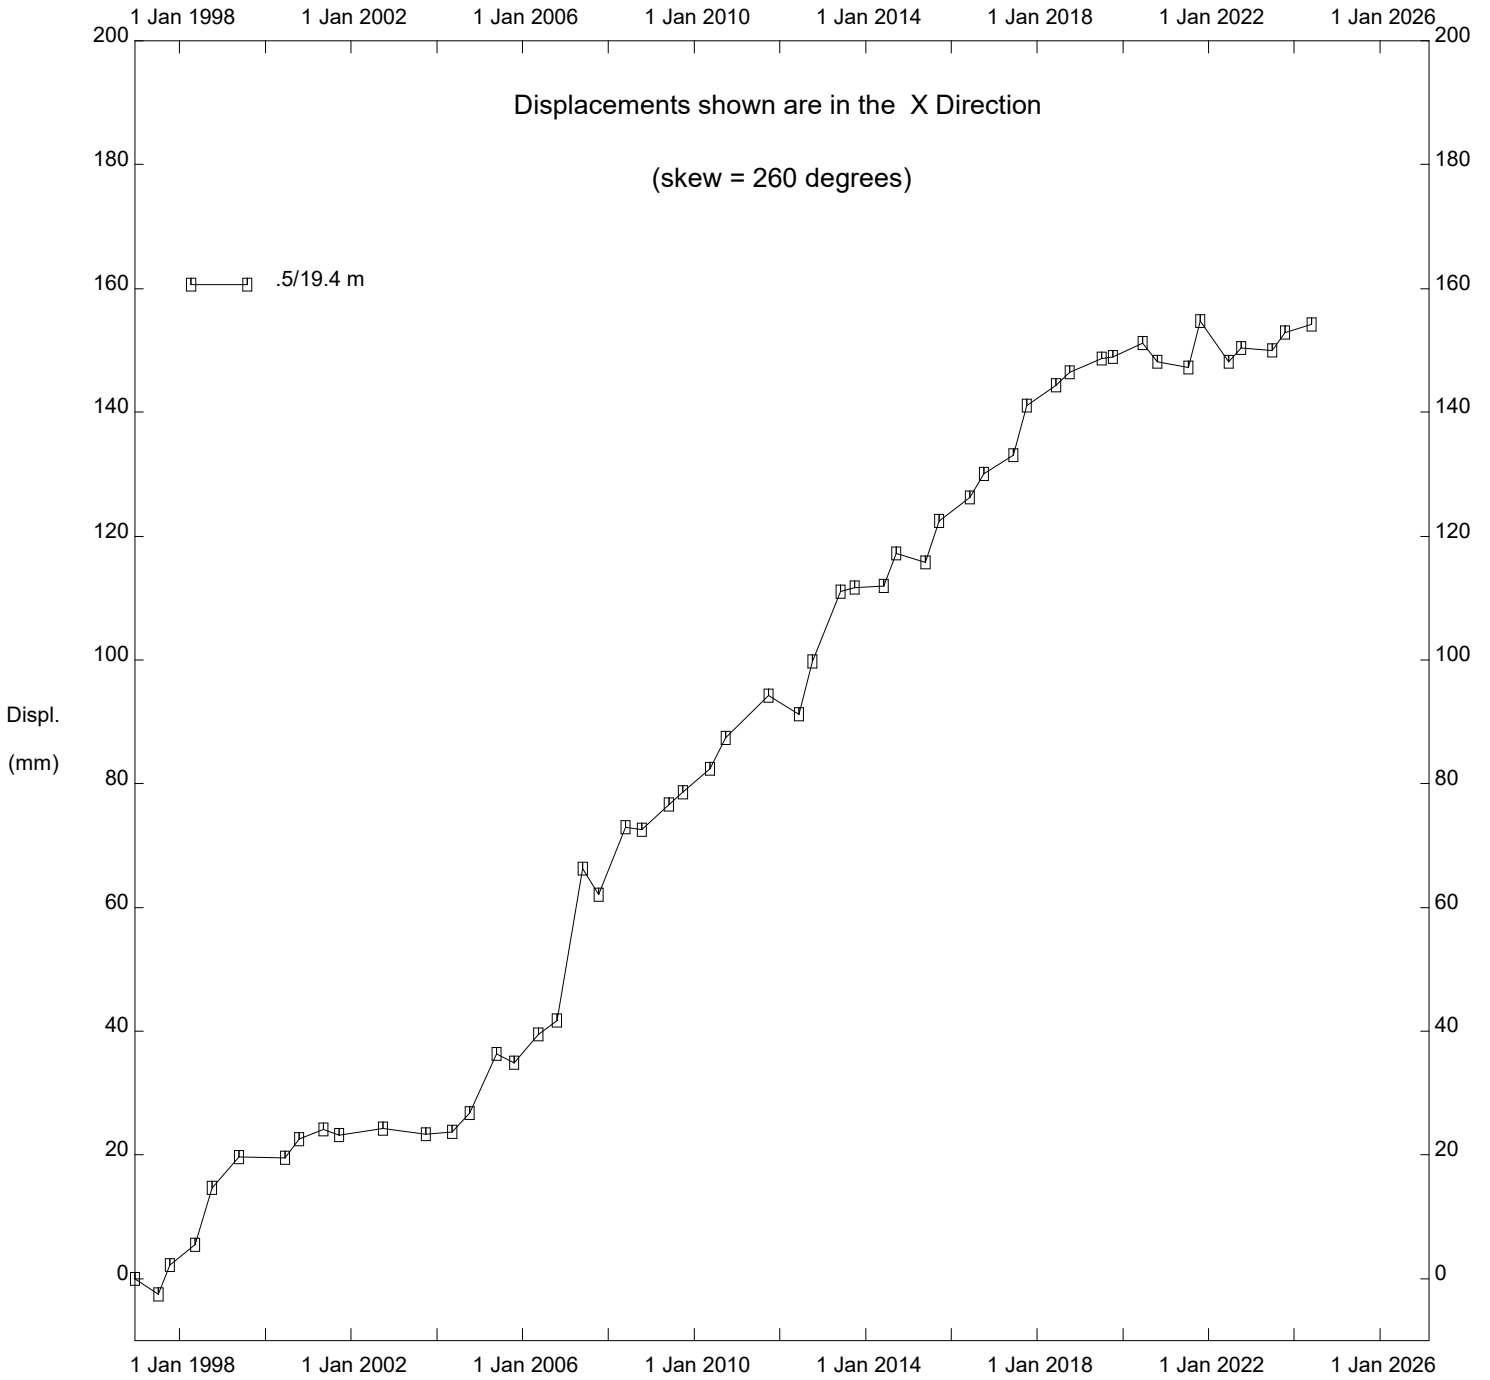
HWY 2:68 (PH037), Inclinometer SI-58

SI-58 is located about 100 m east of the highway and showed a rate of movement of 2.0 mm/yr over 0.5 m to 3.6 m depth. The movement pattern at SI-58 is tilting with no well defined shear zone.
