ALBERTA TRANSPORTATION AND
ECONOMIC CORRIDORS GRMP
GRANDE PRAIRIE REGION –
(GRANDE PRAIRIE NORTH)
INSTRUMENTATION MONITORING - SPRING 2024

Site Number	Location	Name	Hwy	km
PH037	Station 1+250 to 2+000	Dunvegan South	2:68	Km 15.7
Legal Description: 4-7-80-4 W6		UTM Co-ordinates		
		11U E 398593.62	N	6197597.09

Current Monitoring:	28-May-2024	Previous Monitoring	16-Oct-2023
Instruments Read By:	Mr. Niraj Regmi, G.I.T and Mr. Nixon Mationg, of Thurber

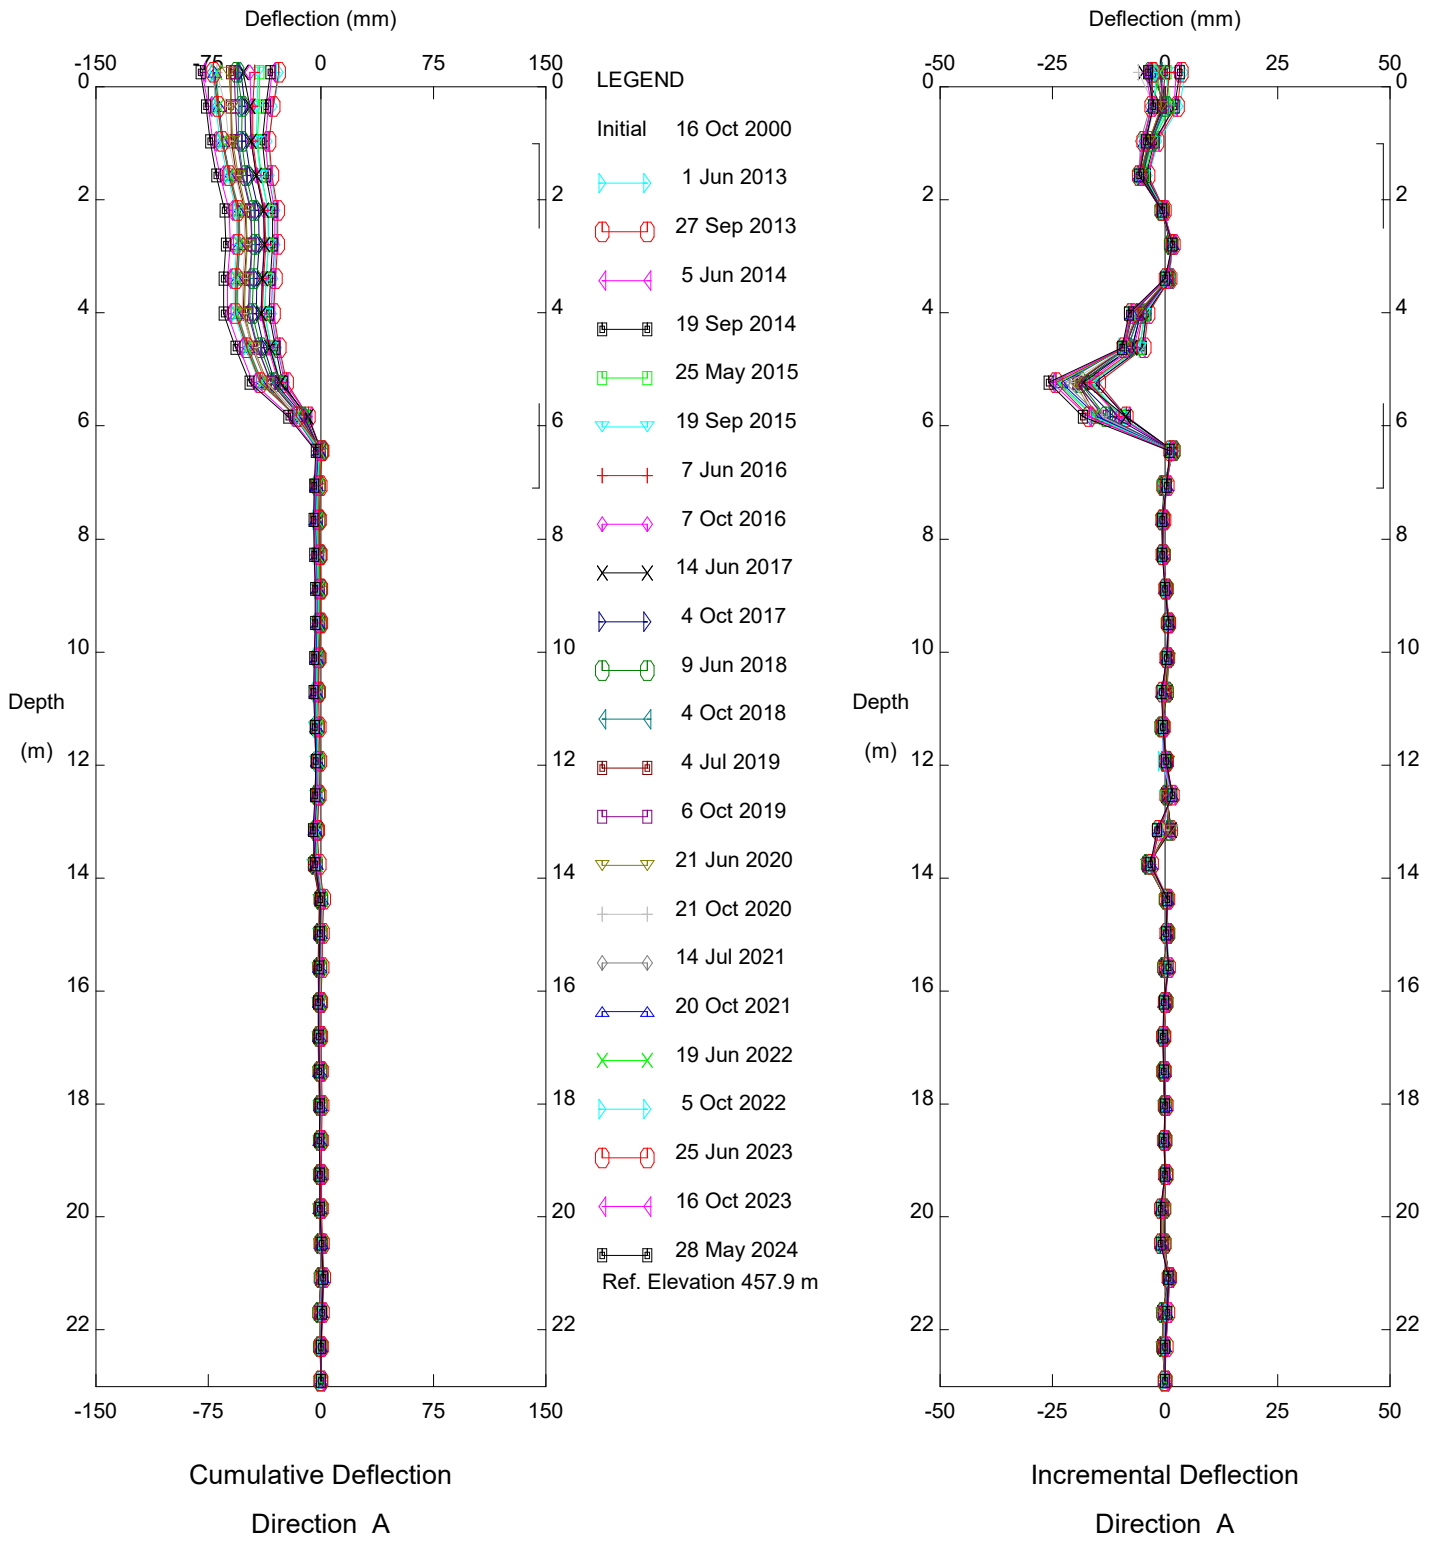
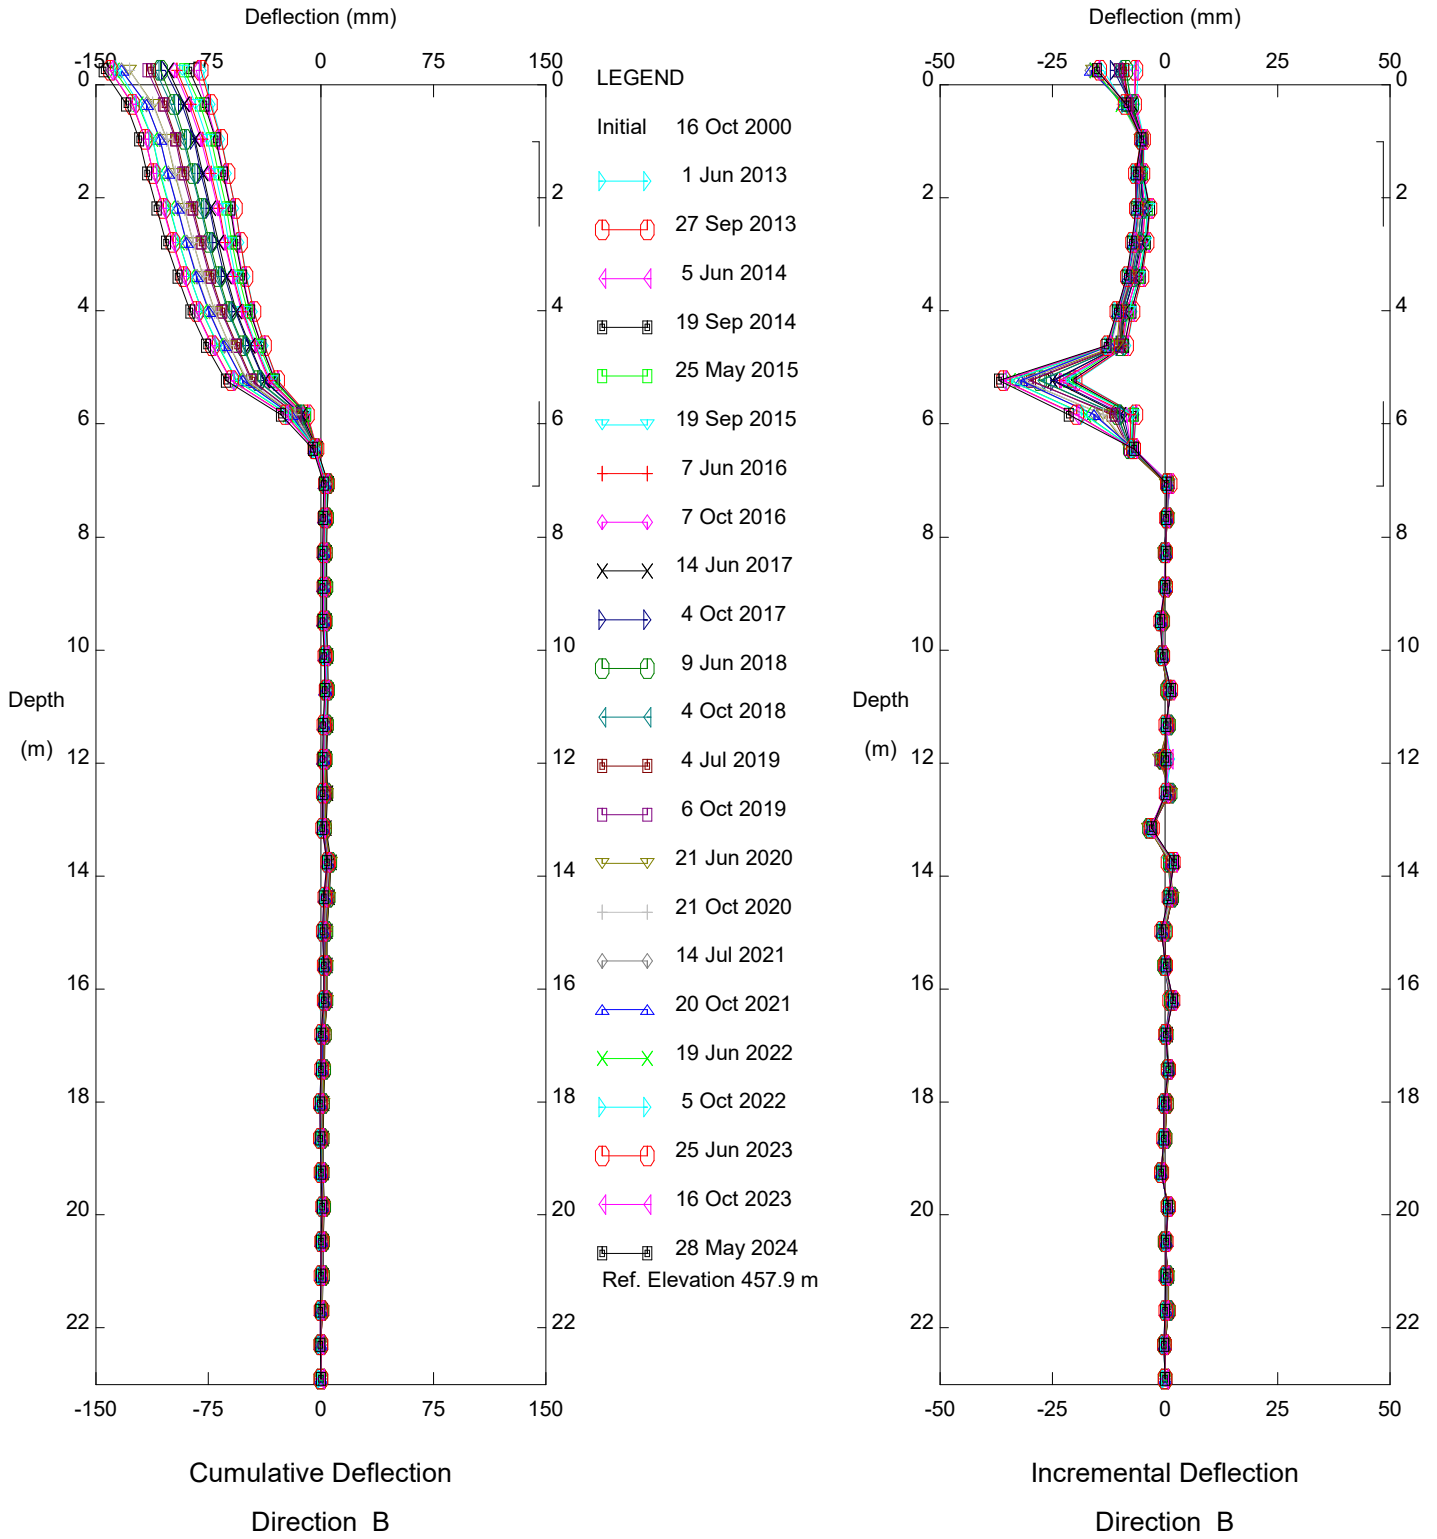
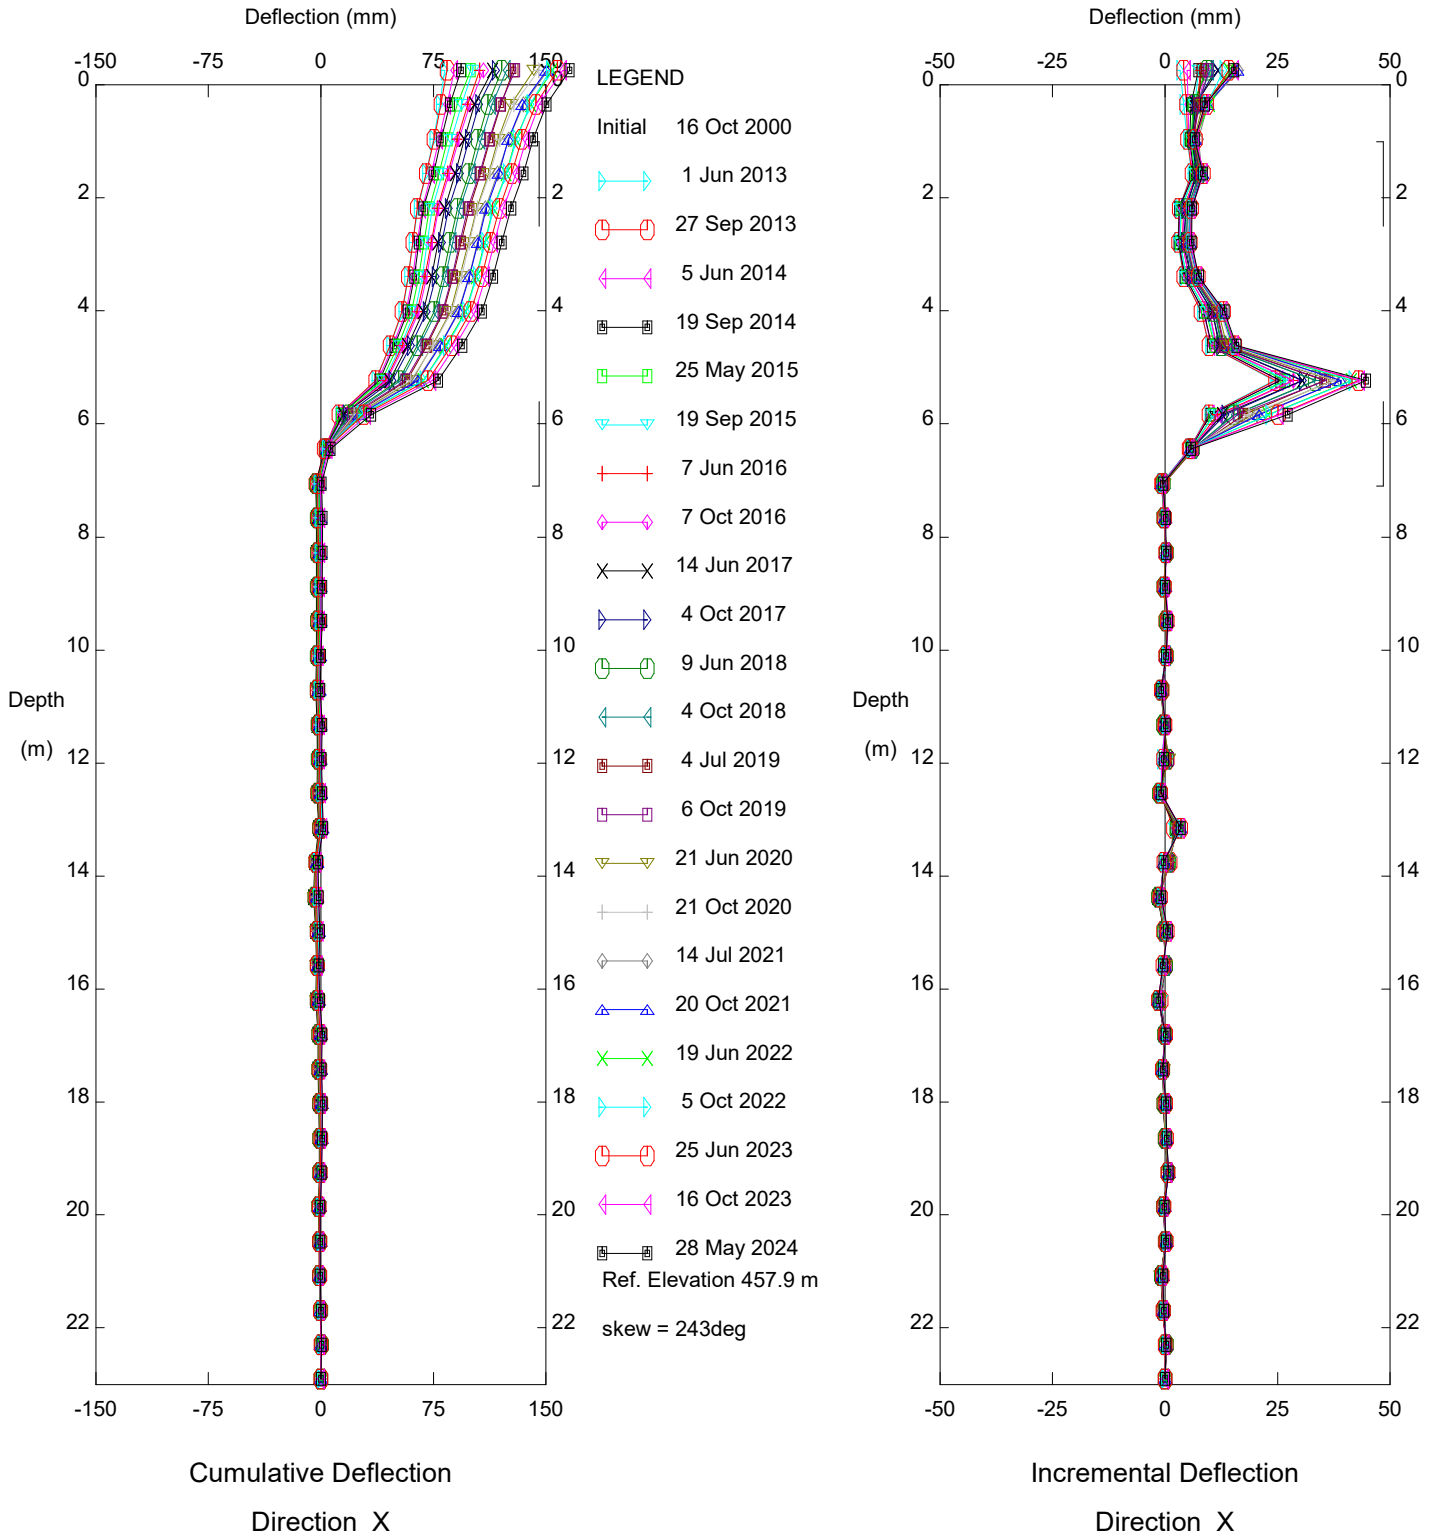
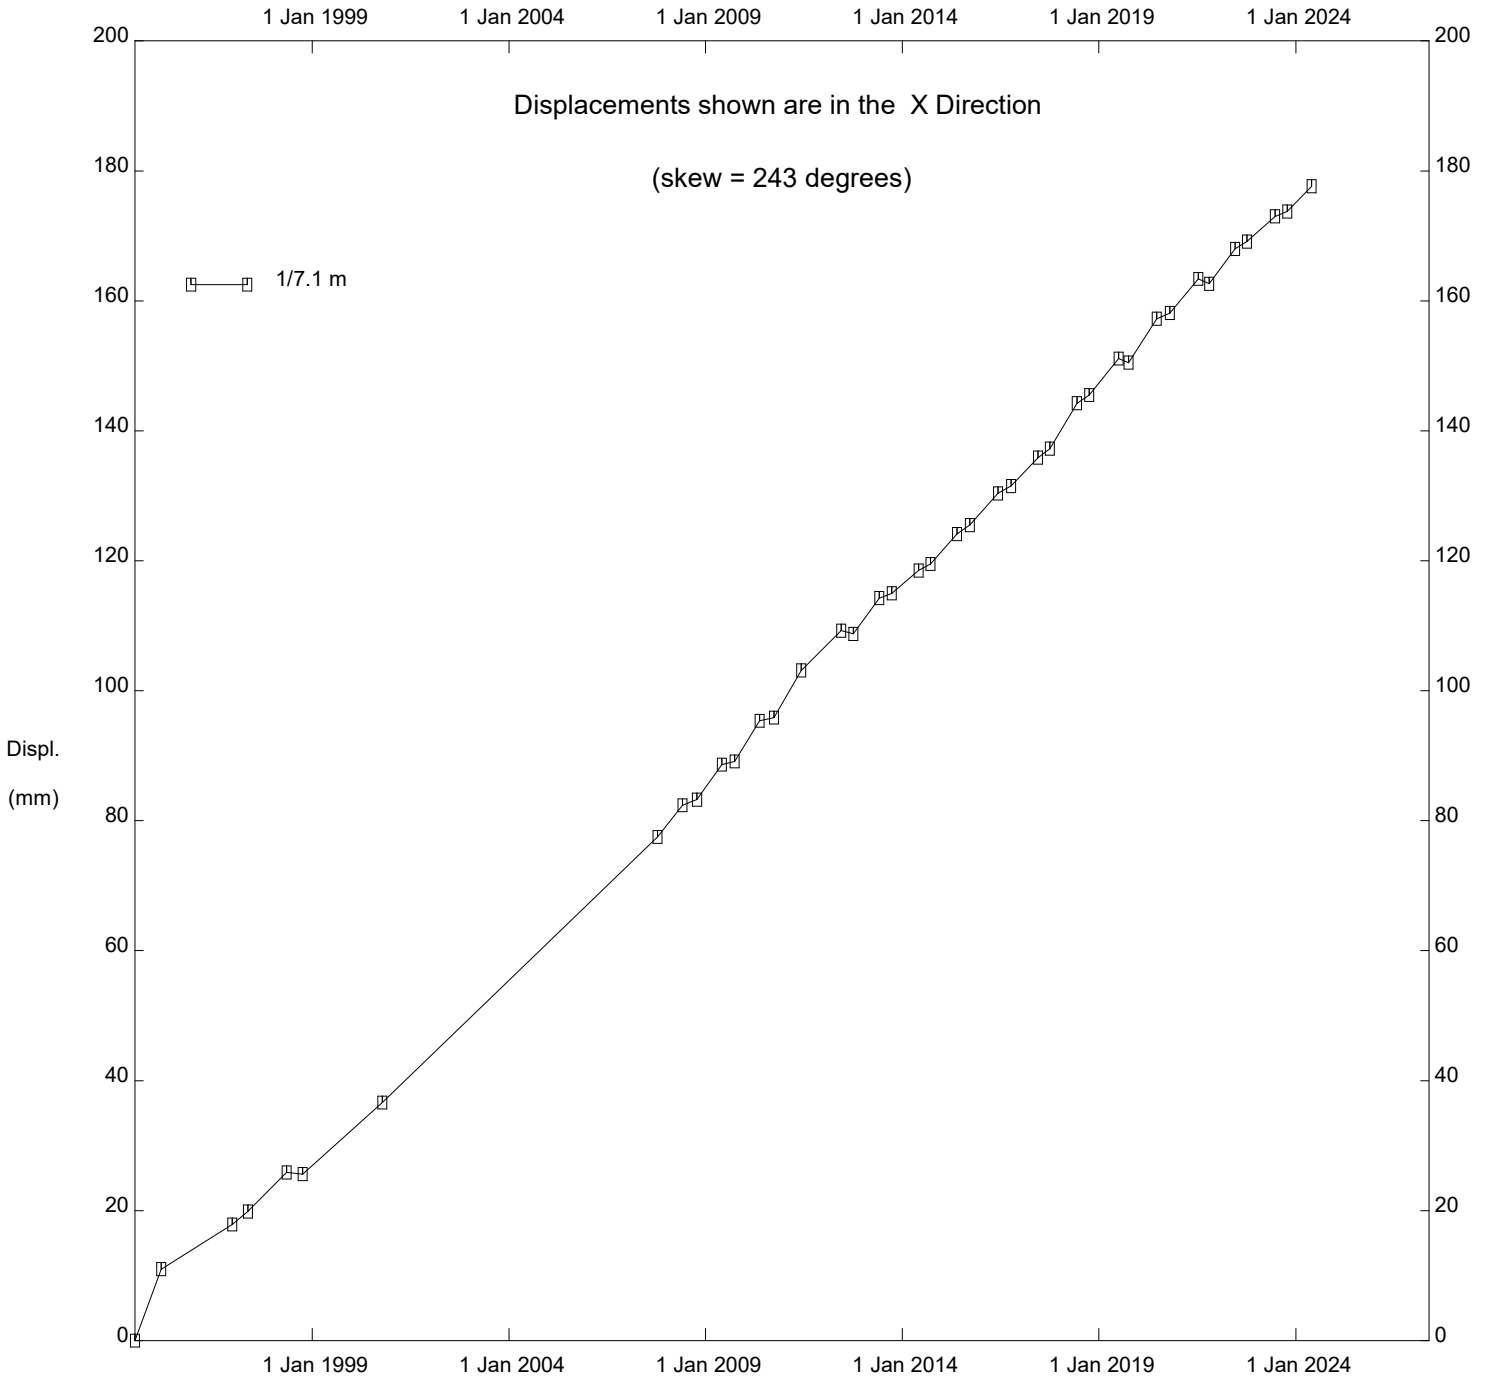
HWY 2:68 (PH037), Inclinometer SI-59

SI-59 showed a rate of movement of 6.3 mm/yr over 1.0 m to 7.1 m depth. This SI is in the highway east ditch near the assumed backscarp of the landslide that is affecting the highway and has moved 177.6 mm over this depth zone, since it was first installed in 1994. A subtle shear zone at 13 m depth may be present.

SI-59	Aug. 26, 1992	177.6 mm over 1.0 m to 7.1 m depth in 300° direction	16.4 mm/yr in March 1995	Operational	October 16, 2023	3.9	6.3	3.9

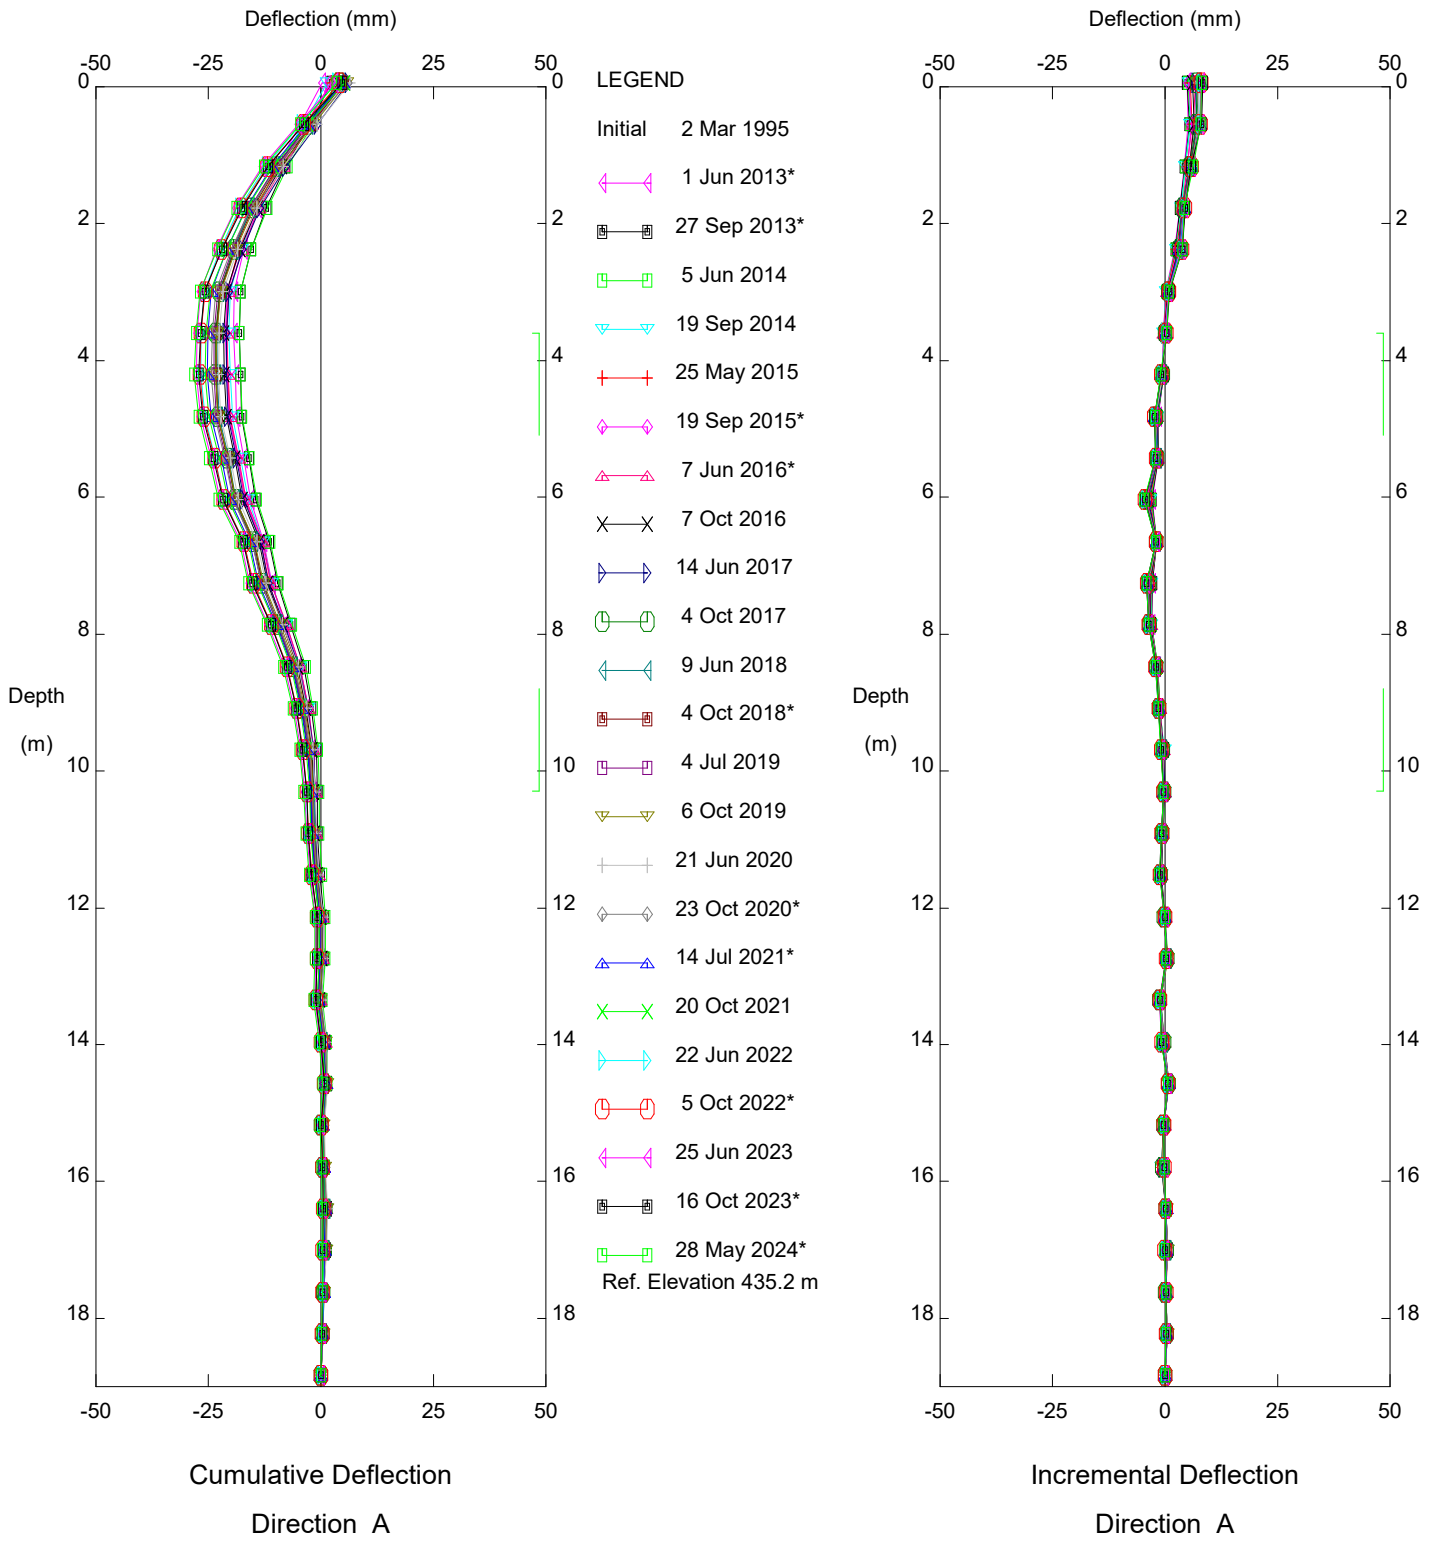
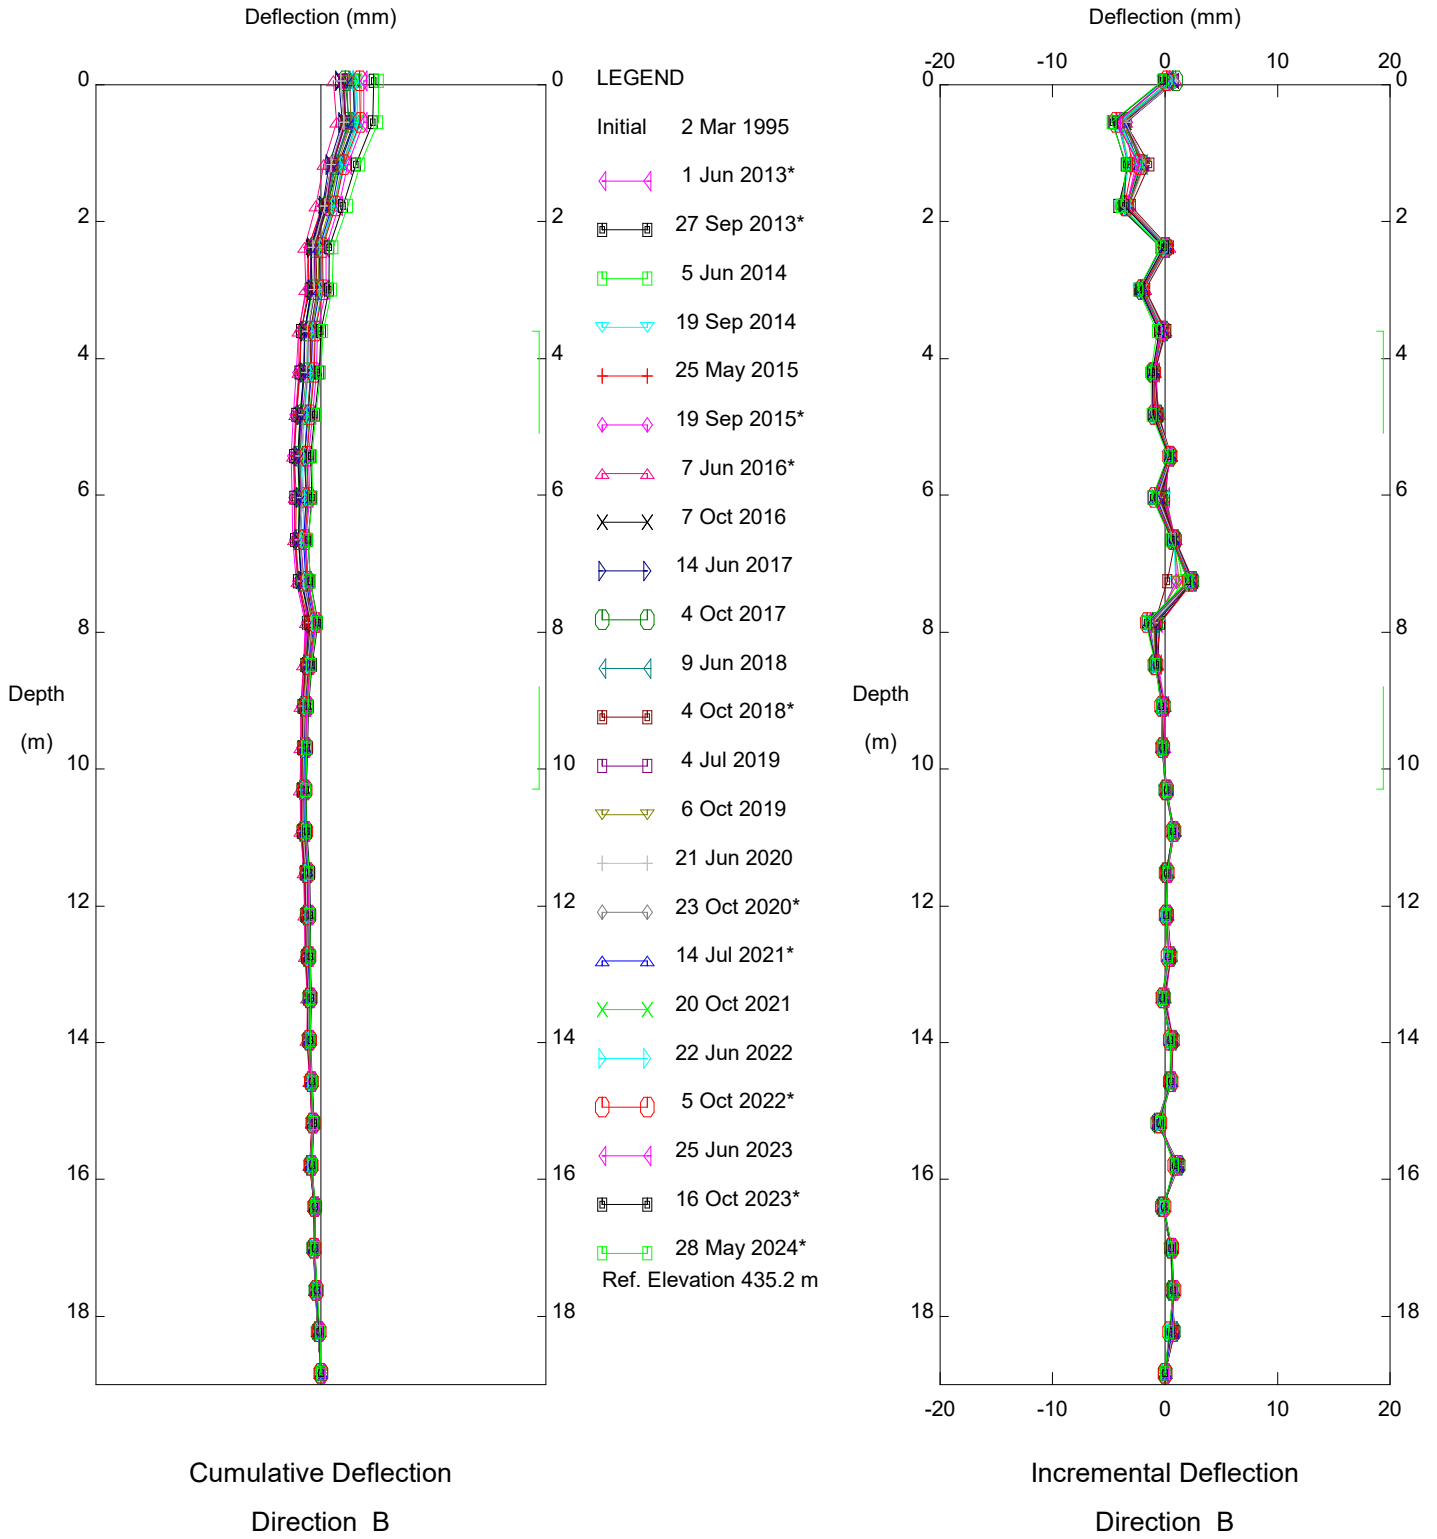
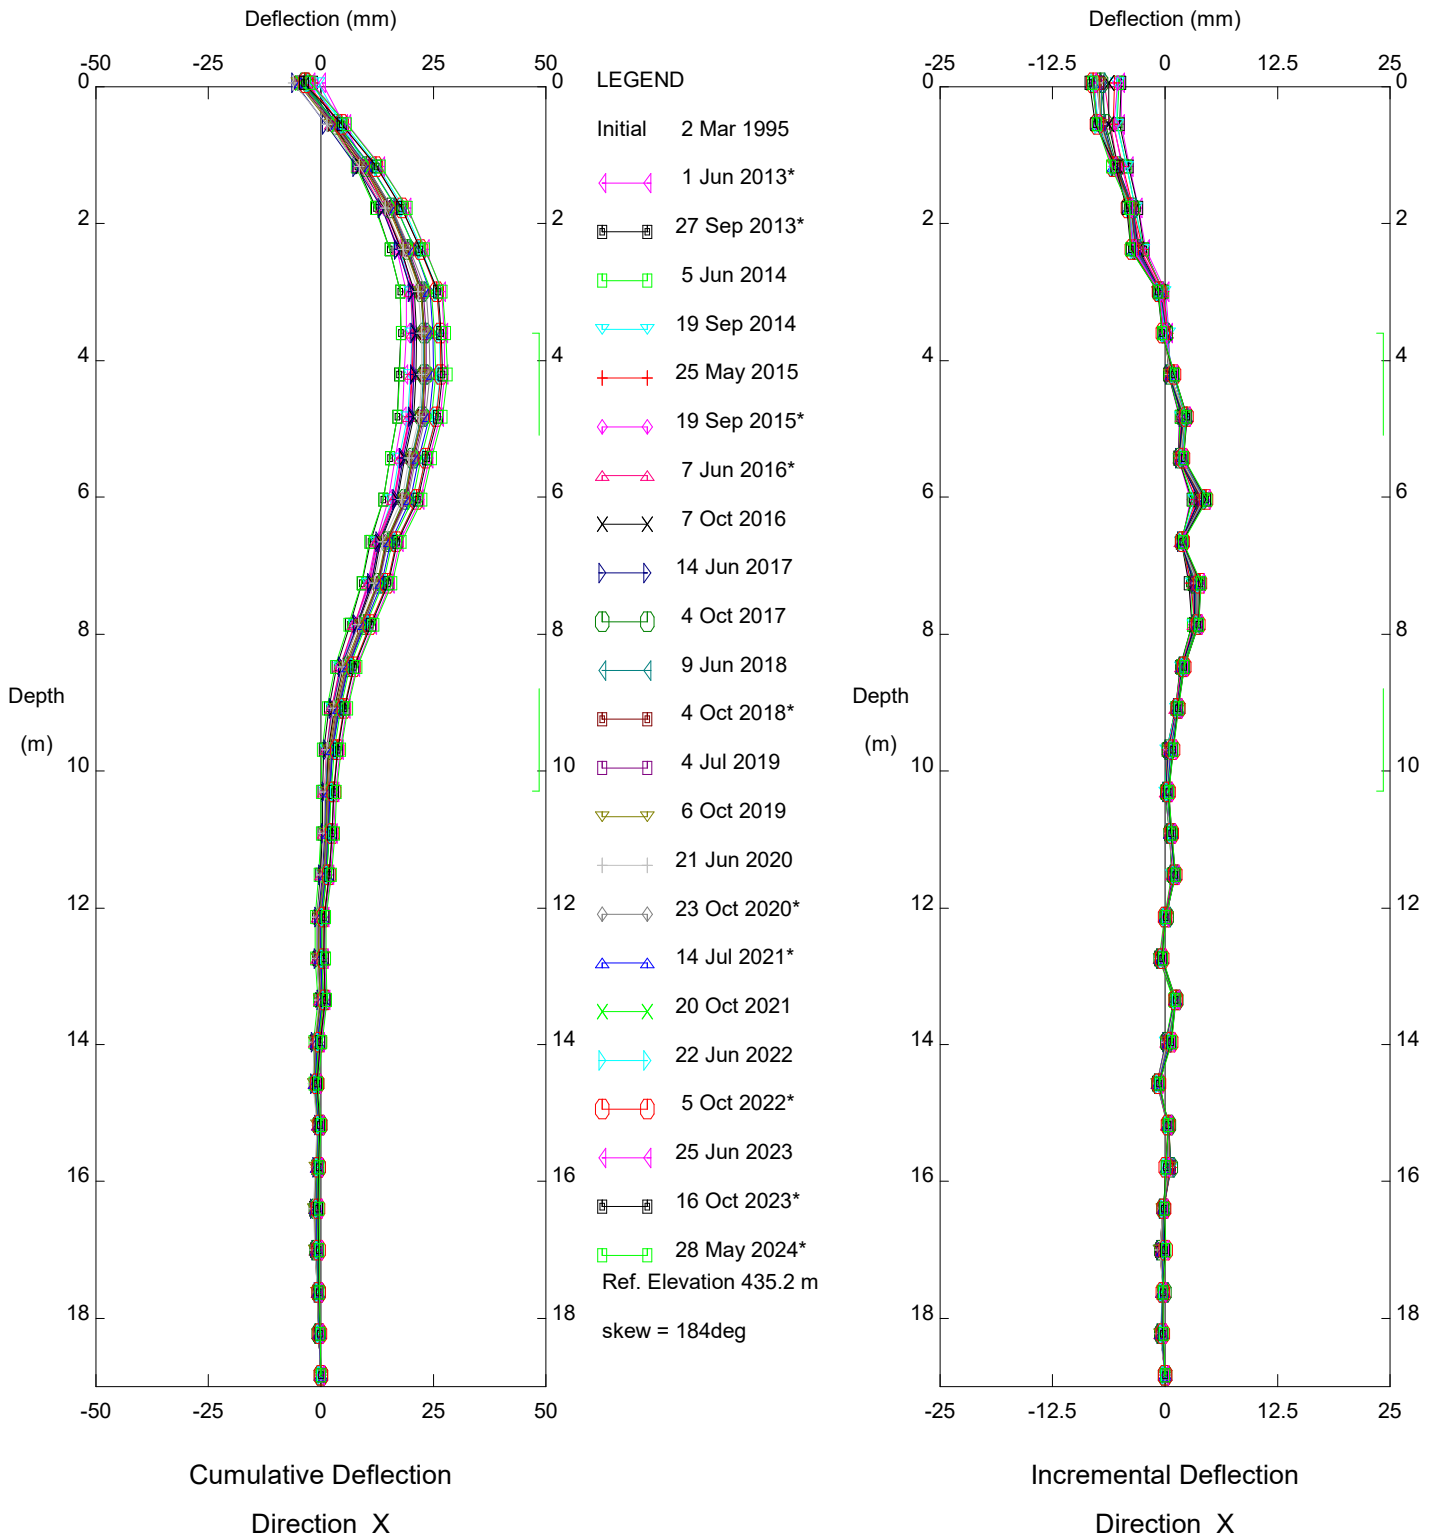
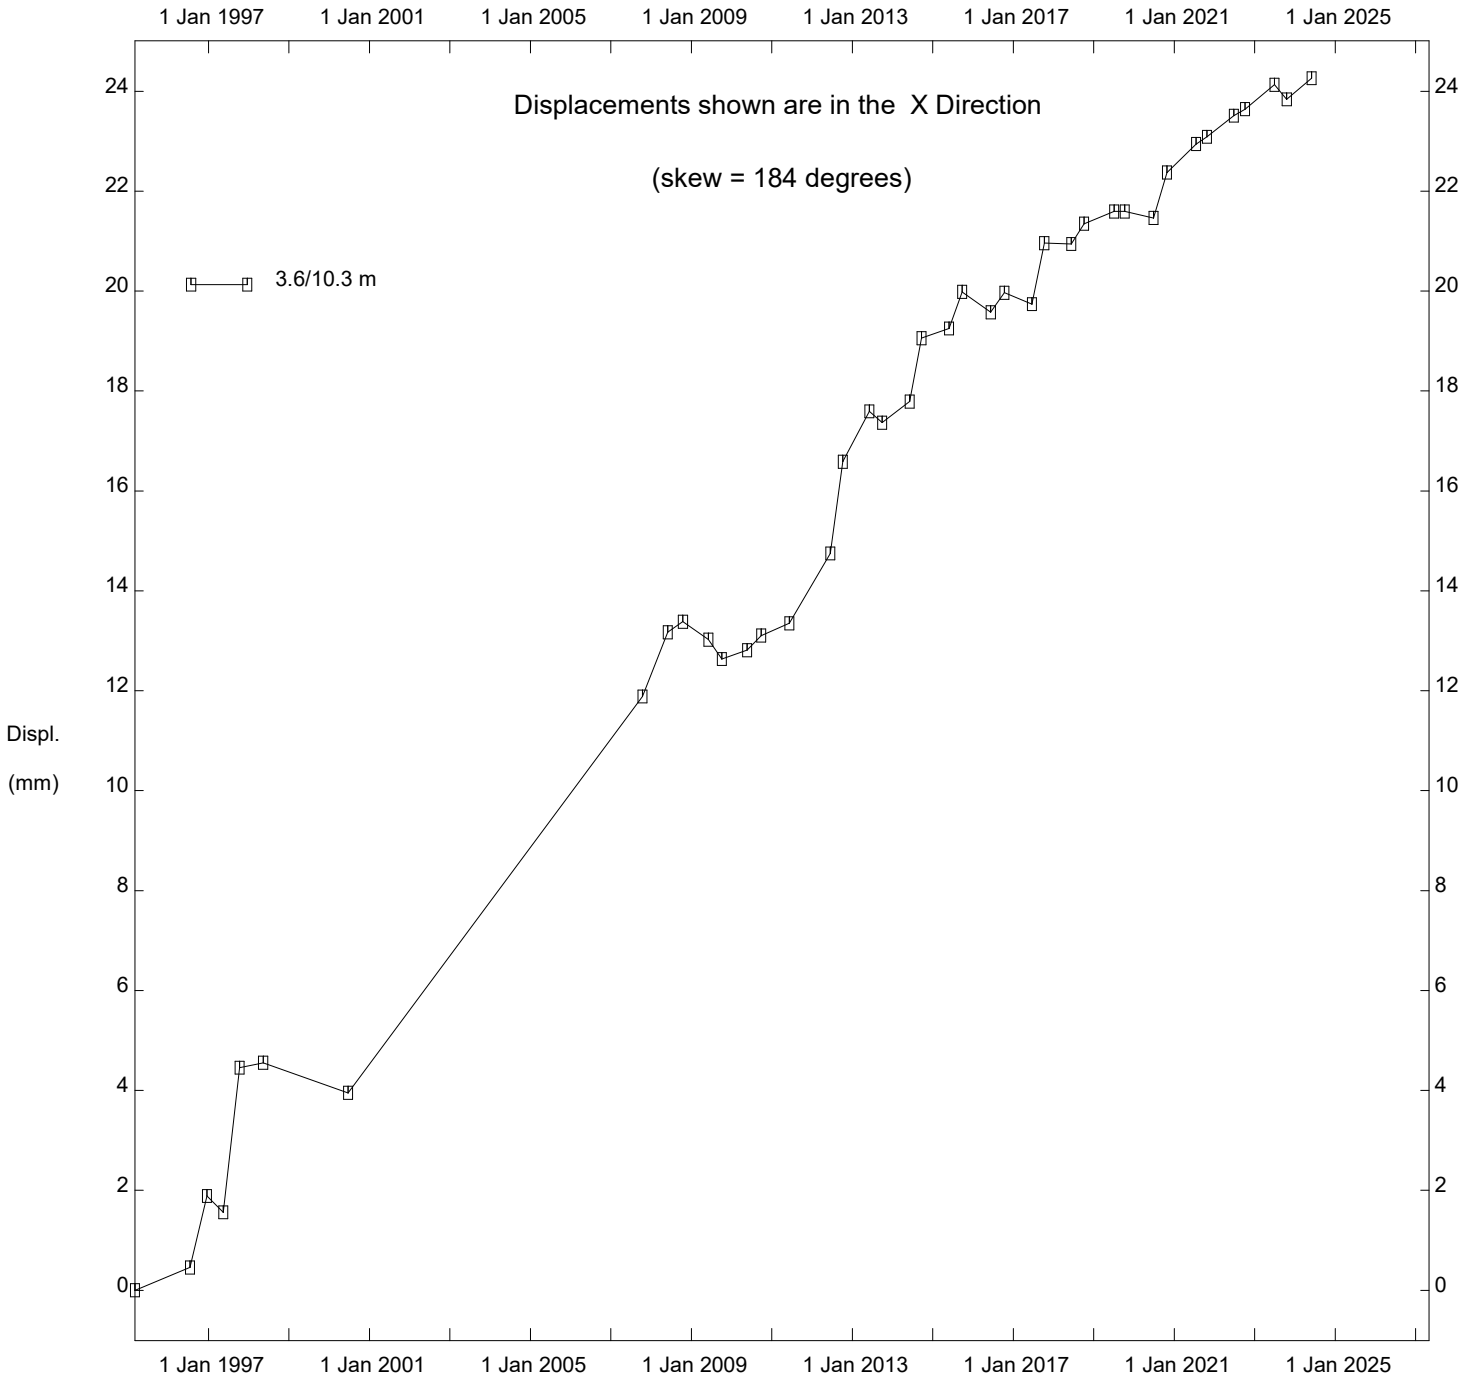
HWY 2:68 (PH037), Inclinometer SI-61

SI-61 is located just west of the highway and just north of SI09-1; it showed a rate of movement of 0.7 mm/yr over 3.6 m to 10.3 m depth. The pattern of movement at SI-61 is best described as a bulge which is unusual for this site.
