ALBERTA TRANSPORTATION AND
ECONOMIC CORRIDORS GRMP
GRANDE PRAIRIE REGION –
(GRANDE PRAIRIE NORTH)
INSTRUMENTATION MONITORING - SPRING 2024

Site Number	Location	Name	Hwy	km
PH037	Station 1+250 to 2+000	Dunvegan South	2:68	Km 15.7
Legal Description: 4-7-80-4 W6		UTM Co-ordinates		
		11U E 398593.62	N	6197597.09

Current Monitoring:	28-May-2024	Previous Monitoring	16-Oct-2023
Instruments Read By:	Mr. Niraj Regmi, G.I.T and Mr. Nixon Mationg, of Thurber

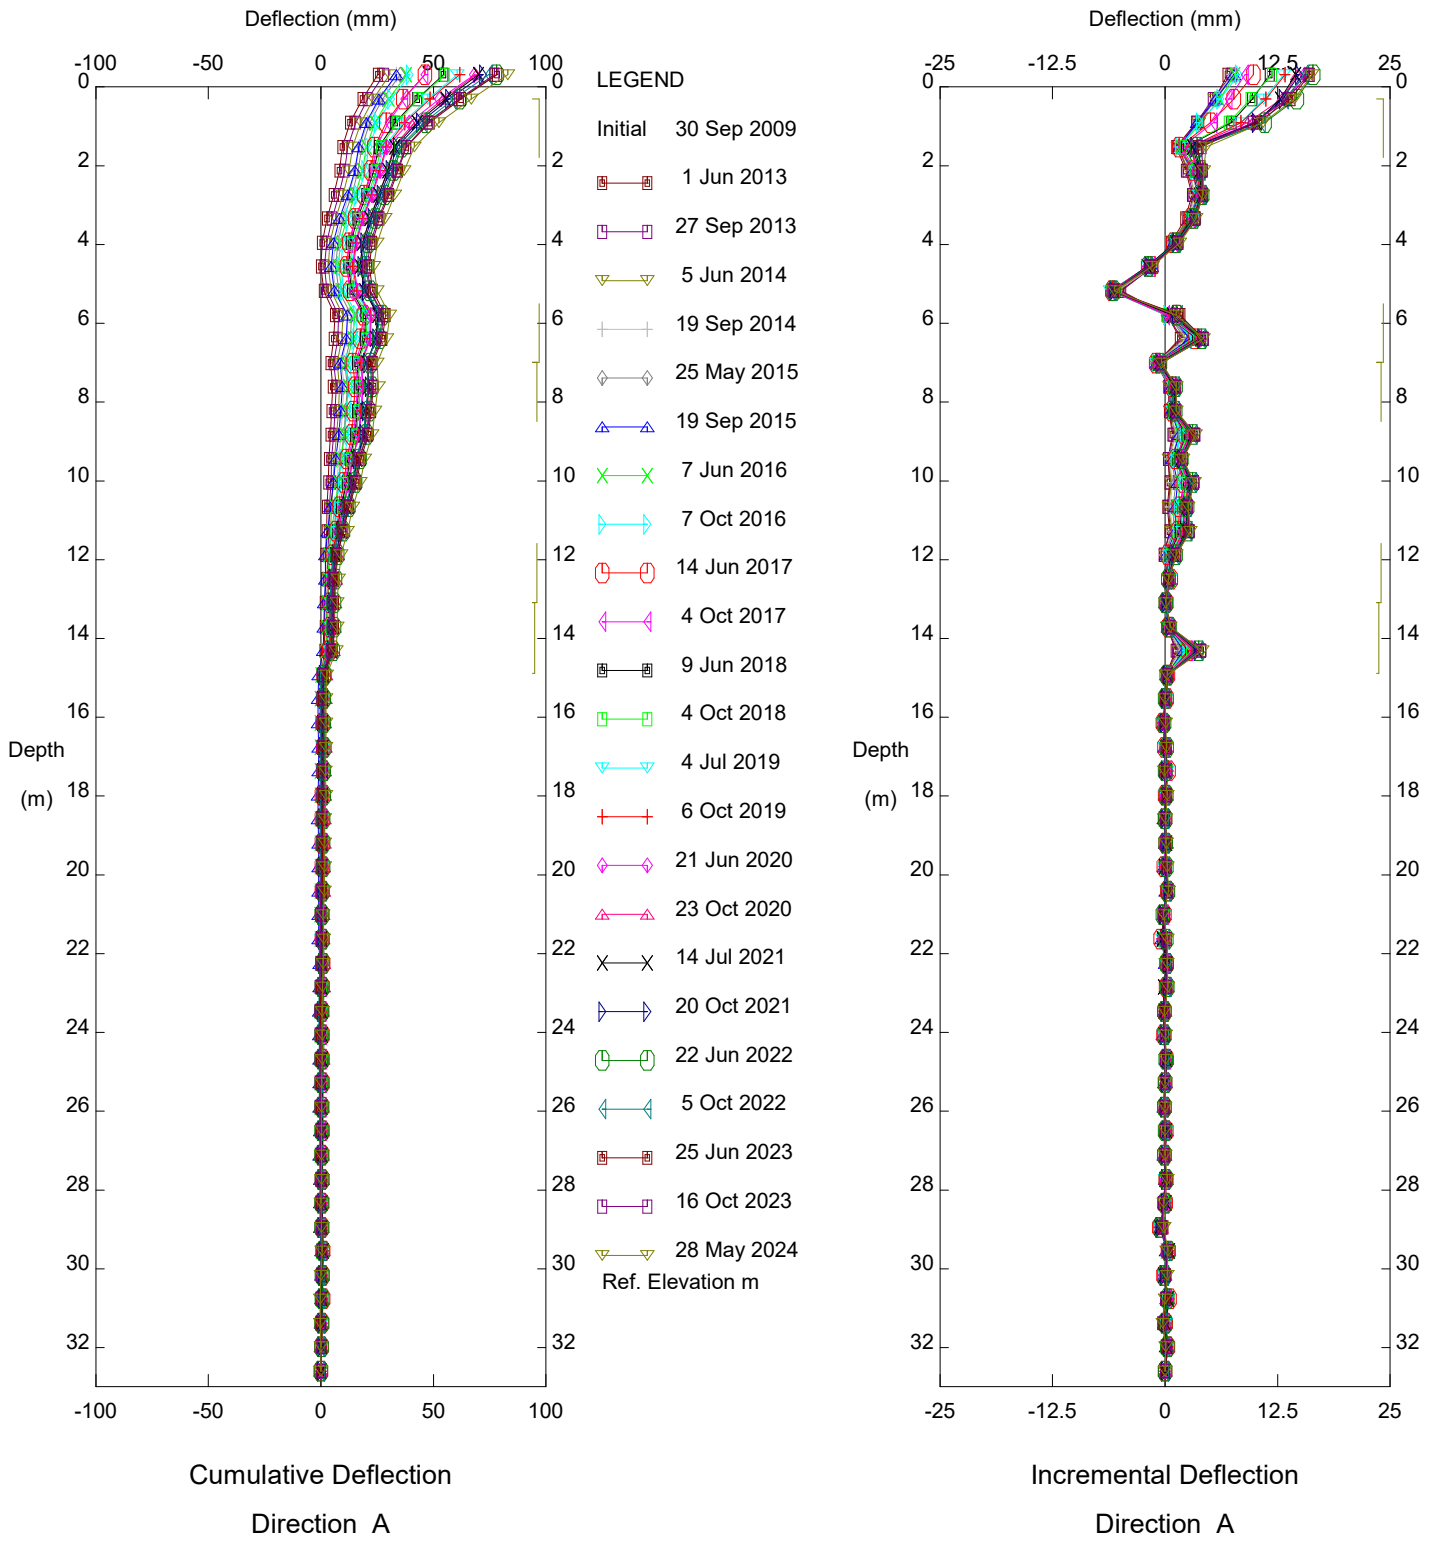
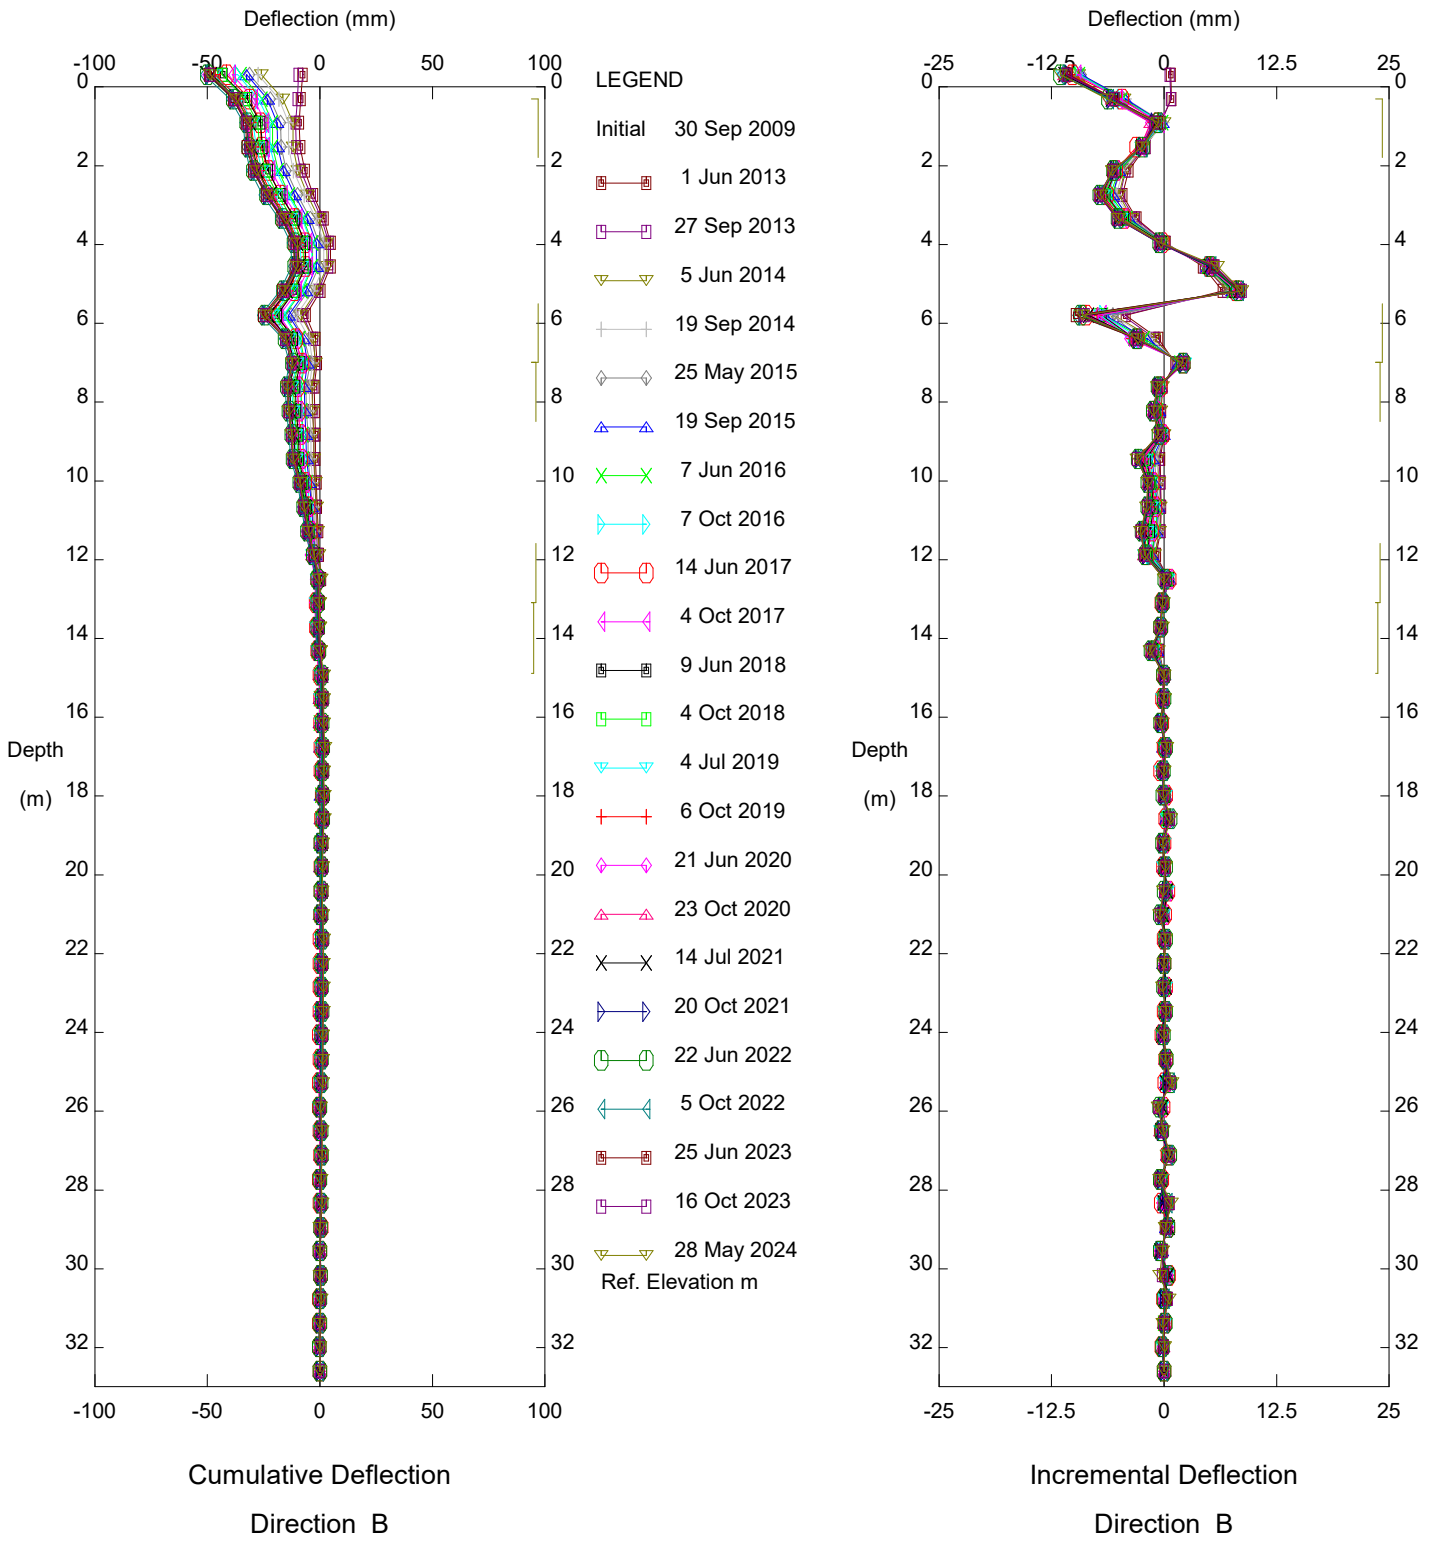
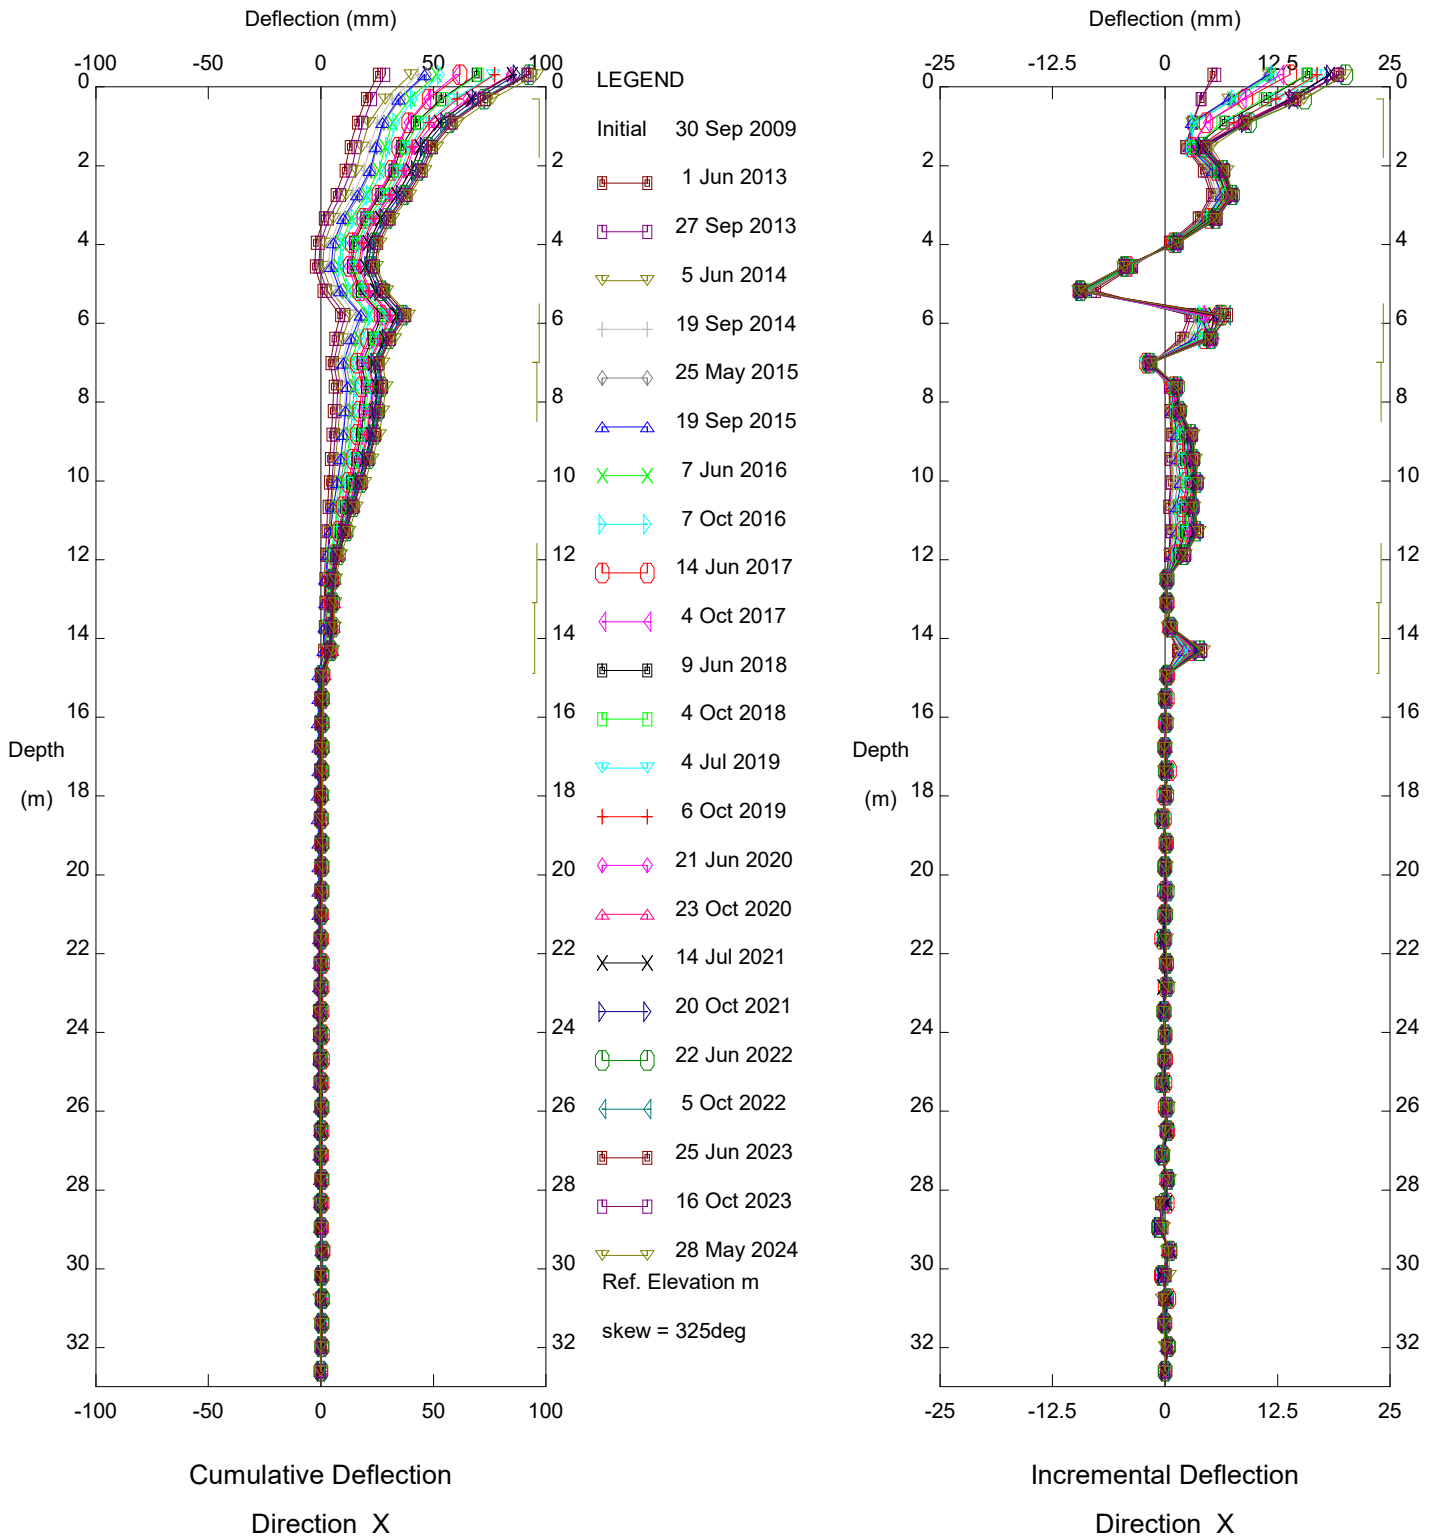
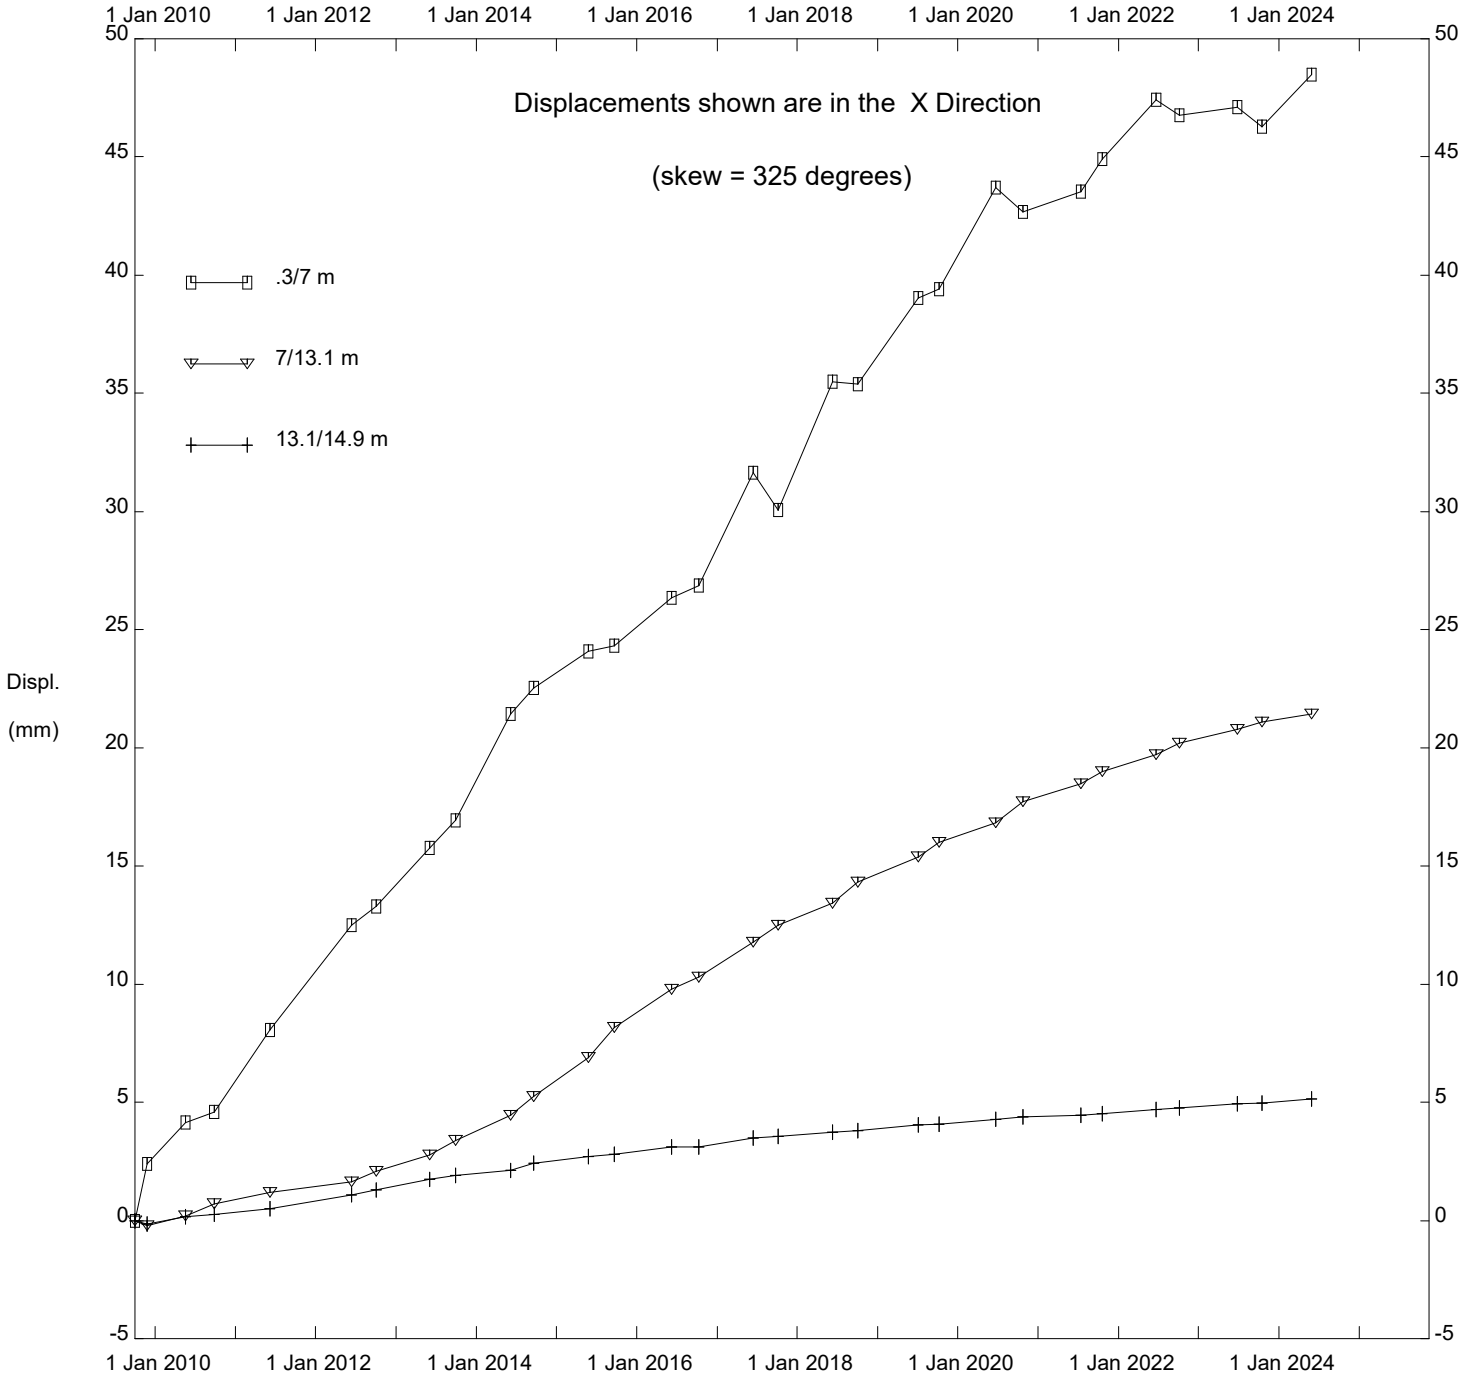
HWY 2:68 (PH037), Inclinometer SI09-1

SI09-1 is located just west of the highway and showed a rate of movement of 3.6 mm/yr over 0.3 m to 7.0 m, and rates of movement of 0.6 mm/yr, and 0.3 mm/yr at depths between 7.0 m to 13.1 m, and 13.1 m to 14.9 m, respectively, since the fall of 2023 readings.

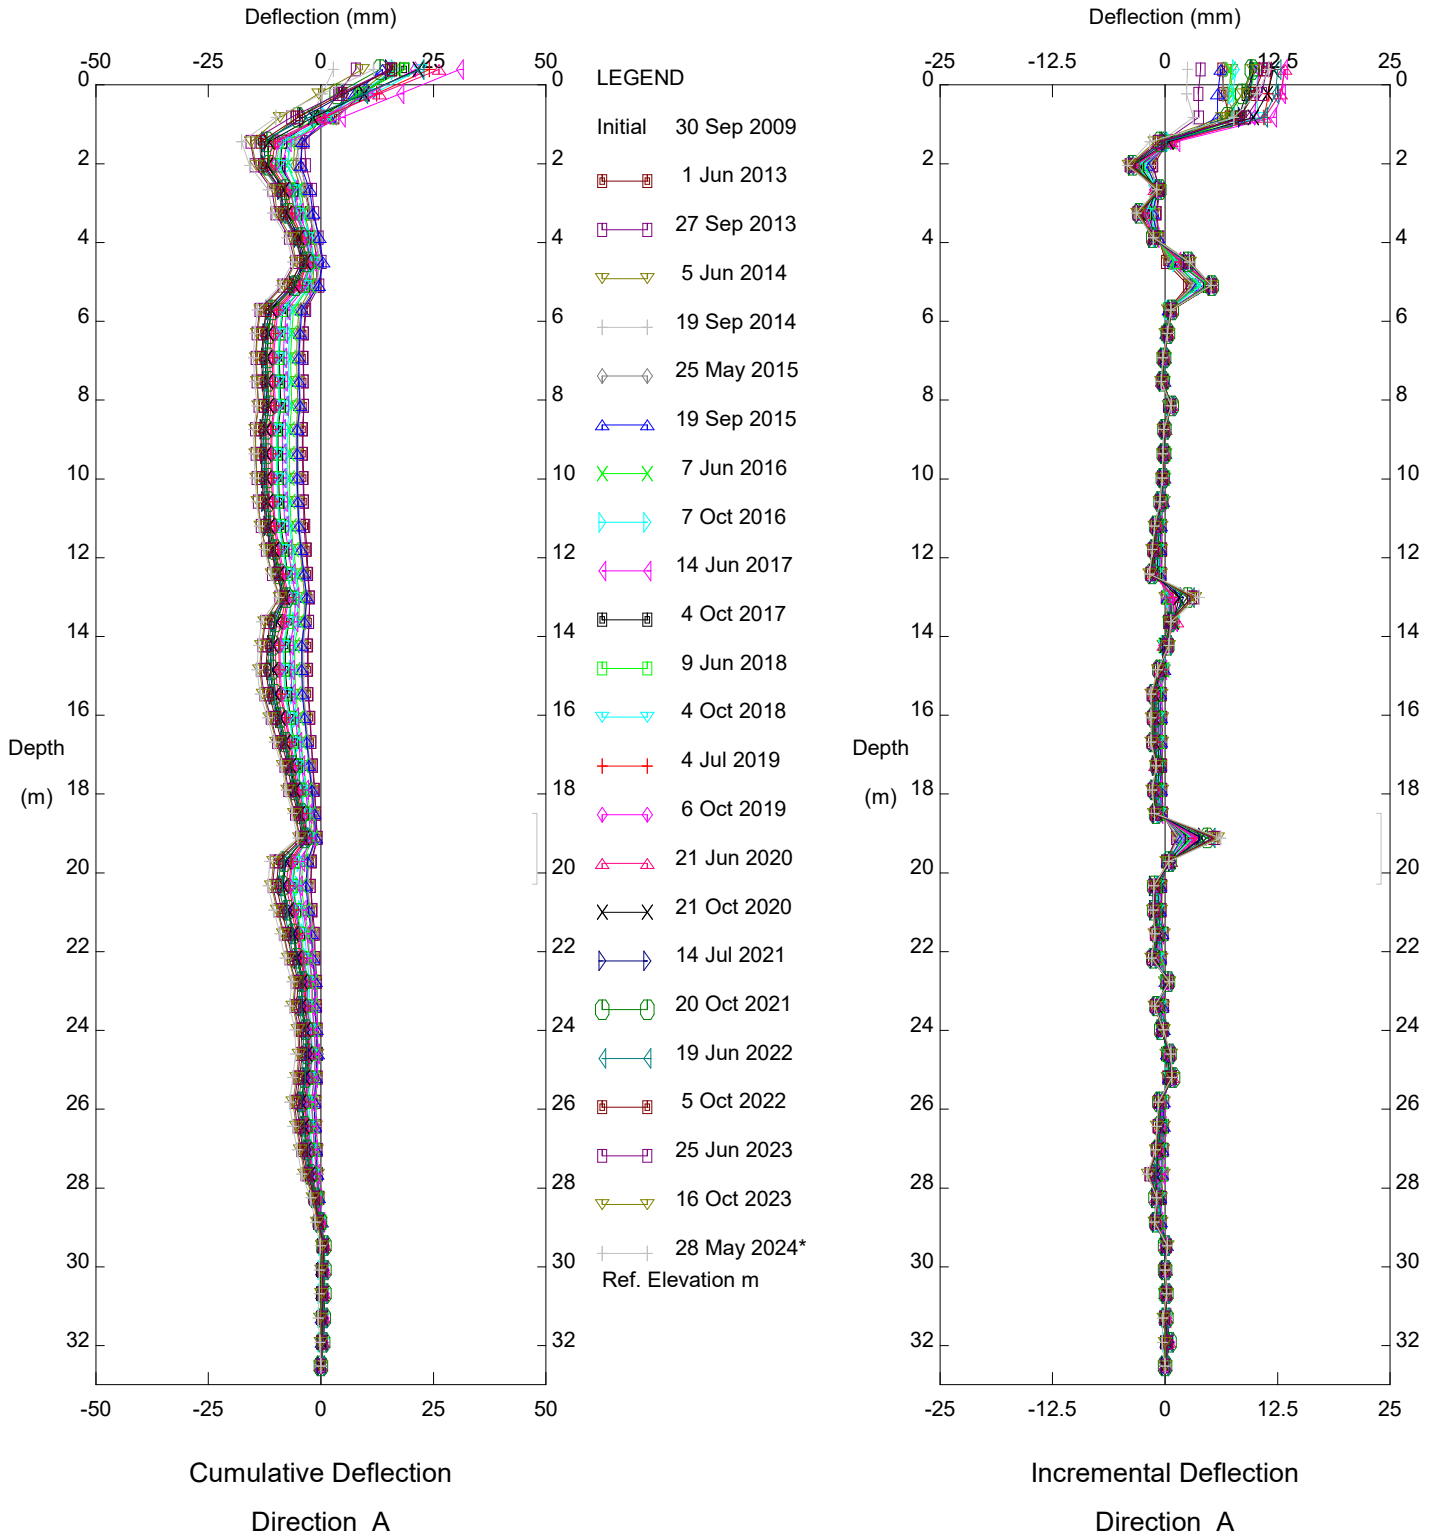
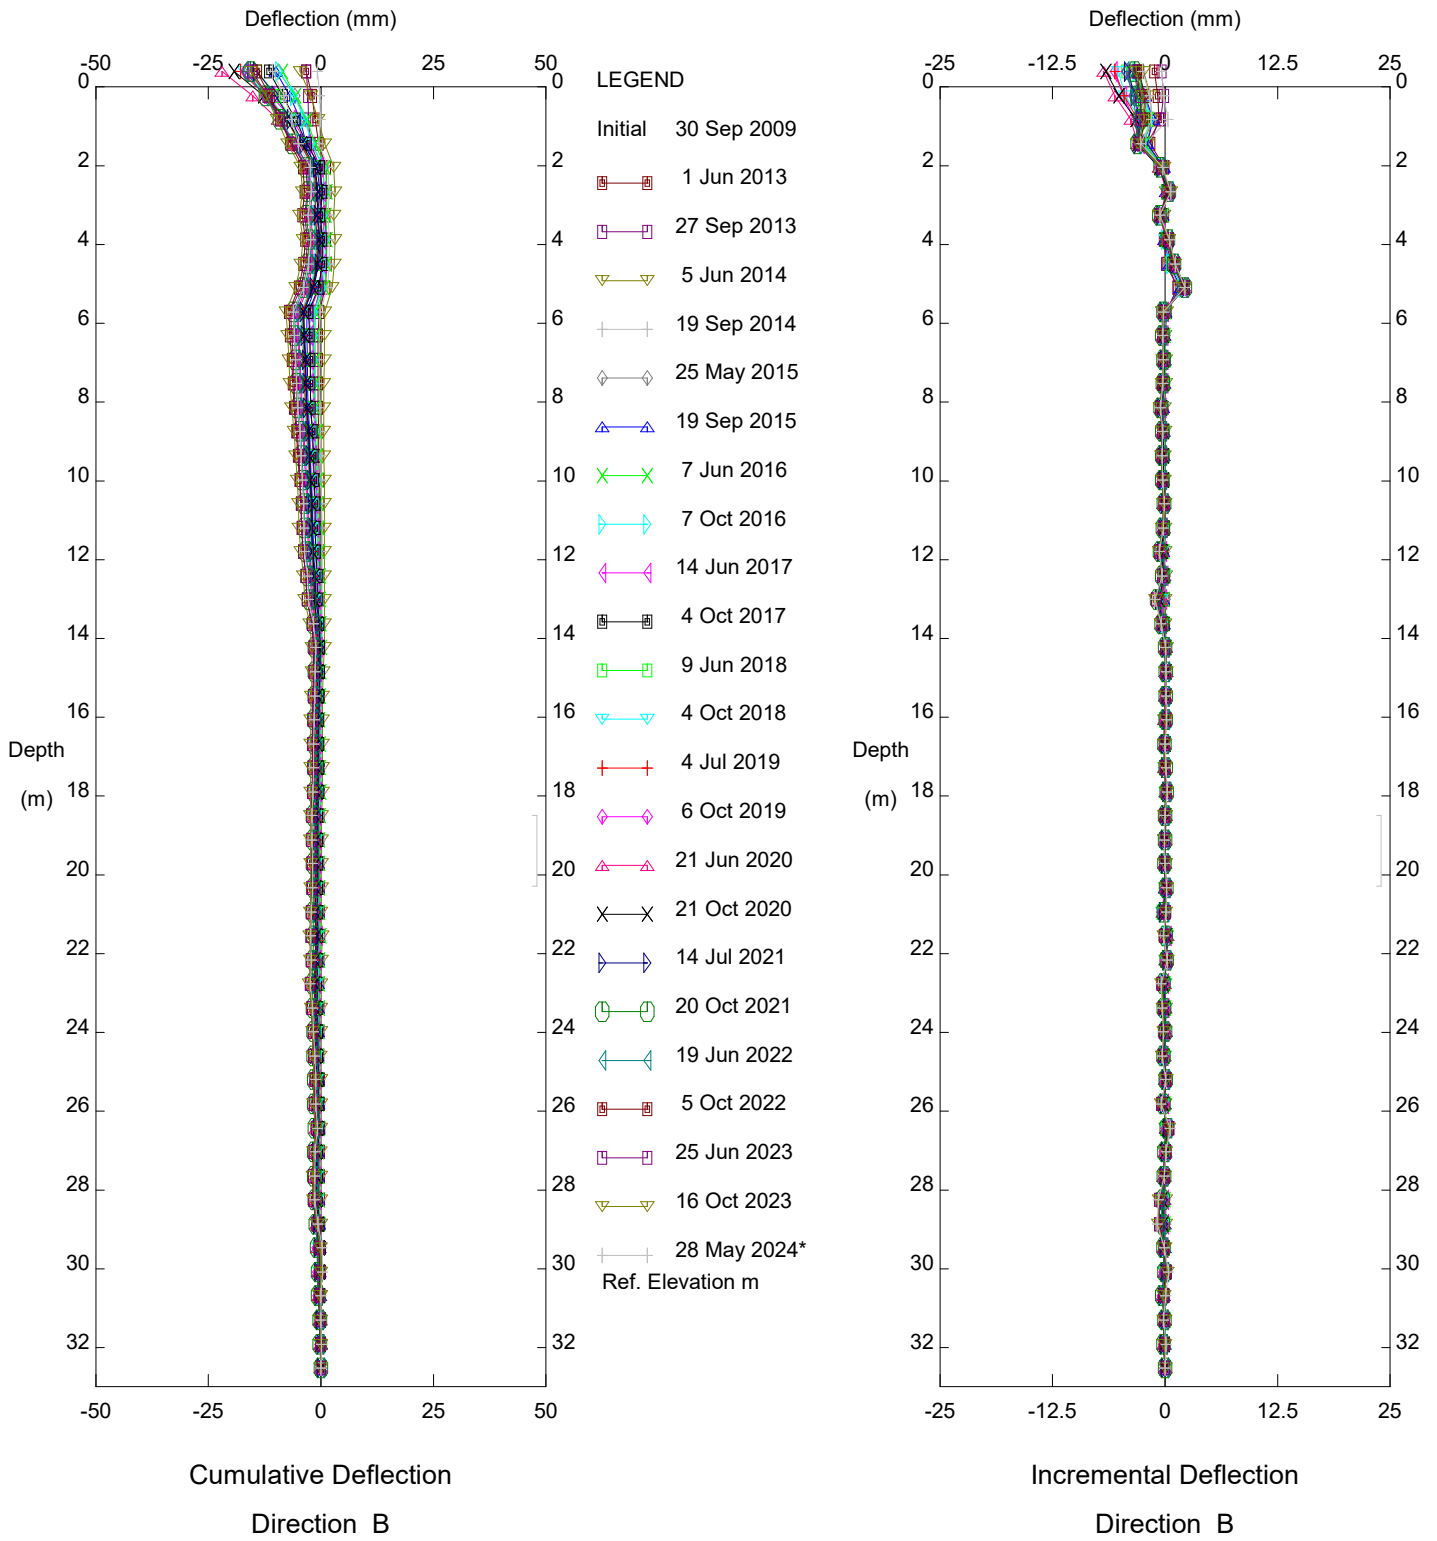
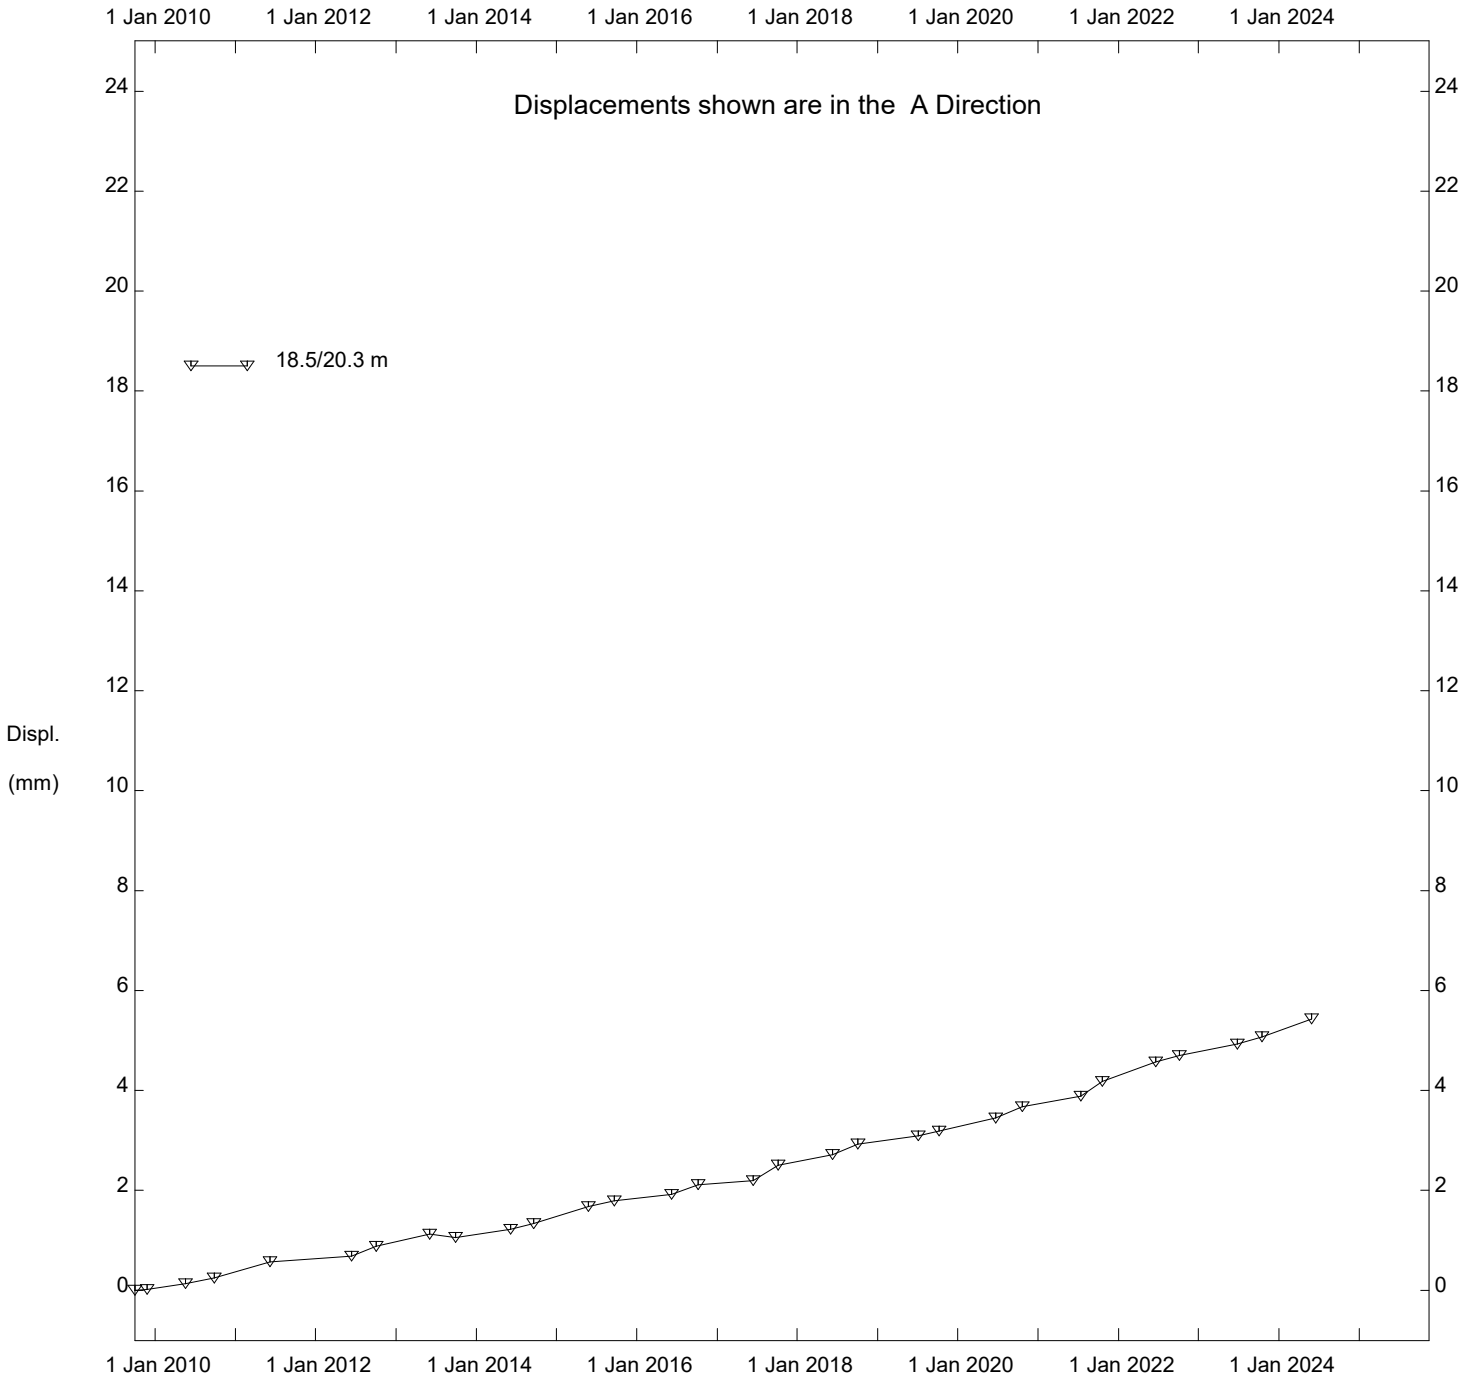
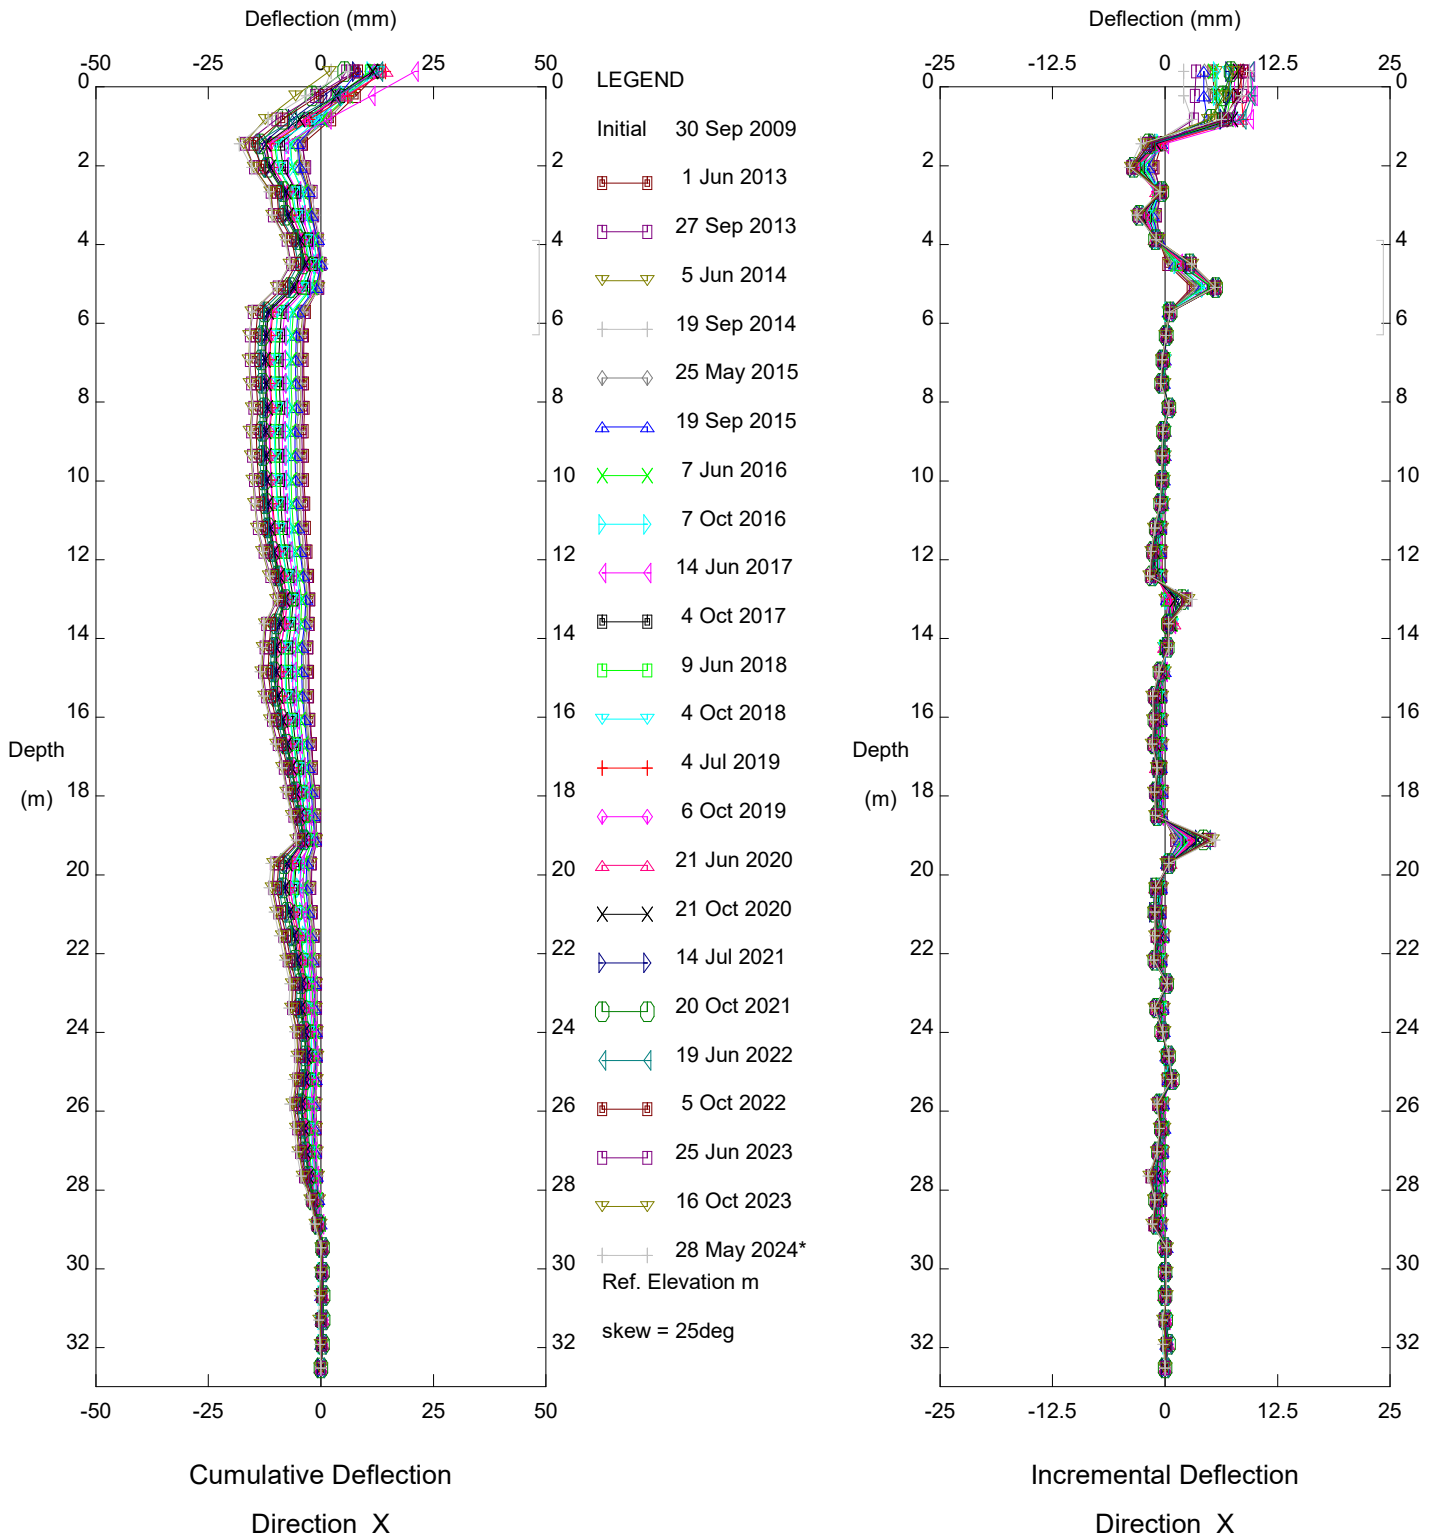
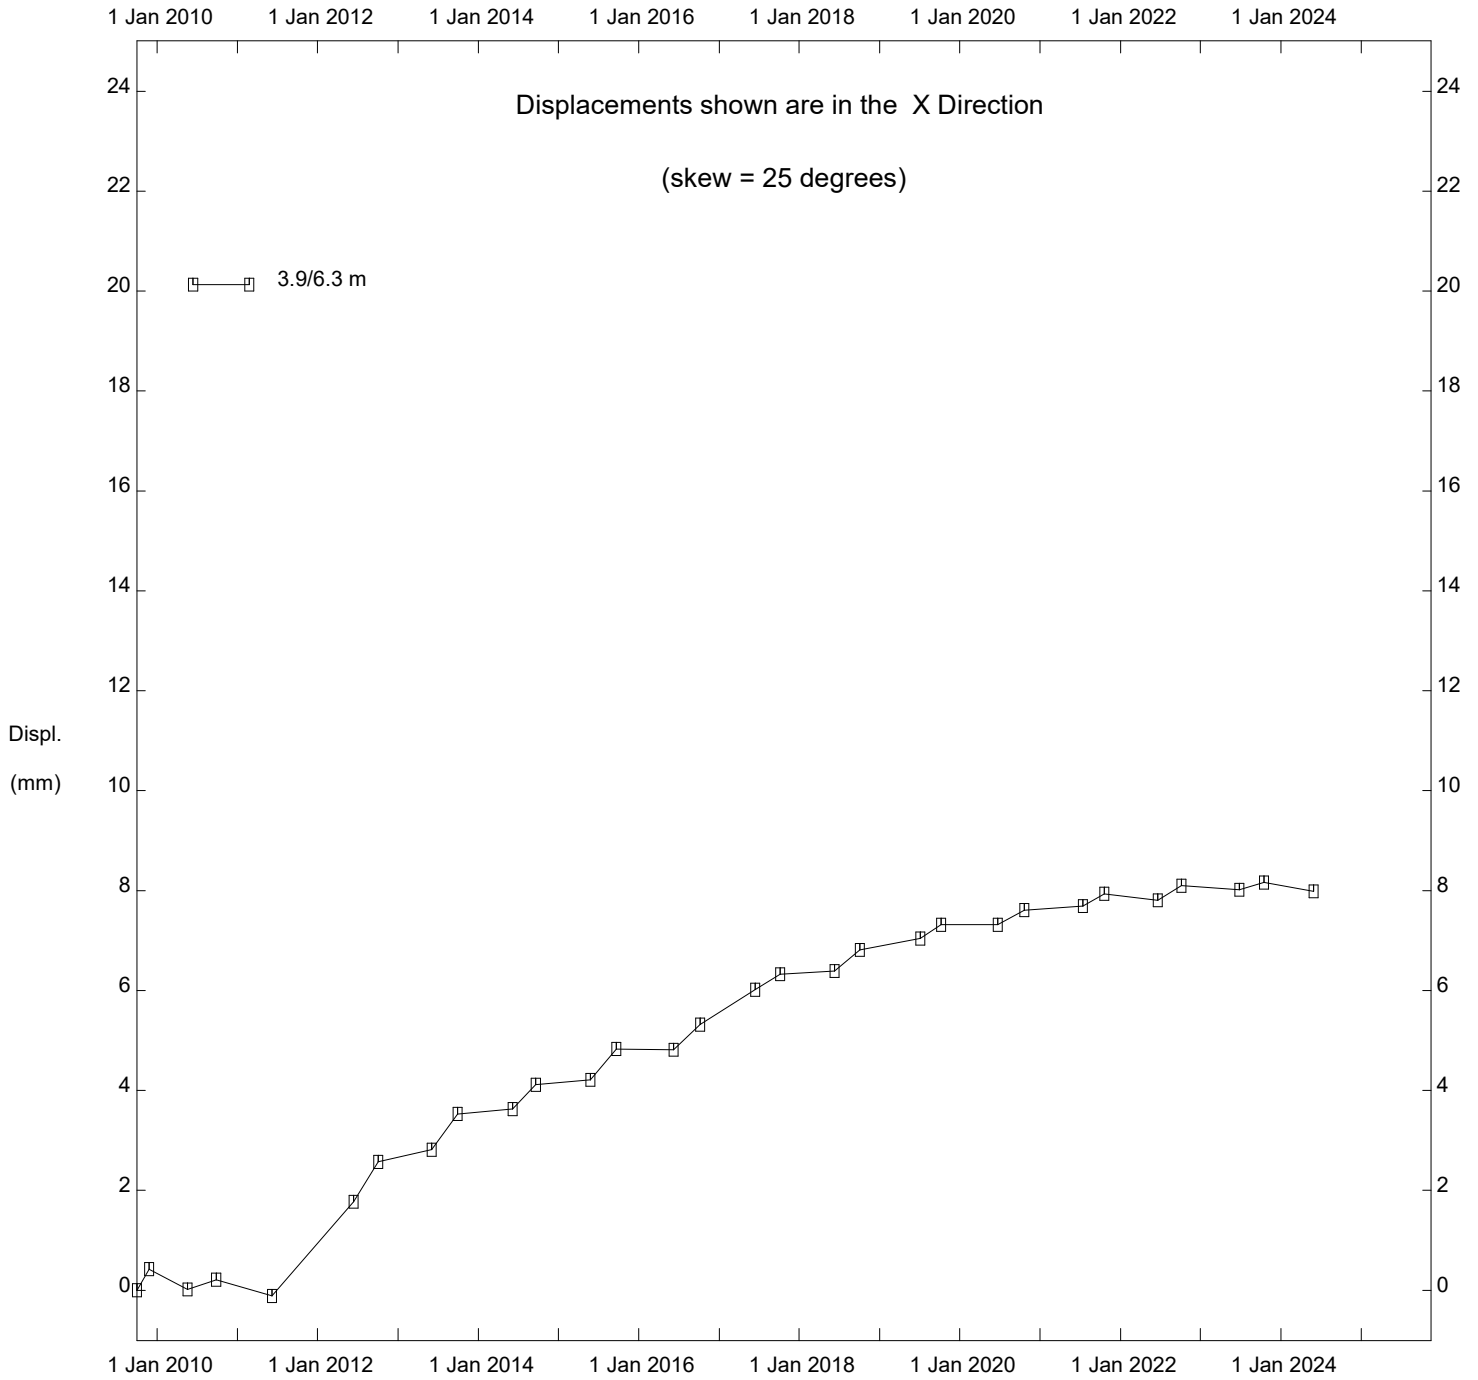
HWY 2:68 (PH037), Inclinometer SI09-7

SI09-7 is located about 90 m west of the highway and has several zones of movement. No discernible movement were measured over the past two years over the shear zone between 3.9 m to 6.3 m depth and the total movement since 2009 is about 8 mm. A rate of movement of 0.6 mm/yr was measured over 18.5 m to 20.3 m depth. This rate of movement has been steady since 2009 and total recorded movements are about 7.5 mm.
