ALBERTA TRANSPORTATION AND
ECONOMIC CORRIDORS GRMP
GRANDE PRAIRIE REGION –
(GRANDE PRAIRIE NORTH)
INSTRUMENTATION MONITORING - SPRING 2024

Site Number	Location	Name	Hwy	km
PH037	Station 1+250 to 2+000	Dunvegan South	2:68	Km 15.7
Legal Description: 4-7-80-4 W6		UTM Co-ordinates		
		11U E 398593.62	N	6197597.09

Current Monitoring:	28-May-2024	Previous Monitoring	16-Oct-2023
Instruments Read By:	Mr. Niraj Regmi, G.I.T and Mr. Nixon Mationg, of Thurber

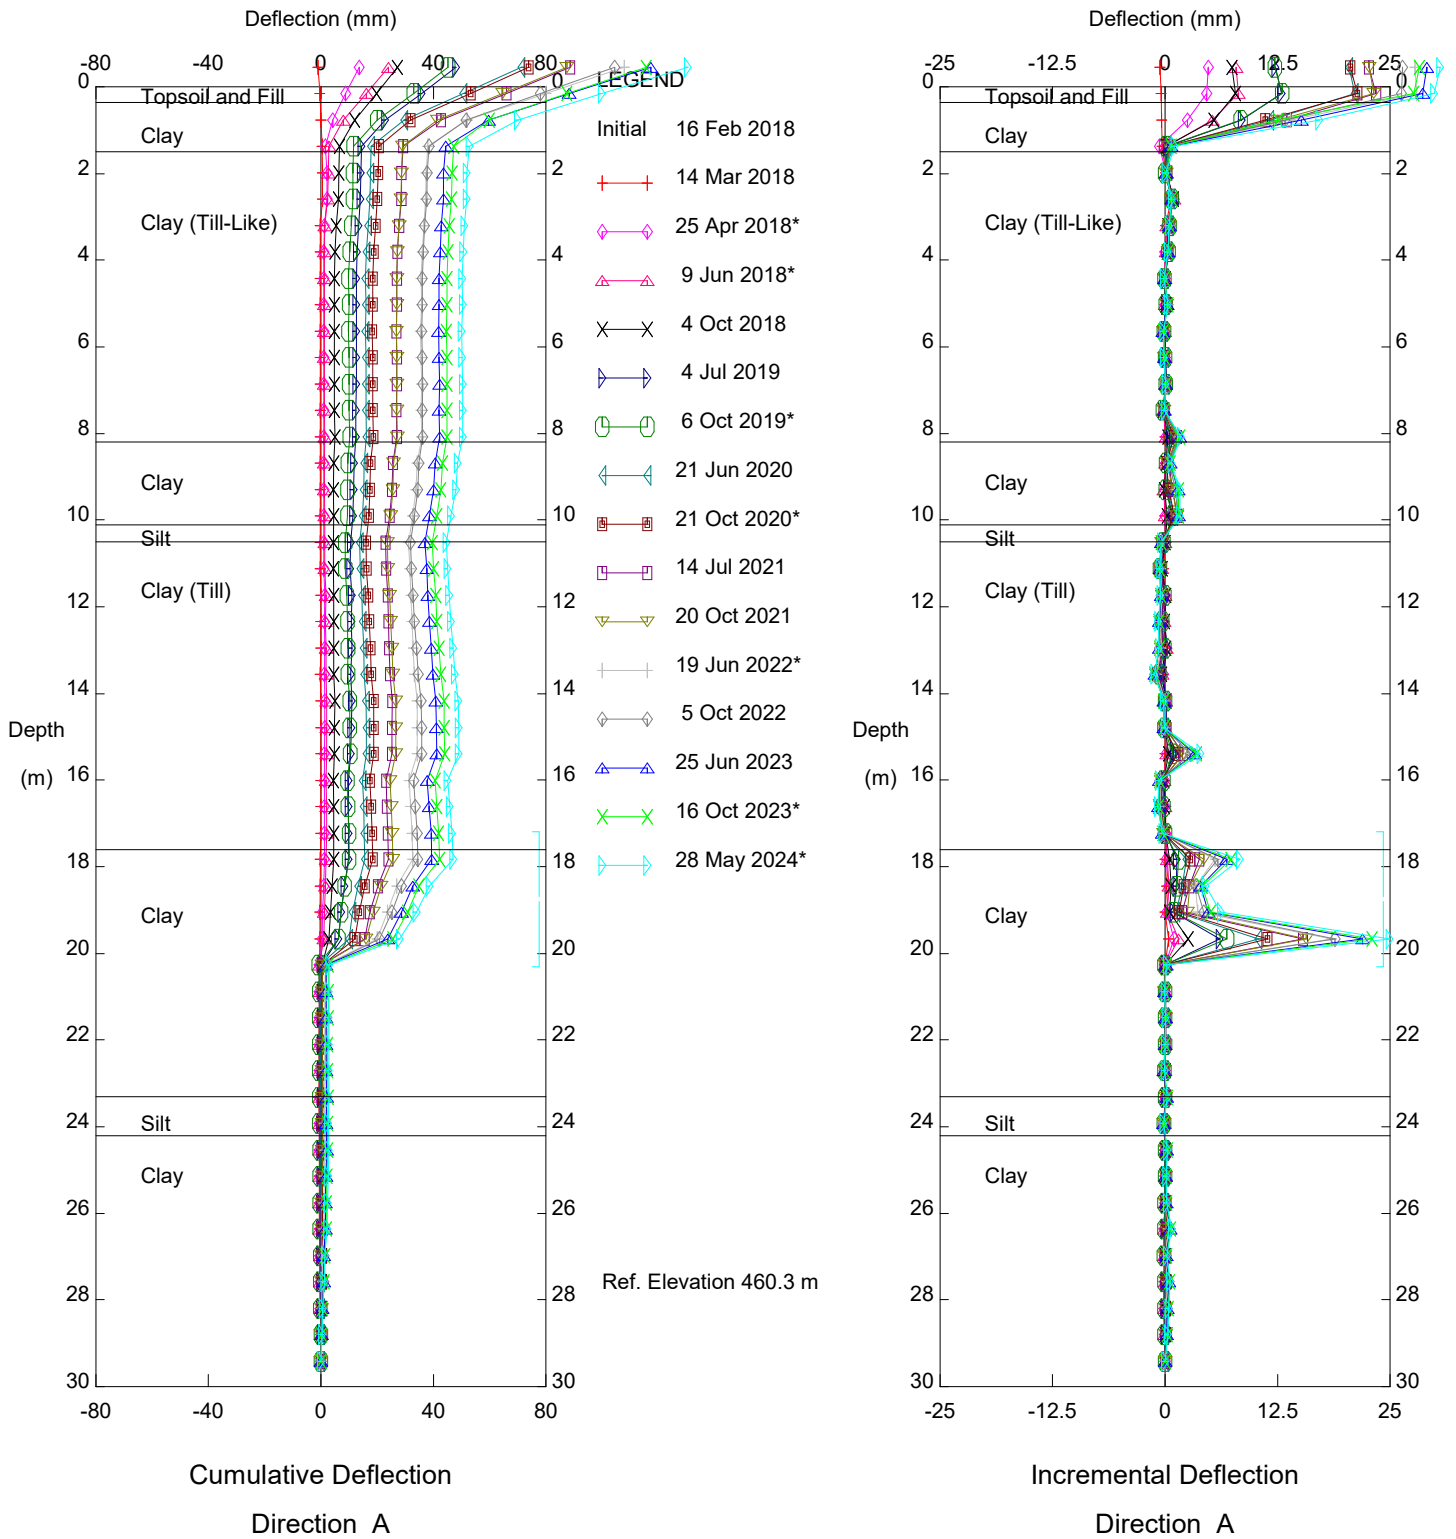
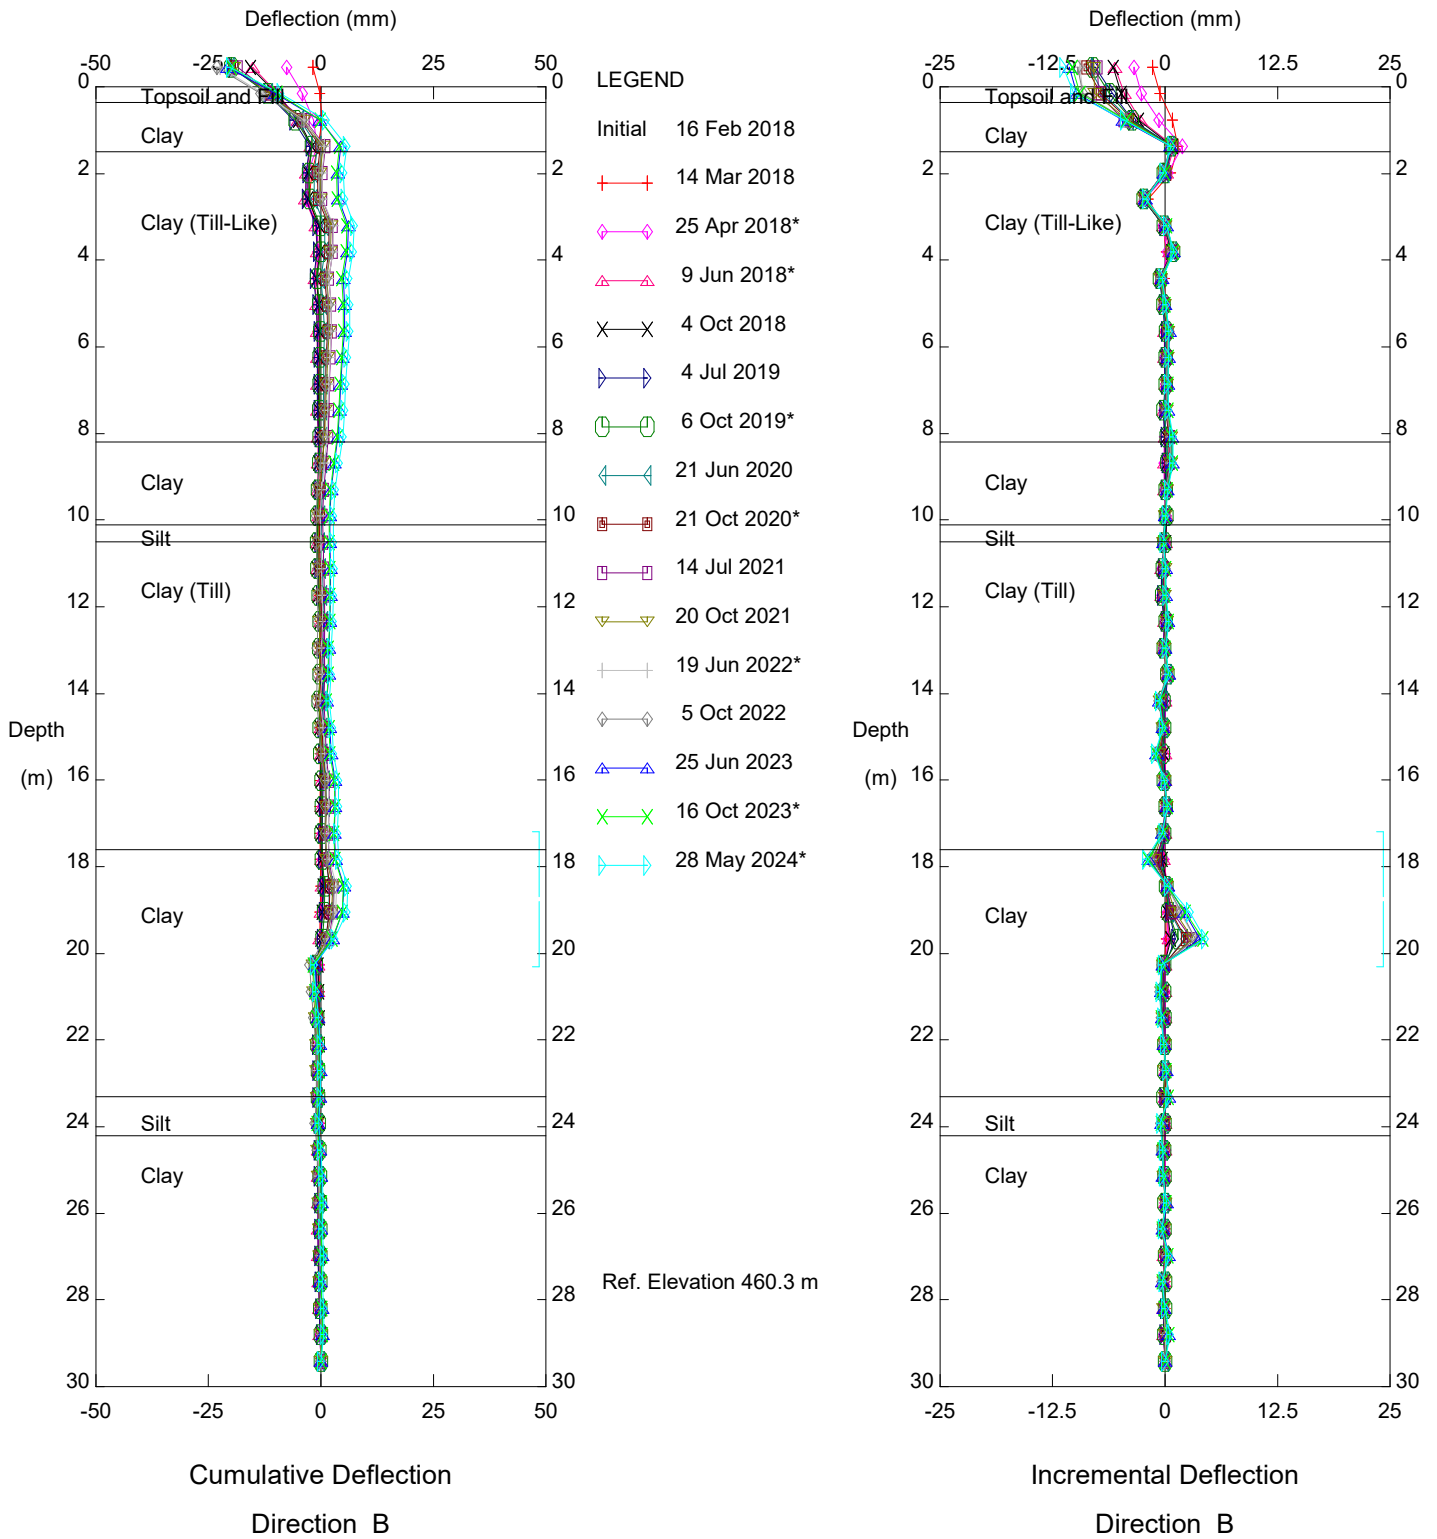
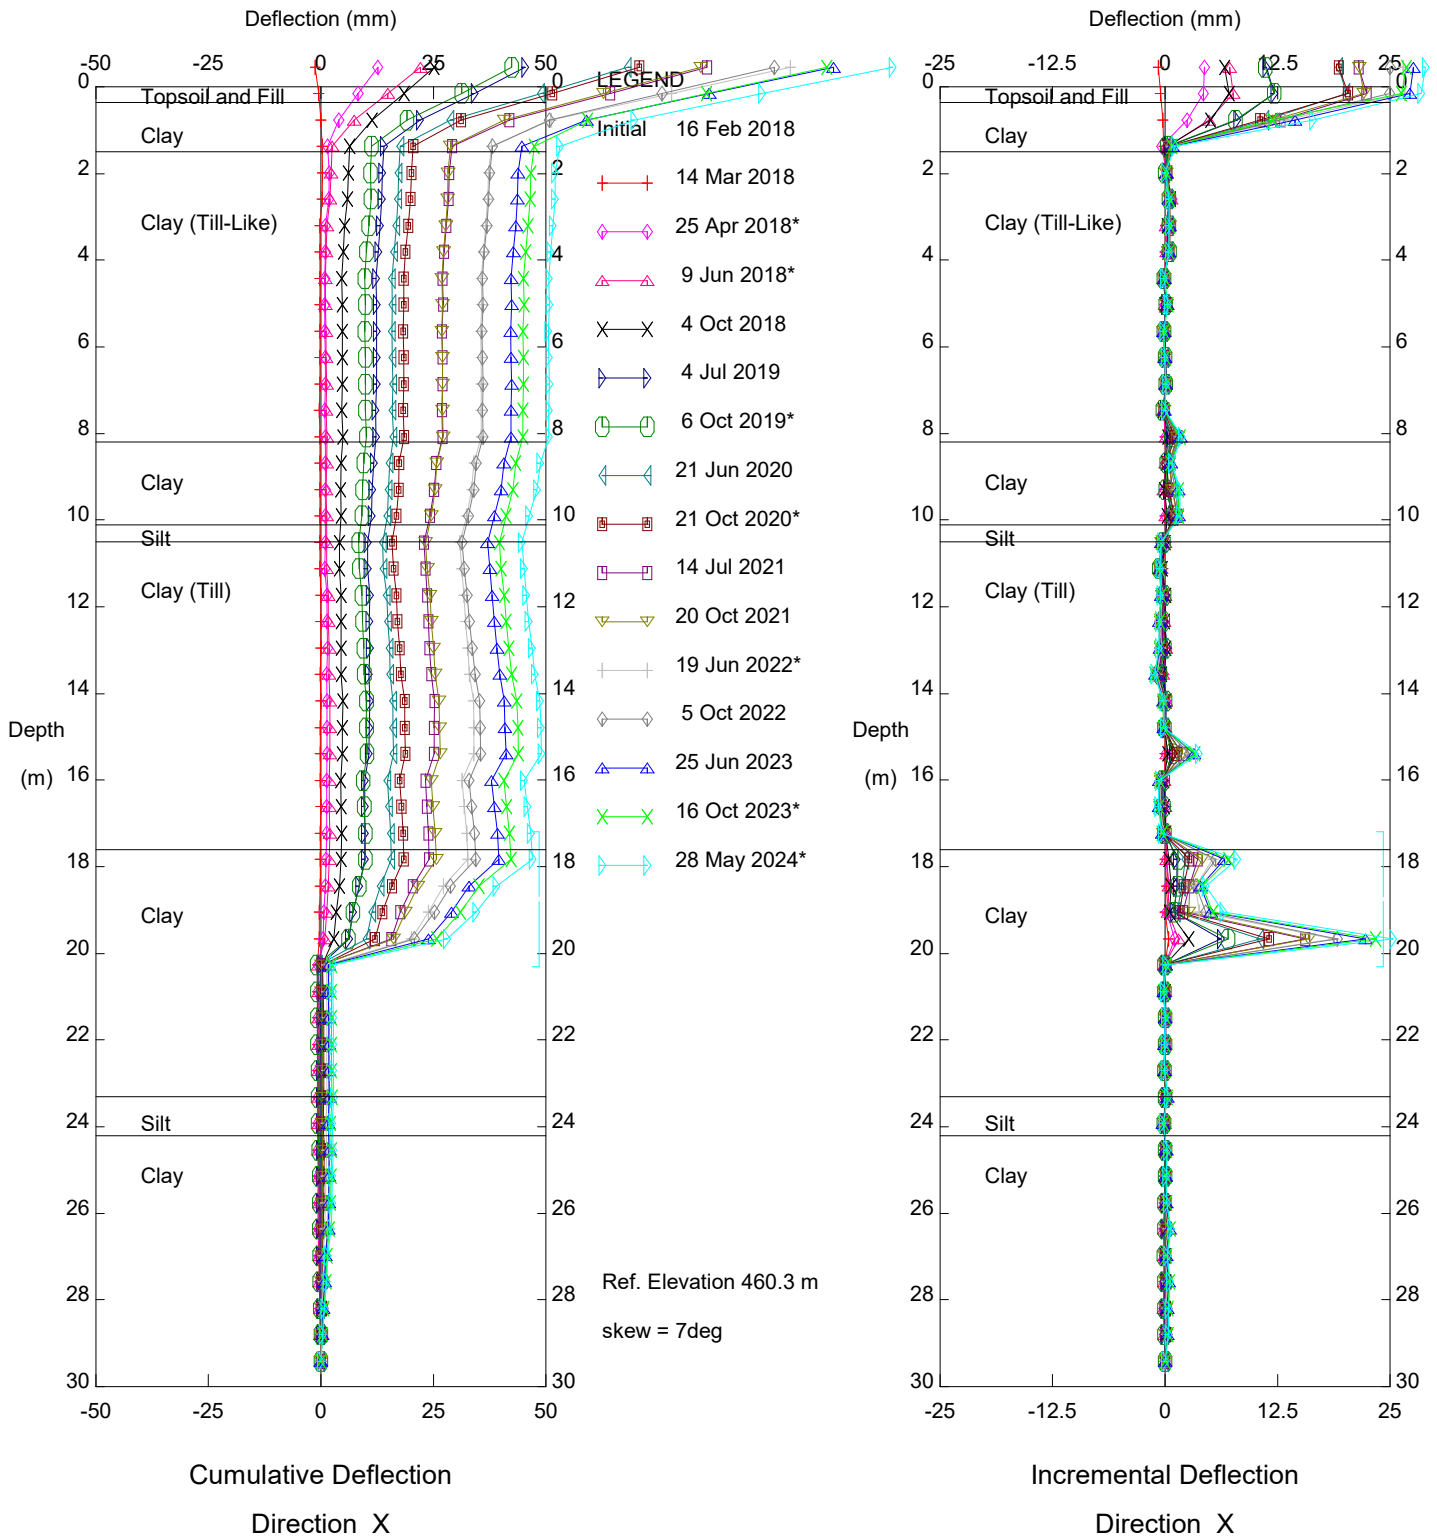
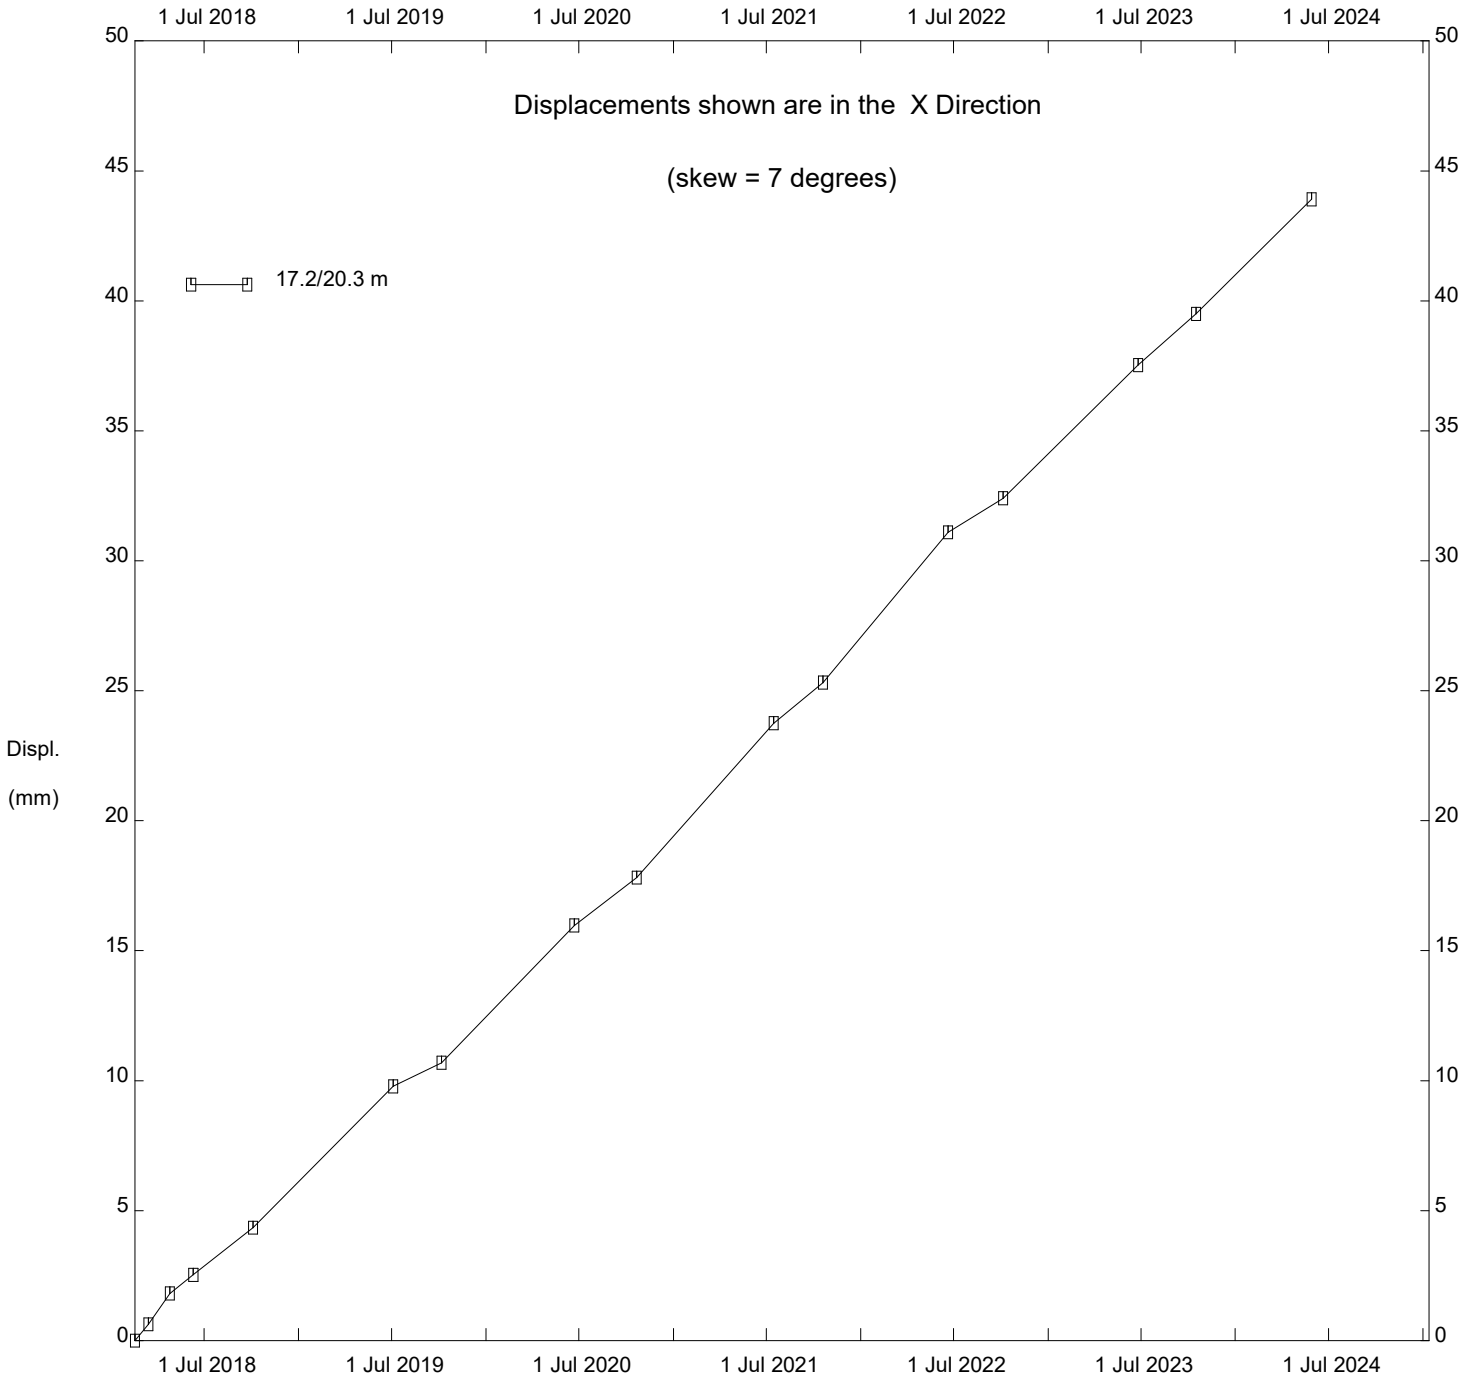
HWY 2:68 (PH037), Inclinometer SI18-5

SI18-5 is located just east of the highway and shows a rate of movement of 7.1 mm/yr over a distinct shear zone between 17.2 m to 20.3 m depth. This movement rate has been steady since the SI was installed in 2018.

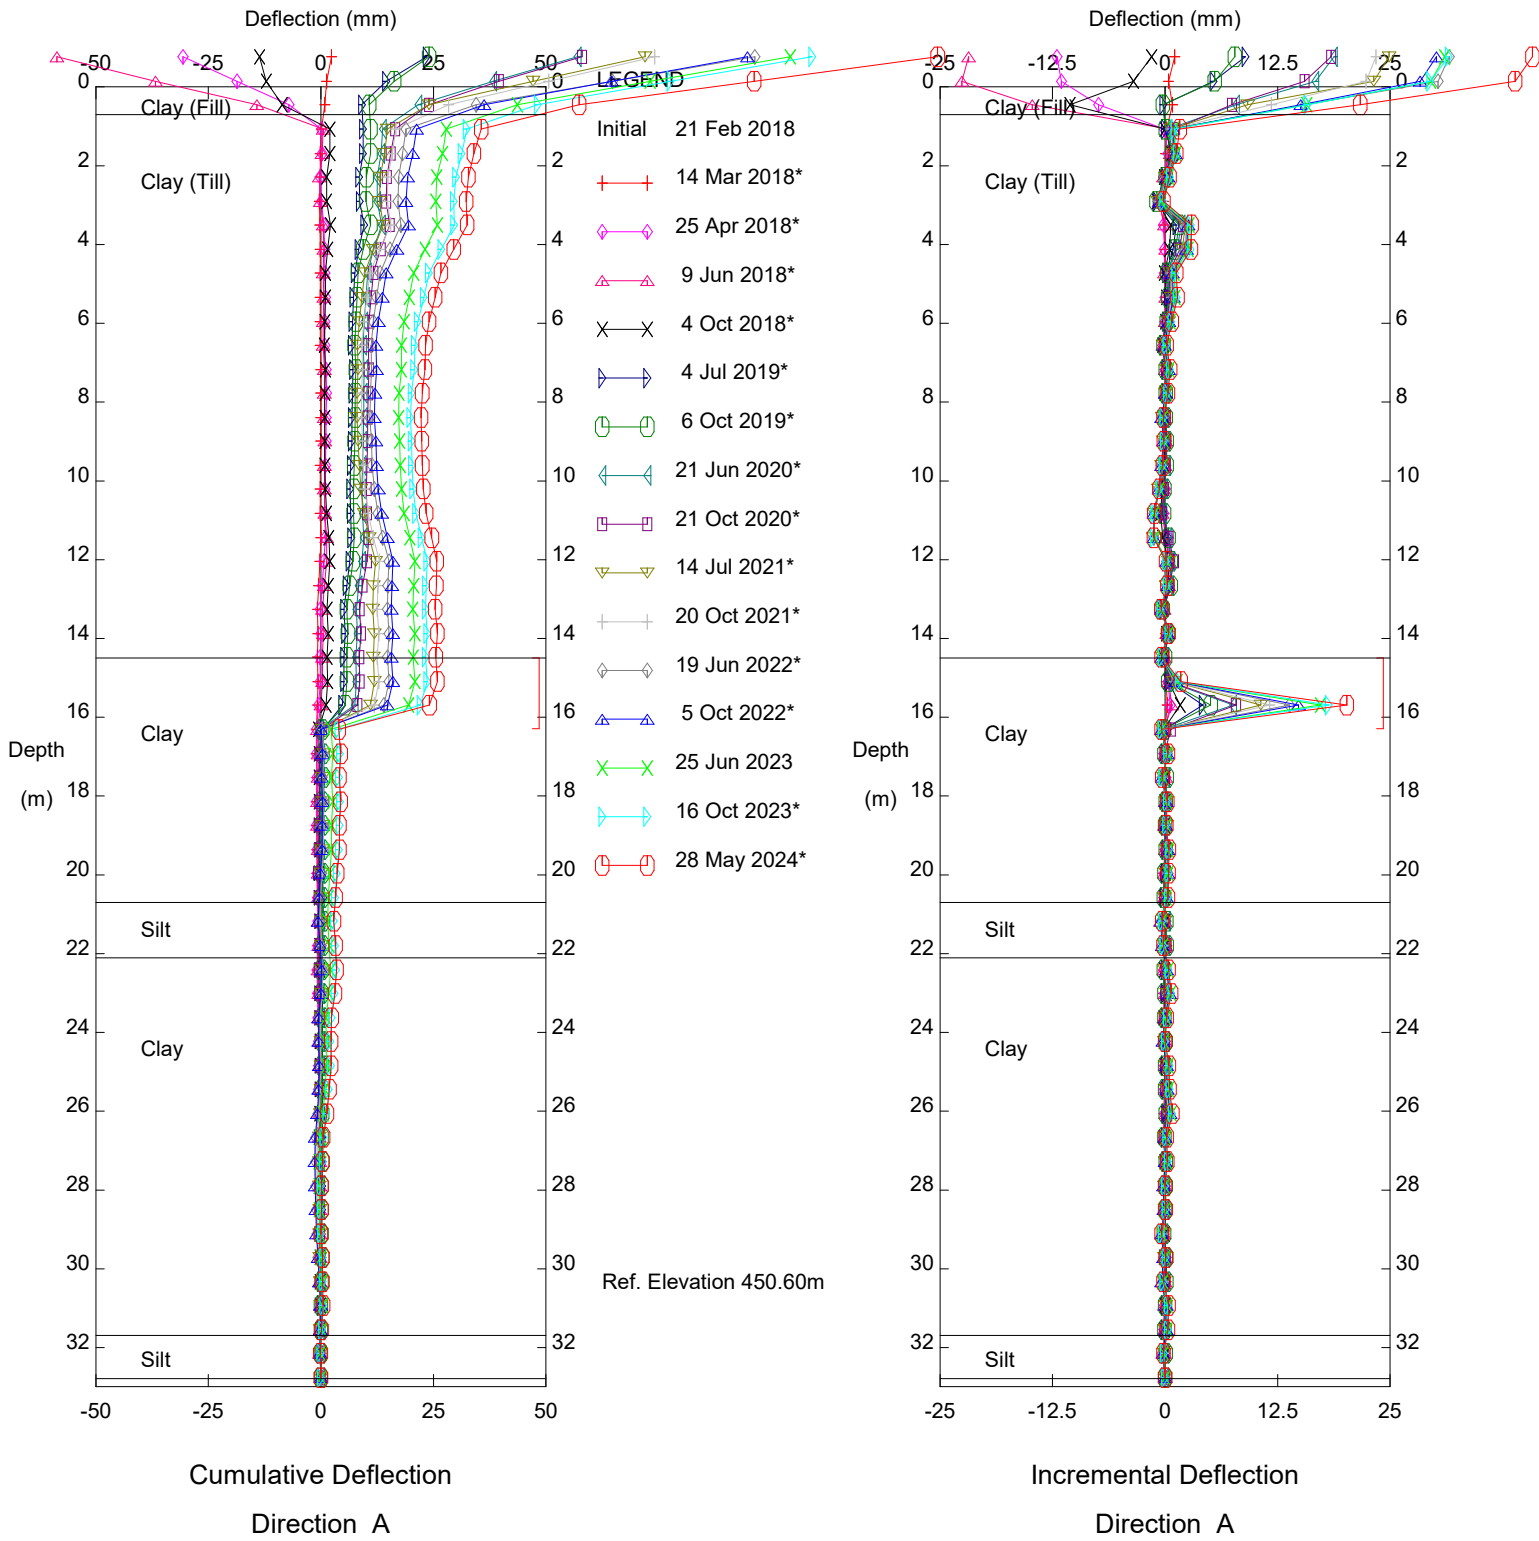
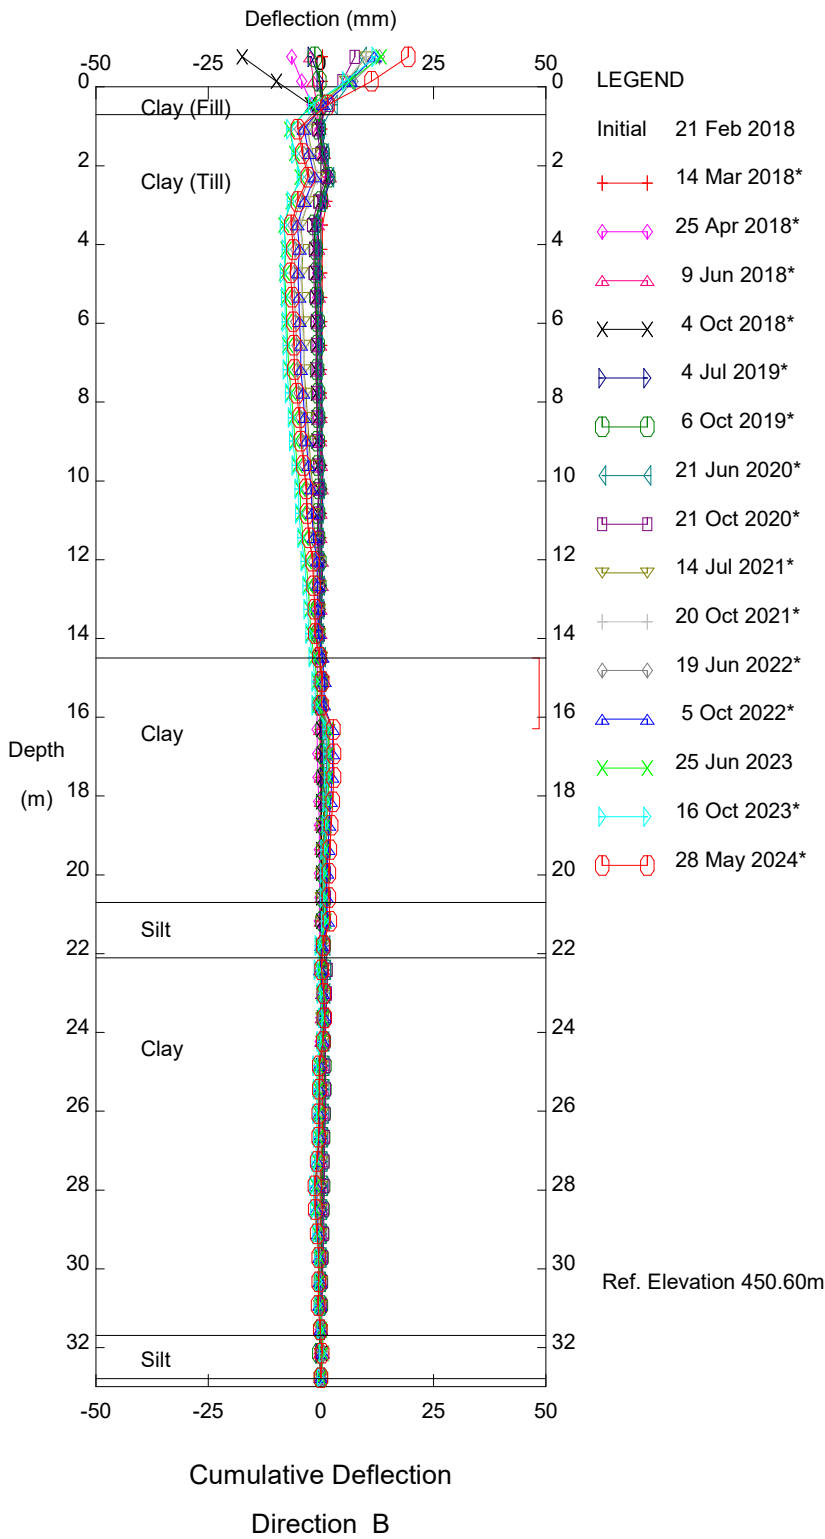
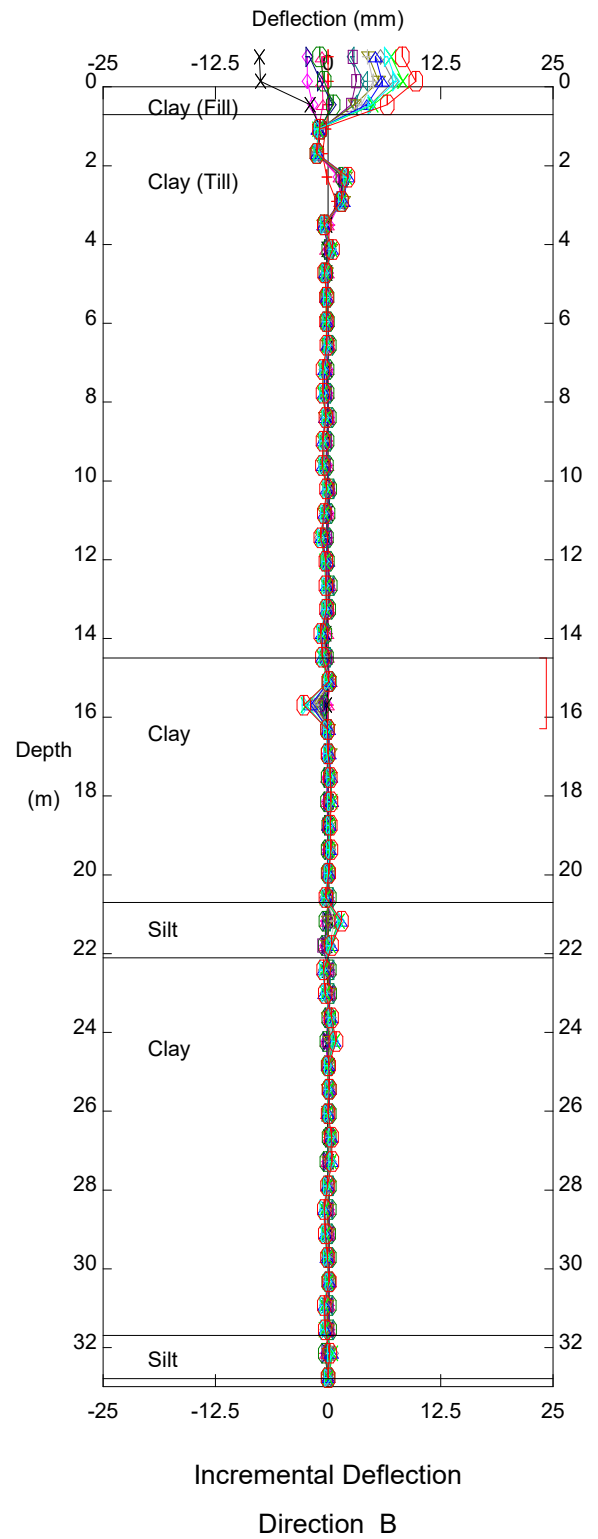
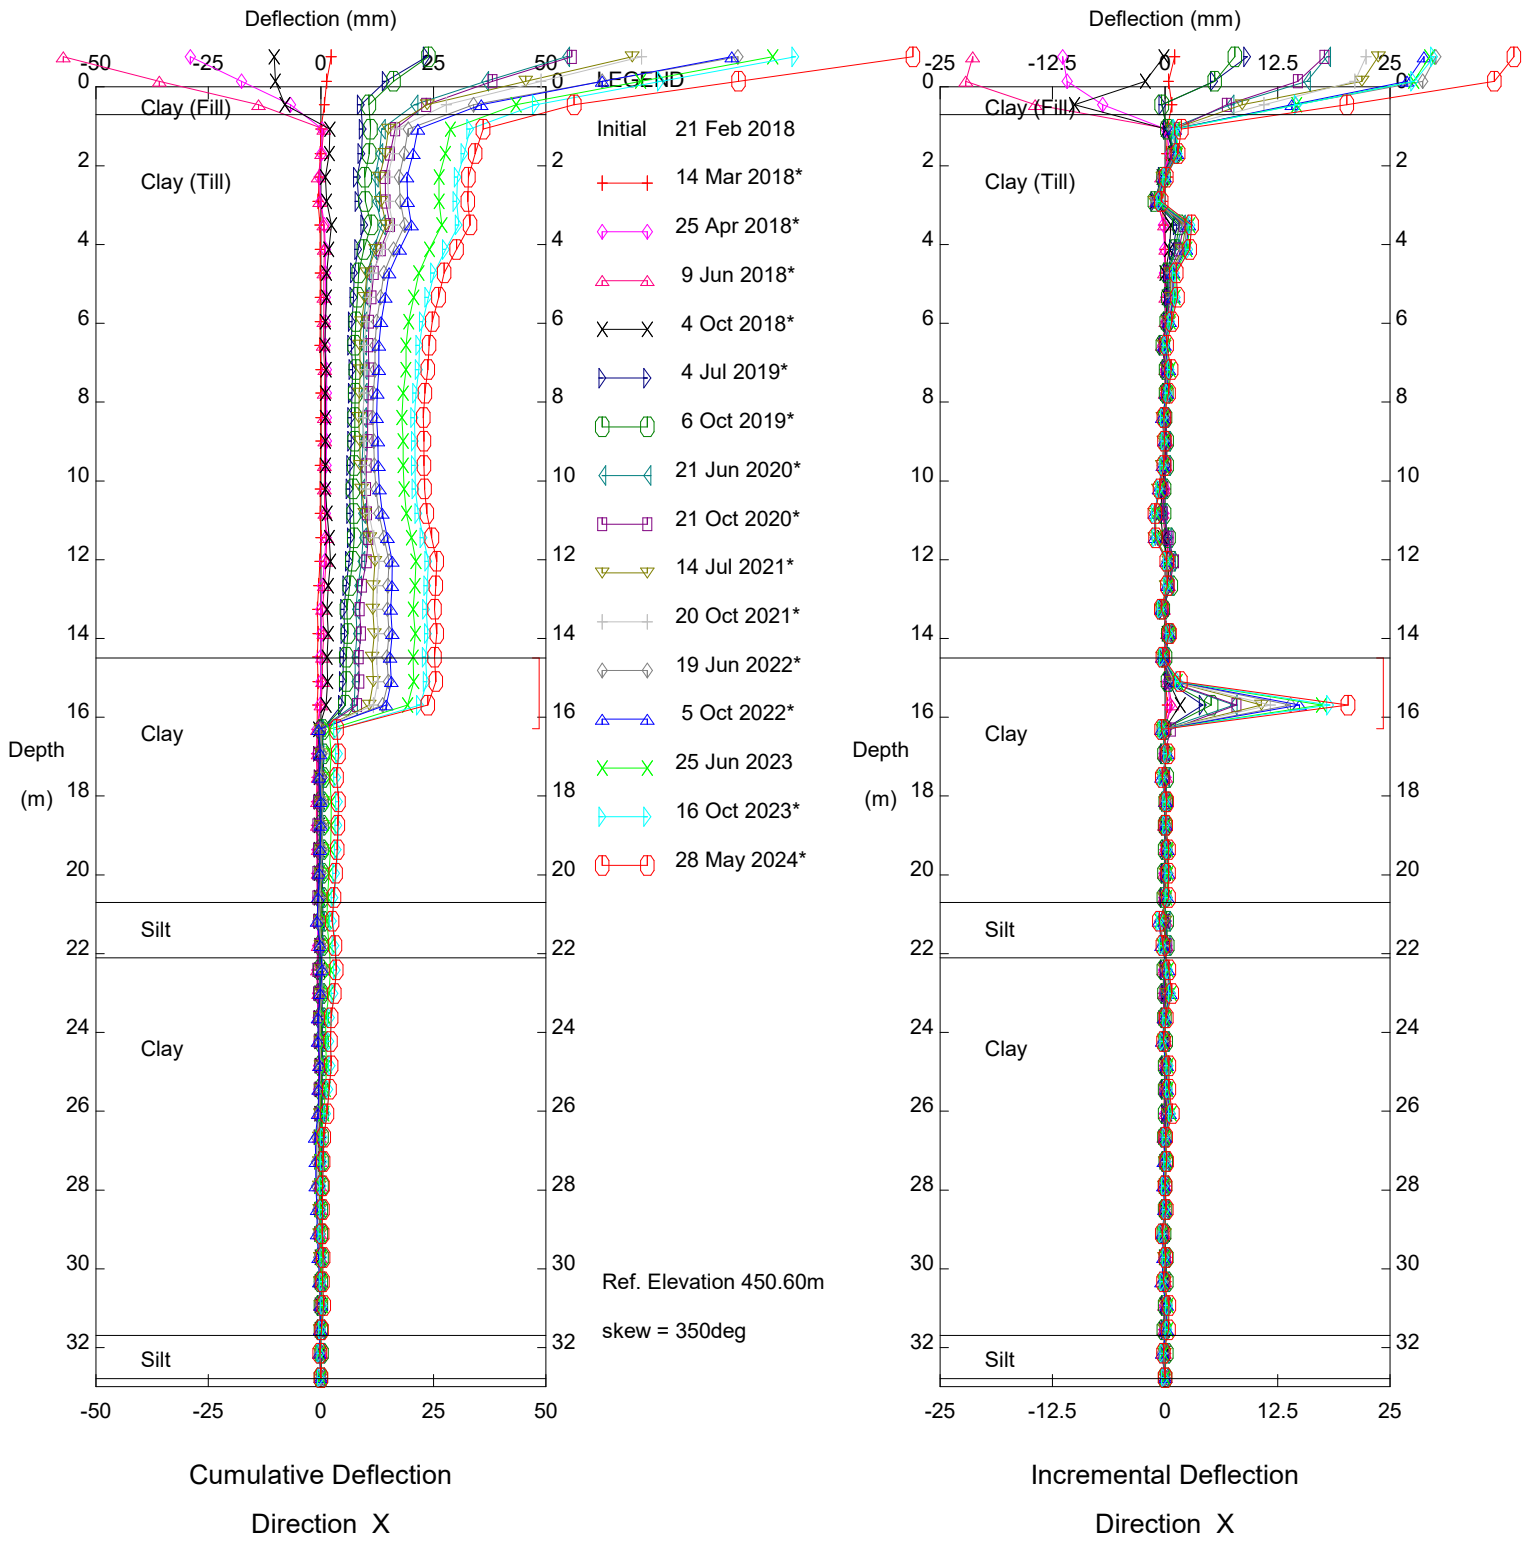
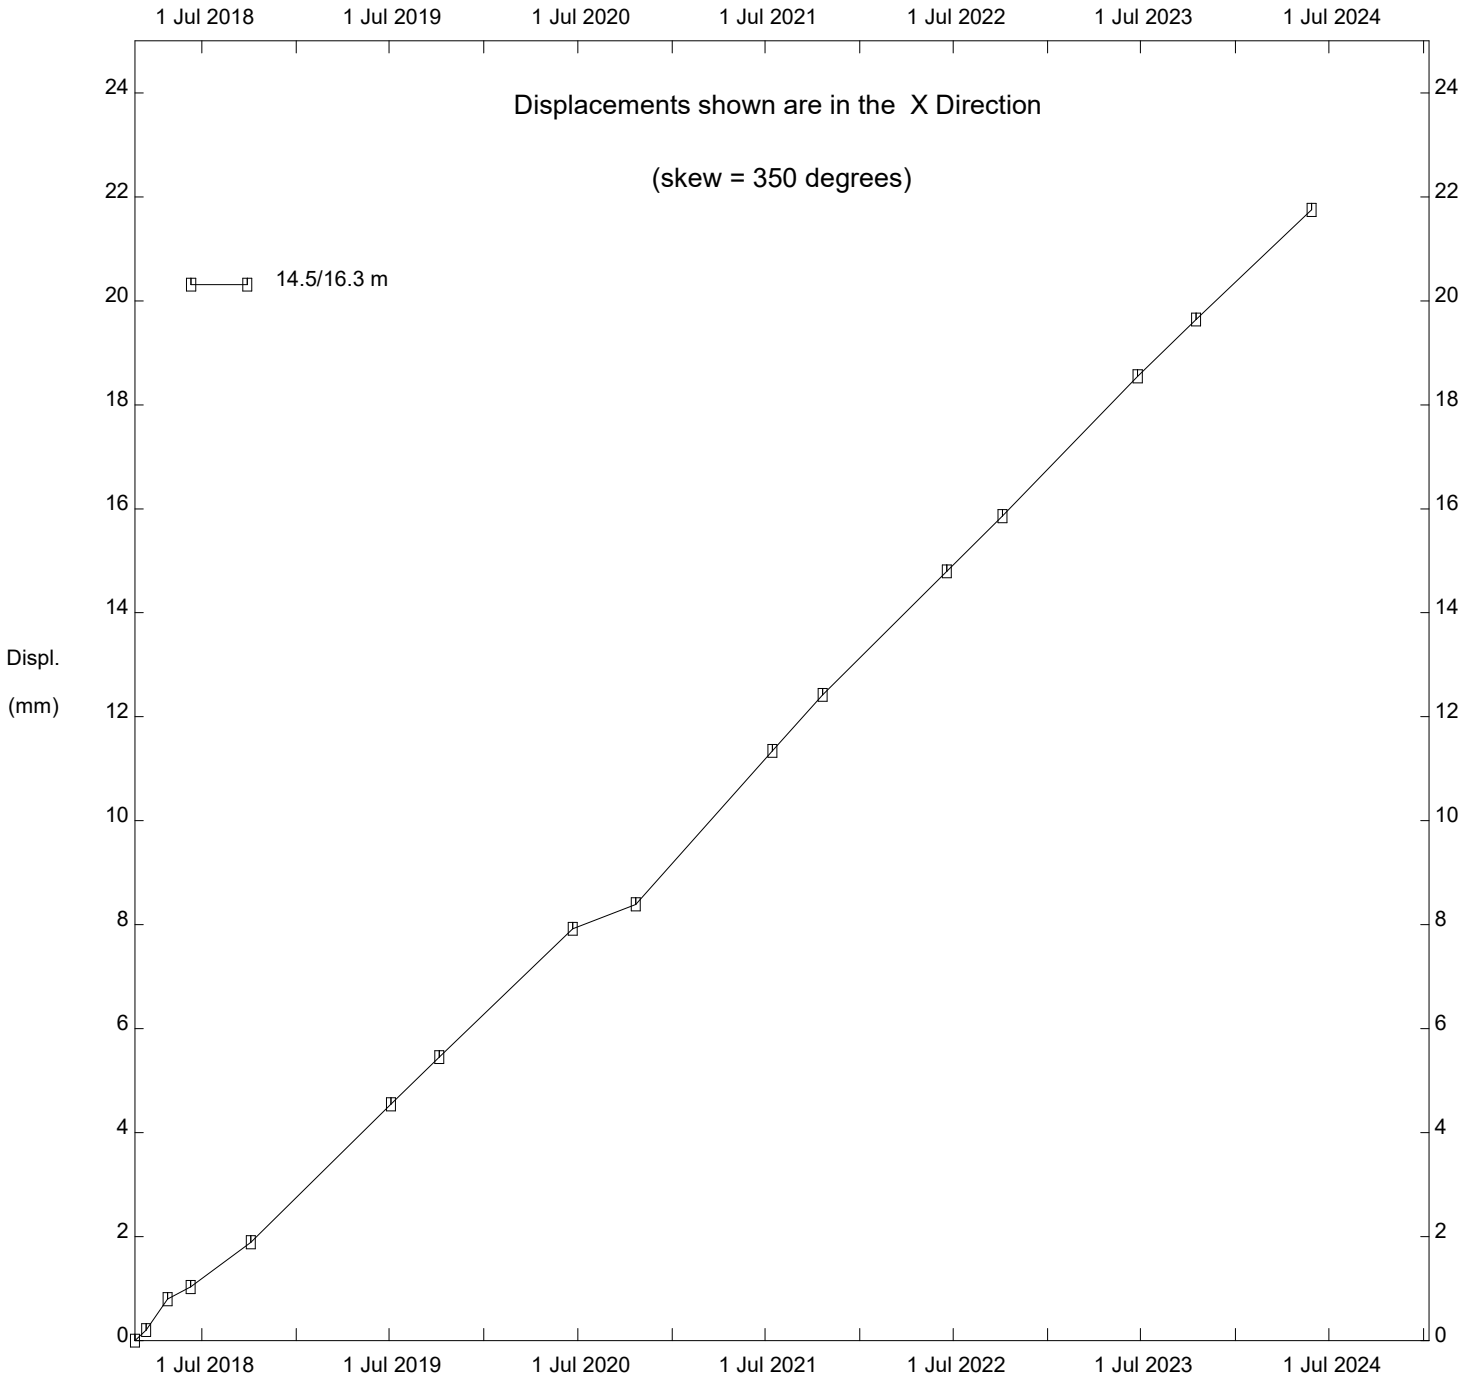
HWY 2:68 (PH037), Inclinometer SI18-8

SI18-8 is located just west of the highway and showed a rate of movement of 3.4 mm/yr along a distinct shear plane over 14.5 m to 16.3 m depth. This movement rate has held steady since 2018 and total movement to date is about 22 mm.
