ALBERTA TRANSPORTATION AND
ECONOMIC CORRIDORS GRMP
GRANDE PRAIRIE REGION –
(GRANDE PRAIRIE NORTH)
INSTRUMENTATION MONITORING - SPRING 2024

Site Number	Location	Name	Hwy	km
PH037	Station 1+250 to 2+000	Dunvegan South	2:68	Km 15.7
Legal Description: 4-7-80-4 W6		UTM Co-ordinates		
		11U E 398593.62	N	6197597.09

Current Monitoring:	28-May-2024	Previous Monitoring	16-Oct-2023
Instruments Read By:	Mr. Niraj Regmi, G.I.T and Mr. Nixon Mationg, of Thurber

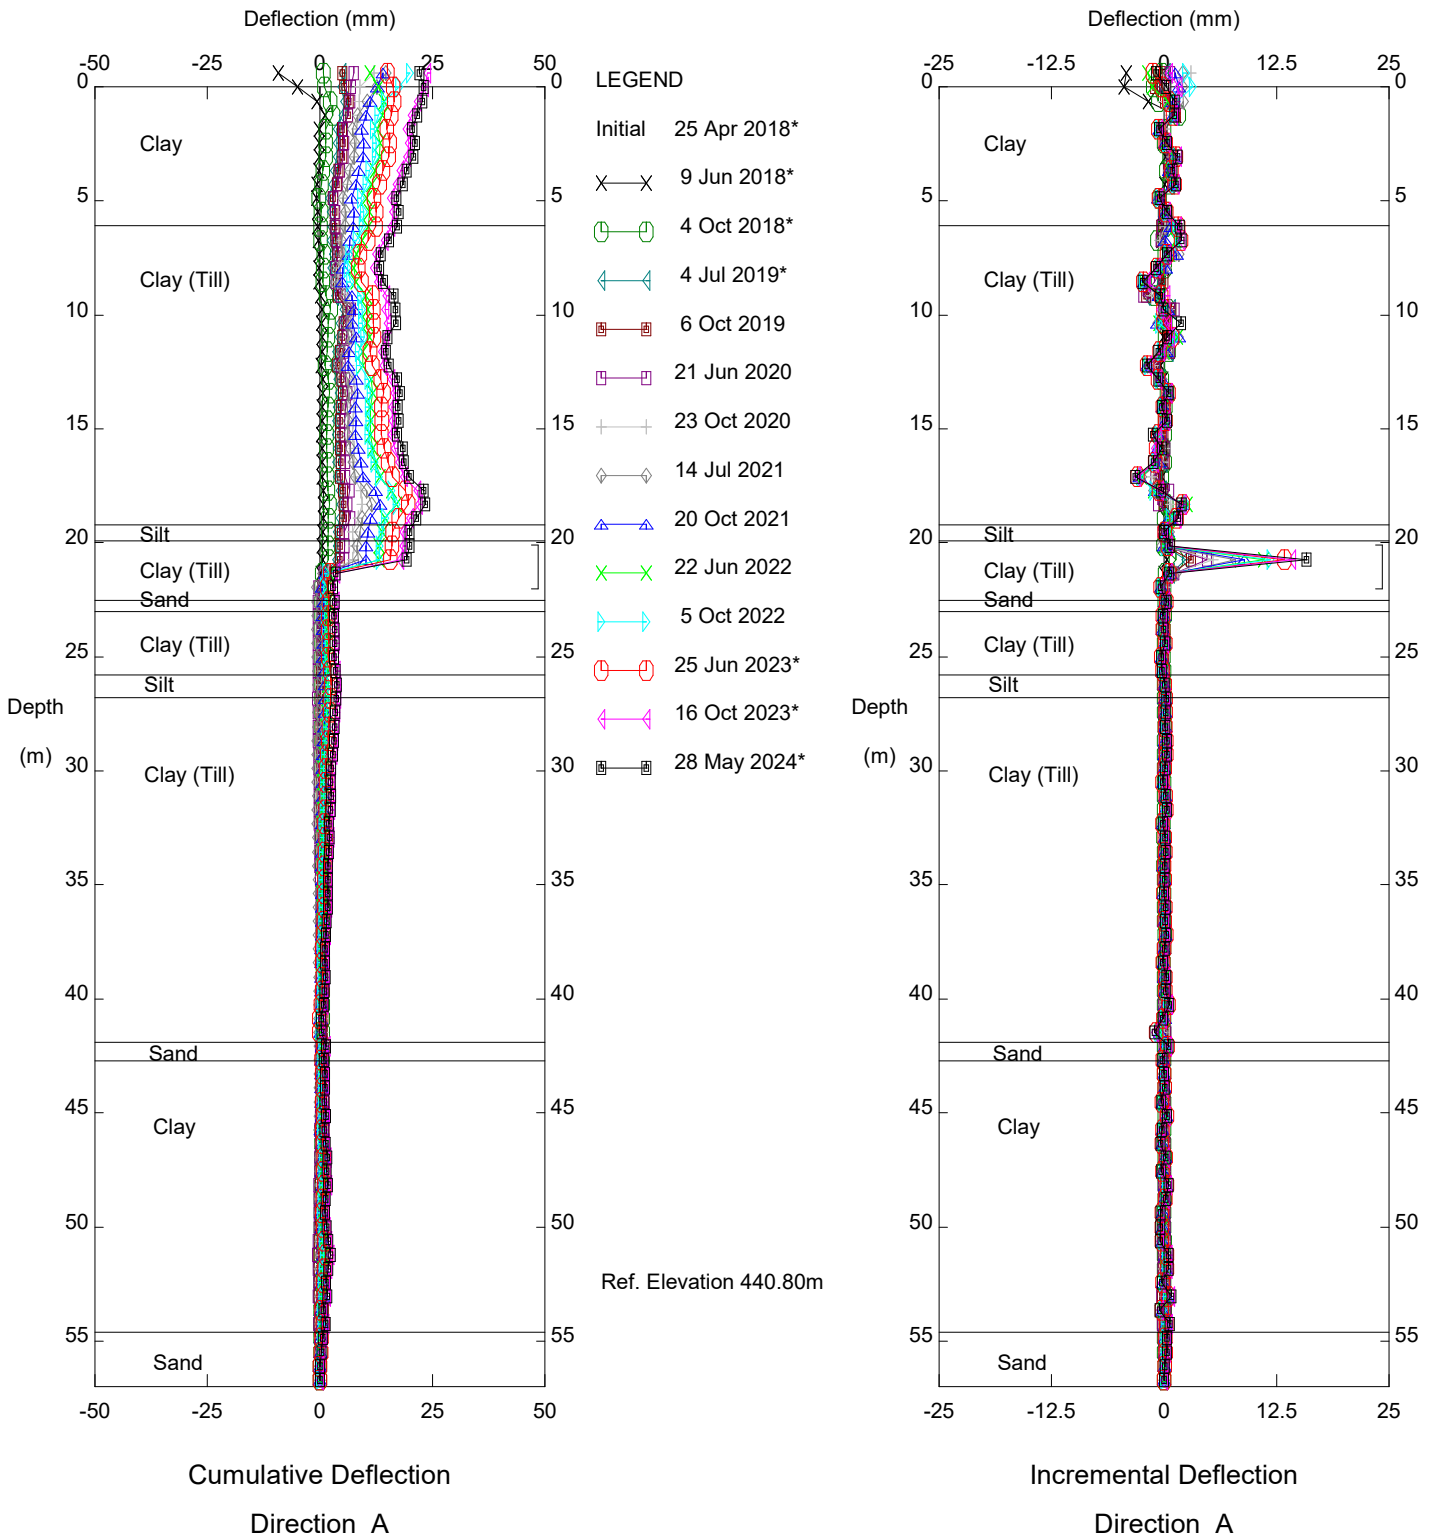
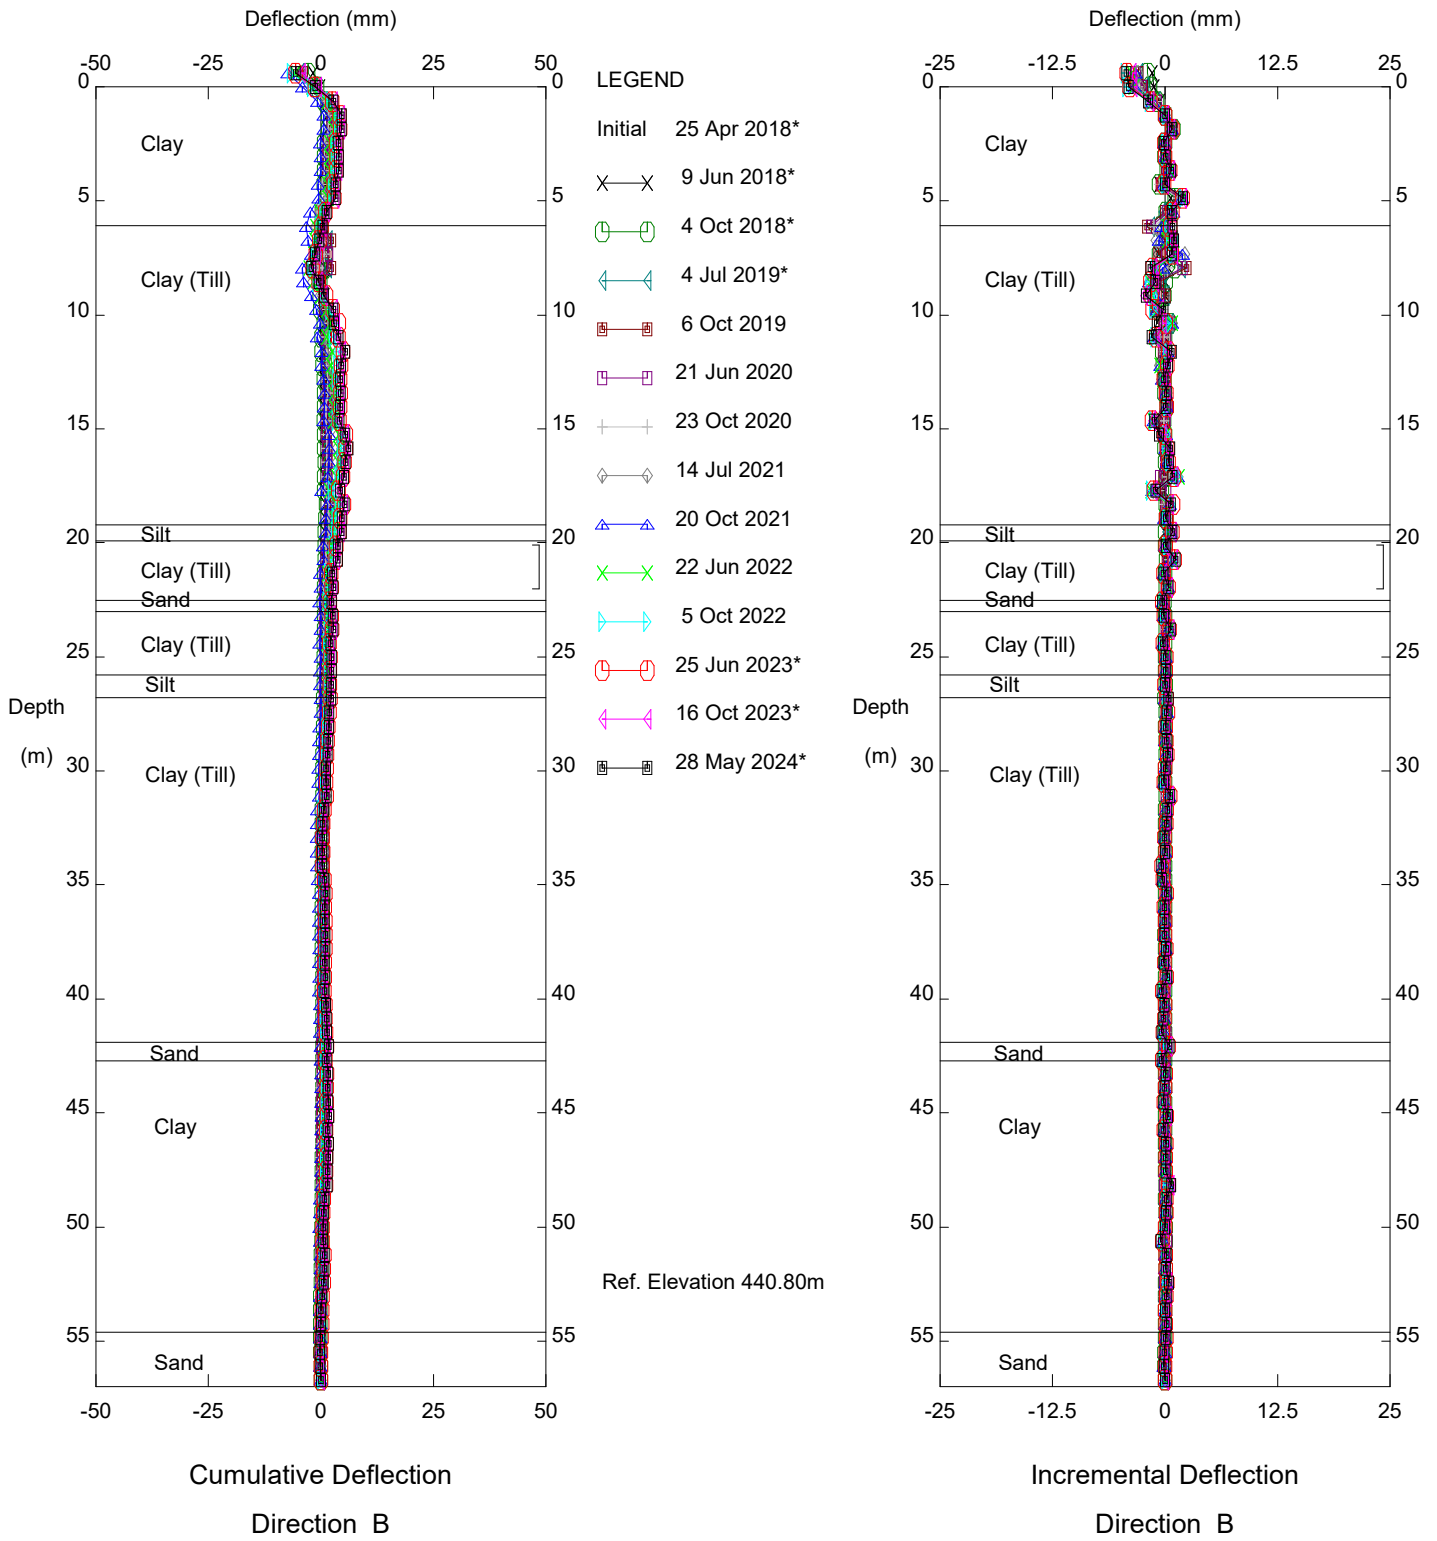
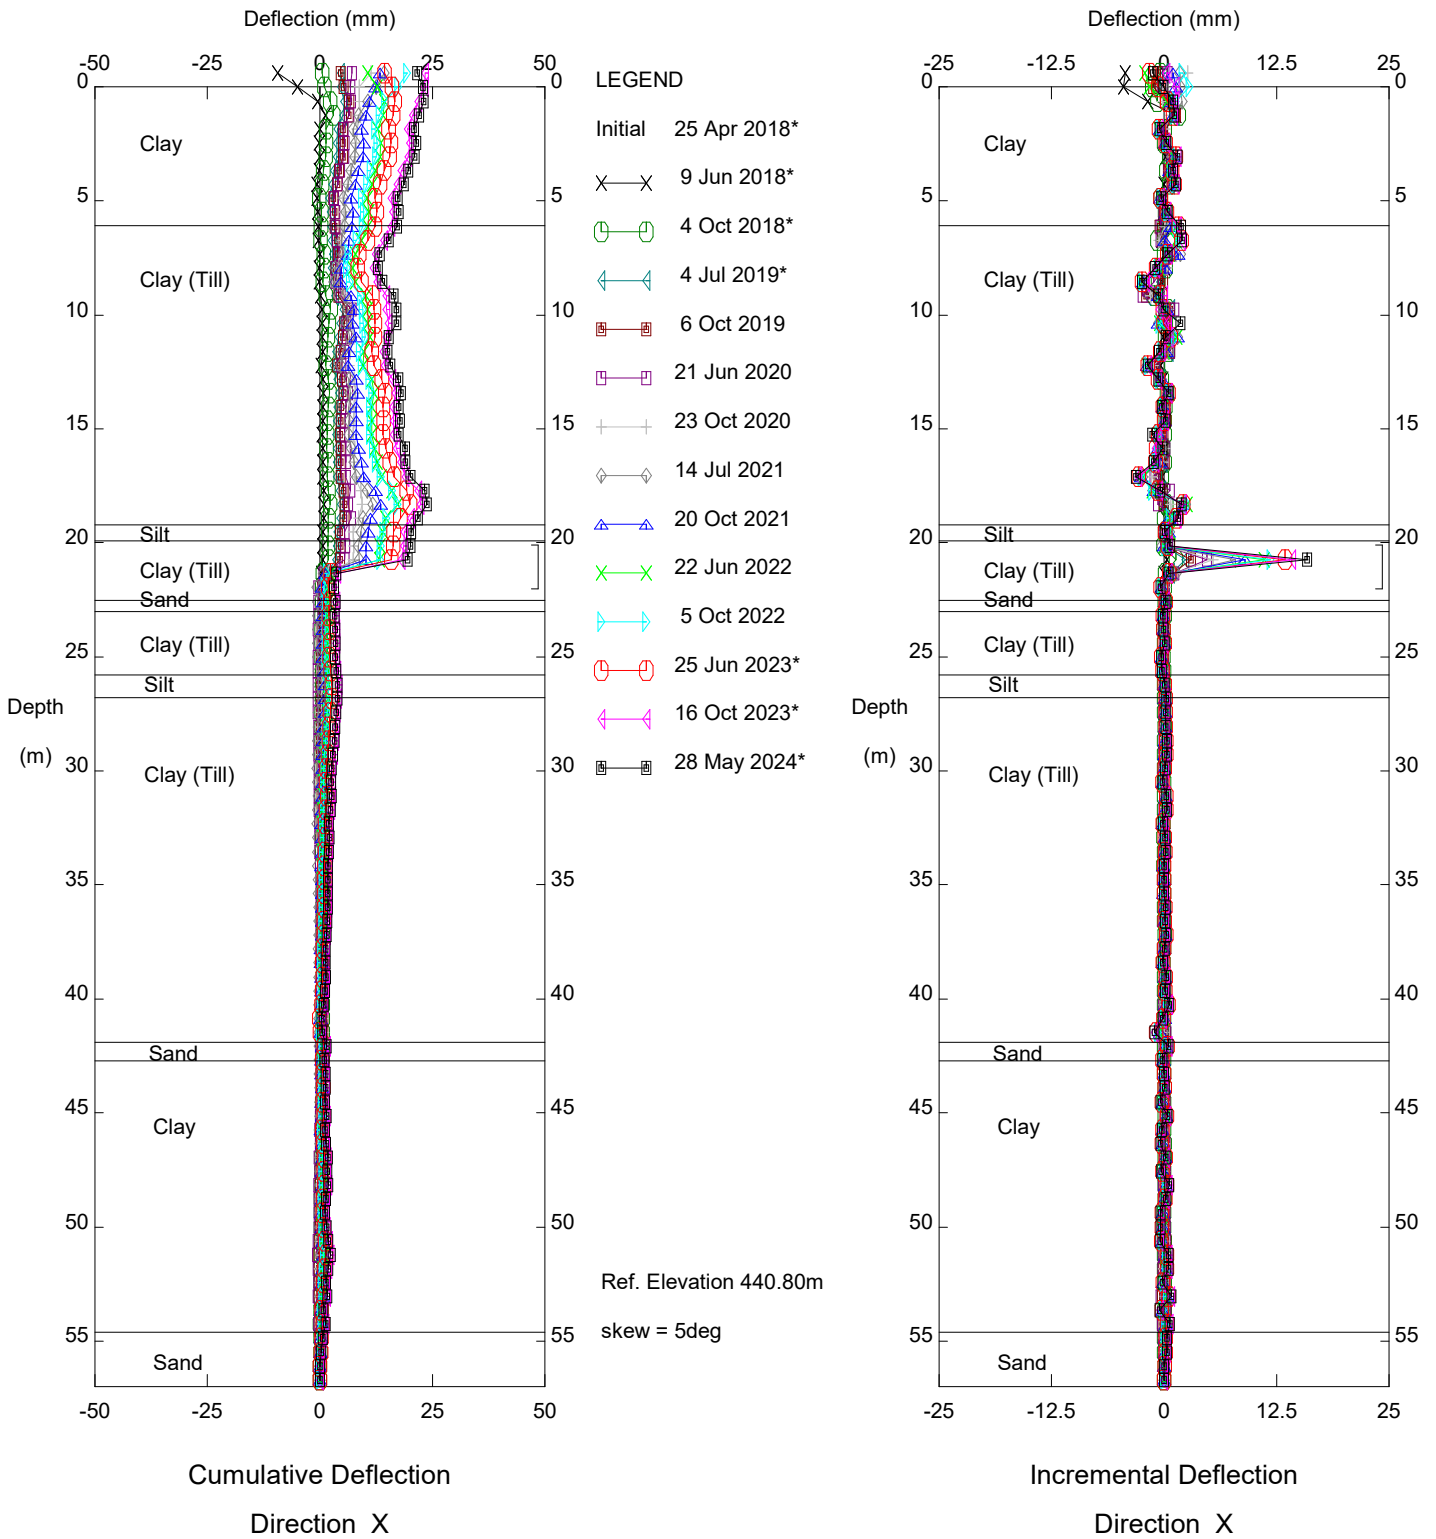
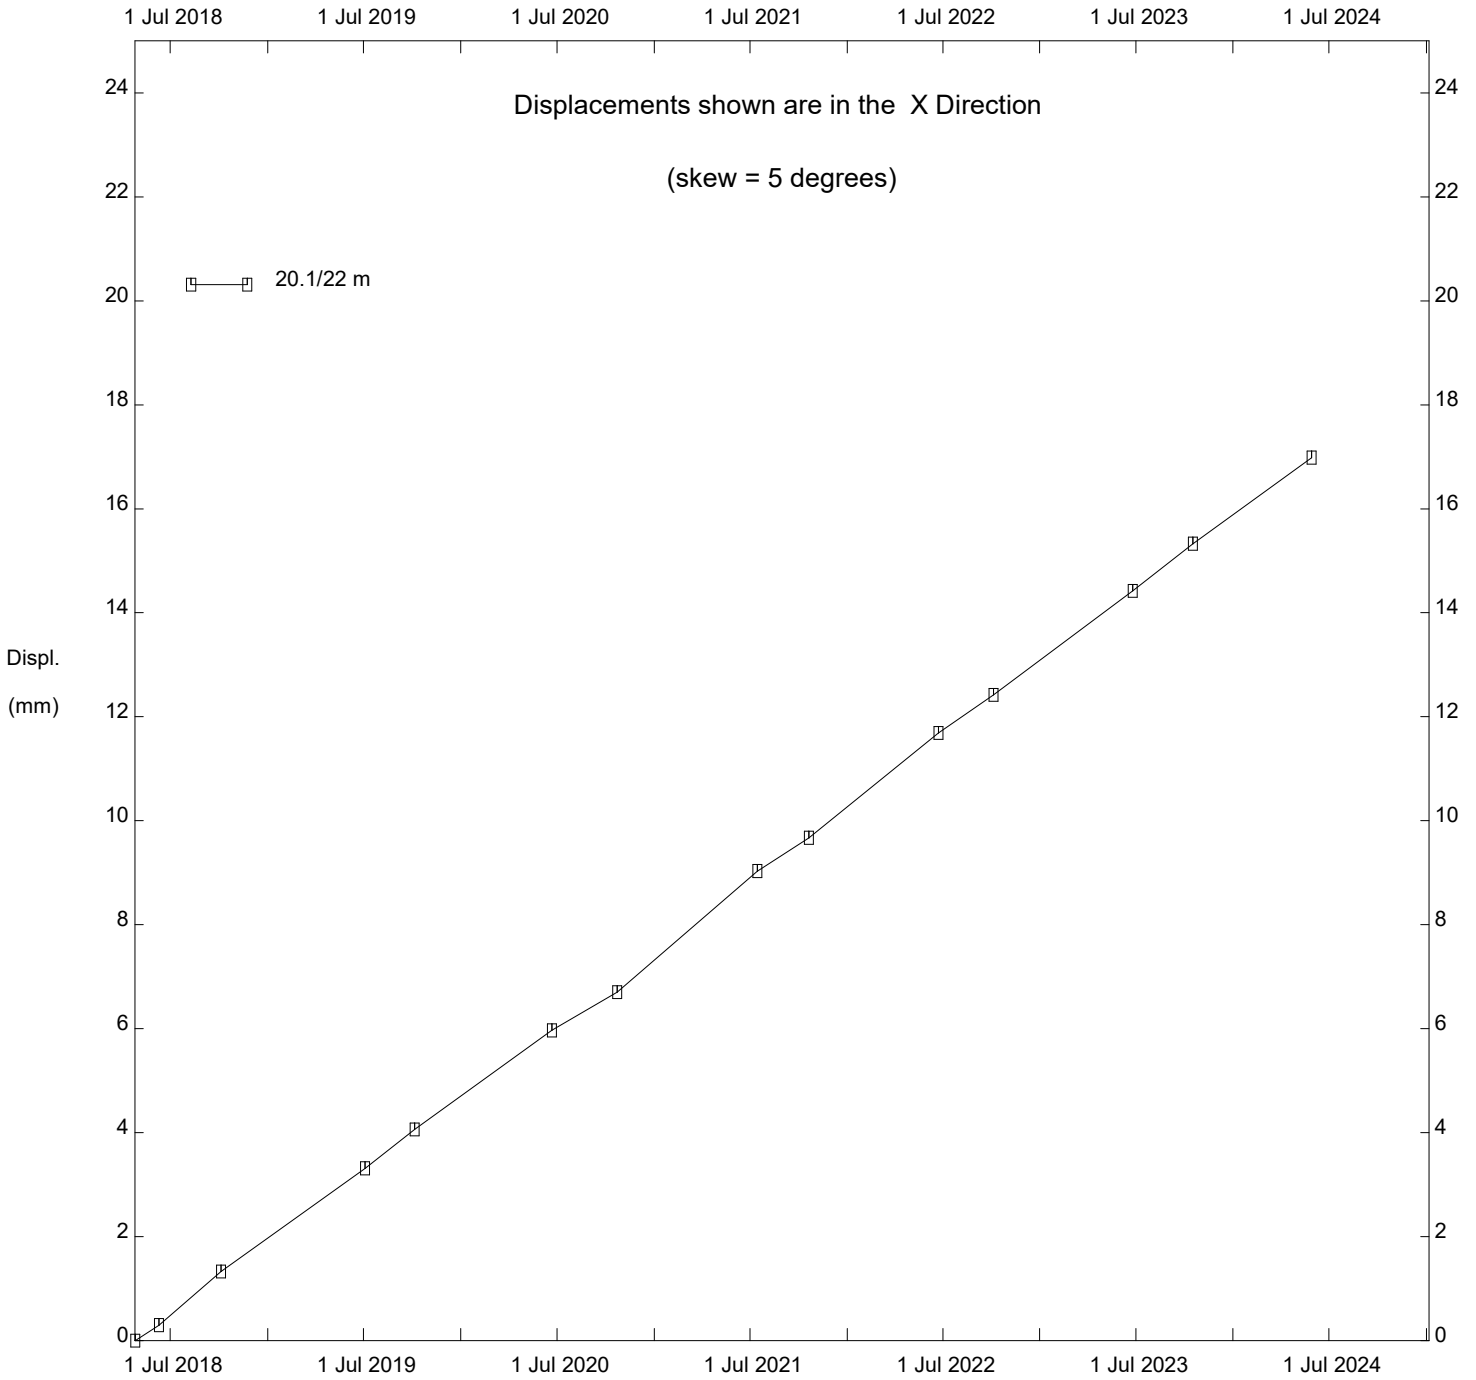
HWY 2:68 (PH037), Inclinometer SI18-9

SI18-9 is located about 35 m west of the highway and showed a rate of movement of 2.7 mm/yr along a well-defined shear plane over 20.1 m to 22.0 m depth.

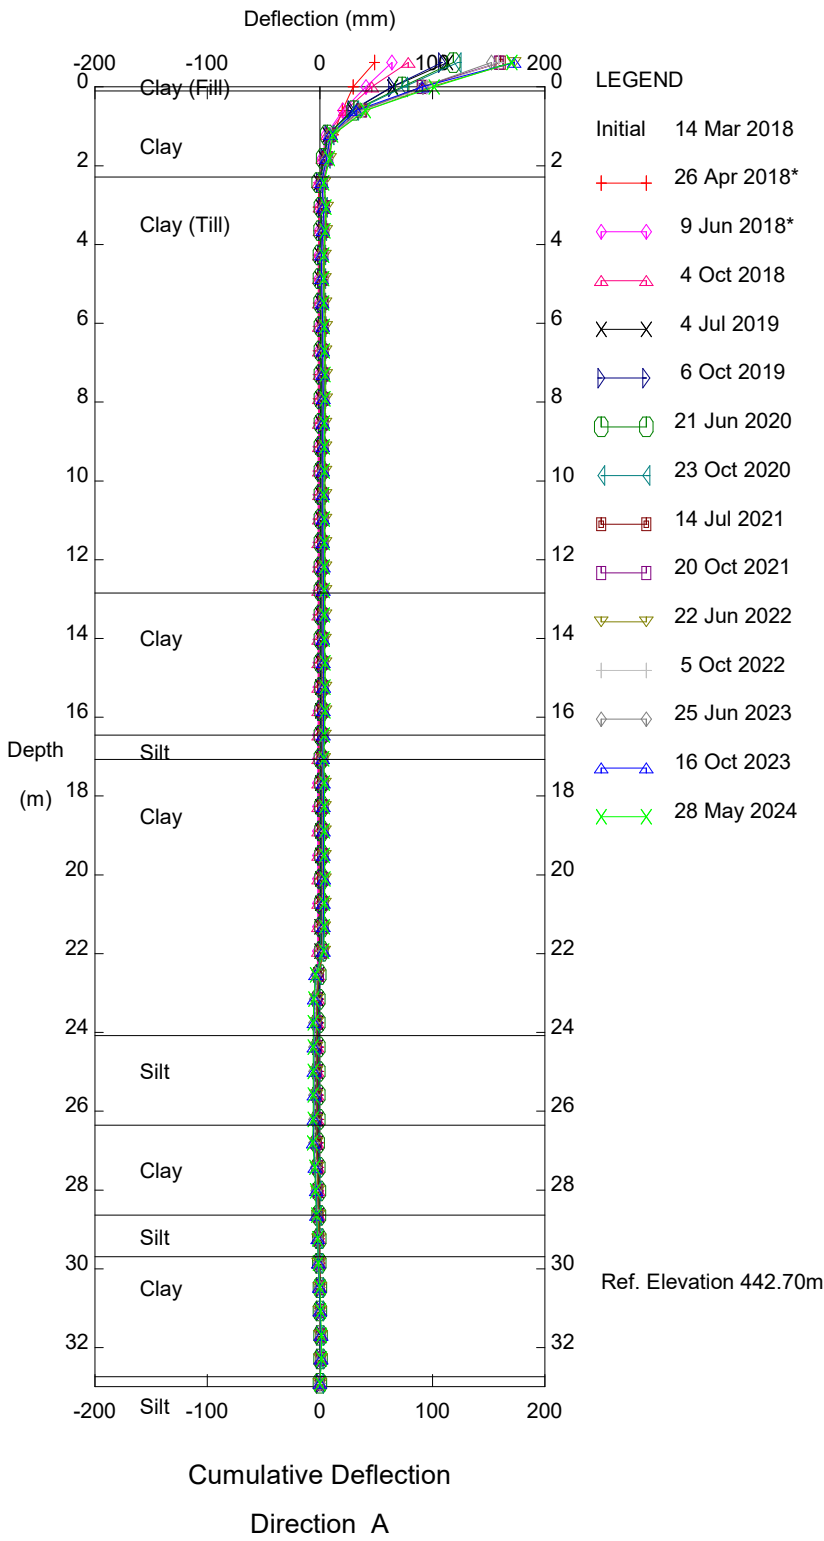
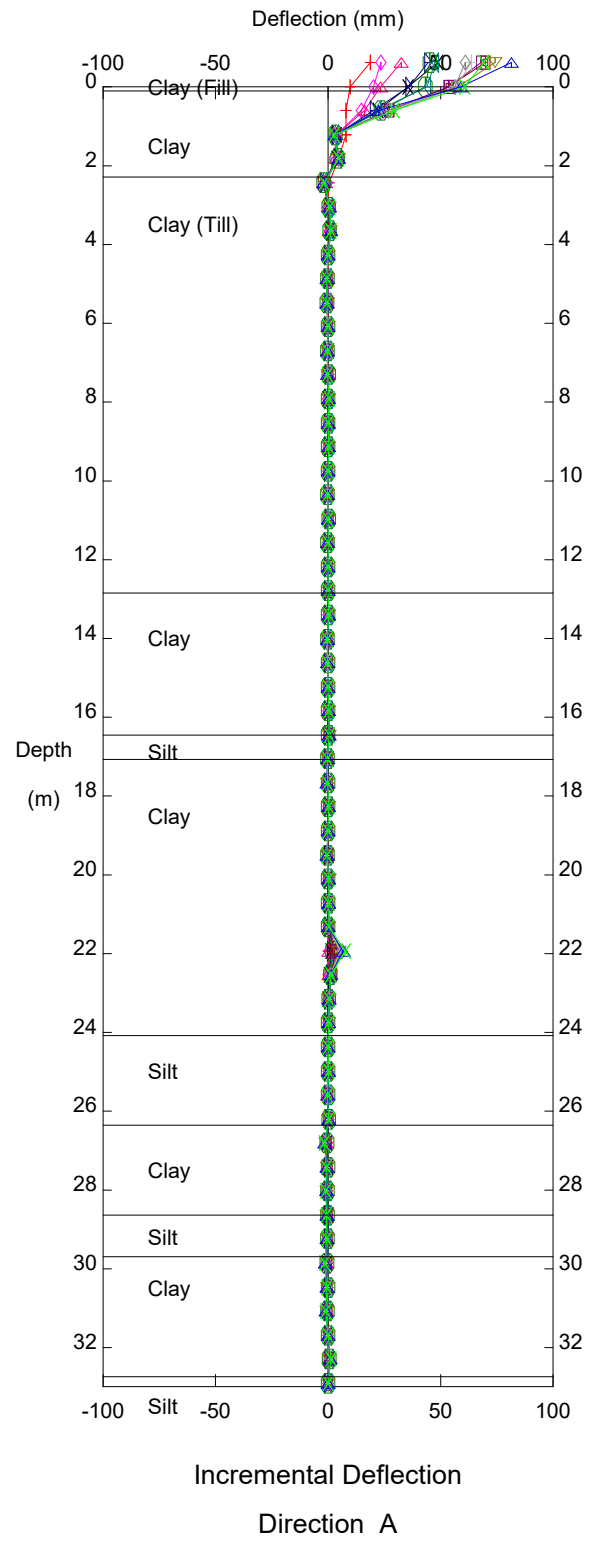
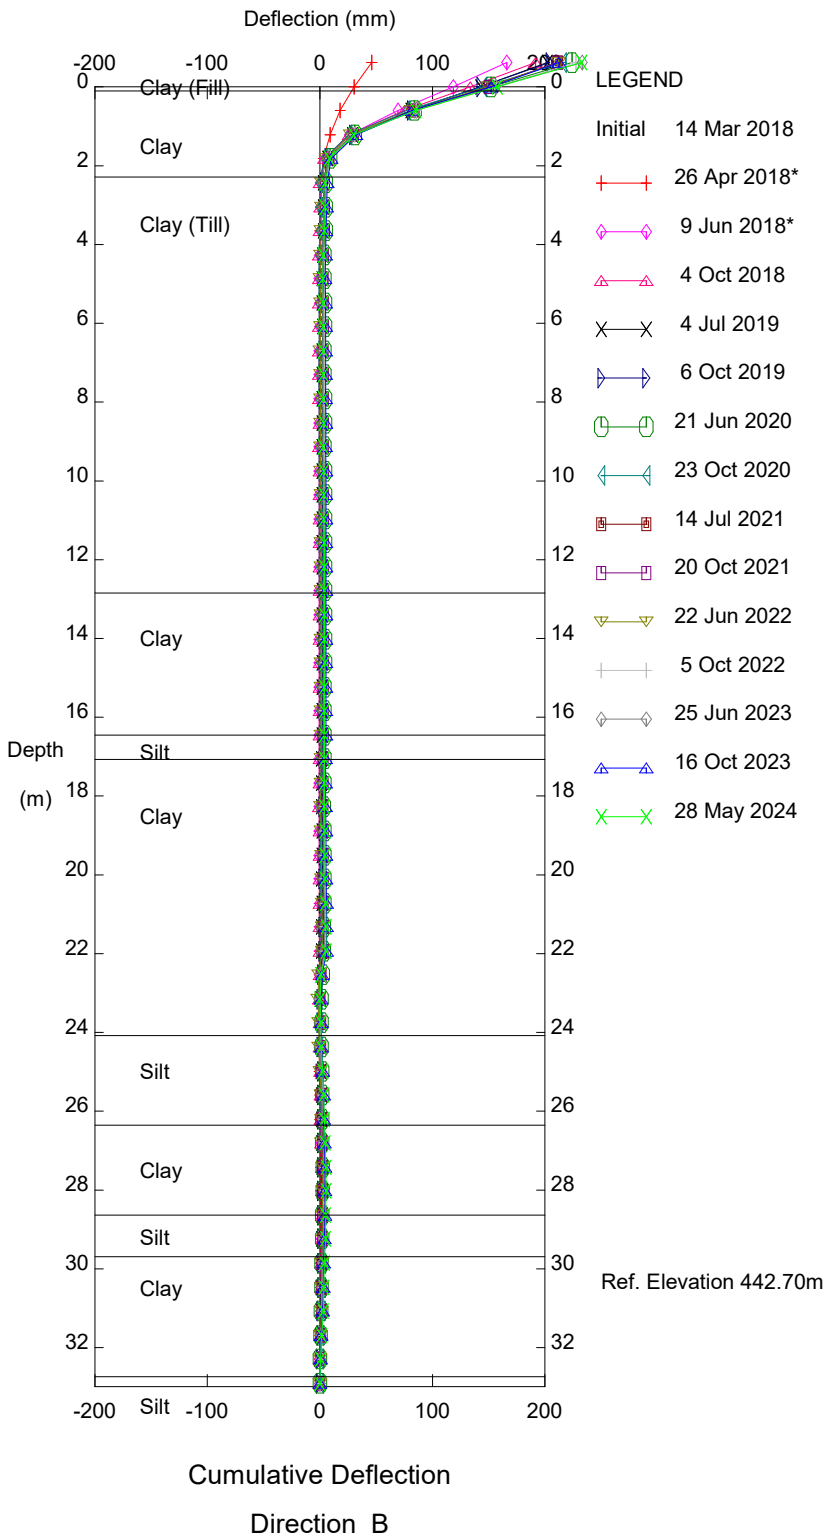
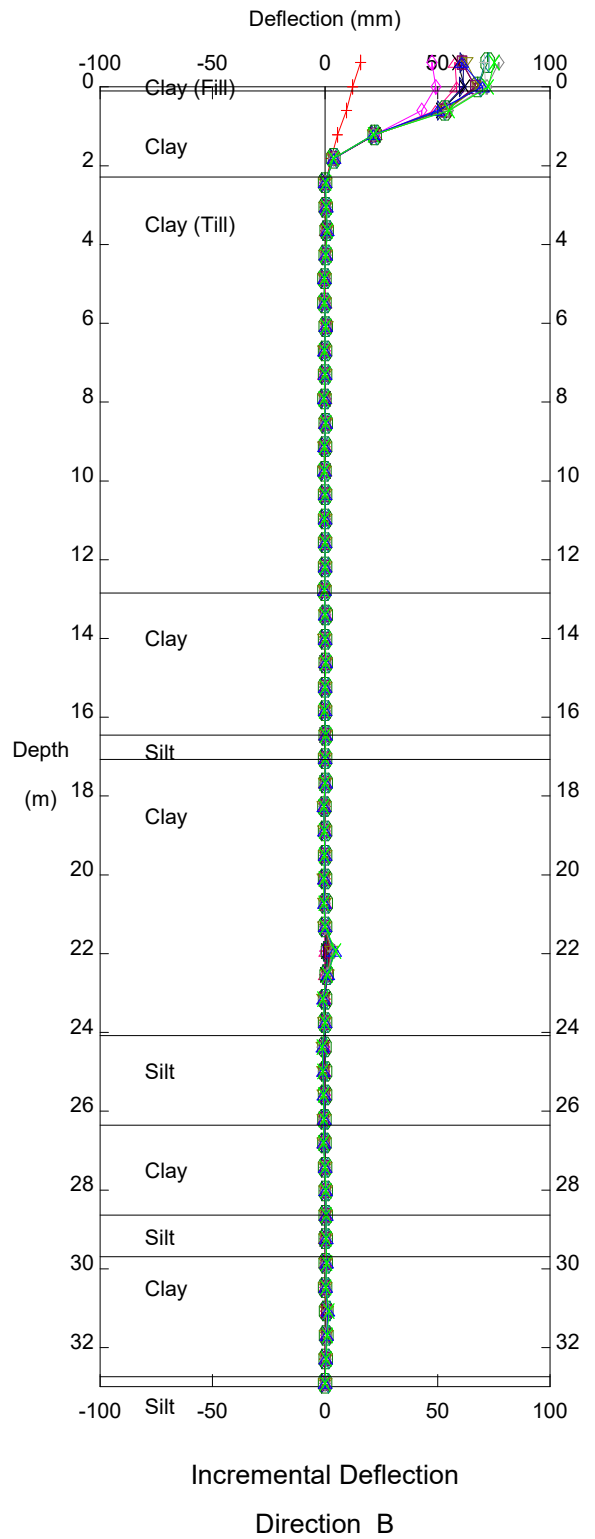
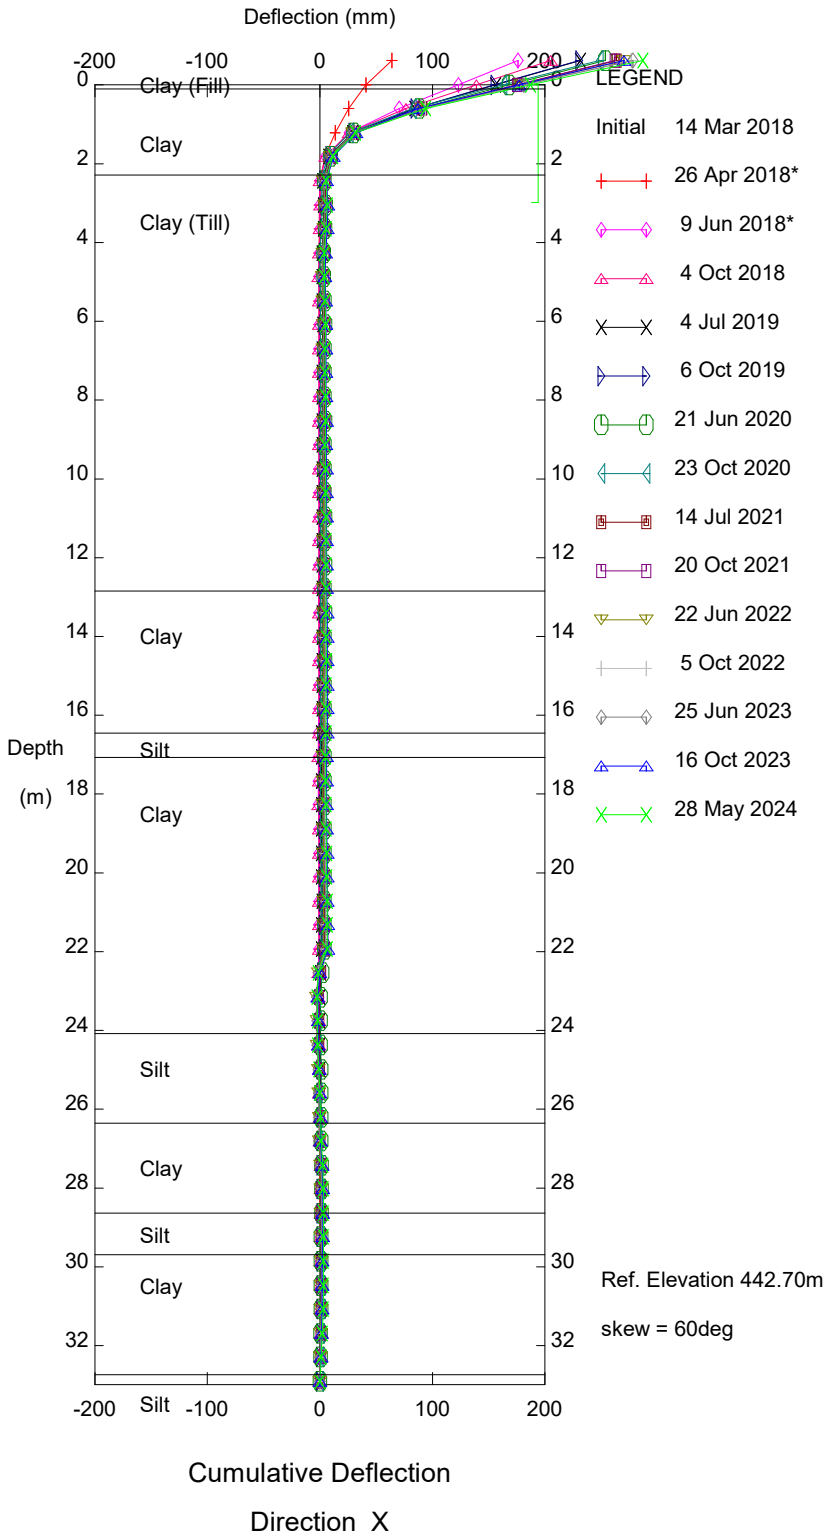
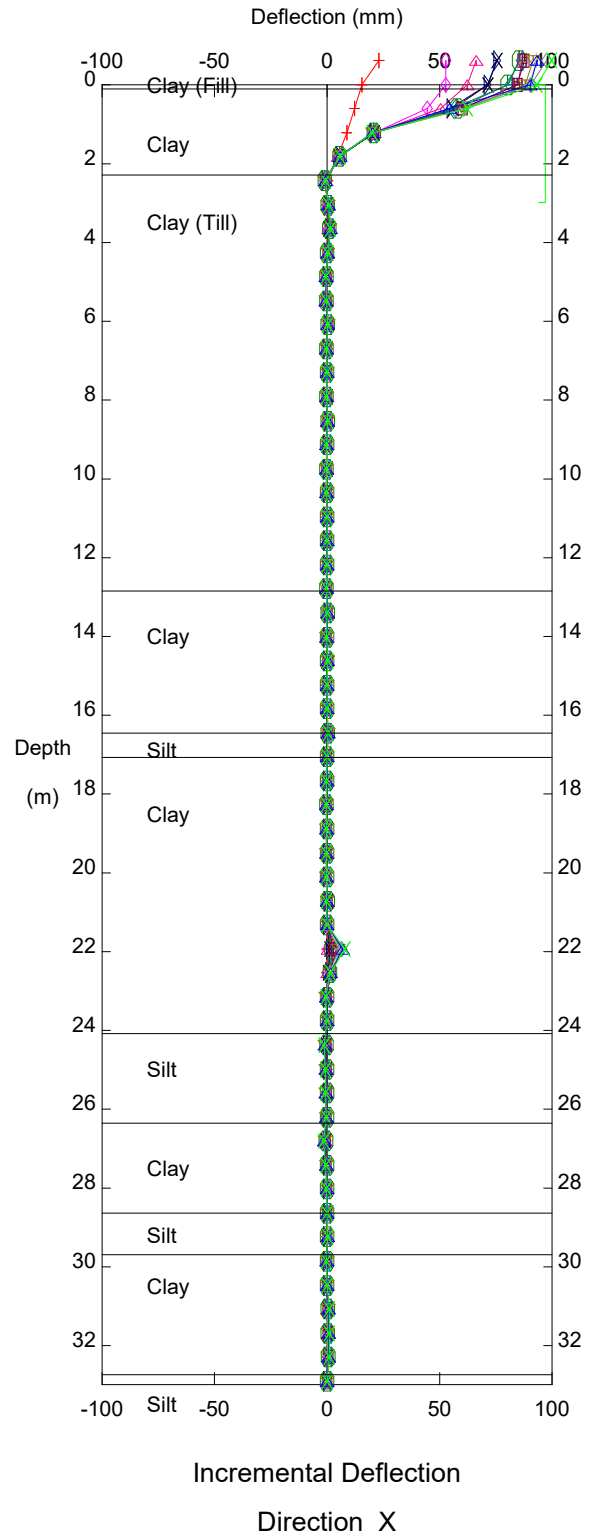
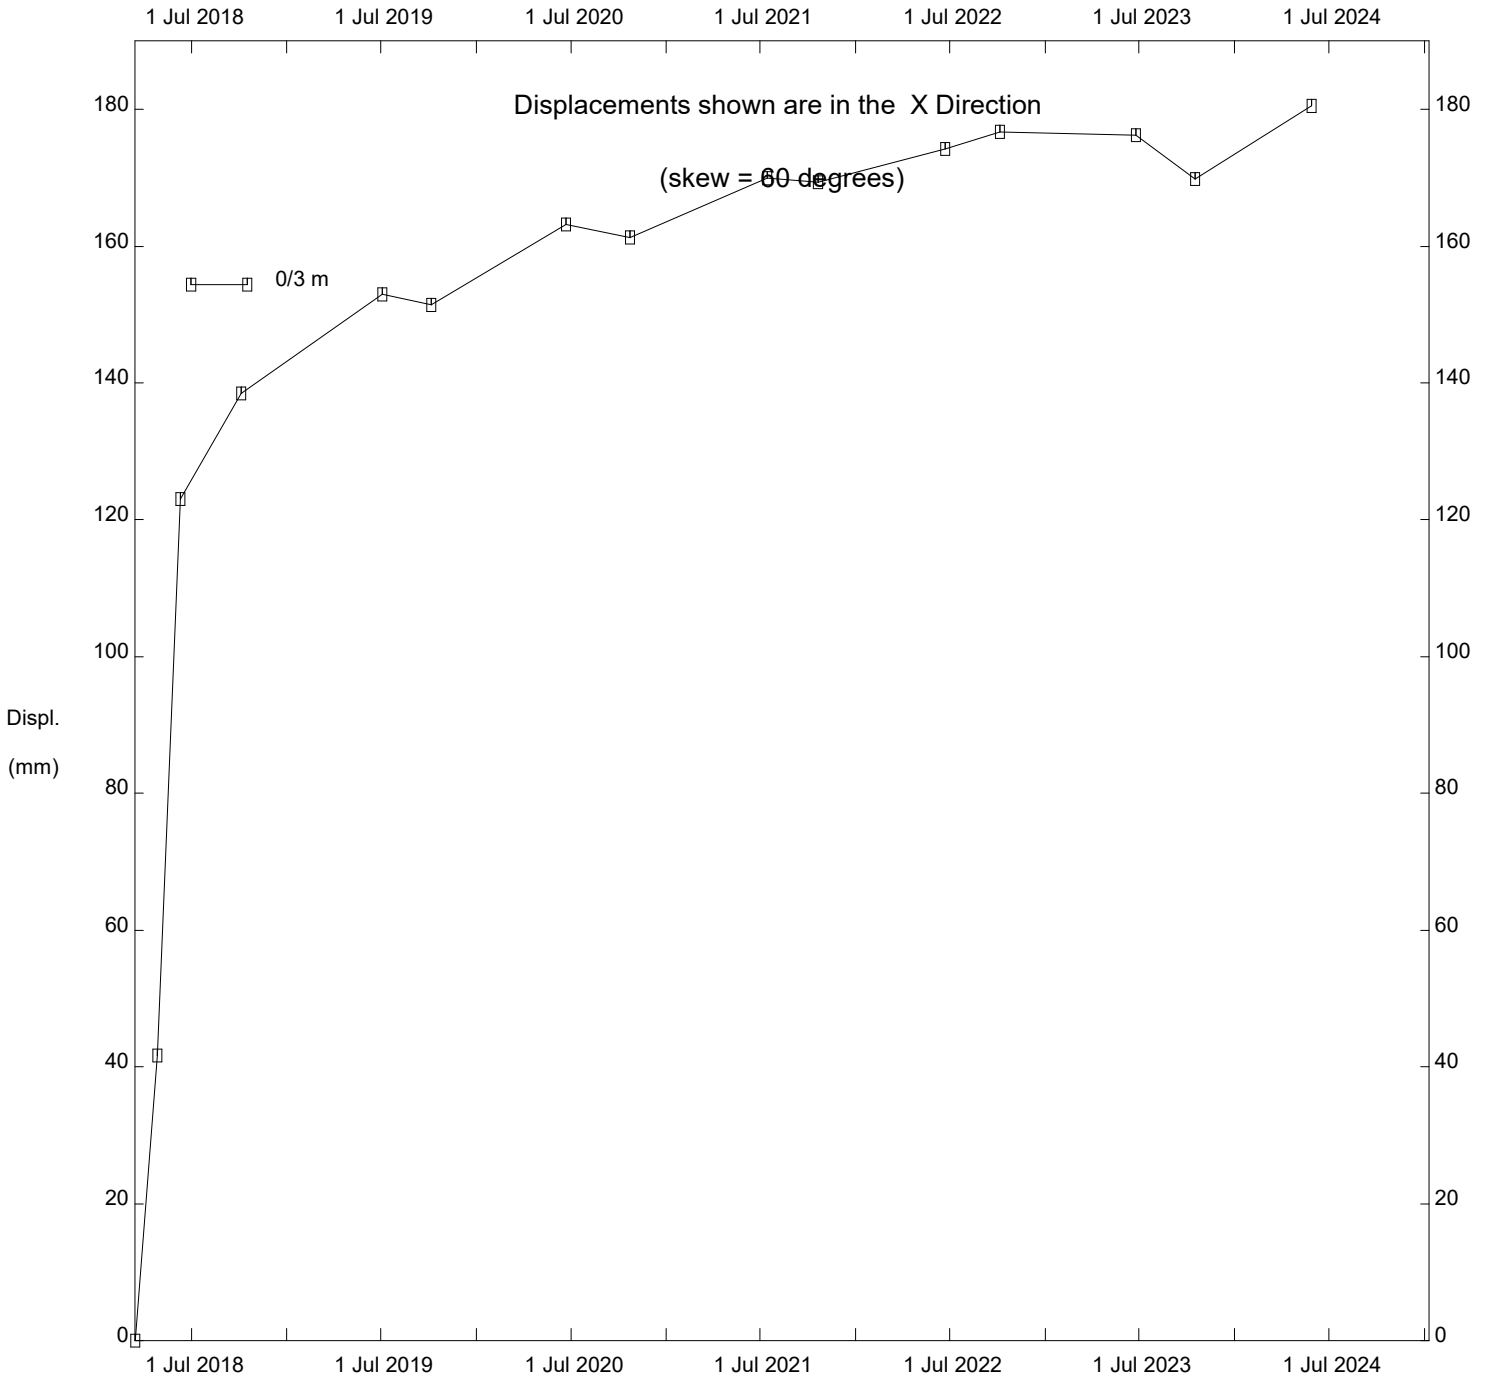
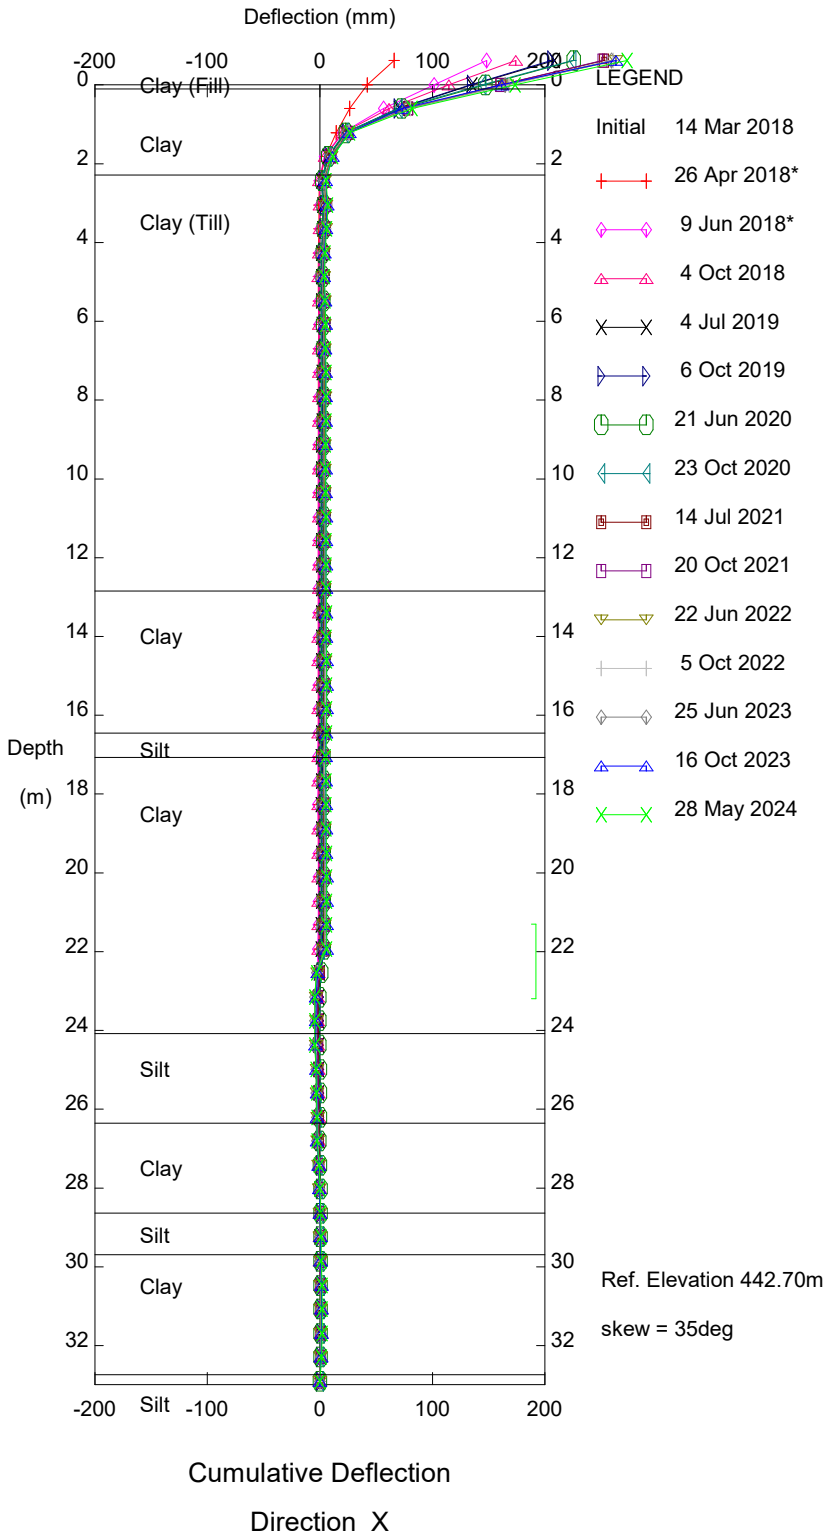
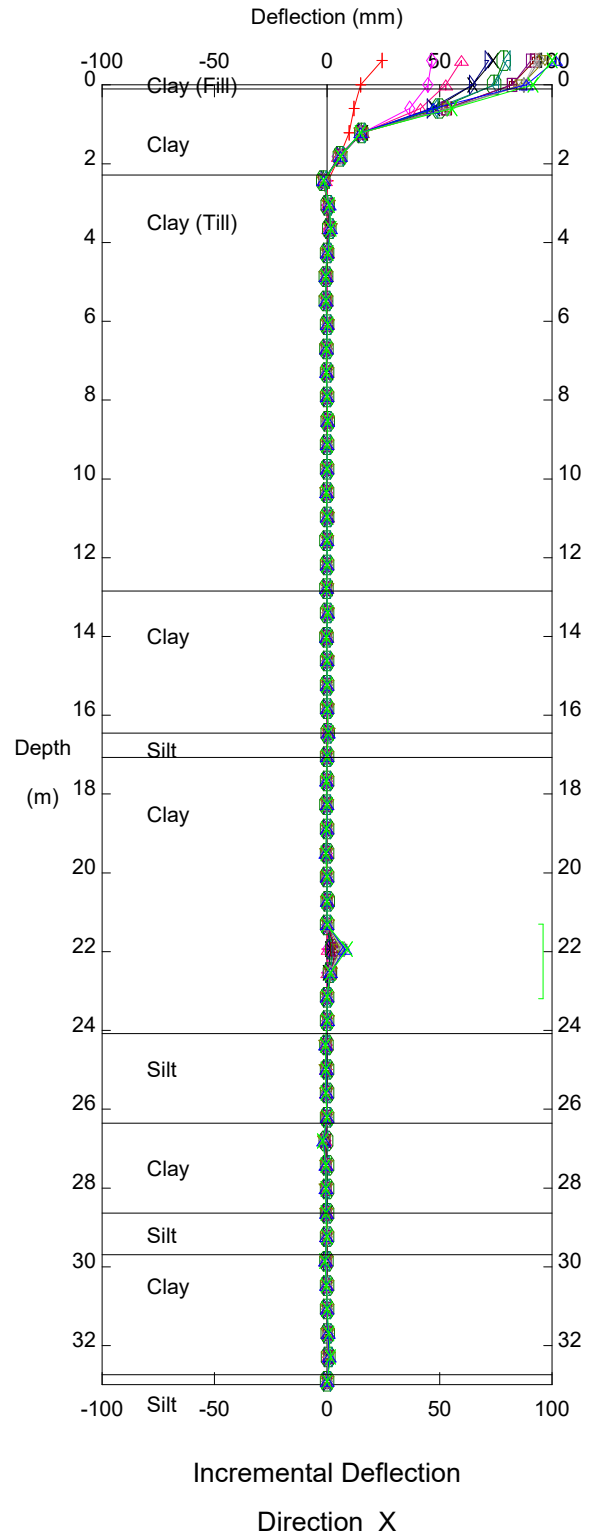
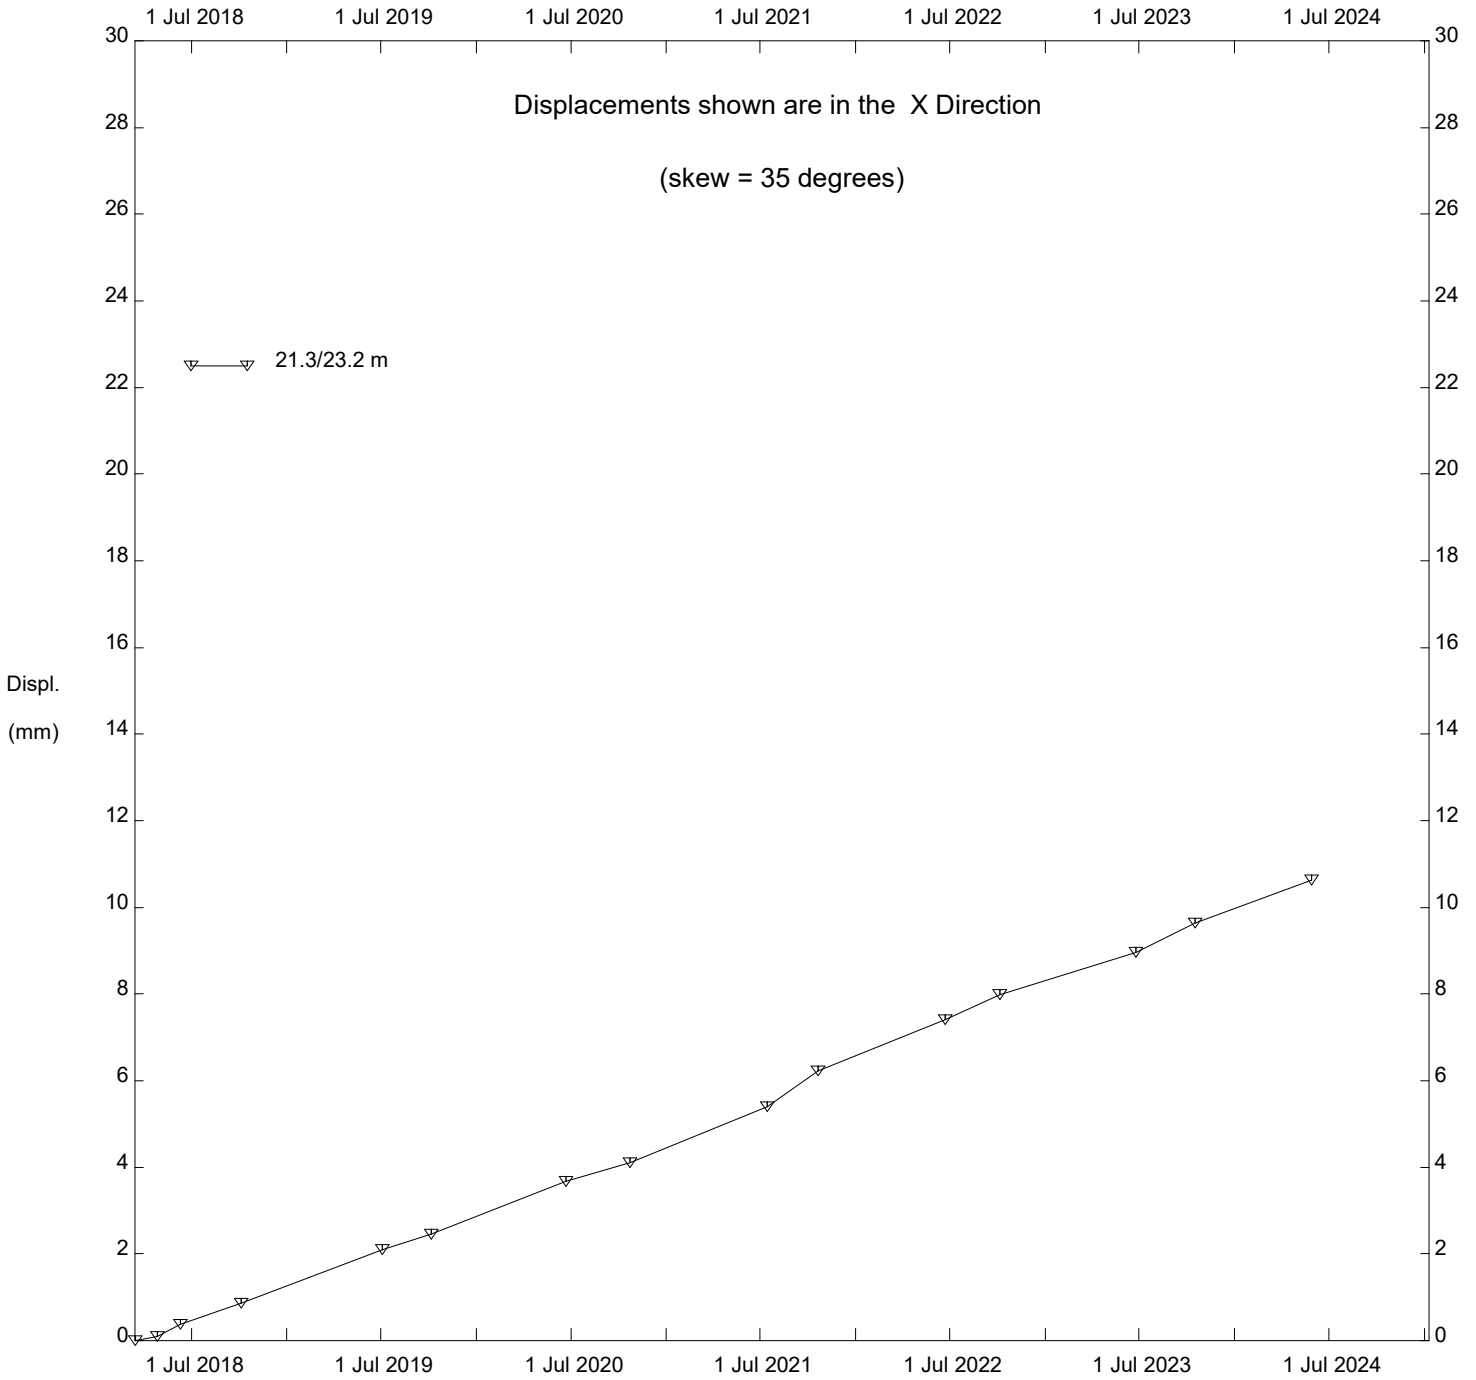
HWY 2:68 (PH037), Inclinometer SI18-10

SI18-10 is located just west of the highway and showed a rate of movement of 17.2 mm/yr over 0 m to 3.0 m depth and a rate of movement of 1.6 mm/yr over 21.3 m to 23.2 m depth. The upper shear zone is tilting while the lower zone is a slowly developing distinct shear.

SI18-10	March 14, 2018	180.5 mm over 0.0 m to 3.0 m depth in 344° direction	675.3 mm/yr in June 2018	Operational	October 16, 2023	10.6	17.2	37.7
		10.6 mm over 21.3 m to 23.2 m depth in 319° direction	3.1 mm/yr in October 2021			1.0	1.6	-0.6
SI18-11	February 21, 2018	41.4 mm over 0.1 m to 6.2 m depth in 332° direction	280.1 mm/yr in April 2018	Sheared at 2.4 m depth	April 25, 2018	N/A	N/A	N/A
