ALBERTA TRANSPORTATION AND
ECONOMIC CORRIDORS GRMP
GRANDE PRAIRIE REGION –
(GRANDE PRAIRIE NORTH)
INSTRUMENTATION MONITORING - SPRING 2024

Site Number	Location	Name	Hwy	km
PH037	Station 1+250 to 2+000	Dunvegan South	2:68	Km 15.7
Legal Description: 4-7-80-4 W6		UTM Co-ordinates		
		11U E 398593.62	N	6197597.09

Current Monitoring:	28-May-2024	Previous Monitoring	16-Oct-2023
Instruments Read By:	Mr. Niraj Regmi, G.I.T and Mr. Nixon Mationg, of Thurber

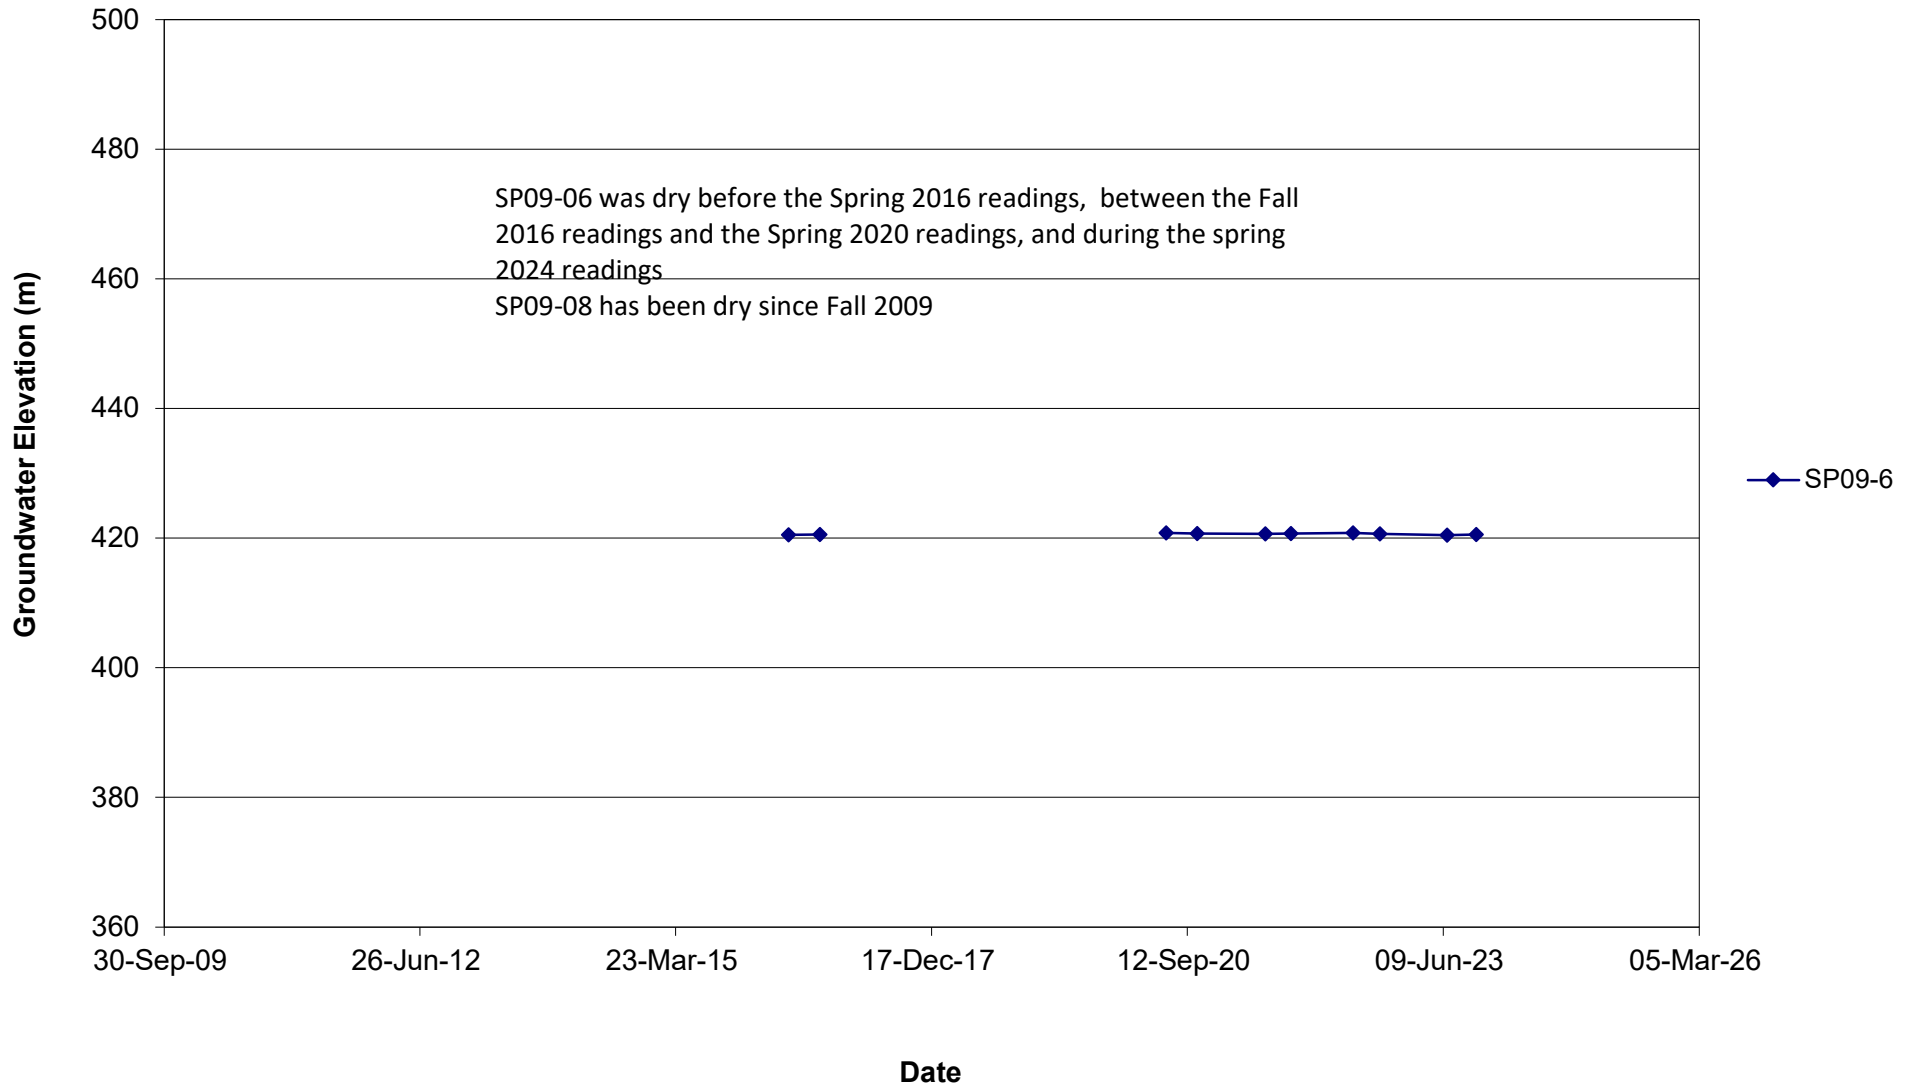
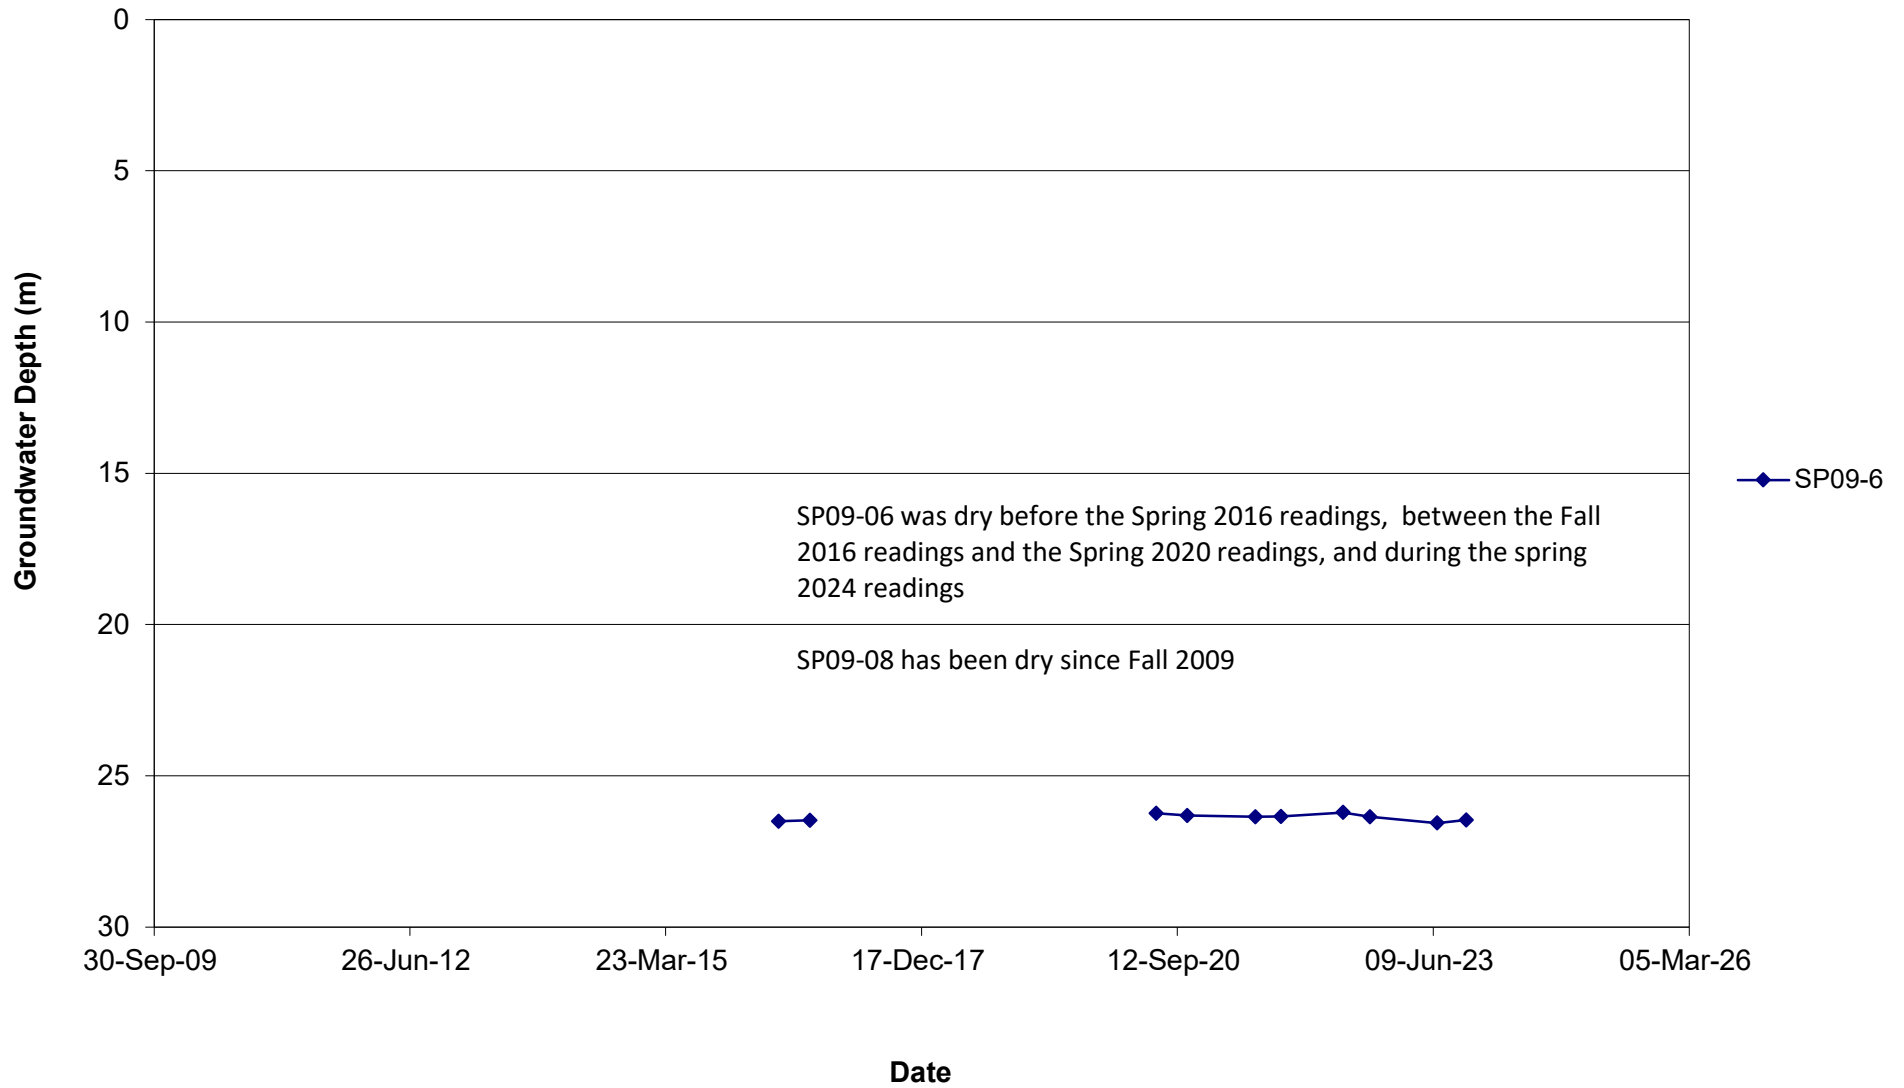
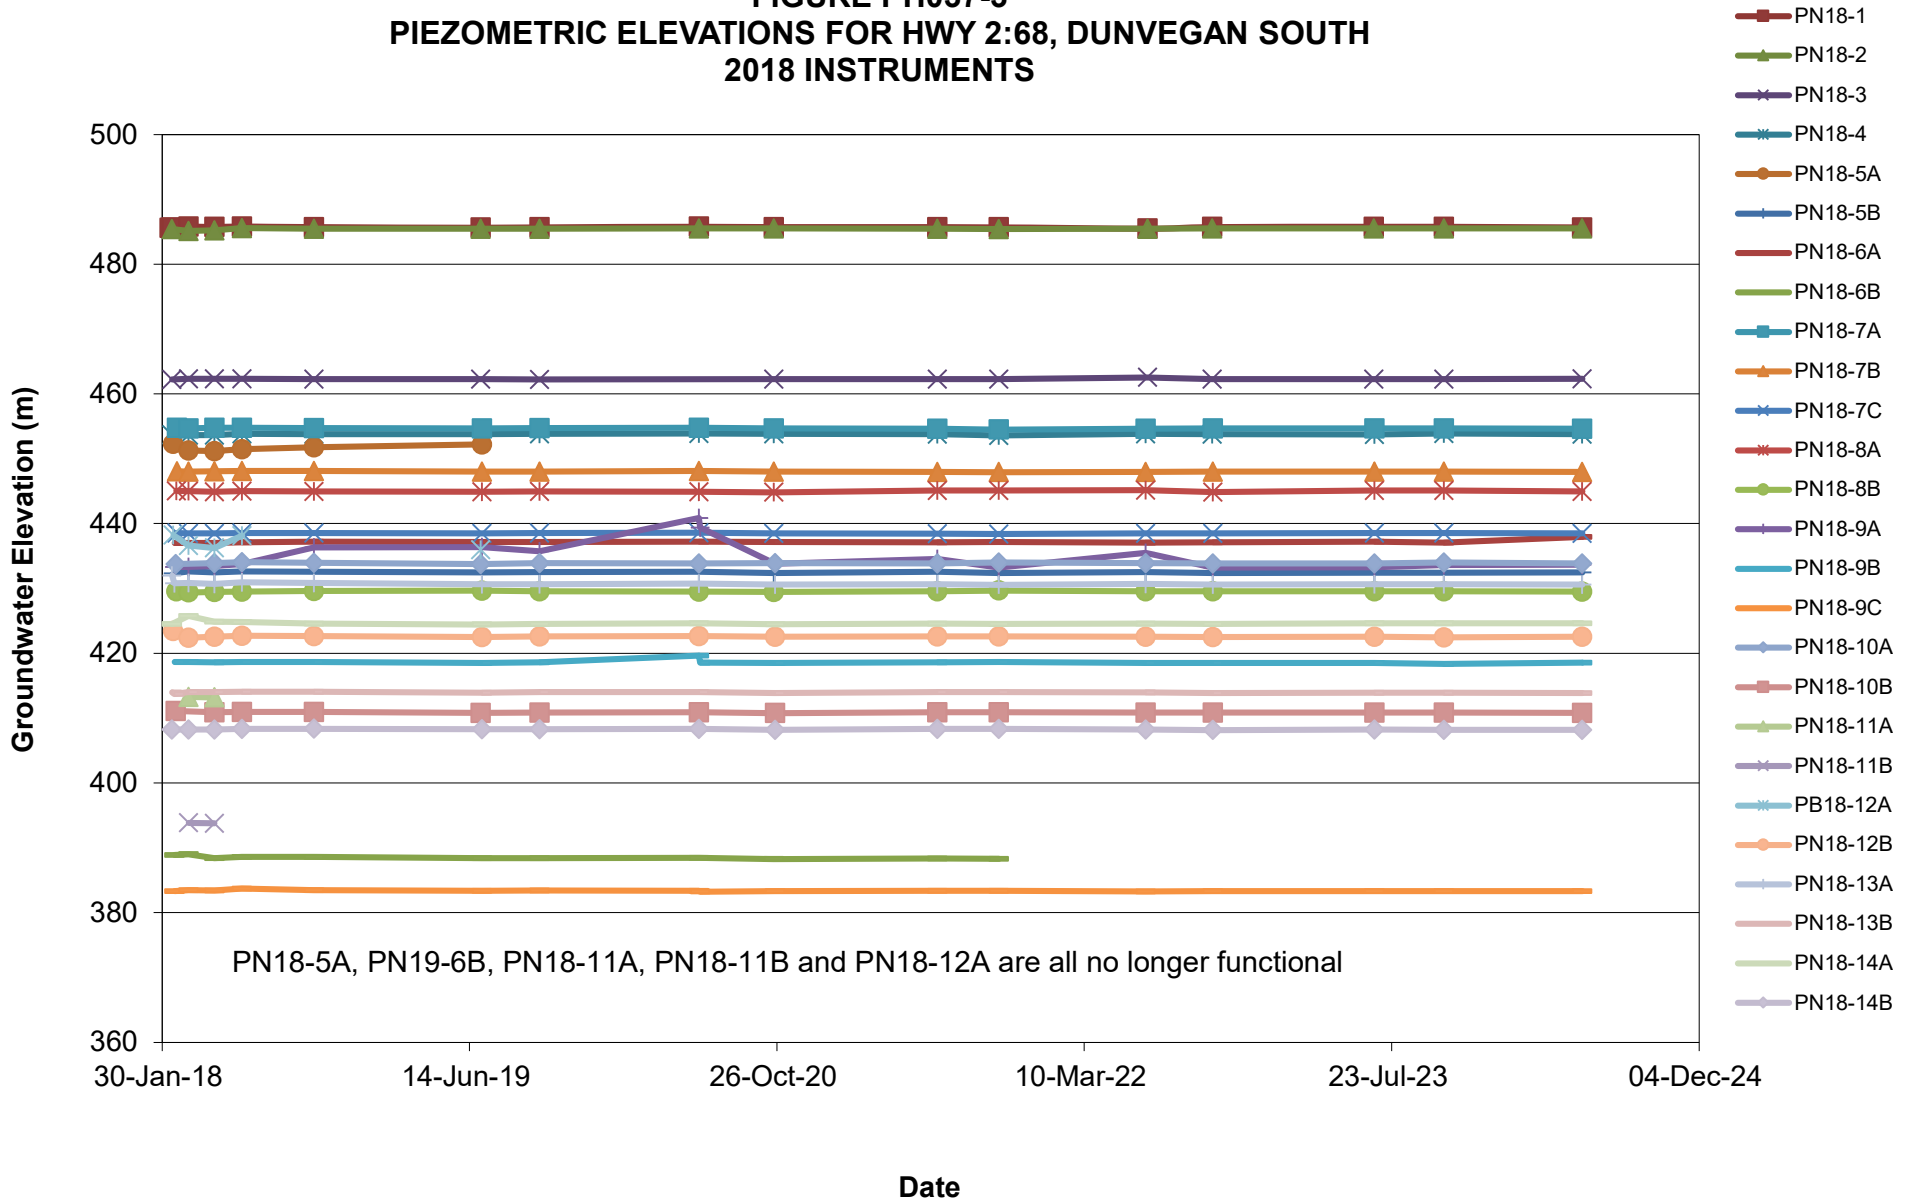
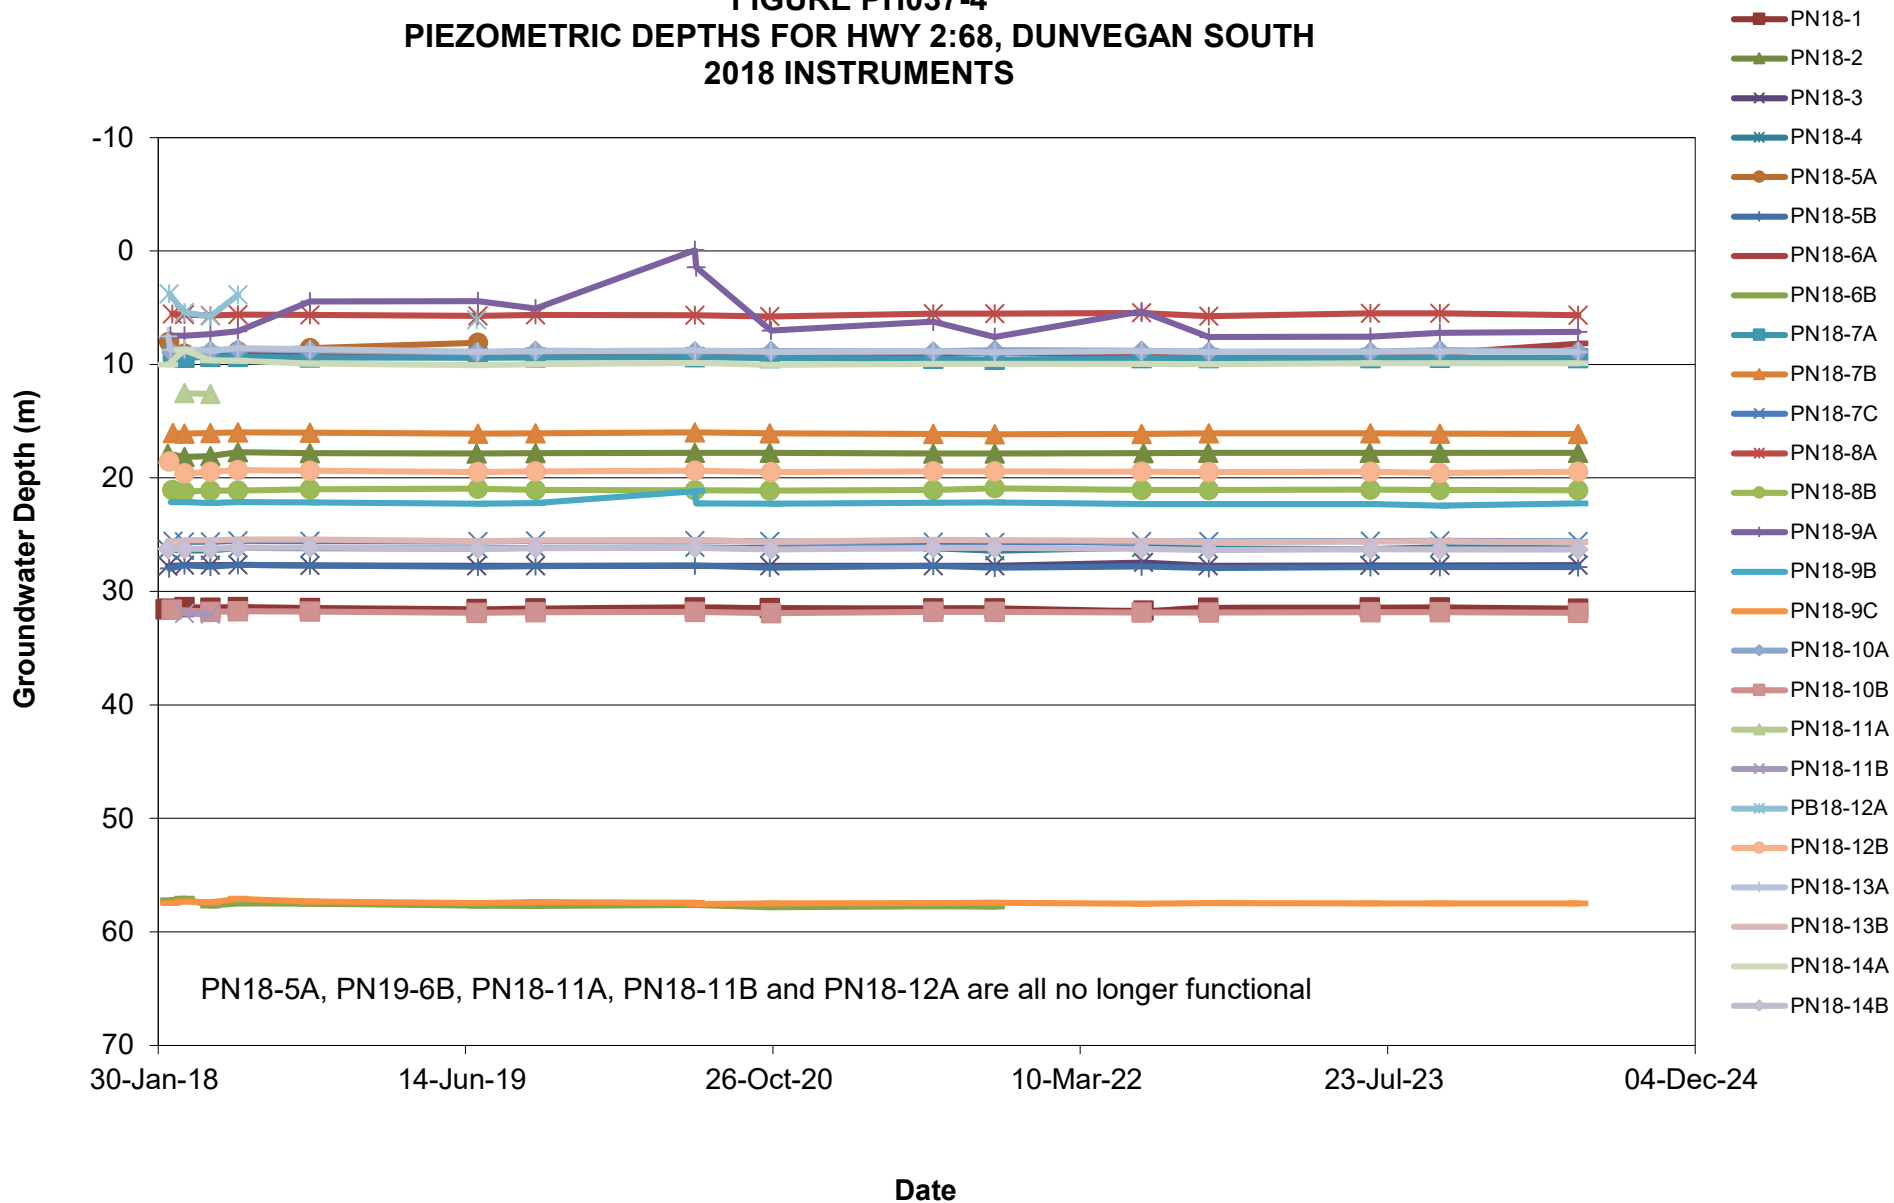
<p>Standpipe piezometer SP09-6 was dry during the spring of 2024 readings. SP09 8 continued to be dry.</p> <p>Most of the pneumatic piezometers except for PN18-6A generally showed relatively small changes in groundwater level compared to the fall of 2023, ranging from a decrease of 0.18 m in PN18-8A to an increase of 0.19 m in PN18-9B. PN18-6A showed a groundwater elevation of 437.95 m, the highest measured in the instrument and corresponding to an increase in water level 0.87 m since the fall of 2023 readings.</p>
Future Work:	The instruments should be read again in the fall of 2024.
Instrumentation Repairs:	No instrument repairs are required at this time.
Additional Comments:
