**GEOHAZARD ASSESSMENT PROGRAM
PEACE REGION – PEACE-HIGH LEVEL
CALL-OUT INSPECTION (MAY 12, 2015)**

Site Number	Location	Name	Hwy	km
PH52	Dunvegan	Dunvegan North 10+800	2:68	10.80
Legal Description		UTM Co-ordinates		
SE¼ 16-080-04 W6M		11U E 402466	N 6199552

PH52 CALLOUT INSPECTION PLAN
 MAY 12, 2015

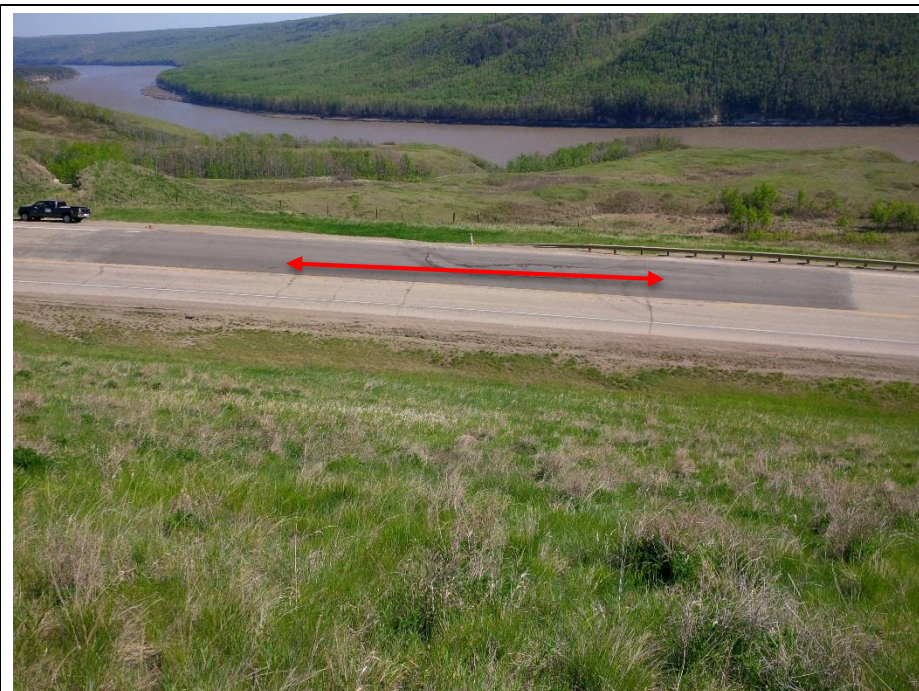
Photo 1.
Looking south across the highway from the SBL backslope. Cracks in the pavement surface and along the edge of the guardrail are visible along a 28 m length.

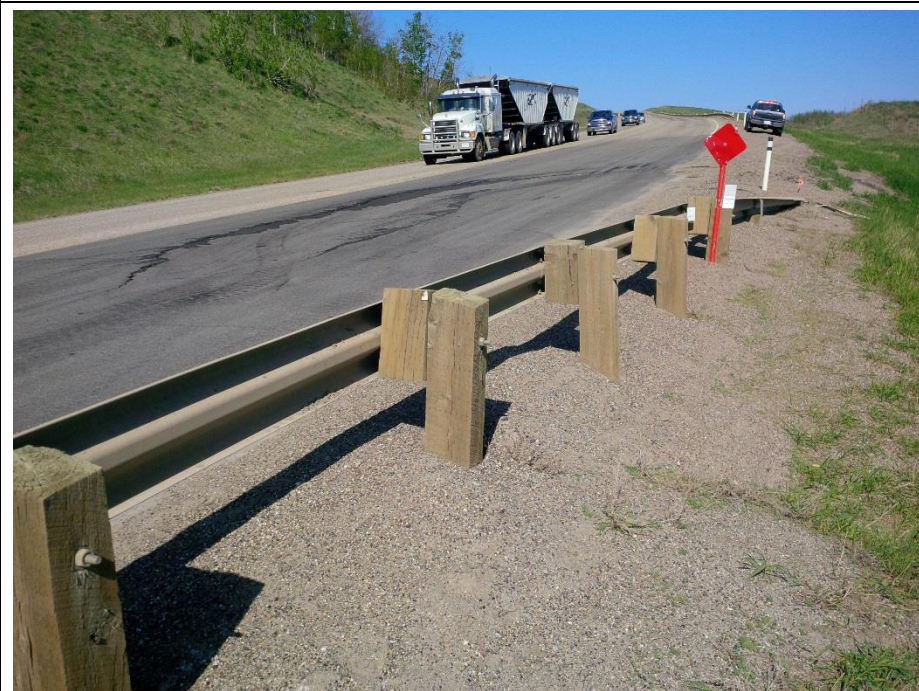
Photo 2.
Looking NE from the NBL guardrail. The drop of the graben within the landslide is at about 50 mm with cracks open to about 50 mm in width.

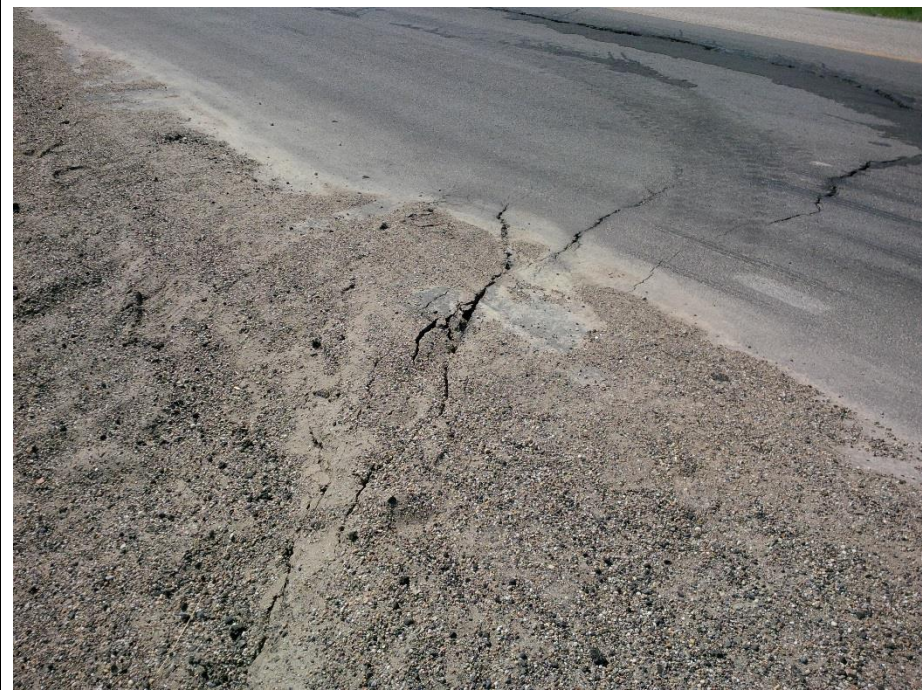
Photo 3.
Looking northwest at cracks from backscarp extending though the highway embankment shoulder. Cracks at the shoulder are open to about 40 mm in width.

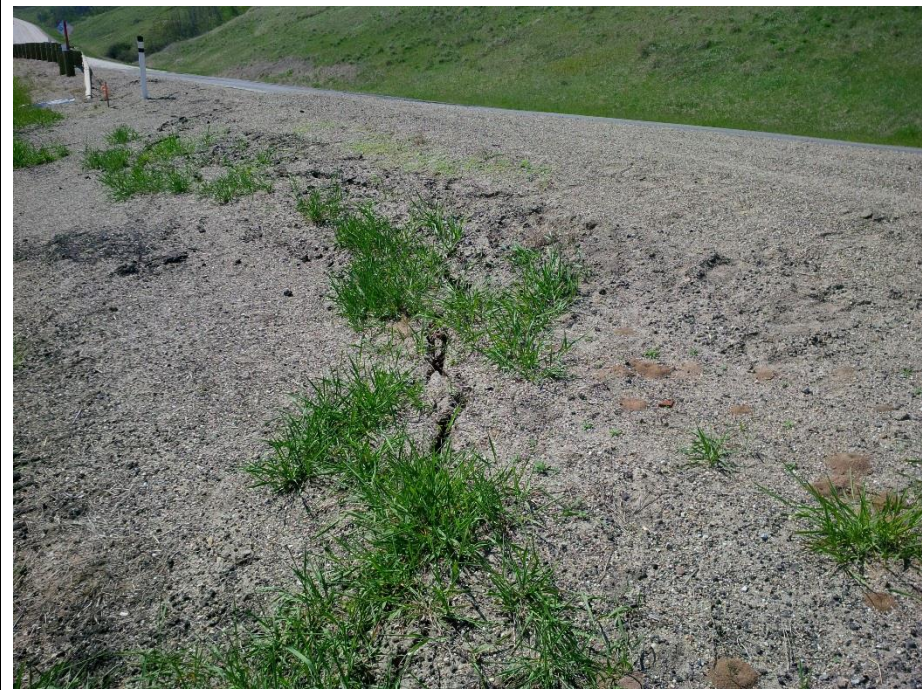
Photo 4.
Looking west from the NBL shoulder. Cracking in the embankment shoulder extends 10 m to the east of the dip in the asphalt. Cracks in embankment shoulder extend about 8 m northeast past the edge of the paved shoulder in the sideslope with offset drops up to 150 mm and are open to about 75 mm.

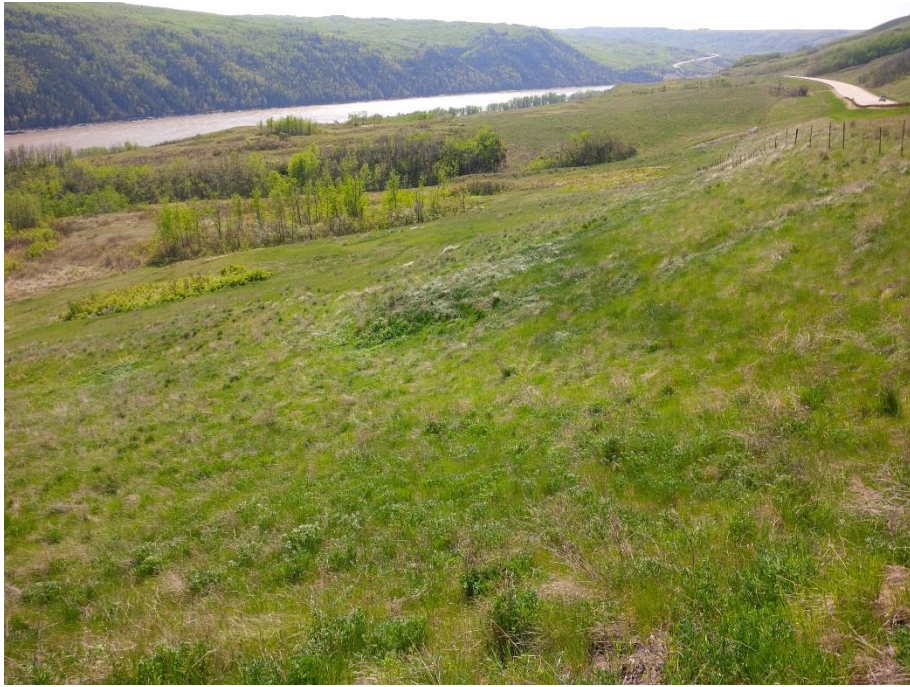
Photo 5.
Looking south-westwards at the highway sideslope. Two lobe-shaped features were noted below highway with greener vegetation growing along the lower perimeter. This is likely a sign of water seepage. Ripples with tension cracks are visible in the surface at the base of the lobes and clay is exposed though the grass.

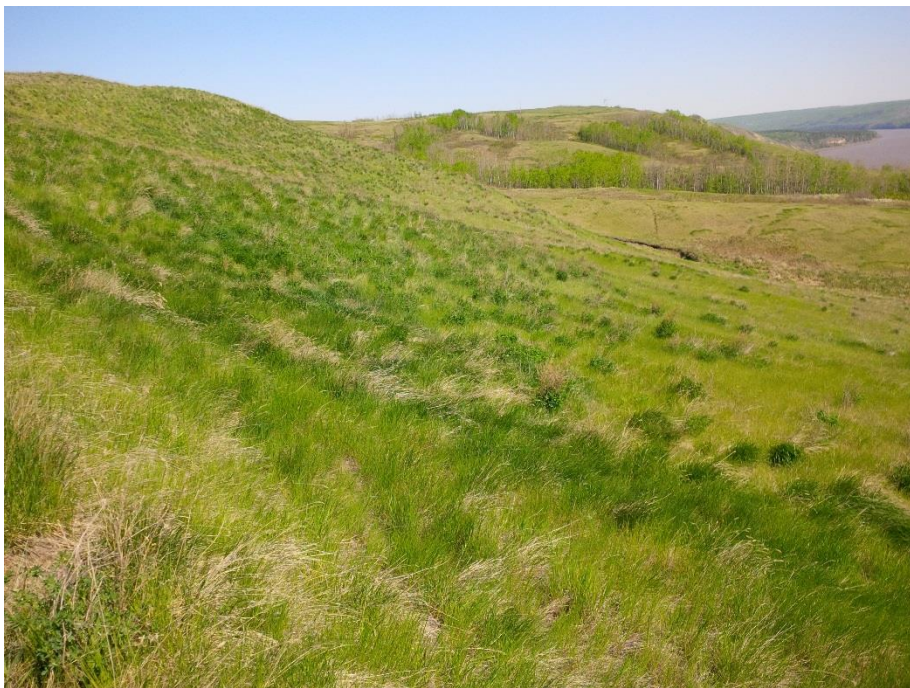
Photo 6.
Looking east across the toe bulge feature along the NBL sideslope. Tension cracks with exposed clay are predominant in the lower half of the bulge.

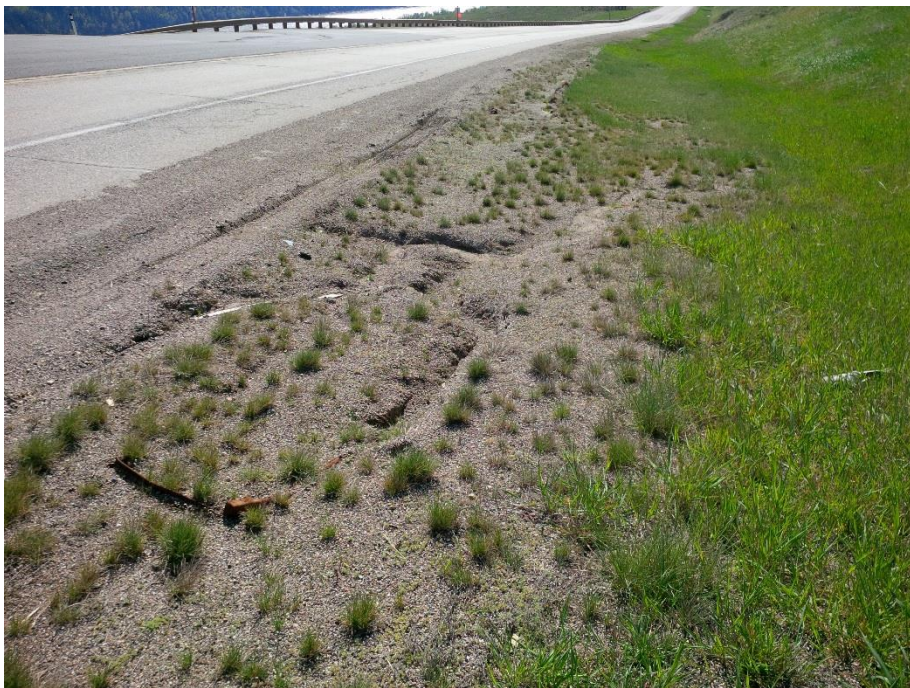
Photo 8.
Looking southwest along the SBL lane ditch. Sediment is accumulated along the shoulder downslope of the ditch block at the culvert inlet. Highway embankment material is rilled, moist and soft.

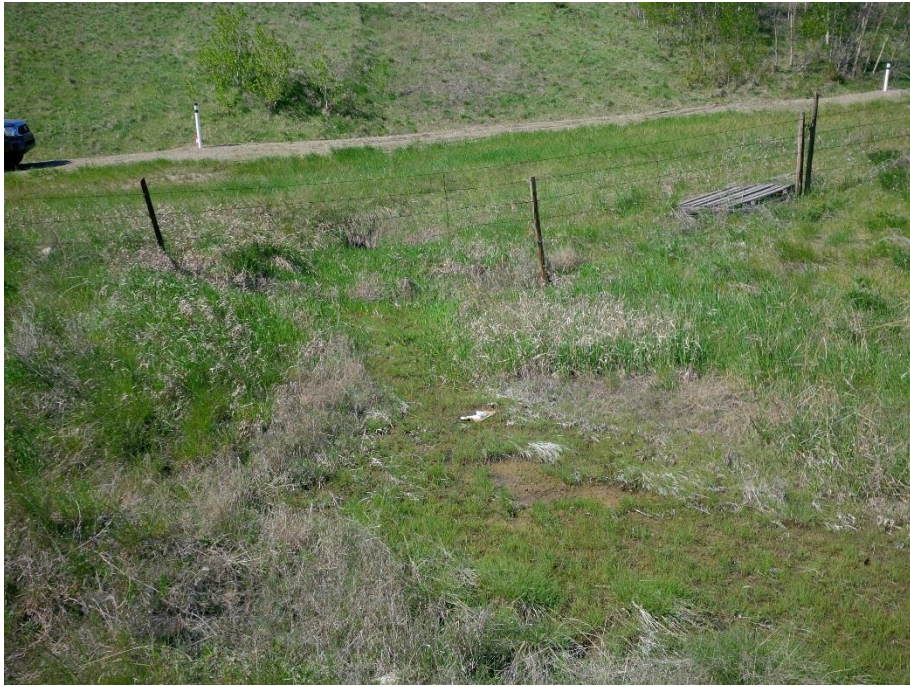
Photo 9.
Looking north at the outlet of the existing centerline culvert. The outlet is partially obstructed.

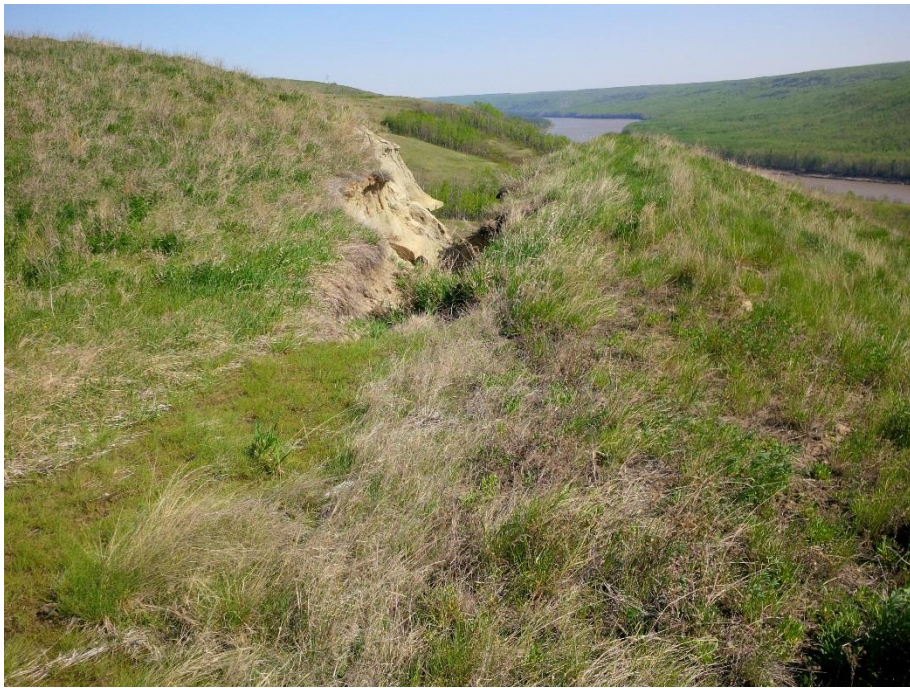
<input checked="" type="checkbox"/> Erosion	Although the head of the eroded gully has not retrogressed significantly since 2009 (Photo 10), erosion within the gully has progressively worsened.	<input checked="" type="checkbox"/>
<input checked="" type="checkbox"/> Seepage	Seepage at the toe of the fill is likely occurring as noted by greener grass growth along the perimeter of the toe bulge below the highway (Photo 5 and 6).	<input checked="" type="checkbox"/>
<input checked="" type="checkbox"/> Bridge/Culvert Distress	The existing centerline culvert inlet and outlet are partially clogged (Photos 7 and 9). Sediment along the northbound lane pavement might be by-passing the clogged culvert inlet.	<input checked="" type="checkbox"/>
<input type="checkbox"/> Other		<input type="checkbox"/>

Photo 10.
There is ongoing erosion in the gully downstream, with steep gully sidewalls in the bedrock. The backscarp of the gully has not retrogressed since 2014.
