**GEOHAZARD ASSESSMENT PROGRAM
PEACE REGION – PEACE-HIGH LEVEL
CALL-OUT INSPECTION (MAY 22, 2015)**

Site Number	Location	Name	Hwy	km
PH52	Dunvegan	Dunvegan North 10+800	2:68	10.80
Legal Description		UTM Co-ordinates		
SE¼ 16-080-04 W6M		11U E 402466	N 6199552

**PEACE REGION (PEACE RIVER/HIGH LEVEL)
PH52 DUNVEGAN NORTH - HIGHWAY 2:68**

**2015 PH52 CALL - OUT INSPECTION PLAN
MAY 22, 2015**

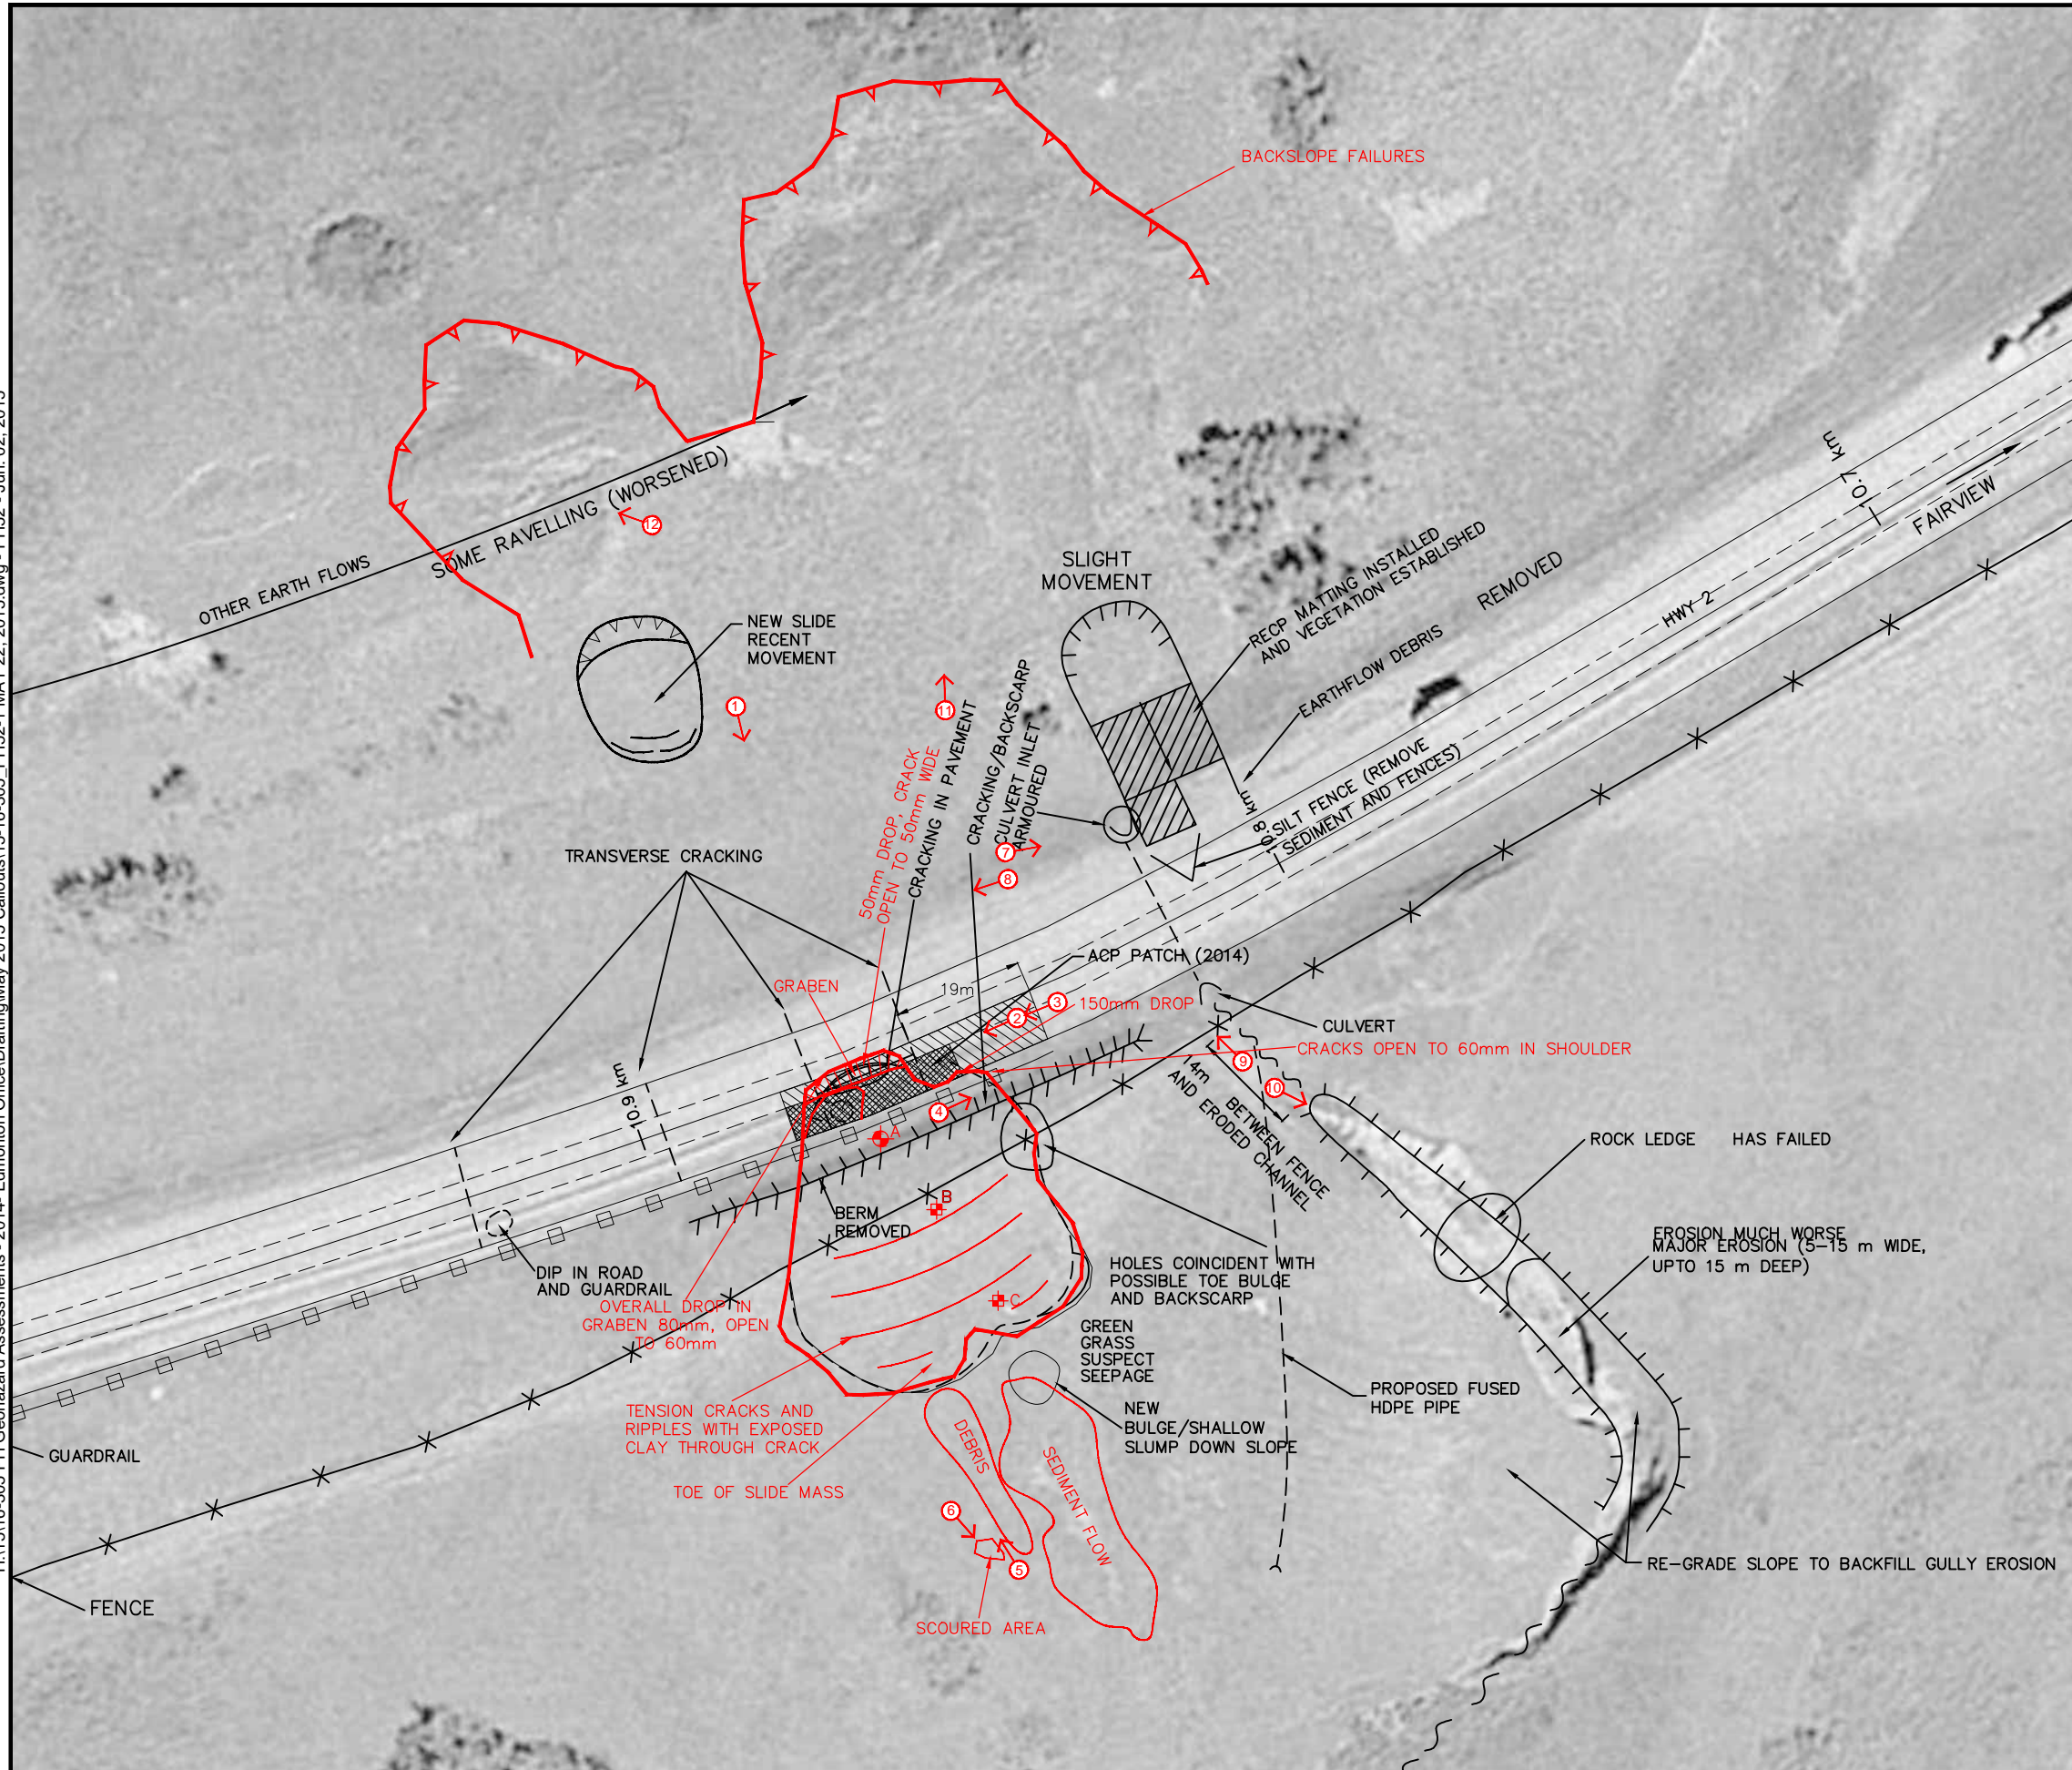
FIGURE 1

Primary Site Issue:	On May 21, 2015, Alberta Transportation was alerted that the dip in the pavement had dropped suddenly in the NBL lanes of Hwy 2.		
Dimensions:	Arcuate cracking defines a slide that is approximately 22 m to 28 m wide at the road shoulder (Photos 1 to 4).		
Maintenance:			
Observations:	Description	Worsened?	
<input checked="" type="checkbox"/> Pavement Distress	Cracks have up to 80 mm drops with openings as wide as 60 mm. as a result TRANS has closed the outer NBL and implemented a localised traffic speed reduction to 50 km/hr through the affected area.	<input checked="" type="checkbox"/>	
<input checked="" type="checkbox"/> Slope Movement	The main landslide feature affecting the roadway is active and a drop in the backscarp of 30 mm has occurred since May 12, 2015. Slide above the highway were also noted in the backslope (Photos 11 and 12).	<input checked="" type="checkbox"/>

Recommendations:	Cost
A geotechnical investigation is required to assess the mechanism of failure and to design repair measures for this slide. Proposed test hole and test pit locations with selected instruments are shown on Figure 1.	\$ 60,000
Due to the recent activity at the site, it is recommended that the geotechnical investigation be implemented as soon as possible.	
Potential long-term repair solutions include excavation to bedrock and replacement of fill with granular material and subdrains, similar to the repairs at PH1N, or installation of a pile wall. Failure depth will need to be established from the geotechnical investigation and instrument readings over a period of time. Drainage could be directed through a welded HDPE down-drain extending to the valley floor, and the gully backfilled.	\$1,000,000 to \$2,000,000
The existing centerline culvert that crosses the highway immediately upslope of the landslide should be grouted and surface water should be directed along the existing southbound lane ditch the exiting bridge culvert further downslope to the southwest if the downstream culvert and ditch can accommodate the extra flow. Alternatively, the culvert should be flushed out and the erosion gully repaired. The cost of repairing and armouring could be in the order of \$500,000.

Investigation work should be completed as soon as possible to ensure a reliable depth to the failure surface can be determined.

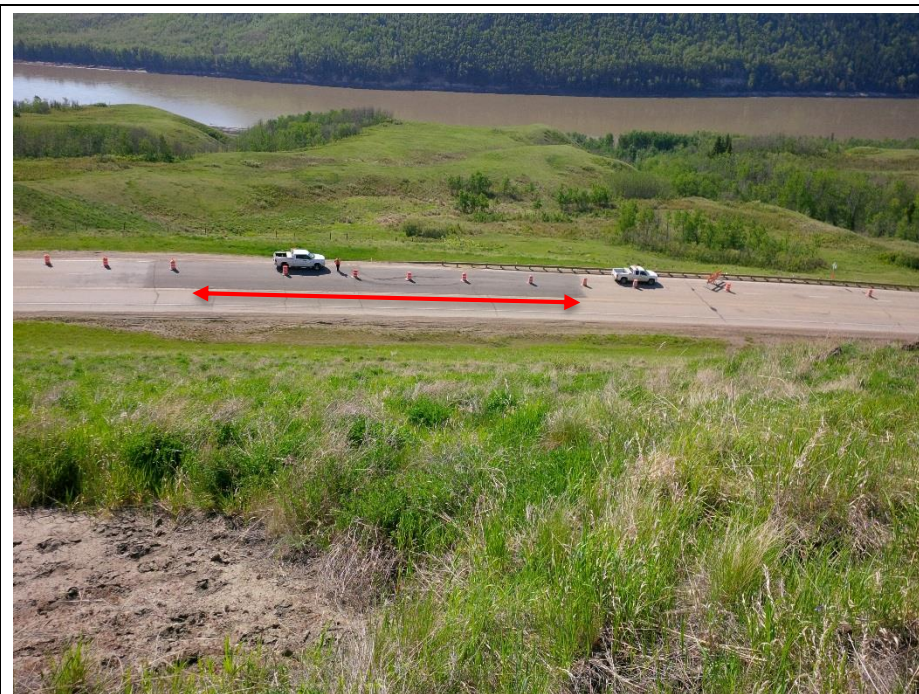
Recent accelerated landslide movement warrant that the affected northbound lane be closed to traffic.

Photo 1.
Looking south across the highway from the SBL backslope. Cracks in the pavement surface and along the edge of the guardrail are visible along a 28 m length. TRANS has closed the outer NBL lane due to the drop in the graben.

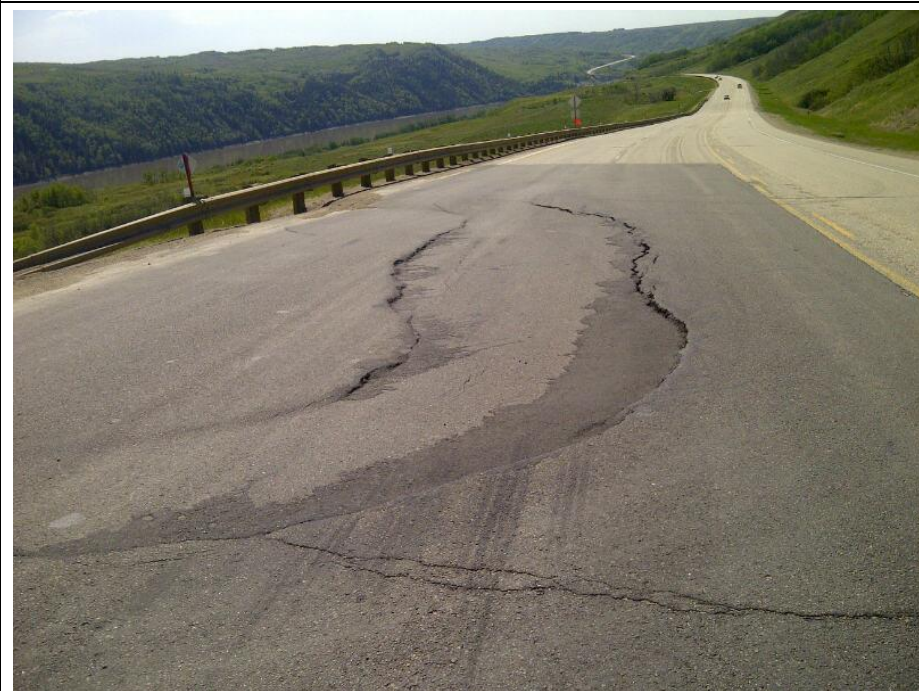
Photo 2.
Looking SW from the NBL. The drop of the graben is at about 80 mm with cracks open to about 60 mm in width.

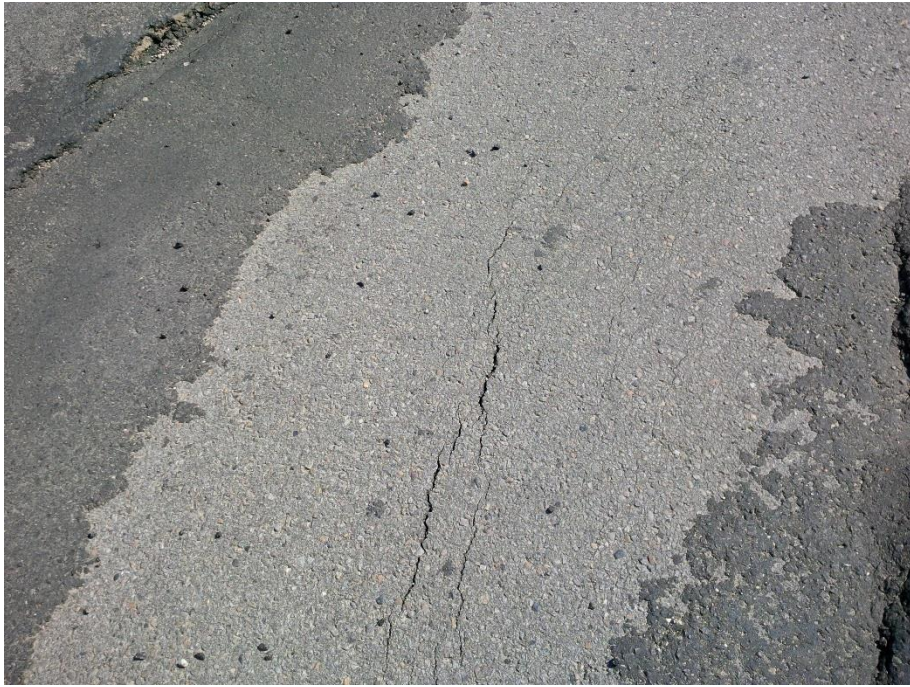
Photo 3.
Hairline tension cracks have appeared within the asphalt pavement within the graben.

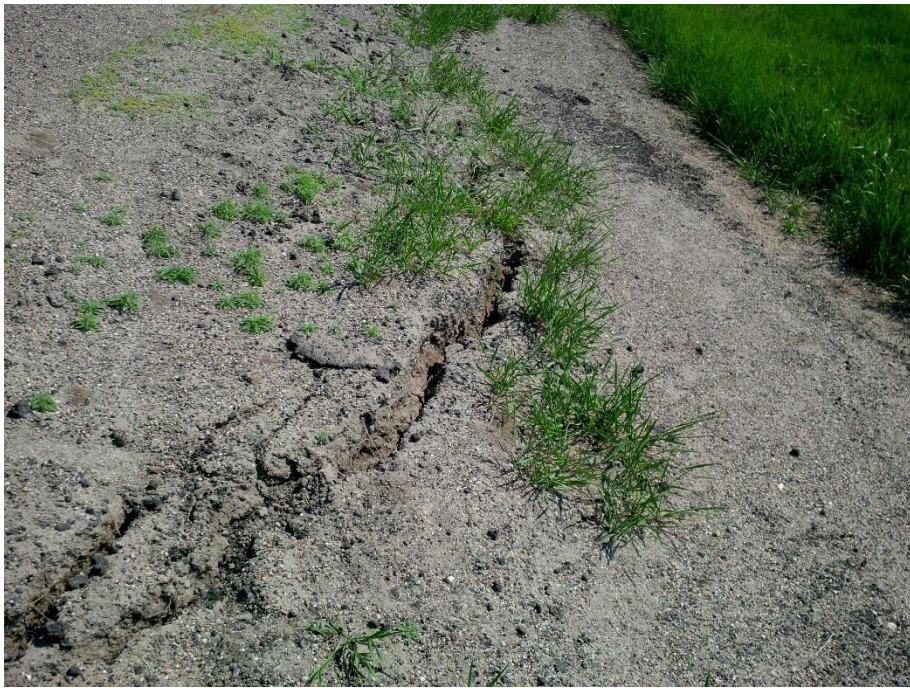
Photo 4.
Looking northeast at cracks from backscarp extending through the highway embankment shoulder. Cracks at the shoulder are open to about 60 mm in width.

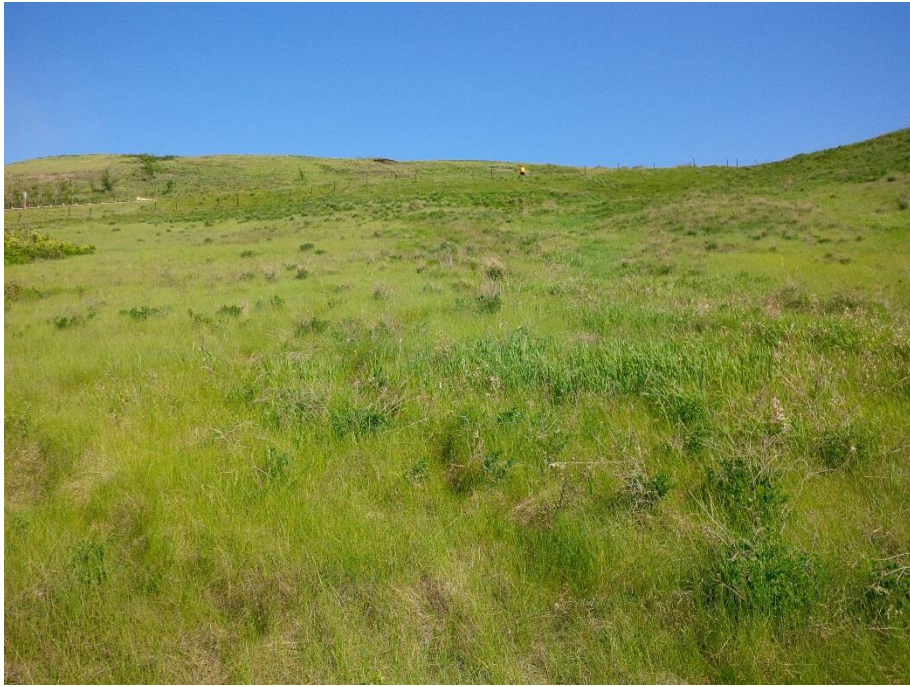
Photo 5.
Looking north at the highway sideslope. Two lobe-shaped features were noted below highway with greener vegetation growing along the lower perimeter. This is likely a sign of water seepage. Ripples with tension cracks are visible in the surface at the base of the lobes and clay is exposed though the grass. No significant change since May 12, 2015.

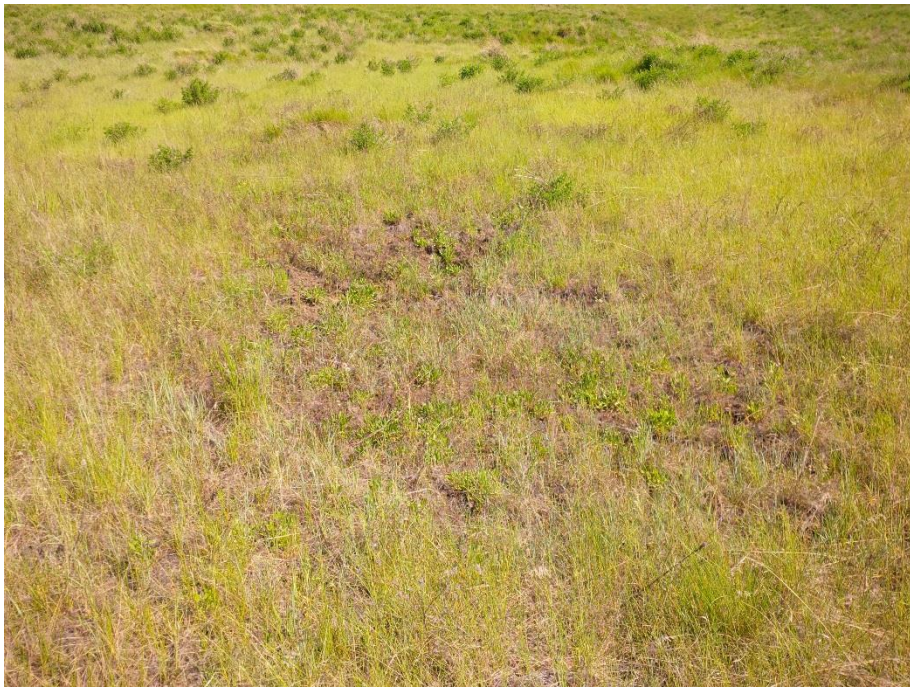
<input checked="" type="checkbox"/> Erosion	Runoff from both the roadway ditch and the scoured channel below the centerline culvert appears to be causing sediment to accumulate about 80 m downslope below the roadway (Photo 6).	<input checked="" type="checkbox"/>	
<input checked="" type="checkbox"/> Seepage	No significant change since May 12, 2015.	<input type="checkbox"/>	
<input checked="" type="checkbox"/> Bridge/Culvert Distress	No significant change since May 12, 2015 (Photos 8 and 9).	<input type="checkbox"/>	
<input type="checkbox"/> Other		<input type="checkbox"/>	
Instrumentation:	There are no instruments installed at this site.		
Assessment:	Landslide cracking in the road continues and the toe bulge is slightly more apparent in the slope below the highway. This failure appears similar to the two other Dunvegan North (PH1N) failures to the west

Photo 6.
Eroded area with exposed clay about 80 m downslope of the highway.

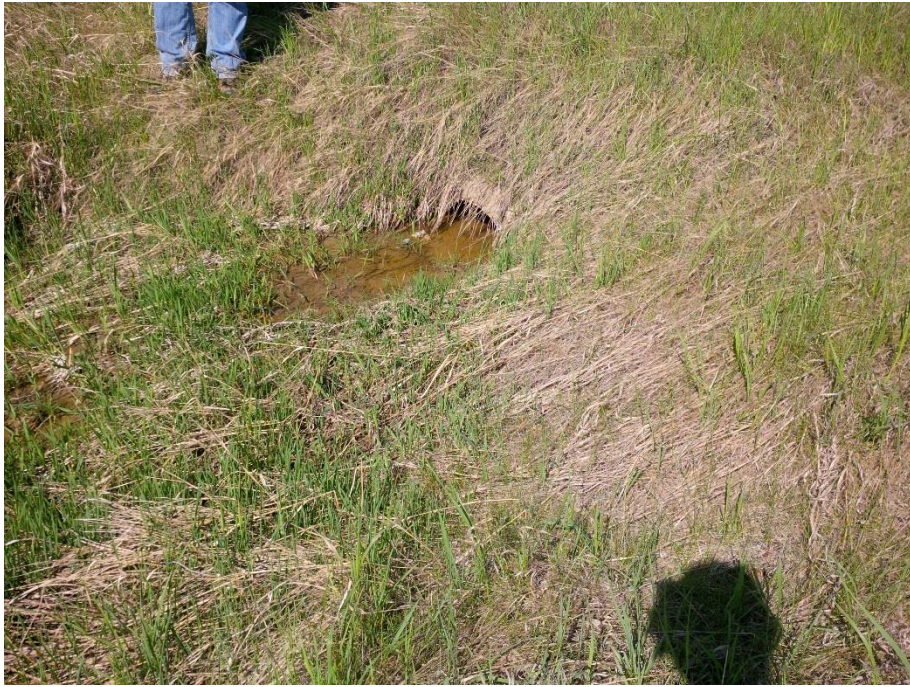
Photo 7.
Looking east at the inlet to the centerline culvert. The inlet is over half filled with sediment.

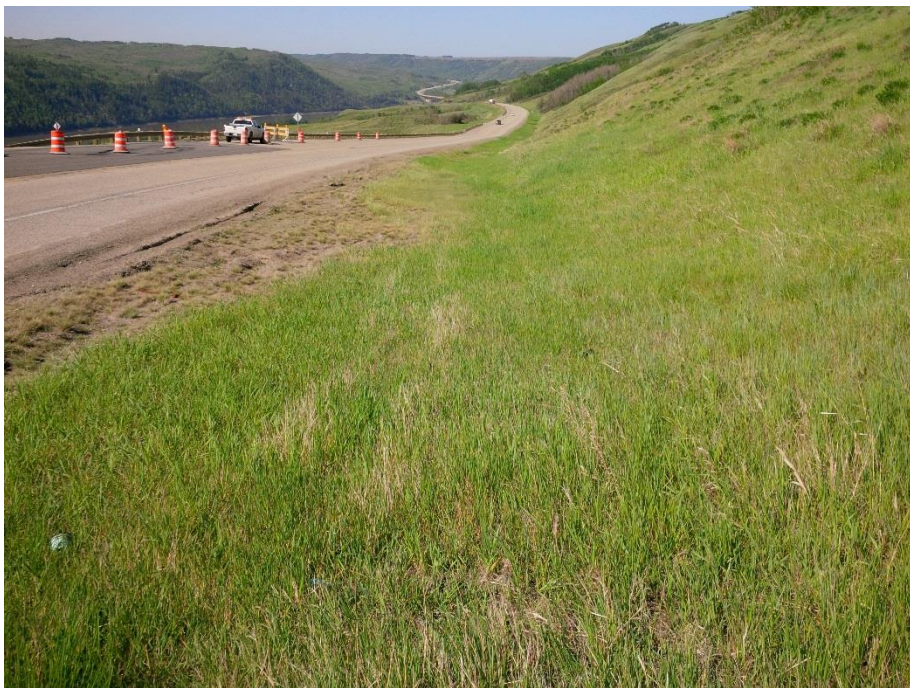
Photo 8.
Looking southwest along the SBL lane ditch. Sediment is accumulated along the shoulder downslope of the ditch block at the culvert inlet. Highway embankment material is rilled, moist and soft.

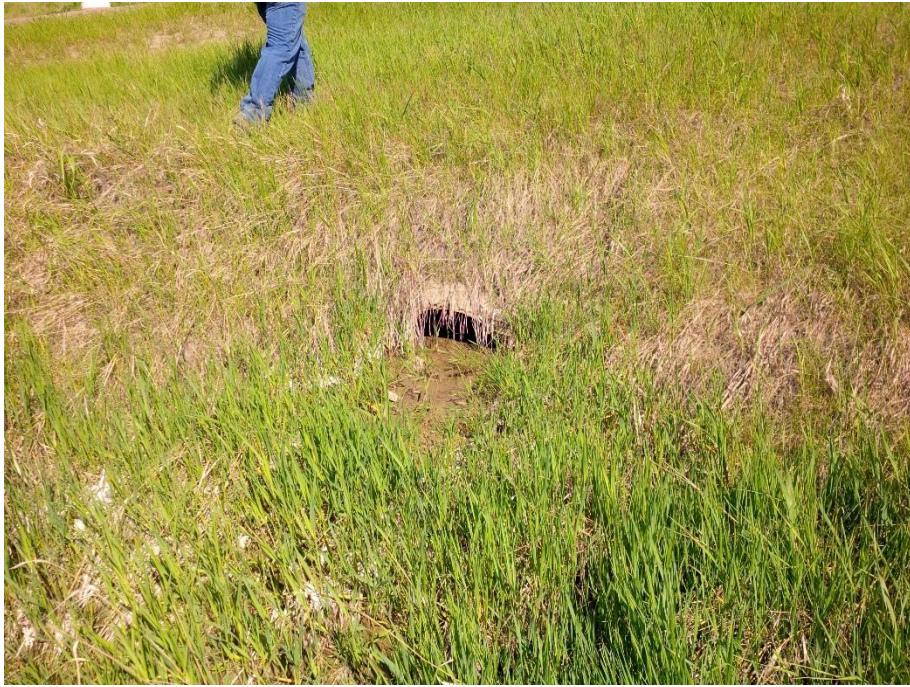
Photo 9.
Looking north at the outlet of the existing centerline culvert. The outlet is partially obstructed. No significant change since May 12, 2015.

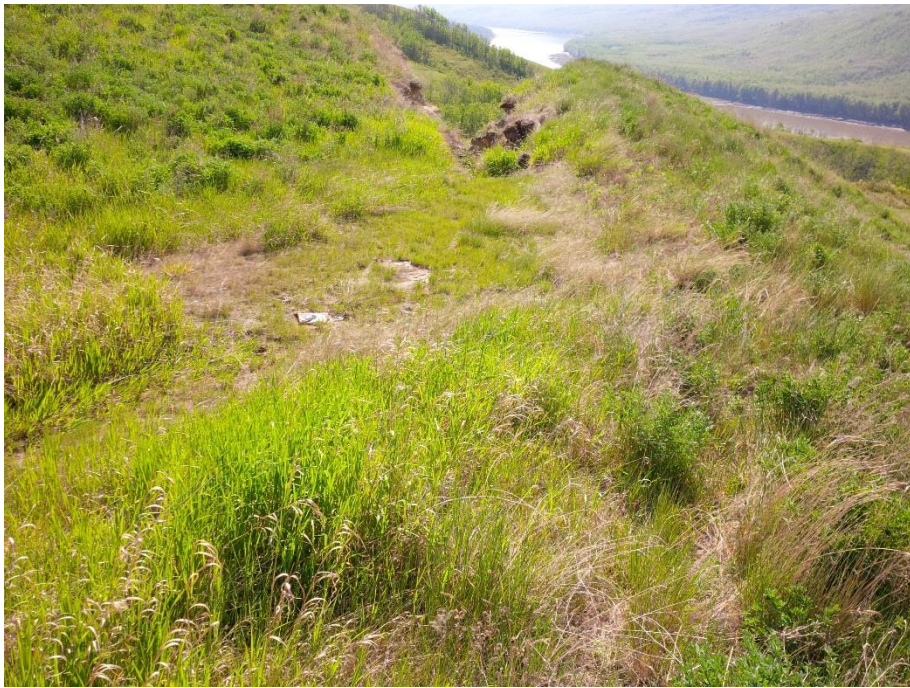
Photo 10.
There is ongoing erosion in the gully downstream, with steep gully sidewalls in the bedrock. No significant change since May 12, 2015.

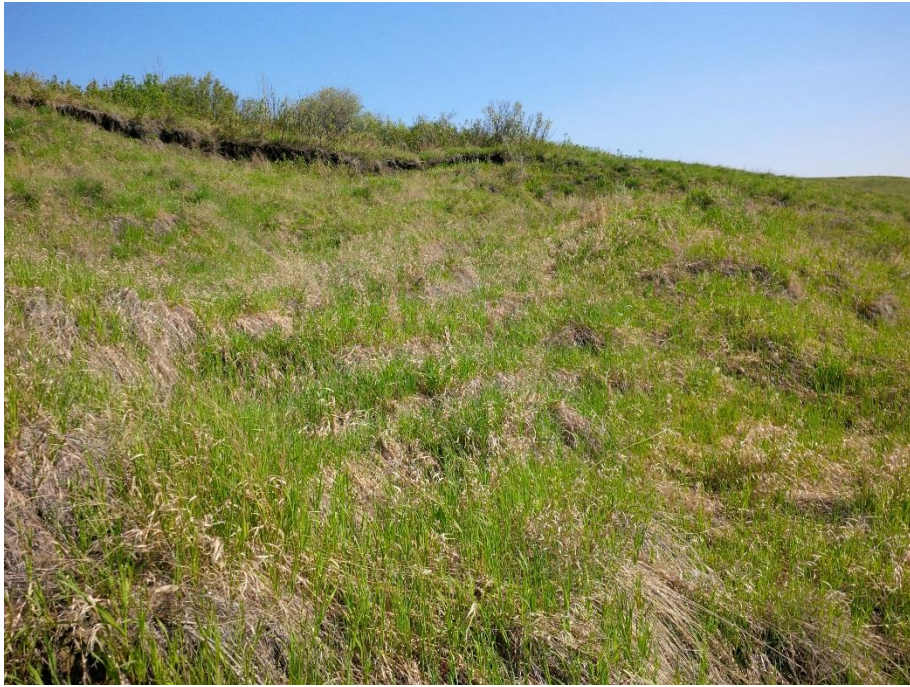
Backslope failures observed at the crest of the valley slope above the affected highway may indicate the additional runoff water if fed into the landslide area below.

Photo 11.
Looking north at large backscarps forming at the crest of the valley slope.

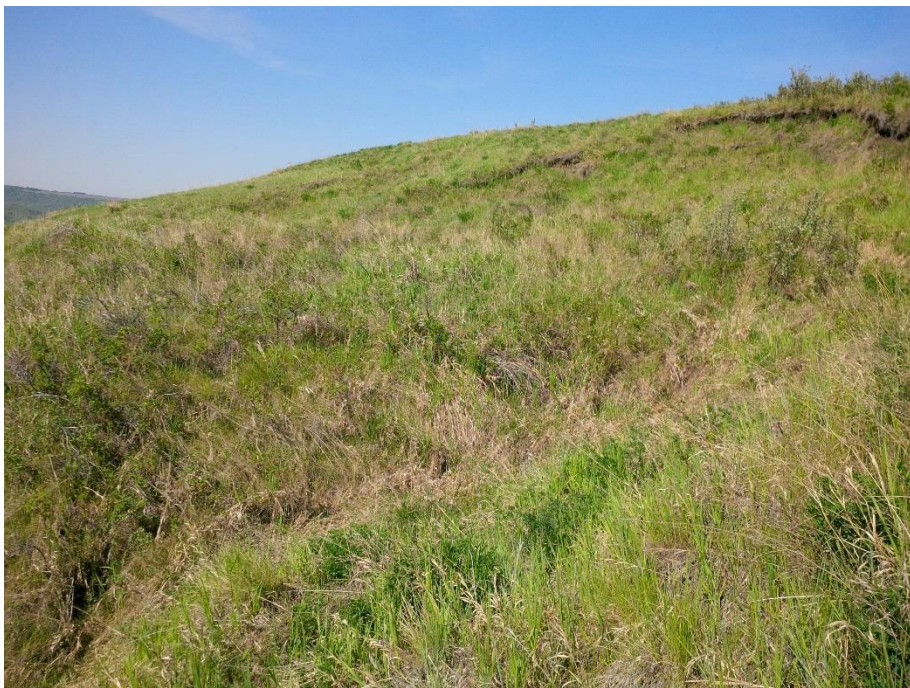
Photo 12.
Looking northwest at large backscarps forming at the crest of the valley slope.
