ALBERTA TRANSPORTATION AND ECONOMIC CORRIDORS GRMP GRANDE PRAIRIE REGION – (GRANDE PRAIRIE NORTH) INSTRUMENTATION MONITORING - SPRING 2024

Site Number	Location	Name	Hwy	km
PH052	HWY 2:68 C1 10.839	Dunvegan North Slide & Erosion	2:68	Km 10.8
Legal Description	n: 7-16-80-4 W6	UTM Co-ordinates		
		11U E 402452	N 619	99542

Current Monitoring:	26-May-2024	Previous Monitoring	19-Jun-2023	
Instruments Read By:	Mr. Niraj Regmi, G.I.T and Mr. Nixson Mationg, of Thurber

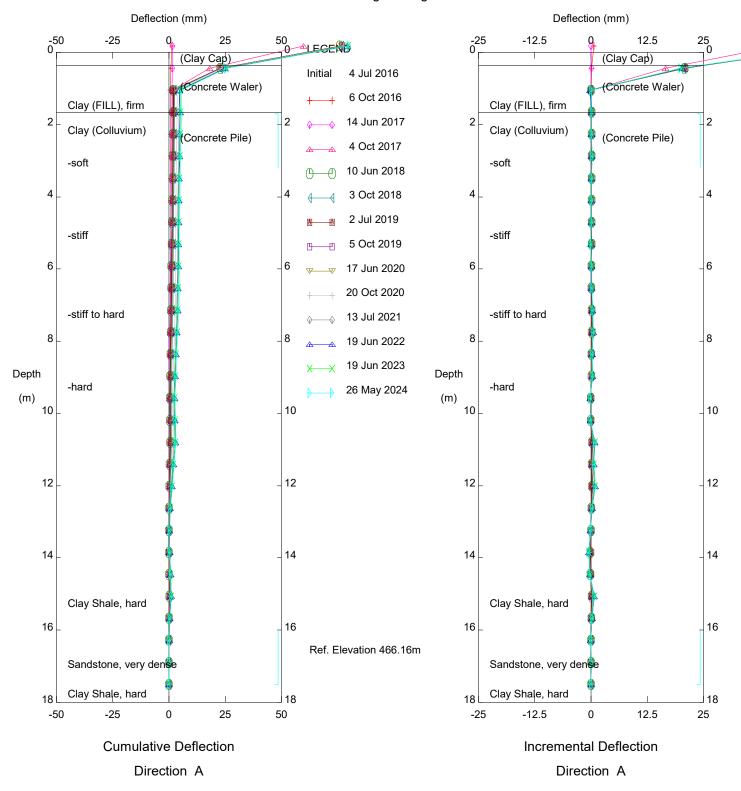
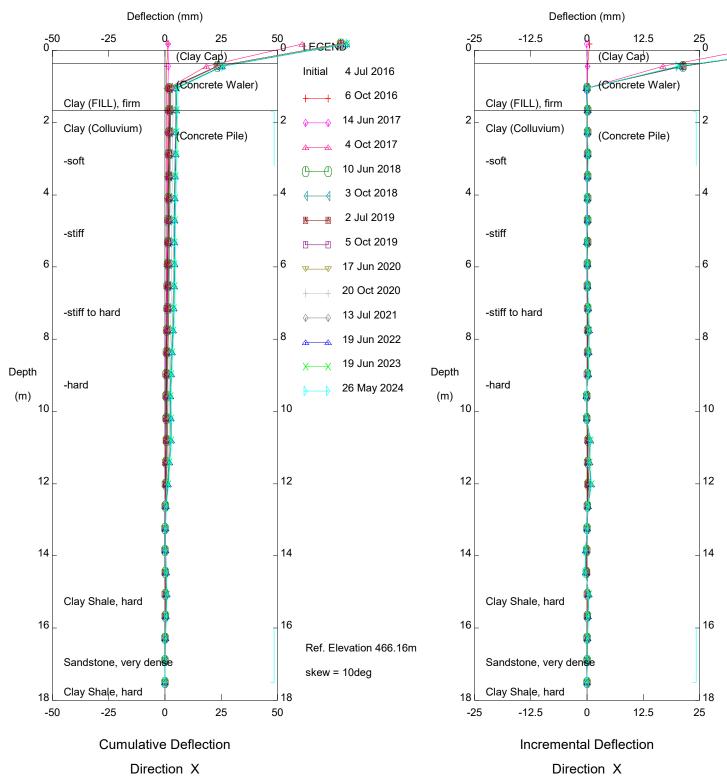
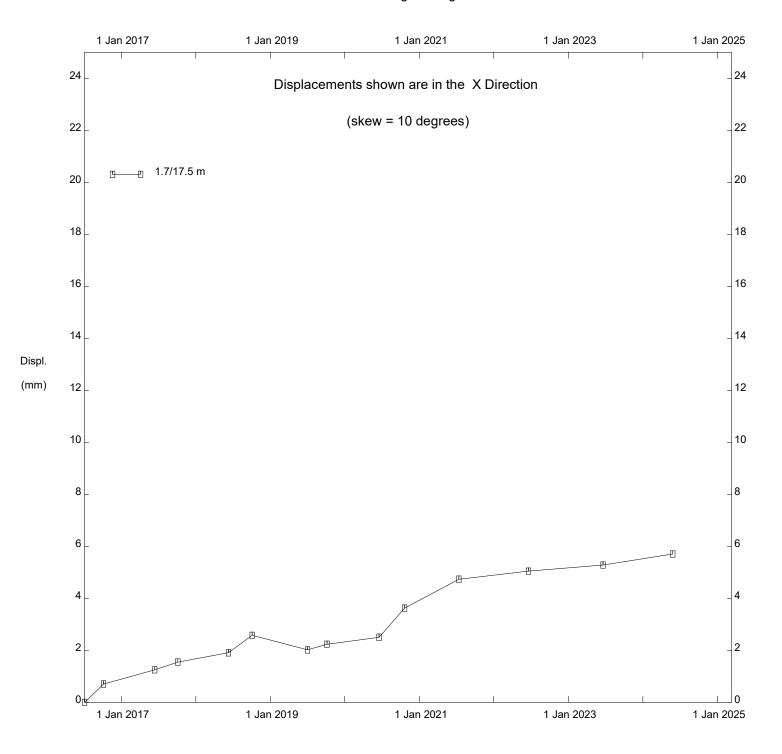
Dunvegan North Slide (PH052), Inclinometer SI16-P12

Zones of New Movement:	None
	Both slope indicators are installed in the pile wall completed in 2016. SI16-P12 showed a rate of movement of 0.4 mm/yr over the length of the pile from 1.7 m to 17.5 m depth since the spring of 2023 readings. The total pile head movement to date has been 5.7 mm. A subtle tilt of the pile appears from about 12 m depth upwards. This it more apparent in SI16-21.
Interpretation of Monitoring Results:	SI16-P21 showed a rate of movement of 1.1 mm/yr over the length of the pile from 1.7 m to 17.5 m depth compared to the spring of 2023 readings. SI16-P21 has shown a total pile head movement of 2.1 mm since it was reinitialized. However, the current calculated movement likely contains some reading error due to a tight bend in the new casing at approximately 12 m depth.
	Both vibrating wire piezometers are installed in a single borehole located between the highway and the pile wall. Vibrating wire piezometer VW16-1 continued to be dry. VW16-2 showed a decrease in groundwater level of 0.89 m compared to the spring of 2023 readings.

Additional Comments:	The movements that may be present at 12 m depth are much deeper than the design shear zone which was at about 6 m depth. Since the measured movements are minor and not well defined this it is advisable to continue monitoring.			
Attachments:	 Table PH052-1 Spring 2024 – HWY 2:68 Dunvegan North Slide and Erosion, Slope Inclinometer Instrumentation Reading Summary Table PH052-2 Spring 2024 – HWY 2:68 Dunvegan North Slide and Erosion, Vibrating Wire Piezometer Instrumentation Reading Summary Statement of Limitations and Conditions APPENDIX A - PH052-1 SPRING 2024 Field Inspector's Report Site Plan Showing Approximate Instrument Locations (Drawing No. 32123-PH052) SI Reading Plots Figure PH052-1 (Piezometric Elevations) Figure PH052-2 (Piezometric Depths)

INSTRUMENT #	DATE INITIALIZED	TOTAL CUMULATIVE RESULTANT MOVEMENT AND DEPTH OF MOVEMENT TO DATE (mm)	MAXIMUM RATE OF MOVEMENT (mm/yr)	CURRENT STATUS OF SI	DATE OF PREVIOUS READING	INCREMENTAL MOVEMENT SINCE PREVIOUS READING (mm)	CURRENT RATE OF MOVEMENT (mm/yr)	CHANGE IN RATE OF MOVEMENT SINCE PREVIOUS READING (mm/yr)
SI16-P12	July 4, 2016	5.7 over 1.7 m to 17.5 m depth in 197° direction	3.3 on October 20, 2020	Active	June 19, 2023	0.4	0.4	0.2
SI16-P21	July 4, 2016 (New initial reading of June 18, 2020)	2.1 over 1.7 m to 17.5 m depth in 252° direction	5.4 on July 13, 2021	Active	June 19, 2023	1.0	1.1	6.2

Future Work:	The instruments should be read again in the spring of 2025.
Instrumentation Repairs:	No instrument repairs are required at this time.

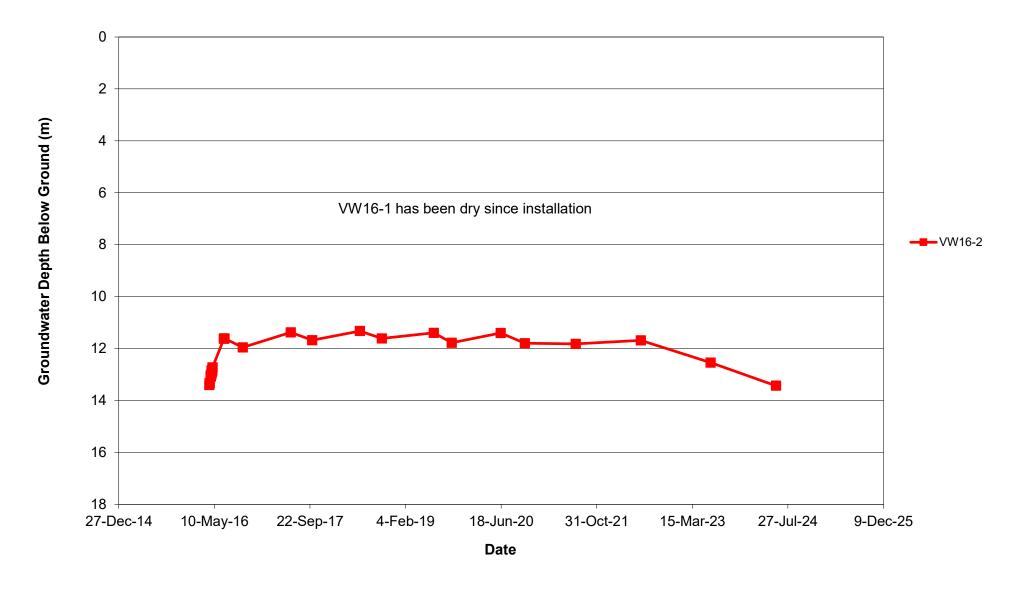
FIGURE PH052-1
PIEZOMETRIC DEPTHS FOR HWY 2:68 DUNVEGAN NORTH 10+800 SLIDE

INSTRUMENT	DATE INITIALIZED	TIP ELEV. (m)	GROUND ELEV. (m)	CURRENT STATUS	HIGHEST RECORDED GROUNDWATER LEVEL (mBGS)	CURRENT GROUNDWATER ELEVATION (mBGS)	PREVIOUS GROUNDWATER ELEVATION (mBGS)	CHANGE IN WATER LEVEL SINCE PREVIOUS READING (m)
VW16-1	April 9, 2016	458.80	467.73	Active	DRY	DRY	DRY	N/A
VW16-2	April 9, 2016	451.80	467.73	Active	456.40 on June 10, 2018	454.30	455.19	-0.89
