**ALBERTA TRANSPORTATION AND
ECONOMIC CORRIDORS GRMP
PEACE REGION
(GRANDE PRAIRIE DISTRICT - NORTH)
INSTRUMENTATION MONITORING - FALL 2024**

Site Number	Location	Name	Hwy	km
GP029	HWY 2:70 km 11.88	Church Camp Slide	2:70	Km 11.9
Legal Description:		UTM Co-ordinates		
16-4-77-5 W6		11U E 393096	N	6168377

Current Monitoring:	25-Sep-2024	Previous Monitoring	29-May-2024
Instruments Read By:	Mr. Neil McDonald and Mr. Nixson Mationg, of Thurber

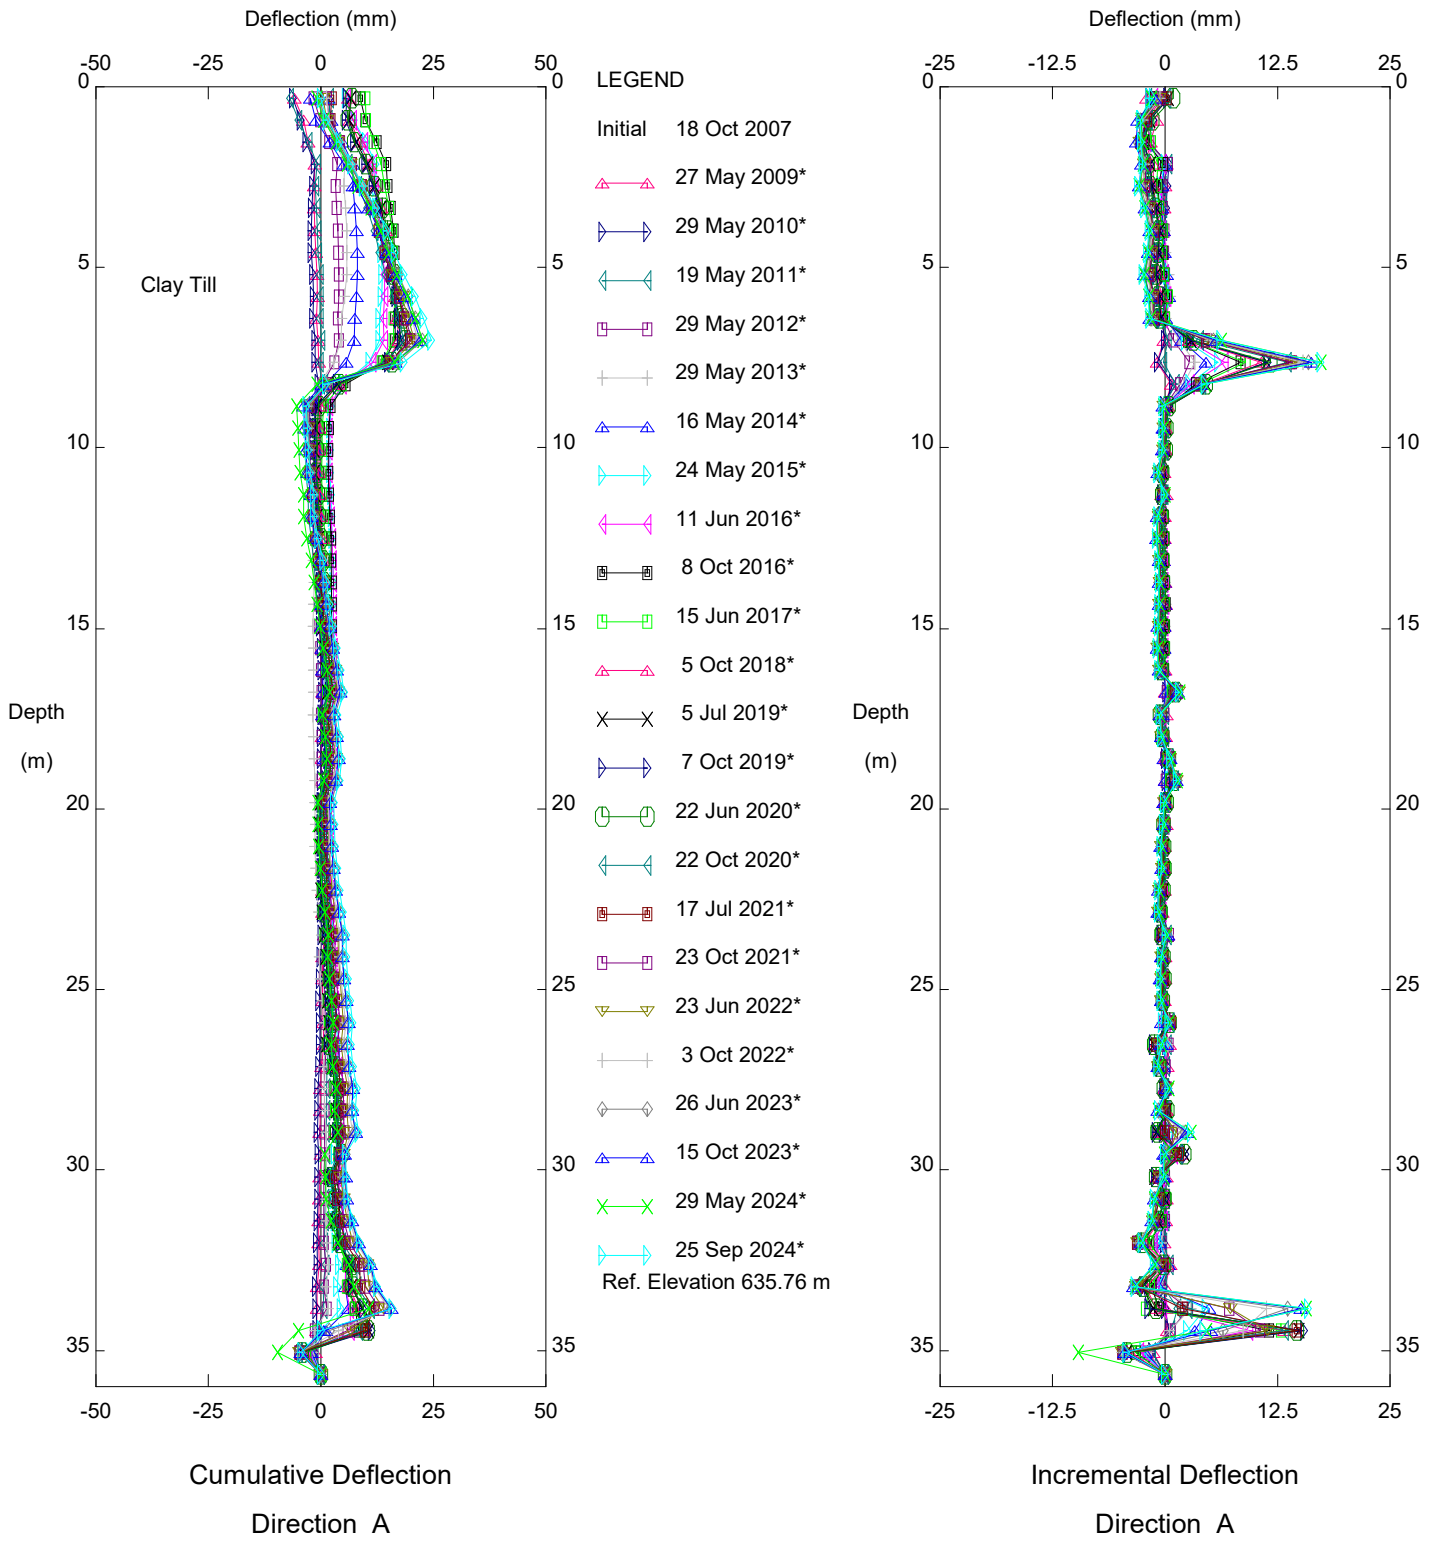
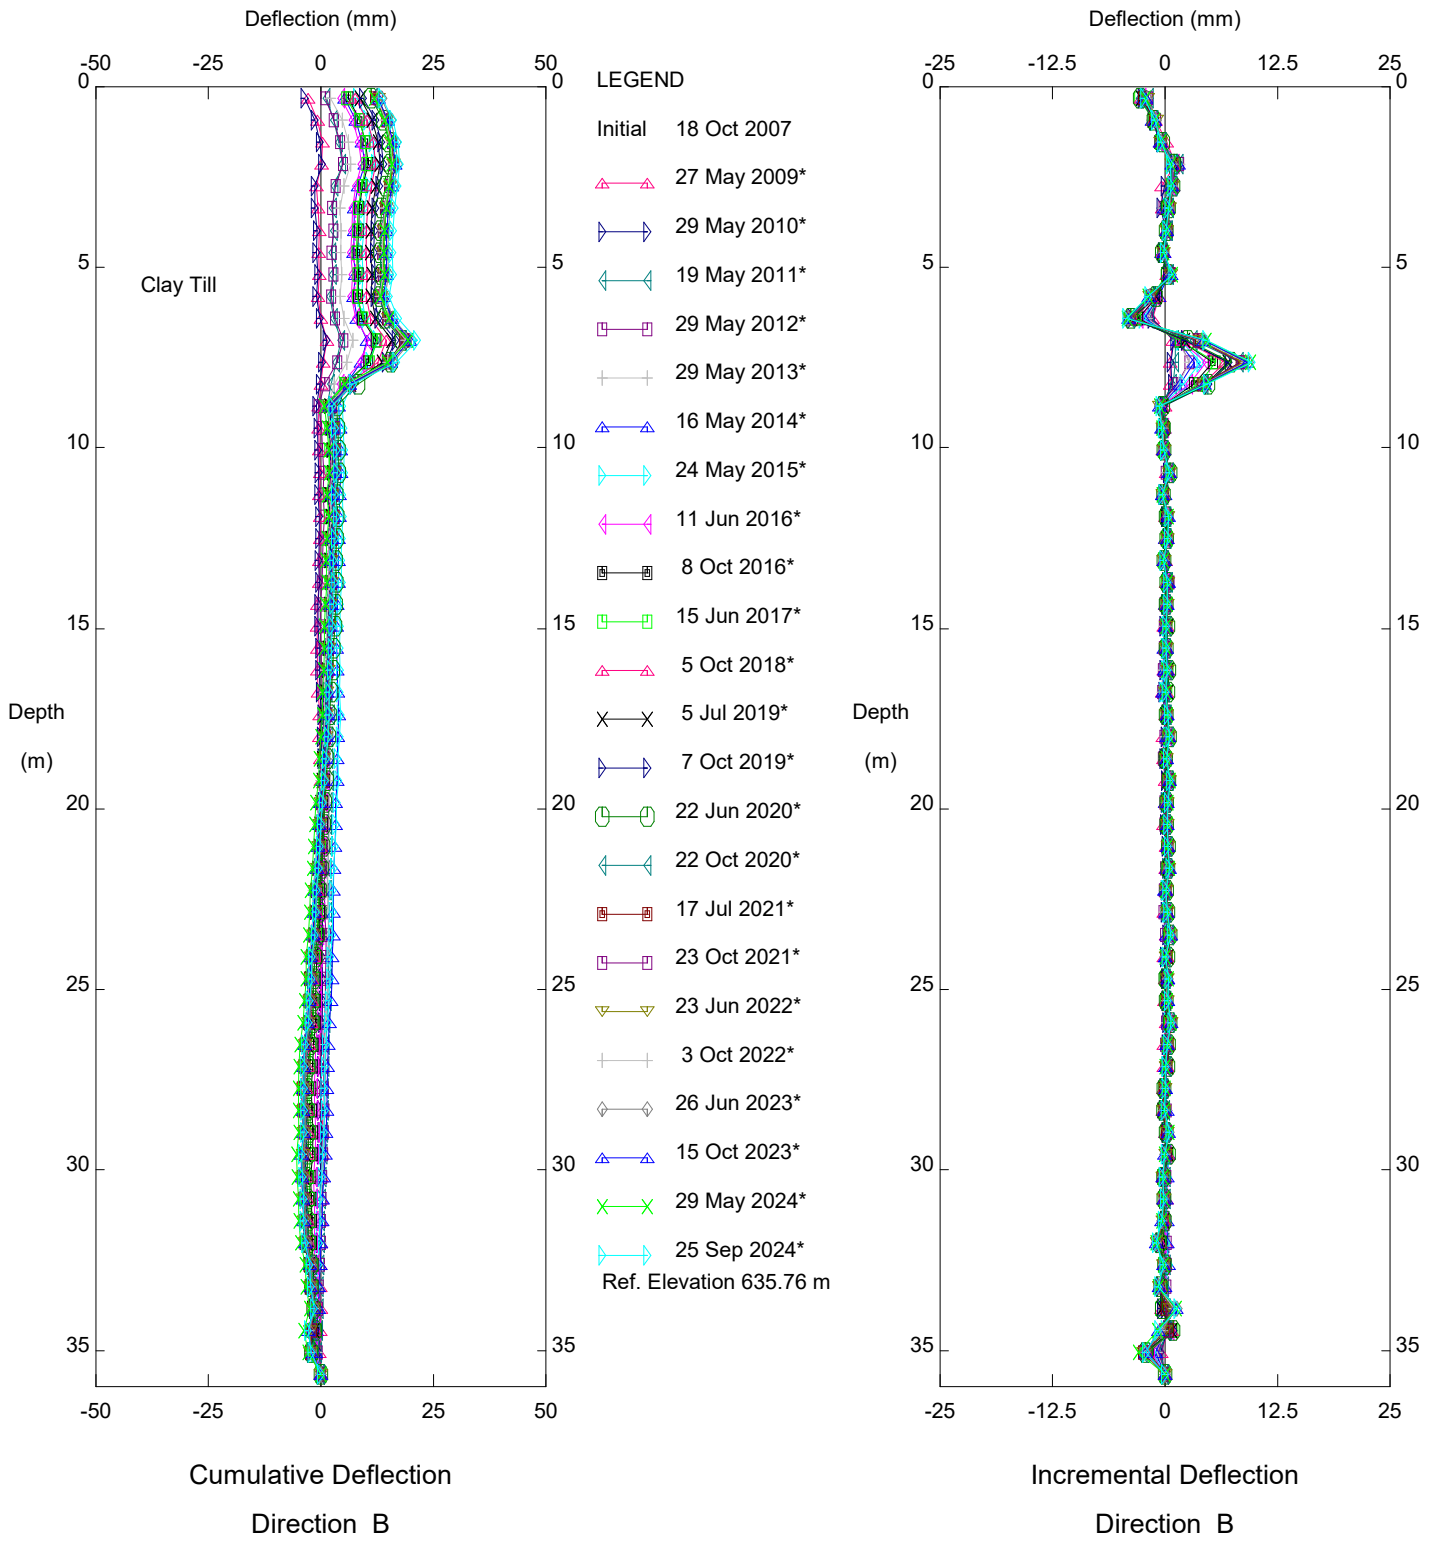
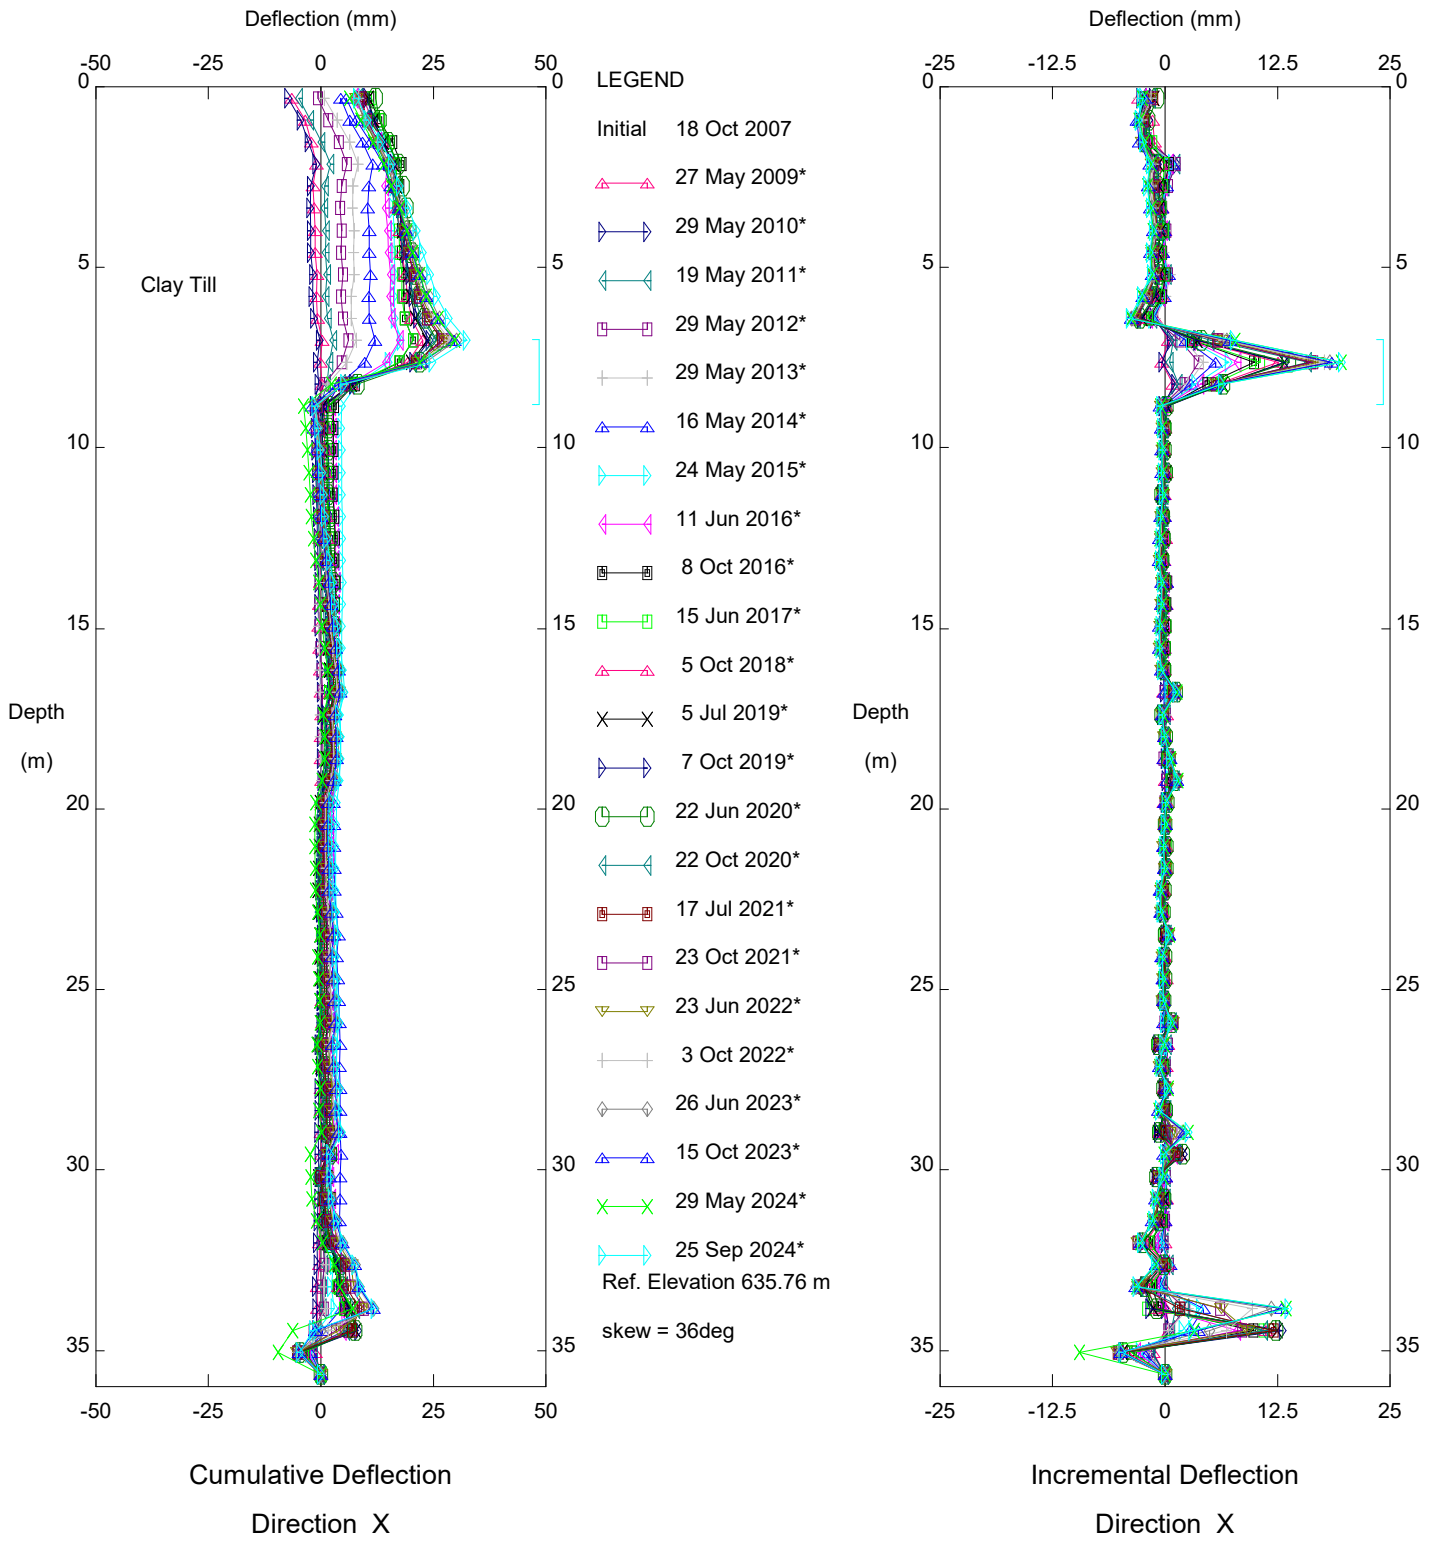
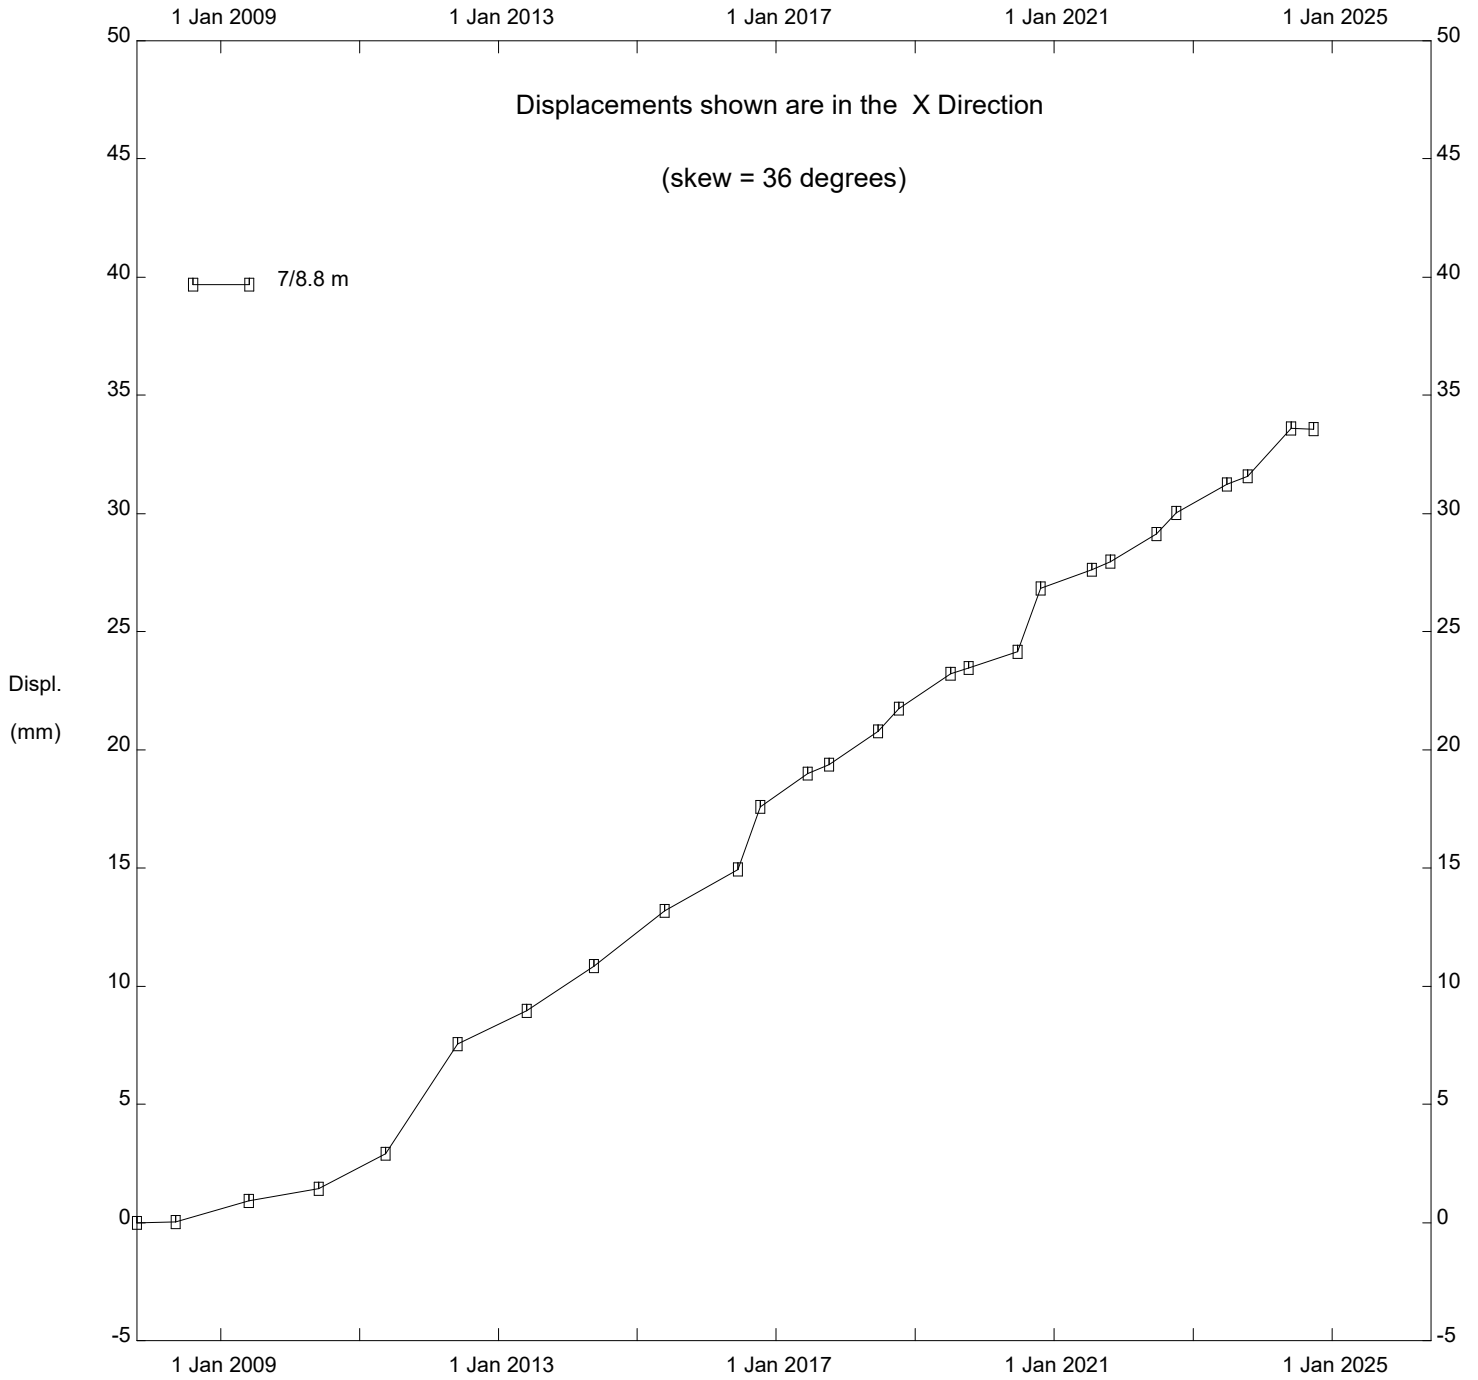
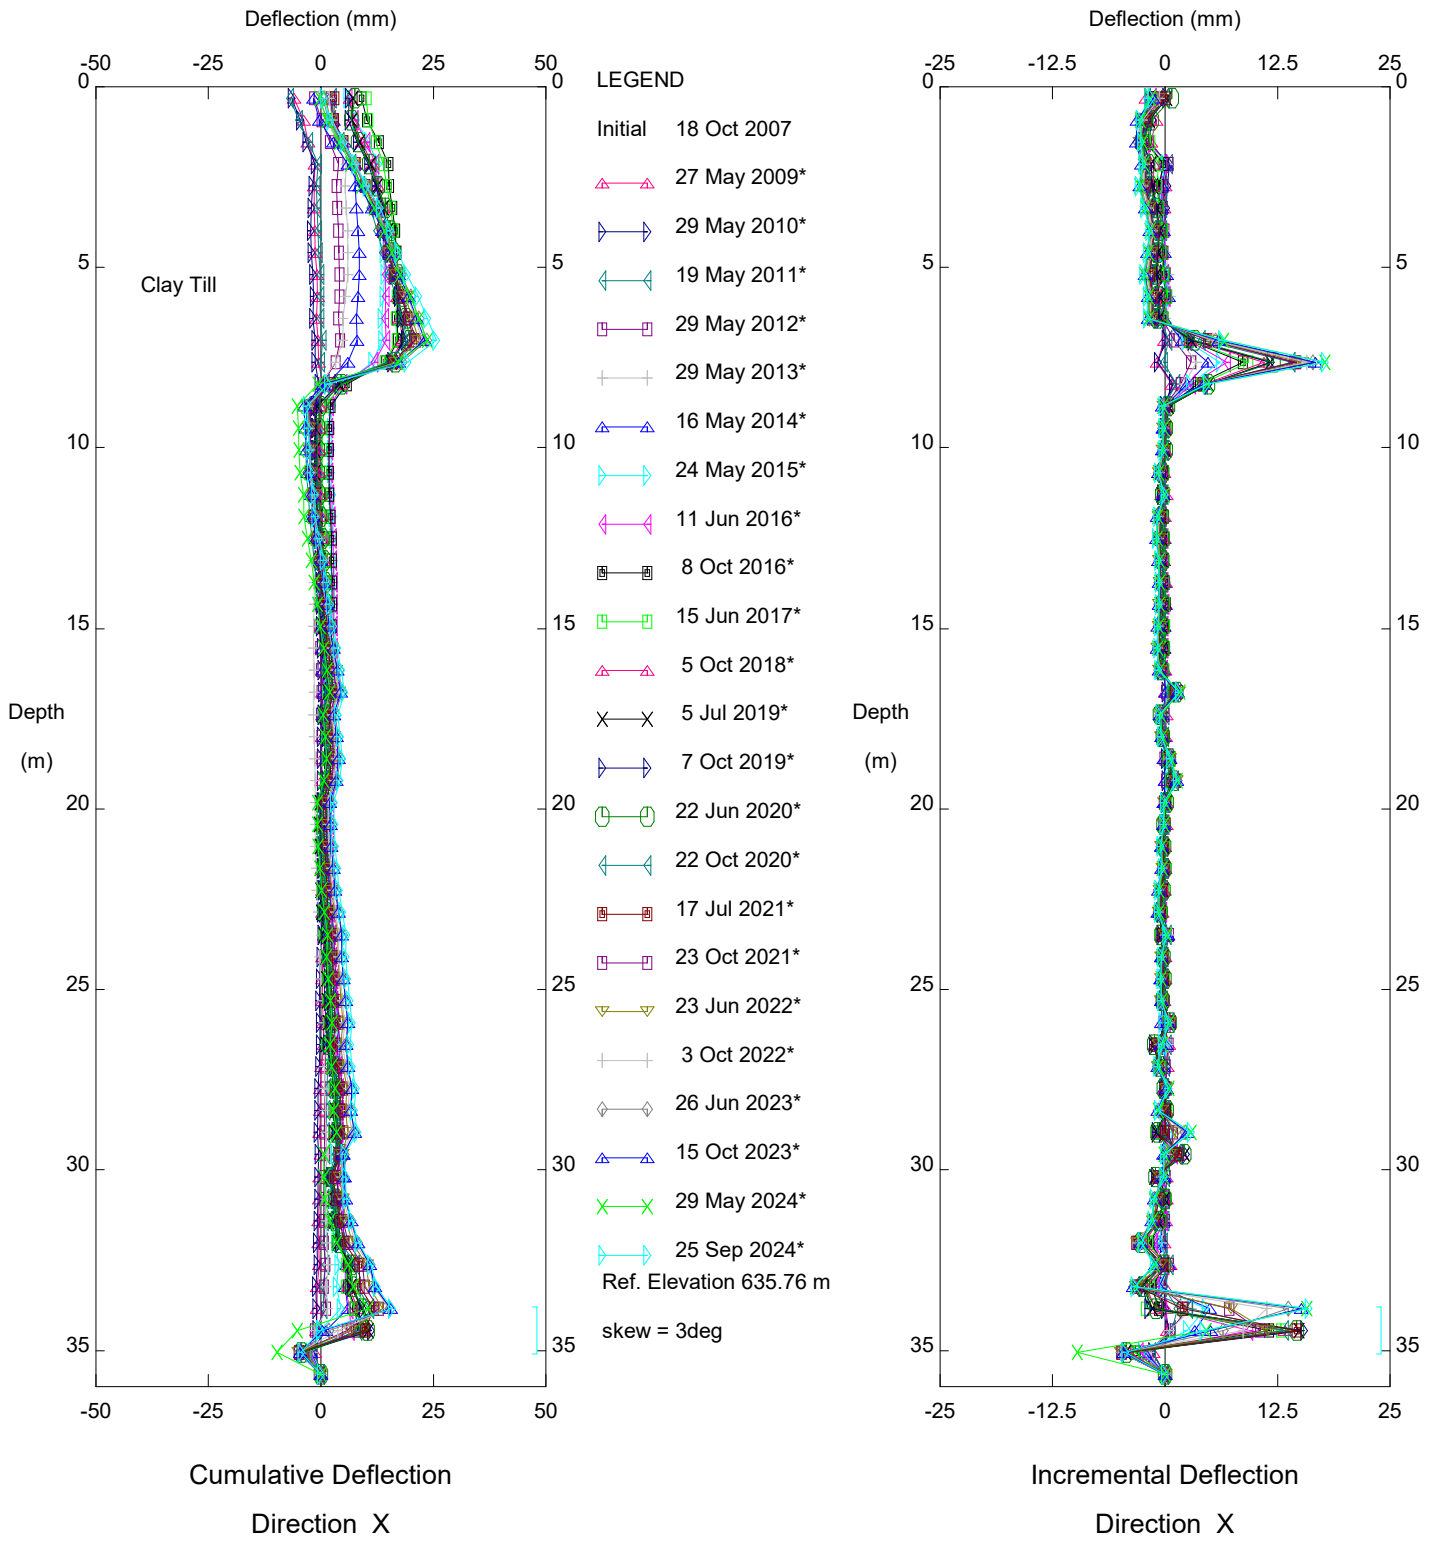
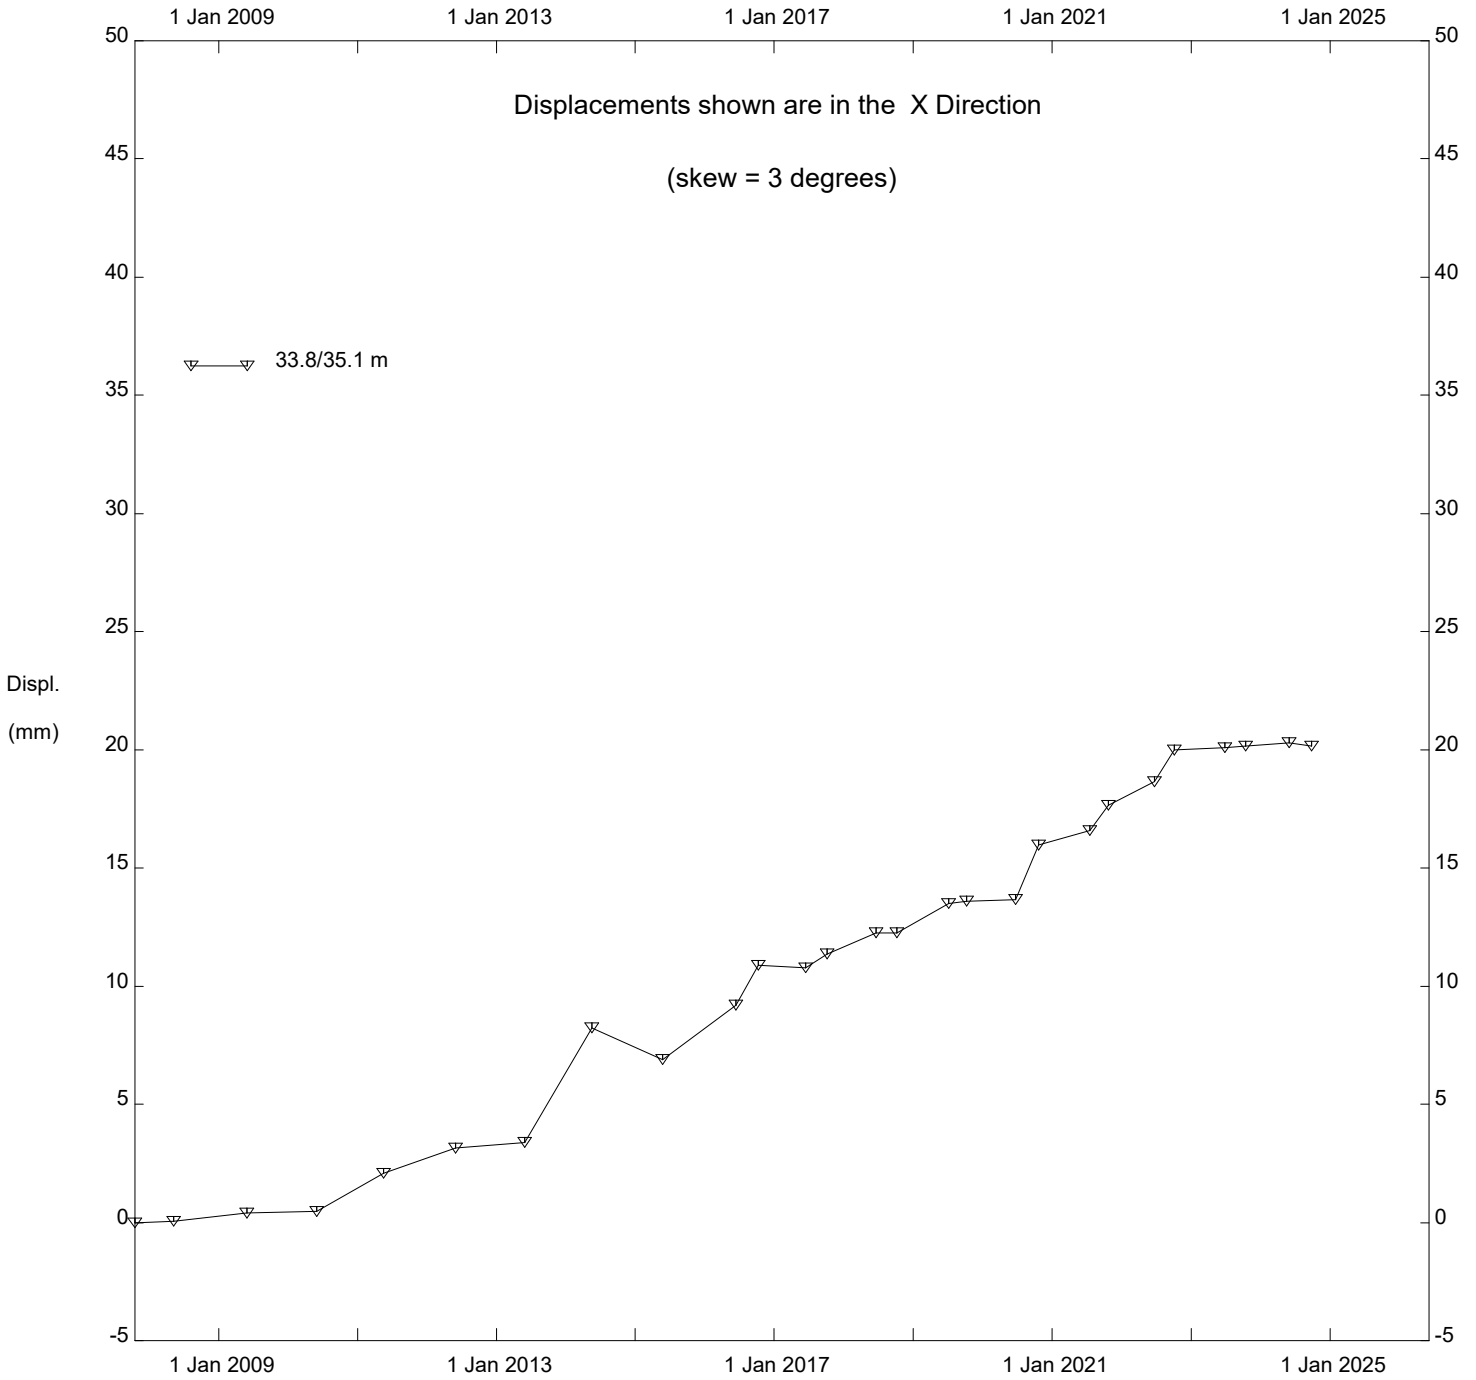
GP029 HWY 2:70 (Church Camp), Inclinometer SI-2

Discussion	
Zones of New Movement:	None
Interpretation of Monitoring Results:	<p>Slope inclinometer SI-2 showed no discernible movement over 7.0 m to 8.8 m depth or over 33.8 m to 35.1 m depth since the spring of 2024 readings. Both zones of movement are very distinct and showed a decrease in rate of movement since the previous readings. Of interest is the upper zone which has a movement vector skew angle of 36 degrees and the lower zone has a skew angle of 3 degrees.</p> <p>SI-3 has four known zones of movement. From top to bottom the movement rates since the spring of 2024 readings are: 3.5 mm/yr over 5.2 m to 7.0 m depth; 0.9 mm/yr over 9.4 m to 10.6 m depth; 0.5 mm/yr over 13.1 m to 14.3 m depth, and; 0.4 mm/yr over 18.0 m to 19.2 m depth. The cumulative movements are: 43 mm over 5.2 m to 7.0 m depth; 13 mm over 9.4 m to 10.6 m depth; 3 mm over 13.1 m to 14.3 m depth, and; 5 mm over 18.0 m to 19.2 m depth. The multitude of movement zones is indicative of the complexity of the slide at this site.</p> <p>SI17-5 has shown no discernible movement since initialization as it is located on the opposite side of the highway just outside of the landslide influence zone.</p>

INSTRUMENT #	DATE INITIALIZED	TOTAL CUMULATIVE RESULTANT MOVEMENT AT NOTED DEPTH SINCE INITIAL READING (mm)	MAXIMUM RATE OF MOVEMENT (mm/yr)	CURRENT STATUS	DATE OF PREVIOUS READING	INCREMENTAL MOVEMENT SINCE PREVIOUS READING (mm)	RATE OF MOVEMENT (mm/yr)	CHANGE IN RATE OF MOVEMENT SINCE PREVIOUS READING (mm/yr)
SI-2	October 18, 2007	33.6 over 7.0 m to 8.8 m depth in 112° direction	8.1 in October 2016	Operational	May 29, 2024	No discernible movement	N/A	-3.4

20.2 over 33.8 m to 35.1 m depth in 79° direction	6.9 in October 2020			No discernible movement	N/A	-0.7
SI-3	October 18, 2007	43.2 over 5.2 m to 7.0 m depth in 113° direction	7.6 in July 2021	Operational	May 29, 2024	1.1	3.5	0.4
