**ALBERTA TRANSPORTATION AND
ECONOMIC CORRIDORS GRMP
PEACE REGION
(GRANDE PRAIRIE DISTRICT - NORTH)
INSTRUMENTATION MONITORING - FALL 2024**

Site Number	Location	Name	Hwy	km
GP029	HWY 2:70 km 11.88	Church Camp Slide	2:70	Km 11.9
Legal Description:		UTM Co-ordinates		
16-4-77-5 W6		11U E 393096	N	6168377

Current Monitoring:	25-Sep-2024	Previous Monitoring	29-May-2024
Instruments Read By:	Mr. Neil McDonald and Mr. Nixson Mationg, of Thurber

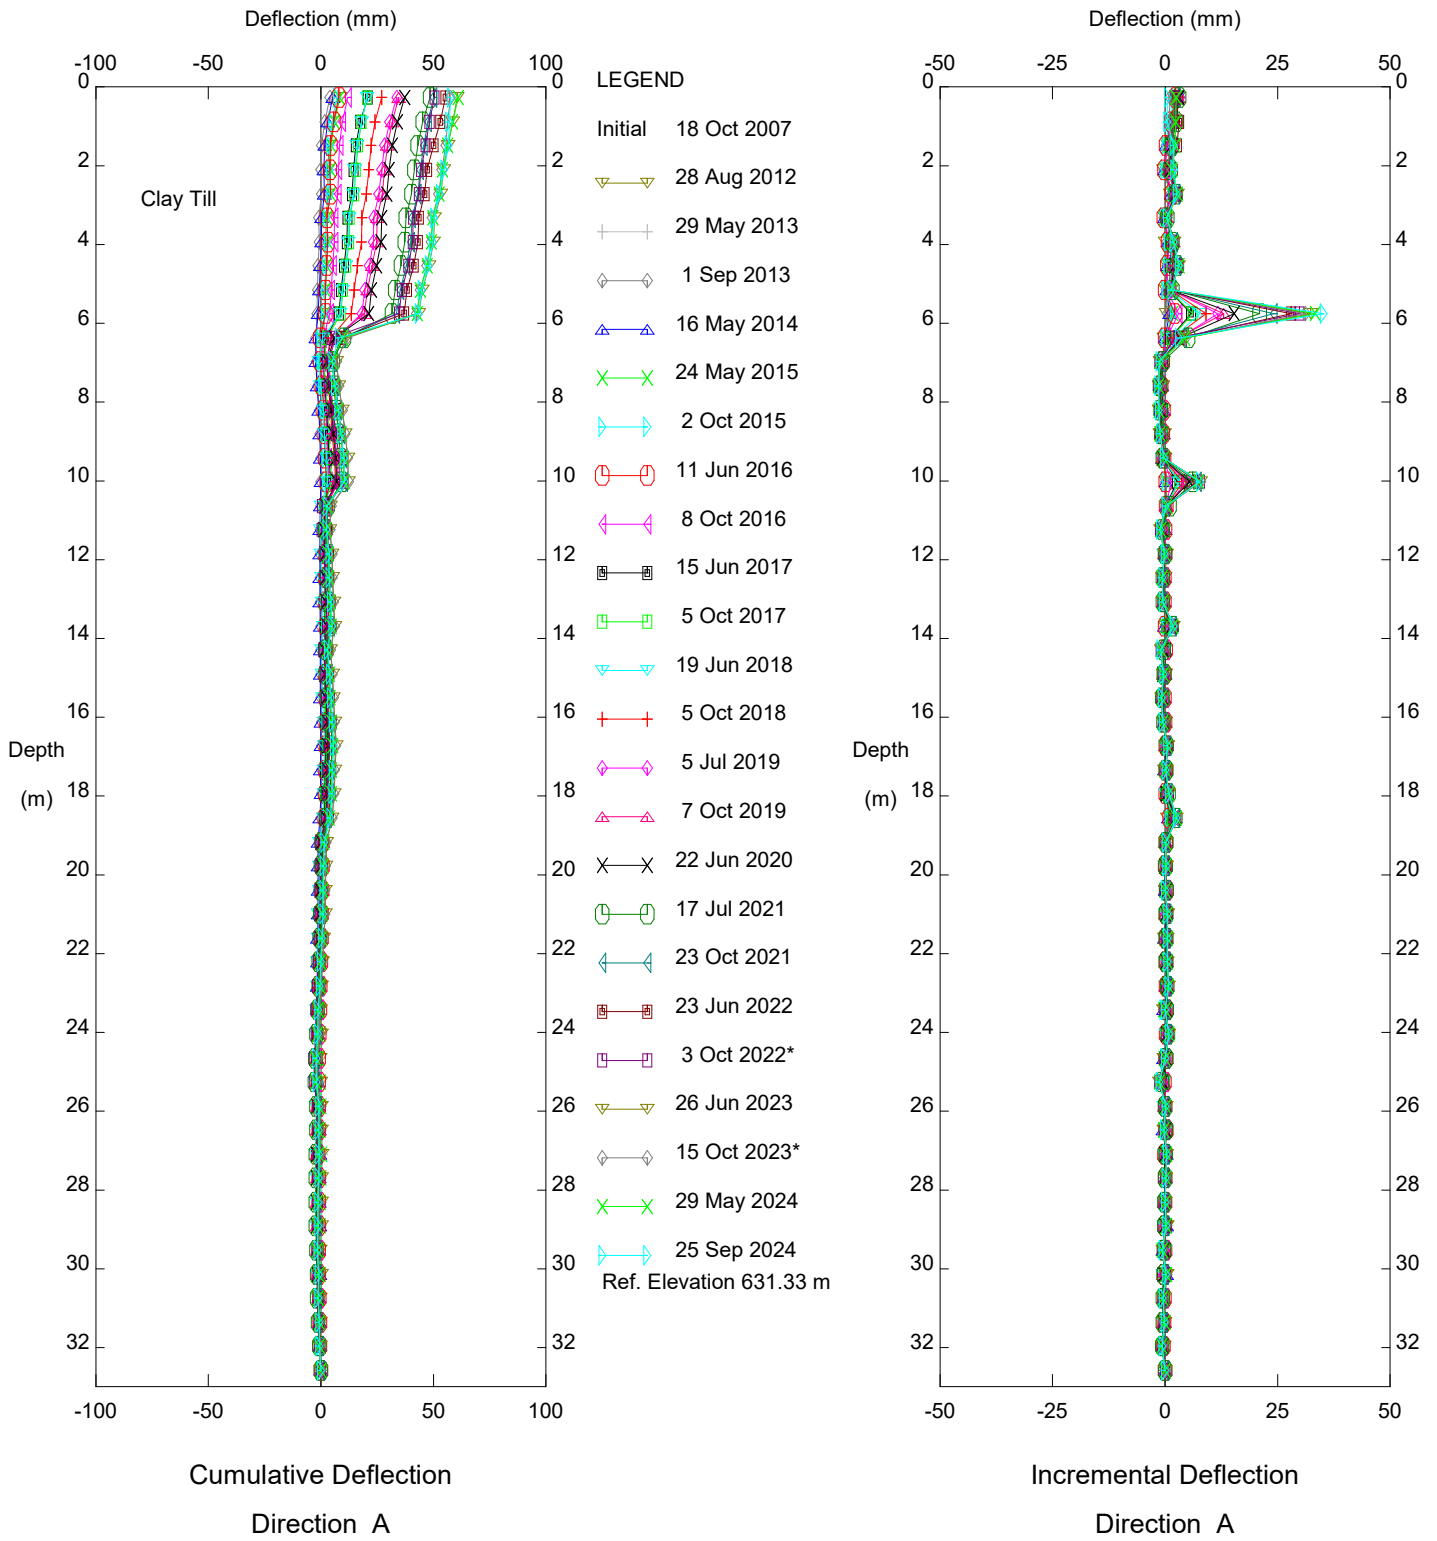
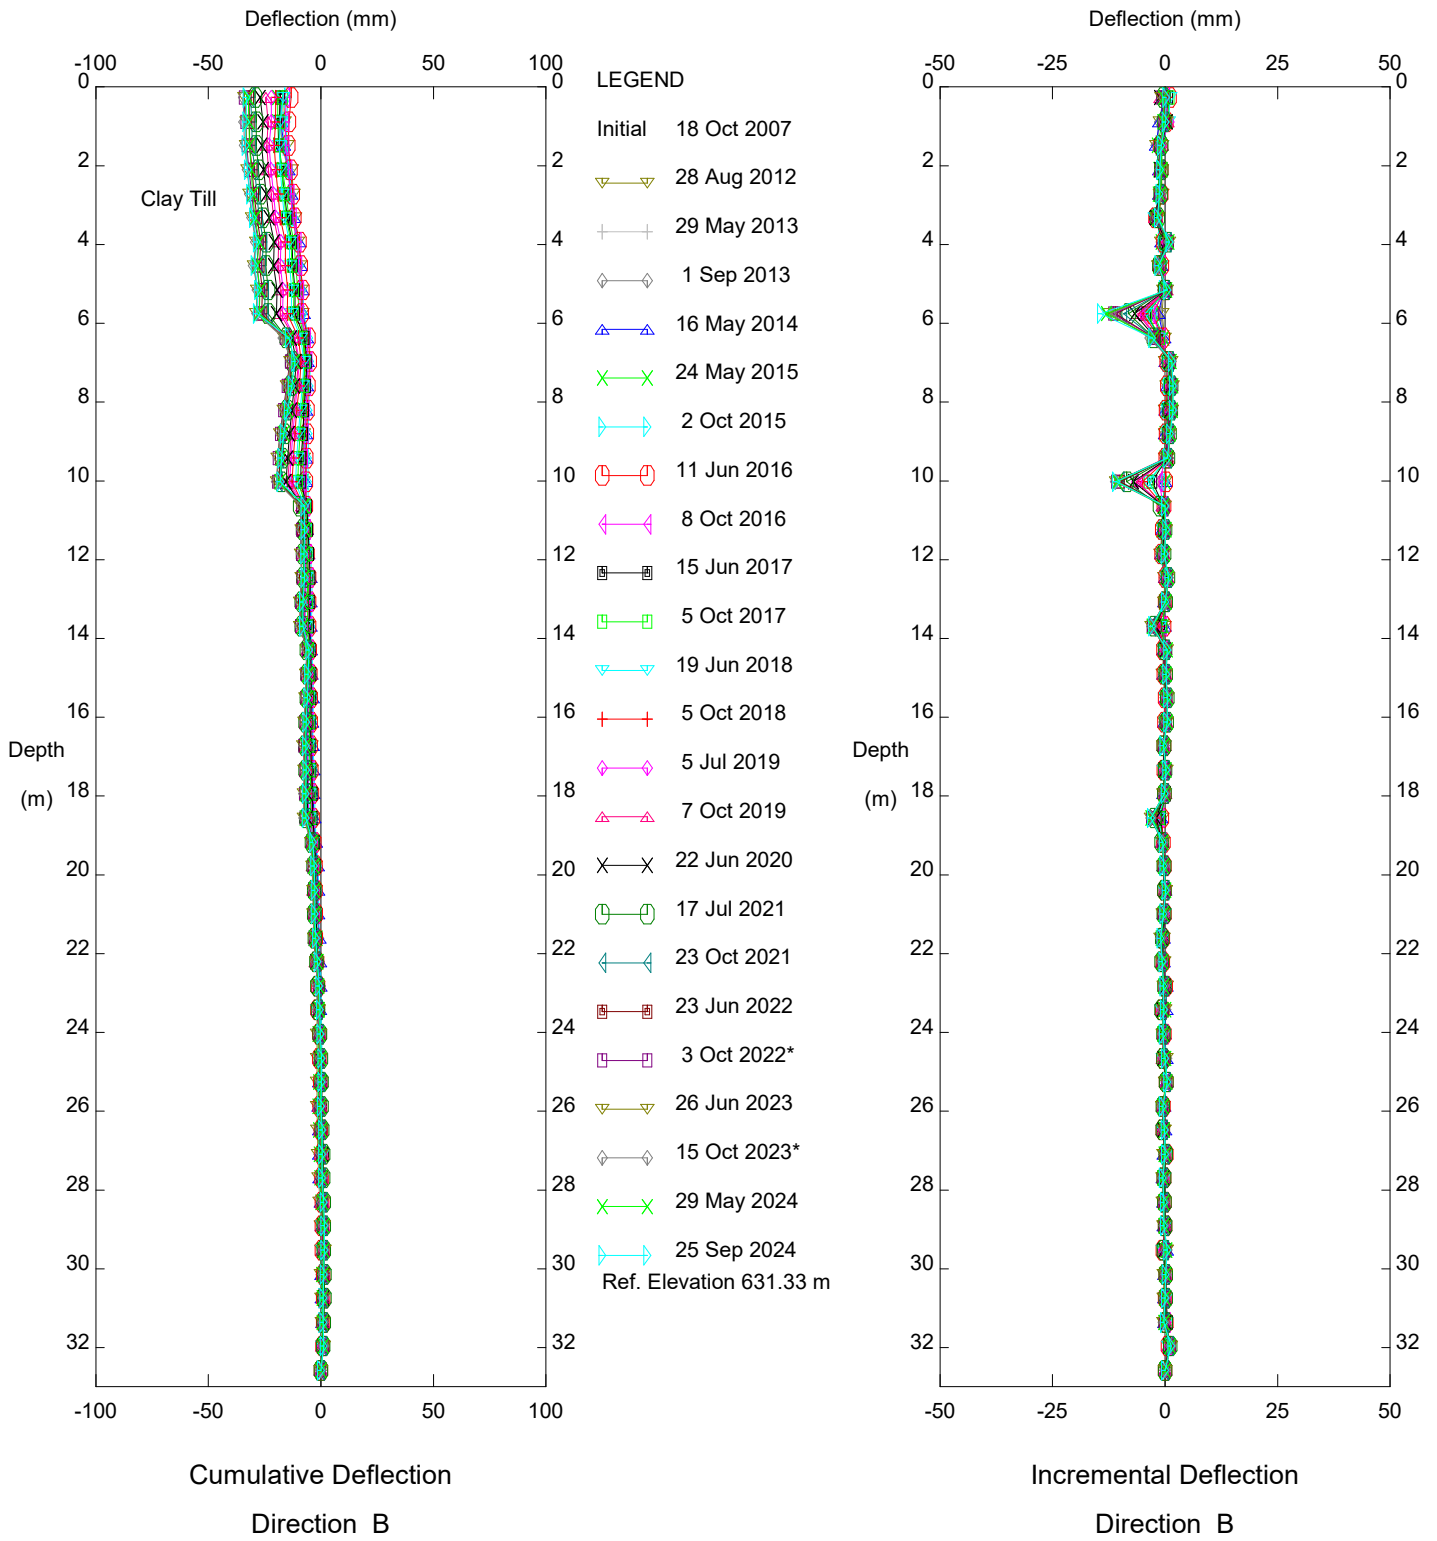
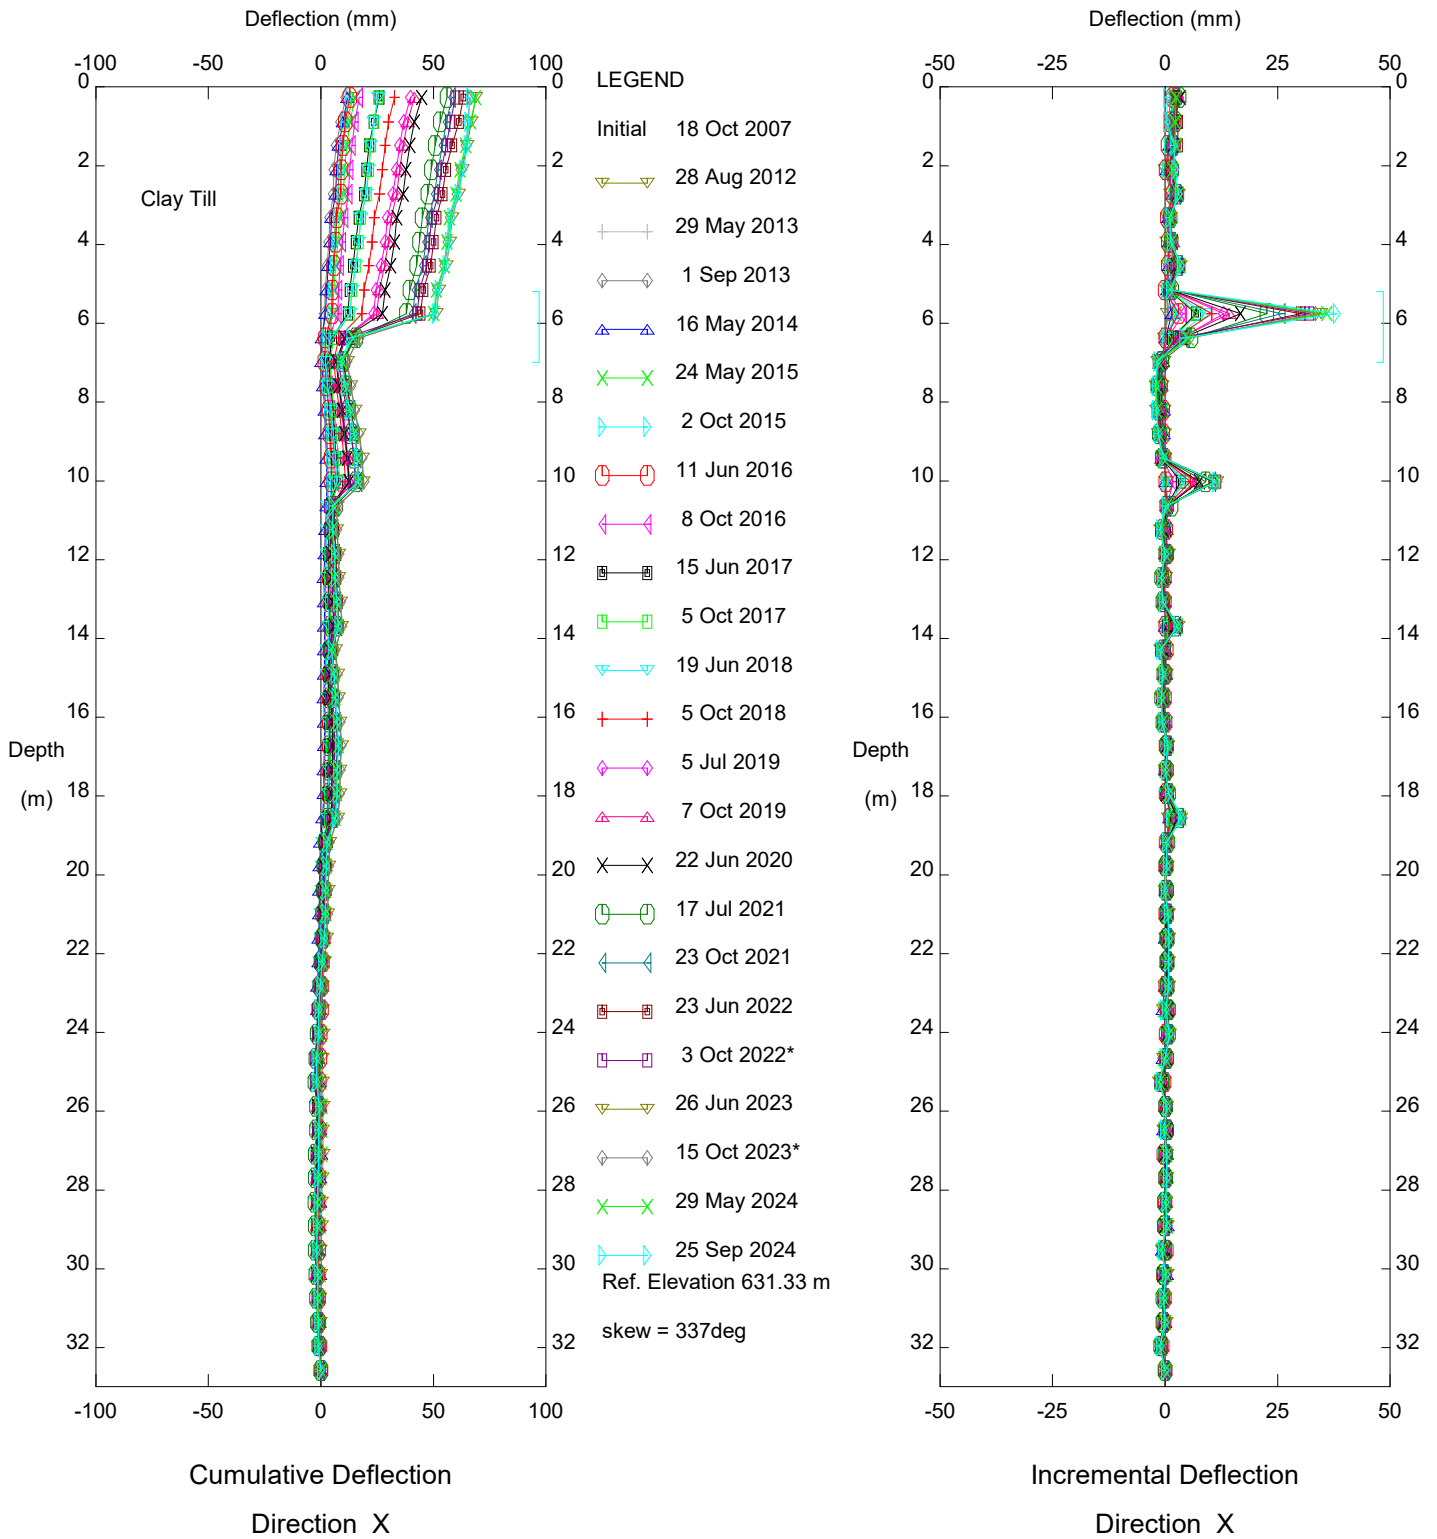
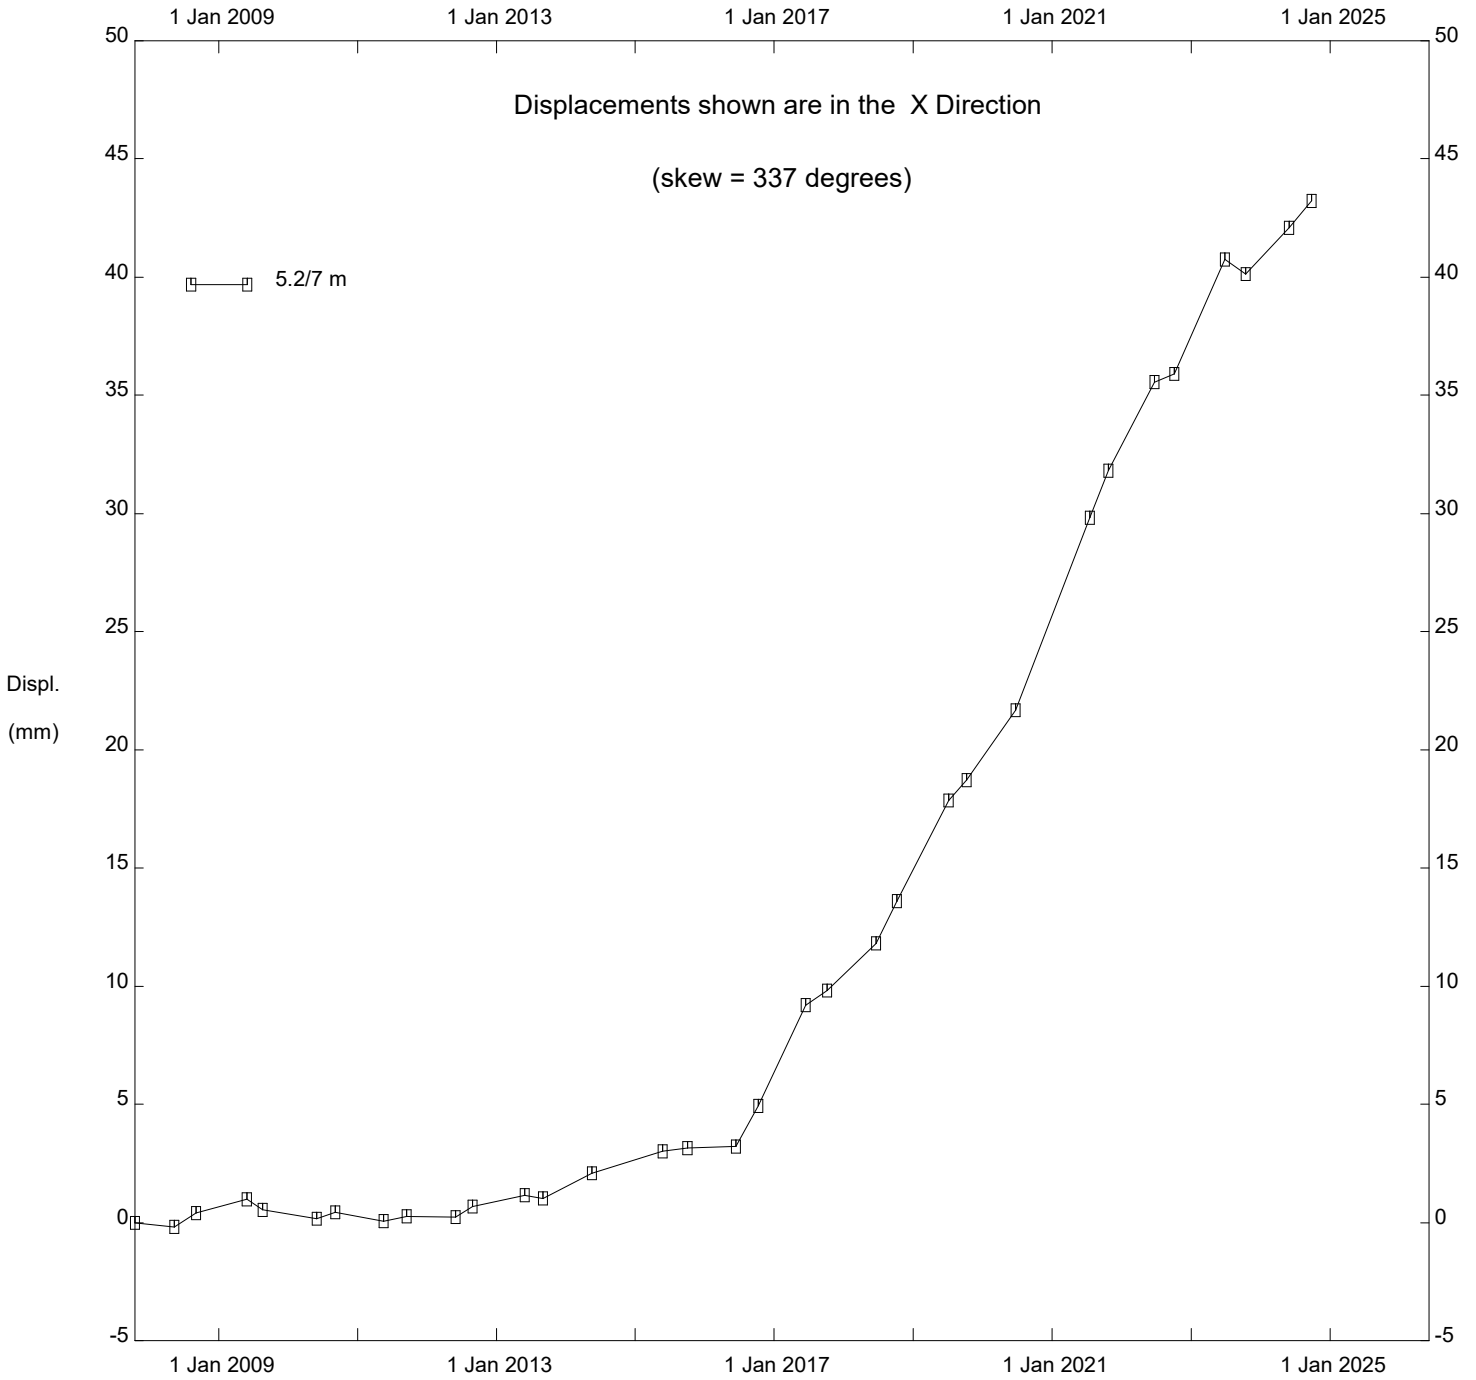
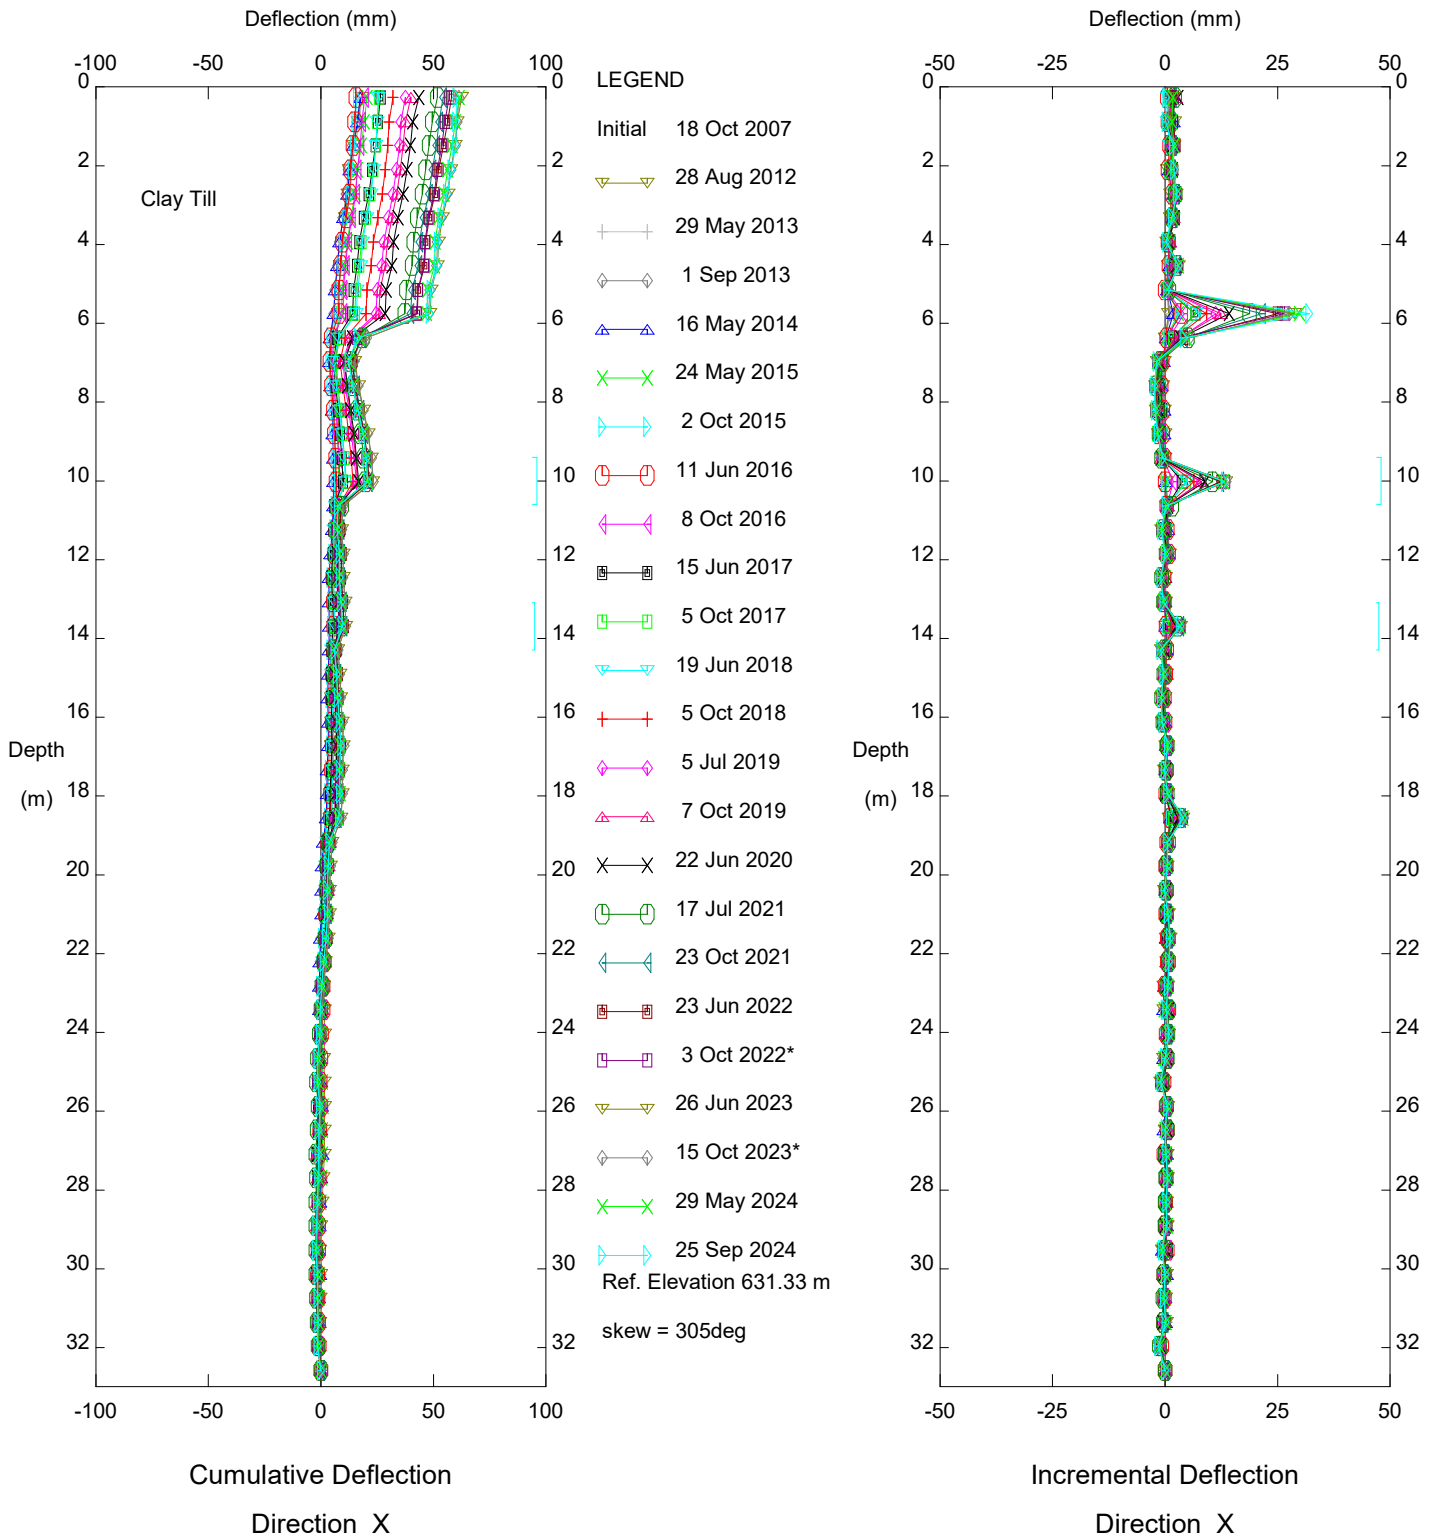
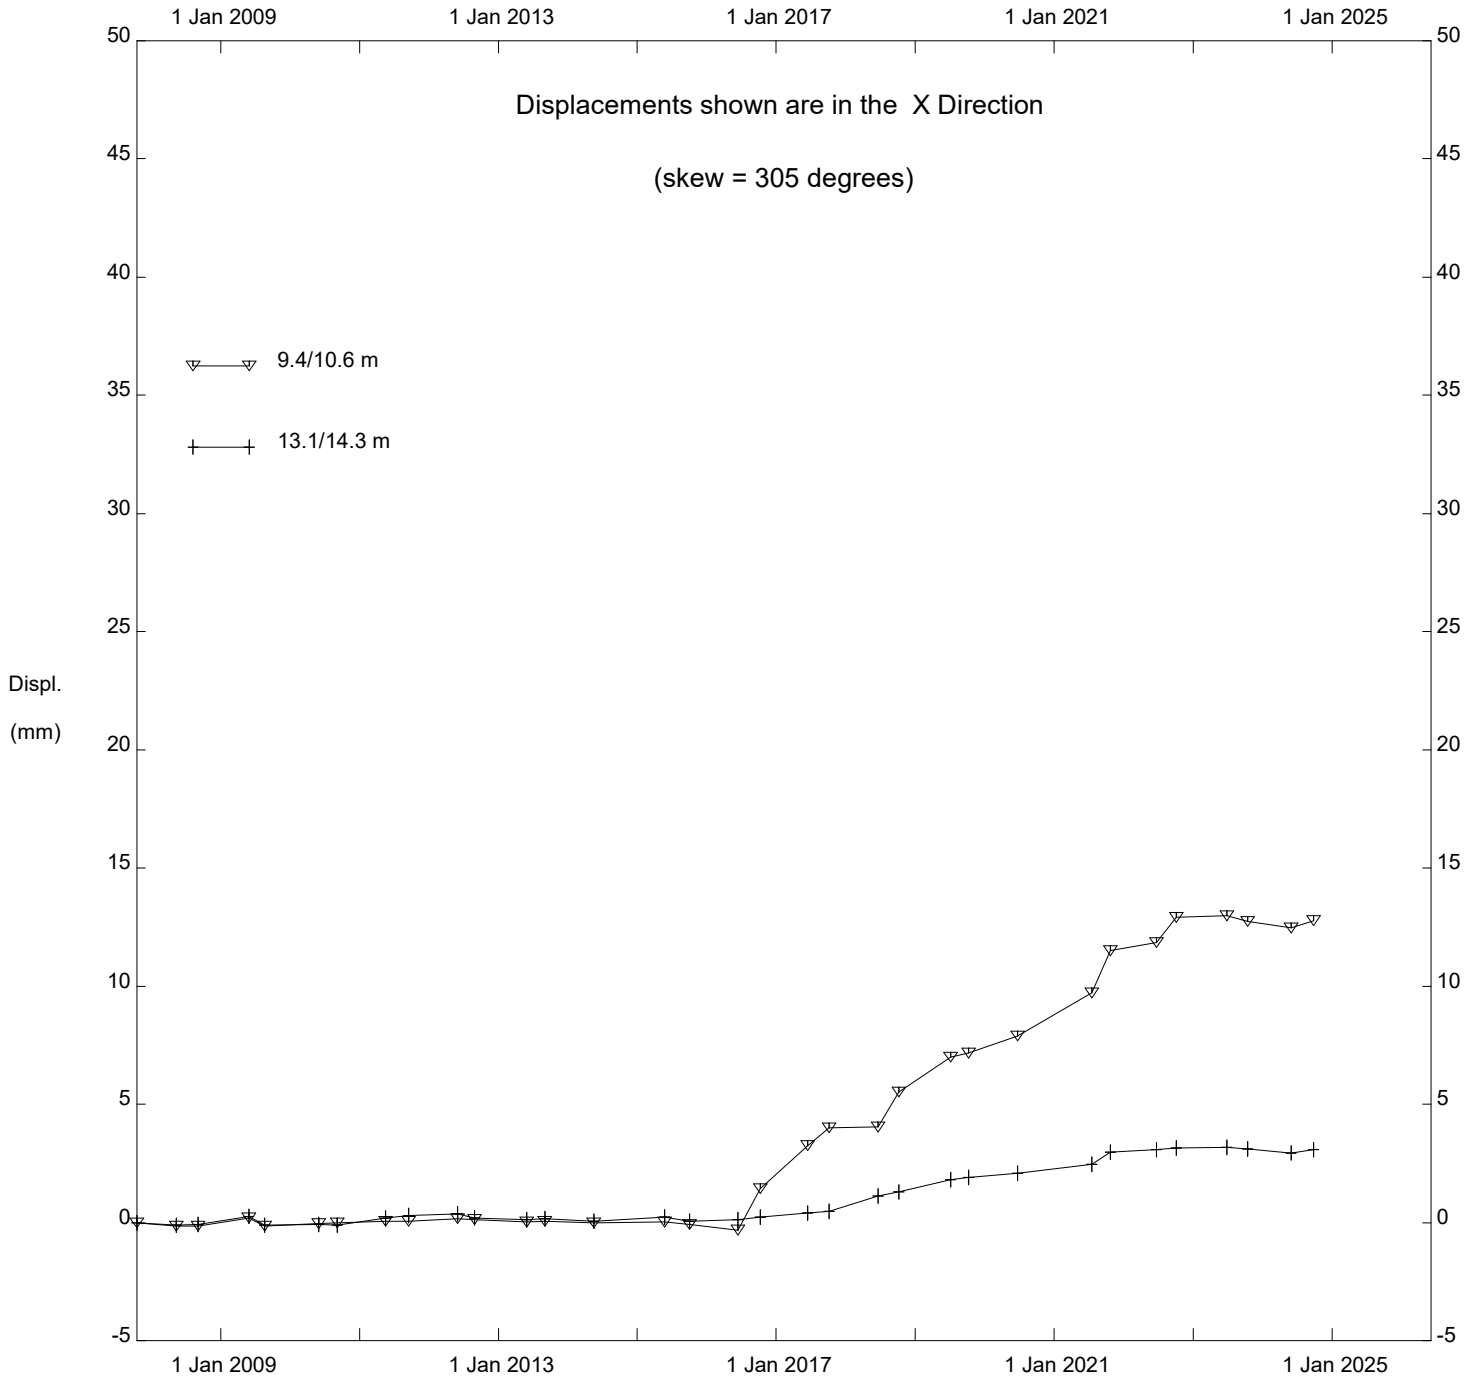
GP029 HWY 2:70 (Church Camp), Inclinometer SI-3

20.2 over 33.8 m to 35.1 m depth in 79° direction	6.9 in October 2020			No discernible movement	N/A	-0.7
SI-3	October 18, 2007	43.2 over 5.2 m to 7.0 m depth in 113° direction	7.6 in July 2021	Operational	May 29, 2024	1.1	3.5	0.4

12.8 over 9.4 m to 10.6 m depth in 81° direction	6.7 in October 2016			0.3	0.9	1.4
		3.1 over 13.1 m to 14.3 m depth in 81° direction	2.0 in October 2021			0.2	0.5	0.8

4.8 over 18.0 m to 19.2 m depth in 91° direction	2.3 in October 2018			0.1	0.4	0.5
SI17-1	September 15, 2017	7.0 over 24.4 m to 26.3 m depth in 85° direction	8.1 in October 2018	Sheared at 33.2 m	June 26, 2023	N/A	N/A	N/A

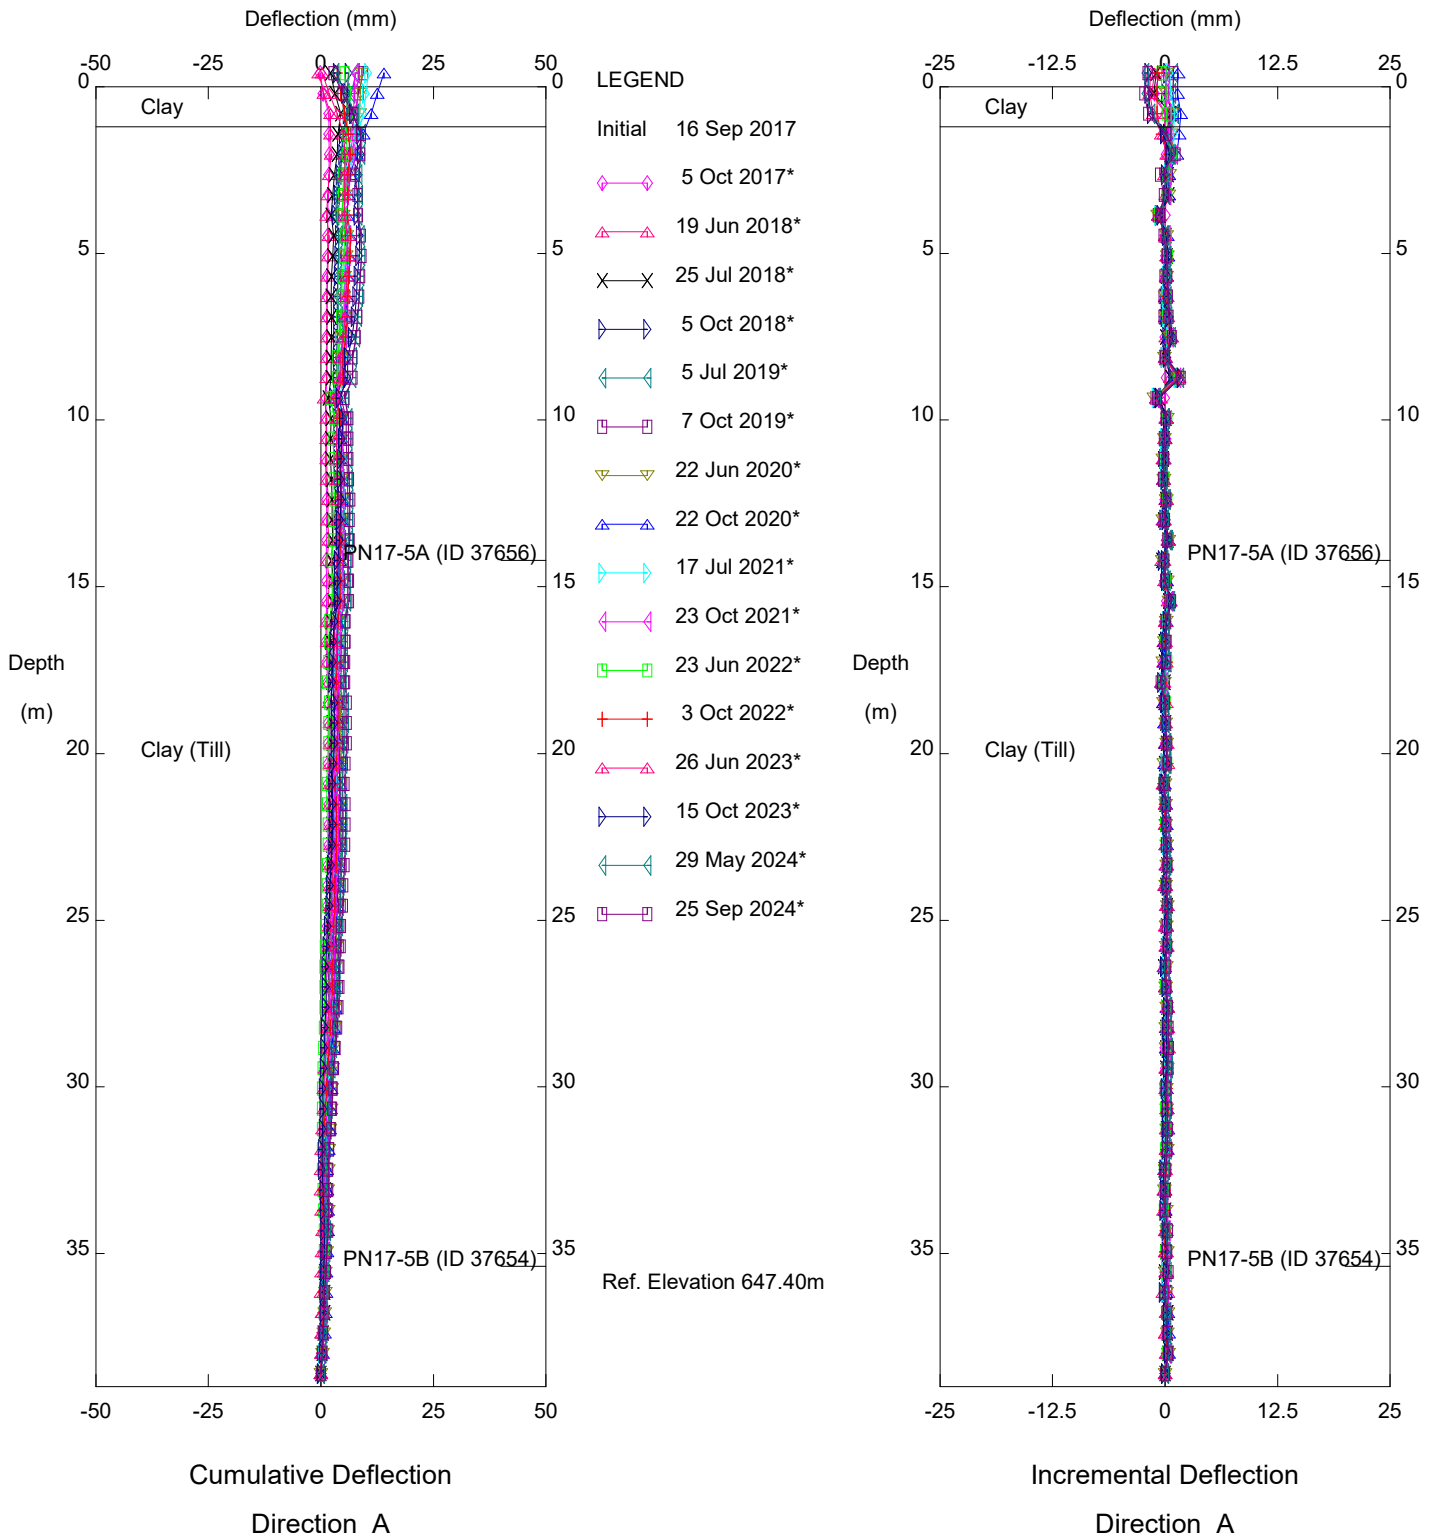
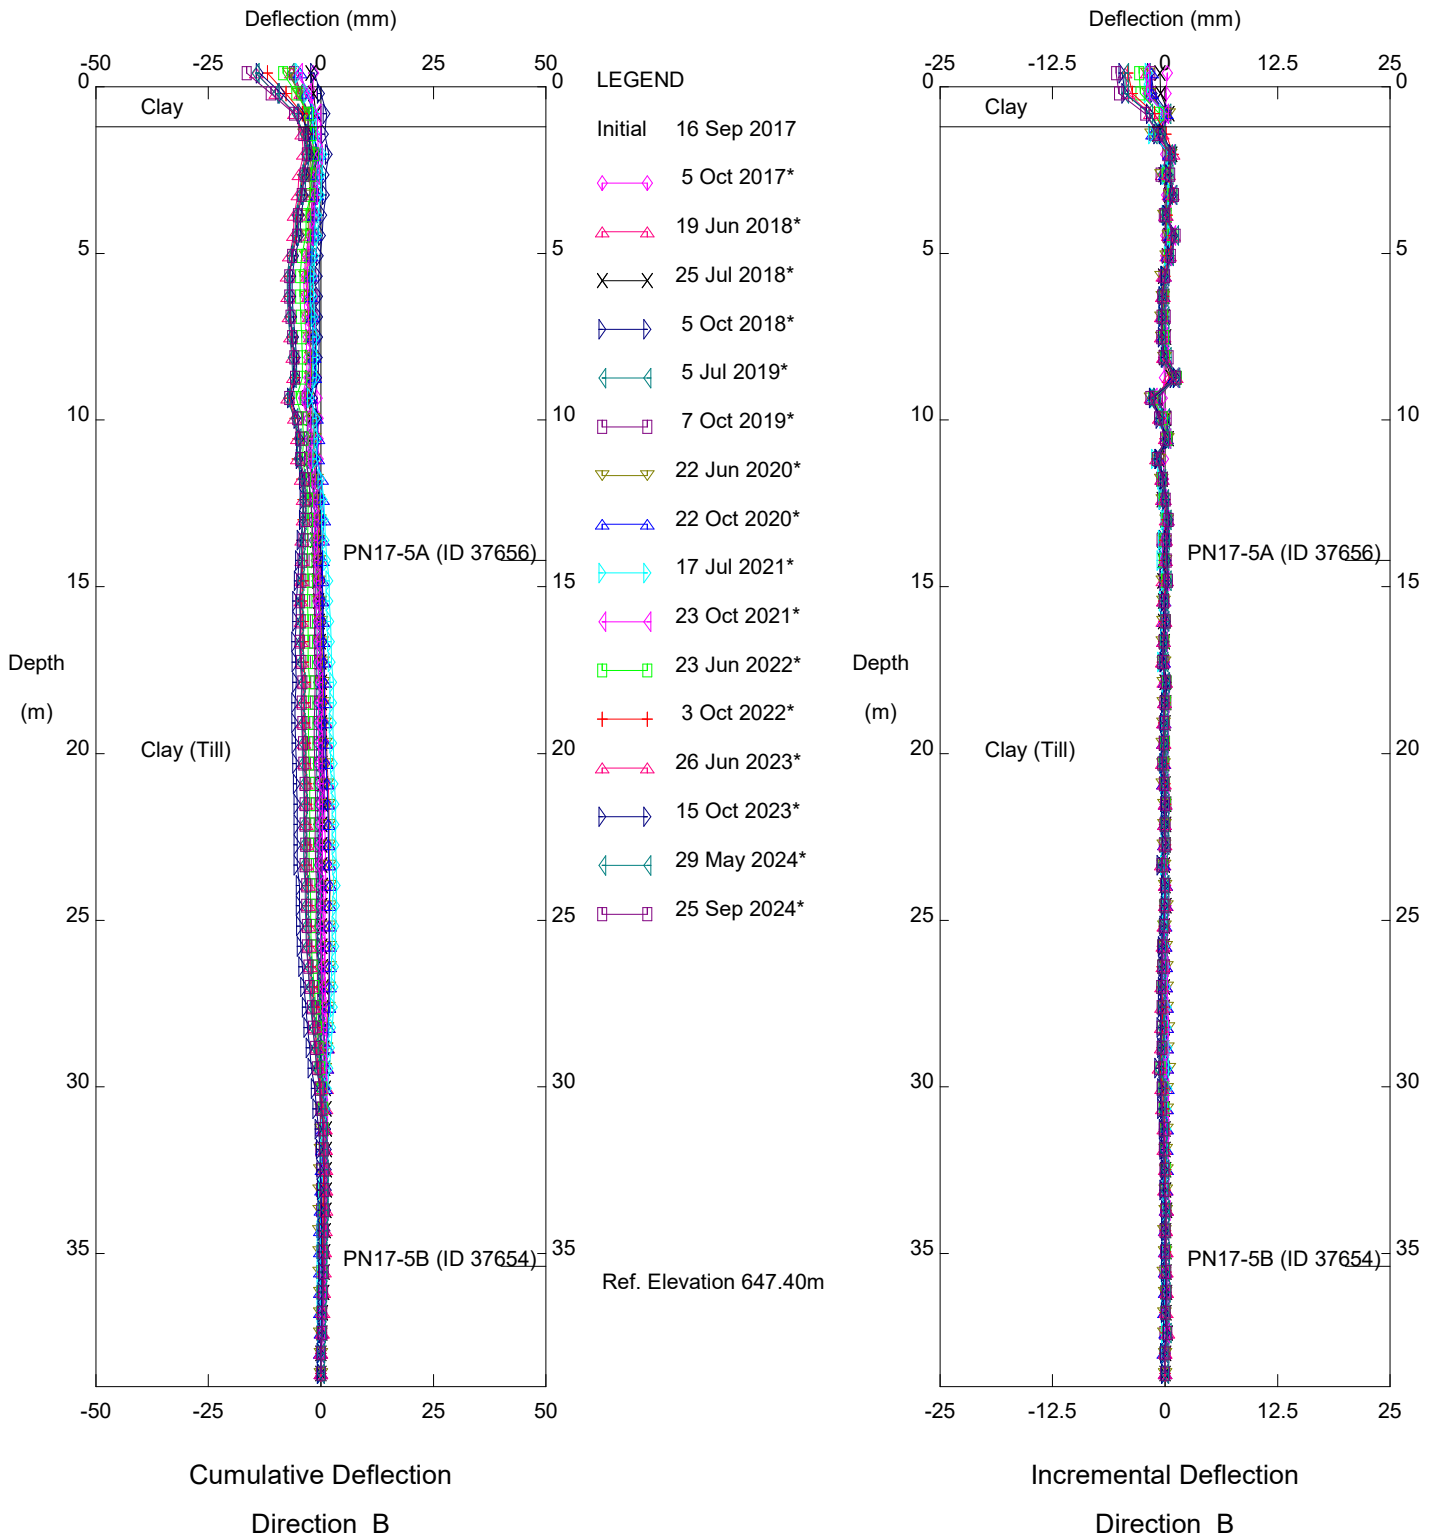
GP029 - Church Camp Slide, Inclinometer SI17-5

6.9 m over 21.5 m to 23.3 m depth in 110° direction	10.4 in October 2018			N/A	N/A	N/A
		38.0 over 47.1 m to 50.8 m depth in 110° direction	31.9 in October 2018			N/A	N/A	N/A
SI17-3	September 15, 2017	No discernible movement	N/A	Sheared at 43.6 m	October 5, 2018	N/A	N/A	N/A
SI17-4	September 15, 2017	11.8 over 37.4 m to 39.2 m depth in 118° direction	17.5 in July 2018	Sheared at 45.1 m	October 5, 2018	N/A	N/A	N/A
SI17-5	September 16, 2017	No discernible movement	N/A	Operational	May 29, 2024	N/A	N/A	N/A

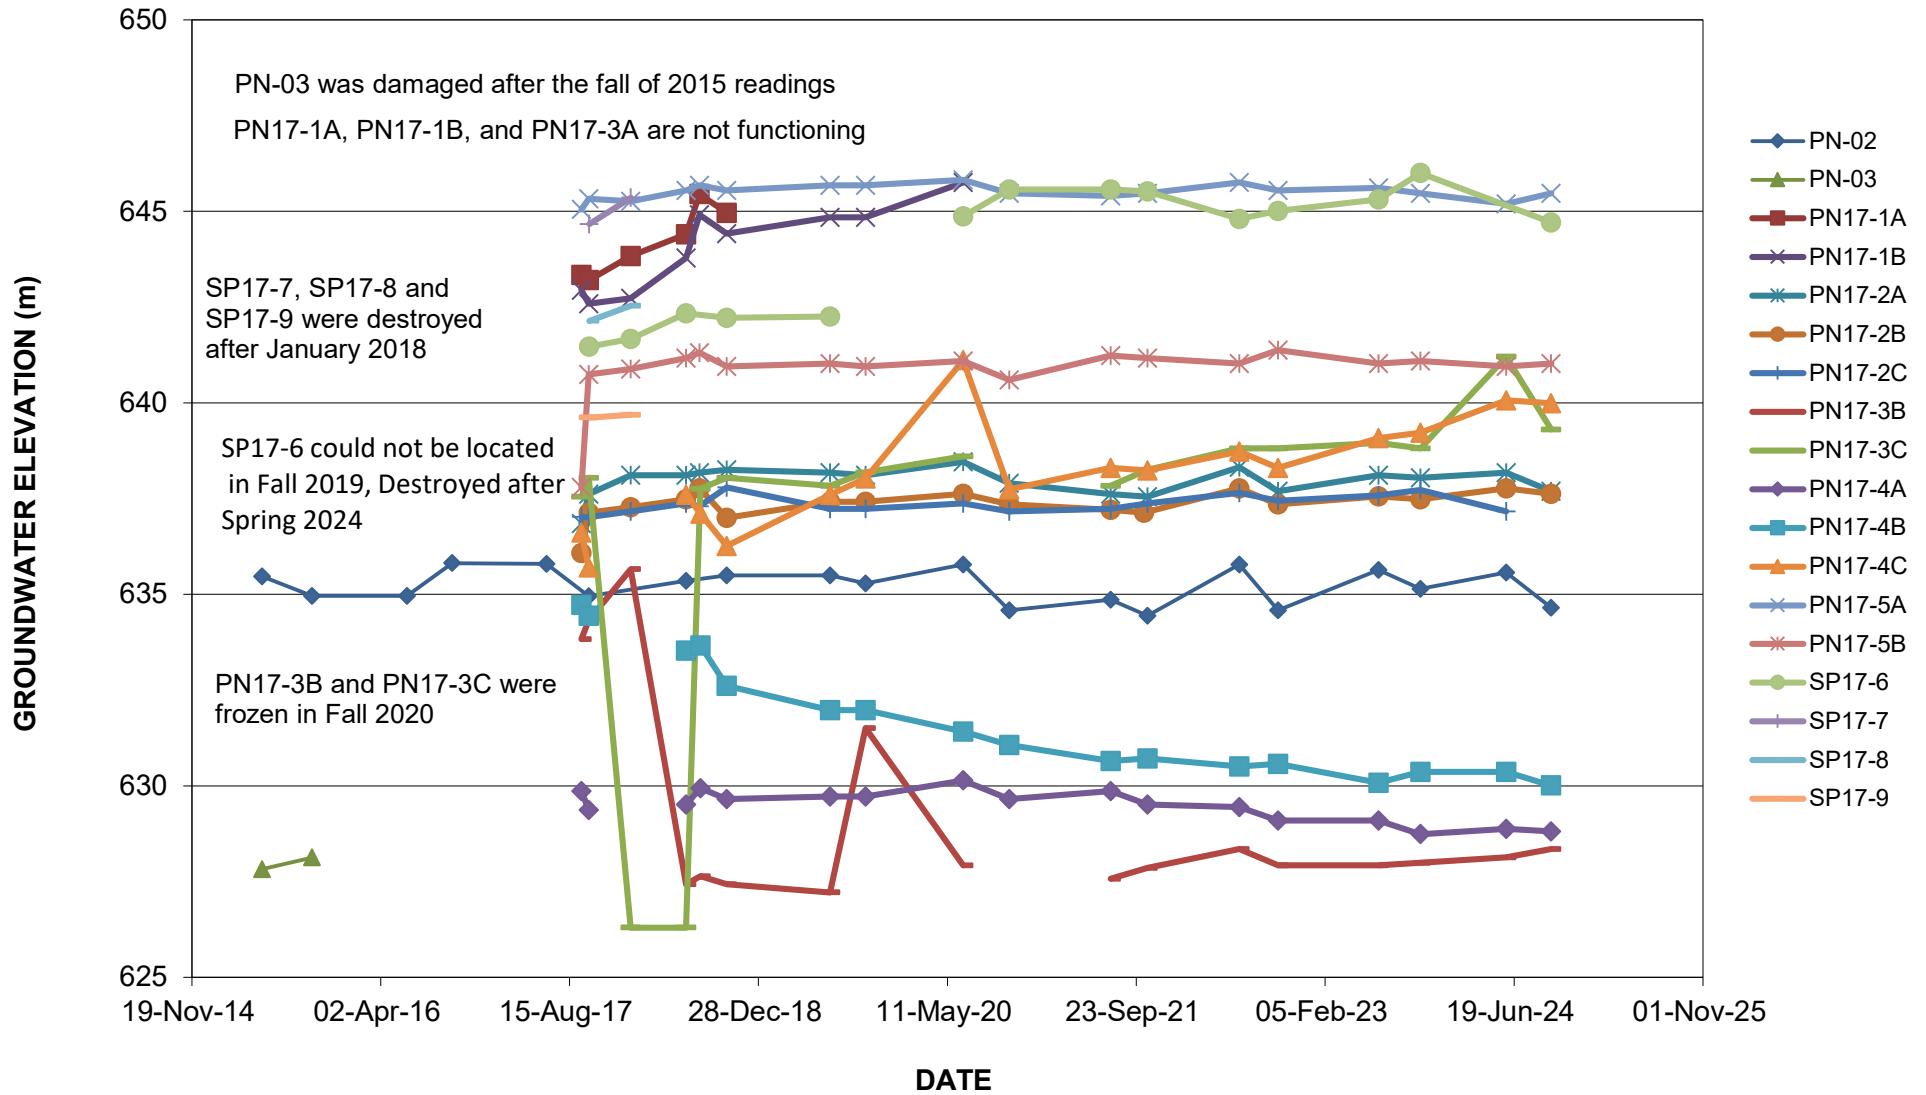
**FIGURE GP029-1
PIEZOMETRIC ELEVATIONS FOR HWY 2:70 CHURCH CAMP SLIDE**

Pneumatic piezometers PN-02, PN17-2A, PN17-2B, PN17-3C, PN17-4A, PN17-4B, and PN17-4C showed decreases in groundwater level of 0.92 m, 0.49 m, 0.14 m, 1.9 m, 0.07 m, 0.35 m, and 0.07 m, respectively, since the spring of 2024 readings. PN17-3C and PN17-4C are currently showing significant above-ground (artesian) groundwater levels of 9.81 m and 8.80 m, respectively. PN17-3B, PN17-5A, and PN17-5B showed increases in groundwater level of 0.21 m, 0.28 m, and 0.07 m, respectively, since the spring of 2024 readings. Overall, the piezometers are generally showing groundwater levels in line with historic groundwater level readings at the site.
Future Work:	The instruments should be read again in the spring of 2025. PN17-2C should be read again and if it is still malfunctioning, it should be removed from future readings.
Instrumentation Repairs:	No instrument repairs are required at this time.
Additional Comments:	Additional readings could be done during construction of the highway realignment; this would be advisable if cracks on the existing highway begin to open as construction proceeds.
