**ALBERTA TRANSPORTATION AND
ECONOMIC CORRIDORS GRMP
GRANDE PRAIRIE REGION –
(GRANDE PRAIRIE NORTH)
INSTRUMENTATION MONITORING - SPRING 2024**

Site Number	Location	Name	Hwy	km
GP029	HWY 2:70 km 11.88	Church Camp Slide	2:70	Km 11.9
Legal Description: 16-4-77-5 W6		UTM Co-ordinates		
		11U E 393096	N	6168377

Current Monitoring:	29-May-2024	Previous Monitoring	15-Oct-2023
Instruments Read By:	Mr. Niraj Regmi, G.I.T and Mr. Nixon Mationg, of Thurber

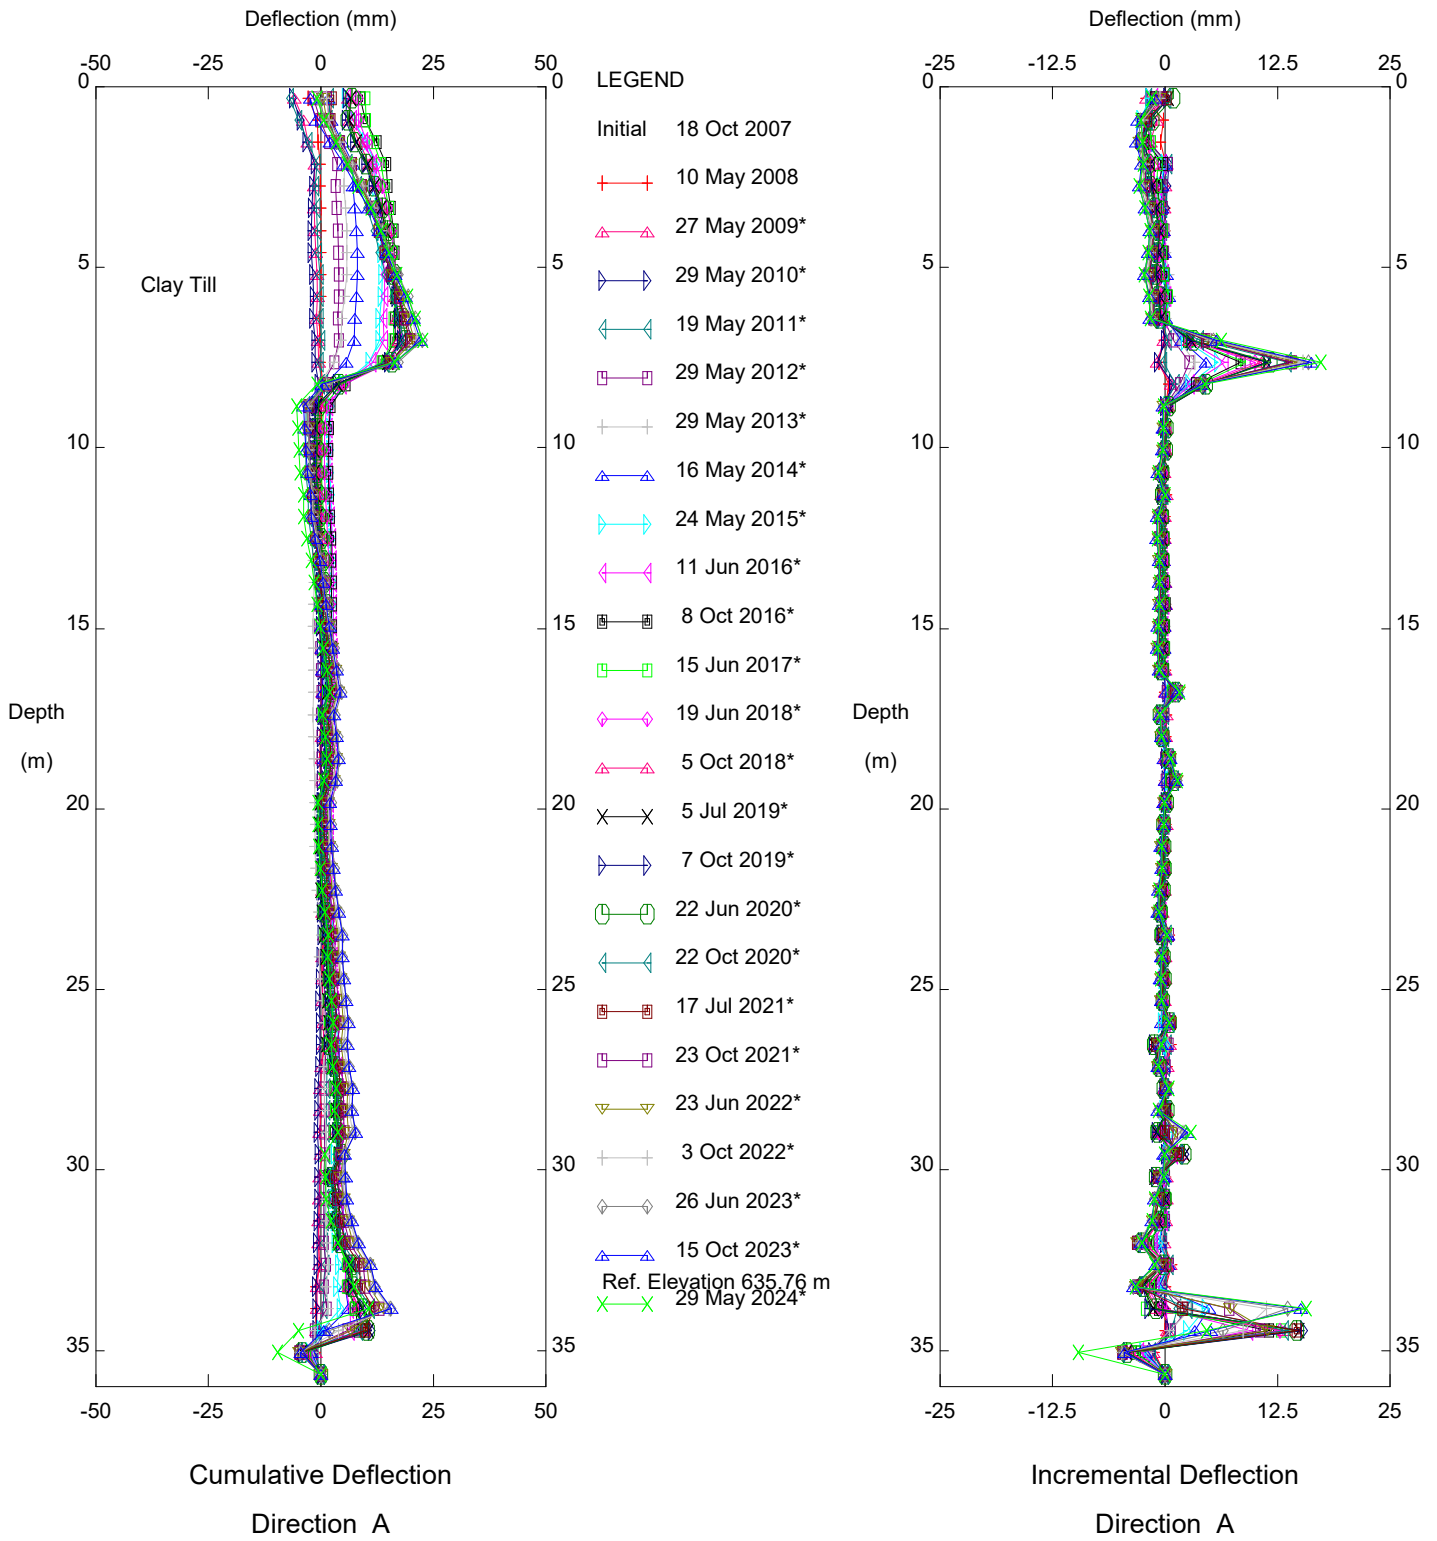
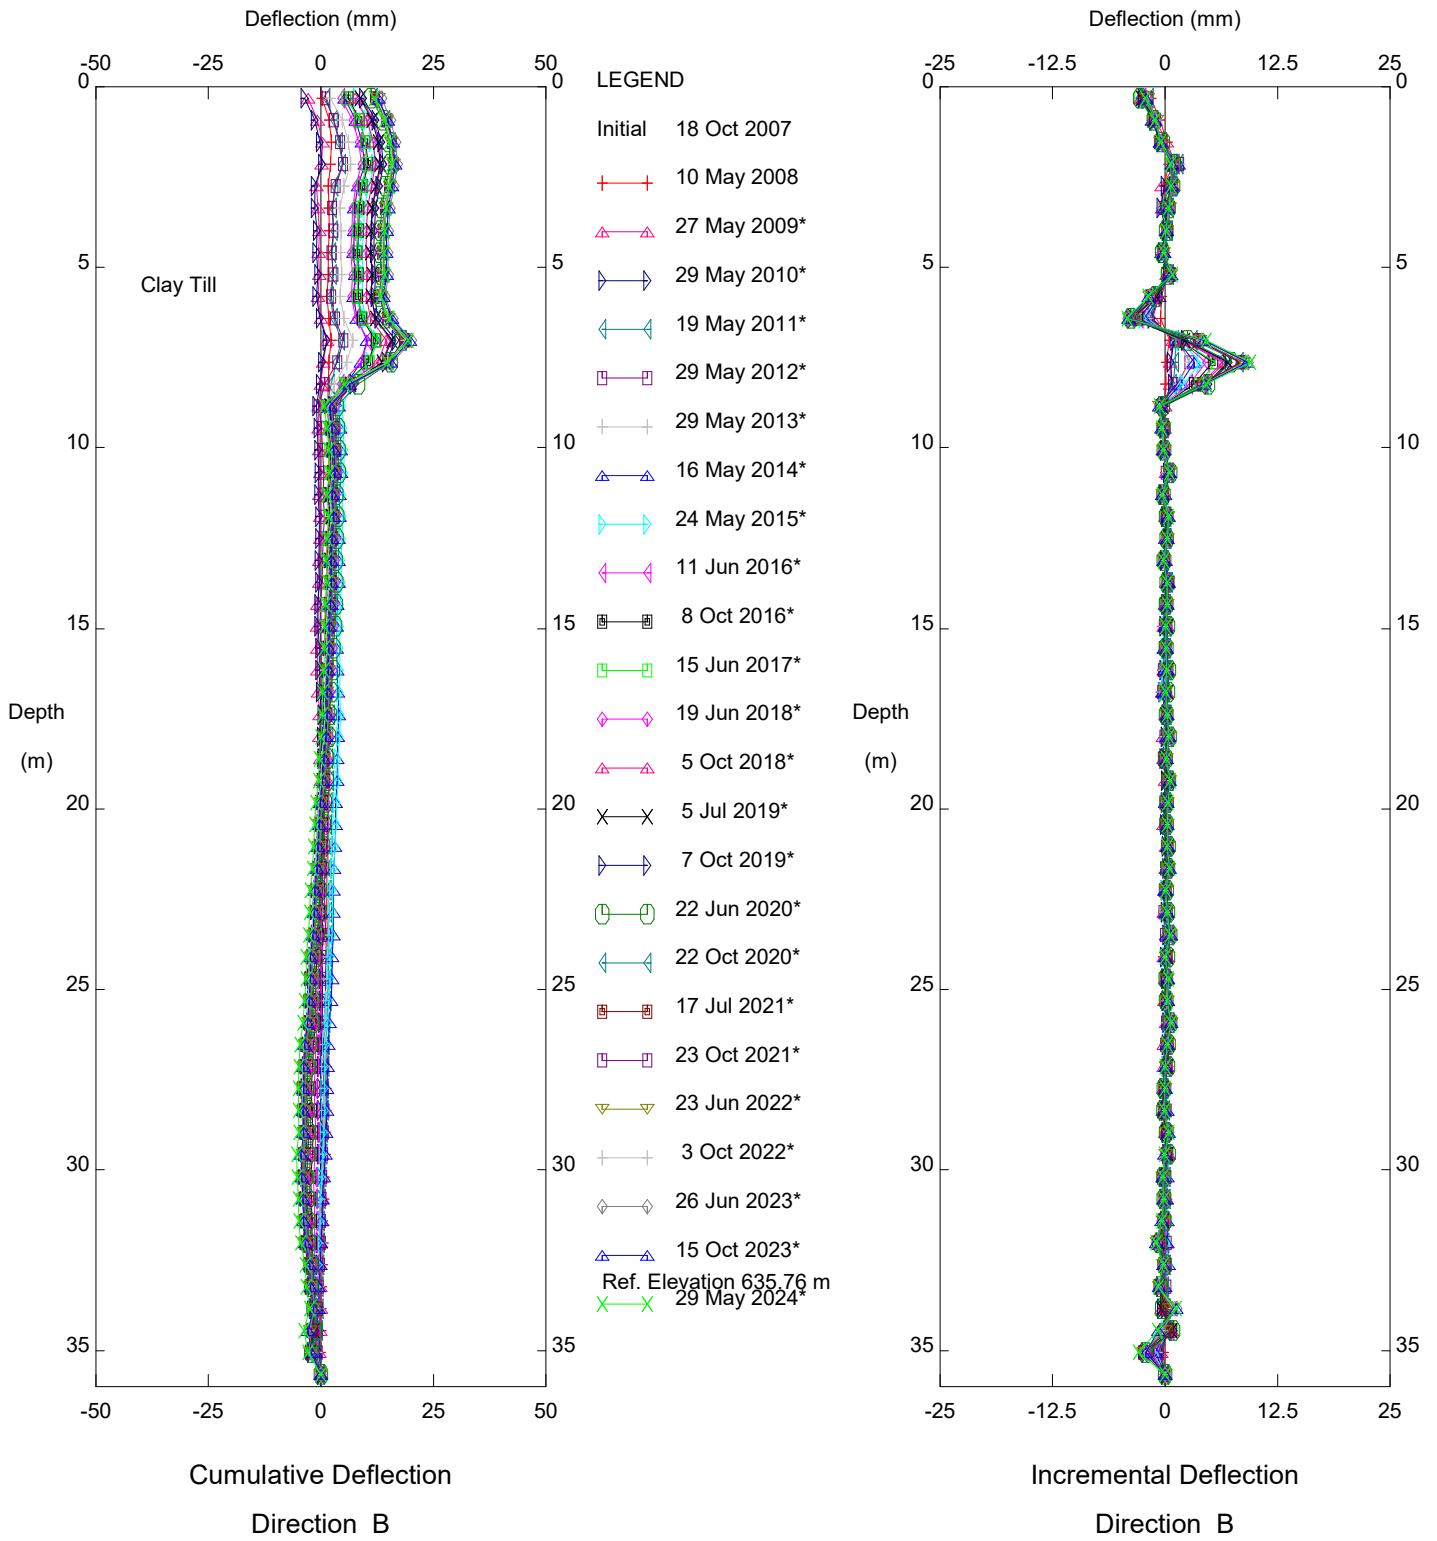
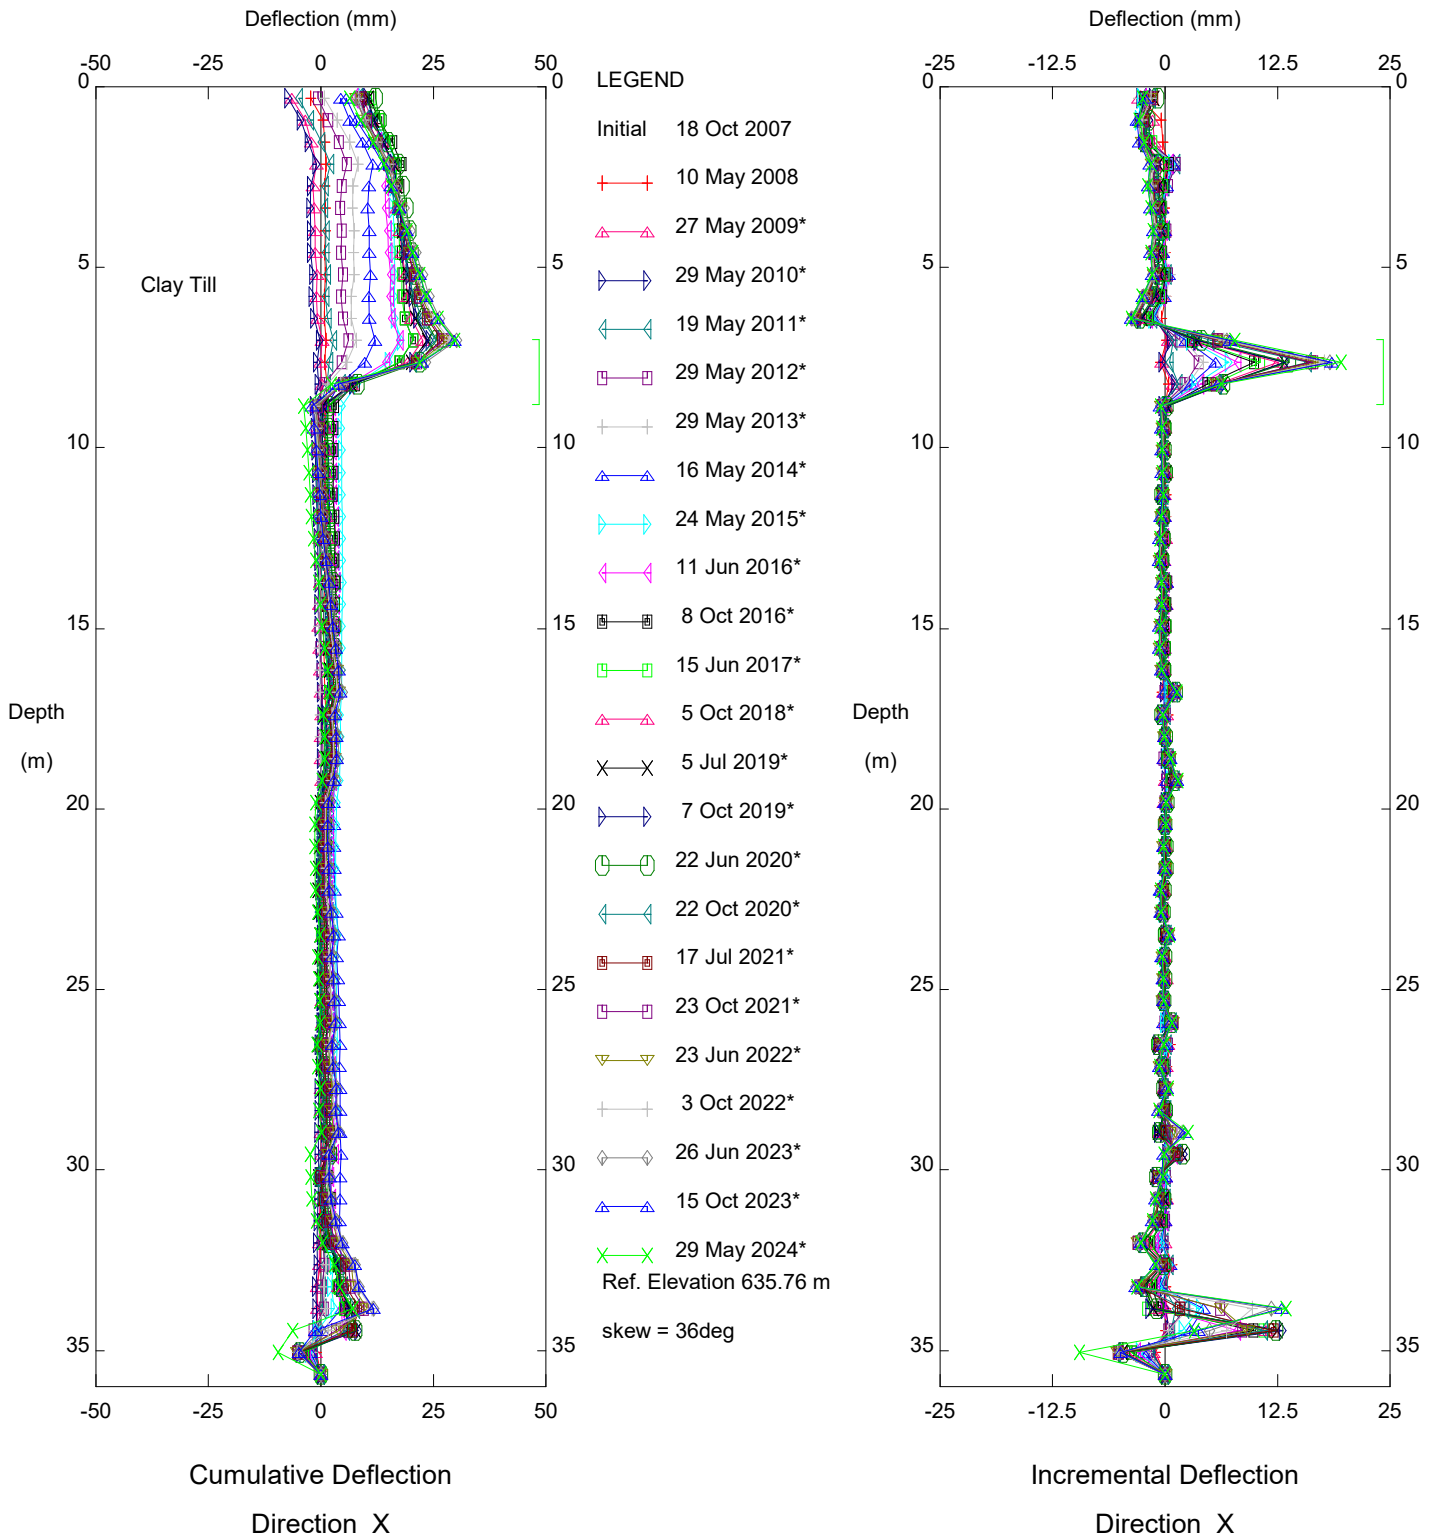
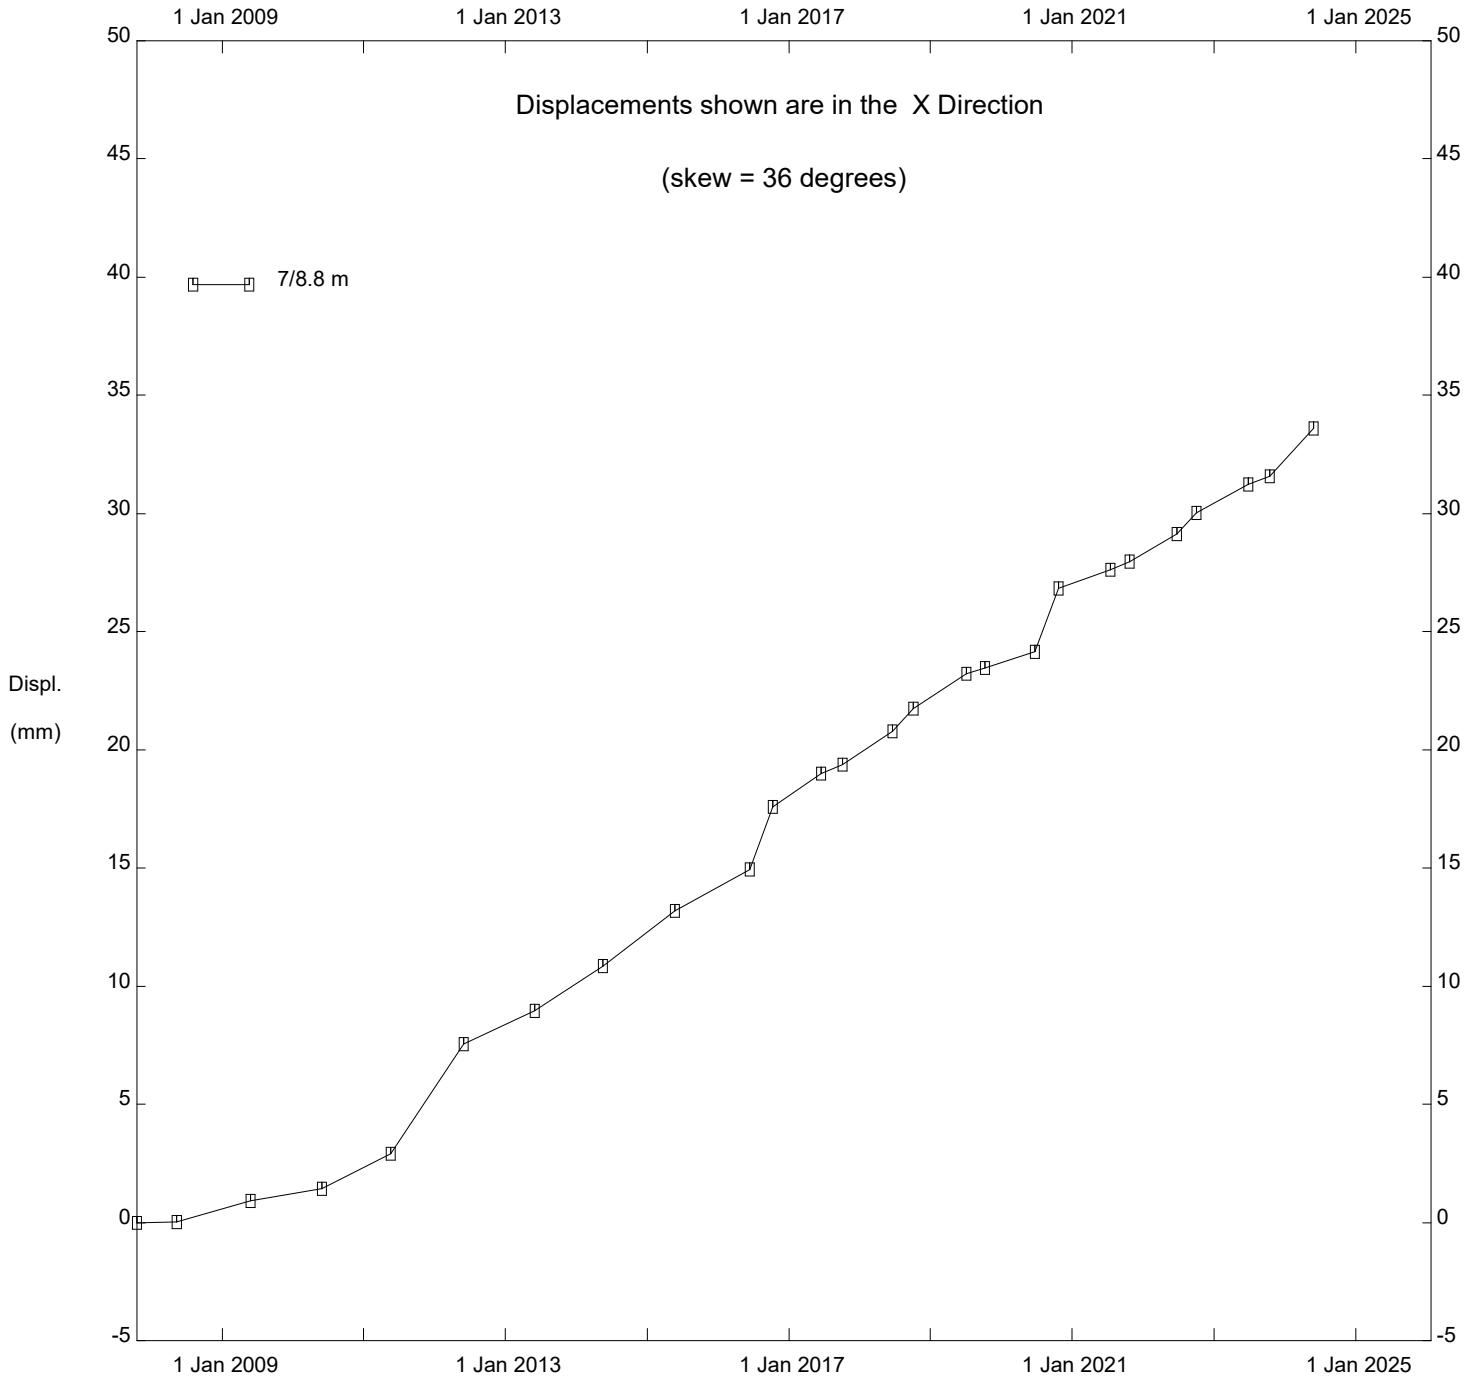
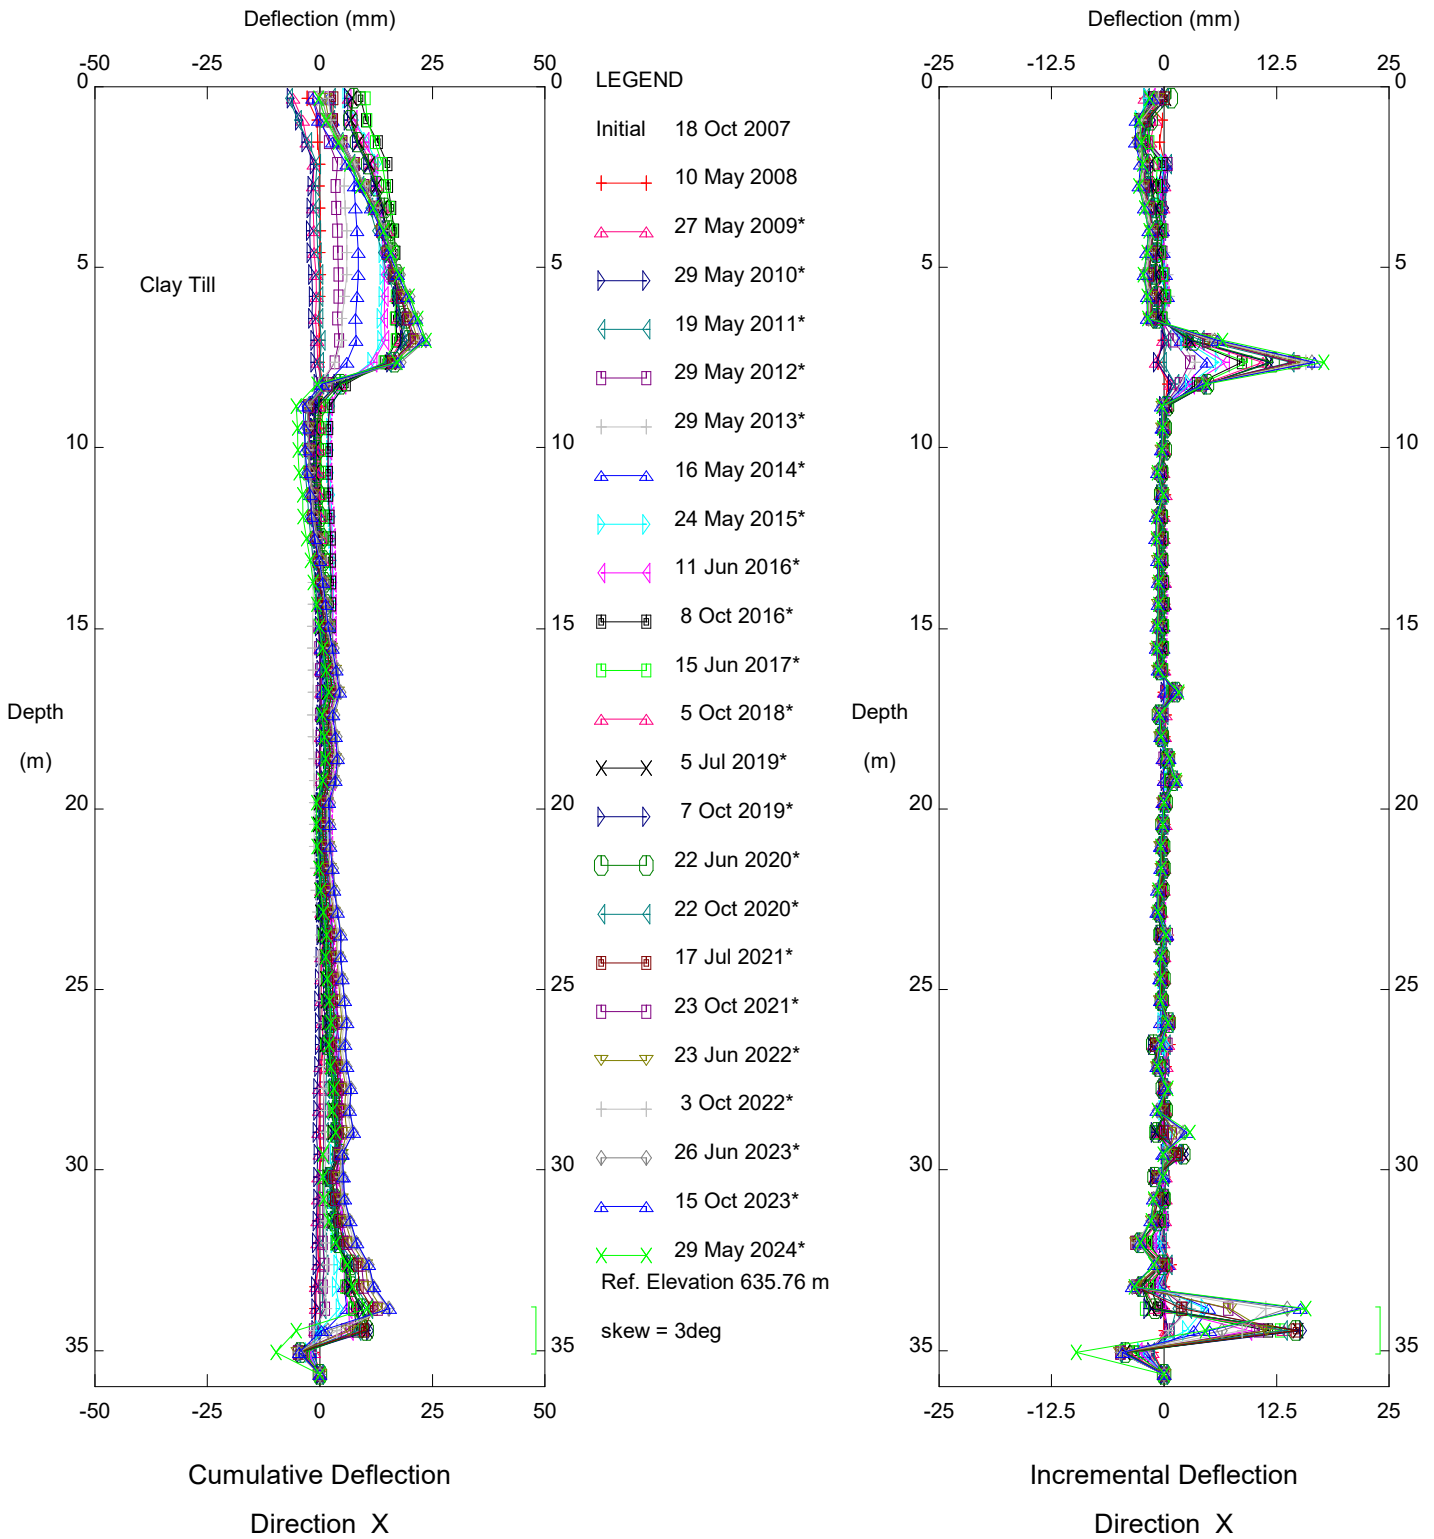
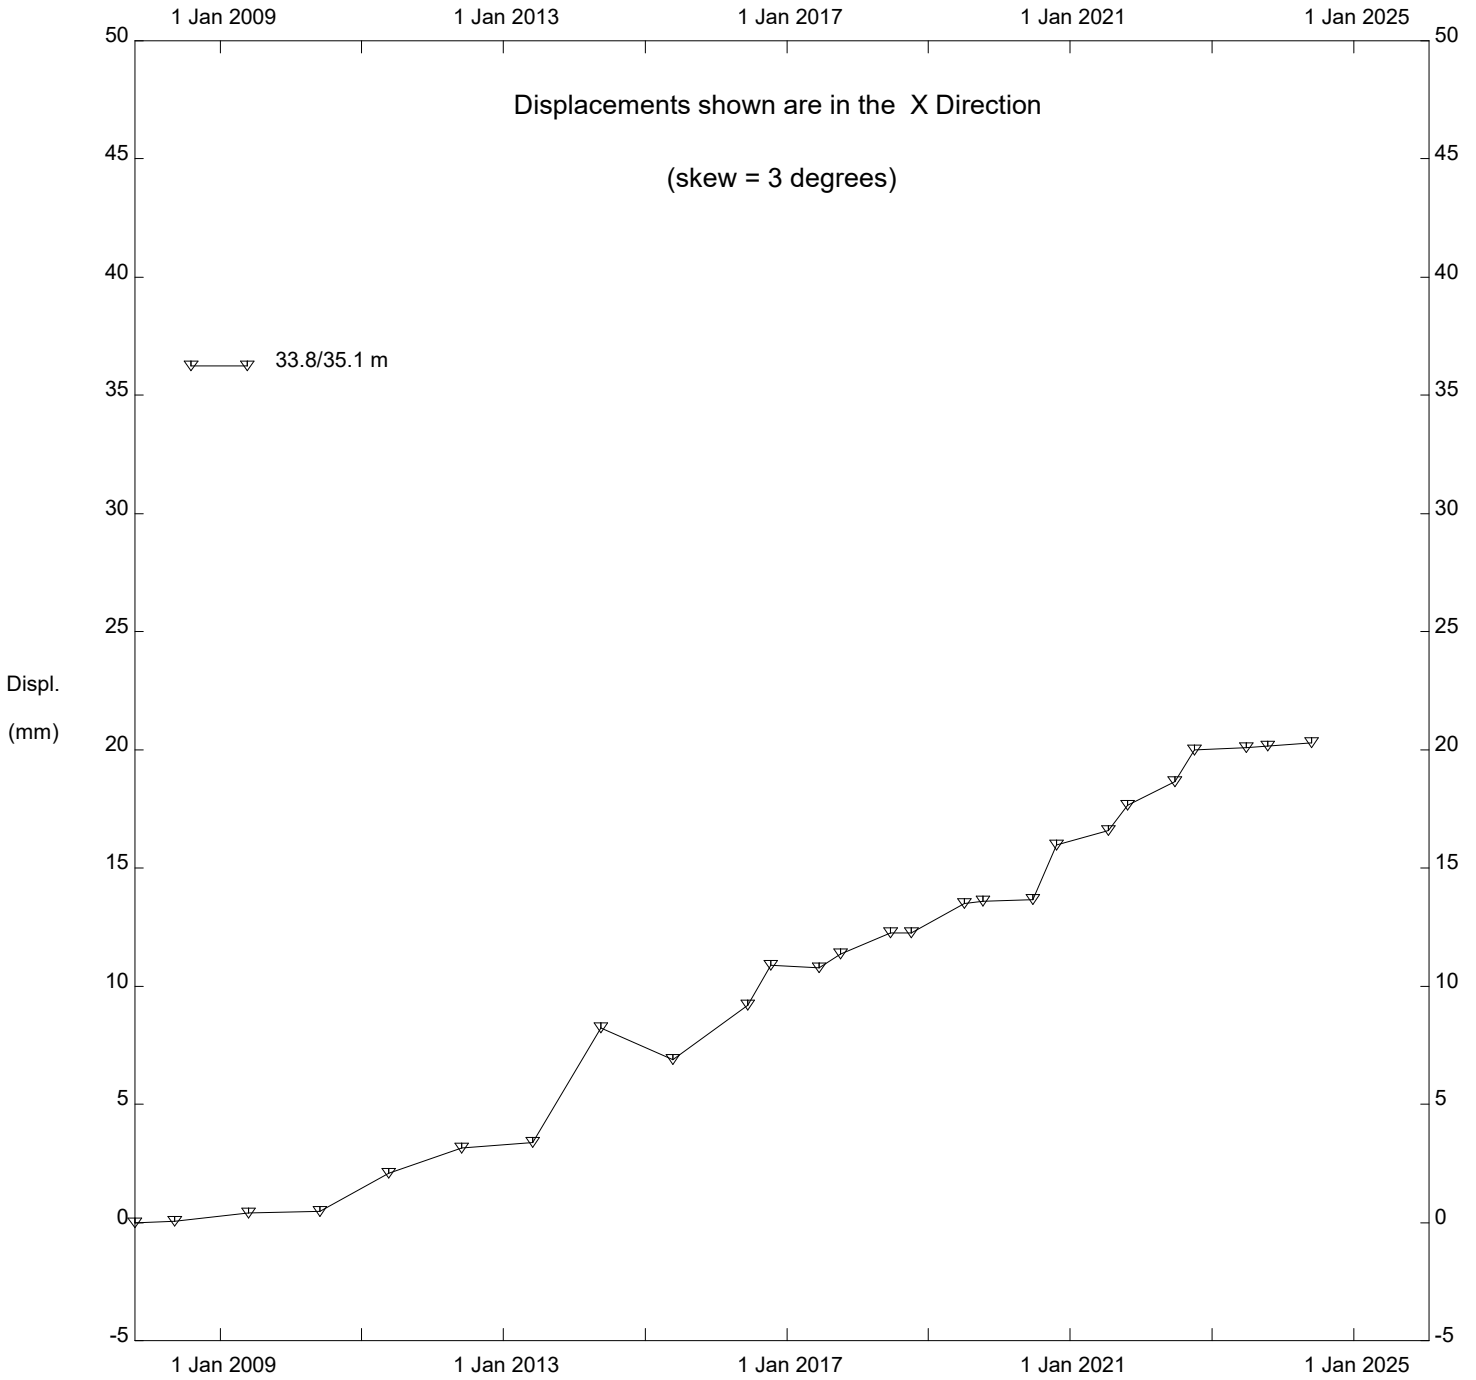
GP029 HWY 2:70 (Church Camp), Inclinometer SI-2

Discussion	
Zones of New Movement:	None
Interpretation of Monitoring Results:	<p>Slope inclinometer SI-2 showed a rate of movement of 3.2 mm/yr over 7.0 m to 8.8 m depth and a rate of movement of 0.2 mm/yr over 33.8 m to 35.1 m depth since the fall of 2023 readings. Both zones of movement have small changes in movement rate compared to the previous readings cycle.</p> <p>SI-3 has four known zones of movement. The uppermost zone showed a rate of movement of 3.1 mm/yr over 5.2 m to 7.0 m depth. There were no discernible movements over 9.4 m to 10.6 m depth, 13.1 m to 14.3 m depth and 18.0 m to 19.2 m depth since the fall of 2023 readings. The zone of movement over 5.2 m to 7.0 m depth in SI-3 showed an acceleration in movement of 5.1 mm/yr compared to the fall of 2023 readings. The other zones of movement showed small changes in movement compared to the fall of 2023 readings.</p> <p>SI17-5 has shown no discernible movement since initialization as it is likely still located just outside of the landslide influence zone.</p>

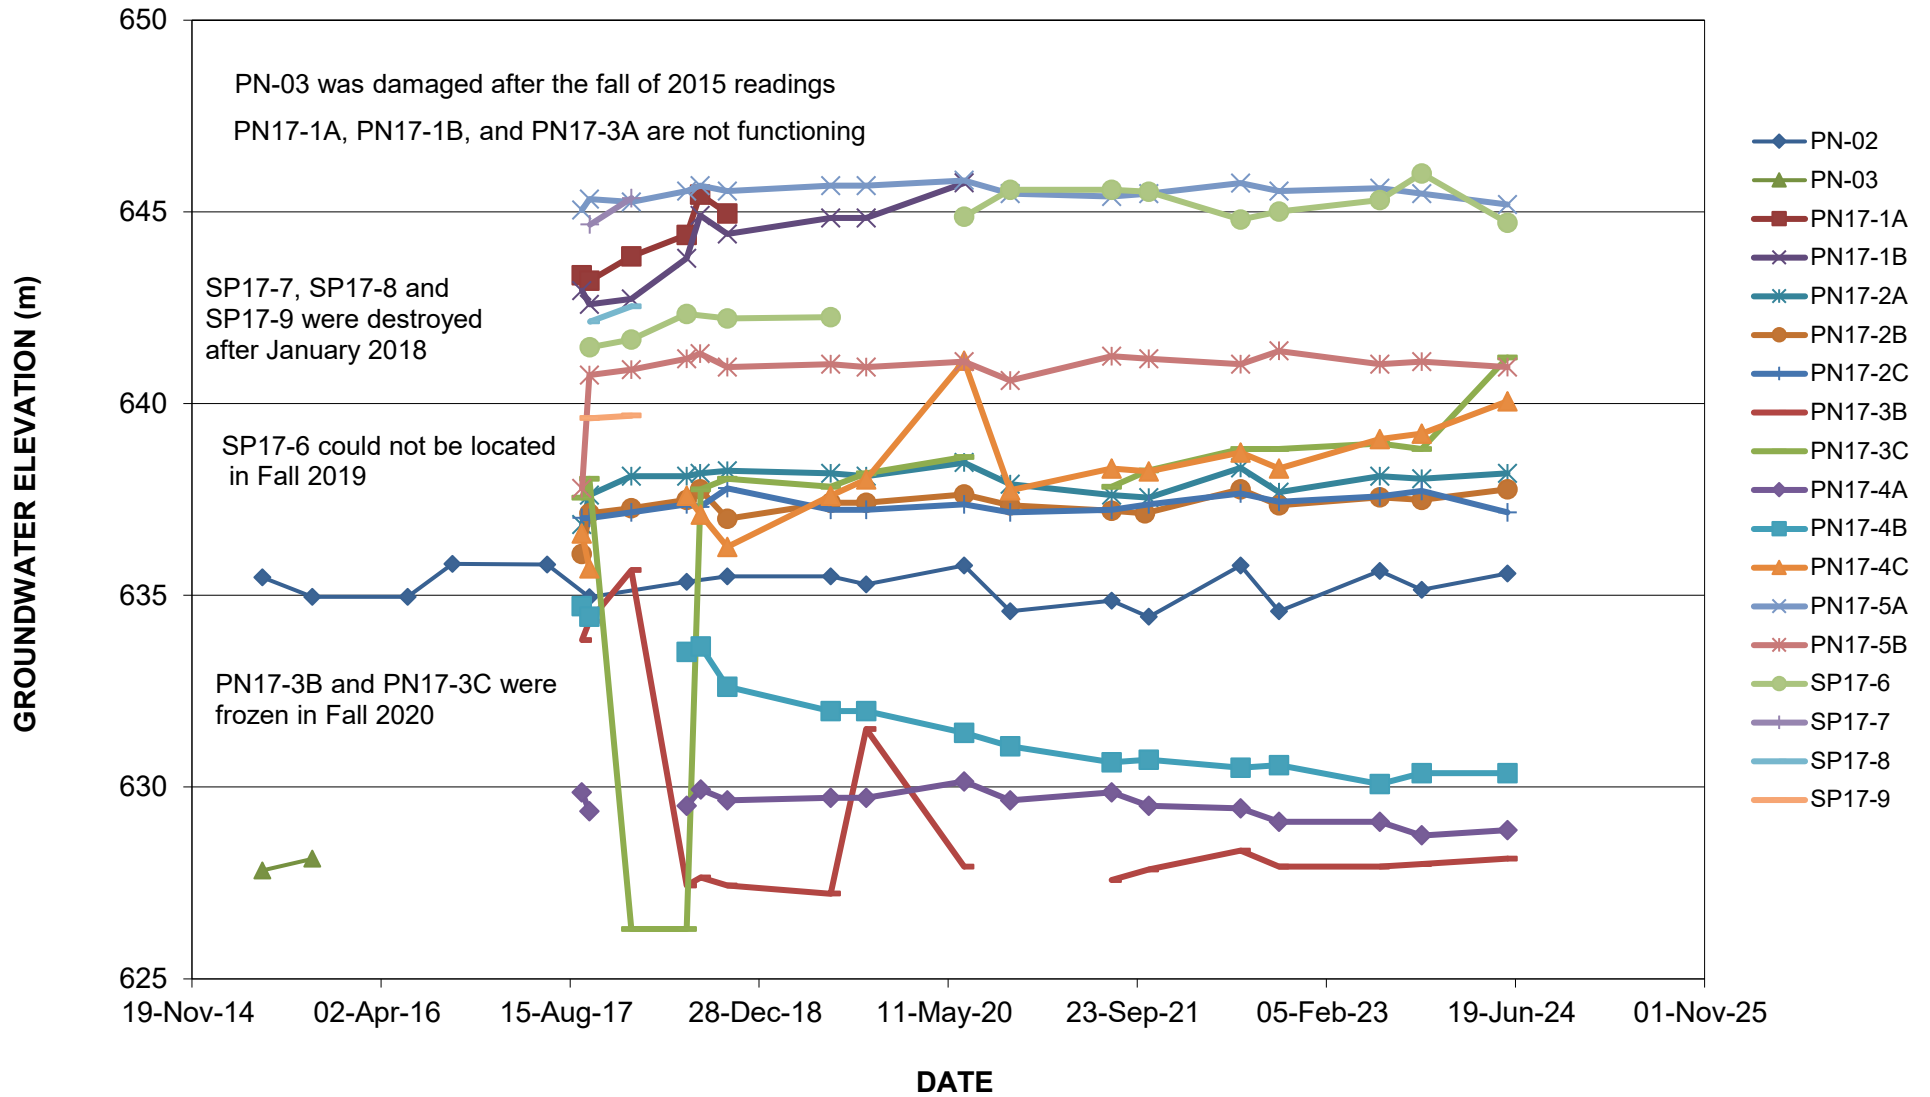
**FIGURE GP029-1
PIEZOMETRIC ELEVATIONS FOR HWY 2:70 CHURCH CAMP SLIDE**

<p>Pneumatic piezometers PN-02, PN17-2A, PN17-2B, PN17-3B, PN17-3C, PN17-4A and PN17-4C showed increases in groundwater level of 0.43 m, 0.14 m, 0.28 m, 0.15 m, 2.39 m, 0.14 m, and 0.84 m, respectively, since the fall of 2023 readings. PN17-3C is currently showing the highest groundwater elevation recorded in the instrument since initialization of 641.20 m. PN17-3C and PN17-4C are currently showing above-ground (artesian) groundwater levels of 11.70 m and 9.93 m, respectively. PN17-2C, PN17-5A, and PN17-5B showed decreases in groundwater level of 0.56 m, 0.28 m, and 0.14 m, respectively, since the fall of 2023 readings.</p> <p>Standpipe piezometer SP17-6 showed a decrease in groundwater level of 1.29 m since the fall of 2023 readings.</p> <p>Overall, the piezometers are generally showing groundwater levels in line with historic groundwater level readings at the site, with the exception of PN17-3C.</p>
