**ALBERTA TRANSPORTATION AND  
ECONOMIC CORRIDORS  
GEOHAZARD ASSESSMENT PROGRAM  
PEACE REGION – GRANDE PRAIRIE DISTRICT - NORTH  
2024 INSPECTION**

Site Number	Location	Name	Hwy	km
PH029	Grimms Creek	Old Site #4	682:02	13.54
Legal Description		UTM Co-ordinates (NAD83)		
NW36-81-5-W6		11	N	6214740
			E	397620

**PH029: GRIMM'S CREEK - HWY 682:02, BF 75379**  
**INSPECTION PLAN**

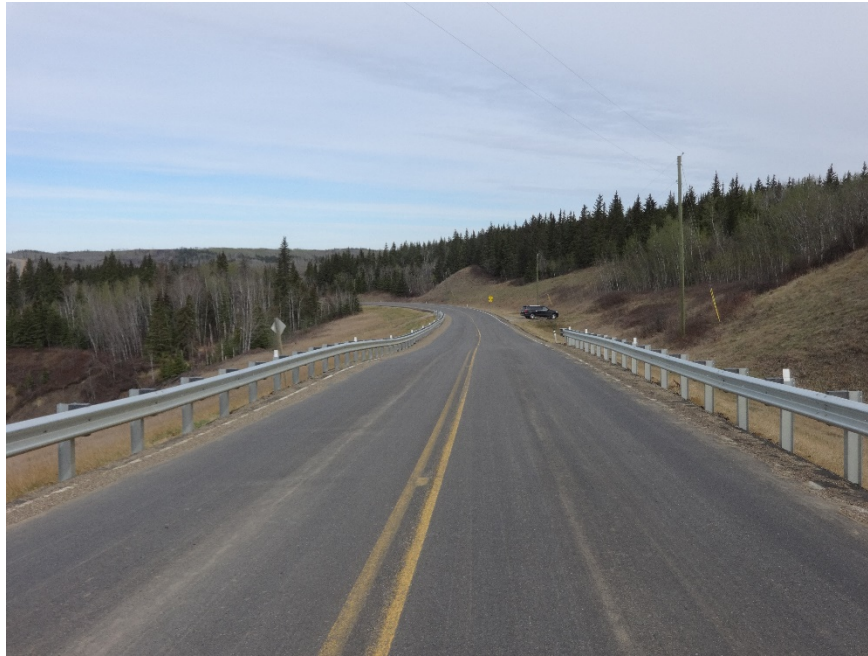
The cracking and settlements previously observed have not yet reflected through the 2023 overlay. Three dips exist on or near the pavement at this site which appeared to be the same or slightly worse, giving the road its undulating appearance. One dip is over top of the new culvert and is anticipated to be due to settlement of the soil since it's installation in 2009. Two other dips exist about 70 m apart on the highway. The east dip previously contained a diagonal crack across the highway which has not reflected through the 2023 overlay but could be coincident with each end of a large scarp that is developing north of the highway, directly above the subsidence and connected to active sliding observed further downslope on the south embankment.

**Photo 1. Looking west along the highway at where the highway was overlaid, note the dip in the guardrail. Photo credit: Don Proudfoot.**

Continue to monitor, and seal/patch/mill the pavement crack and dips as required.

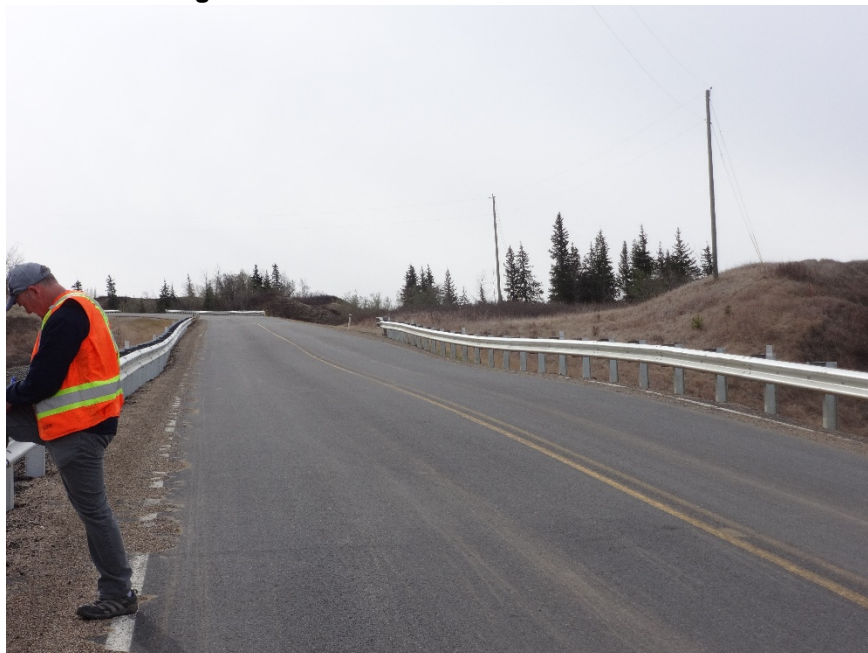
**Photo 2. View of where the slide scarp crack was located looking east along the highway from near the west end of the north guardrail. Photo credit: Nicole Wilder.**

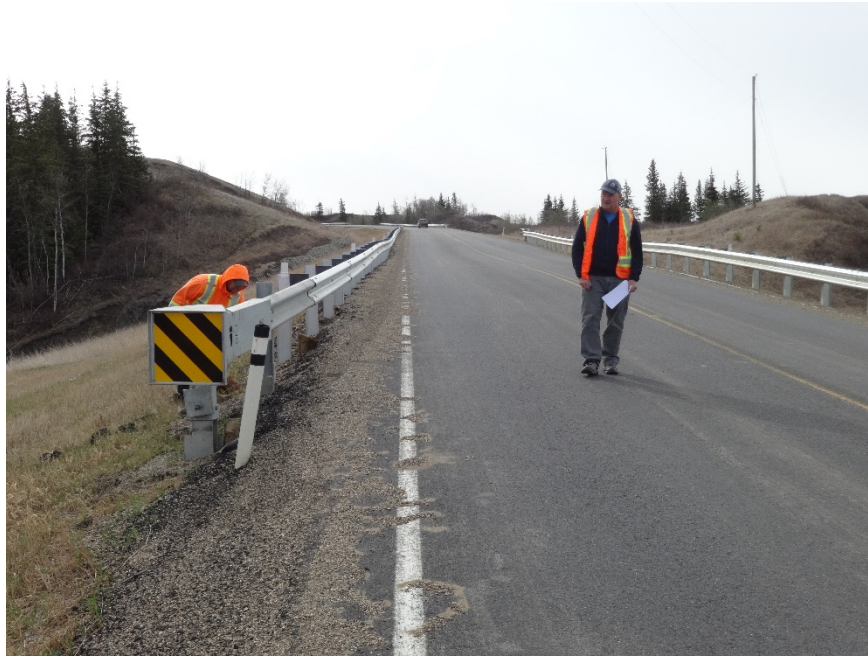
**Photo 3. Looking east along the highway at the west end of where the scarp crack was located but was overlayed. Photo credit: Nicole Wilder.**

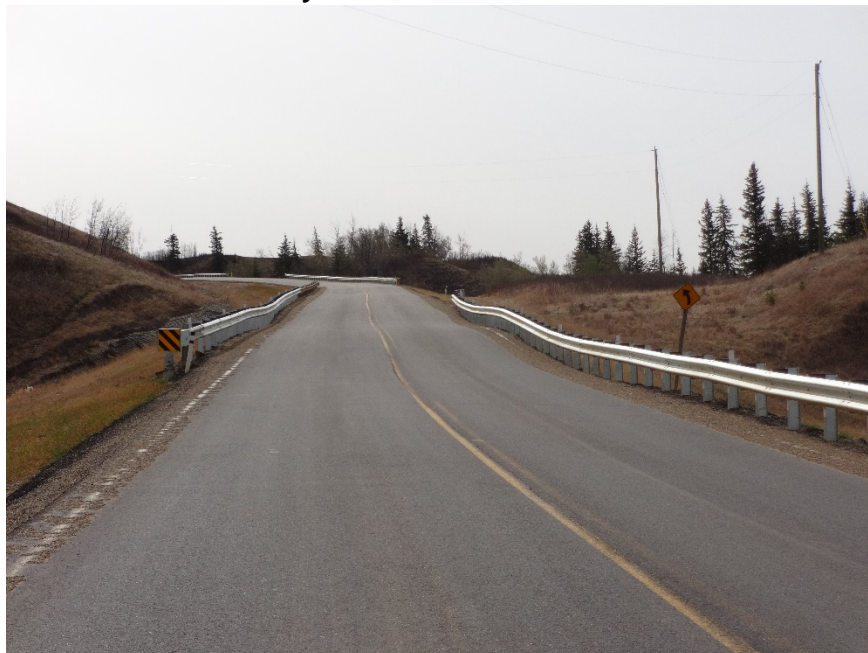
**Photo 4. Looking east along the highway at where it was paved but you can see the dip in the guardrail. Photo credit: Don Proudfoot.**

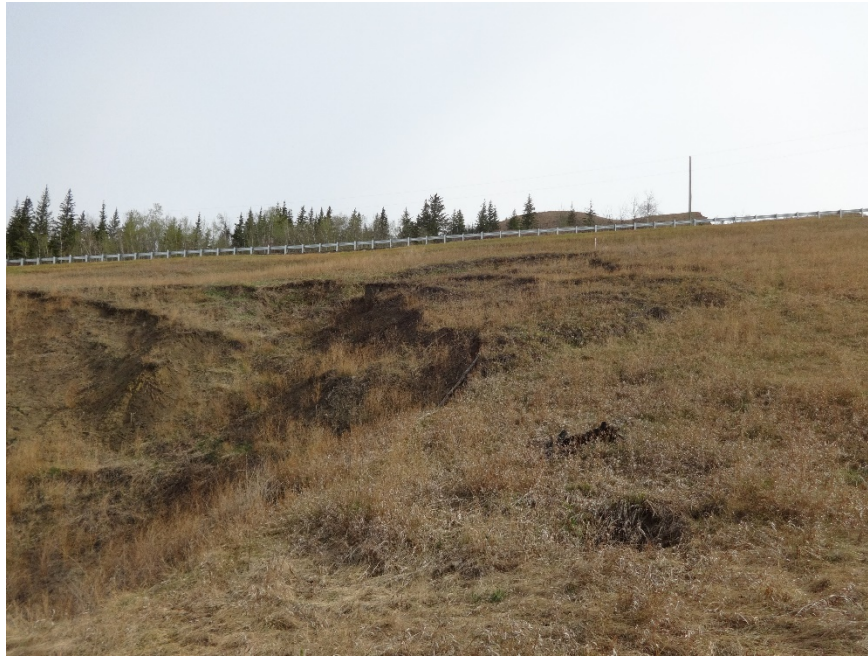
**Photo 5. Looking northwest towards the landslide and backscarp. Photo Credit: Don Proudfoot.**

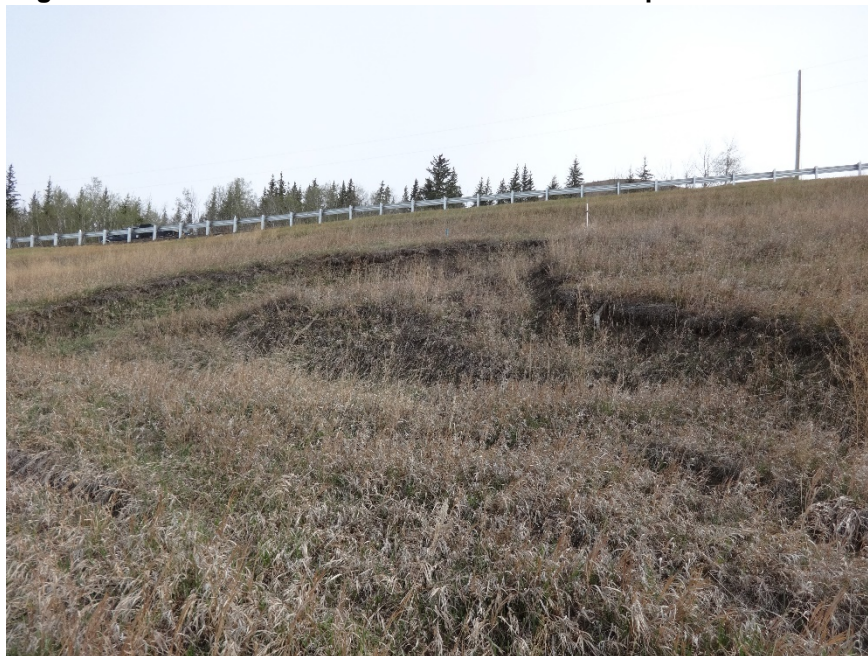
Movements were previously observed in the downstream embankment slope along the old culvert alignment. In 2024 they mainly appeared in similar condition as in 2023, and the rate of movement appears to have slightly decreased at SI-2 this year. Of the three remaining inclinometers, SI-2 near the west end of the site nearer to the highway is showing a decreased rate of movement, SI-3 in the flat area past the sideslope has never measured movement, and SI-4 between the new and old culverts near the highway is currently showing a very slight increase in movement rate.

**Photo 6. Looking north at slumping above the old culvert alignment on the south highway embankment. Photo Credit: Don Proudfoot.**

In order to curtail the increasing movements on the downstream embankment, it was proposed to flatten the slope further downslope into the old channel and construct a toe berm across it. Common fill for this repair could possibly be obtained from the ridge on the west side of the old channel.

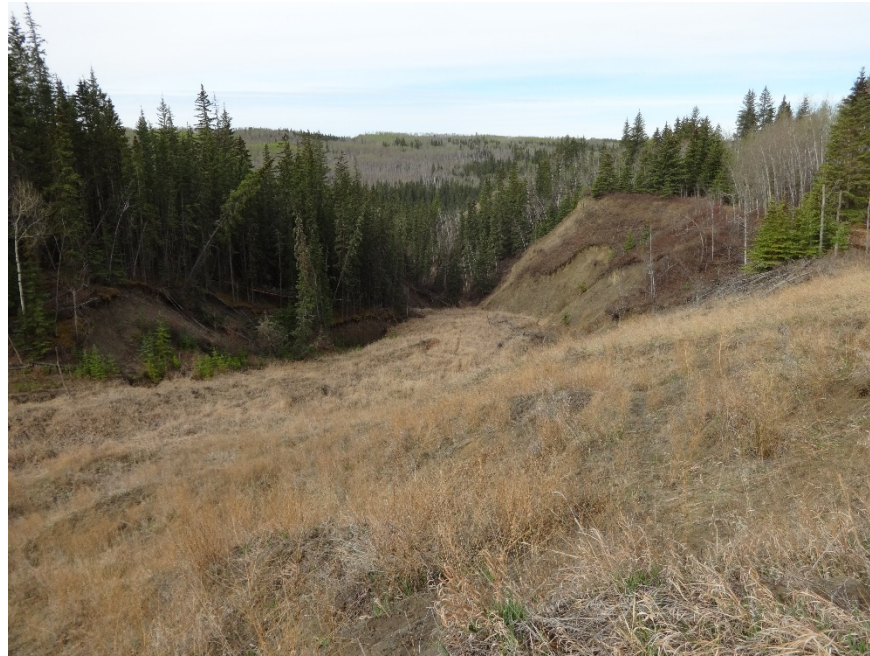
**Photo 7. Looking southwest down at landslide mass. Photo Credit: Don Proudfoot.**

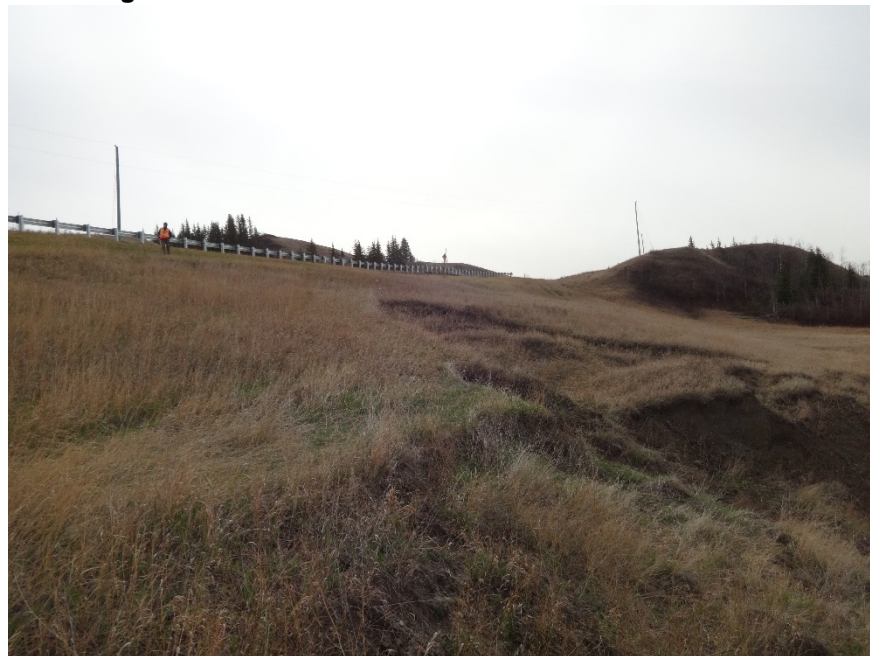
**Photo 8. Looking southeast up at the backscarp and flank of the landslide. Photo Credit: Don Proudfoot.**
