**GEOHAZARD ASSESSMENT PROGRAM
PEACE REGION–GRANDE PRAIRIE DISTRICT - NORTH
2023 INSPECTION**

Site Number	Location	Name	Hwy	km
GP012B	Ksituan River West Valley Slope (east of Jct. with Hwy 725)	Ksituan Pile Wall	49:04	2.398
Legal Description		UTM Co-ordinates		
NW¼10-079-08-W6M		11U E 364030		N 6189796

**GP012B-1: HWY 49:04 KSITUAN PILE WALL
2023 INSPECTION FIGURE**

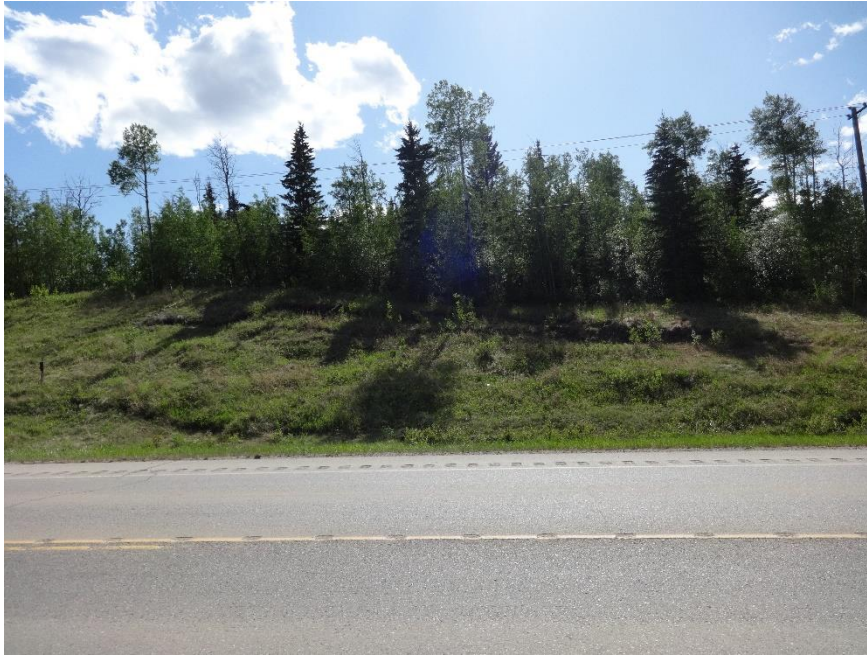
Photo 1. Looking southwest at backslope failure on other side of highway. Photo credit: Nicole Wilder.

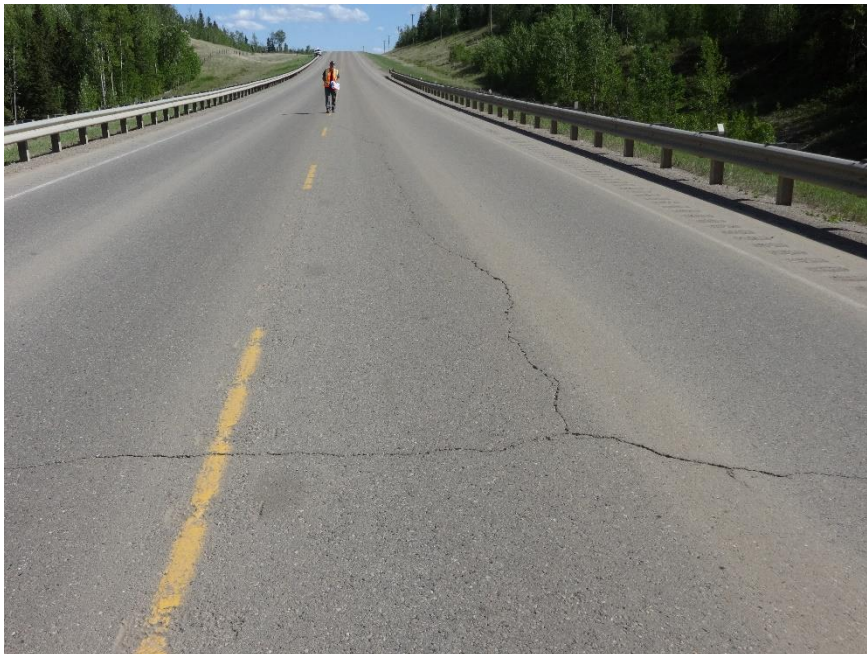
Photo 2. Looking southeast from the southeast bound lane at cracking in pavement. Photo credit: Nicole Wilder.

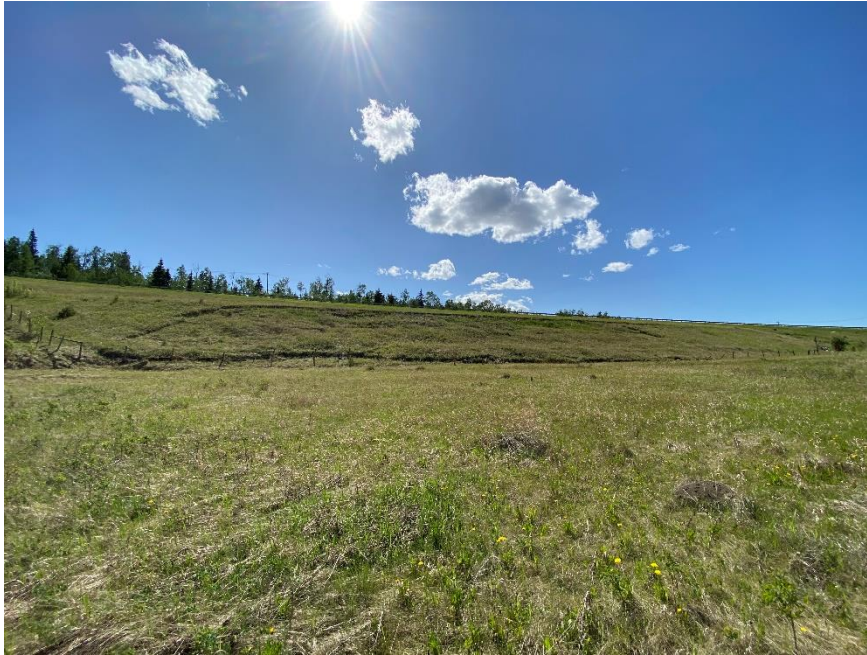
<input checked="" type="checkbox"/> Slope Movement	Failure of the 2H:1V sideslope of the toe berm located below the pile wall constructed in 2002. Fresh sloughing was observed and the soil was moist in 2017. In 2020 the scarp appeared to be slightly active. The fence posts at the bottom of the slope were pushed over from movement of the toe, and they were tilted over more with some posts now horizontal. The backscarp extended approximately 10 m to the northwest since the last inspection and there was 15 m wide subtle overgrown scarp above the existing gabion wall.	<input checked="" type="checkbox"/>
<input type="checkbox"/> Erosion		<input type="checkbox"/>
<input checked="" type="checkbox"/> Seepage	Seepage was observed near the base of the toe roll.	<input checked="" type="checkbox"/>

Photo 3. Looking southwest towards the landslide in the toe berm. Photo credit: Don Proudfoot.

<p>The most cost-effective measure could be to flatten the upper portion of the toe berm by cutting the crest of the toe berm into the pile wall location. However, it is recommended that stability analyses be carried out to assess the impact of reducing the size of the toe berm on the global stability of the pile wall and highway embankment.</p>		
<p>The scarp of the toe berm slump has extended northwest since the last inspection, there is now a scarp crack above the gabion wall and some noticeable crack in the pavement between these two locations. This suggests that the slope between the north end of the pile wall and the bridge culvert might be creeping and if this continues it might be necessary to stabilize this section of the highway embankment at some time in the future.</p>

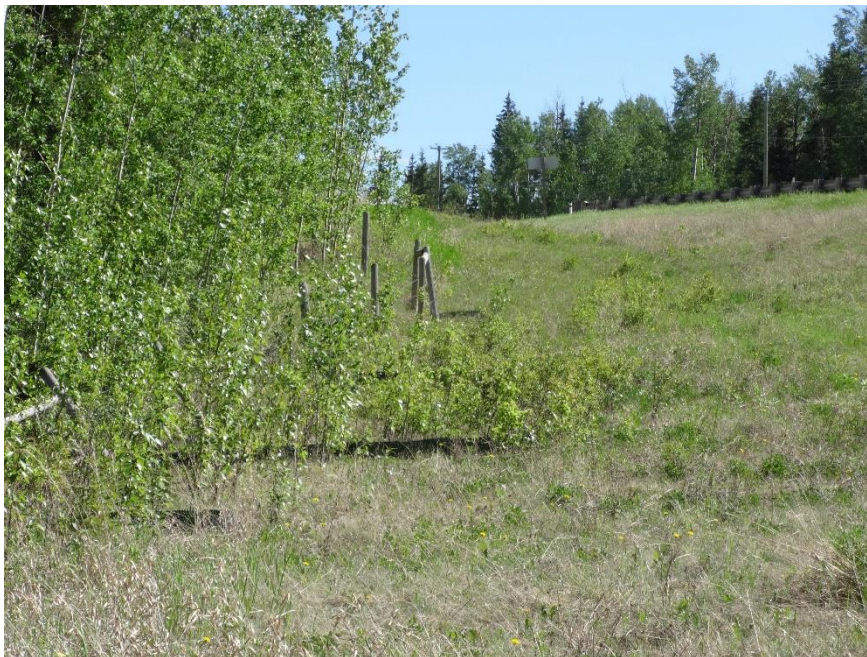
Photo 4. Looking southeast at water dissipation barriers that are grown over. Photo credit: Nicole Wilder.

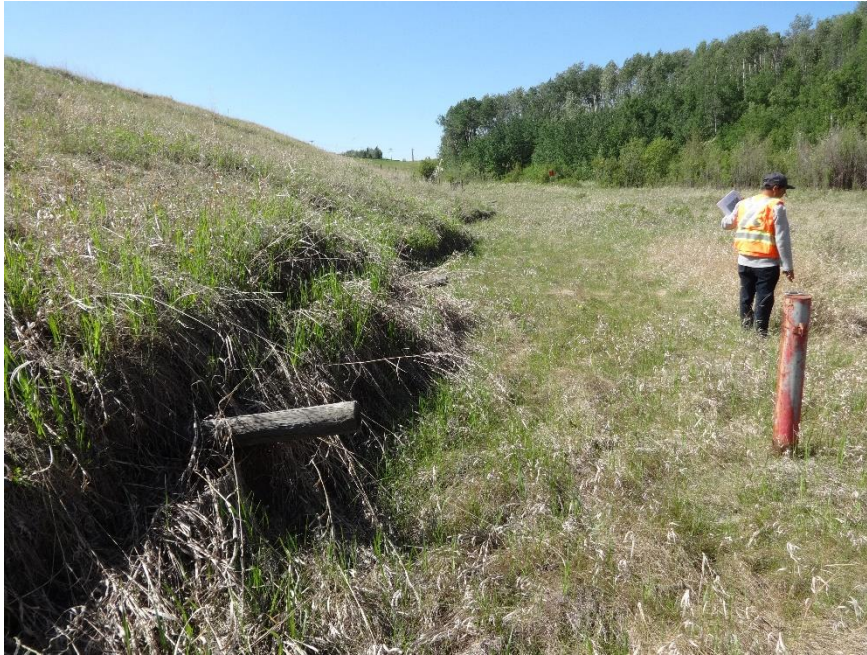
Photo 5. Looking northwest along the toe of the landslide. The fence posts are bent over further from movement of the toe bulge. Photo Credit: Nicole Wilder.

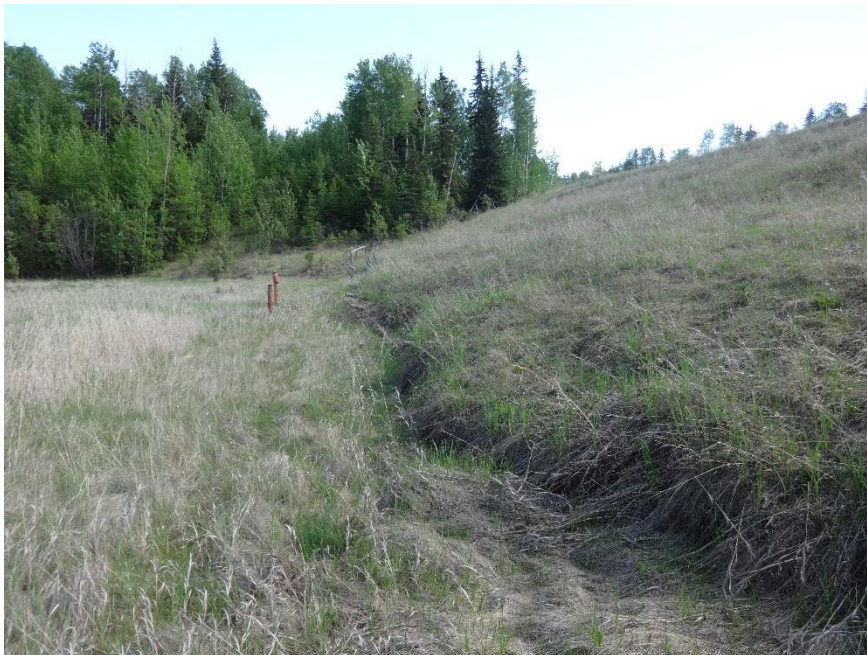
Photo 6. Looking at the toe bulge and bent over posts. Photo Credit: Nicole Wilder.

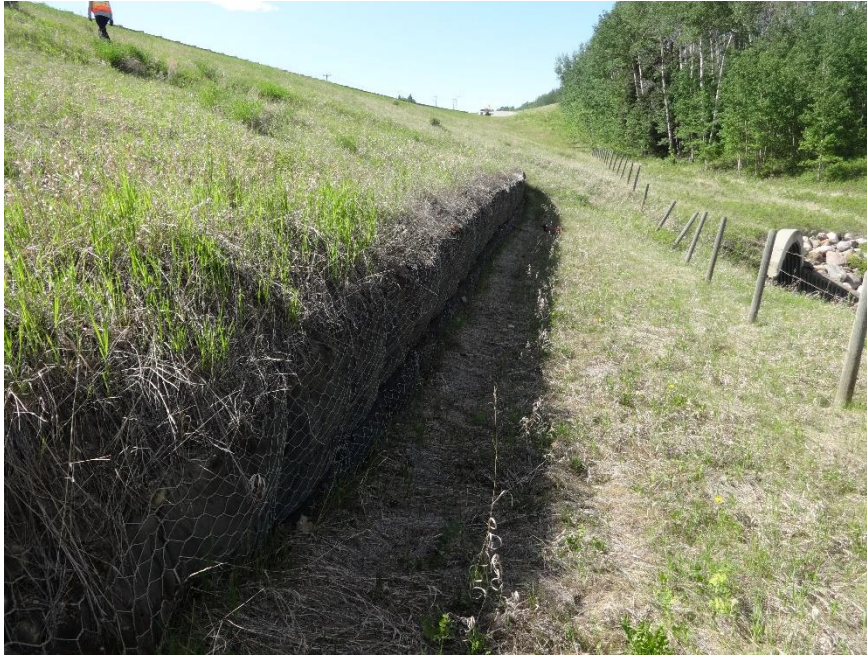
Photo 7. Looking northwest along the gabion wall. Photo Credit: Don Proudfoot.

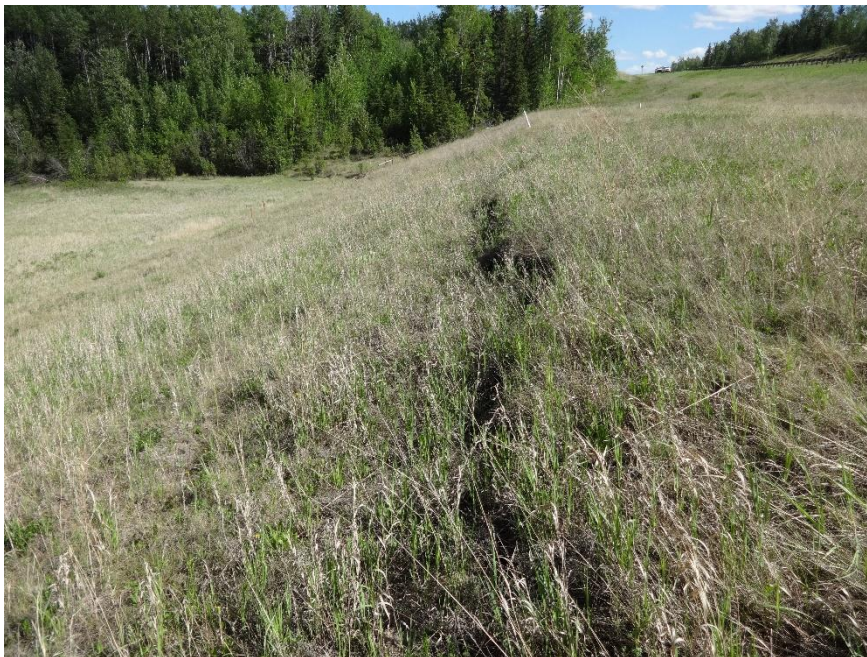
Photo 8. Looking southeast at somewhat overgrown slumping from head scarp. Photo Credit: Nicole Wilder.

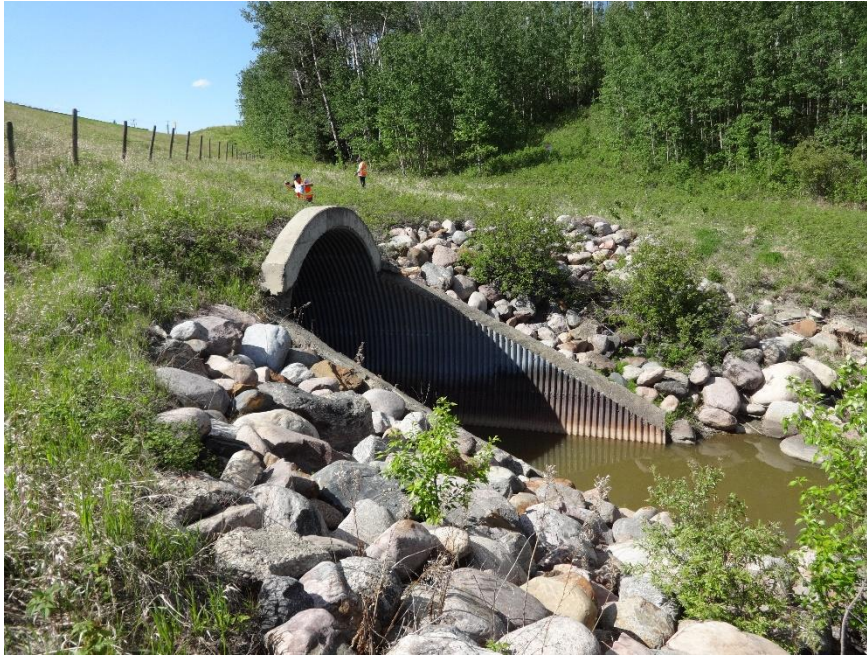
Photo 9. Looking northwest towards the 6.1 m diameter SPCSP centerline culvert outlet. Photo Credit: Nicole Wilder.

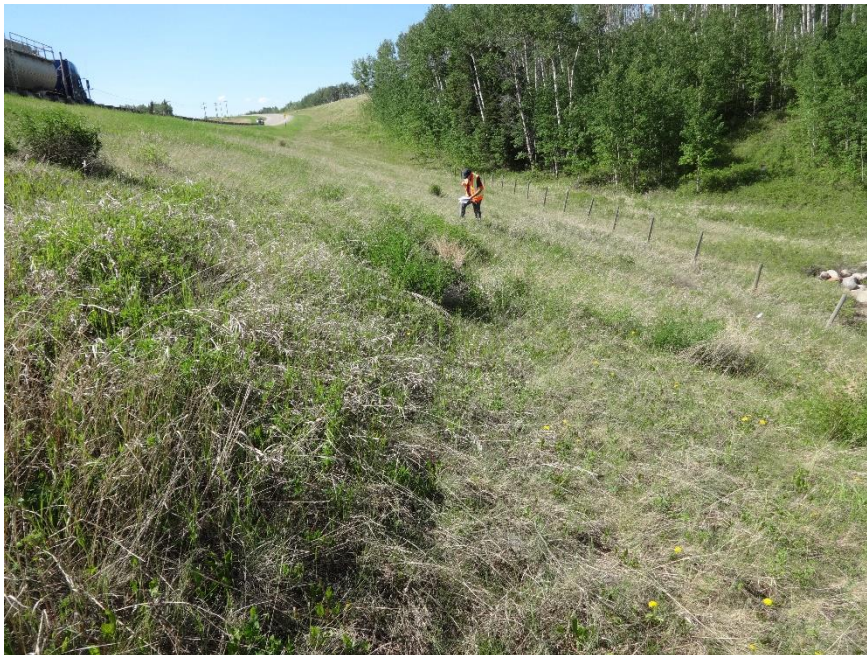
Photo 10. Looking northwest at a scarp crack in the highway sideslope. Photo Credit: Nicole Wilder.
