**ALBERTA TRANSPORTATION AND
ECONOMIC CORRIDORS GRMP
GRANDE PRAIRIE REGION –
(GRANDE PRAIRIE NORTH)
INSTRUMENTATION MONITORING - SPRING 2024**

Site Number	Location	Name	Hwy	km
GP012B	HWY 49:04 C1 2.398	Ksituan Pile Wall	49.04	Km 2.4
Legal Description: 12-10-79-8 W6		UTM Co-ordinates		
		11U E 364166.28	N	6189642.38

Current Monitoring:	29-May-2024	Previous Monitoring	24-Jun-2023
Instruments Read By:	Mr. Niraj Regmi, G.I.T and Mr. Nixon Mationg, of Thurber

**ALBERTA TRANSPORTATION AND ECONOMIC CORRIDORS
PEACE REGION (GRANDE PRAIRIE - NORTH DISTRICT)
INSTRUMENTATION MONITORING FIELD SUMMARY (GP012B)
SPRING 2024**

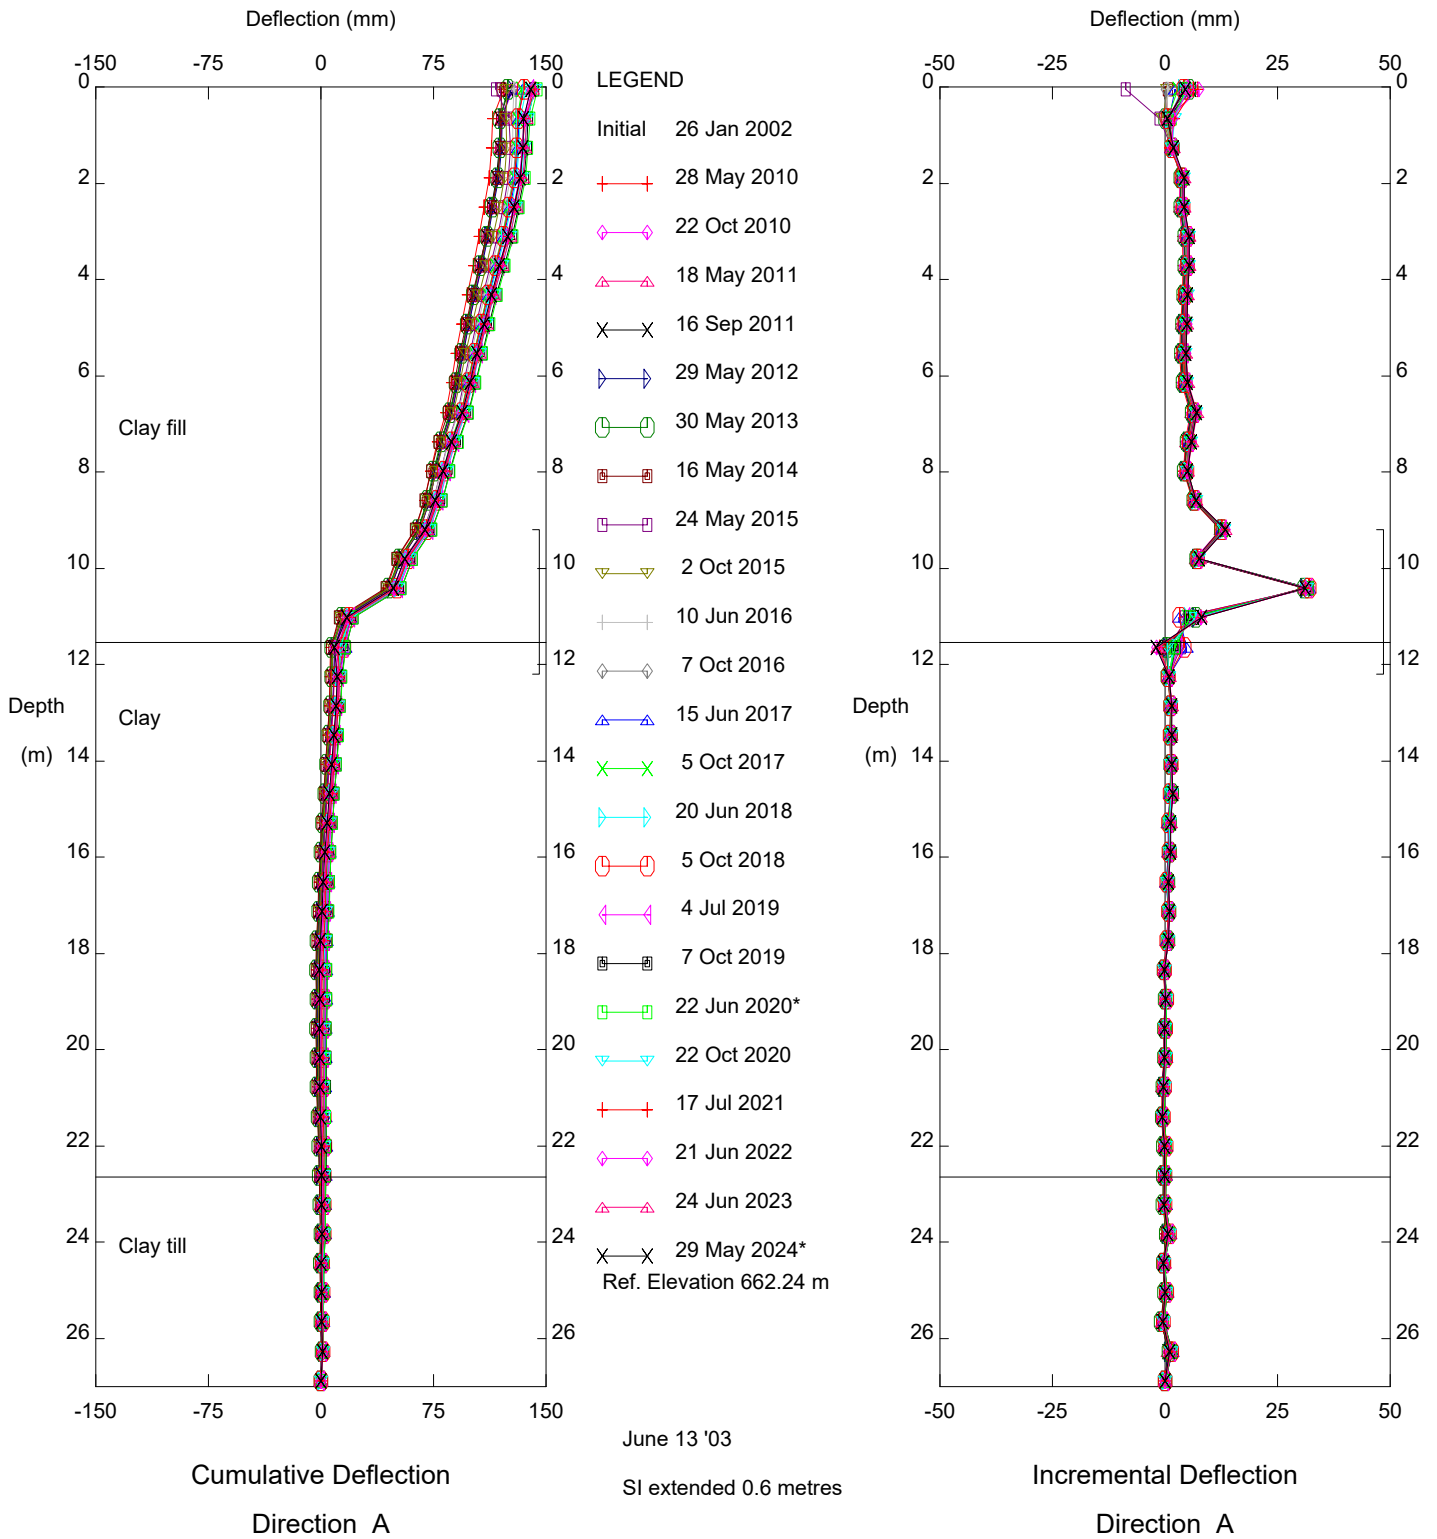
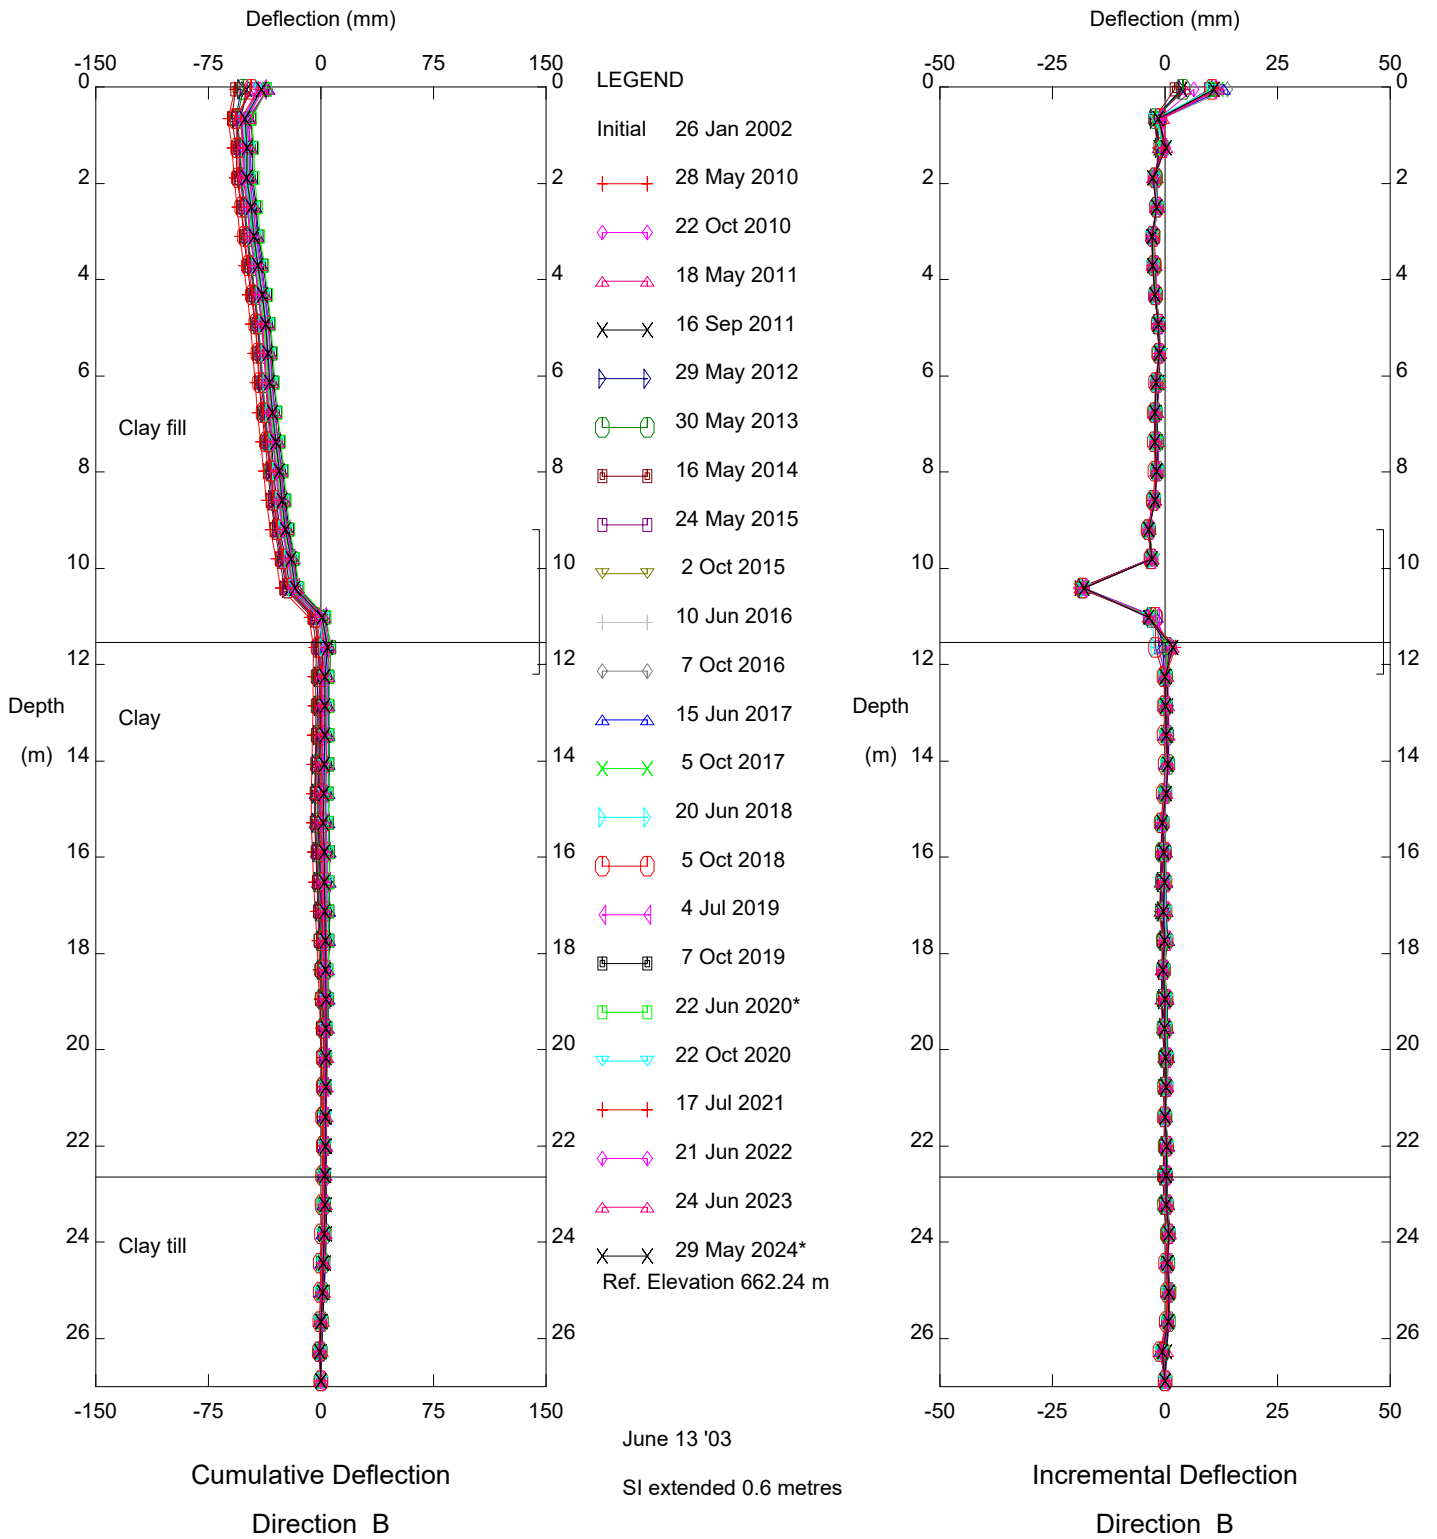
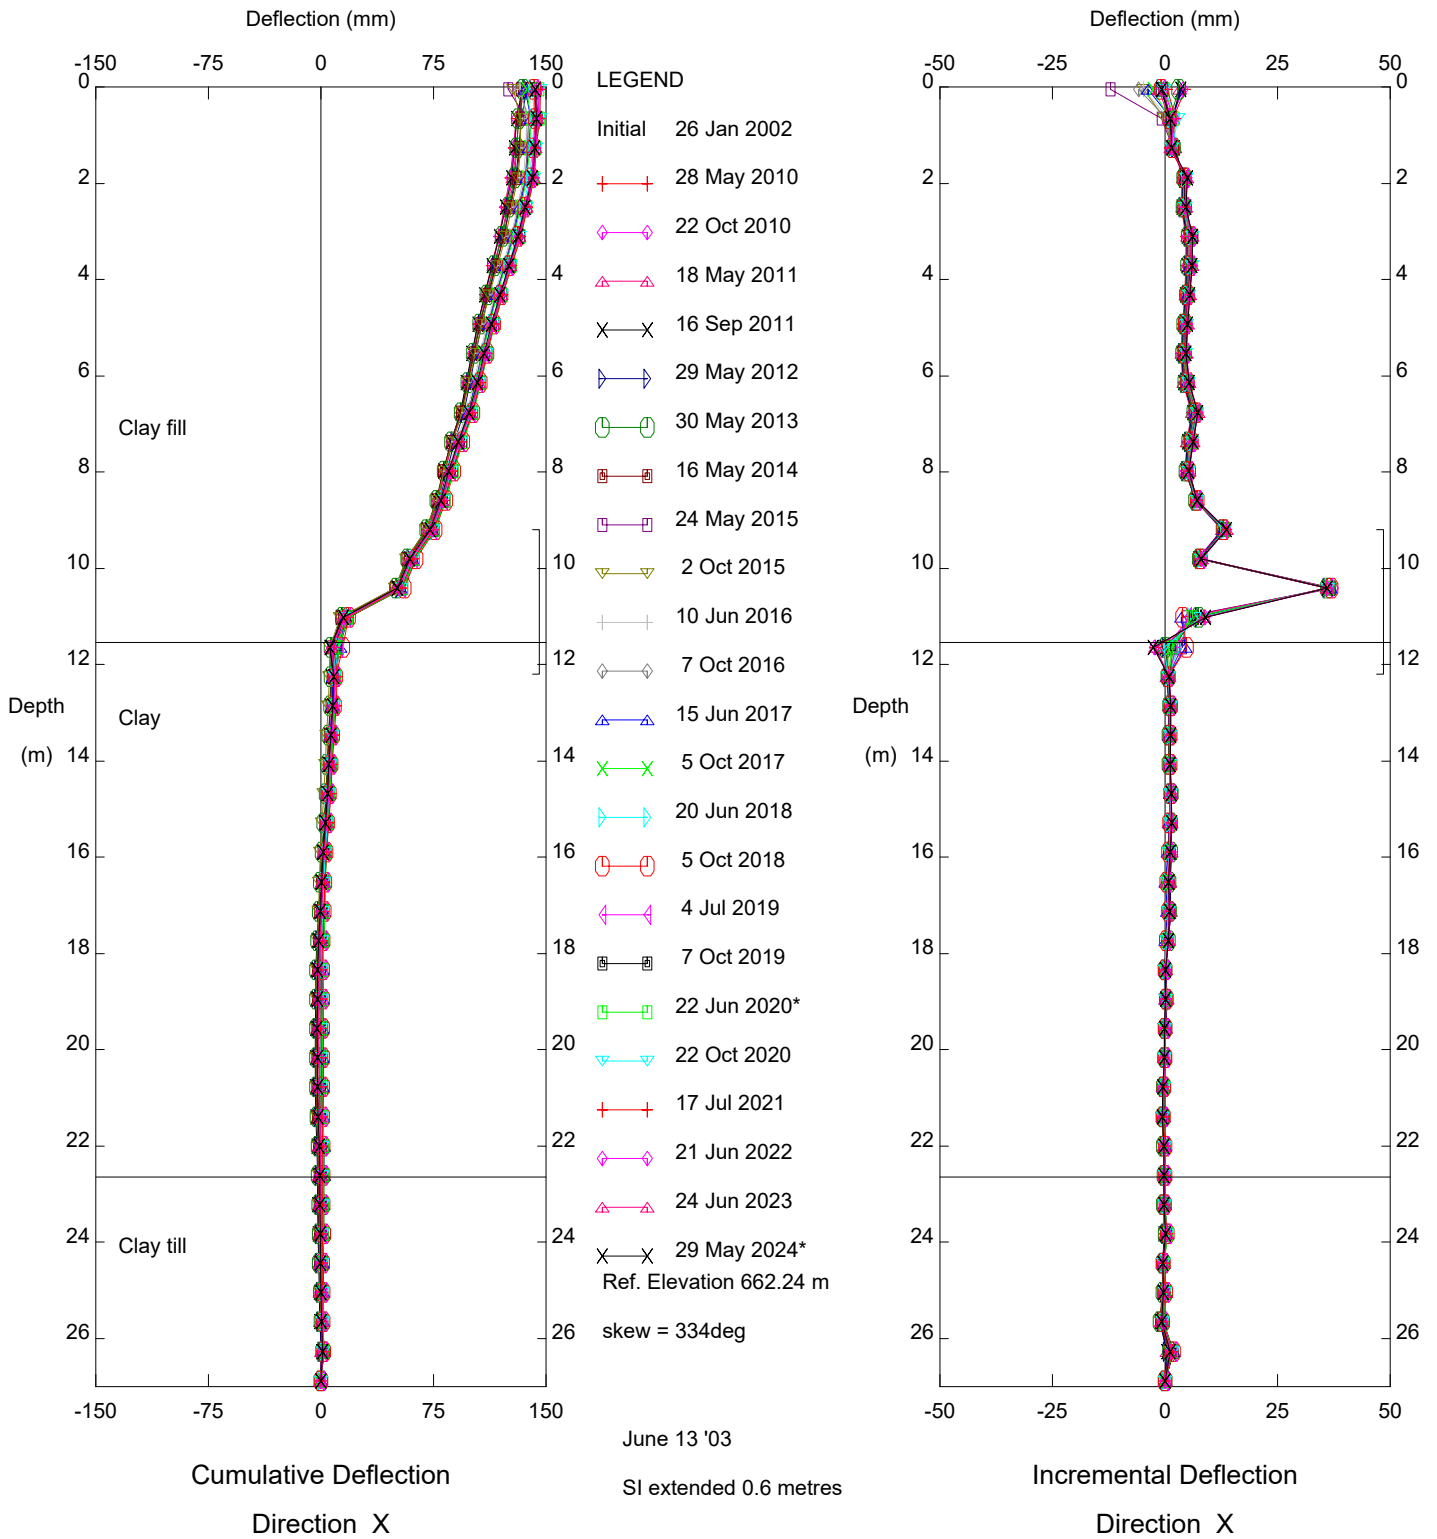
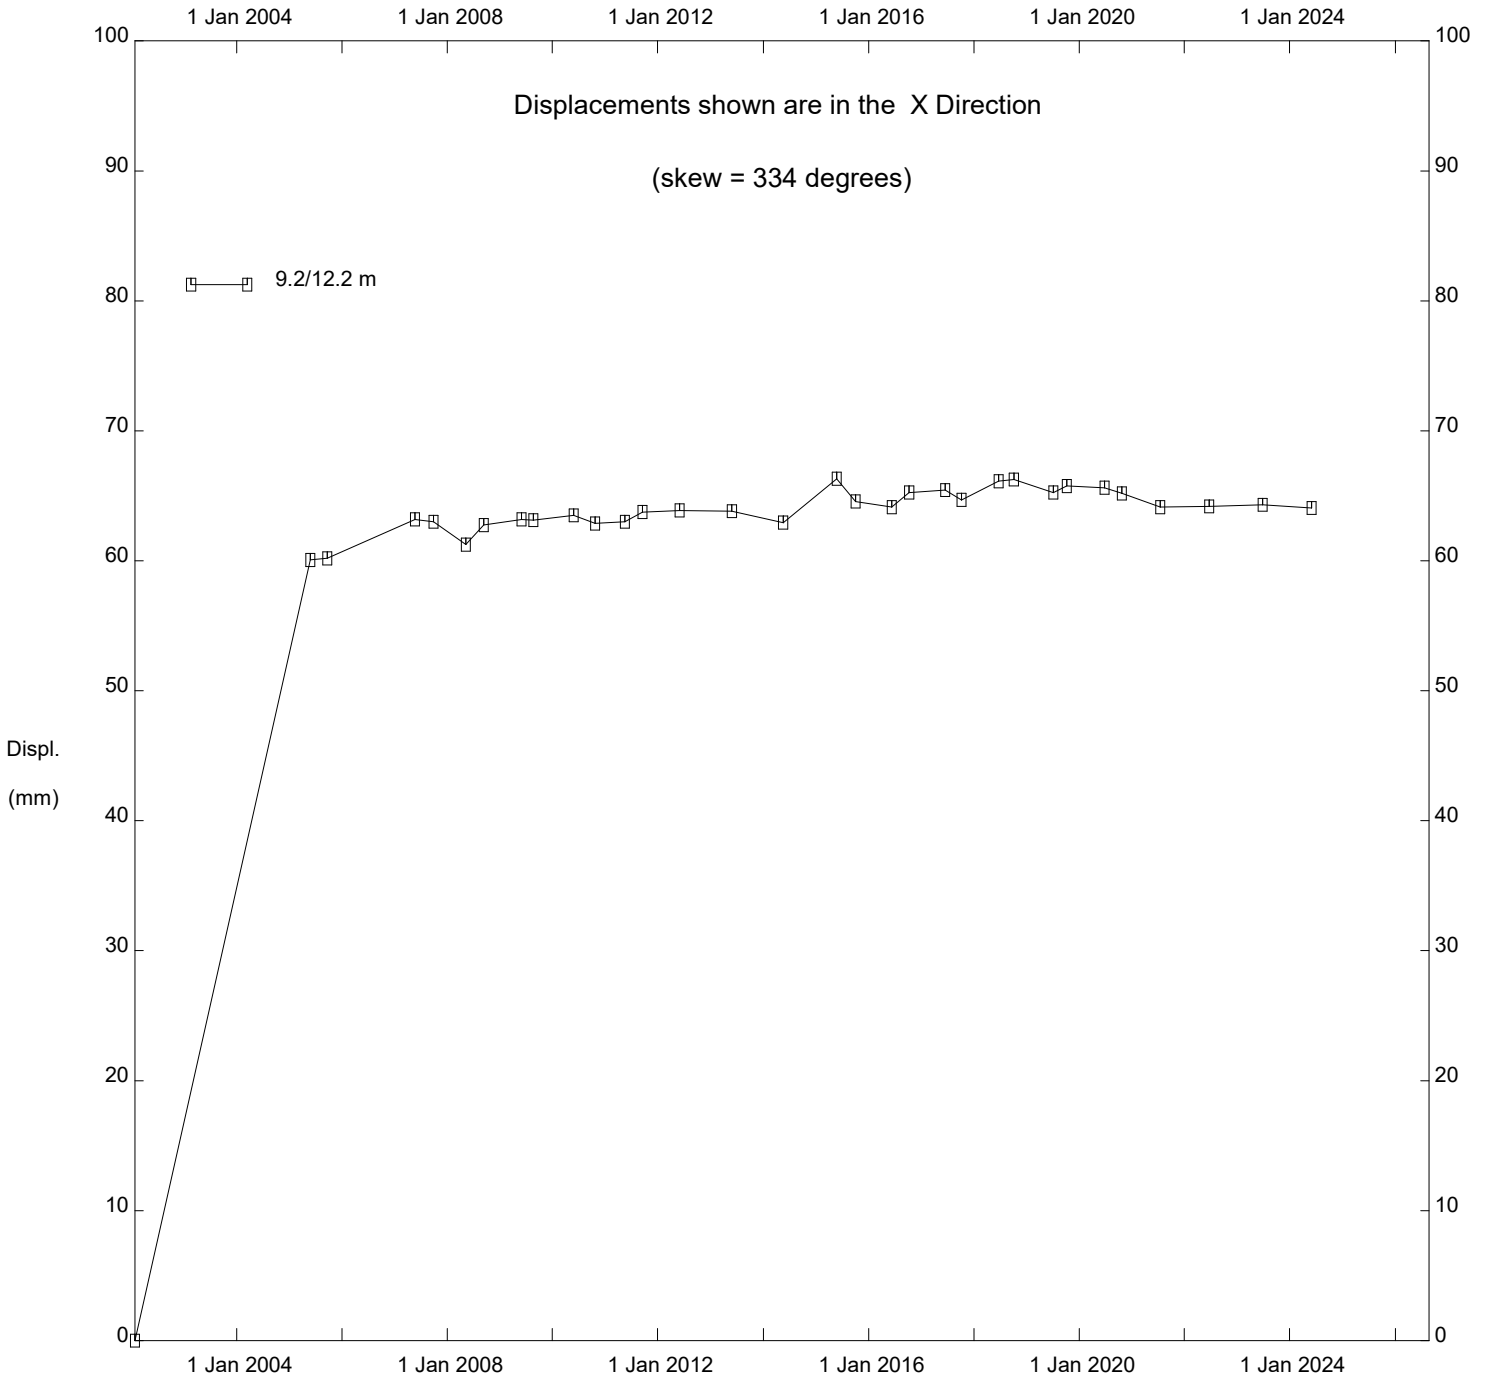
GP012B Ksituan River Crossing, Inclinometer SI-1

Discussion	
Zones of New Movement:	None
Interpretation of Monitoring Results:	<p>Slope inclinometer SI-1 showed no discernible movement over 9.2 to 12.2 m since the spring of 2023 readings.</p> <p>SI-3 showed a rate of movement of 0.3 mm/yr over 11.2 m to 14.3 m since the spring of 2023 readings.</p> <p>SI-6 showed no discernible movement over 1.1 m to 2.3 m depth since the spring of 2023 readings.</p> <p>SI-8 showed a rate of movement of 1.1 mm/yr over 0.9 m to 19.2 m depth since the spring of 2023 readings. This rate of movement has been more or less consistent since 2008. SI-8 has shown a total pile head movement of 59.8 mm to date.</p> <p>PN 5B showed a decrease in groundwater level of 0.22 m compared to the spring of 2023 readings.</p>
Future Work:	The instruments should be read again in the spring of 2025.
Instrumentation Repairs:	No instrument repairs are required at this time.
Additional Comments:	A review of the pile wall design could be undertaken to determine how the measured pile head deflection compares to the design.
