**ALBERTA TRANSPORTATION
GEOHAZARD ASSESSMENT PROGRAM
PEACE REGION–GRANDE PRAIRIE
2023 INSPECTION REPORT**

Site Number	Location	Name	Hwy	km
GP004a	Burnt River Bridge (BF73877)	Burnt River Bridge (West Approach Slide)	49:06	10.586
GP004d (Not Visited)		Burnt River Bridge (East Approach Slide)		11.000
Legal Description		UTM Co-ordinates		
NW¼10-078-04-W6M		11U E 403300	N 6178800

**PEACE REGION (GRANDE PRAIRIE DISTRICT - NORTH)
GP004A-1: HWY 49:06 BURNT RIVER BRIDGE**

2023 INSPECTION FIGURE

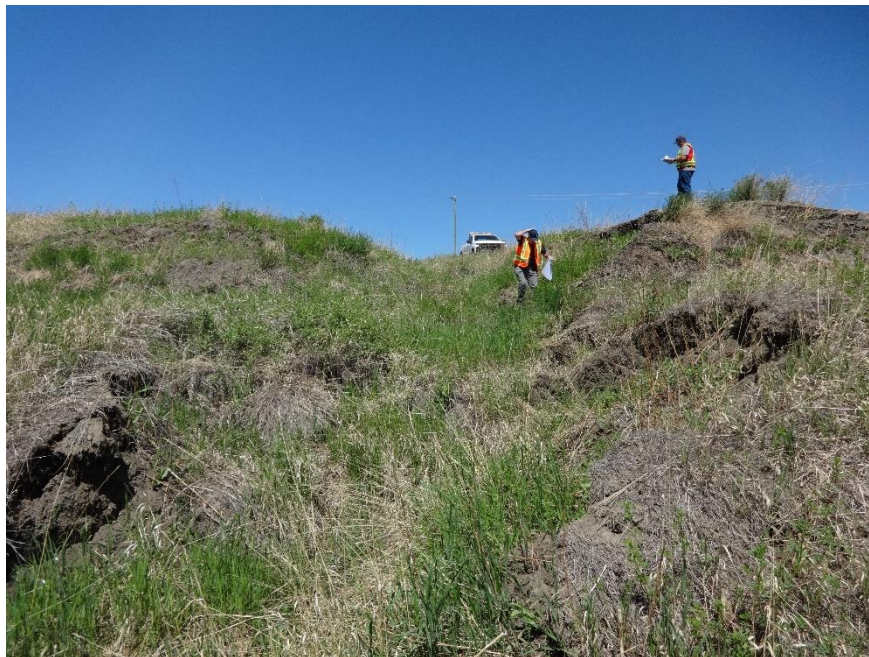
Photo 2. Looking north from edge of erosion gully. Note the ditch along south side of highway tails off and has been the contributor to this erosion. Photo credit: Nicole Wilder.

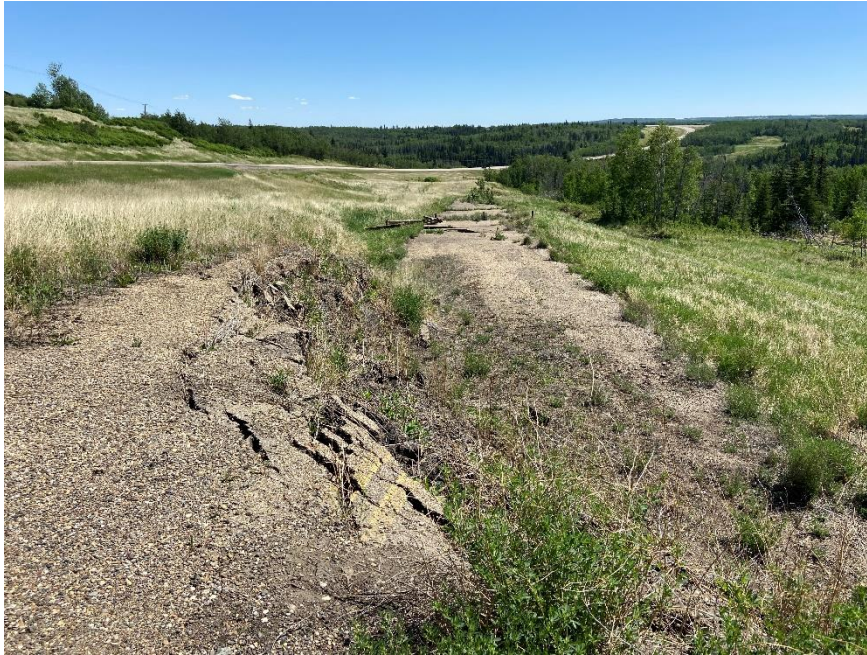
Photo 3. Looking southeast at where scarp crosses the old highway alignment. Photo credit: Don Proudfoot.

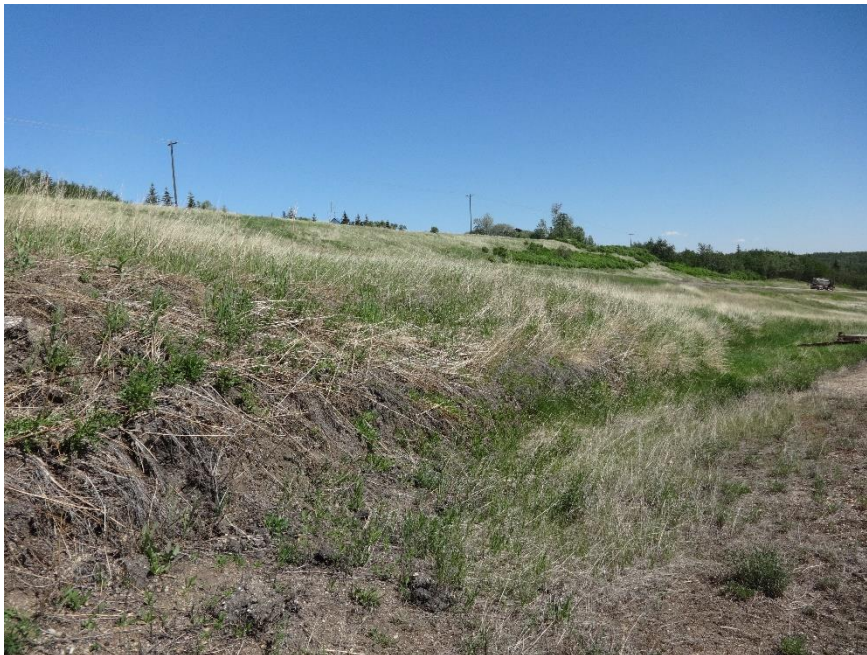
Photo 4. Looking northeast at southern slide scarp which crosses the old highway alignment. Photo credit: Nicole Wilder.

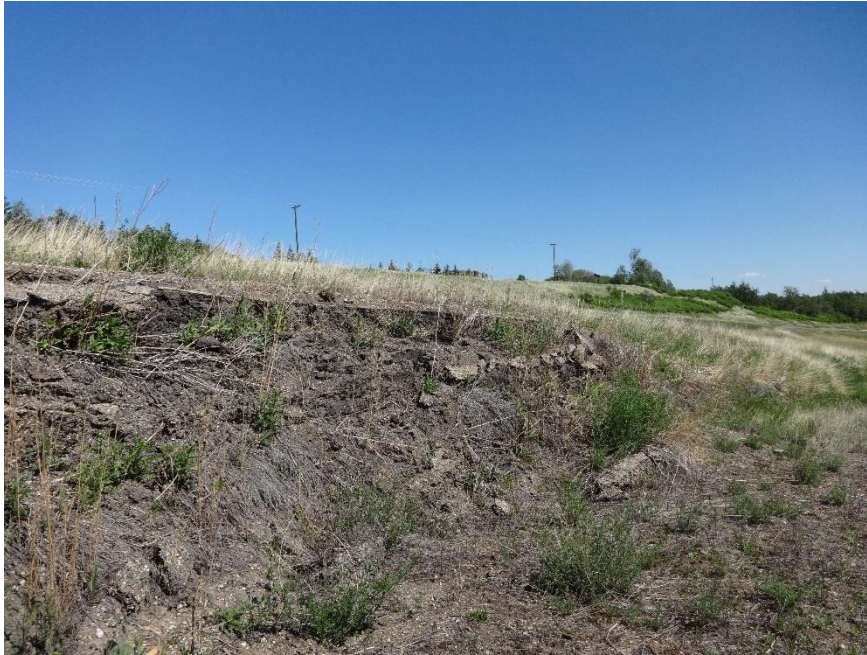
Photo 5. Looking southeast from old highway alignment at south slide scarp. Photo Credit: Nicole Wilder.

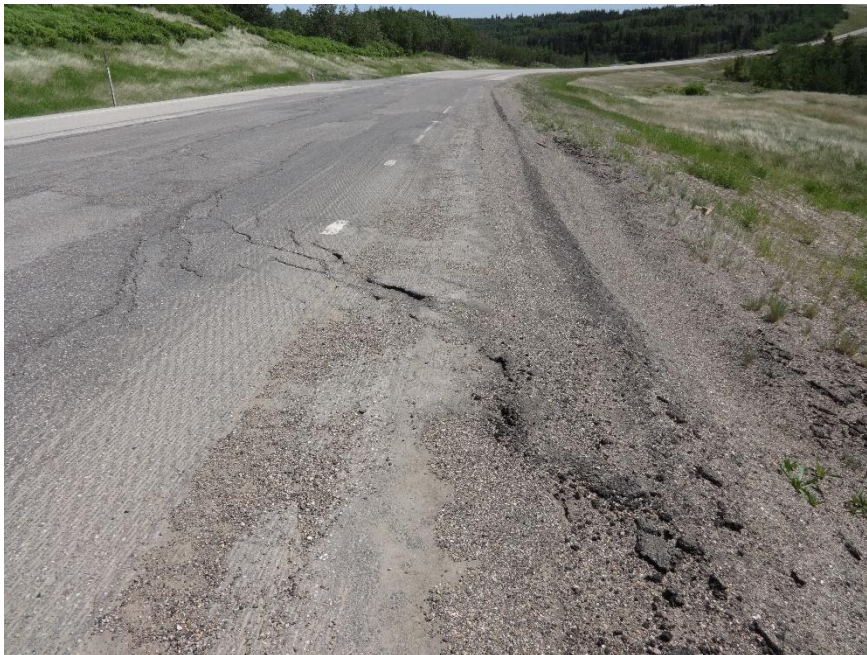
Photo 6. Looking east from the shoulder of the EBL of Hwy 49:06 at the westmost dip in the 2021 ACP patch. Photo Credit: Nicole Wilder.

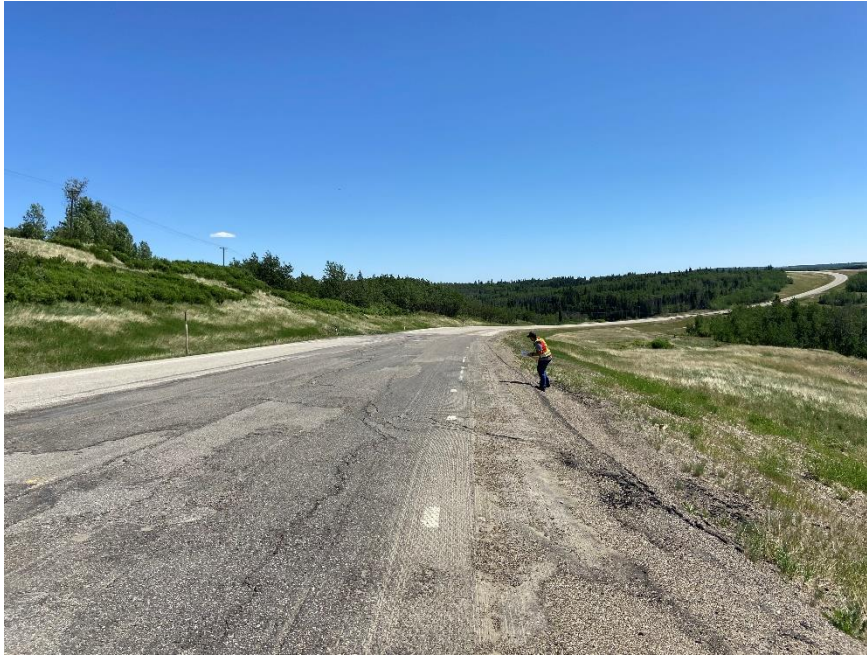
**Photo 7. Looking east from the shoulder of the EBL of Hwy 49:06 at the dip in the 2021 ACP patch.
Photo Credit: Don Proudfoot.**

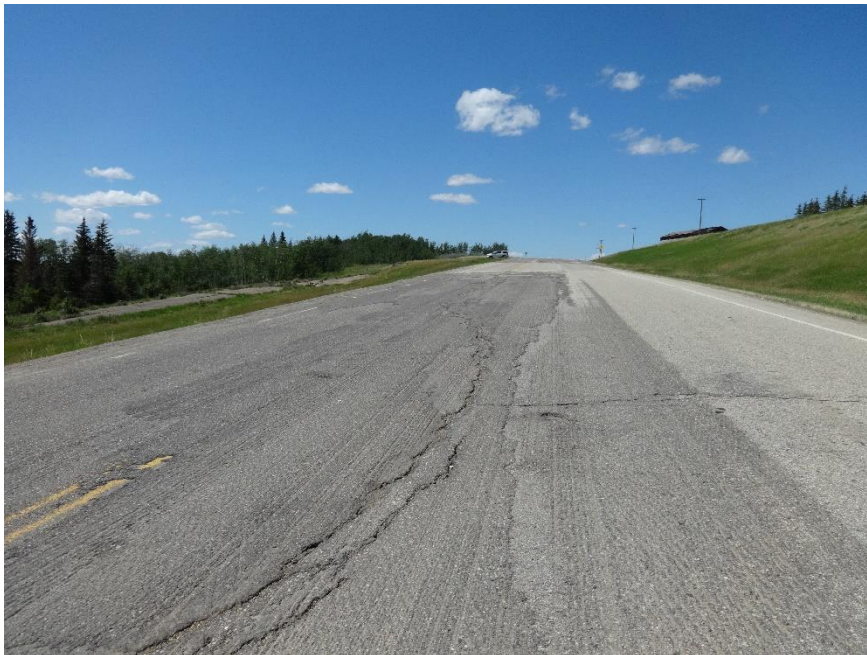
**Photo 8. Looking northwest from the middle of Hwy 49:06 from the south end of the 2021 ACP patch.
Photo Credit: Nicole Wilder.**

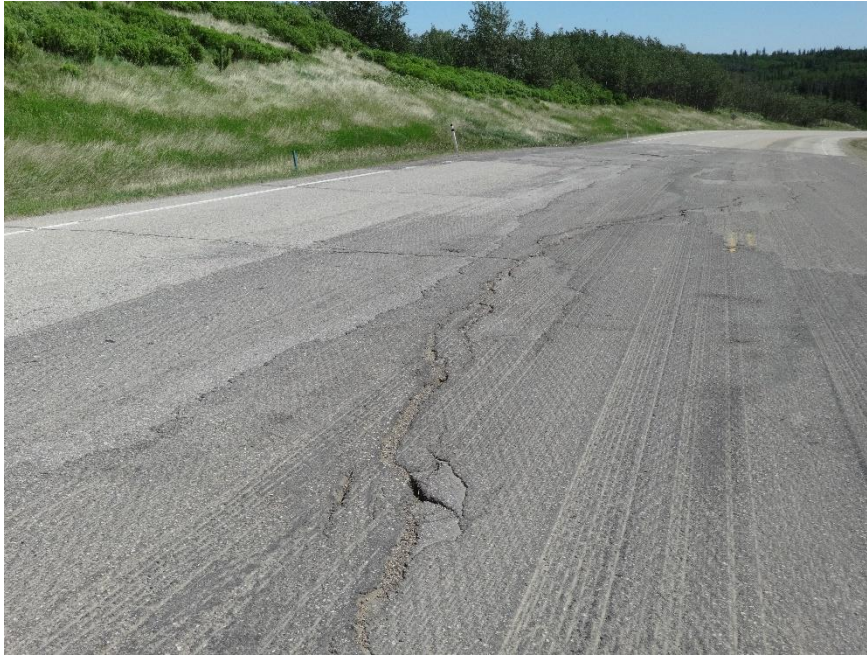
**Photo 9. Looking east from near the middle of the 2021 ACP patch where crack continues into WBL.
Photo Credit: Nicole Wilder.**

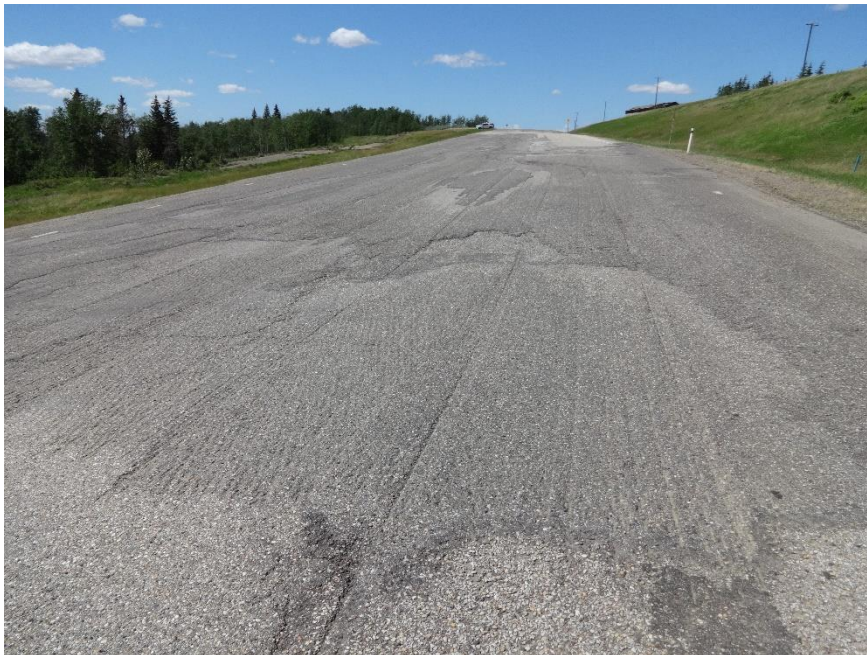
**Photo 10. Looking northwest from the EBL of Hwy 49:06 at the south end of the site. Photo Credit:
Nicole Wilder.**

Due to continued patching/milling of the roadway the south shoulder of the road is currently quite steep and sharp. Consideration should be given to add some compacted gravel on the south side slope to minimize the differential drop. This work may be done at the next time TEC is patching the roadway.

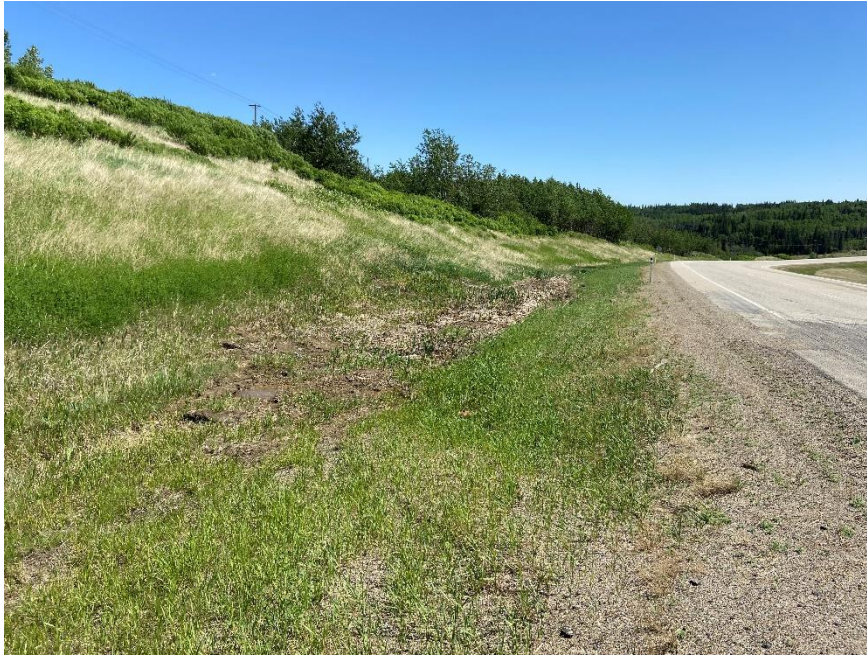
Photo 11. Looking southeast at ponded water and reeds on north side of highway. Photo Credit: Don Proudfoot.

The aperture/extent of the cracks in the pavement affected by the West Approach Slides should be regularly monitored for signs of development and deterioration. Open cracks should be sealed or patched as soon as practical. A subdrain could be constructed in the north ditch. The presence of a spring and permanent wet ditch area suggest that there is a high water table at the ditch level

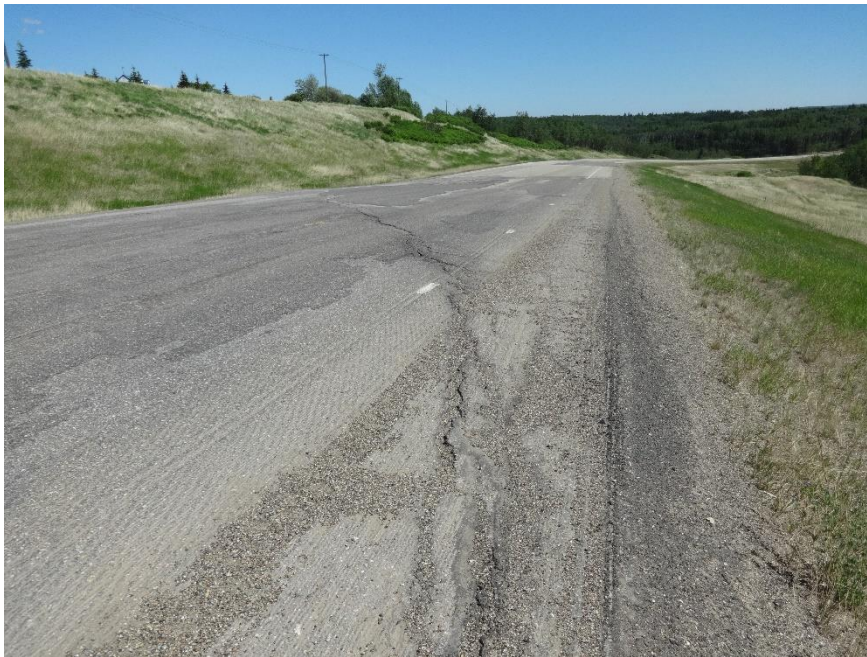
Photo 12. Looking southeast at the northwest end of the site at scarp crack open on the SBL shoulder. Photo Credit: Nicole Wilder.

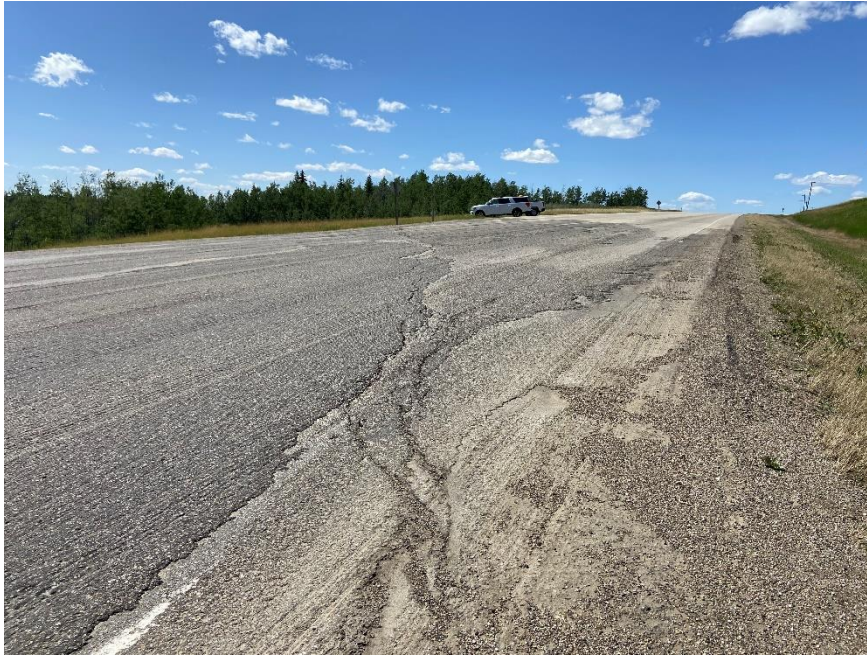
Photo 13. Looking southwest at the northwest end of the site at the scarp crack. Photo Credit: Don Proudfoot.

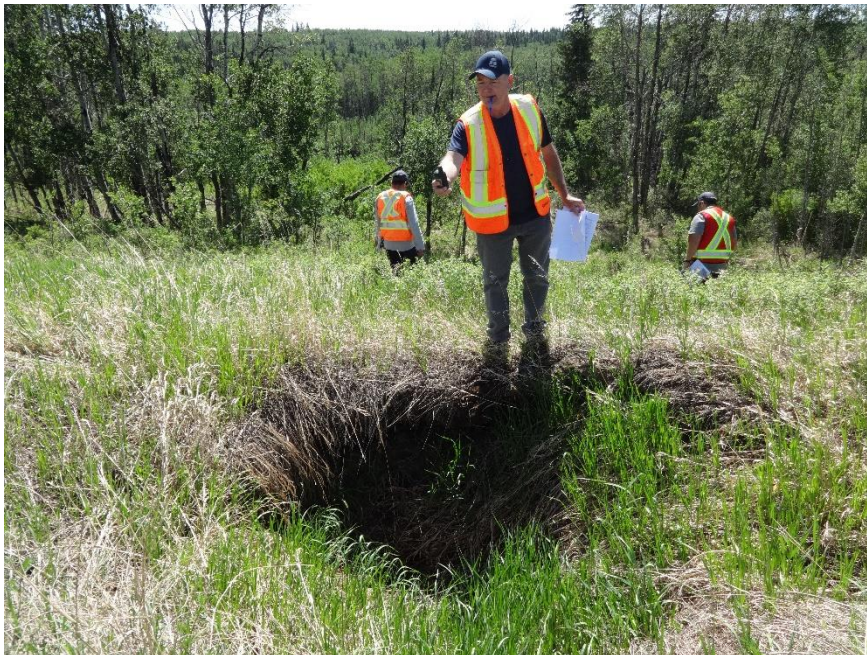
<input type="checkbox"/> Bridge/Culvert Distress		<input type="checkbox"/>
<input checked="" type="checkbox"/> Other	A 1.5 m diameter sinkhole was observed over an existing 800 mm diameter CSP culvert.	<input checked="" type="checkbox"/>
Instrumentation:		
SI-16	Installed about 70 m downslope of the Hwy 49:06 EBL at approximately the middle height of the Burnt River north valley slope. This SI showed a rate of 0.6 mm/year at a depth between 22 m and 28 m below ground surface.	
PN-13	Installed about 10 m upslope of the Hwy 49:06 EBL had previously showed a water level of 0.32 m below ground surface during the fall 2021; however, the instrument would not stabilize since spring 2022 and is likely damaged.	
PN-15	Installed about 10 m downslope of the Hwy 49:06 WBL and showed an decrease in water level of 5.41 m since the fall 2022 readings, the piezometer shows a water level of 9.56 m below ground surface.

Photo 14. Looking south at 1.5 m diameter sinkhole. Photo Credit: Nicole Wilder.

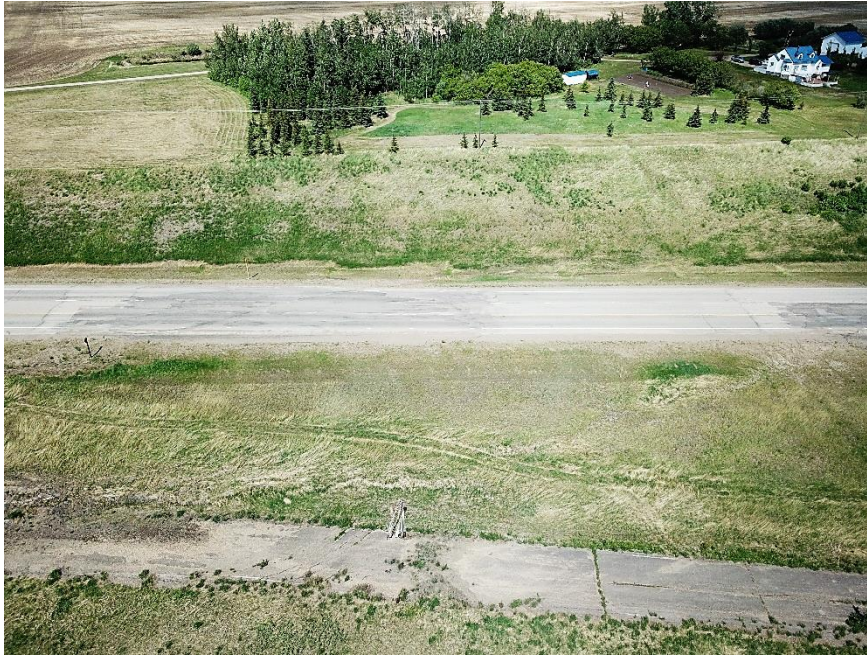
Photo 15. Looking north at westmost scarp that leads into the backslope and scarp just north of the old road. Photo Credit: Drone-Nicole Wilder.

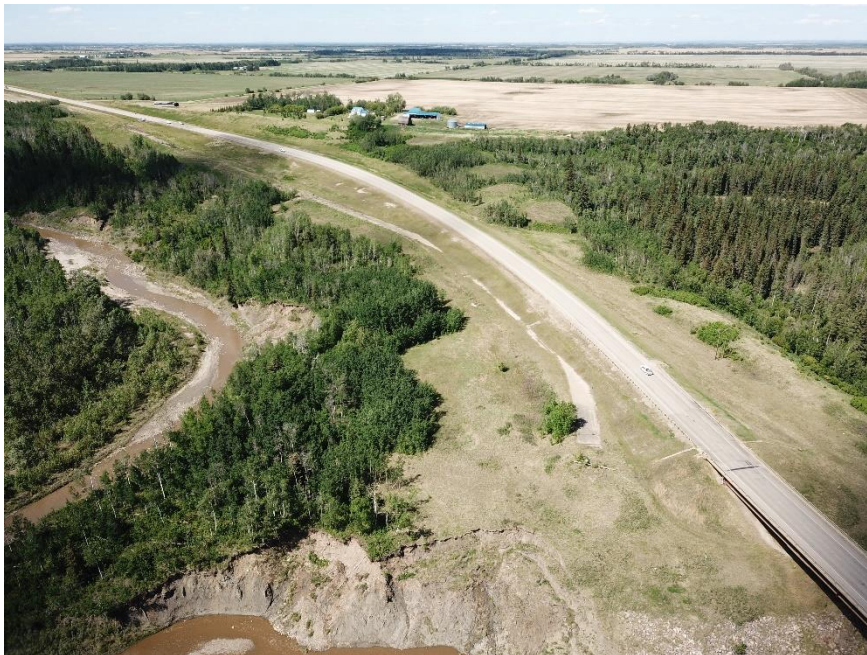
The origin of the large deep-seated landslide that effects the roadway was very likely triggered by river erosion at the toe of the north valley slope in a meander loop of the Burnt River. The long-term mitigation measures would be to either realign the highway further upslope, which may require relocating the highway on the upper plateau completely out of the river valley and implement riverbank reinforcement at the toe of the valley slope. The river re-alignment would likely require bypassing a bend and require drop structures. The actual extent and configuration of riverbank reinforcement would need to be assessed by a river hydraulics specialist.

Photo 16. Looking northwest at river and river bank slumping. Photo Credit: Drone- Nicole Wilder. |

Realign the highway out of the river valley or realign the river to allow a toe berm buttress and river channel armouring works to be installed. The extent and associated cost for each of these options would need to be further assessed.
