**ALBERTA TRANSPORTATION
AND ECONOMIC CORRIDORS
GEOHAZARD ASSESSMENT PROGRAM
PEACE REGION–GRANDE PRAIRIE
2024 INSPECTION REPORT**

Site Number	Location	Name	Hwy	km
GP004a	Burnt River Bridge (BF73877)	Burnt River Bridge (West Approach Slide)	49:06	10.586
GP004d (Not Visited)		Burnt River Bridge (East Approach Slide)		11.000
Legal Description		UTM Co-ordinates		
NW¼10-078-04-W6M		11U E 403300 N 6178800

Date	PF	CF	Total
Previous Inspection:	29-May-2023	12	7	84
Current Inspection:	6-May-2024	12	7	84
Road AADT:	1060	Year:		2023
Inspected by:	Robert Senior, TEC Rocky Wang, TEC		Don Proudfoot, Thurber Nicole Wilder, Thurber	
Report Attachments:	<input checked="" type="checkbox"/> Photographs	<input checked="" type="checkbox"/> Plans	<input type="checkbox"/> Maintenance Items

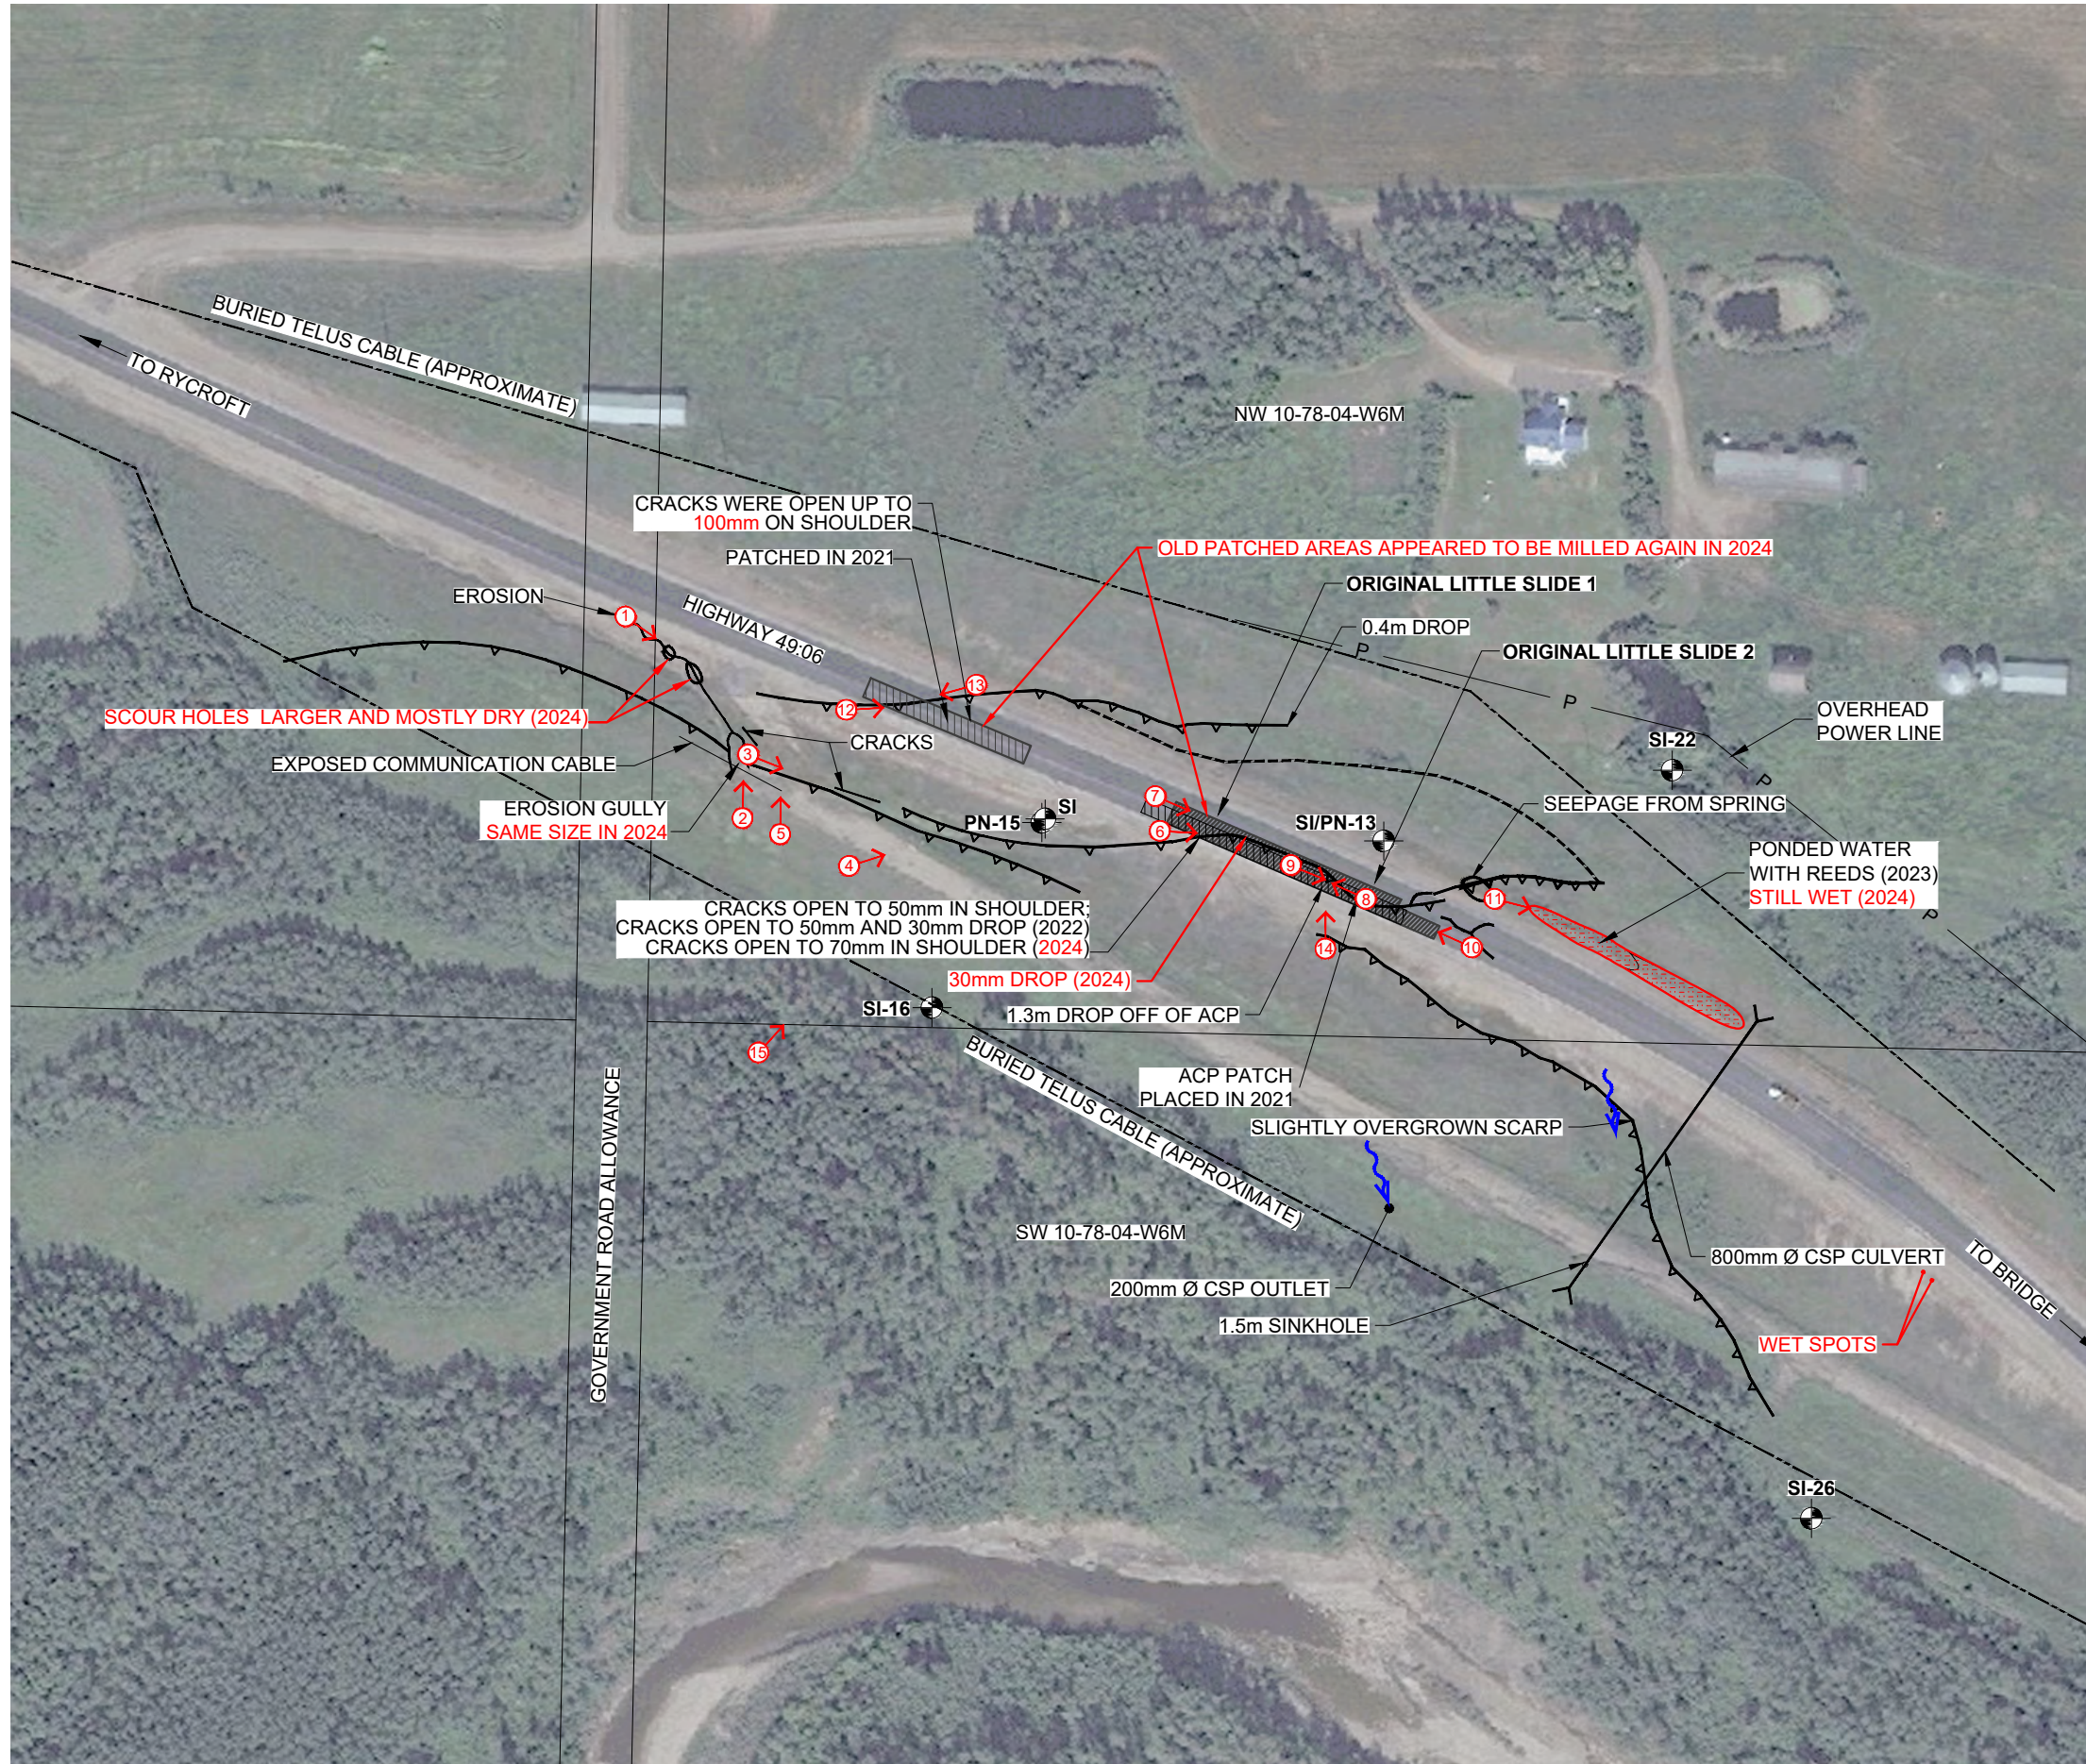
**PEACE REGION (GRANDE PRAIRIE DISTRICT - NORTH)
GP004A-1: HWY 49:06 BURNT RIVER BRIDGE**

<p><input checked="" type="checkbox"/> Slope Movement</p>	<p>The roadway was affected by landslides at the west approach to the Burnt River Bridge (BF73877) crossing (the east side was not looked at this year). The west approach slide appeared to have worsened as the scarp crack has distorted the recently milled pavement with a measured vertical drop of up to 70 mm and it is open to 100 mm. The scarp crack was also tracked about 180 m further east south of the highway during the 2023 inspection.</p>	<p><input checked="" type="checkbox"/></p>
<p><input checked="" type="checkbox"/> Erosion</p>	<p>River erosion is ongoing at the toe of the larger deep-seated landslide on the west as the Burnt River continuously erodes the toe of the north valley slope. The scour holes in the erosion gully along the south ditch appeared in similar condition as in 2023 and were mostly dry.</p>	<p><input type="checkbox"/></p>

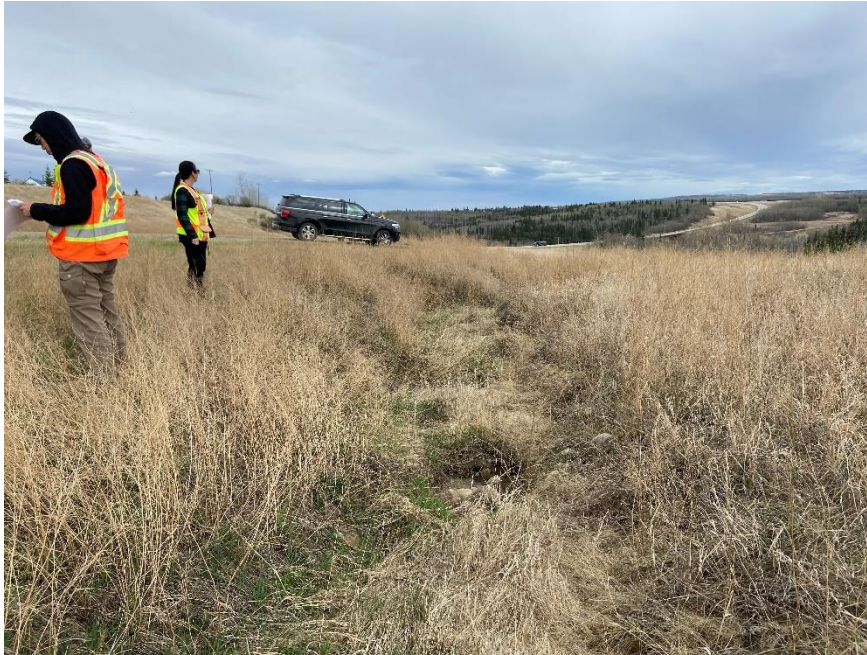
Photo 1. Looking southeast at erosion gully that had formed in the south ditch which had pooling water in it in 2022 but the scour holes were mainly dry with slight moisture in 2024. Photo credit: Don Proudfoot.

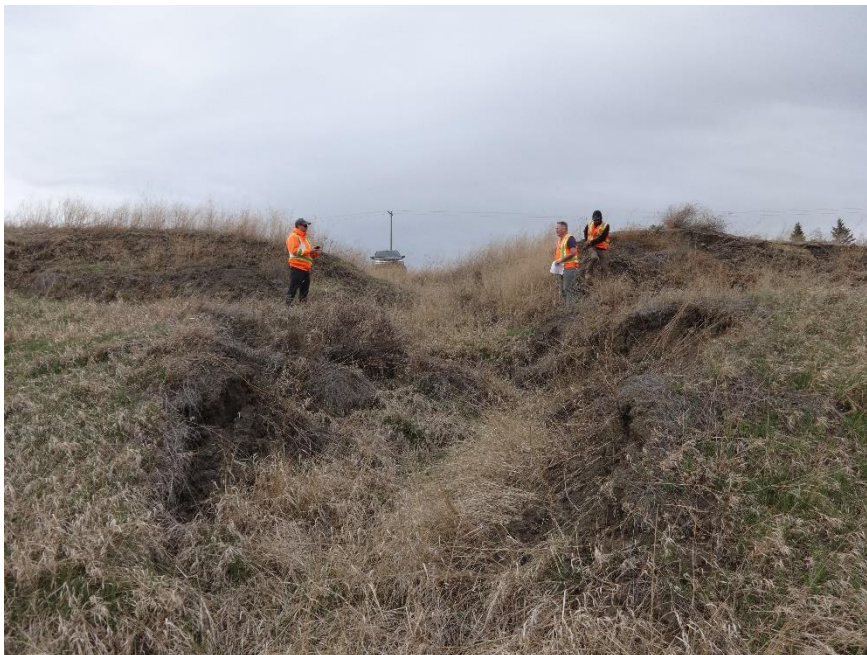
Photo 2. Looking north from edge of erosion gully. Note the ditch along south side of highway tails off and has been the contributor to this erosion. Photo credit: Nicole Wilder.

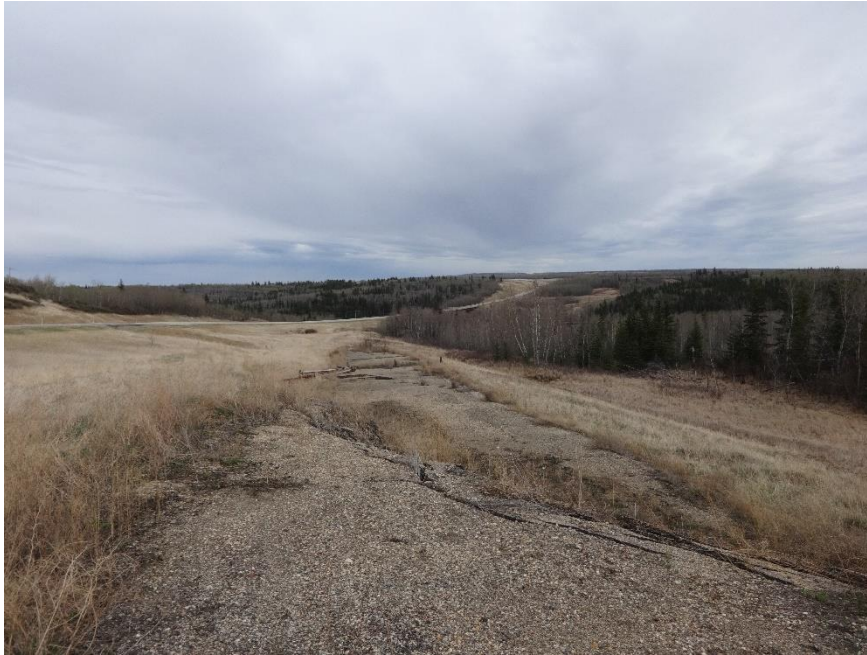
Photo 3. Looking southeast at where scarp crosses the old highway alignment. Photo credit: Don Proudfoot.

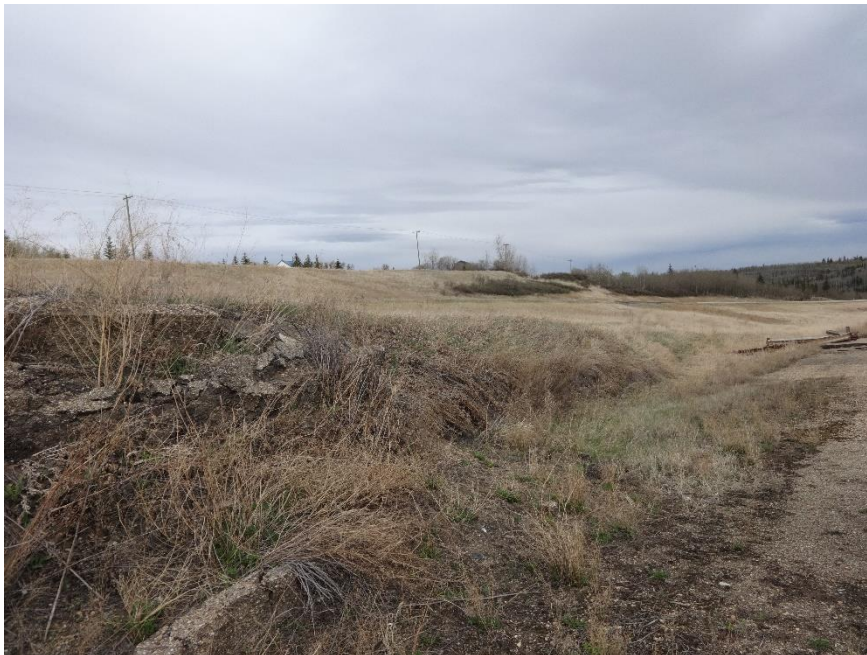
Photo 4. Looking northeast at southern slide scarp which crosses the old highway alignment. Photo credit: Nicole Wilder.

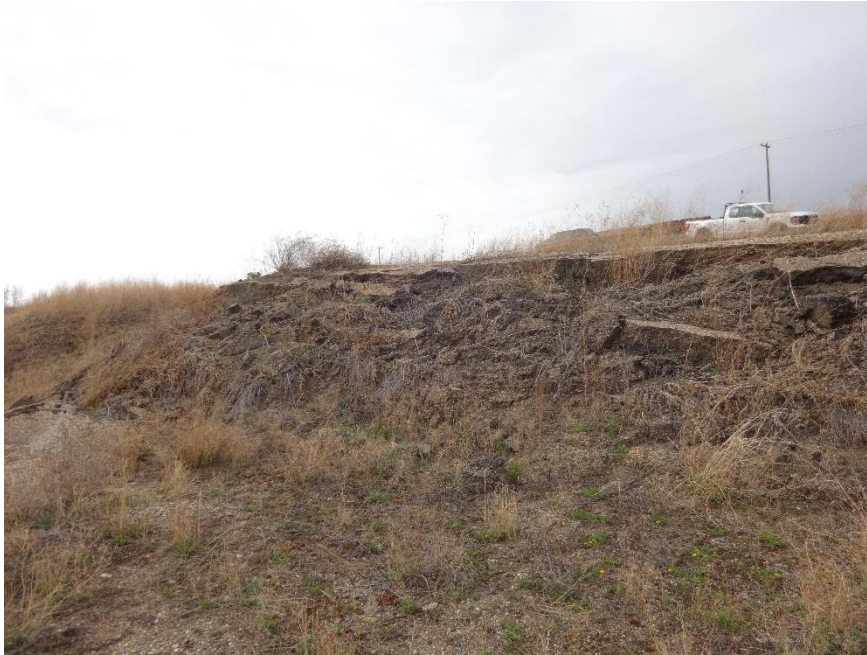
Photo 5. Looking southeast from old highway alignment at south slide scarp. Photo Credit: Nicole Wilder.

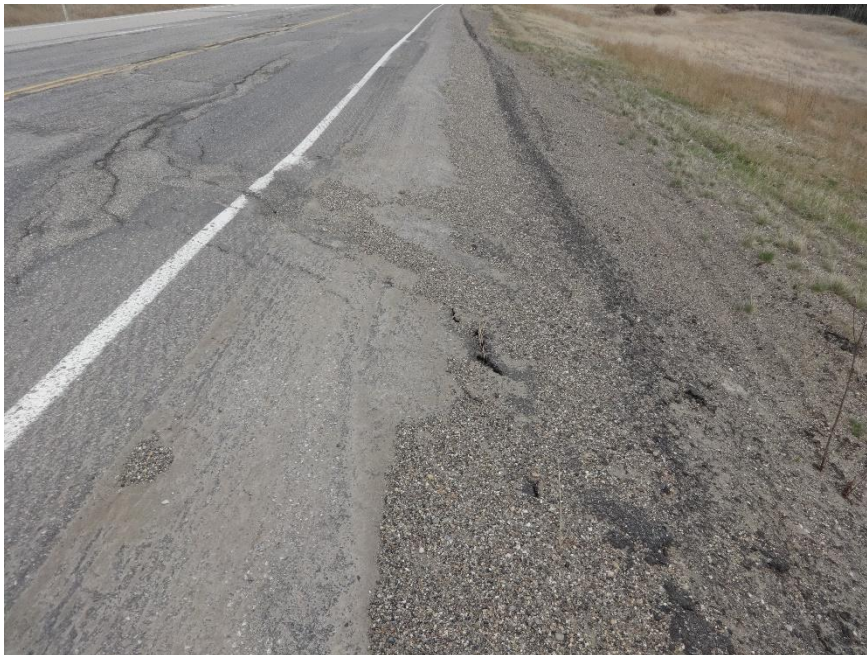
Photo 6. Looking east from the shoulder of the EBL of Hwy 49:06 at the westmost dip in the 2021 ACP patch. Photo Credit: Nicole Wilder.

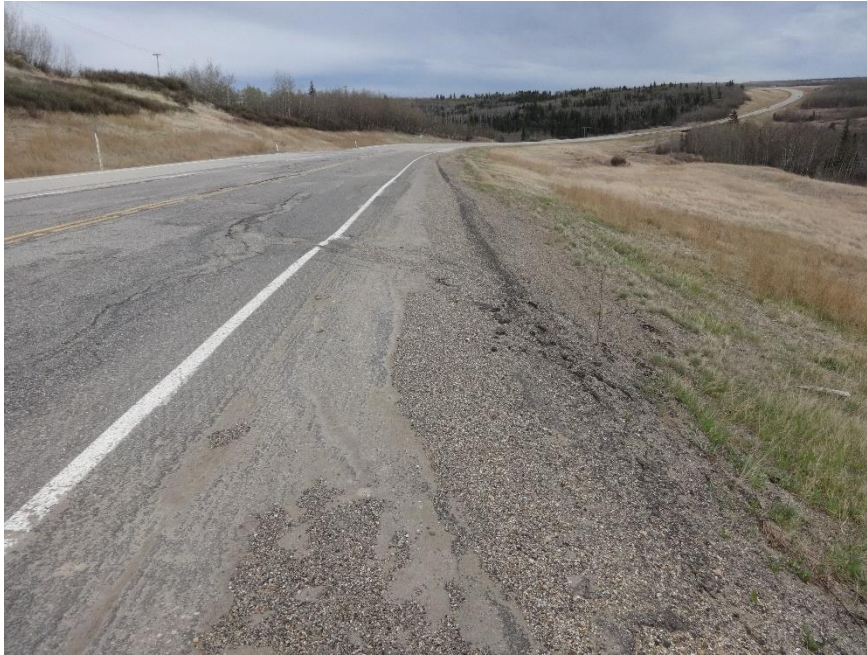
**Photo 7. Looking east from the shoulder of the EBL of Hwy 49:06 at the dip in the 2021 ACP patch.
Photo Credit: Nicole Wilder.**

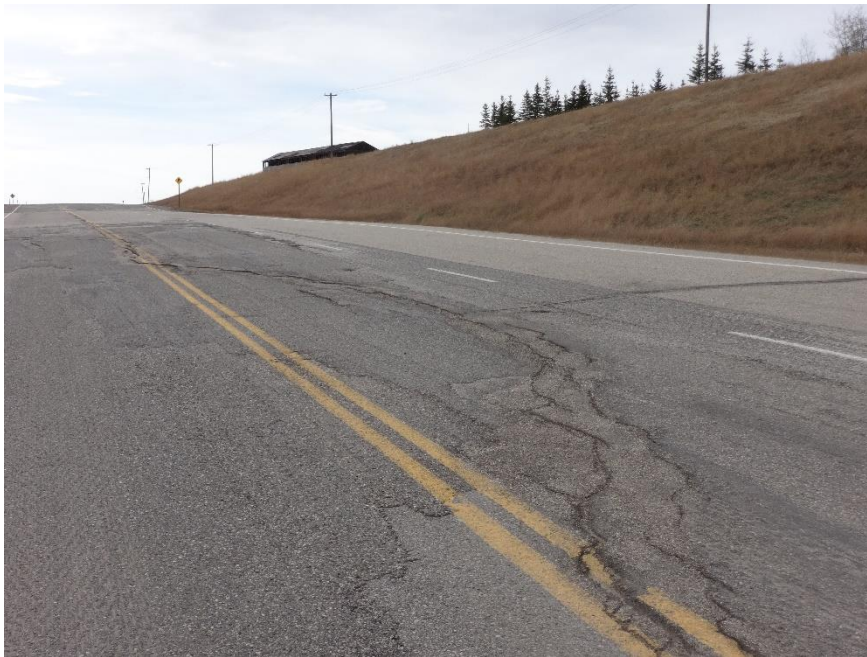
**Photo 8. Looking northwest from the middle of Hwy 49:06 from the south end of the 2021 ACP patch.
Photo Credit: Nicole Wilder.**

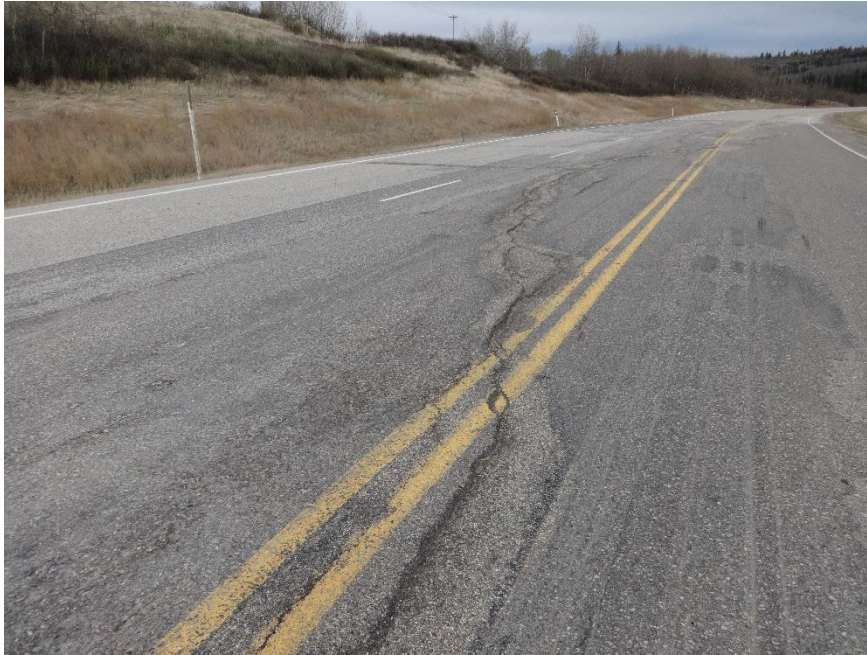
**Photo 9. Looking east from near the middle of the 2021 ACP patch where crack continues into WBL.
Photo Credit: Nicole Wilder.**

The aperture/extent of the cracks in the pavement affected by the West Approach Slides should be regularly monitored for signs of development and deterioration. Open cracks should be sealed or patched as soon as practical. A subdrain could be constructed in the north ditch to lower the groundwater level and potentially slow down slide movements.

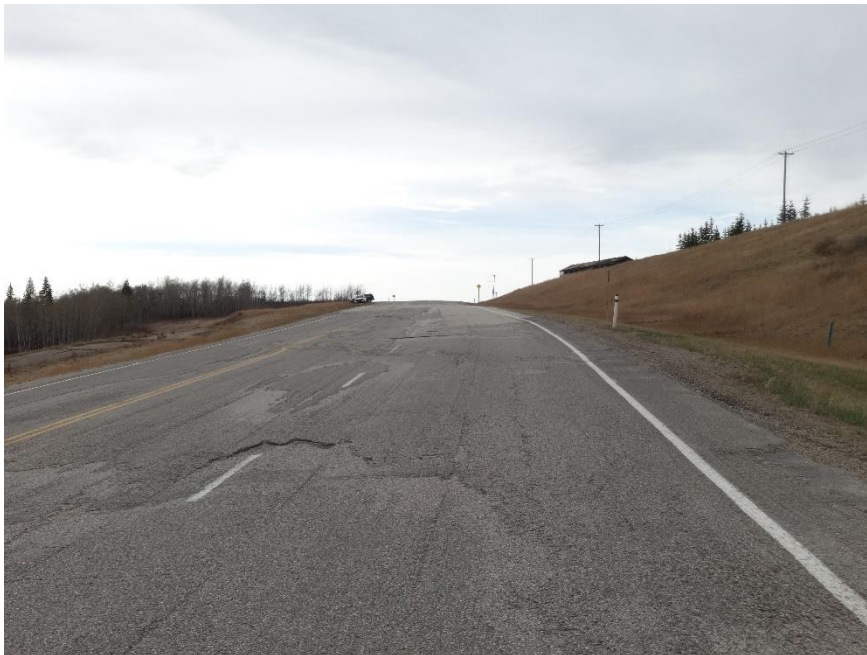
**Photo 10. Looking northwest from the EBL of Hwy 49:06 at the south end of the site. Photo Credit:
Nicole Wilder.**

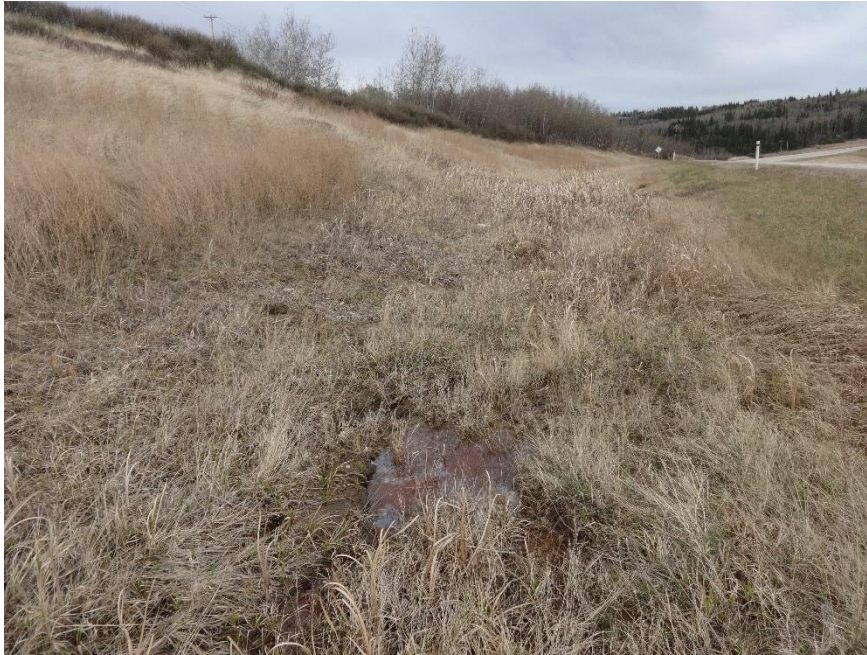
<p><input checked="" type="checkbox"/> Seepage</p>	<p>The previously ponded water area on the north side of the Highway was wet during the 2024 inspection and a larger area was wet from what appeared to be a spring. The two scour holes within the erosion gully formed to the northwest of the site were mostly dry. There was also some seepage observed above an existing 200 mm diameter CSP subdrain downslope of the scarp crack during the last inspection.</p>	<p><input checked="" type="checkbox"/></p>
<p><input checked="" type="checkbox"/> Bridge/Culvert Distress</p>		<p><input type="checkbox"/></p>
<p><input checked="" type="checkbox"/> Other</p>	<p>A 1.5 m diameter sinkhole was observed over an existing 800 mm diameter CSP culvert.</p>	<p><input type="checkbox"/></p>
<p>Instrumentation:</p>		
<p>SI-16</p>	<p>Installed about 70 m downslope of the Hwy 49:06 EBL to a depth of 30 m below ground surface at approximately the middle height of the Burnt River north valley slope. This SI showed no discernible movement since the last reading; however, between 2014 and 2016 there was an increase</p>

Photo 11. Looking southeast at ponded water and reeds on north side of highway. Photo Credit: Don Proudfoot.

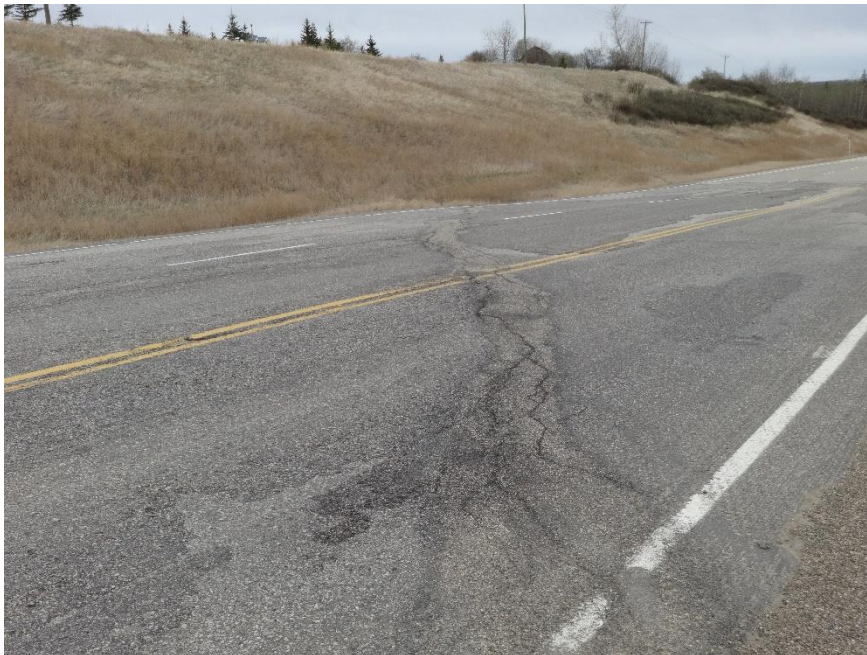
Photo 12. Looking southeast at the northwest end of the site at scarp crack open on the SBL shoulder. Photo Credit: Nicole Wilder.

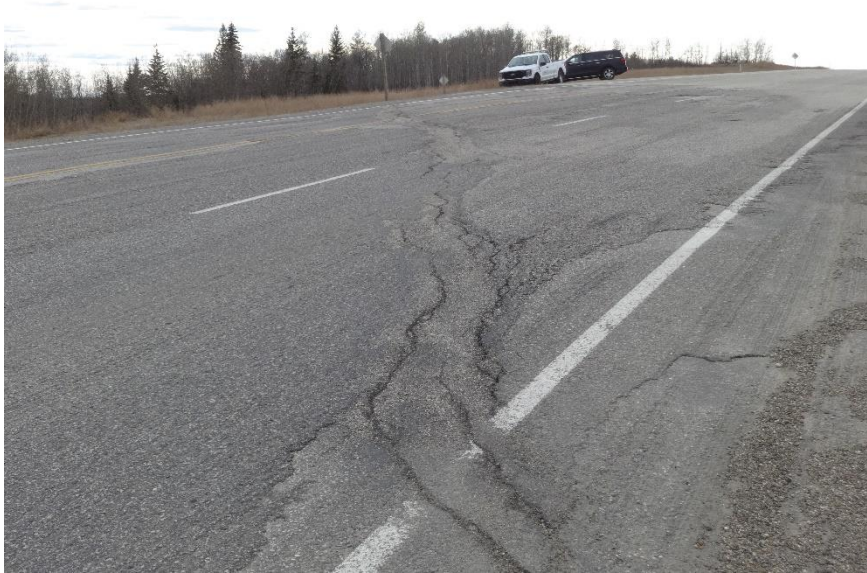
Photo 13. Looking southwest at the northwest end of the site at the scarp crack. Photo Credit: Don Proudfoot.

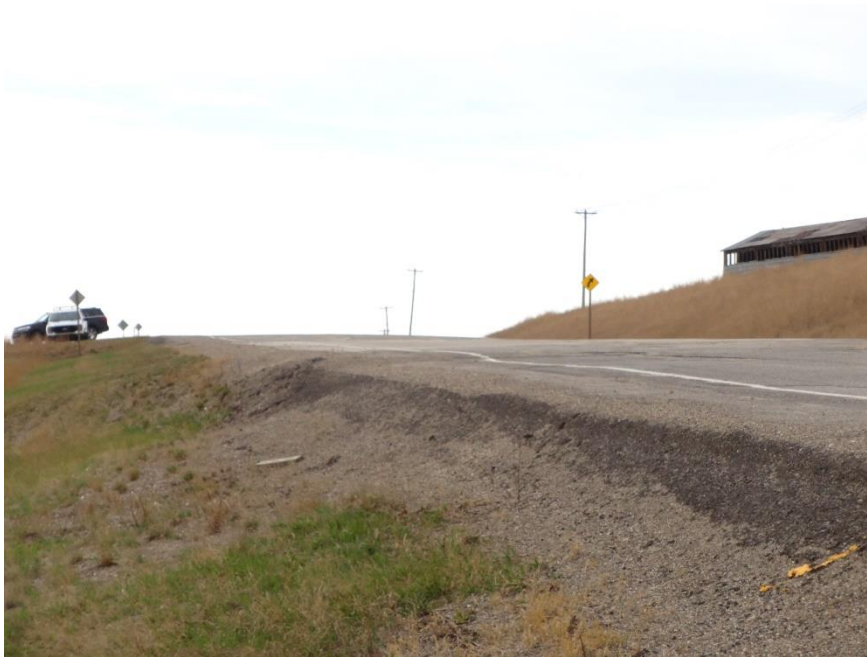
Photo 14. Looking north at the thick accumulation of asphalt patches in the landslide area . Photo Credit: Nicole Wilder.

Due to continued patching/milling of the roadway the south shoulder of the road is currently quite steep and sharp. Consideration should be given to add some compacted gravel on the south side slope to minimize the differential drop. This work may be done at the next time TEC is patching the roadway. A guardrail should also be installed along the eastbound lane shoulder
