**ALBERTA TRANSPORTATION  
GEOHAZARD ASSESSMENT PROGRAM  
PEACE REGION (GRANDE PRAIRIE DISTRICT-NORTH)  
2023 INSPECTION**

**THURBER ENGINEERING LTD.**

Site Number	Location	Name (Old Site 5)	Hwy	km
PH023	12 km W. Cleardale	Clear River East Hill-Twin Pipes	64:02	23.4-24.1
Legal Description		UTM Co-ordinates (NAD 83)		
NE28/NW27-84-11-W6		11 N 6244273	E 335460

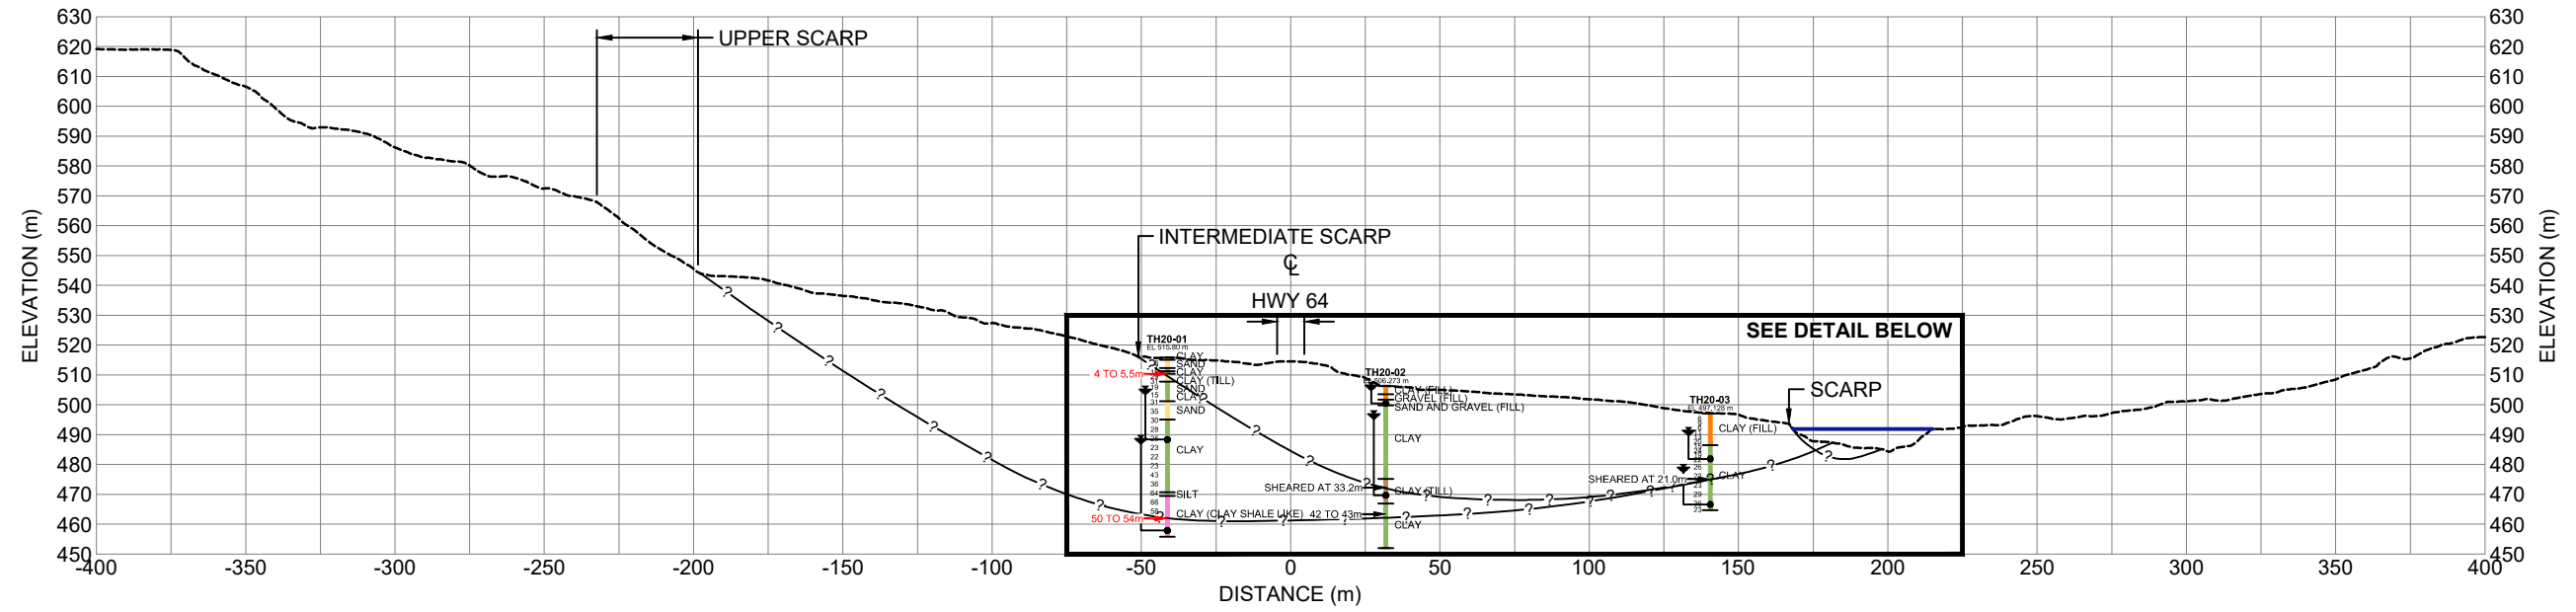
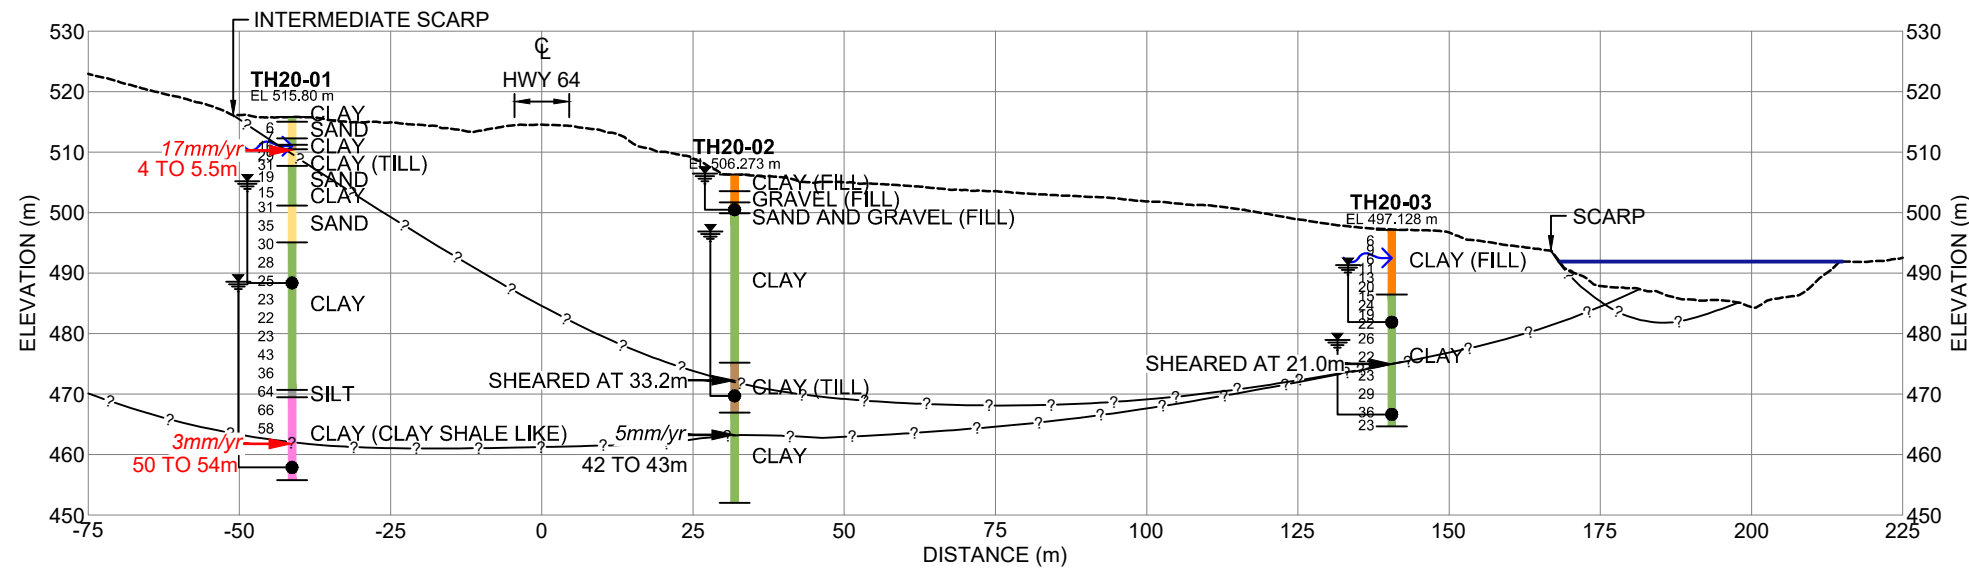
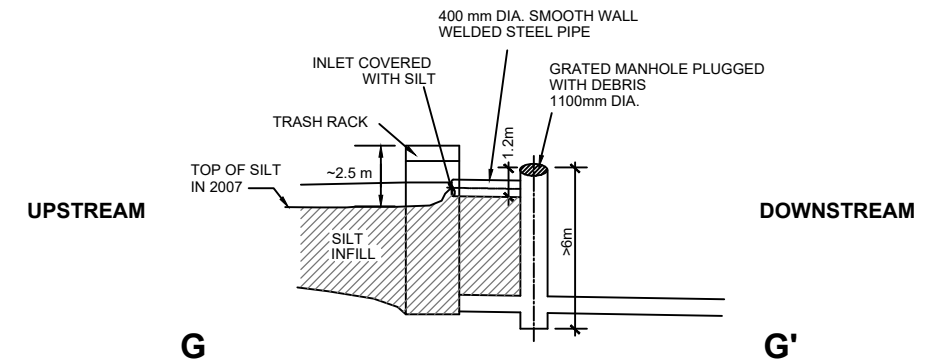
**DWG No. 32123-PH023-4**

**Instrumentation:** Last read June 23, 2023 - The inclinometer movement zones, and piezometer tip depth measurements are shown on the cross-sections attached (Drawings PH023-4 to -6).

**20-1:** 17mm/yr @ 4 to 5.5m; & 3mm/yr @ 50 to 54m. **20-2:** Sheared off at 33.2m (but former movement zones @ 32 to 34m & 42 to 43m). **20-3:** Sheared off at 21.0m (former movement zone @ 19.5 to 21m). **20-4:** Sheared off at 7.6m (but former movement zones @ 6 to 8m & 60 to 62m). **20-5:** Sheared off at 11.6m (but former movement zones @ 9 to 12m & 31 to 36m). **20-6:** Sheared off at 20.1m, (but former movement zones @ 18 to 20m & 28 to 31m). **20-7:** 8mm/yr @ 18 to 20m; & 3mm/yr @ 32 to 34m. **20-8:** Sheared off at 36.2m (former movement zone @ 34 to 37m).

- At Section A (near the east end), two additional measures include: a) Lowering the water table by 2 to 3 m over a 100 m wide x 250 area long area by installing a series of closely spaced trench (slot) drains that drain into the base of the tributary fill; and b) Reconstructing a 200 m length of slide compromised highway with lightweight fill by excavating a 5 m thickness of ACP, GBC, and clay fill.

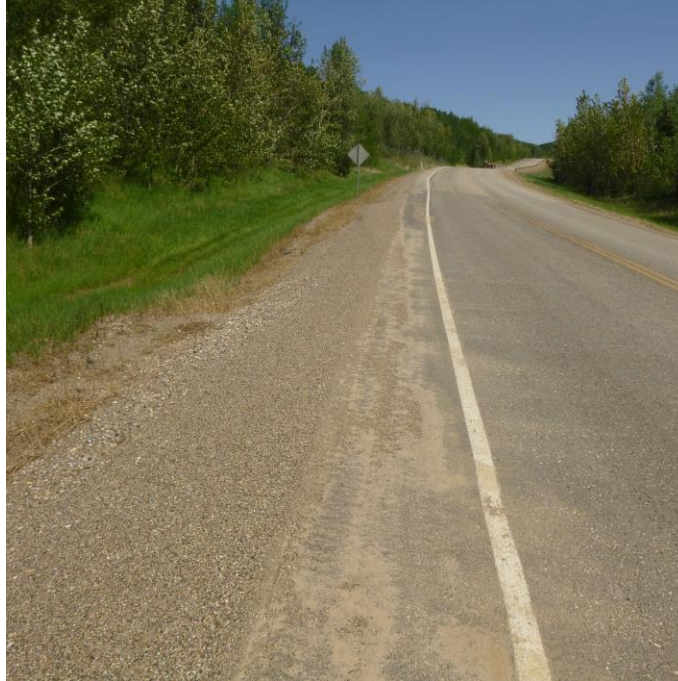
Photo 1 - Looking east along the highway at the milled/patched area over the two cracks first observed in 2013 that mark the west boundary of the slide on the highway. Note the two settled areas along the north edge of the hwy embankment.

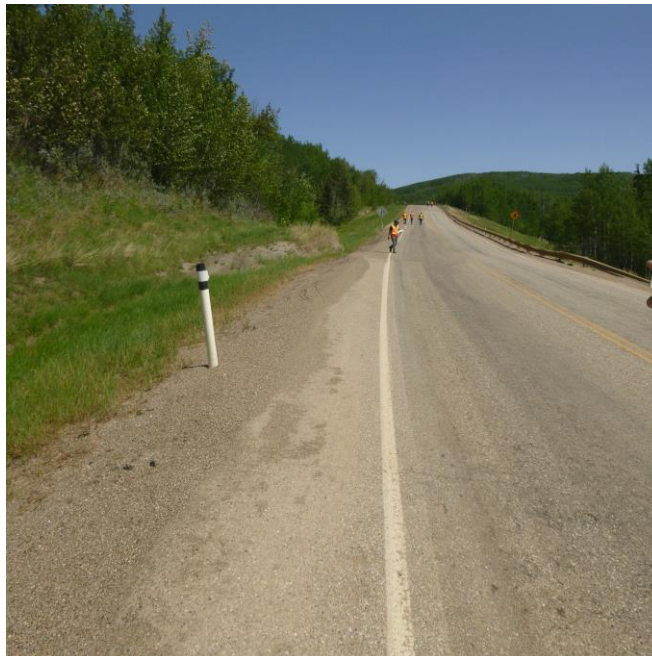
Photo 2 – Looking east along the highway and scarp in the north ditch, and large dip that extends across the highway at this location, near the west end of the site.

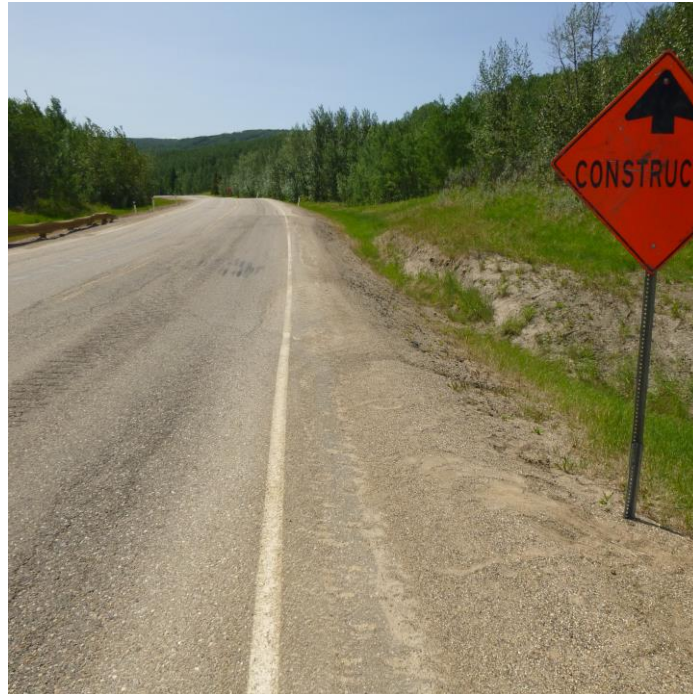
Photo 3 – Looking west from near the west end of the guardrails along the slide scarp that extends along the north highway ditch.

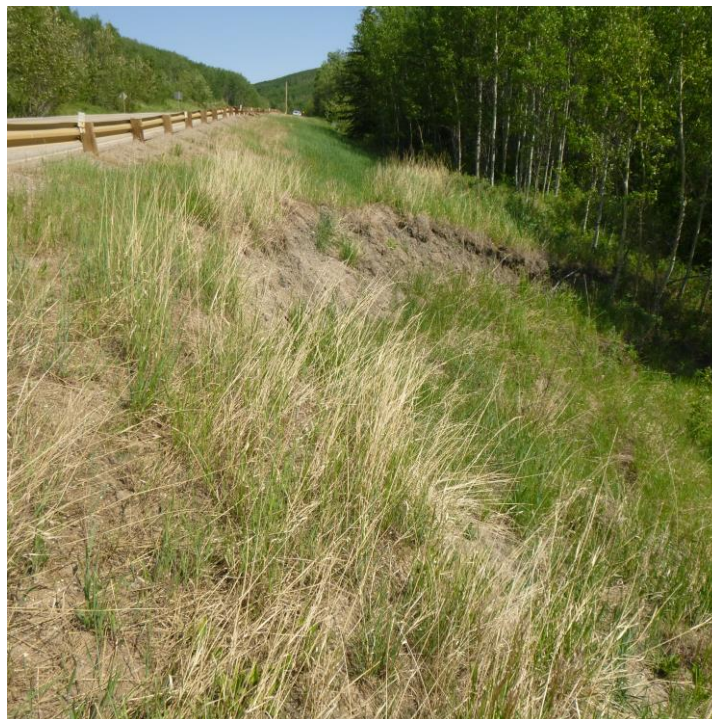
Photo 4 – Looking east at Embankment Slump A on the south side of the hwy.

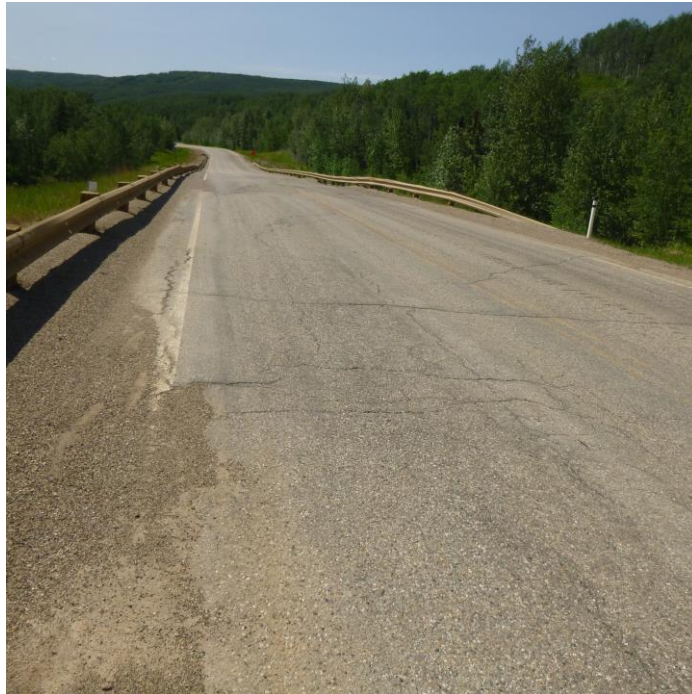
Photo 5 – Looking west along the distorted highway at previous slide cracks east of the northeast guardrail end.

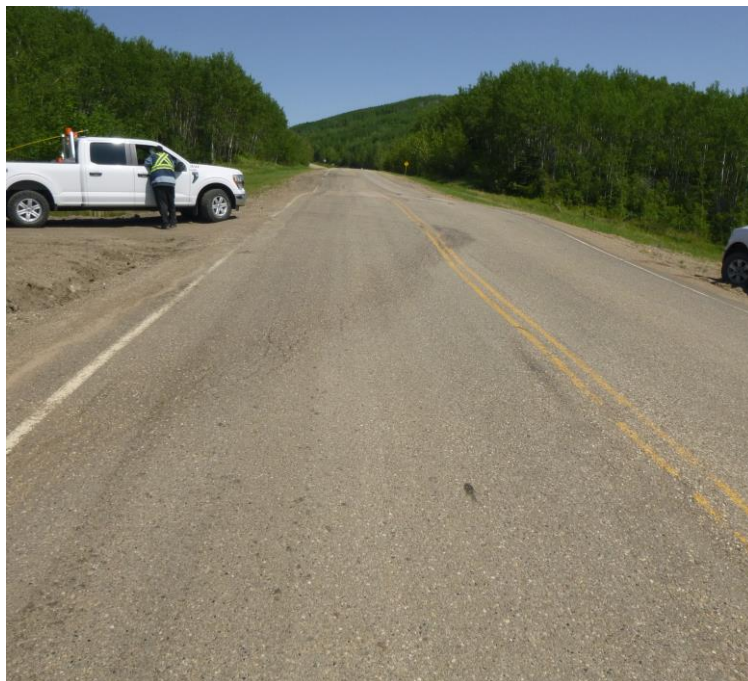
Photo 6 – Looking east at the west milled/patched area over the east slide crack.

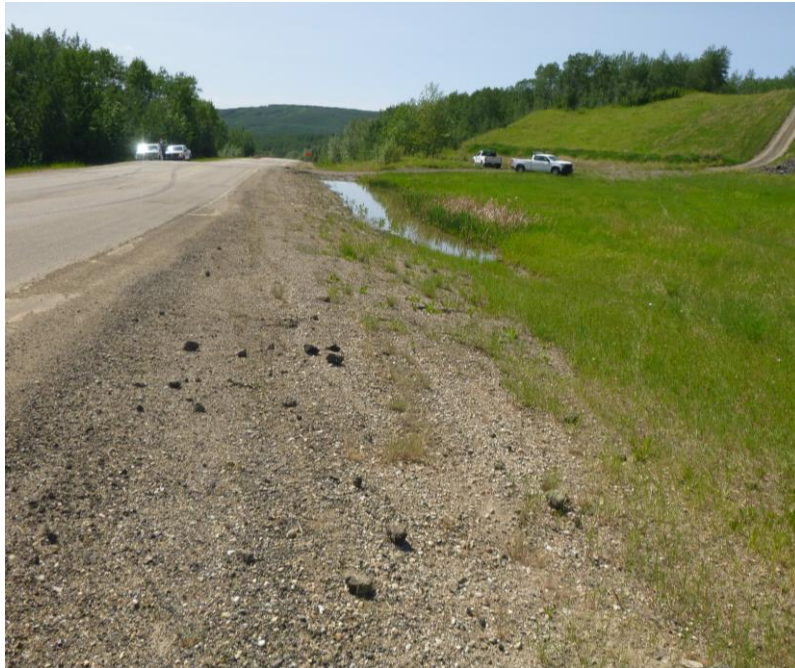
Photo 7 – Looking west along the north highway ditch at the sagged area with ponded water and north approach in the background.

- Remove approach on north side of Hwy (once all temporary stockpiling work is completed but prior to draining the ponded water and regrading the ditch).

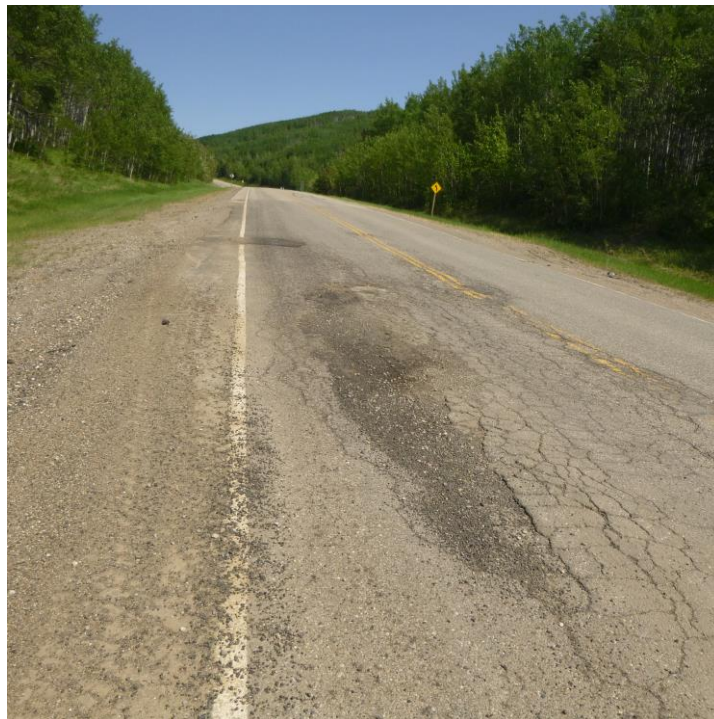
Photo 8 - Looking east along the highway at the alligator cracked hwy area at the east end of the site.

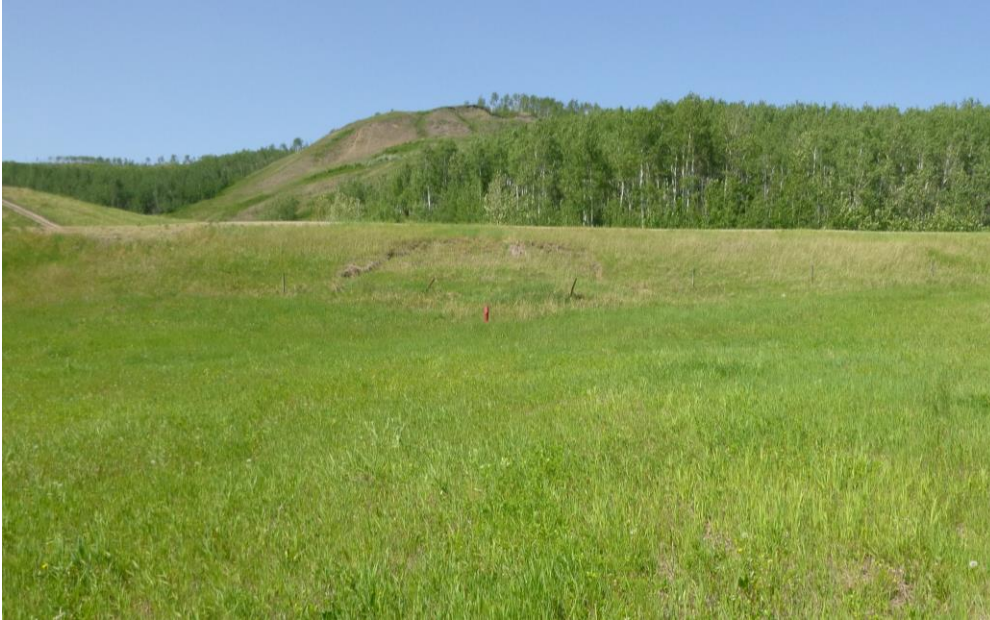
Photo 9 – Looking north at the slump in the south hwy embankment, from the top of the piping area.

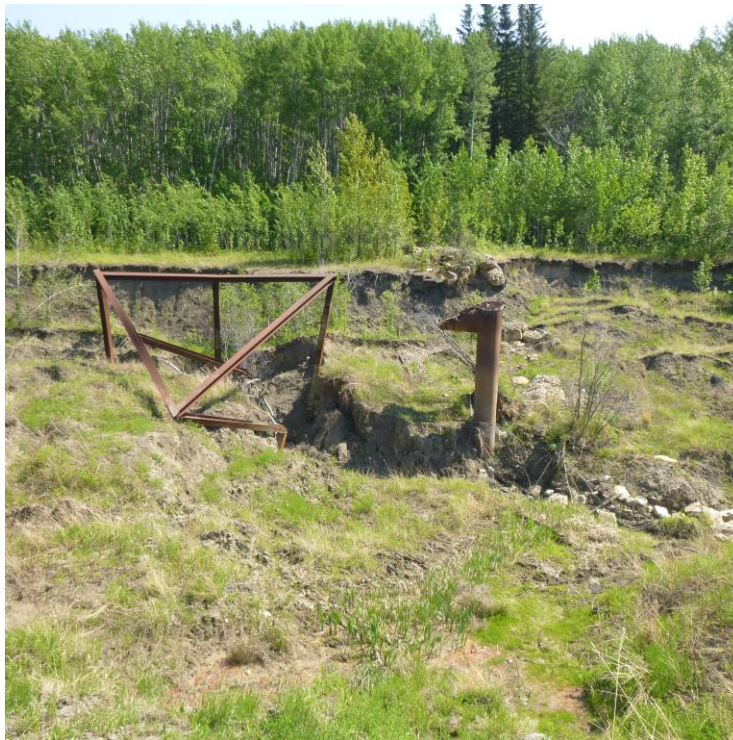
Photo 10 – Looking south across the eroded channel at the twin pipe riser inlets and eroded trash rack.

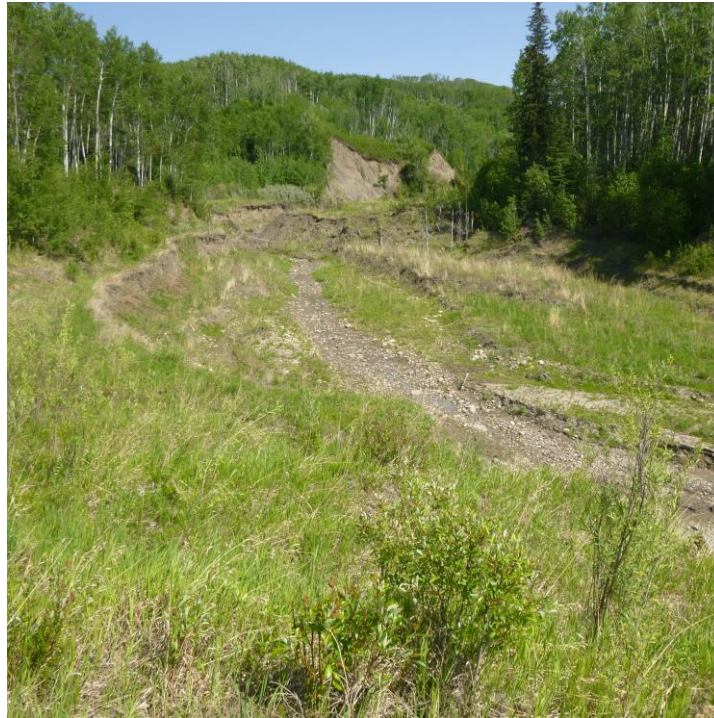
Photo 11 – Looking east at the upstream end of the eroded and silted in tributary channel.

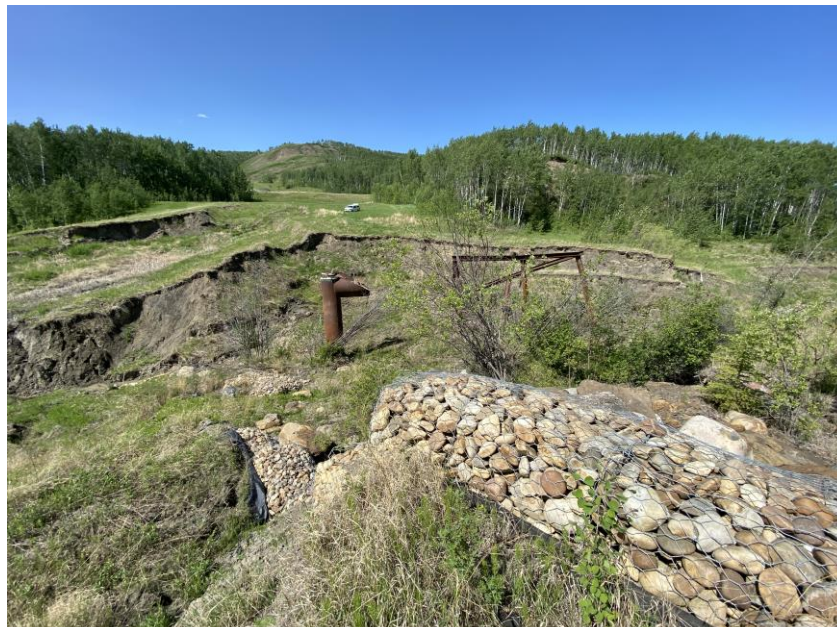
Photo 12 - Looking north across the eroded tributary channel towards the highway, at the eroded piping area (LHS), twin pipe inlets and trash rack (Center), and eroded gabion weir (Foreground).

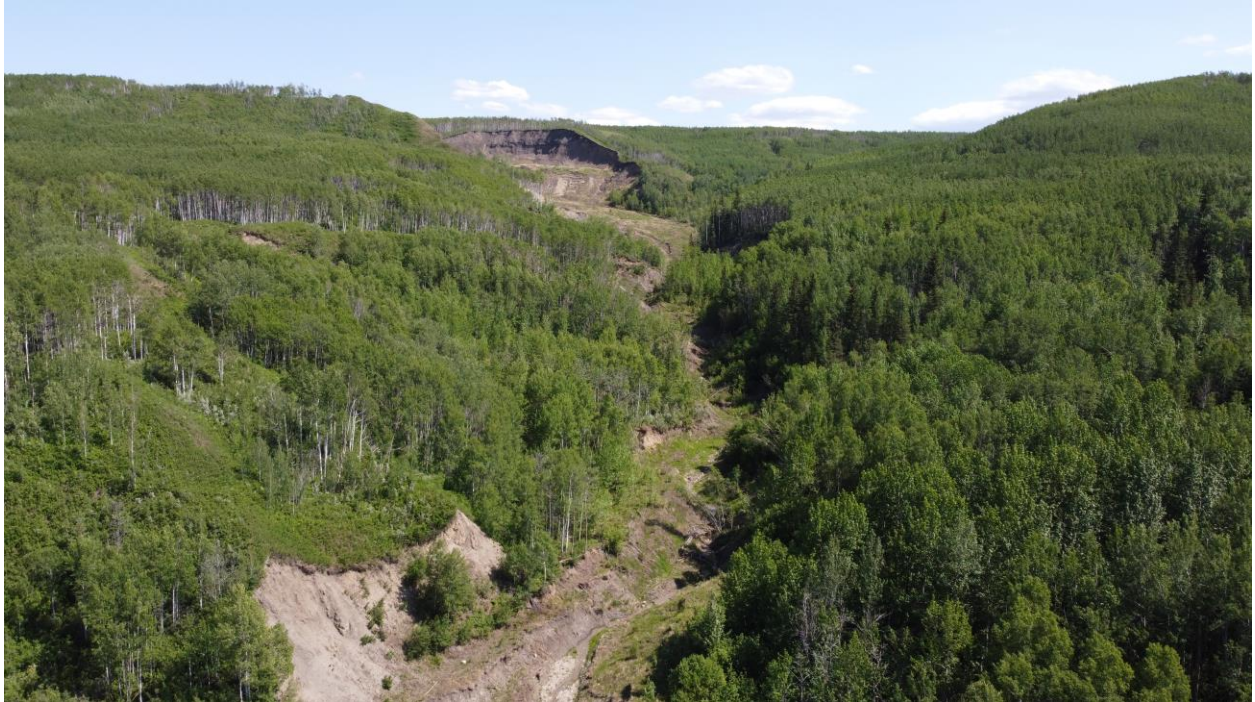
Drone Photo 13 – Looking southeast along the south tributary branch. Note the erosion bowl near the top part of the photo.

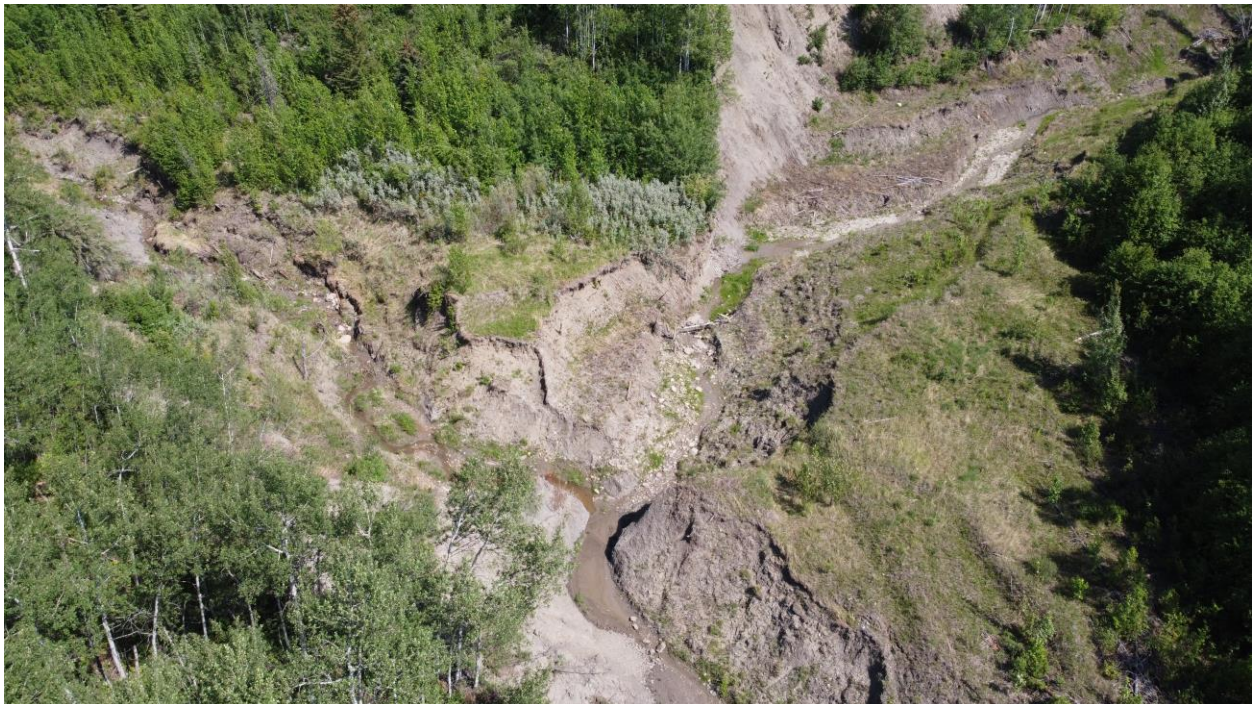
Drone Photo 14 – Looking east at the point where the two tributary branches merge into one.

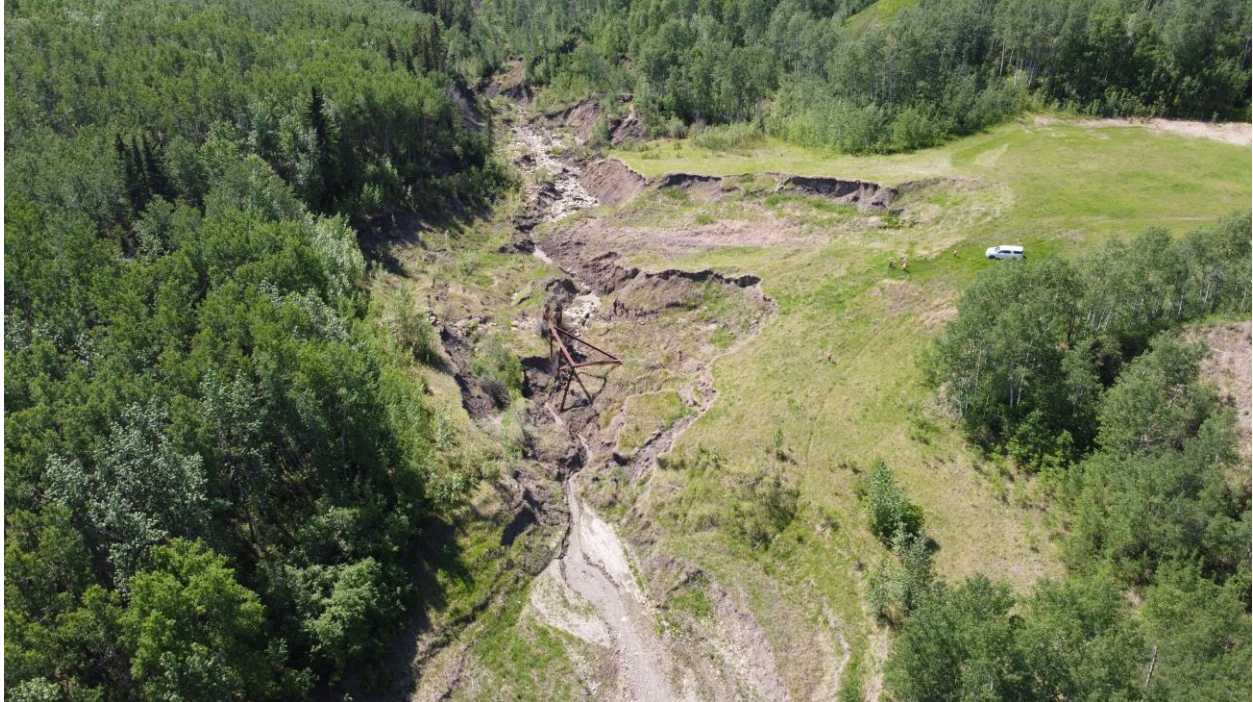
Drone Photo 15 – Looking west along the eroded creek channel at the twin pipe inlet risers, and the eroded trash rack.

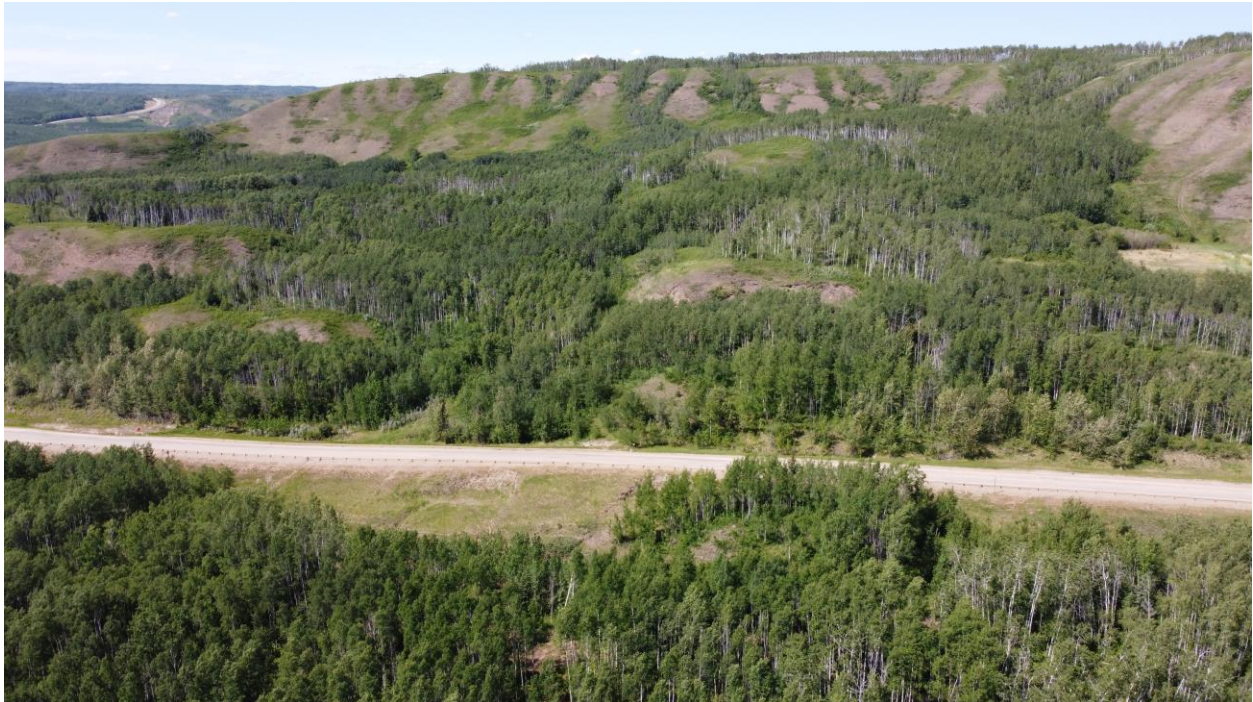
Drone Photo 16 – Looking north across the highway and north slope from the site center.
