**ALBERTA TRANSPORTATION AND
ECONOMIC CORRIDORS GRMP
PEACE REGION
(GRANDE PRAIRIE DISTRICT - NORTH)
INSTRUMENTATION MONITORING - FALL 2024**

Site Number	Location	Name	Hwy	km
PH023	HWY 64:02 km 24.10	Clear River East Hill (Site 5- Twin Pipes Landslide)	64:02	Km 24.1
Legal Description: 12-27-84-11 W6		UTM Co-ordinates		
		11U E 335453	N	6244315

Current Monitoring:	24-Sep-2024	Previous Monitoring	27-May-2024
Instruments Read By:	Mr. Neil McDonald and Mr. Nixson Mationg of Thurber

**SITE PH023: HWY 64:02, CLEAR RIVER EAST HILL
(SITE 5 – TWIN PIPES LANDSLIDE)**

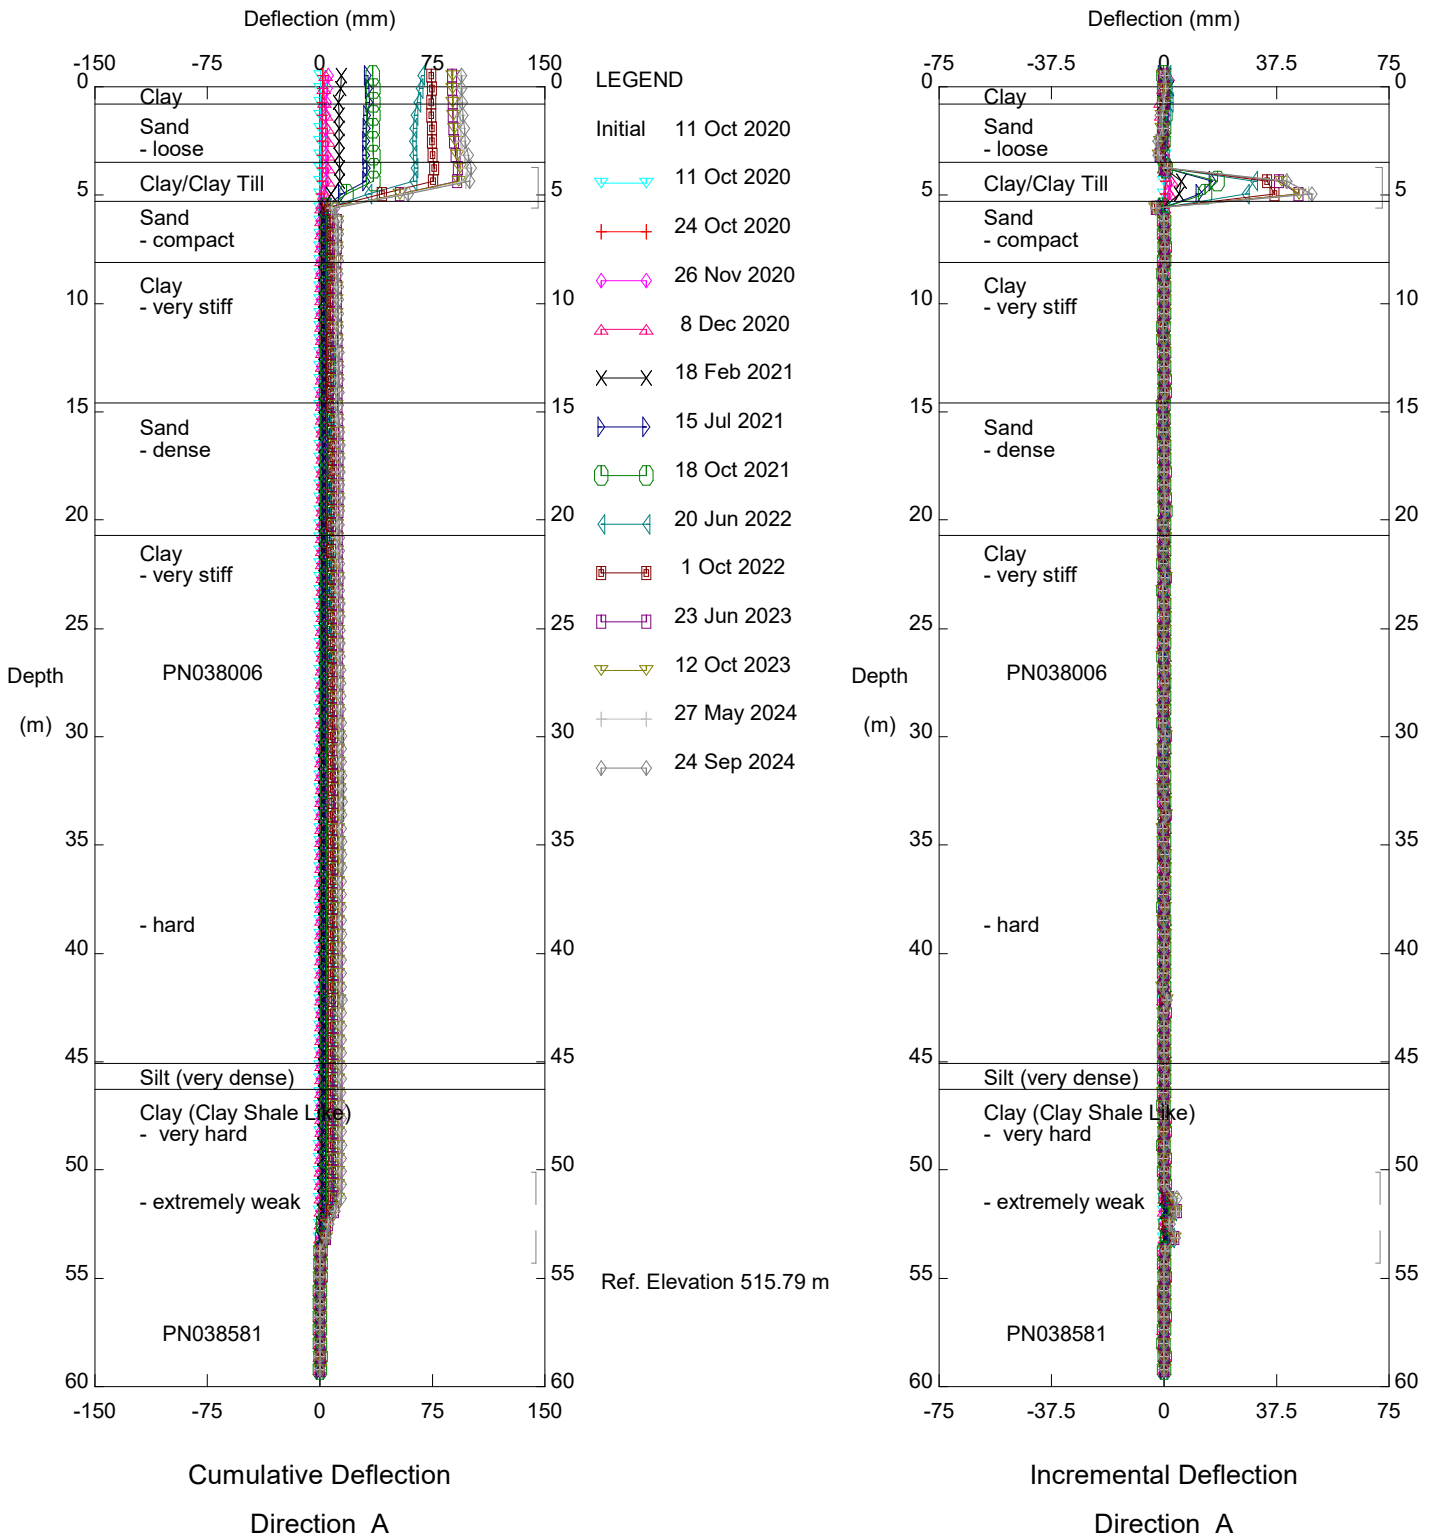
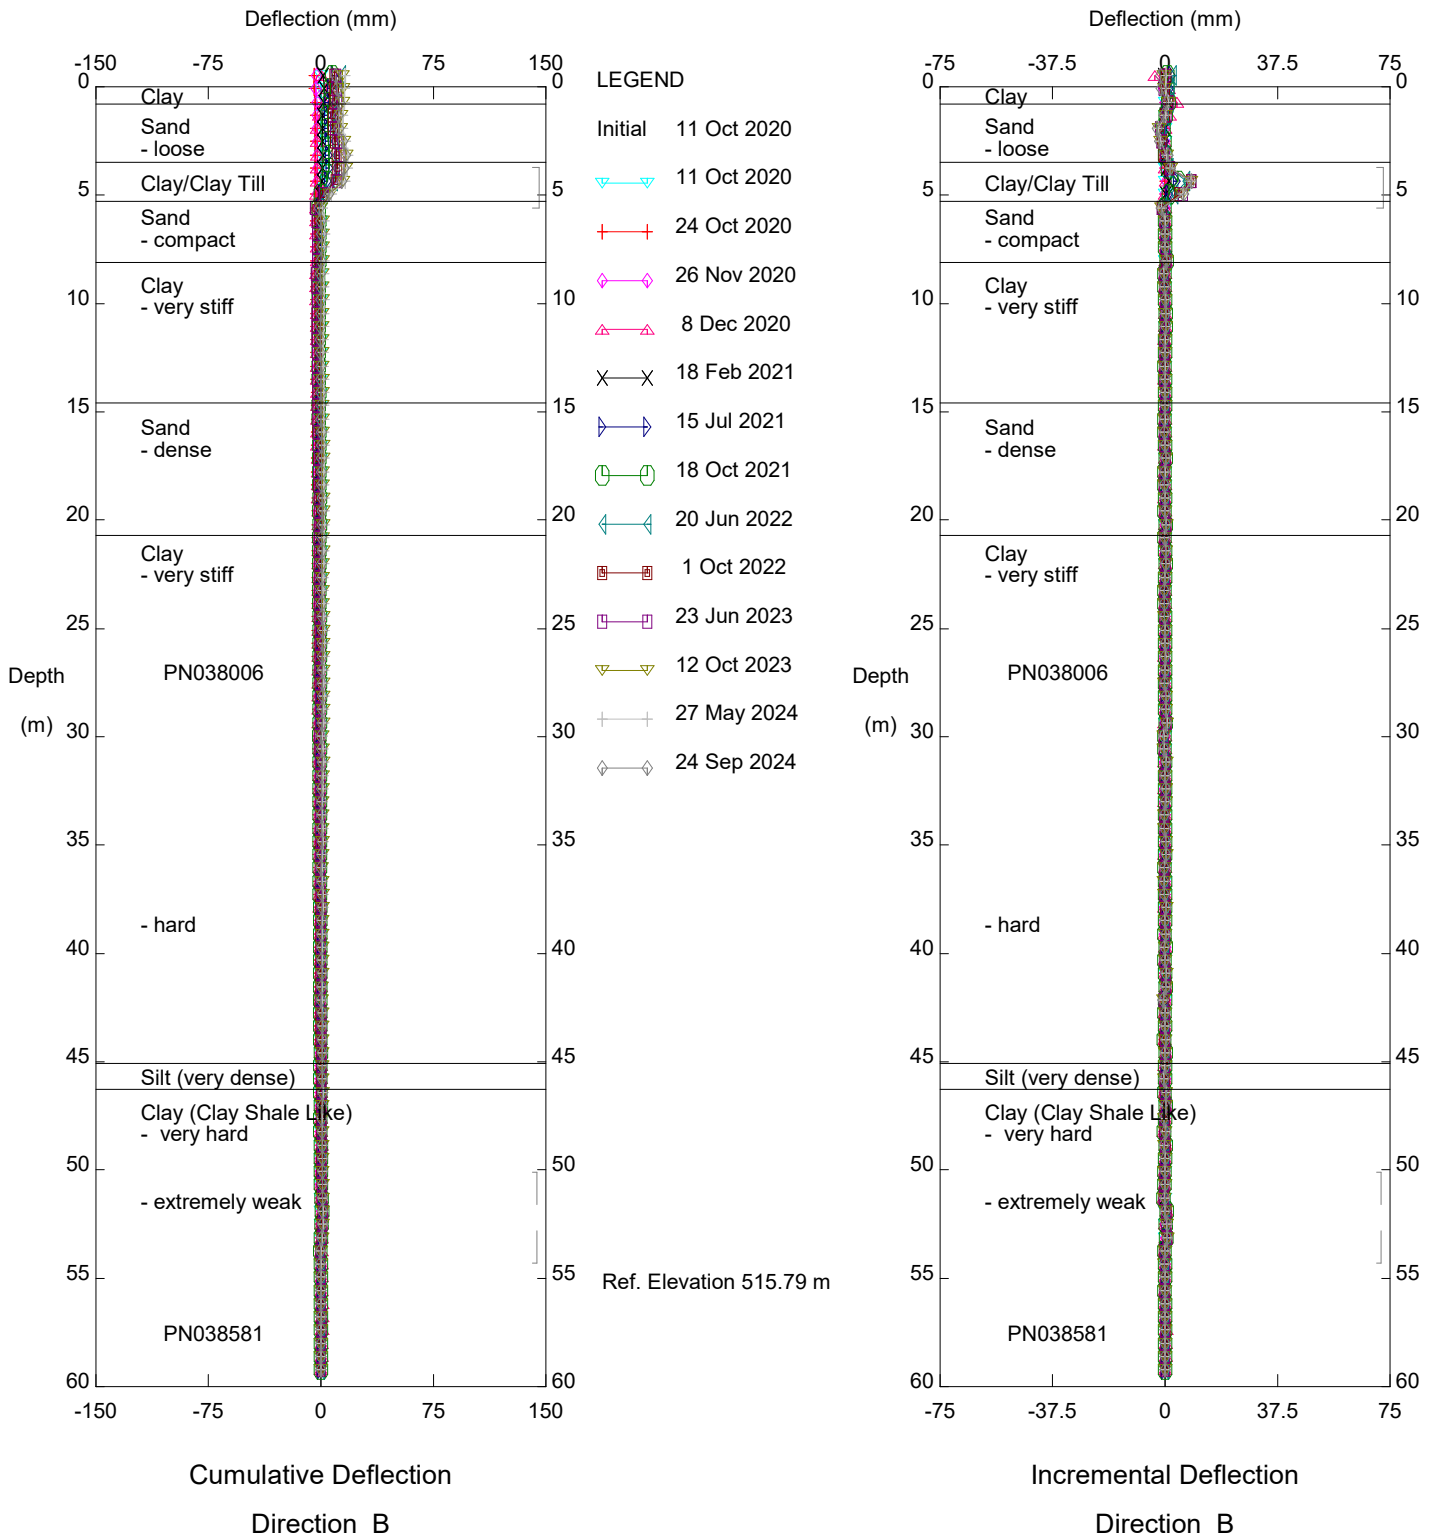
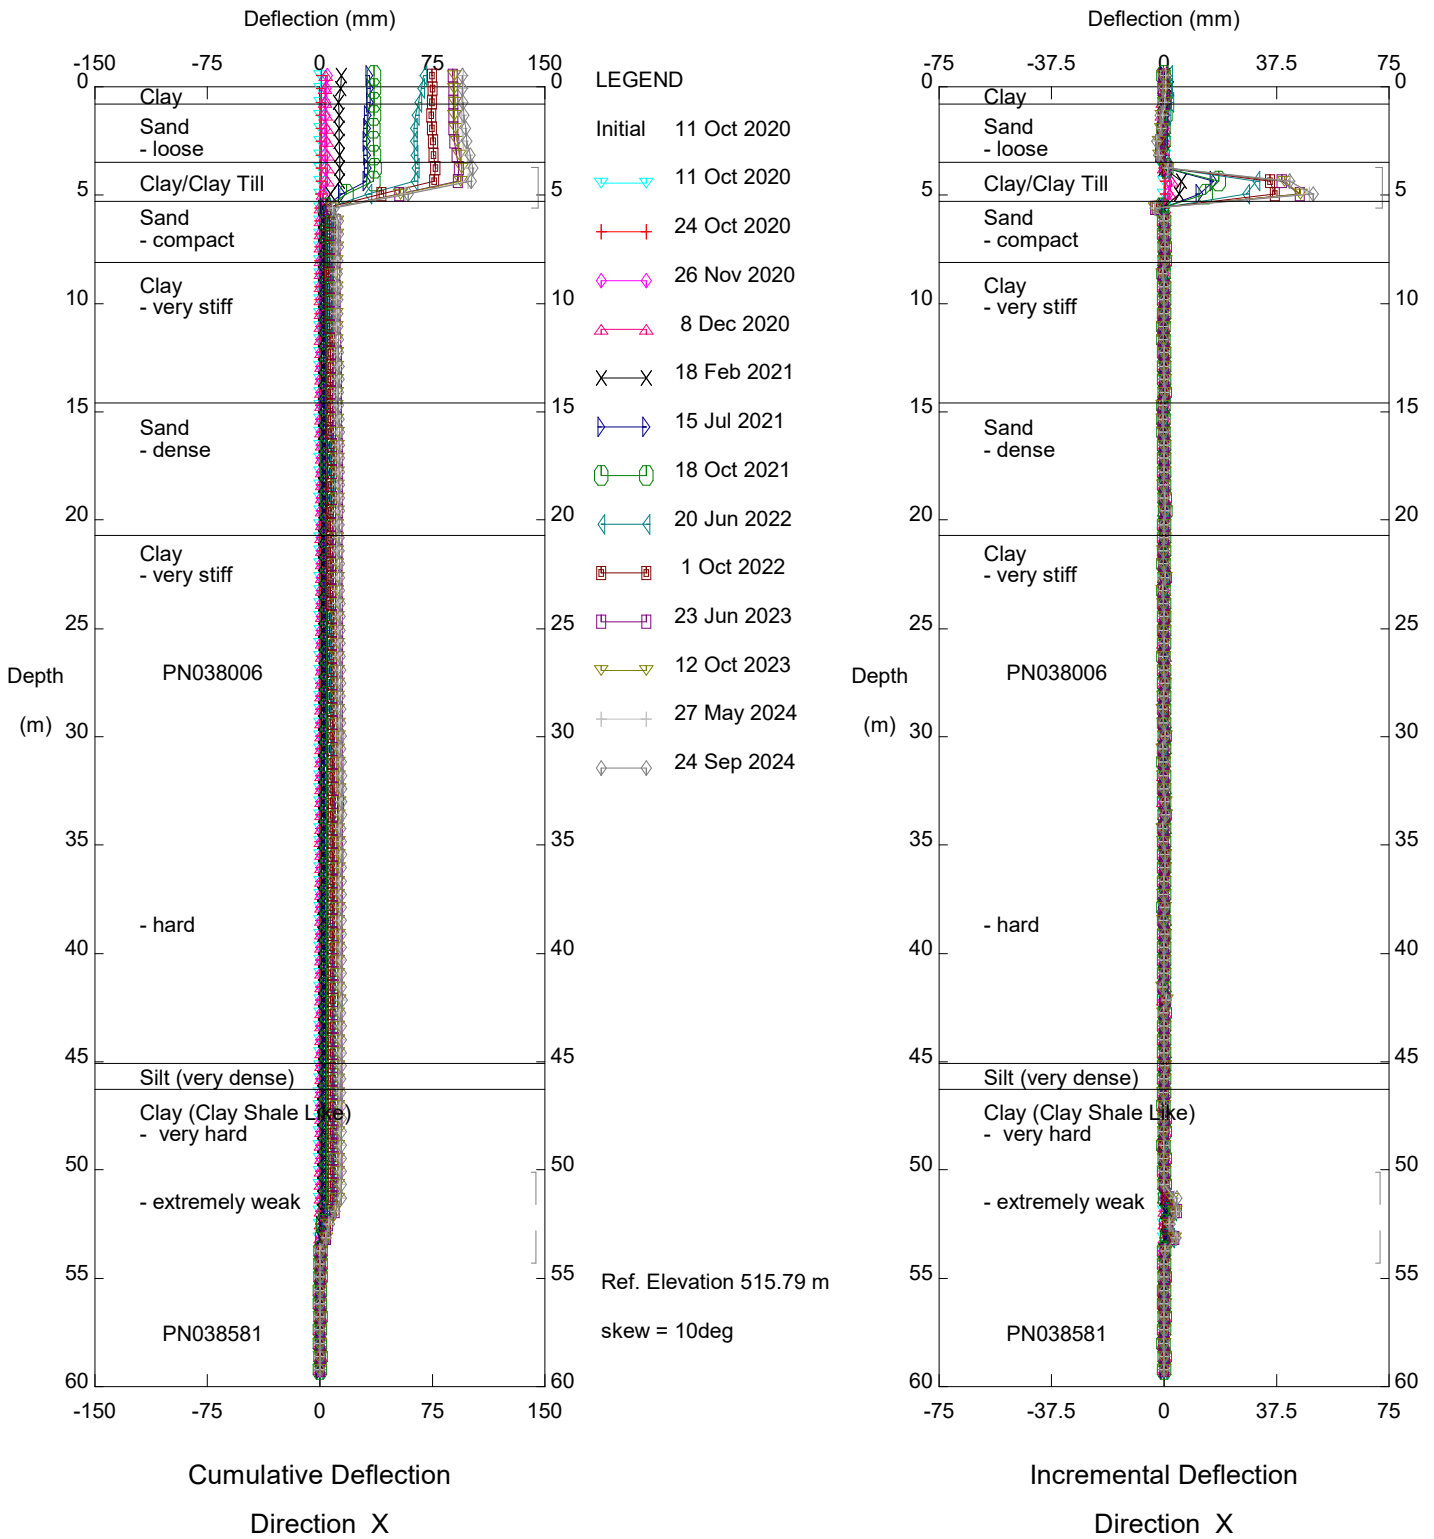
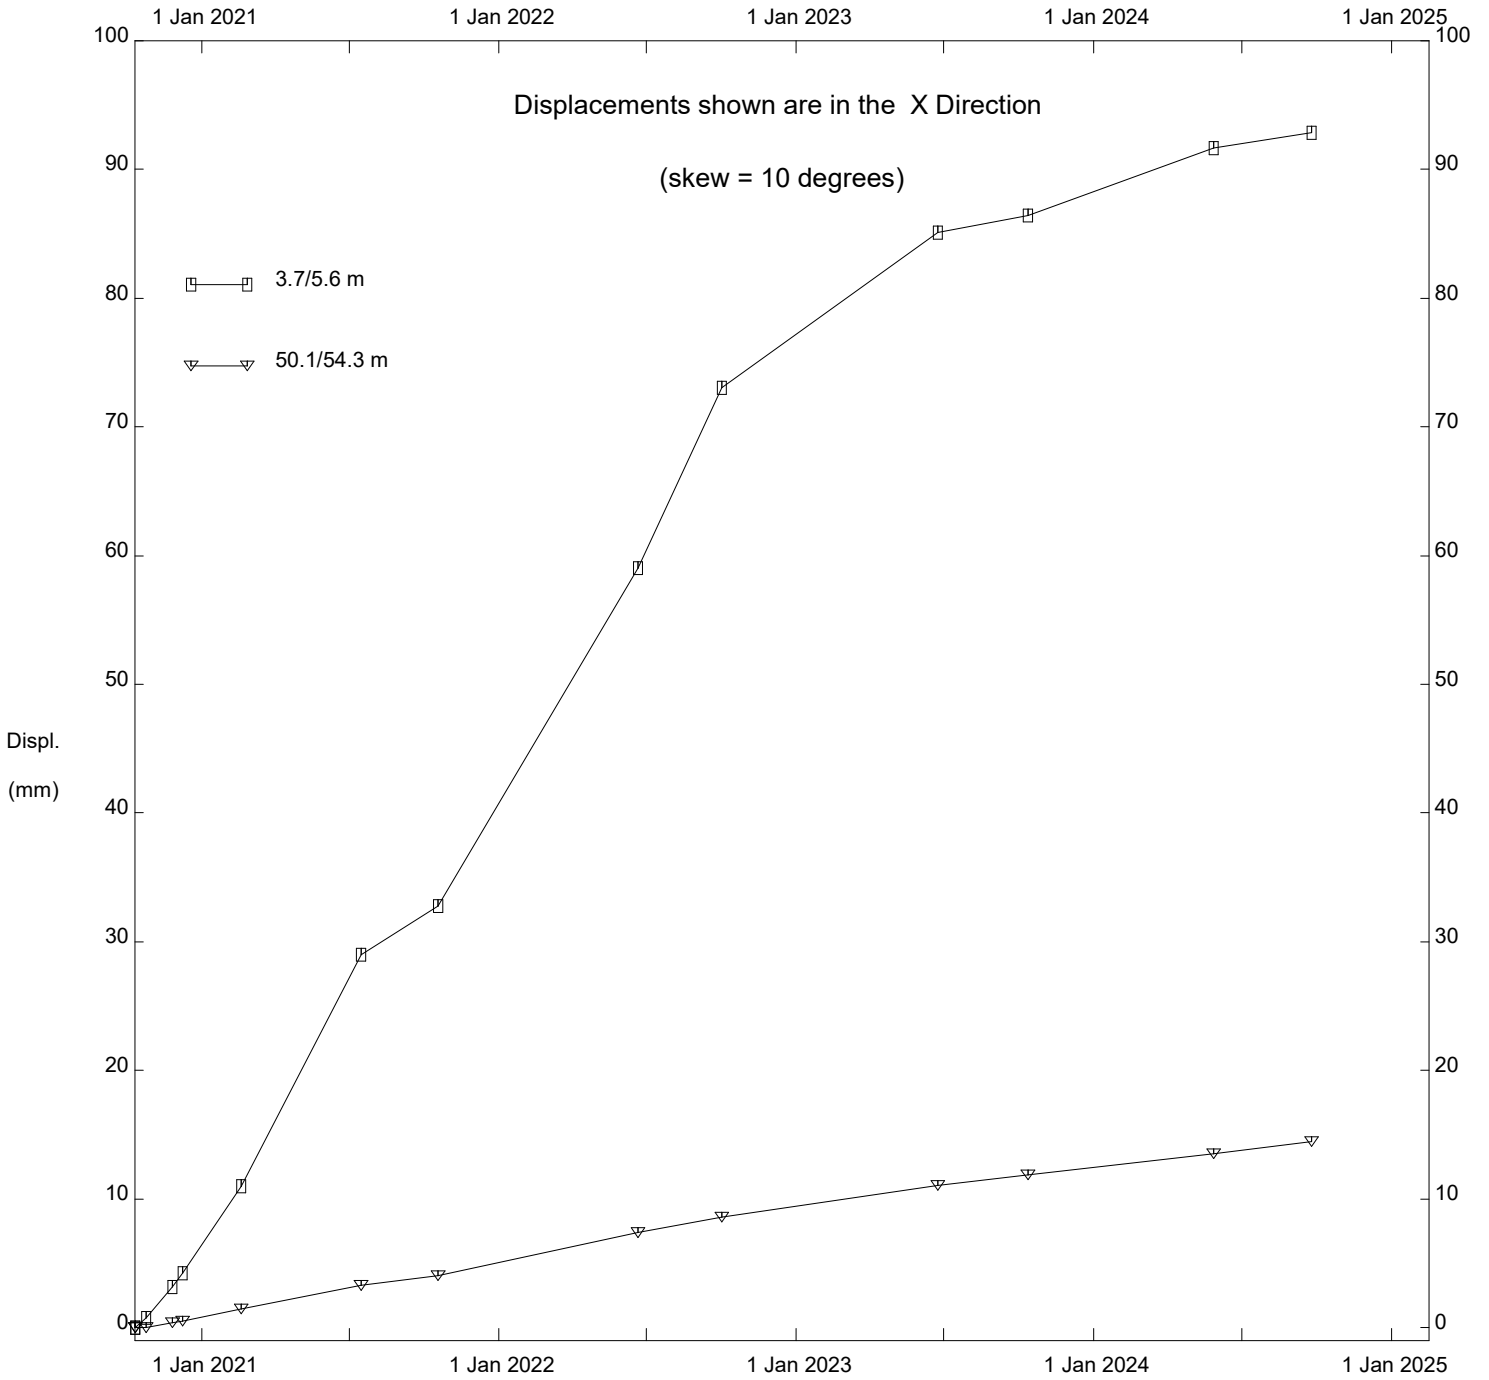
Hwy 64:02 Twin Pipes Landslide (PH023), Inclinometer SI20-1

Discussion	
Zones of New Movement:	None
Interpretation of Monitoring Results:	<p>Overall, the SIs showed similar or accelerated rates of movement compared to the previous readings in the fall of 2023.</p> <p>SI20-1 showed current movement rates of 3.6 mm/yr over 3.7 m to 5.6 m depth and 2.8 mm/yr over 50.1 m to 54.3 m depth. SI20-7 showed rates of movement of 0.8 mm/yr over 17.8 m to 19.6 m and 1.2 mm/yr over 31.8 m to 33.6 m depth. SI 20-1 and 20-7 are about 600 m apart but both show comparable movement rates and elevation of the deeper movement zones (both SI are moving at about elevation 460 m in a weak clay strata) which is a confirmation of a very large and deeply seated movement mass.</p> <p>The groundwater levels in piezometers PN20-1A, PN20-4A, and PN20-7A showed increases in ground water levels of 2.18 m, 0.07 m, and 0.21 m, respectively, since the spring of 2024 readings. The water level elevation of 506.85 m measured in PN20-1A is the highest since the instrument was initialized. PN20-1B, PN20-2A, PN20-3B, PN20-5A, PN20-7B, PN20-8A, and PN20-8B showed decreases in groundwater</p>

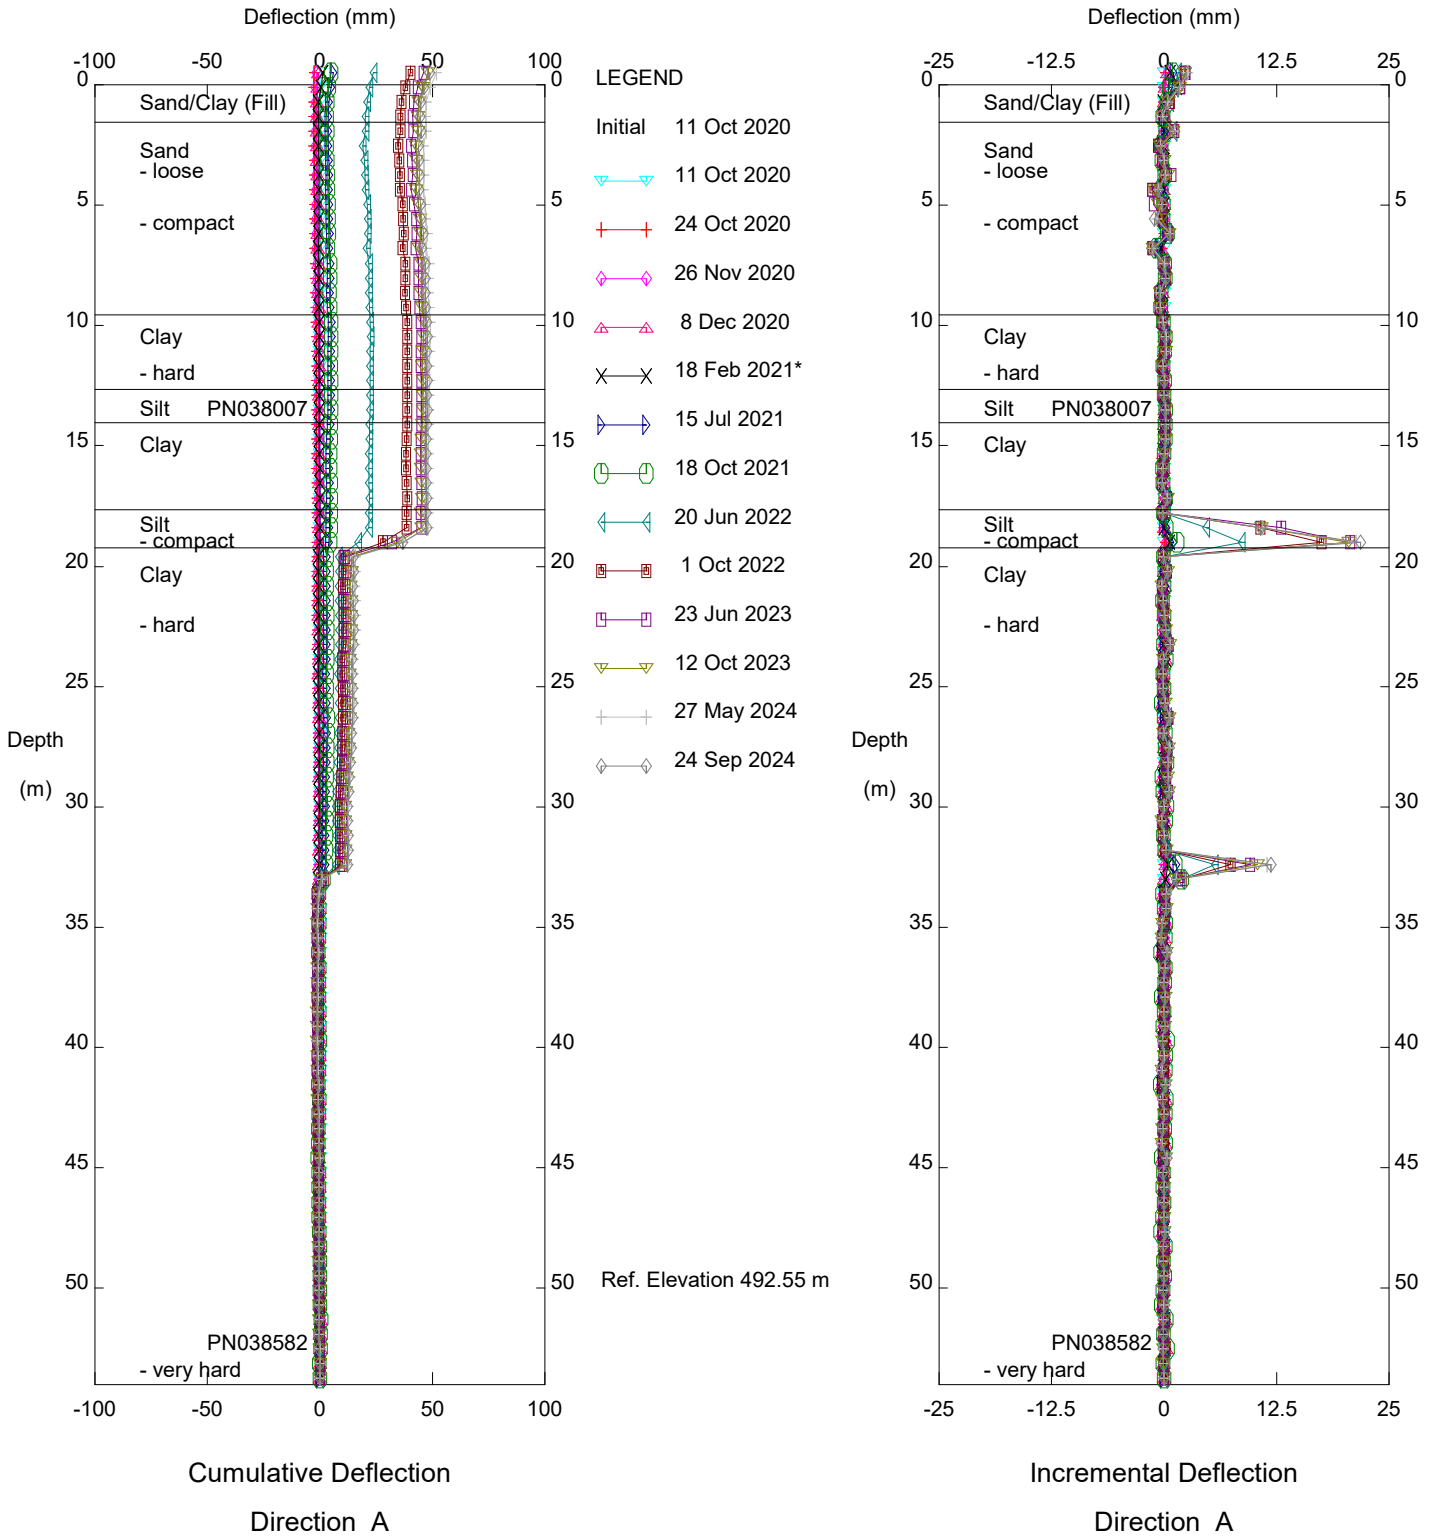
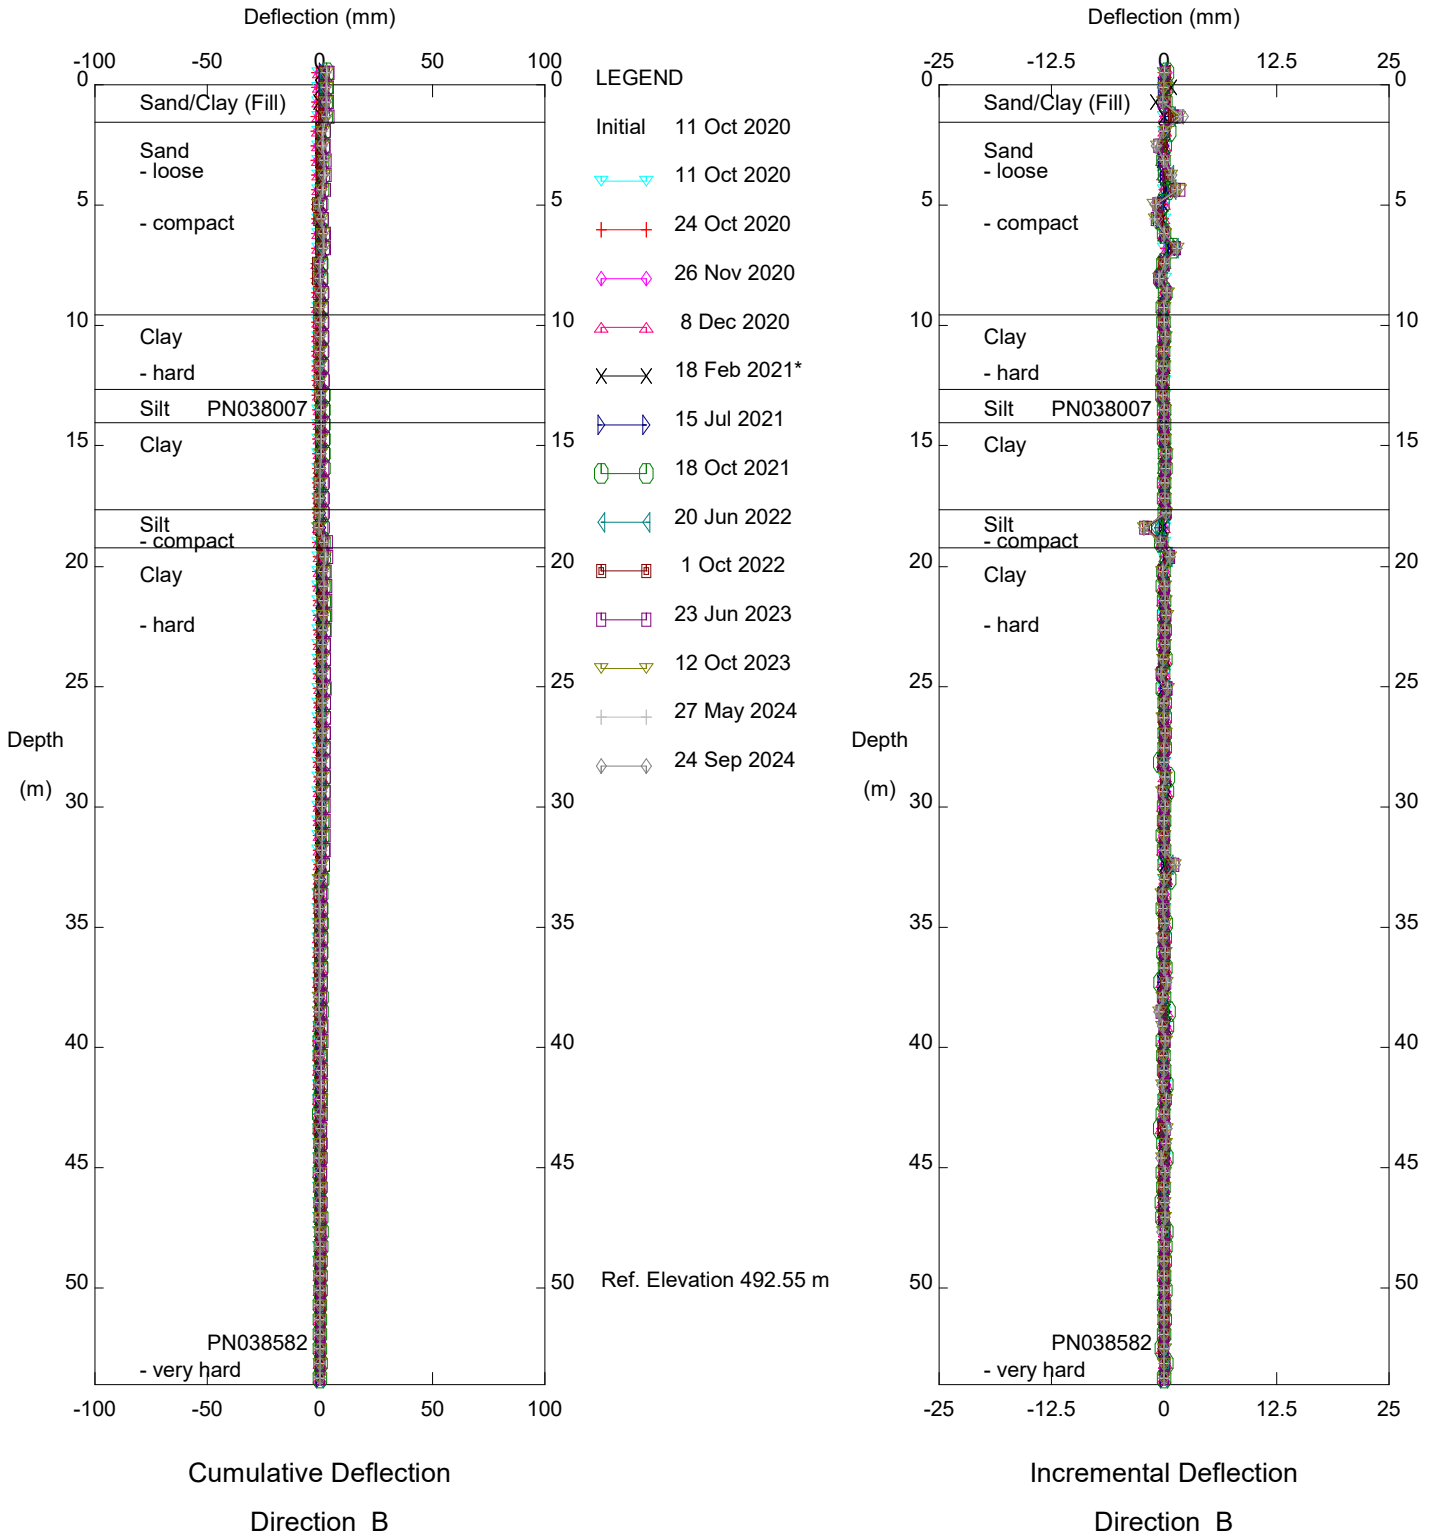
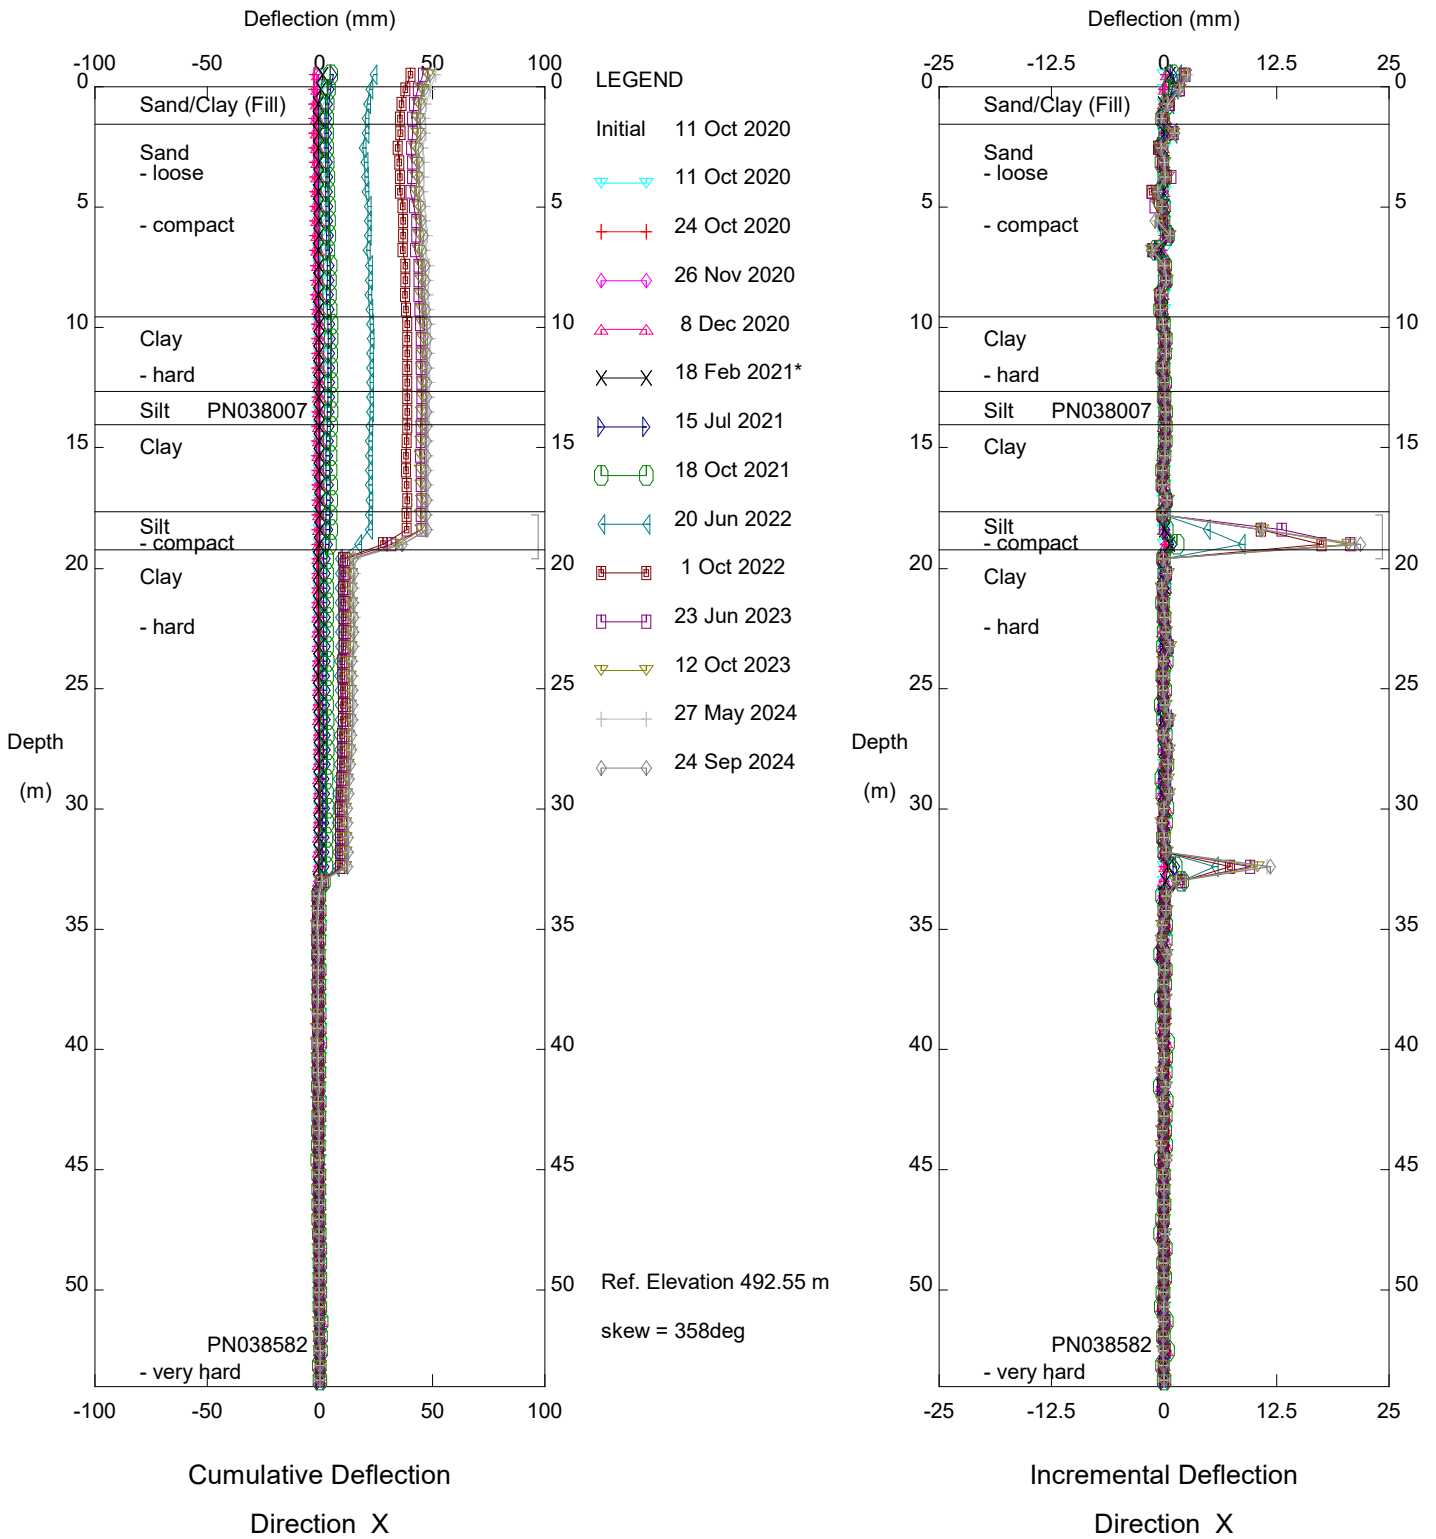
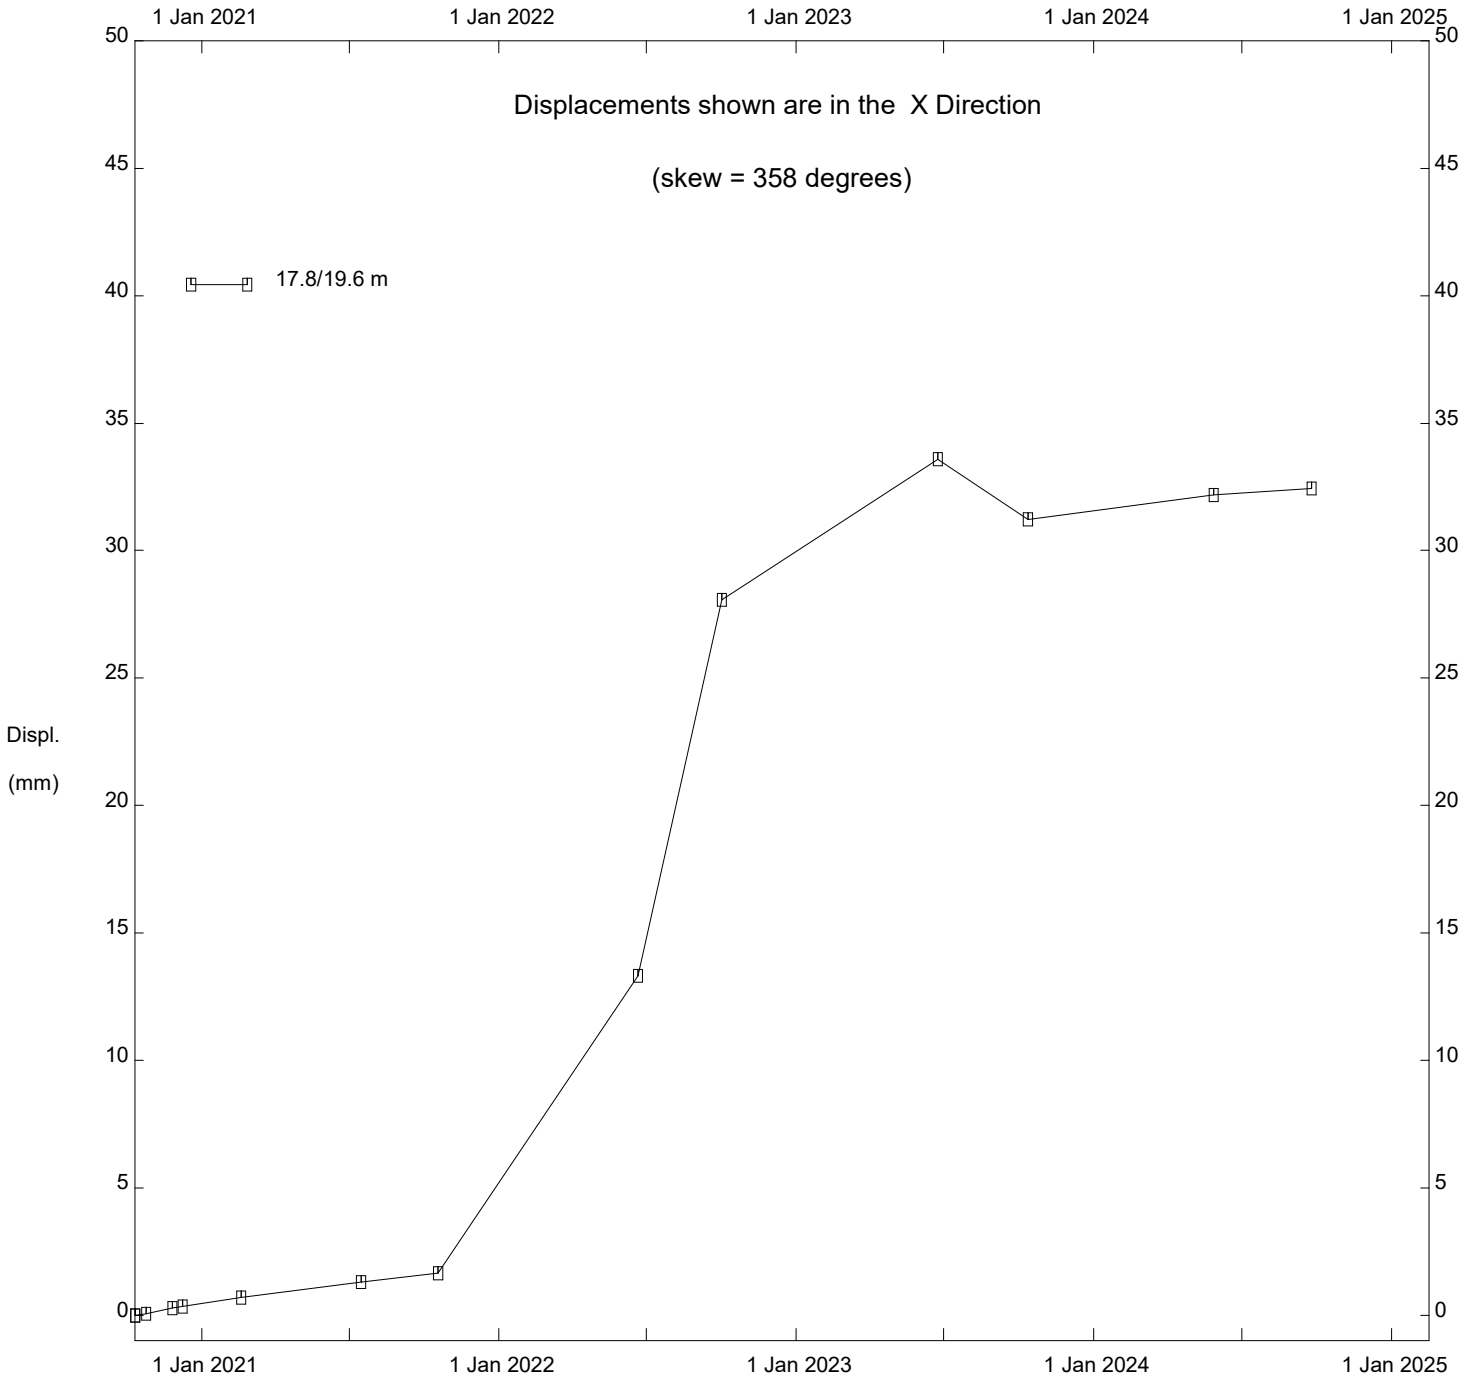
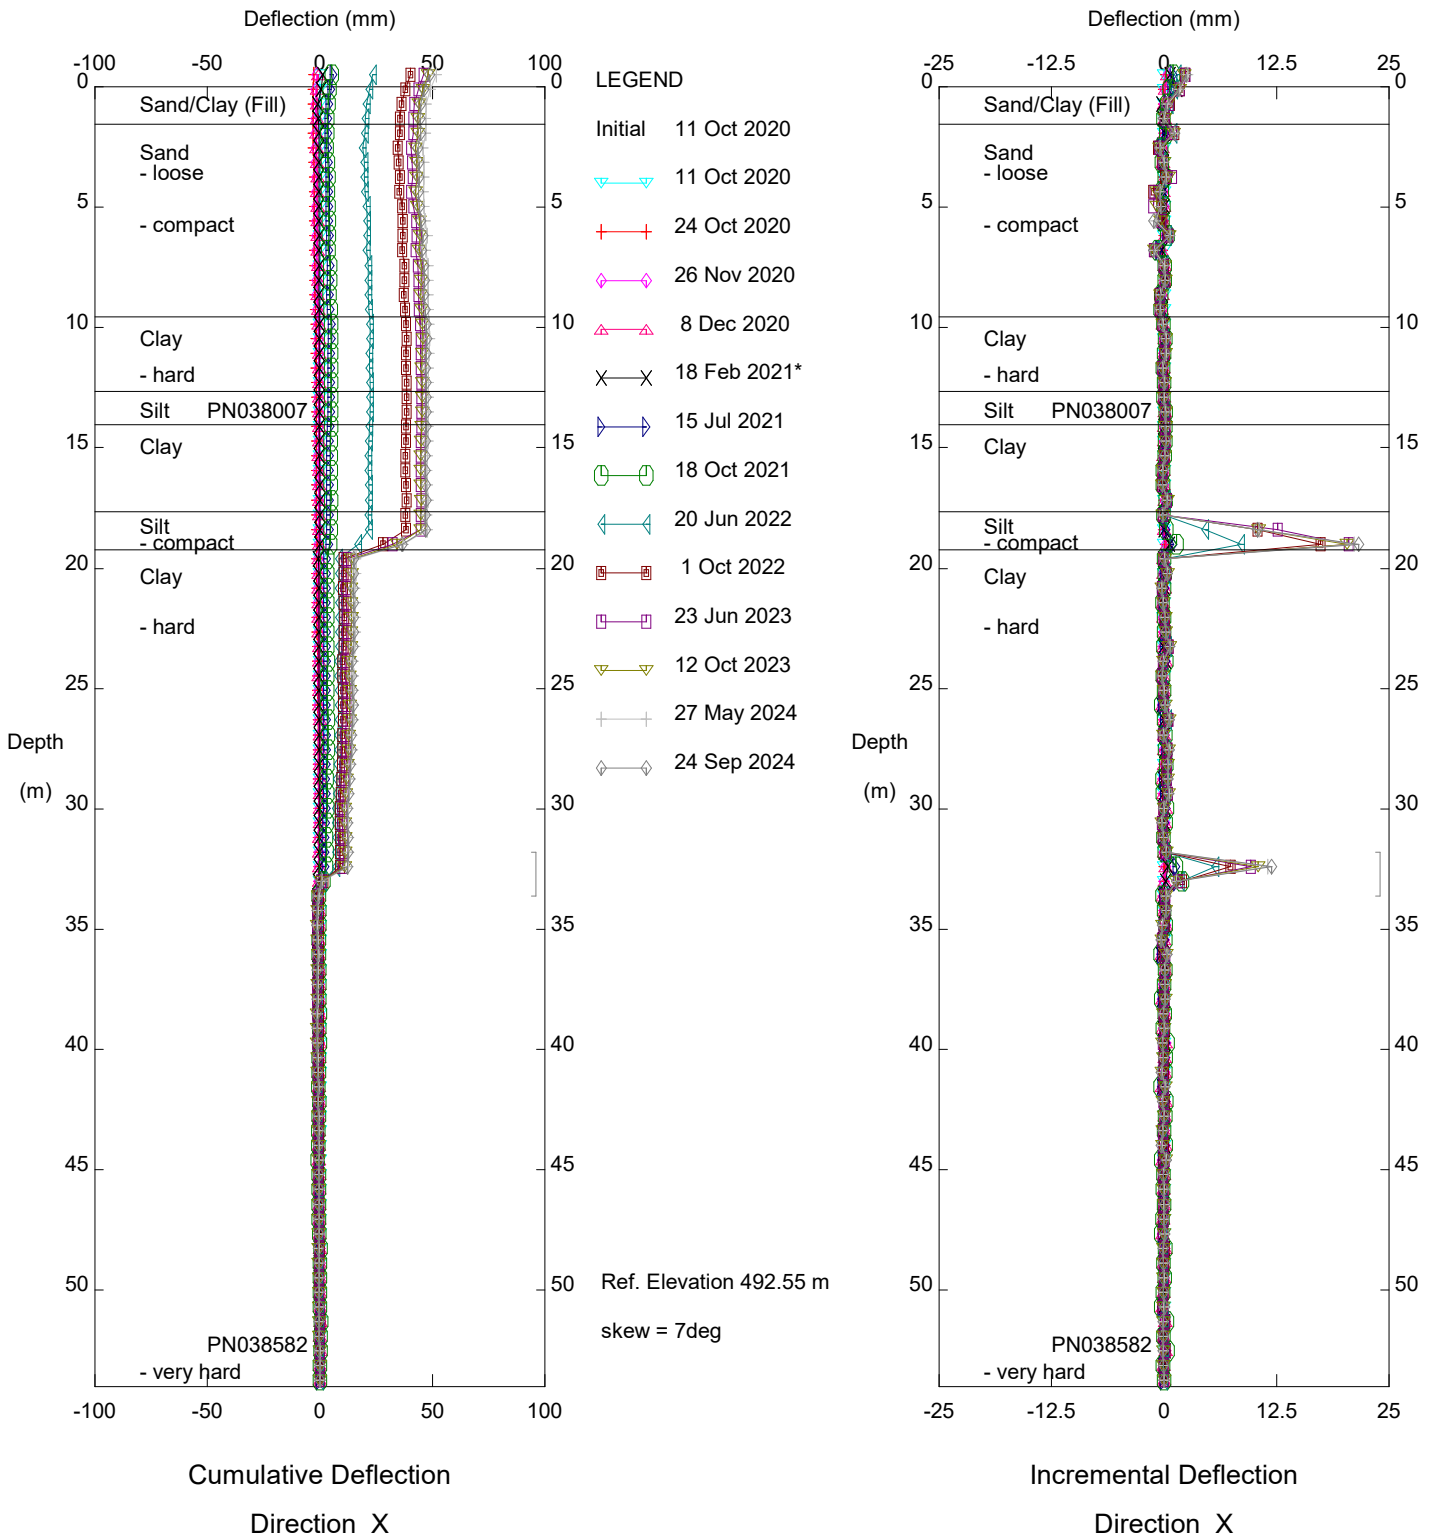
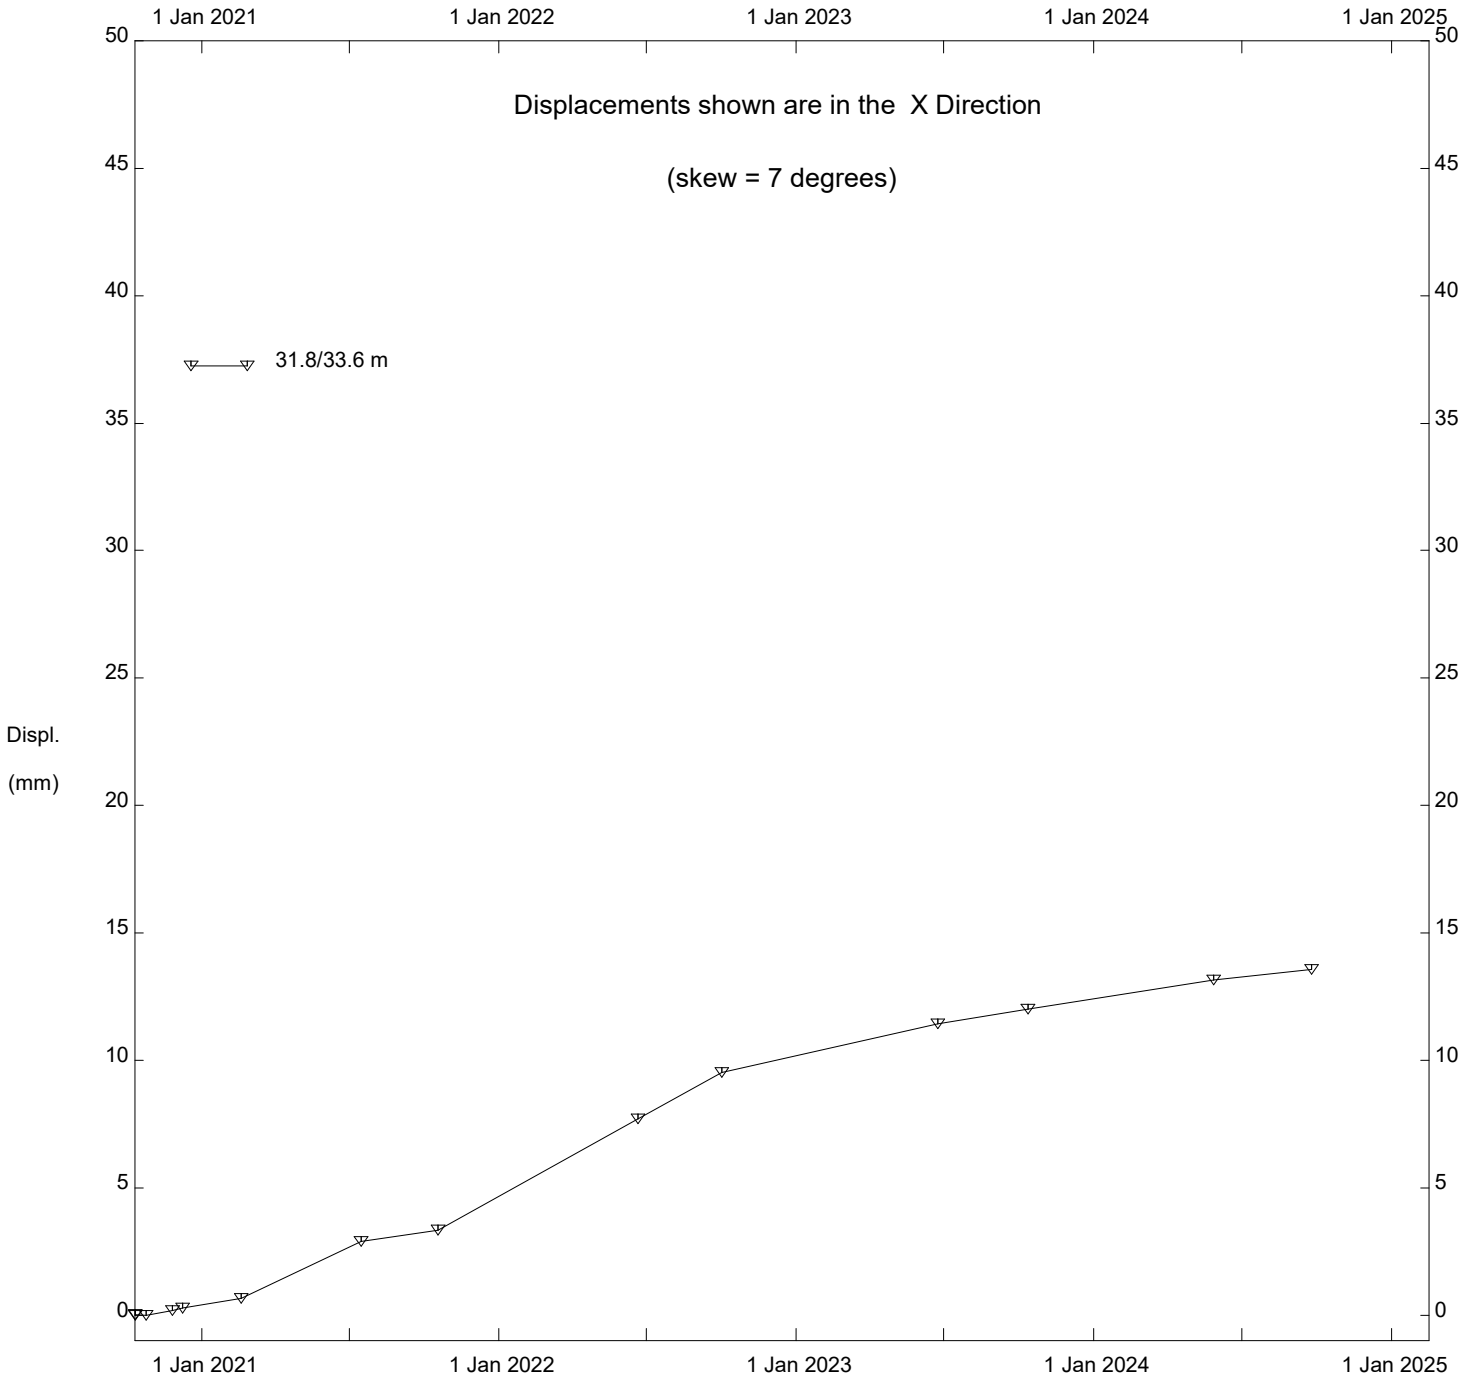
Hwy 64:02 Twin Pipes Landslide (PH023), Inclinometer SI20-7

36.8 mm over 28.1 m to 31.1 m depth in 230° direction	62.6 mm/yr in July 2021			N/A	N/A	N/A
SI20-7	October 11, 2020	32.4 mm over 17.8 m to 19.6 m depth in 195° direction	52.3 mm/yr in October 2022	Operational	May 27, 2024	0.3	0.8	-0.7

13.6 mm over 31.8 m to 33.6 m depth in 204° direction	6.5 mm/yr in June 2022			0.4	1.2	-0.6
