**ALBERTA TRANSPORTATION AND
ECONOMIC CORRIDORS GRMP
PEACE REGION
(GRANDE PRAIRIE DISTRICT - NORTH)
INSTRUMENTATION MONITORING - FALL 2024**

Site Number	Location	Name	Hwy	km
PH023	HWY 64:02 km 24.10	Clear River East Hill (Site 5- Twin Pipes Landslide)	64:02	Km 24.1
Legal Description: 12-27-84-11 W6		UTM Co-ordinates		
		11U E 335453	N	6244315

Current Monitoring:	24-Sep-2024	Previous Monitoring	27-May-2024
Instruments Read By:	Mr. Neil McDonald and Mr. Nixson Mationg of Thurber

**SITE PH023: HWY 64:02, CLEAR RIVER EAST HILL
(SITE 5 – TWIN PIPES LANDSLIDE)**

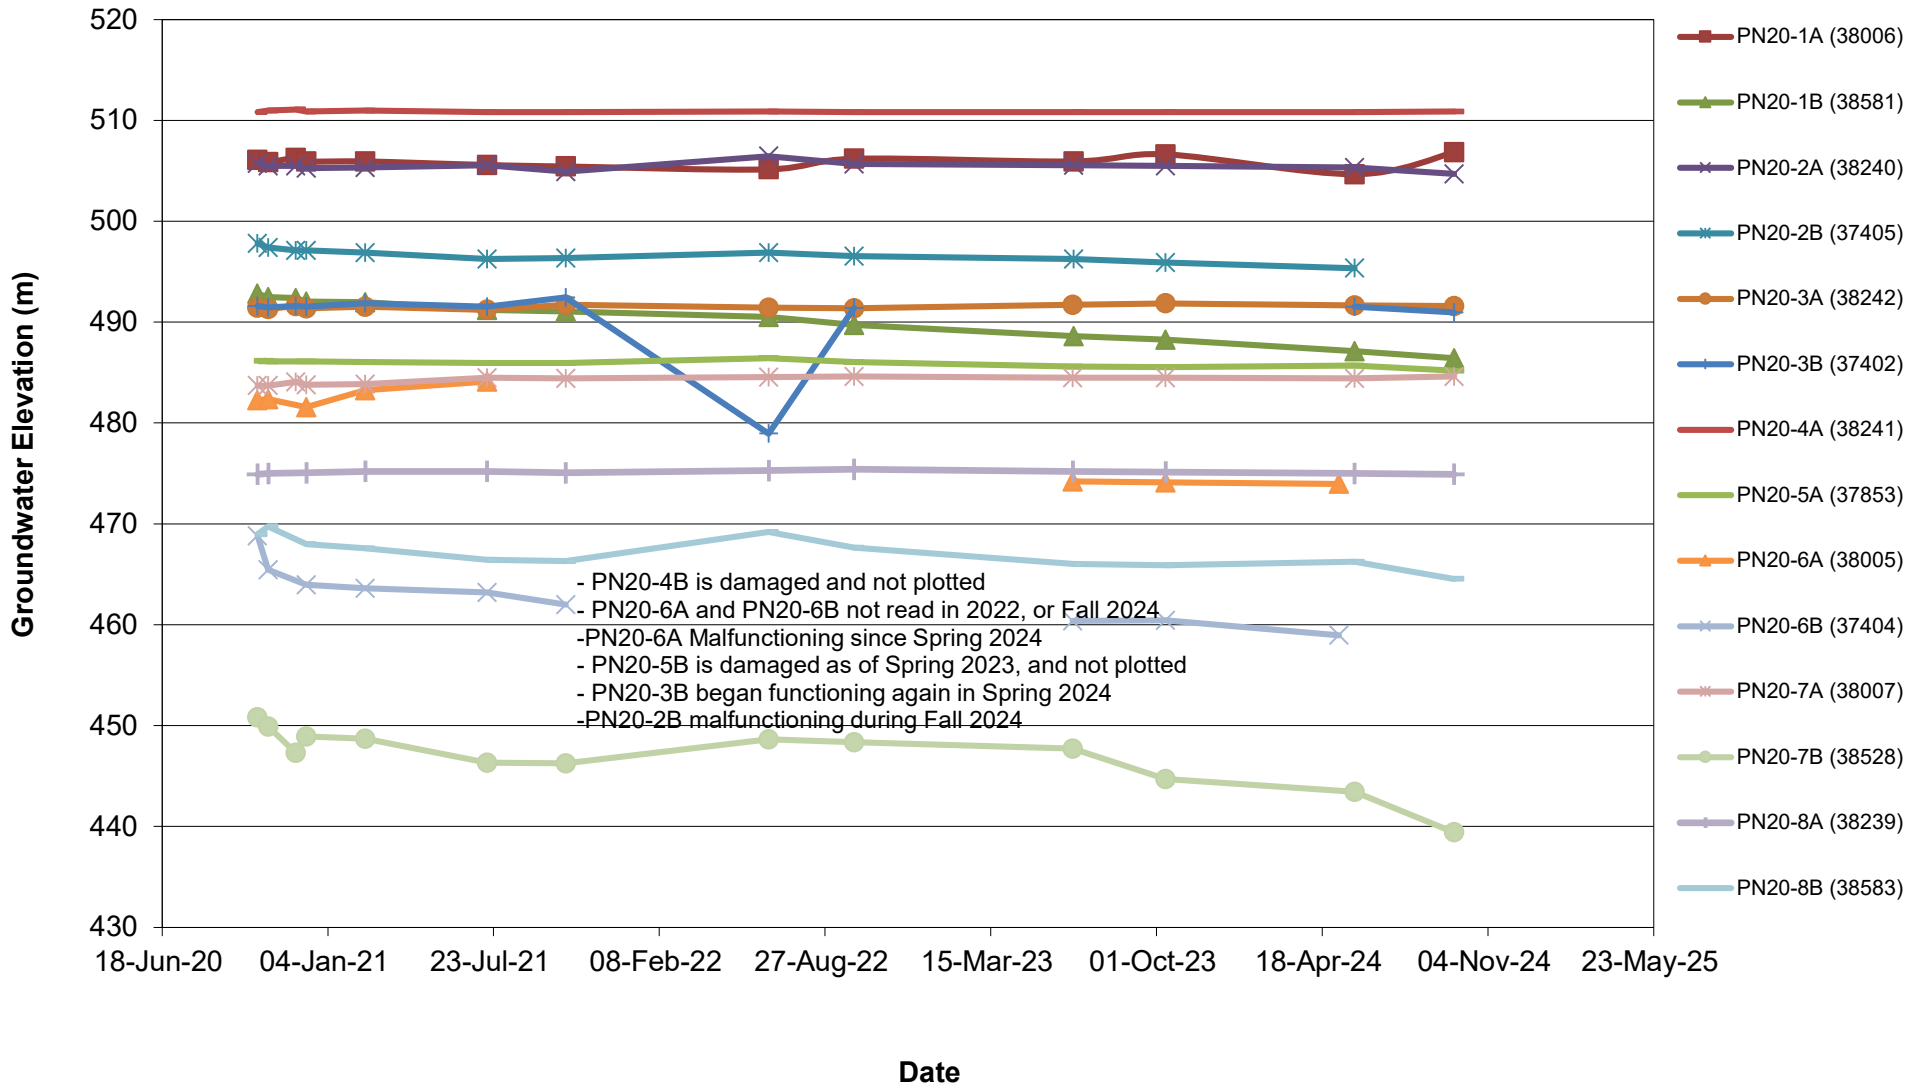
**FIGURE PH023-1
HWY 64:02 - CLEAR RIVER EAST HILL - (SITE #5)
PIEZOMETRIC ELEVATIONS**

<p>level of 0.71 m, 0.63 m, 0.07 m, 0.57 m, 0.49 m, 4.01 m, 0.07 m, and 1.69 m, respectively, since the spring of 2024 readings.</p> <p>PN20-2B appears to be malfunctioning and the reading wasn't tabulated this cycle. PN20-7B has shown a trend of decreasing pressures and readings over the last few reading cycles to near 0 PSI and is likely malfunctioning.</p>
Future Work:	<p>The instruments should be read again in the spring of 2025. PN20-2B and PN20-7B should be read again to confirm if they are still malfunctioning. If they are malfunctioning, they should be removed from future reading cycles.</p> <p>A third party wildlife escort should be considered to read PN20-6B due to the presence of a bear den near the instrument location.</p>
Instrumentation Repairs:	No instrument repairs are required at this time.
Additional Comments:
