**ALBERTA TRANSPORTATION AND  
ECONOMIC CORRIDORS  
GEOHAZARD ASSESSMENT PROGRAM  
PEACE REGION (GRANDE PRAIRIE DISTRICT - NORTH)  
2024 INSPECTION**

<b>Site Number</b>	<b>Location</b>	<b>Name (Old Site 5)</b>	<b>Hwy</b>	<b>km</b>
PH023	12 km W. Cleardale	Clear River East Hill-Twin Pipes	64:02	23.4-24.1
<b>Legal Description</b>		<b>UTM Co-ordinates (NAD 83)</b>		
NE28/NW27-84-11-W6		11 N 6244273	E 335460

**PEACE REGION (GRANDE PRAIRIE DISTRICT - NORTH)  
PH023: HWY 64:02 CLEAR RIVER EAST HILL**

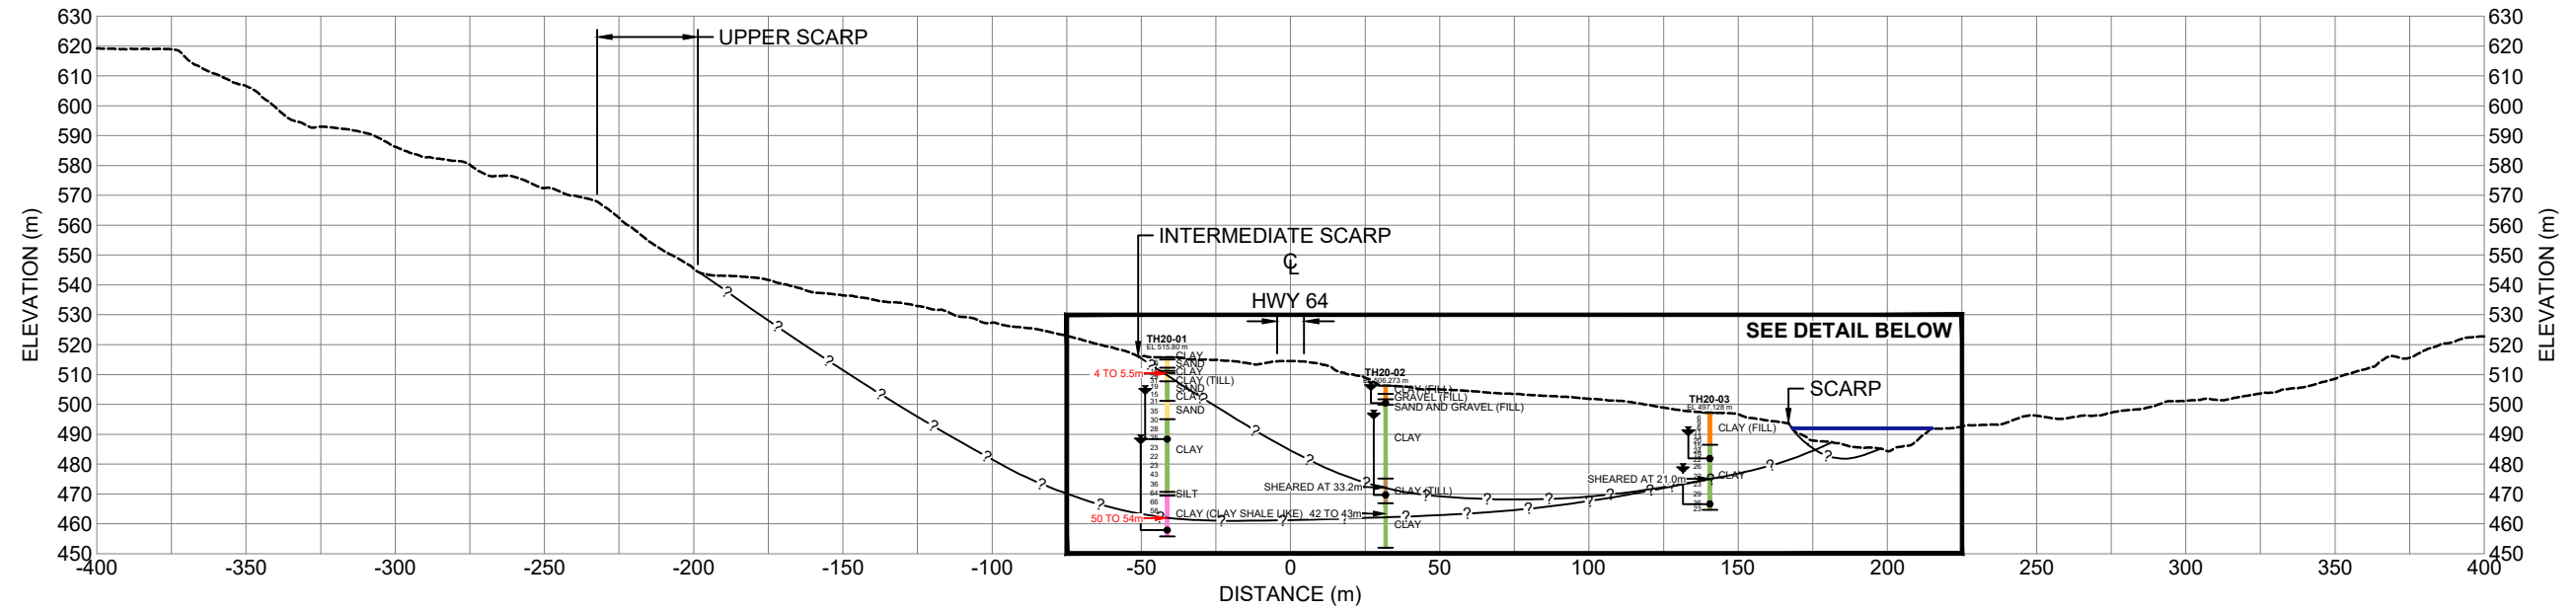
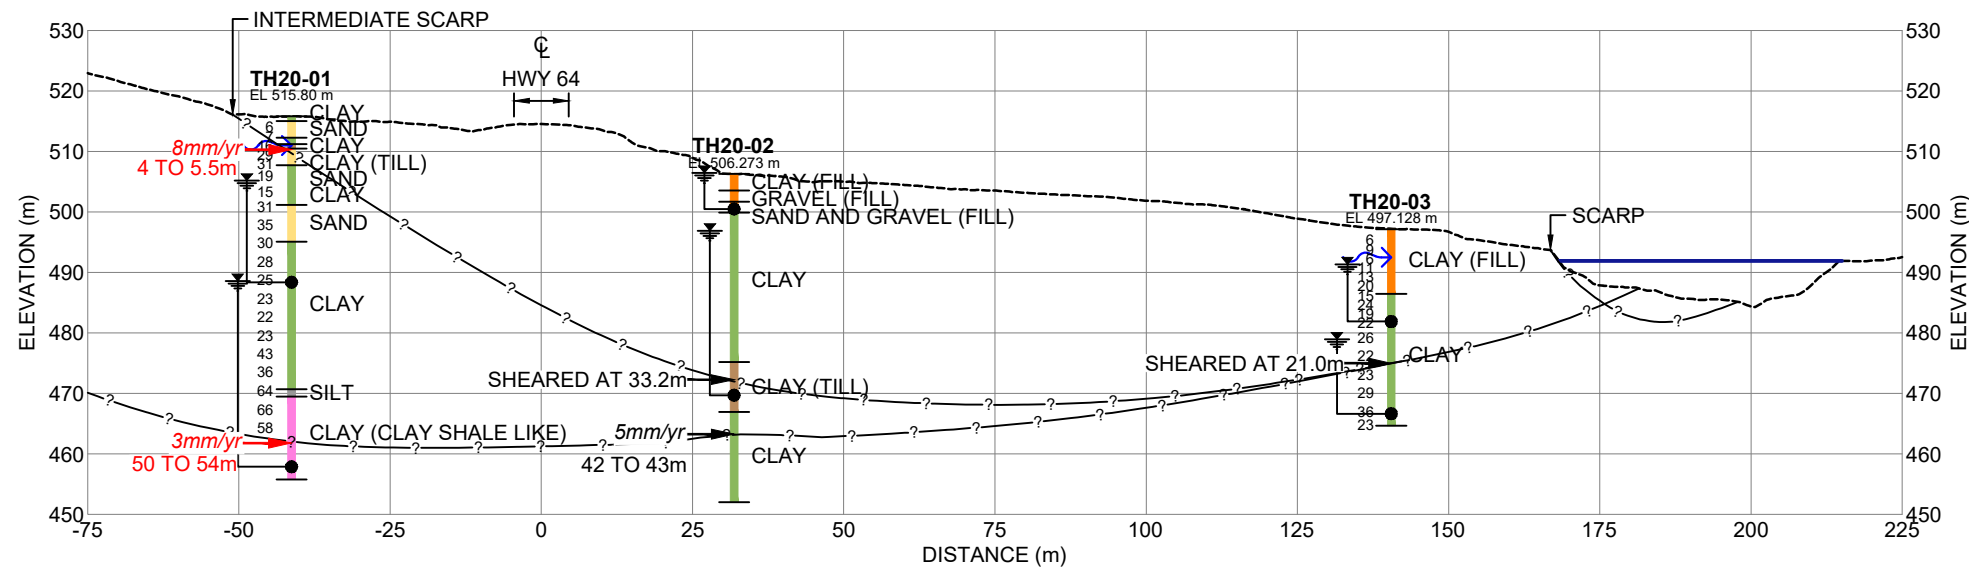
**DWG No. 32123-PH023-4**

**Instrumentation:** Last read May 27, 2024 - The inclinometer movement zones, and piezometer tip depth measurements are shown on the cross-sections attached (Drawings PH023-4 to -6).

**88-09:** Sheared at 5.5m. **20-1:** 8mm/yr @ 4 to 5.5m; & 3mm/yr @ 50 to 54m. **20-2:** Sheared off at 33.2m (but former movement zones @ 32 to 34m & 42 to 43m). **20-3:** Sheared off at 21.0m (former movement zone @ 19.5 to 21m). **20-4:** Sheared off at 7.6m (but former movement zones @ 6 to 8m & 60 to 62m). **20-5:** Sheared off at 11.6m (but former movement zones @ 9 to 12m & 31 to 36m). **20-6:** Sheared off at 20.1m, (but former movement zones @ 18 to 20m & 28 to 31m). **20-7:** 2mm/yr @ 18 to 20m; & 2mm/yr @ 32 to 34m. **20-8:** Sheared off at 36.2m (former movement zone @ 34 to 37m).

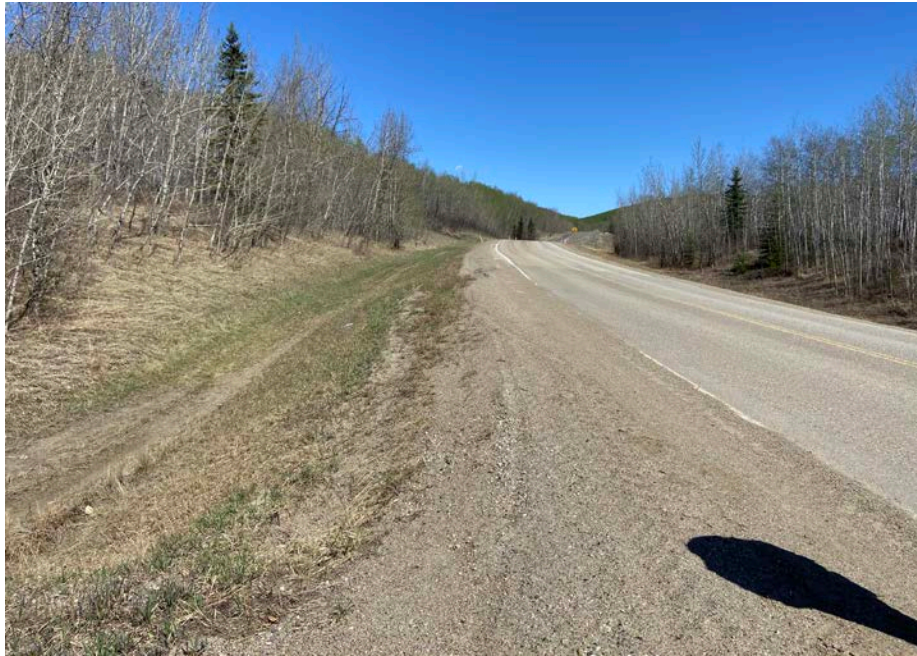
**Photo 1 - Looking east at the milled/patched area over the two slide cracks first observed in 2013 that mark the west boundary of the slide on the highway. Note the two settled areas along the north edge of the highway embankment.**

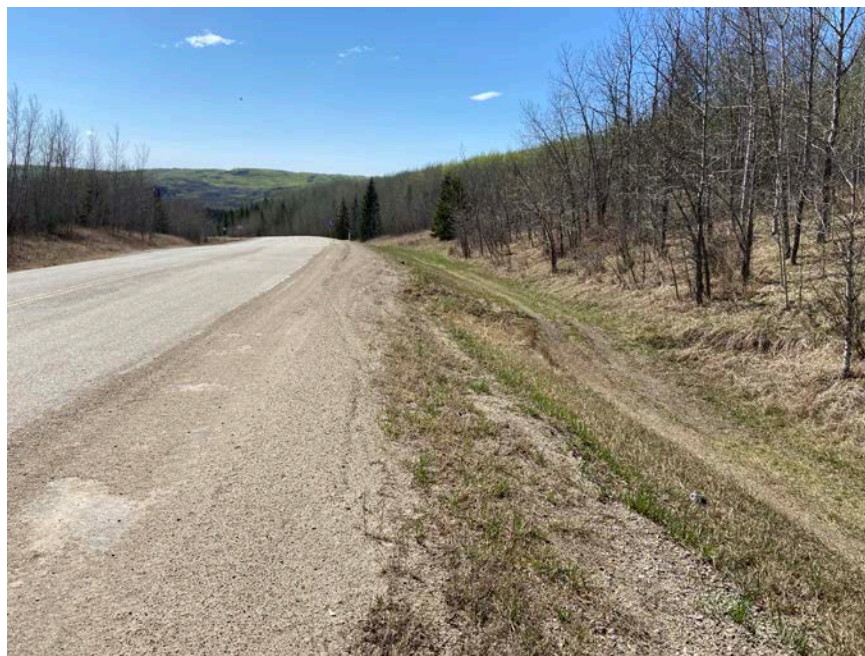
**Photo 2 – Looking west at the same slide crack and scarp that extends into the north ditch.**

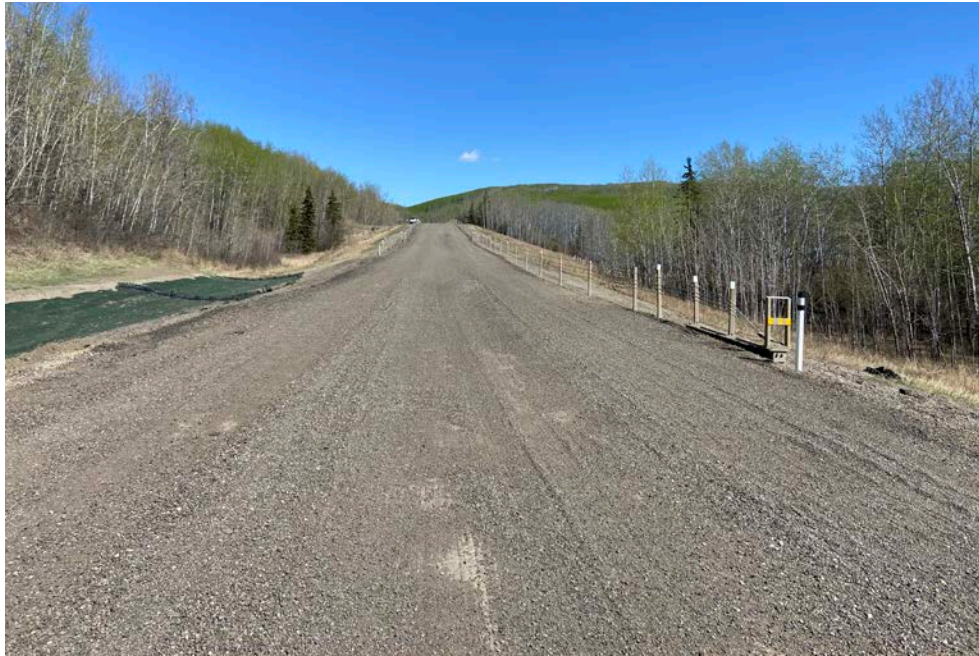
**Photo 3 – Looking east at the location where a landslide crack and large dip used to be visible in the road surface before the road surfacing was converted to gravel in 2023. The ditch that had been distorted by landslide movement was also regraded and the ditch lined with TRM.**

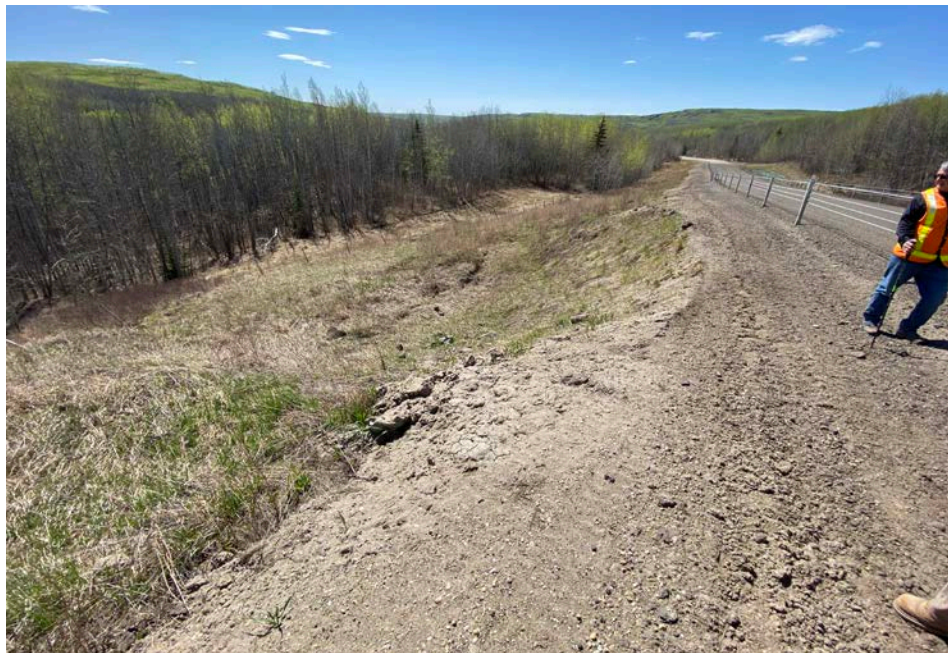
**Photo 4 – Looking west at Embankment Slump B on the south side of the hwy.**

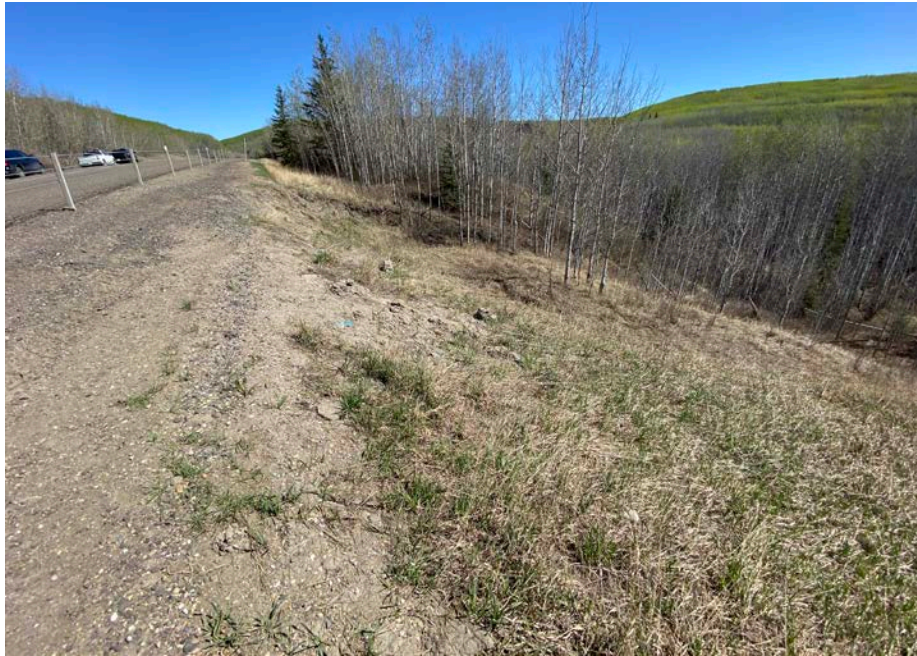
**Photo 5 – Looking east along the south edge of the highway at Embankment Slump A.**

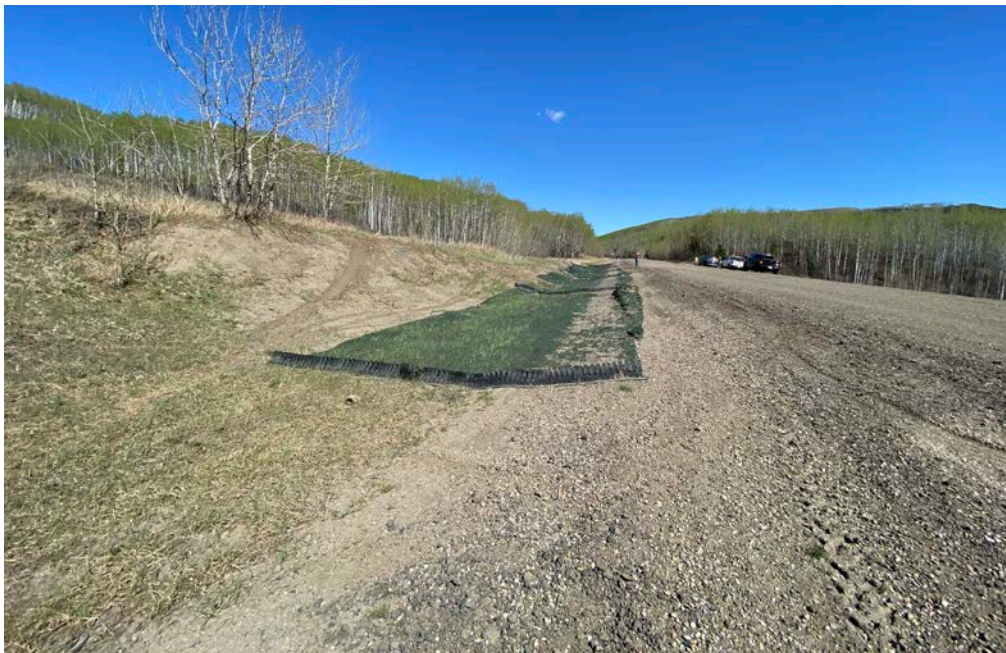
**Photo 6 – Looking east along the north ditch that was re-graded and lined with TRM, across the area where the east slide crack was affecting the highway.**

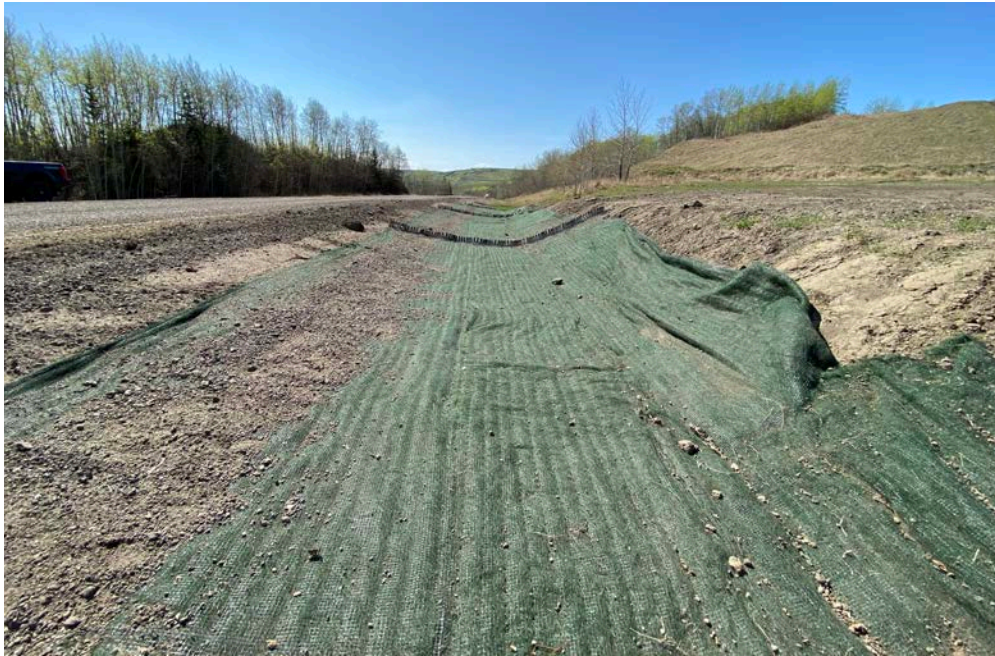
**Photo 7 – Looking west along the north highway ditch at the former sagged area that had ponded water. Water was drained, the former north approach was removed and the ditch was graded and lined with TRM as part of the 2023 road surface gravel conversion project.**

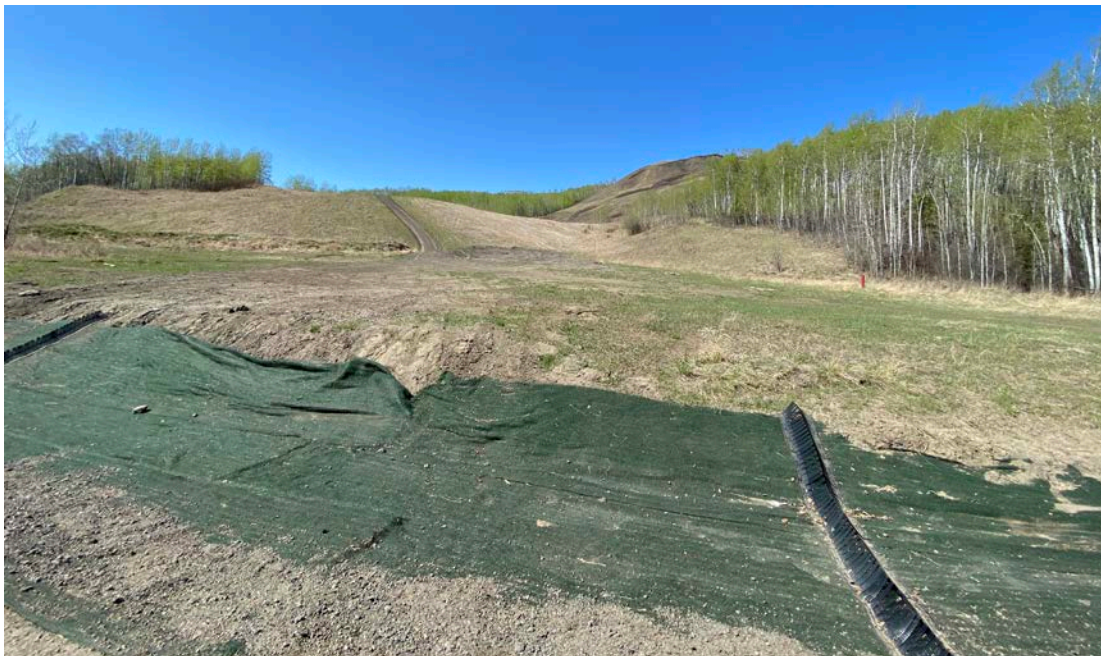
**Photo 8 - Looking north across the repaired highway ditch from the former alligator cracked highway area at the east end of the site.**

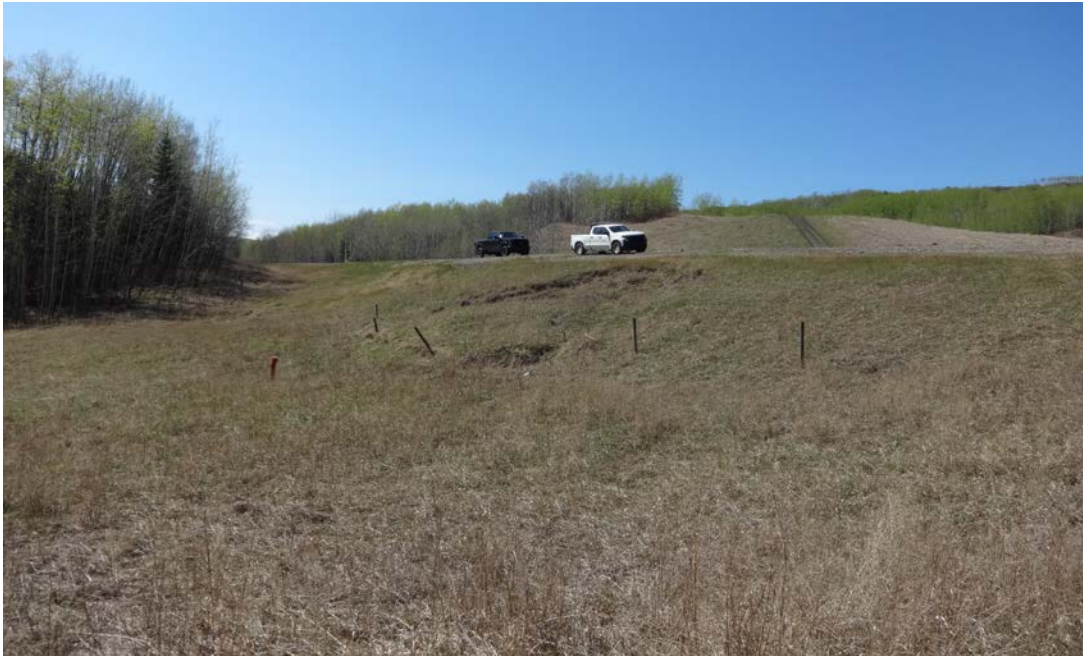
Photo 9 – Looking northwest at the slump in the south highway embankment sideslope.

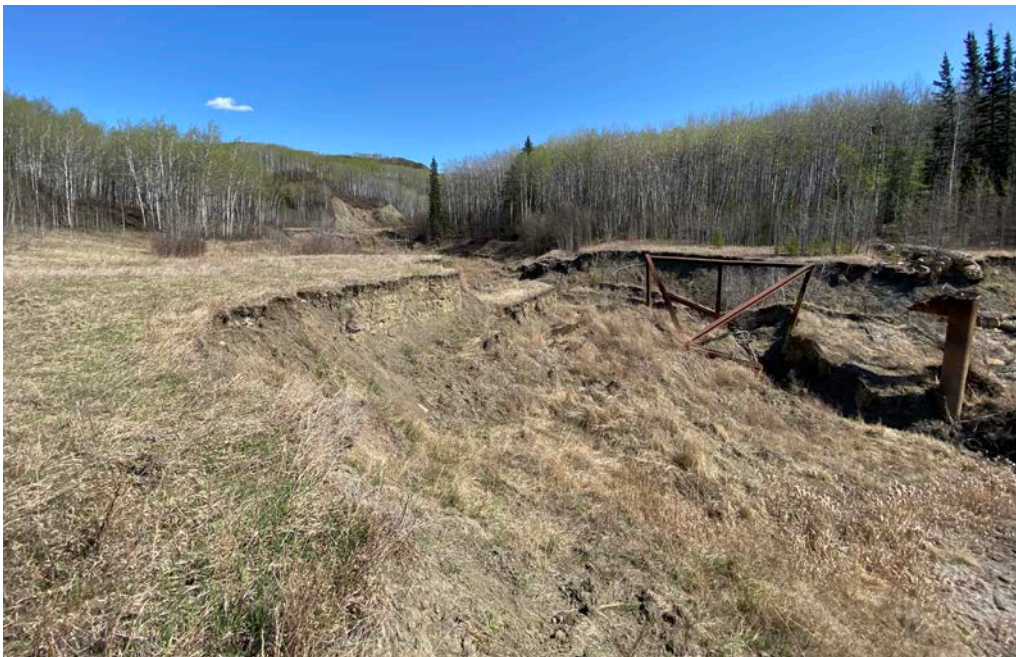
<input checked="" type="checkbox"/> Bridge/Culvert	The twin culverts installed in the creek below the toe berm are ineffective due to silt build-up and channel erosion. The trash rack is toppling due to loss of support.	<input checked="" type="checkbox"/>	<input type="checkbox"/>
----------------------------------------------------	--------------------------------------------------------------------------------------------------------------------------------------------------------------------------	-------------------------------------	--------------------------

Photo 10 – Looking southeast across the eroded channel at the twin pipe riser inlets and eroded trash rack.

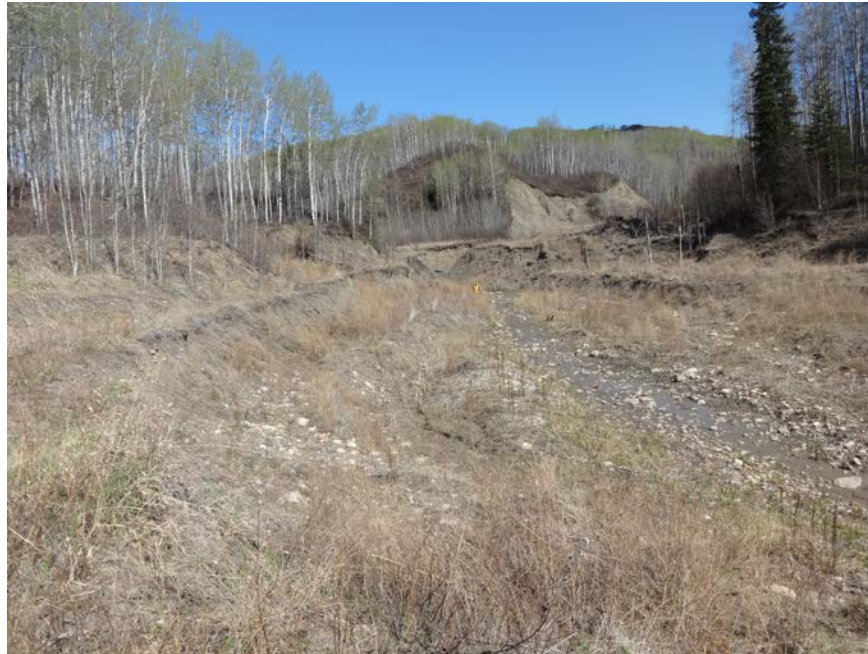
**Photo 11 – Looking east at the upstream end of the eroded and silted in tributary channel.**

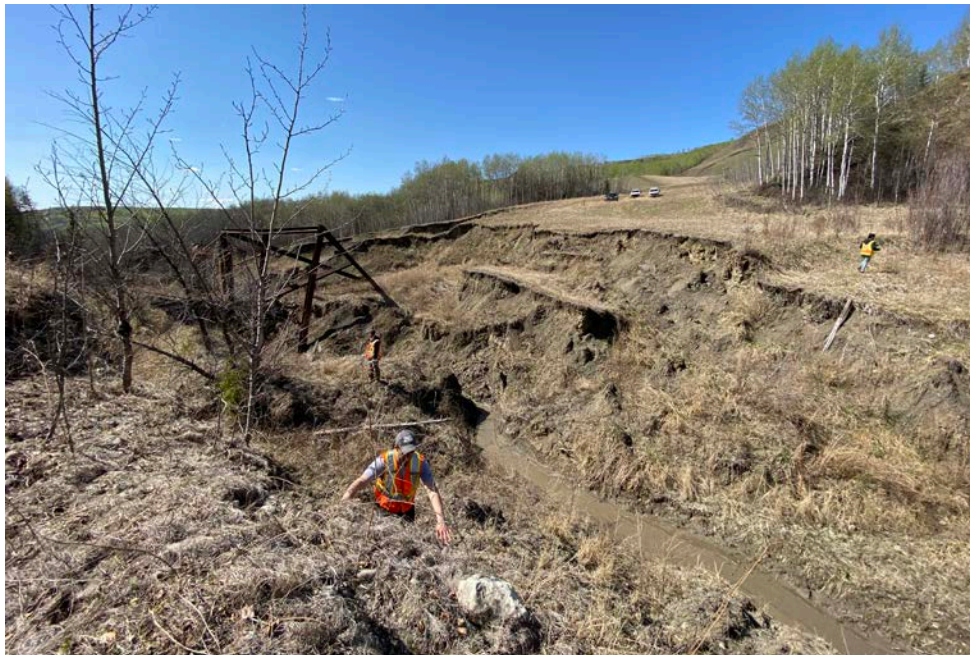
Sliding has also been aggravated by severe creek erosion at the toe of the valley slope over the years. There appears to be a recent large slide block that has moved towards the creek on the north side, centered about 300 m west of the drainage trench erosion area at the east end of the site. The large slump below the east end of the site is a result of the toe buttress fill blocking off the drainage trenches, causing erosion and earth flows that are retrogressing back towards the highway. The original twin culverts in the creek were not big enough to pass storm flows and to handle large amounts of silt and debris coming into the channel. As a result, channel lining/gabions below the east end of the site have eroded away and are ineffective. Recent creek erosion has completely eroded the gabion weirs and exposed the twin pipe outlets, rendering them ineffective. This creek erosion has also displaced the large riprap laid in the channel and has caused the trash rack piles to lean and bend.

**Photo 12 – Looking northwest across the eroded tributary channel and trash rack. Note a fresh slide block has moved about half-way down the north channel slope face.**

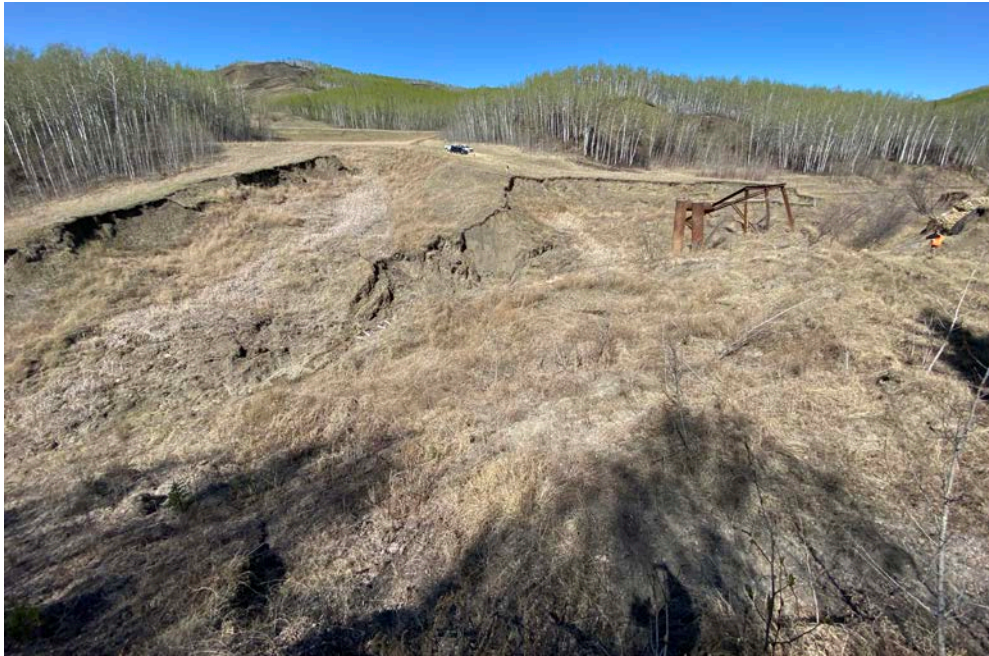
**Photo 13 – Looking north across the eroded tributary channel towards the highway, at the eroded piping area (LHS), twin pipe inlets and trash rack (Center), and eroded gabion weir (RHS).**

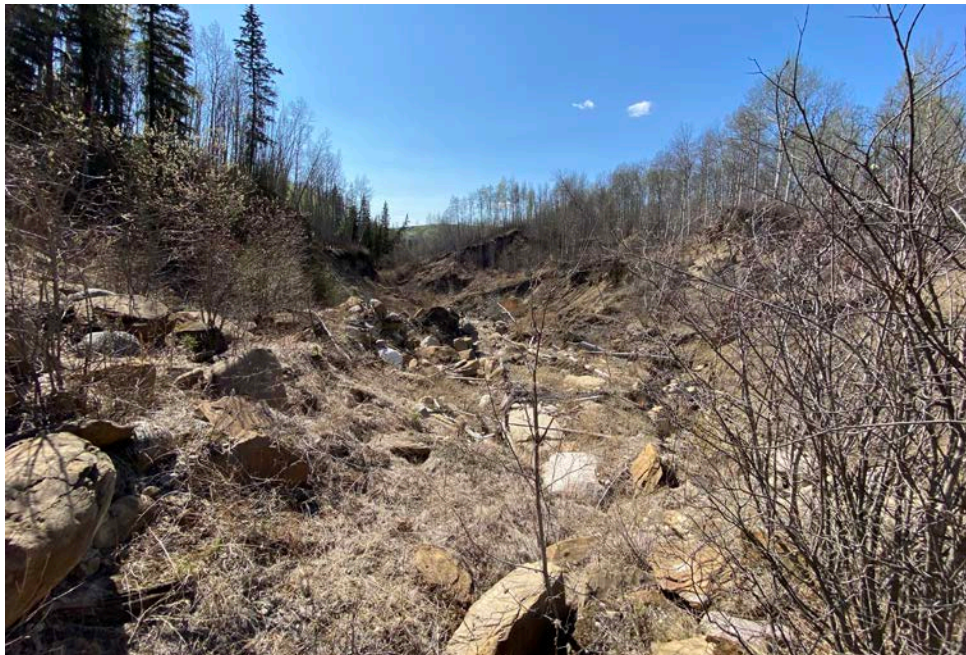
**Photo 14 – Looking west along the eroded channel from west of the point where the two tributary branches merge into one.**

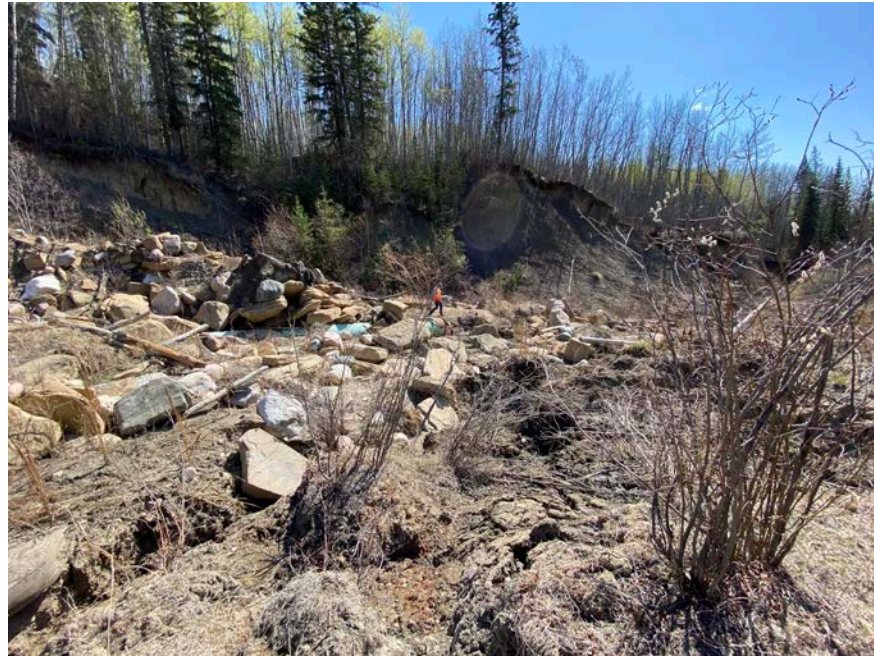
Photo 15 – Looking west along the eroded creek channel at the twin pipe outlets.

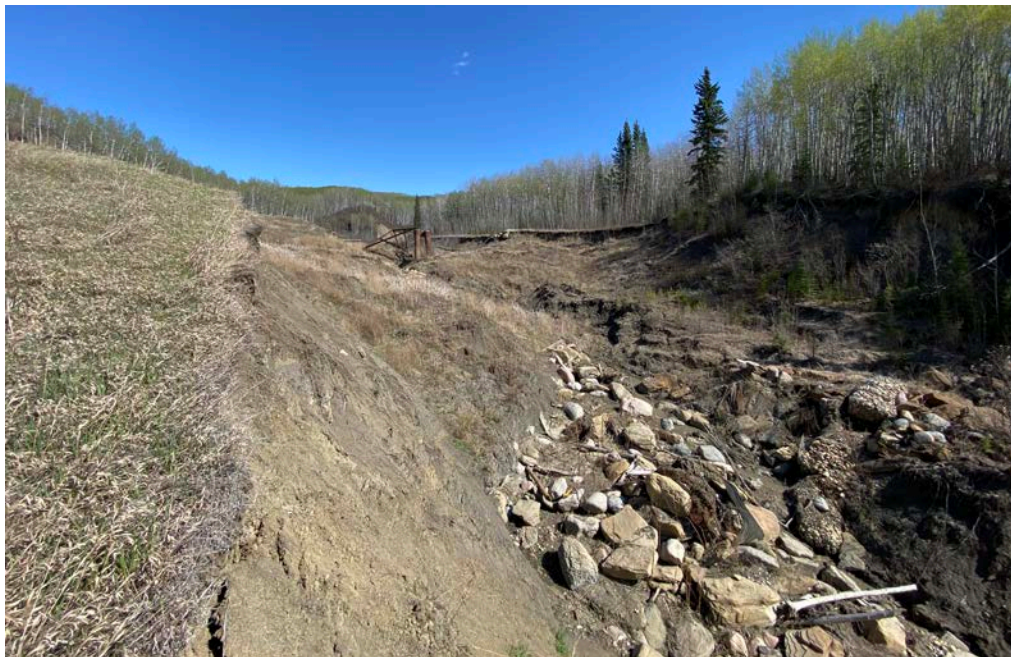
Photo 16 – Looking east along the eroded channel from the site center.
