**ALBERTA TRANSPORTATION AND
ECONOMIC CORRIDORS GRMP
GRANDE PRAIRIE REGION –
(GRANDE PRAIRIE NORTH)
INSTRUMENTATION MONITORING - SPRING 2024**

Site Number	Location	Name	Hwy	km
PH023	HWY 64:02 km 24.10	Clear River East Hill (Site 5- Twin Pipes Landslide)	64:02	Km 24.1
Legal Description: 12-27-84-11 W6		UTM Co-ordinates		
		11U E 335453	N	6244315

Current Monitoring:	27-May-2024	Previous Monitoring	12-Oct-2023
Instruments Read By:	Mr. Niraj Regmi, G.I.T and Mr. Nixon Mationg, of Thurber

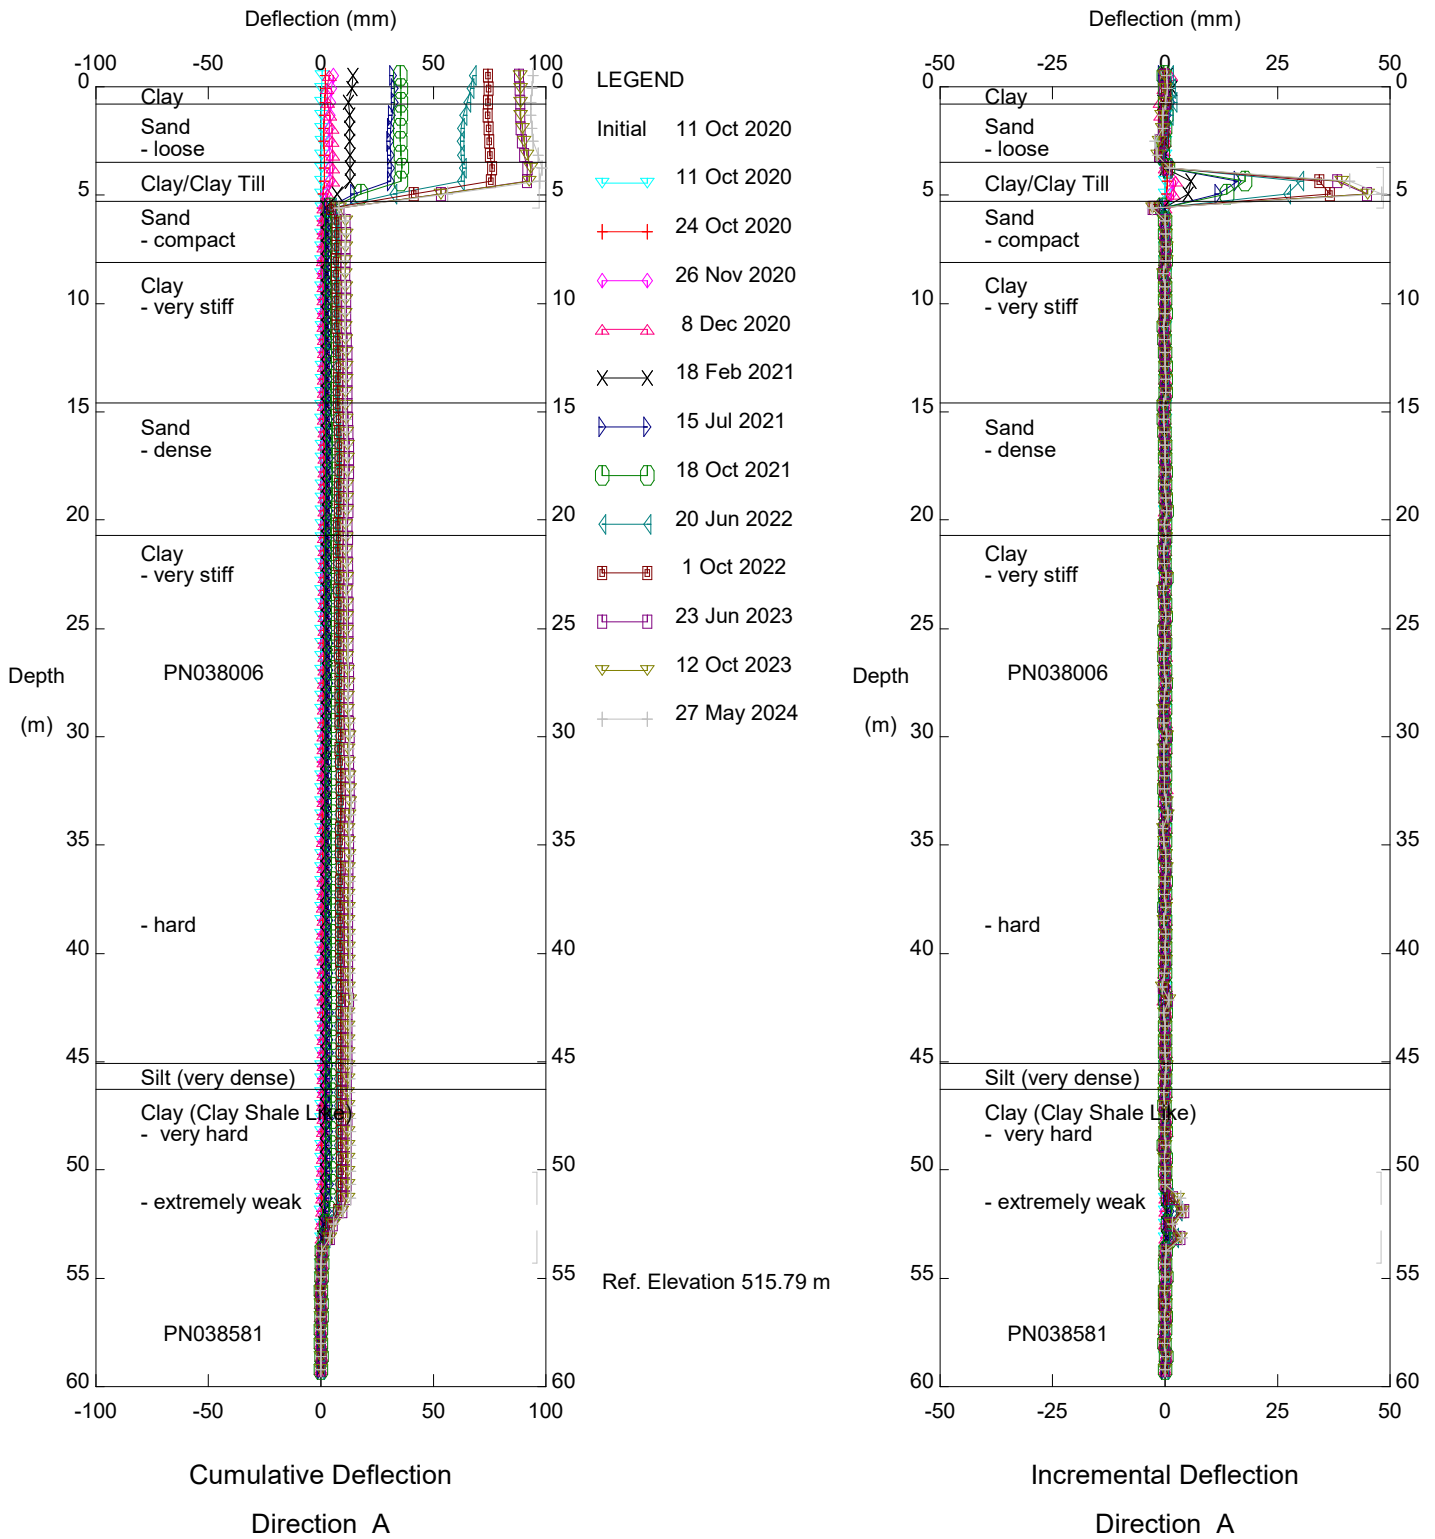
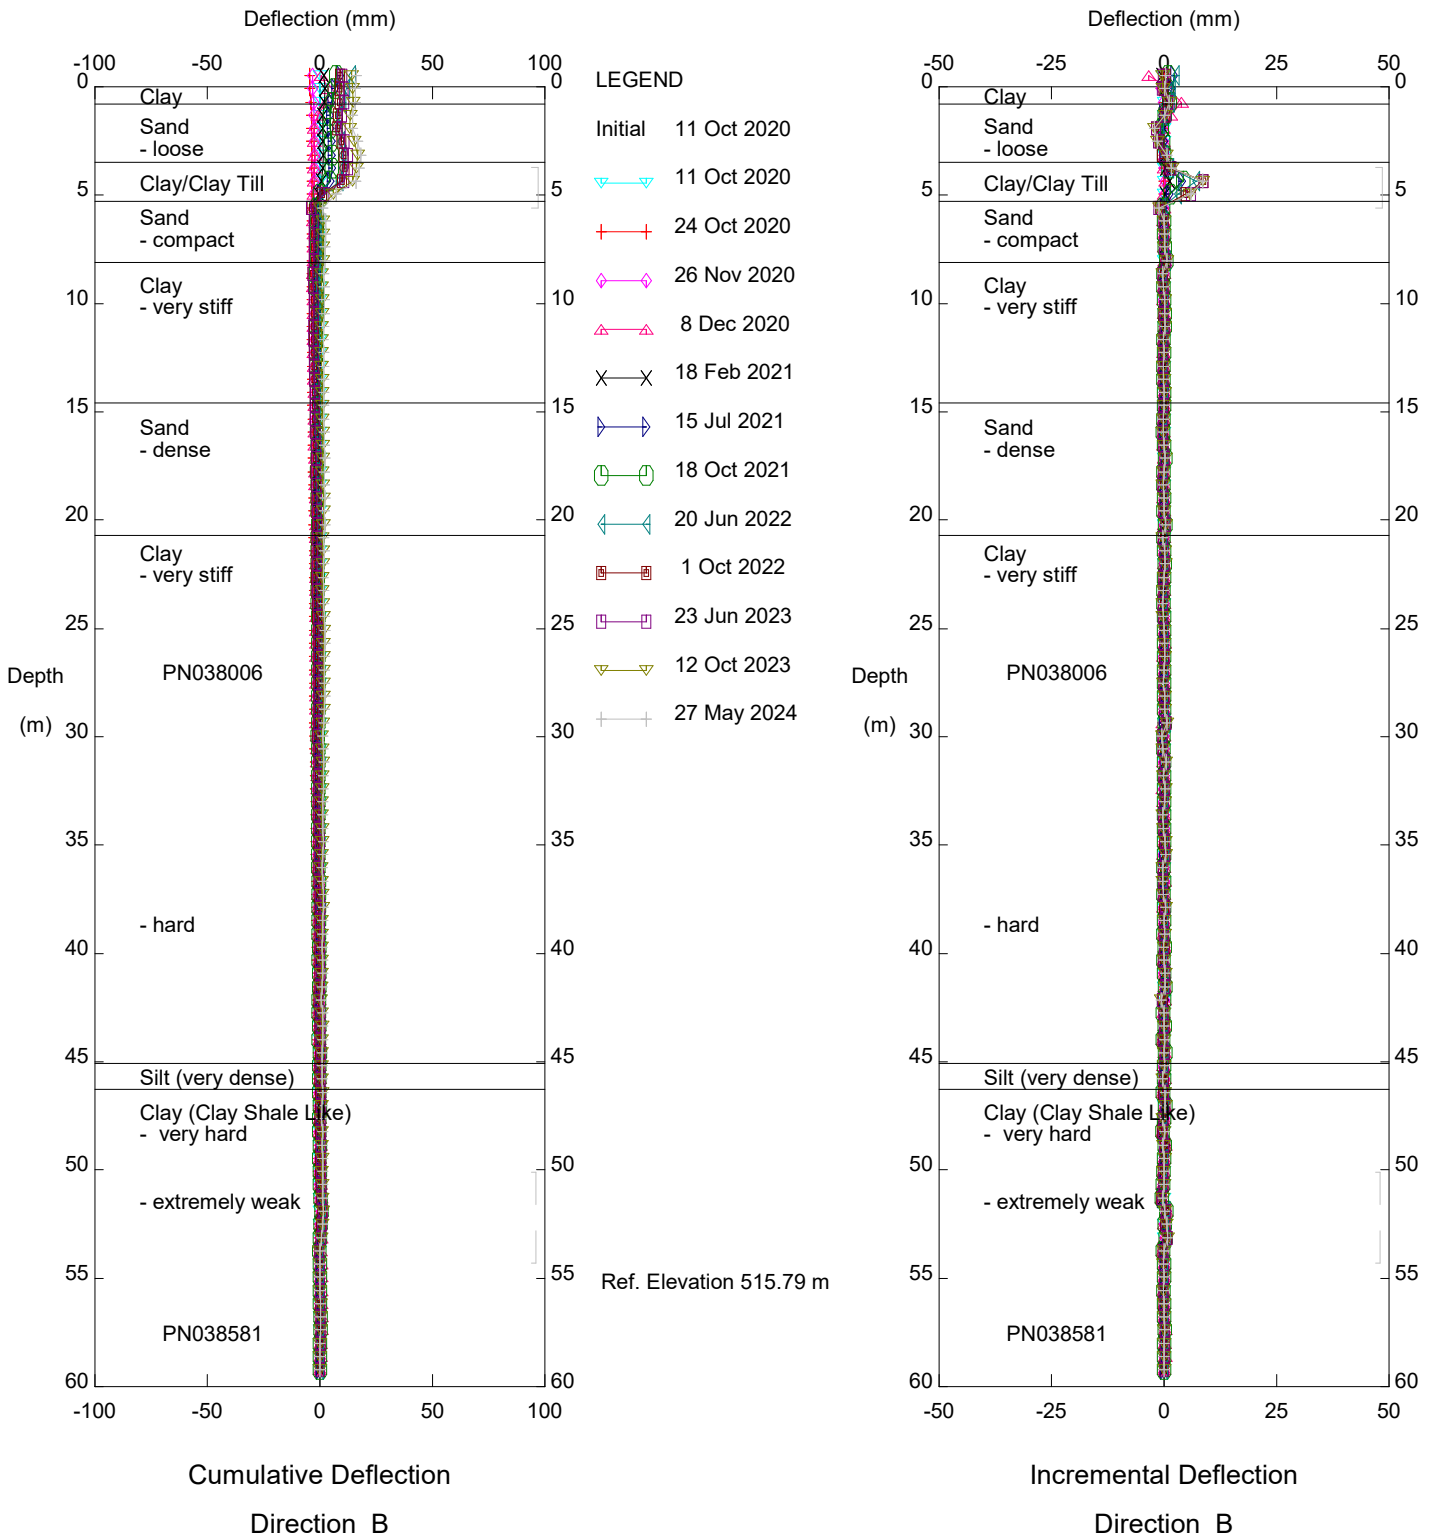
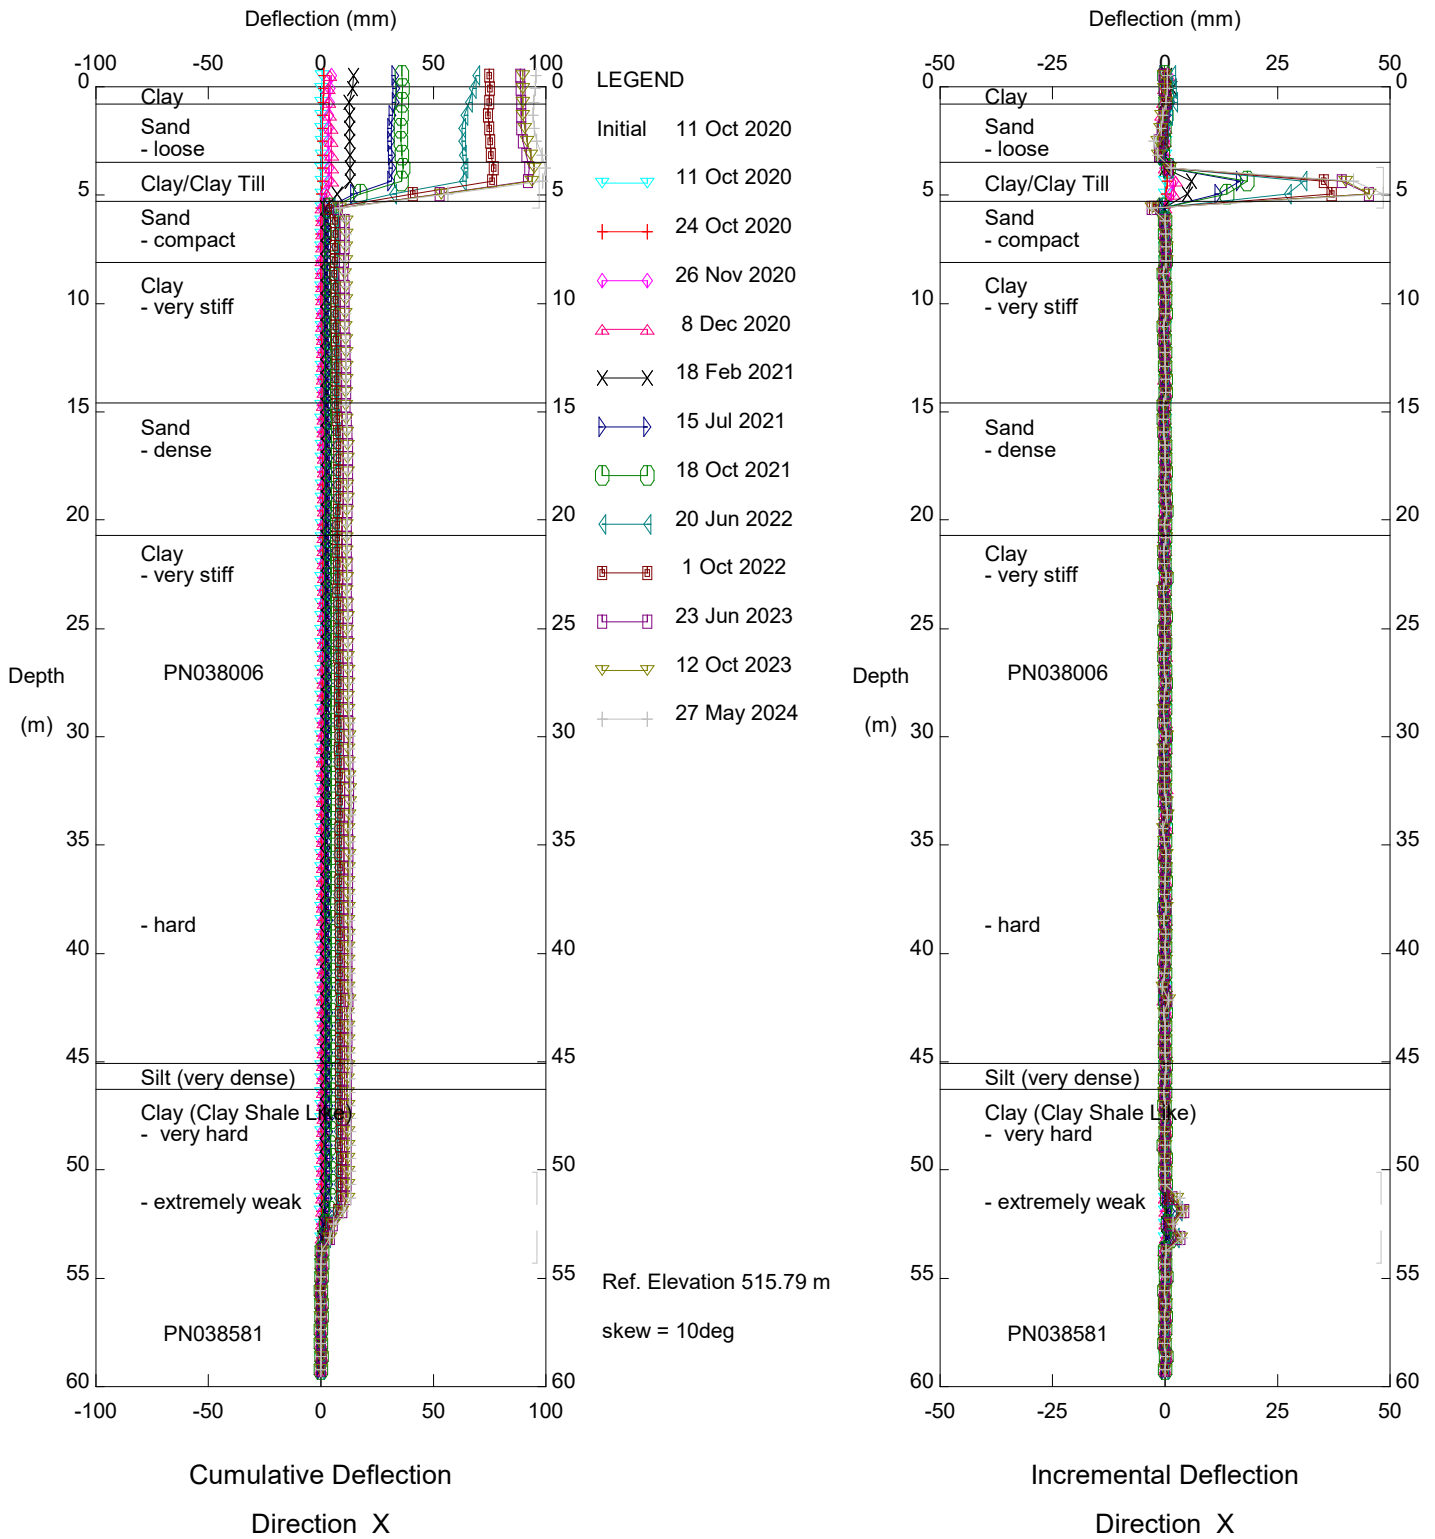
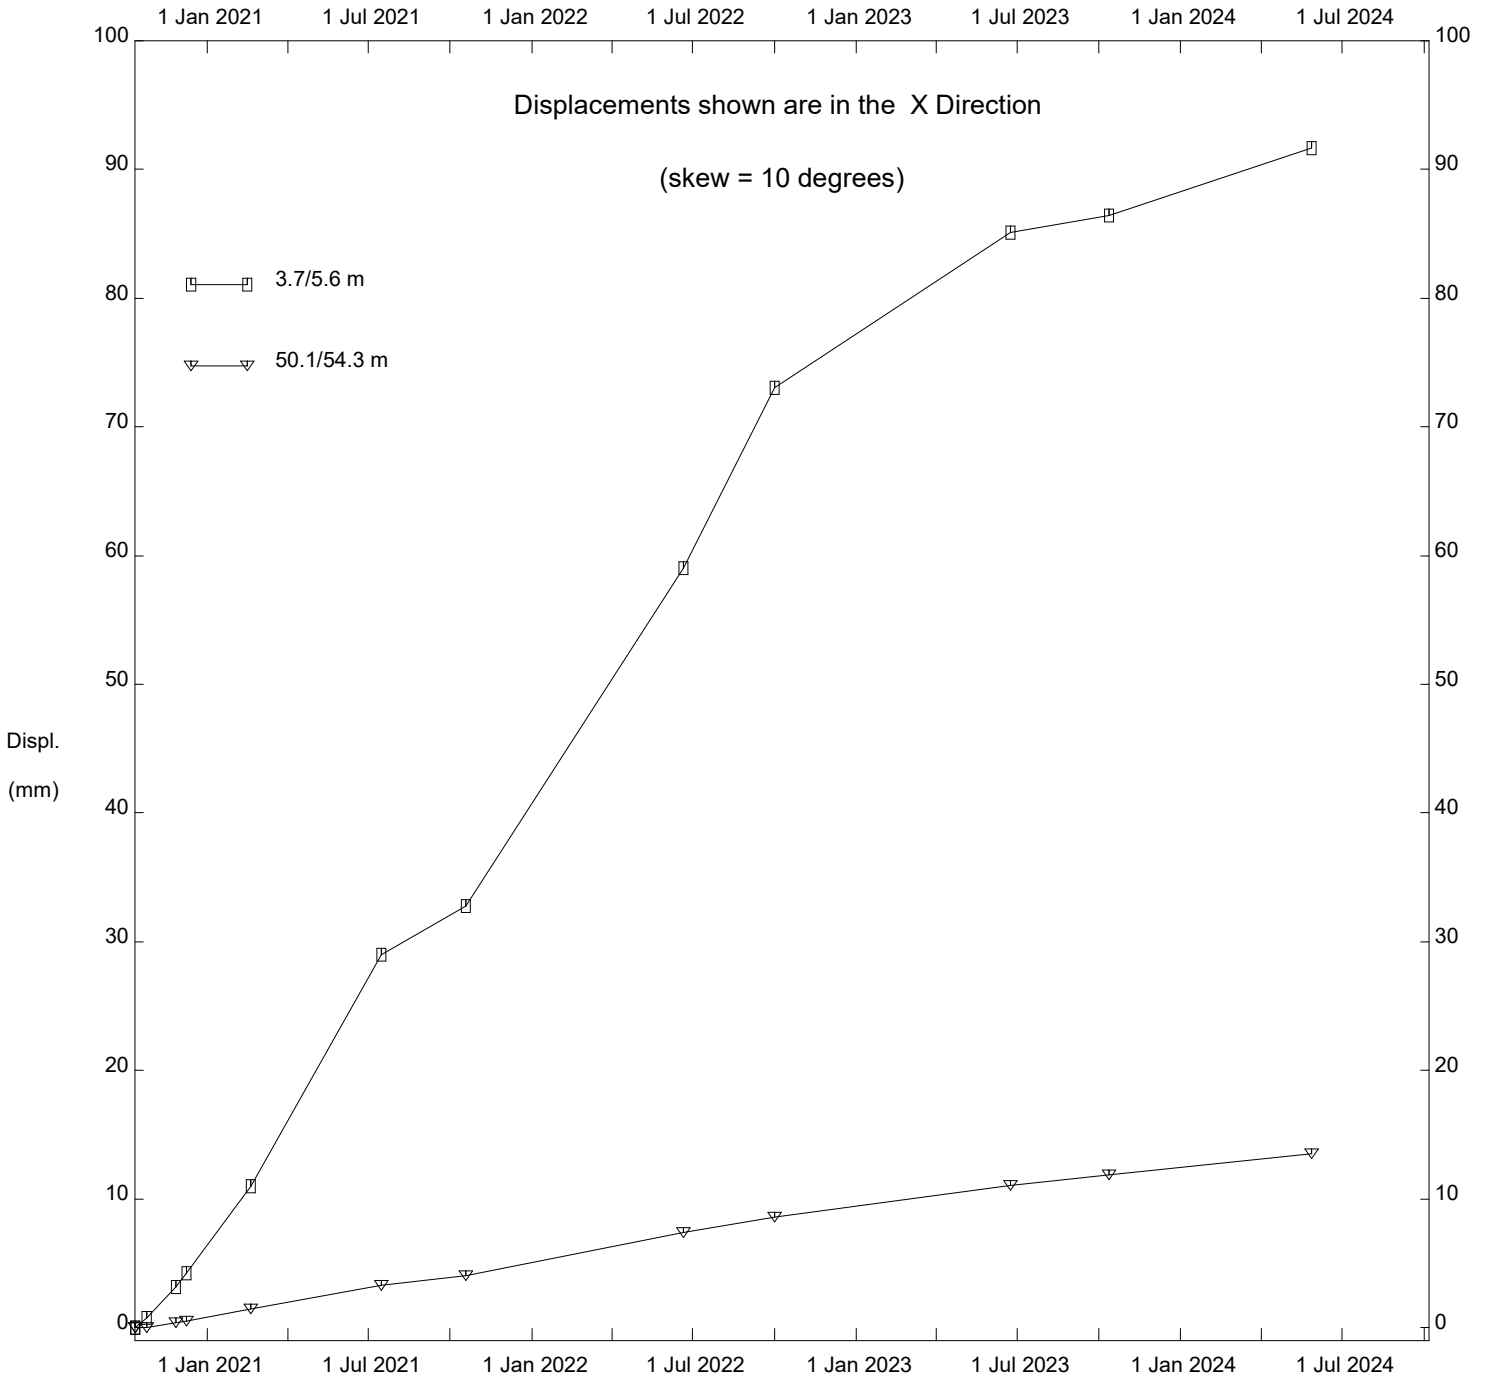
Hwy 64:02 Twin Pipes Landslide (PH023), Inclinometer SI20-1

Discussion	
Zones of New Movement:	None
Interpretation of Monitoring Results:	<p>Overall, the SIs showed similar or accelerated rates of movement compared to the previous readings in the fall of 2023.</p> <p>SI20-1 showed current movement rates of 8.4 mm/yr over 3.7 m to 5.6 m depth and 2.6 mm/yr over 50.1 m to 54.3 m depth. SI20-7 showed rates of movement of 1.5 mm/yr over 17.8 m to 19.6 m and 1.9 mm/yr over 31.8 m to 33.6 m depth. SI 20-1 and 20-7 are about 600 m apart but both show comparable movement rates and elevation of the deeper movement zones (both SI are moving at about el 460 m) which is a confirmation of a very large and deeply seated movement mass</p> <p>Piezometers PN20-6A and PN20-6B were read on May 8, 2024 during the GRMP inspection to avoid the need for third party wildlife escort due to the known presence of bears in the area. The remaining piezometers were read on May 27, 2024 during the spring 2024 instrumentation readings.</p> <p>The groundwater levels in piezometers PN20-1A, PN20-1B, PN20-2A, PN20-2B, PN20-3A, PN20-5A, PN20-6B, PN20-7A, PN20-7B, and PN20-8A showed decreases in ground water levels ranging from 0.07</p>

36.2 mm over 9.7 m to 11.6 m depth in 116° direction	43.0 mm/yr. in October 2020			N/A	N/A	N/A
		16.9 mm over 11.6 m to 13.4 m depth in 116° direction	14.7 mm/yr. in October 2020			N/A	N/A	N/A
SI20-1	October 11, 2020	91.7 mm over 3.7 m to 5.6 m depth in 7° direction	49.6 mm/yr in October 2022	Operational	October 12, 2023	5.3	8.4	4.0

13.5 mm over 50.1 m to 54.3 m depth in 7° direction	5.0 mm/yr in June 2022			1.6	2.6	0
SI20-2	October 11, 2020	39.5 mm over 31.8 m to 34.2 m depth in 193° direction	59.6 mm/yr in July 2021	Sheared at 33.2 m below top of casing	October 18, 2021	N/A	N/A	N/A

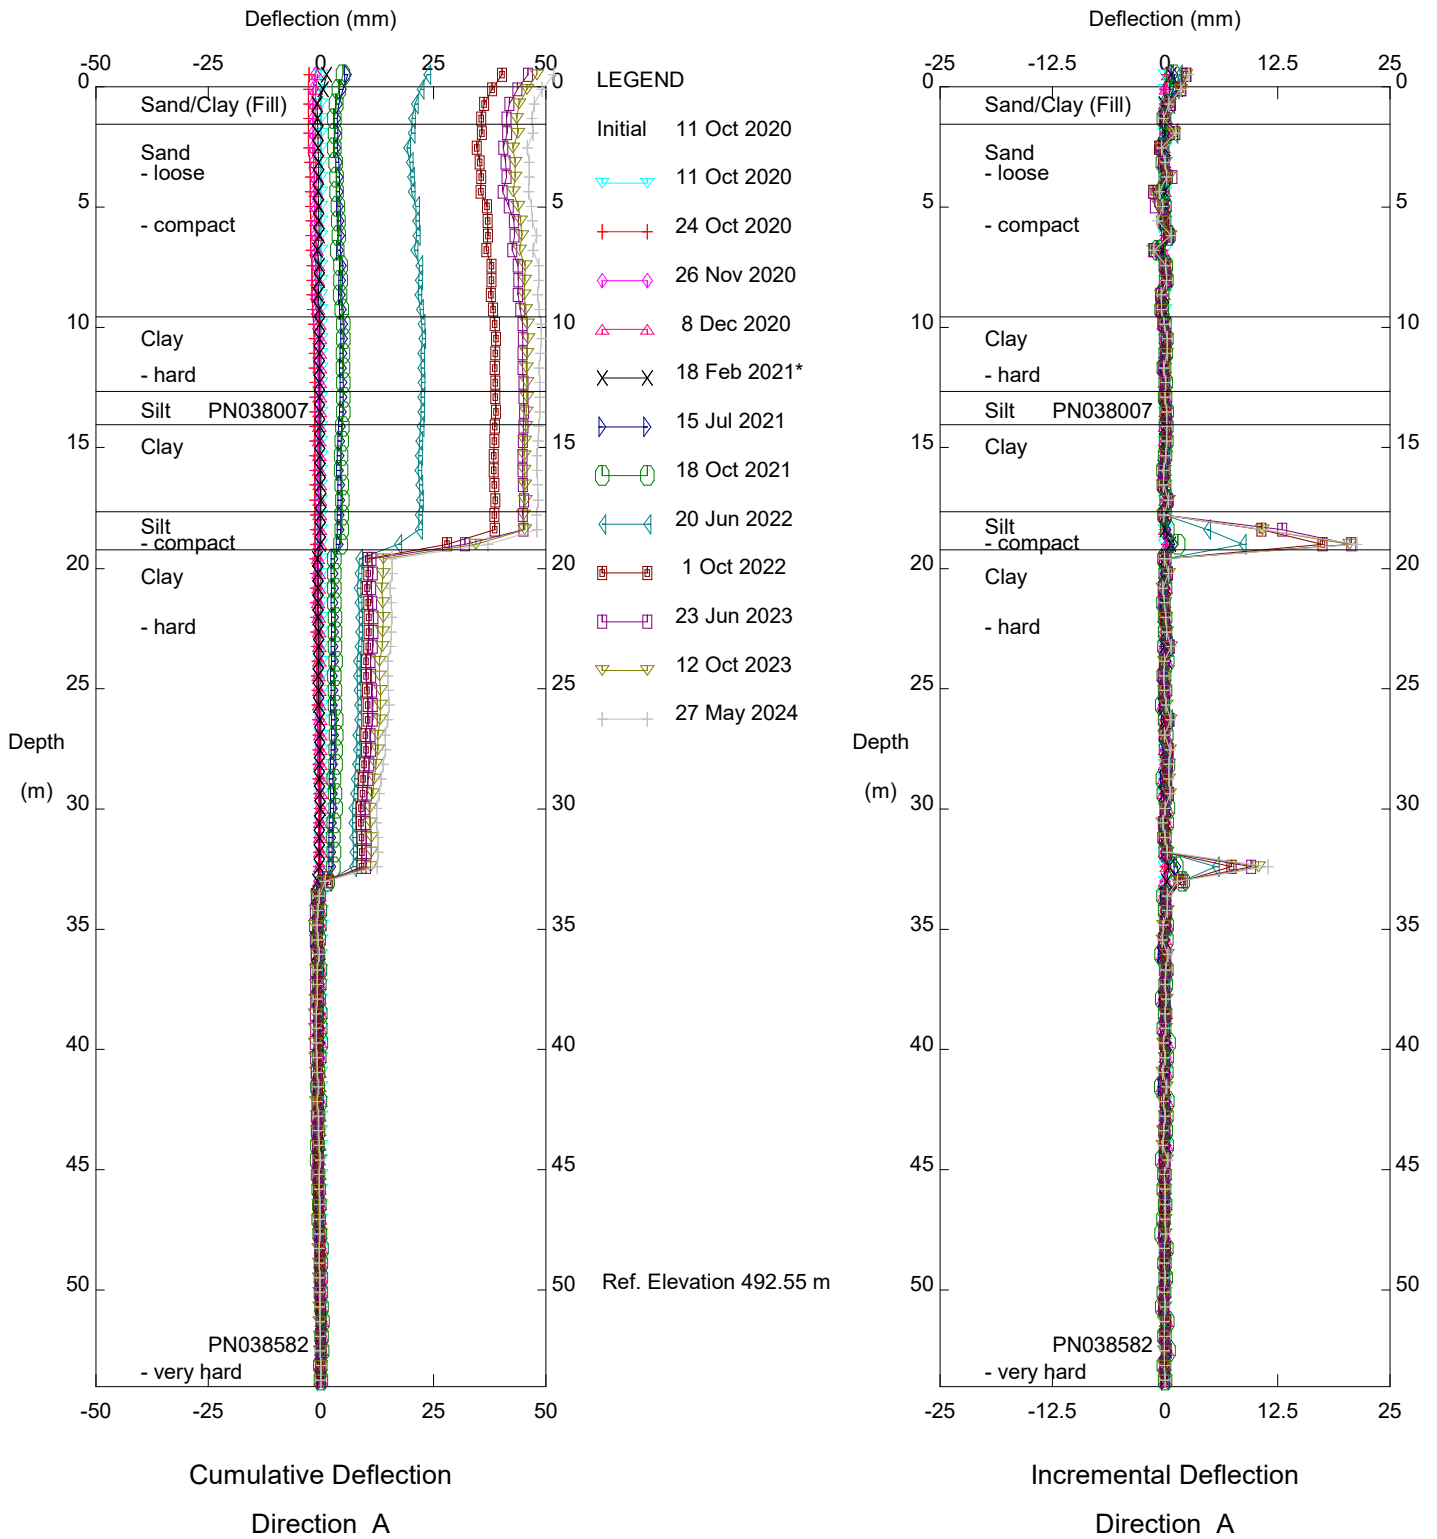
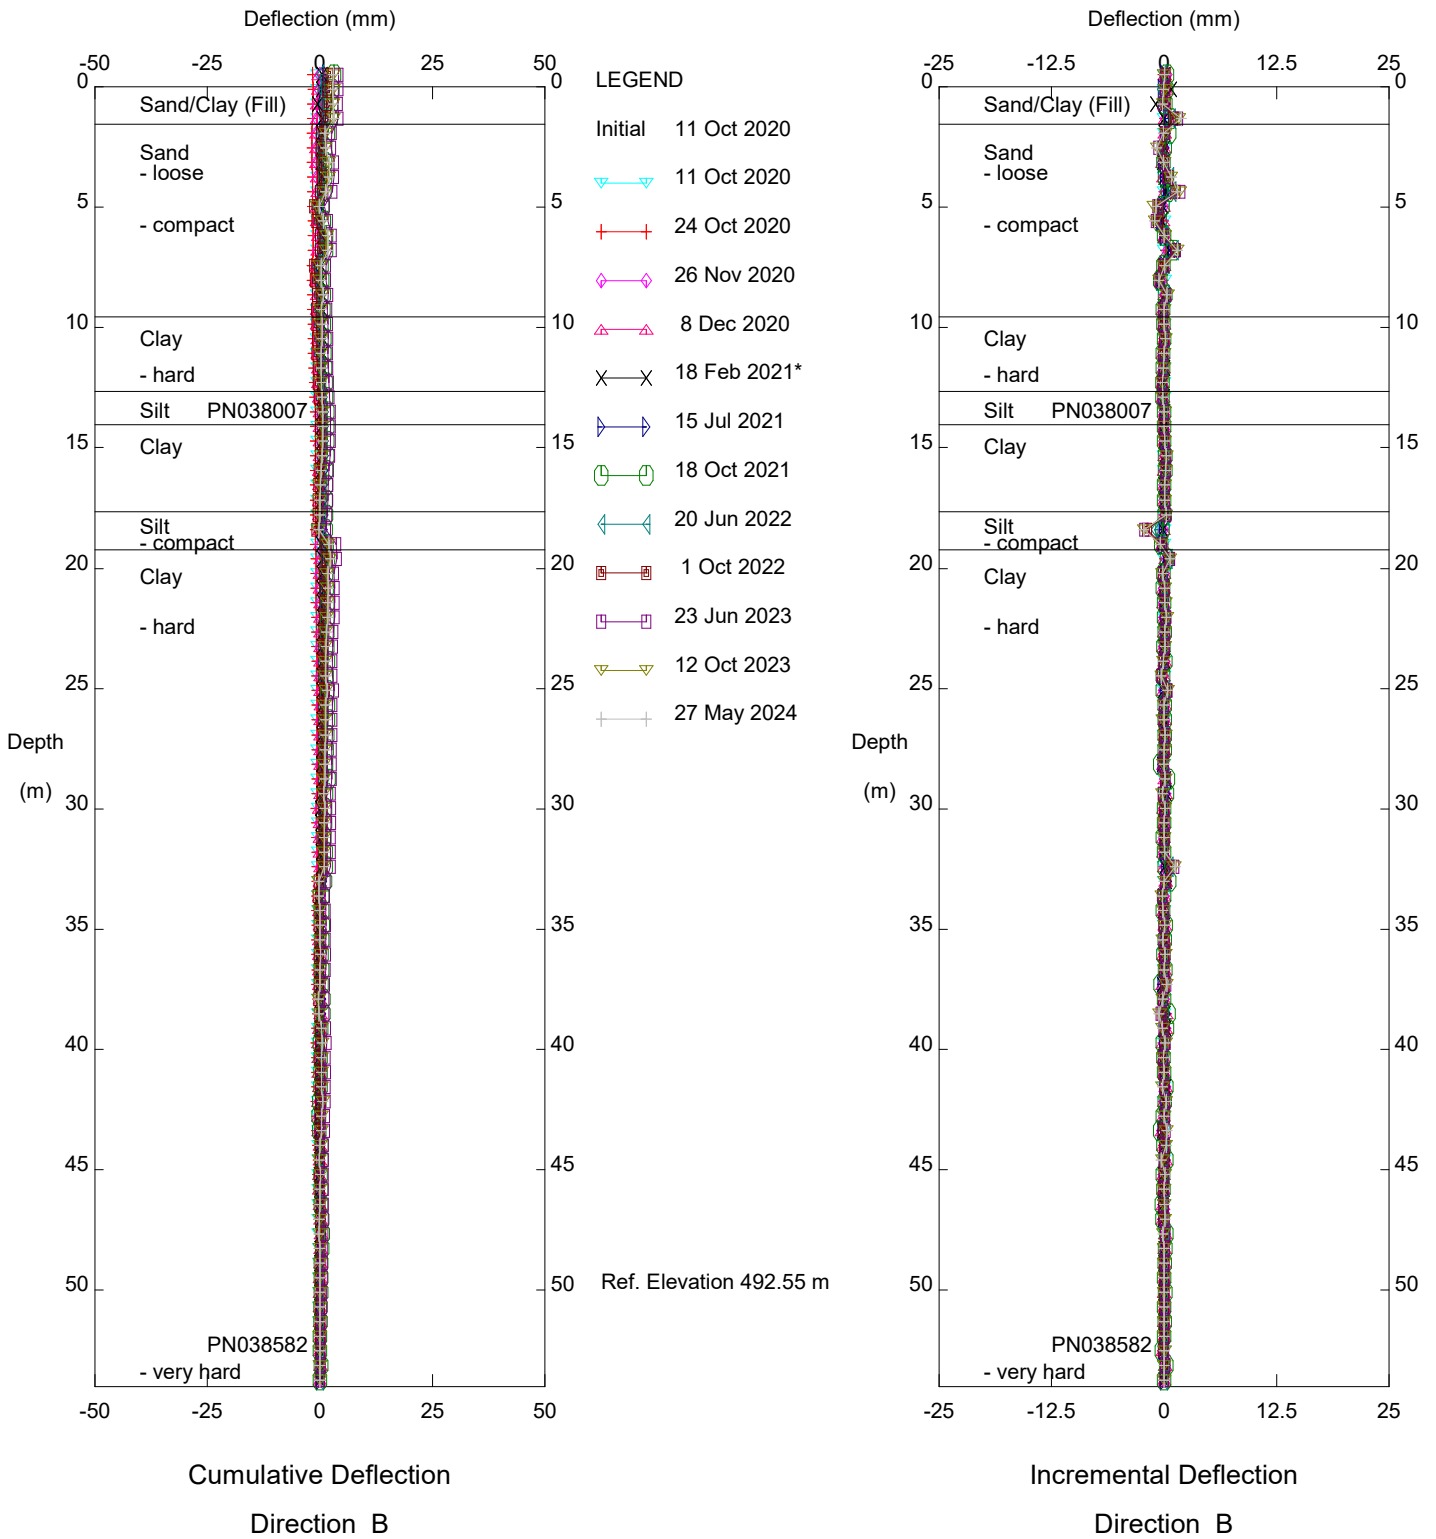
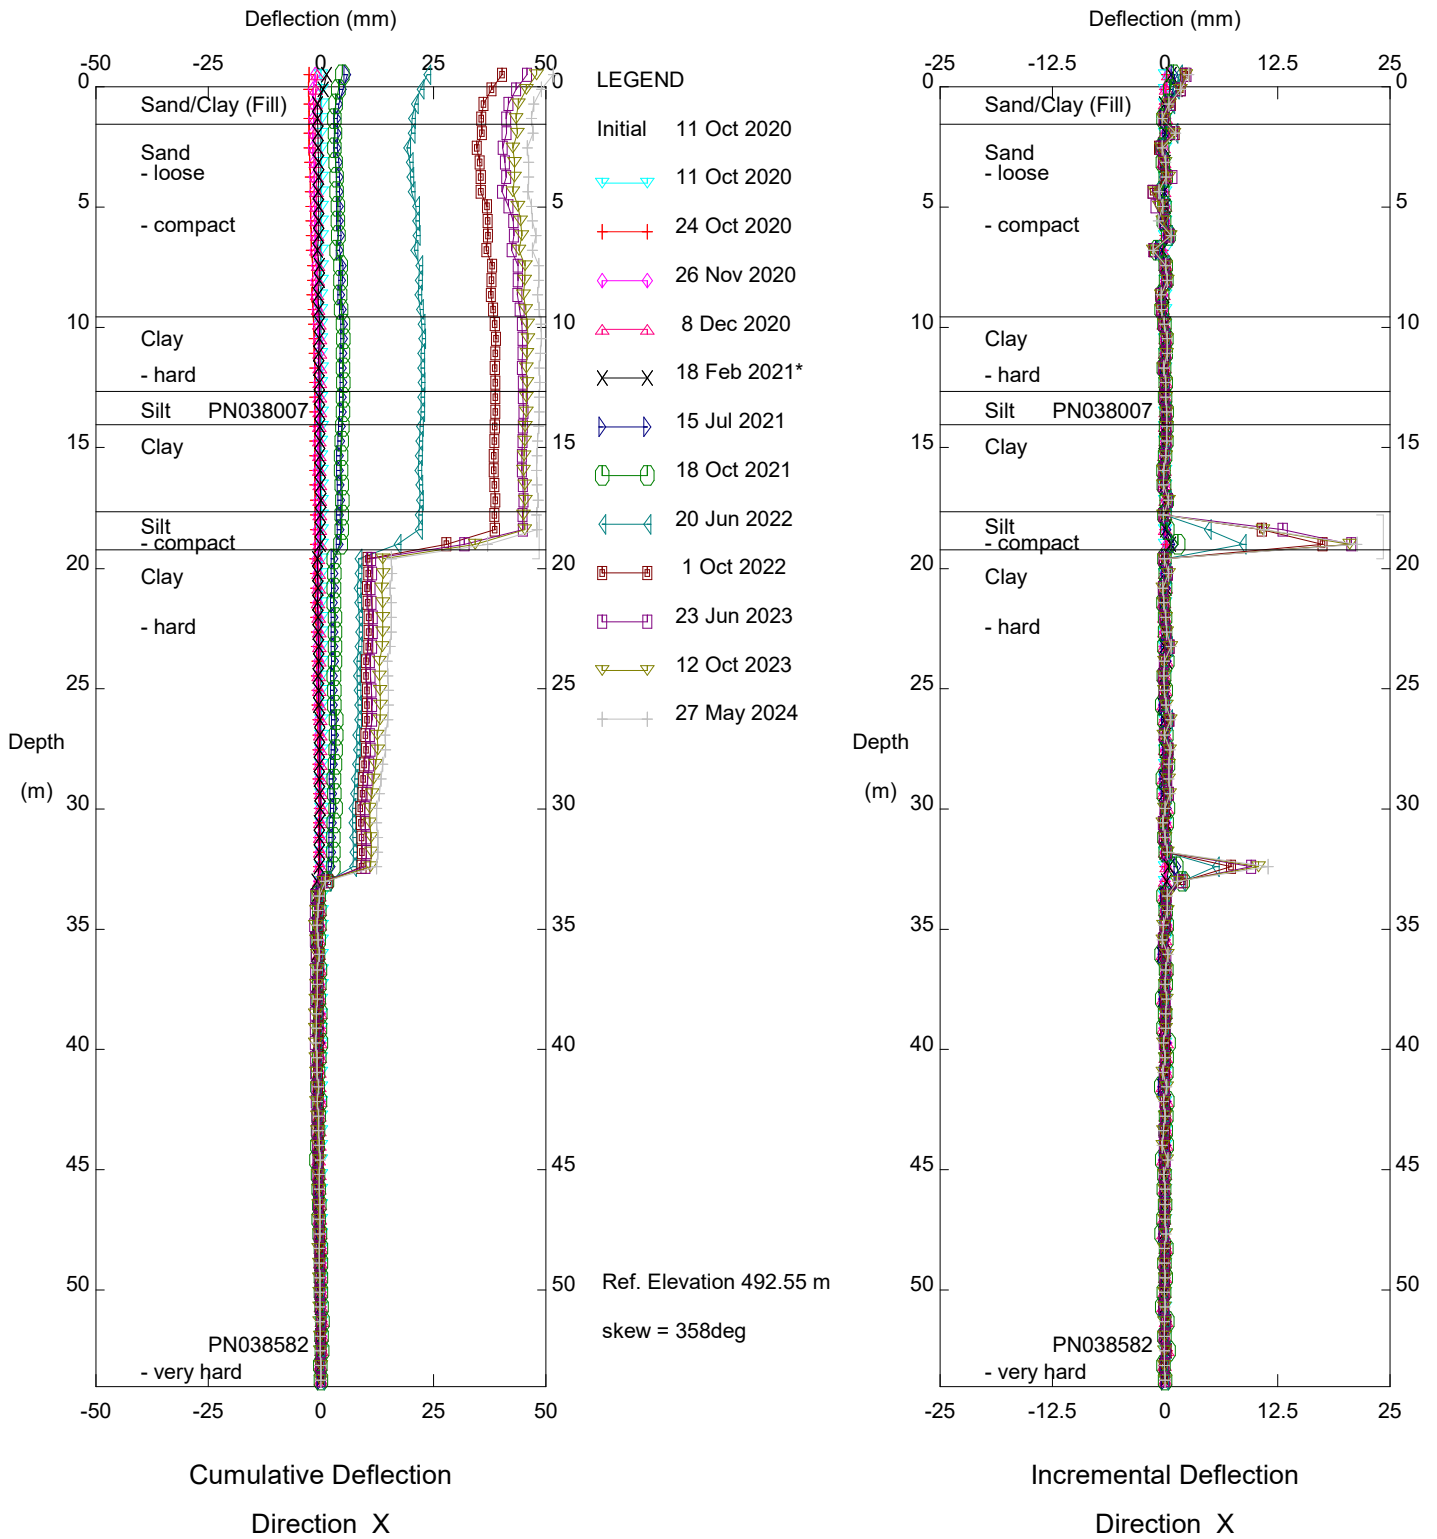
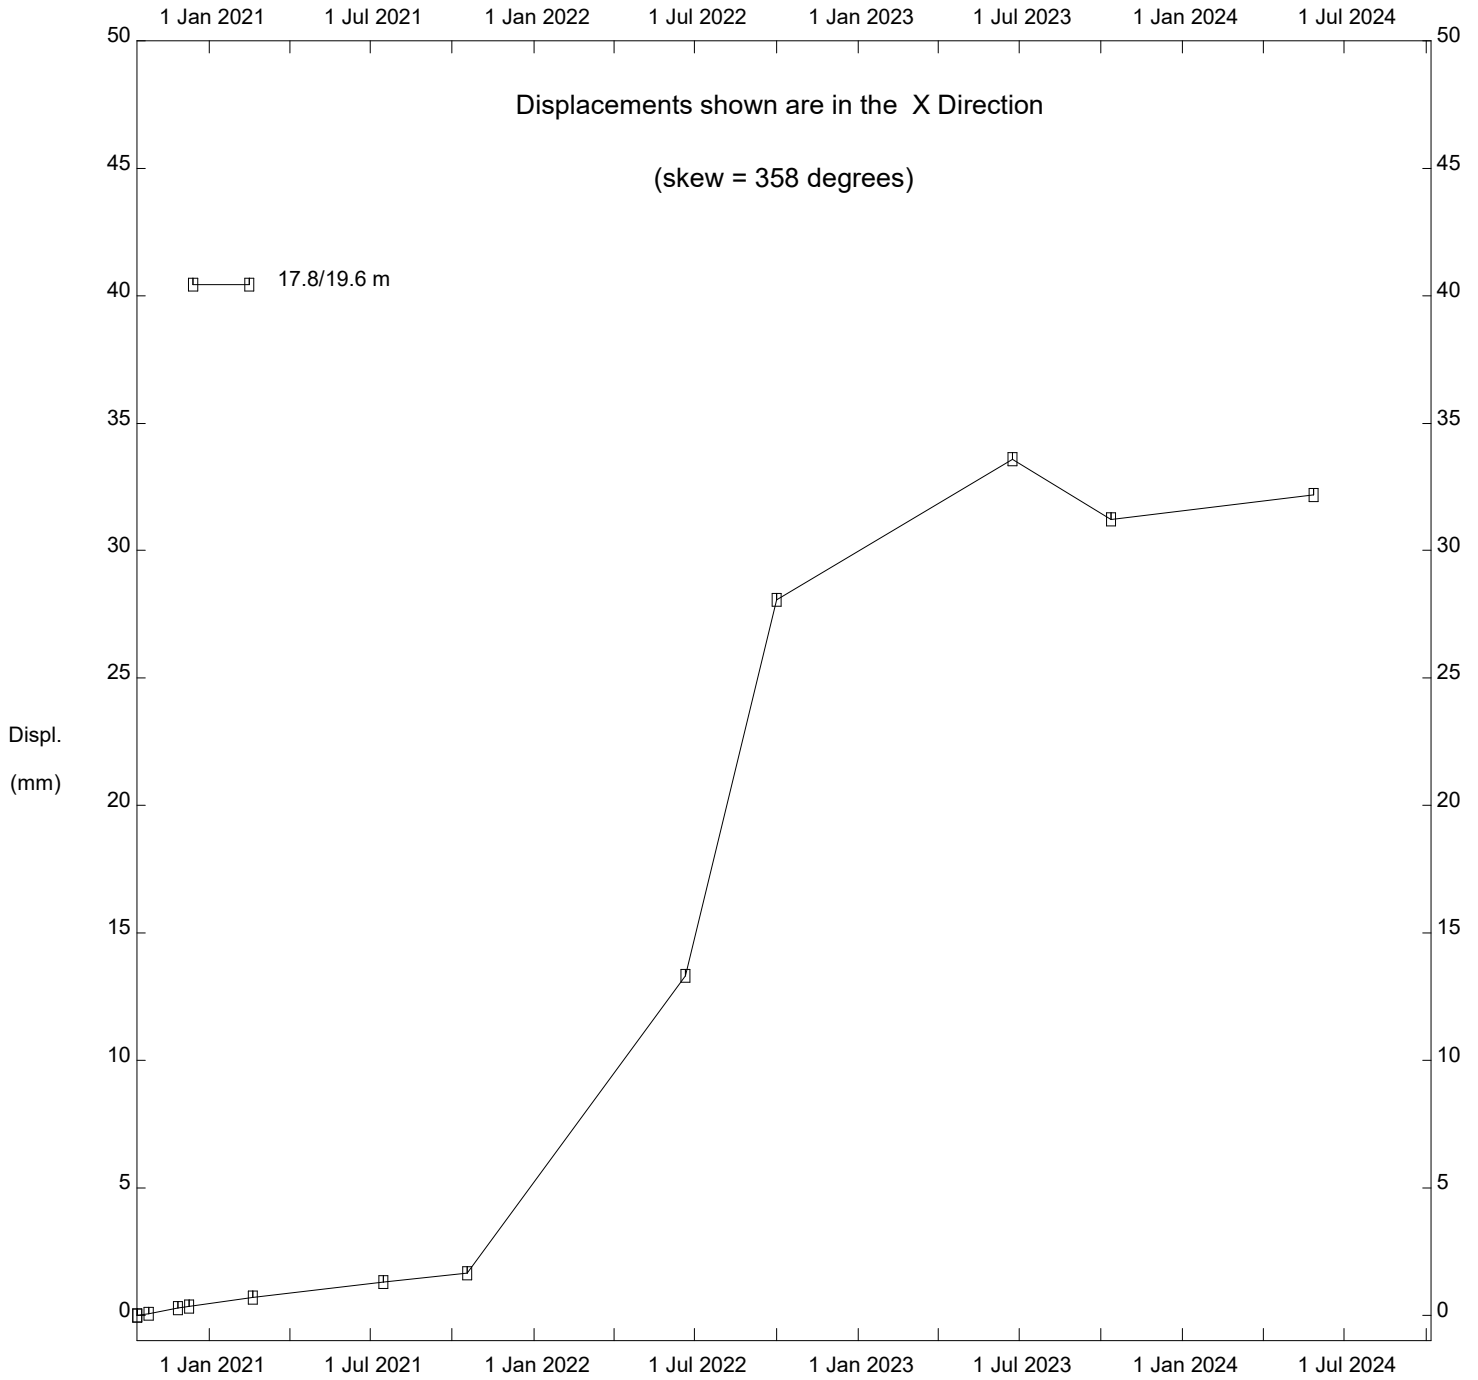
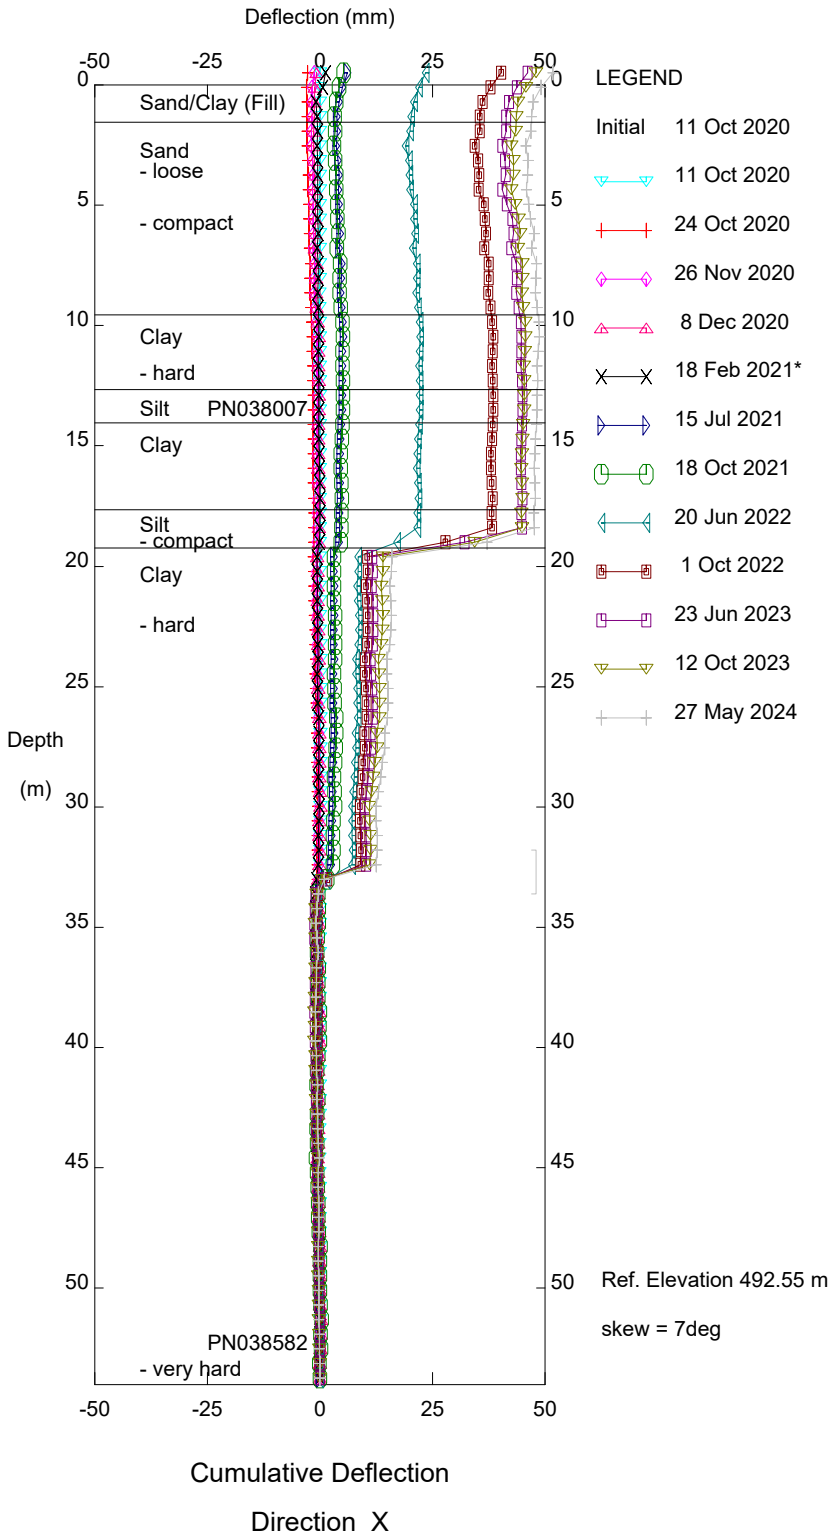
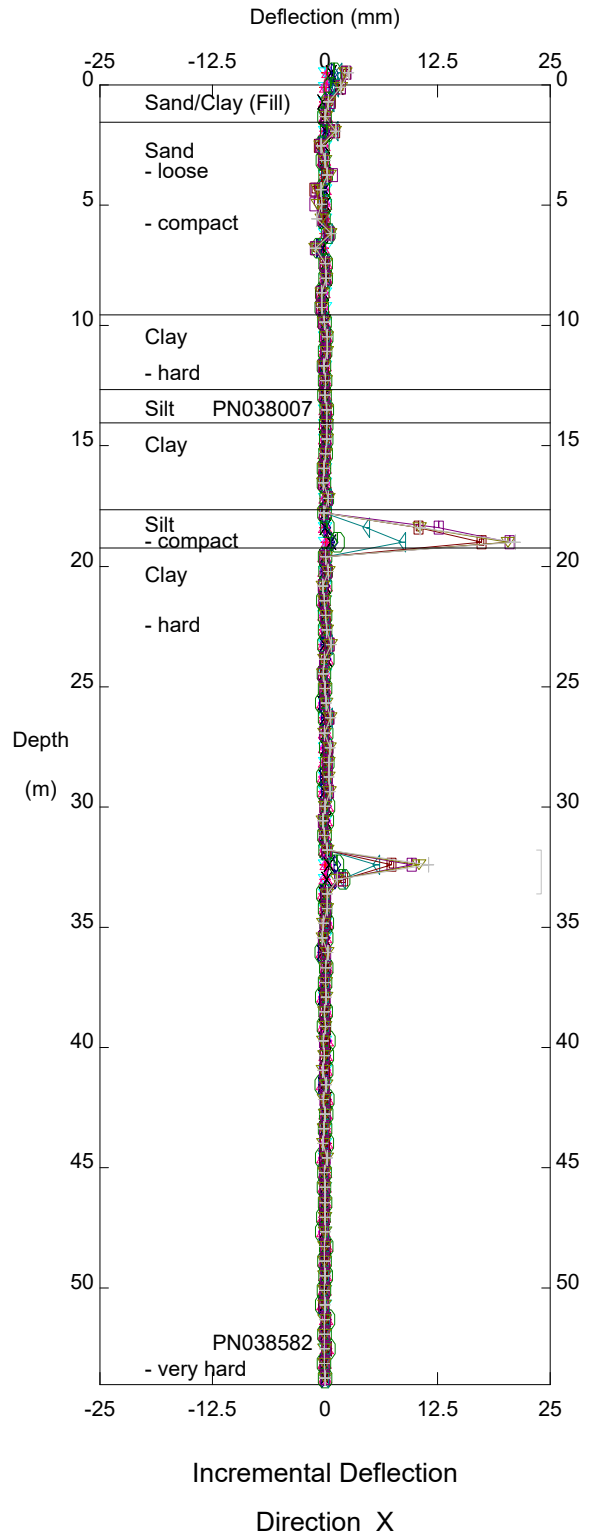
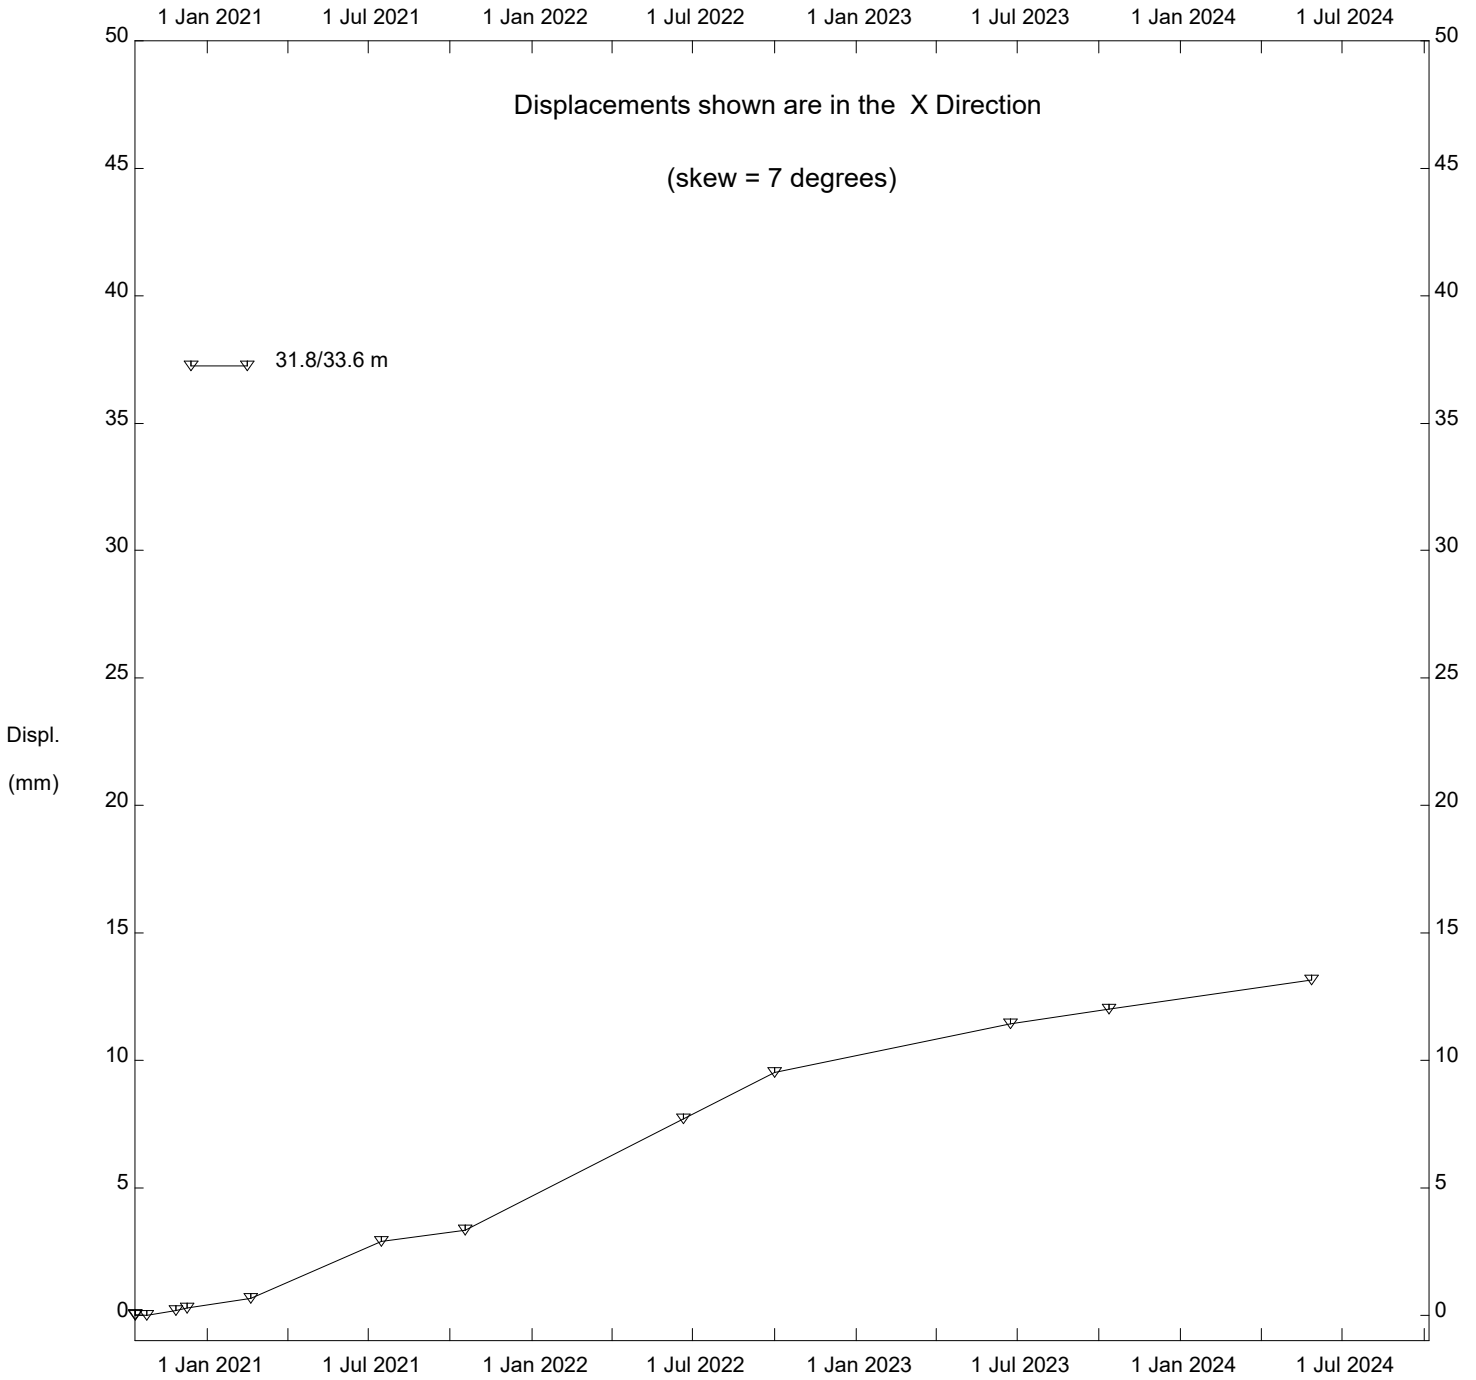
Hwy 64:02 Twin Pipes Landslide (PH023), Inclinometer SI20-7

36.8 mm over 28.1 m to 31.1 m depth in 230° direction	62.6 mm/yr in July 2021			N/A	N/A	N/A
SI20-7	October 11, 2020	32.2 mm over 17.8 m to 19.6 m depth in 195° direction	52.3 mm/yr in October 2022	Operational	October 12, 2023	1.0	1.5	9.3

13.2 mm over 31.8 m to 33.6 m depth in 204° direction	6.5 mm/yr in June 2022			1.2	1.9	<-0.1
