**ALBERTA TRANSPORTATION AND
ECONOMIC CORRIDORS GRMP
GRANDE PRAIRIE REGION –
(GRANDE PRAIRIE NORTH)
INSTRUMENTATION MONITORING - SPRING 2024**

Site Number	Location	Name	Hwy	km
PH023	HWY 64:02 km 24.10	Clear River East Hill (Site 5- Twin Pipes Landslide)	64:02	Km 24.1
Legal Description: 12-27-84-11 W6		UTM Co-ordinates		
		11U E 335453	N	6244315

Current Monitoring:	27-May-2024	Previous Monitoring	12-Oct-2023
Instruments Read By:	Mr. Niraj Regmi, G.I.T and Mr. Nixon Mationg, of Thurber

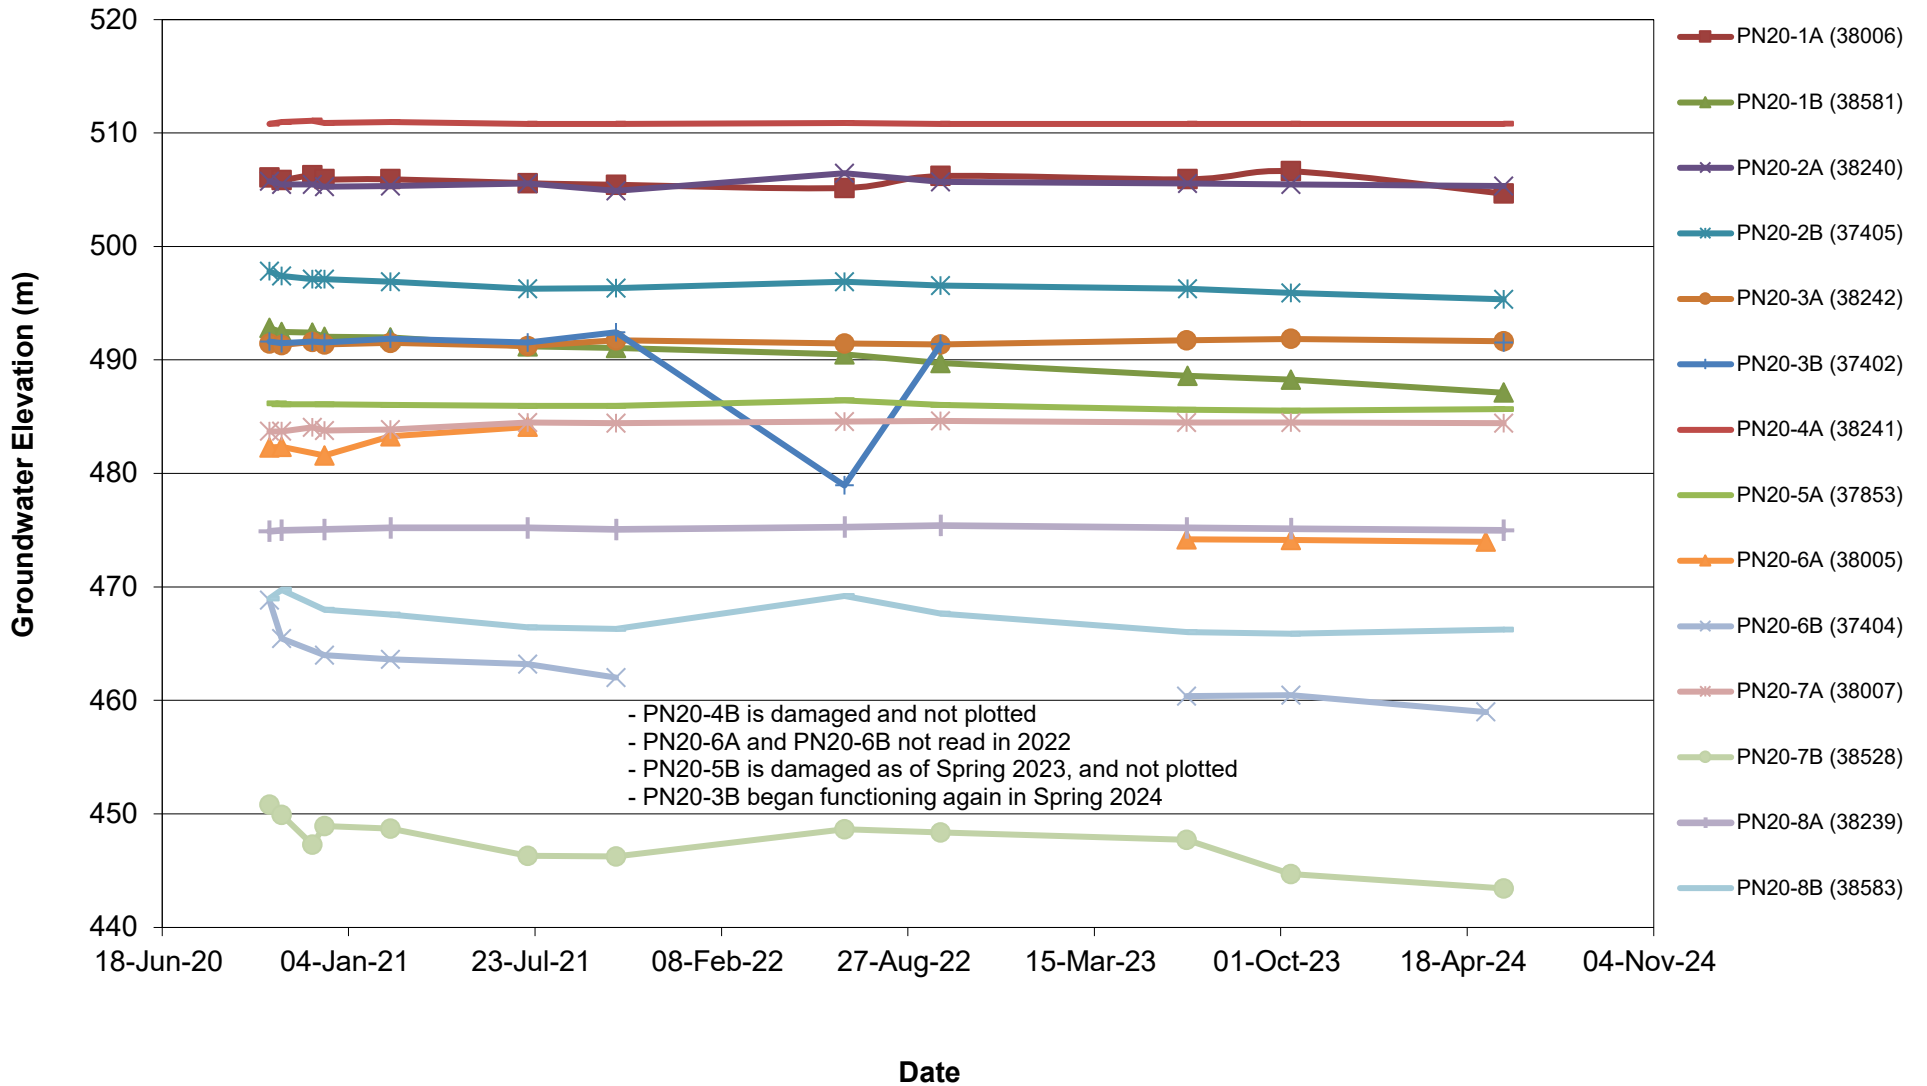
**FIGURE PH023-1
HWY 64:02 - CLEAR RIVER EAST HILL - (SITE #5)
PIEZOMETRIC ELEVATIONS**

<p>m (in PN20-7A) to 1.97 m (in PN20-1A), since the fall of 2023 readings., PN20-8B showed an increase 0.36 m since the fall of 2023 readings. PN20-4A showed no change since the fall of 2023 readings.</p> <p>PN20-6A has shown a trend of decreasing pressures and readings to near 0 PSI and is likely malfunctioning.</p> <p>PN20-3B began functioning again during the spring 2024 readings and showed a ground water level increase of 0.14 m since the fall of 2022 readings, the last time it functioned.</p>
Future Work:	<p>The instruments should be read again in the fall of 2024. PN20-6A has malfunctioned for the last few reading cycles and should be removed from future readings.</p> <p>A third party wildlife escort should be considered to read PN20-6B due to the presence of a bear den near the instrument location.</p>
Instrumentation Repairs:	No instrument repairs are required at this time.
Additional Comments:
