**ALBERTA TRANSPORTATION AND
ECONOMIC CORRIDORS
GEOHAZARD ASSESSMENT PROGRAM
PEACE REGION (GRANDE PRAIRIE DISTRICT - NORTH)
2024 INSPECTION**

Site Number	Location	Name	Hwy	km
PH024	11 km W. Cleardale	Clear River East Hill-(Old Site 8)	64:02	24.2-25.5
Legal Description		UTM Co-ordinates (NAD 83)		
NE27/SE34-84-11-W6		11 N 6244830	E 336445

Date	PF	CF	Total
Previous Inspection:	May 31, 2023	9	4	36 (Risk Eros. Scale)
Current Inspection:	May 8, 2024	9	4	36 (Risk Eros. Scale)
Road AADT:	560		Year:	2023
Inspected By:	Don Proudfoot, Nicole Wilder (Thurber). Rocky Wang, Robert Senior (TEC)			
Report Attachments	<input checked="" type="checkbox"/> Photographs <input checked="" type="checkbox"/> Plans <input type="checkbox"/> Maintenance Items

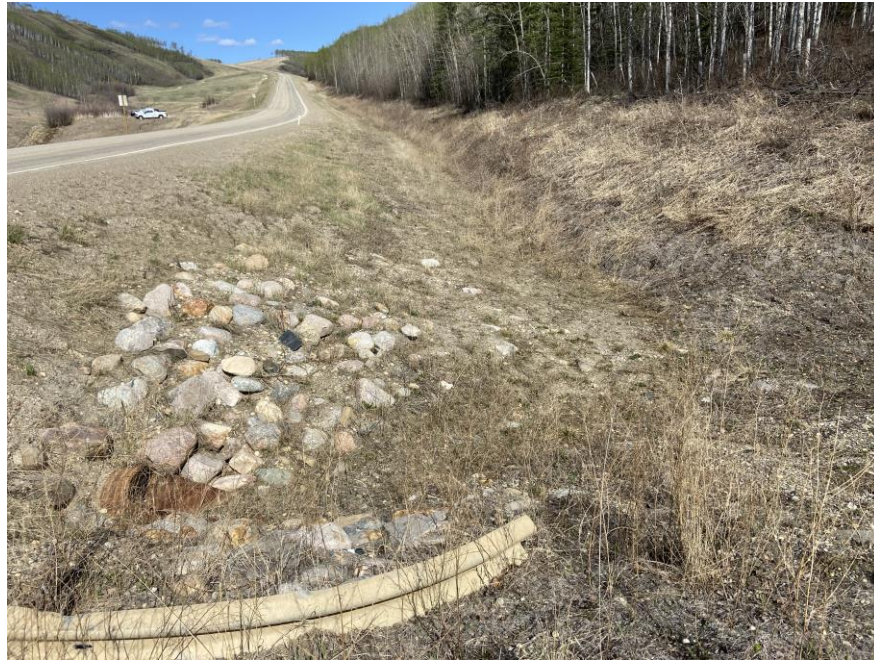
Photo 1 – Looking east along the south ditch at the ditch block and inlet of the 810 CSP on the south side of the hwy embankment.

Grade/shape the downstream banks of the ditch blocks at the inlets of the 760mm SWSP and the 810mm CSP, and then add some Class 2 riprap over non-woven geotextile to induce more flow into these culverts. **\$5,000**

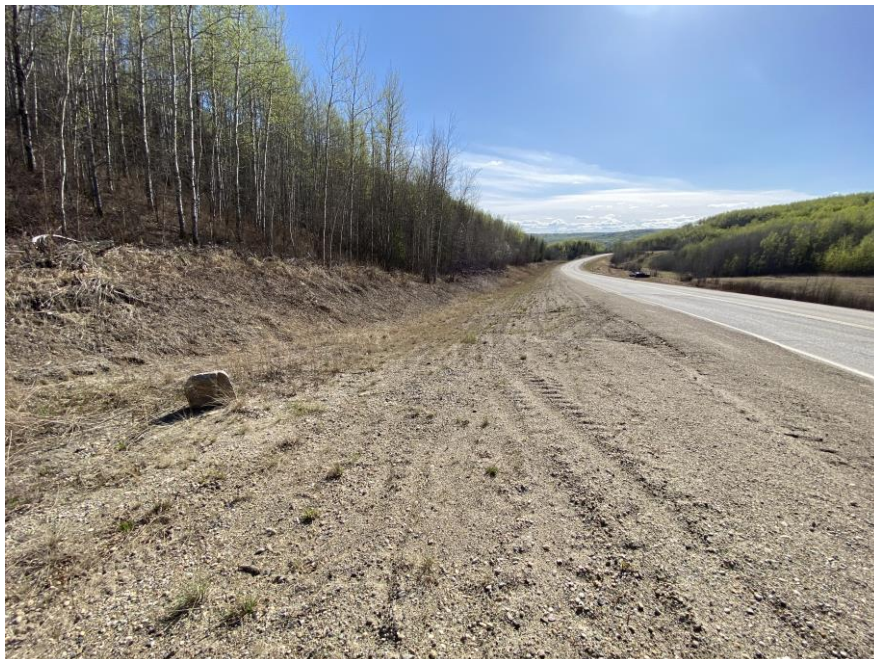
Photo 2 - Looking west along the unlined south highway ditch from the inlet of the 760 mm dia. SWSP.

As a minimum, the ~330 m long segment of the currently unlined south ditch bottom extending west of the riprap lined segment up to the 810 CSP culvert, should be topsoiled, seeded, and covered with TRM.

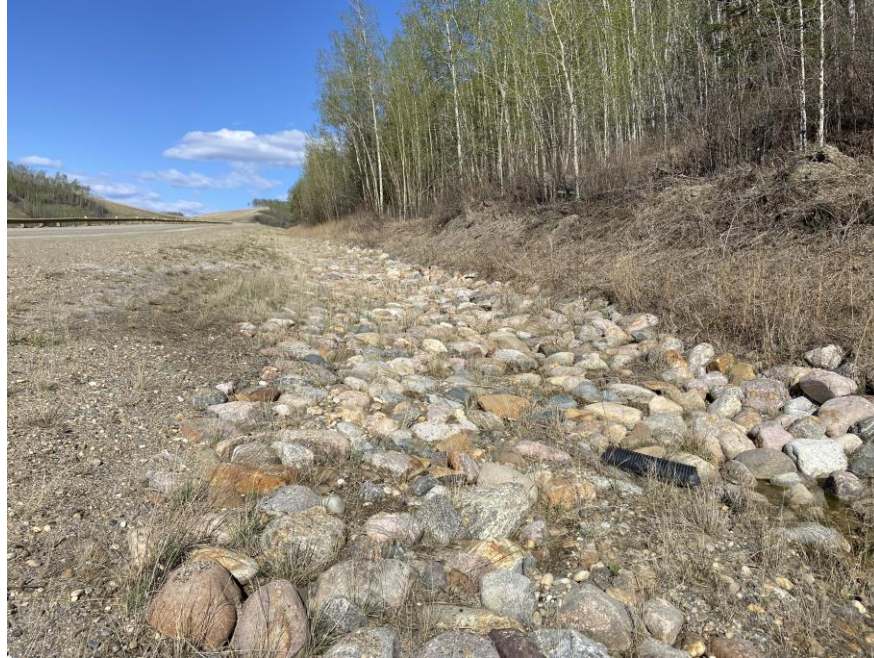
Photo 3 – Looking east from near the ditch block along the riprapped south ditch channel from just upslope of the inlet of the 760 mm dia. SWSP.

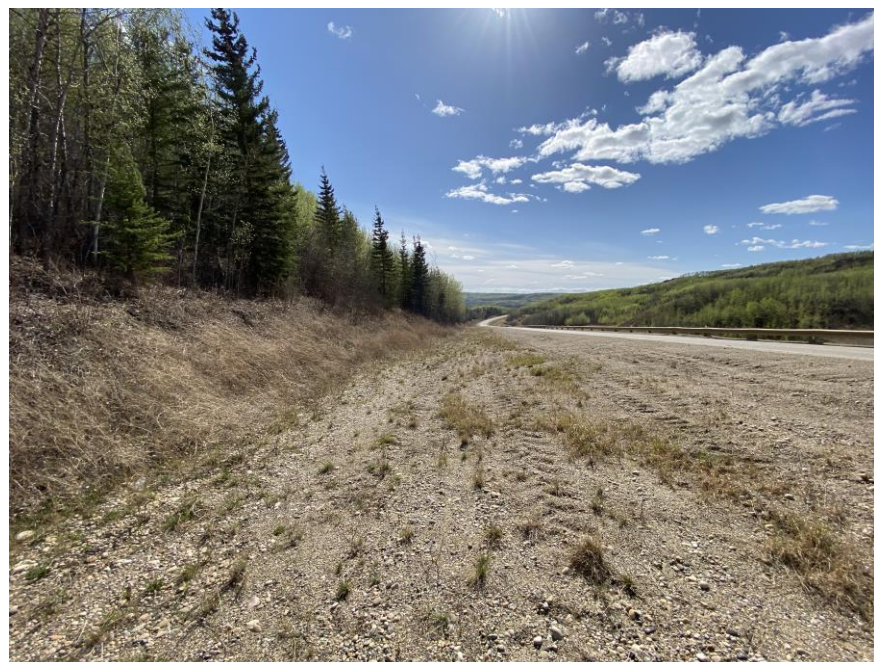
Photo 4 – Looking west along the south ditch channel and hwy embankment that was lined with 6-80 gravel.

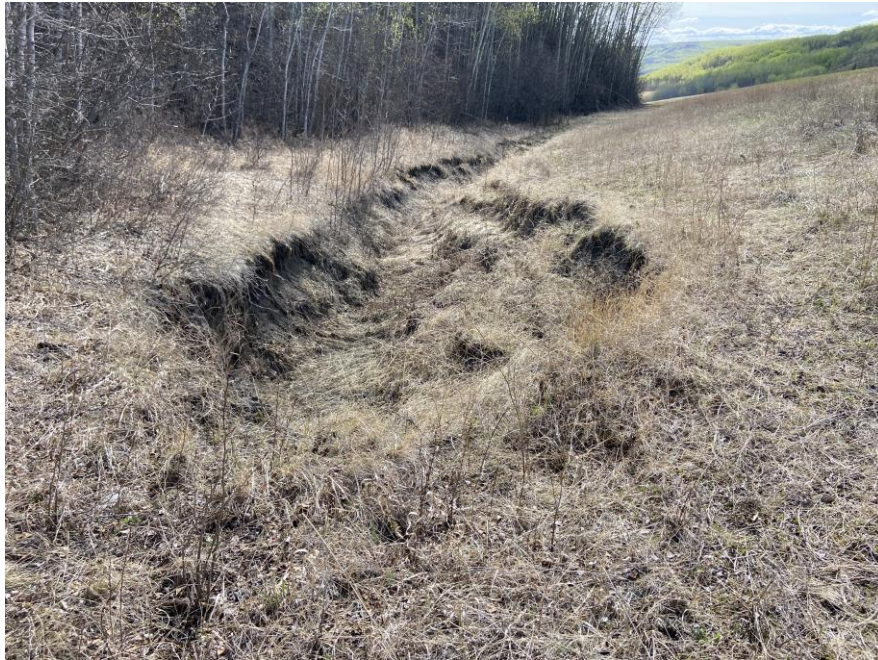
Photo 5 – Looking west at the erosion that formed in 2020 along the boundary of the south embankment fill and the bush line.

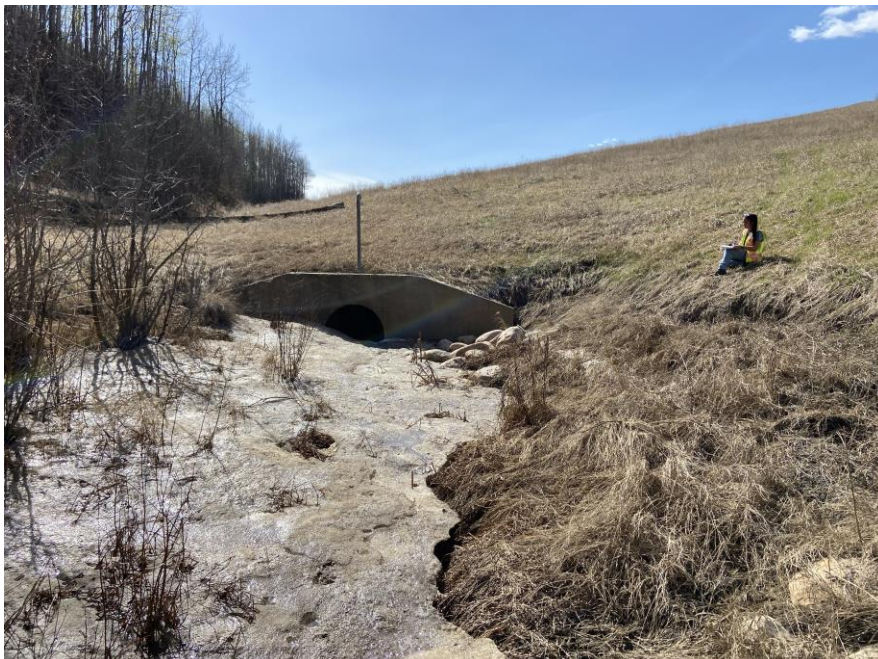
of snow/ice prior to spring break-up 2022). In 2024, ice was build up over the riprap leading to the 1200 CSP, and the outlet end of the 900 mm drop pipe was almost full of ice also (possibly blocked by valley ice/snow build-up).

Photo 6 - Looking northwest at the 1200 CSP inlet headwall. Note the ice build-up in the channel in front of the culvert.

The 1200 mm dia. CSP inlet should be inspected and steamed each spring (if required) to remove ice build-up with a backhoe and establish unrestricted flow. We recommend that this late winter/early spring check and steaming be formally added to the maintenance contractor's annual maintenance work requirements (as was done in 2022, which may have prevented an overflow). **\$5,000 annually**

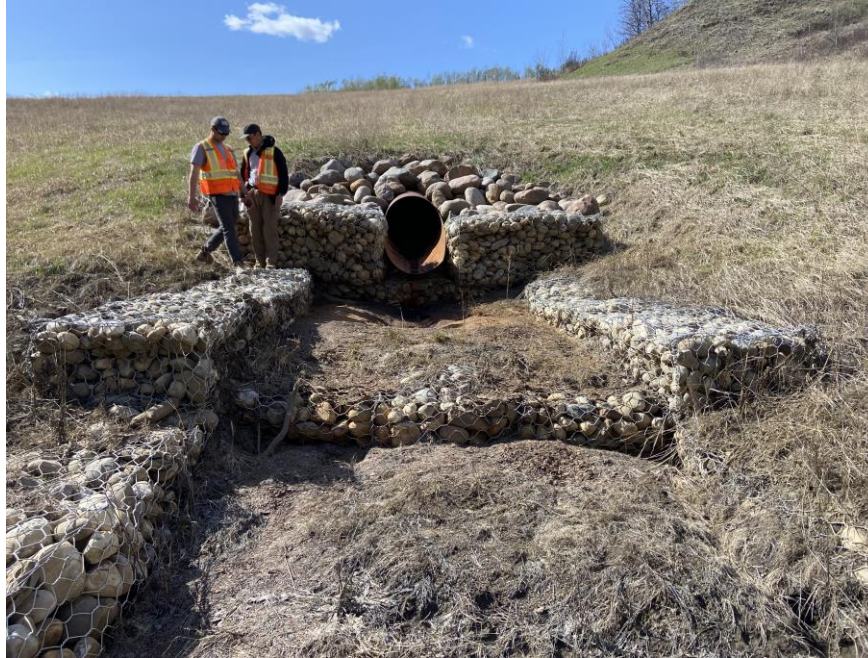
Photo 7 – Looking north at the 900 SWSP outlet and gabion outlet structure. There was significant ice inside this pipe this year.

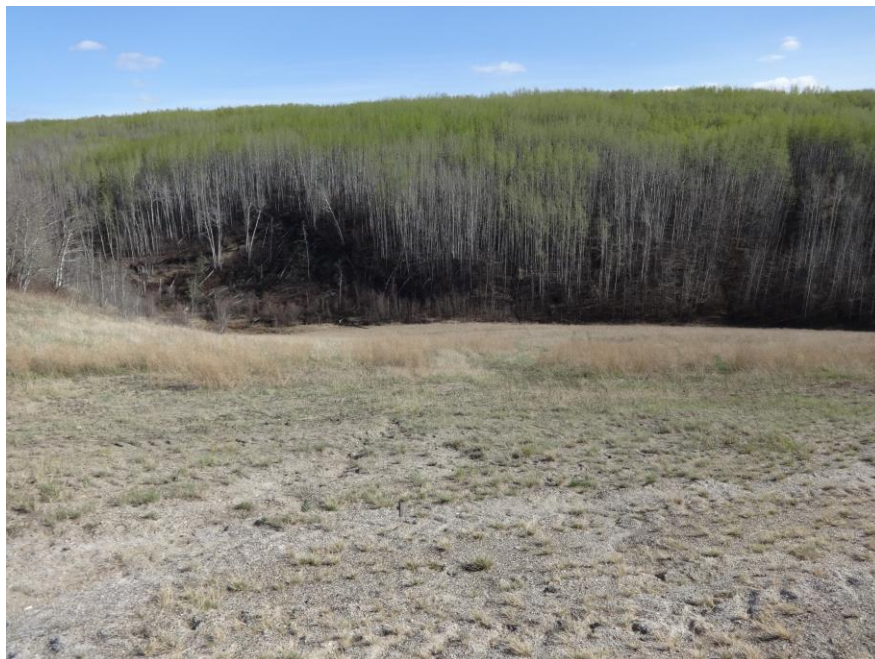
The backed-up water from the flood surges nearer the inlet of the 1200 mm dia. culvert saturated the native soil along the toe of the natural valley slope and combined with toe erosion from flowing water and a likely sudden drawdown scenario, caused toe slumping of the natural tree covered slope. This has gotten worse the last few years but is not currently affecting the functionality of the site, although some slide debris was observed beyond the toe of the slope in recent years.

Photo 8 – Looking south at the valley slope slumping above the 1200 culvert inlet and gabion outlet area, caused by rapid drawdown of built-up floodwater.

Clean out future slide toe debris accumulations from in front of the 1200 culvert inlet area, and along the south ditch, if required.

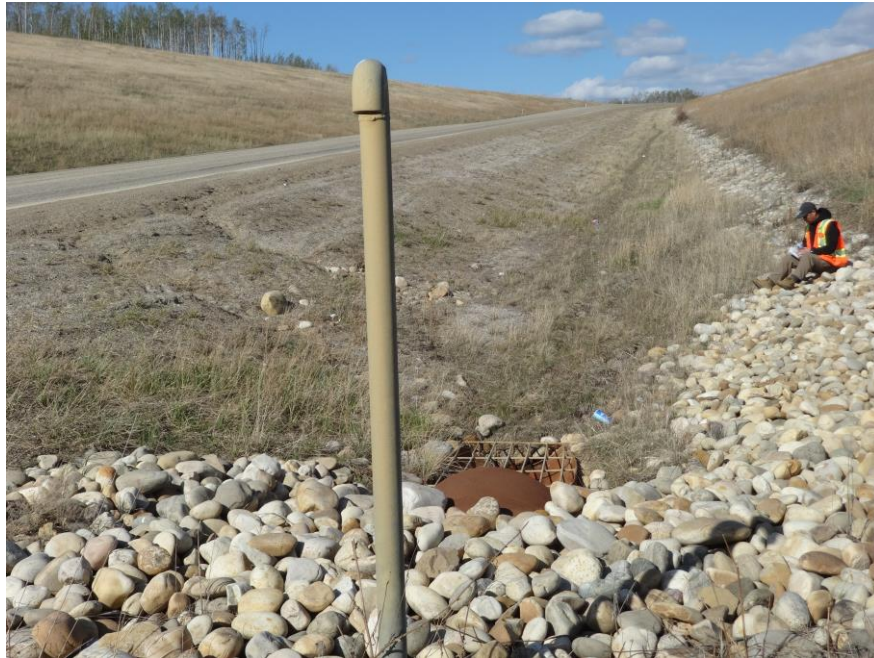
Photo 9 – Looking east along the south gabion-lined ditch from the north 900 mm SWSP entrance.

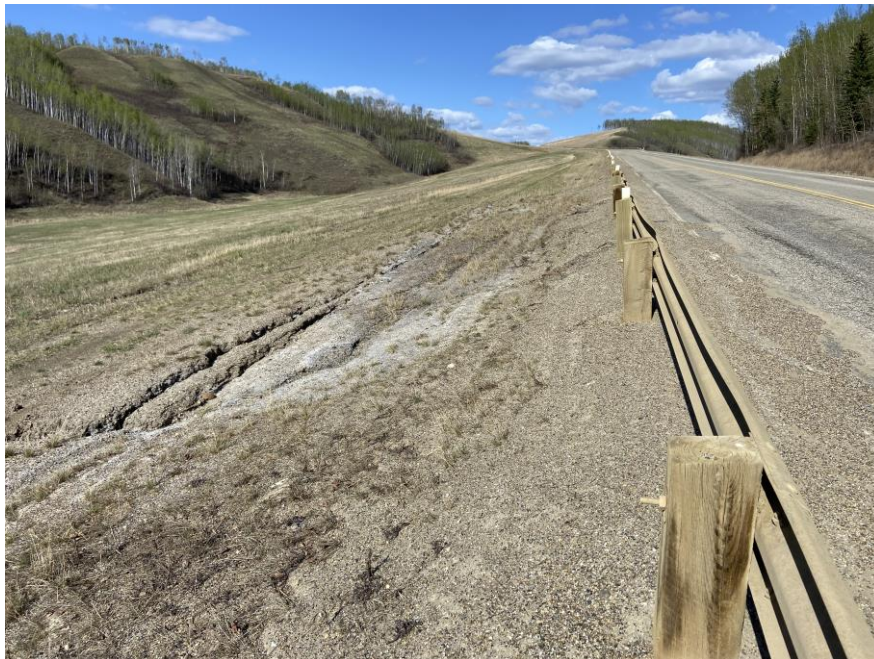
Photo 10 – Looking east at the rilling adjacent to the north guardrail (just west of the repaired rilling on the north embankment).

Some of the rilling erosion near the north hwy embankment guardrail had been graded/smoothened. Repair the remaining rill erosion outside the north edge of the guardrail and along the edge of the eroded ACP north shoulder (Photo 10), by first grading the existing surface, then adding/track-packing/shaping with a few loads of gravel infill, and then covering with topsoil and TRM. **\$5,000**

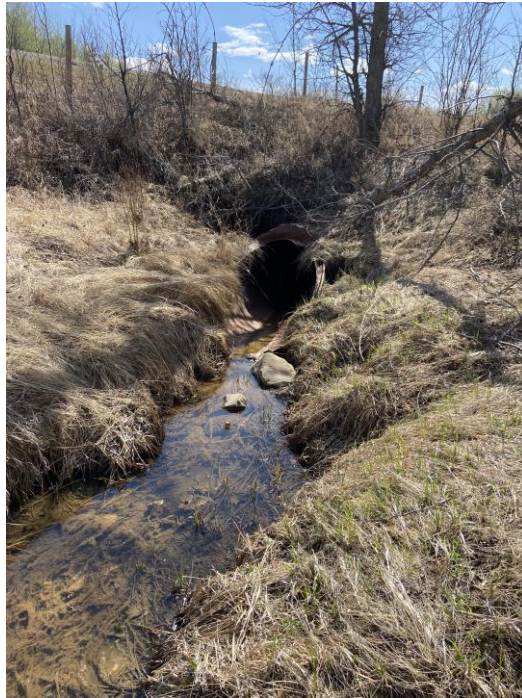
Photo 11 - Looking southwest at the 1040 SWSP inlet, at the west end of the north ditch channel.

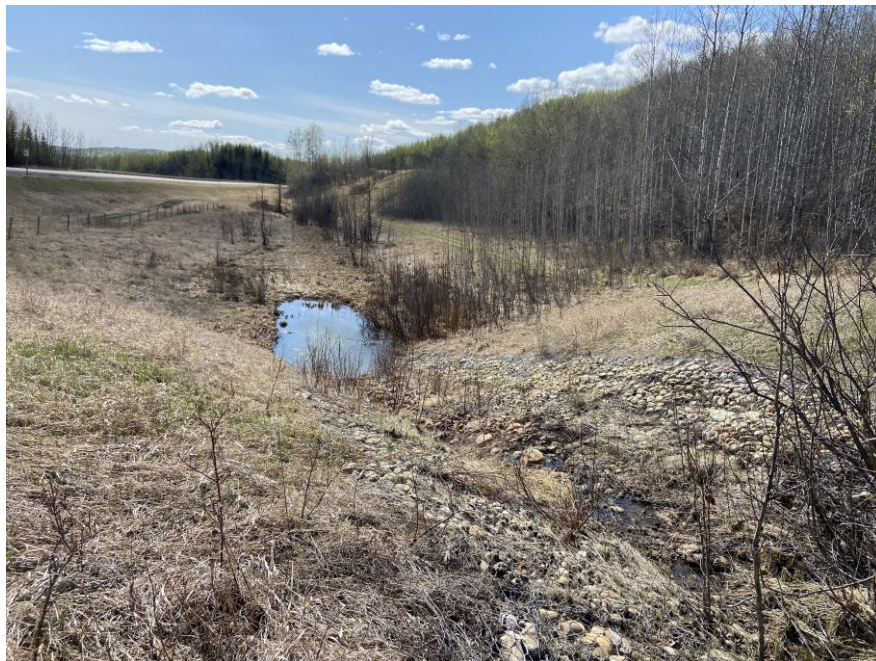
Photo 12 - Looking west (downstream) along the north ditch channel upstream of the 810 CSP outlet. Note the gabions are still intact here.

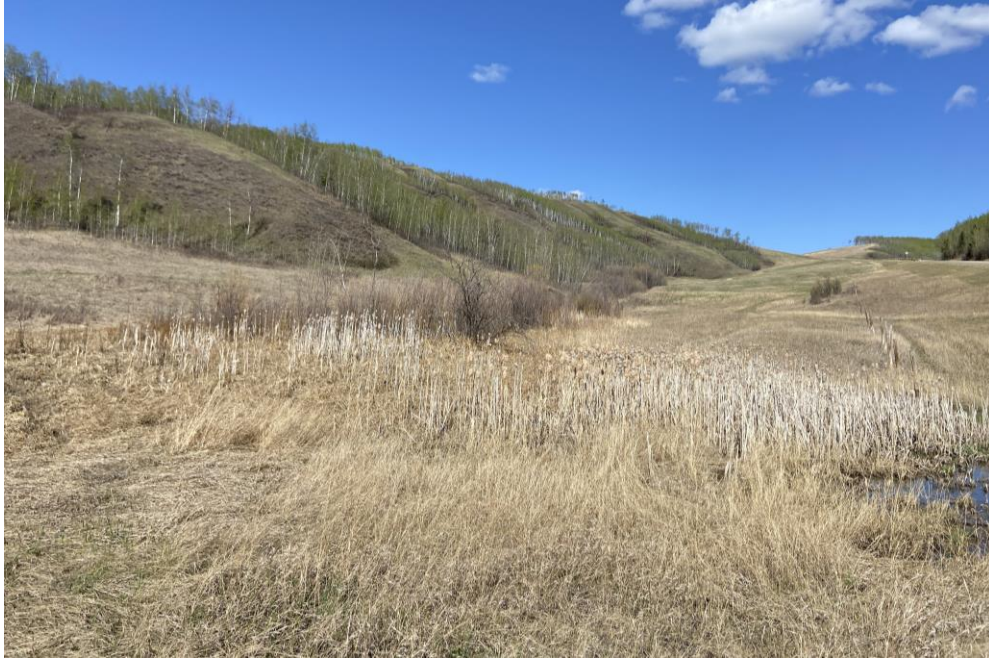
Photo 13 – Looking east (upstream) along the north ditch channel (downstream of the 760 SWSP outlet), at the area where flow has bypassed the sediment-filled channel and is creating a wetland south of the channel.

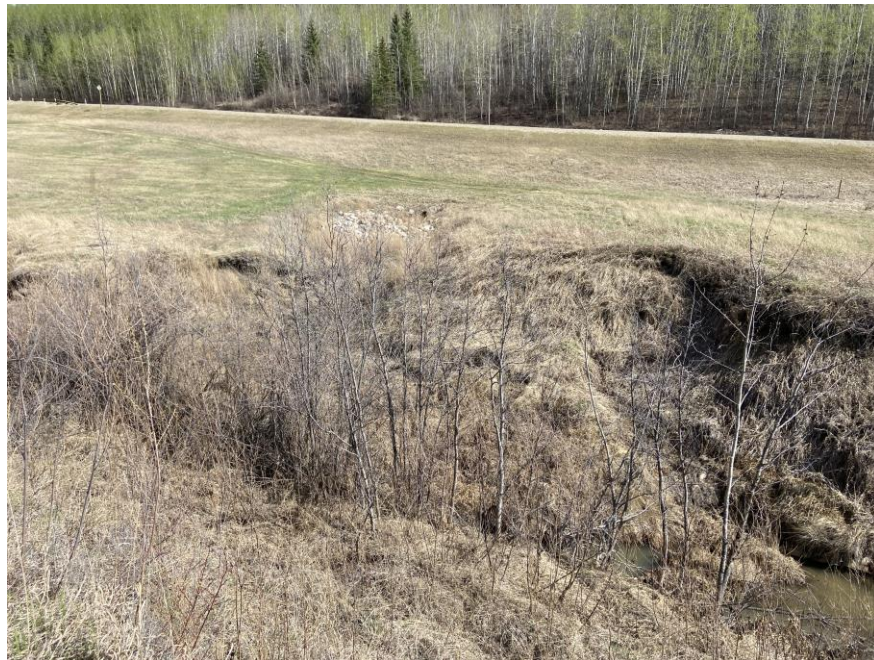
Photo 14 - Looking southeast at the 760 mm SWSP outlet. Note the fresh erosion and associated slumping inside the channel.

The erosion gully between the outlet of the recently opened 760 mm diameter SWSP and north channel (Photo 14) should be repaired by grading a trapezoidal channel and lining it with Class 1 riprap over non-woven geotextile.

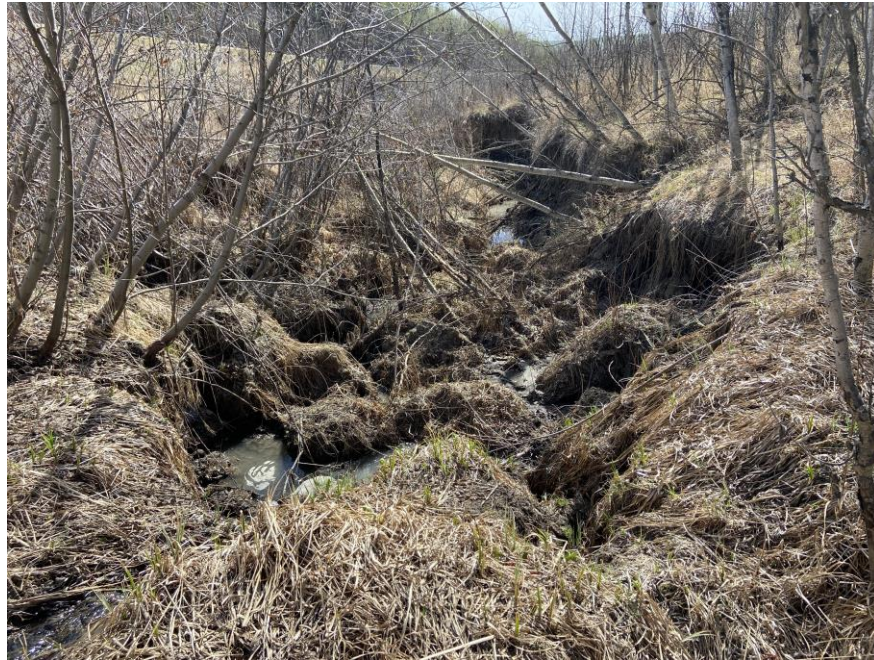
Photo 15 – Looking west (downstream) at the erosion just upstream of the 760 SWSP outlet.

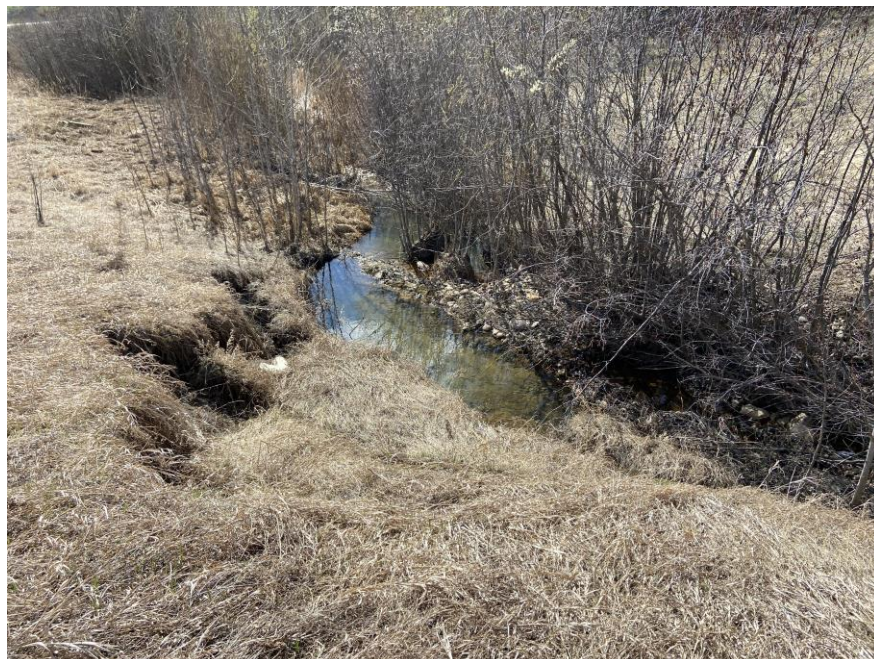
Photo 16 - Looking west at the erosion in the north ditch channel at the completely eroded gabion liner between the 760 SWSP and 1200 CSP outlets.

The heavy willow growth in the areas where the gabion drop structures were eroded by high flows seem to be gradually reaching a level of equilibrium with the flows in the tributary channel by providing a natural liner against lateral erosion of the channel. A few more years of monitoring are recommended to assess whether further remedial measures are required at these locations.

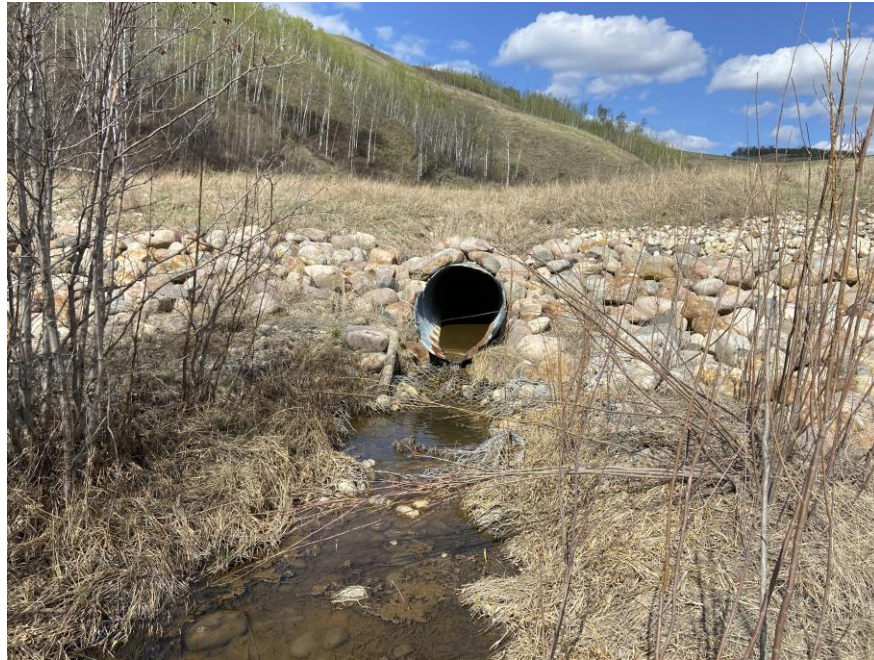
On the north side of the highway, the 1200 mm dia. CSP flowing full was also likely combined with runoff from the area/slopes to the north, which caused damage to two of the steeper sloping gabion lined channel sections further west and created a scour hole in the channel further west of this. The channel was overgrown with willows which reduced the flow capacity causing water to flow around and erode the sides of the gabion structure, and is creating a wetland adjacent to the channel (Photo 13). Conversely, the willows at some locations may provide some protection against lateral bank erosion. In the 2013 event, there was also an erosion scour around the outlet of the 760 mm dia. SWSP in the north ditch, resulting from runoff originating from the south ditch flowing beneath the highway, which may have also contributed to the large erosion feature around the gabions immediately west (downslope) of this outlet. Both the inlet and outlet of this pipe were covered with pitrun in 2019, but this culvert was flushed/cleaned in 2020. A runoff gully has since formed beyond this culvert outlet and joined the gully that exists around the channel gabion.

Photo 17 - Looking east at the 1200 CSP outlet area in the north channel. Note the damaged gabions.

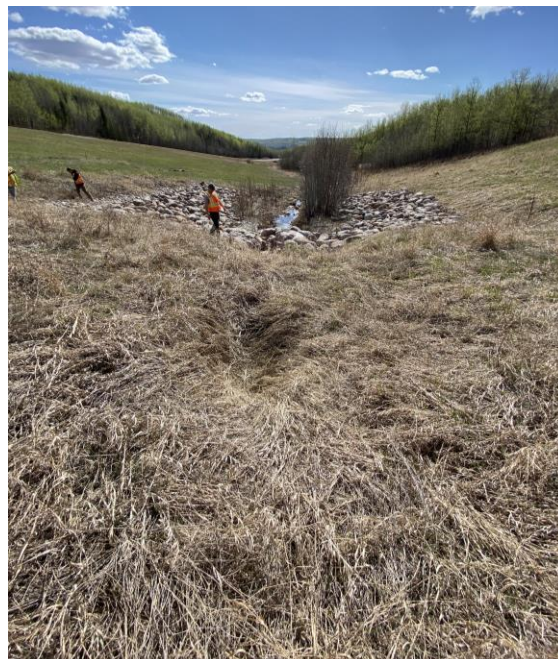
Photo 18 – Looking west at the 1200 culvert outlet area. Note the old subsidence behind the riprap.
