ALBERTA TRANSPORTATION LANDSLIDE RISK ASSESSMENT

**SITE PH67: HWY 682:02 EAST HILL DITCH EROSION
(KM 13.8 TO KM 14.1)**

2015 PH67 INSPECTION PLAN

FIGURE PH67-1

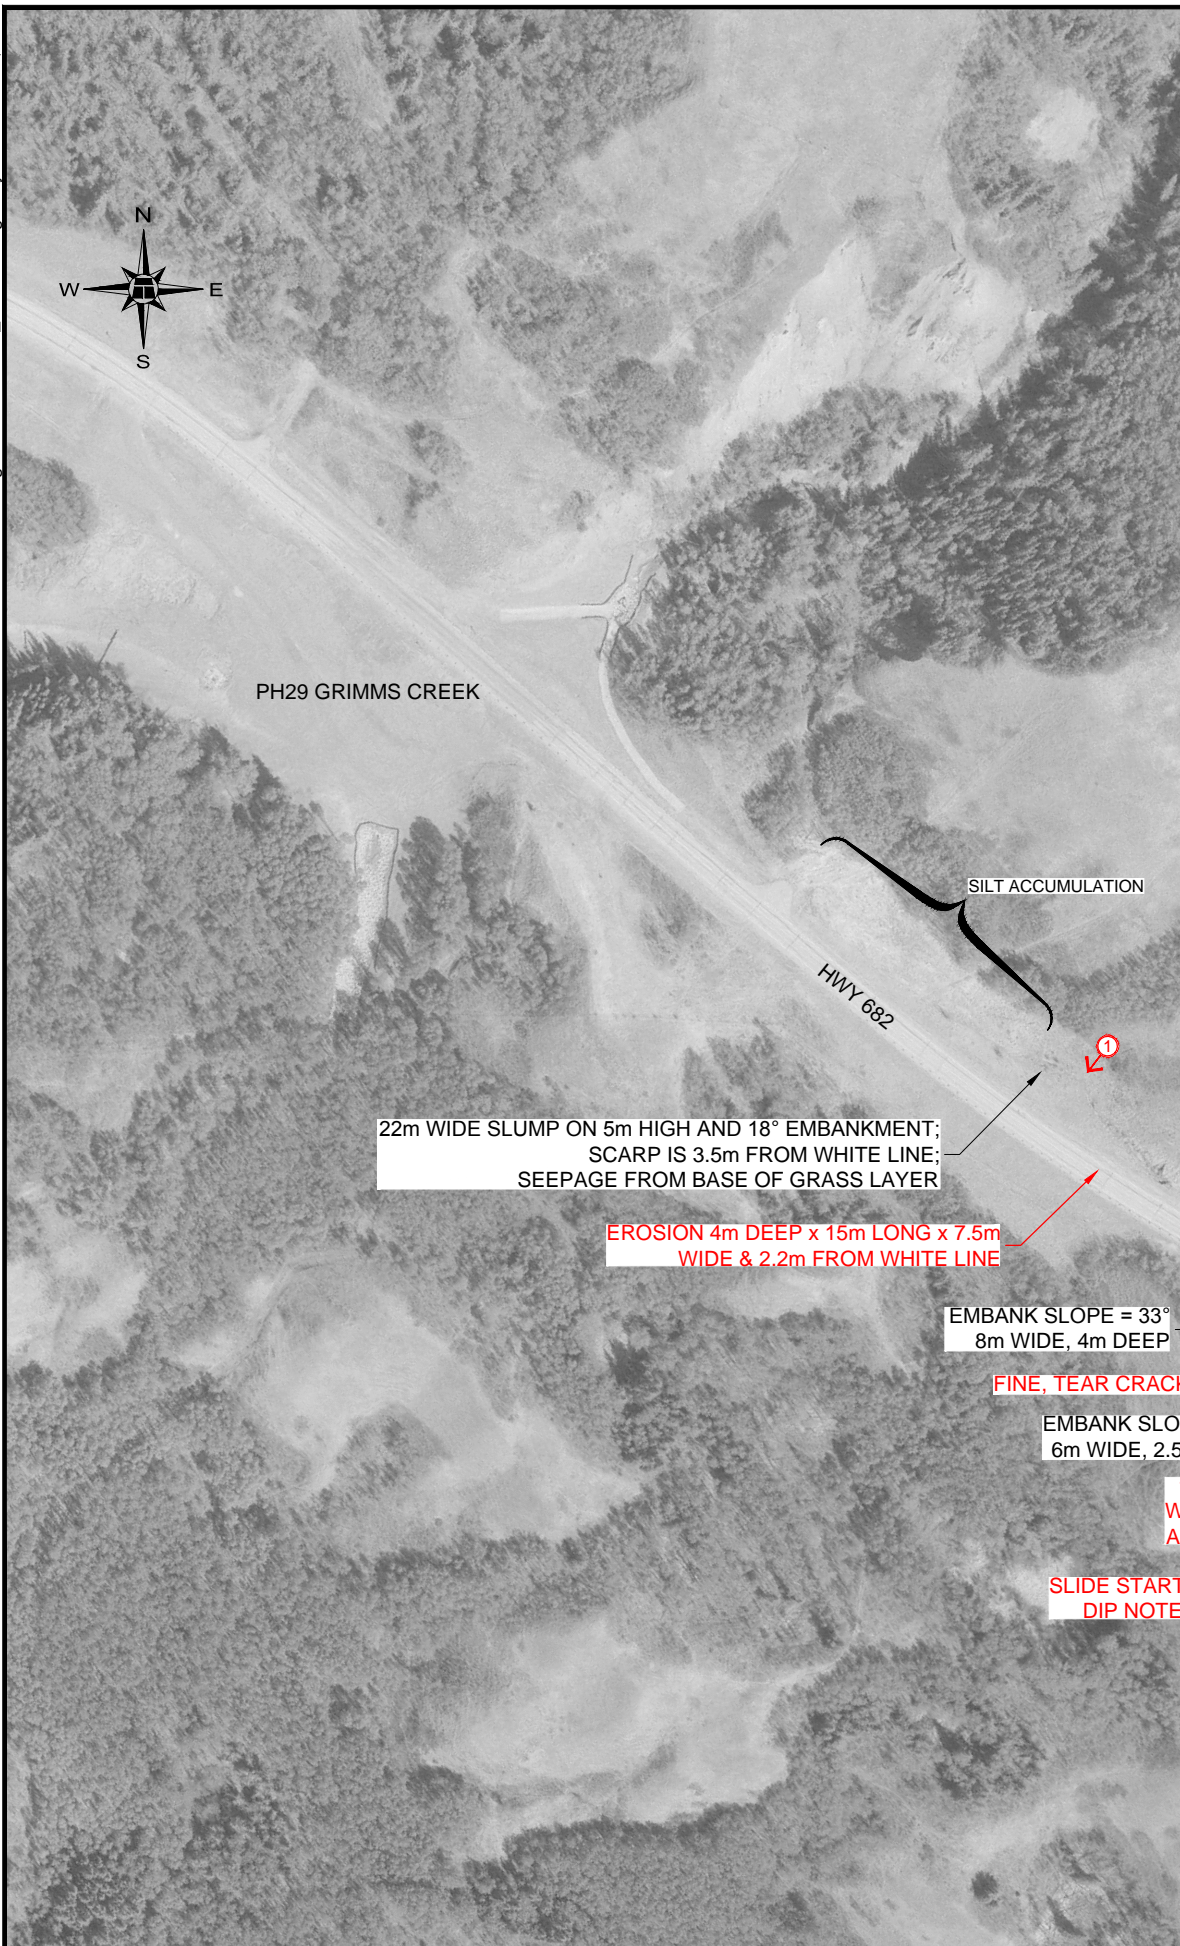
22m WIDE SLUMP ON 5m HIGH AND 18° EMBANKMENT;
SCARP IS 3.5m FROM WHITE LINE;
SEEPAGE FROM BASE OF GRASS LAYER

EROSION 4m DEEP x 15m LONG x 7.5m
WIDE & 2.2m FROM WHITE LINE

11m LONG, 100mm
WIDE OPEN CRACK
ALONG WHITE LINE

SLIDE STARTING ON SOUTH SIDE.
DIP NOTED ACROSS HIGHWAY

OVERLAND FLOW EROSION BESIDE CULVERT OUTLET
IN EMBANKMENT (5m WIDE x 4m HIGH)
- PITRUN IN SIDESLOPE & DITCH BOTTOM IS ERODING &
SLUMPING LEAVING THE SIDESLOPE TOO STEEP
OPPOSITE THE CULVERT.
-10 LARGE RIPRAP ADDED BELOW CULVERT OUTLET

FRESH, 2m HIGH BACKSLOPE
SCARP ALONG BUSH LINE,
DUE TO DITCH EROSION

EROSION SCARP IN
SIDESLOPE 0.7m FROM
WHITE LINE

20m LONG, ACP PATCH (ON
NORTH HALF OF WESTBOUND
LANE) HAS DROPPED 50mm, AND
IS SETTLING / SHIFTING TOWARDS
DITCH (CRACKS IN PATCH)

EROSION ENCROACHING
WITHIN 0.8m OF WHITE LINE

6m EROSION GULLY
IN DITCH - HITS NEW
RIPRAP & GETS
DEFLECTED INTO
SIDESLOPE &
ERODES IT

5m LONG CRACK 0.8m
OUTSIDE WHITE LINE
