**ALBERTA TRANSPORTATION
GEOHAZARD ASSESSMENT PROGRAM
PEACE REGION (GRANDE PRAIRIE DISTRICT– NORTH)
2023 INSPECTION**

| Site Number | Location | Name | Hwy | km |
|---|---|---|---|---|
| PH067 | West of Fairview | East Hill Ditch Erosion Section | 682:02 | 13.8-14.1 |

| Primary Site Issue: | Highway North Ditch Erosion – from top of East Hill to Grimm's Creek. | |

PH067-1: HWY 682:02 - HINES CREEK
2023 INSPECTION PLAN

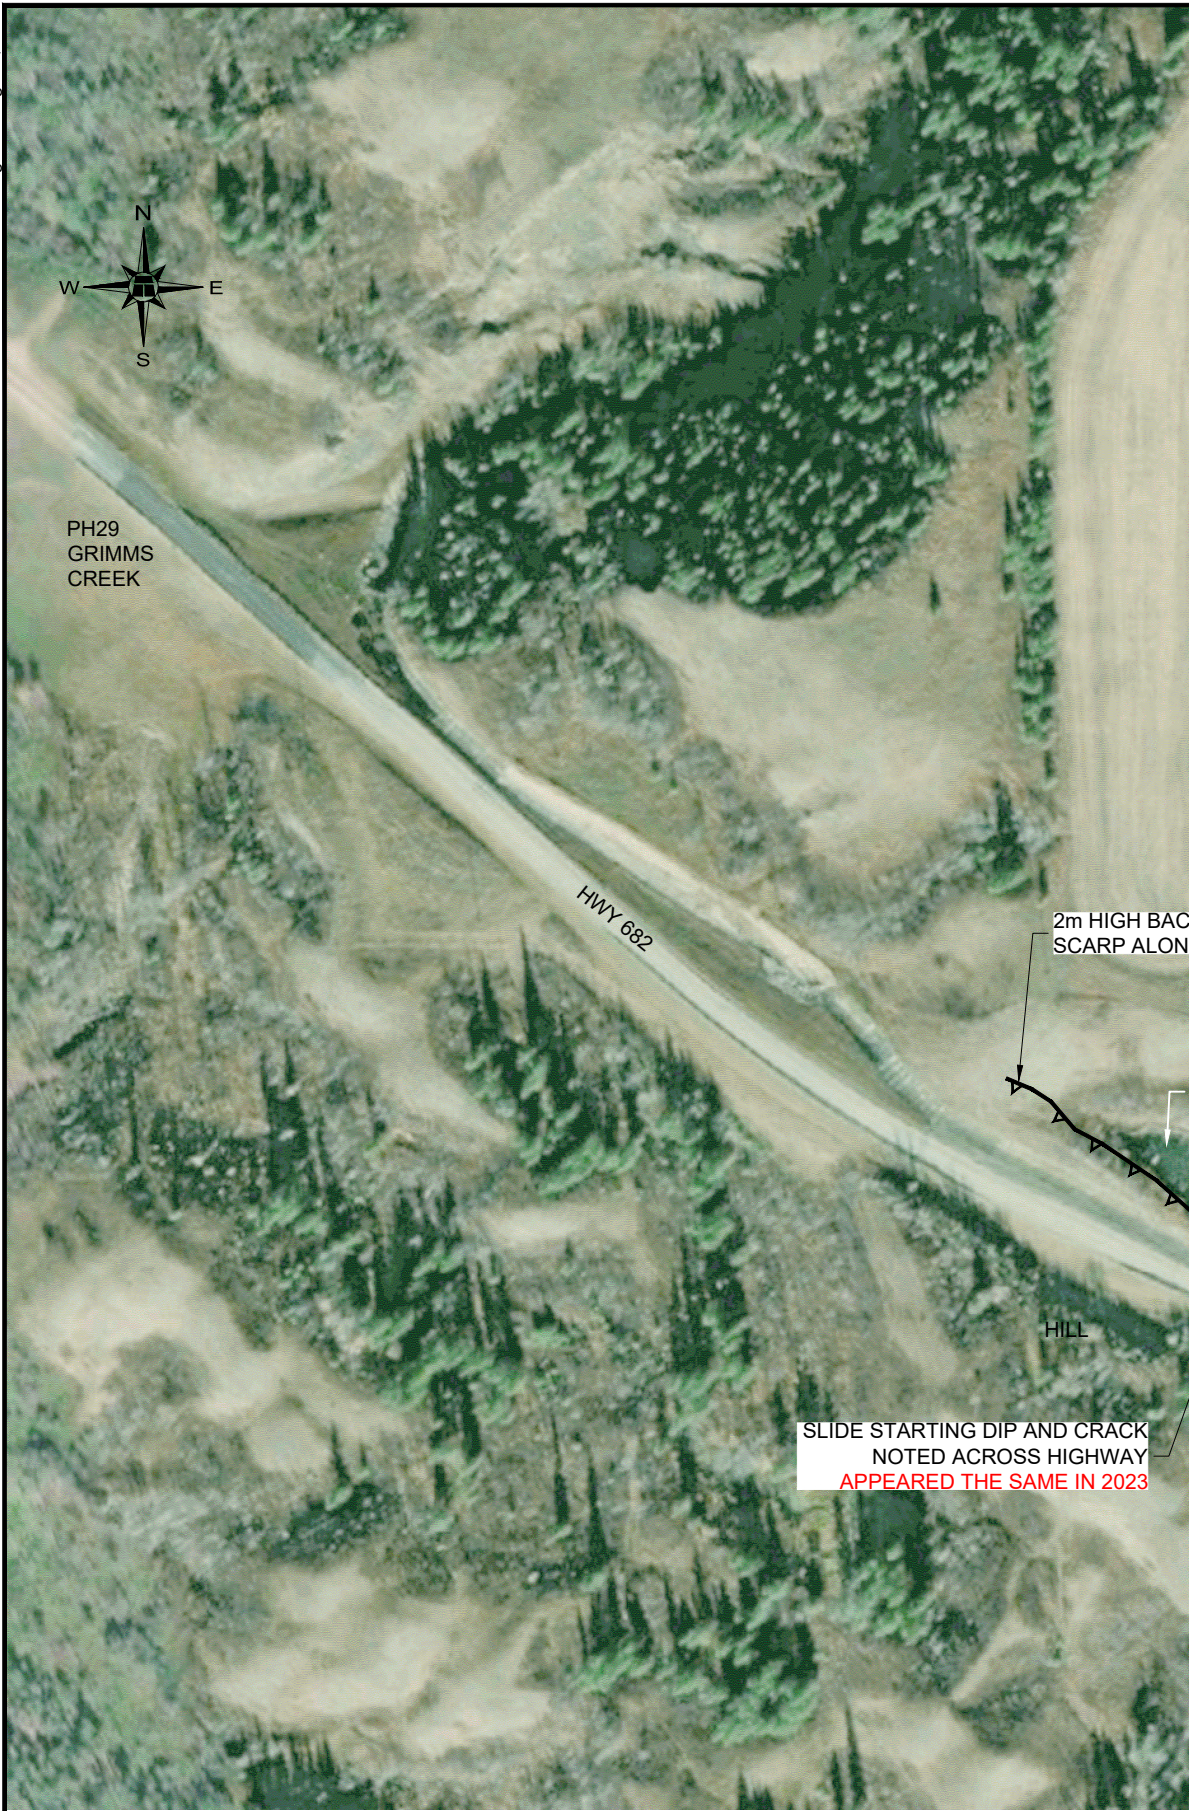
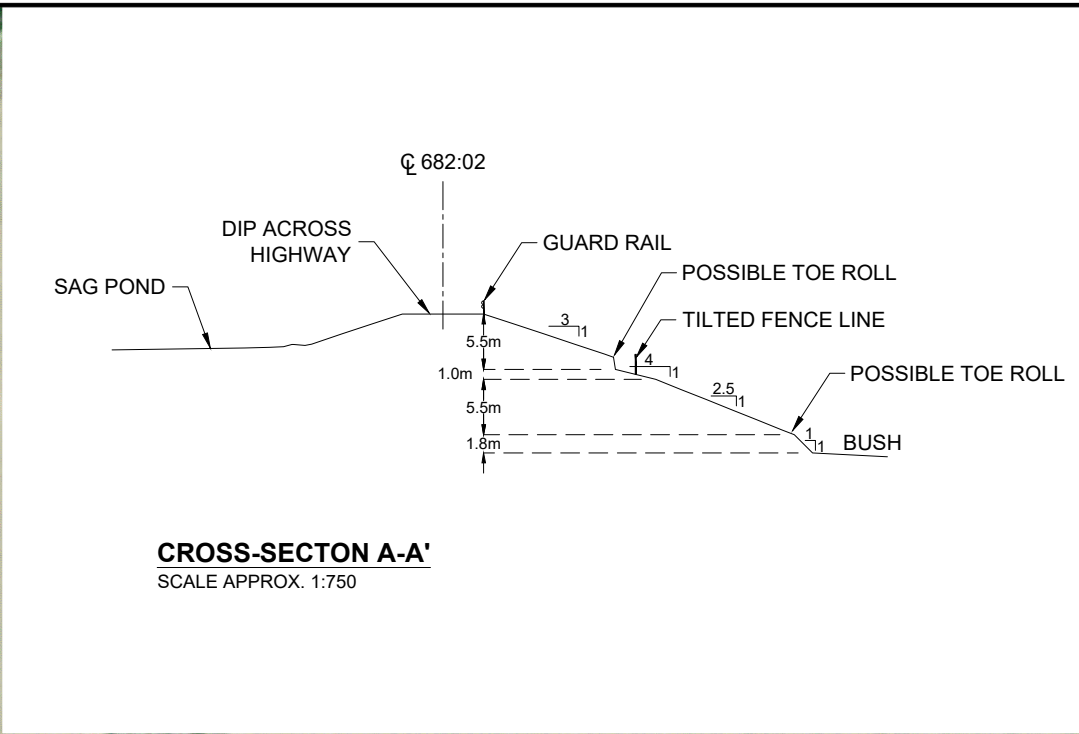
| <input checked="" type="checkbox"/> Slope Movement | A dip and crack across the highway adjacent to the sag pond (first observed in 2014) had no noticeable change. Some north hwy. embankment slumping caused by the adjacent north ditch erosion was worse in 2023. There was more slumping on the north slope near where the ACB blocks began caving in. | <input checked="" type="checkbox"/> |

SLIDE STARTING DIP AND CRACK NOTED ACROSS HIGHWAY APPEARED THE SAME IN 2023

Continue monitoring the slide that appears to be developing across the highway near the sag pond.

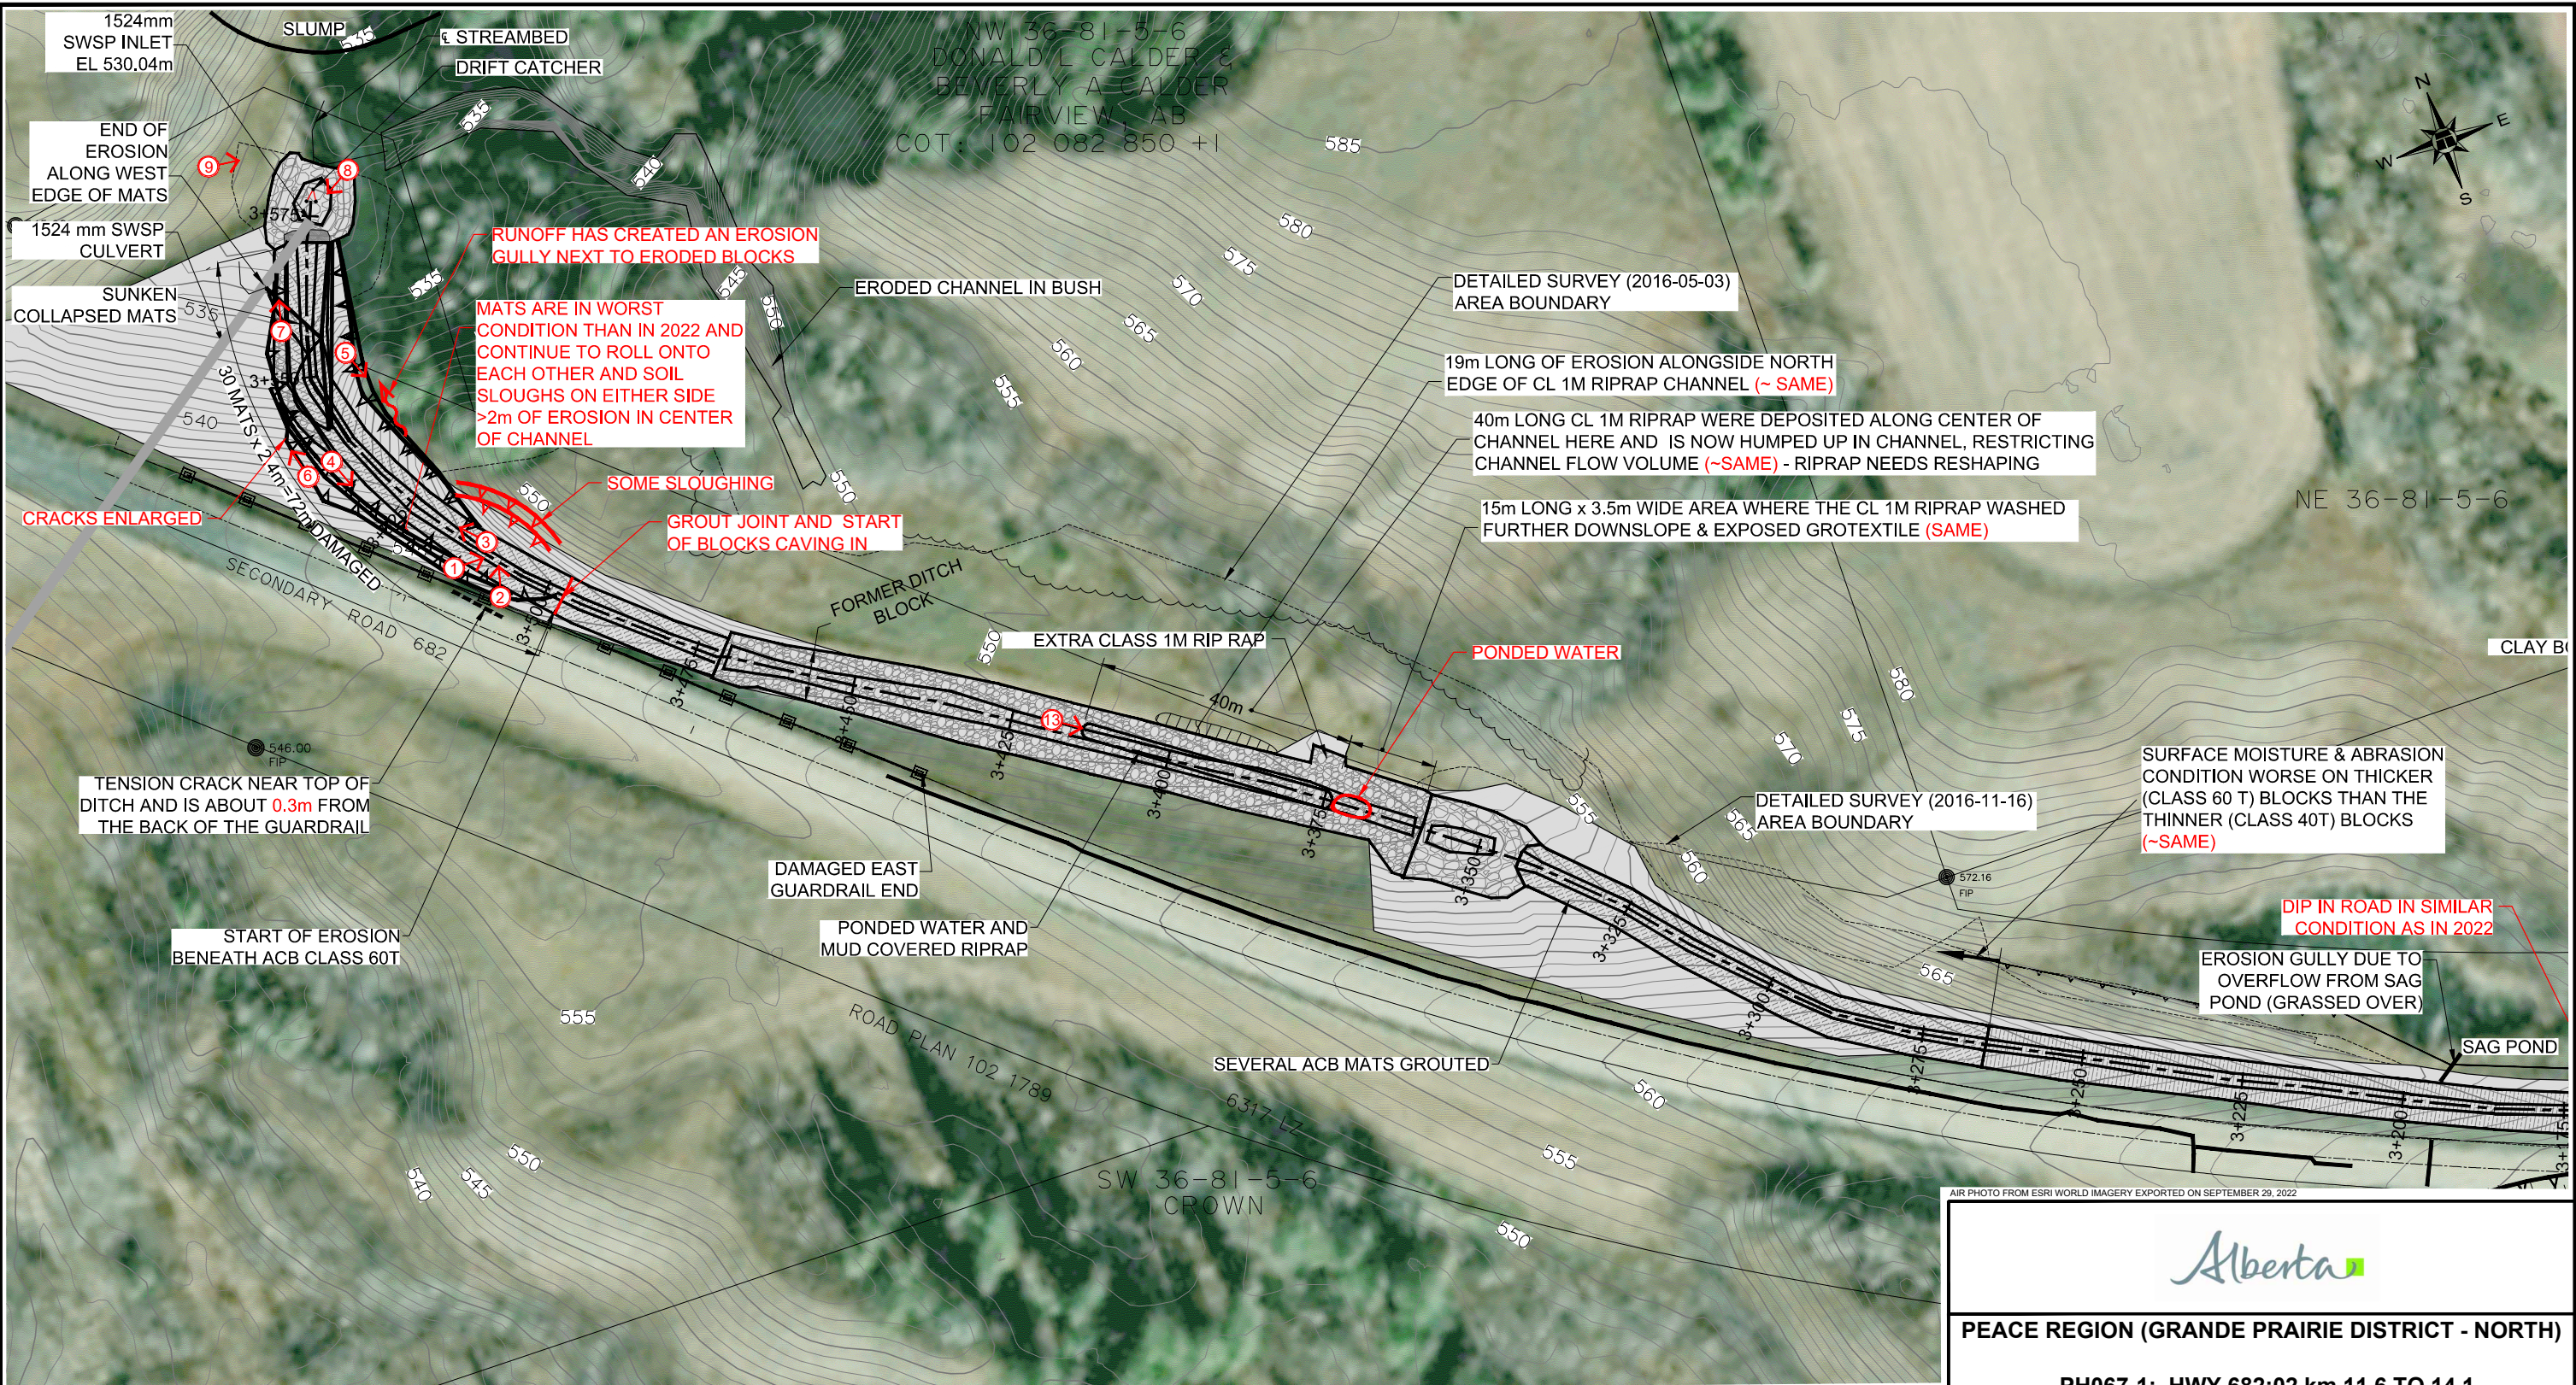
PEACE REGION (GRANDE PRAIRIE DISTRICT - NORTH)
PH067-1: HWY 682:02 km 11.6 TO 14.1
DITCH EROSION REPAIRS
SITE 3
DWG No. 32123-PH067-1-2

| <input checked="" type="checkbox"/> Erosion | There were a few areas showing erosion activity at intermittent locations along the north ditch. The most severe was near the west end at the steep gradient leading to Grimm's Creek where a 75 m length of the ACB mat is now undermined and new erosion gullies and tension cracks have formed. The ditch erosion ~100 m long upslope of the ACB mats installed in 2017 at the top of the east hill has also gotten slightly worse. There is erosion in the north ditch east of where the ACB blocks begin that has significantly worsened and is up to 3.6 m wide and 1 m deep and 2.1 m away from the white pavement line on the highway. | <input checked="" type="checkbox"/> |

1. FEATURE LOCATIONS ARE APPROXIMATE
2. PREVIOUS OBSERVATIONS SHOWN IN BLACK
3. **MAY 30, 2023 FEATURES SHOWN IN RED**
4. ADVANCED ABRASION & SPALLING OF ACB MAT BLOCKS AND MANY BROKEN BLOCKS ALONG CENTER BASE OF CHANNEL; SOME MATS WORSE THAN OTHERS.
5. HIGHWAY SAND / SALT STAINING ALONG BASE & HIGHWAY SIDE OF ACB MATS IN CHANNEL.

- 1) Sta 3+500 to Grimms Creek: Completely remove the damaged ACB block mats then fill/compact the eroded bottom with clay then repair with a stepped structure consisting of sheet piles and class 3 or grouted Class 2 riprap.
- 2) Extending the length of the CI 2 riprap dissipation bowl by at least 15 m (Sta 3+360 to 3+375), where flow scoured the existing CI 1M riprap and exposed the underlying non-woven geotextile and deepening the channel to accommodate the larger riprap. Then re-arranging the moved CI 1M riprap over the 40 m length of channel downstream of this.
- 3) Repairing the short erosion gully that outlets from the sag pond onto the ACB mats (Sta 3+195) and installing a CI 1 riprap channel with a compacted clay cut-off leading onto the top of the mats.

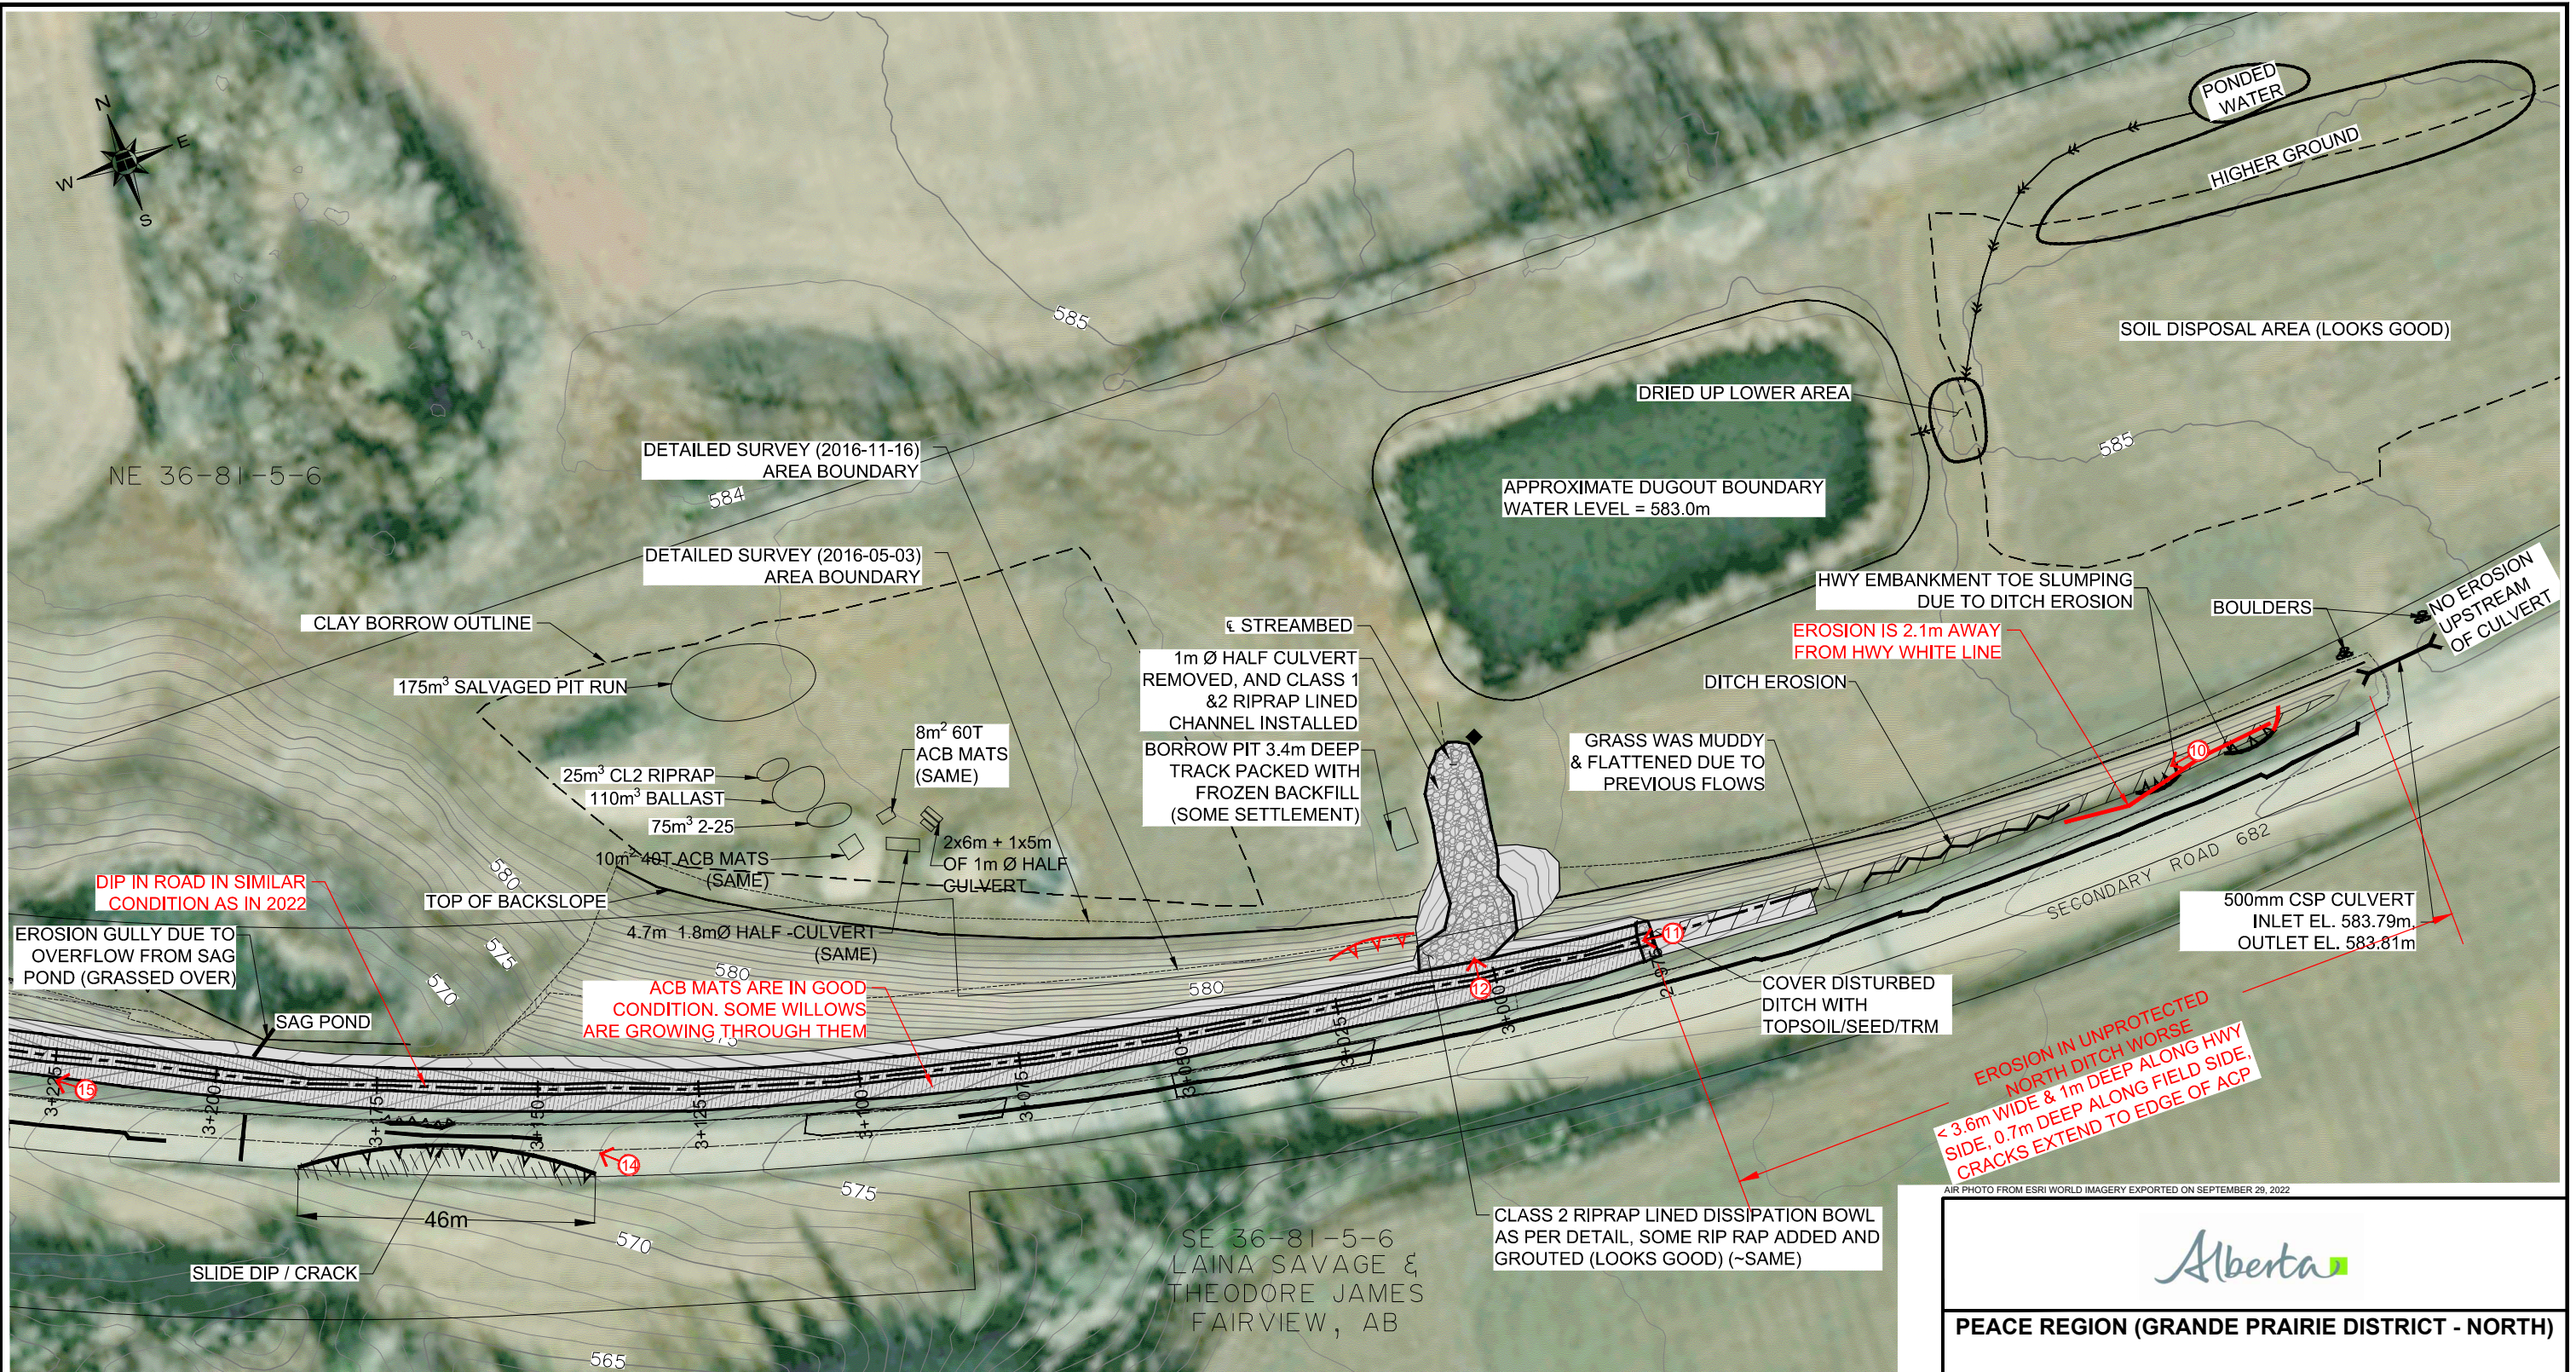
PH067-2: HWY 682:02 km 11.6 TO 14.1
DITCH EROSION REPAIRS
SITE 3

The newly eroded 120 m section of north ditch at the east end of the site that extends from the beginning of the 40T ACB mats at Sta 2+975 to the 500 mm dia. approach ditch culvert further east will eventually need to be repaired, using either Class 2 riprap, or gabion mattress.

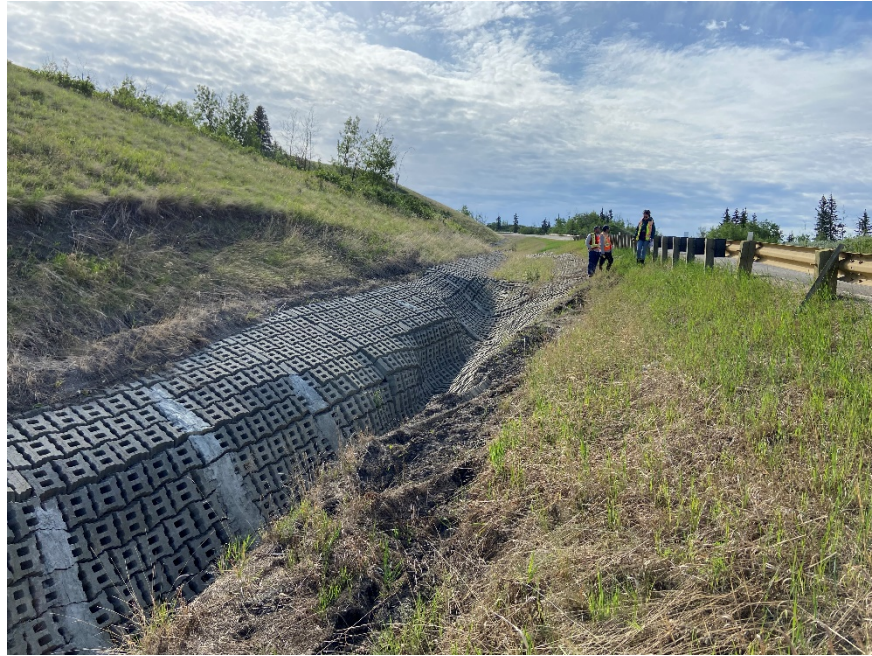
Photo 1. Looking east along the beginning of the eroded ACB mat area north of the highway. Photo credit: Nicole Wilder.

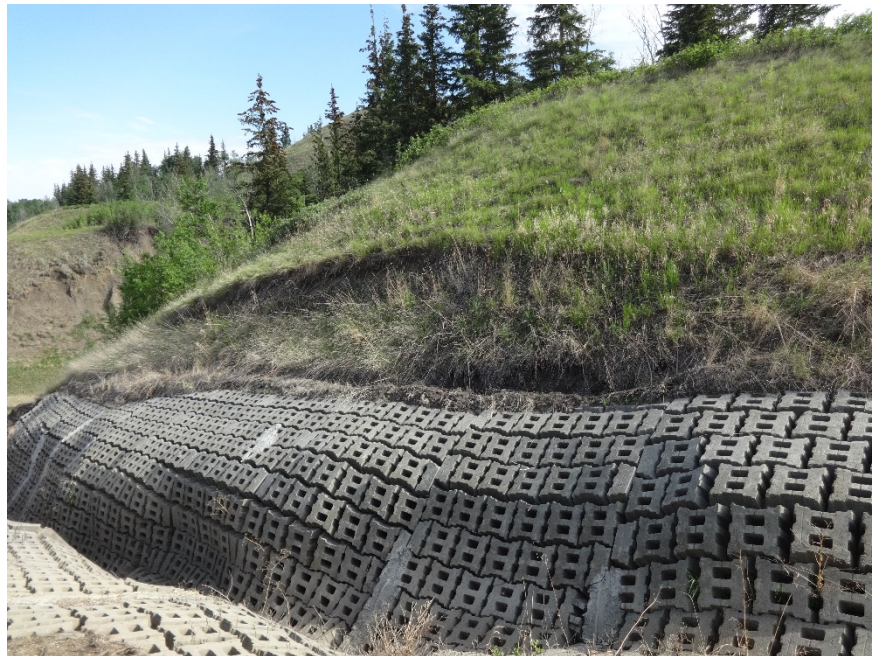
Photo 2. Looking north along the edge of the eroded ACB mat area. Note the recent scarp extension along the north edge of the mats. Photo credit: Nicole Wilder.

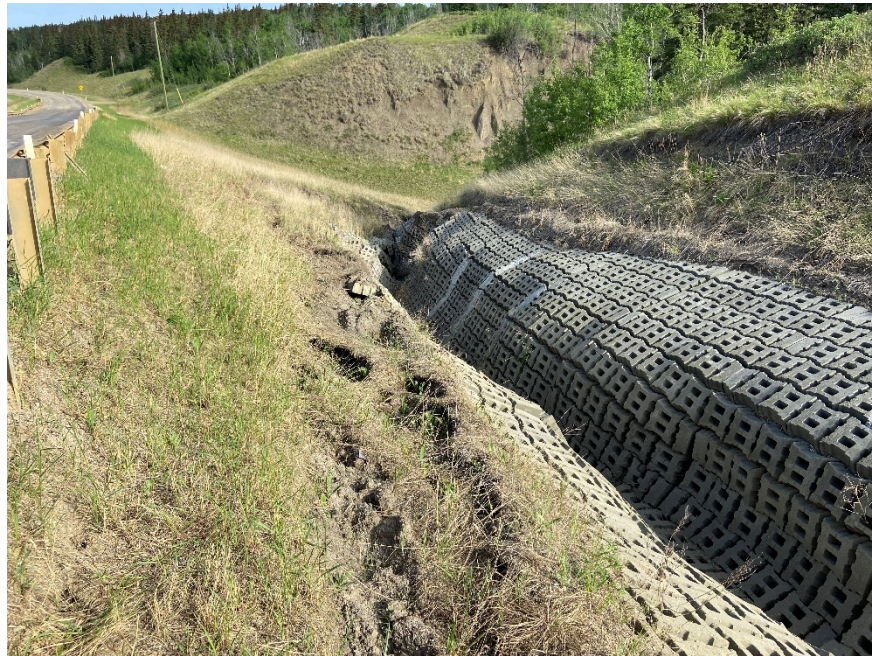
**Photo 3. Looking northwest along the severely damaged ACB mat area and enlarged slide scarp area.
Photo credit: Don Proudfoot.**

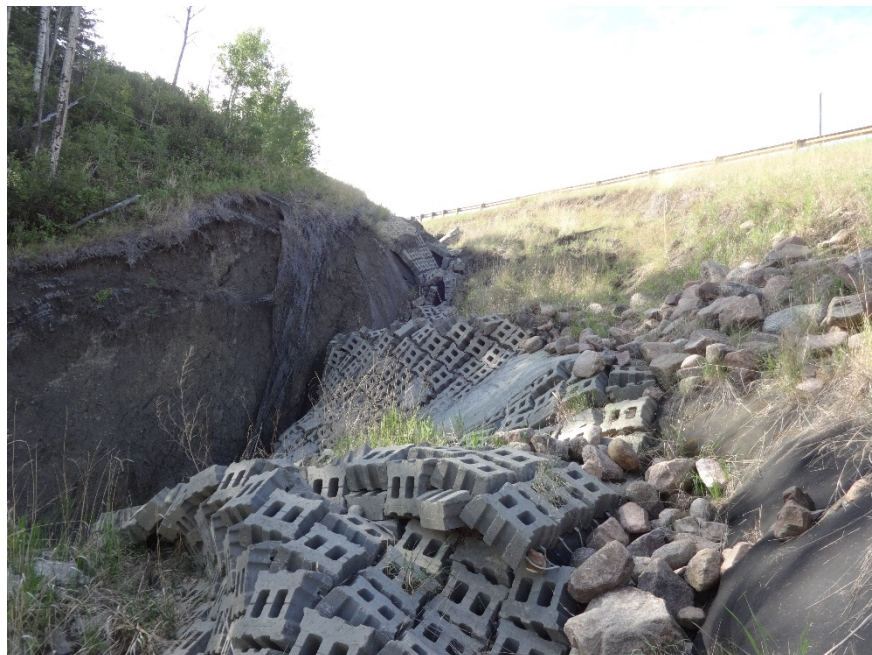
Photo 4. Looking southeast at the severe erosion through the ACB mats. Note the enlarged erosion and slide developing south of the mats. Photo credit: Nicole Wilder.

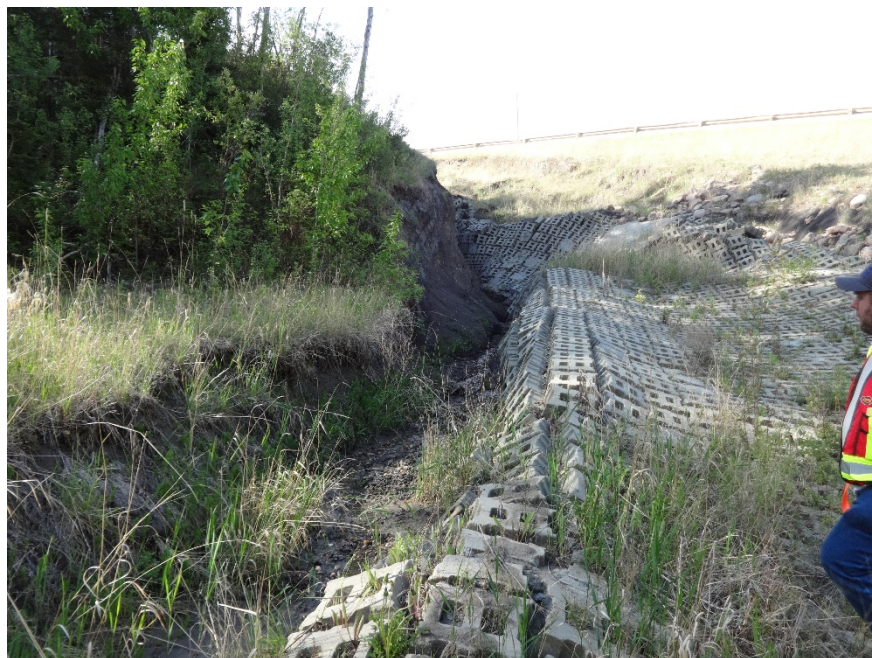
Photo 5. Looking southeast along the north edge of the eroded ACB mats. Here the mats have slid down into the deeply eroded channel, exposing the underlying gravel. Photo Credit: Nicole Wilder.

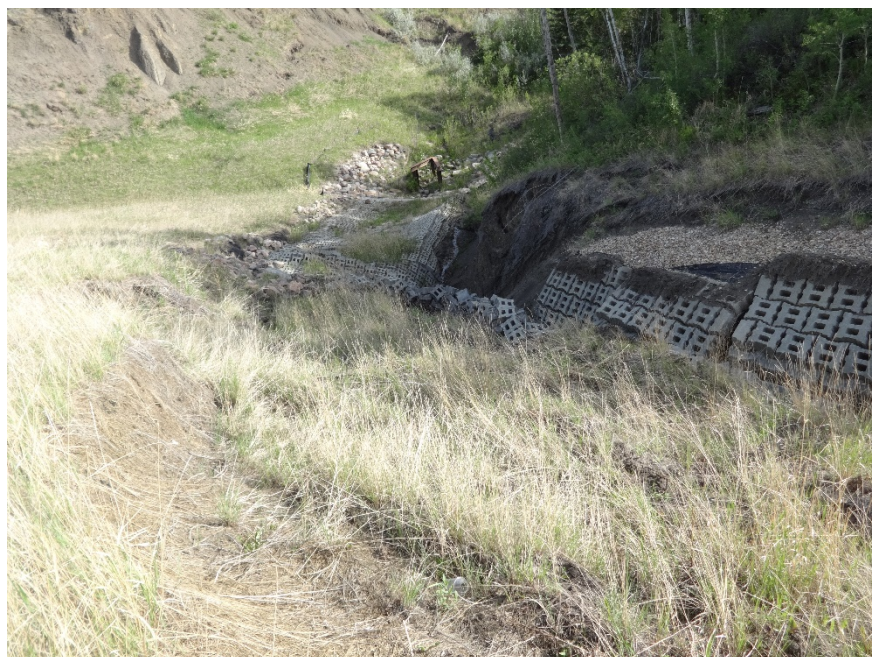
Photo 6. Looking north along the southwest side of the damaged and eroded ACB mats. Photo Credit: Nicole Wilder.

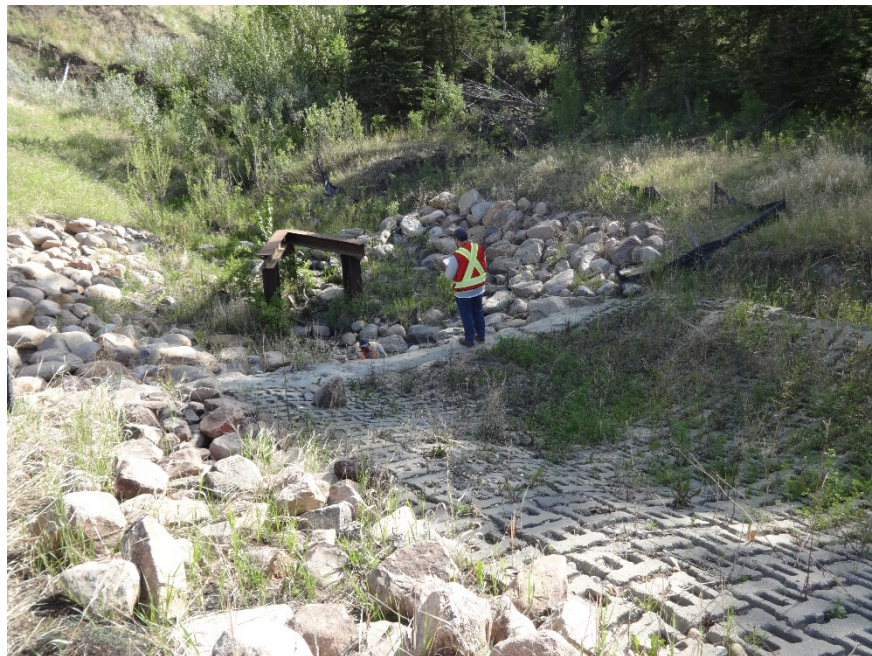
Photo 7. Looking northwest across the eroded mat area near the bottom of the slope. Photo Credit: Don Proudfoot.

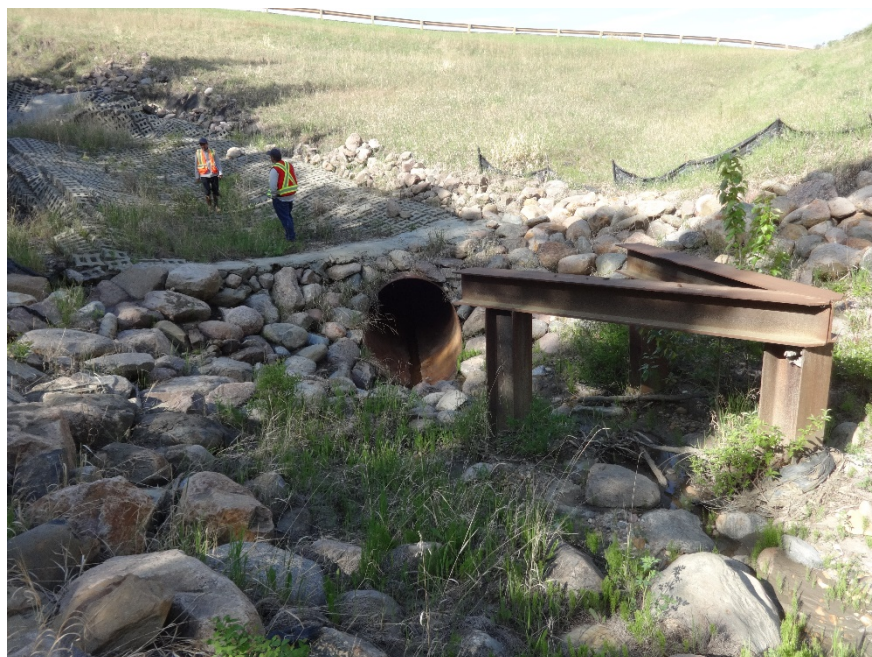
Photo 8. Looking southwest at the culvert inlet, trash rack and eroded ACB mat area leading to it. Photo Credit: Nicole Wilder.

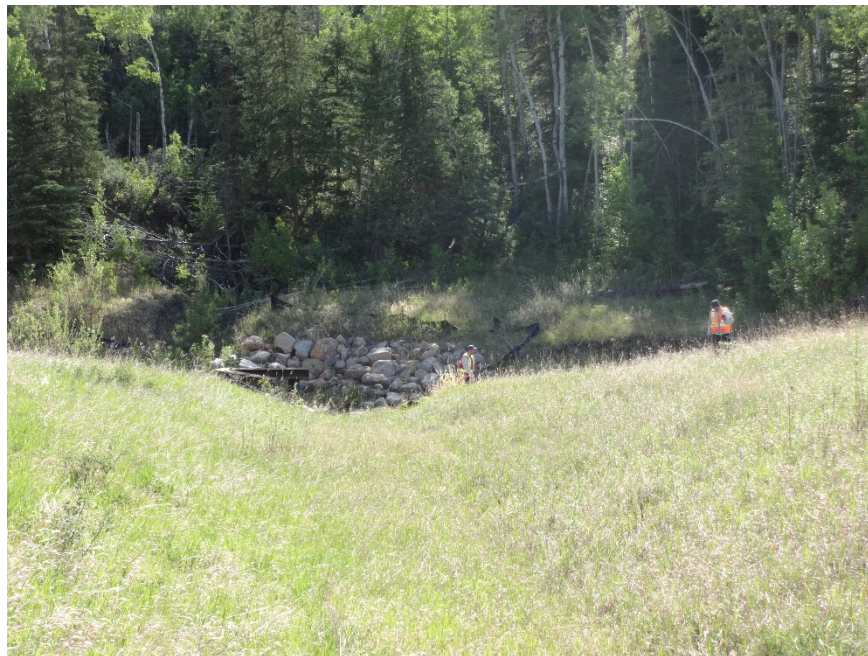
Photo 9. Looking north at the slumping and infill occurring into the channel upstream of the 1524 SWSP culvert entrance. Photo Credit: Nicole Wilder.

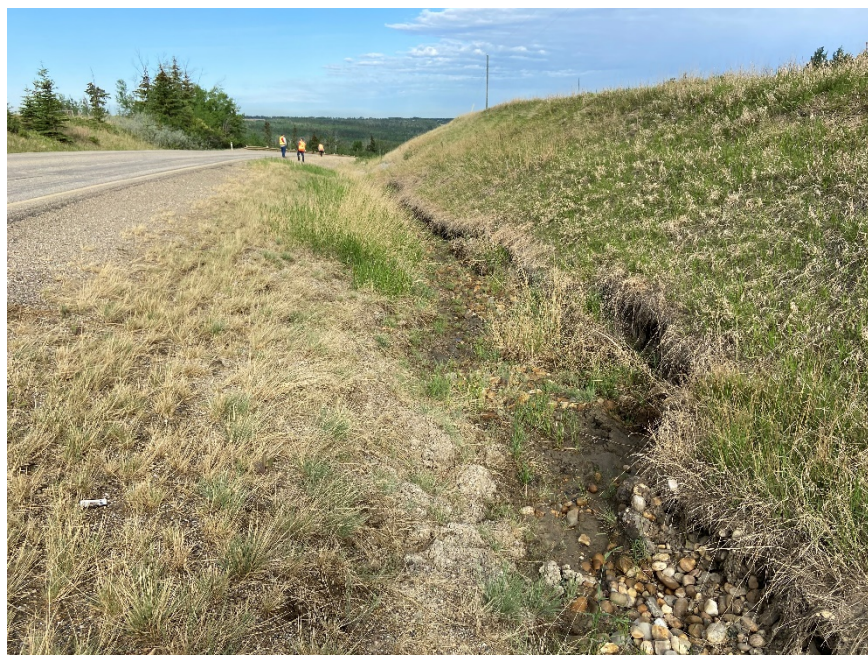
Photo 10. Looking northwest from the EBL of Hwy 49:06 at the east end of the site. Photo Credit: Nicole Wilder.

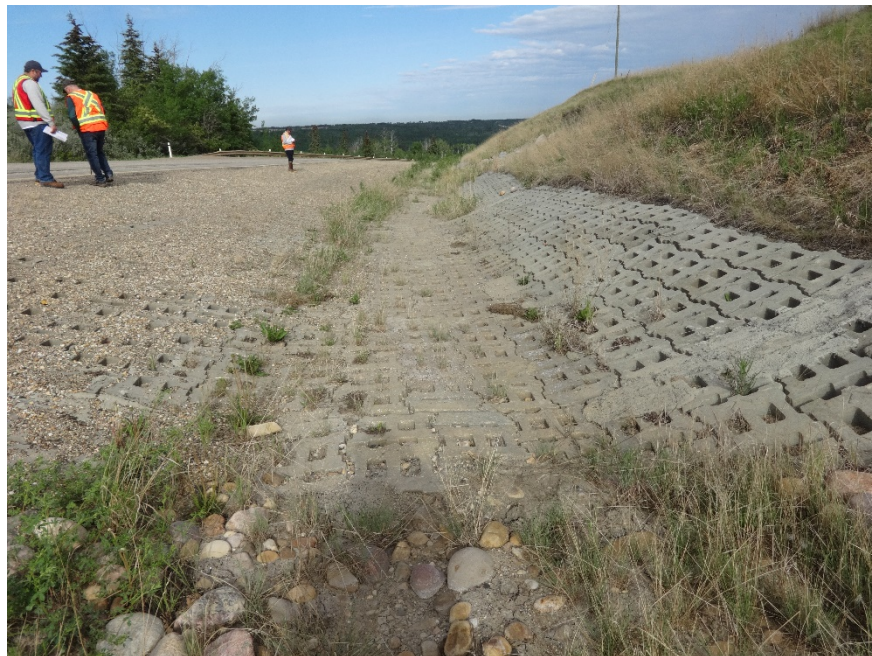
Photo 11. Looking west at blocks and where grass had previously been flattened by mud. Photo Credit: Nicole Wilder.

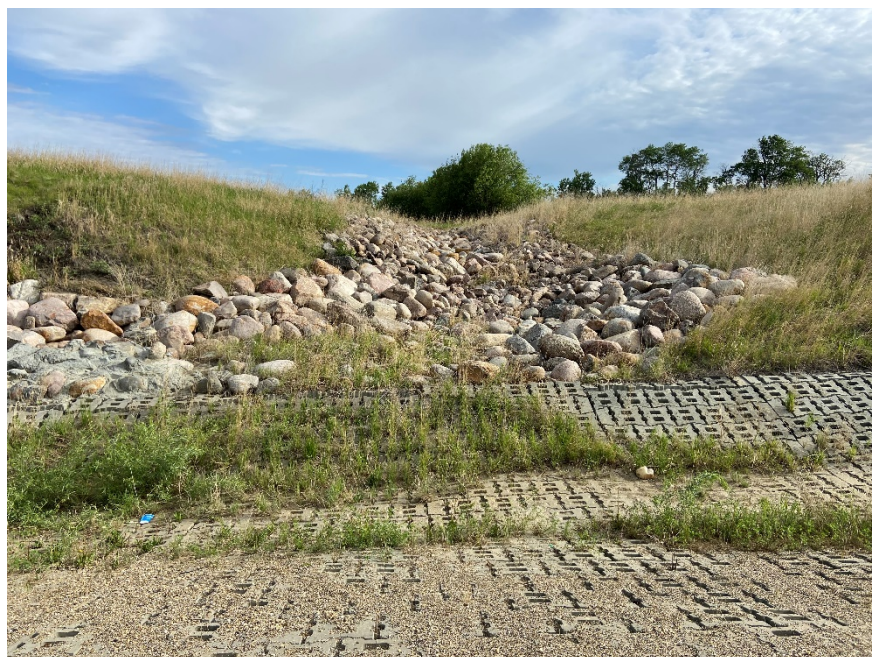
Photo 12. Looking north at where riprap was previously placed, appears to be in good condition. Photo Credit: Don Proudfoot.

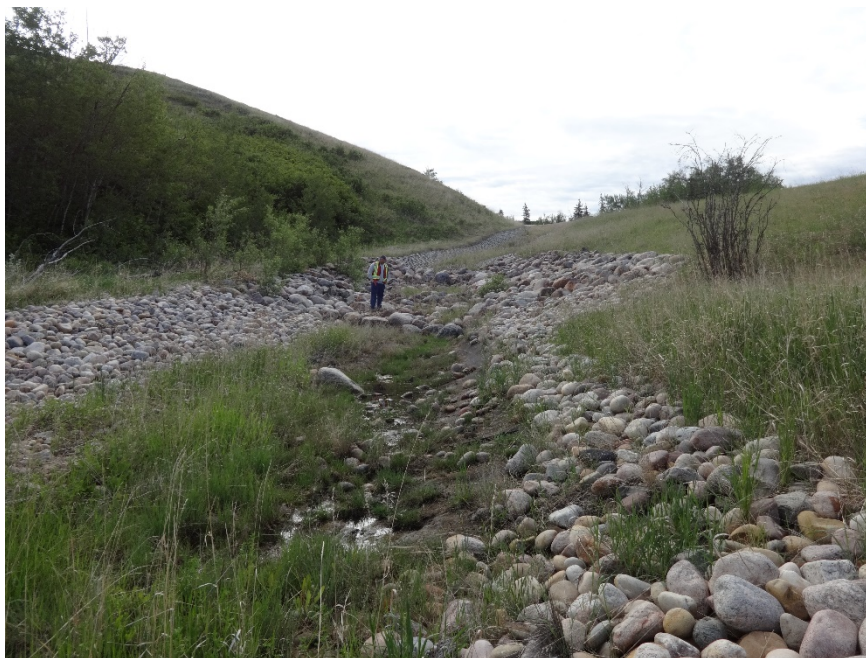
Photo 13. Looking east at area within riprap that now has mud covering some of the riprap likely from high runoff flow events and ponding afterwards. Photo Credit: Nicole Wilder.

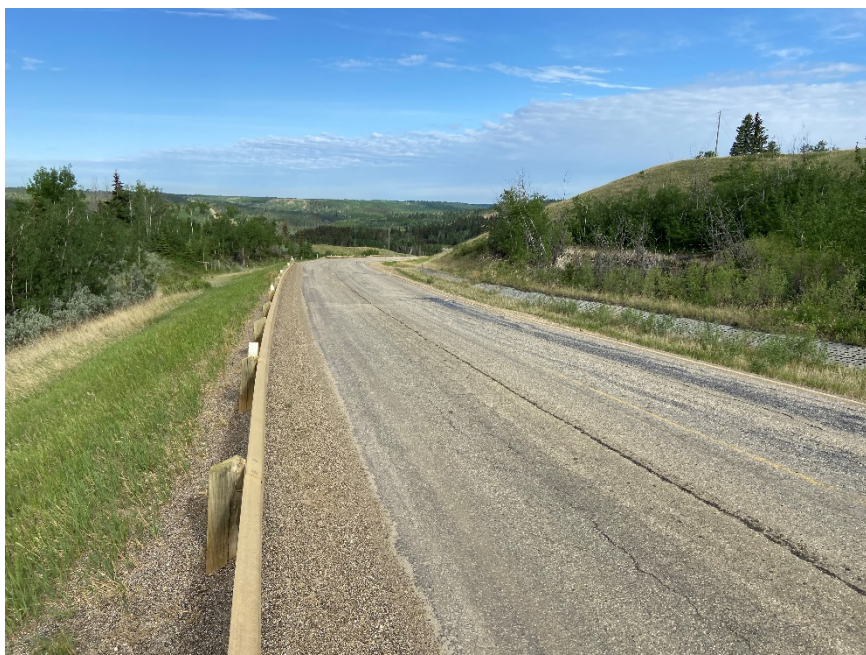
Photo 14. Looking northwest at cracks in asphalt and dip in highway. Photo Credit: Nicole Wilder.

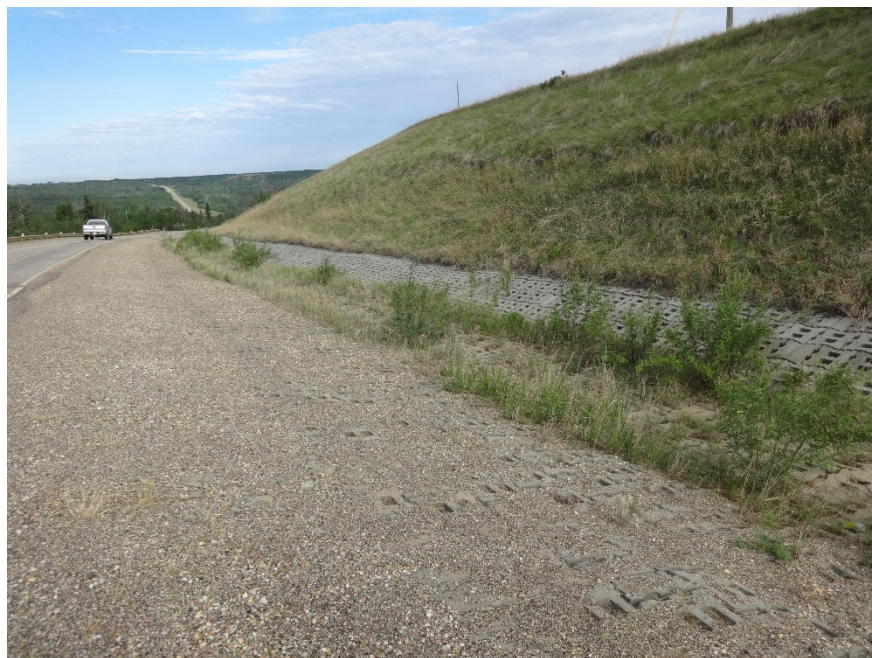
| <input checked="" type="checkbox"/> Other | Some willows were observed growing through the ACB mats where they were in good condition. | <input checked="" type="checkbox"/> |

Photo 15. Looking northwest at the ACB Matting performing well but had some willows growing out of them. Photo Credit: Nicole Wilder.

Spray the willows that are growing in the lined channel with broadleaf pesticide to eliminate the trees from growing larger as their presence, if left unchecked, could impede drainage and cause high flows to erode outside the lined channel

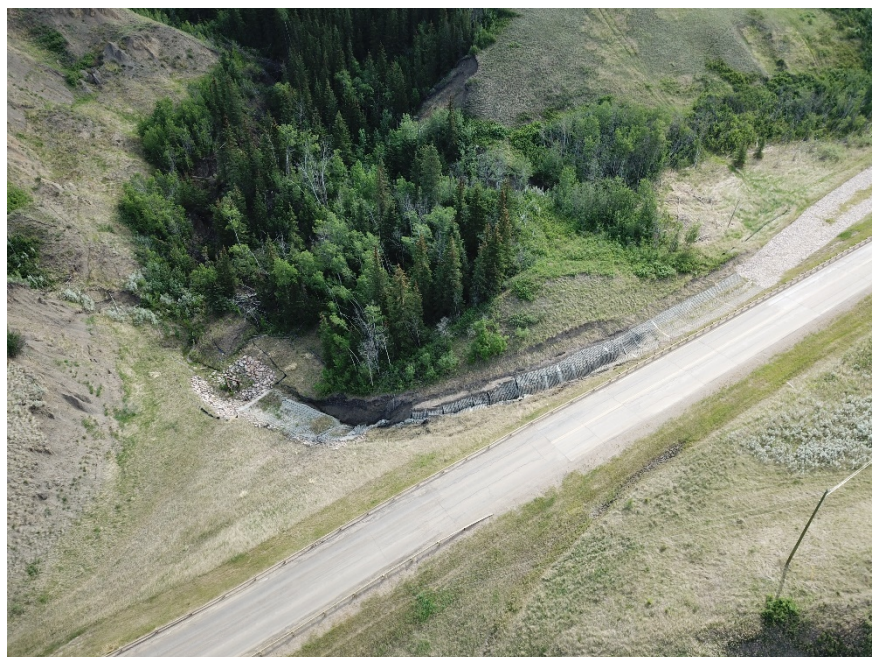
Photo 16. Looking northeast down at eroded ACB blocks and channel along them. Photo Credit: Drone-Nicole Wilder.
